**Region 6 - Enforcement & Compliance Assurance Division  
INSPECTION REPORT**

| Inspection Date(s): | 01/14-17/2020 | |
| Company Name: | Evergreen Packaging, Inc. | |
| Facility Name: | Pine Bluff Mill | |

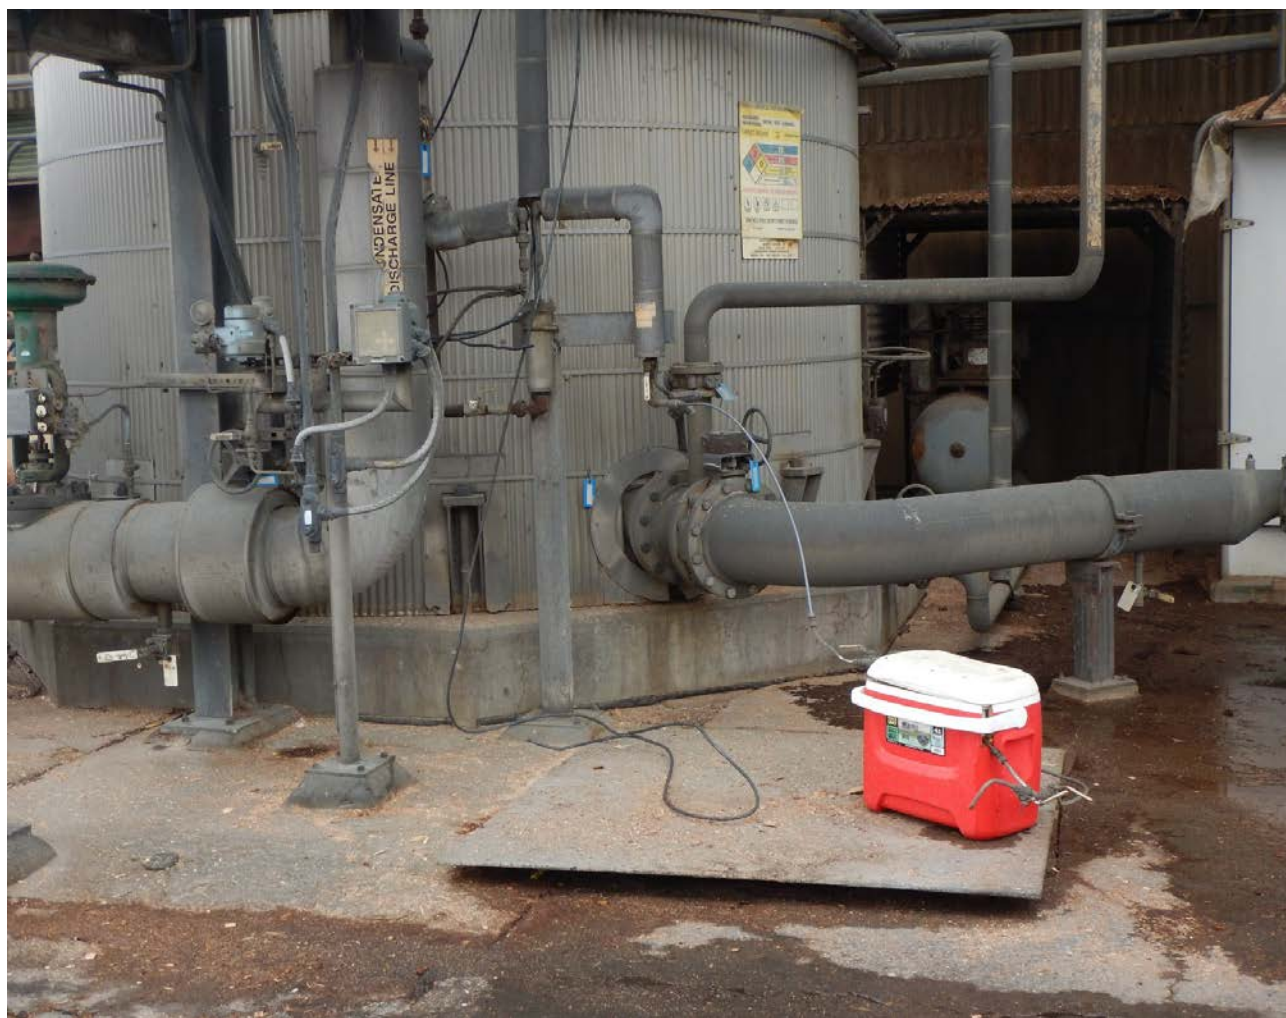
| Description: | Wastewater Treatment System sample point at Main Condensate Tank. | | | | |

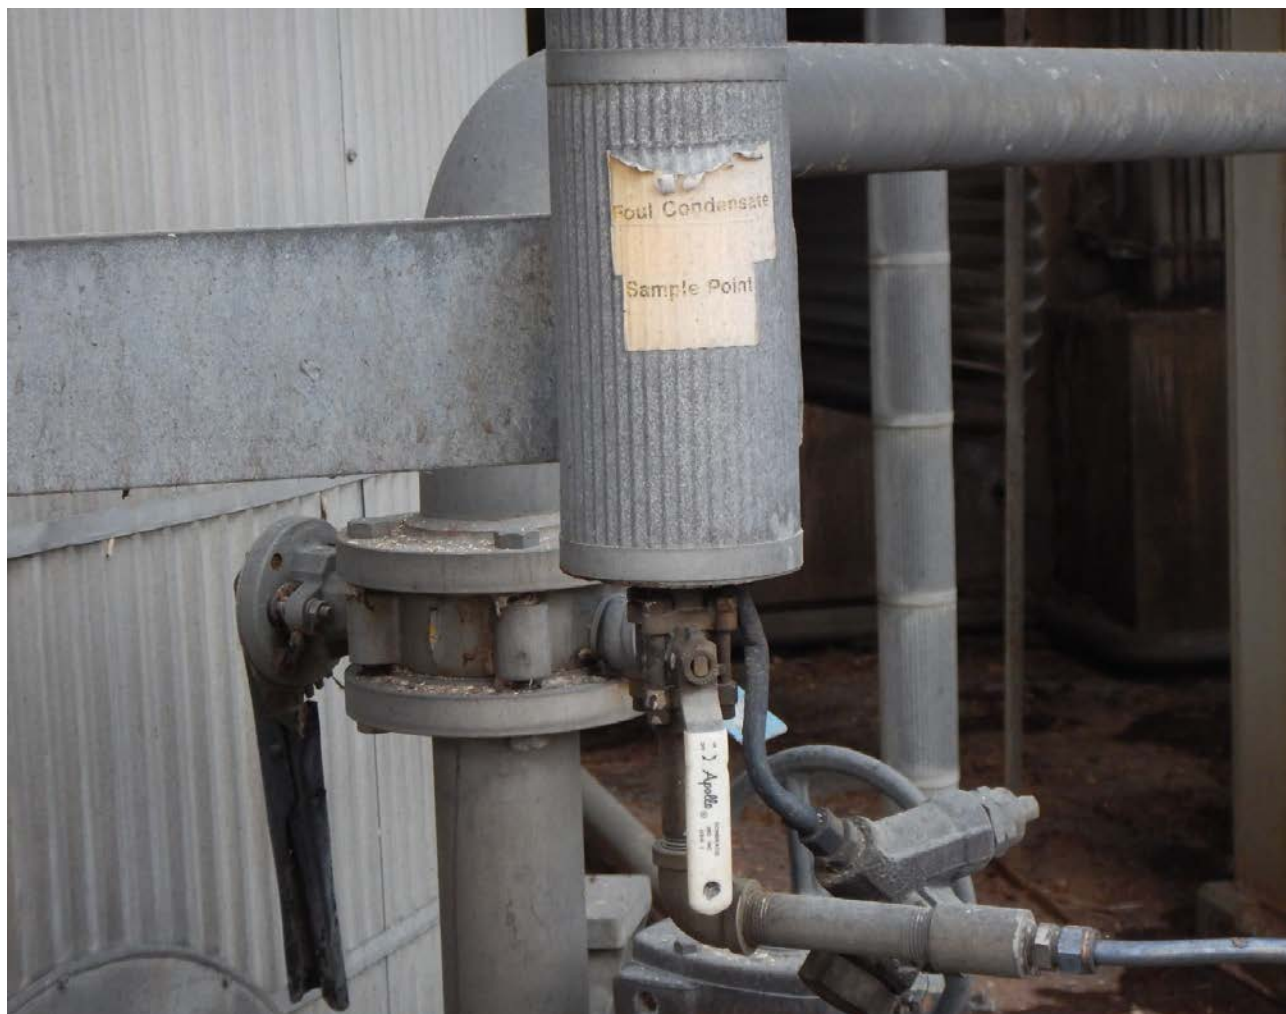
| Description: | Wastewater Treatment System sample point at Main Condensate Tank. | | | | | |

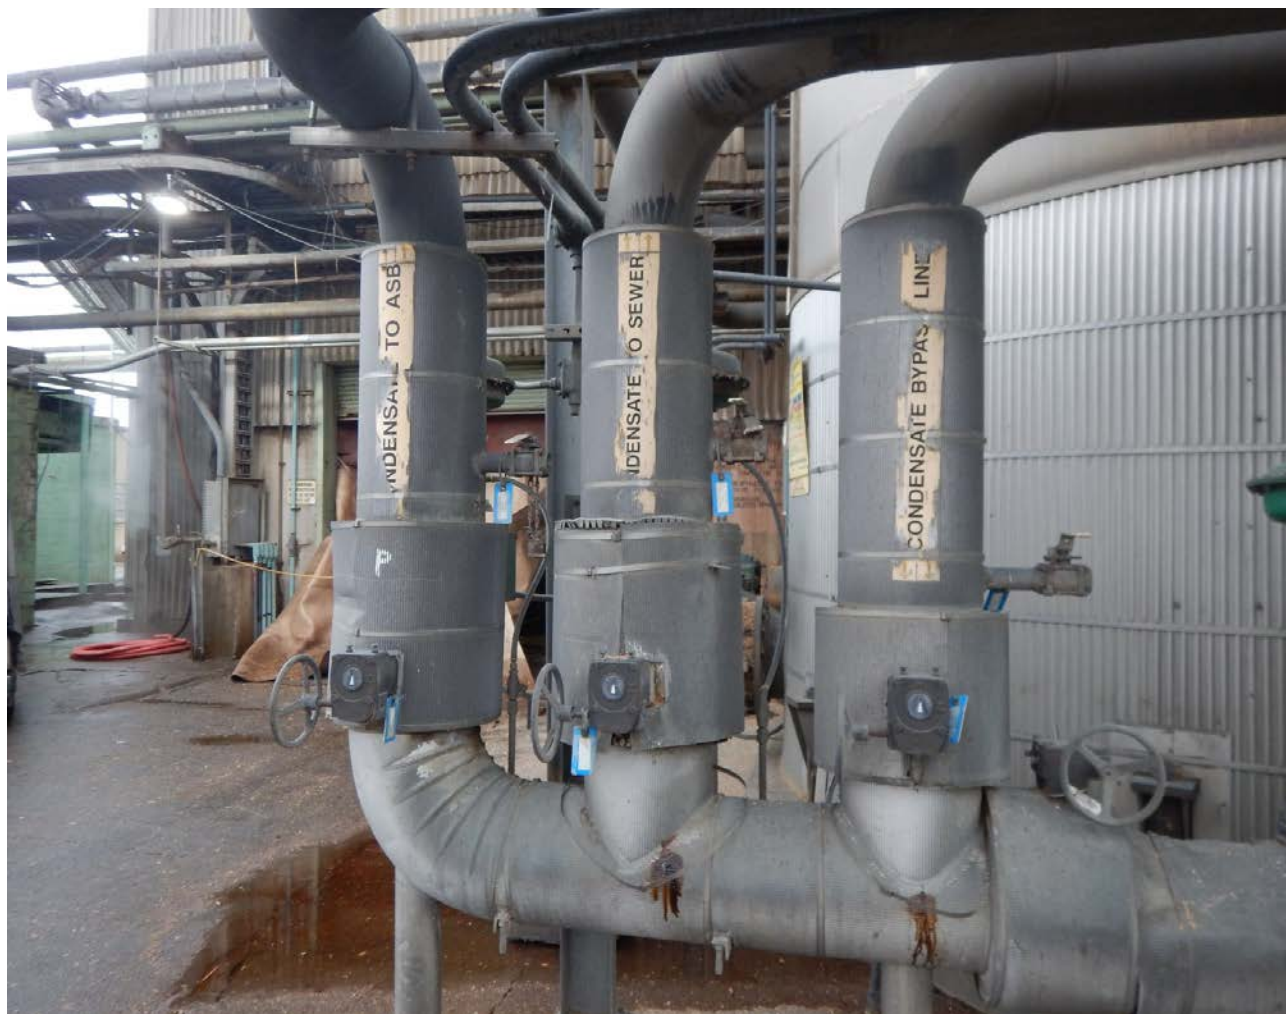
| Description: | Wastewater Treatment System Main Condensate Tank Header. | | | | |

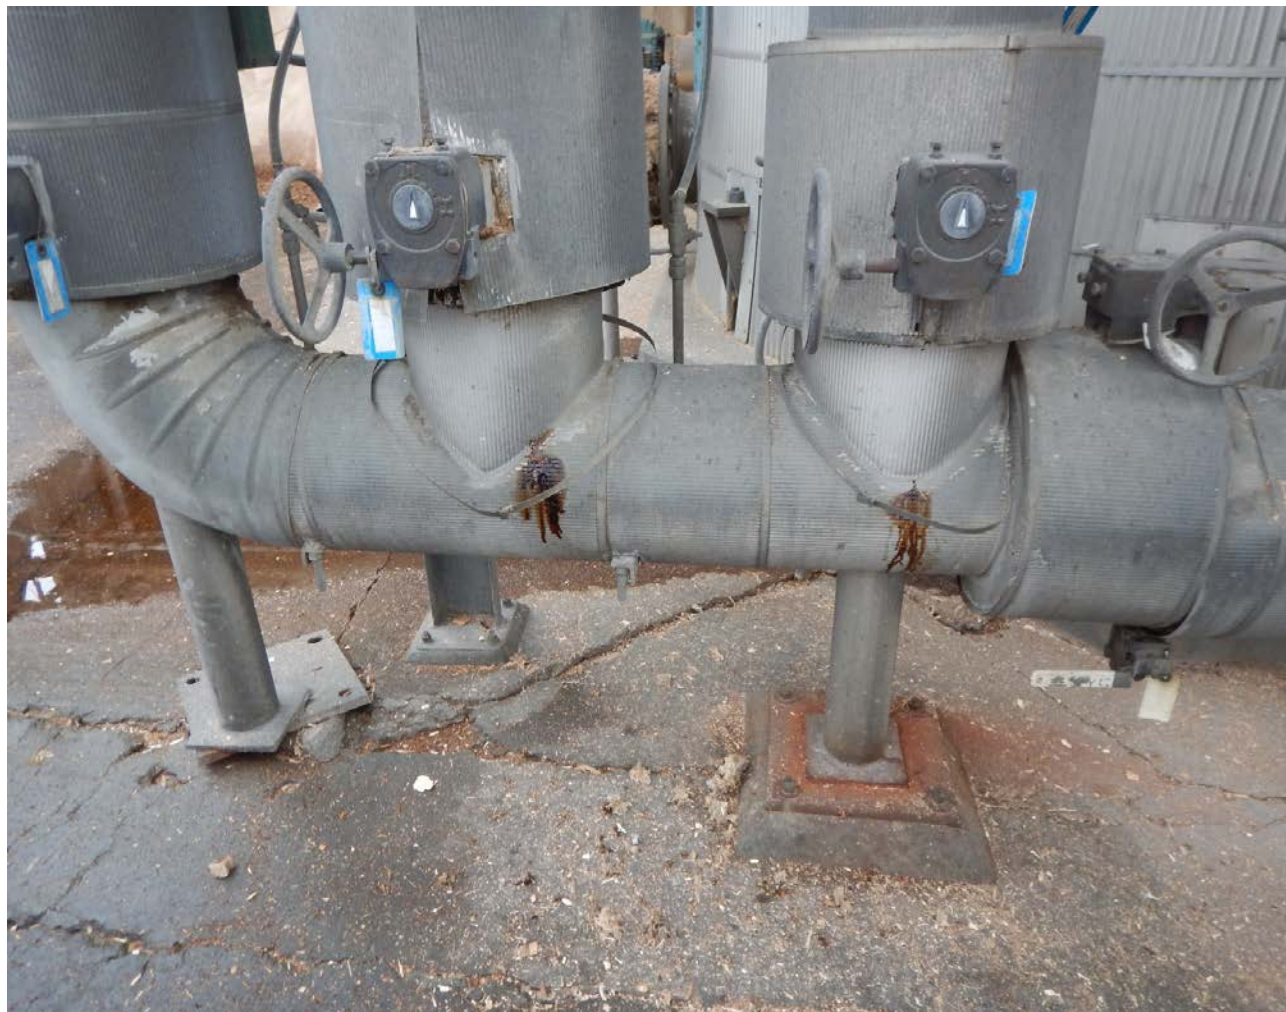
The inspection team began a tour of the facility at 9:30AM. We first stopped at the Main Condensate Tank where we observed small leaks at the condensate header below LDAR components MV-10025 and MV-10023 (Photos 1-5). We then moved to the digester area, where we observed visual emissions from a gas line exiting the Number 1 Digester Capping Valve at the flange while the digester was cooking (Photo 6 and Video 1). We moved to the top floor to inspect the chip chute area, visual emissions were observed at the following digesters: Number 1 while it was actively cooking (Video 2), the Number 2 Digester, the Number 3 Digester while it was capped (Video 3), the Number 5 Digester while capped and cooking, the Number 6 Digester, the Number 7 Digester while cooking, the Number 9 Digester while cooking, the Number 10 digester while cooking, the Number 11 Digester while cooking (Photo 7), the Number 14 Digester while cooking, and the Number 15 Digester. We then walked down one floor to observe the capping valves below the digester chip chutes. We observed the Number 14 Digester CV leaking and observed visual emissions (Photo 8 and Video 4). We then viewed the top of the liquor storage tanks (Photo 9) and the C Blow Tank. We moved to the BHA, where I observed steam and visual emissions from a hole (Photo 10). We returned to the interior of the pulping area to inspect more of the digester CVs. We saw a water leak at the Number 11 Digester CV, and visual emissions at the NCG piping (Video 5). Dr. Frey observed visual emissions from the Number 9 Digester CV and a leak that was possibly condensate from the Number 10 Digester NCG exit line (Photo 12). Mr. Otis Hill said that the Number 10 Digester CV wasn't actively leaking from the NCG piping, but that the facility was waiting for a shutdown to clean off the leaked condensate. We then observed visual emissions from the Number 7 Digester CV, including an existing leak on its NCG piping. We then observed chips loading into the Number 5 Digester and saw an active liquid leak with past liquid staining on the NCG line. Mr. Hill stated that he was not sure how old the leak was and what its source was. I then moved towards the Number 4 Digester CV and my hydrogen sulfide (H<sub>2</sub>S) monitor alarm went off at 5 parts per million (ppm). I also observed visual emissions coming from the CV (Photo 13 and Video 6). We then saw what were called the "gas off jugs", one of which was damaged and out of service (Photo 14). Mr. Hill stated that the equipment required further repair and that a leak was recently fixed. Next, we observed the Number 3 Digester CV loading chips and saw an active leak on the NCG line. We also saw visual emissions from the

| Description: | Leaks at Main Condensate Tank Header. | | | | |

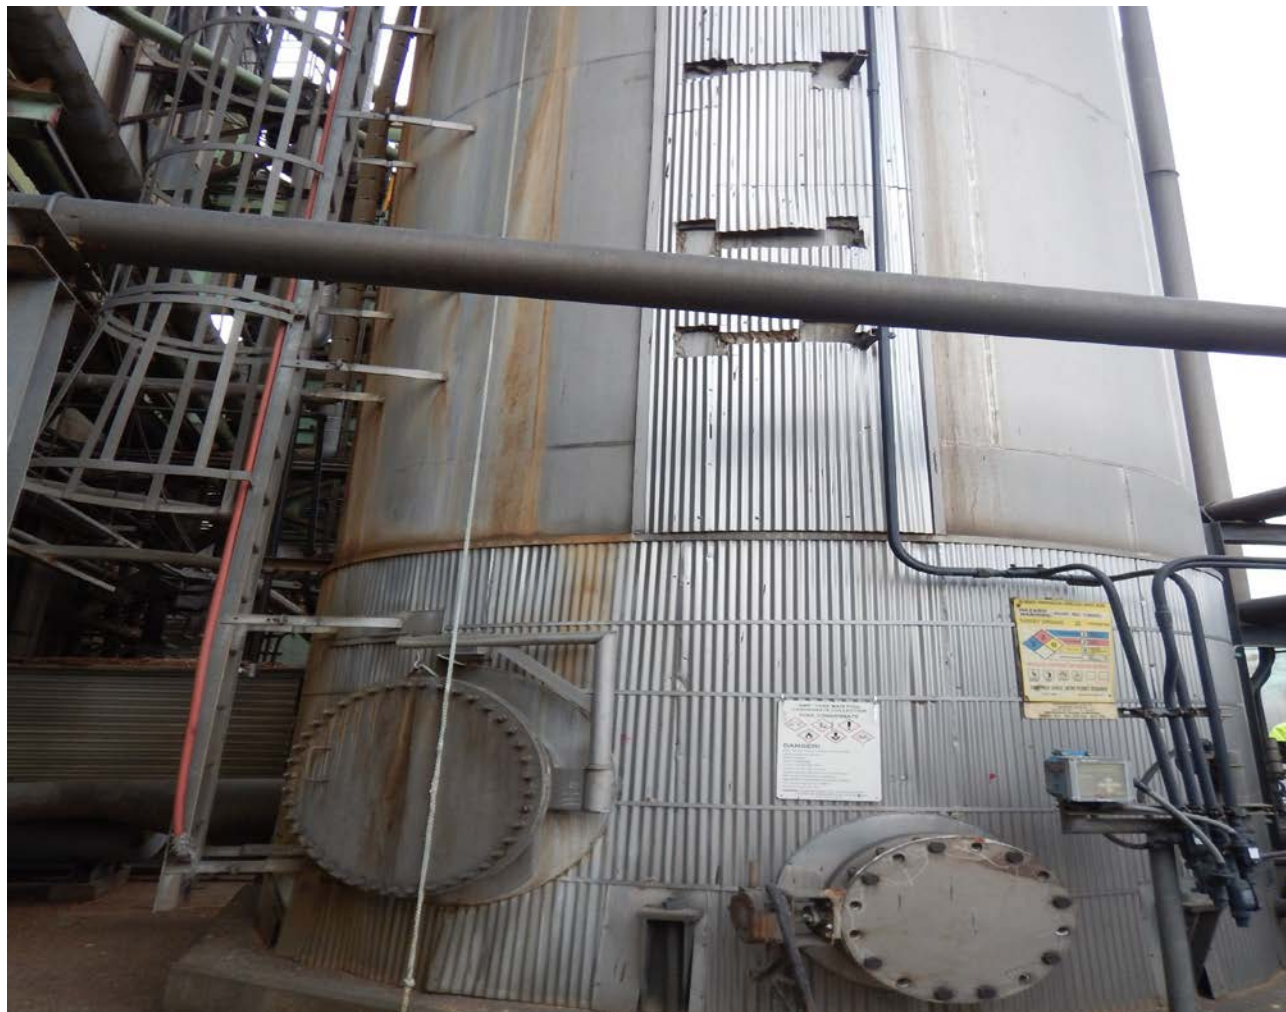
| Description: | Main Condensate Tank. | | | | |

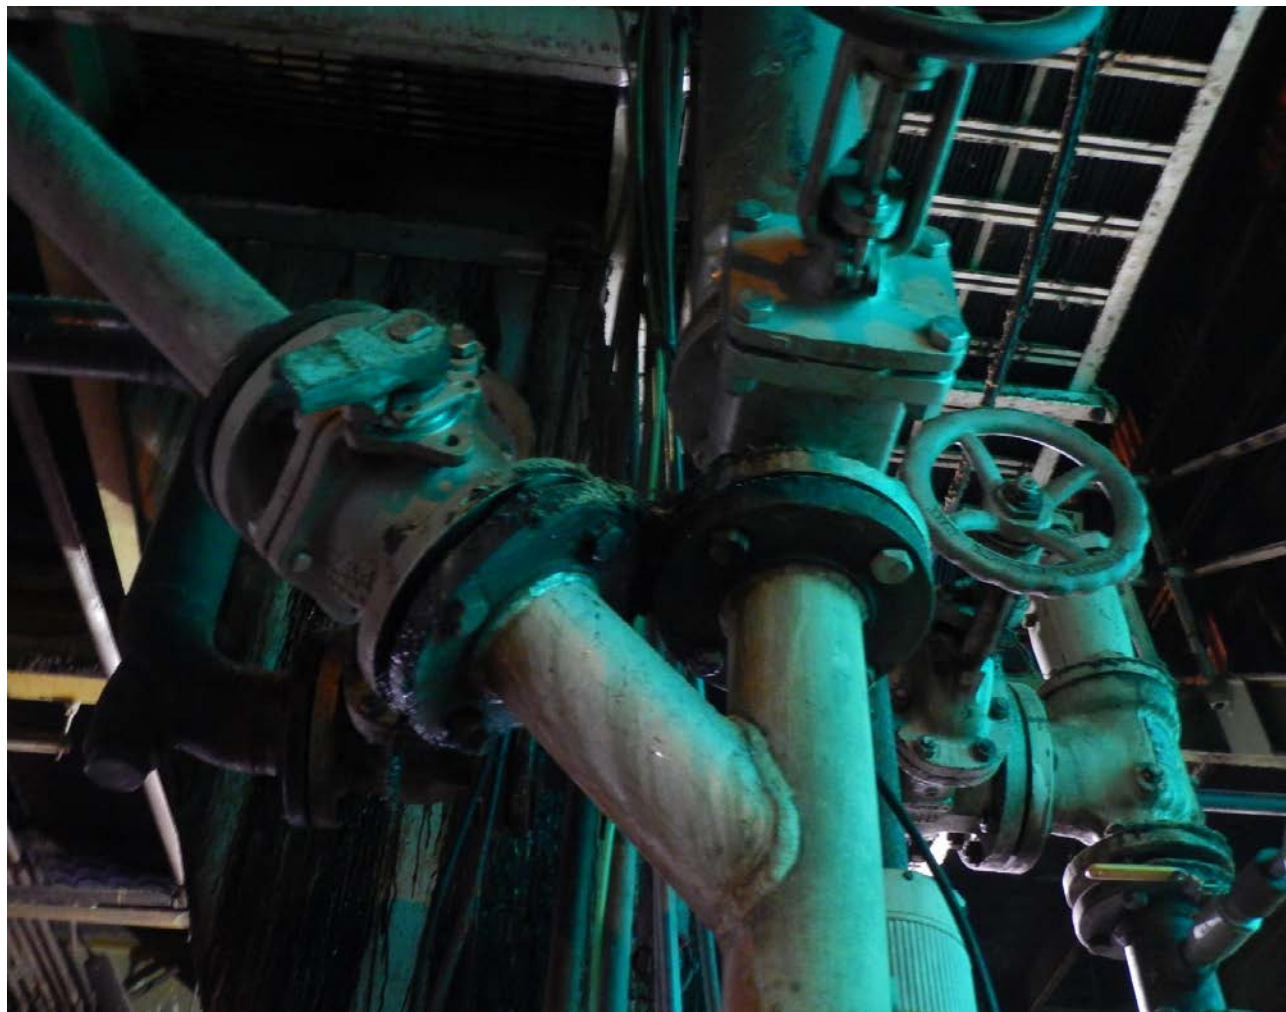
1) The inspection team observed visible emissions at thirteen out of the fourteen CVs of the digesters, and H<sub>2</sub>S monitors carried by both EPA inspectors alarmed at 5ppm and 7ppm detection when touring the area. Per §63.443(a)(1)(i), the total HAP emissions from each LVHC system, which includes digesters, must be controlled. The March 31, 2000 EPA guidance document titled "Questions and Answers for the Pulp and Paper NESHAP, Second Volume" clarifies that it is not required to control emissions from batch digesters during uncapping processes, however emissions should not be present during the cooking process.

| Description: | Visual emissions leak at Digester 1 capping valve piping. | | | | |

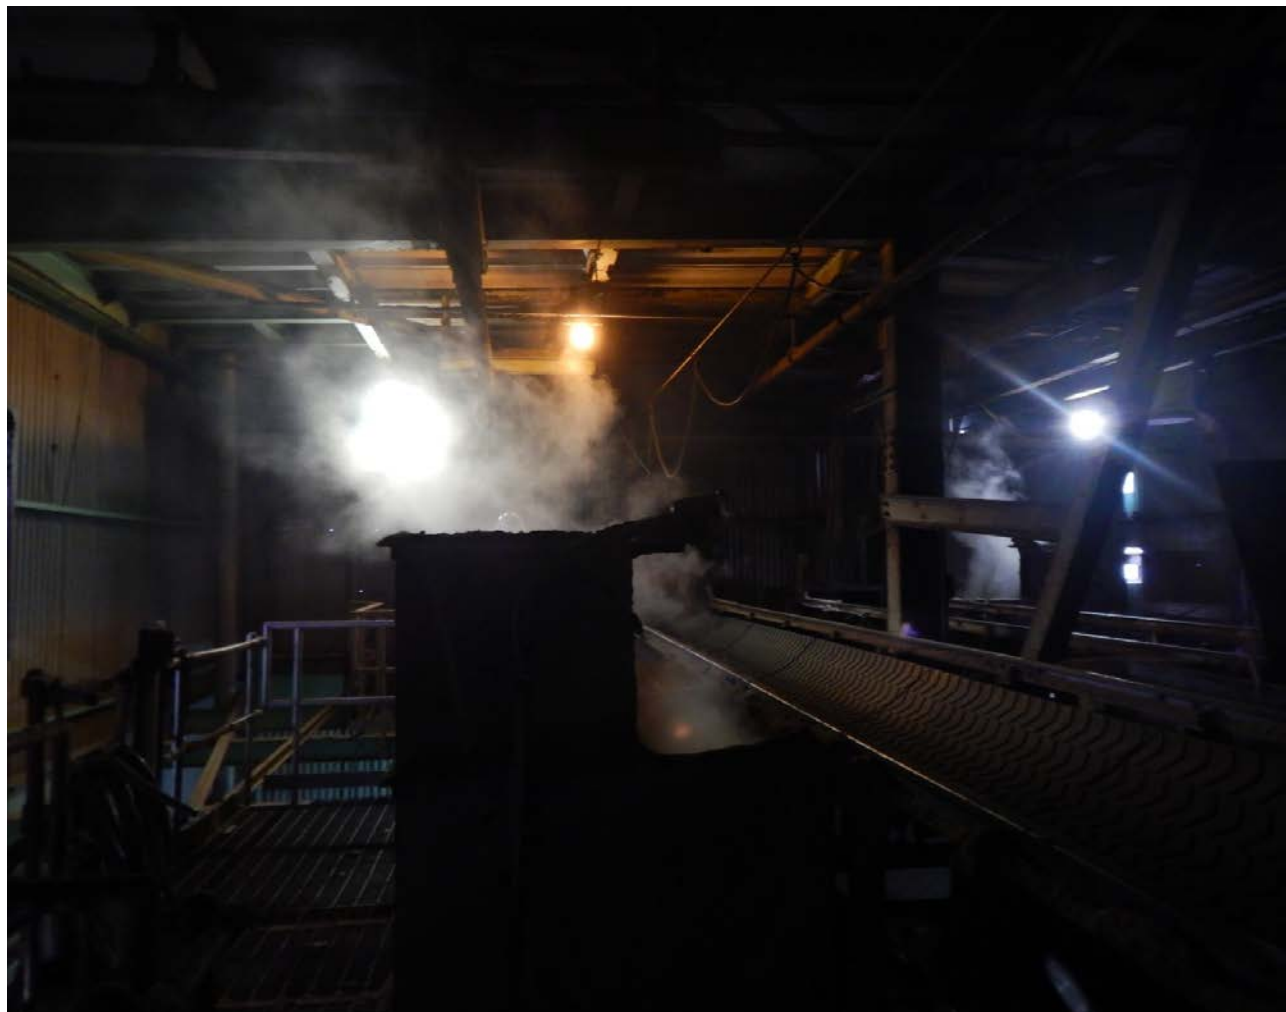
| Description: | Top of Digester 11 visual emissions leak during cook. | | | | | |

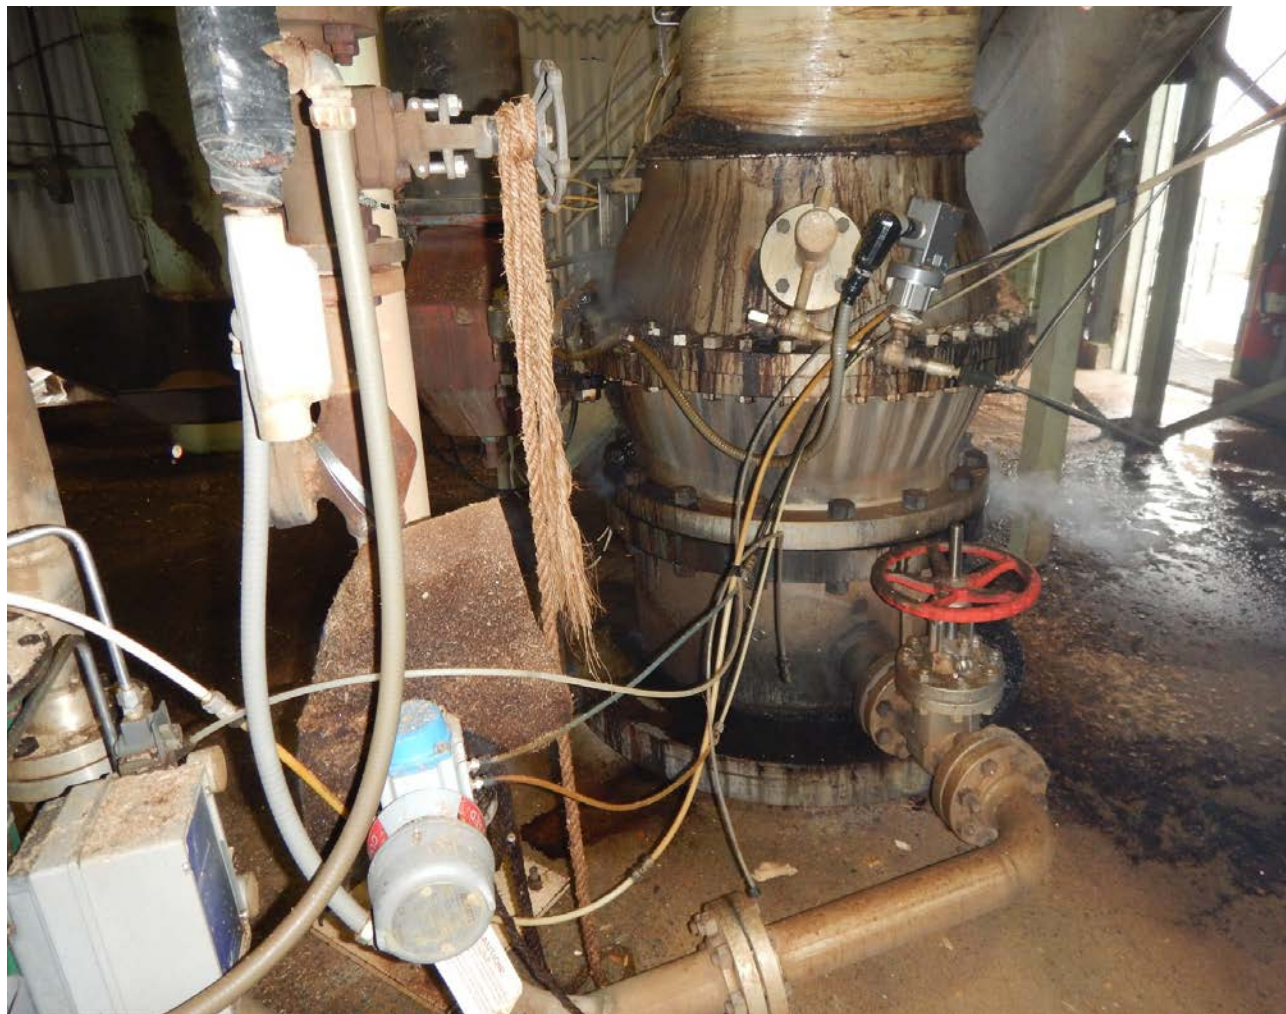
| Description: | Digester 14 capping valve leak. | | | | |

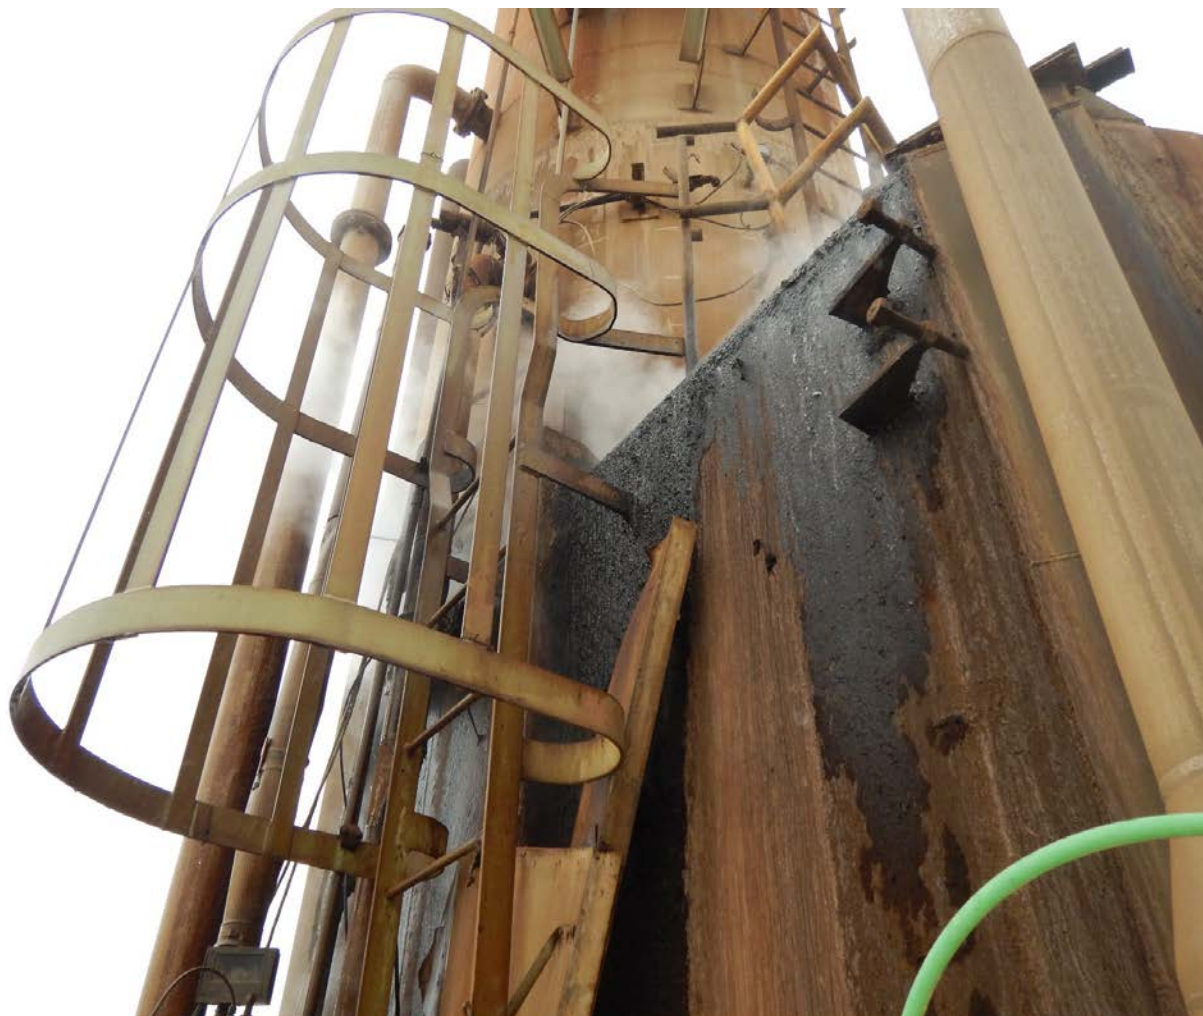
| Description: | Visual emissions released from Blow Heat Accumulator. | | | | |

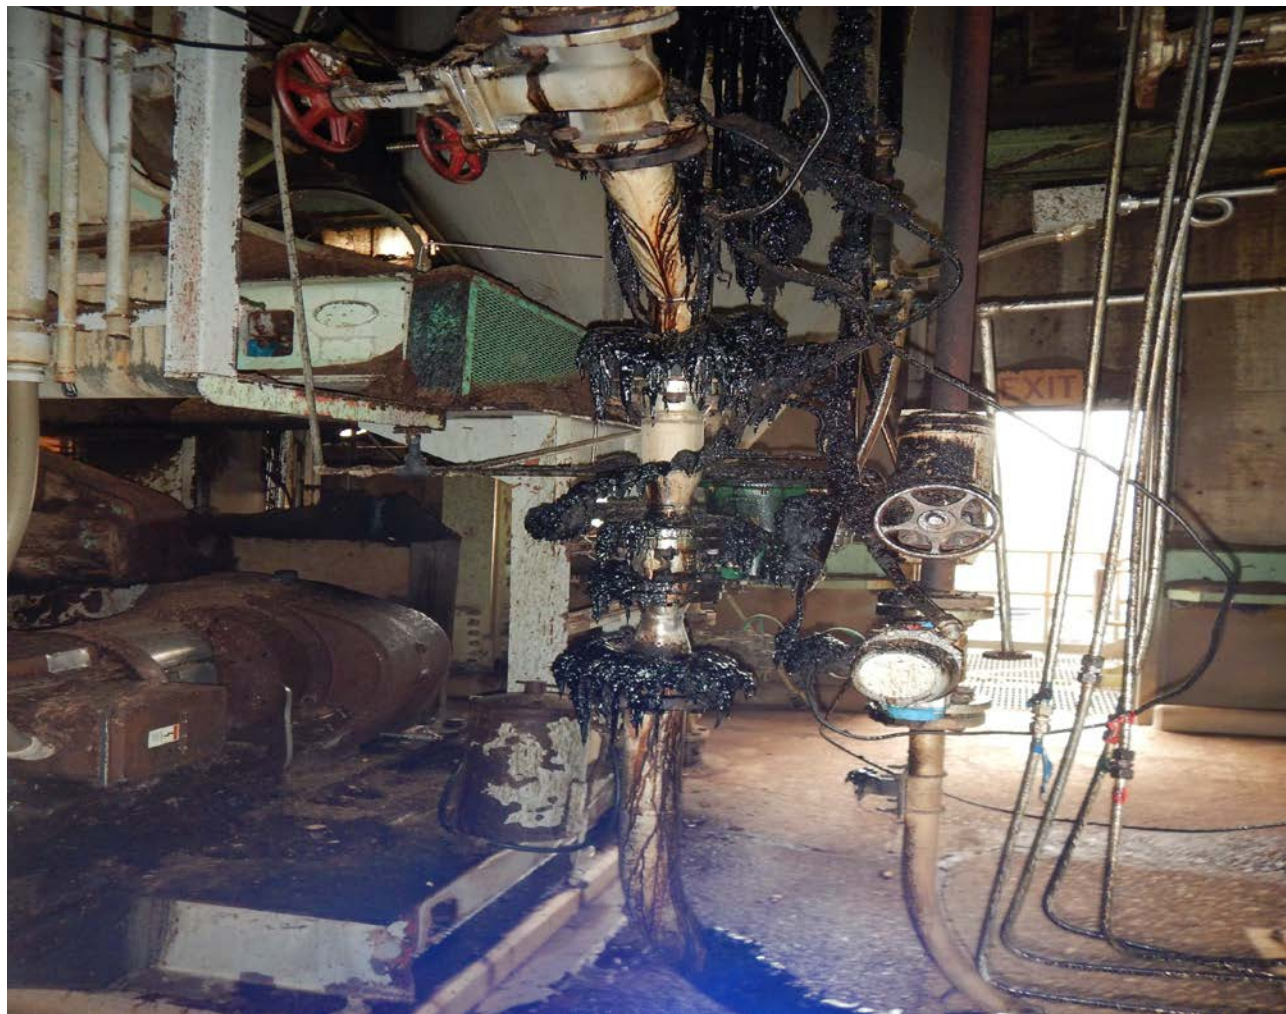
| Description: | Digester 10 non-condensable gas line with buildup of condensate. | | | | |

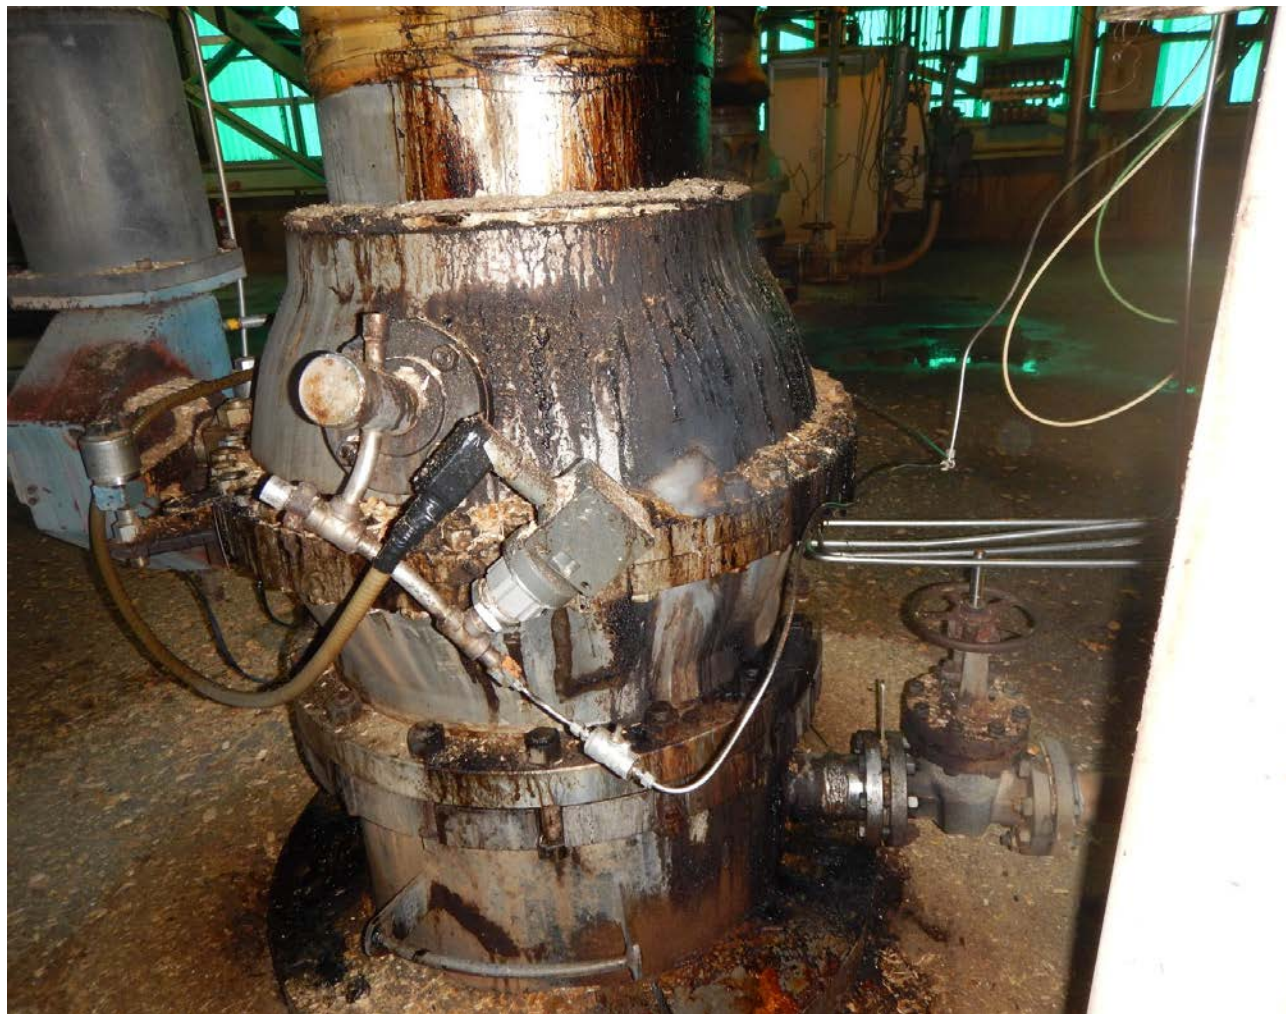
| Description: | Digester 4 missing bolt leaking visual emissions. | | | | |

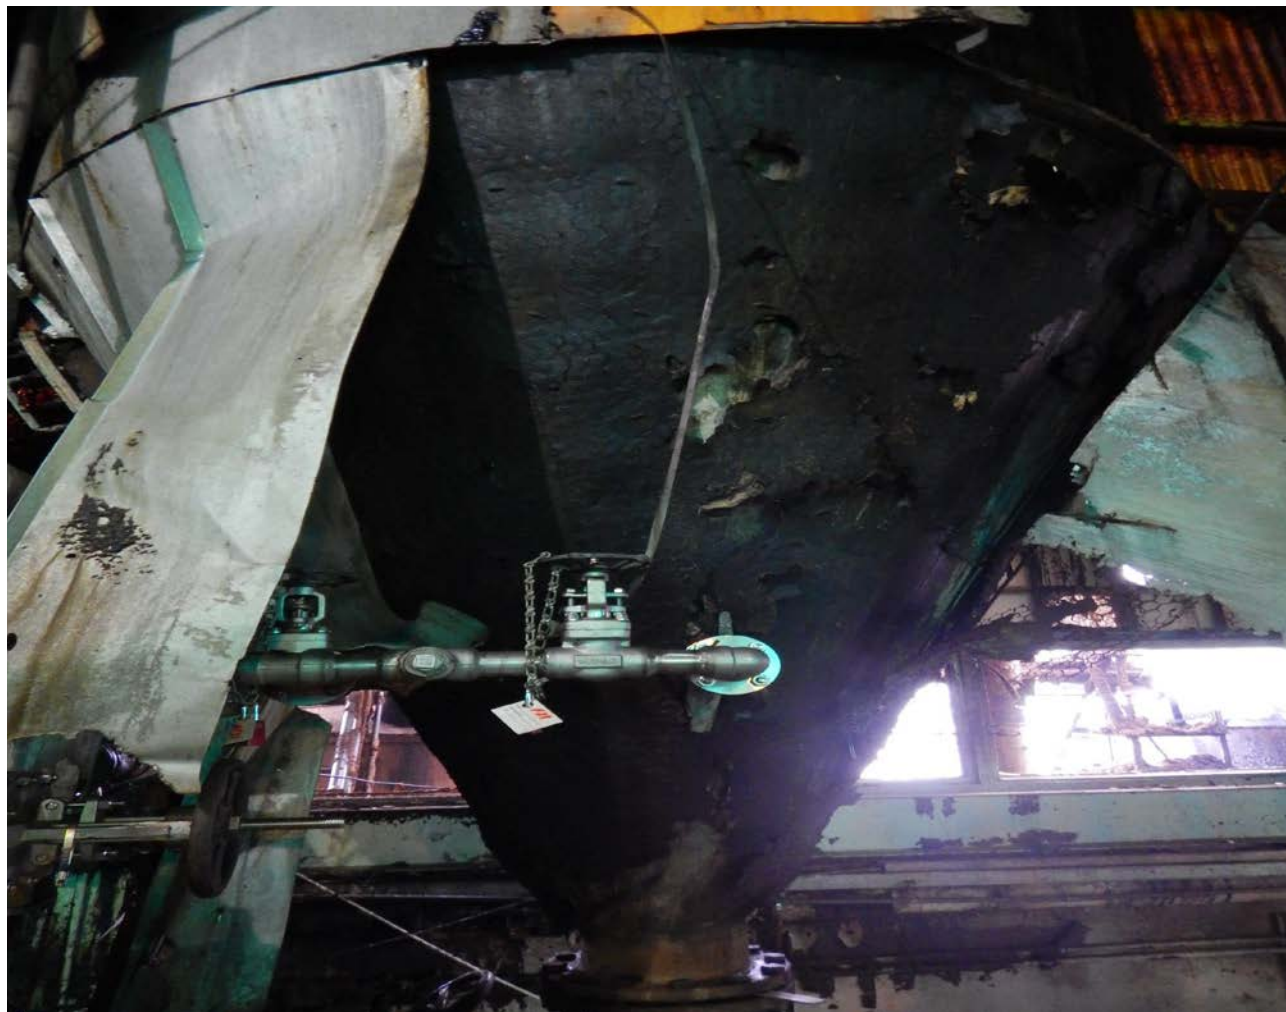
| Description: | Gas off jug/separator (out of service). | | | | |

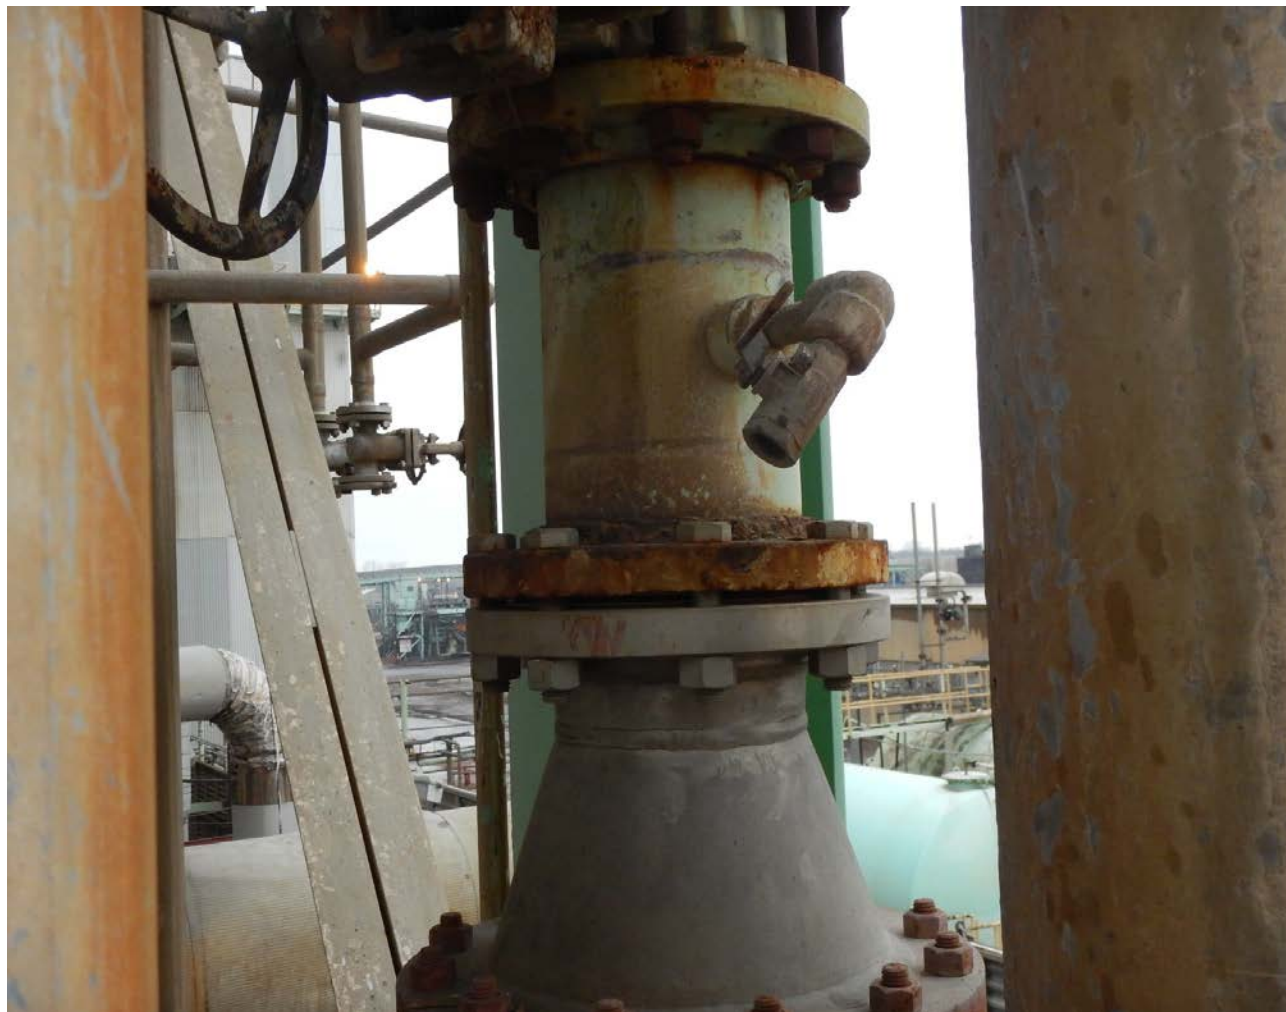
3) When reviewing LDAR monthly inspection records, missing car seals were observed in the pulping area, an example of which includes the bypass at the BHRE Condenser/NCG cooler (Photo 15).

| Description: | Potential bypass at blow heat accumulator precooler. | | | | |

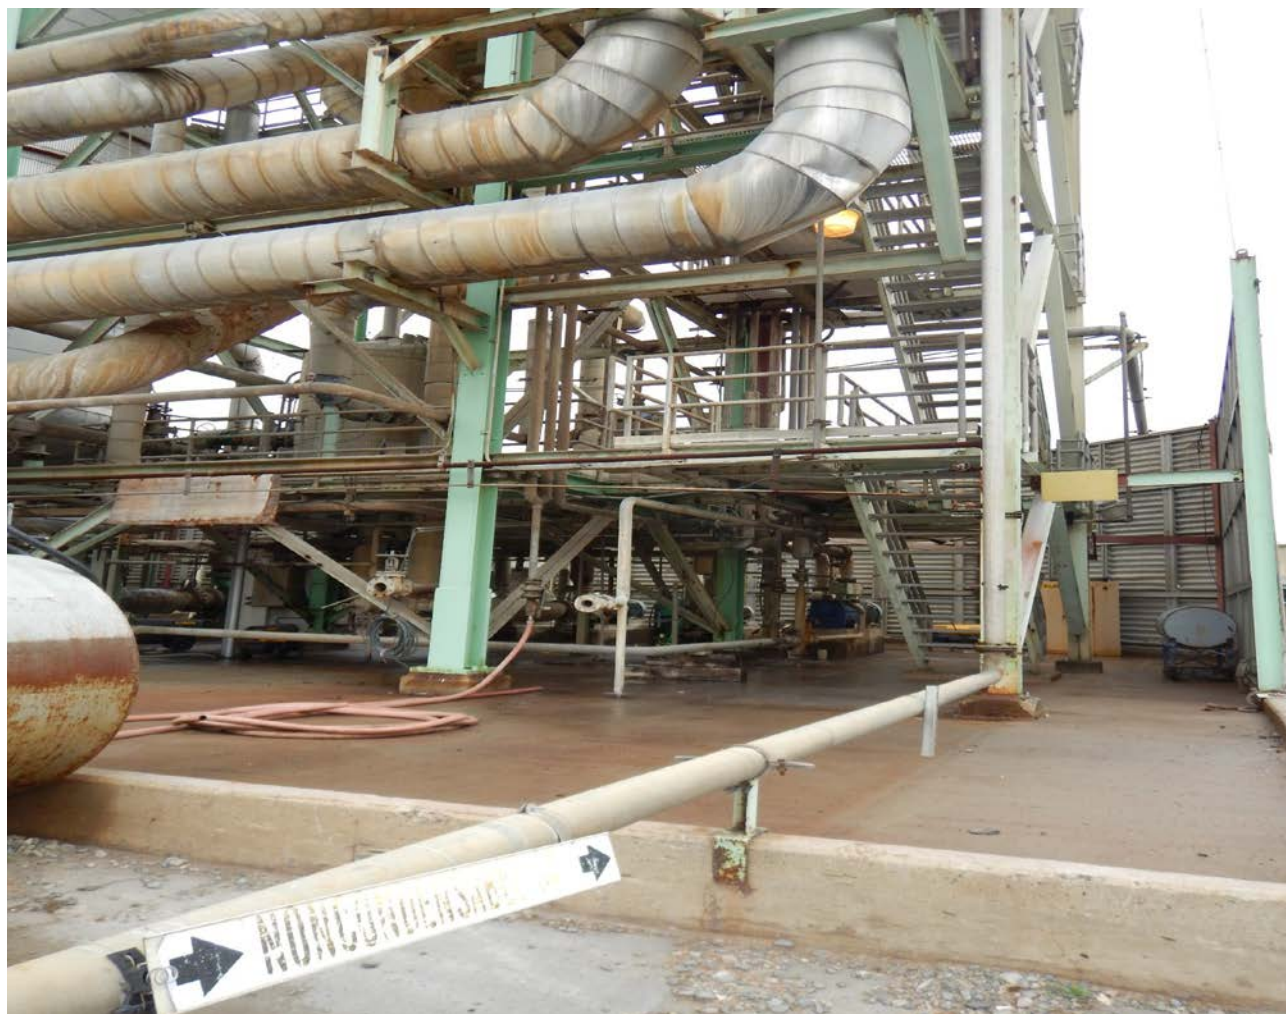
| Description: | Unknown line labeled "noncondensable gas" at base near foul condensate tank. | | | | | |

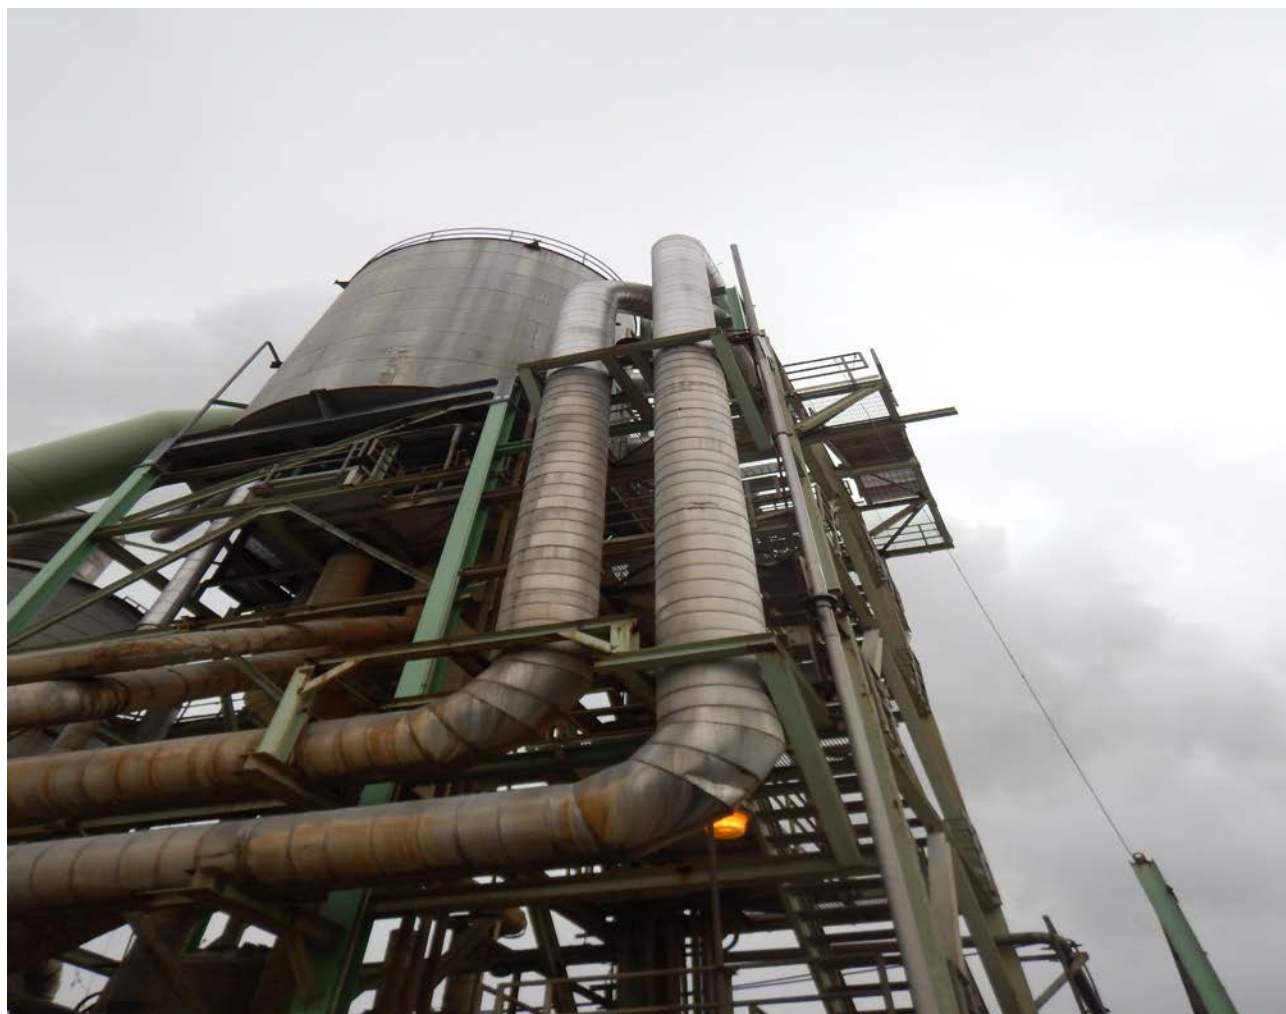
| Description: | Unknown line labeled "noncondensable gas" with open end to atmosphere. | | | | | |

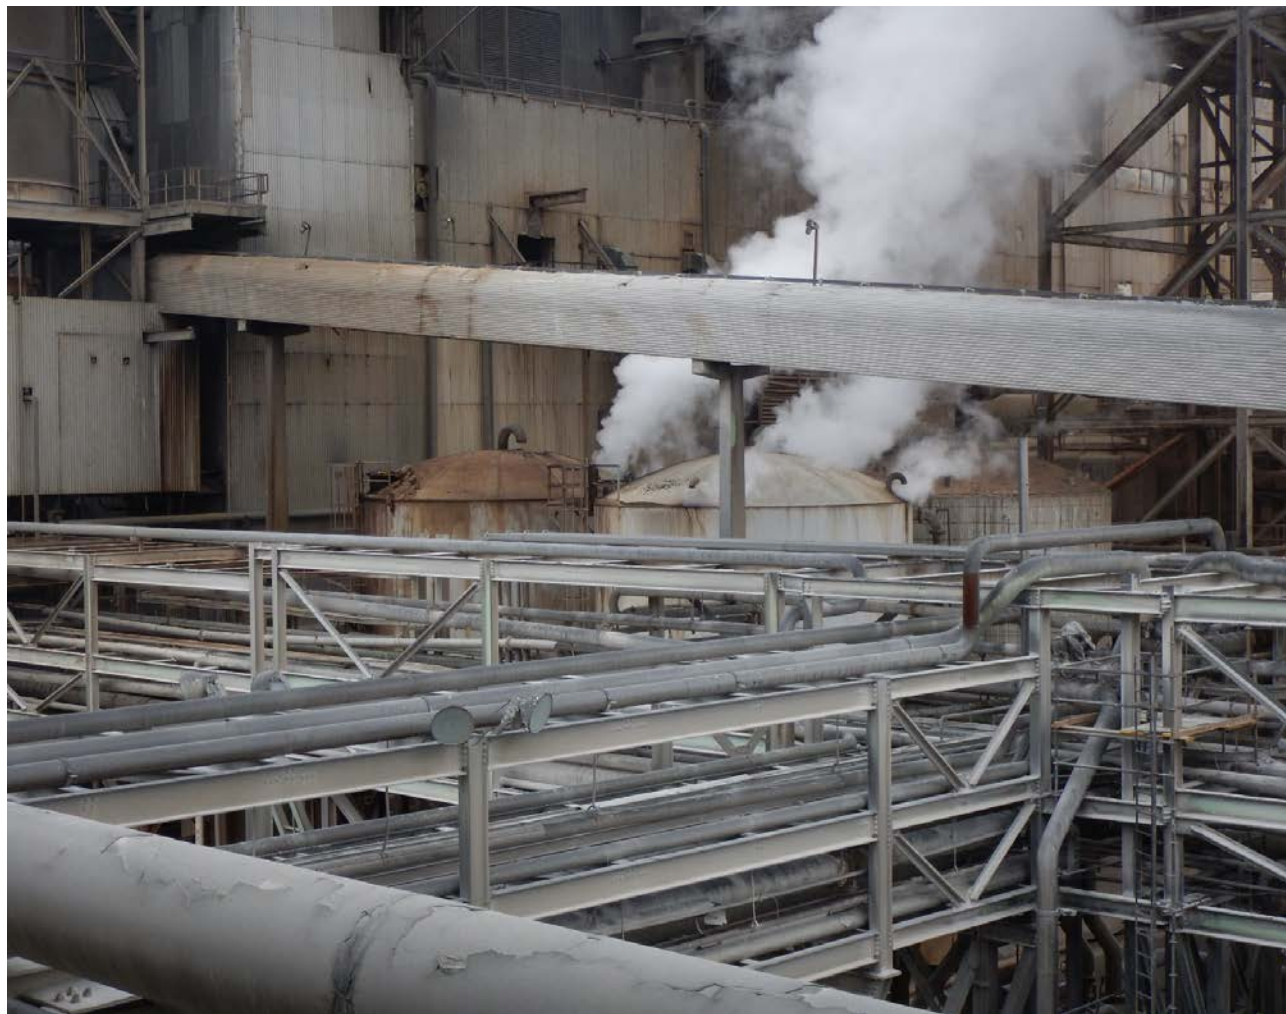
| Description: | Steaming from gas tanks in power/recovery area. | | | | |
