**Region 6 - Enforcement & Compliance Assurance Division  
INSPECTION REPORT**

| Inspection Date(s): | 01/14-17/2020 | |
| Company Name: | Evergreen Packaging, Inc. | |
| Facility Name: | Pine Bluff Mill | |

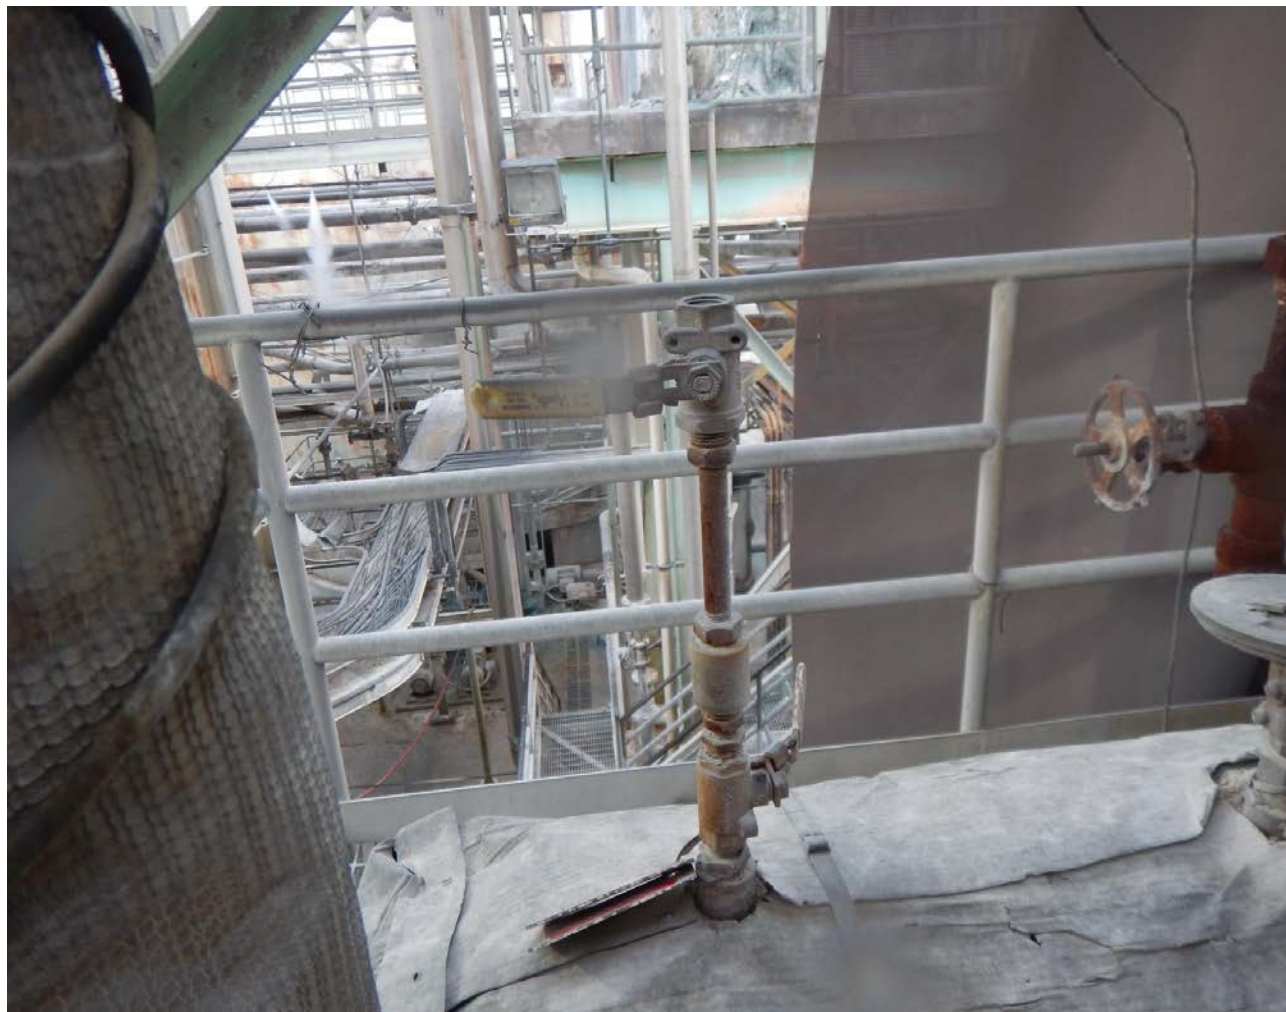
| Description: | Missing car seal on T-7007. | | | | |

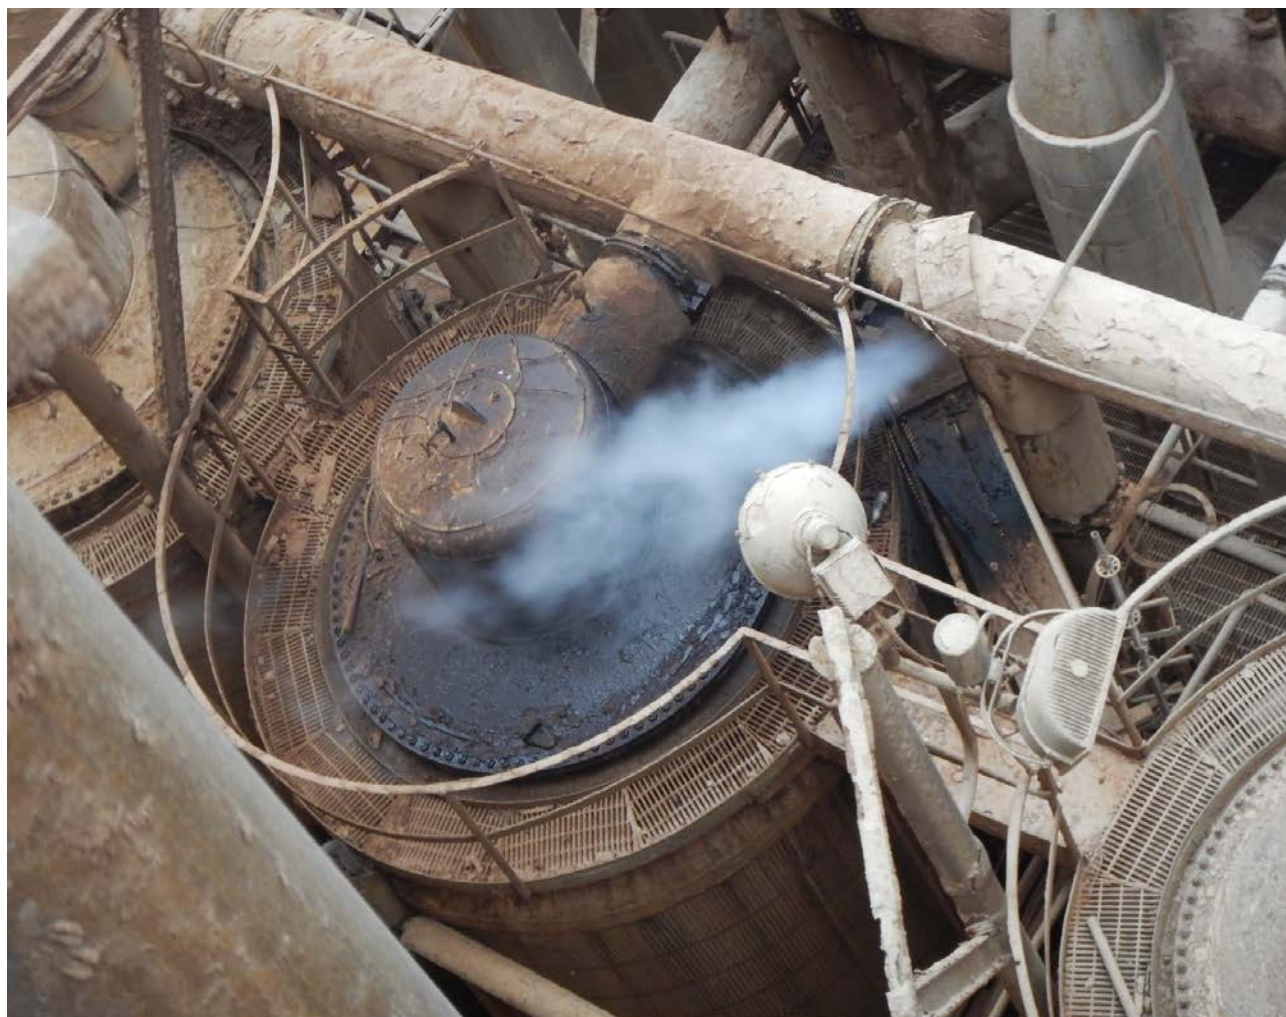
| Description: | Visual emissions at the No. 2 Multiple Effect Evaporator set in the piping between Body 1 and Body 2. | | | | |

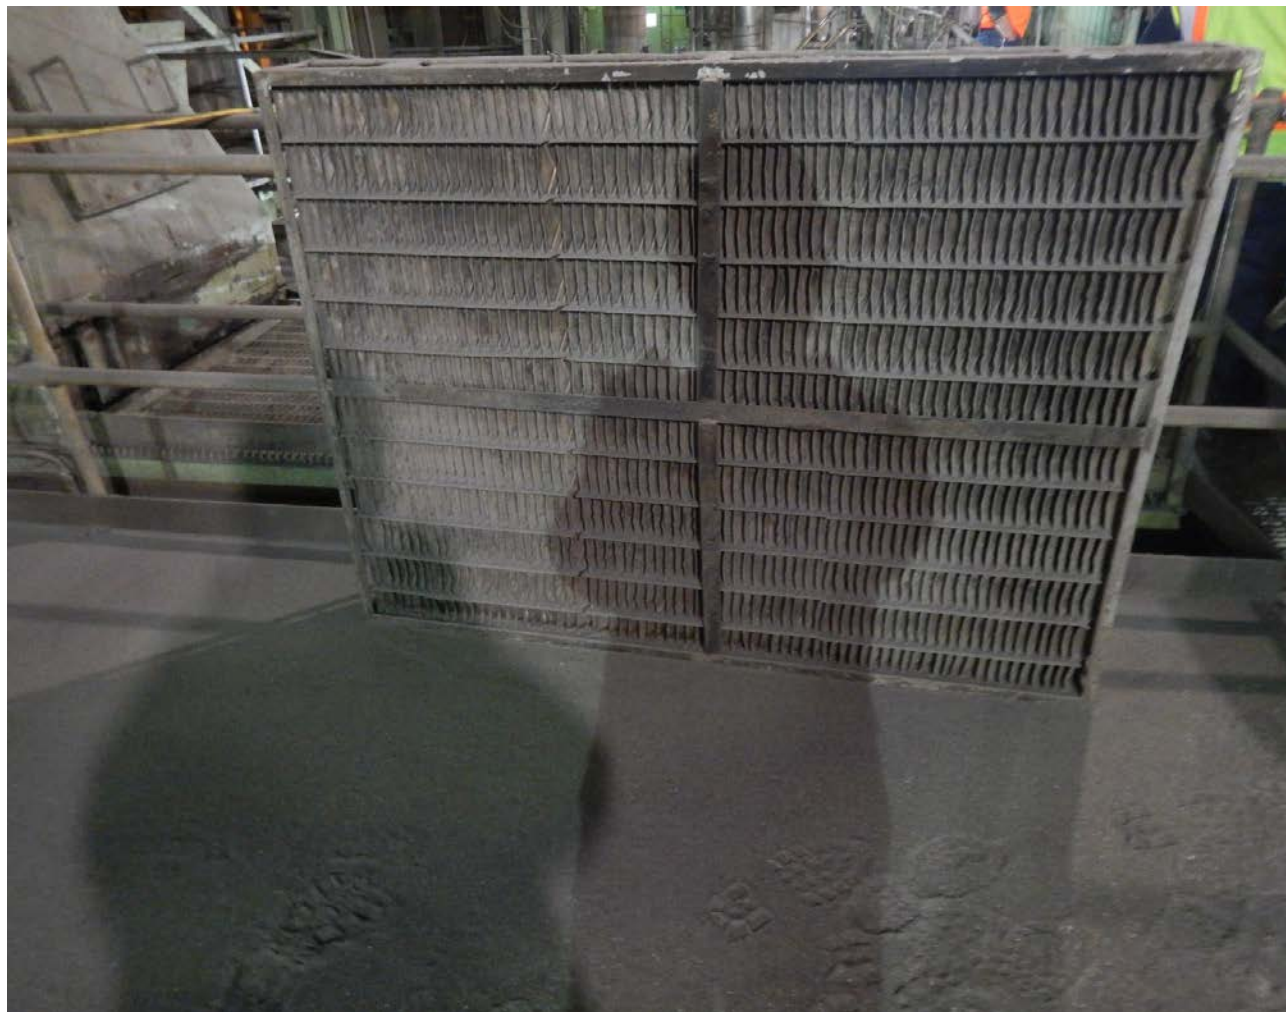
| Description: | Demister pad waiting to be cleaned. | | | | |

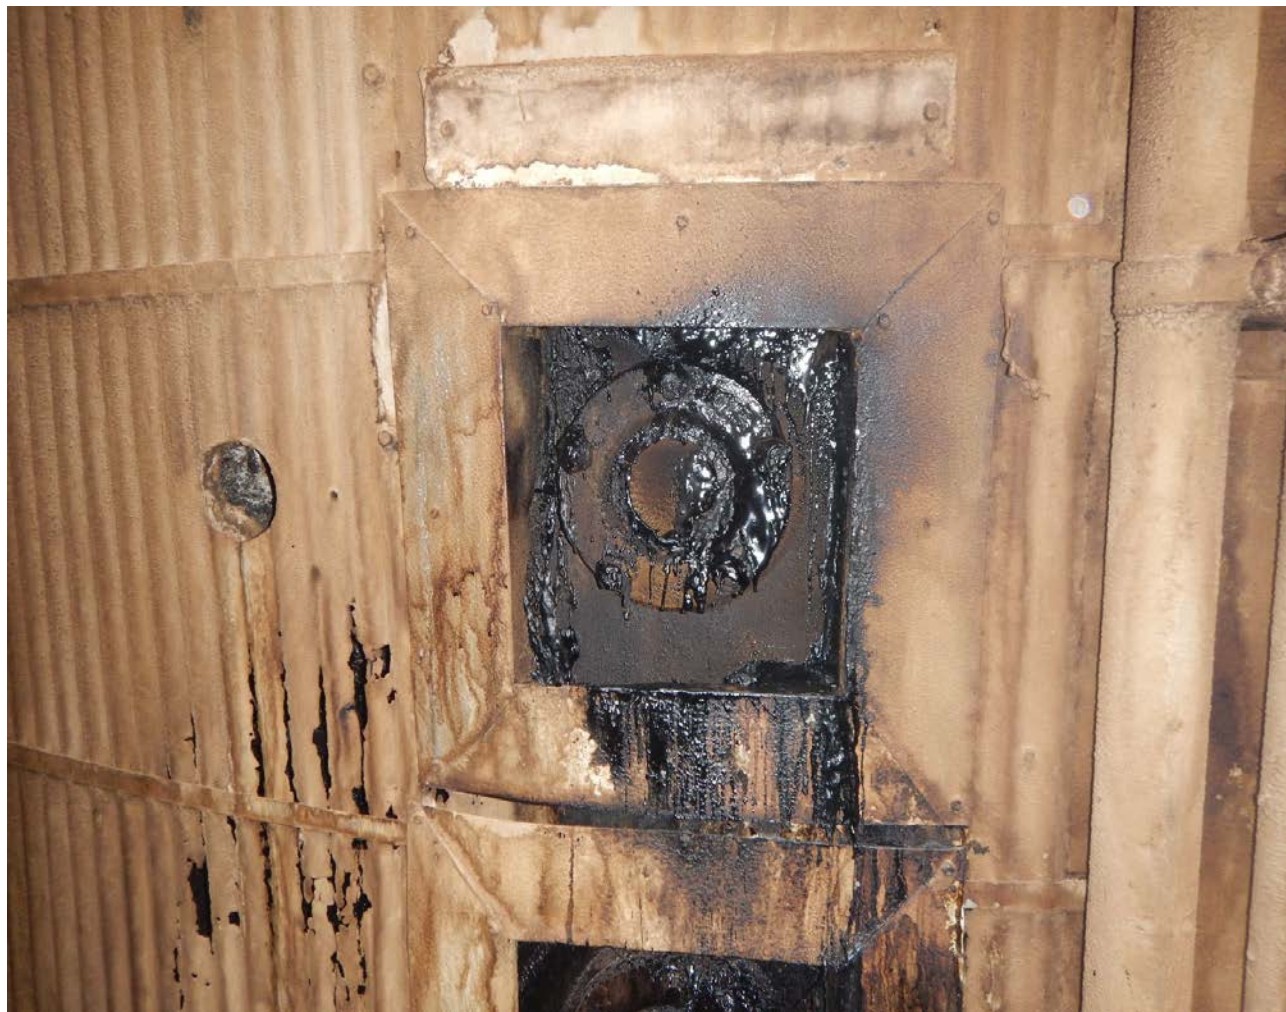
| Description: | Liquid leaks from the No.2 Multiple Effect Evaporator Body 2. | | | | |

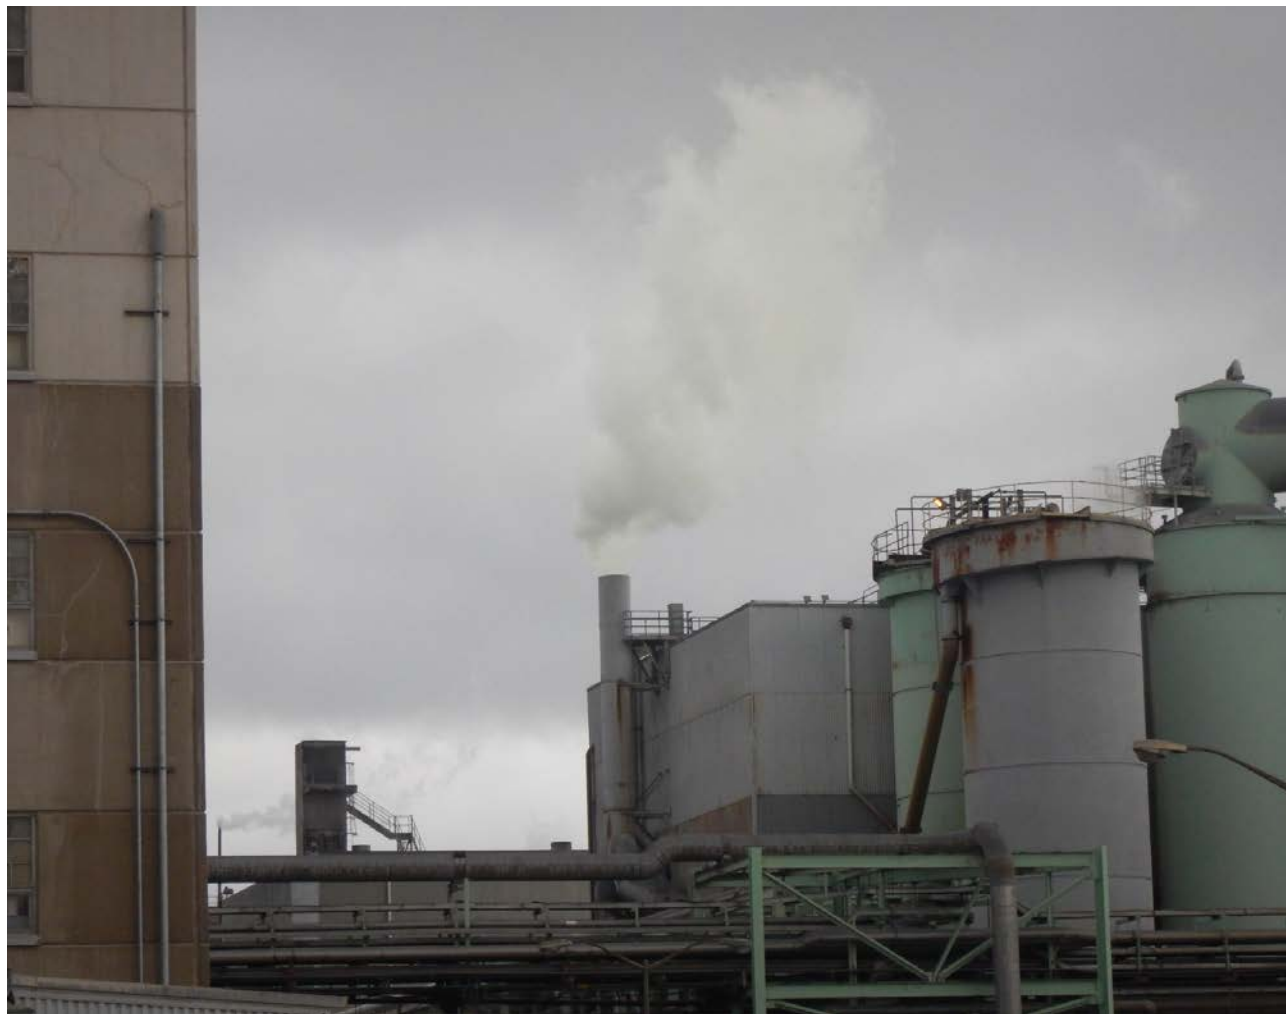
7) On January 16, 2020, the inspection team observed emissions from the Bleach Plant's scrubber stack. It is unknown how the facility ensures that permitted hourly emission limits of chlorinated HAPs are not exceeded. In a follow up email dated February 10, 2020, Julie Brimer stated that the observed emissions from the stack was a result of upset conditions in the Bleach Plant. It is unknown whether Start Up, Shut Down, and Malfunction (SSM) Plan and associated procedures were followed in order to minimize emissions as required by §63.6(e).

| Description: | Green smoke released from Bleach Plant Scrubber Stack. | | | | |

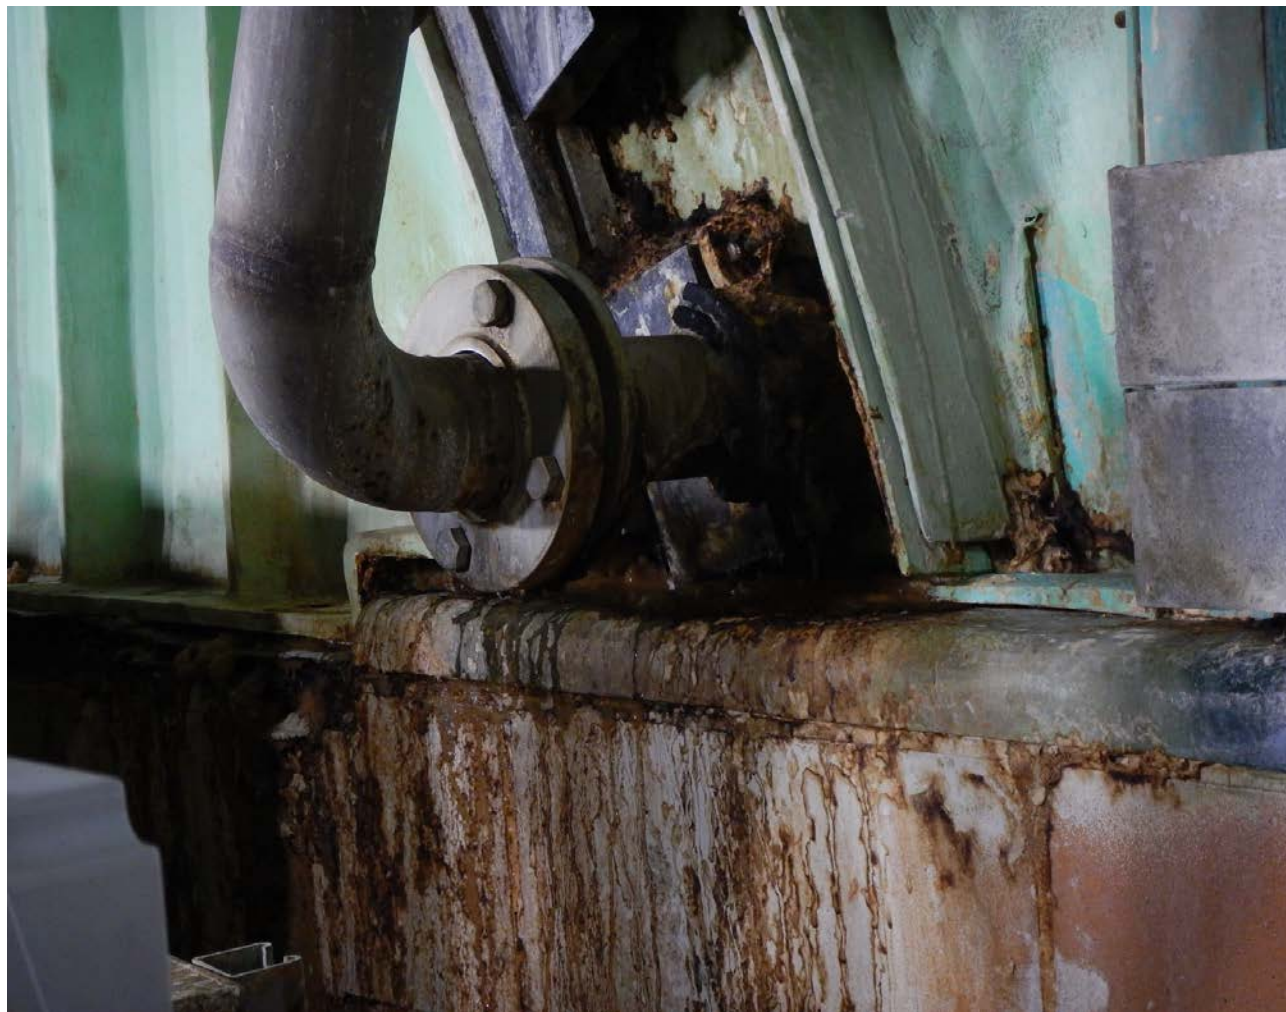
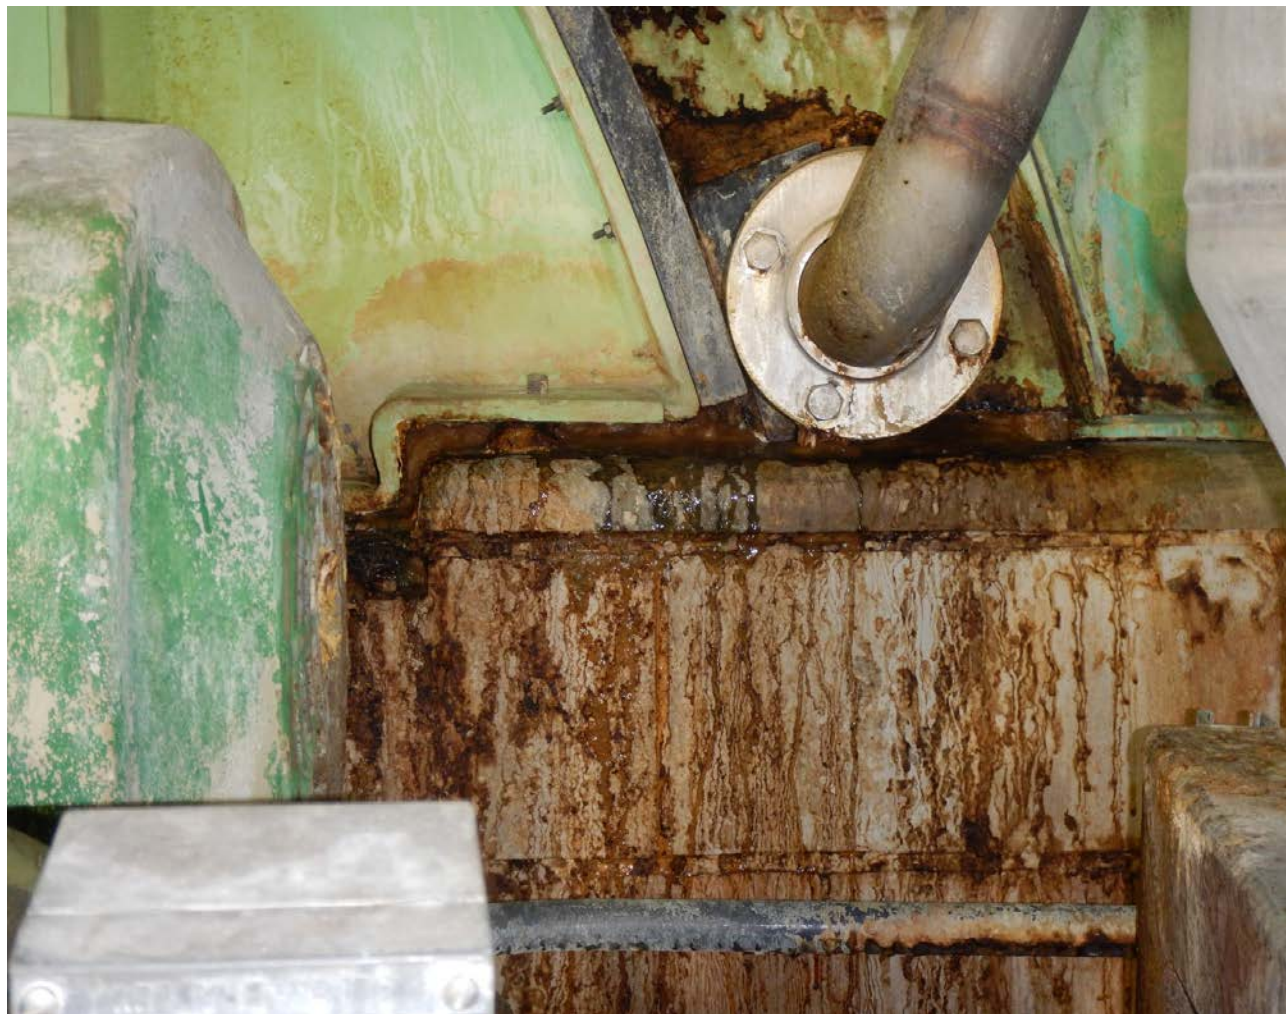
| Description: | Front Side liquid leak from 3B Washer Vat at Bleach Plant. | | | | | |

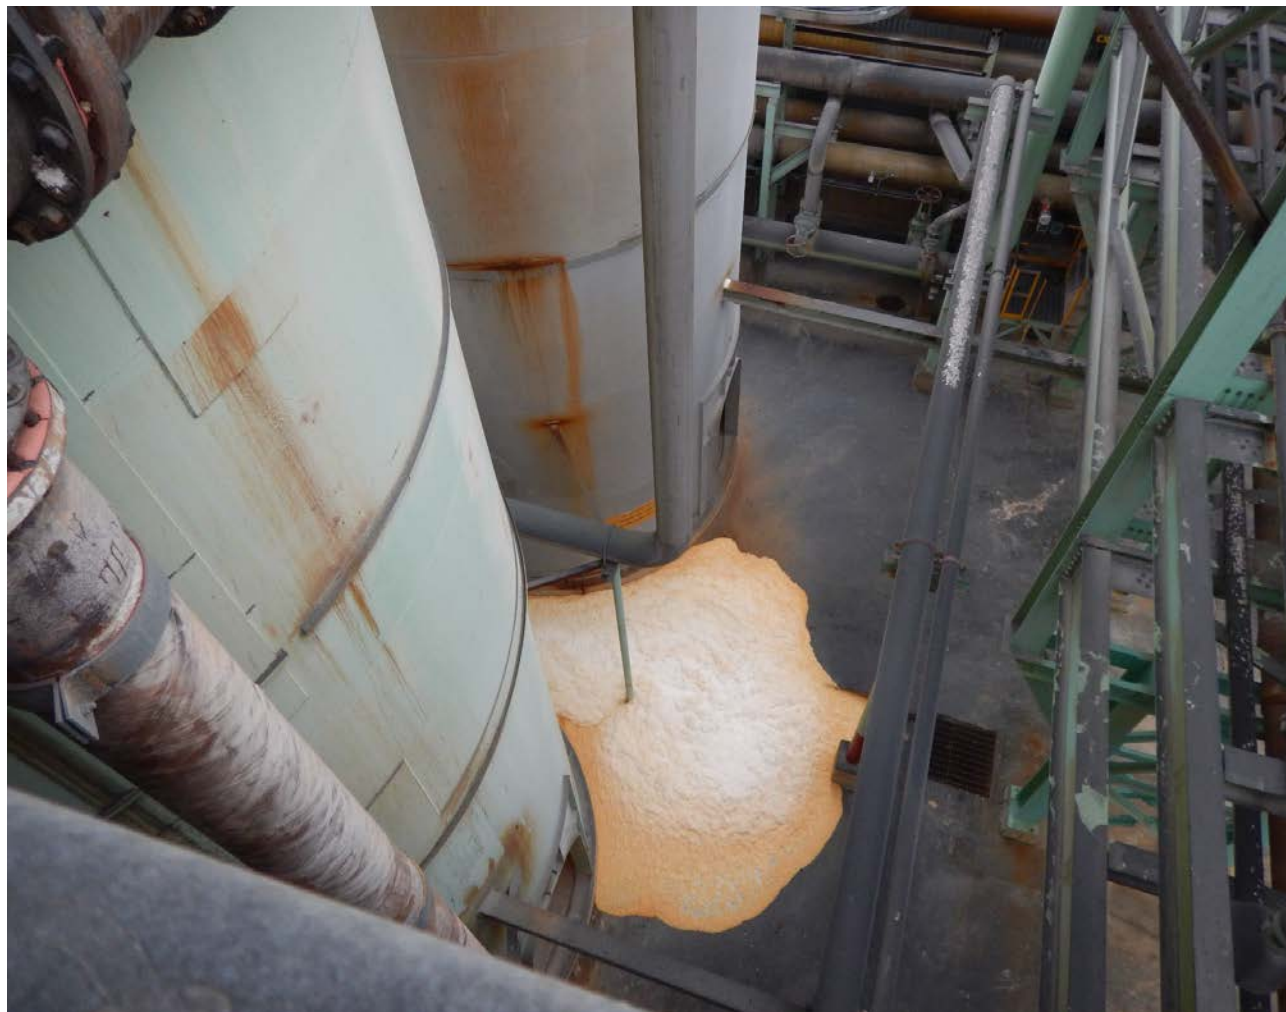
| Description: | 3B Tower pulp spill. | | | | |

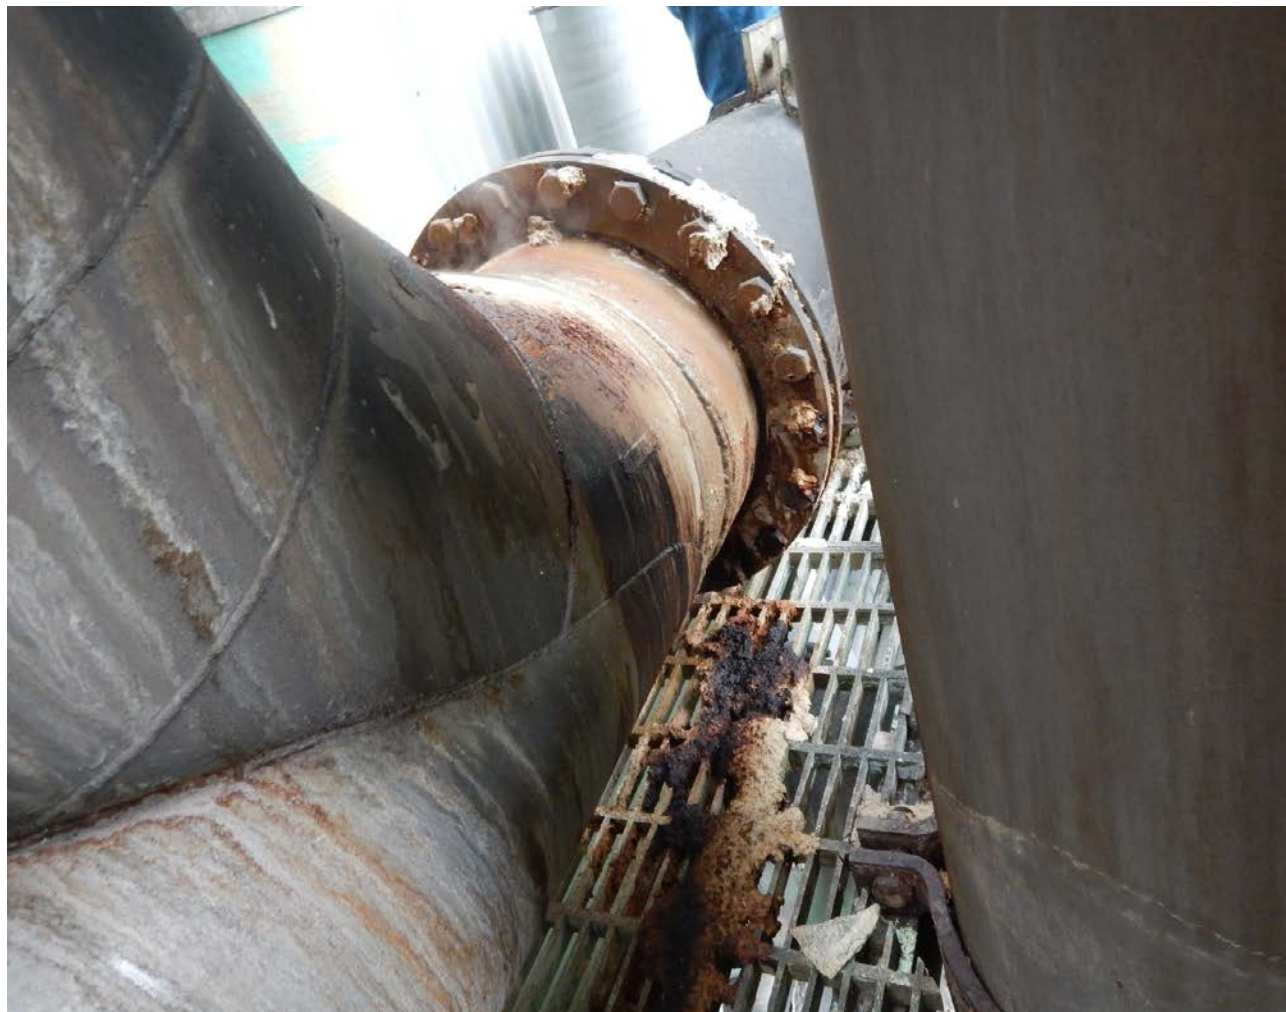
| Description: | Exit piping from 4B Tower with visual emissions. | | | | | |

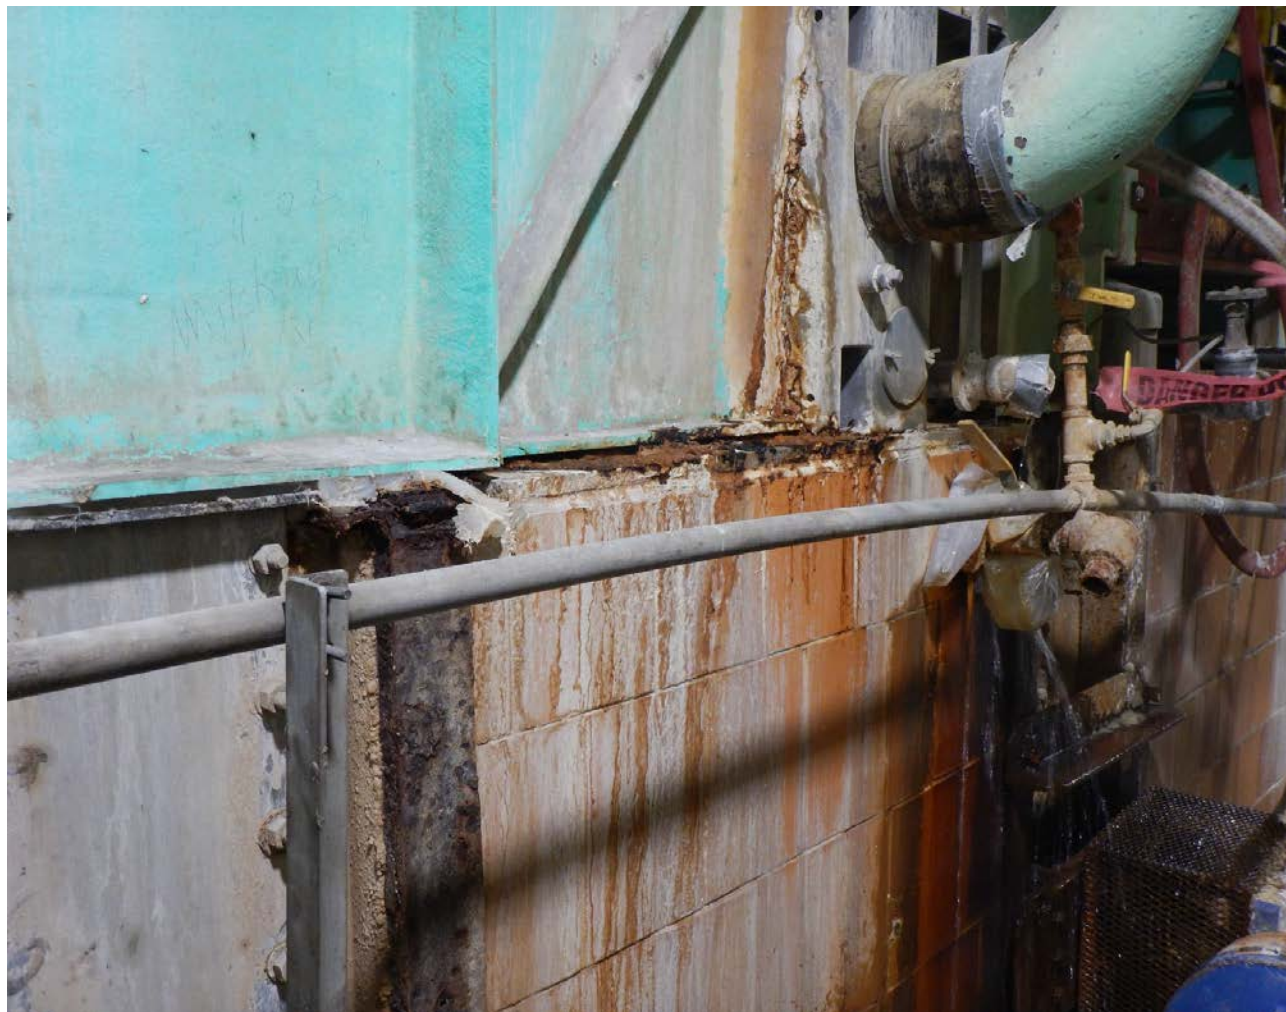
| Description: | Backside liquid leak from 3B Washer. | | | | | |

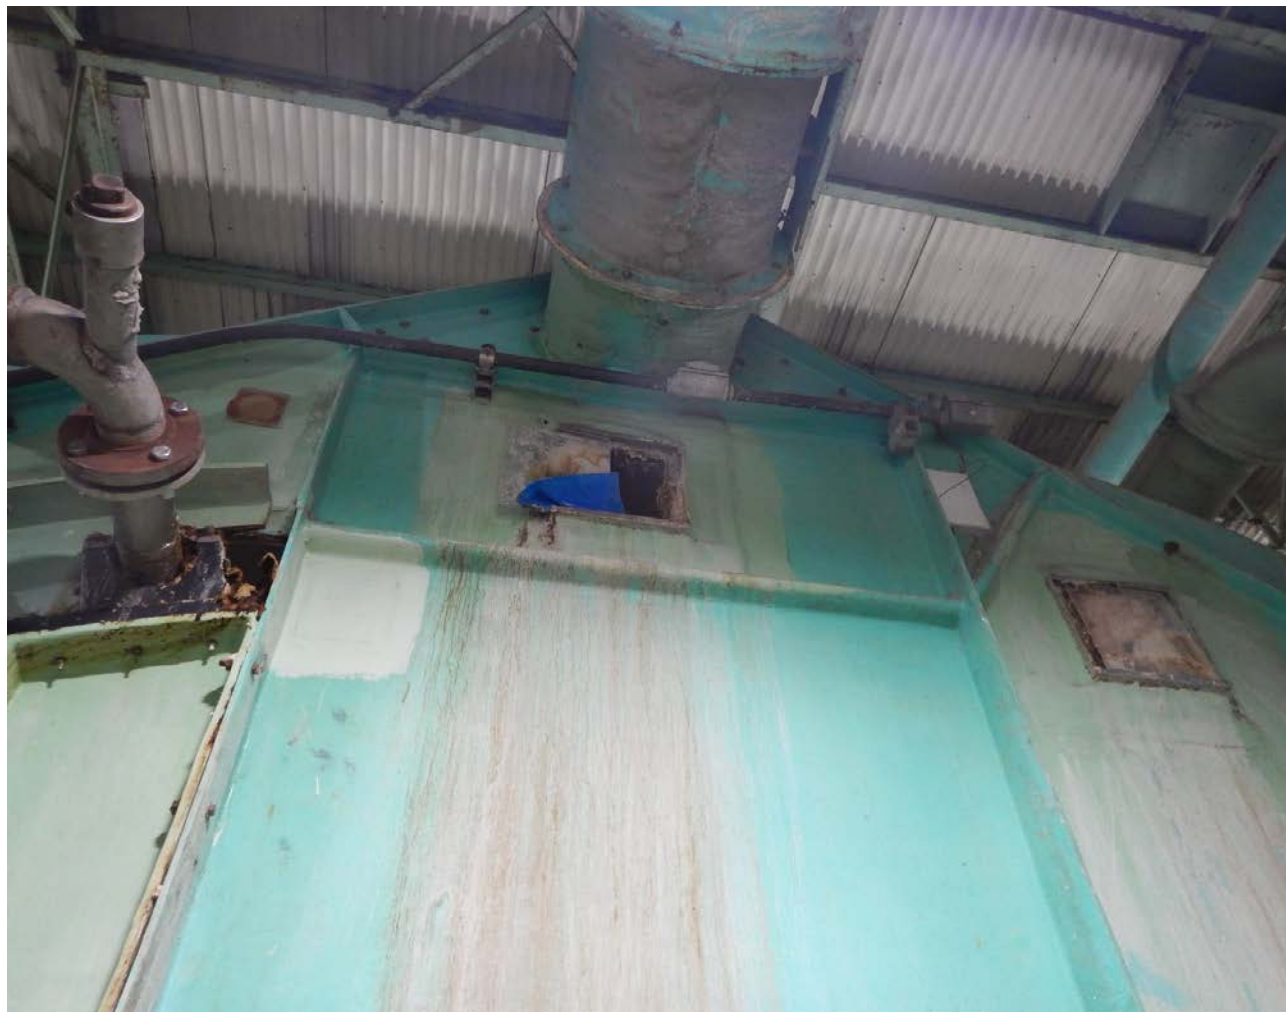
| Description: | Open window on the 3B Washer. | | | | |

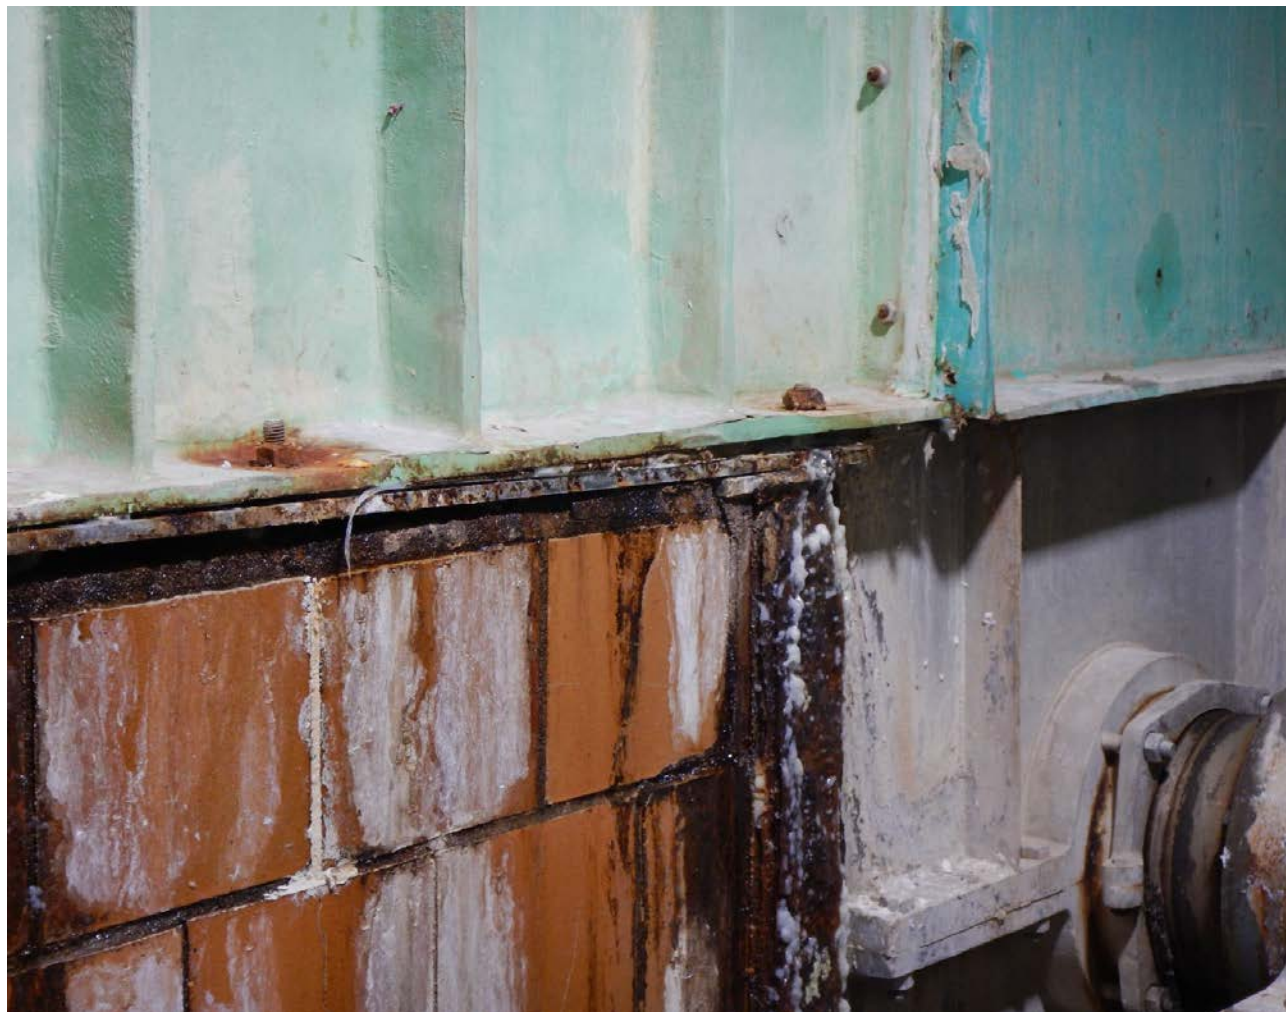
multiple liquid leaks located on its back side (Photo 31), from a corroded discharge pipe (Photo 32), and from its front (Video 8). We also saw significant damage to the roof of the 5B Bleach Plant Washer body (Photo 33). Dr. Frey observed vapors out of every door and hole in the body of the 4B Bleach Plant Washer. We then saw the bypassed and decommissioned 6B Bleach Plant Washer. Next, we saw the 7B Bleach Plant Washer where some visual emissions were observed as the washer hood was not entirely enclosed. We then moved to the C-Line, which was not in operation at the time. At the 1C Bleach Plant Washer, I saw a liquid leak on the backside of the washer (Photo 34). We observed similar evidence of liquid leaks at the 3C and 4C Bleach Plant Washers. We moved outside to see more of the Bleach Plant Towers and saw that 1C Bleach Plant Tower had significant buildup of material on its vessel body. We then saw a large visible emission leak from the 7B Bleach Plant Tower at the flange and connecting pipe (Video 9). We moved to the top of the 3B Bleach Plant Tower and saw an open hole at the top of the tower (Photo 35) that was releasing visible emissions. We moved to the seal pit area of the Bleach Plant and observed a large water leak from the 7B Seal Pit. We next observed visual emissions from a leak on the 1B Seal Pit (Video 10). Dr. Frey observed large amounts of visual emissions from the 4B Seal Pit and could not confirm the status of multiple LDAR components because the view was obstructed by the emissions coming from the 4B Seal Pit.

| Description: | 5B Washer liquid leak on backside. | | | | | | |

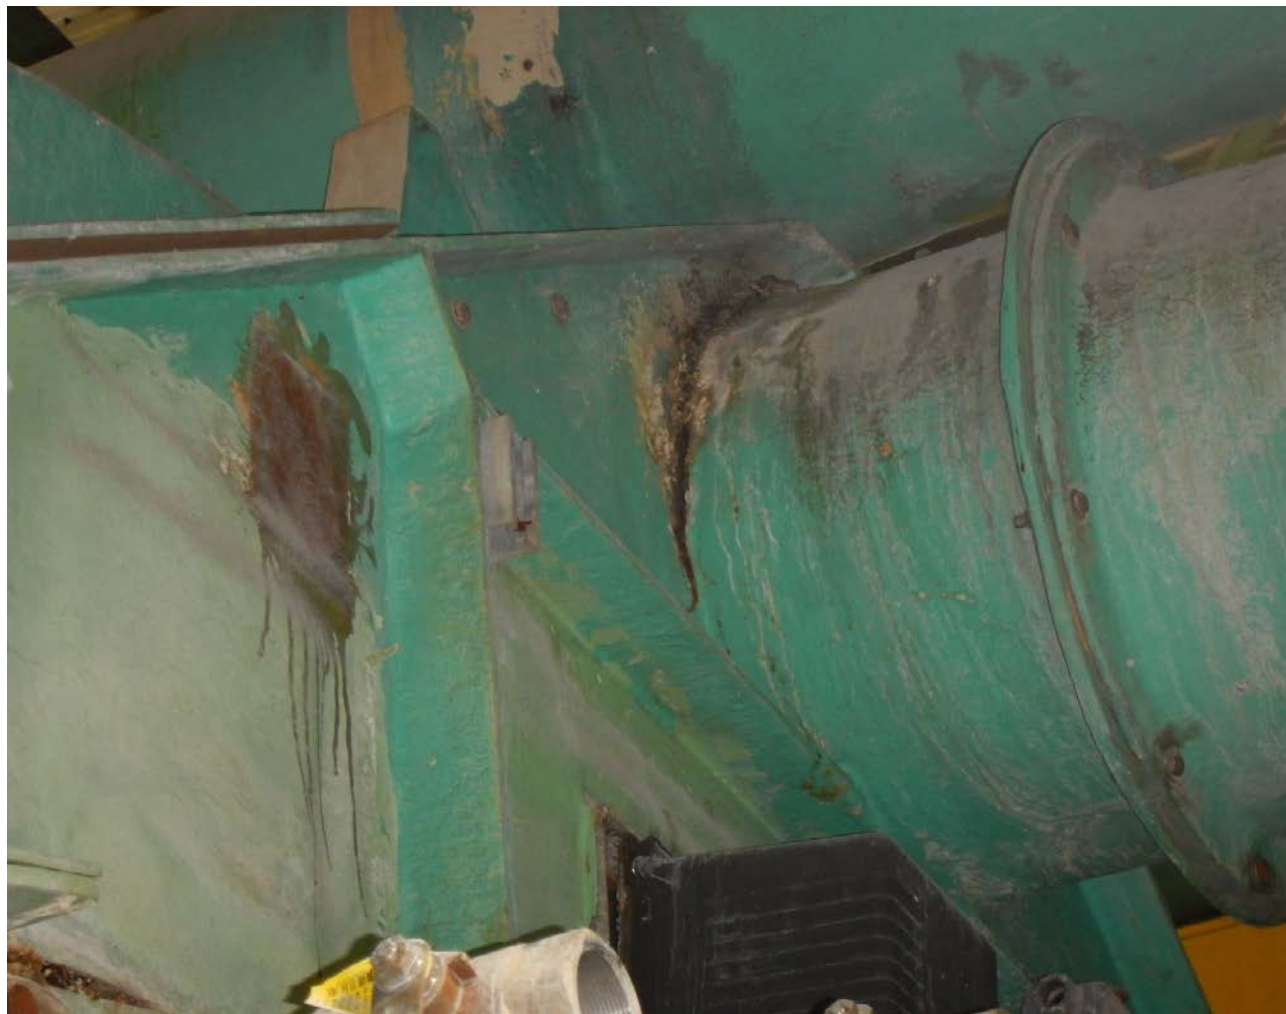
| Description: | 5B Washer discharge pipe corrosion. | | | | |

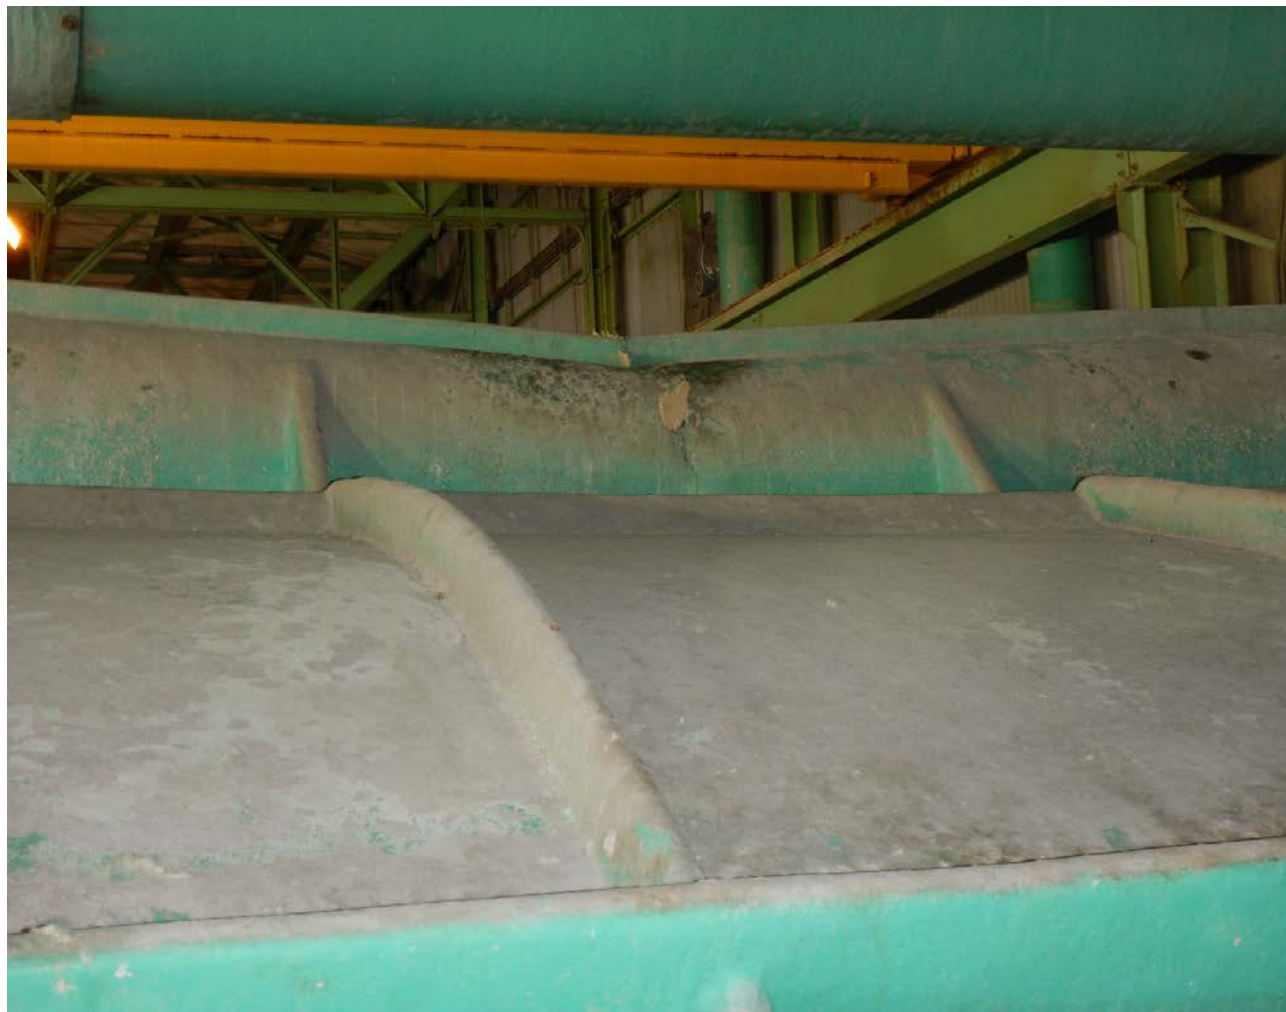
| Description: | 5B Washer collapsing shell. | | | | |

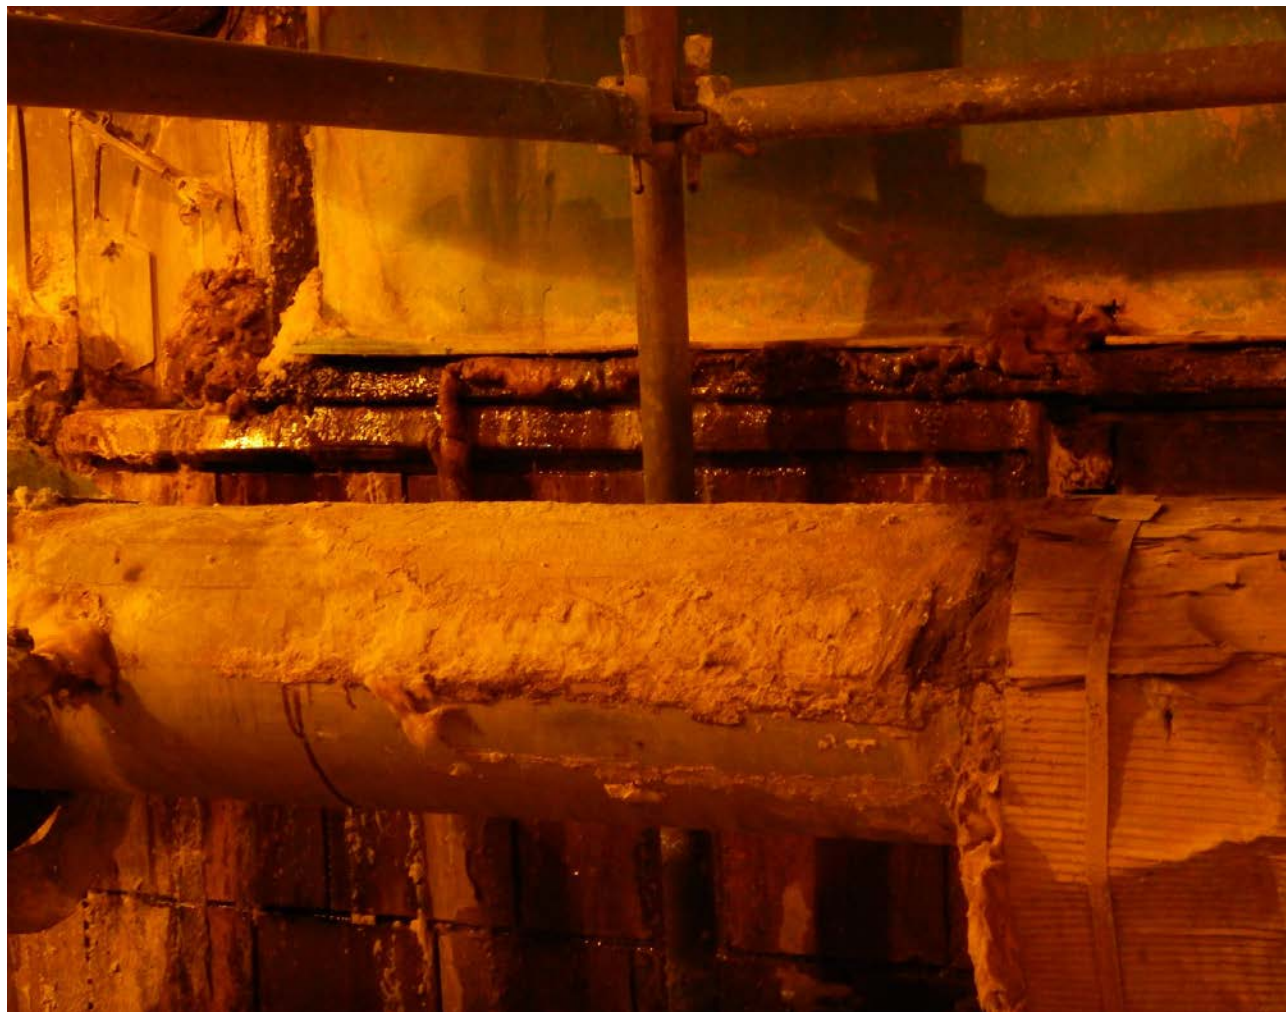
| Description: | 1C Washer backside liquid leak. | | | | |

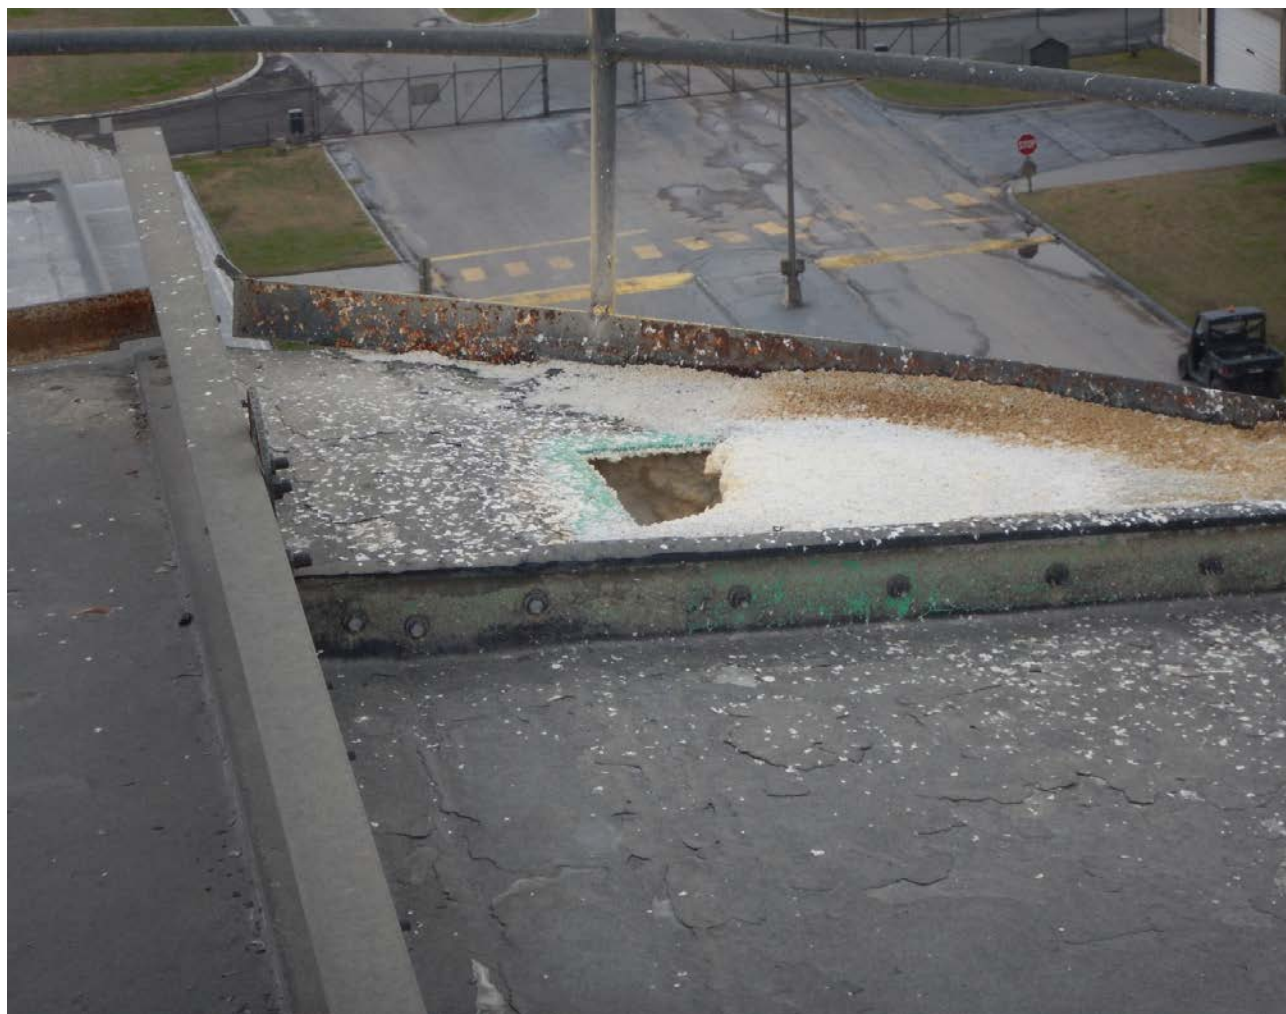
| Description: | Open hole with pulp on top of 3B Bleach Plant tower. | | | | |

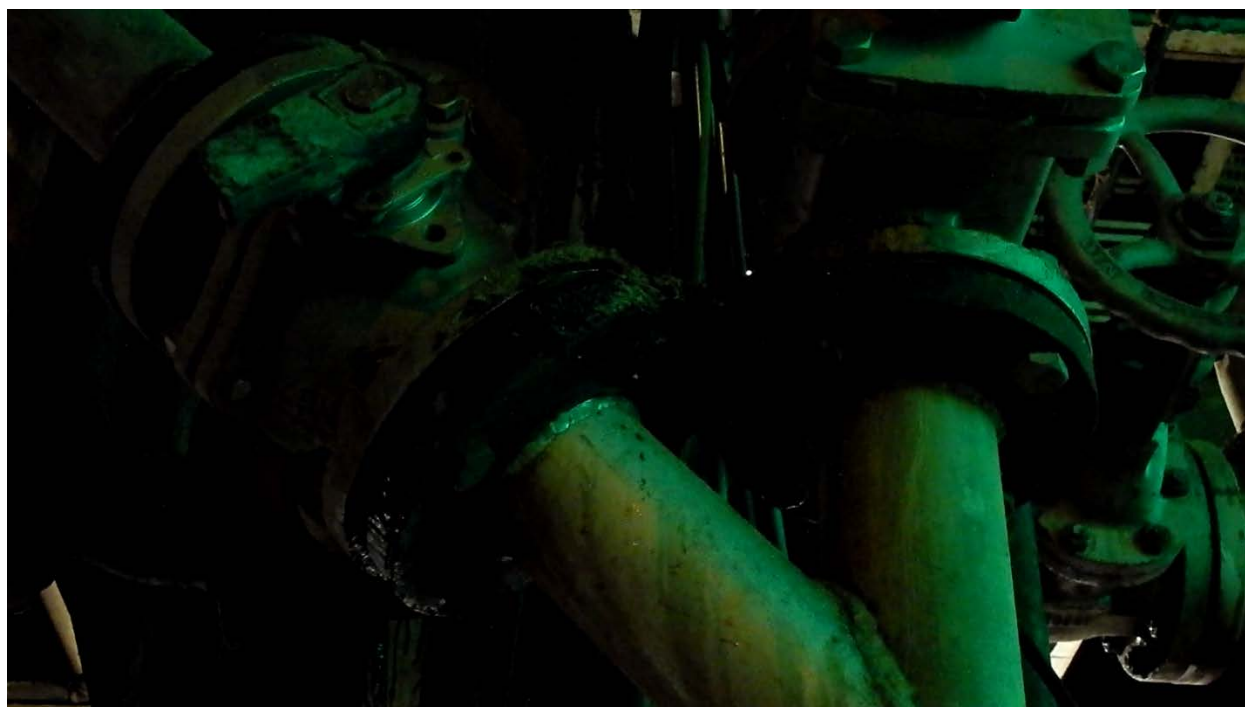
| Description: | Visual Emissions Leak from Digester 1 capping valve piping. | | | | |
