**Region 6 - Enforcement & Compliance Assurance Division  
INSPECTION REPORT**

| Inspection Date(s): | 01/14-17/2020 | |
| Company Name: | Evergreen Packaging, Inc. | |
| Facility Name: | Pine Bluff Mill | |

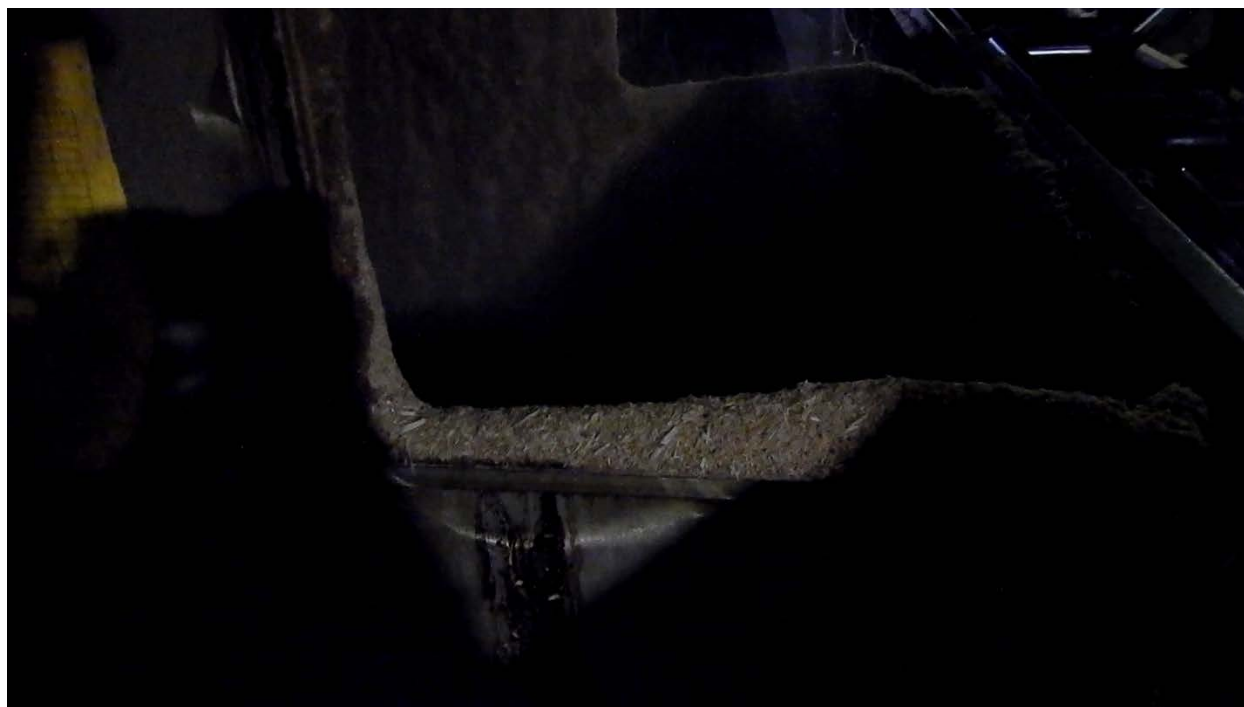
| Description: | Top of Digester 1 visual emissions leak during cook. | | | | | |

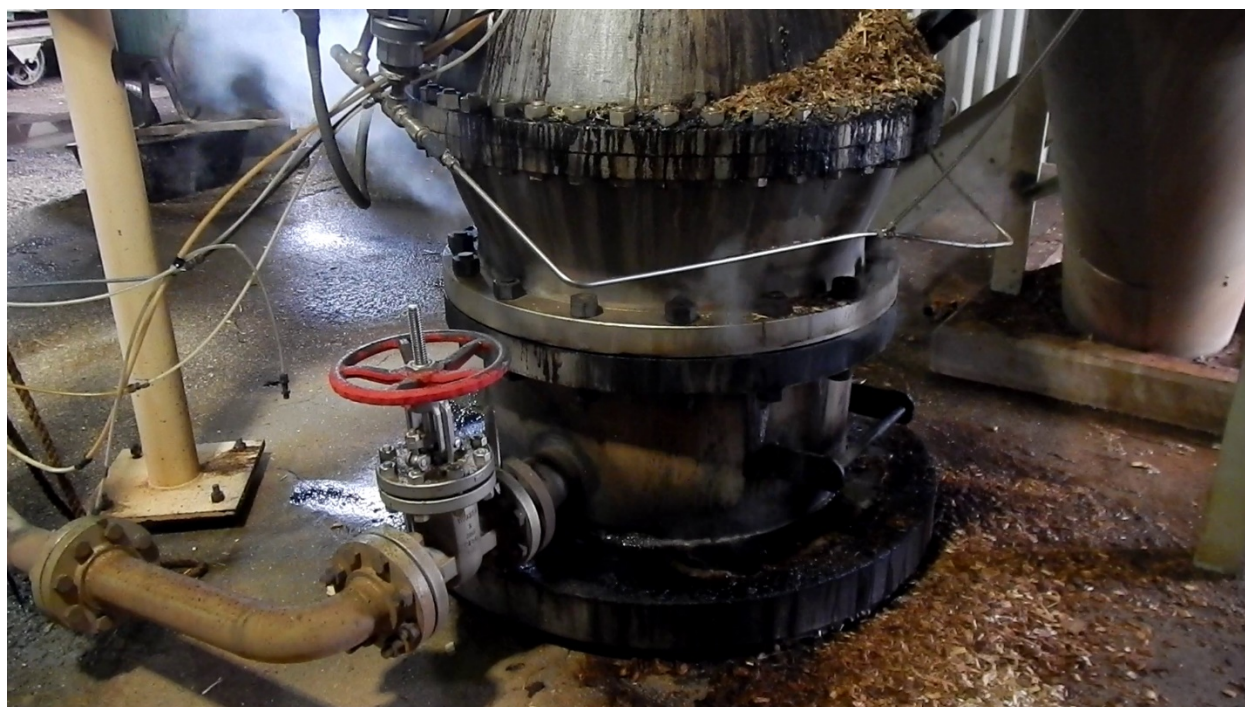
| Description: | Digester 14 capping valve leak. | | | | |

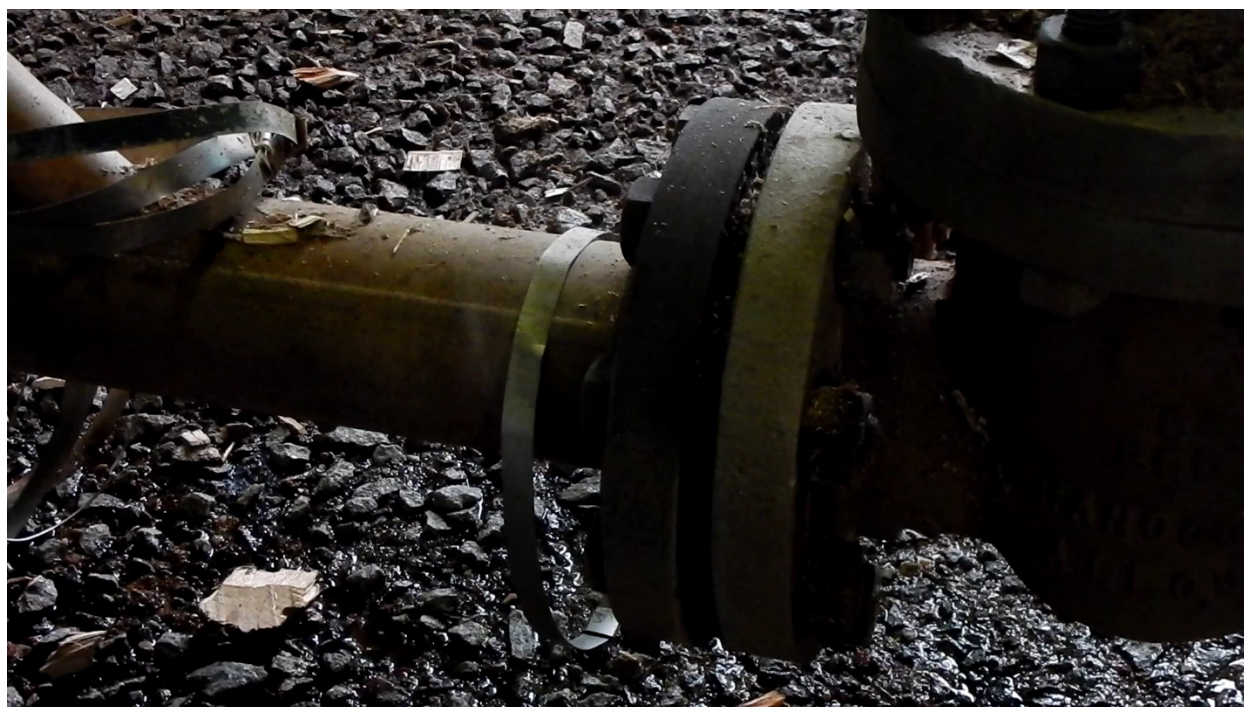
| Description: | Flange leak on NCG Line piping on Digester 11 capping valve. | | | | | |

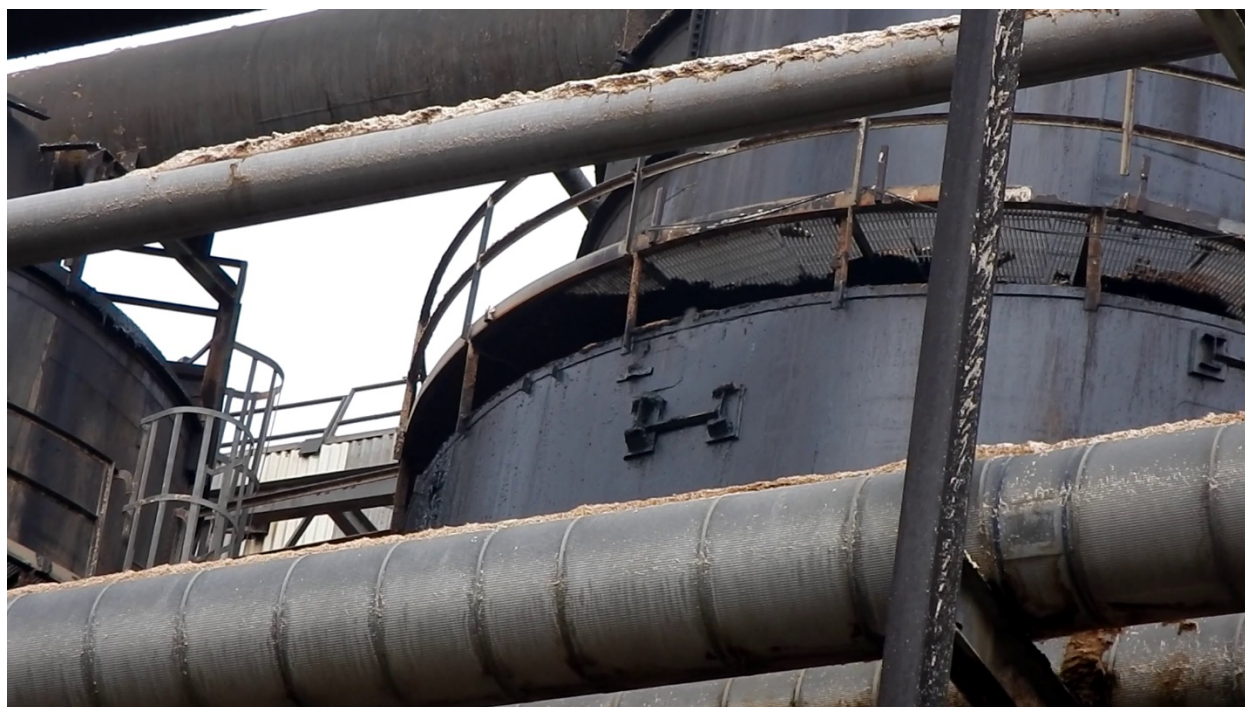
| Description: | Visual emissions leak from Blow tank C. | | | | | |

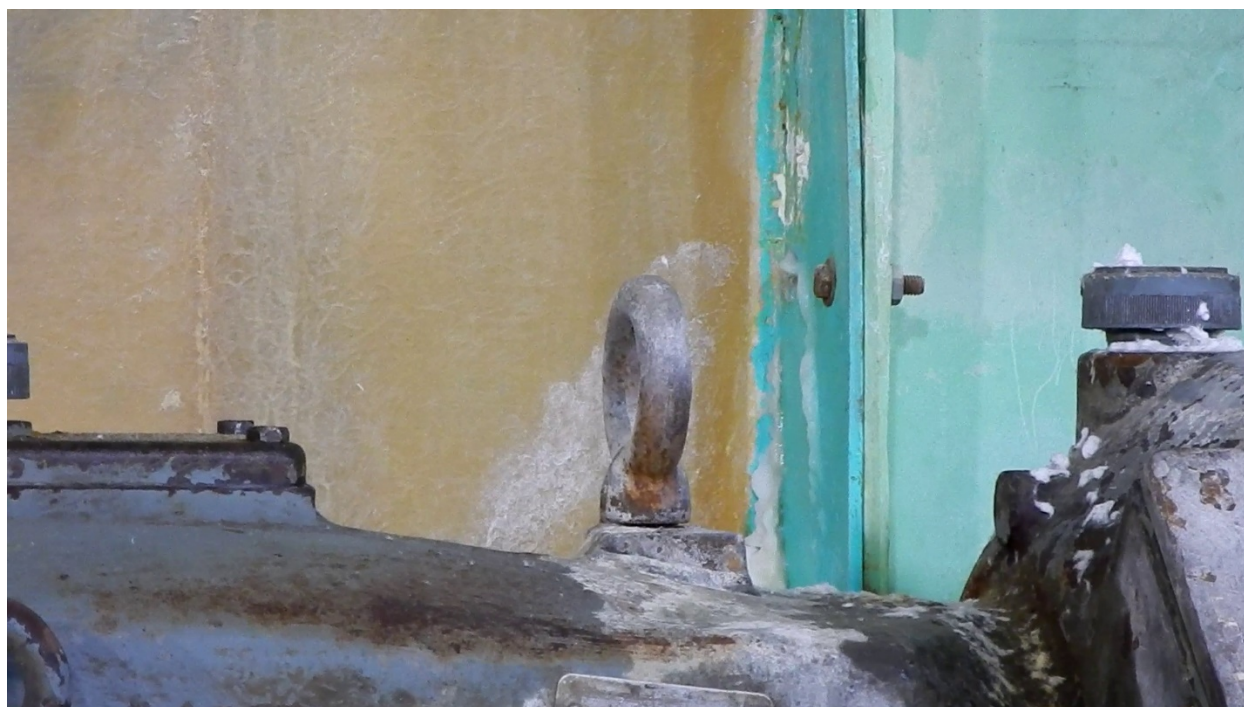
| Description: | 5B Washer liquid leak on front side. | | | | |

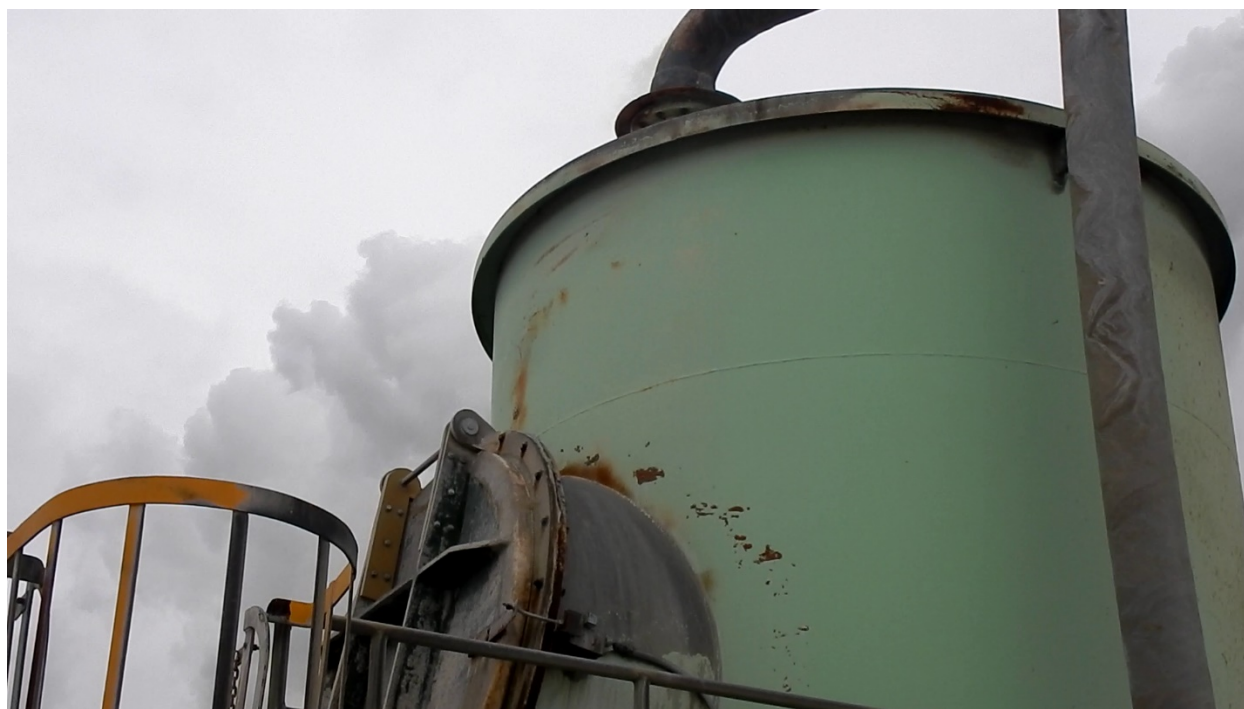
| Description: | Visual emission leak from 7B Bleach Plant Tower at flange and connecting pipe. | | | | |

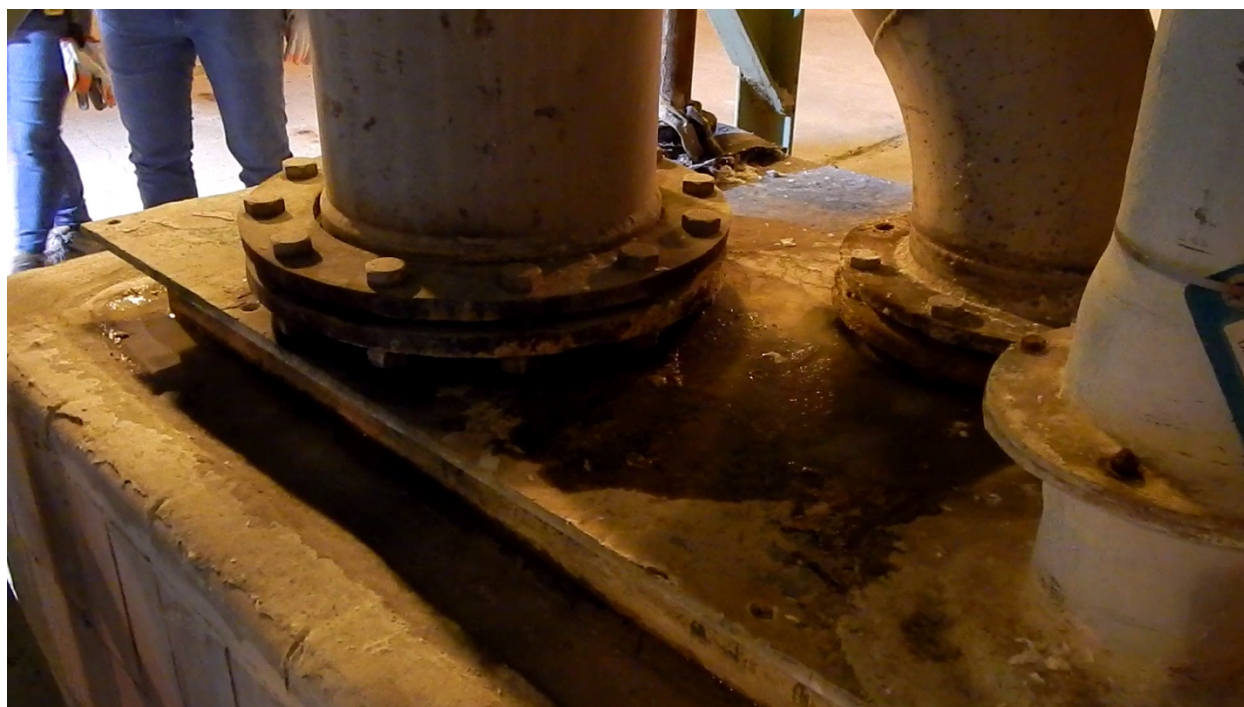
| Description: | Visual emissions from leak on 1B Seal Pit. | | | | |
