INSPECTION REPORT

| Type of Inspection | Compliance Evaluation Inspection | | |
| Permittee Name | Perlenfein, Inc | | |
| Facility Name | American Auto Salvage | | |

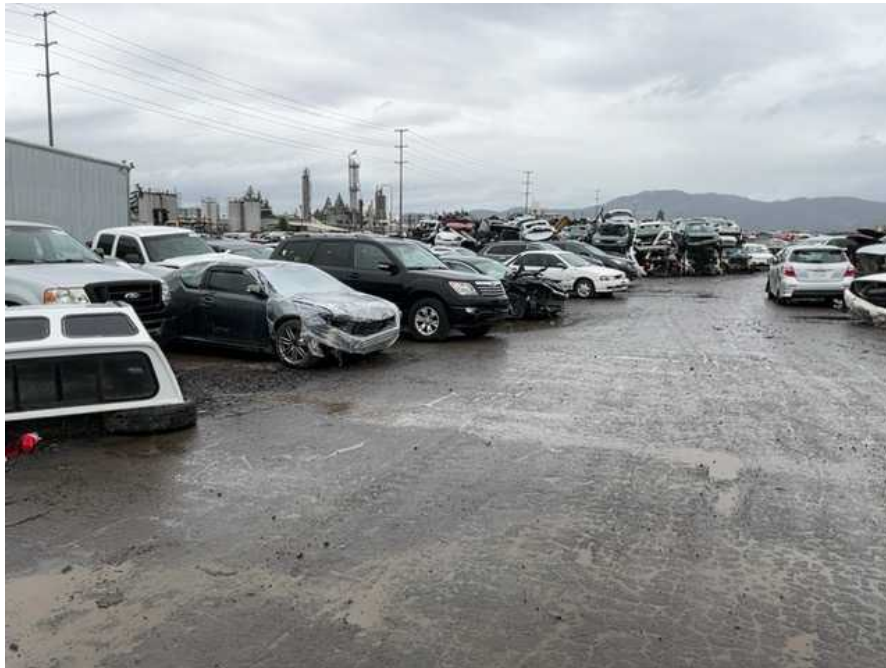
| Down Grade | | | IMG-2024112012170517598656.jpg |

| Yard with slight down slope to north. | | | |

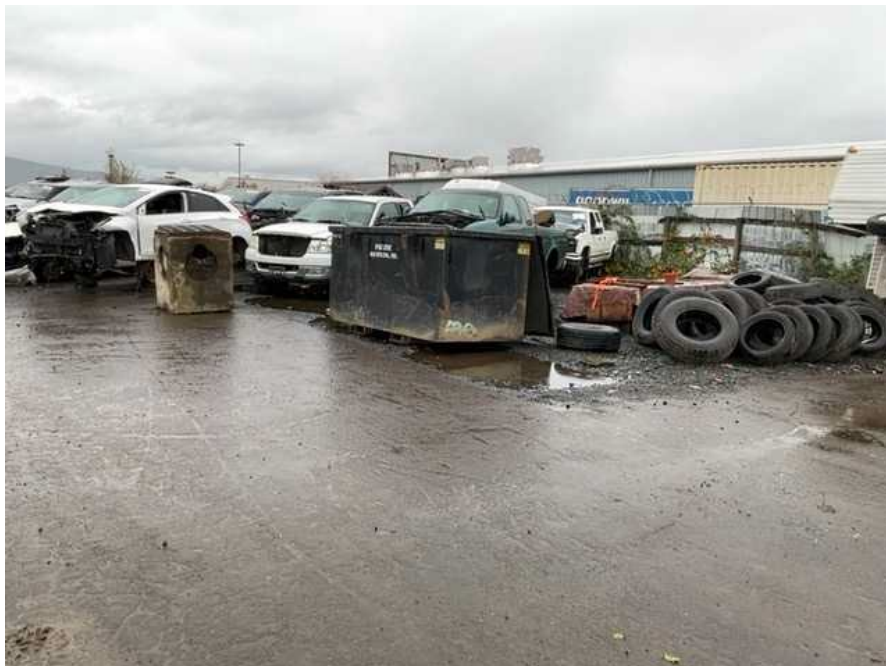
| Dumpster 1 | | | IMG-2024112012180618695352.jpg |

| At the time of the inspection, I observed two dumpsters in different areas of the yard that were not covered. One of the dumpsters contained miscellaneous items. The second dumpster contained old radiators that had been removed from waste vehicles. | | |

| <b>Permit Requirement</b><br>Schedule A.1.c of the permit states, in part, "Cover all waste contained in bins or dumpsters where there is a potential for drainage of stormwater through the waste to prevent exposure of stormwater to these pollutants." | |
| <b>AOC:</b><br>At the time of the inspection, I observed two dumpsters in different areas of the yard that were not covered. One of the dumpsters contained miscellaneous items. The second dumpster contained old radiators that had been removed from waste vehicles. | |

| Uncovered dumpster containing miscellaneous items. | | | |

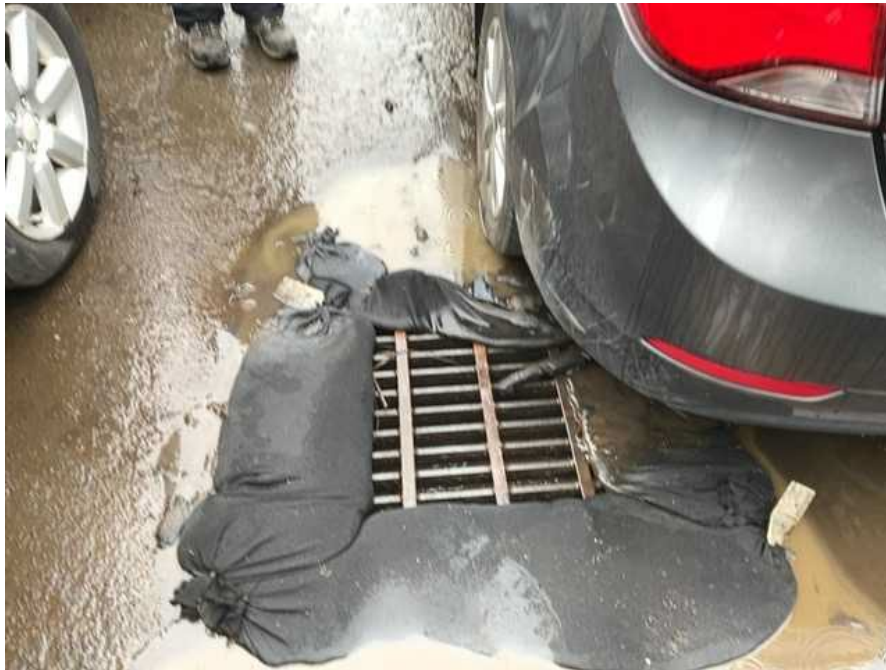
| Catch Basin 1 | | | IMG-20241120121921192196302.jpg |

| At the time of the inspection, I observed two catch basins that were encircled with bio-char bags. The bags were use as Best Management Practices (BMPs) to filter pollutants from the stormwater prior to the water entering the catch basin. The bio-char bags around catch basin 1 had been flattened, were ineffective, and needed replacement/maintenance. The bio-char bags around catch basin 2 were also ineffective and needed replacement/maintenance. (The facility has three catch basins. Catch basin three was properly encircled by the bio-char bags.) | | |

| <b>Permit Requirement</b><br>Schedule A.2.a of the permit states, in part, "The permit registrant must select, design, install, implement and maintain control measures, including all best management practices (BMPs)..." | |
| <b>AOC:</b><br>At the time of the inspection, I observed two catch basins that were encircled with bio-char bags. The bags were use as Best Management Practices (BMPs) to filter pollutants from the stormwater prior to the water entering the catch basin. The bio-char bags around catch basin 1 had been flattened, were ineffective, and needed replacement/maintenance. The bio-char bags around catch basin 2 were also ineffective and in need of replacement/maintenance. | |

| Catch basin 1 with biochar filter bag showing lack of maintenance. Need replacing. | | | |

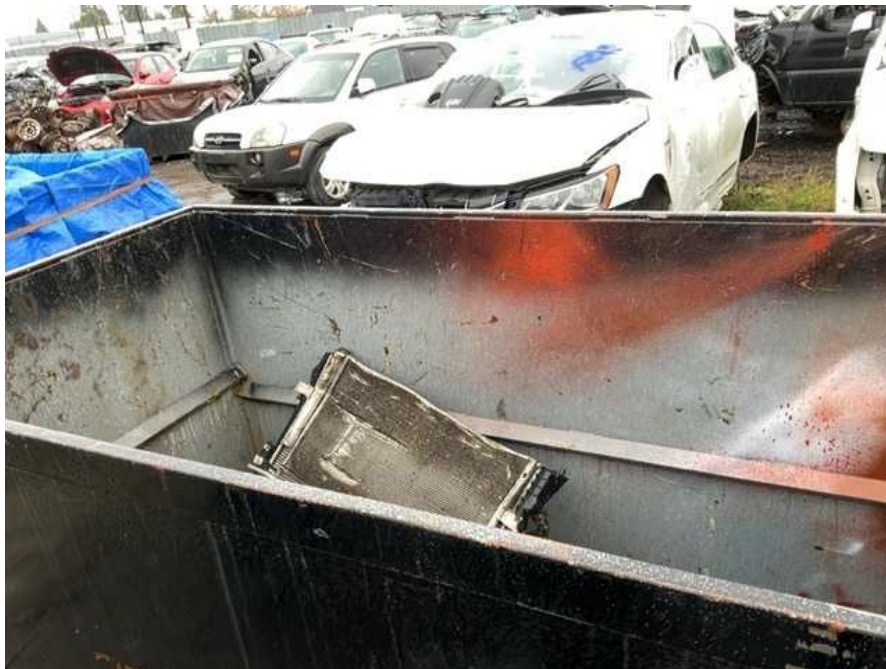
| Dumpster 2 | | | IMG-202411201224562456115206.jpg |

| Uncovered dumpster containing old radiators. | | | |

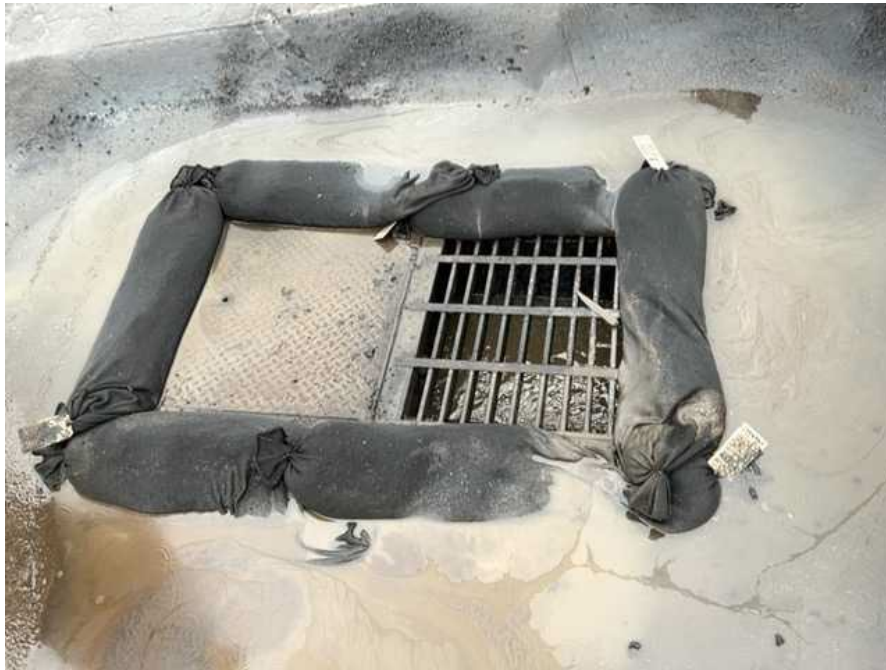
| Catch Basin 2 | | | IMG-20241120122719271996898.jpg |

| Catch basin 2 with biochar bags. Requires maintenance. The bags are ineffective in lower right corner. | | | |

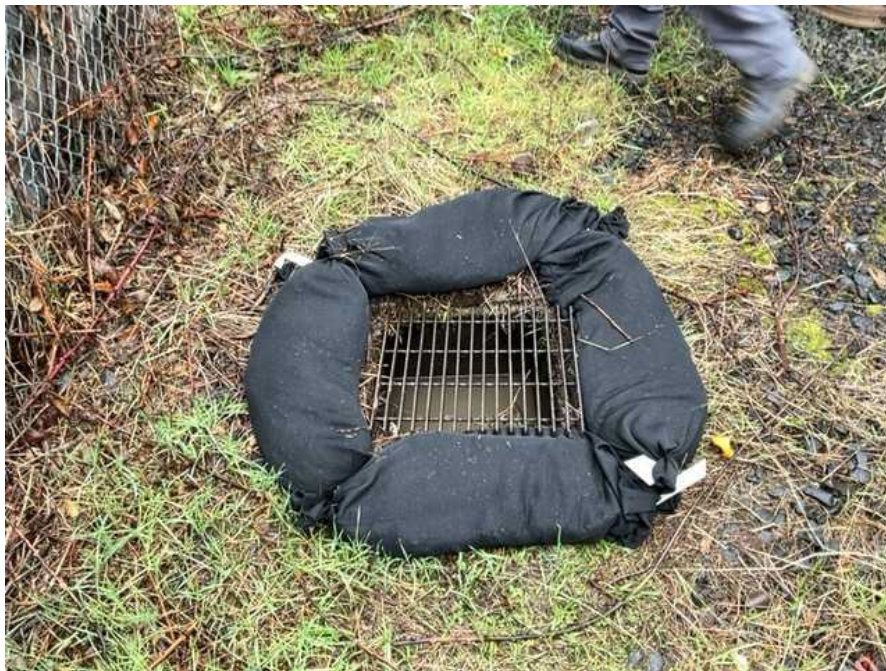
| Catch basin 3 | | | IMG-20241120123201321198184.jpg |

| Catch basin 3 in good repair. | | | |

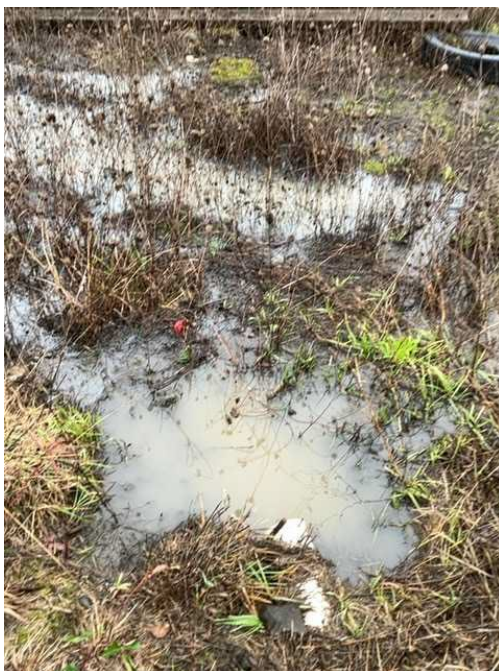
| Discharge Point | | | IMG-202411201237533753177992.jpg |

| The site discharges into a ditch through a 6-inch diameter PVC pipe. The ditch flows to the receiving water, Mill Race Creek. At the time of the inspection, the water level in the ditch had almost fully submerged the discharge pipe. The facility could not obtain a representative sample of its discharge due to the discharge mixing with water from other sources. | | |

| <b>Permit Requirement</b><br>Schedule B.7.a.i of the permit states, "Samples must be representative of the discharge." | |
| <b>AOC:</b><br>The site discharges into a ditch through a 6-inch diameter PVC pipe. The ditch flows to the receiving water, Mill Race Creek. At the time of the inspection, the water level in the ditch had almost fully submerged the discharge pipe. The facility could not obtain a representative sample of its discharge due to the discharge mixing with water from other sources. | |

| The facility cannot acquire a representative sample due to the discharge pipe being partially submerged. Water discharges into a ditch which flows to Mill Race creek. | | | |
