## Region 6 - Enforcement & Compliance Assurance Division

### INSPECTION REPORT

| Inspection Date(s): | April 15, 2025 | |
| Facility Name: | <b>Bloomfield Wastewater Treatment Plant</b> | |

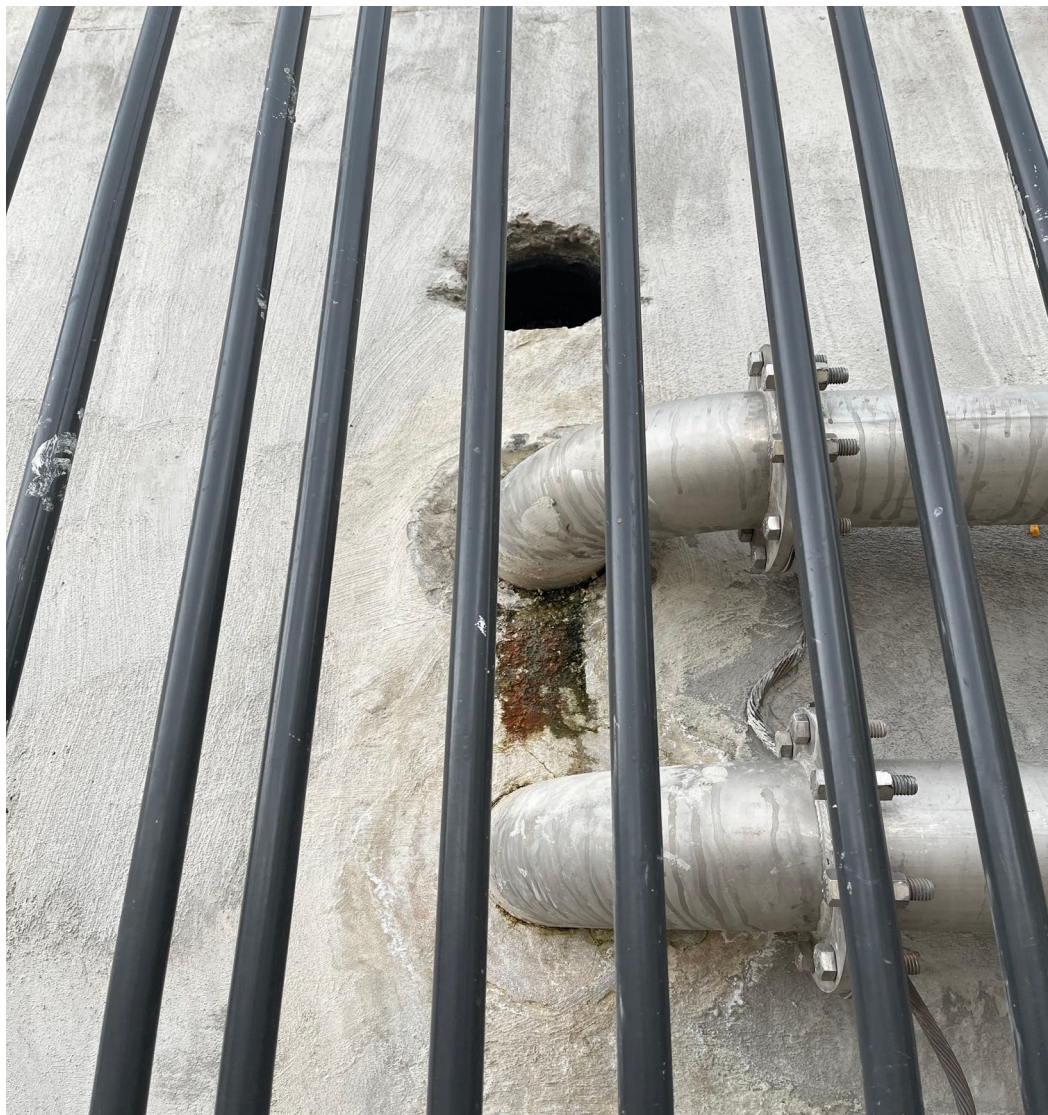
Photo No. 1

- The newly constructed SBR basins exhibited significant leaking at the sidewall penetrations for the air piping. The insertion of an expandable rubber seal (LINK-SEAL®) failed to prevent leakage. The plastic sleeves placed during the concrete pouring for sidewall penetration were not rigid enough to prevent movement; thus, not allowing adequate contact with LINK-SEAL®.

View of air piping sidewall penetration along the southeast corner. **Note:** the visible leaking and staining. Additionally, the visible upper penetration is sealed on the interior of the basin. (IMG\_0307).  
03/27/2025 11:21 AM Photographed by D. Esparza

- Suggest current photographic documentation around air piping penetrations and visible exterior sidewall leakage/algae growth, thence cleaning (power washing), thence photographic documentation at the same location(s), thence periodic (recorded) photographic documentation to denote degradation of sidewall penetrations or air piping. Keep track of evidence of further degradation on a regular basis to ensure timely repairs as necessary.

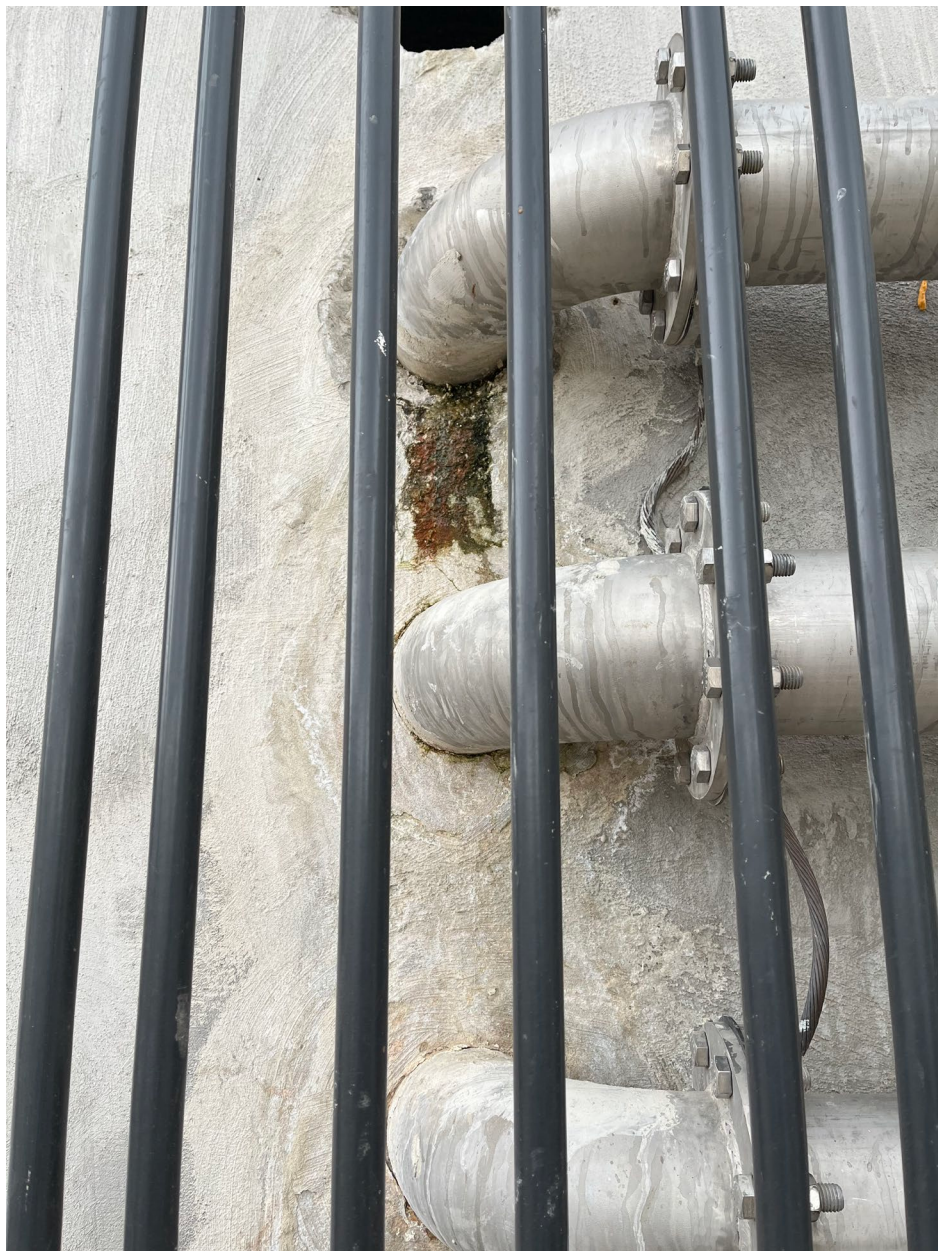
Photo No. 2

Another view of the same sidewall penetration. (IMG\_0308). 03/27/2025 11:22 AM Photographed by D. Esparza

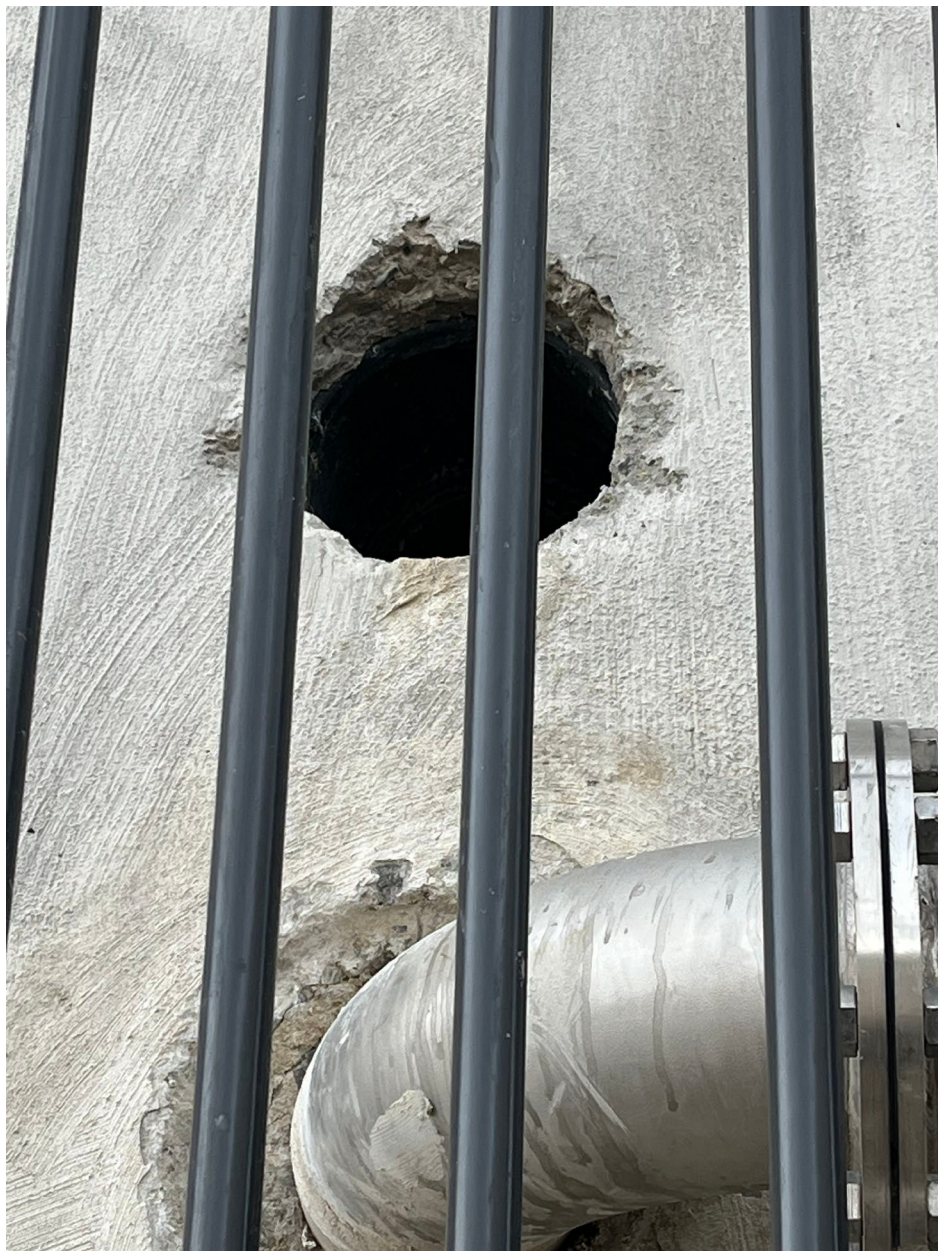
Photo No. 3

A closer view of the upper penetration along the southeast corner. **Note:** the potential avenue for exterior degradation or storm event intrusion. (IMG\_0311). 03/27/2025 11:22 AM Photographed by D. Esparza

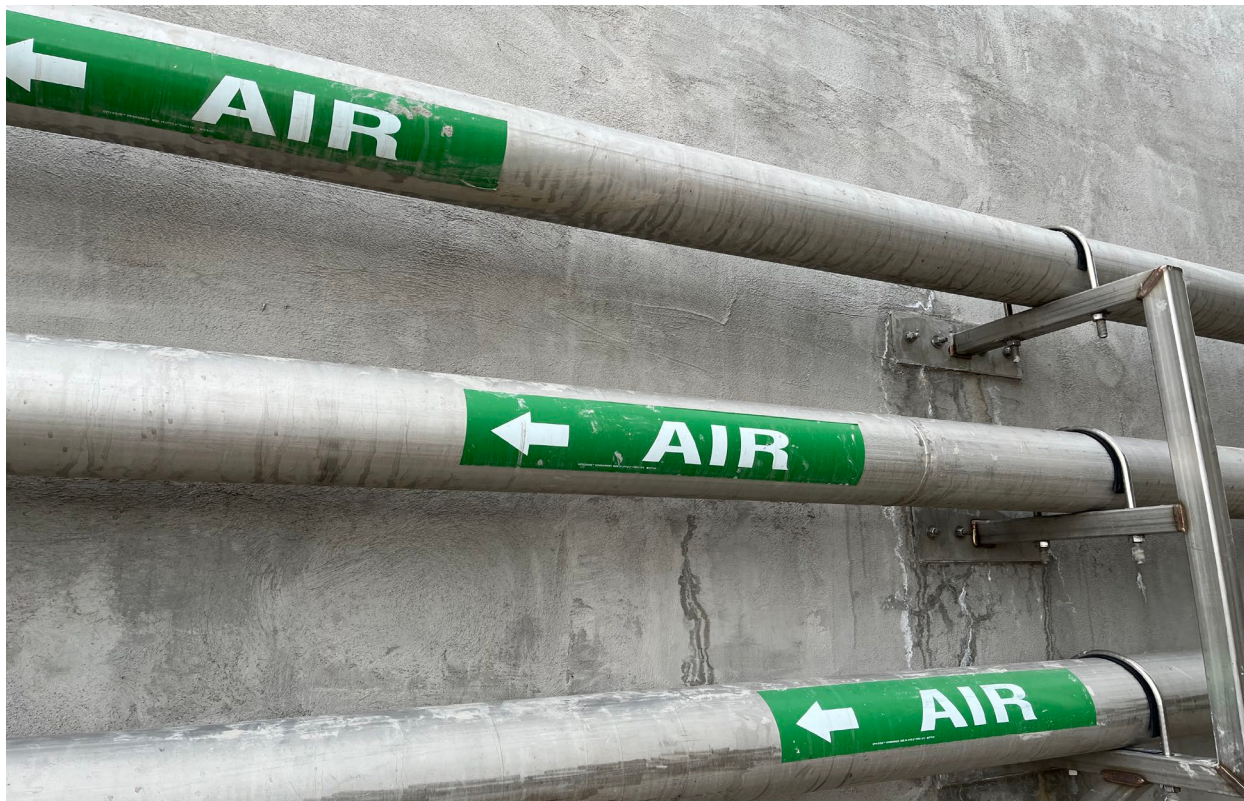
Photo No. 4

- Typically, the lack of proper concrete vibration (which removes entrapped air bubbles from fresh pours and helps it flow evenly around the reinforcement) during the concrete pour can result in cracks and honeycombing as exhibited with the visible exterior staining and algae growth (see **Appendix 1 Photograph #4, Photograph #5 and Photograph #6**) of concrete. This sidewall leaking and algae growth could exacerbate the degradation of the concrete and integrity of the air piping; thus, potentially lessening their service life (Appendix 1 **Photograph #9, Photograph #10, Photograph #11 and, Photograph #12 and Photograph #13**).

View of the air piping support brackets approximately midway along new SBR basins. **Note:** the visible leaking. (IMG\_0309). 03/27/2025 11:22 AM Photographed by D. Esparza

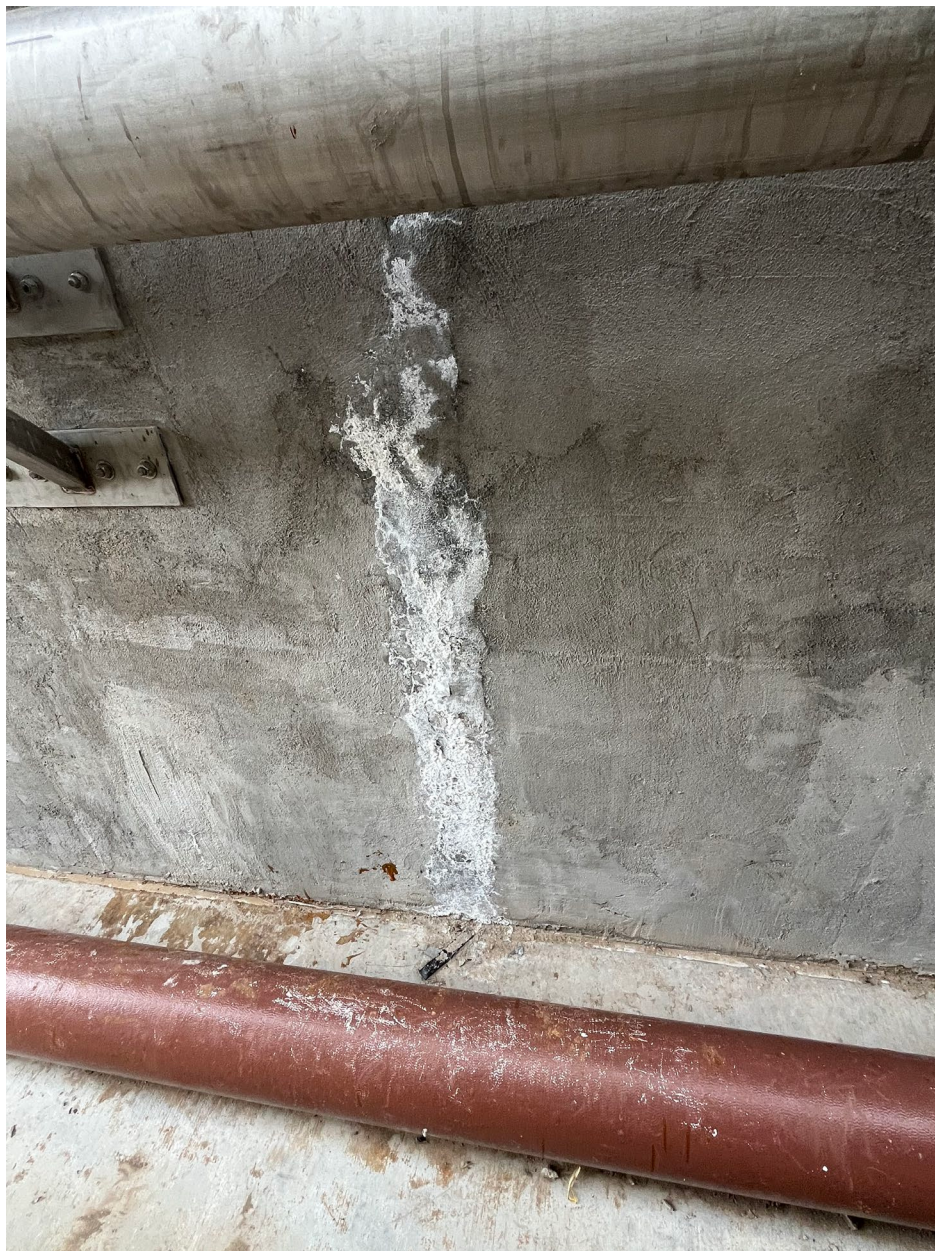
Photo No. 5

Another view of leaking along the new SBR basins approximately at land surface. (IMG\_0312).  
03/27/2025 11:23 AM Photographed by D. Esparza

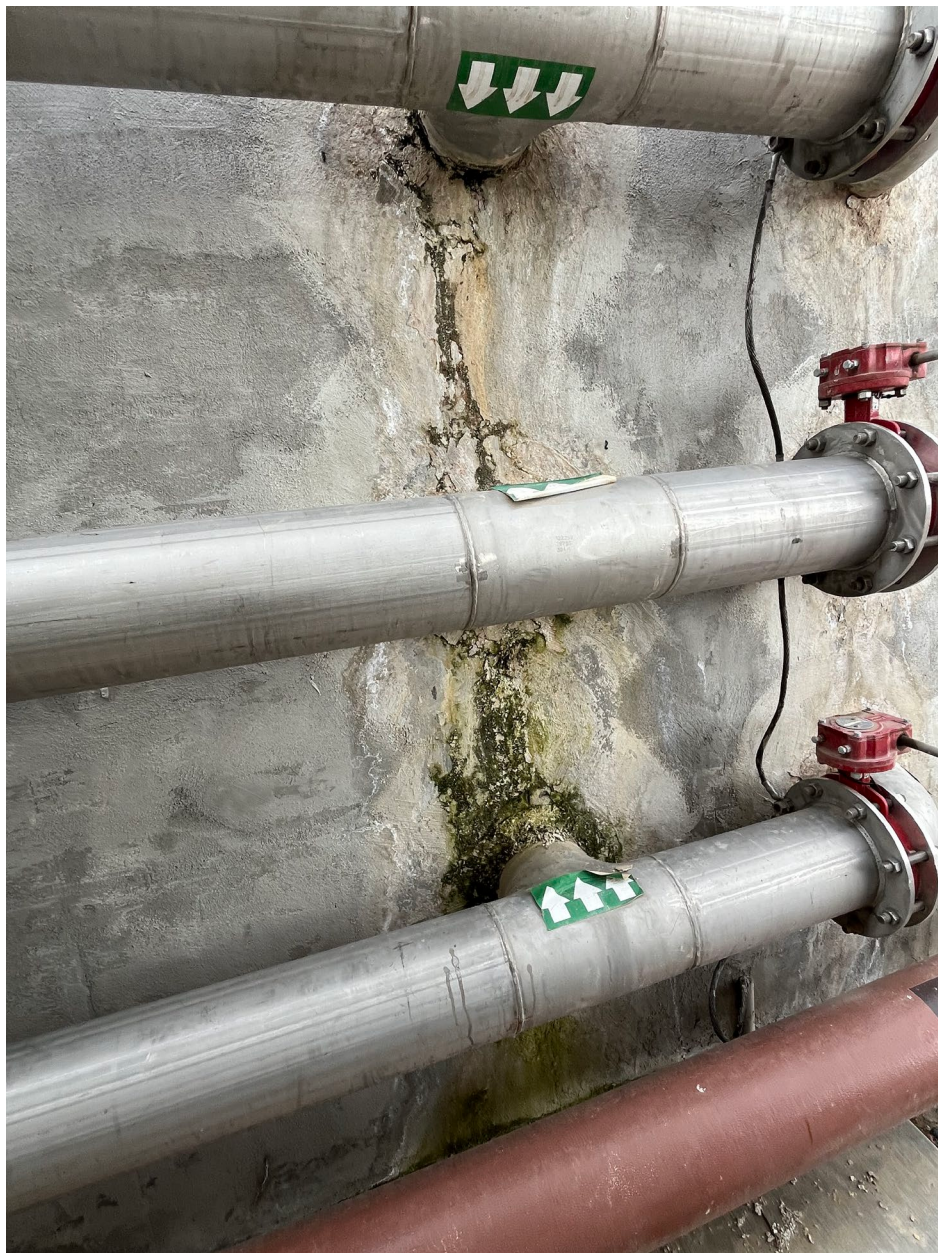
Photo No. 6

View of the air piping penetrations along the Northeast corner of the new SBR basins. **Note:** the leaking and algae growth. (IMG\_0315). 03/27/2025 11:24 AM Photographed by D. Esparza

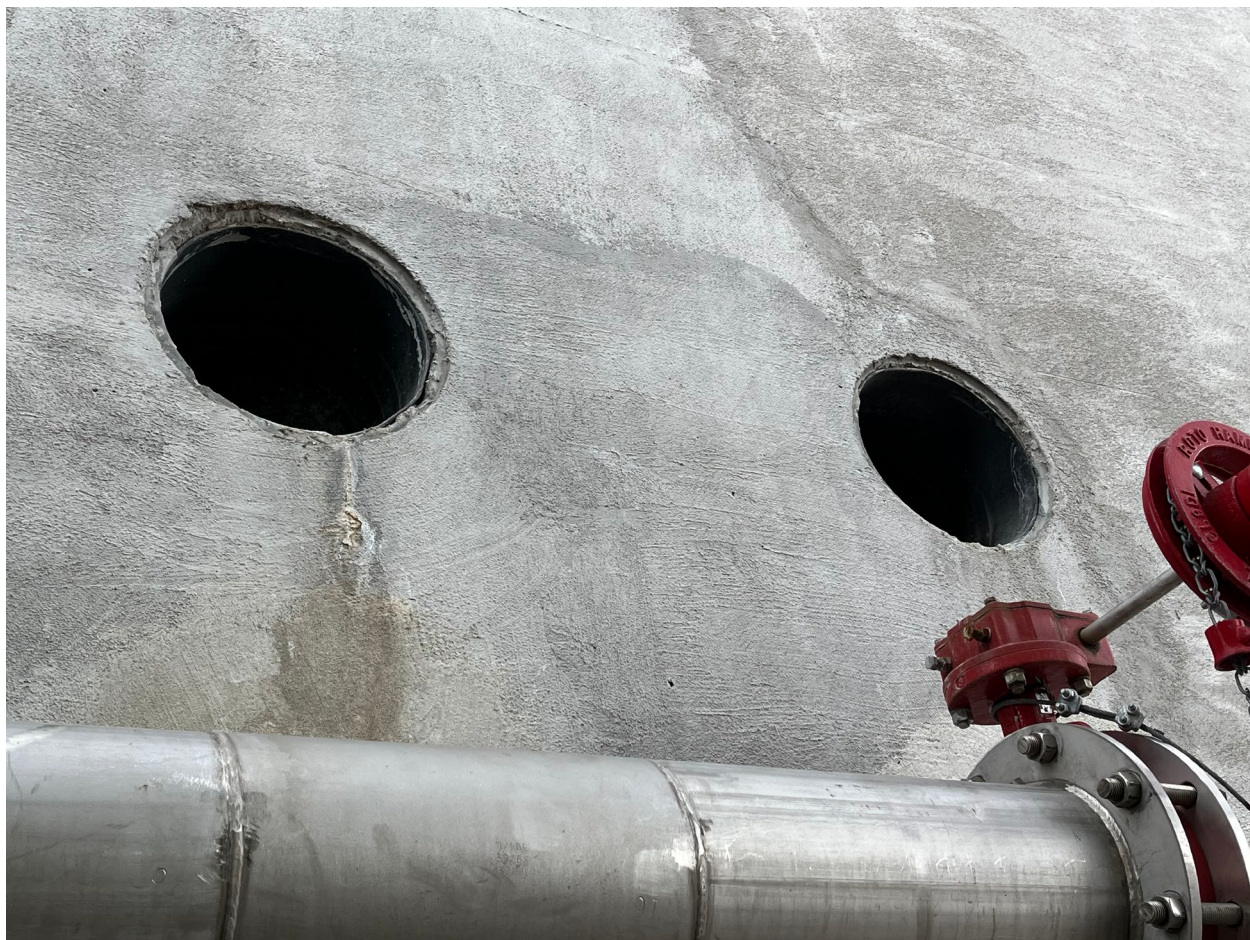
Photo No. 7

View of 2 upper sidewall penetrations along the Northeast corner of the SBR basins. **Note:** the leaking of the left penetration, indicative of the expandable rubber seal failure. (IMG\_0316). 03/27/2025 11:25 AM  
Photographed by D. Esparza

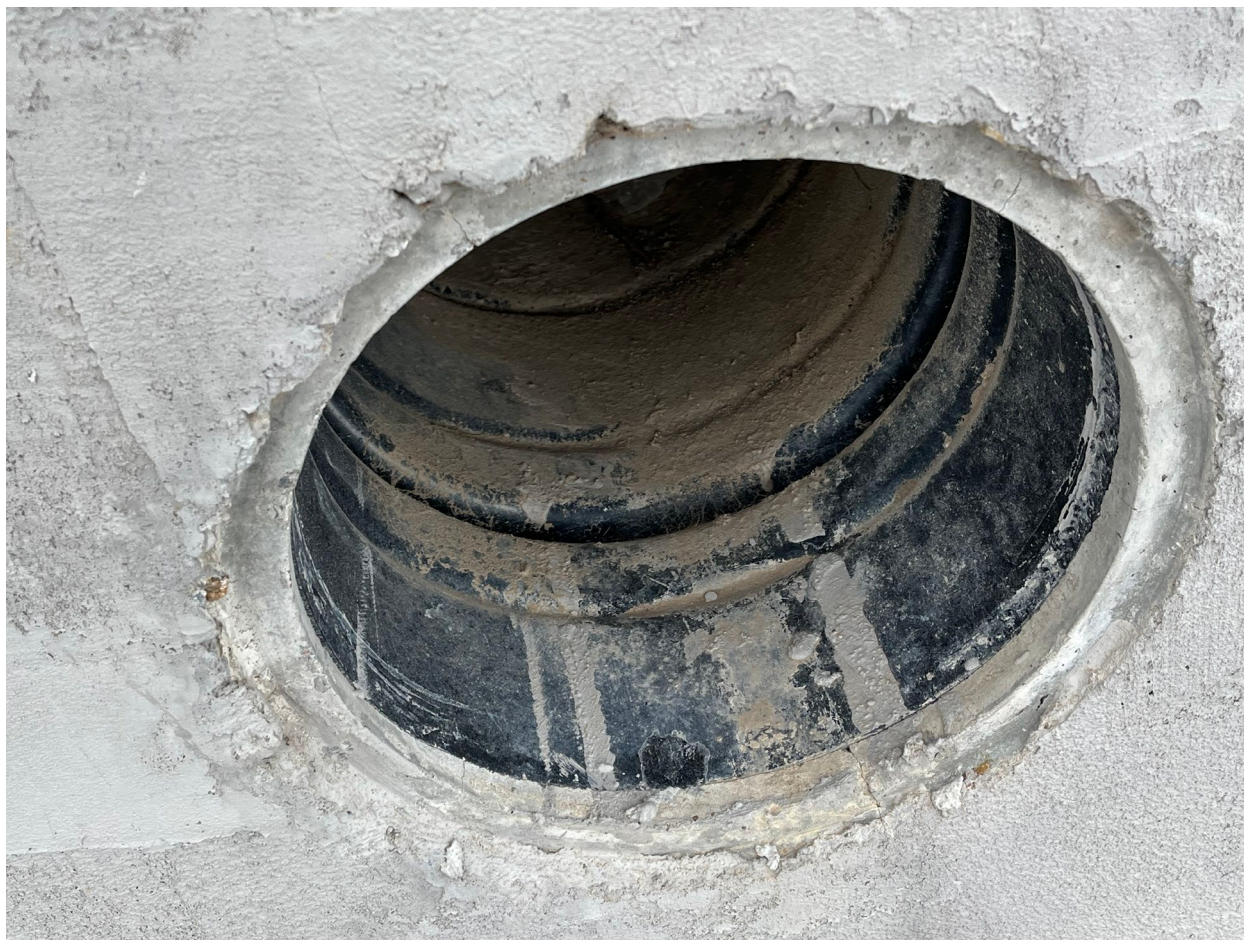
Photo No. 8

Close-up view of a sidewall penetration. **Note:** the cracking and spalling of the concrete around penetration. (IMG\_0317). 03/27/2025 11:26 AM Photographed by D. Esparza

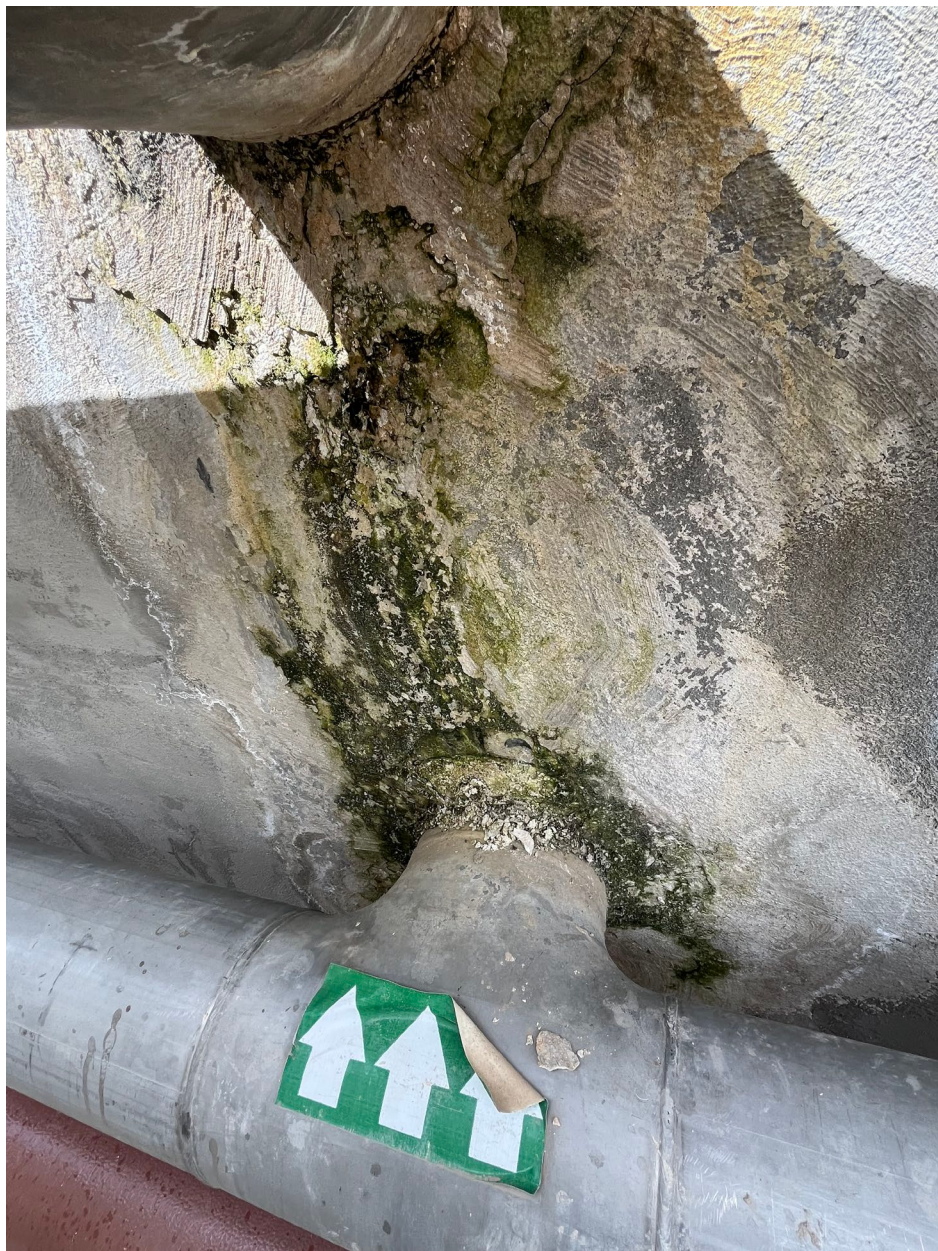
Photo No. 9

Close-up view of the same air piping penetrations identified in Photo No. 6 above. (IMG\_0324).  
03/27/2025 11:36 AM Photographed by D. Esparza

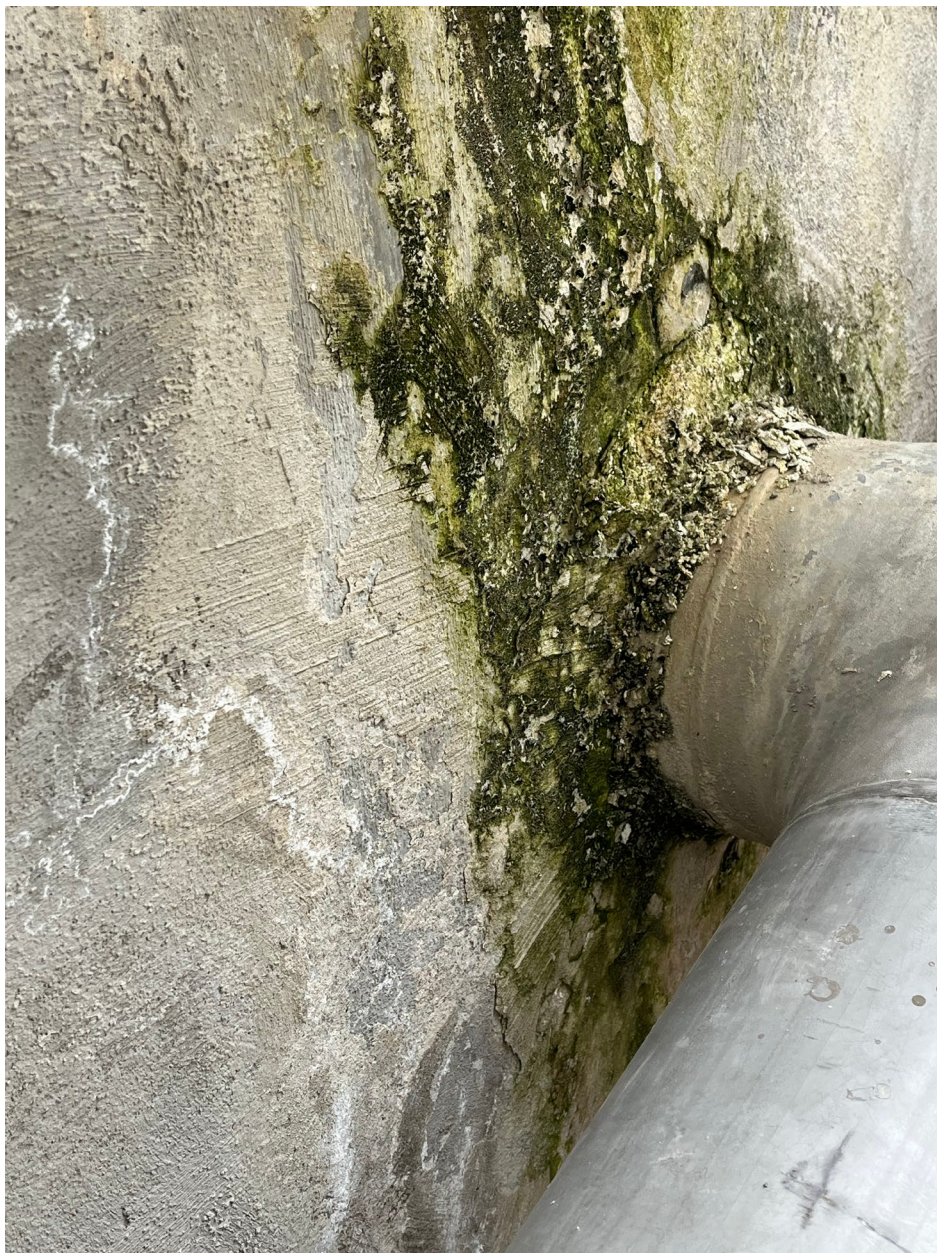
Photo No. 10

Closer view of the same air piping penetrations identified in Photo No. 6 and Photo No. 7 above.  
(IMG\_0326). 03/27/2025 11:37 AM Photographed by D. Esparza

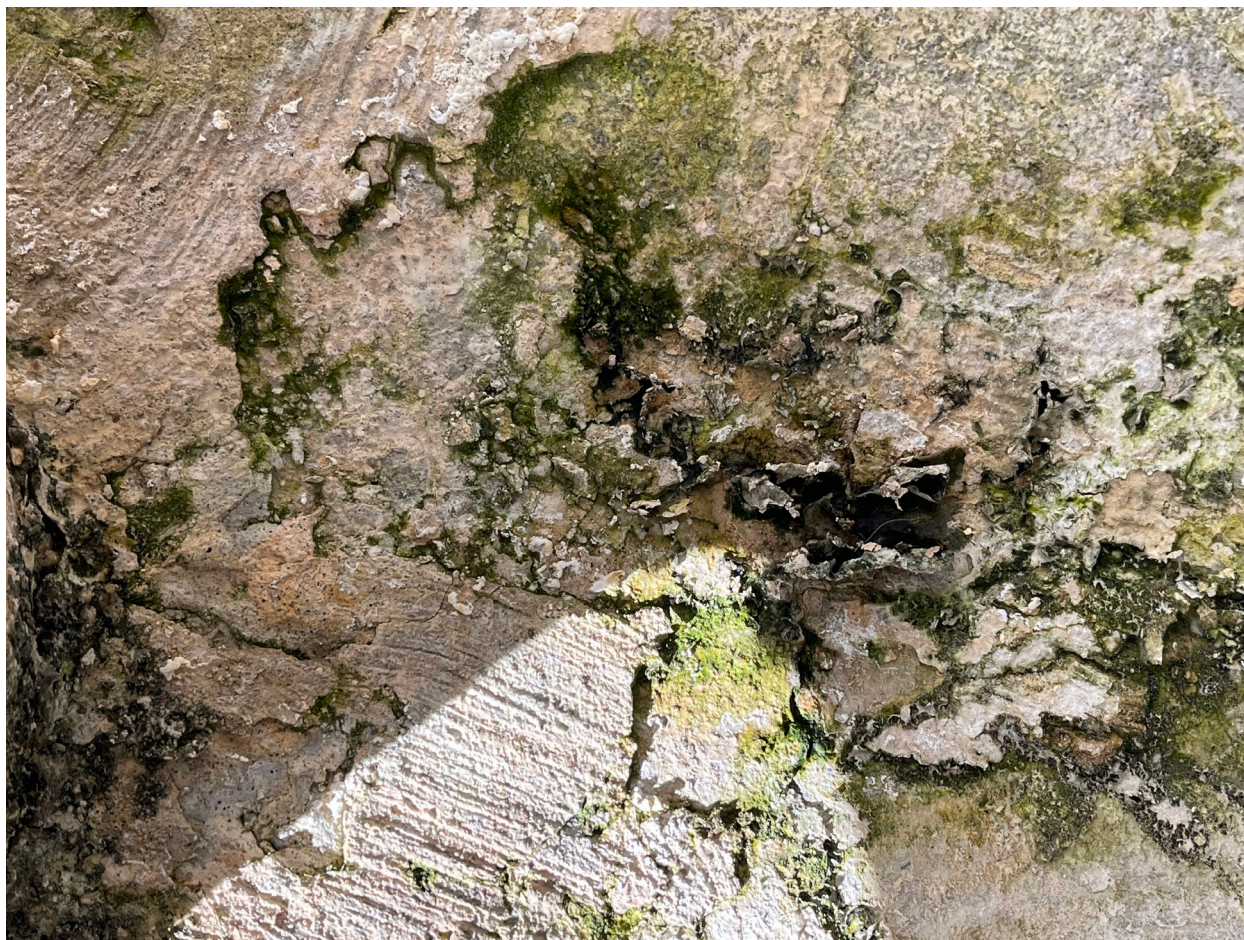
Photo No. 11

View of the concrete degradation and algae growth along the SBR sidewall. (IMG\_0327). 03/27/2025 11:37 AM Photographed by D. Esparza

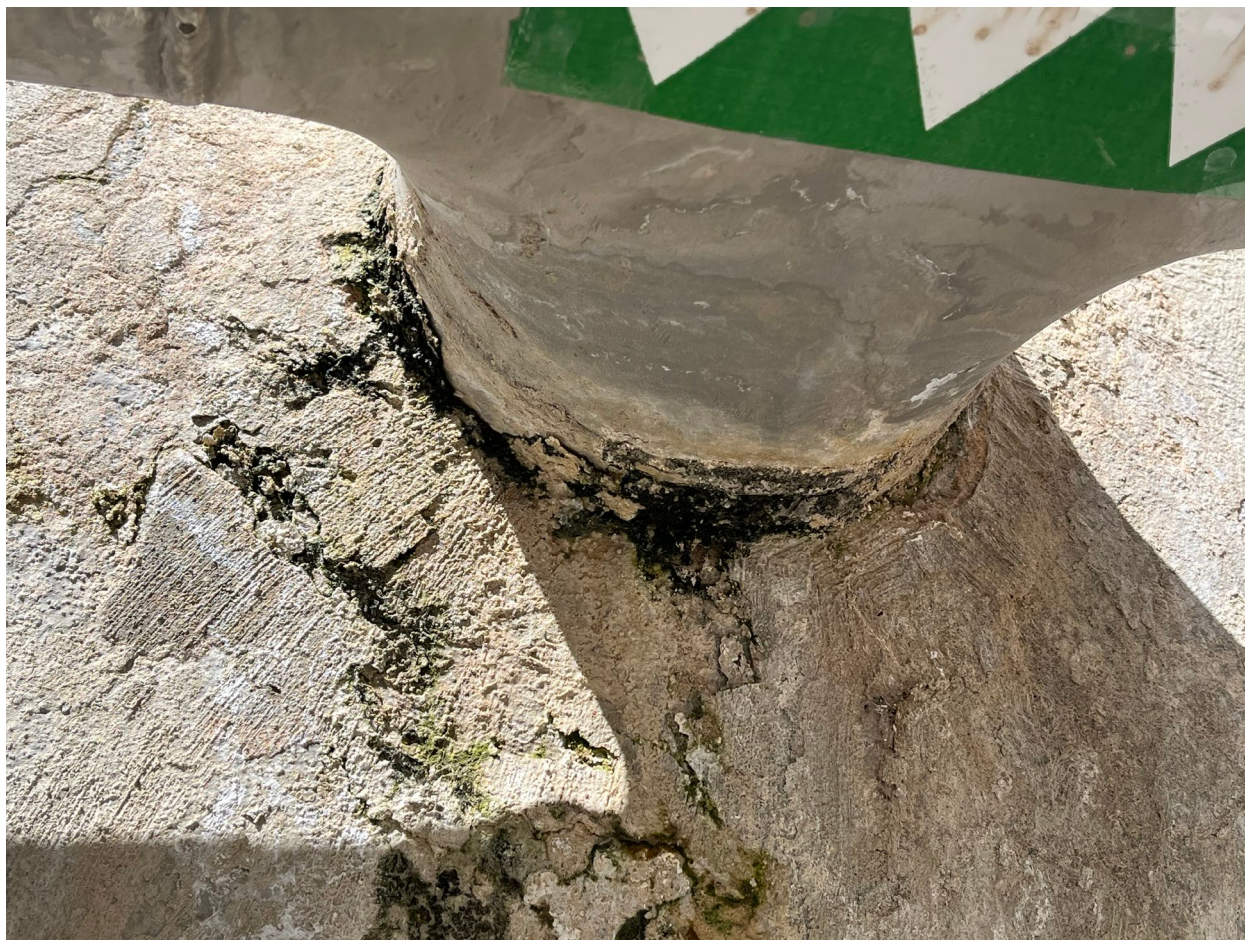
Photo No. 12

Another view of the concrete degradation and algae growth along the SBR sidewall. (IMG\_0328). **Note:** the appearance of the air piping corrosion. 03/27/2025 11:38 AM Photographed by D. Esparza

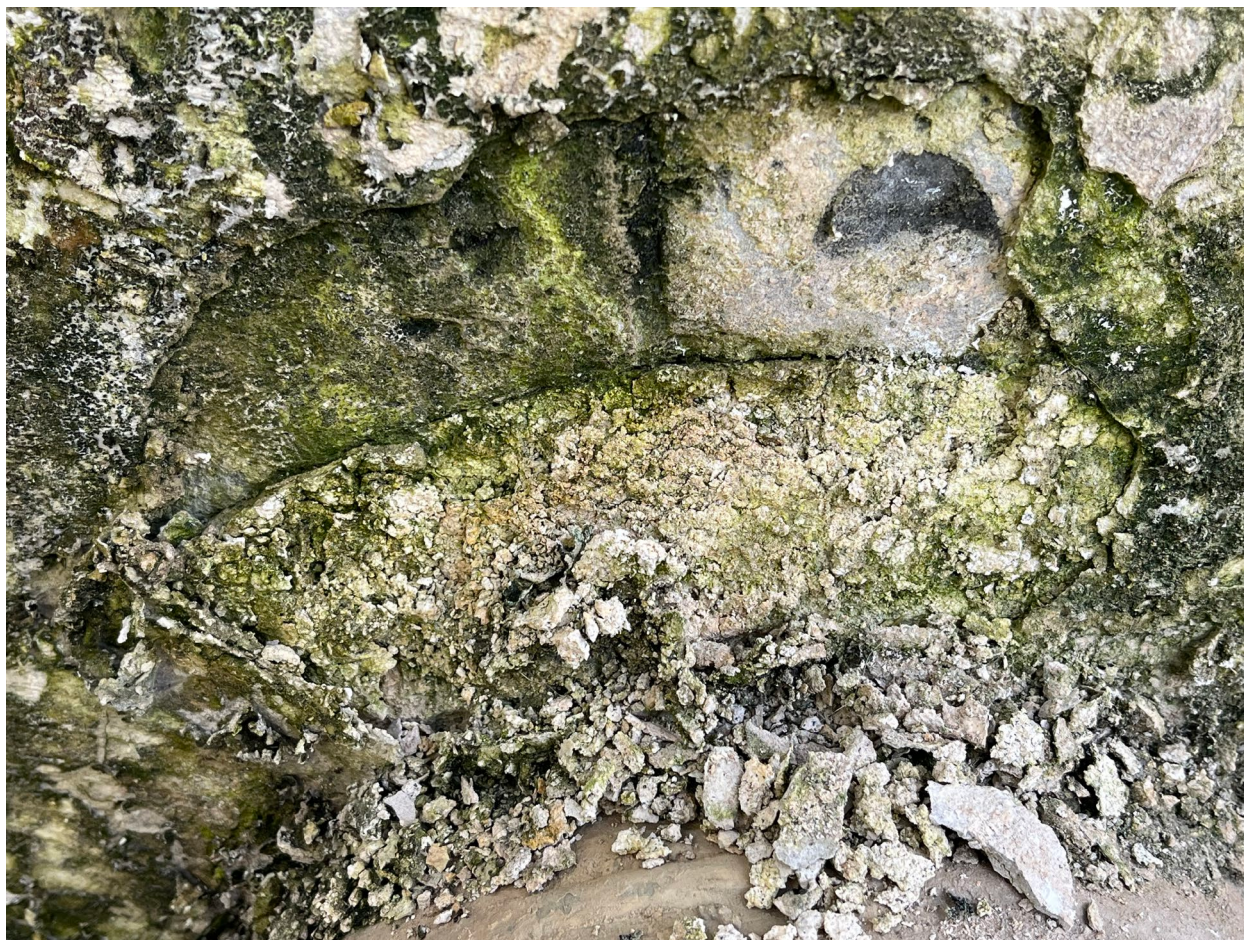
Photo No. 13

A clear close-up view of the concrete degradation and algae growth along the SBR sidewall. (IMG\_0330).

**Note:** the appearance of the air piping corrosion. 03/27/2025 11:39 AM Photographed by D. Esparza

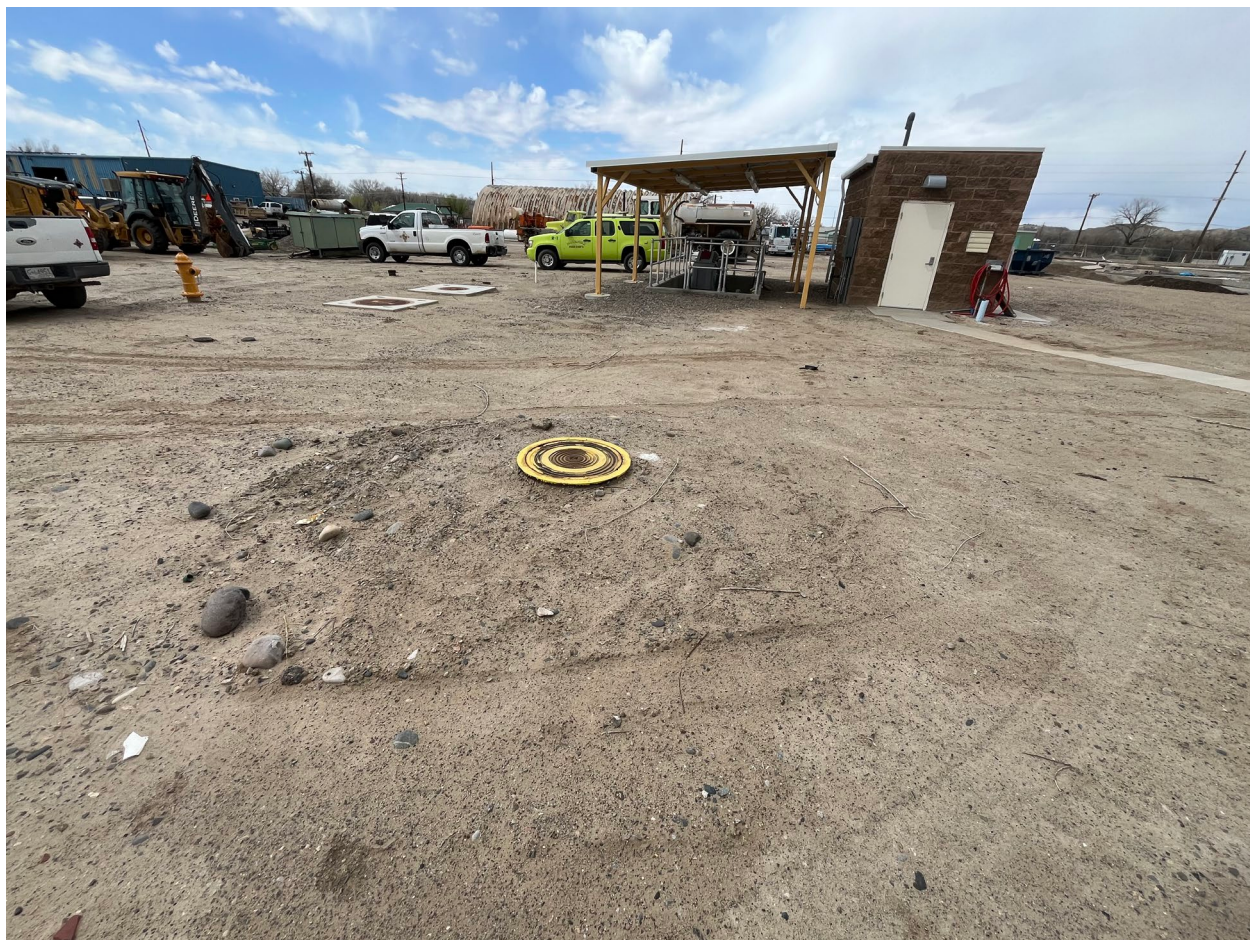
Photo No. 14

- Injection point (manway) for the sodium bisulfite lacked typical bollards or devices to prevent potential vehicular damage. Vehicle tire tracks were visible around both sides of the manway (**Appendix 1 Photograph #14**).

View of sodium bisulfite injection manway. Note: the visible vehicle tire marks around the manway and lack of structure protection, i.e., bollards. (IMG\_0318) 03/27/2025 11:32 AM Photographed by D. Esparza

- **Section IV – RECOMMENDATIONS**
  - Install vehicular traffic barriers i.e., bollards or similar devices around the injection point (manway) for the sodium bisulfite to prevent potential damage (**Appendix 1 Photograph #14**).
