# **NPDES Compliance Inspection Report**

## **Weyerhaeuser – Santiam Lumber Lebanon, Oregon**

**Permit #: ORR221262**

**Inspection Date: December 16, 2021**

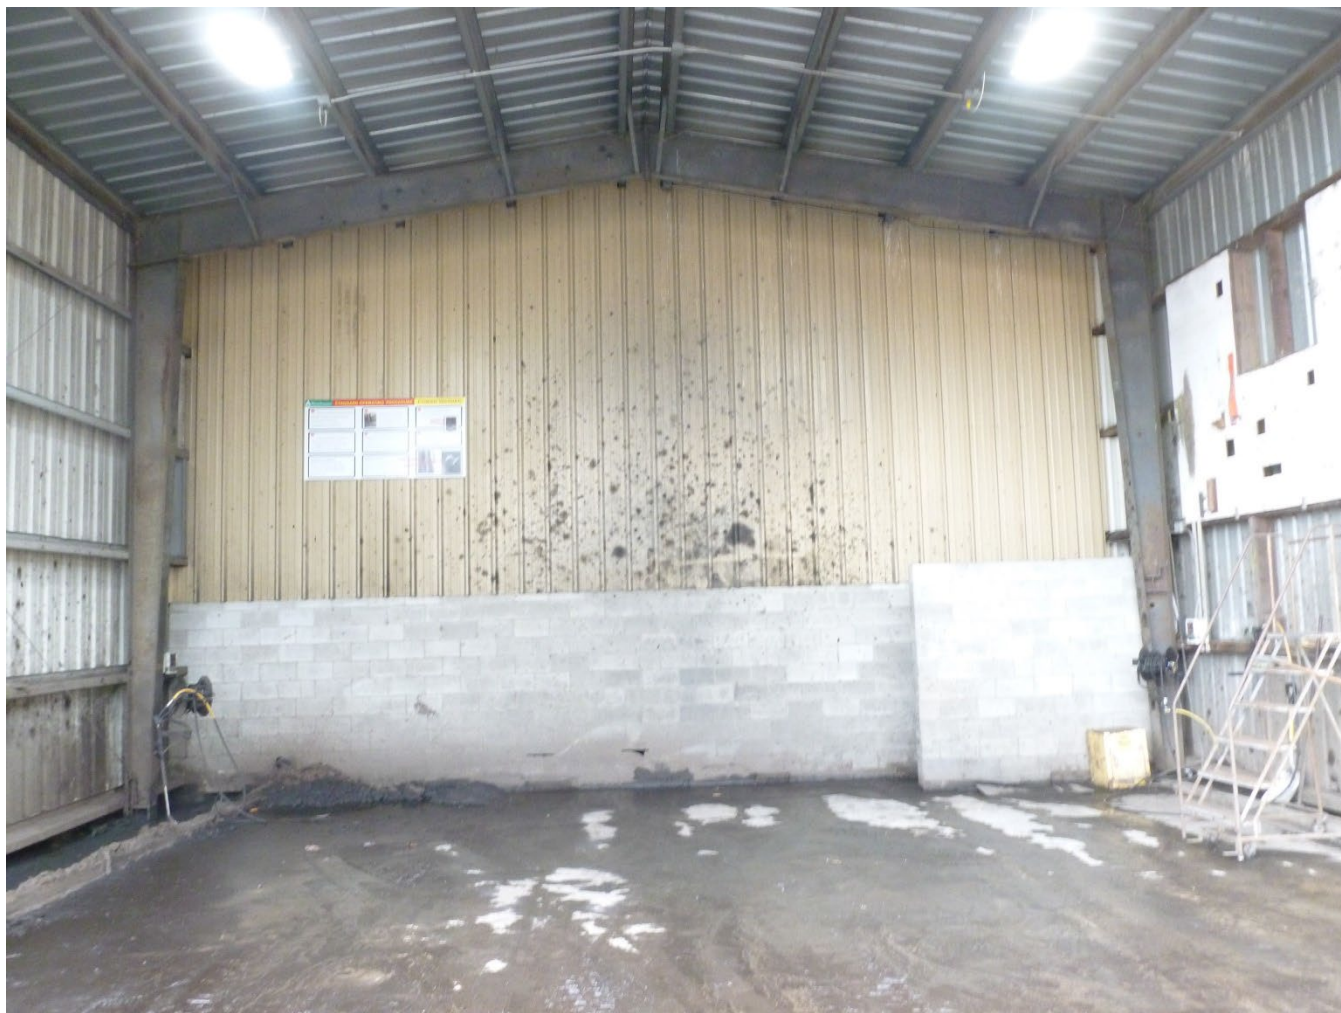
**Photo 1 / P1010091 – Truck Wash Bay**

From the office, we headed to the perimeter fence on the west side of the site because several discharge points discharge into a ditch that lies adjacent to the western perimeter fence. Along our route, we came to the vehicle wash bay (**Photo 1**). The bay is graded so wash water flows to the back wall which has cut-outs to allow water to flow through and enter a ditch. The ditch holds the water which is then pumped into a water recycler for reuse.

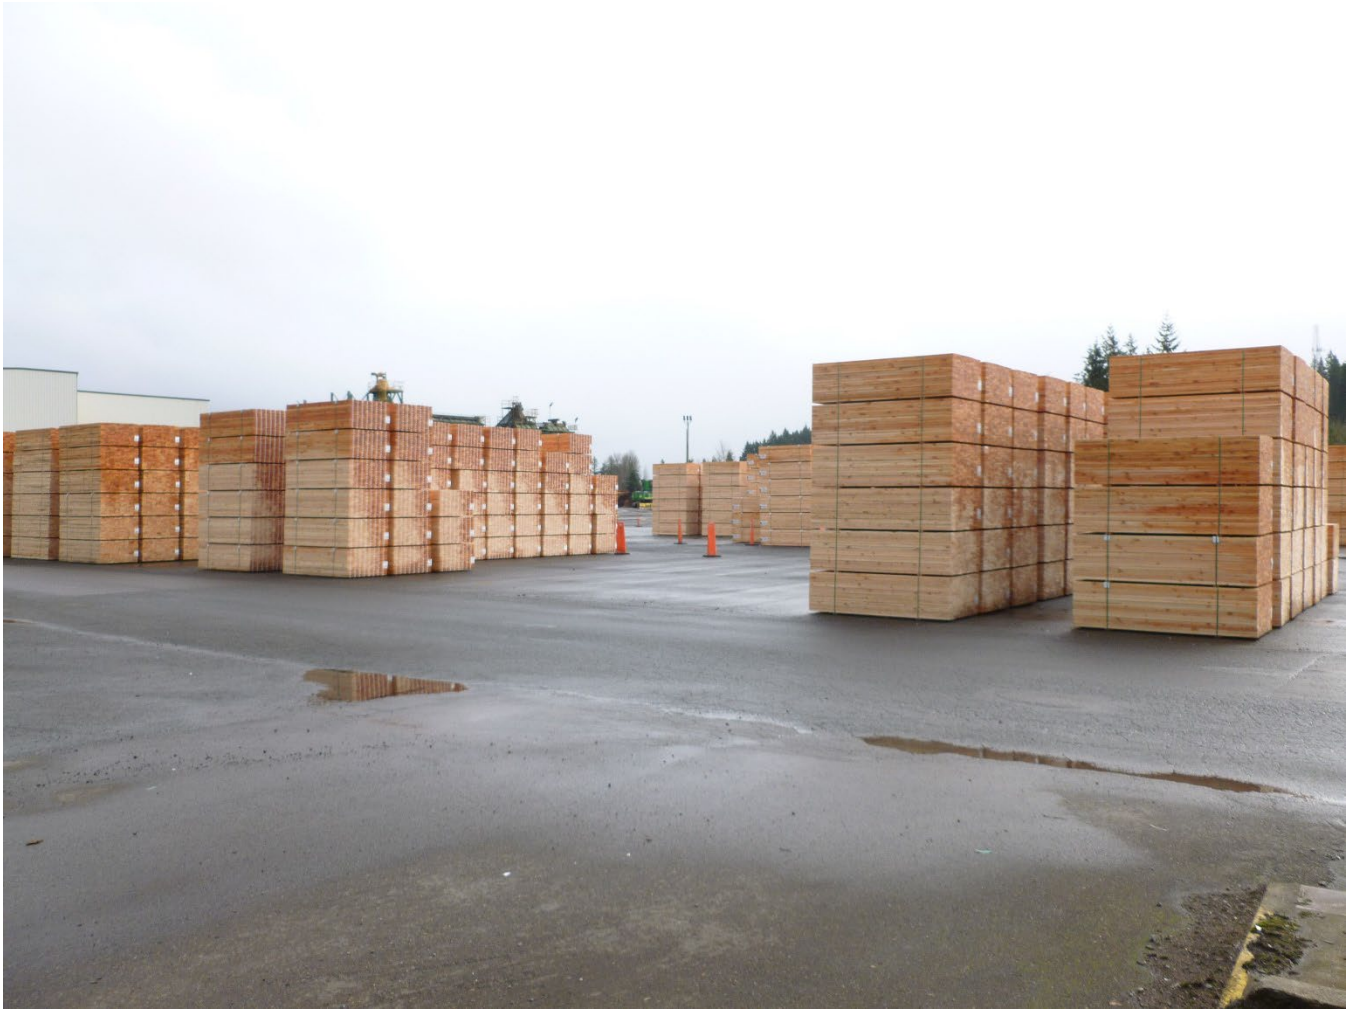
**Photo 2 / P1010092** – Lumber Awaiting Ship-out

As we continued west, we passed lumber packaged and awaiting ship-out (**Photo 2**). Photo 2 also shows puddles of residual stormwater from a recent rain event. Although there were residual puddles throughout the site, no flow was occurring at the time of my visit.

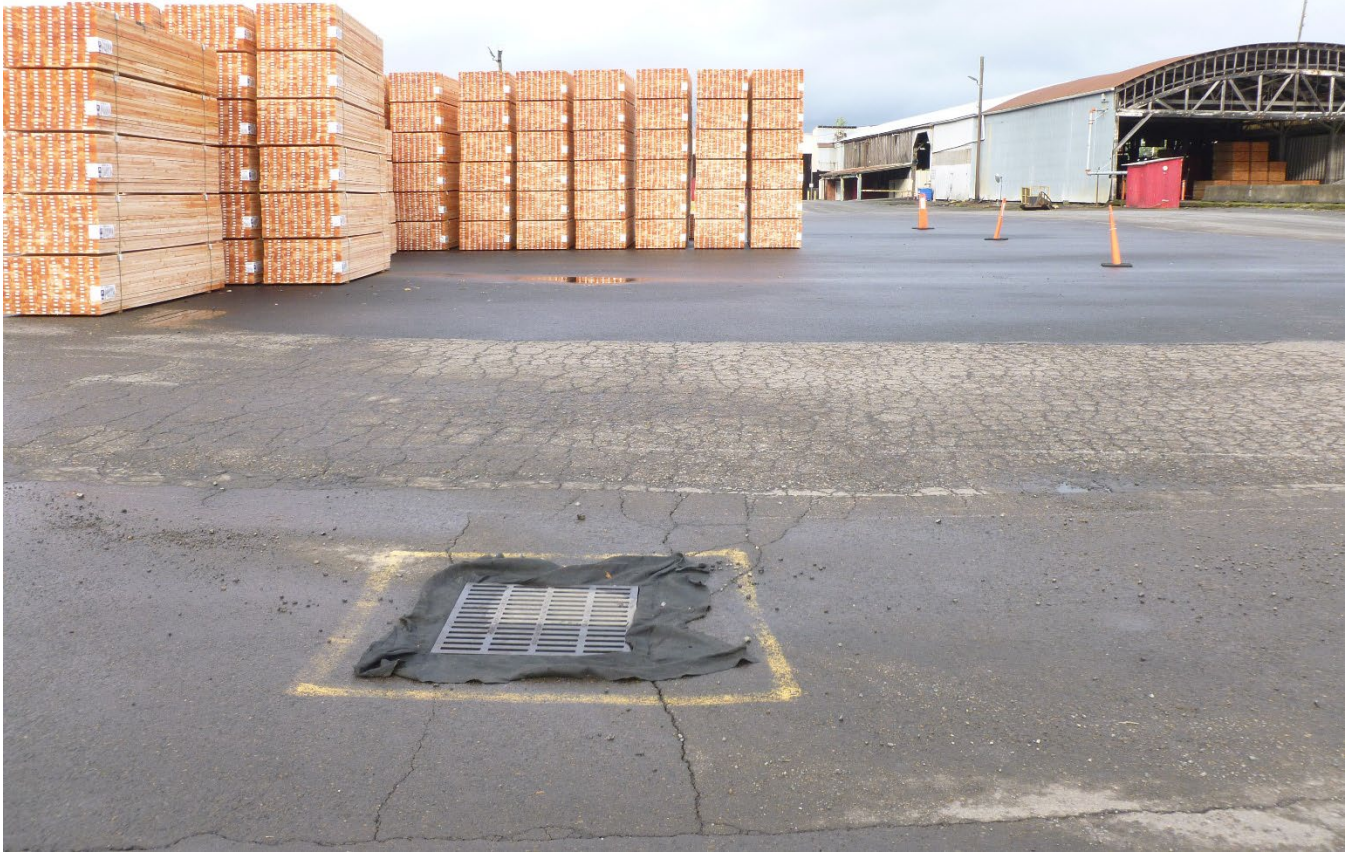
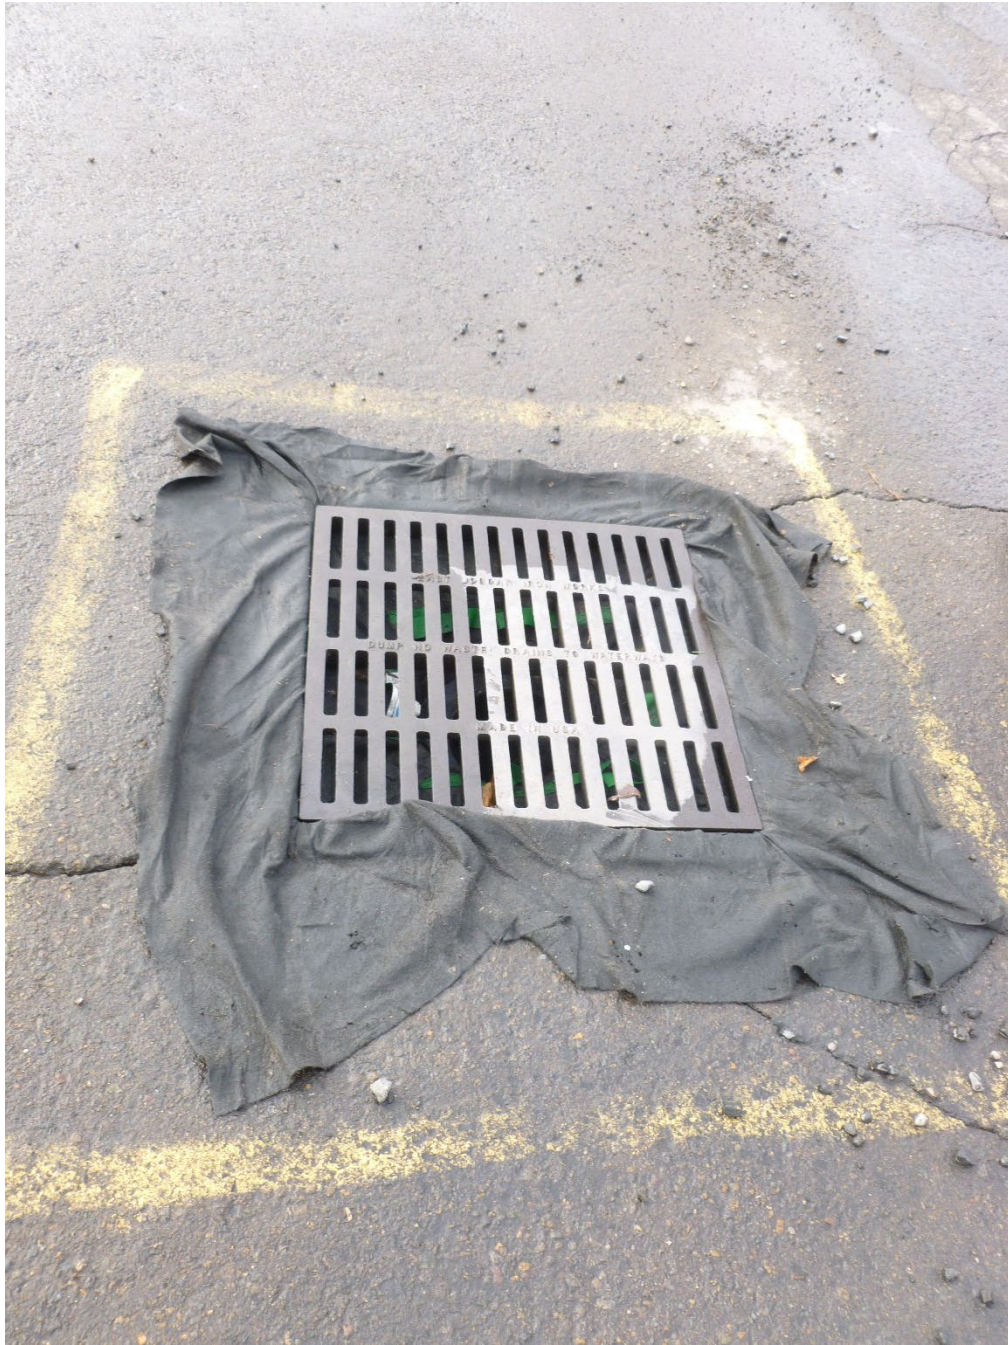
**Photo 3 / P1010093** – Catch Basin/Monitoring Point 006

The monitoring point (MP) 006 (**Photos 3 & 4**) is a catch basin situated in the thoroughfare near some lumber that is awaiting ship-out. During sampling, the grate is removed, and a grab sample is collected. A sediment filter is visible in the grate for MP-006. The basin also has a zinc filter insert, which is not visible. The stormwater continues traveling until it discharges into a ditch outside the perimeter fence. The narrative of the SWPCP seems to conflict with the site map, my observances, and conversations with the Representatives. The SWPCP says “monitoring site 006 is located at discharge point 005”. The monitoring point is several hundred feet from the discharge point. DP-005 through DP-007 were submerged at the time of the inspection.

Upon review of the facility's SWPCP and site map, I found the narrative in the SWPCP did not match the information acquired from the map. The SWPCP says “monitoring site 006 is located at discharge point 005”. The map appears to show, and my observations on the ground would support, that monitoring site 006 is several hundred feet from discharge point 005. It does not appear that the SWPCP is current.

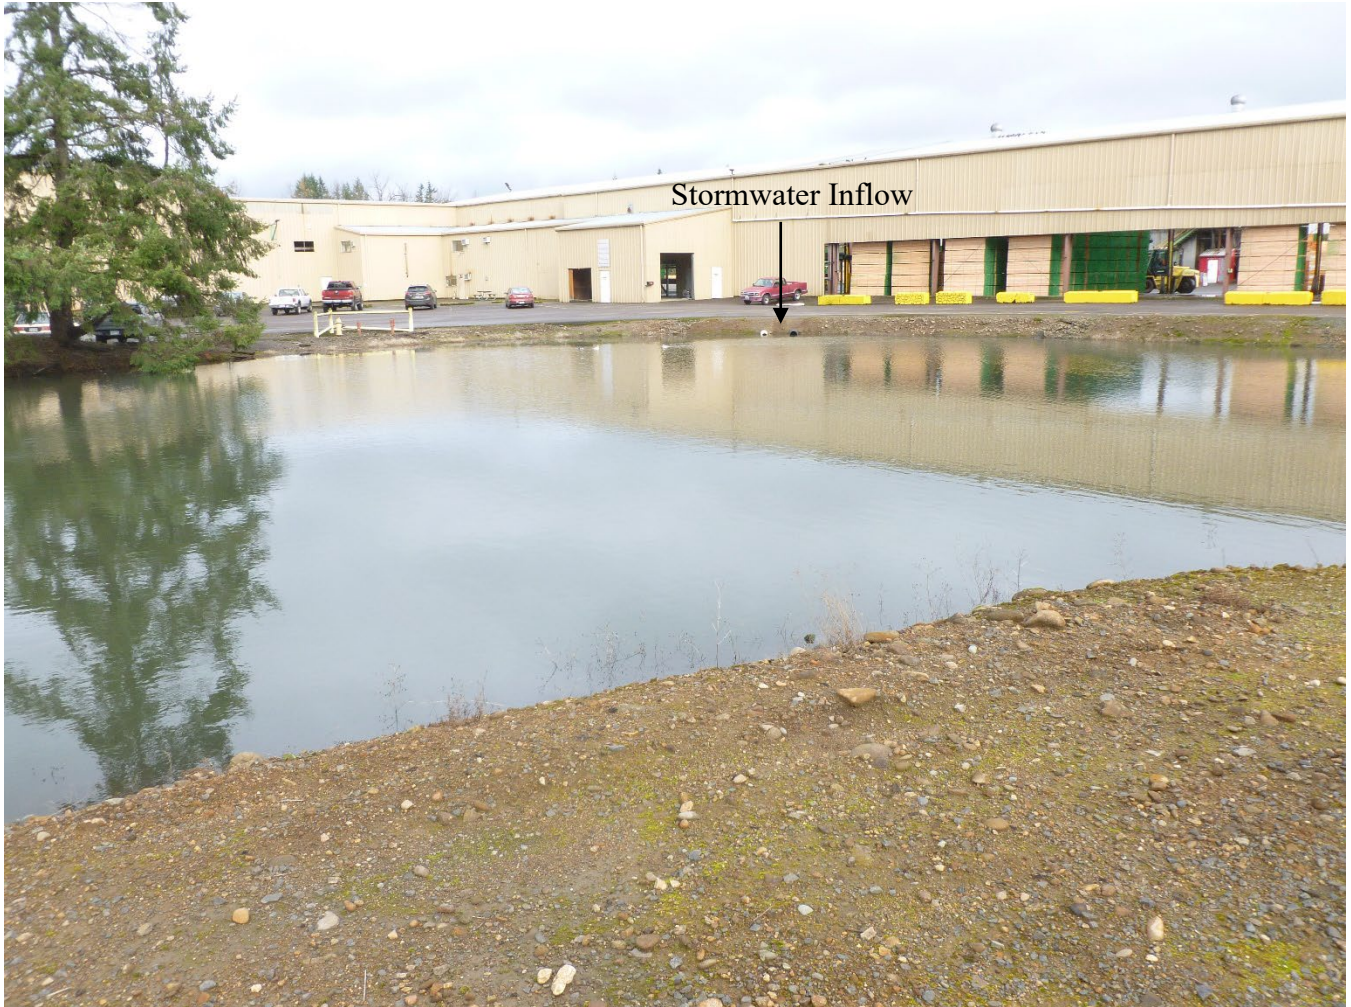
**Photo 5 / P1010099 – Fire Pond, east end**

We followed the western perimeter fence and turned slightly north to arrive at the site’s “Fire Pond”. Discharge Point 008 was eliminated when the flow was diverted to the Fire Pond. Stormwater enters the Fire Pond on the east end (**Photo 5**). On the west end of the pond (**Photo 6**) is an overflow control. Once the water in the pond tops the culvert opening (**Photo 7**), it is discharged into a ditch by DP-009 (**Photo 8**).

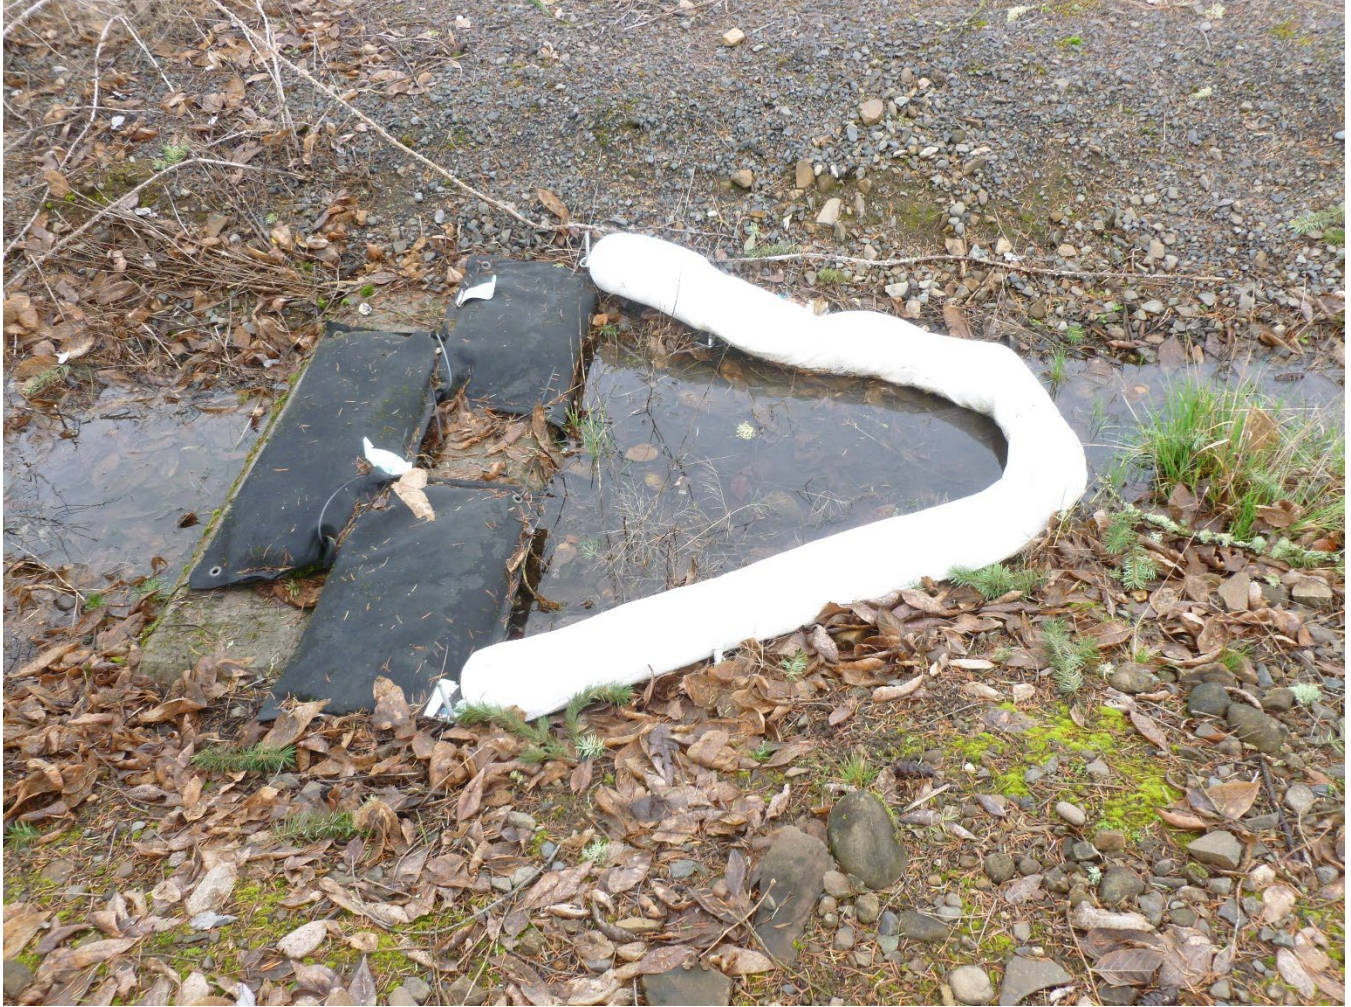
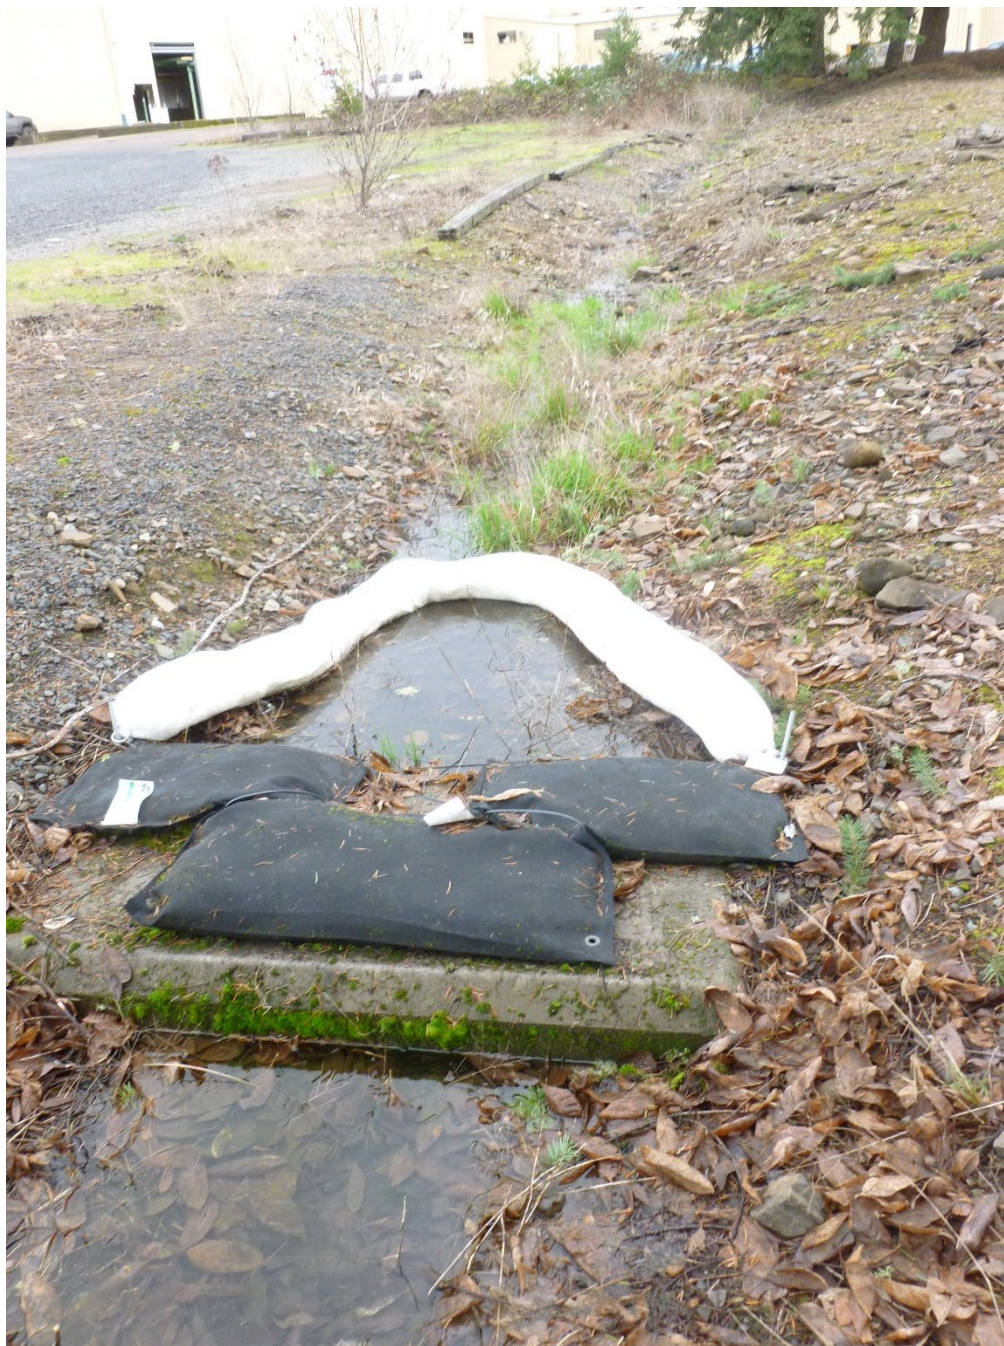
**Photo 9 / P1010102 – Discharge Point 010**

We continued our tour by turning west and heading to DP-010 (**Photo 9**). DP-010 drains stormwater from the employee parking area and discharges the stormwater into a ditch (**Photo 10**). In photos 9 and 10, a filter sock is also observed. The filter sock is used to remove sediment and other particulate matter from the water as it flows.

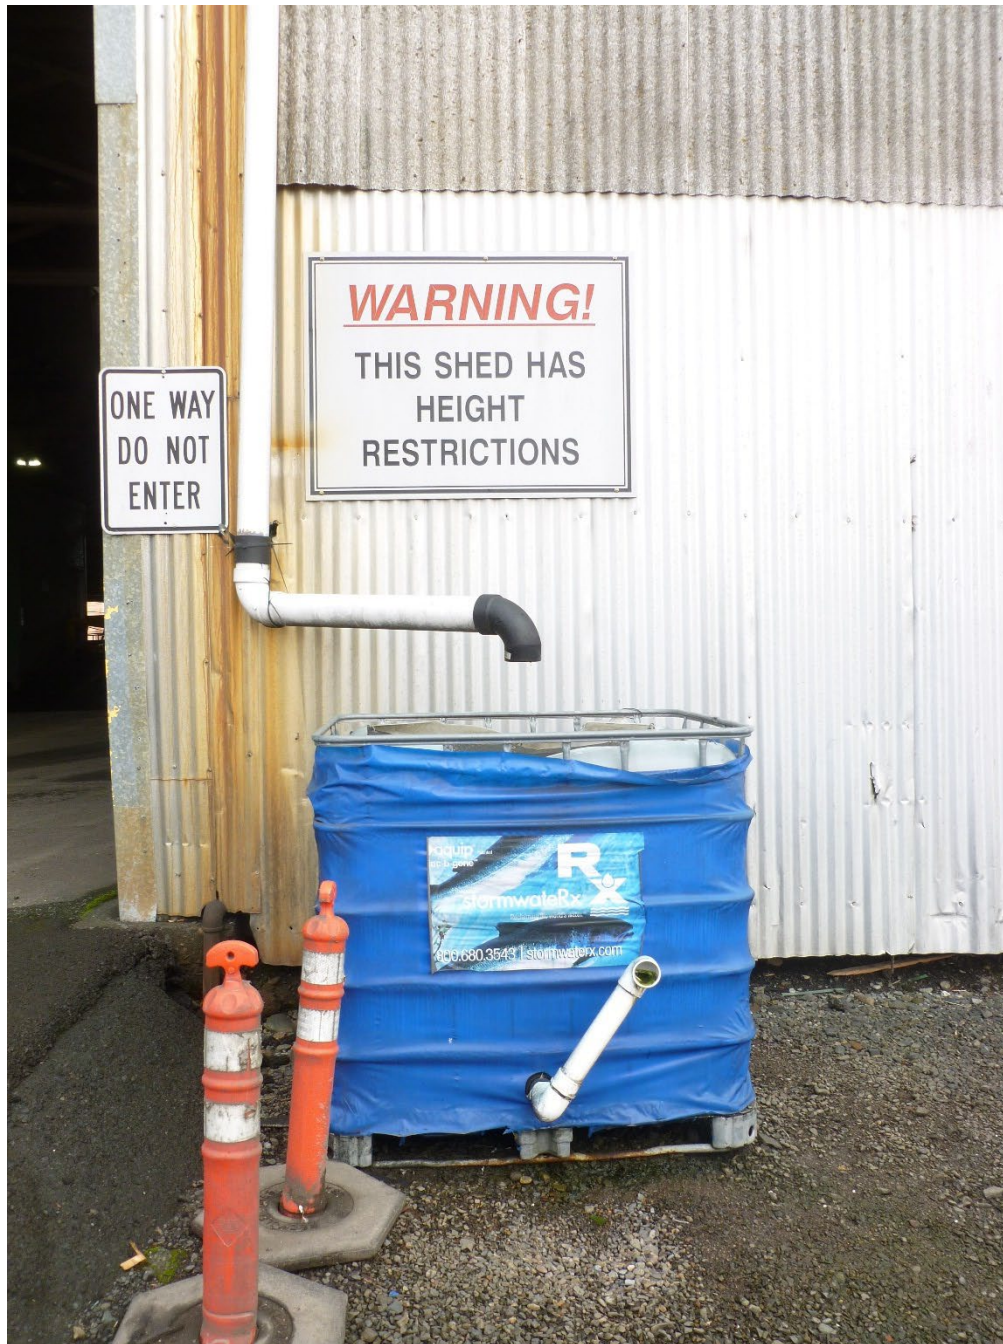
Photo 11 / P1010104 – stormwaterRx™ Zinc Filtration System

As we were walking the site, I observed stormwaterRx™ Zinc-B-Gone filtration systems (**Photo 11**). The filtration systems reduce the amount of zinc in the stormwater coming from the facility’s rooftops. The facility has four of the zinc filtration systems located near buildings at various points around the site.

Upon review of the facility's SWPCP, I found the document did not adequately meet the requirement for “Operations and Maintenance Plans”. For example, the SWPCP did not contain the “system schematic, and manufacturer's maintenance/operation specifications” for the stormwater<sup>TM</sup> Zinc-B-Gone filtration system.

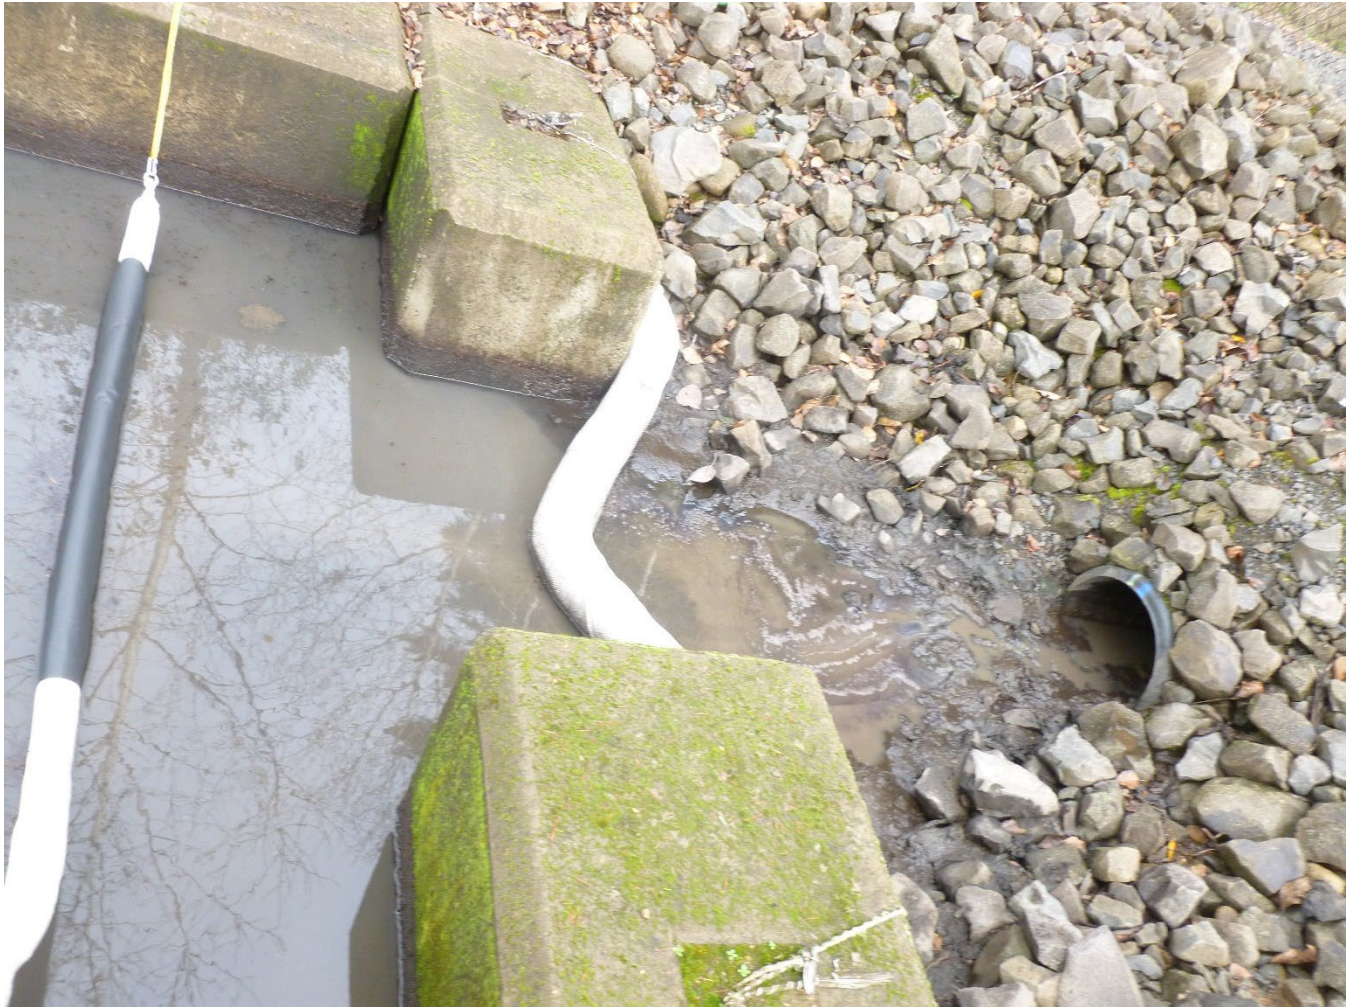
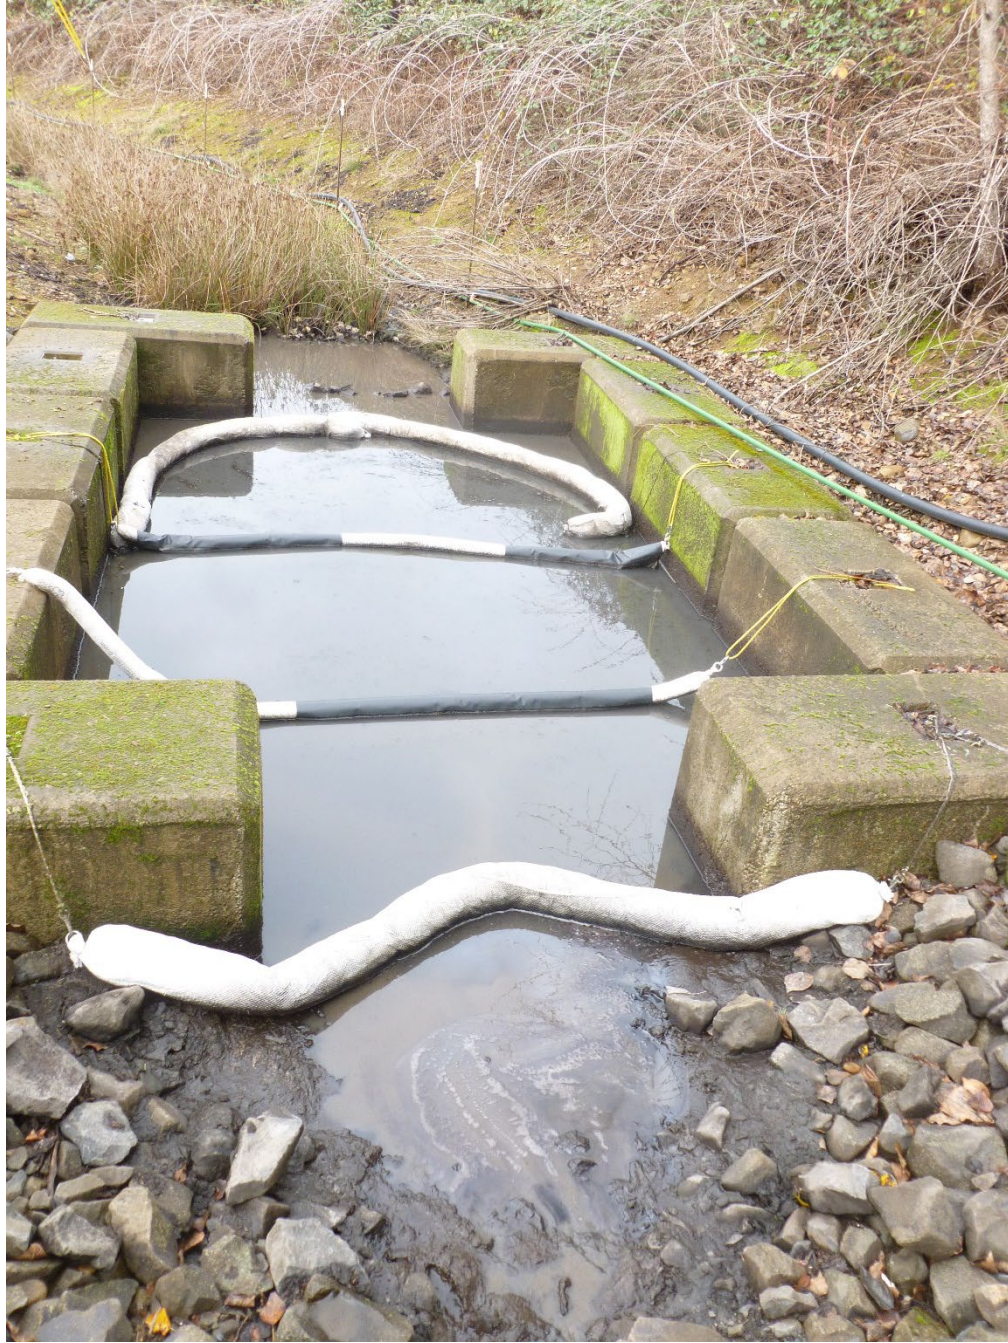
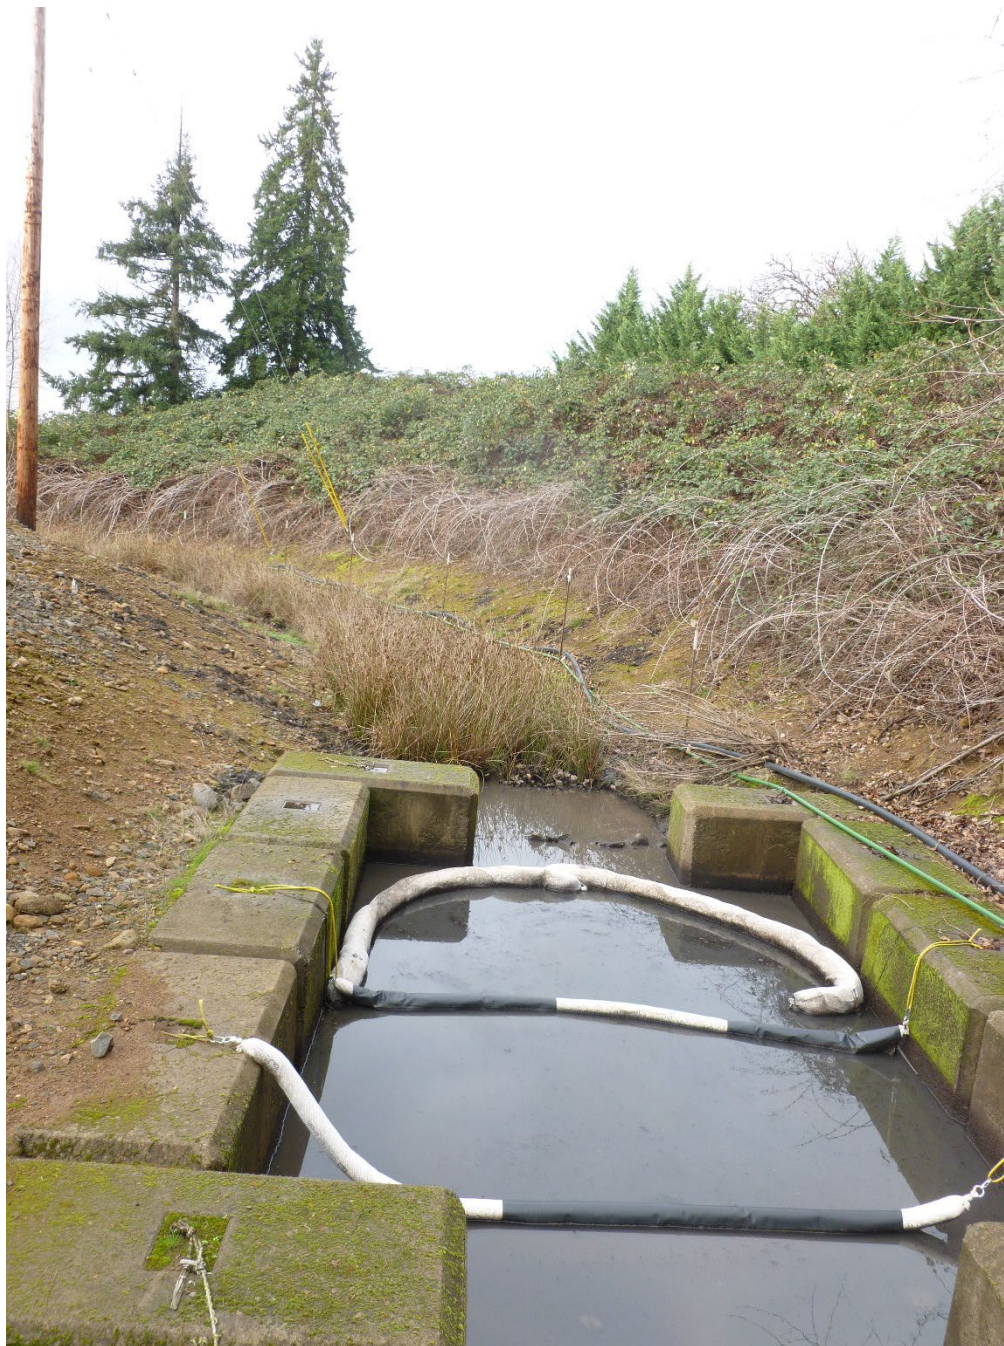
**Photo 12 / P1010105** – Settling Basin, photo 1

We turned east and proceeded to the settling basin. The settling basin receives water from the nearby log yard. The basin uses filter socks to slow water flow and filter out particulate matter (**Photos 12 – 14**).

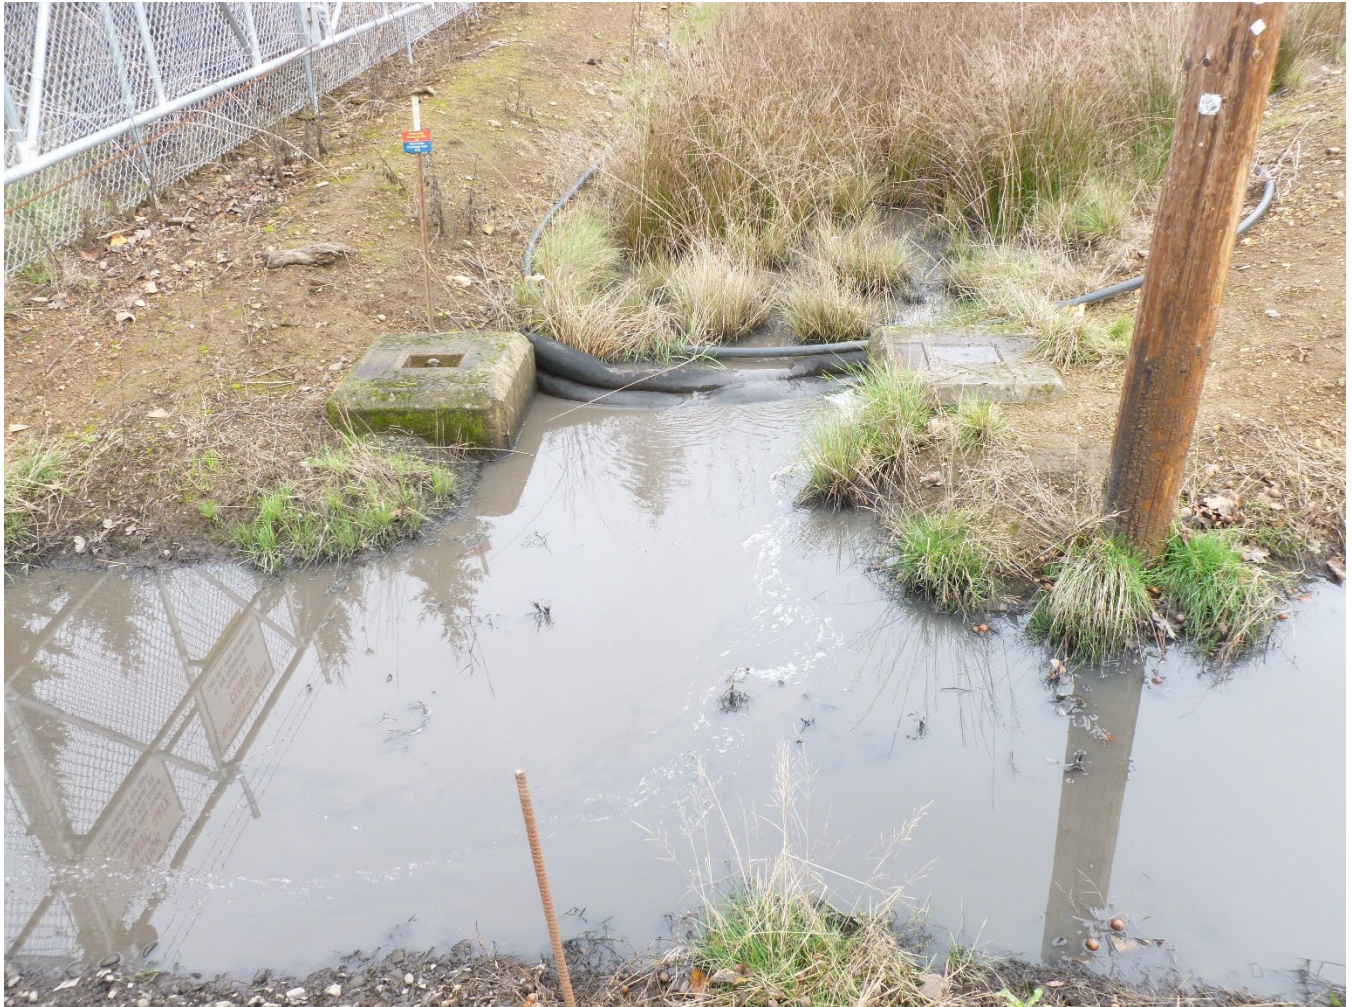
**Photo 15 / P1010108 – Monitoring Point 005**

Monitoring Point 005 (**Photo 15**) is at the end of the settling basin just prior to the bioswale (**Photos 16 & 17**). A grab sample is collected as the water tops the filter sock seen in the middle of photo 15. The water will remain in the bioswale until it infiltrates or evaporates.

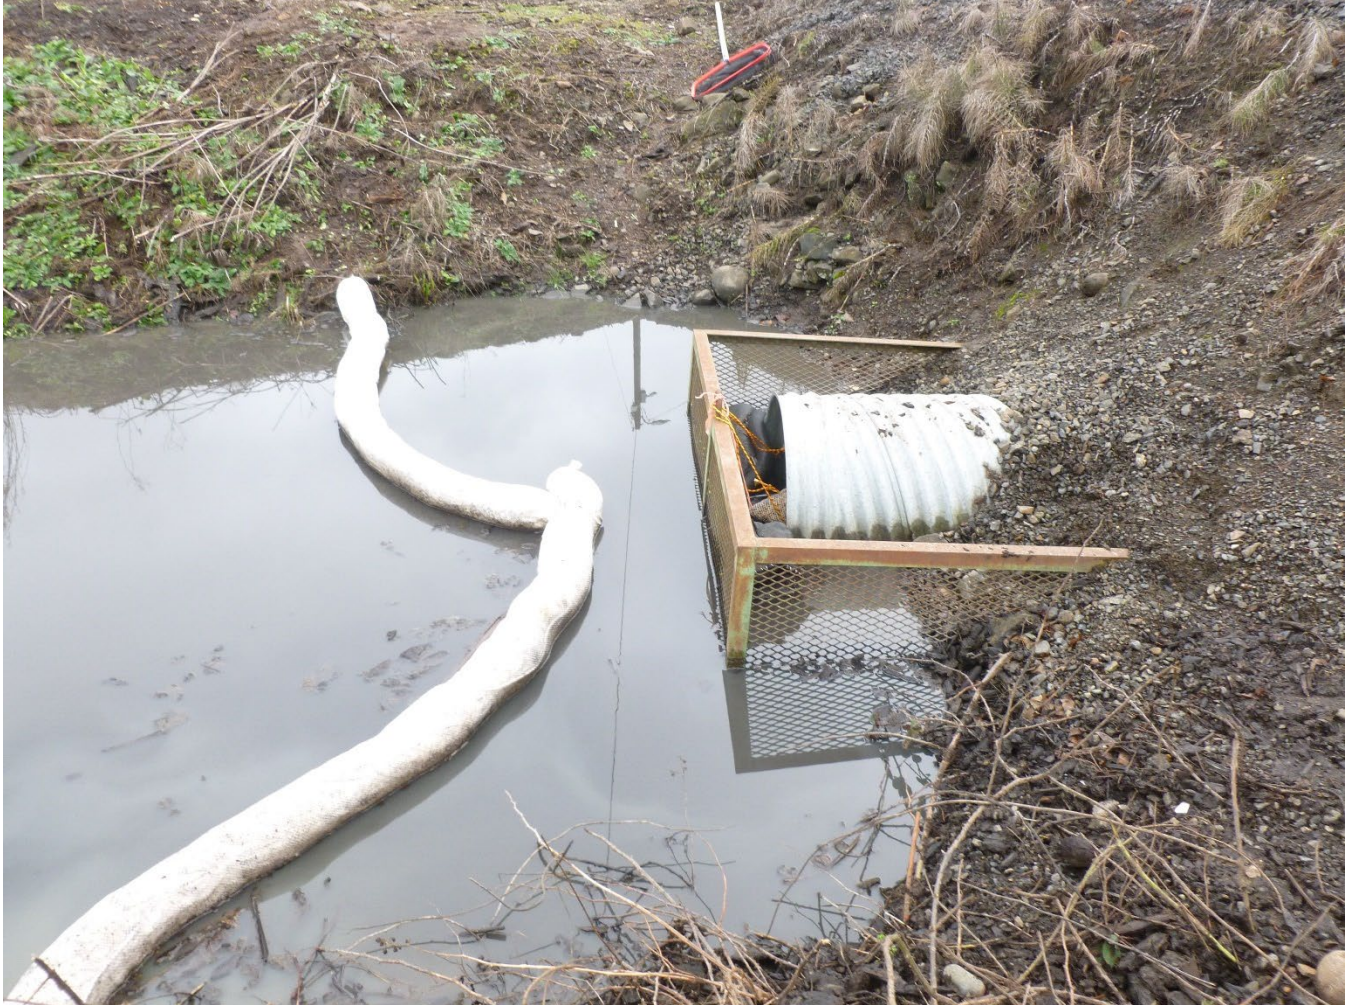
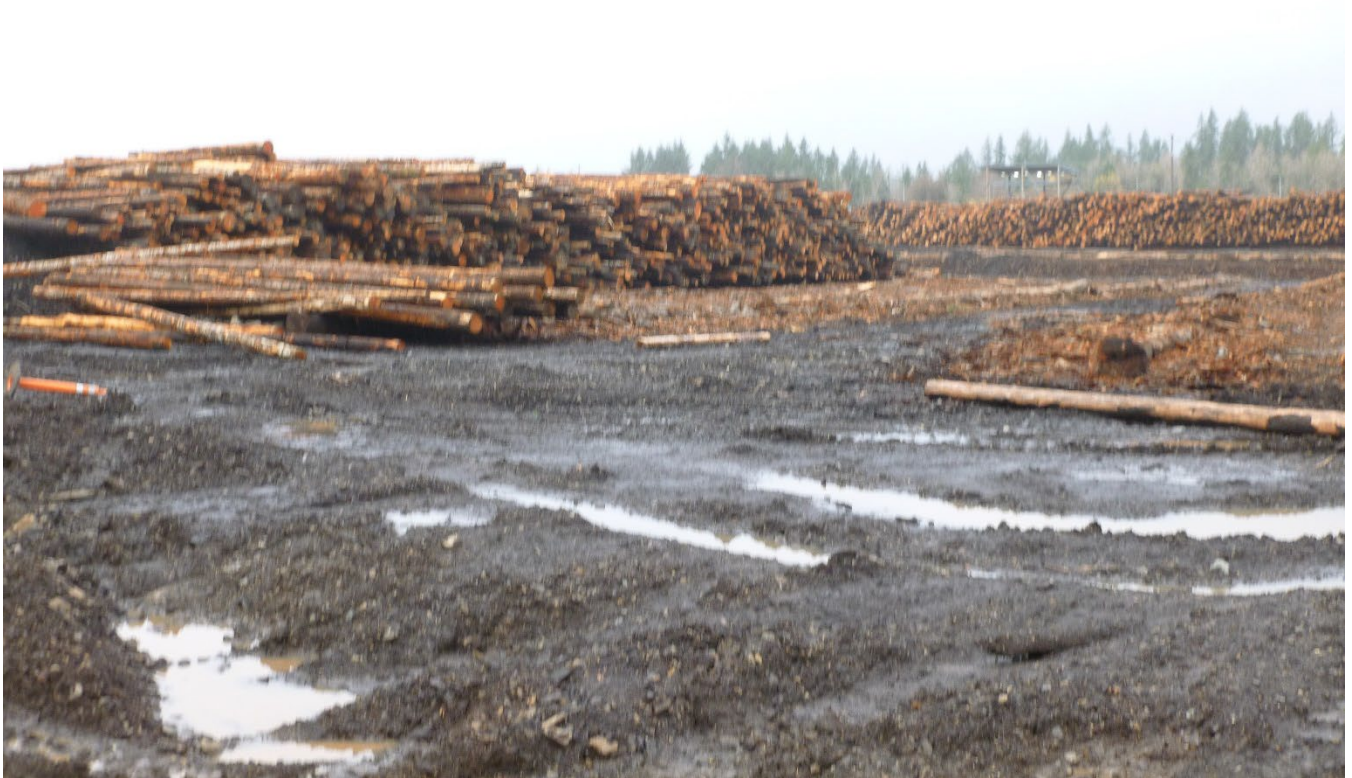
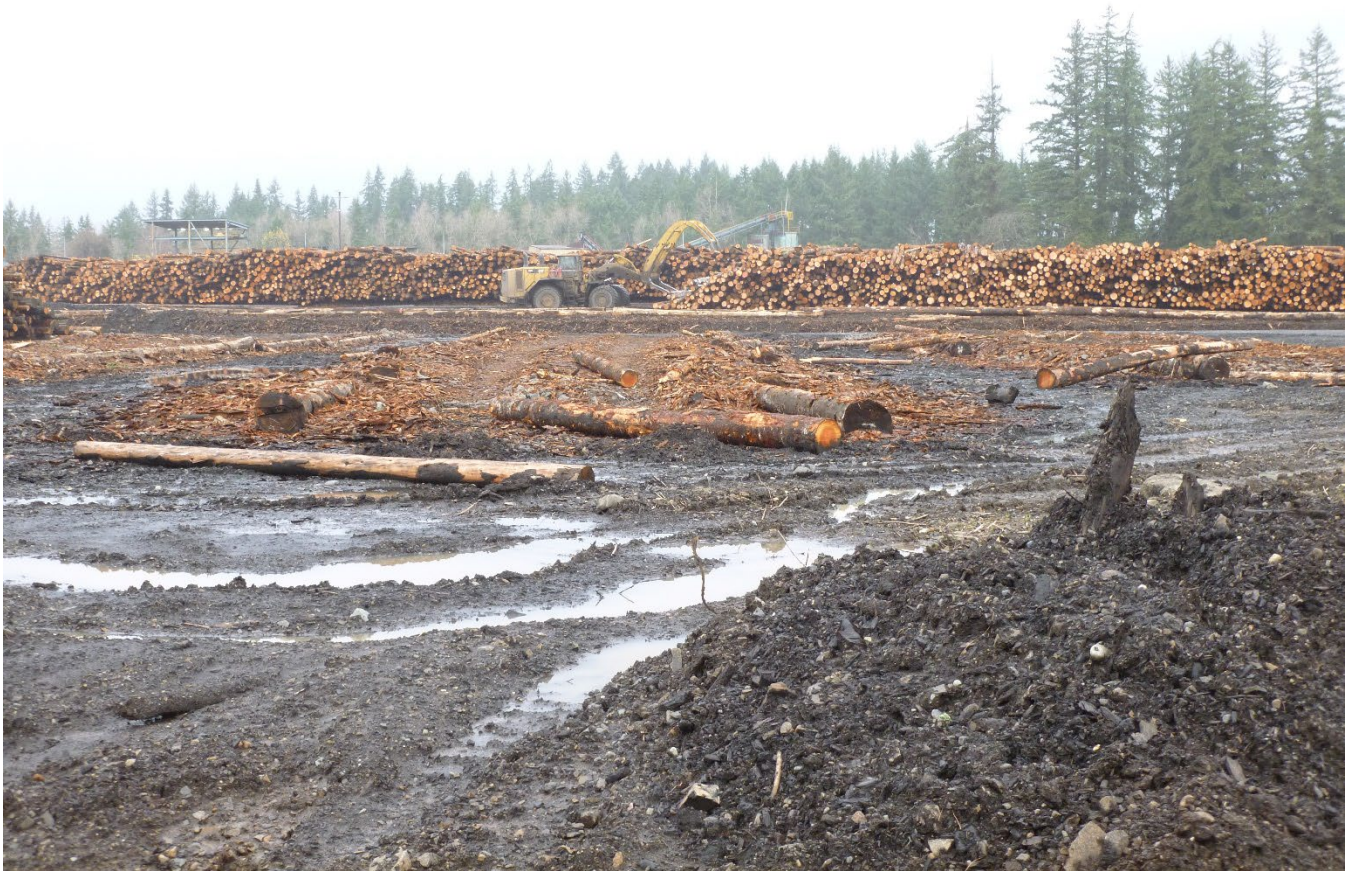
**Photo 18 / P1010111 – Monitoring Point 001**

Monitoring Point 001 was located at the far southeastern portion of the site. Due to its distance, the Representatives and I agreed that we'd drive to MP-001. The Representatives used a company vehicle and I followed in my personal vehicle. MP-001 (**Photo 18**) receives stormwater from the log yard (**Photos 19 & 20**) through a series of collection ditches and connecting culverts. MP-001, also known as, DP-001, discharges into a retention ditch (**Photo 21**).
