**INSPECTION REPORT**

| <b>Type of inspection:</b> | CEI - Compliance Evaluation Inspection | |
| <b>Facility or Site Name:</b> | Caterpillar, Inc. – Pontiac, IL | |
| <b>Permit Numbers:</b> | 2022-EP-67798; ILR006863 | |

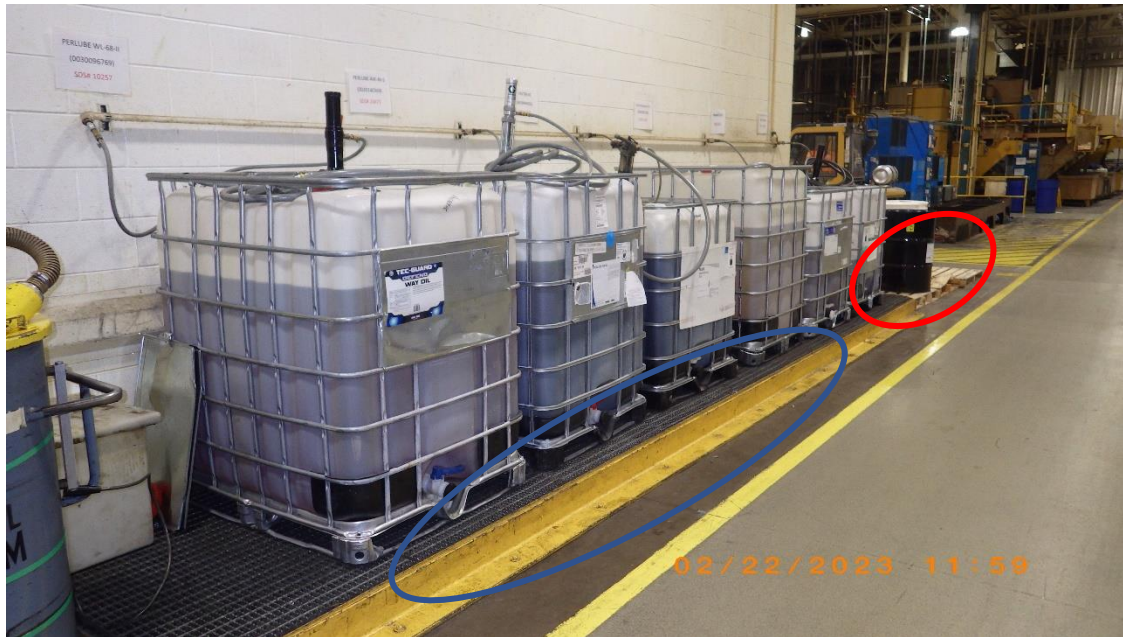
5: RIMG0128

| Unique Identifying No. | Observation | Area of Concern? |
|---|---|---|
| <b>TF-OB-004</b> | On the manufacturing floor there is designated areas for oil storage and a designated area for additional liquid chemical storage. These areas are both surrounded by a berm that provides secondary containment in the event of a spill. The storage areas were observed to be at capacity and chemicals/oil were stored immediately outside the berm area and did not have secondary containment. See Photo 5. | <b>Yes</b> |

| Unique Identifying No. | Record |
|---|---|
| <b>TF-OB-004</b> | <p>On the manufacturing floor there is designated areas for oil storage and a designated area for additional liquid chemical storage. These areas are both surrounded by a berm that provides secondary containment in the event of a spill. The storage areas were observed to be at capacity with and chemicals/oil were stored immediately outside the berm area and did not have secondary containment. See Photo 5.</p> <p><b>40 C.F.R. 112</b></p> |

Description: New oil stored outside of the white cinderblock oil storage room. This room is immediately behind the wall in the background of the photo. The blue oval depicts secondary containment for the oil totes. The red circle depicts the lack of secondary containment for the 55 gallon drum.

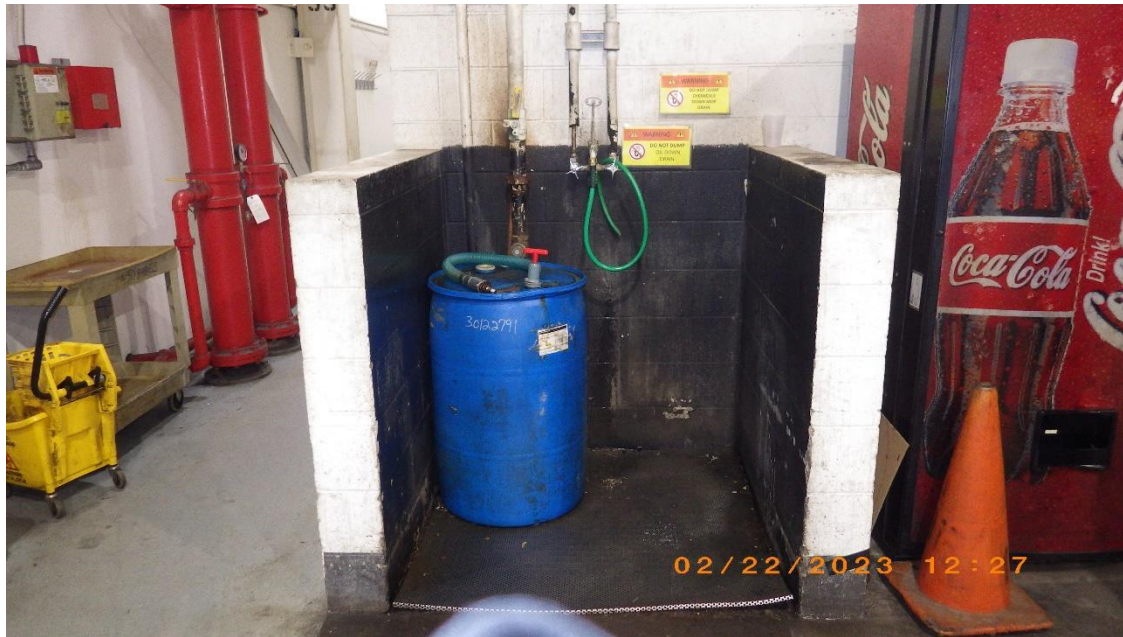
10: RIMG0133

| Unique Identifying No. | Observation | Area of Concern? |
|---|---|---|
| <b>TF-OB-006</b> | A 55-gallon drum of Cynamic Alti-Mate 64, a disinfecting agent, was observed to be stored immediately on top of a floor drain leading to the wastewater treatment system. See Photo 10. | <b>Yes</b> |

| <b>TF-OB-006</b> | <p>A 55-gallon drum of Cynamic Alti-Mate 64, a disinfecting agent, was observed to be stored immediately on top of a floor drain leading to the wastewater treatment system. See Photo 10.</p> <p><b>40 C.F.R. 112</b></p> |

Description: Liquid waste disposal area. Note storage of Cynamic Alti-Mate 64 in blue container directly above drain.

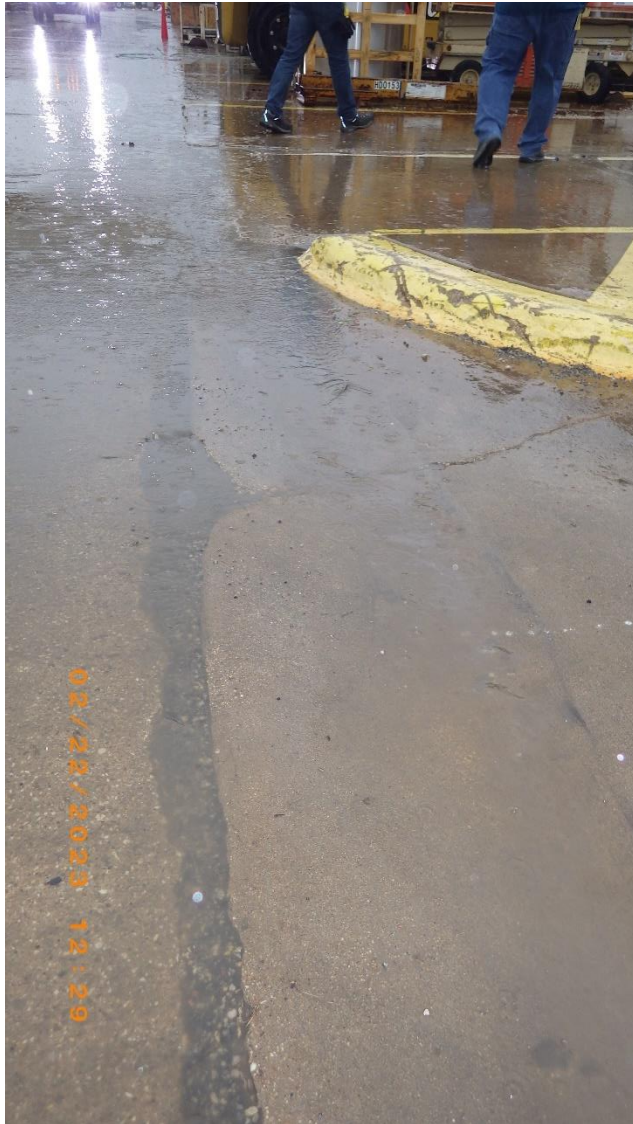
11: RIMG0134

| <b>TF-OB-011</b> | A sheen was observed in stormwater runoff between the Manufacturing 1 and wastewater treatment areas. See Photo 11. | <b>Yes</b> |

| <b>TF-OB-011</b> | <p>A sheen was observed in stormwater runoff between the Manufacturing 1 and wastewater treatment areas. See Photo 11.</p> <p><b>Permit No. ILR006863 – Section H.1.d</b></p> |

Description: Stormwater flow with visible sheen.

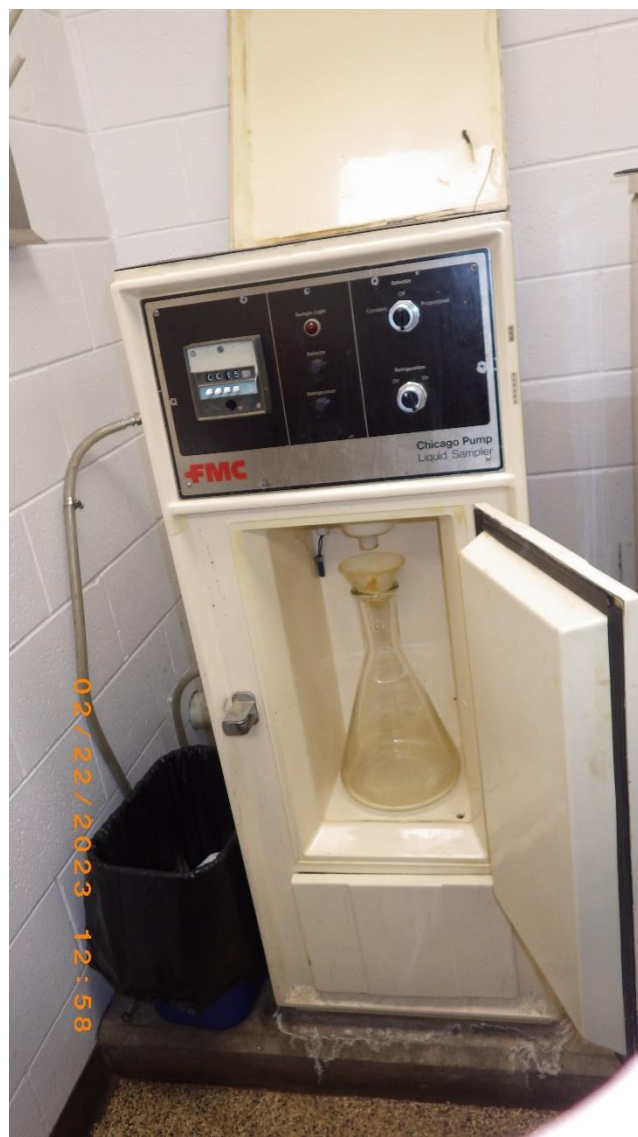
14: RIMG0137

| Unique Identifying No. | Observation | Area of Concern? |
|---|---|---|
| <b>TF-OB-007</b> | In the wastewater lab area, Mr. Ranta showed the inspection team a FMC liquid sampler. See Photo 14. Mr. Ranta explained this is the sampler used for composite effluent compliance sample collection. The sampler collects samples based on a time interval, not a flow interval. The sampler has a built-in refrigeration system. There was no thermometer in the sampler and Mr. Ranta was unable to provide a temperature log. | <b>Yes</b> |

Description: Effluent composite sampler.

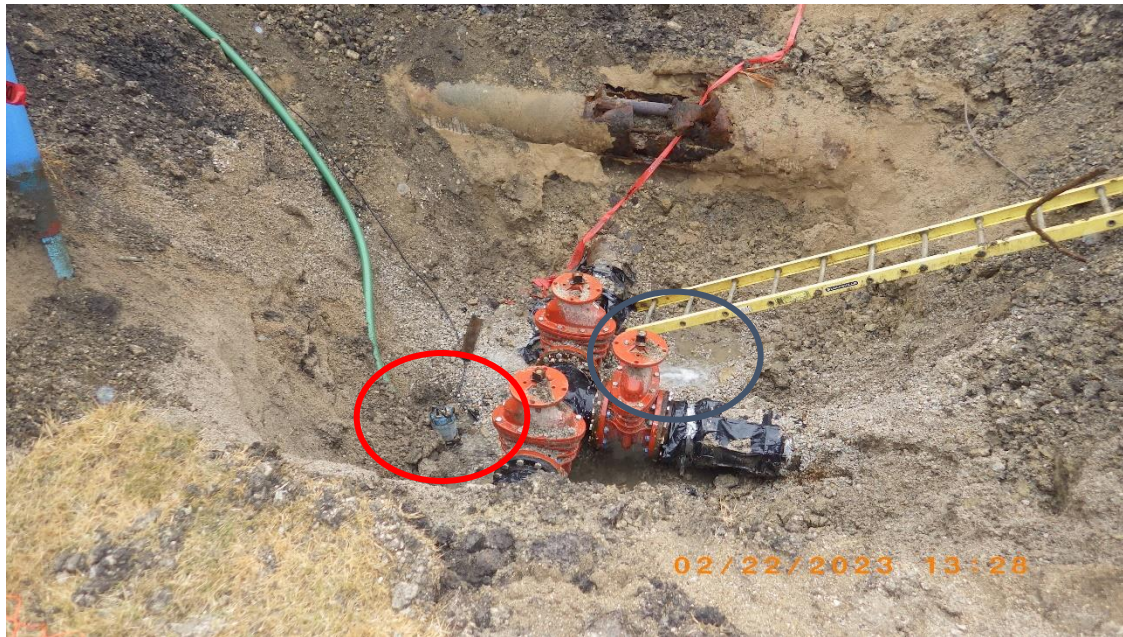
18: RIMG0141

The United States Geological Survey (USGS) rain gage in the Vermilion River in Pontiac, Illinois measured 0.61 inches of rain between 3:00 AM and 3:00 PM on February 22, 2023. Stormwater that falls on the Facility is conveyed by gravity to one of two oil-water separators before it is discharged to an Outfall into the North Creek. The inspection team observed the Facility while it was raining and observed both stormwater Outfalls actively discharging. The inspection team observed a sheen on a stormwater flow within the Facility. Additionally, the inspection team observed a large pit dug immediately north to the fire suppression system water storage tanks located at the south end of the Facility. Mr. Irwin explained that the pipes that supply the tanks were leaking and were in the process of being repaired. Mr. Flatebo observed the pipes actively leaking at a rate of approximately 10 gallons per minute. There was a sump pump placed in the pit that was collecting the leaked water and discharging it into the stormwater conveyance system. See Photo 18.

Description: Valve assembly that feeds potable water to the two fire suppression system storage tanks. Blue circle denotes active leak in the valve assembly. Red circle denotes sump pump actively draining water.

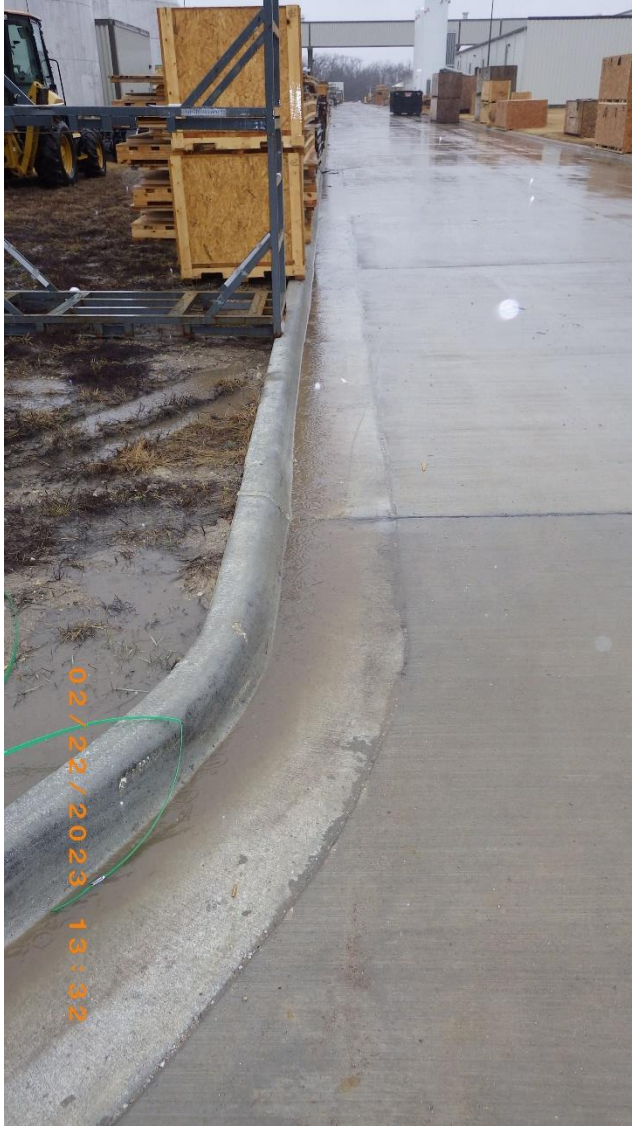
19: RIMG0142

| <b>TF-OB-012</b> | Turbid stormwater runoff was observed in the gutter immediately east of the fire suppression system water storage tanks. See Photo 19. | <b>Yes</b> |

| <b>TF-OB-012</b> | <p>Turbid stormwater runoff was observed in the gutter immediately east of the fire suppression system water storage tanks. See Photo 19.</p> <p><b>Permit No. ILR006863 – Section H.1.d</b></p> |

Description: Turbid stormwater flowing through gutter towards storm drain.

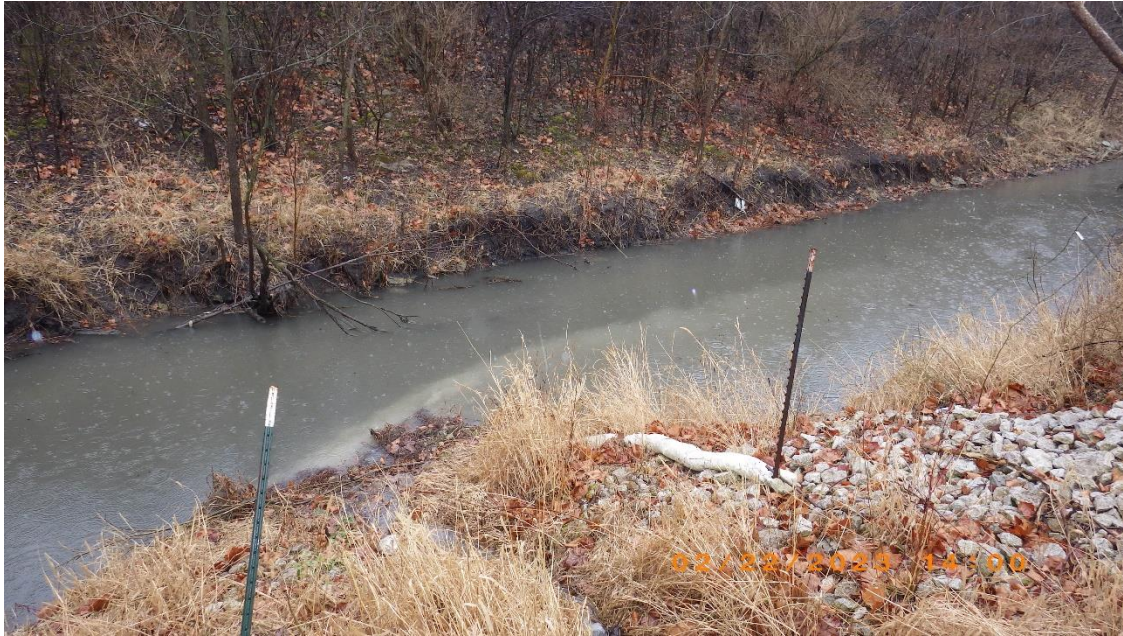
20: RIMG0143

| <b>TF-OB-013</b> | Stormwater Outfall 002 and Outfall 003 were observed discharging during the inspection. Both outfalls were discharging water which was discolored and the water immediately downstream of the outfalls was discolored compared to upstream. See Photos 20, 21, 24, and 25. | <b>Yes</b> |

| <b>TF-OB-013</b> | <p>Stormwater Outfall 002 and Outfall 003 were observed discharging during the inspection. Both outfalls were discharging water which was discolored and the water immediately downstream of the outfalls was discolored compared to upstream. See Photos 20, 21, 24, and 25.</p> |

Description: Stormwater Outfall 002. Note brown streak of brown material in North Creek originating at the Outfall.

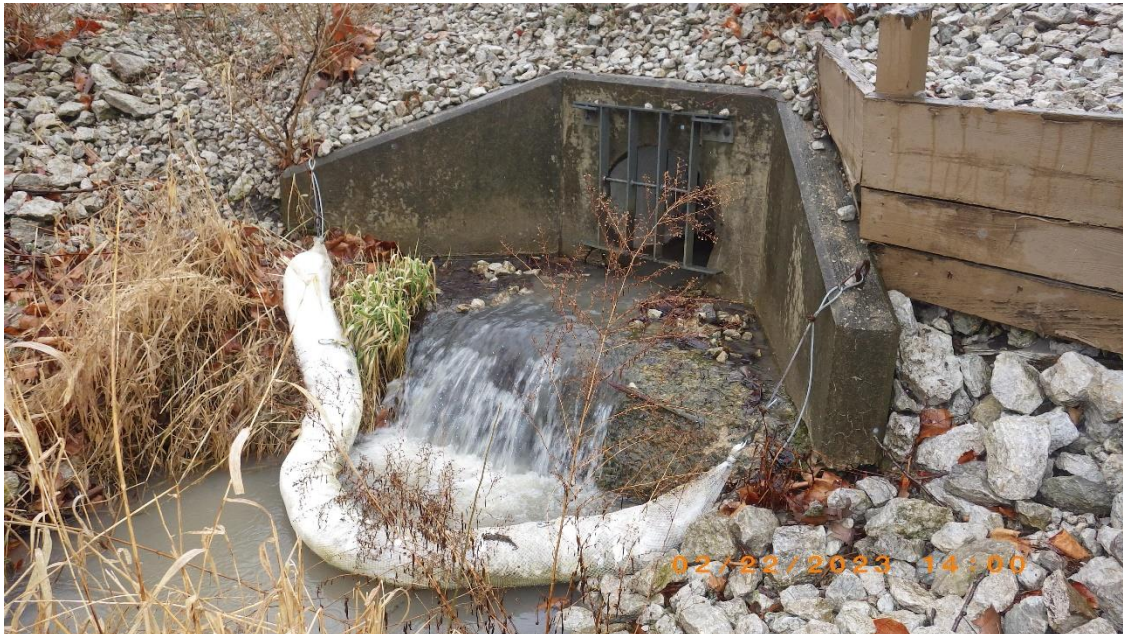
21: RIMG0144

Description: Stormwater Outfall 002.

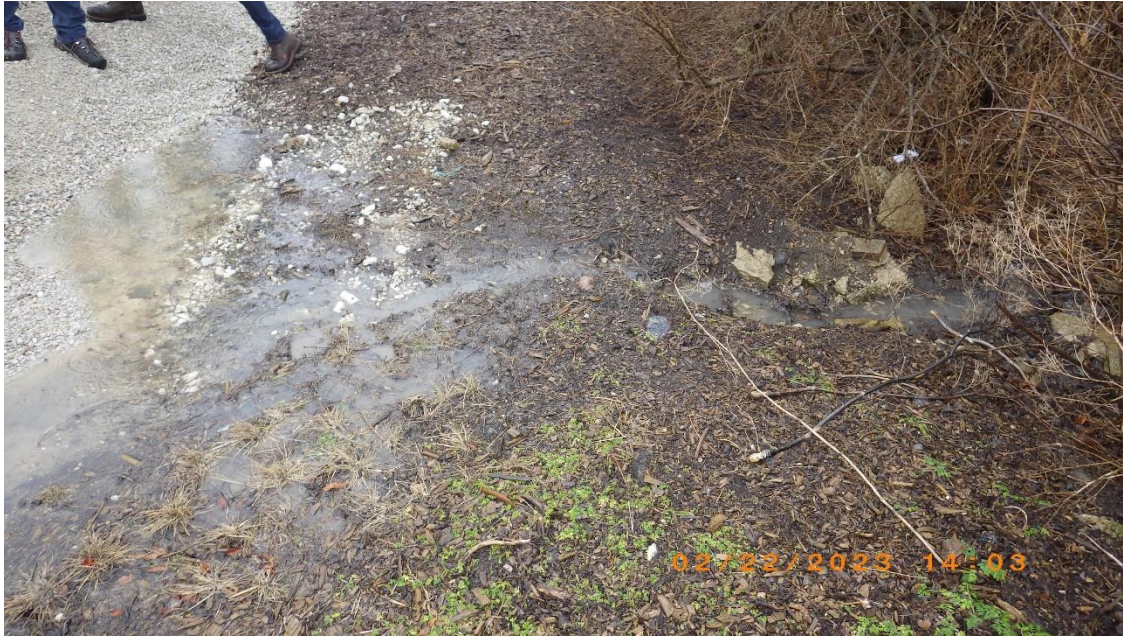
22: RIMG0145

Description: Stormwater flowing through Facility fence towards North Creek.

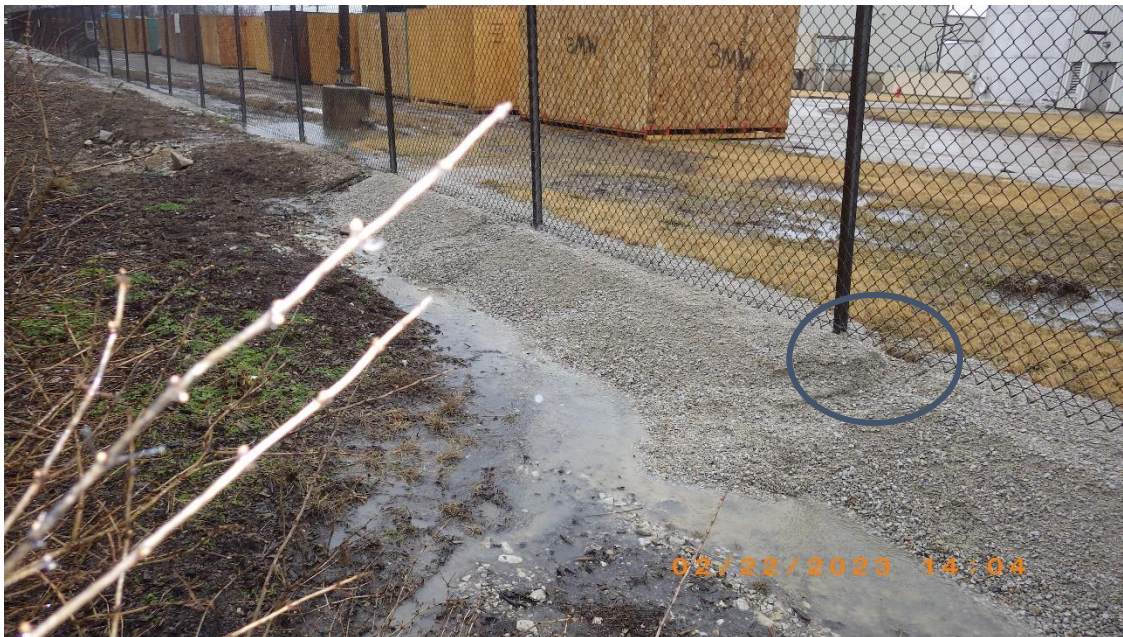
23: RIMG0146

| <b>TF-OB-014</b> | Stormwater was observed flowing under the Facility fence line and towards the North Creek in two places between Outfall 002 and Outfall 003. Per the Facility's SWPPP, the two afore mentioned outfalls are the only two locations where stormwater discharges are monitored. See Photos 23, 26, and 27, | <b>Yes</b> |

| <b>TF-OB-014</b> | Stormwater was observed flowing under the Facility fence line and towards the North Creek in two places between Outfall 002 and Outfall 003. Per the Facility's SWPPP, the two aforementioned outfalls are the only two locations where stormwater discharges are monitored. See Photos 23, 26, and 27,<br><br><b>Permit No. ILR006863 – Section F.f</b> |

Description: Overview of stormwater flow depicted in Photo 22. Blue circle denotes erosion of material under Facility fence line.

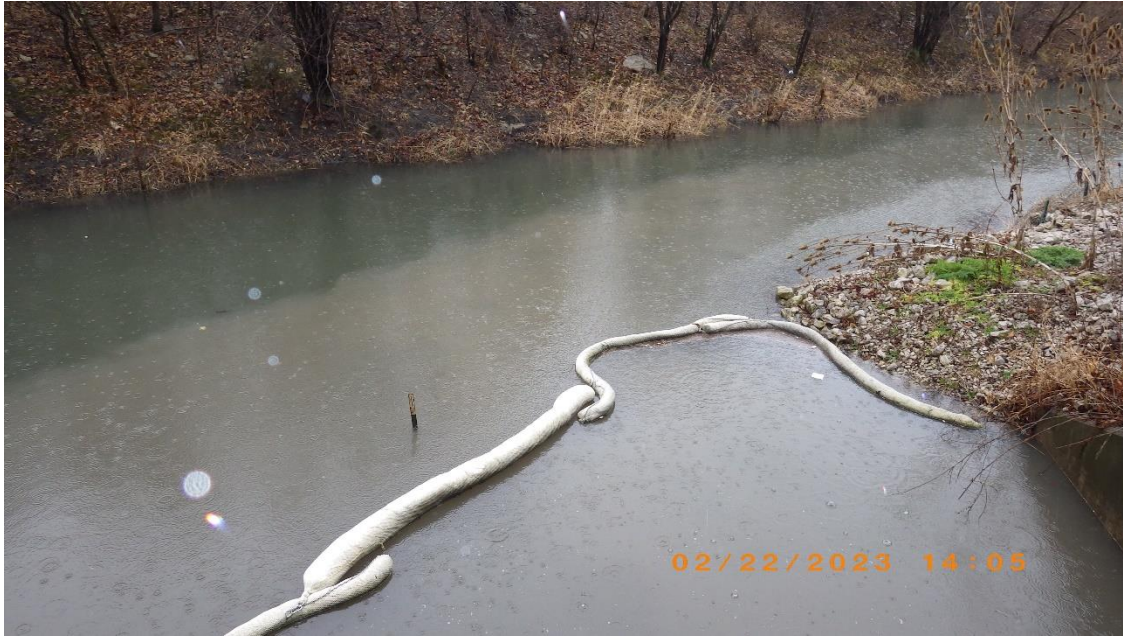
24: RIMG0147

Description: Stormwater Outfall 003. Note brown streak of material in North Creek originating at the Outfall.

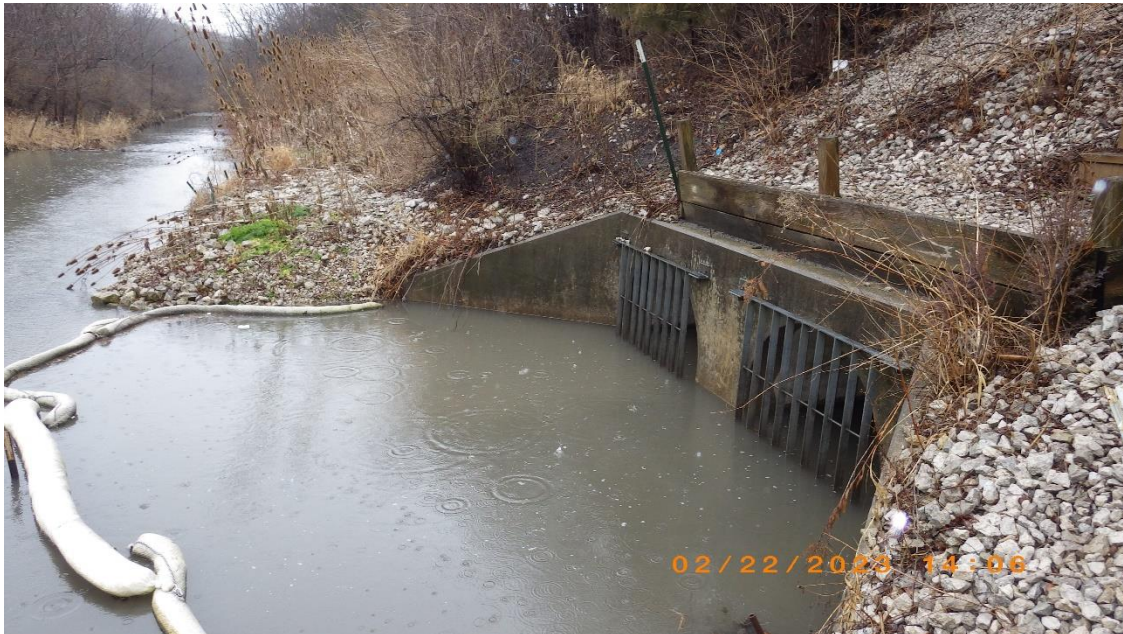
25: RIMG0148

Description: Stormwater Outfall 003.

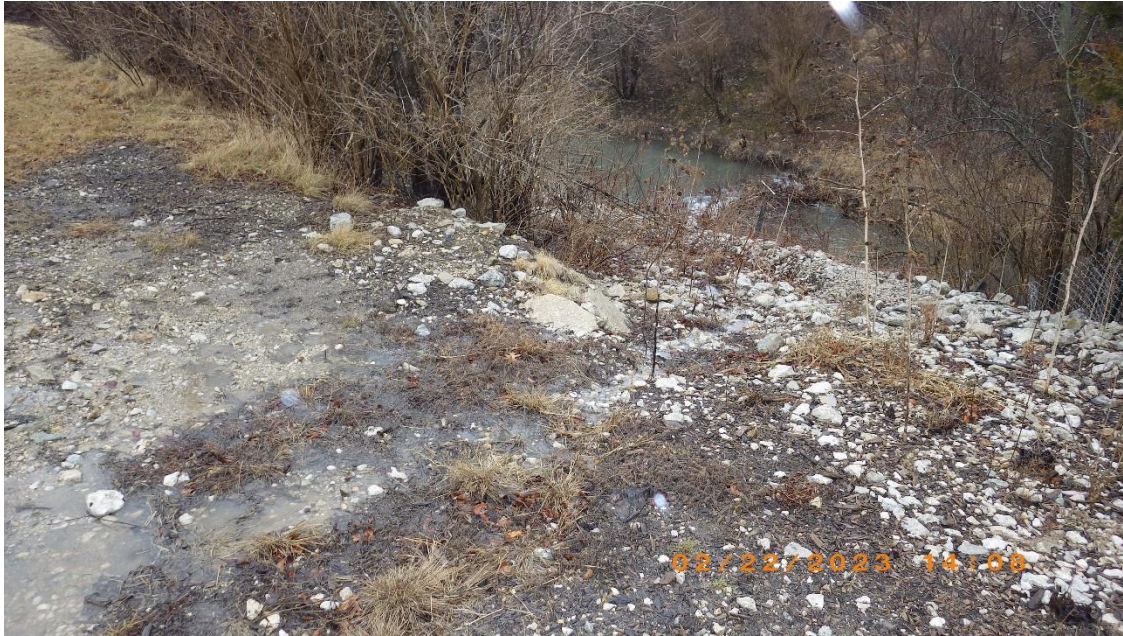
26: RIMG0149

Description: Stormwater flow through Facility fence towards North Creek.

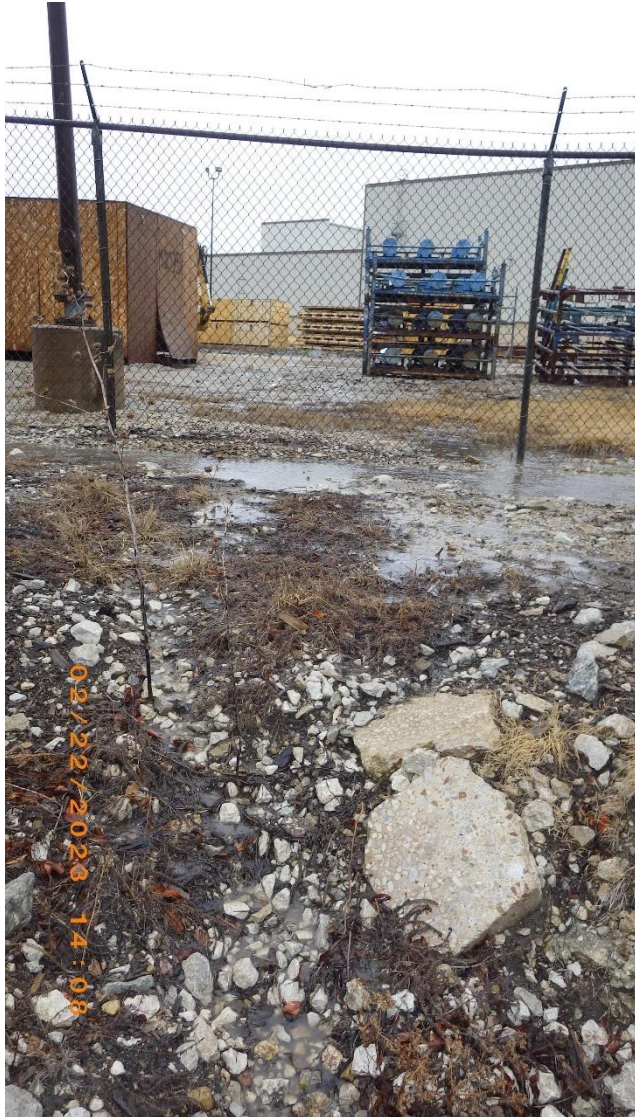
27: RIMG0150

Description: Overview of stormwater flow depicted in Photo 26.

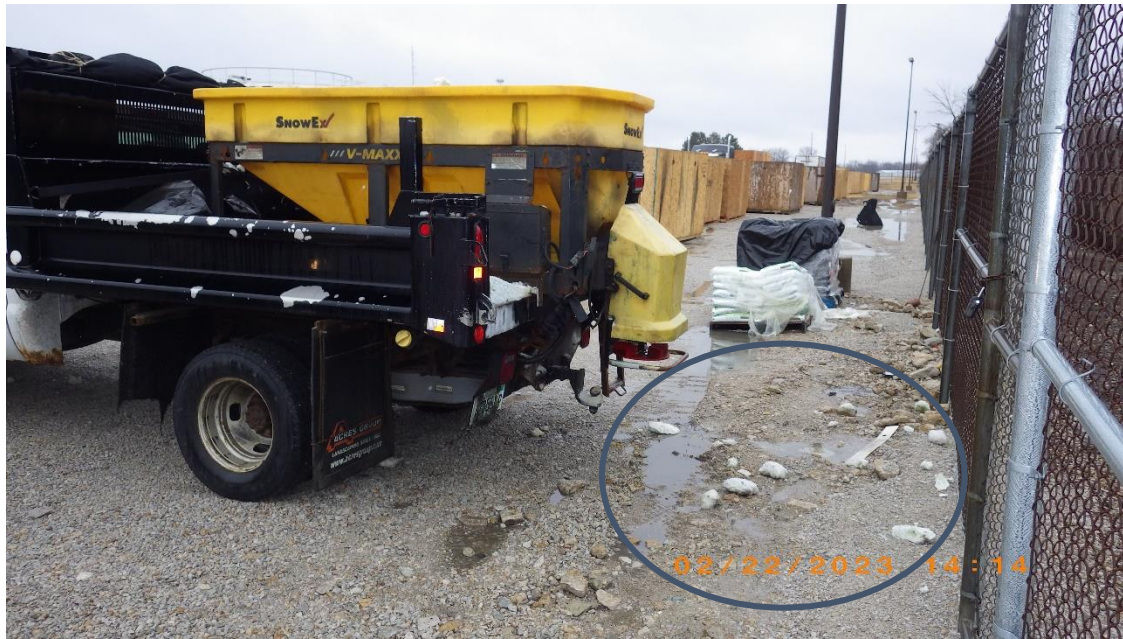
28: RIMG0151

| <b>TF-OB-016</b> | Softball size chunks of road salt were on the ground in the immediate vicinity of a salt application truck. See Photo 28. | <b>Yes</b> |

Description: Road salt application truck. Hopper in truck bed was full at time of inspection. Blue circle denotes chunks of road salt exposed to storm water.

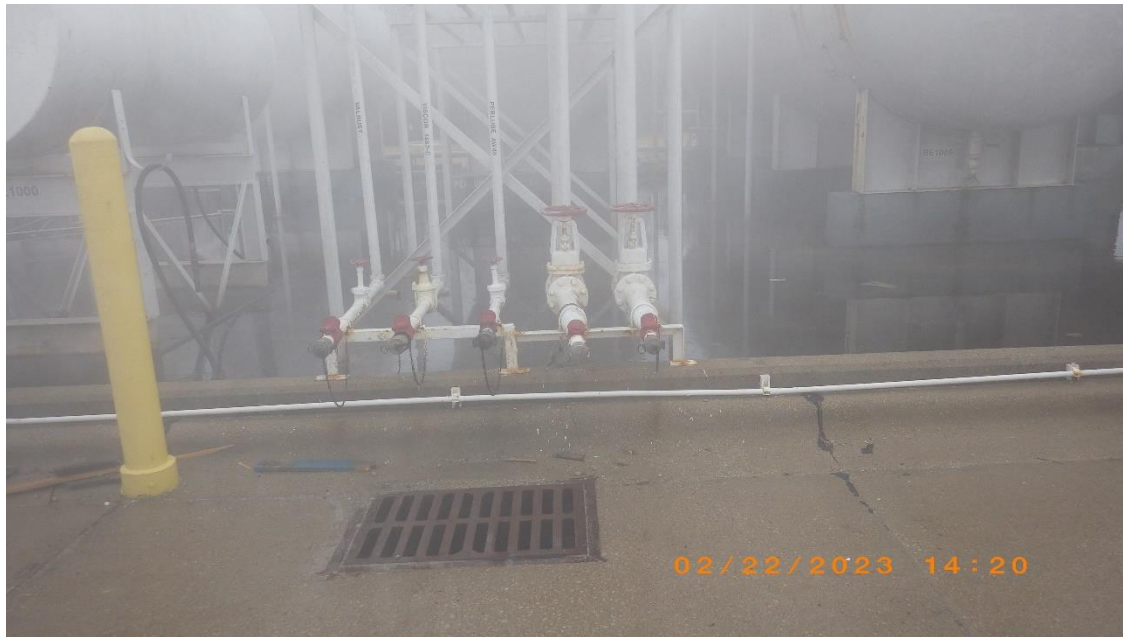
30: RIMG0153

Description: Tank farm loading/unloading location. Note catch basin directly beneath the end of the pipes.

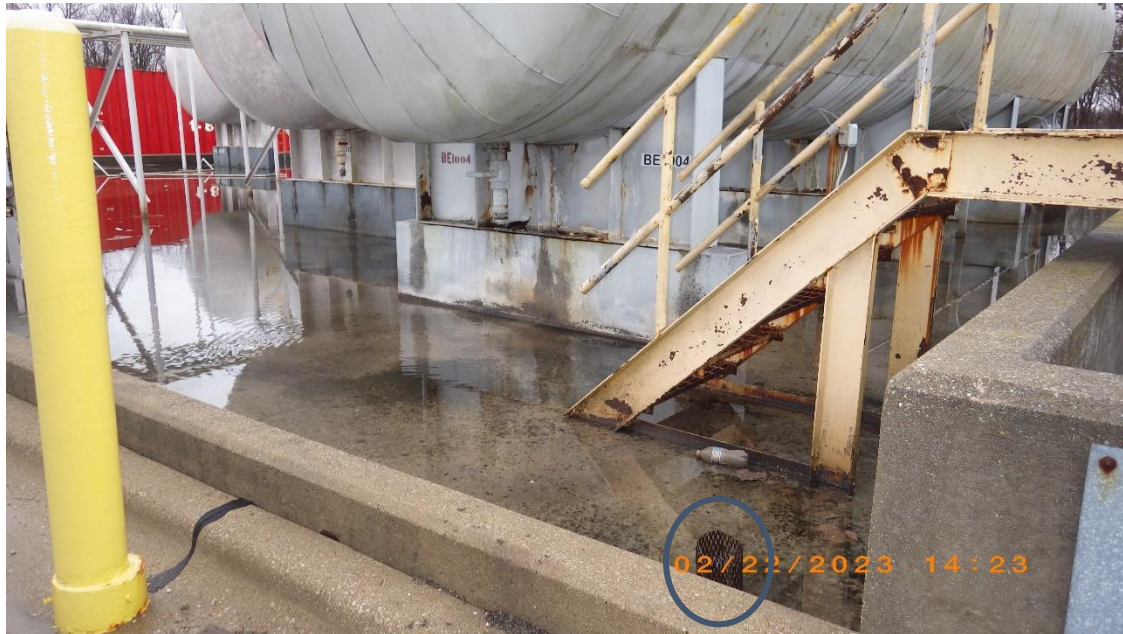
31: RIMG0155

| <b>TF-OB-015</b> | A pipe was observed in the northeast corner of the tank farm at the Facility. The pipe had stormwater flowing into it. | <b>Yes</b> |

| <b>TF-OB-015</b> | A pipe was observed in the northeast corner of the tank farm at the Facility. The pipe had stormwater flowing into it.<br><br><b>Permit No. ILR006863 – Section G</b> |

Description: Overview of stormwater captured in tank farm secondary containment. Blue circle denotes pipe in Photo 32.

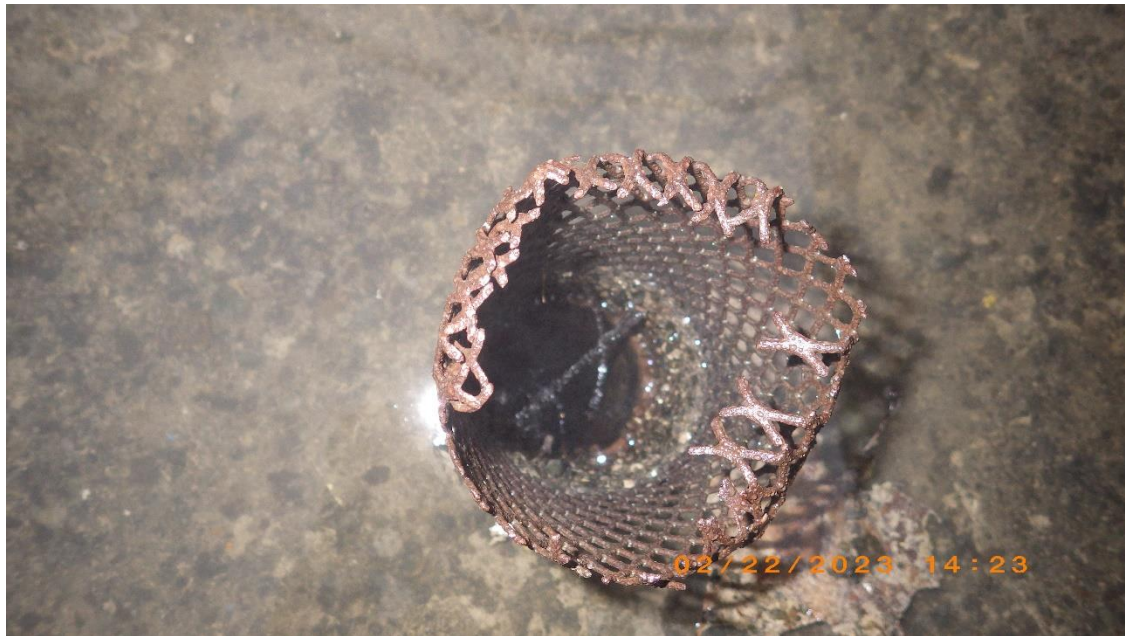
32: RIMG0156

Description: Pipe actively taking on water from within tank farm secondary containment. See overview of pipe location in Photo 31.
