## Clean Water Act Section 404: Site Visit/Case Development

| Inspector Name(s) | Chelsey Sherwood | Time In | 12:30 PM | Start Date | February 28, 2024 | | |
| Site Name | Alexander Land Co, LLC | | | | | | |

| Inspection Purpose | Initial site visit | | |

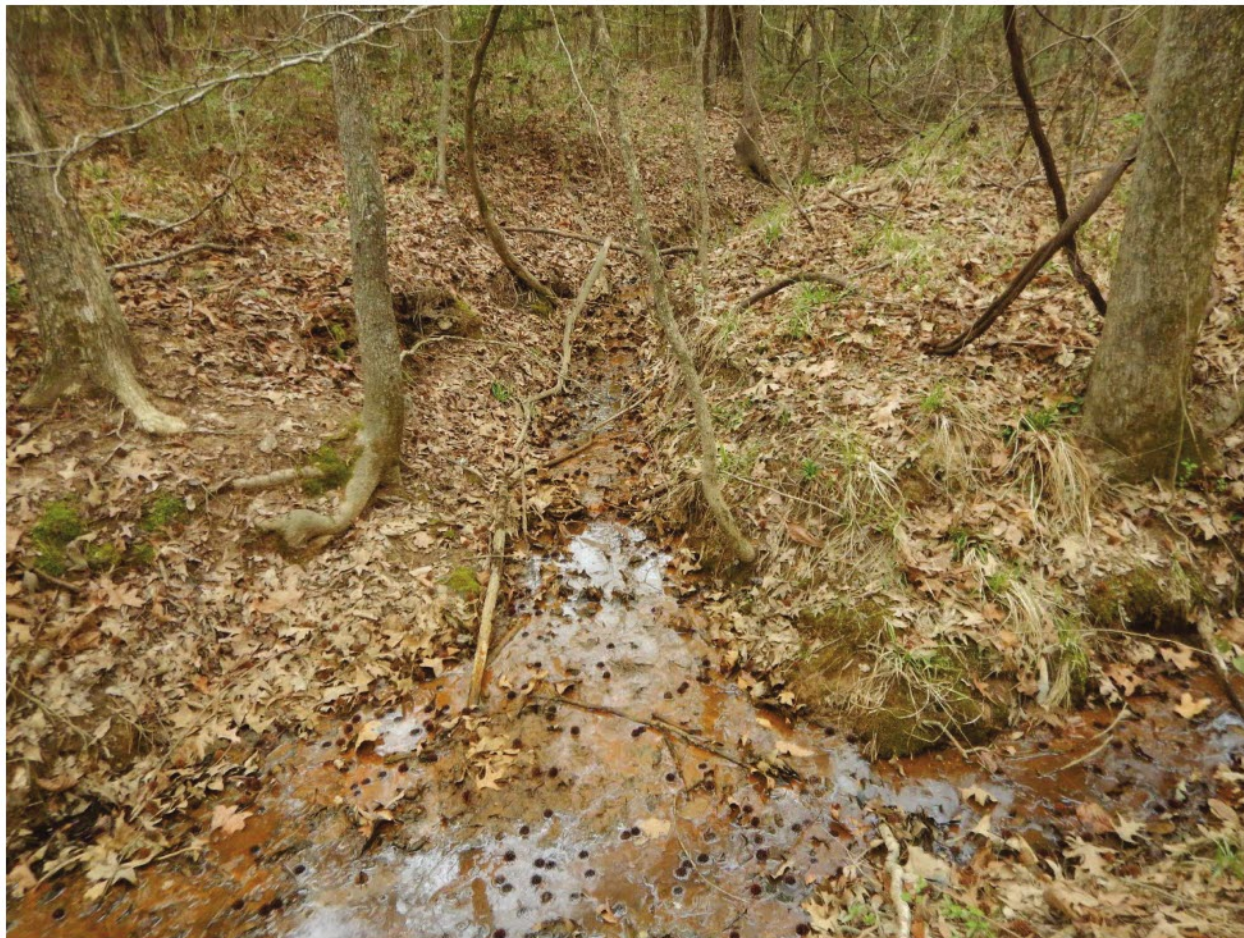
Photo No. 1

| Photo File Name | Date and Time of Photo | Photographer | Description |
|---|---|---|---|
| DSCN6355.JPG | 02/28/2024, 12:53 PM | Chelsey Sherwood | Showing orange-tinted water and sheen indicating iron-oxidizing bacteria present. Picture taken facing west. |

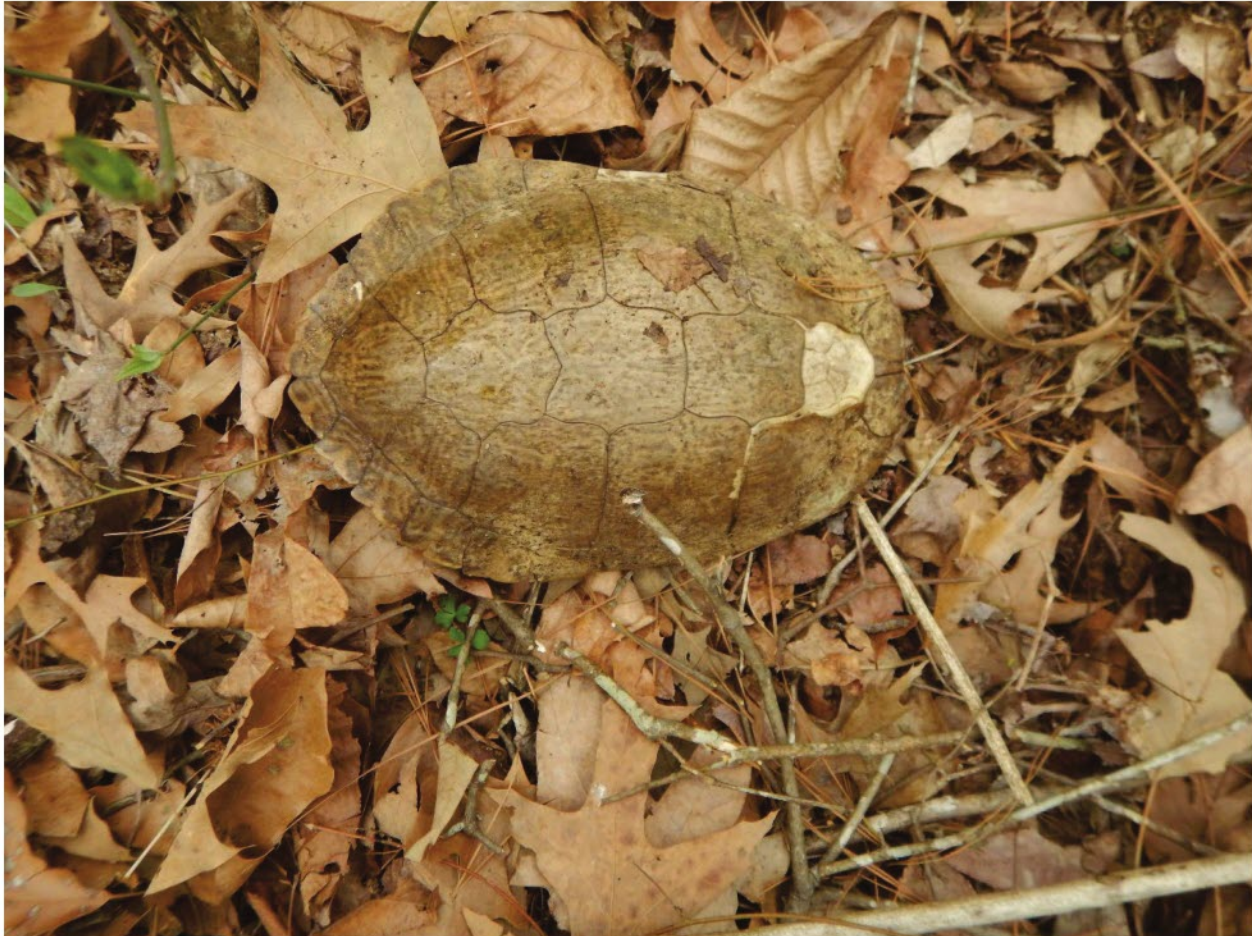
Photo No. 2

| Photo File Name | Date and Time of Photo | Photographer | Description |
|---|---|---|---|
| DSCN6356.JPG | 02/28/2024, 12:53 PM | Chelsey Sherwood | Showing dead aquatic turtle found next to stream. |

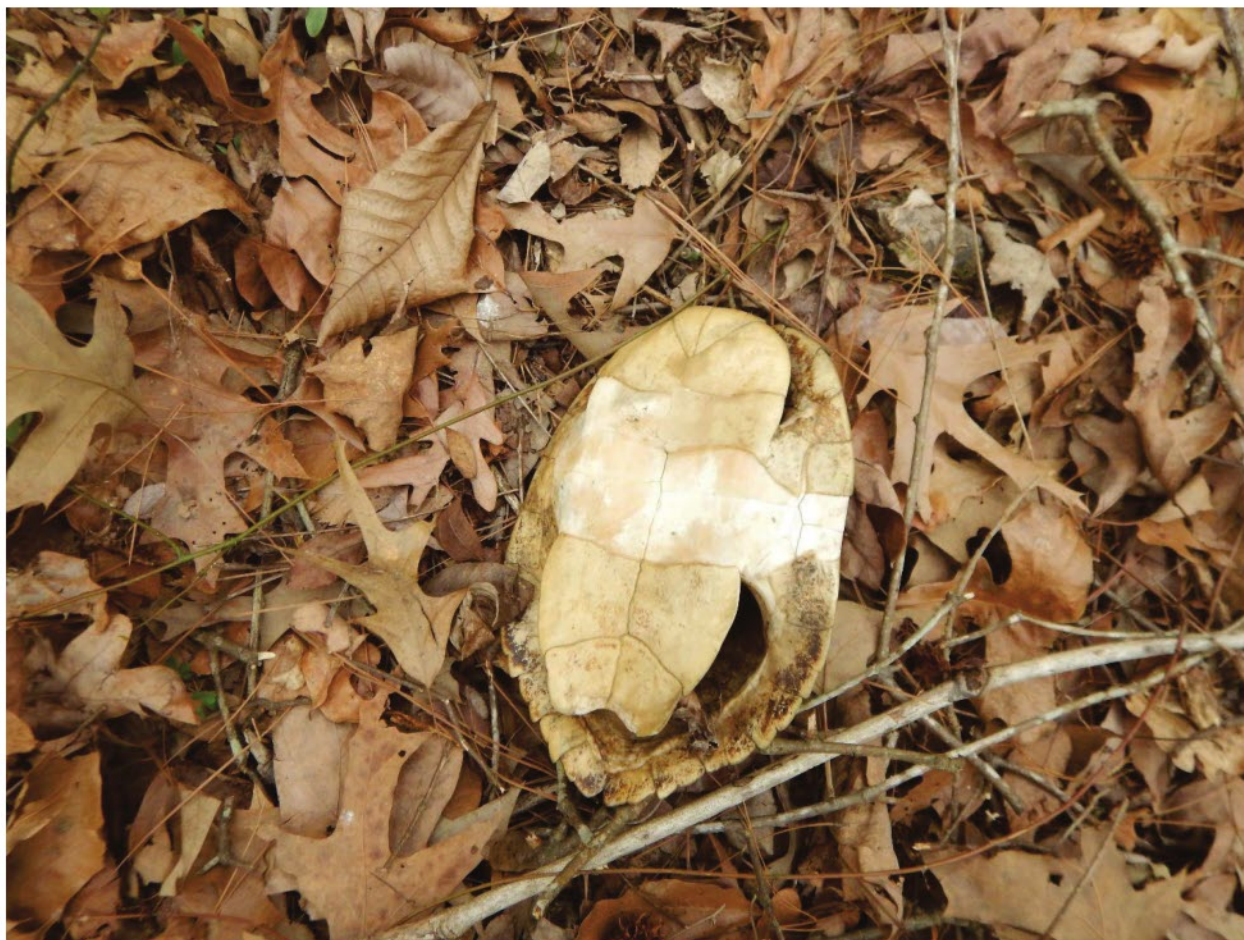
Photo No. 3

| Photo File Name | Date and Time of Photo | Photographer | Description |
|---|---|---|---|
| DSCN6357.JPG | 02/28/2024, 12:54 PM | Chelsey Sherwood | Showing dead aquatic turtle found next to stream. |

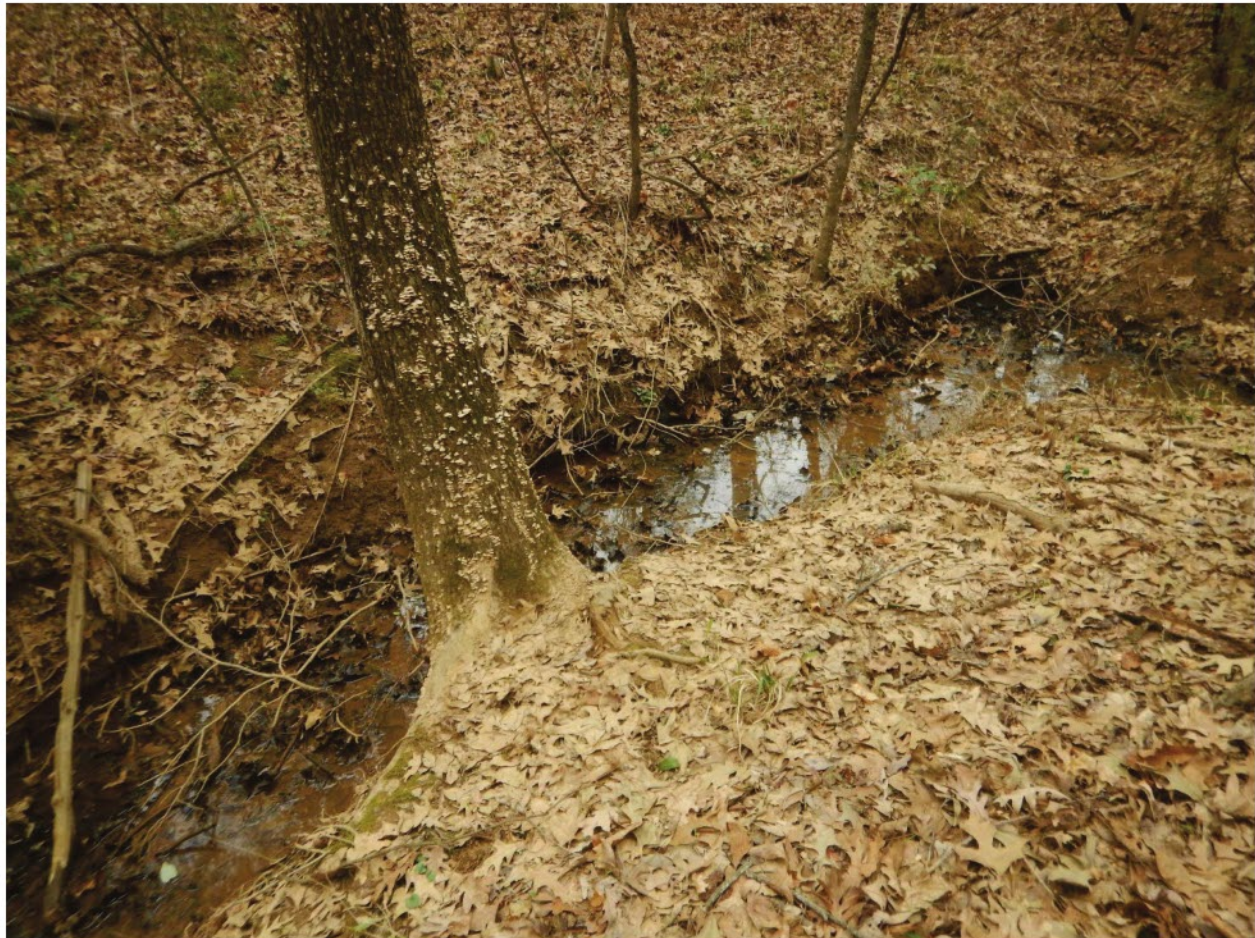
Photo No. 4

| Photo File Name | Date and Time of Photo | Photographer | Description |
|---|---|---|---|
| DSCN6358.JPG | 02/28/2024, 12:59 PM | Chelsey Sherwood | Showing excessive sediment deposition on debris and tree. Picture taken looking south from left bank. |

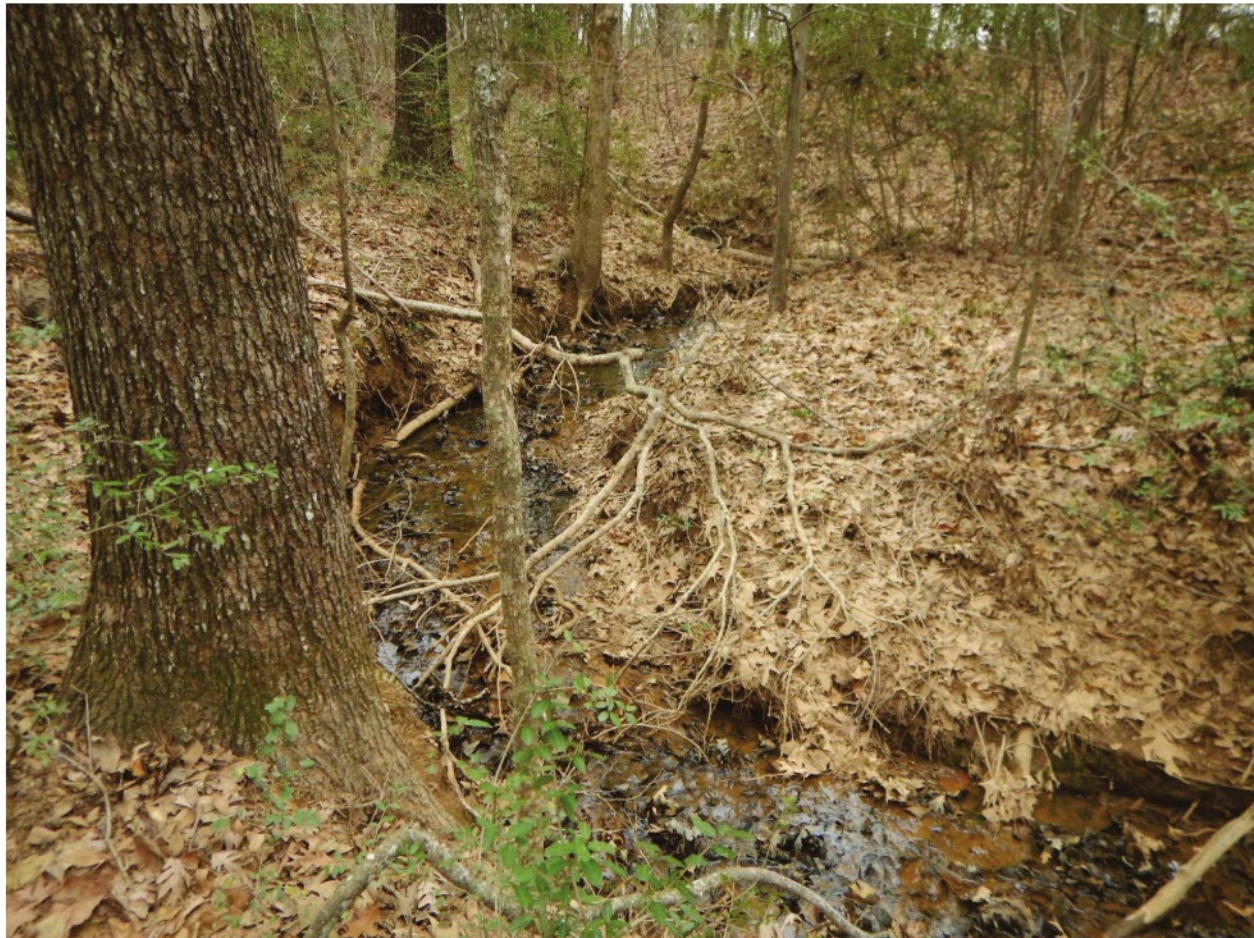
Photo No. 5

| Photo File Name | Date and Time of Photo | Photographer | Description |
|---|---|---|---|
| DSCN6359.JPG | 02/28/2024, 12:59 PM | Chelsey Sherwood | Showing excessive sediment deposition on floodplain and orange tinted water. Picture taken facing downstream, east. |

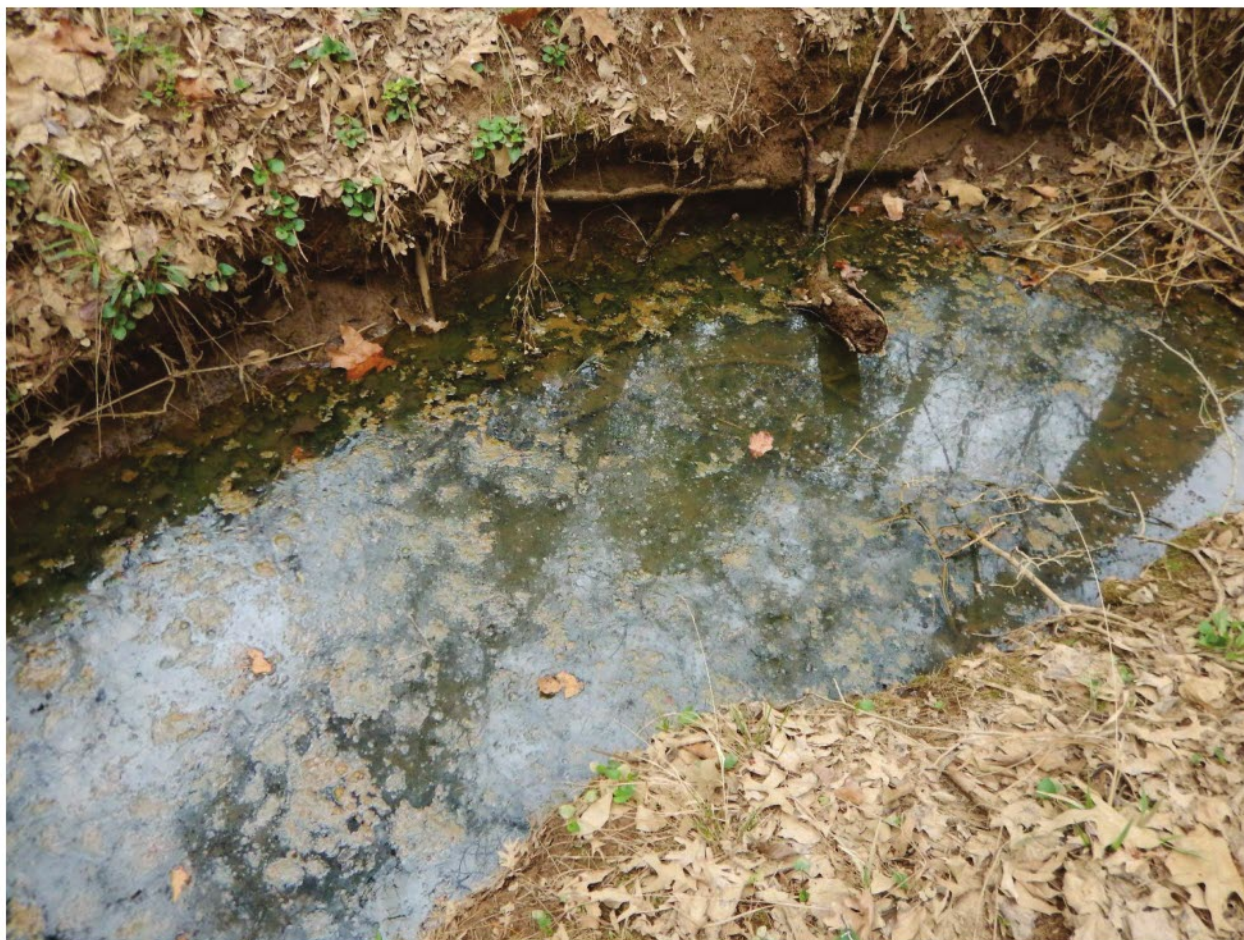
Photo No. 6

| Photo File Name | Date and Time of Photo | Photographer | Description |
|---|---|---|---|
| DSCN6360.JPG | 02/28/2024, 1:03 PM | Chelsey Sherwood | Showing algal growth and sheen on water. Note fish observed here. Picture taken looking south from left bank. |

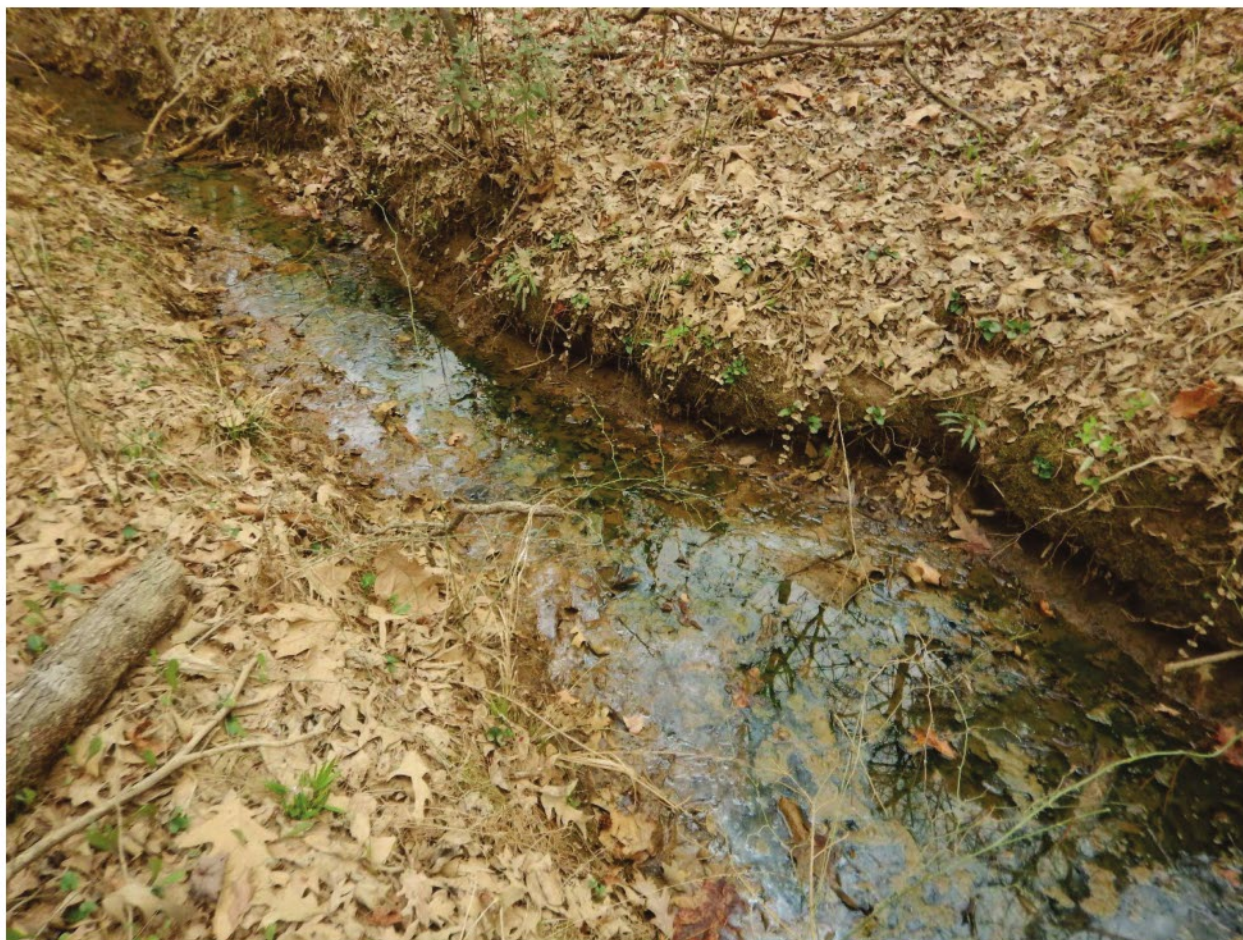
Photo No. 7

| Photo File Name | Date and Time of Photo | Photographer | Description |
|---|---|---|---|
| DSCN6361.JPG | 02/28/2024, 1:03 PM | Chelsey Sherwood | Showing algal growth and sheen on water. Note sediment deposition on floodplain. Picture taken facing downstream, east. |

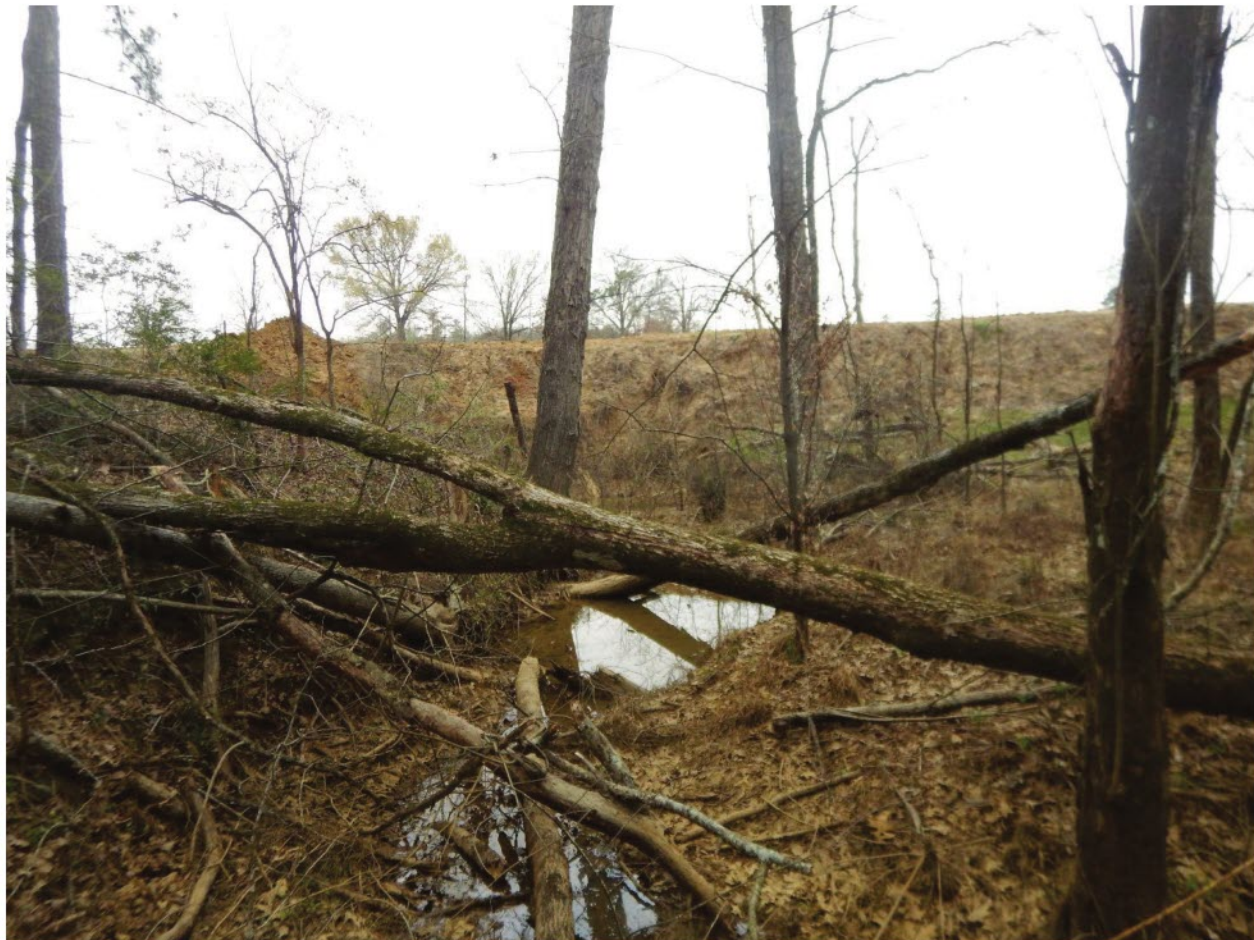
Photo No. 8

| Photo File Name | Date and Time of Photo | Photographer | Description |
|---|---|---|---|
| DSCN6362.JPG | 02/28/2024, 1:10 PM | Chelsey Sherwood | Showing spillway and excessive sediment deposition in stream channel. Picture taken facing upstream, south. |

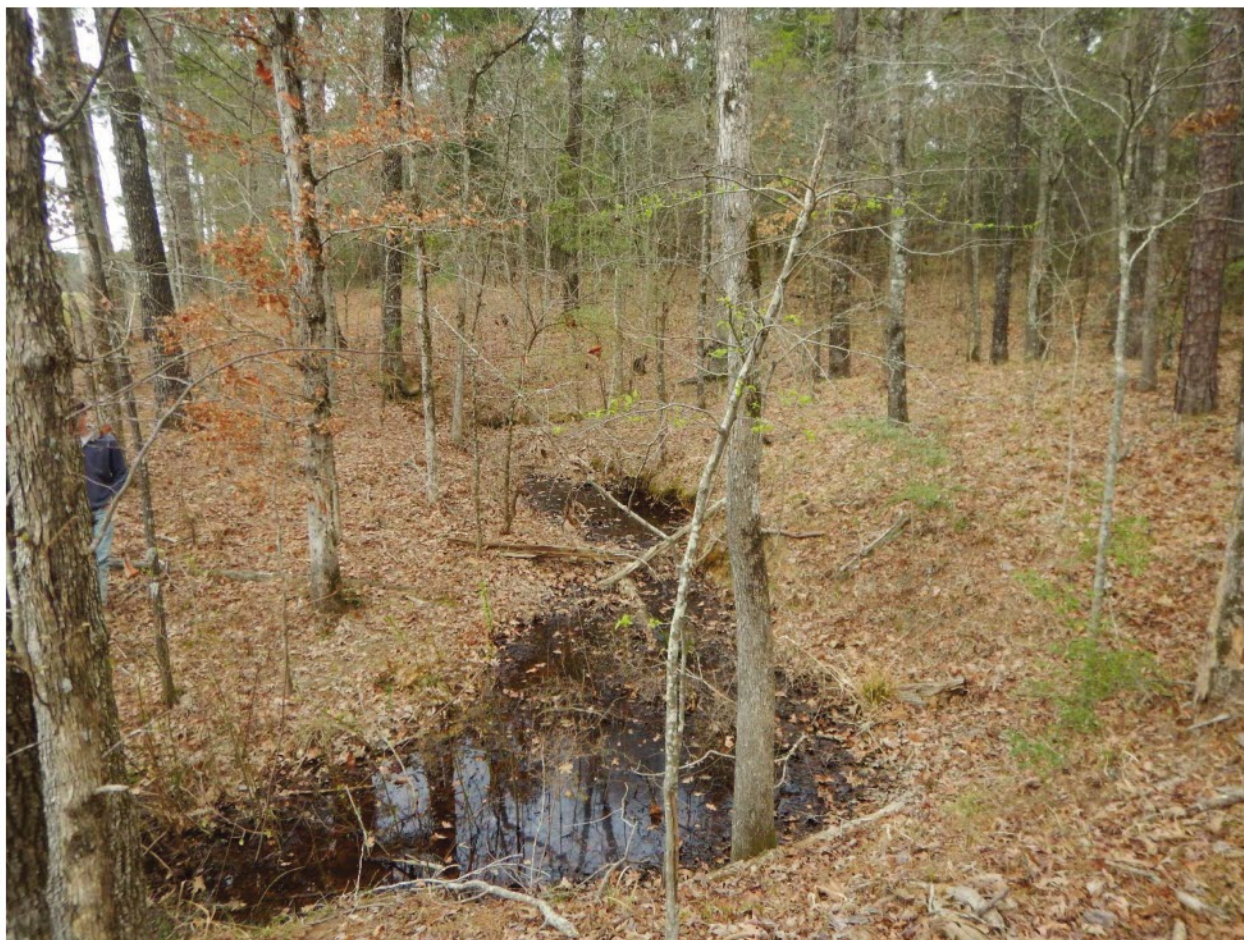
Photo No. 9

| Photo File Name | Date and Time of Photo | Photographer | Description |
|---|---|---|---|
| DSCN6363.JPG | 02/28/2024, 1:25 PM | Chelsey Sherwood | Showing downstream of spillway. Note dark tinted water and stained debris. Picture taken facing downstream, northeast. |

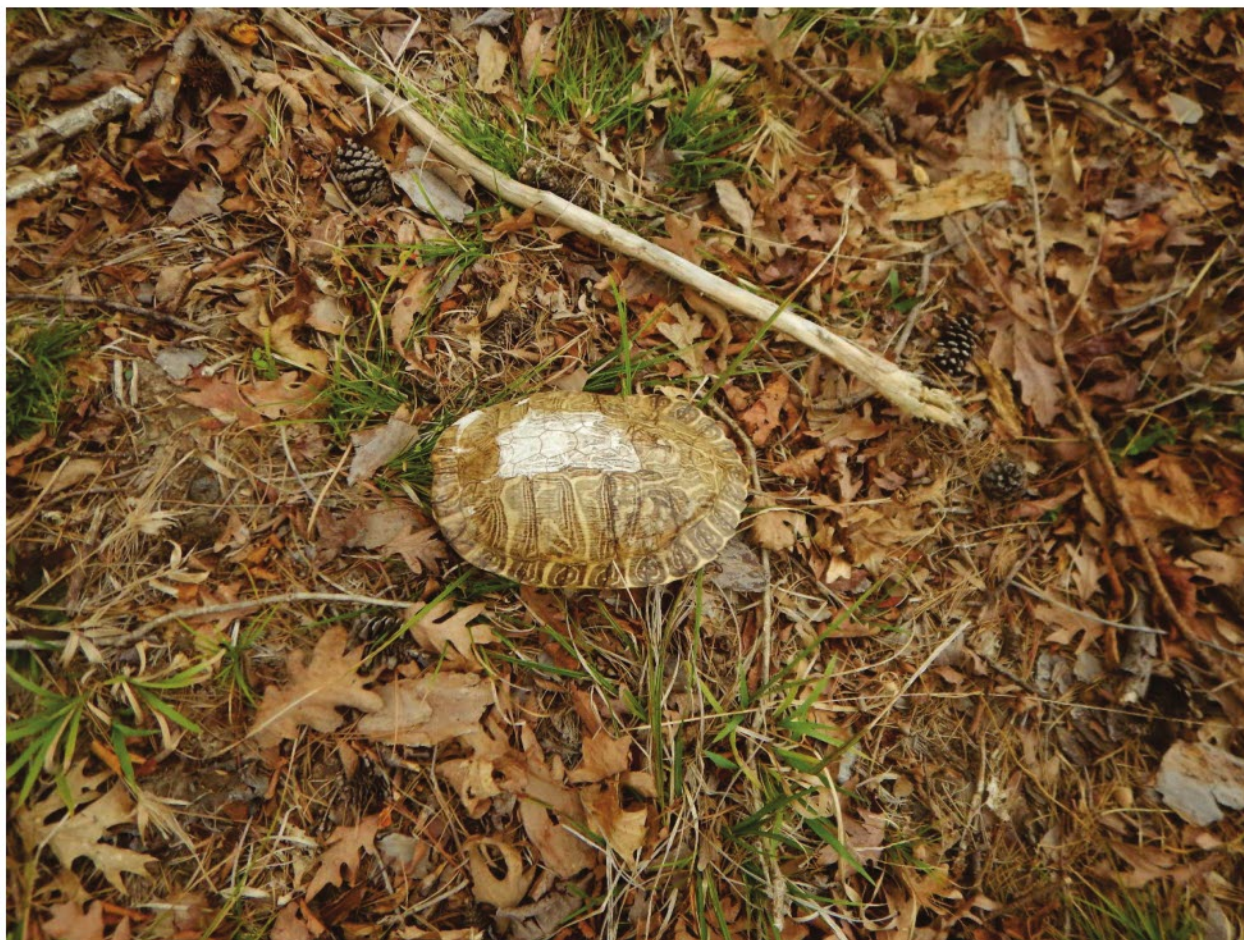
Photo No. 10

| Photo File Name | Date and Time of Photo | Photographer | Description |
|---|---|---|---|
| DSCN6364.JPG | 02/28/2024, 1:30 PM | Chelsey Sherwood | Showing dead aquatic turtle. |

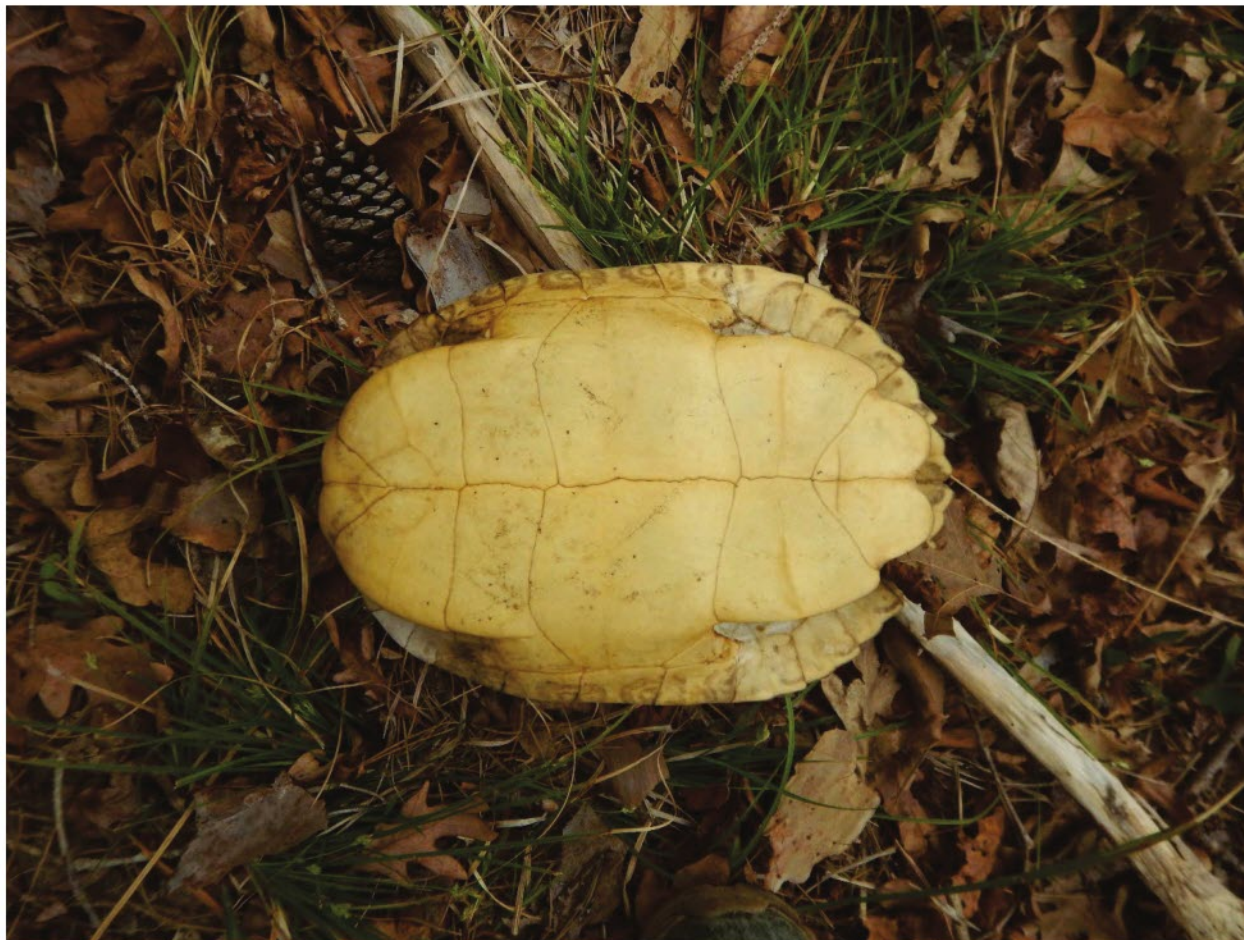
Photo No. 11

| Photo File Name | Date and Time of Photo | Photographer | Description |
|---|---|---|---|
| DSCN6365.JPG | 02/28/2024, 1:30 PM | Chelsey Sherwood | Showing dead aquatic turtle. |

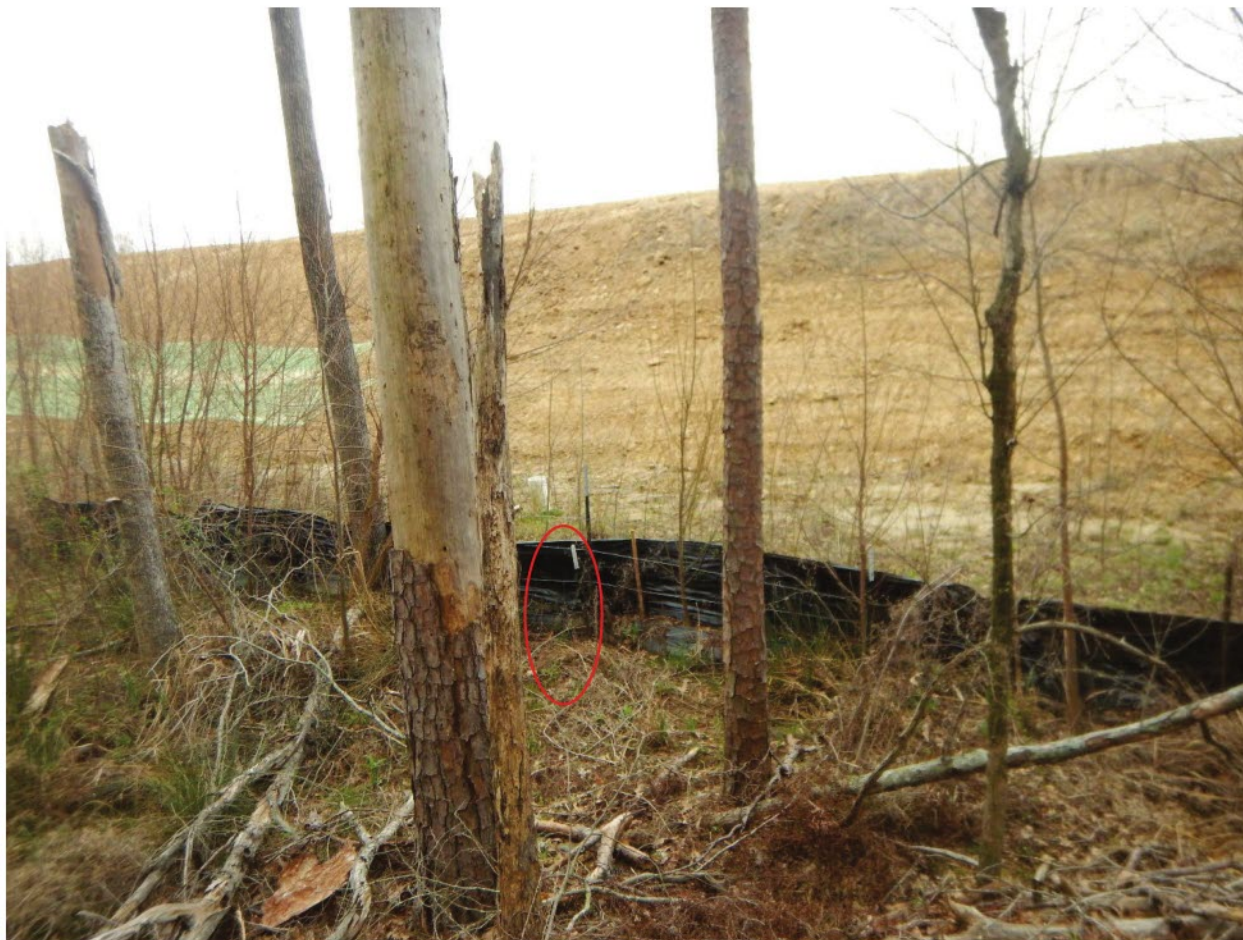
Photo No. 12

| Photo File Name | Date and Time of Photo | Photographer | Description |
|---|---|---|---|
| DSCN6366.JPG | 02/28/2024, 1:33 PM | Chelsey Sherwood | Showing original silt fence and T-post circled in red that has been buried approximately 5 feet from sedimentation. Note spillway in back and bare earth. Picture taken facing southeast. |

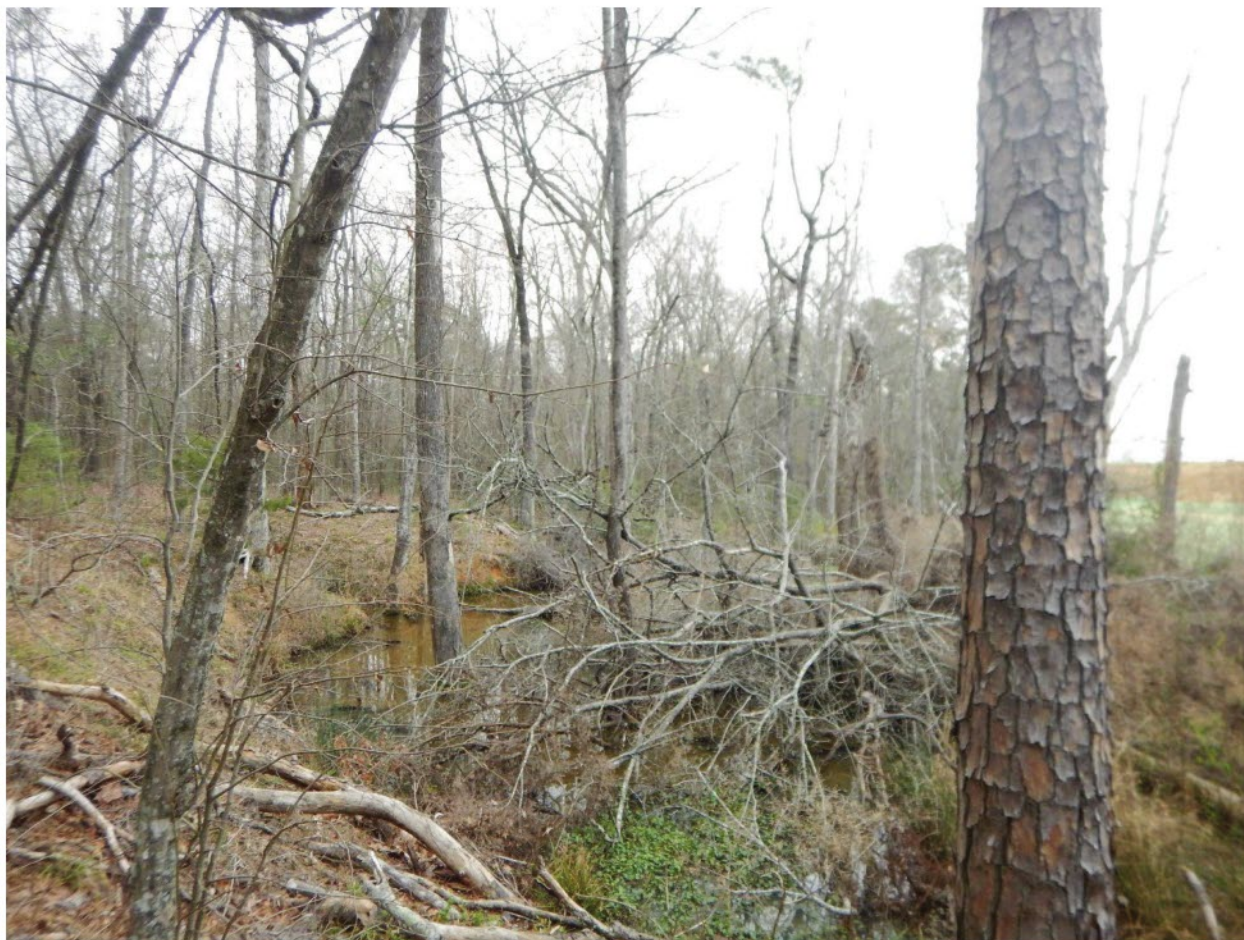
Photo No. 13

| Photo File Name | Date and Time of Photo | Photographer | Description |
|---|---|---|---|
| DSCN6367.JPG | 02/28/2024, 1:36 PM | Chelsey Sherwood | Showing part of original stream channel that is now an inundated wetland due to direct filling of the stream channel and severing of the stream connection by the spillway. Note stressed vegetation and dead trees Picture taken facing east. |

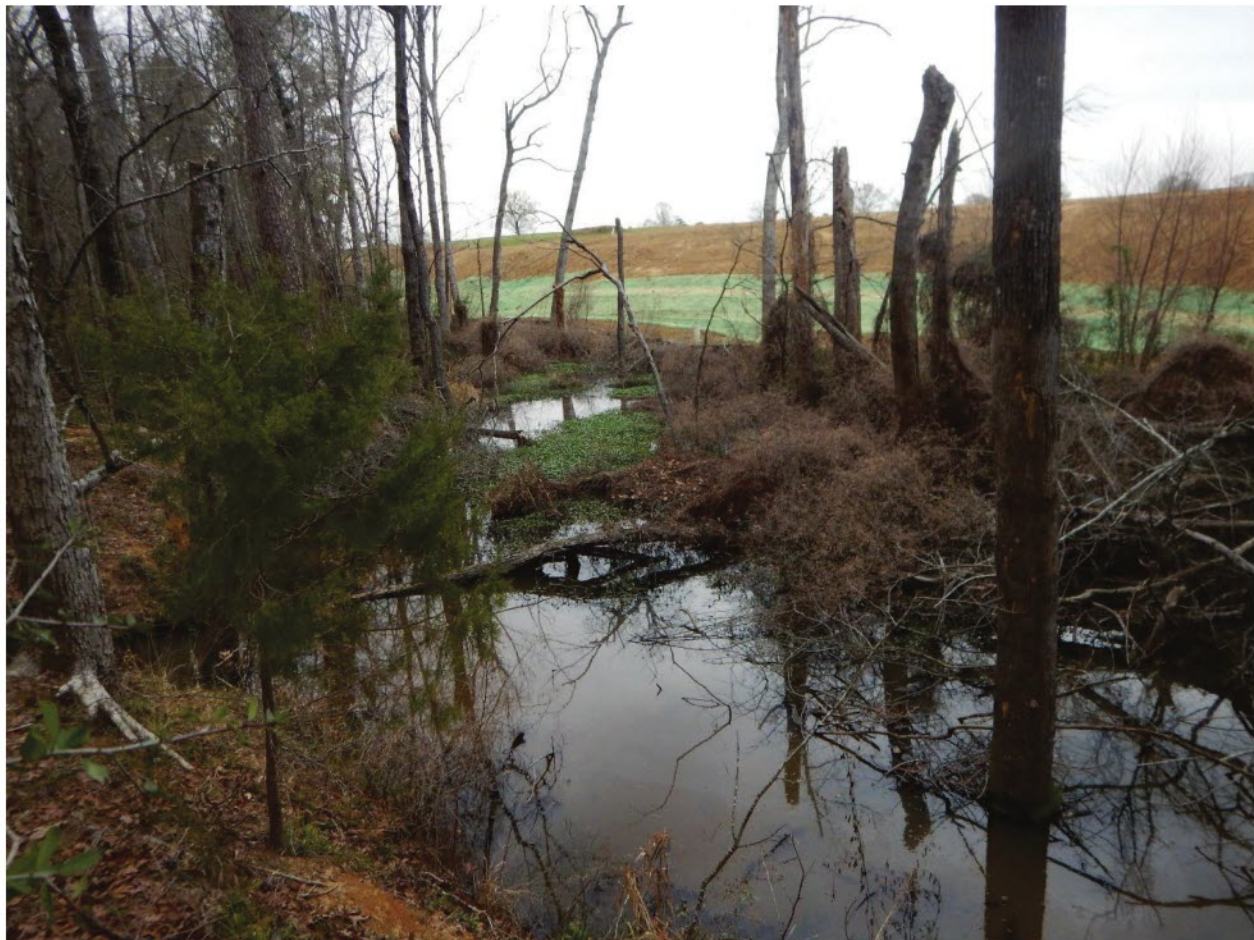
Photo No. 14

| Photo File Name | Date and Time of Photo | Photographer | Description |
|---|---|---|---|
| DSCN6368.JPG | 02/28/2024, 1:36 PM | Chelsey Sherwood | Showing part of original stream channel that is now an inundated wetland due to direct filling of the stream channel and severing of the stream connection by the spillway. Note stressed vegetation and dead trees. Picture taken facing southeast. |

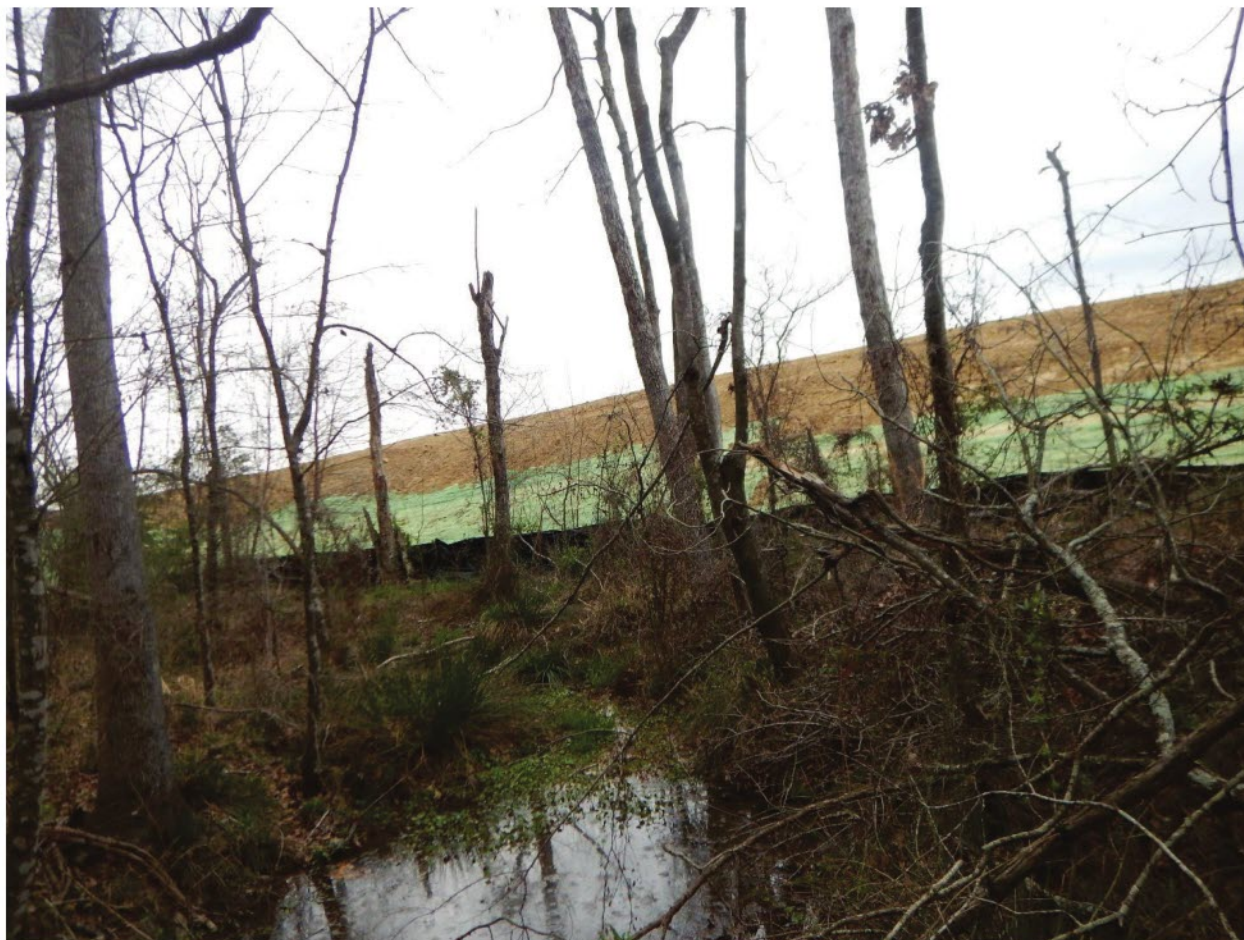
Photo No. 15

| Photo File Name | Date and Time of Photo | Photographer | Description |
|---|---|---|---|
| DSCN6369.JPG | 02/28/2024, 1:39 PM | Chelsey Sherwood | Showing part of original stream channel that is now an inundated wetland. Note stressed vegetation, dead trees, and <i>Juncus spp.</i> Picture taken facing southeast. |

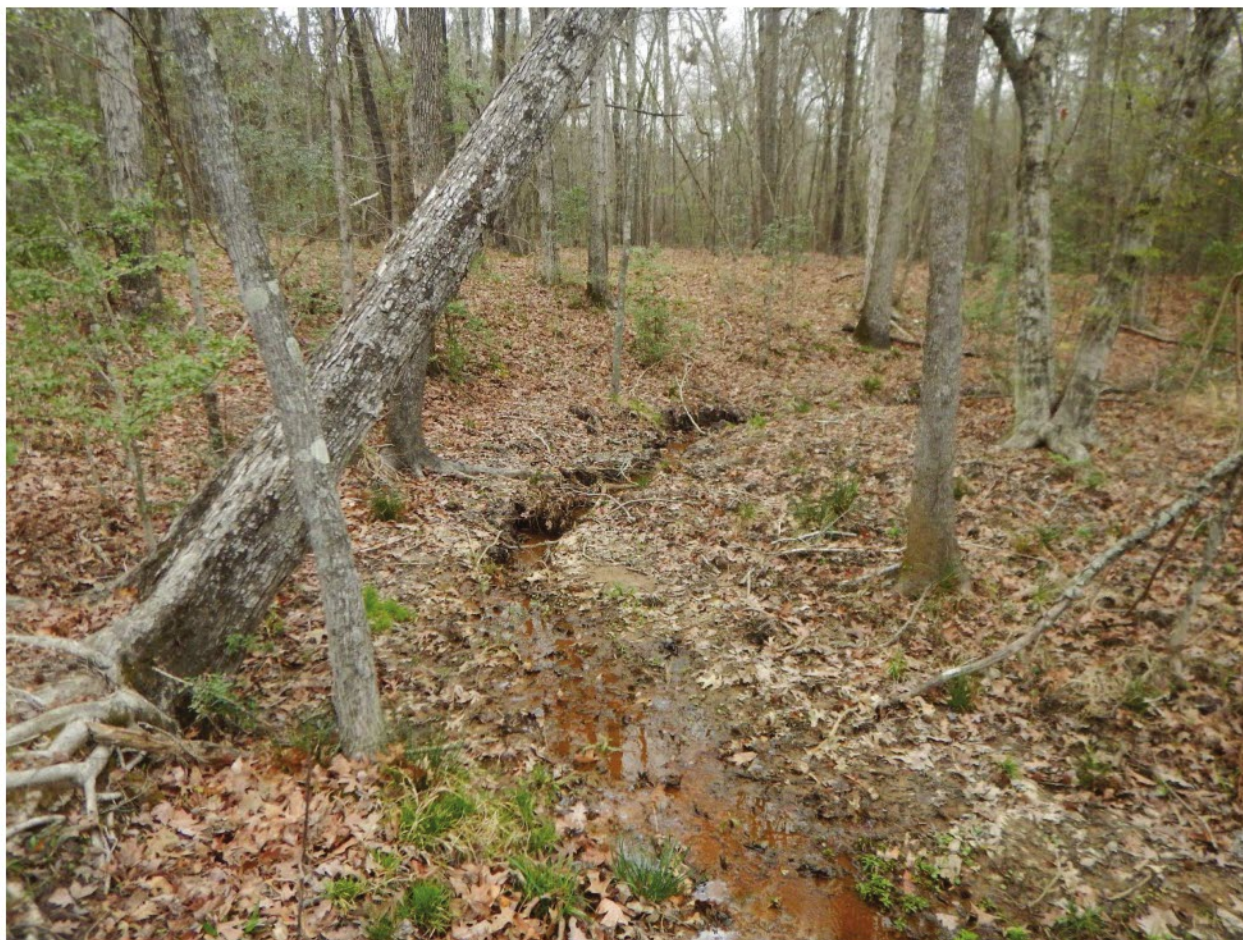
Photo No. 16

| Photo File Name | Date and Time of Photo | Photographer | Description |
|---|---|---|---|
| DSCN6370.JPG | 02/28/2024, 1:39 PM | Chelsey Sherwood | Showing erosional channel. Note sediment deposition and orange tinted water. Picture taken facing north. |

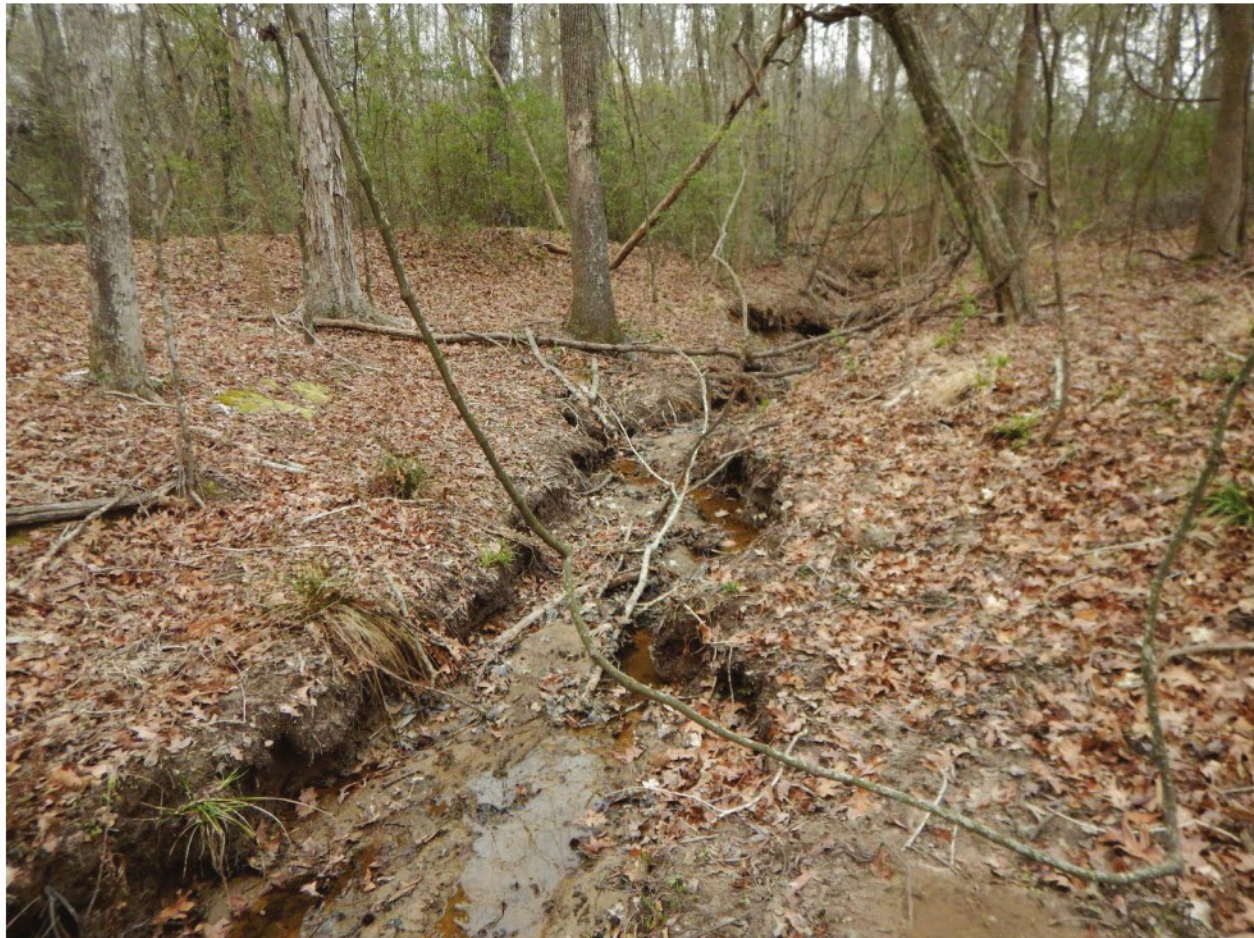
Photo No. 17

| Photo File Name | Date and Time of Photo | Photographer | Description |
|---|---|---|---|
| DSCN6371.JPG | 02/28/2024, 1:42 PM | Chelsey Sherwood | Showing washed out channel, excessive sediment deposition, eroded banks, and exposed roots. Picture taken facing downstream. |

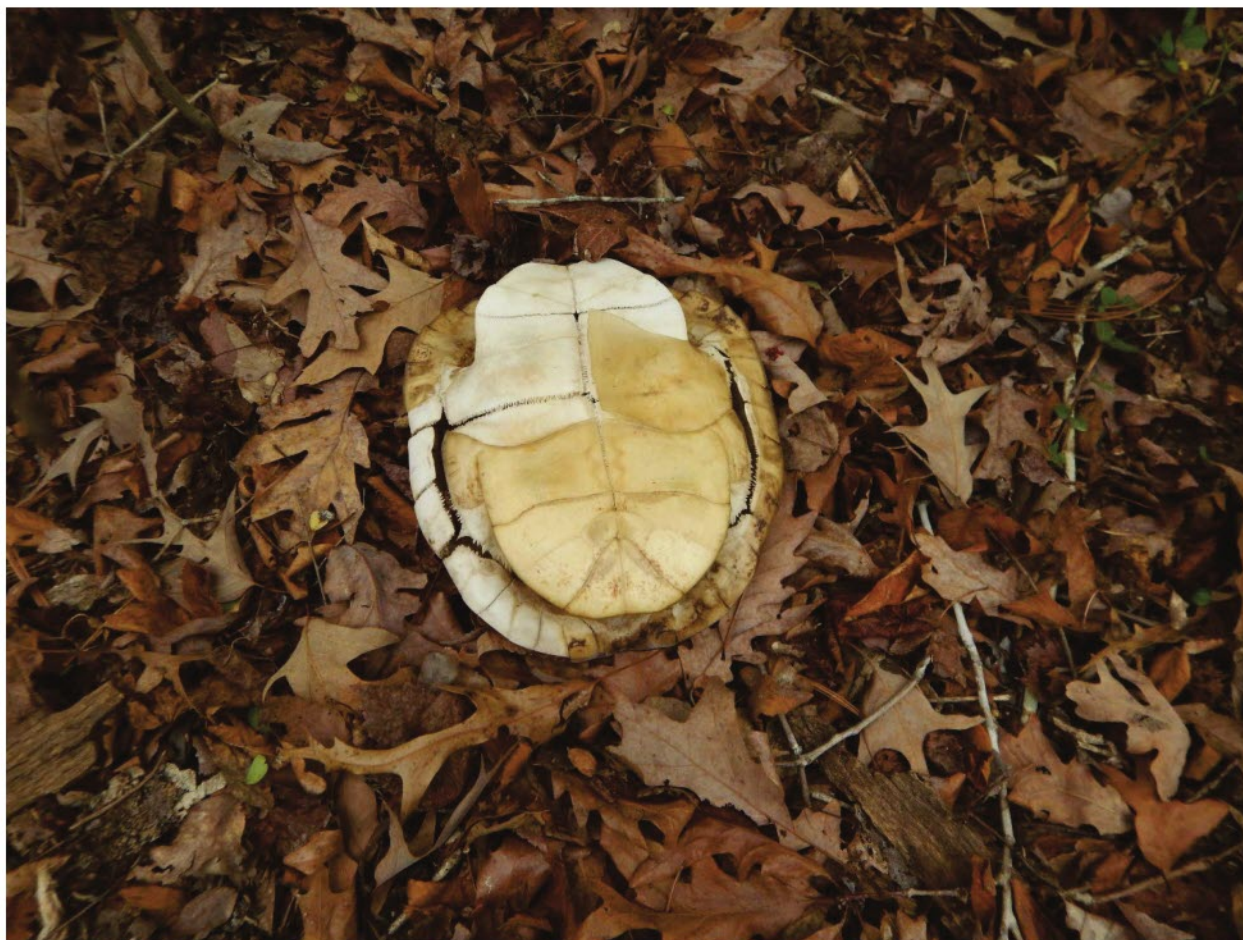
Photo No. 18

| Photo File Name | Date and Time of Photo | Photographer | Description |
|---|---|---|---|
| DSCN6372.JPG | 02/28/2024, 1:43 PM | Chelsey Sherwood | Showing dead aquatic turtle. |
