## Clean Water Act Section 404: Site Visit/Case Development

| Inspector Name(s) | Chelsey Sherwood | Time In | 12:30 PM | Start Date | February 28, 2024 | | |
| Site Name | Alexander Land Co, LLC | | | | | | |

| Inspection Purpose | Initial site visit | | |

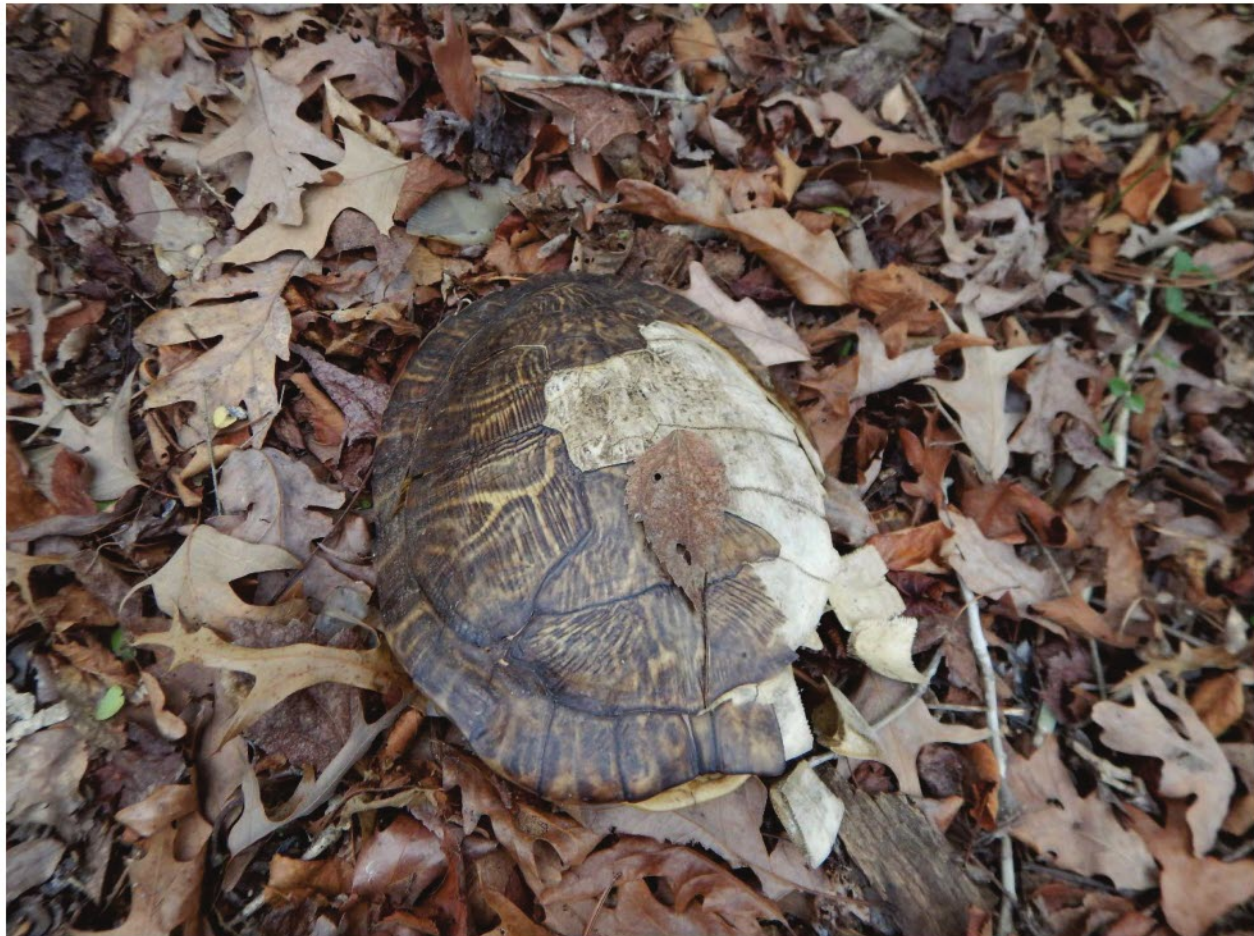
Photo No. 19

| Photo File Name | Date and Time of Photo | Photographer | Description |
|---|---|---|---|
| DSCN6373.JPG | 02/28/2024, 1:43 PM | Chelsey Sherwood | Showing dead aquatic turtle. |

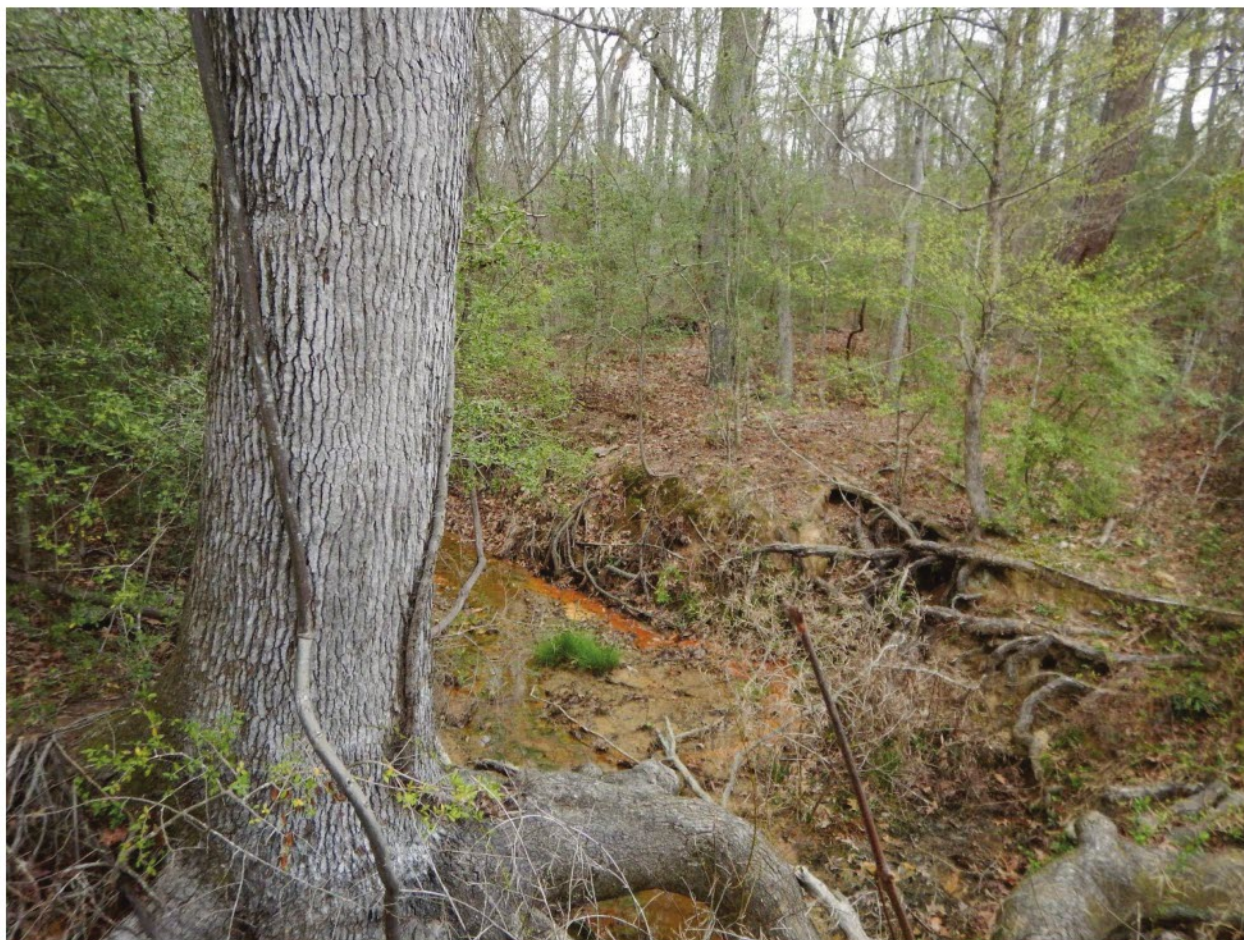
Photo No. 20

| Photo File Name | Date and Time of Photo | Photographer | Description |
|---|---|---|---|
| DSCN6374.JPG | 02/28/2024, 1:48 PM | Chelsey Sherwood | Showing erosion, exposed roots, excessive sedimentation, algae, and orange tinted water in stream channel. Picture taken facing north, downstream. |

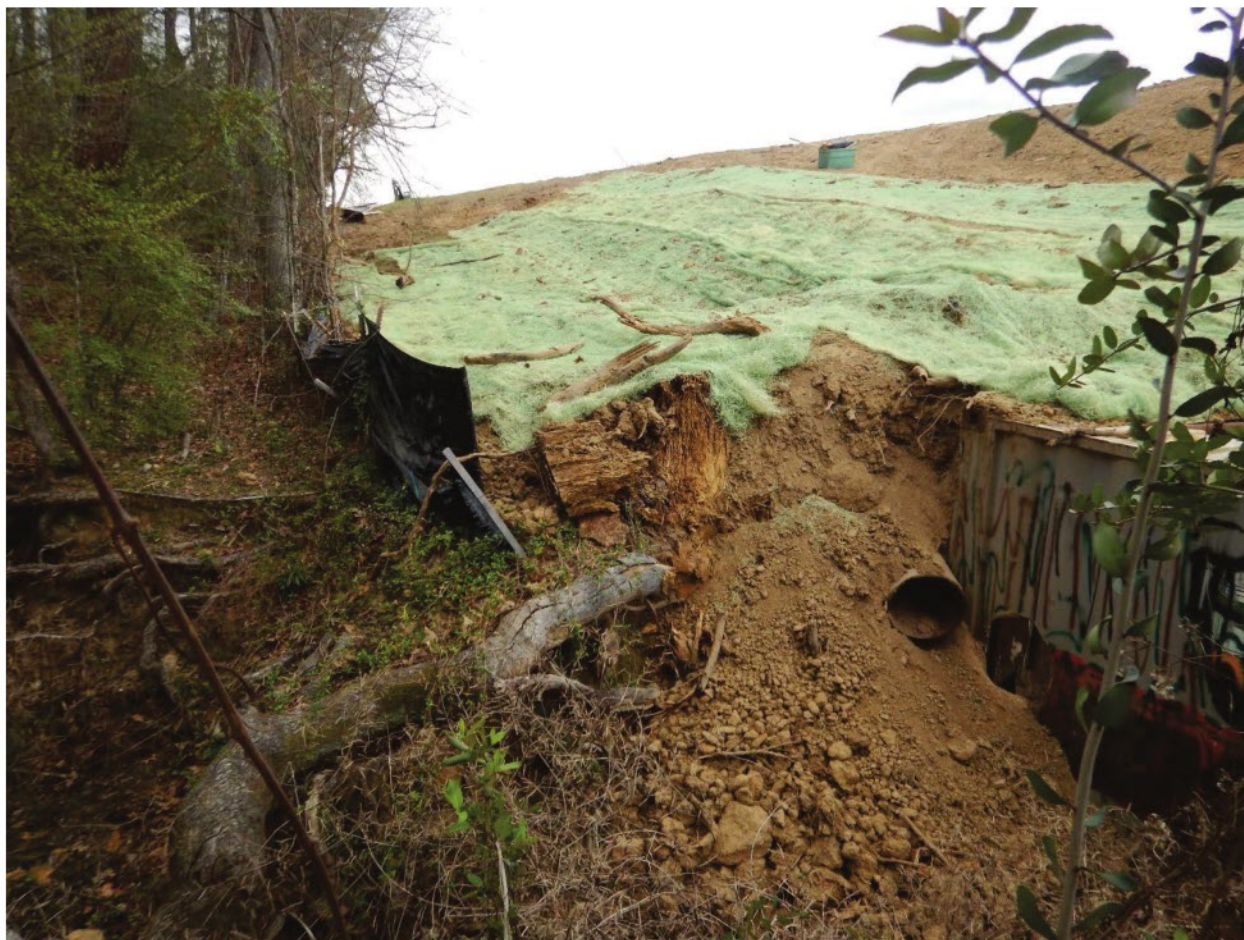
Photo No. 21

| Photo File Name | Date and Time of Photo | Photographer | Description |
|---|---|---|---|
| DSCN6375.JPG | 02/28/2024, 1:49 PM | Chelsey Sherwood | Showing spillway and catch box with bare earth exposed. Note the fill material below Ordinary High Water Mark sloughing into stream and fence posts buried in sediment. Picture taken facing east, from river left bank. |

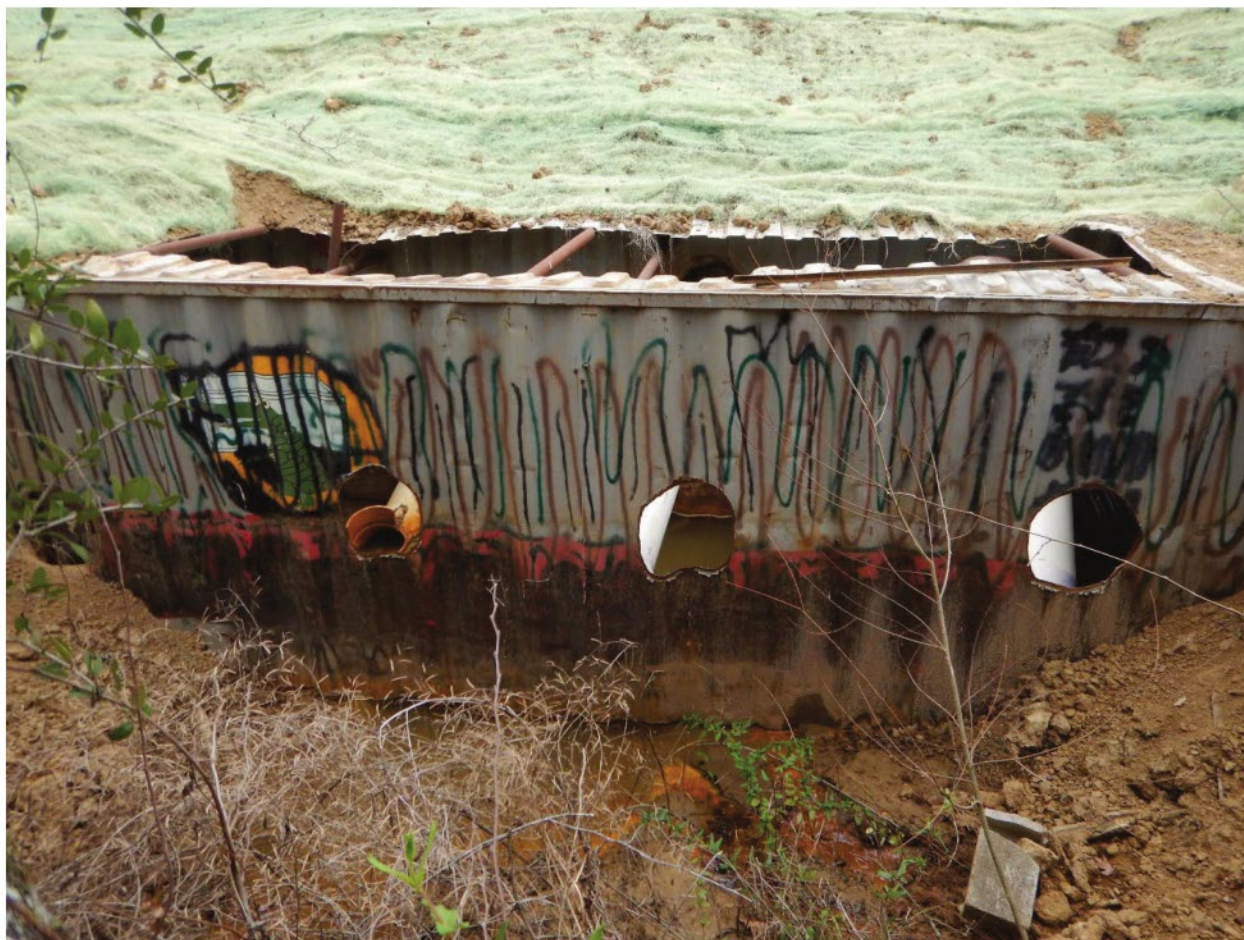
Photo No. 22

| Photo File Name | Date and Time of Photo | Photographer | Description |
|---|---|---|---|
| DSCN6376.JPG | 02/28/2024, 1:49 PM | Chelsey Sherwood | Showing spillway and catch box that all water from upstream is directed to now. Note the fill material below Ordinary High Water Mark sloughing into stream channel and orange tinted water. Picture taken facing upstream, south. |

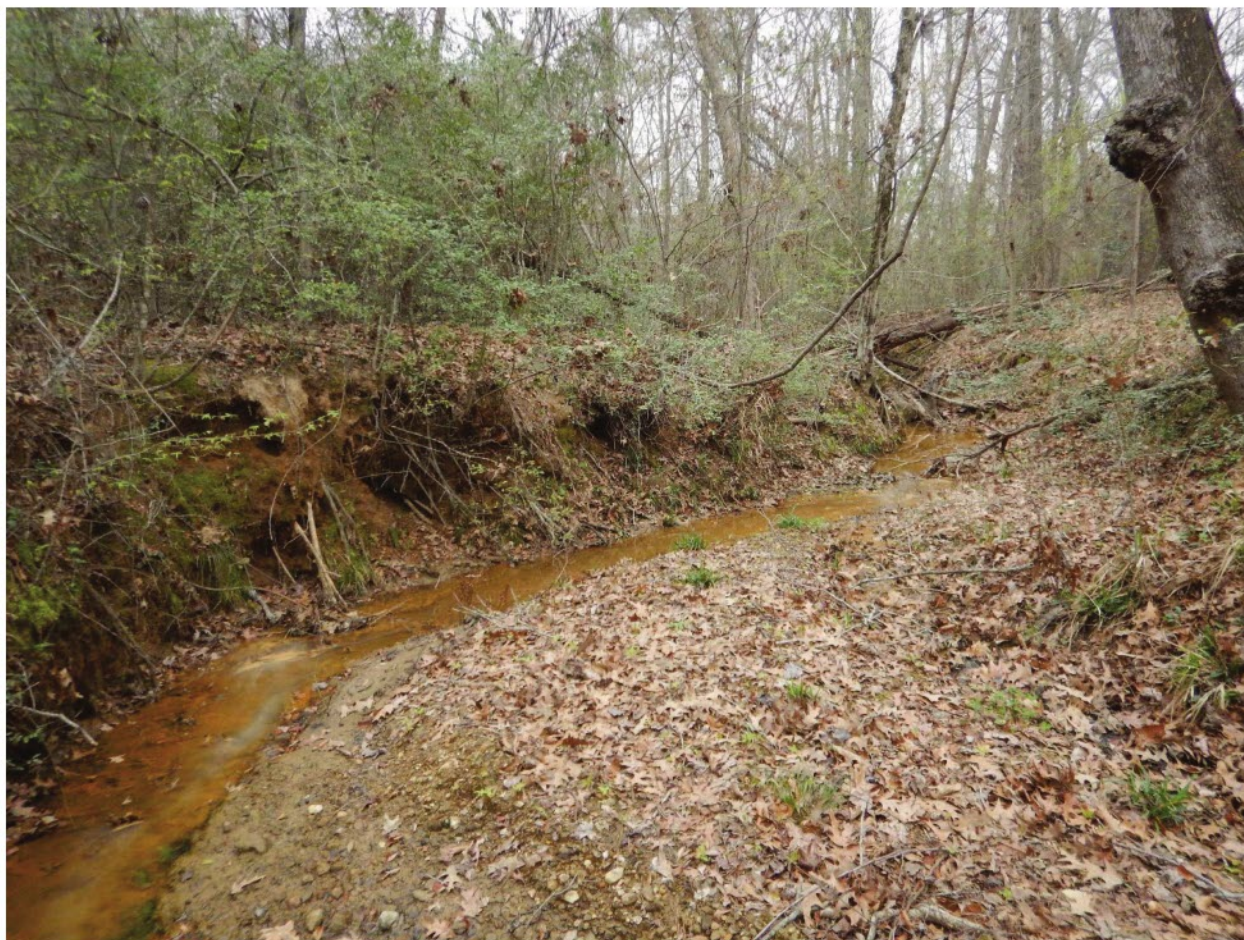
Photo No. 23

| Photo File Name | Date and Time of Photo | Photographer | Description |
|---|---|---|---|
| DSCN6377.JPG | 02/28/2024, 1:55 PM | Chelsey Sherwood | Showing eroded banks, sedimentation, and orange tinted water. Picture taken facing downstream, north. |

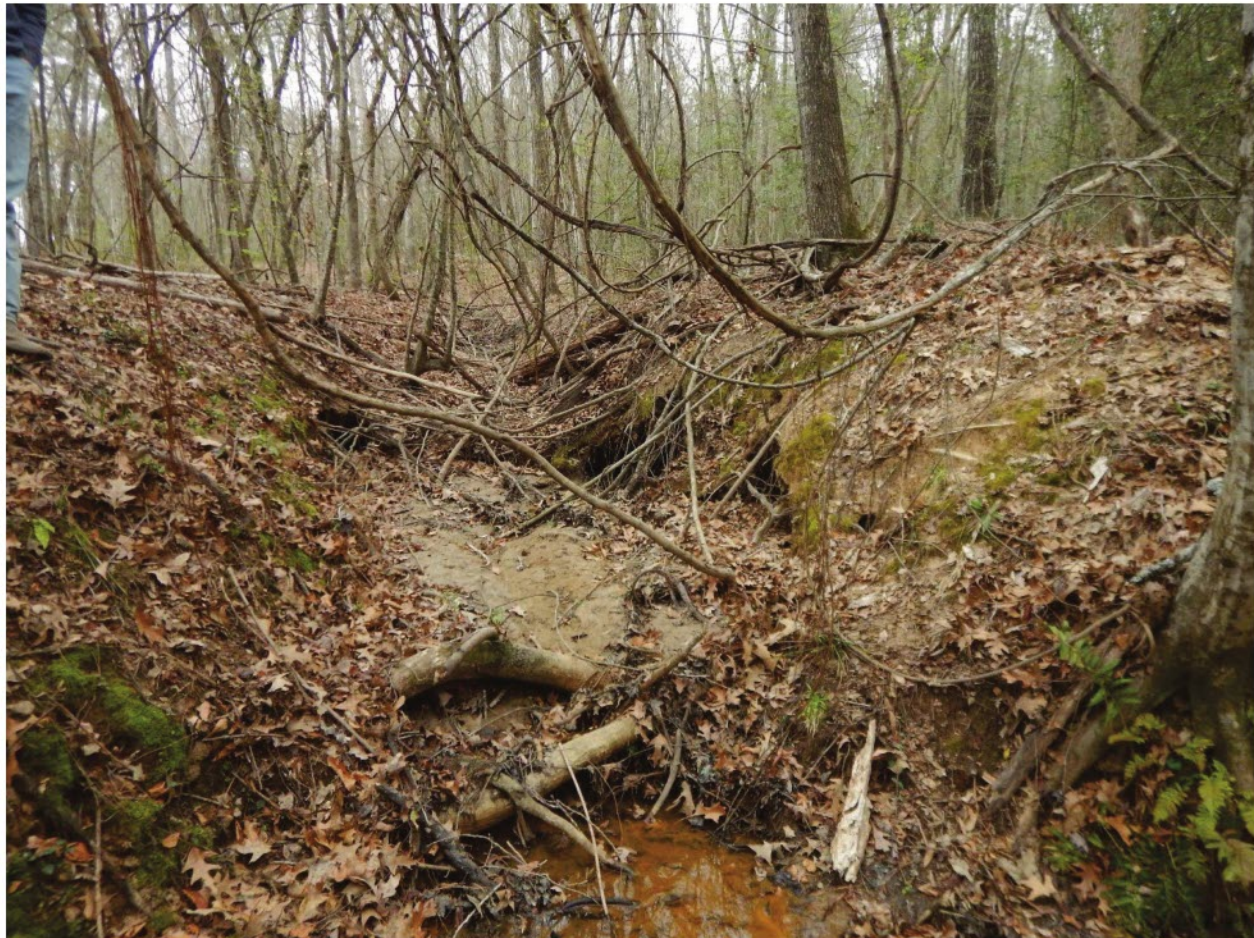
Photo No. 24

| Photo File Name | Date and Time of Photo | Photographer | Description |
|---|---|---|---|
| DSCN6378.JPG | 02/28/2024, 1:55 PM | Chelsey Sherwood | Showing approximately 14 inches deep of sedimentation in channel. Note the exposed roots and undercut bank. Picture taken facing west. |

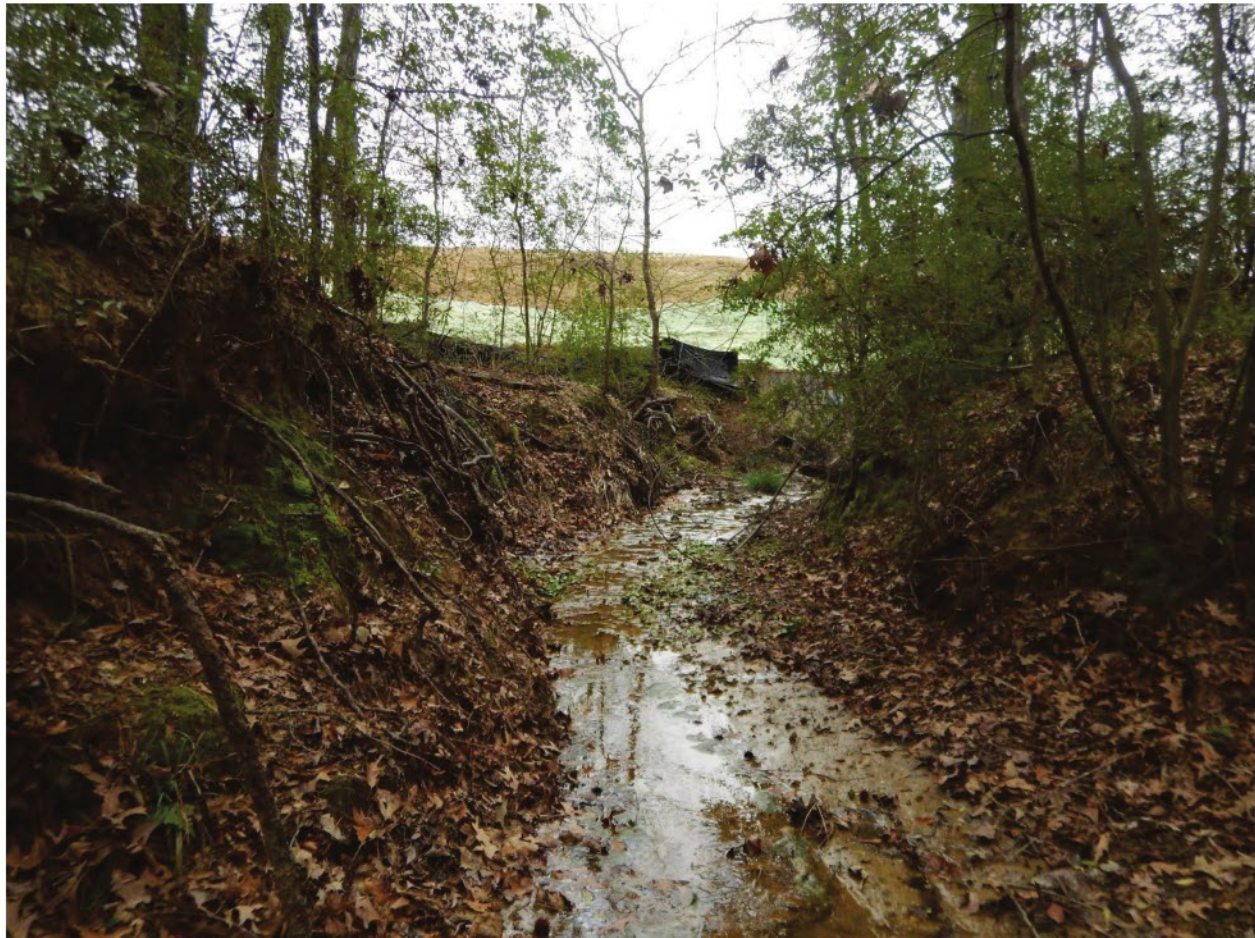
Photo No. 25

| Photo File Name | Date and Time of Photo | Photographer | Description |
|---|---|---|---|
| DSCN6379.JPG | 02/28/2024, 1:55 PM | Chelsey Sherwood | Showing stream channel filled with sediment below catch box and eroded banks and exposed roots. Picture taken facing south, upstream. |

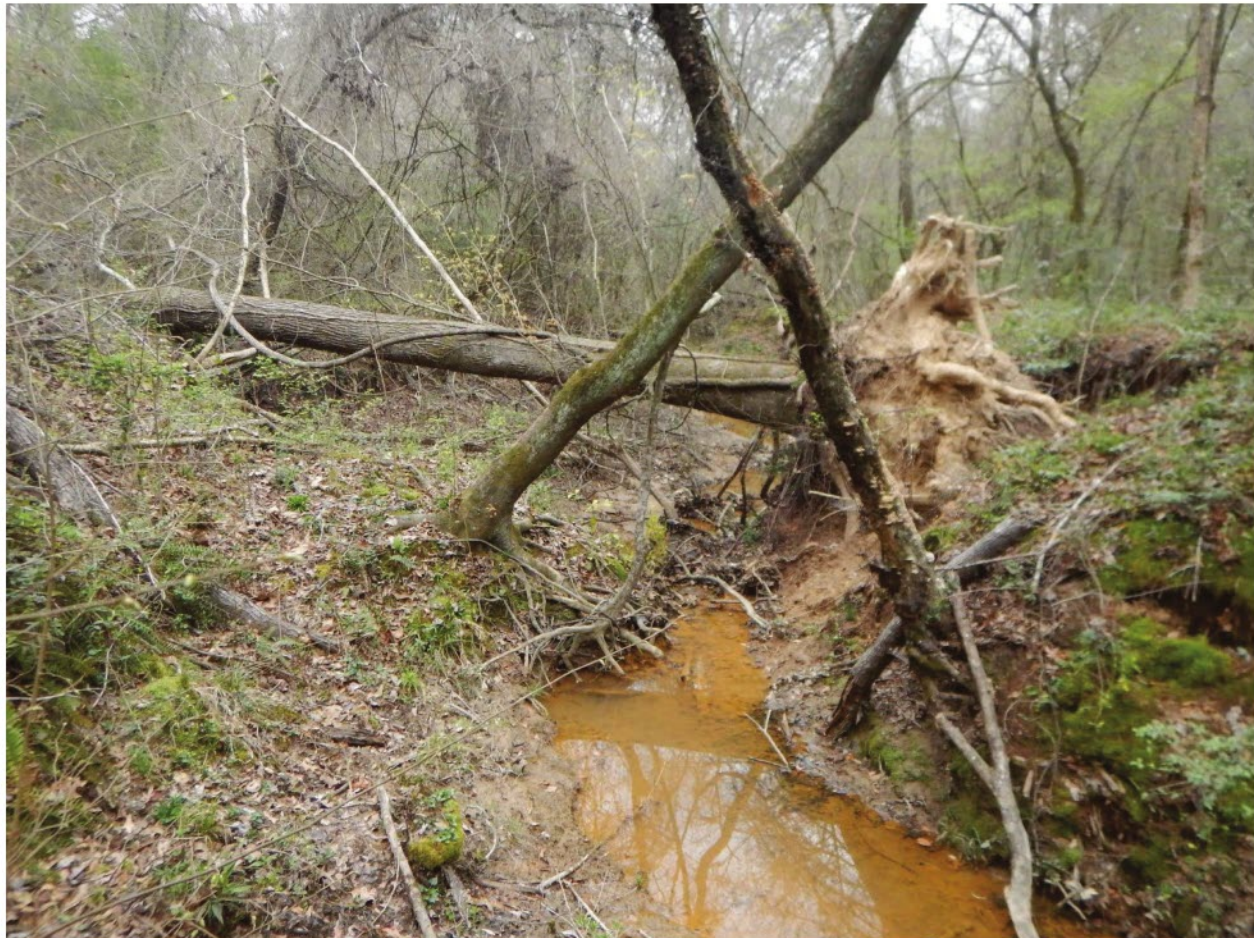
Photo No. 26

| Photo File Name | Date and Time of Photo | Photographer | Description |
|---|---|---|---|
| DSCN6380.JPG | 02/28/2024, 2:13 PM | Chelsey Sherwood | Showing stream channel approximately 1770 feet downstream from catch box. Note orange tinted water. Picture taken facing east, downstream. |

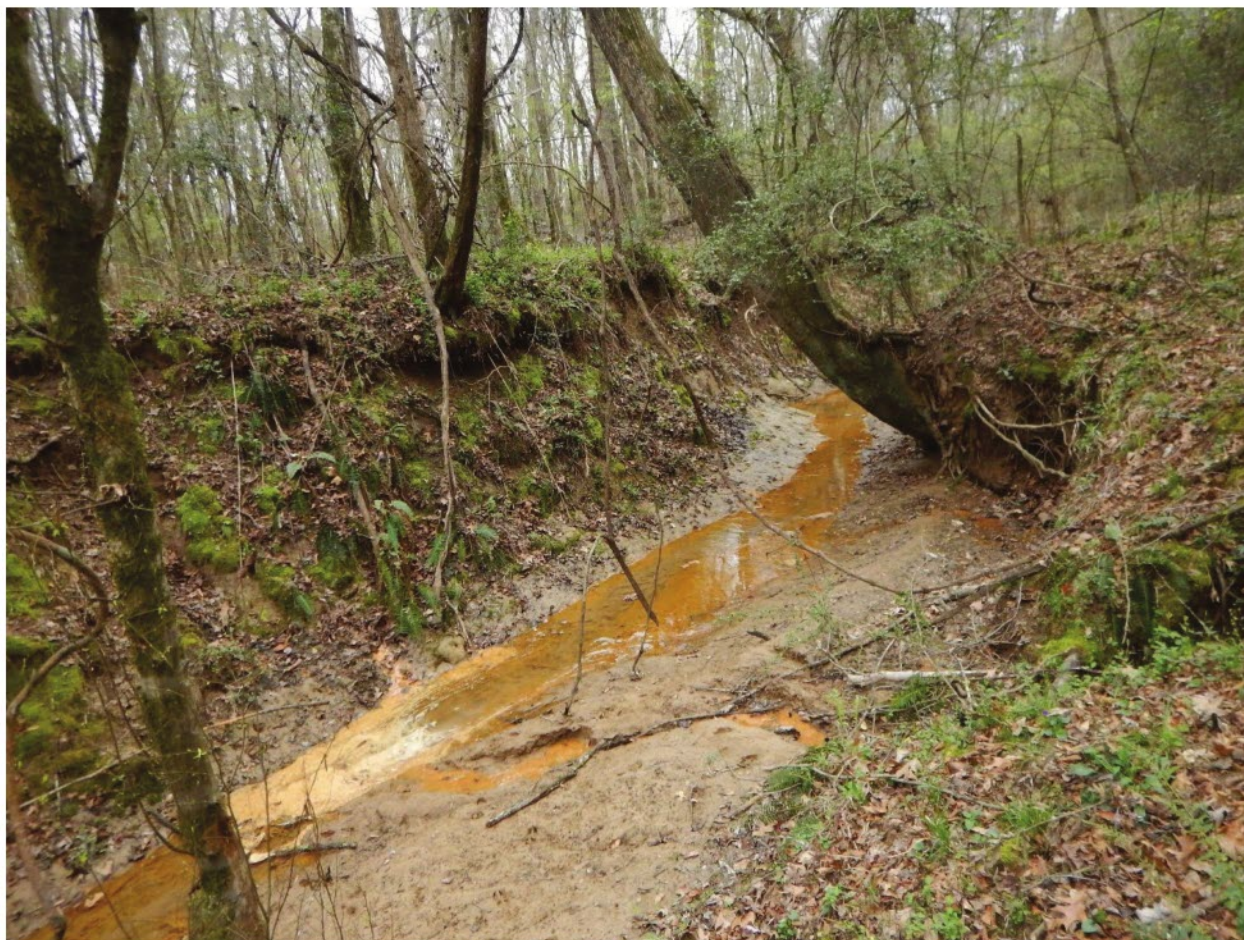
Photo No. 27

| Photo File Name | Date and Time of Photo | Photographer | Description |
|---|---|---|---|
| DSCN6381.JPG | 02/28/2024, 2:13 PM | Chelsey Sherwood | Showing stream channel approximately 1770 feet downstream from catch box. Note orange tinted water and sediment. Picture taken facing west, upstream. |

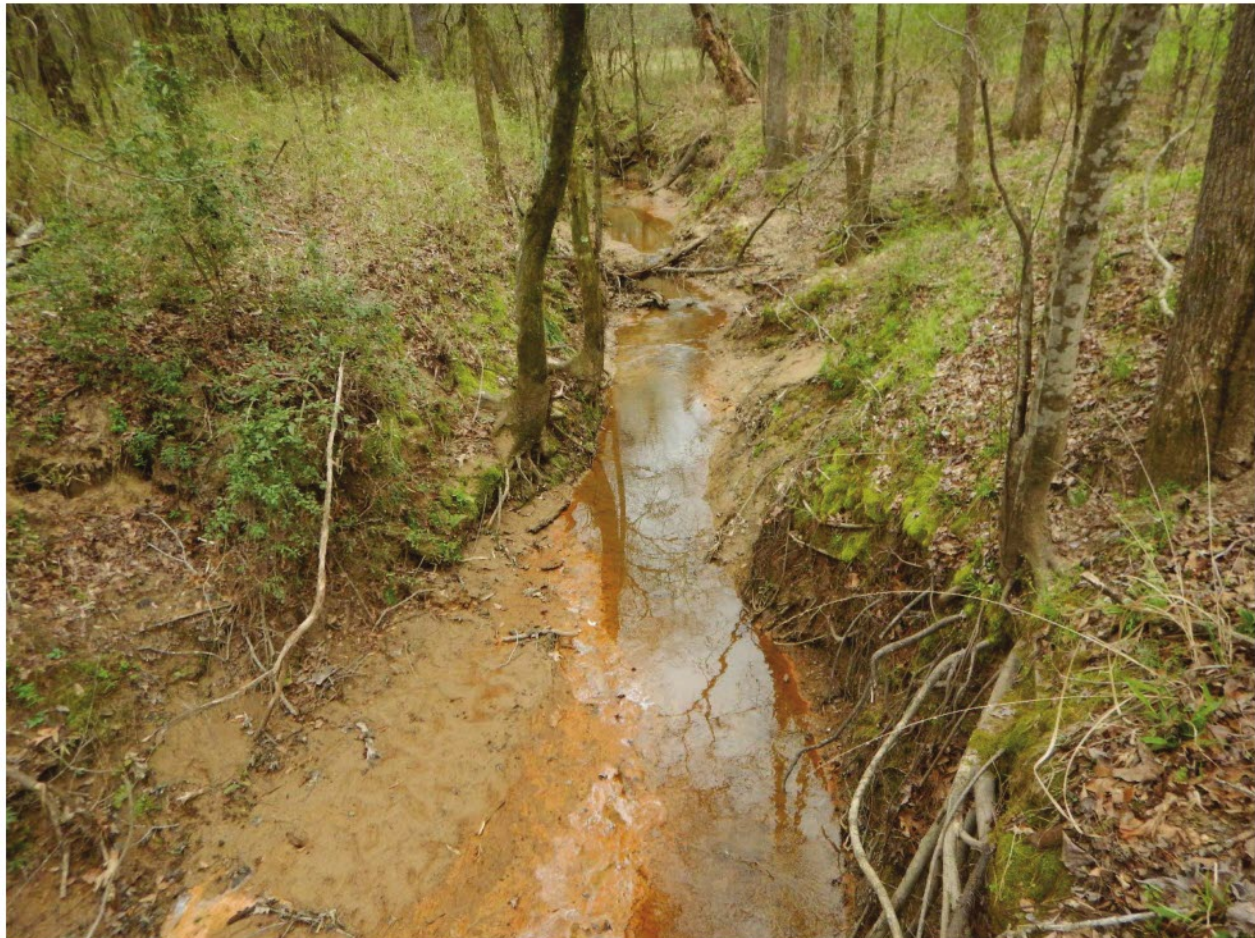
Photo No. 28

| Photo File Name | Date and Time of Photo | Photographer | Description |
|---|---|---|---|
| DSCN6383.JPG | 02/28/2024, 2:24 PM | Chelsey Sherwood | Showing orange tinted water in stream channel. This is approximately 0.75 miles downstream from the catch box. Picture taken facing southwest, upstream. (Photo 6382 was duplicate so not included). |

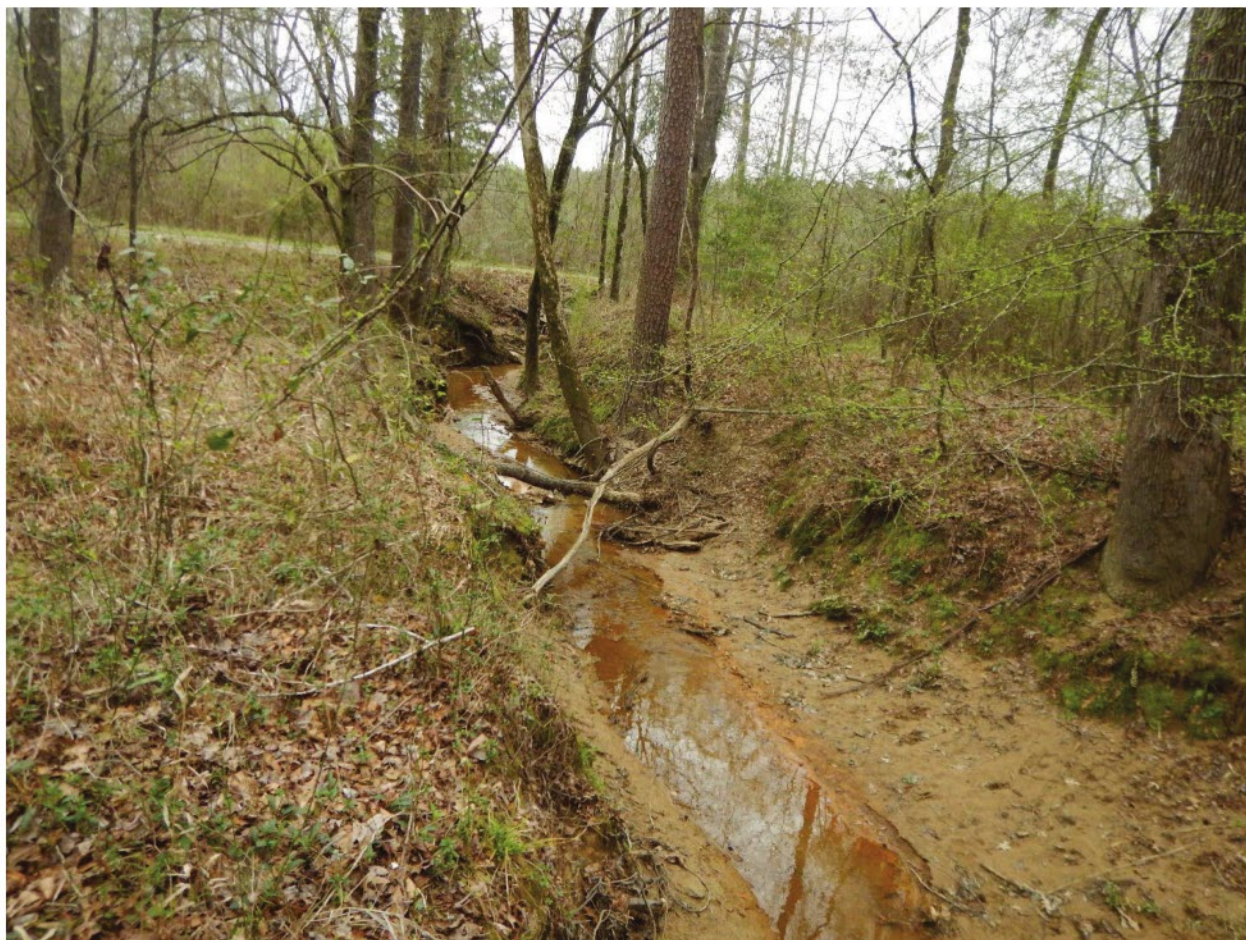
Photo No. 29

| Photo File Name | Date and Time of Photo | Photographer | Description |
|---|---|---|---|
| DSCN6384.JPG | 02/28/2024, 2:25 PM | Chelsey Sherwood | Showing orange tinted water in stream channel. This is approximately 0.75 miles downstream from the catch box. Picture taken facing northeast, downstream. |
