# NPDES Compliance Inspection Report

## LKQ Barger Auto Parts – Caldwell Caldwell, Idaho

Permit #: IDR05J00P

Inspection Date: May 11, 2021

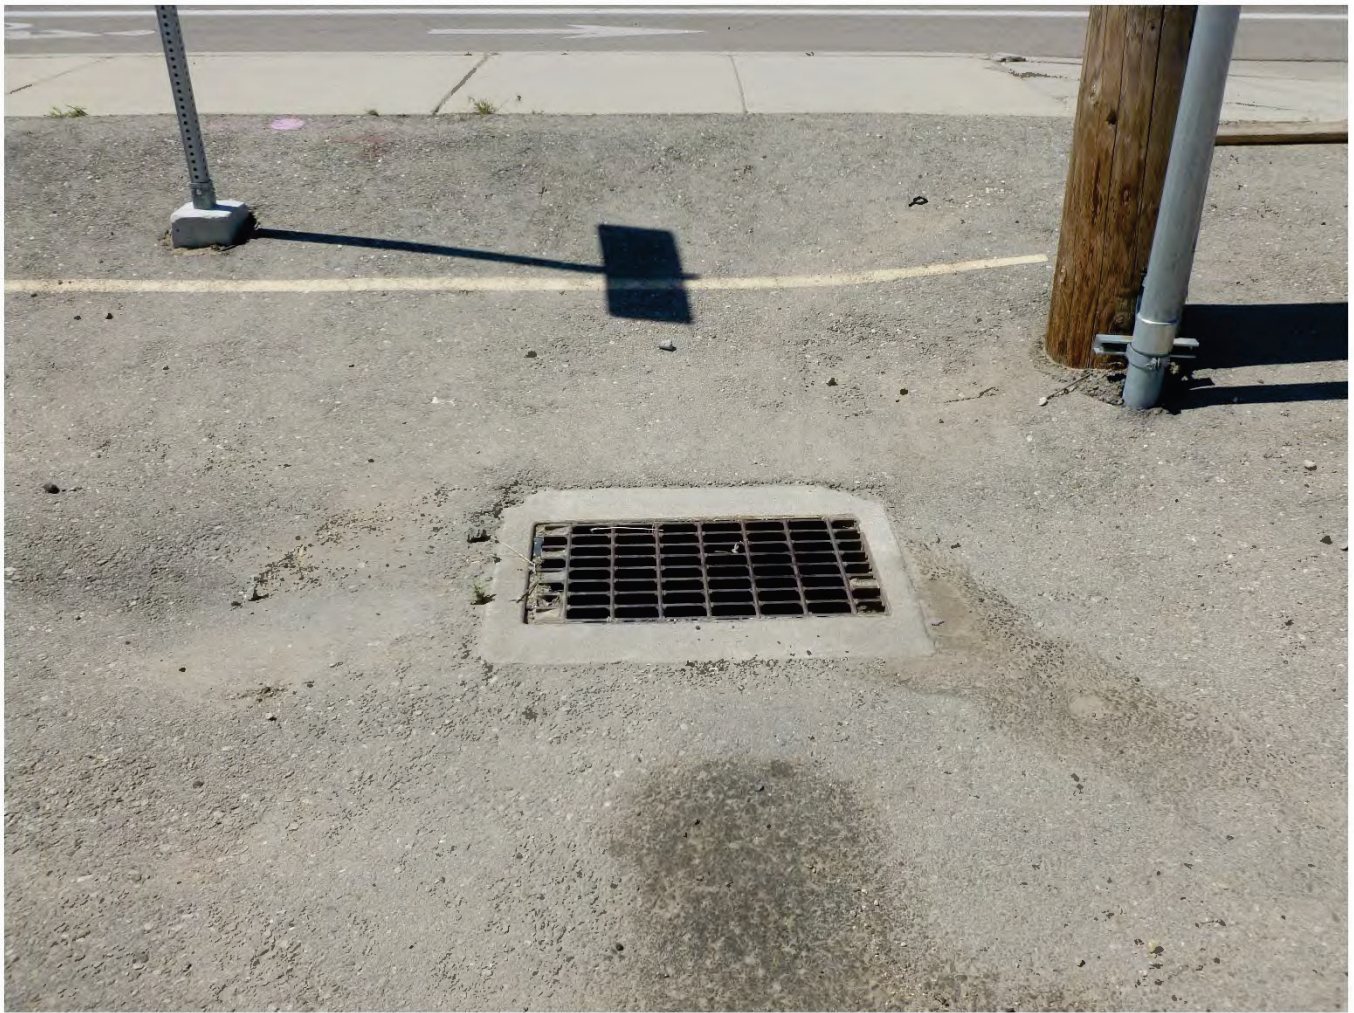
We exited the office into the facility parking lot which is located on the southwestern side of the property adjacent to Nampa-Caldwell Boulevard. The parking lot is sloped towards the boulevard. Facing southwest, two storm drains (**Photos 1 & 2**) are located near the boulevard on the right and left edges of the property. Both storm drains empty into the City's MS4 system. The storm drain on the left (**Photo 2**) is labeled as Outfall 001/Sampling Point 1. During rainfall events, a water sample is collected through sheet flow prior to the water entering the drain.

**Photo 2 / P1000882** – Storm Drain/Sampling Point 1

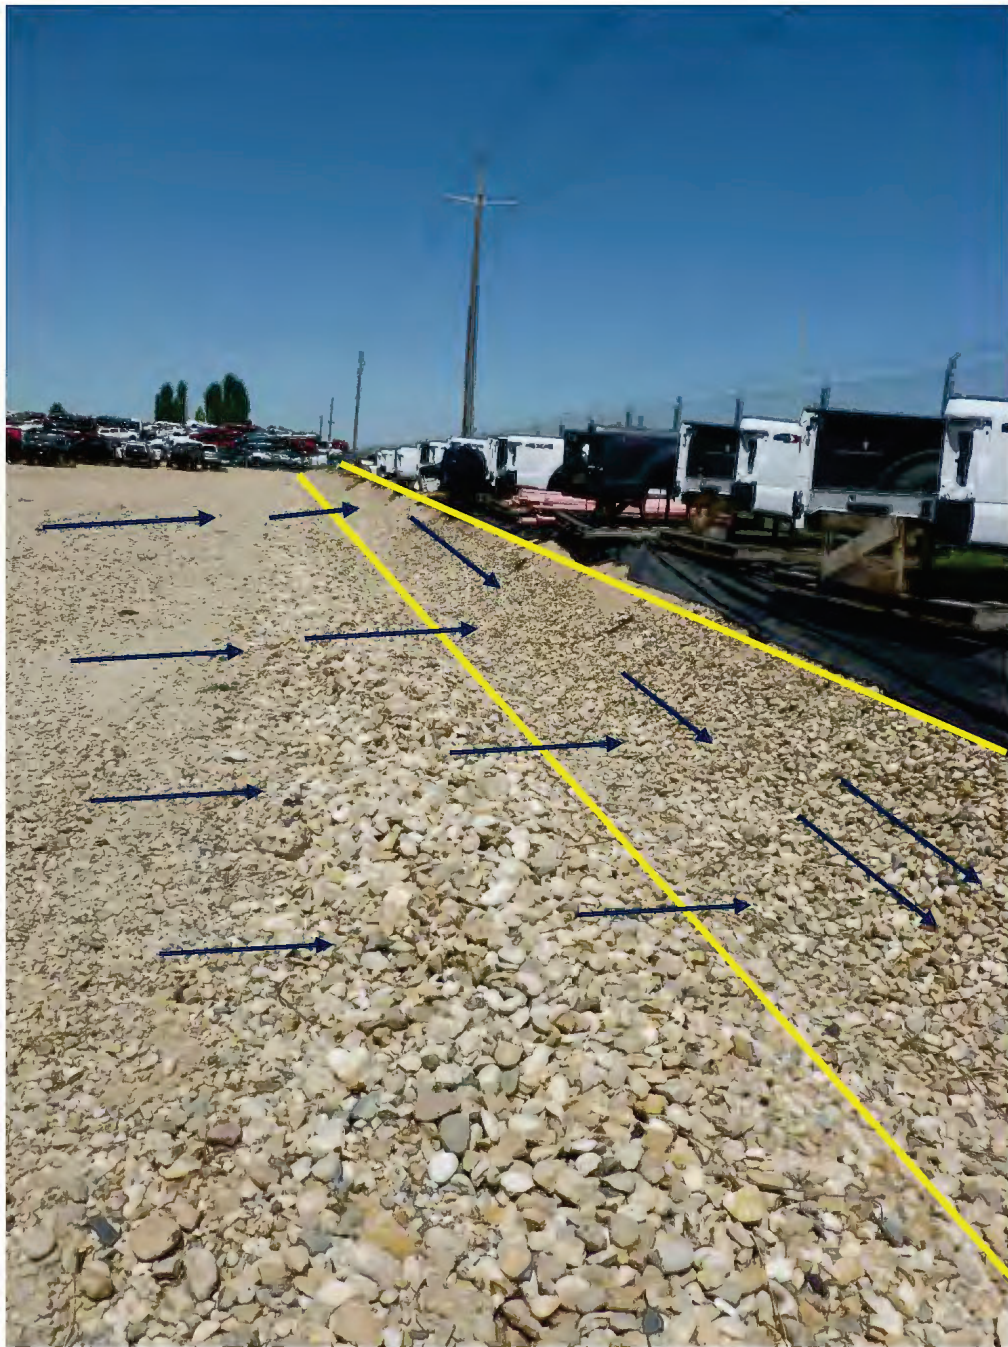
We proceeded to the vehicle storage yard which occupies the northwestern portion of the facility. The storage yard is sloped toward the northwest so storm water sheet flows into a rock lined ditch (**Photo 3**) which slopes toward the retention basin (**Photo 4**). The upper bank of the retention basin is covered by a liner to reduce the potential for erosion. Facing northeast, Outfall 003/Sampling Point 3 is located on the upper left end of the retention pond. Per the Representatives, there has never been a need to sample Sampling Point 3 because there had never been a discharge due to the low average annual rainfall. The Representatives also said the retention pond is dredged out annually at the end of summer to facilitate stormwater infiltration.

**Photo 3 / P1000888 – Rock-lined Ditch**

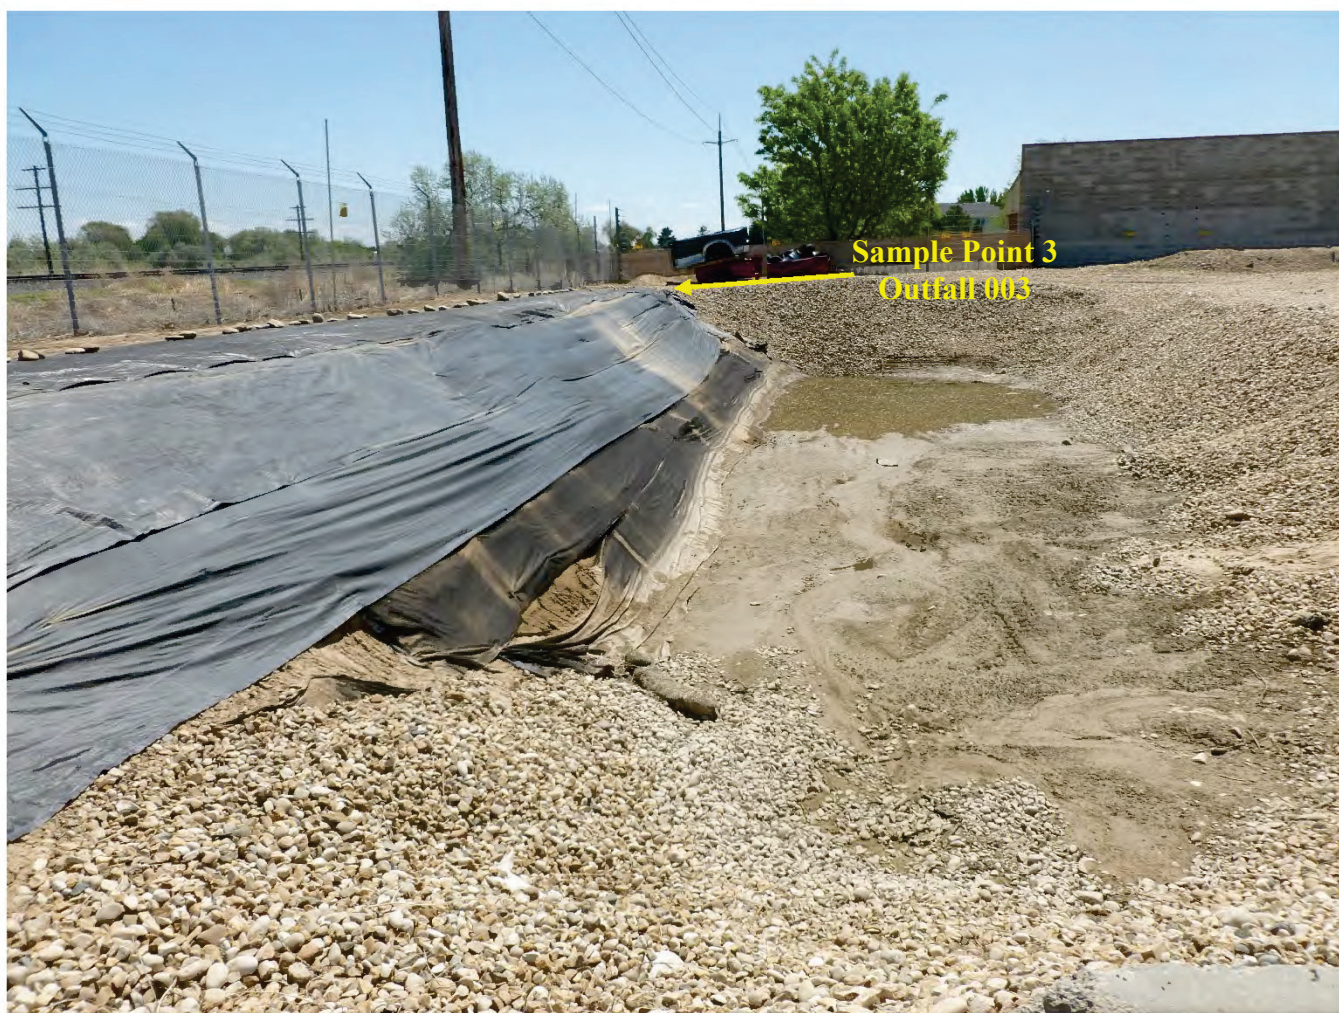
**Photo 4 / P1000887** – Retention pond, with liner

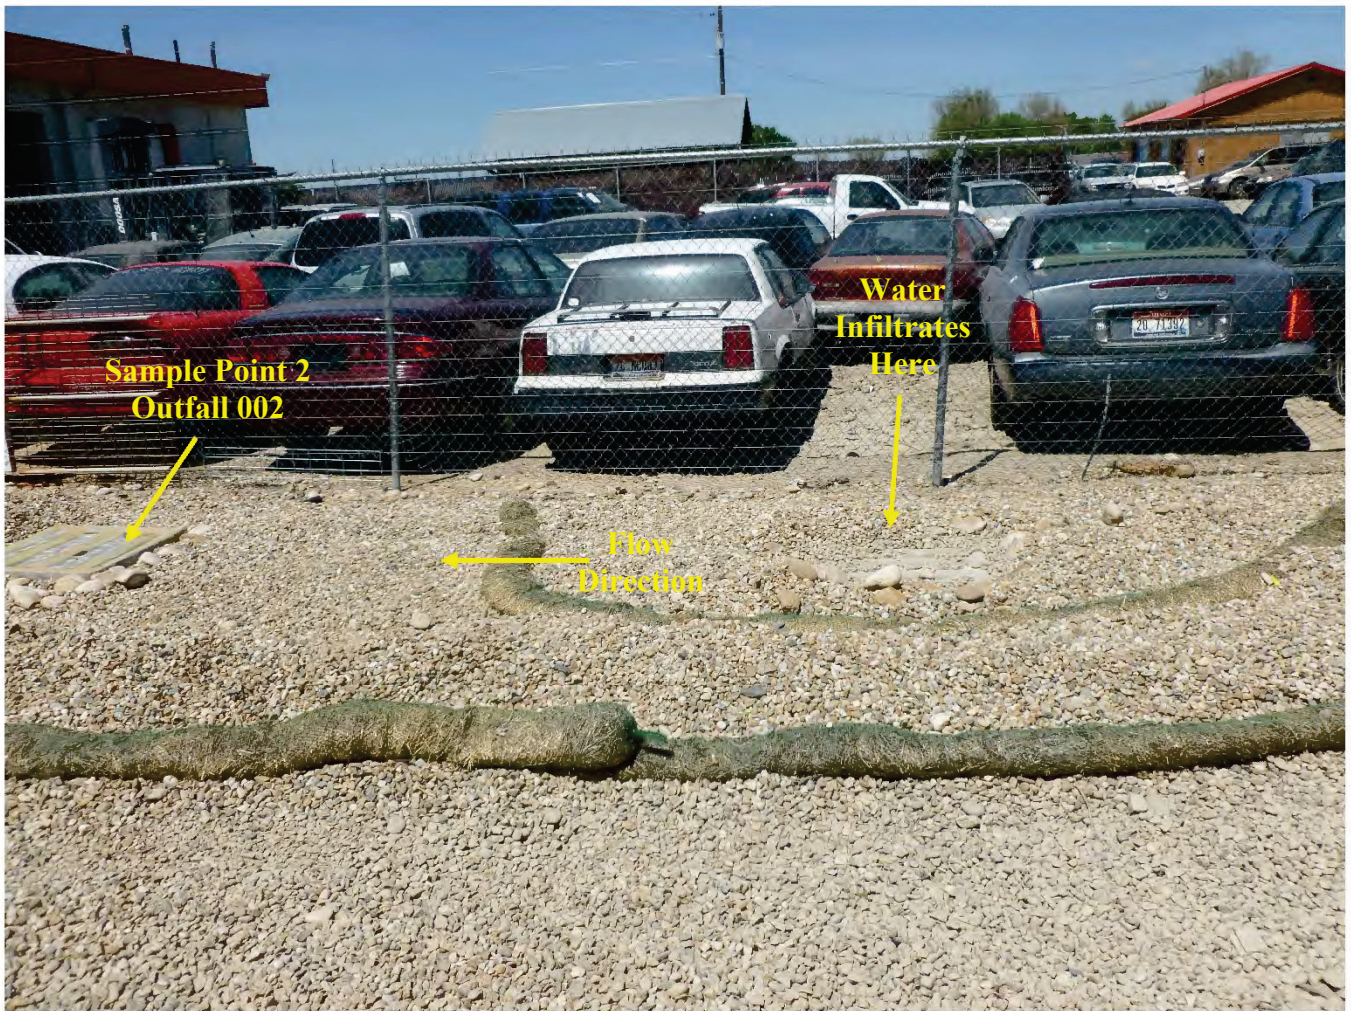
We walked in a southwestern direction to Outfall 002/Sampling Point 2 (**Photos 5 & 6**). Sampling point 2 receives stormwater from the vehicle holding area. Outfall 002 is enclosed on the uphill side by sandbags. The stormwater enters the rock-filled pit of Outfall 002 and enters a manhole. The manhole has a hose that travels underground to another manhole. Stormwater samples are collected from the hose in the second manhole.

**Photo 5 / P1000890** – Sample Point 2, wide view

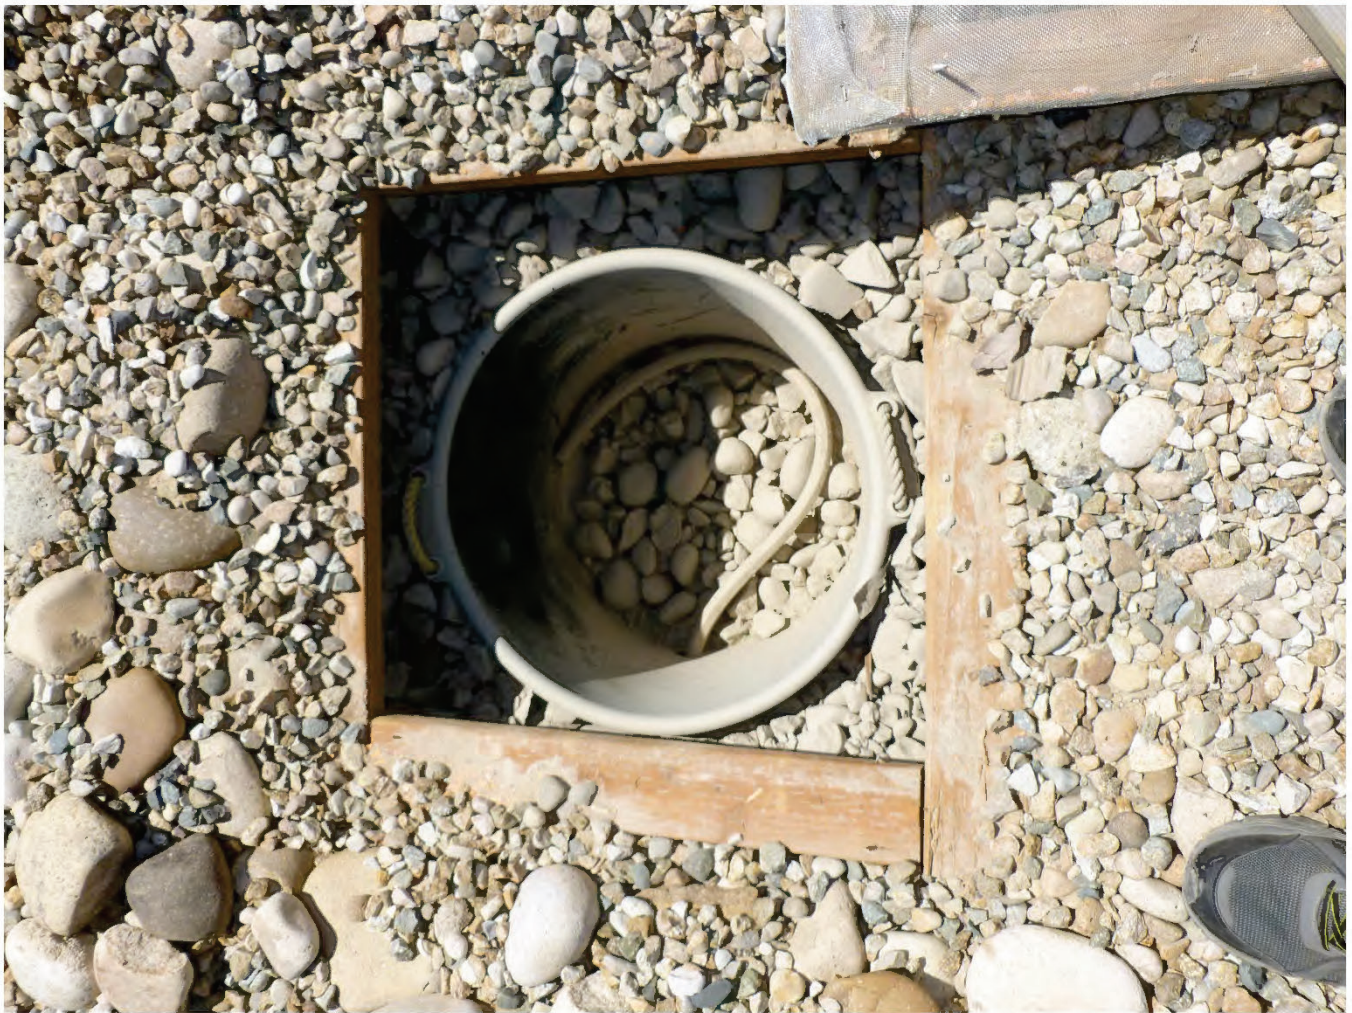
**Photo 6 / P1000889** – Sample Point 2, close up

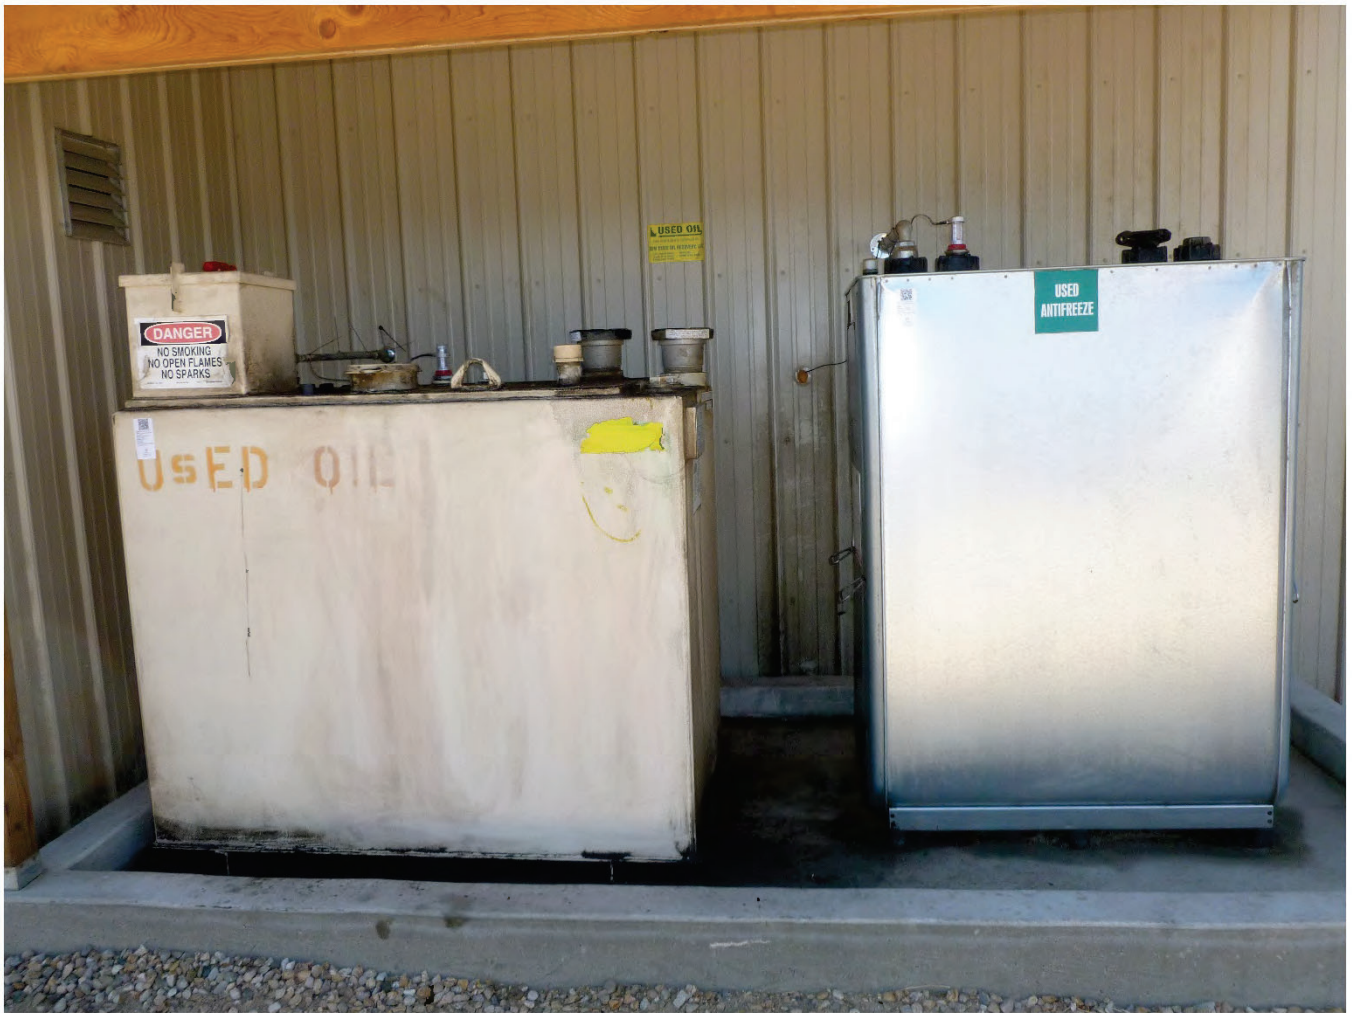
From Outfall 002, we headed back towards the dismantling building and office. On the northwest end of the dismantling building was a pair of double-walled tanks (**Photo 7**) seated on top of secondary containment. The tanks held used oil and anti-freeze that was collected from dismantled vehicles. The Representatives said the tanks were pumped out by a contractor as need and the contents hauled offsite for disposal. Beside the tanks was a 3-chamber oil/water separator (**Photo 8**) which received water from the dismantling building. The chamber closest to the building receives the contaminated water, starts the separation process, and traps most of the sludge. The middle chamber continues the separation of the oil and water. The chamber furthest from the building contains the clean water. The contents of the chambers are pumped out three to four times a year and hauled away for disposal.

**Photo 7 / P1000891** – Used Oil & Antifreeze Tanks

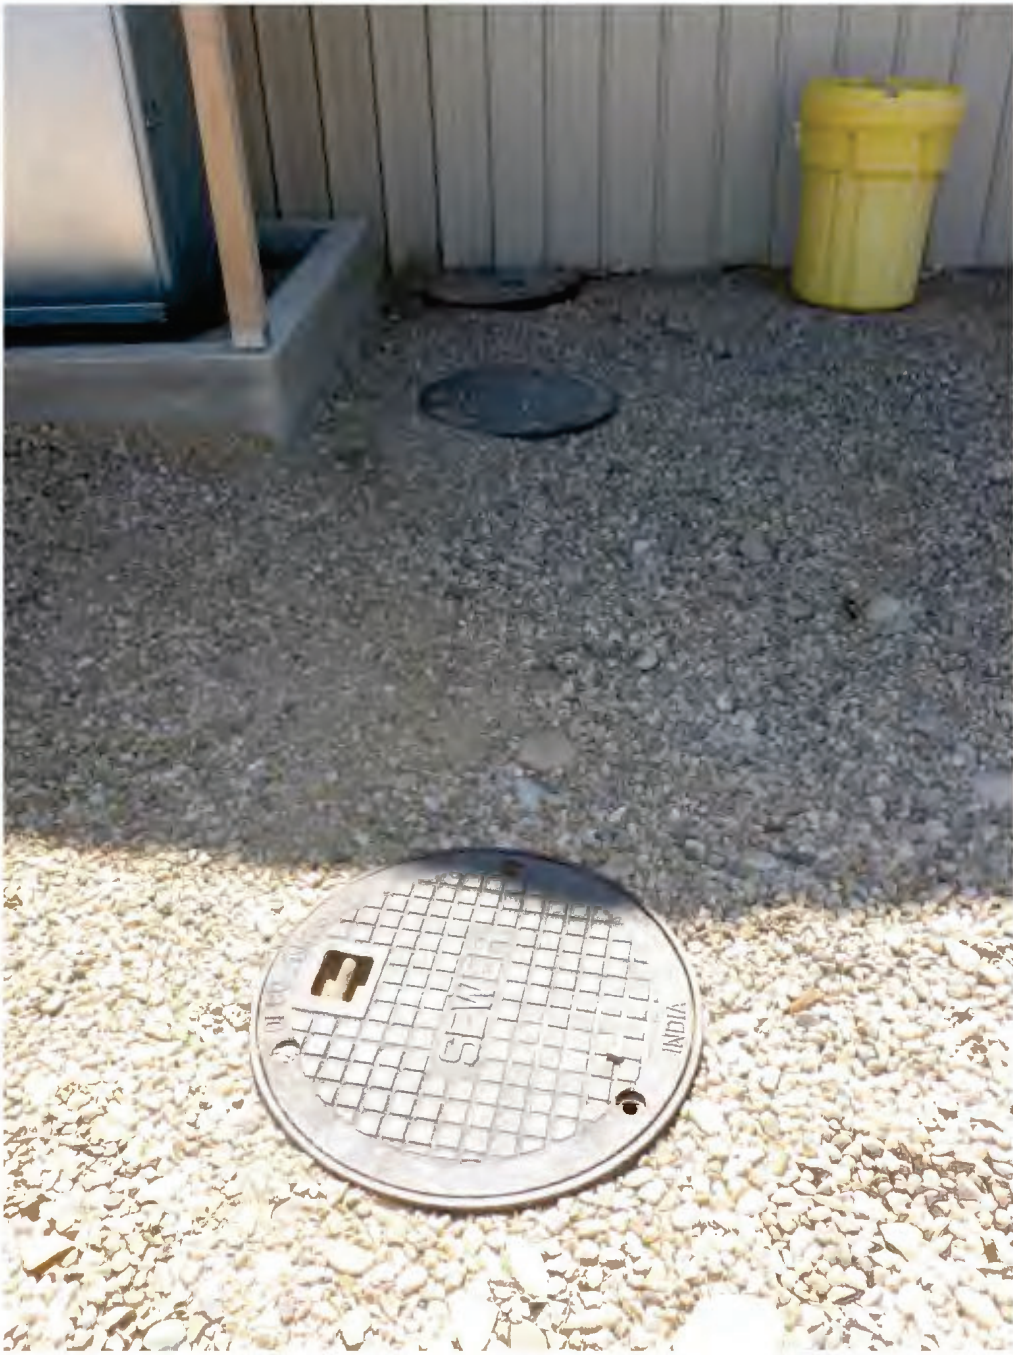
**Photo 8 / P1000892 – 3 Chamber Oil/Water Separator**

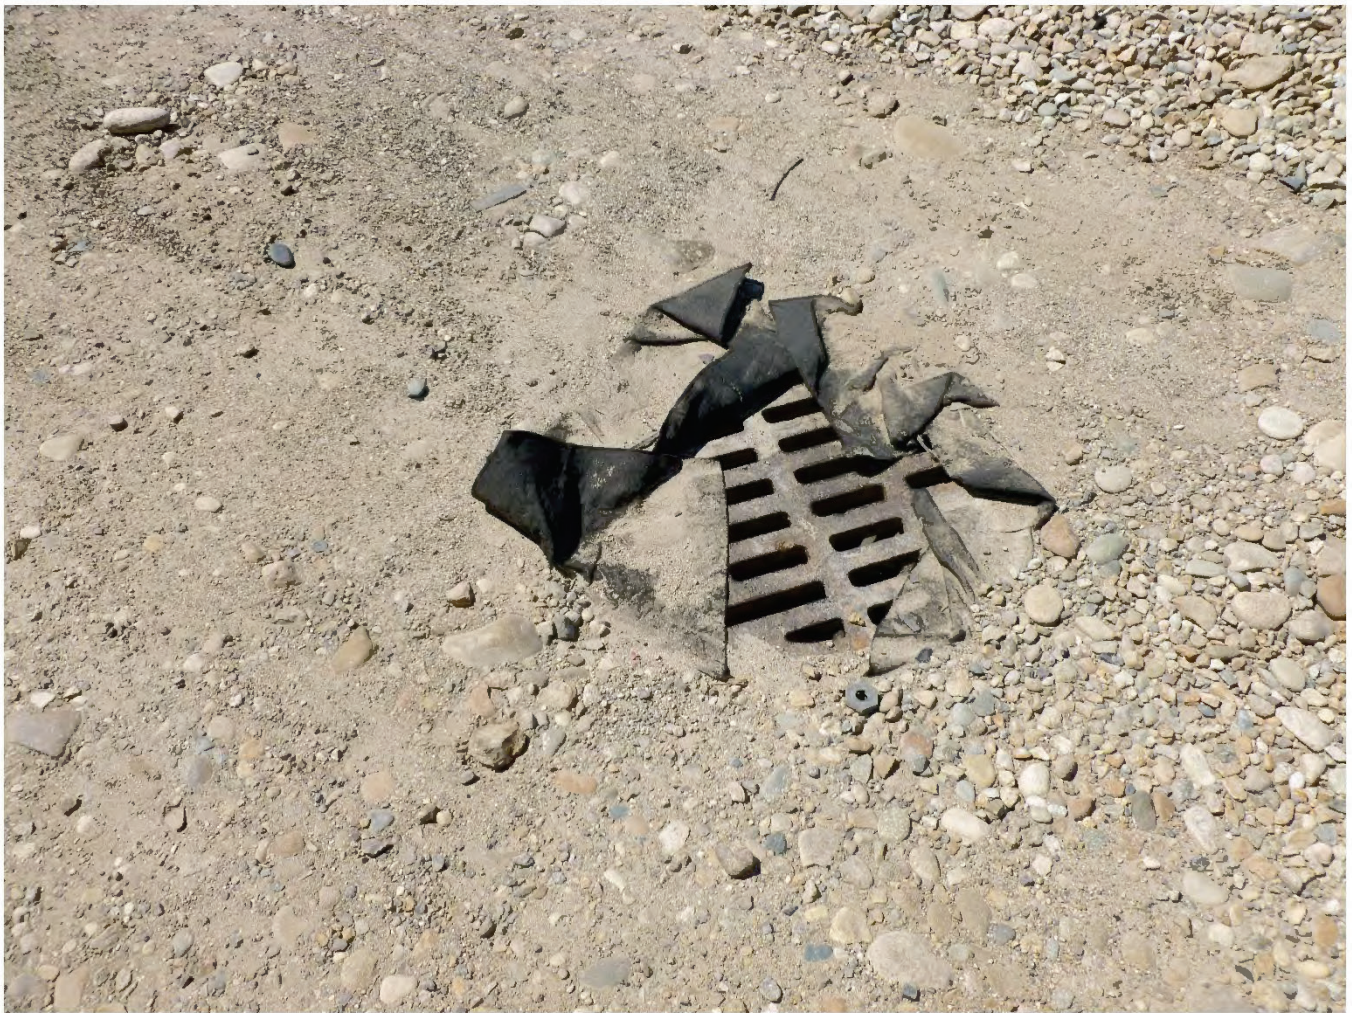
The final observation I made on the walk back to the office was a storm drain (**Photo 9**) situated between the dismantling building and the office. The storm drain receives water from the local surrounding area. The Representatives said the storm drain sequesters stormwater in a self-contained catch basin. The basin is pumped out twice a year and the contents hauled offsite for disposal by a contractor.

**Photo 9 / P1000883** – Storm Drain, to catch basin
