**U.S. ENVIRONMENTAL PROTECTION AGENCY  
REGION III WATER BRANCH, ENFORCEMENT  
AND COMPLIANCE ASSURANCE DIVISION  
CLEAN WATER ACT  
COMPLIANCE INSPECTION REPORT**

**Name of Facility:** Antrim Township

| <b>Type of Inspection:</b> | MS4 Compliance Inspection |
| <b>NPDES Permit No:</b> | PAI133536 |

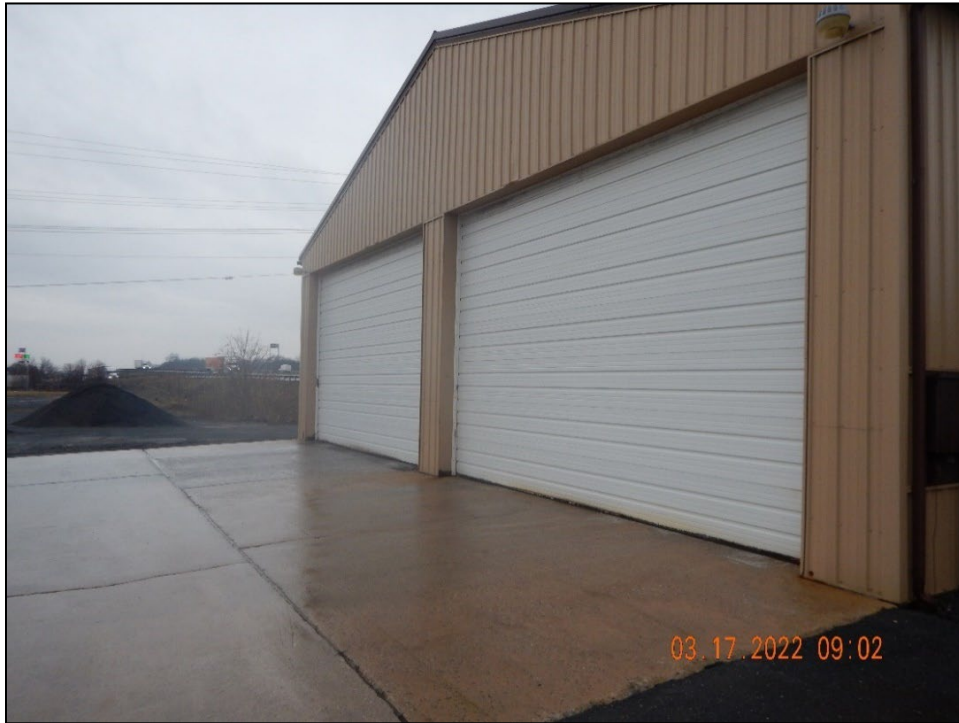
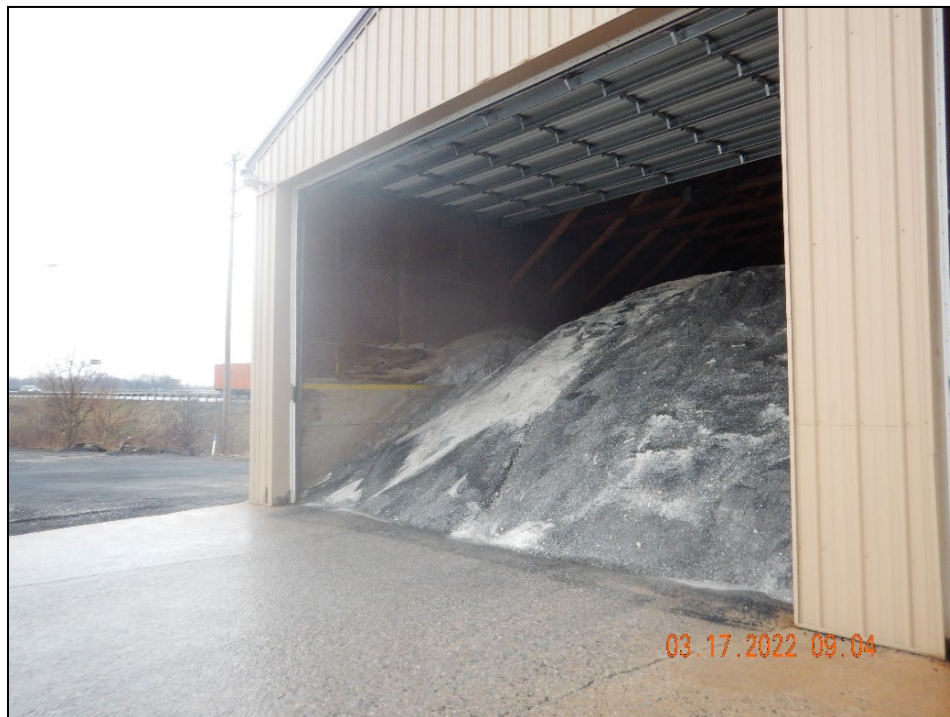
- 1) Salt and sand were stored entirely under cover in a storage garage in the Municipal Building’s south area (refer to Photographs 1 and 2). Township representatives stated that the road crew salts the roads when necessary.

**Photograph 1. Township Municipal Building:** (DSCN3633.JPG) View, facing west, of the salt and sand storage garage in the Municipal Building.

**Photograph 2. Township Municipal Building:** (DSCN3637.JPG) View, facing west, of a mixture of salt and sand stored under cover in a garage in the Municipal Building.

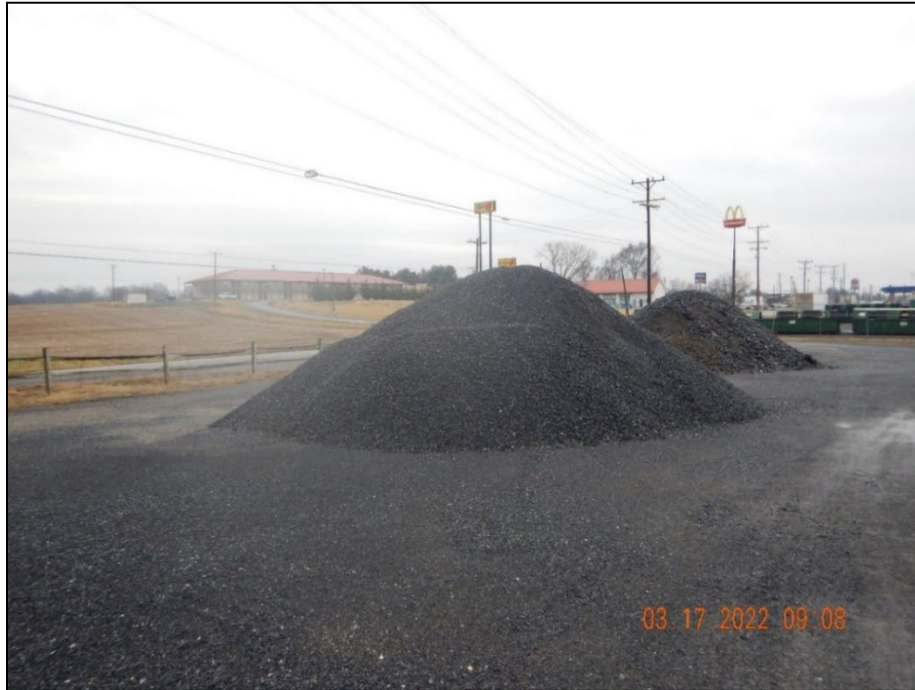
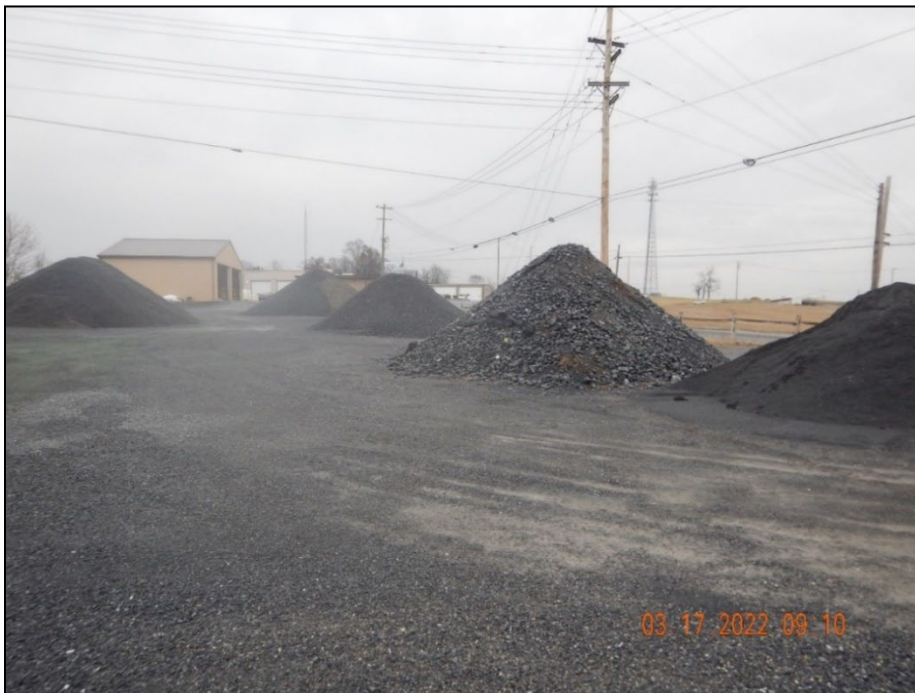
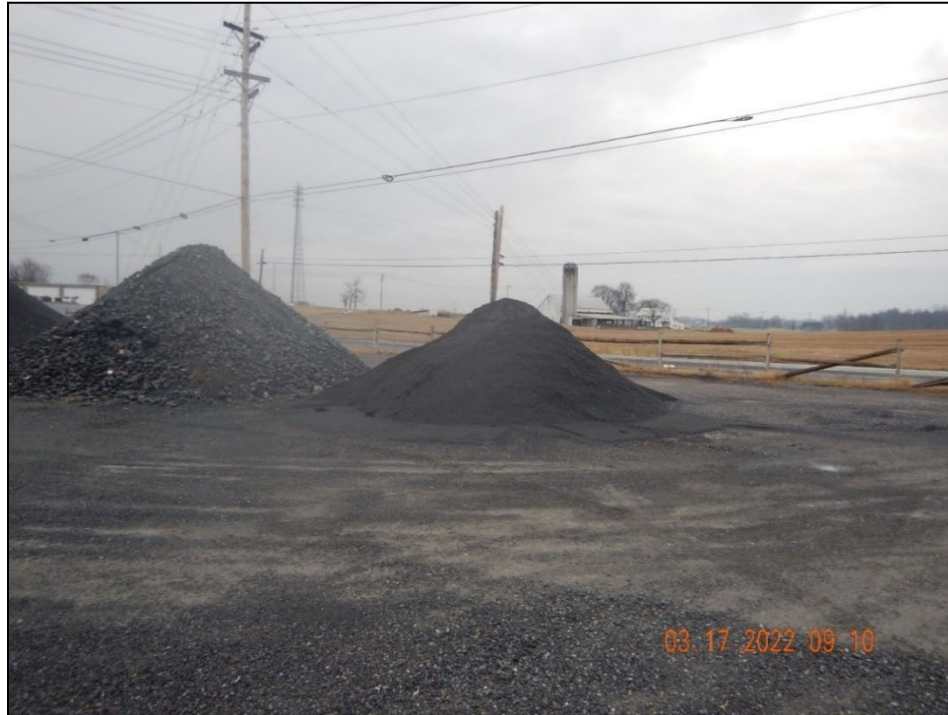
- 2) Aggregate piles in the outdoor aggregate stockpile storage area were not located within barriers and there were no observed containment measures (refer to Photographs 3 through 5). Township representatives stated that the piles were used for road maintenance.

**Photograph 3. Township Municipal Building:** (DSCN3639.JPG) View, facing south, of aggregate material stored in the southern area of the Municipal Building. The aggregate material did not have containment measures or covers at the time of the inspection.

**Photograph 4. Township Municipal Building:** (DSCN3640.JPG) View, facing north, of aggregate material stored in the southern area of the Municipal Building, as shown in Photograph 3.

**Photograph 5. Township Municipal Building:** (DSCN3641.JPG) View, facing east, of aggregate material stored in the southern area of the Municipal Building, as shown in Photographs 3 and 4.

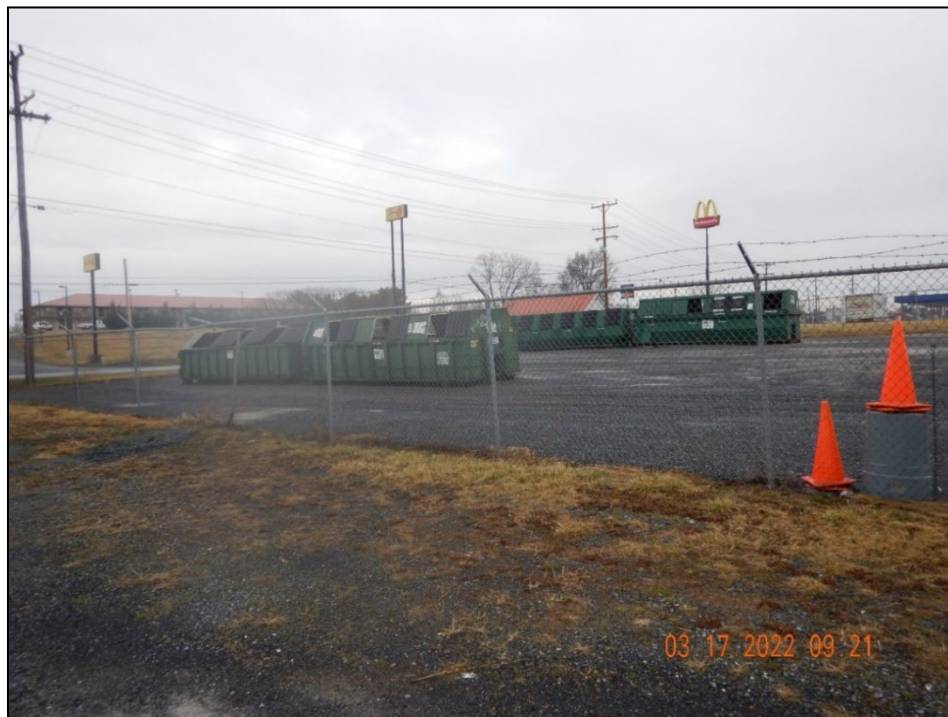
- 3) The recycling area appeared to be free of trash or debris (refer to Photograph 6). The area accepts cardboard, cans, plastic, and paper. Recyclables gathered in the covered dumpsters are removed every week.

**Photograph 6. Township Municipal Building:** (DSCN3642.JPG) View, facing south, of the recycling collection area in the southern area of the Municipal Building.

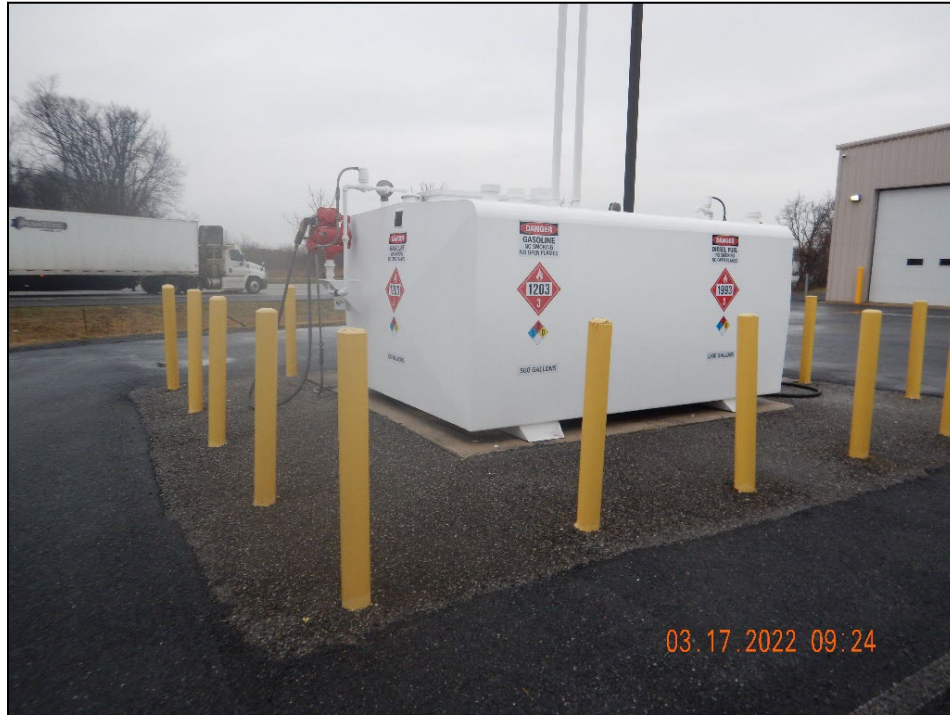
- 4) The aboveground 500-gallon gas tank, 1,500-gallon gas tank, and 200-gallon used oil tank were uncovered, but Township representatives stated that the tanks were double-walled (refer to Photographs 7 and 8). No stains were observed around the tanks. Township representatives stated that the municipal vehicles are fueled using the gas and diesel tanks. Township representatives also stated that used oil from municipal vehicles kept in the 200-gallon tank is emptied at least once every two weeks. A spill kit was observed in the vehicle maintenance garage in the Municipal Building close to the tanks (refer to Photographs 9 and 10).

**Photograph 7. Township Municipal Building:** (DSCN3643.JPG) View, facing west, of the aboveground 500-gallon gas and 1,500-gallon diesel aboveground storage tanks (ASTs). Township representatives stated that they are double-walled.

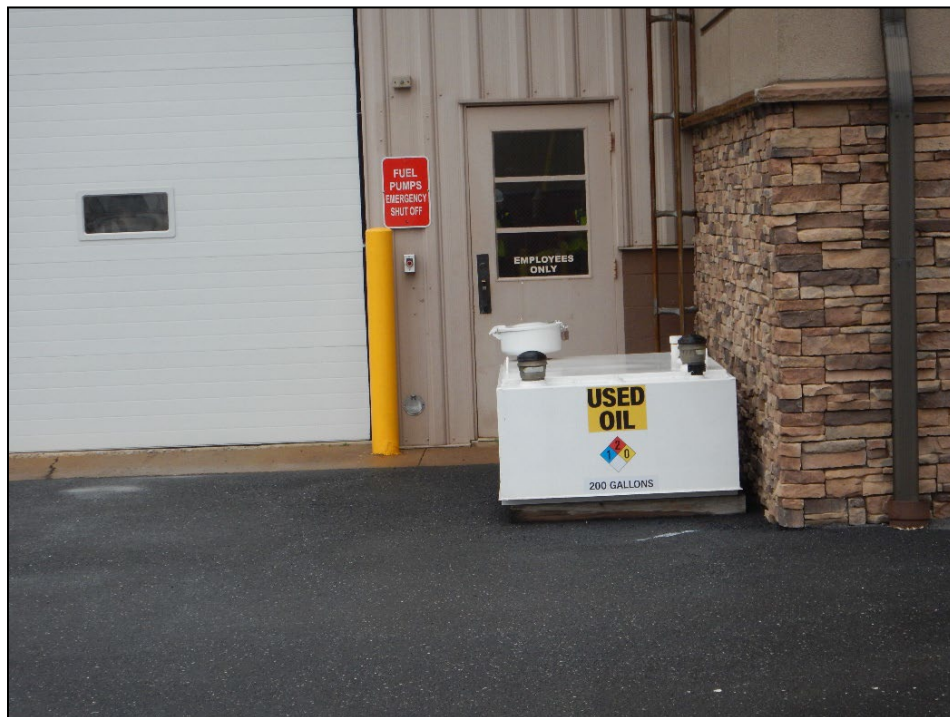
**Photograph 8. Township Municipal Building:** (DSCN2954.JPG) View, facing north, of the aboveground 200-gallon used oil tank. Township representatives stated that it is double-walled.

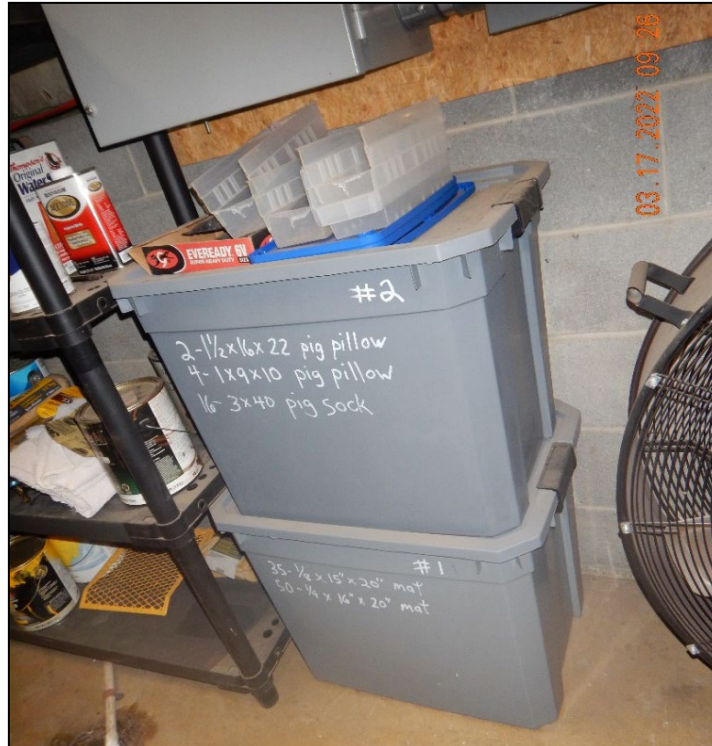
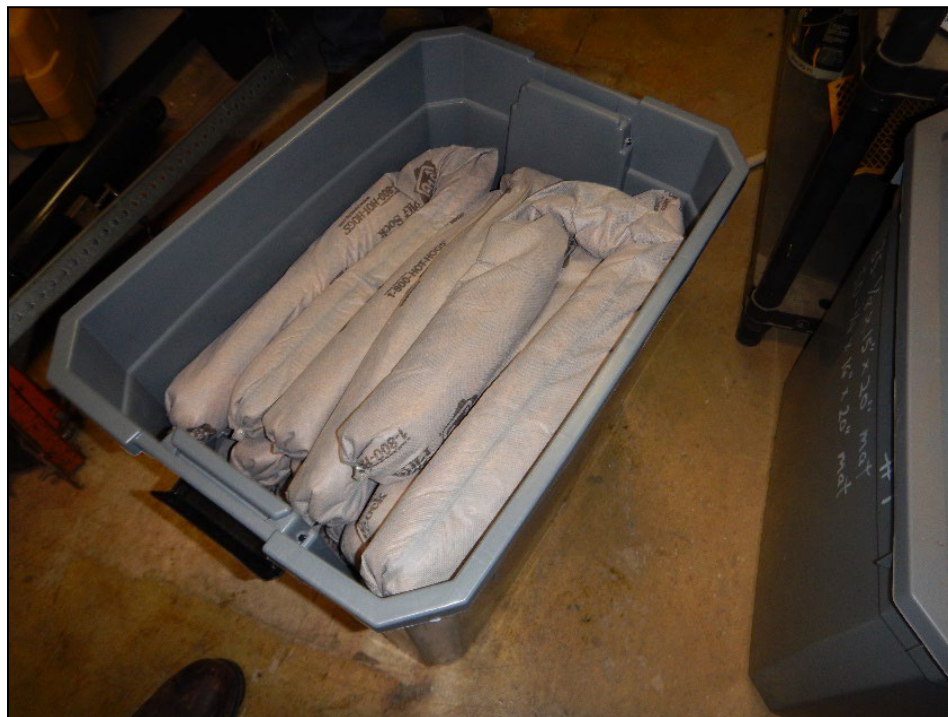
**Photograph 9. Township Municipal Building: (DSCN3646.JPG)** View of the spill kit located inside the vehicle maintenance garage in the Municipal Building, adjacent to the ASTs.

**Photograph 10. Township Municipal Building: (DSCN2955.JPG)** View inside the spill kit located in the vehicle maintenance garage in the Municipal Building.

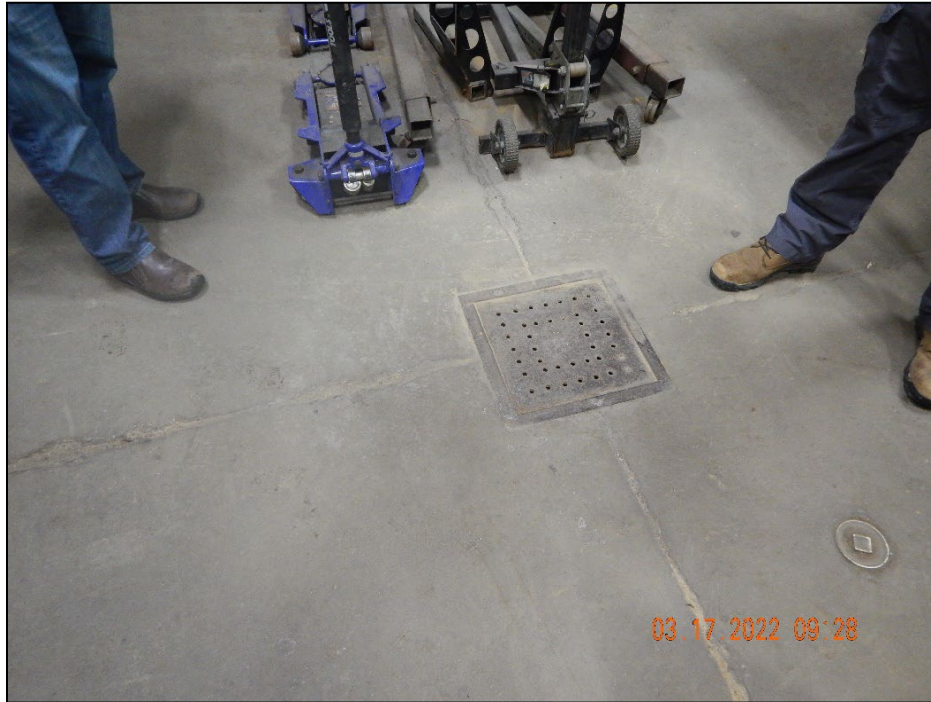
- 5) The vehicle maintenance garage appeared to be in good condition and not exposed to stormwater. Township representatives stated the drain in the garage discharges directly to the sanitary sewer system (refer to Photograph 11). Township representatives stated that all vehicle maintenance except for changing engines is performed in the garage. Township representatives also stated that changed vehicle batteries are not stored in the garage.

**Photograph 11. Township Municipal Building: (DSCN3650.JPG)** View of a drain in the vehicle maintenance garage in the Municipal Building. The drain leads to the sanitary sewer system.

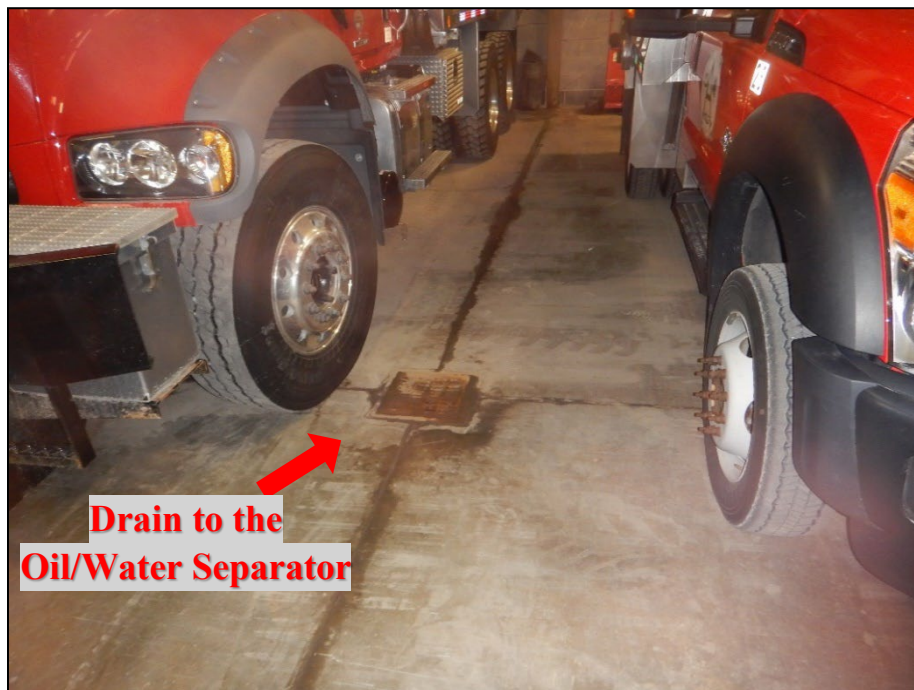
- 6) The two truck and equipment storage garages appeared to be in good condition. Township representatives stated the drains in both garages lead to the oil/water separator before discharging into the sanitary sewer system (refer to Photographs 12, 13, and 16).

**Photograph 12. Township Municipal Building: (DSCN2962.JPG)** View of a drain in the first truck and equipment storage garage. The drain leads to the oil/water separator before discharging to the sanitary sewer system.

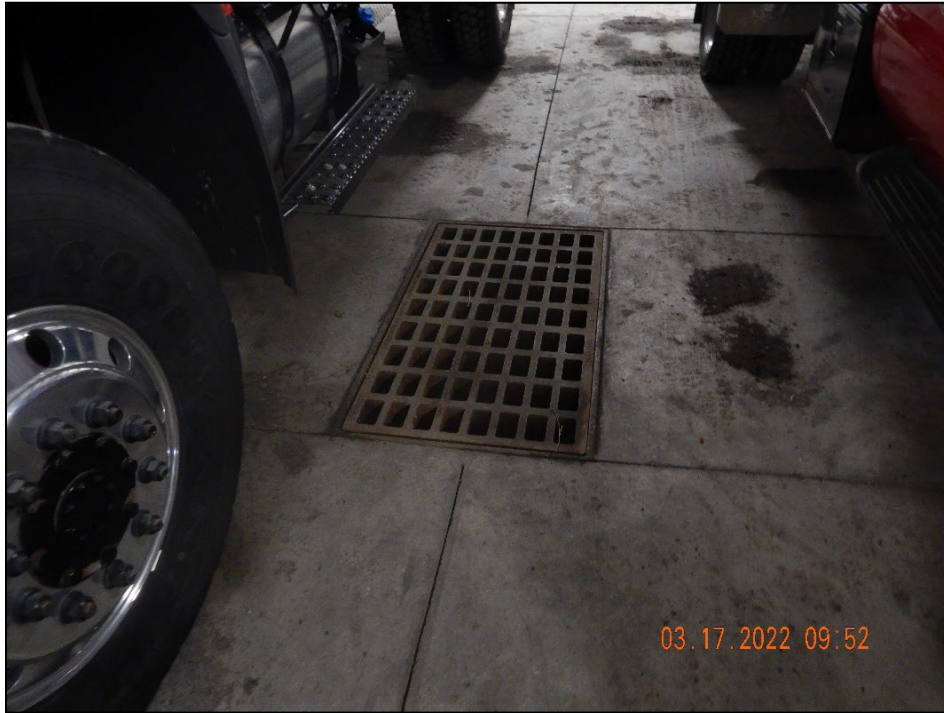
**Photograph 13. Township Municipal Building:** (DSCN3665.JPG) View of a drain in the second vehicle and equipment storage garage. The drain leads to the oil/water separator before discharging to the sanitary sewer system.

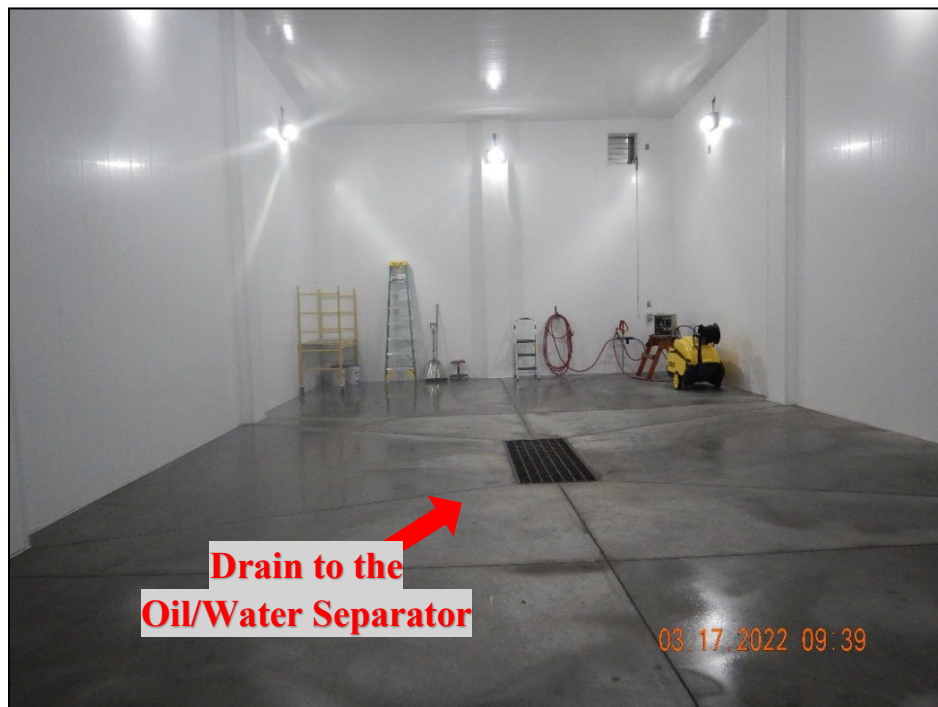
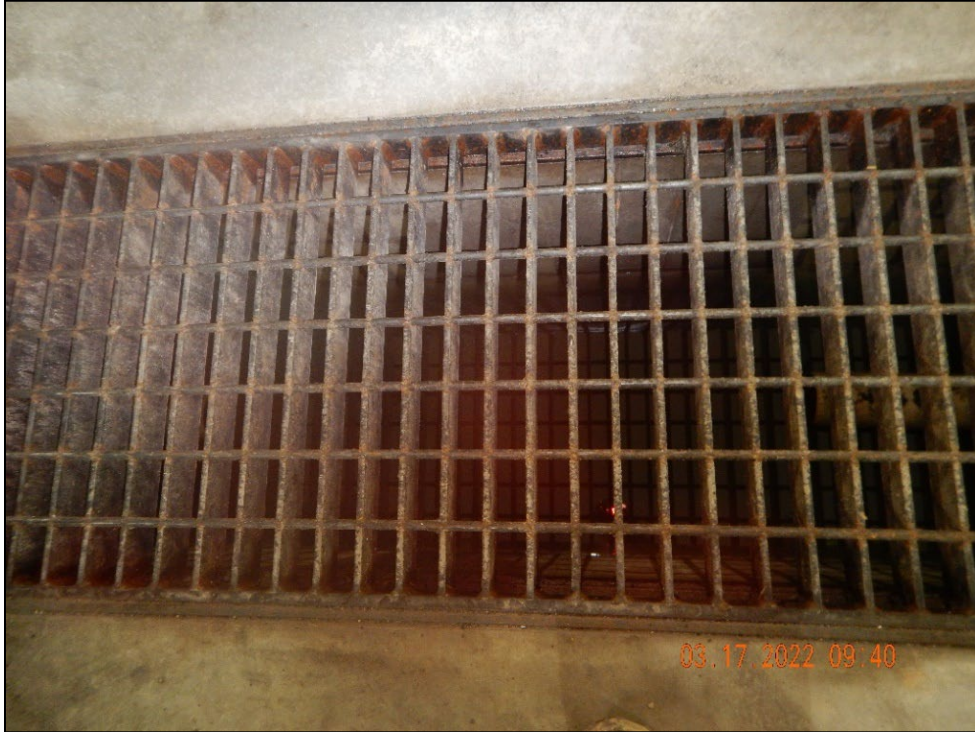
- 7) The vehicle wash garage appeared to be in good condition. The drain in the wash garage leads to the oil/water separator before discharging into the sanitary sewer system (refer to Photographs 14 and 15).

**Photograph 14. Township Municipal Building:** (DSCN3655.JPG) View inside the vehicle wash garage in the Municipal Building. Note the drain that leads to the oil/water separator.

**Photograph 15. Township Municipal Building:** (DSCN3657.JPG) Closer view of the drain in the vehicle wash garage in the Municipal Building, as shown in Photograph 14.

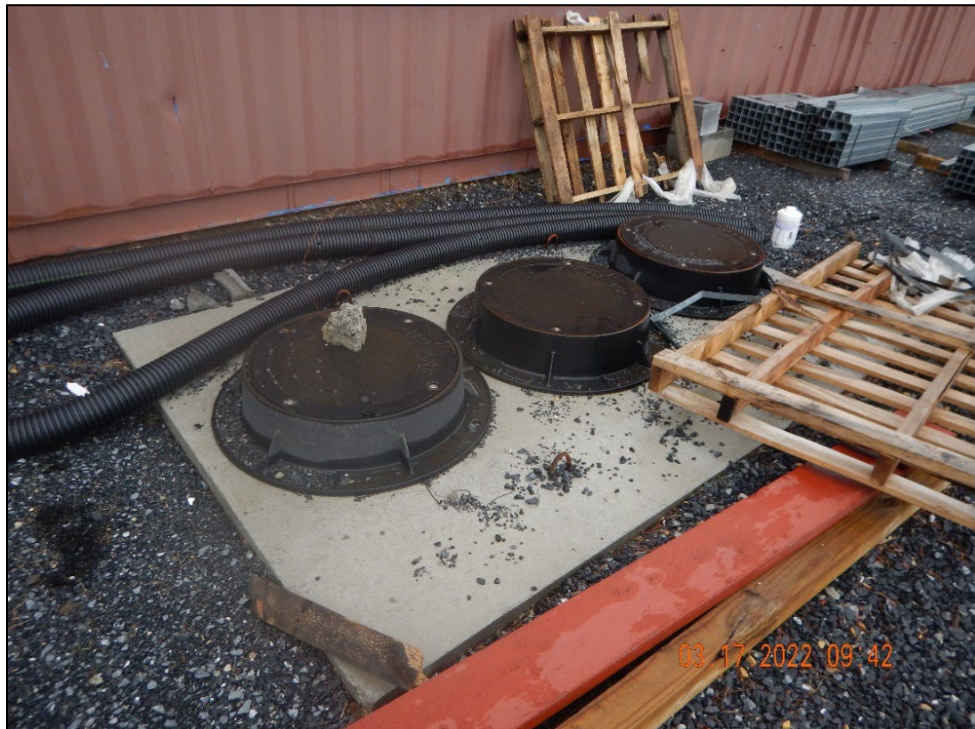
**Photograph 16. Township Municipal Building:** (DSCN3658.JPG) View of the oil/water separator access outside of the Main Building.

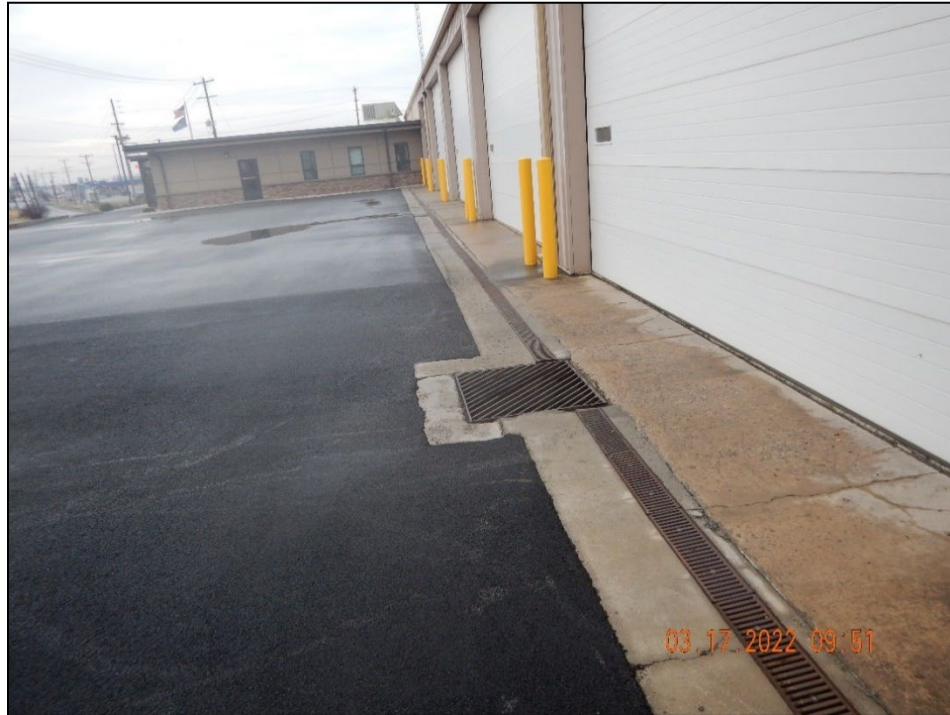
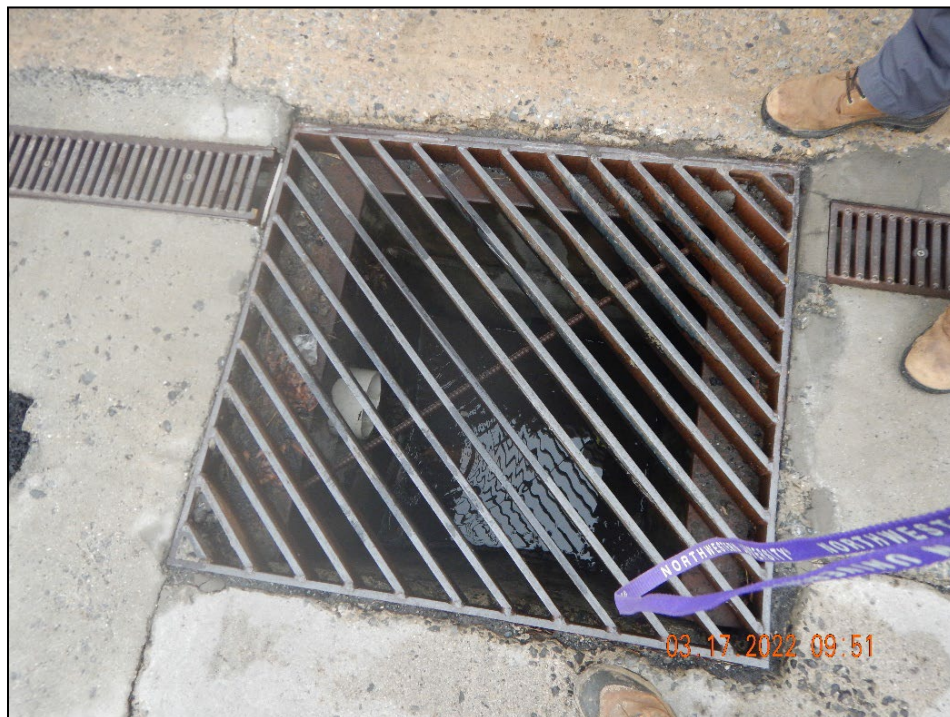
- 8) Drains in the loading dock appeared to be clean and free of debris. The drains also lead to the oil/water separator before discharging into the sanitary sewer system (refer to Photographs 17 and 18).

**Photograph 17. Township Municipal Building:** (DSCN3661.JPG) View, facing south, of drains outside of the vehicle storage garages in the Municipal Building. The drains convey stormwater to the oil/water separator and then to the sanitary sewer.

**Photograph 18. Township Municipal Building:** (DSCN3663.JPG) View inside one of the drains outside of the vehicle storage garages in the Municipal Building.

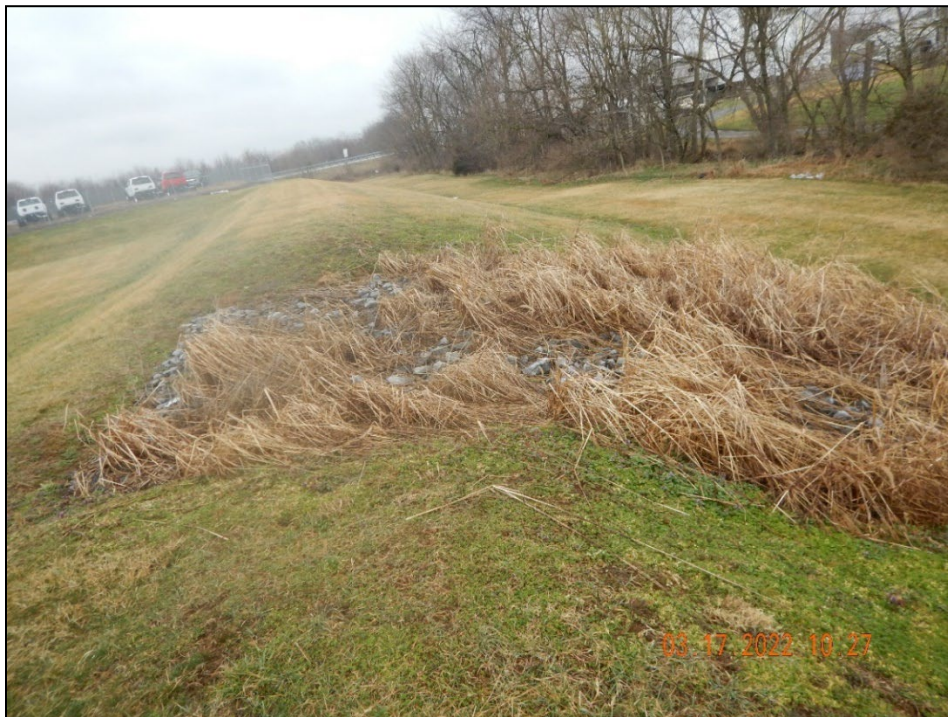
**Photograph 28. Vehicle Facility Yard: (DSCN3681.JPG)** View, facing west, of the overflow spillway from stormwater basin 3. Vegetation was observed growing in the overflow spillway at the time of the inspection.

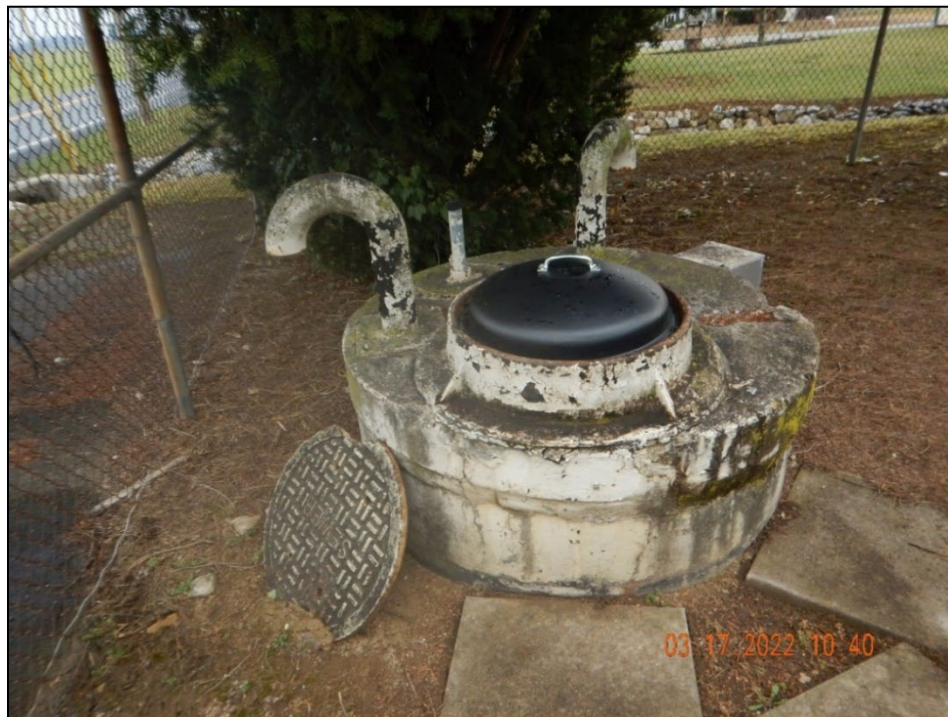
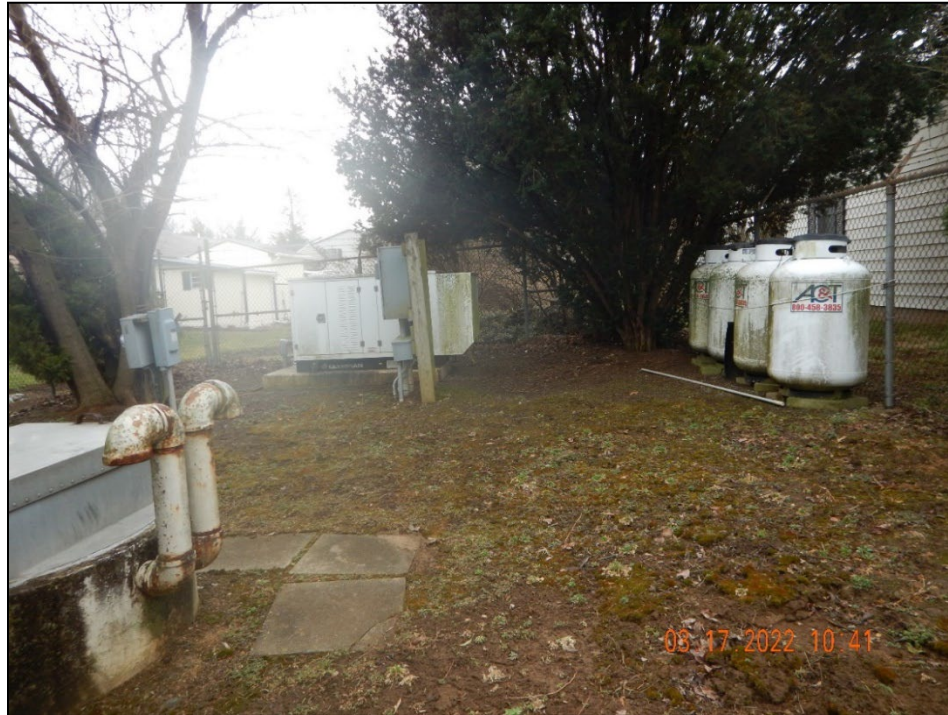
- 1) The lift station appeared to be in good condition and at the time of the inspection was not experiencing any problems (refer to Photographs 30 and 31).

**Photograph 30. Lift Station #3:** (DSCN3691.JPG) View, facing north, of the Lift Station #3 Grindstone Hill Road (Ryan Lane) Pump Station. The station appeared to be in good condition.

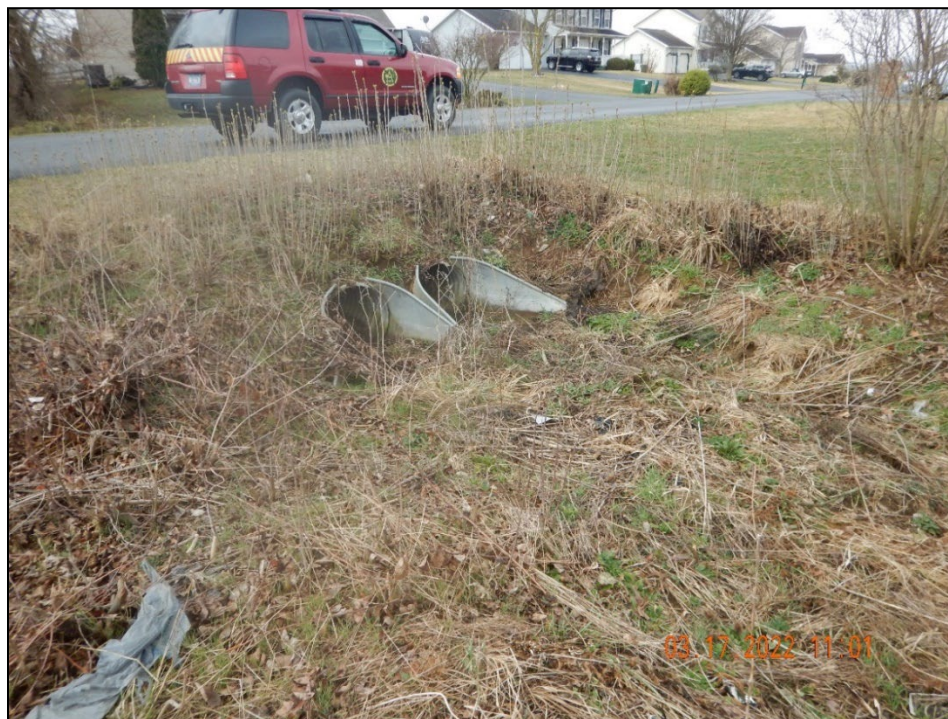
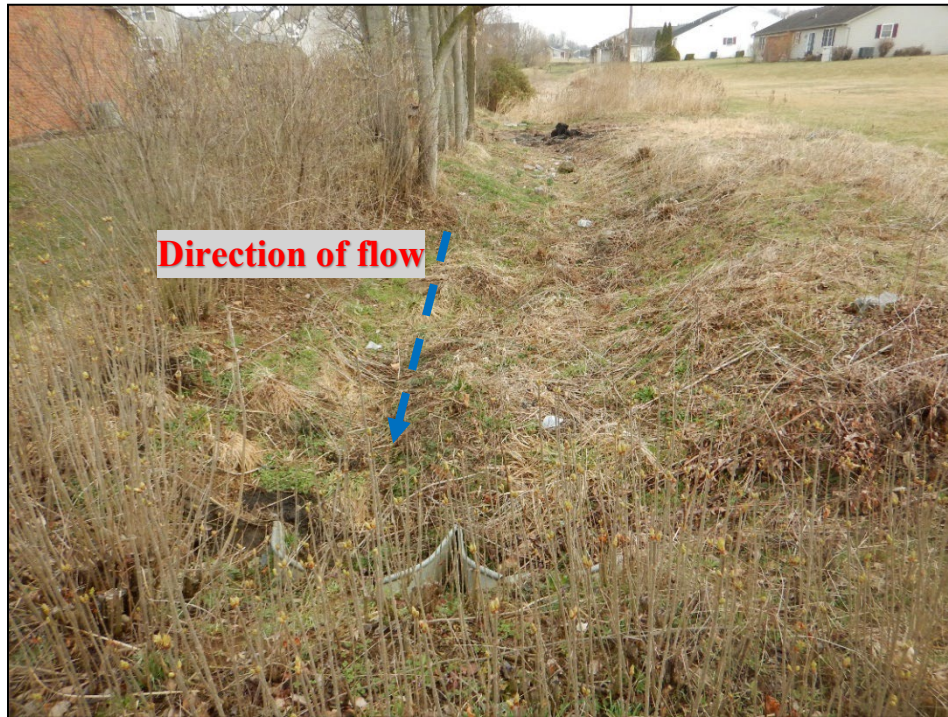
- 1) Stormwater flow was not observed at the outfalls at the time of the inspection (refer to Photographs 32 through 35). Runoff from neighboring private properties' yards contribute to Paddy Run upgradient of the outfalls. Paddy Run's channel is maintained by the owners of the adjacent private properties. Vegetation was growing inside the channel. The Township representatives stated that the Township did not have a formal agreement with the owners to maintain the channels.
- 2) Outfall #0245 appeared to be in good condition and was free of sediment and debris. Sediment and debris were observed at Outfall #0240 (refer to Photograph 33). Township representatives stated that the road crew is responsible for cleaning out the culvert that connects Outfalls #0245 and #0240. Township representatives did not specify the frequency in which the culvert is serviced.

**Photograph 32. Outfalls #0240 & #0245 Jason Drive:** (DSCN3700.JPG) View, facing south, of Outfall #0245. No discharge was observed at the time of the inspection.

**Photograph 33. Outfalls #0240 & #0245 Jason Drive: (DSCN2991.JPG)** View, facing north, upstream of Outfall #0245 of Paddy Run. Paddy Run was dry at the time of the inspection.

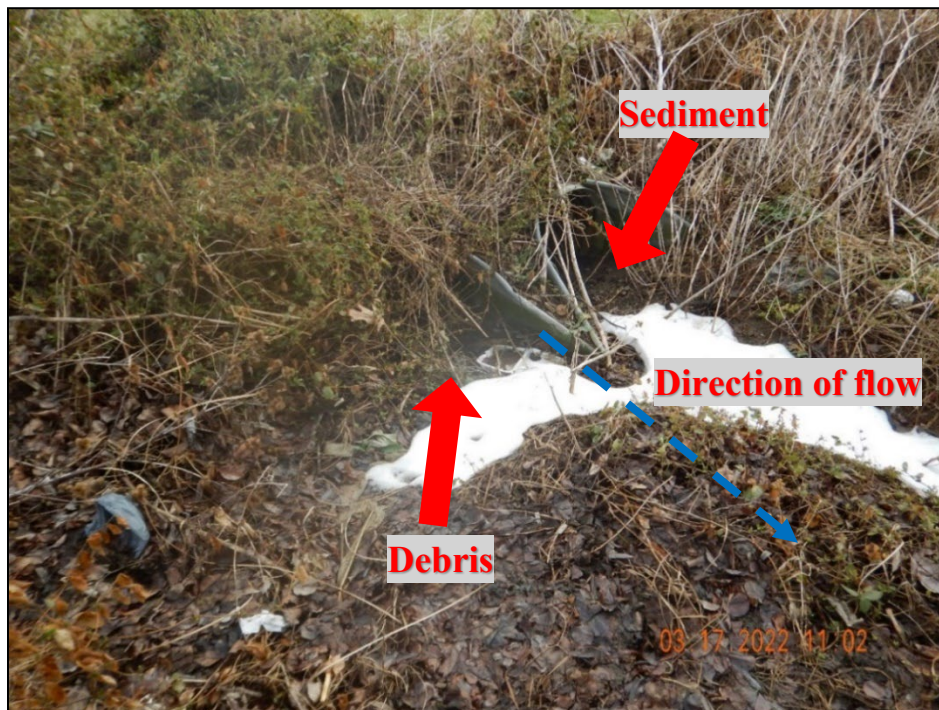
**Photograph 34. Outfalls #0240 & #0245 Jason Drive: (DSCN3702.JPG)** View, facing northeast, of Outfall #0240. No discharge was observed at the outfall at the time of the inspection. The EPA Inspection Team observed snow, sediment, and debris at the outfall.

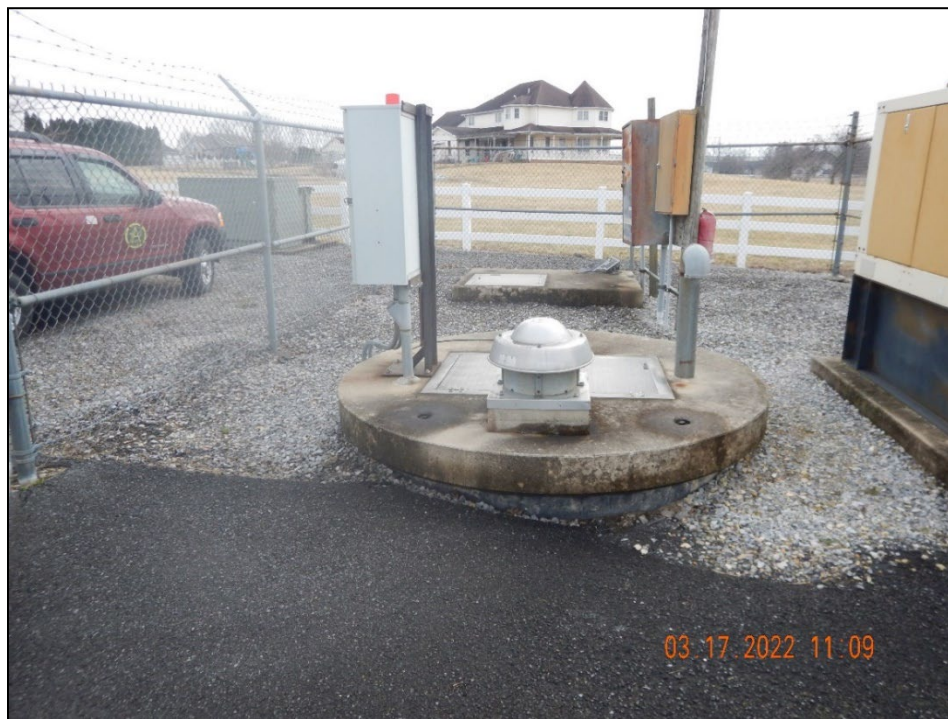
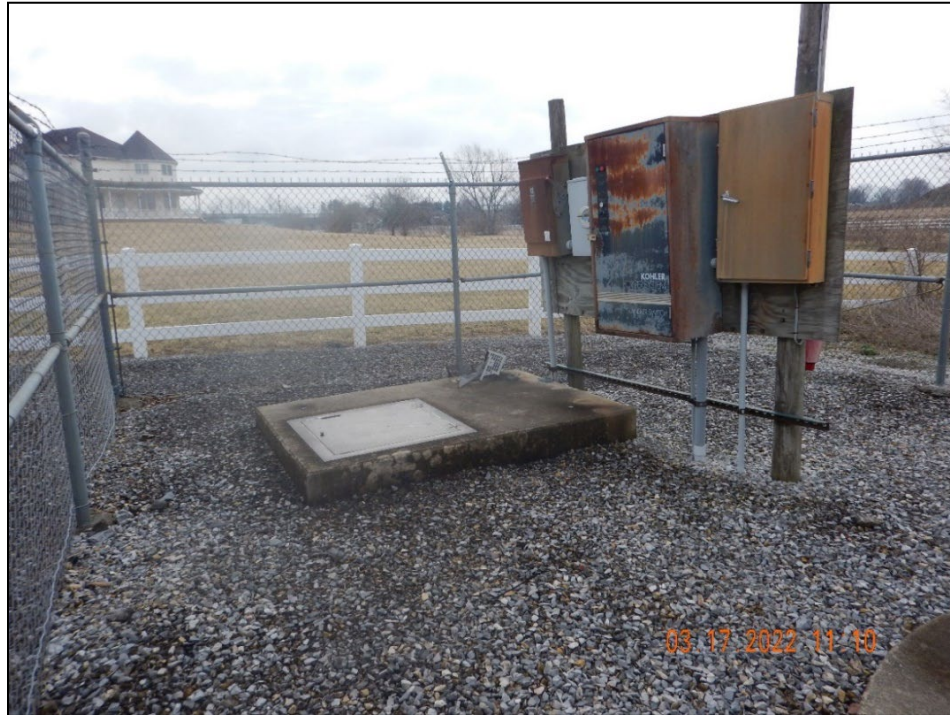
- 1) Lift Station #21 appeared to be in good condition, and at the time of the inspection was not experiencing any problems (refer to [Photographs 36 and 37](#)).

**Photograph 36. Lift Station #21:** (DSCN3704.JPG) View, facing east, of the Lift Station #21 Jason Drive Pump Station.

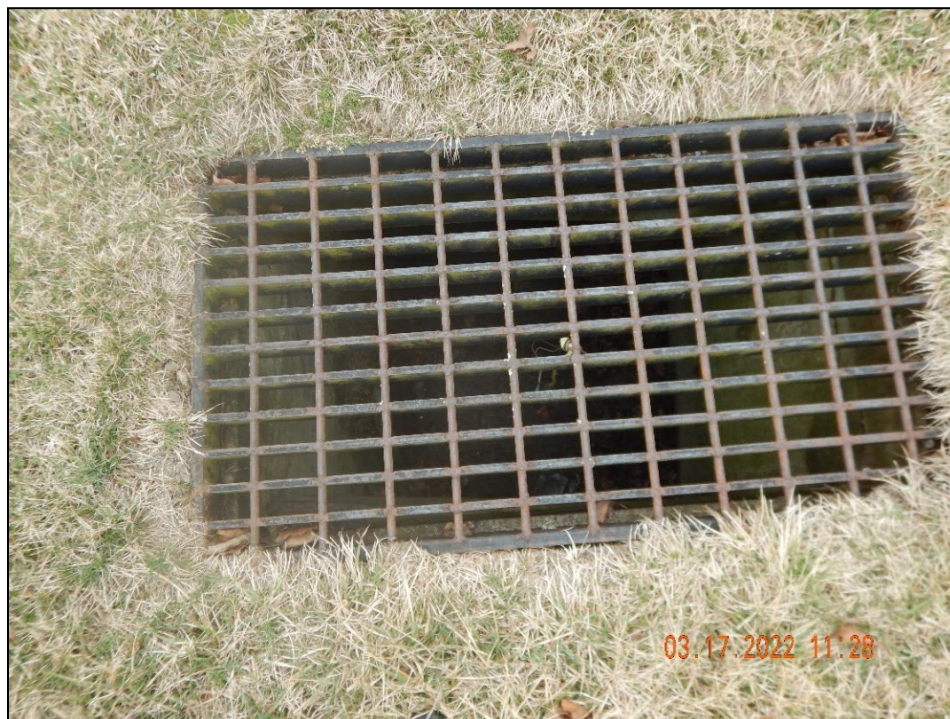
- 1) The storm drain Outfall #0250 appeared to be in good condition and did not have debris or trash (refer to Photograph 38).
- 2) The inlets in the stormwater basin that receives discharge from Outfall #0250 were free of sediment, debris, and trash (refer to Photograph 39 and 40).
- 3) All stormwater basins did not appear to connect to waters of the U.S. and therefore this “outfall” location would potentially not qualify as an outfall.

**Photograph 38. Outfall #0250 Nicole Drive:** (DSCN3712.JPG) View of Outfall #0250. The stormwater inlet is owned by PennDOT.

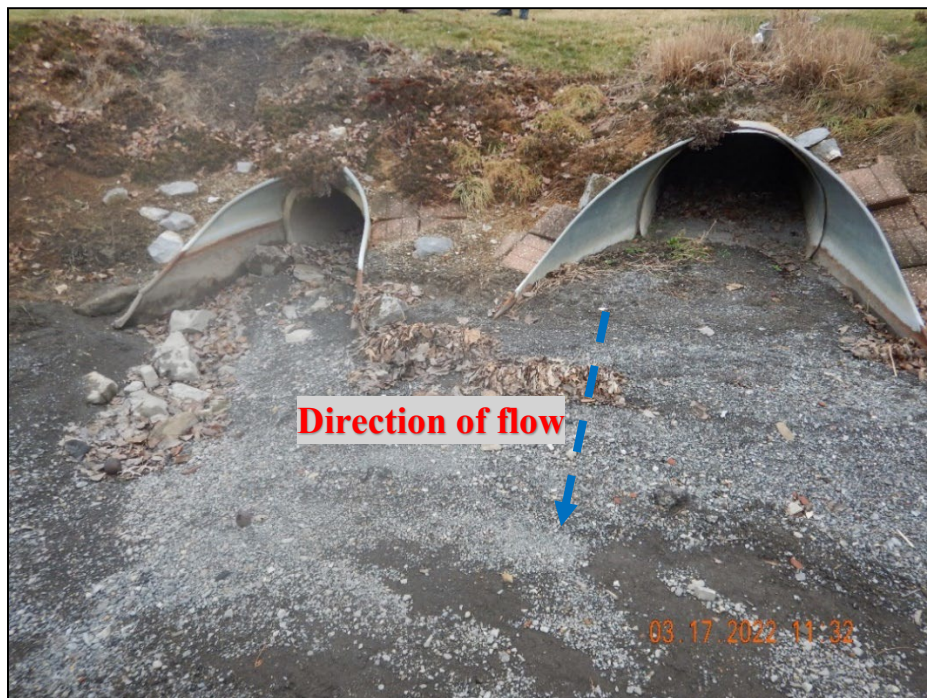
**Photograph 40. Outfall #0250 Nicole Drive: (DSCN3717.JPG)** View, facing north, of the inlets to the stormwater basin to which Outfall #0250 discharges. Stormwater from Outfall #0250 does not discharge into a surface water.
