**Region 6 - Enforcement & Compliance Assurance Division**  
**INSPECTION REPORT**

| Company Name: | <b>Jerry Langley Oil Company, LLC</b> | |
| Facility Name: | <b>Flowline Spill</b> | |

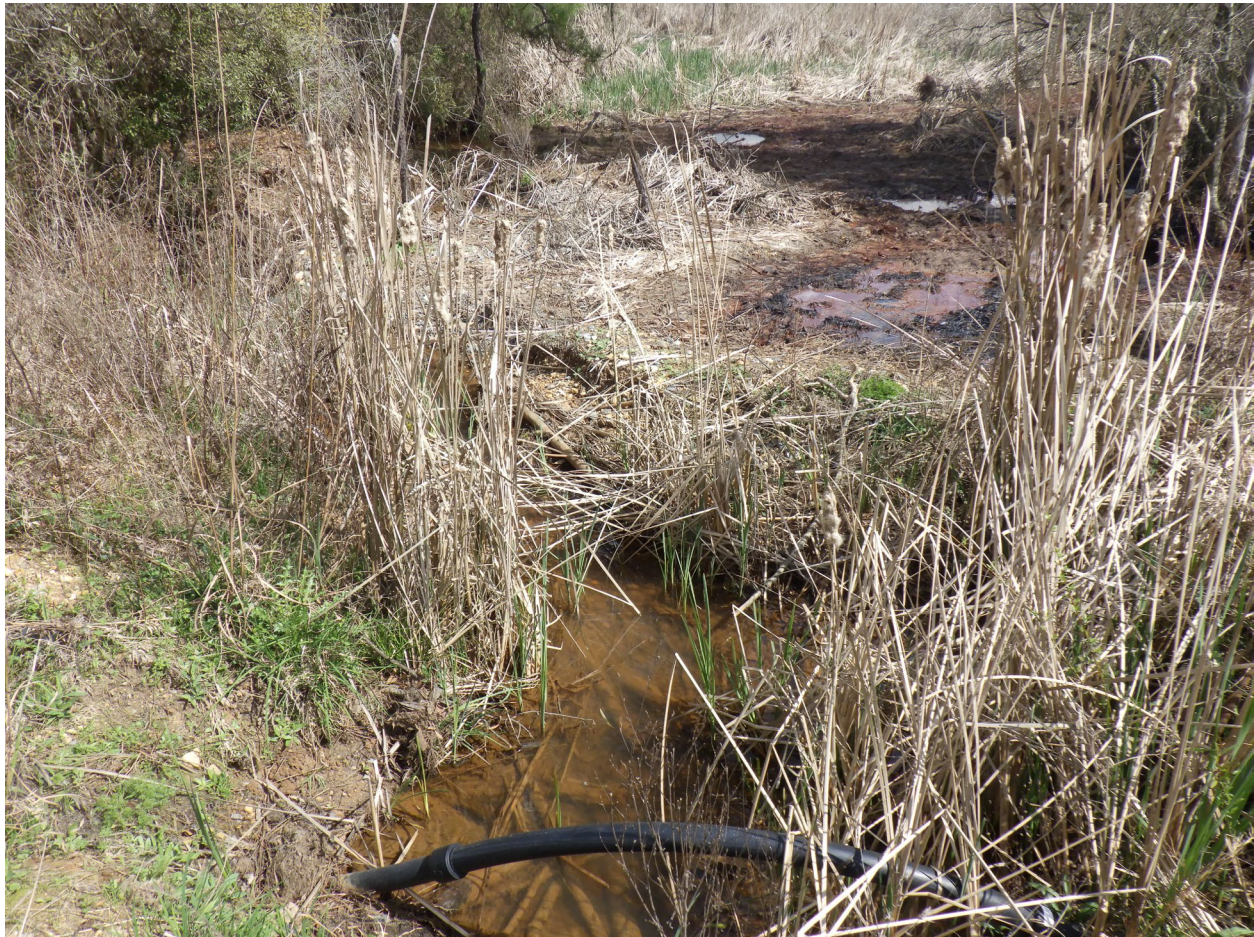
Photo No. 1

I observed loose oil on the east side of the lease road from a recent spill; see Appendix 1 (photo log), photo No. 1. For additional GPS location and photo metadata, see Appendix 1.

**Photo File Name:** R0010206**Orientation:** E**Date of Photo:** 03/12/2024**Time of Photo:** 2:34 PM**Latitude:** 33.34160**Longitude:** -92.68681**Photographer:** Uma Lad**Description:** This photo was taken looking east and shows an overview of the oil spill.

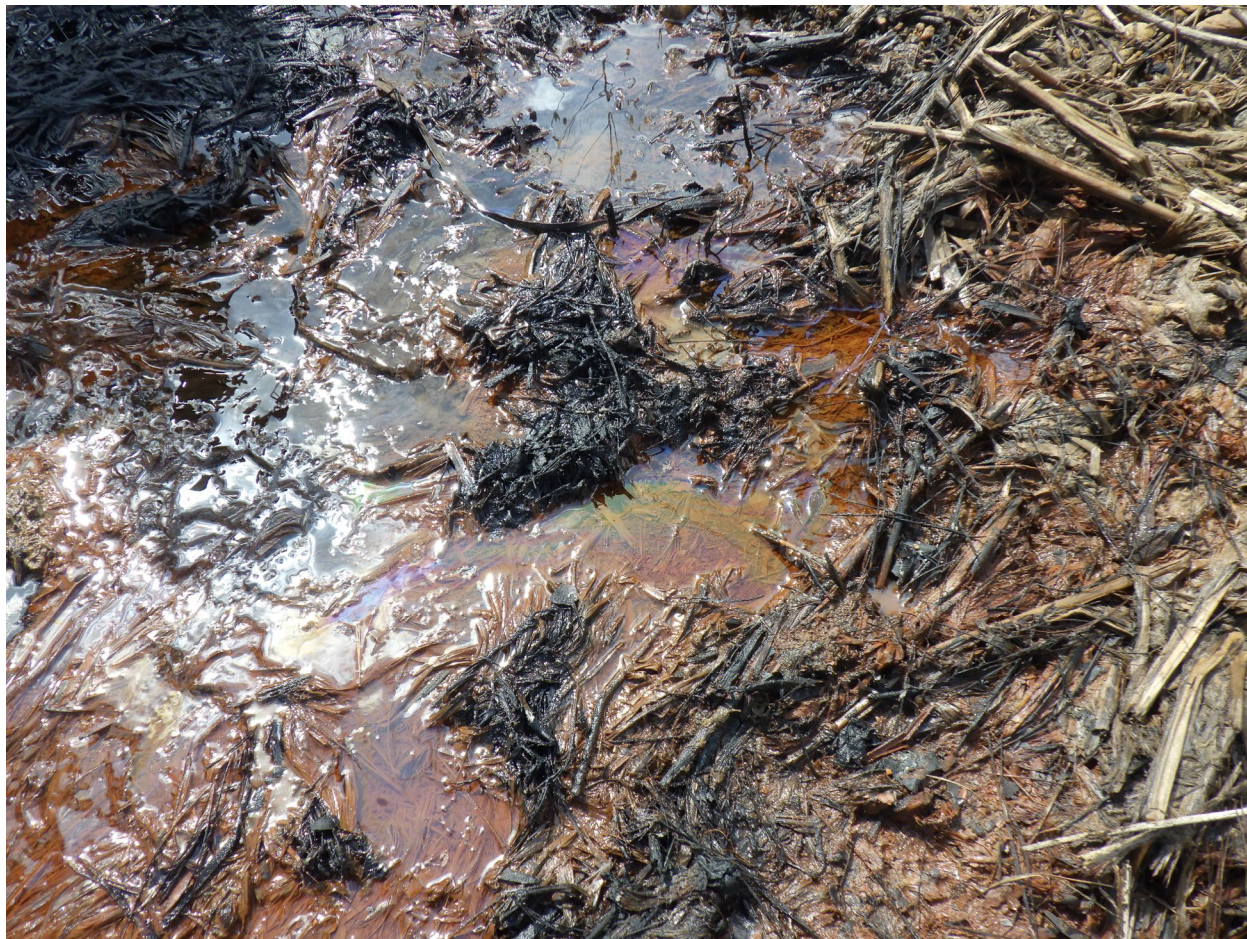
Photo No. 2

I also observed several areas with loose oil, oil sheen, and oil staining, see photo No. 2 through No. 4. I observed oil staining on trees, soil, and flattened vegetation, see photo No. 3.

**Photo File Name:** R0010205**Orientation:** W**Date of Photo:** 03/12/2024**Time of Photo:** 2:31 PM**Latitude:** 33.34146**Longitude:** -92.68676**Photographer:** Uma Lad**Description:** This photo was taken looking west and shows an oil sheen and oil staining on flattened vegetation.

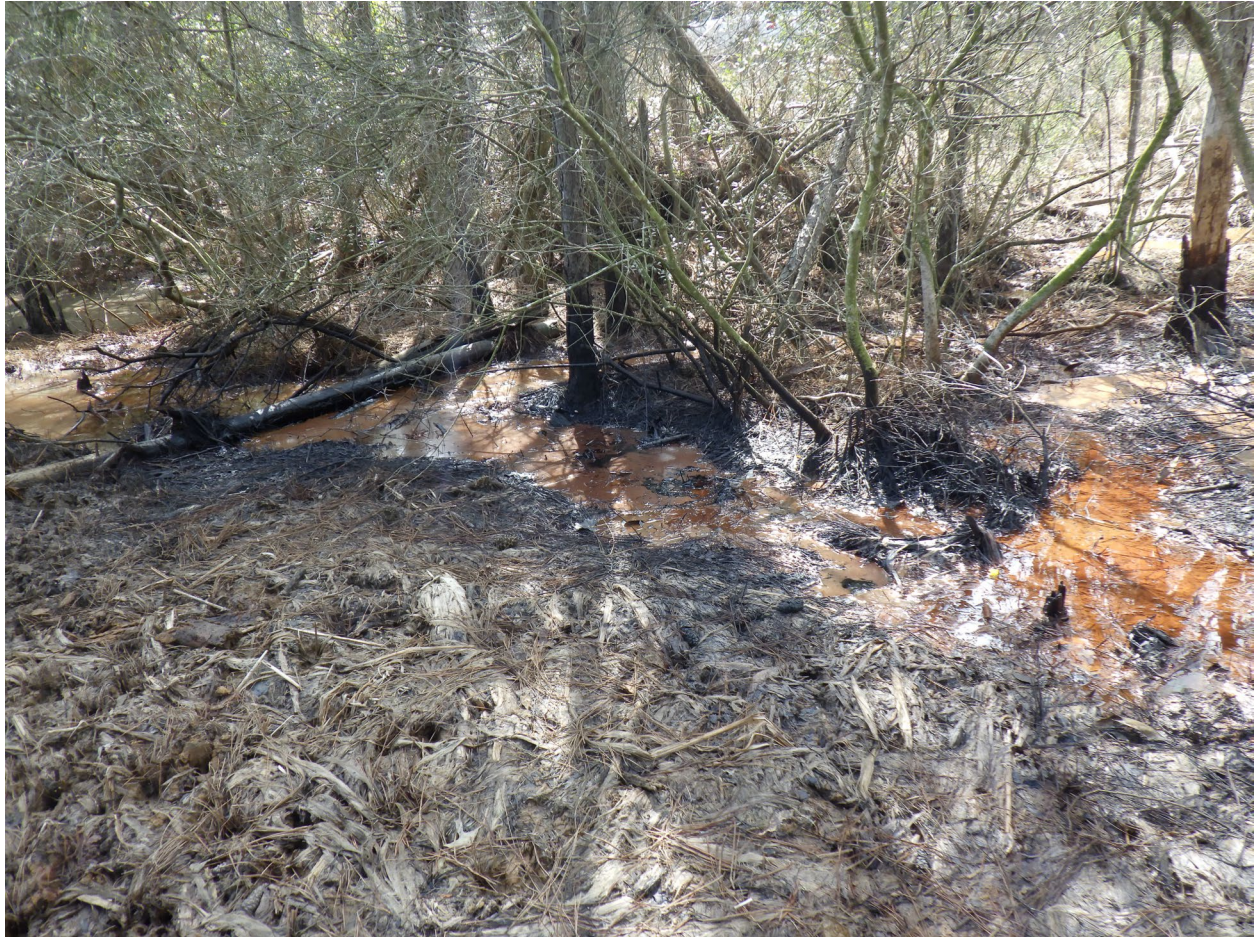
Photo No. 3

**Photo File Name:** R0010207**Orientation:** WSW**Date of Photo:** 03/12/2024**Time of Photo:** 2:38 PM**Latitude:** 33.34133**Longitude:** -92.68665**Photographer:** Uma Lad**Description:** This photo was taken looking west-southwest and shows oil staining on trees, soil, and flattened vegetation surrounded by loose oil.

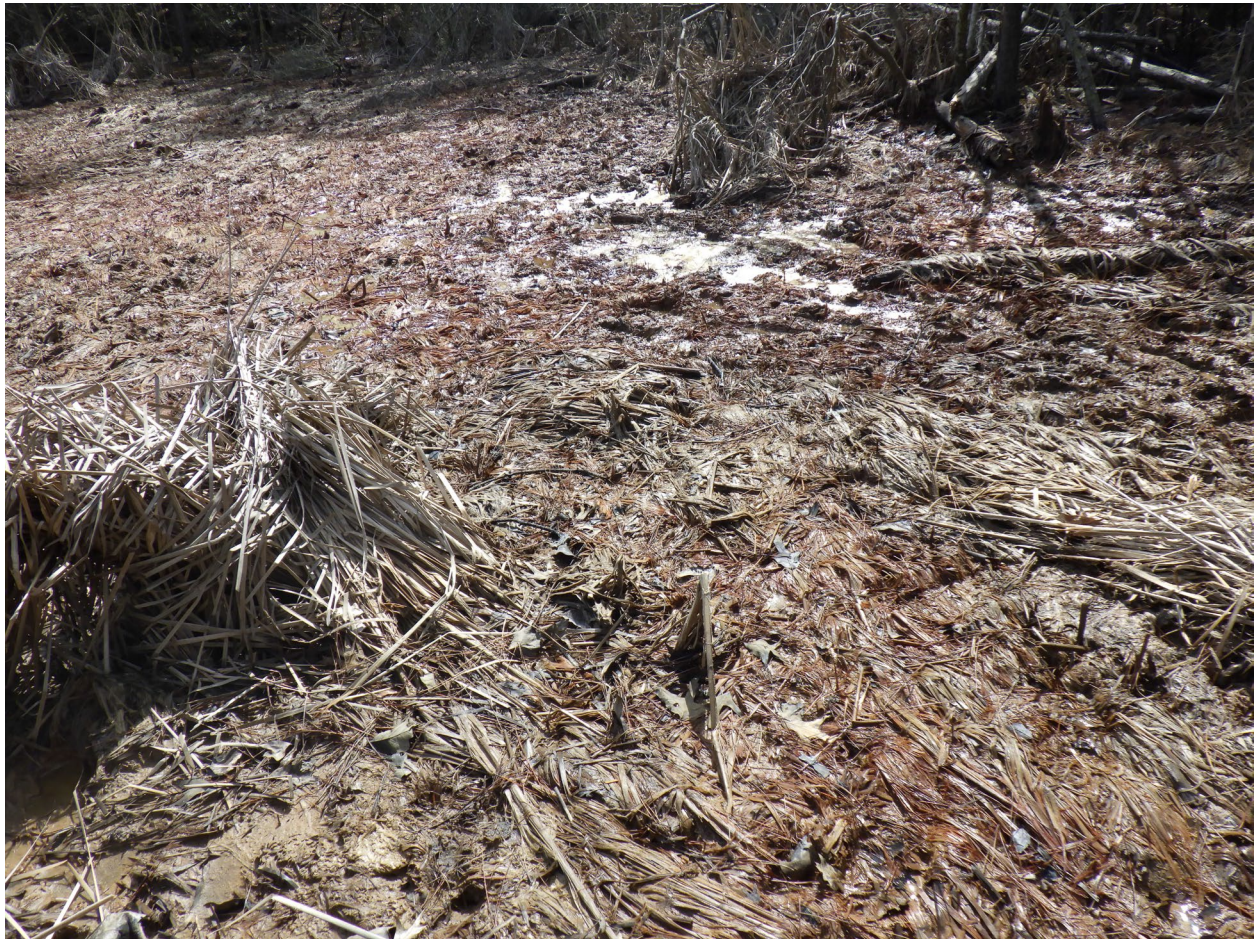
Photo No. 4

The oil spill is located within a wetland, see photo No. 4 and No. 5.

**Photo File Name:** R0010208**Orientation:** SW**Date of Photo:** 03/12/2024**Time of Photo:** 2:38 PM**Latitude:** 33.33261**Longitude:** -92.50759**Photographer:** Uma Lad**Description:** This photo was taken looking southwest and shows oil sheen on flattened vegetation within a wetland.

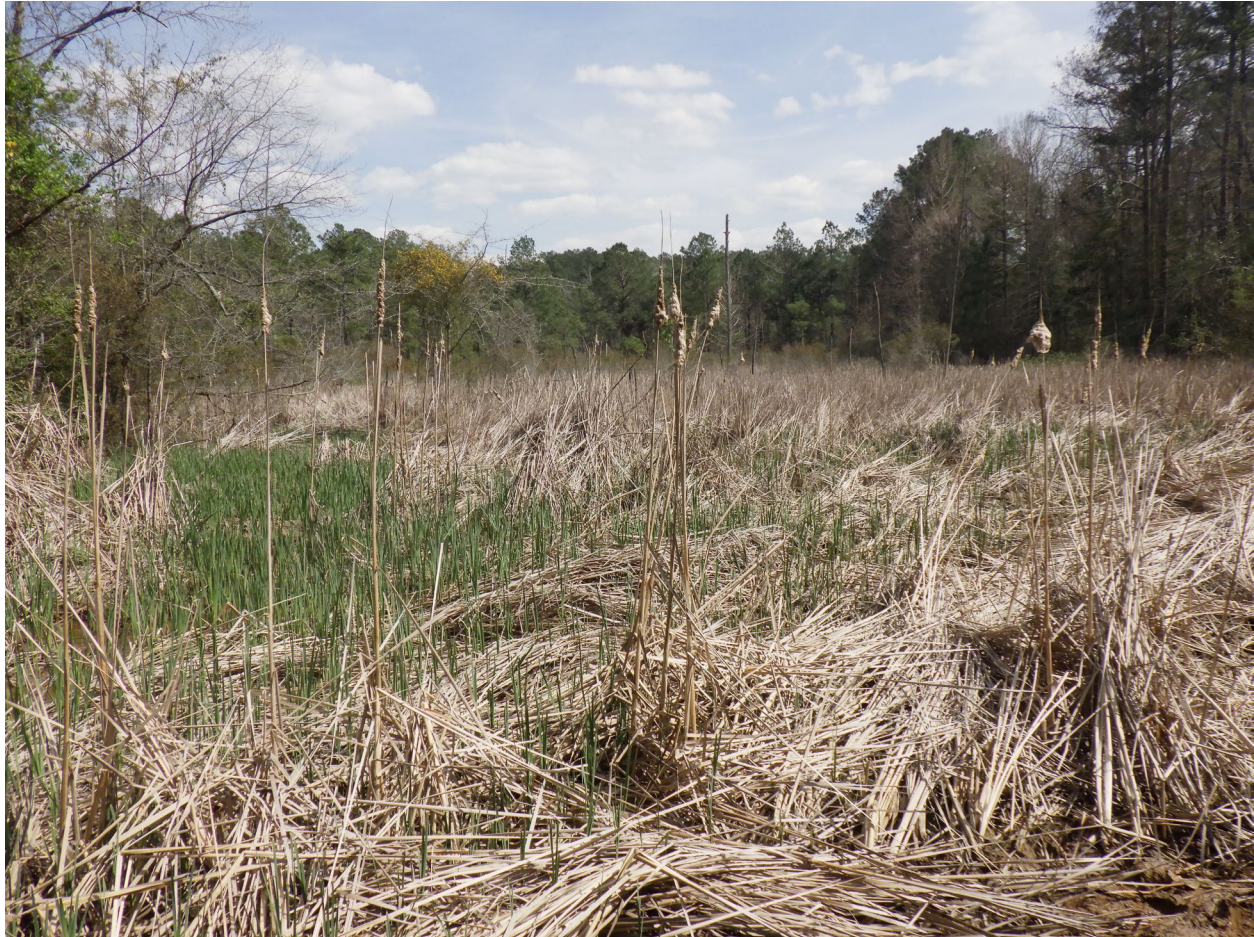
Photo No. 5

**Photo File Name:** R0010209**Orientation:** E**Date of Photo:** 03/12/2024**Time of Photo:** 2:39 PM**Latitude:** 33.33261**Longitude:** -92.50759**Photographer:** Uma Lad**Description:** This photo was taken looking east and shows wetlands near the oil spill.
