**U.S. Environmental Protection Agency  
Region 5**

**Purpose:** Clean Water Act National Pollutant Discharge Elimination System Compliance Evaluation Inspection

**Facility:** MPR Sand Terminals, LLC  
5330 Guernsey Street  
Bellaire, Ohio 43906

**Inspection Date:** February 22, 2023

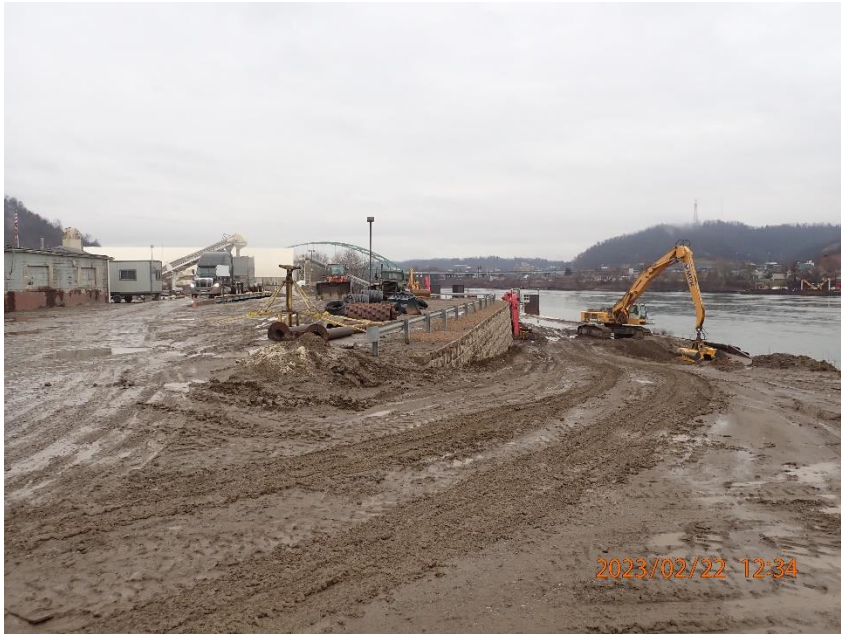
1: P2220027

Description: Overview of supply area

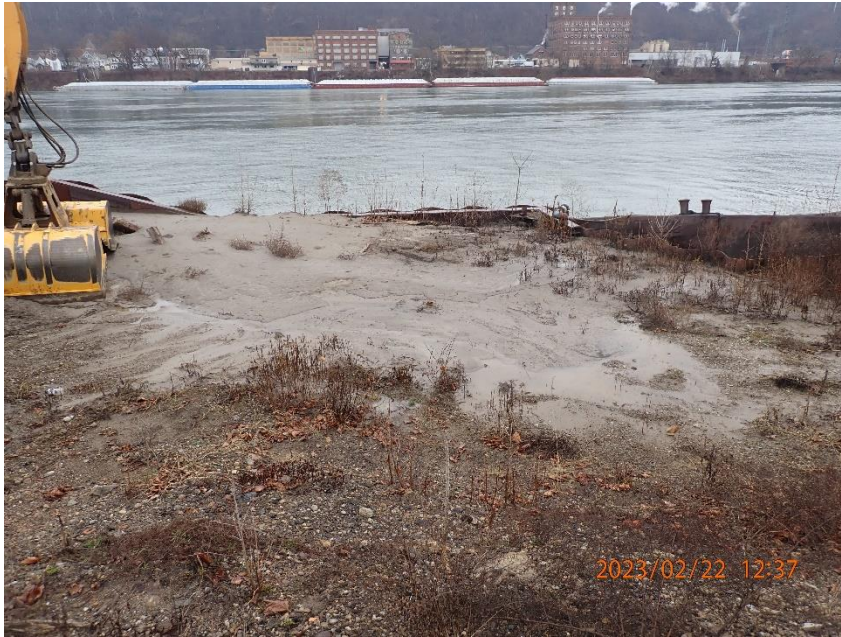
2: P2220028

- The metal walls used to retain sediment and sand in the Supply Area are not sufficiently preventing stormwater, sand, and sediment from entering the Ohio River (Photos 2 – 5). Holes in the retaining wall are seen at a height lower than the retained sand and stormwater, allowing for a discharge of stormwater, sand, and sediment through the wall and into the Ohio River (Photo 3). Similar deficiencies are seen in the corners between the metal parts of the retaining walls (Photo 4). Sand and sediment have accumulated behind the retaining walls, to the extent that it has filled up behind the wall, and is overflowing into the Ohio River (Photo 5).

Description: Sand accumulation in supply area

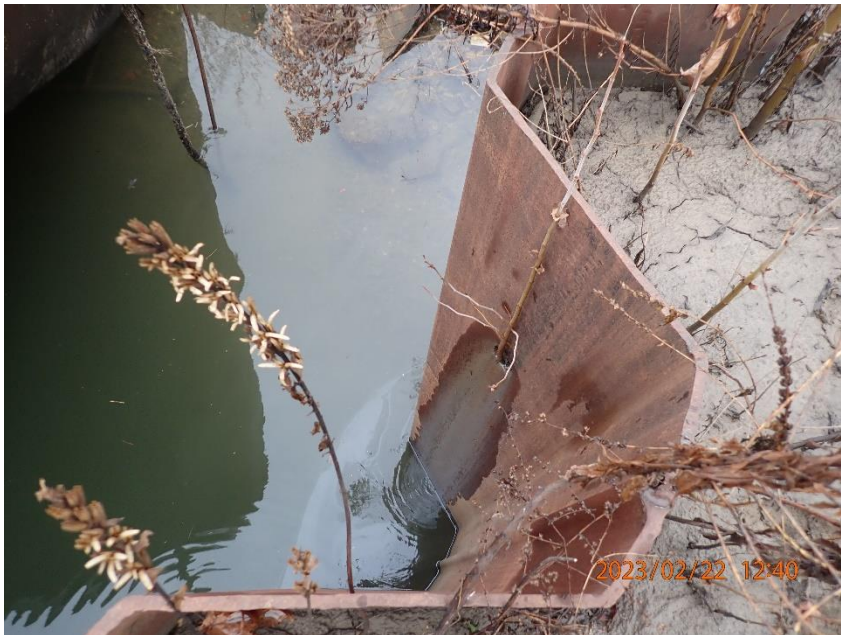
3: P2220029

Description: Seepage from the near top of the sediment/sand retaining wall, actively discharging stormwater into the Ohio River

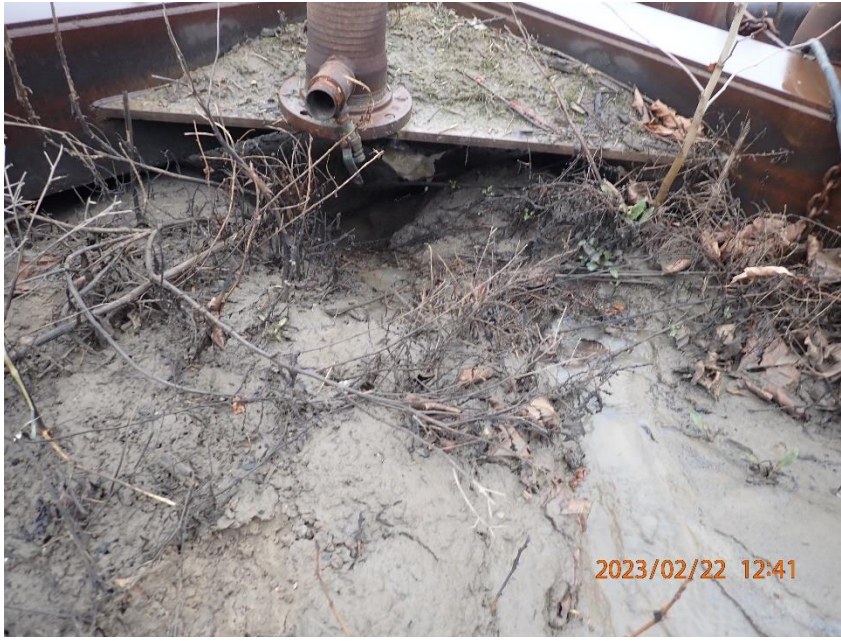
4: P2220030

Description: Stormwater runoff exiting through the corner of the sediment/sand retaining wall into the Ohio River

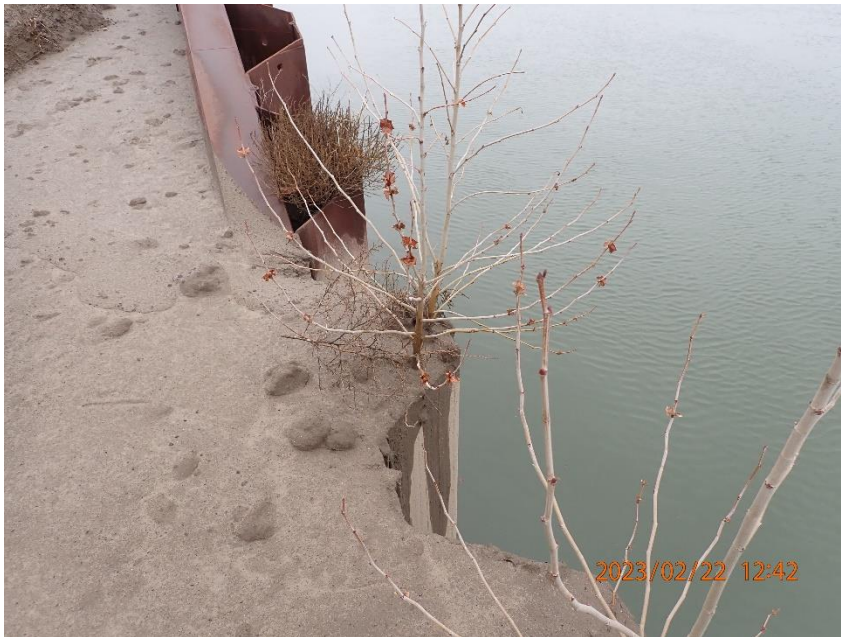
5: P2220031

Description: Sand overflowing the edge of the retaining wall into the Ohio River

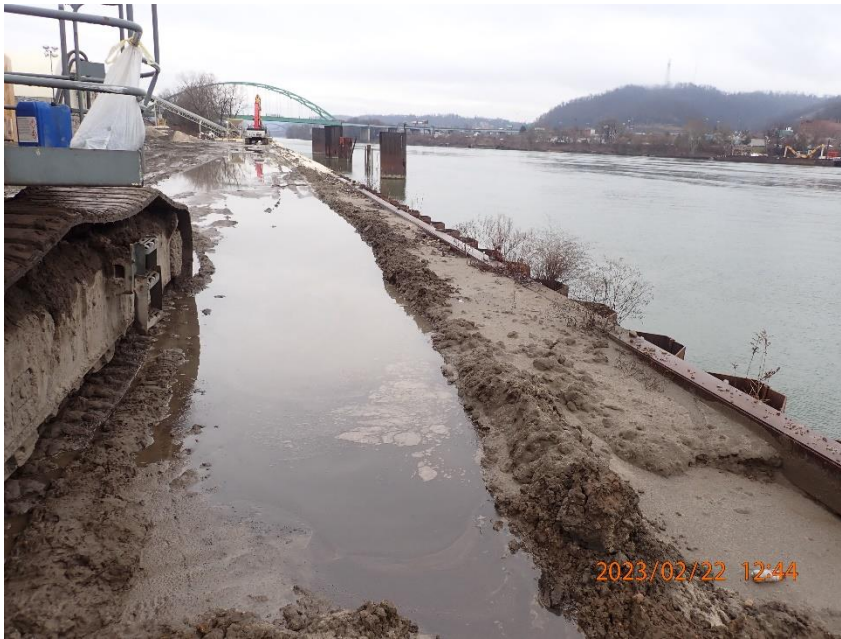
6: P2220032

- Sand, sediment, and stormwater have also accumulated behind the walls of the Harbor Area up to the same height as the wall (Photos 6 – 8). Sand and sediment are evident on the top surface of the harbor wall, directly above the Ohio River (Photo 8).
- Stormwater is collected in two catch basins beside the sand loading station (Photos 13 and 14) and is discharged to the Ohio River through a permanently installed pipe (Photo 10).
- A channel of stormwater runoff, sand, and sediment, which leads into the Ohio River, is evident at the north boundary of the Harbor Area (Photo 11).

Description: Poned stormwater runoff and sand next to the Ohio River

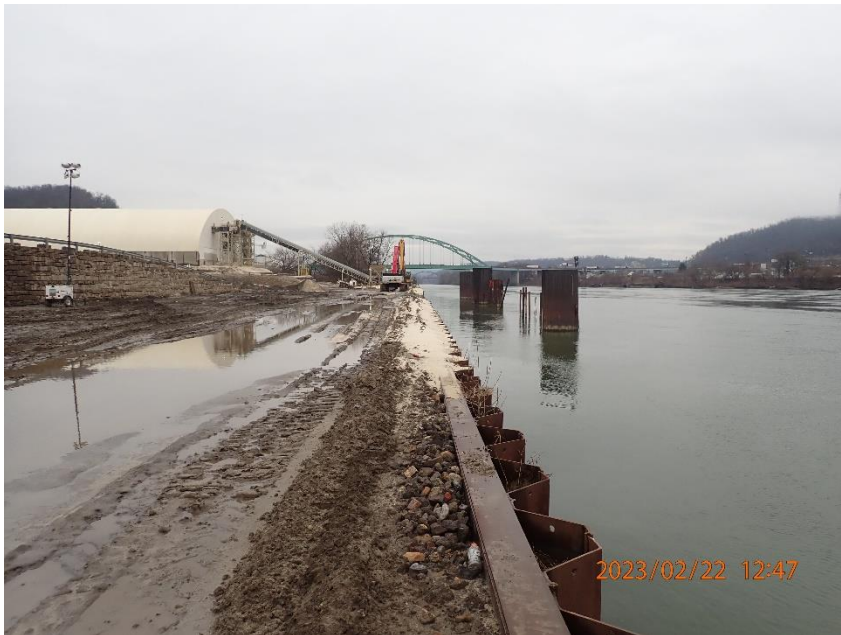
7: P2220033

Description: Poned stormwater and sand next to the Ohio River

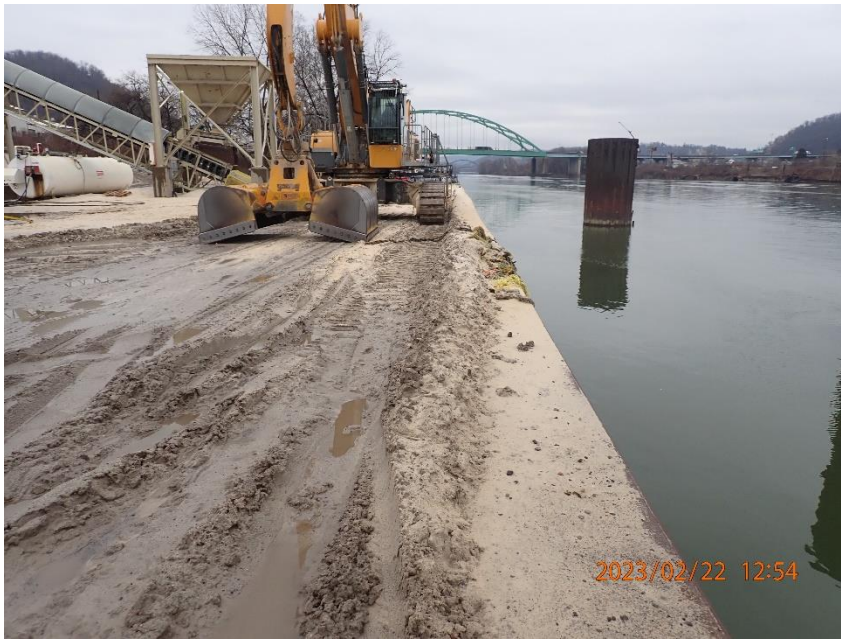
8: P2220034

Description: Sand on top of the harbor wall on the Ohio River

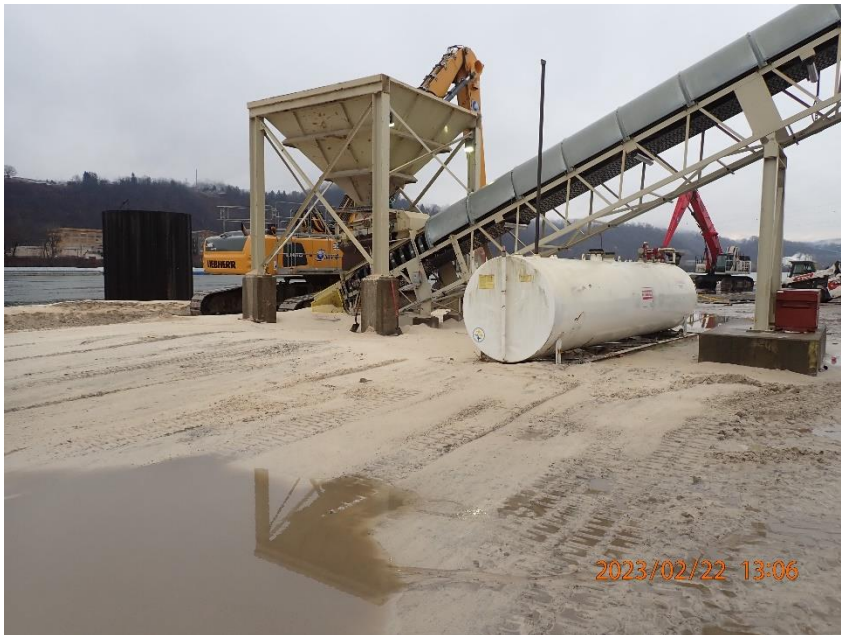
9: P2220035

Description: Double walled fuel tank

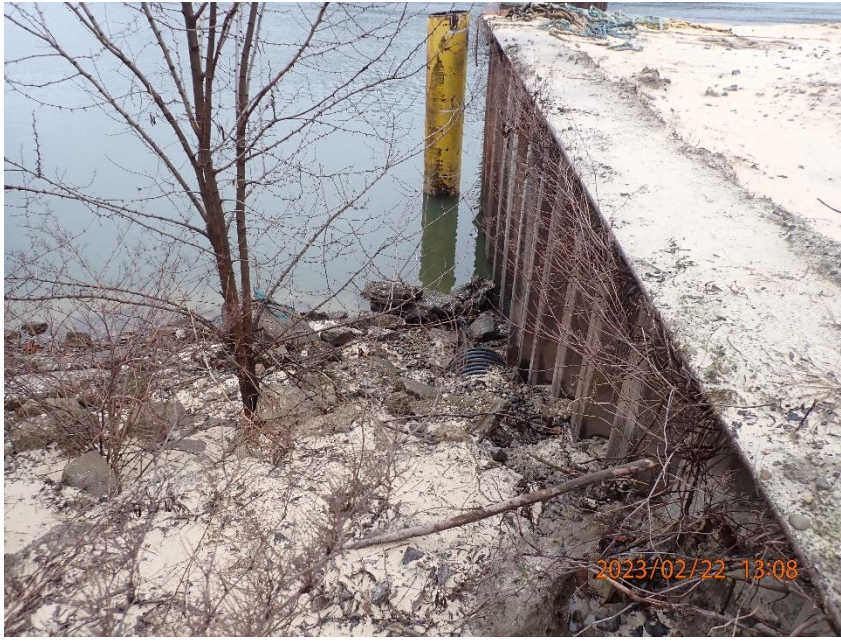
10: P2220036

Description: Black pipe discharging stormwater into the Ohio River

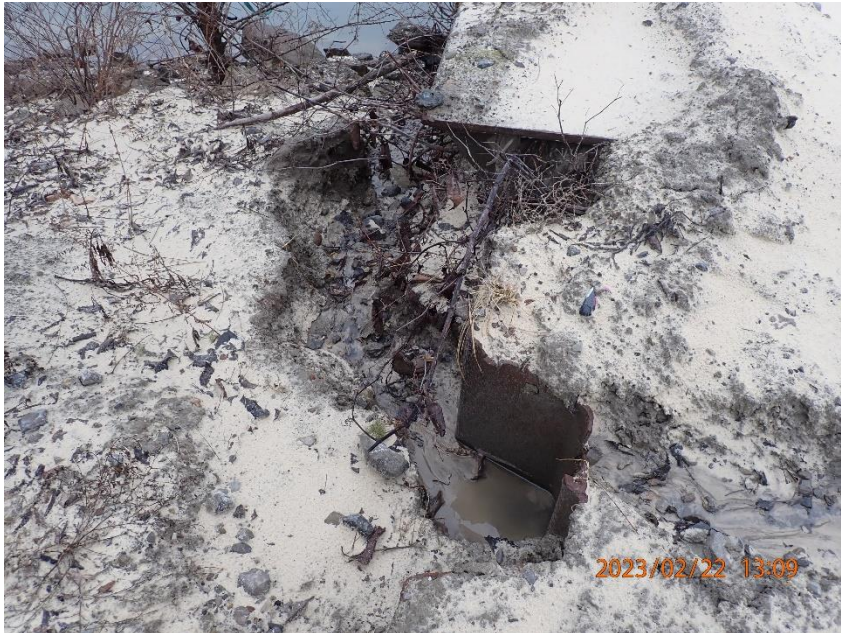
11: P2220037

Description: Runoff channel flowing around the north boundary wall of the harbor area

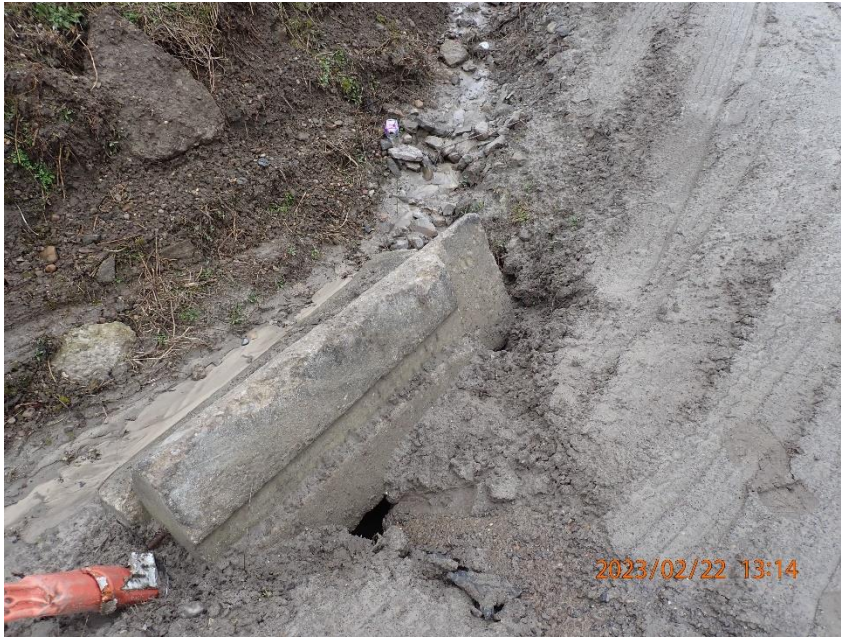
12: P2220038

Description: Drainage pipe below the sand waste pile

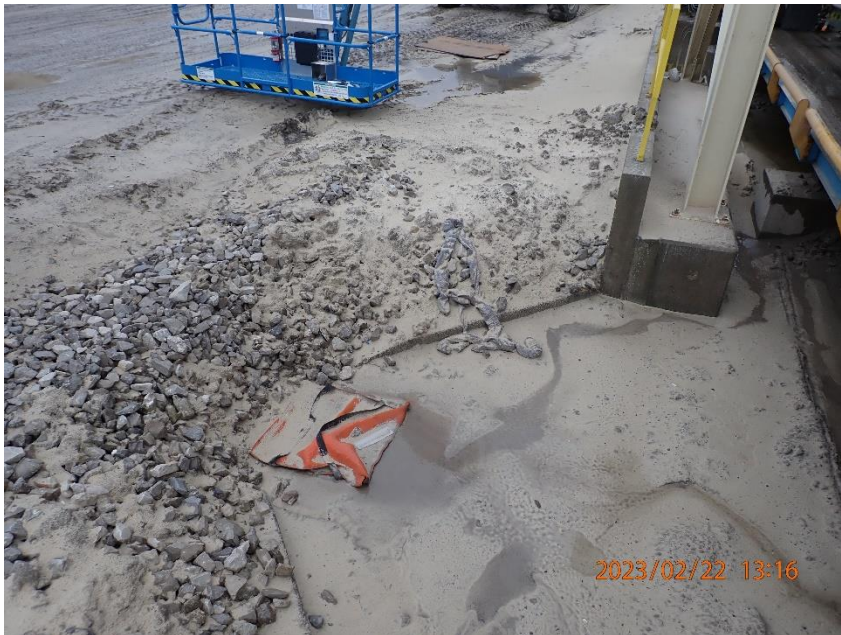
13: P2220039

Description: Catch basin with opening covered by orange dandy bag, south of the truck filling station. Drains to the black discharging pipe in Photo 10.

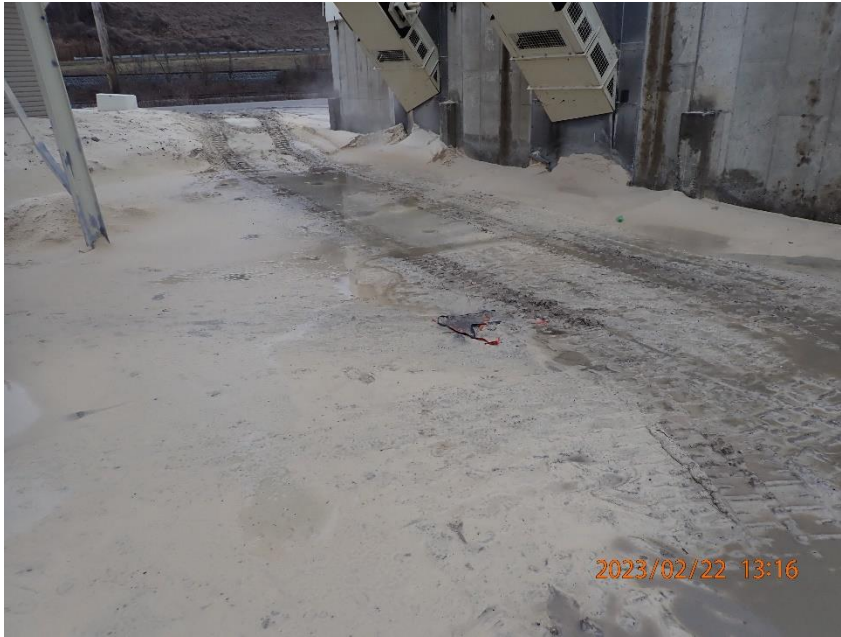
14: P2220040

Description: Catch basin with opening covered by orange dandy bag, north of the truck filling station. Drains to the black discharging pipe in Photo 10.

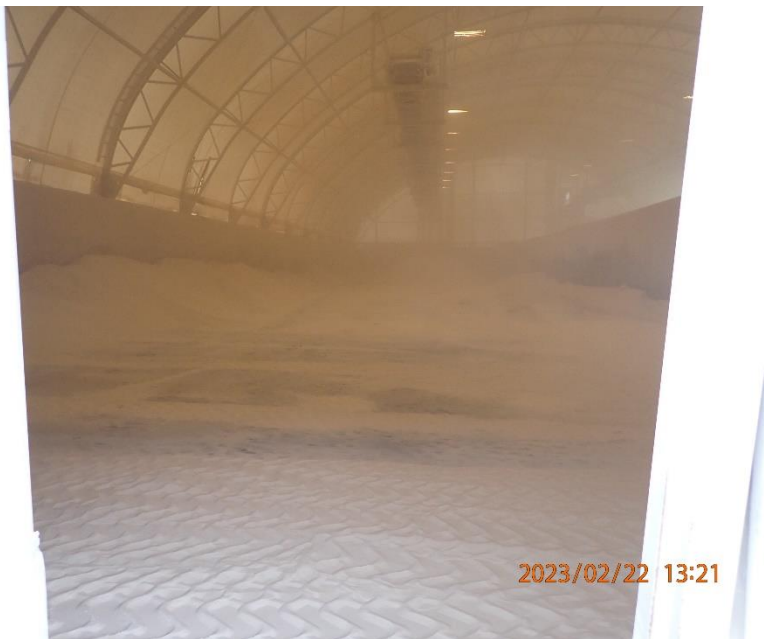
15: P2220041

Description: Inside of sand storage warehouse

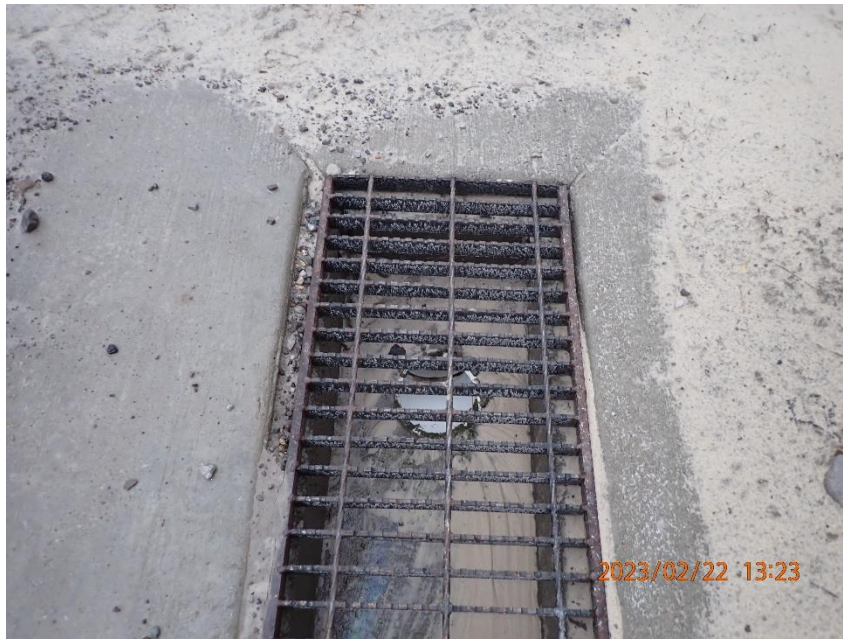
16: P2220042

Description: Drain next to the sand warehouse. Drains to the ditch north of the property and into the Ohio River.
