**Region 6 - Enforcement & Compliance Assurance Division**  
**INSPECTION REPORT**

| Inspection Date(s): | 3/15/2024 | |
| Company Name: | <b>Arklatex Operating Company, Inc.</b> | |
| Facility Name: | <b>Flenniken A. Lease Tank Battery</b> | |

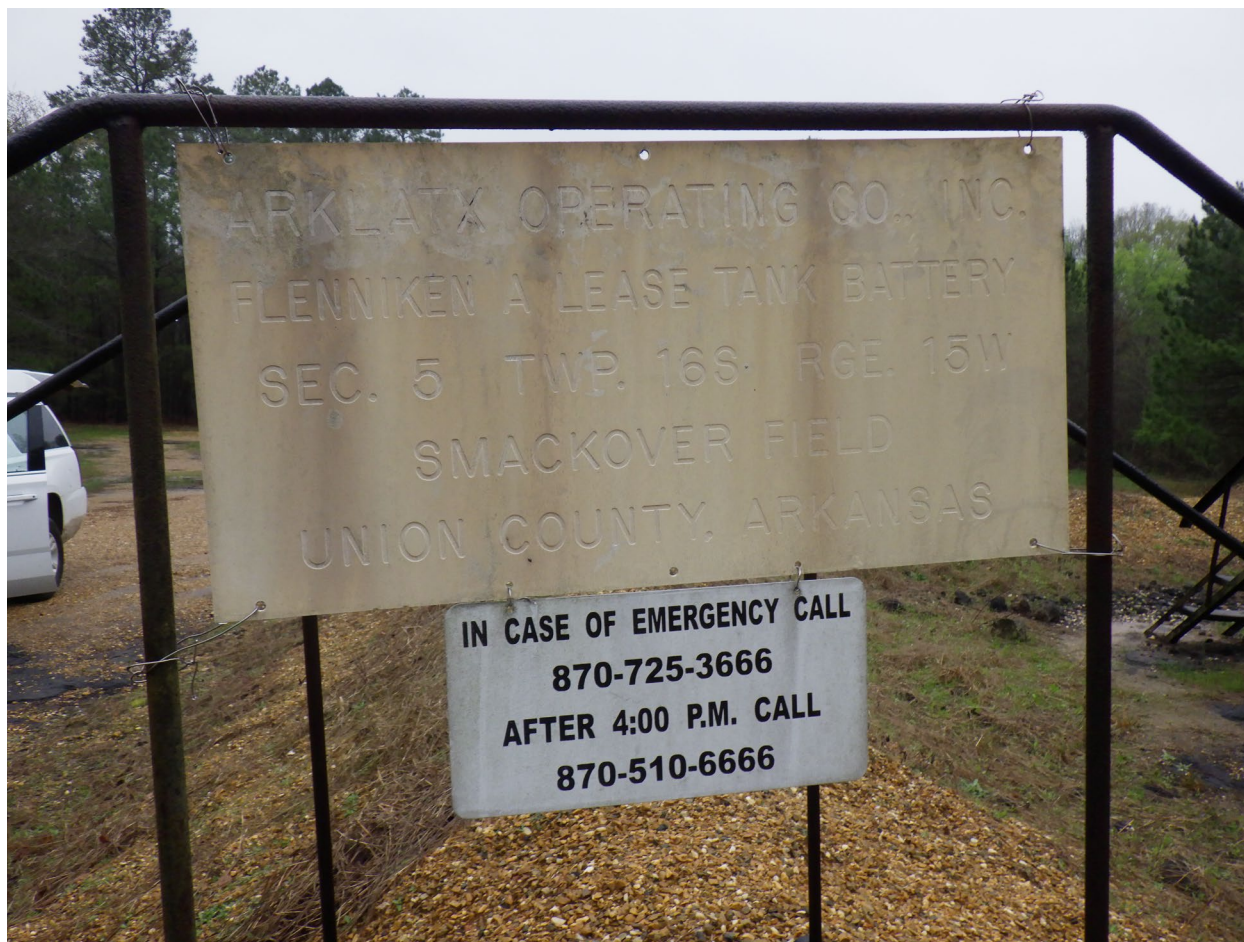
Photo No. 1

I observed the facility sign, secondary containment, oil separators, pipes, and tanks located at the facility, see Appendix 1 (photo log), photo No. 1. For additional GPS location and photo metadata, see Appendix 1.

**Description:** This photo was taken looking N at the facility showing the facility sign.

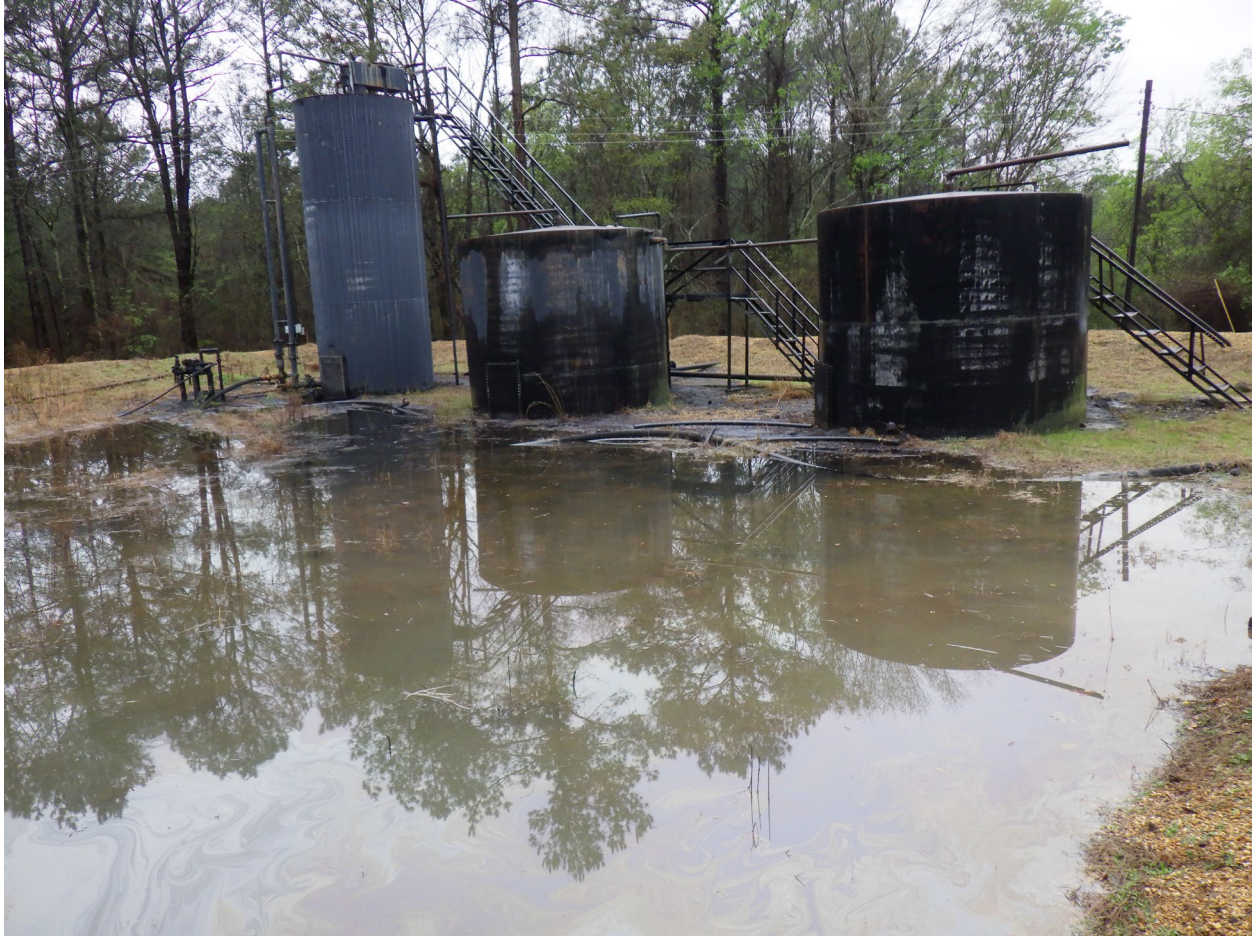
Photo No. 2

I observed the standing water within secondary containment with oil sheen on the water, see photo No. 2.

**Description:** This photo was taken looking SW at the facility showing an overview of the facility as well as sheen on the water within secondary containment.

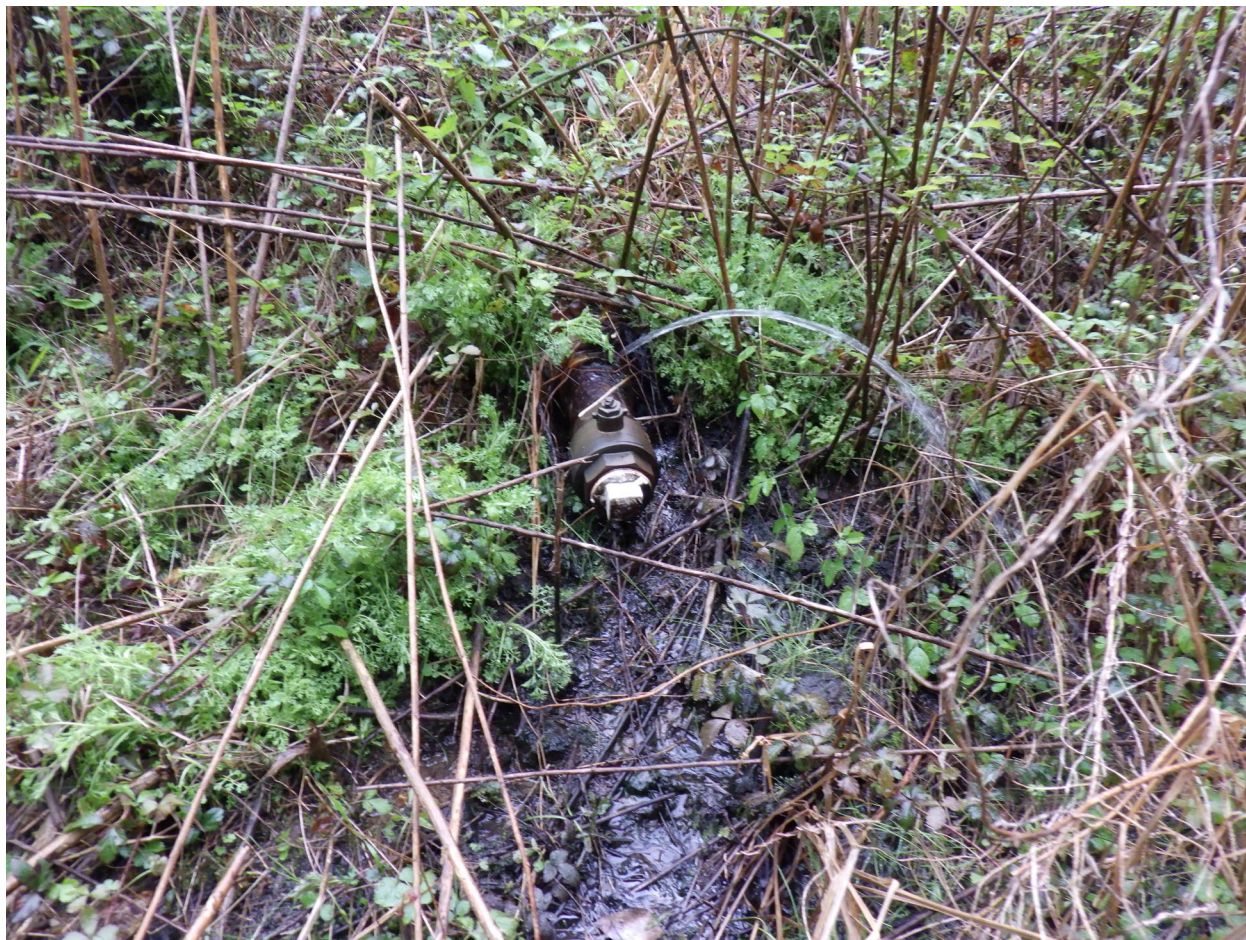
Photo No. 3

I observed the secondary containment's rainwater discharge/drain valve, which had a leak near the connection of the valve and pipe, see photo No. 3.

**Description:** This photo was taken looking W, on the back side of the facility outside of secondary containment showing the discharge pipe that was capped but leaking near the valve connection.

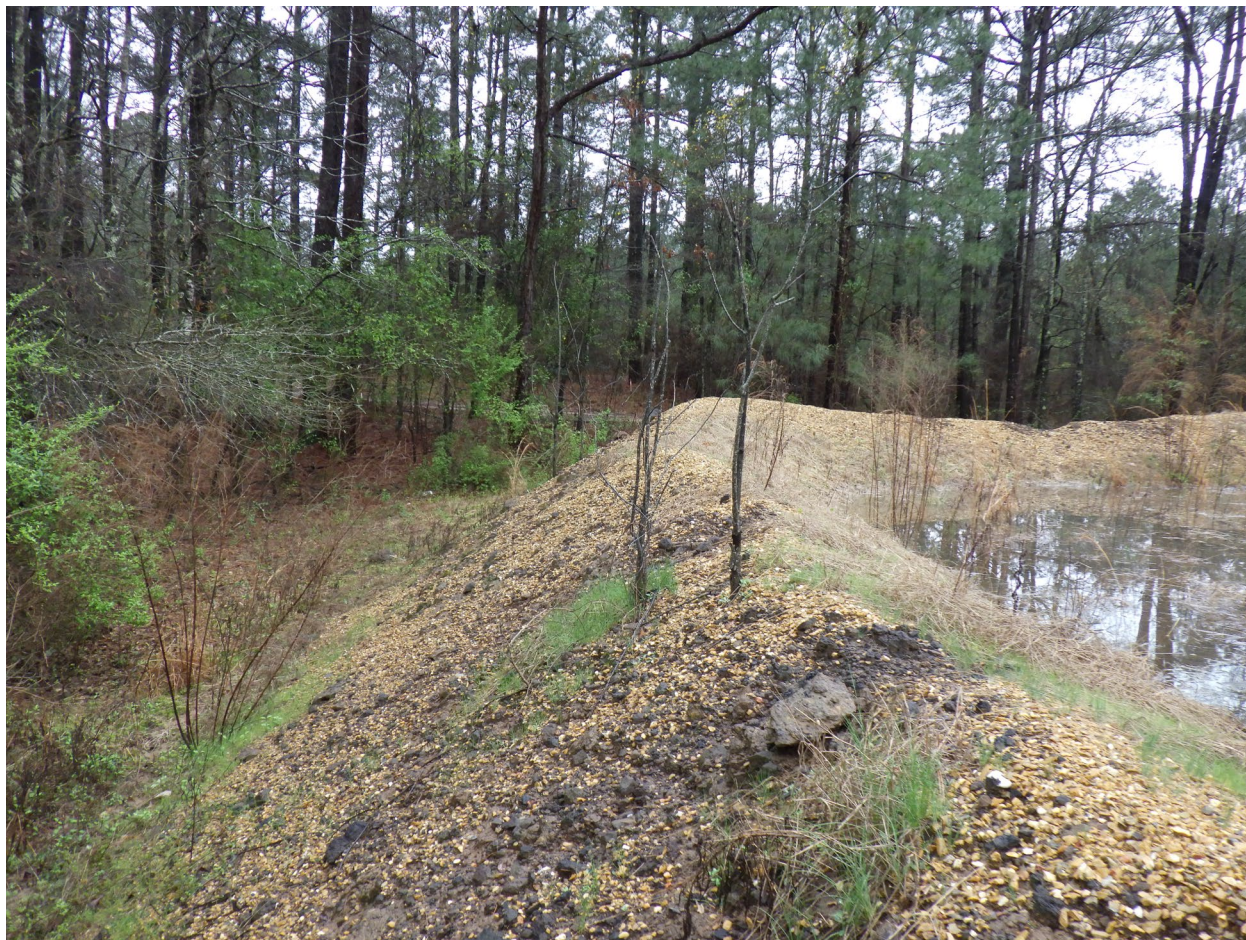
Photo No. 4

I observed vegetation growing into the secondary containment berm, see photo No. 4.

**Description:** This photo was taken looking SSW showing vegetation growing into the secondary containment berm.
