INSPECTION REPORT

<b>Inspection Date(s):</b>	05/10/2022	Announced: No
<b>Time:</b>	Entry: 08:25 AM (ET)	Exit: 11:14 AM (ET)
<b>Media:</b>	Water	
<b>Statute(s)/Program(s):</b>	Clean Water Act, NPDES, WWTP	
<b>Type of inspection:</b>	CEI - Compliance Evaluation Inspection	
<b>Access:</b>	Granted	
<b>Permittee Name:</b> Village of Mt. Orab		
<b>Facility or Site Name:</b> Mt. Orab WWTP		
<b>Facility/Site Physical Address:</b> 12943 US Route 68		
<b>(City, state, zip code)</b> Mt. Orab, OH 45154		
<b>County/Parish:</b> Brown County		
<b>Facility GPS Coordinates:</b> 38.993133, -83.921373		
<b>Mailing address:</b>		
<b>(If different)</b>		
<b>(City, state, zip code)</b>		
<b>Facility/Site Identifier:</b> Mt. Orab WWTP		
<b>Permit Number:</b> OH0026646		
<b>SIC or NAICS:</b> 4952

## SECTION I – INTRODUCTION

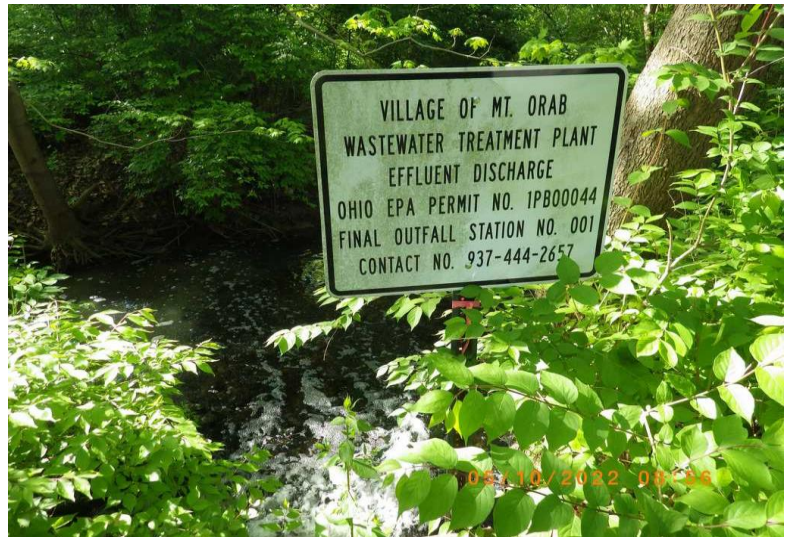
<p>EPA observed outfall 001 discharging into Snapping Turtle Run and the outfall signage. The outfall signage was facing away from the creek, not towards the creek.</p>	
<p><b>Photo(s)</b></p> <ol style="list-style-type: none"> <li>1. <a href="#">RIMG2676.JPG</a></li> </ol>	
<b>Unit:</b> Pretreatment	<b>Contains CBI:</b> No
<b>Observation #:</b> AH2-OB-001	<b>Date:</b> 05/10/2022
<p>EPA observed the influent channel, the vortex grit separator, the grit dumpster and the influent autosampler inside the pretreatment building. The grit from the dumpster is taken by Rumpke of Ohio, Inc. (Rumpke) as needed, according to Mr. Standring. The pretreatment building was built in 2016 and also houses the control room. The Facility has a supervisory control and data acquisition (SCADA) system that monitors flows and one of the clarifiers. During the inspection, EPA observed two influent 10" pipes that convey flows from the Villages of Mt. Orab and Hamersville. According to the Facility, it uses geothermal heating to keep pipes from freezing in the pretreatment building. During the inspection, EPA observed a thermometer reading of 5°C at the influent autosampler. From the top of the pretreatment building, EPA observed the EQ tank that was about a quarter full of rain water. Mr. Standring stated that monthly copper samples are taken from both the influent and effluent in order to understand what has caused recent copper limit exceedances in the effluent. Mr. Standring stated that based on the data so far, increased copper concentrations were due to the copper sulfate that was added at the drinking water treatment plant for algae control. Since the drinking water plant substituted the copper sulfate with ultrasonic radiation to treat for algae, no high copper readings have occurred at the Facility since November 2021.</p>

Outfall 001
RIMG2676.JPG
05/10/2022 09:56 AM (ET)
Andi Hodaj
Outfall 001
No CBI
No PII
Signage for outfall 001. Camera looking south.

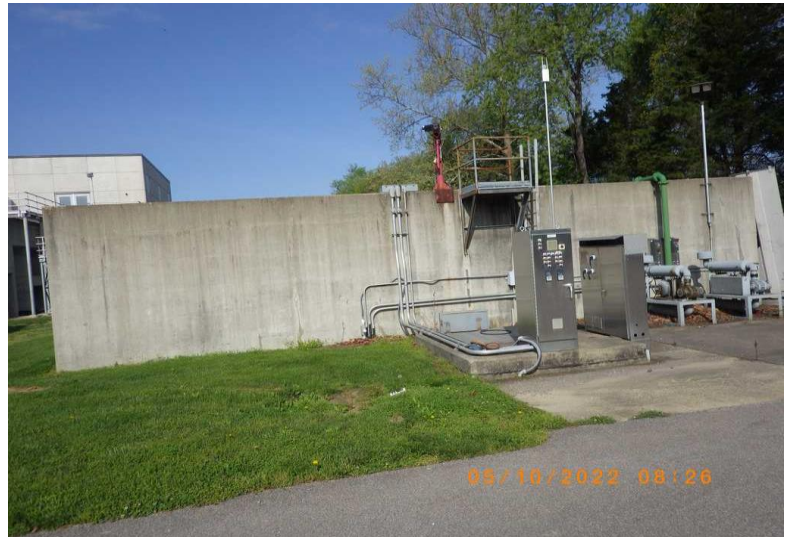
<b>Is there currently any portion of the treatment train that is non-operational?</b>	Equalization (EQ) tank was out of operation at the time of inspection.
<b>Are there any plans for renovation or additional equipment to allow for increased wastewater flow?</b>	Yes. A PTI has been submitted and approved by Ohio EPA. The upgrades will include a new clarifier, repurposing the EQ tank into an aeration basin, adding a new UV system and monitoring upgrades.

EQ Tank
RIMG2663.JPG
05/10/2022 09:26 AM (ET)
Andi Hodaj
Pretreatment
No CBI
No PII
The EQ tank was not in operation. Camera looking west.

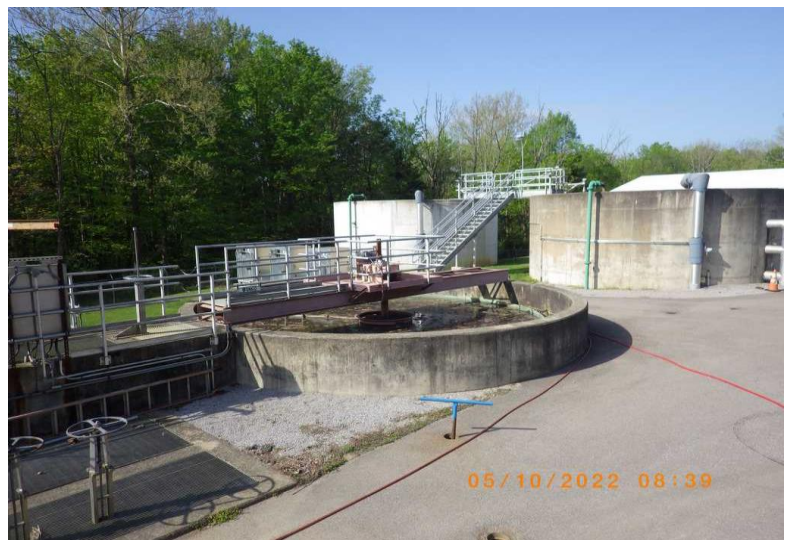
Clarifier
RIMG2668.JPG
05/10/2022 09:39 AM (ET)
Andi Hodaj
Secondary treatment
No CBI
No PII
The west of the two old clarifiers. Camera looking southwest.

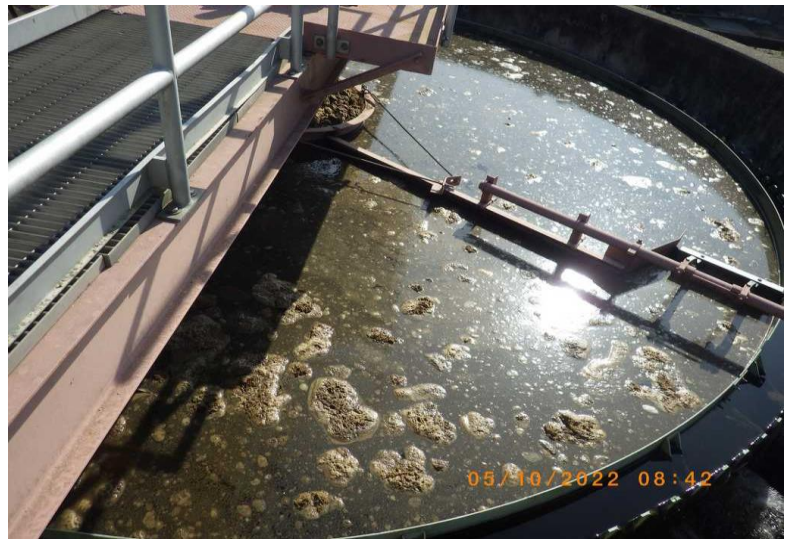
<b>Unit:</b>
<b>AH2-OC-NT</b>
The modified NPDES permit includes a compliance schedule that requires the Village to complete construction of Facility improvements as soon as possible, but not later than March 1, 2023. Mr. Standring stated that the Village has not yet started work on expanding treatment capacity due to funding issues.
<b>AH2-RR-002</b>
For the month of February, the effluent flow was above the 0.7 MGD average daily design rate for most of the month and as high as 1.9 MGD.
<b>Unit: Outfall 001</b>
<b>AH2-OB-003</b>
The outfall signage was facing away from the creek and needs to be facing the creek.
<b>Unit: Secondary treatment</b>
<b>AH2-OB-002</b>
EPA observed floating foam and solids on the two older clarifiers.

Clarifier
RIMG2669.JPG
05/10/2022 09:42 AM (ET)
Andi Hodaj
Secondary treatment
No CBI
No PII
Middle clarifier with foam floating on it. Camera looking down.

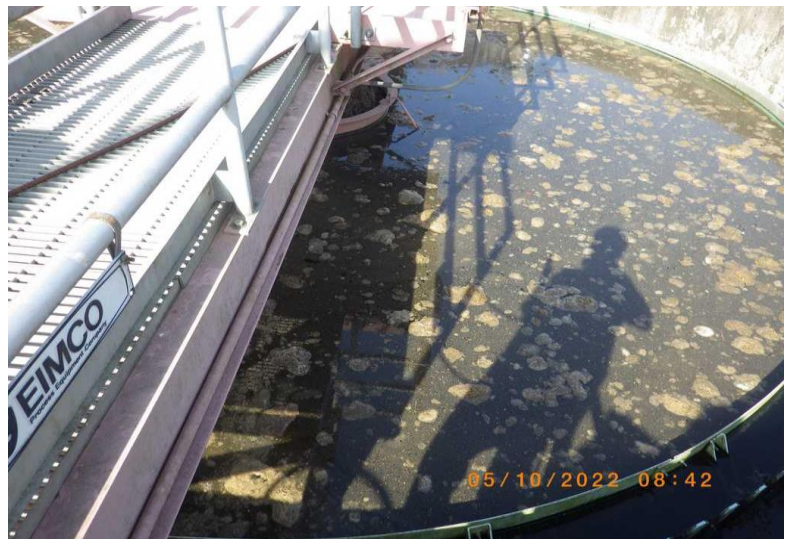
Clarifier
RIMG2670.JPG
05/10/2022 09:42 AM (ET)
Andi Hodaj
Secondary treatment
No CBI
No PII
The west clarifier. Camera looking west, down.
