Monsanto Company  
Springfield Plant  
Indian Orchard, Mass.

November 2, 1971

SUBJECT: Near-Miss Investigation #14-71, PVC Burning Stack

PVC BURNING STACK INVESTIGATION - NEAR-MISS #14 (9/21/71)

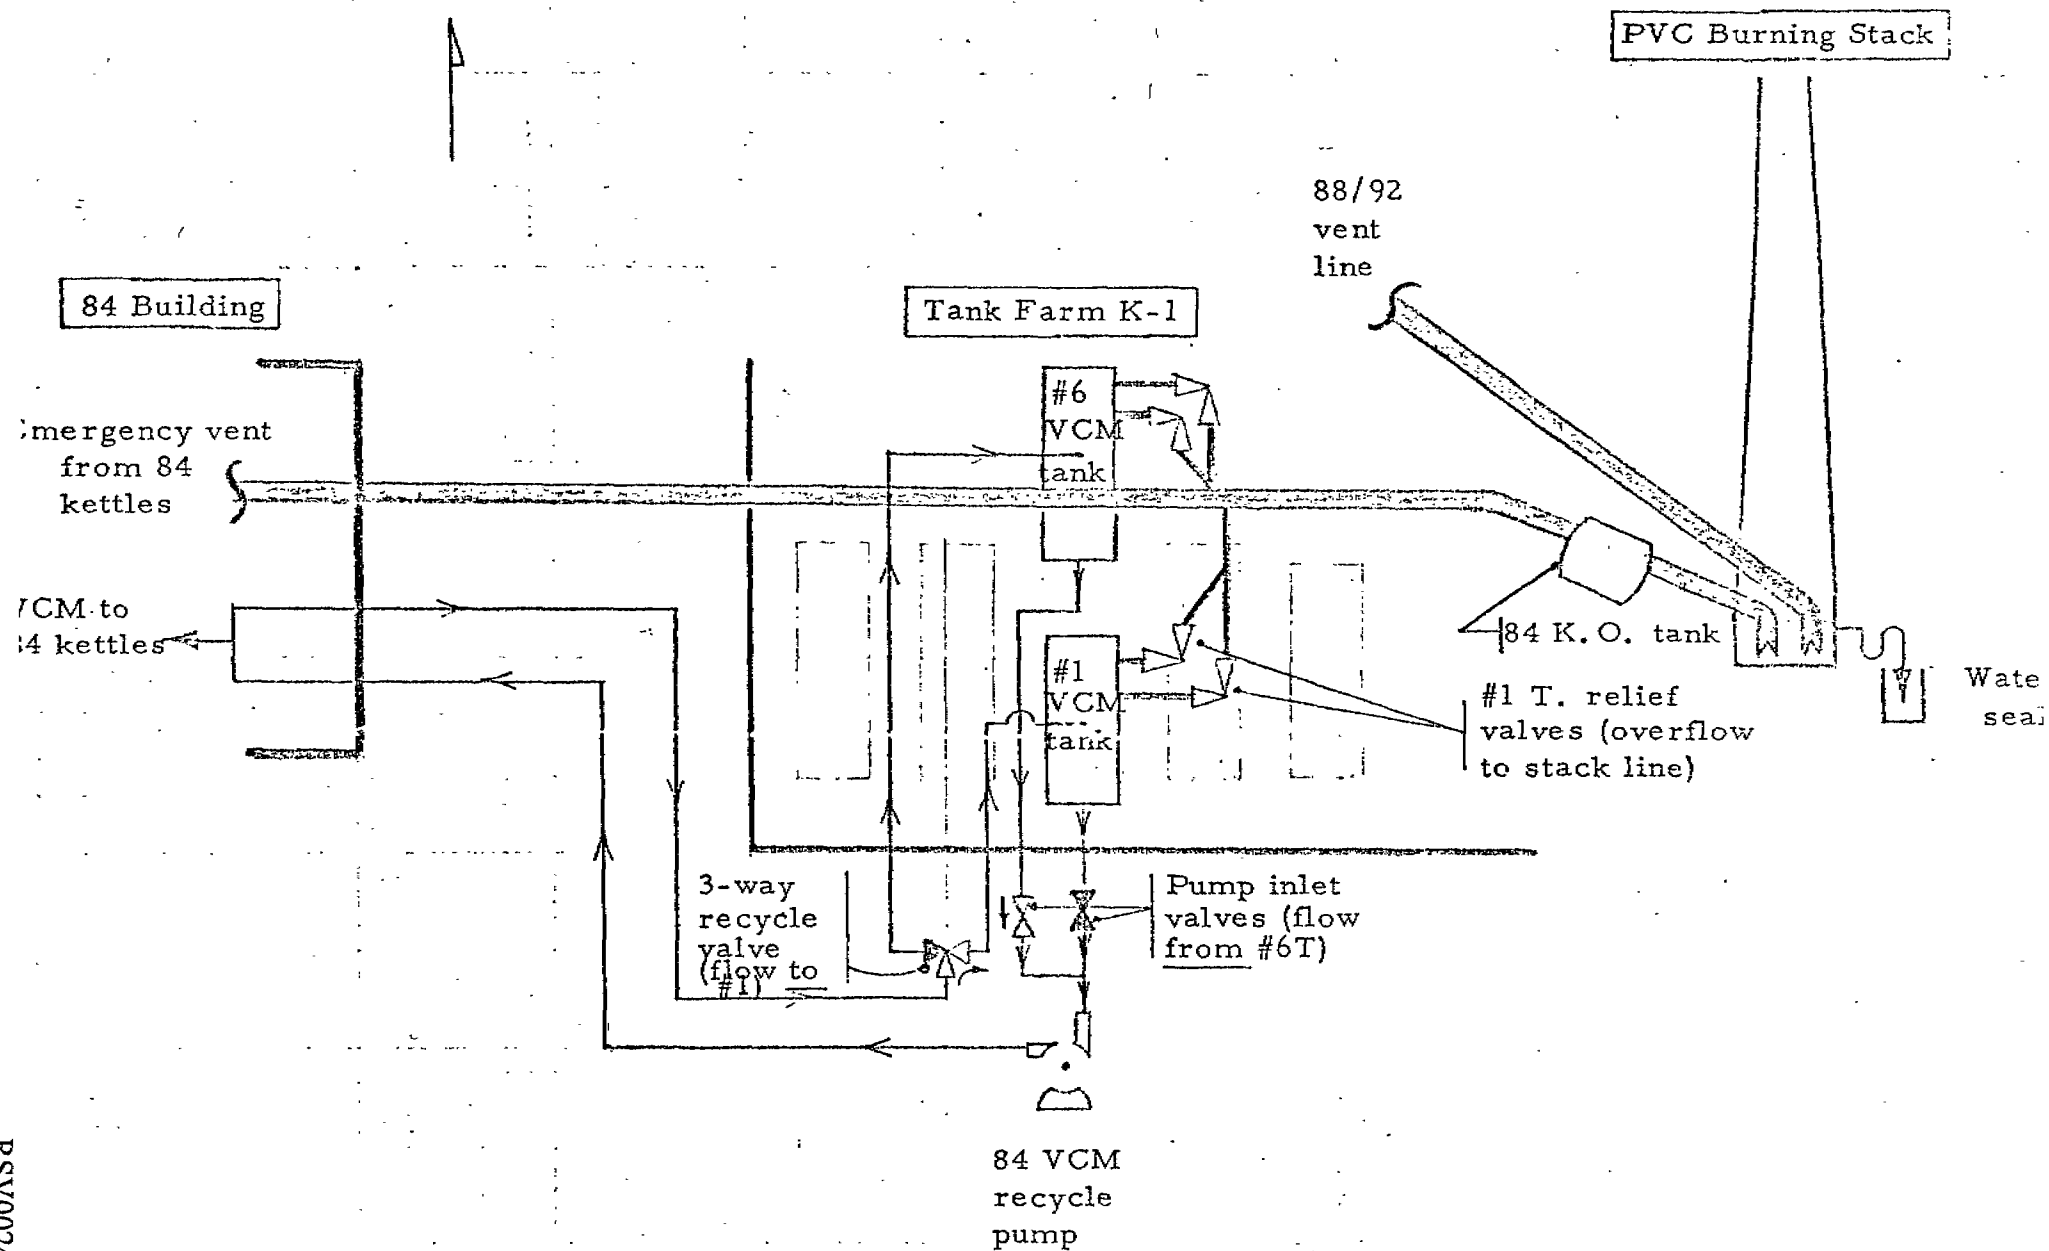
The overflow of VCM, contained within the emergency vent system, was caused by incorrect valve positioning in tank farm K-1...an operator error.

Contributing to the potential of this near miss was the failure of the stack pilot burning system which then gave no visible flame; and, also, no immediate alarm system to detect the VCM overflow.

The Building 84 vent line knockout tank was found frosted around the entire circumference of the reinforcing rings, all the way to the top. (This knockout tank has a 4,000-gallon capacity.) There also was evidence of frosting on the vent line leading to Building 84 and tank farm K-1 (common to both).

The supervisory personnel then split up in order to determine the source of monomer in the vent system. One member of the group stayed at the stack and attempted to restore the seal. Another member proceeded to tank farm K-1, where he found the emergency relief valves on #1 VCM storage tank cold and frosted. At approximately 1:30 PM, a tank farm operator was summoned and found that #1 VCM storage tank was completely filled and #6 VCM tank was at a low level.

Next, a lead operator from Building 84 was brought to the tank farm to determine the position of the three-way recycle monomer valve. This lead operator determined at 1:45 PM that the three-way valve was incorrectly positioned, drawing monomer from #6 VCM tank and recycling to #1 VCM tank, thereby overfilling #1 VCM tank. The valve was temporarily changed to draw from #1 and recycle to #6, to immediately bring down the #1 tank level. (This valve was then later returned to the correct position of drawing and recycling to the same tank.)
