# NPDES Compliance Inspection Report

## **Atkore Plastic Pipe Corporation Eugene, Oregon**

**Permit #: ORR231302**

**Inspection Date: March 23, 2021**

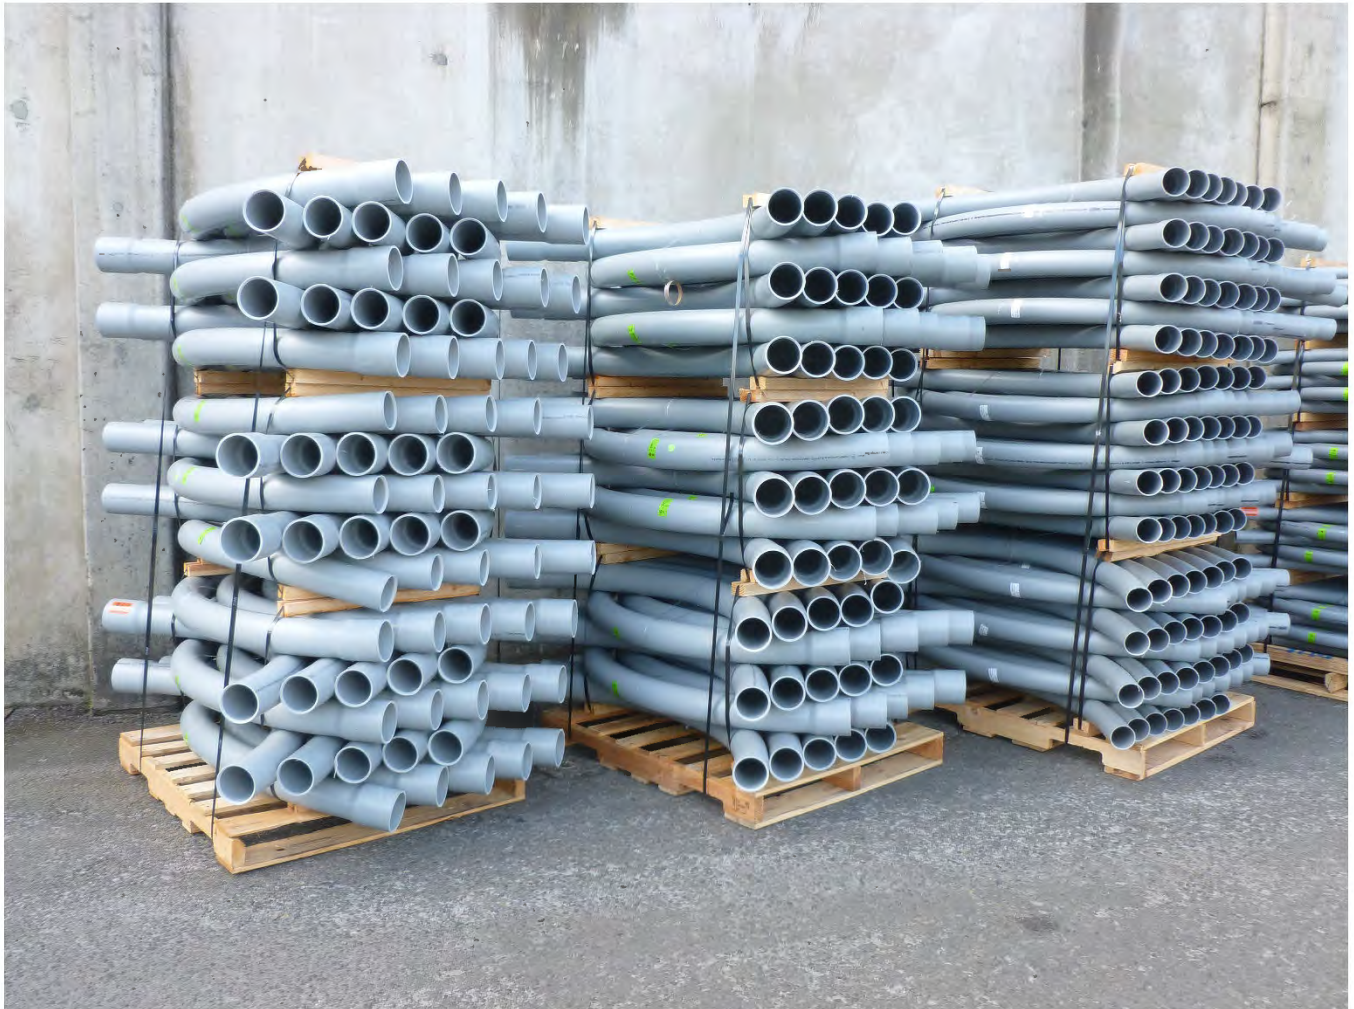
Once the Opening Conference concluded, I asked to be shown to the center of the property so that I could try to discern the slope. Upon exiting the office building, I saw several stacks of plastic pipe which were banded to pallets (**Photo 1**). Mr. Dinkheller said those stacks of pipe were waiting to be loaded up and shipped to storage. The site had several locations where plastic pipe were either waiting to be shipped to storage or waiting to be taken into the production building to be cut and shaped (**Photo 2**). I also observed a covered, three-sided structure, which was used to store tanks and barrels containing oil and glycerin (**Photo 3**). The tanks were double-walled, and the floor of the structure was raised and grated to act as secondary containment.

**Photo 1 / P1000793** – Plastic Pipe, awaiting transport to storage

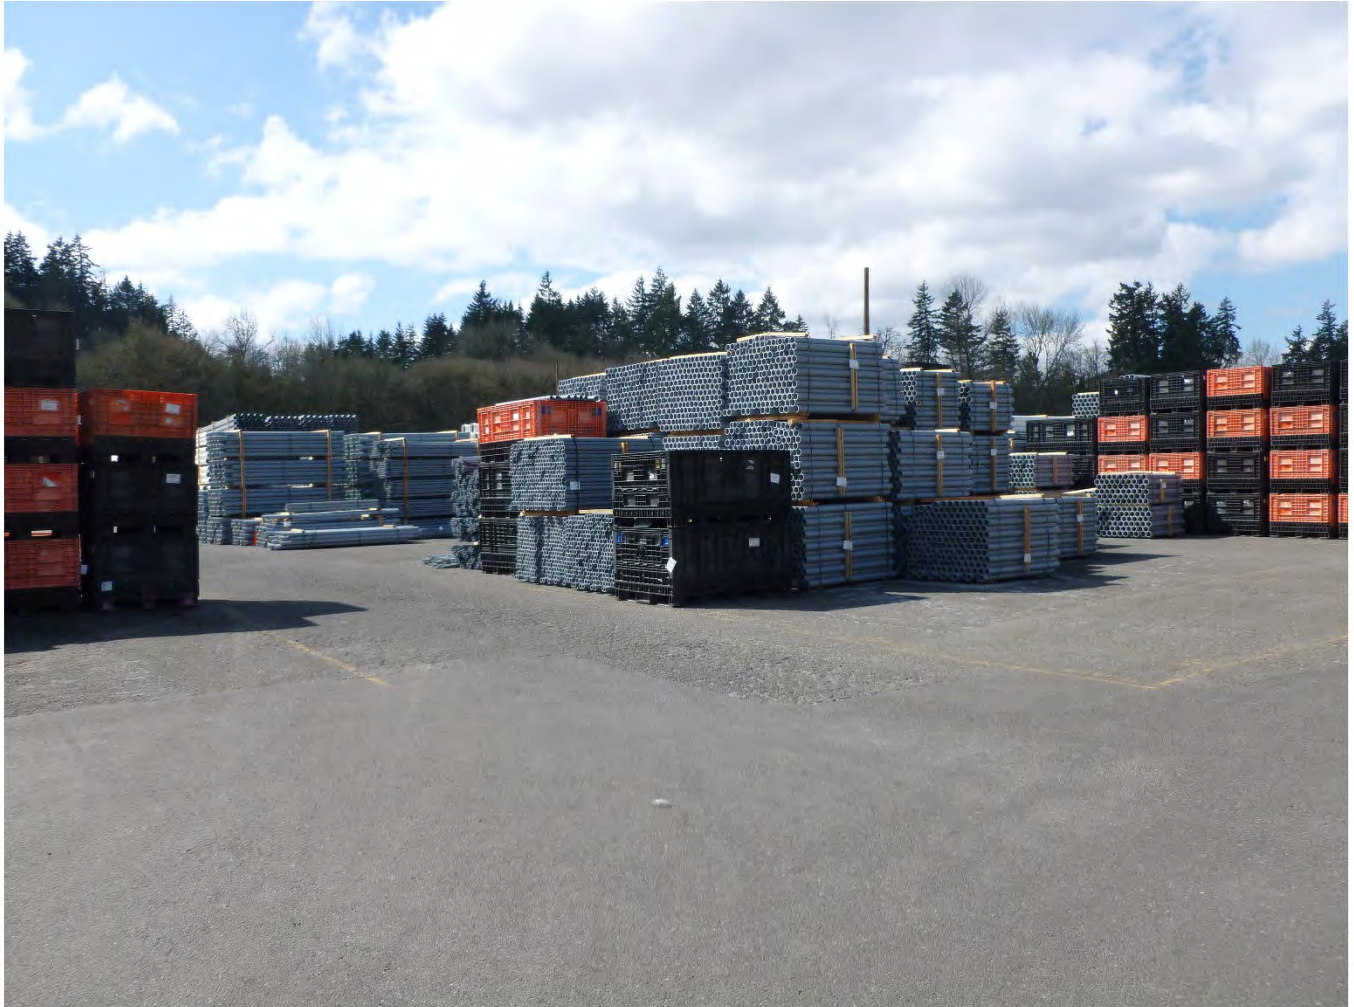
**Photo 2 / P1000794** – Plastic Pipe, waiting to be processed

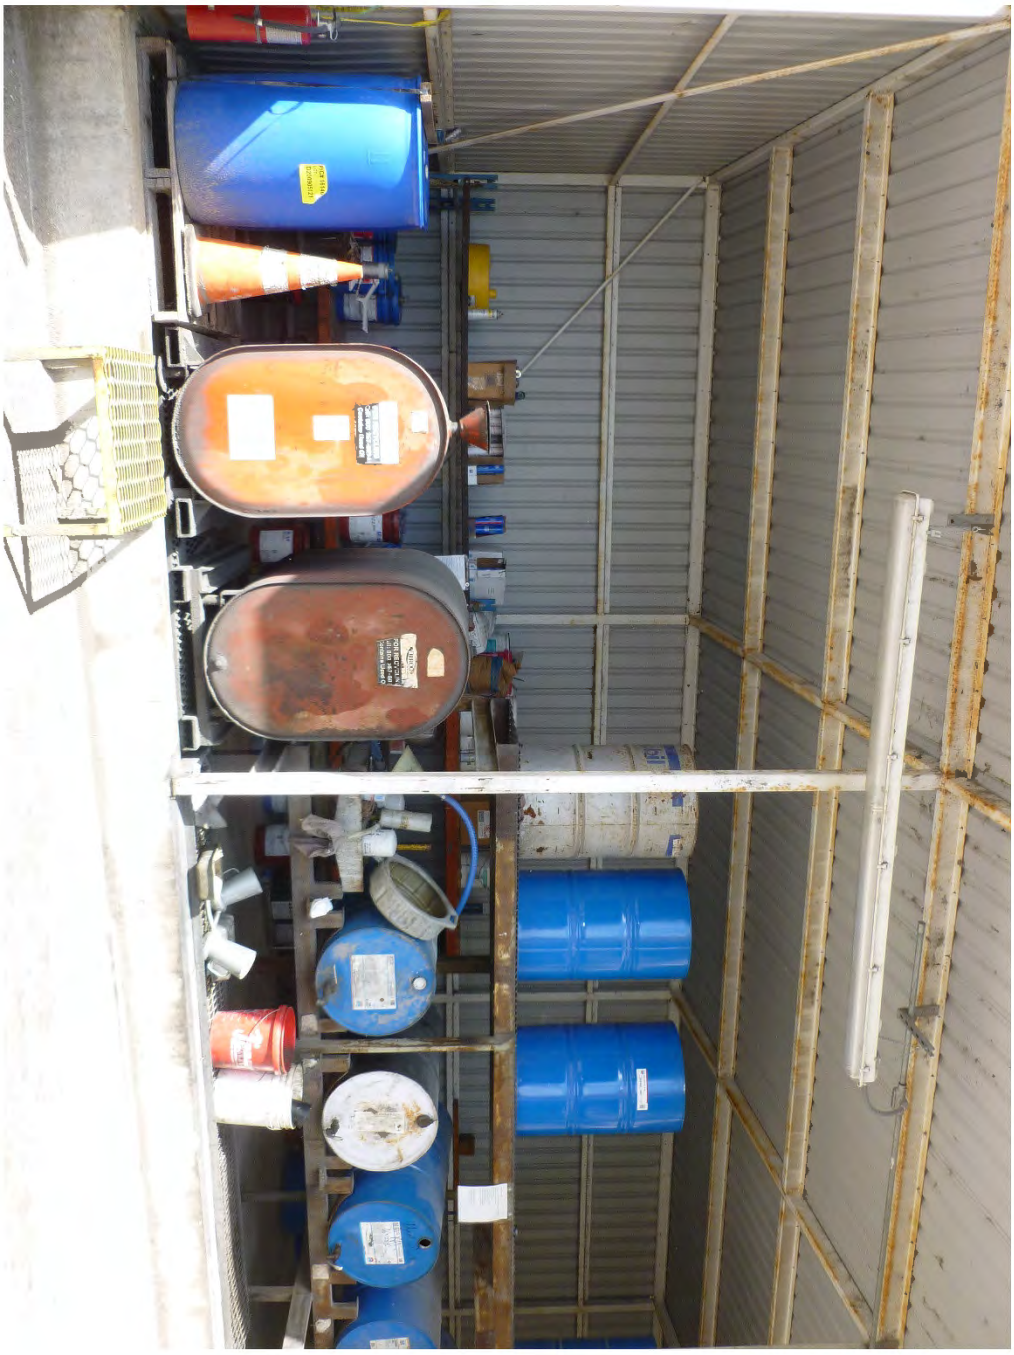
Photo 3 / P1000801 – Drum & Tank, storage area

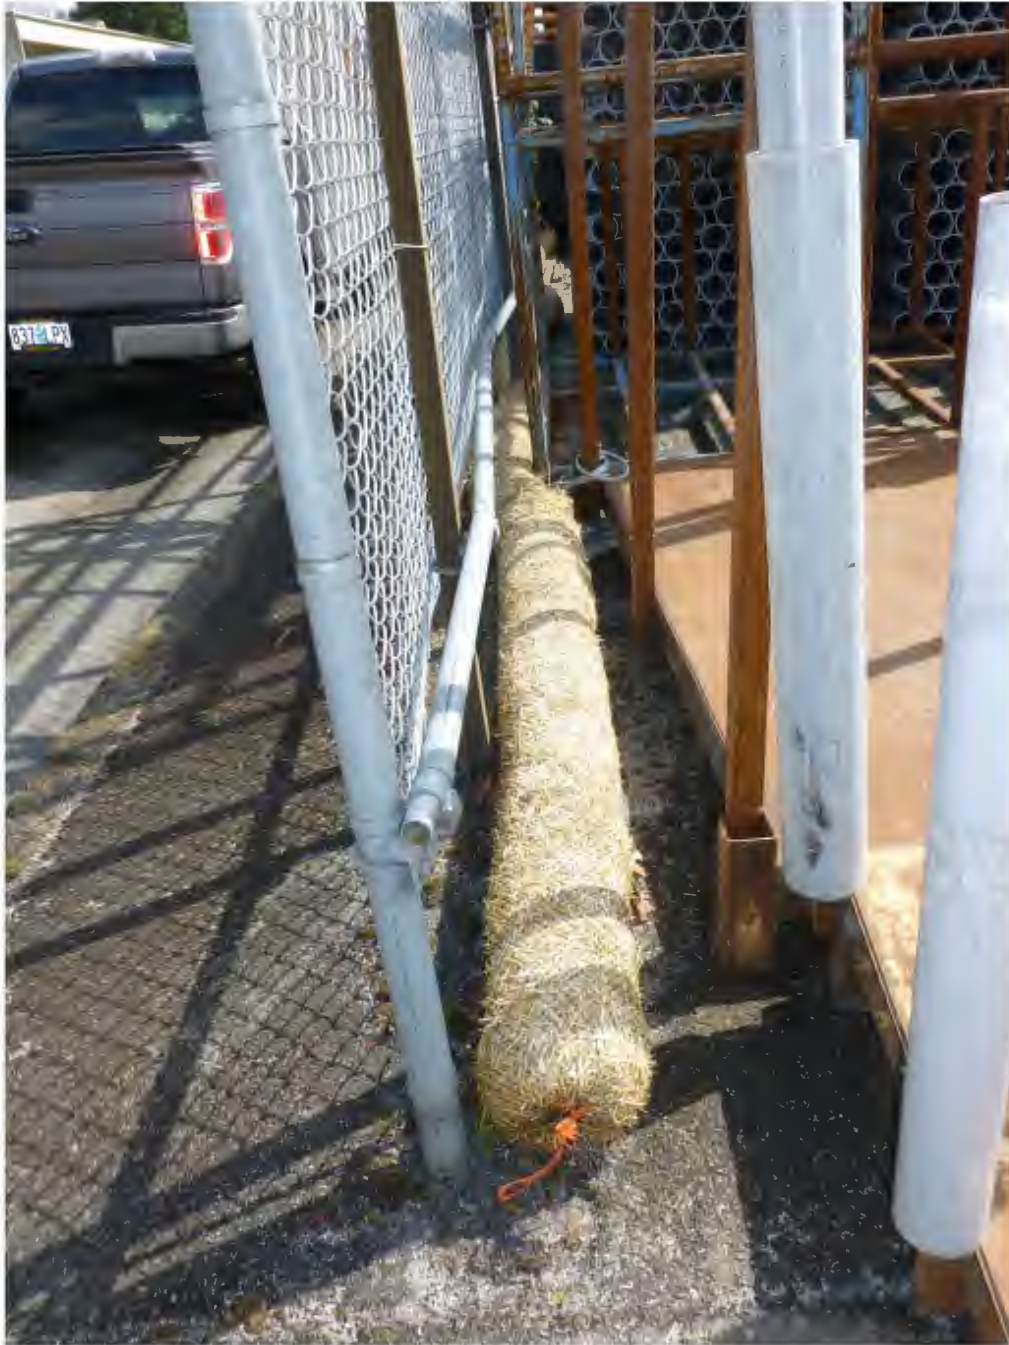
**Photo 4 / P1000795 – Straw Waddle**

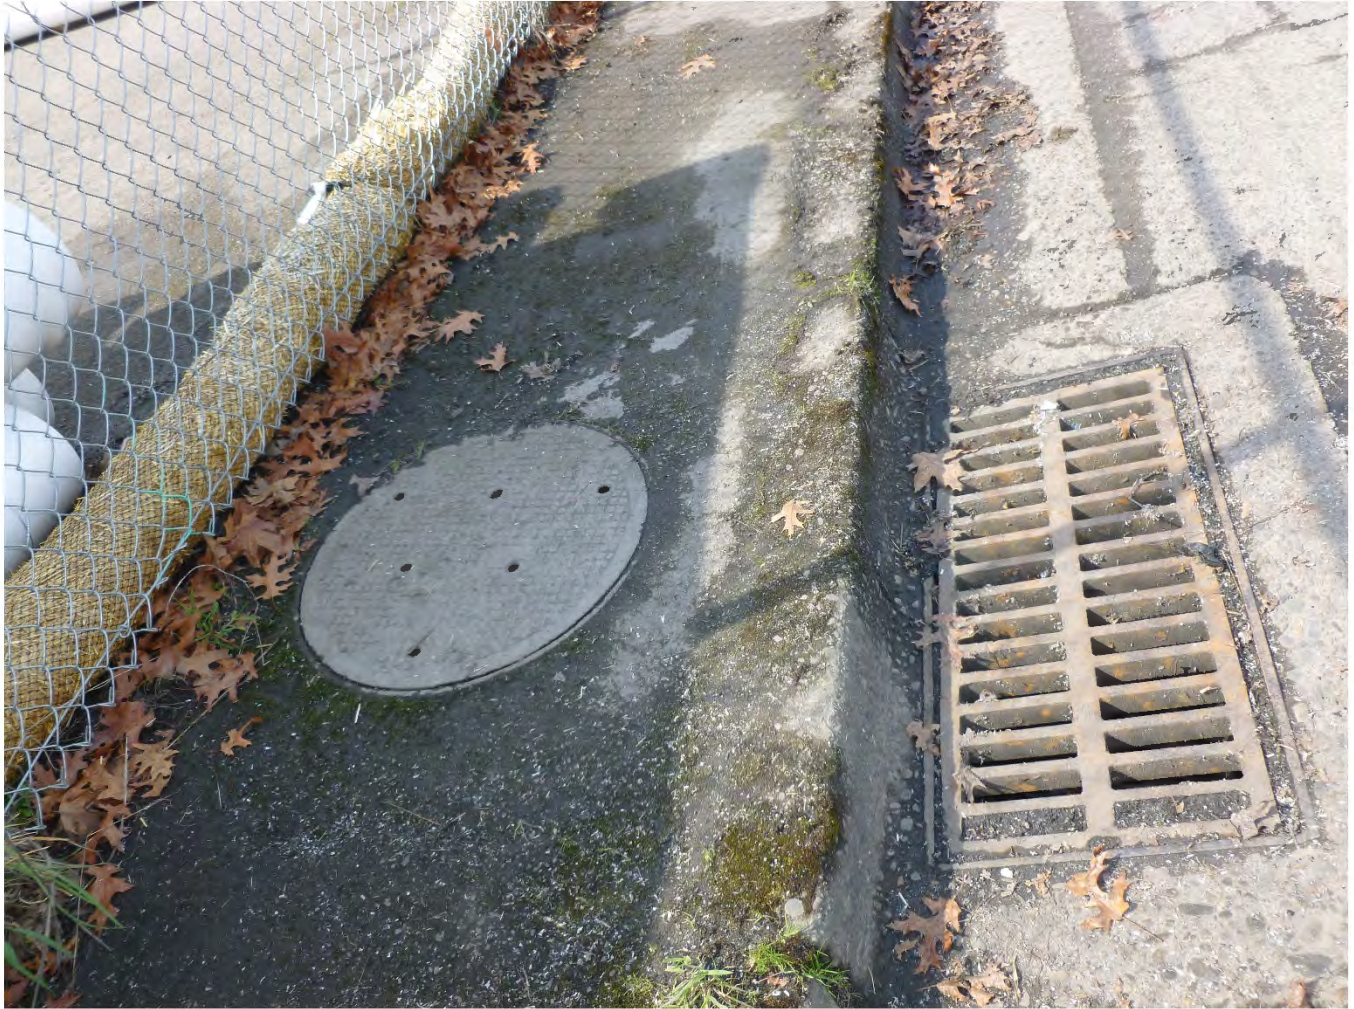
**Photo 5 / P1000796** – Storm Drain, east side

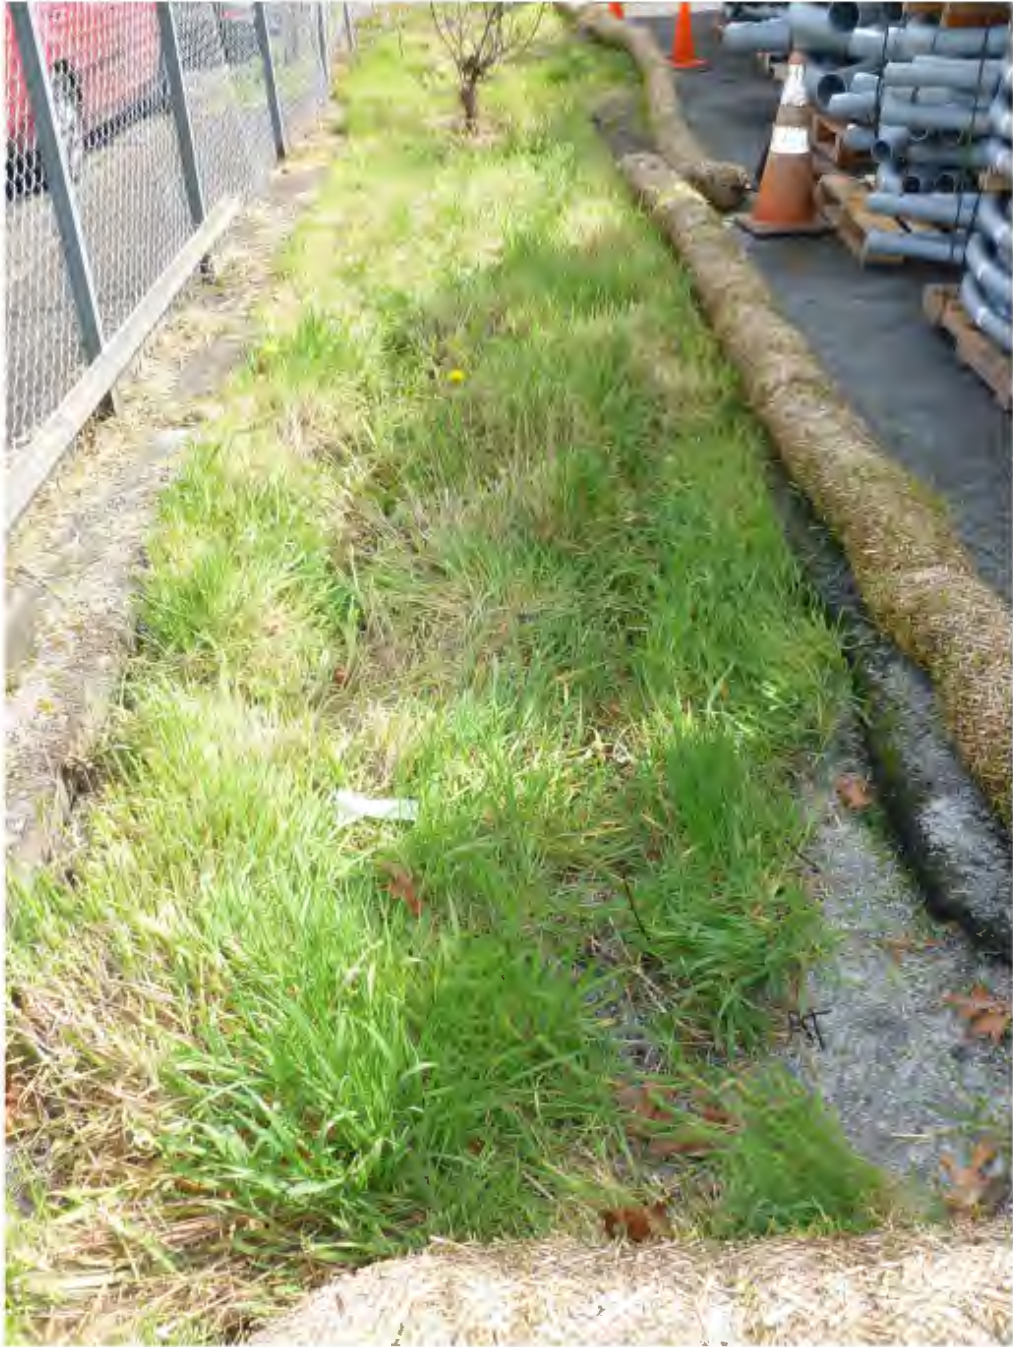
The facility maintains a bioswale (**Photo 6**) on the eastern edge of the site just inside the perimeter fence, it catches stormwater that sheet flows from the southeastern section of the site. Mr. Dinkheller said the bioswale allows some stormwater to infiltrate.

**Photo 6 / P1000803 – Bioswale**

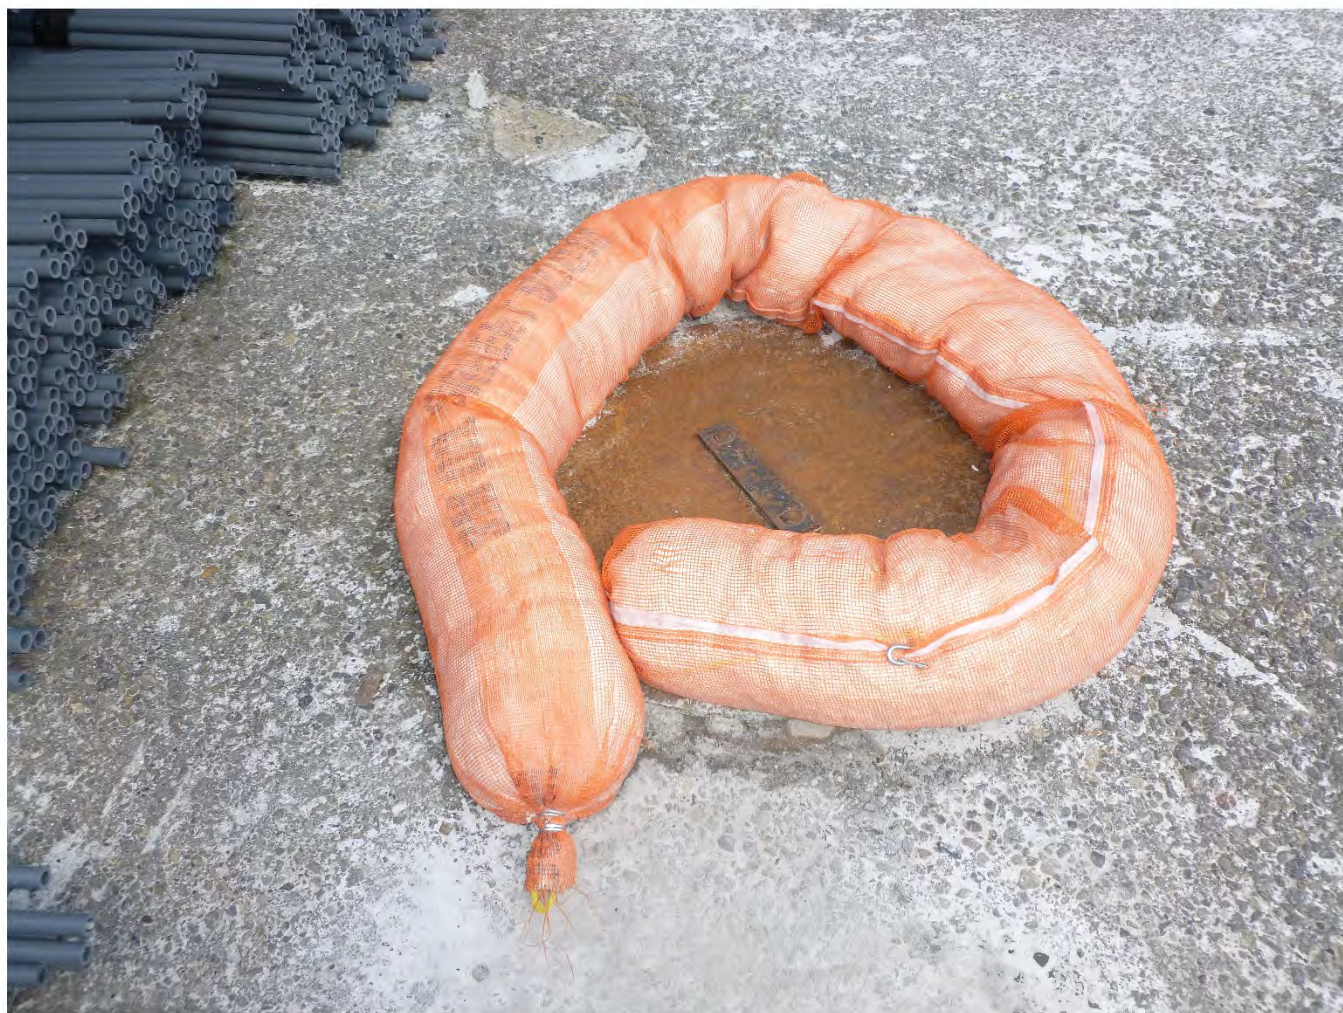
The site has two sampling points. The first sampling point is in the northeastern section of the site. A representative of Analytic Laboratory Group (ALG) takes a grab sample from a manhole (**Photo 7**) on the site.

**Photo 7 / P1000802 – Sampling Location**

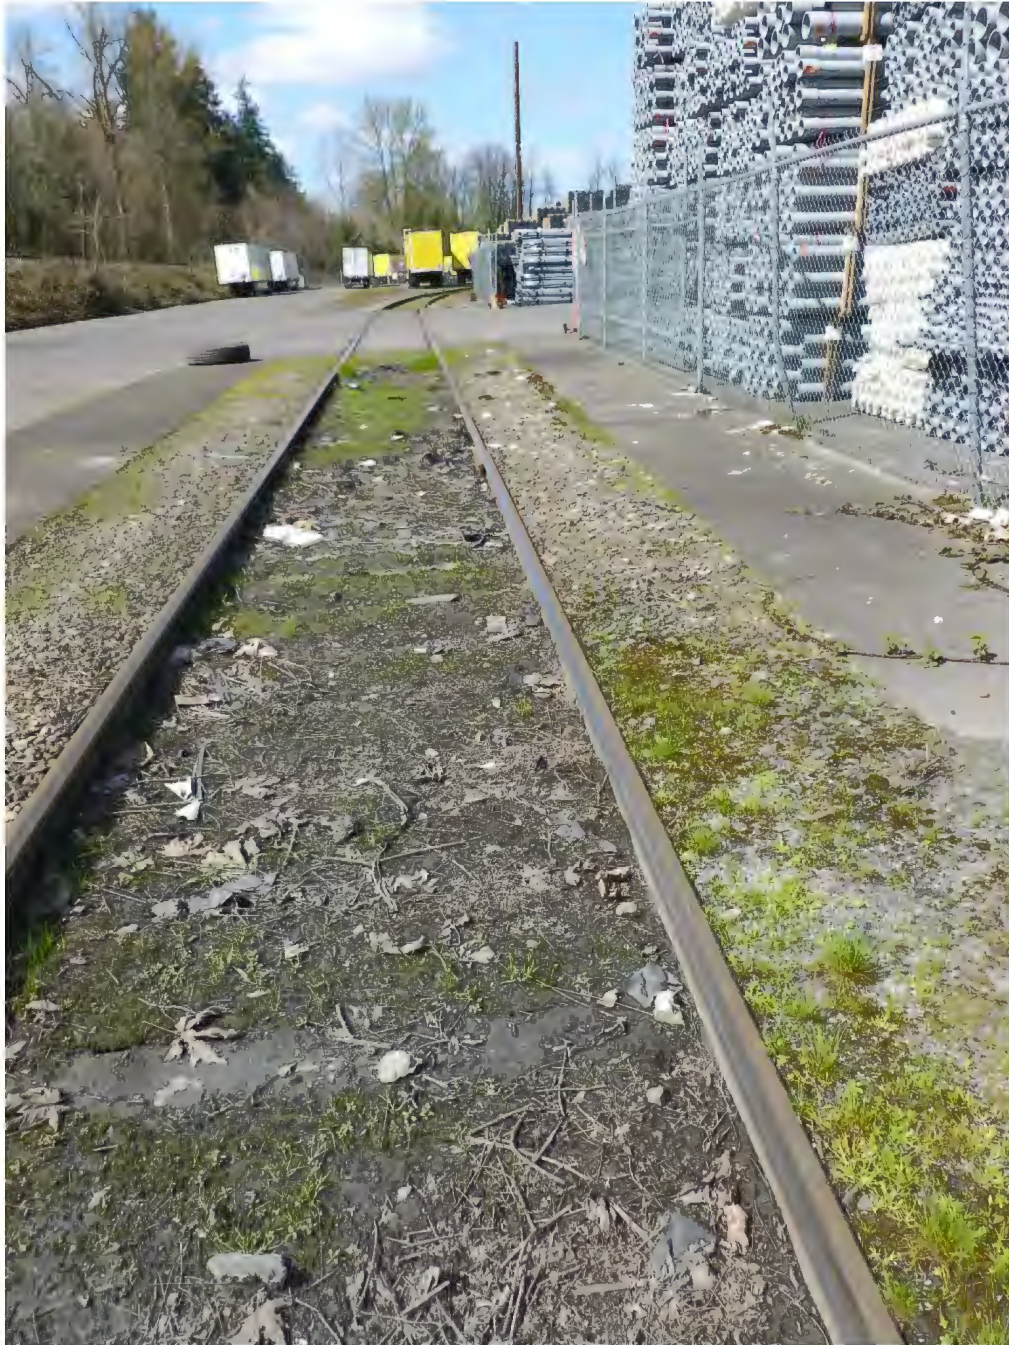
**Photo 8 / P1000800** – Railroad Track Path, facing north

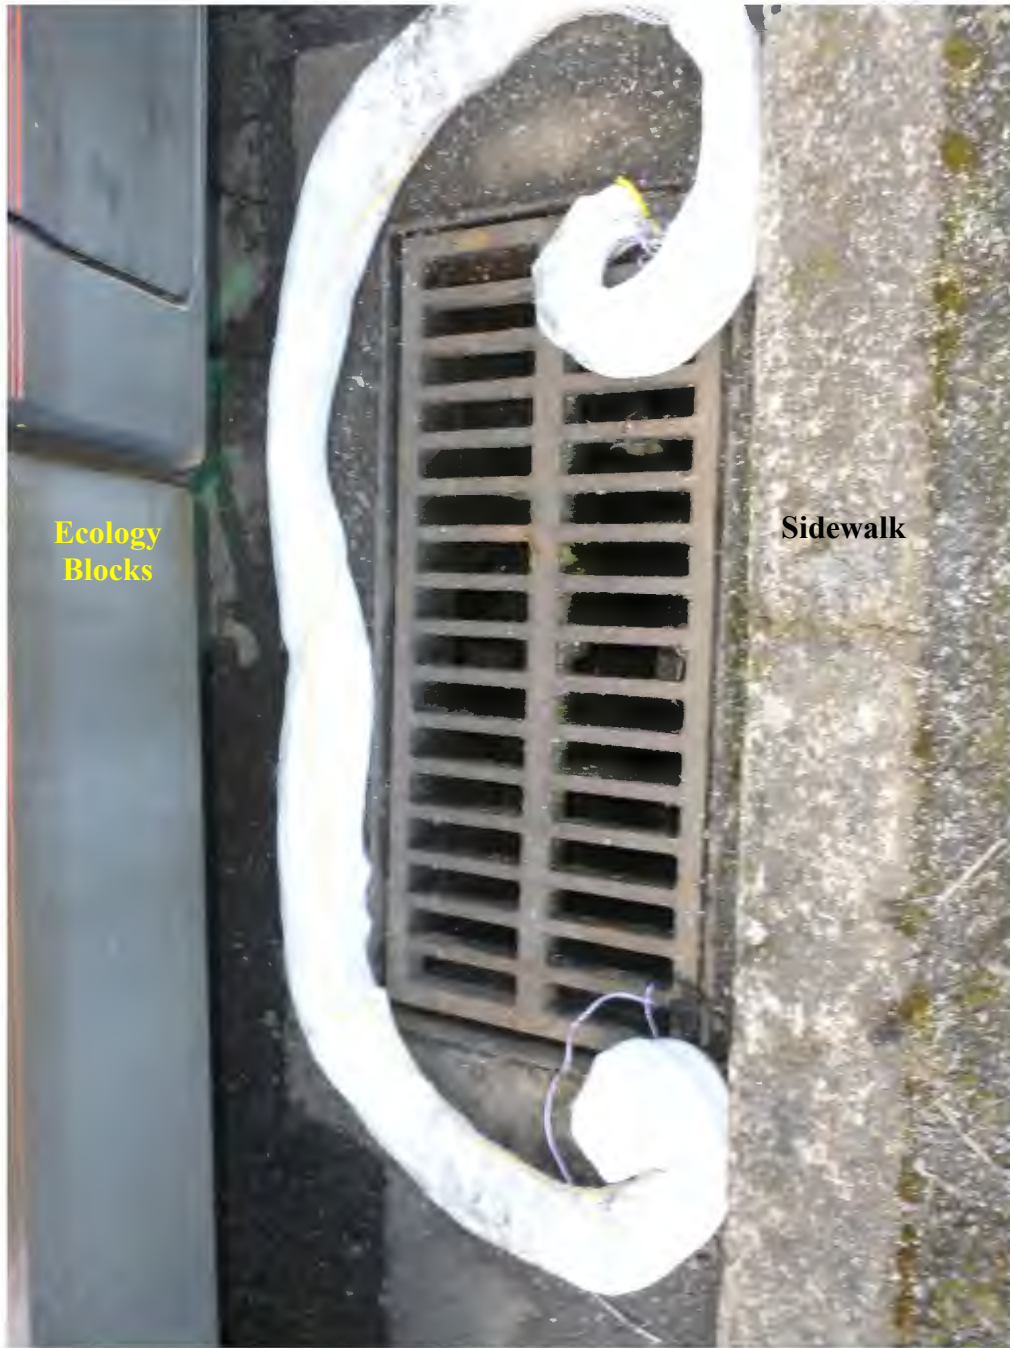
We turned west and walked to the northwestern corner of the site. The northwestern corner of the property is the terminus of the stormwater collection system for the west side of the site. Stormwater sheet flows from the west side of the site into an old gravel-covered railroad track spur. The stormwater “typically” follows the railroad tracks (**Photo 8**). Any stormwater that does not infiltrate enters a storm drain (**Photo 9**). The drain is protected from excessive particulate matter by a filter sock on the upstream side.

**Photo 9 / P1000799** – Storm Drain, west side
