## **RCRA Inspection Report**

Allworth, LLC  
500 Medco Road  
Birmingham, Alabama 35217  
EPA ID No: ALD094476793  
NAICS: 325998 – All Other Miscellaneous Chemical Product and Preparation Manufacturing  
562112 – Hazardous Waste Collection  
562211 – Hazardous Waste Treatment and Disposal

June 17, 2021

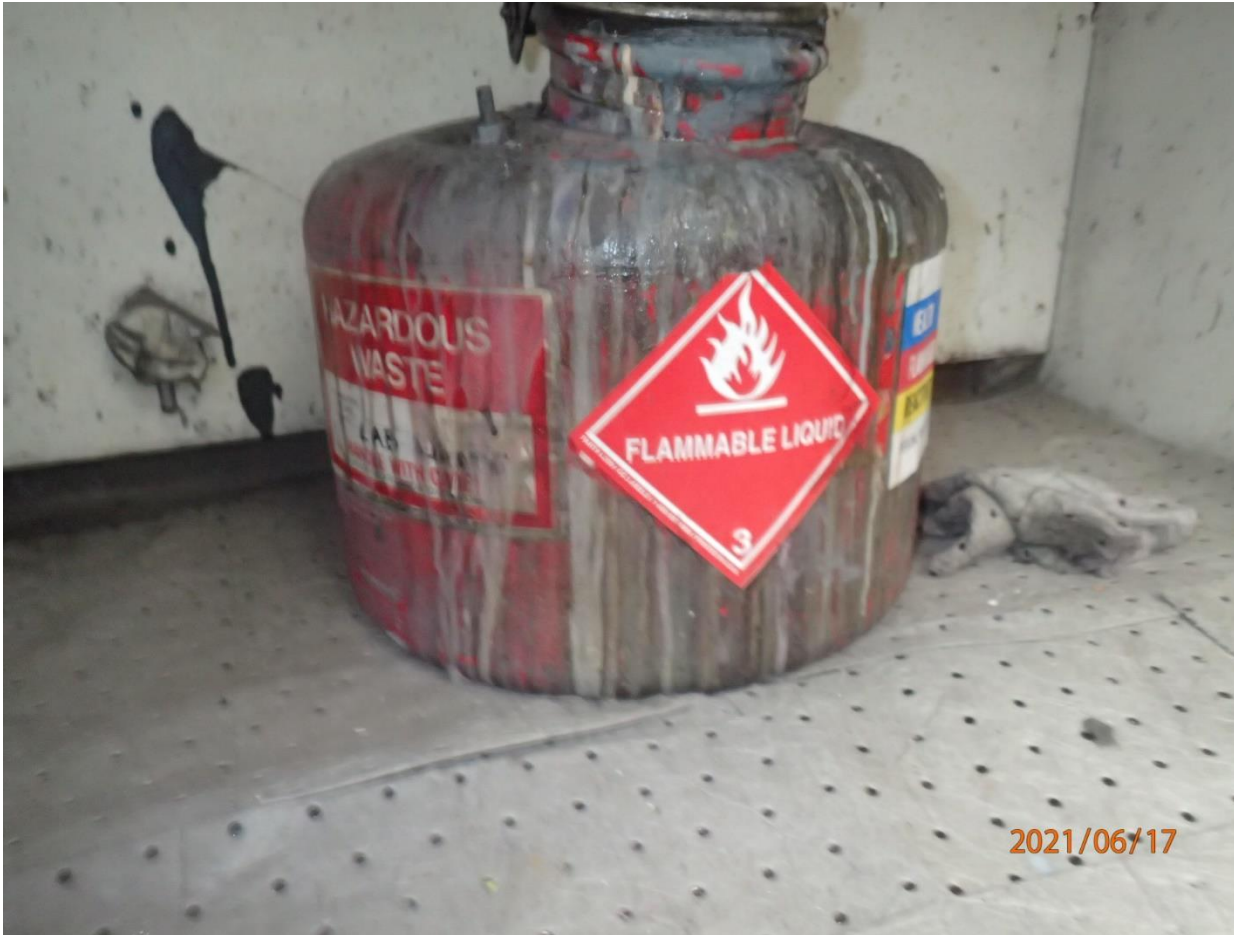
**Photo 3:** 5-gallon container of lab sample waste under a fume hood labeled “Hazardous Waste”, closed, and with an indication of hazard for flammability

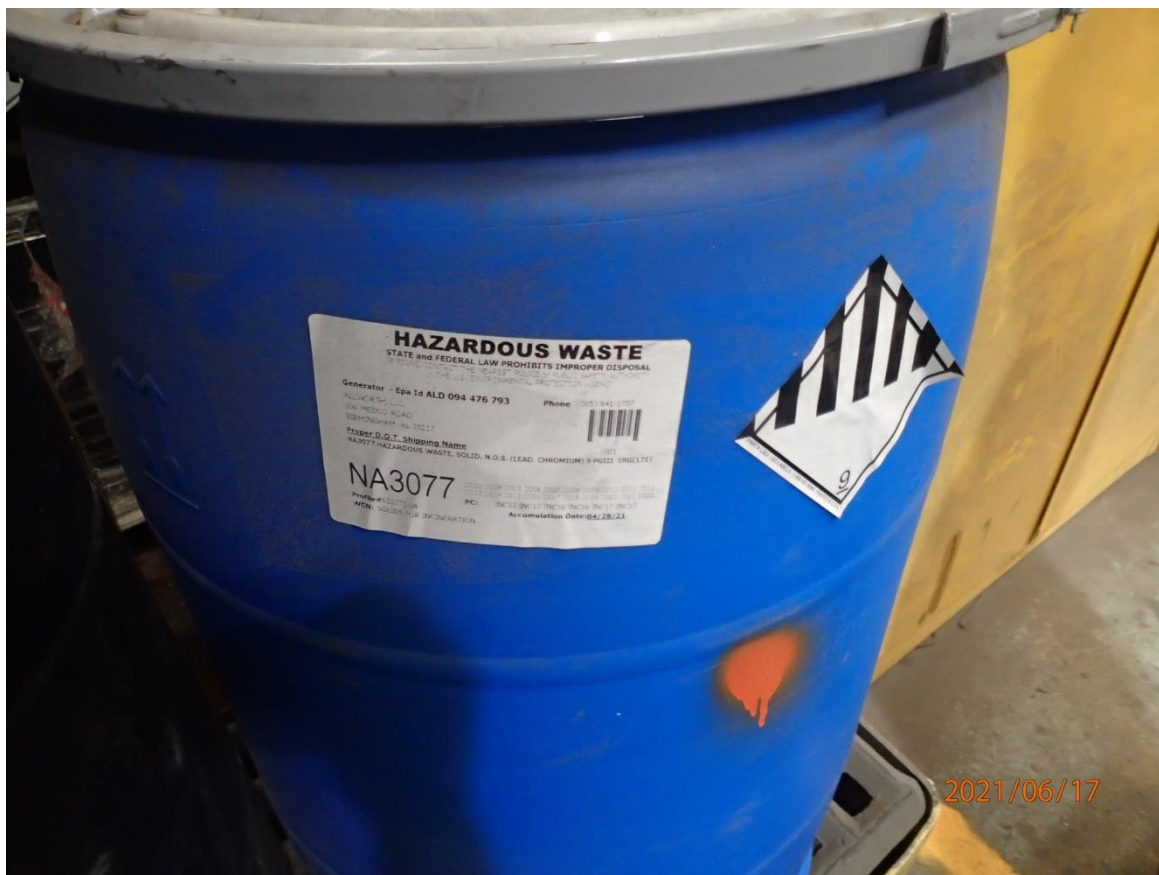
- Two (2) 55-gallon drums of laboratory waste on spill containment pallets labeled "Hazardous Waste", closed, dated, and with DOT placards to indicate the hazardous contents. (Photos #4 and #5)
- Approximately 71 additional pallets of hazardous waste containers were observed varying in size from 5-55 gallons and one (1) cubic yard box. All hazardous waste containers were properly labeled, placarded, dated, and closed.

**Photo 4:** 55-gallon drums of laboratory waste on spill containment pallet labeled “Hazardous Waste”, closed, dated, and with DOT placards to indicate the hazardous contents.

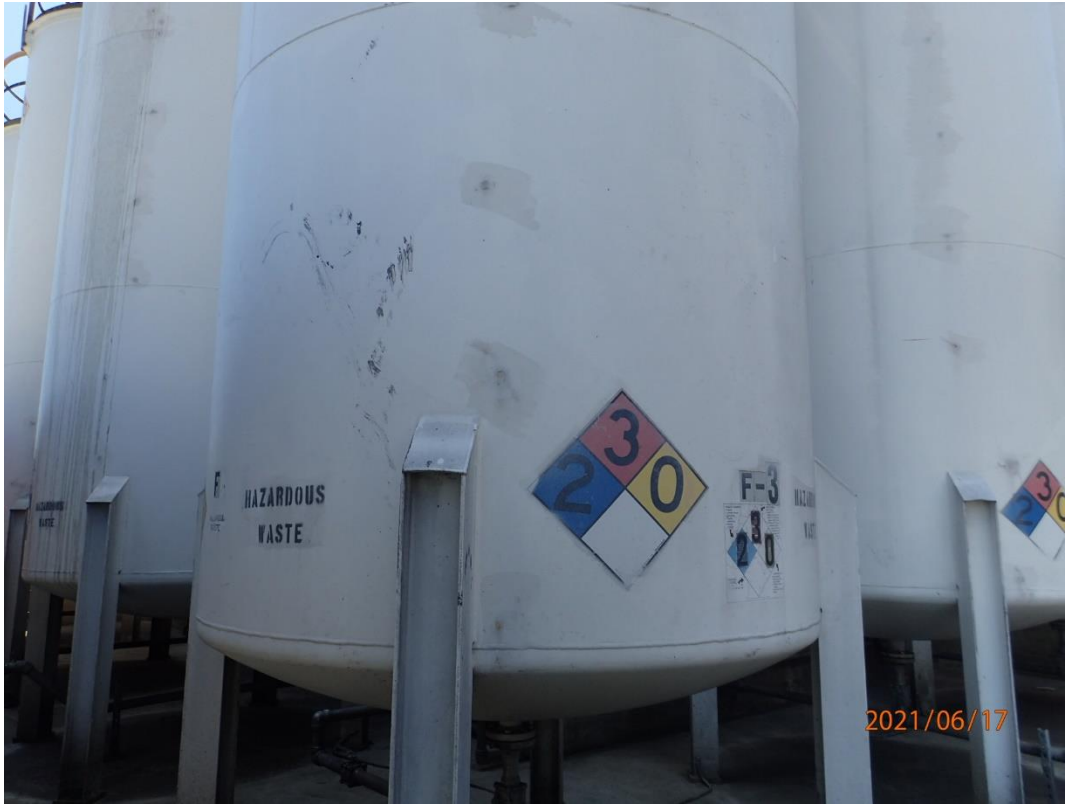
**Photo 11:** Tank System 2

Tank System 2: Located outside of the warehouse next to the Maintenance Storage Area and near the Solvent Recycling Area. This area consists of six (6) fixed-roof above ground storage tanks (F-1, F-2, F-3, F-4, F-5, and F-6). Each tank has a permitted storage capacity of 6,000 gallons or 36,000 gallons in total. The tank farm is situated within a coated concrete secondary containment structure with a total containment capacity of 8,387 gallons. The tanks store spent solvent wastes prior to being introduced into the facility's solvent recovery unit. All tanks were labeled with the words "Hazardous Waste". Tanks lines and associated equipment (flanges/pumps/end caps) used when transferring the hazardous waste to the tank were tagged as required by Subpart BB (Photo #11). As required by Subpart CC, no visible cracks, holes, or gaps between each fixed roof's edge and tank walls were observed. All openings in the roof were secured in their closed positions. Tags were observed in place on latched manway hatch (Photo #12).

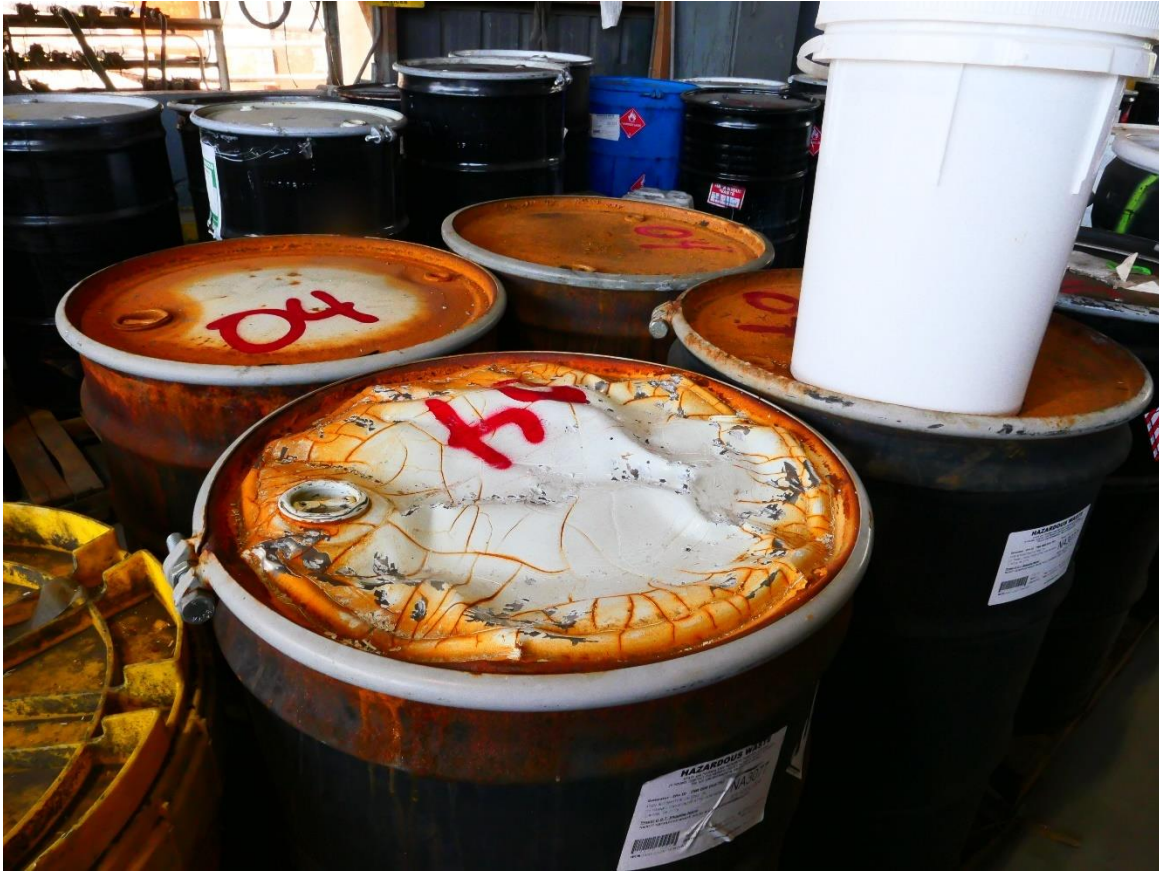
Container Storage Area-D: Container Storage Area D has a permitted storage capacity of 18,480 gallons. According to the facility's permit the concrete secondary containment in this area has a total capacity of 3,308 gallons and appeared to be in good condition with adequate aisle space. All hazardous waste containers in this area were properly labeled, closed, placarded, and properly dated. However, several containers were observed not to be in good condition, either due to rusting or bulging (Photo #18 and Photo #19). Mr. Williamson stated that these drums would be placed in an oversized drum.

**Photo 19:** Rusted drums with damaged/ dented top.

**Pursuant to Permit Condition III.E. Condition of Containers, if a container holding hazardous waste is not in good condition (e.g., severe rusting, apparent structural defects) or if it begins to leak, upon discovery the Permittee shall immediately transfer the hazardous waste from such container to a container that is in good condition or otherwise manage the waste in compliance with the conditions of ADEM Admin. Code Rule 335-14-5.09(2).**

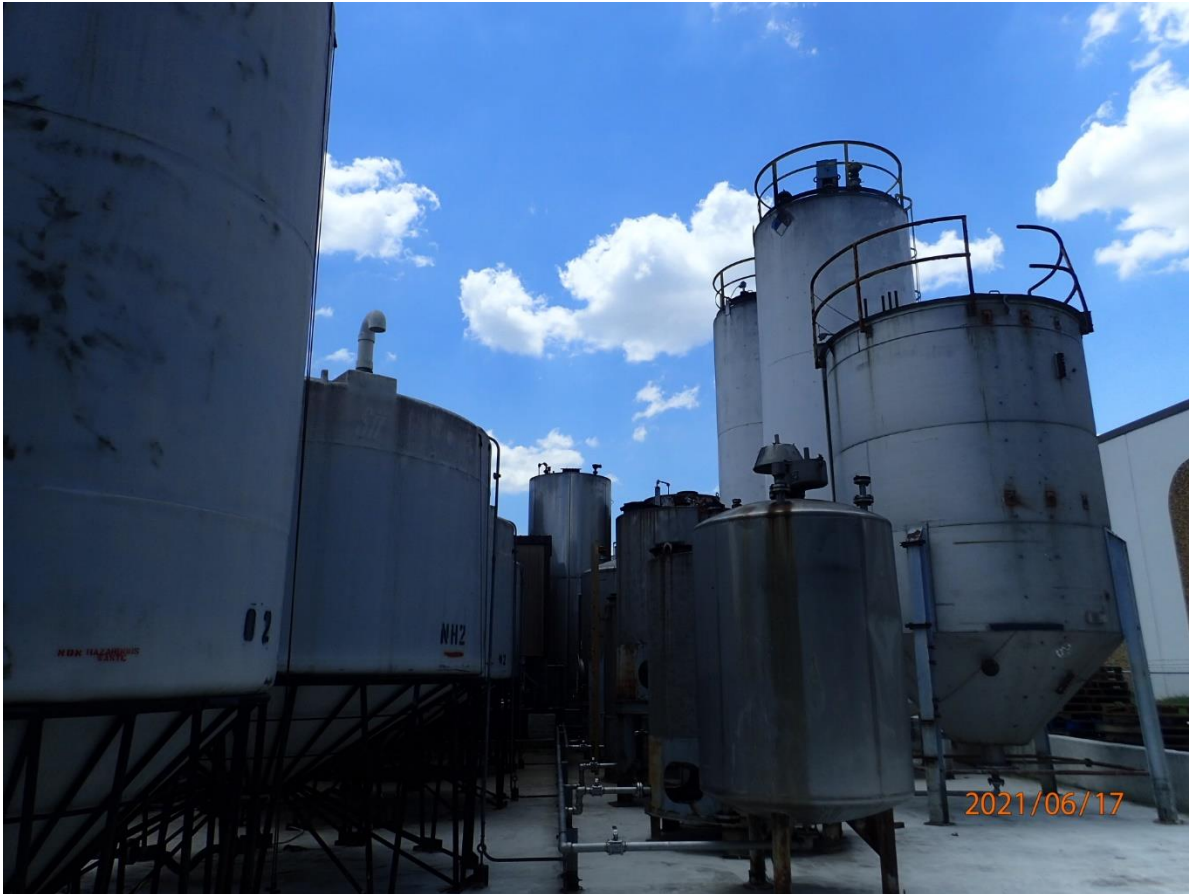
**Photo 20:** Tank System 1

- One (1) 4,100-gallon above ground storage tank (O-1), not in use.
- Three (3) 6,000-gallon above ground storage tanks (W-1, W-2, NH-2), not in use.
- Two (2) 18,000-gallon above ground storage tanks (B-5 and B-7), which store hazardous waste fuel generated by the Luwa® solvent recovery unit. These tanks were labeled with the words “Hazardous Waste”. Tanks lines and associated equipment (flanges/pumps/end caps) were tagged as required by Subpart BB (Photo #20).
