Re: *Bemer Petroleum Corporation*: Notice of Potential Violations Pursuant to Section 112(r) of the Clean Air Act, Inspection Close-Out List in Attachment 2, and Notice of Upcoming Compliance Order

## ATTACHMENT 1

### Sample Photographs from EPA's Inspection

### **INSPECTION CLOSE-OUT-- AREAS OF CONCERN**

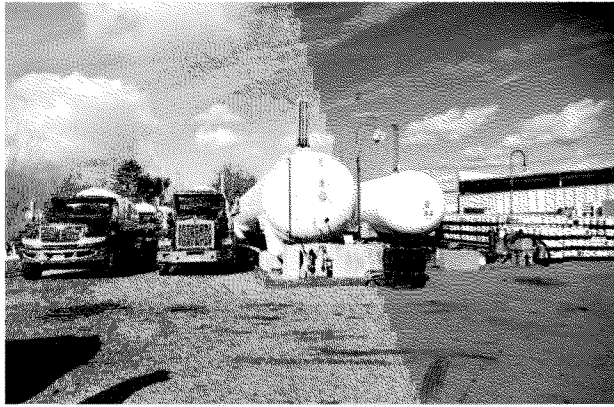
30,000-gallon and 60,000-gallon tanks of propane, filled by trucks. Not in compliance with industry standards of care (NFPA 58).

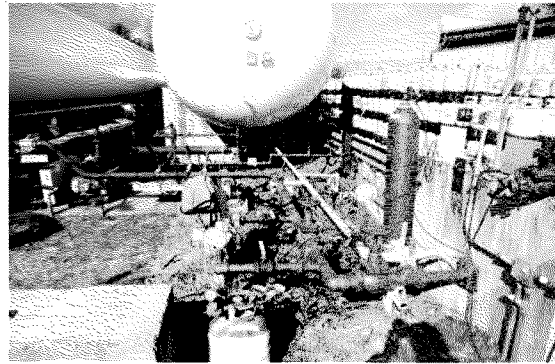
Tank support system in poor repair.
