Clean Water Act Section 404: Site Visit/Case Development

| Site Name | Cioffi Property | Start Date | October 5, 2021 |
| Inspection Purpose | Initial site visit | | |

CWA 404 Inspection
Jerry Cioffi Property / Cioffi Services
5 Mountainside Lane
Stony Point, Rockland County, NY

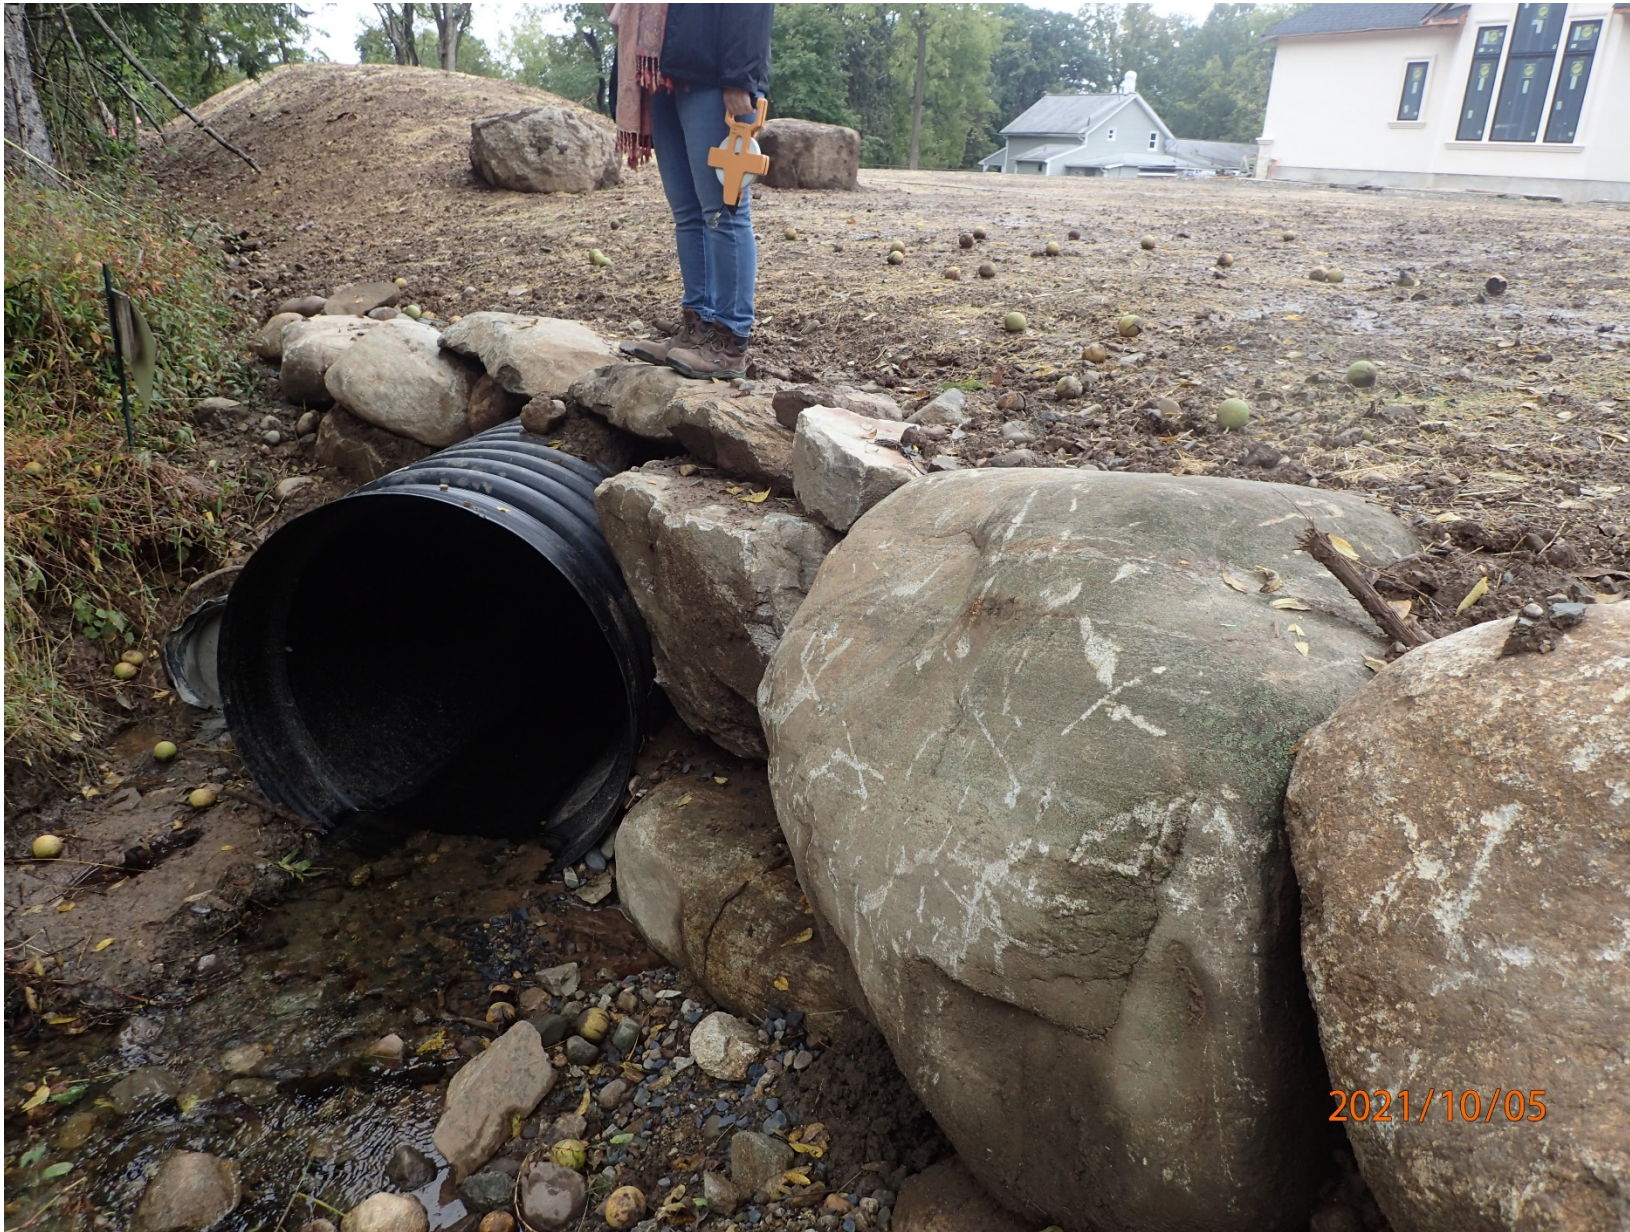
Date: 10/05/2021
Time: 11:57 AM
Photographer: SSA
Photo ID: 1 – PA050132

| EPA began the inspection by observing the western perimeter of the property where a stream entered a 48" corrugated plastic pipe that ran west to east under the property. The stream was flowing, approximately 1-2 ft wide, and had a defined bed and banks upstream of the pipe. | | | |

Stream placed into 48”
corrugated plastic pipe

Photo taken from western edge
of property

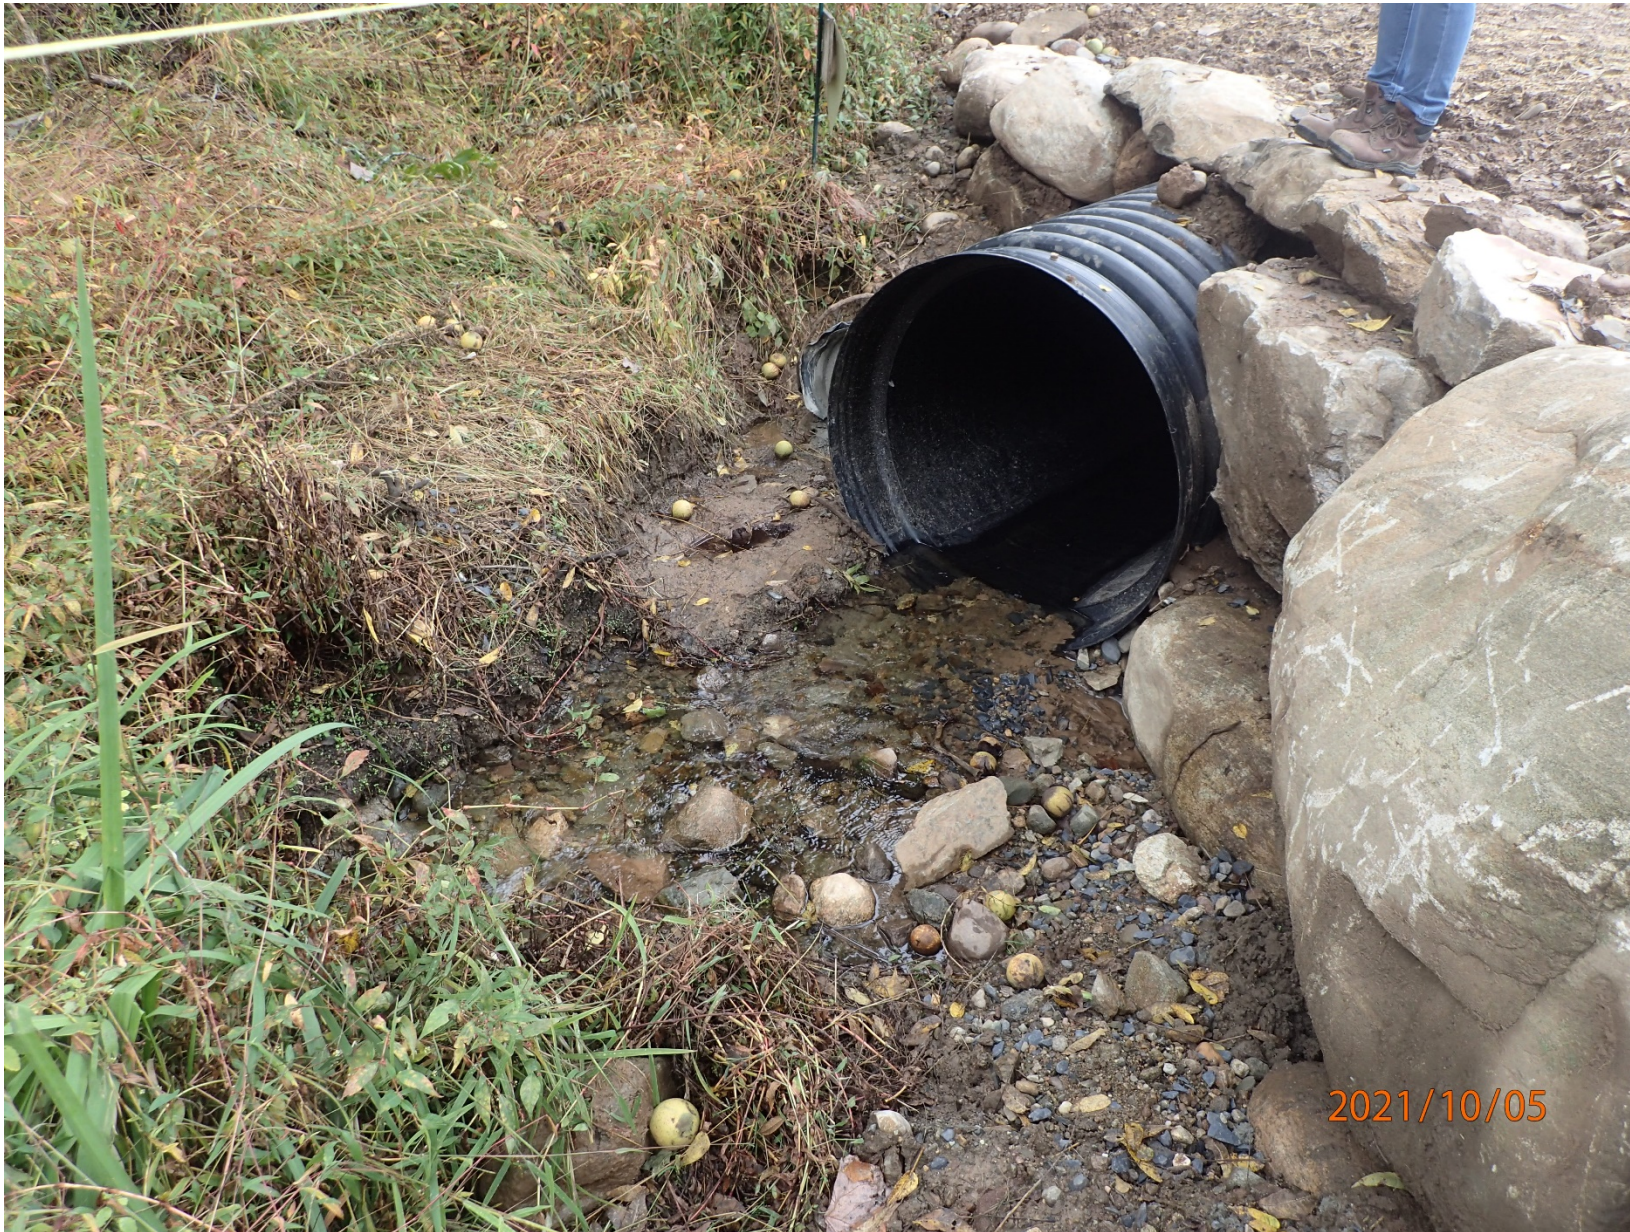
Date: 10/05/2021
Time: 11:57 AM
Photographer: SSA
Photo ID: 2 – PA050133

Stream placed into 48”
corrugated plastic pipe

Photo taken from western edge
of property

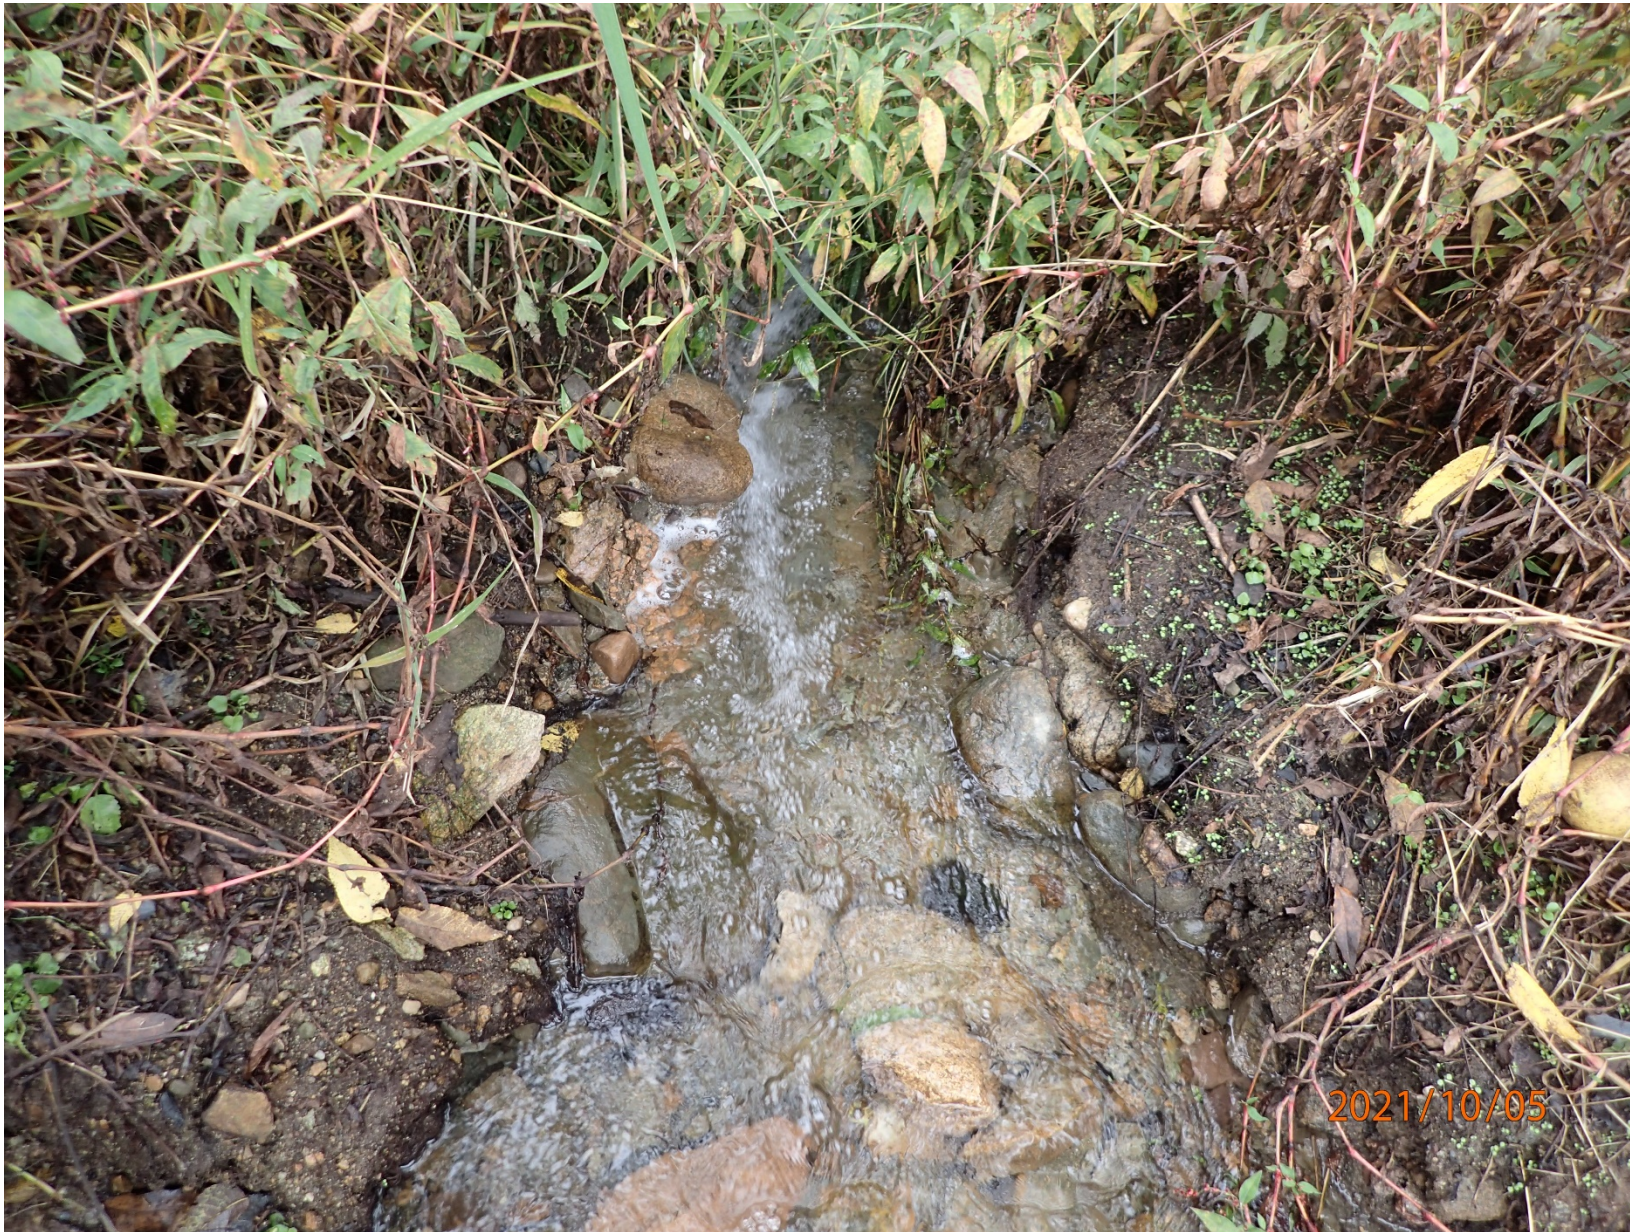
Date: 10/05/2021
Time: 11:59 AM
Photographer: SSA
Photo ID: 3 – PA050134

Photo of stream before entering pipe

Photo taken looking upstream at property boundary

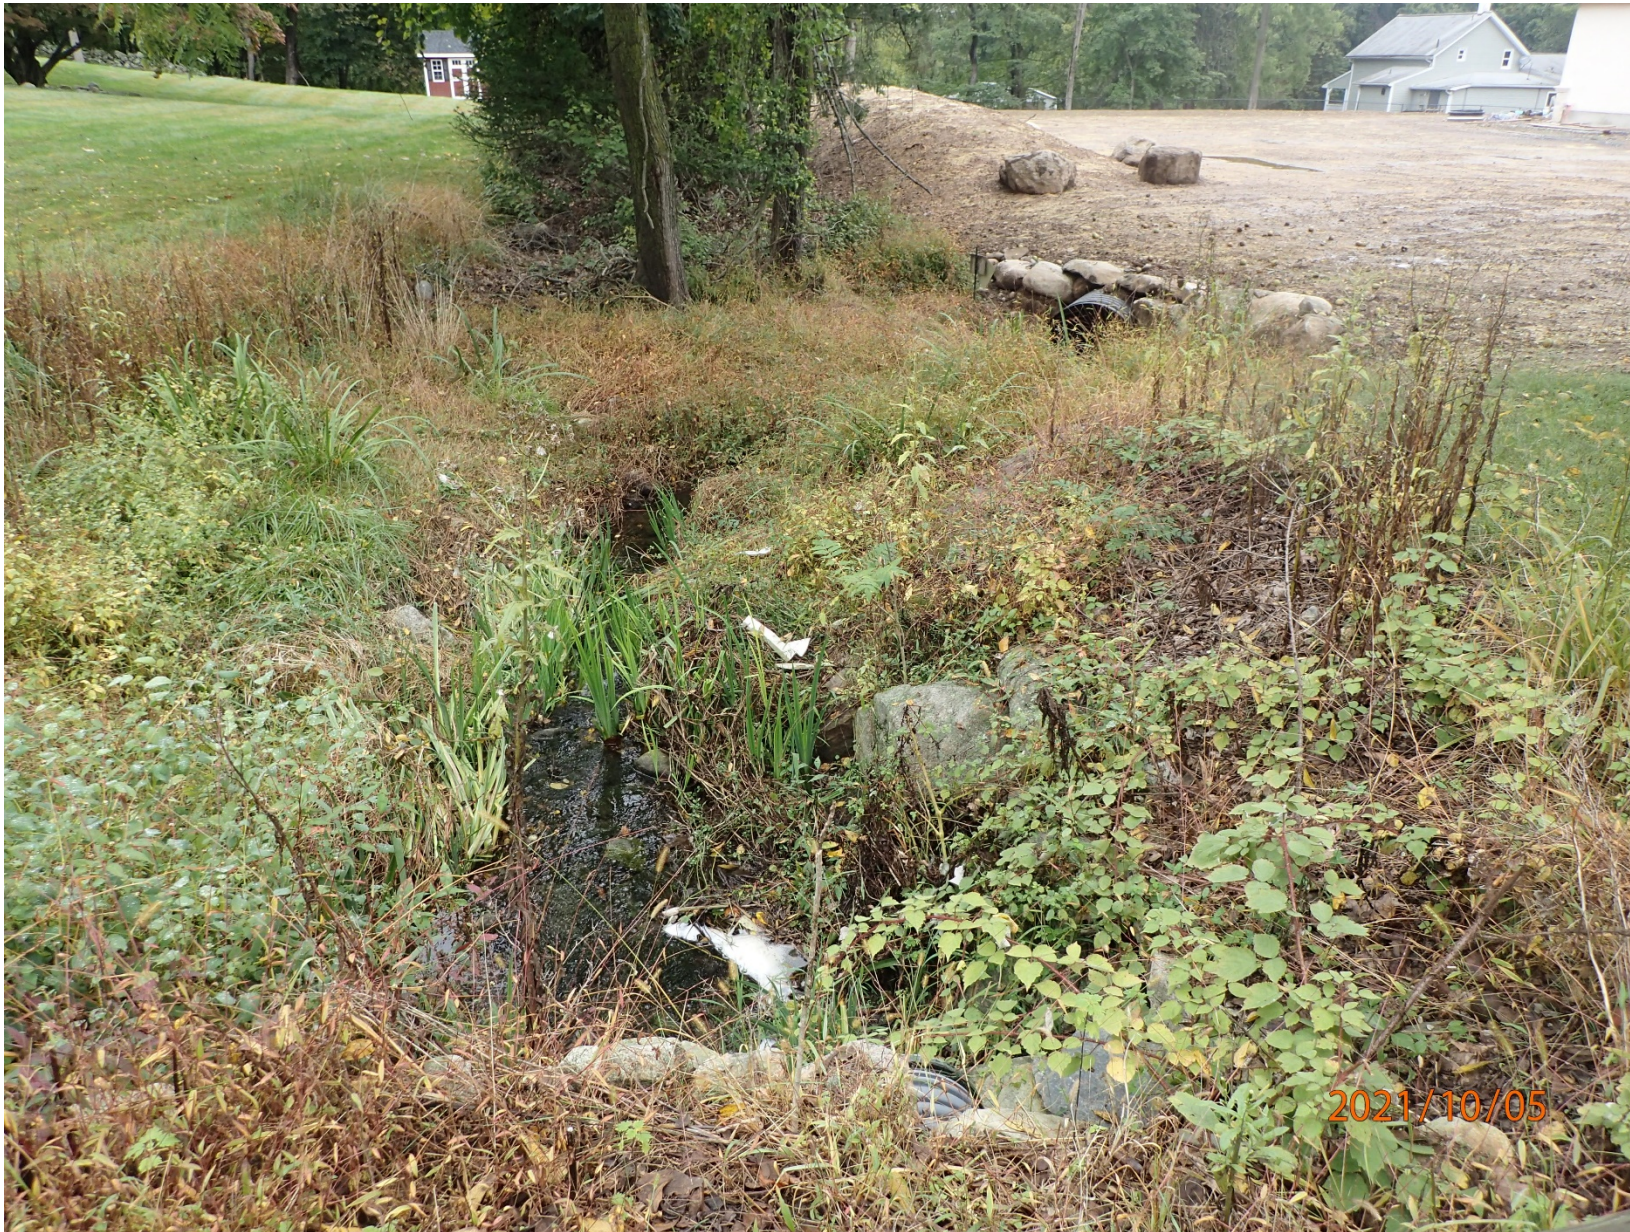
Date: 10/05/2021
Time: 12:01 PM
Photographer: SSA
Photo ID: 4 – PA050135

| EPA also observed the stream from Mountainside Lane, a private road just upstream of the parcel. From the road, EPA observed that the stream was flowing, cobble substrate, defined bed and banks, and cattails (<i>Typha</i> spp.) within the stream channel. | | | |

Photo of stream culverted
under Mountainside Lane and
piped under property

Photo looking downstream,
taken from northern edge of
Mountainside Lane

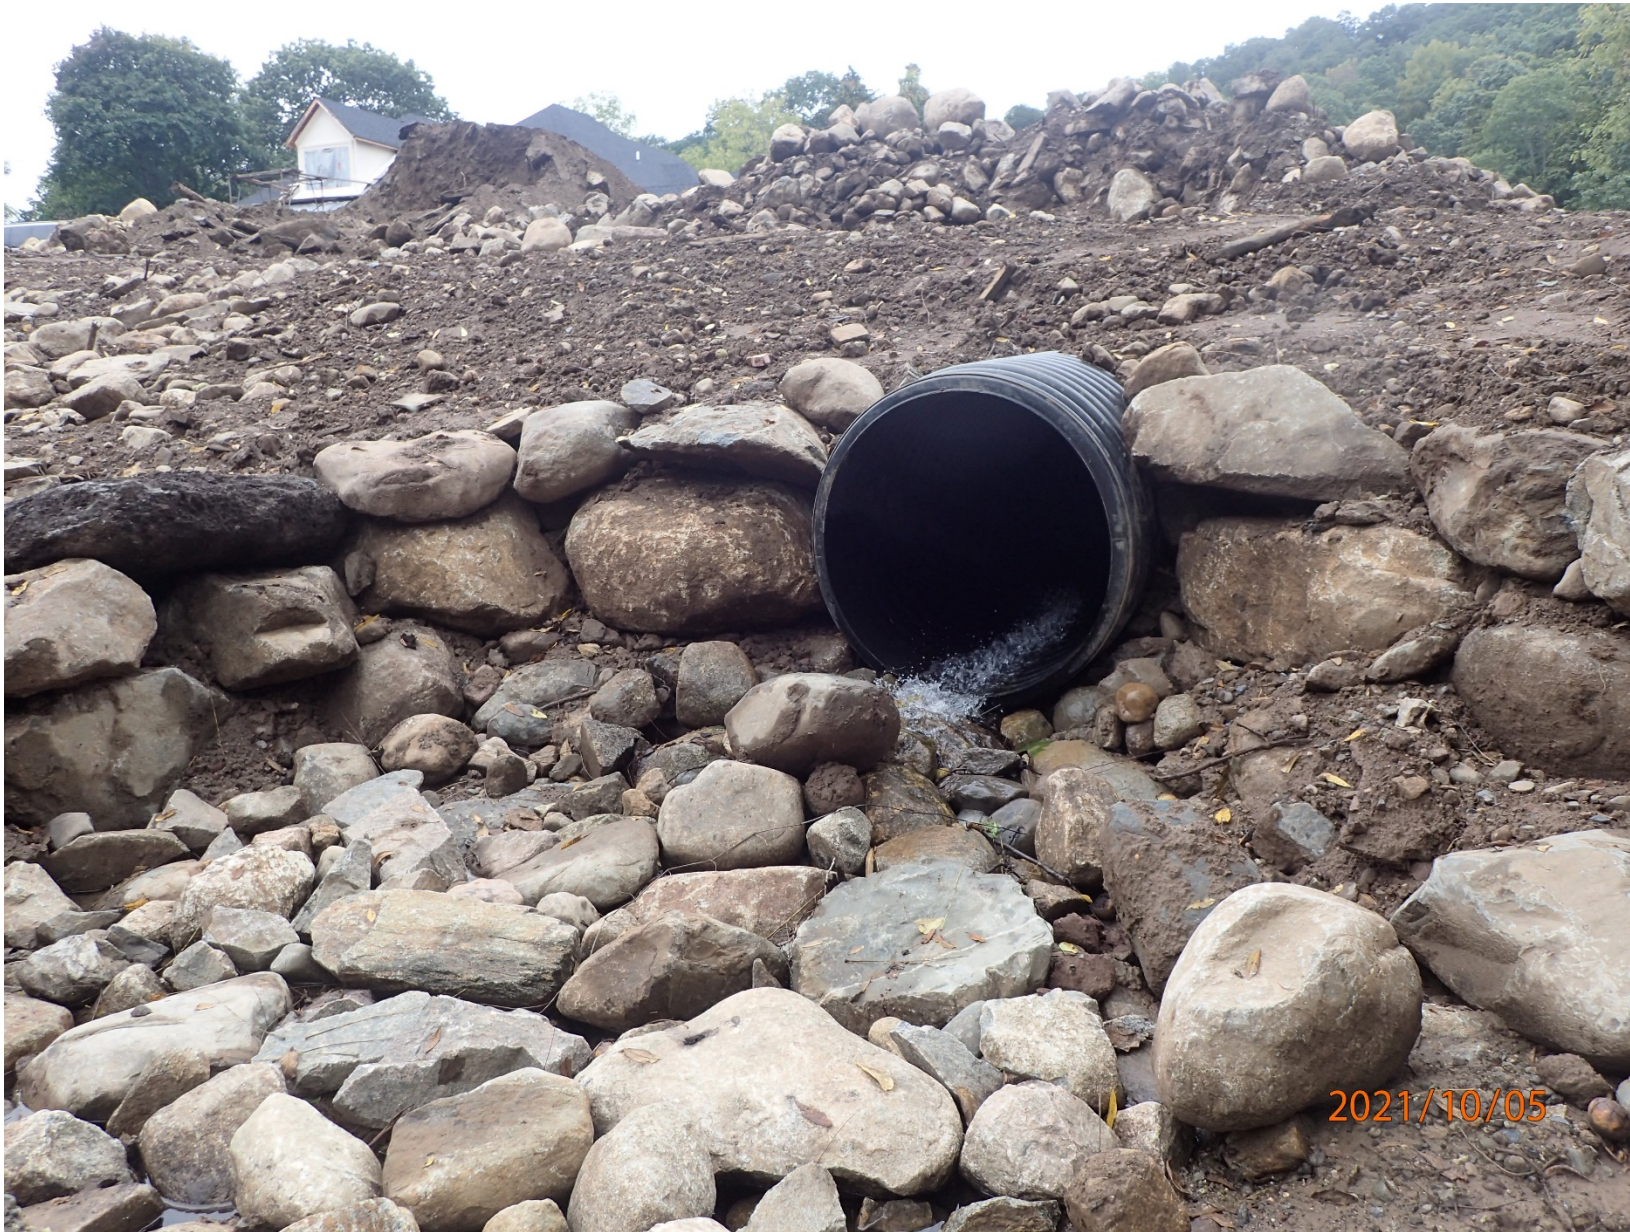
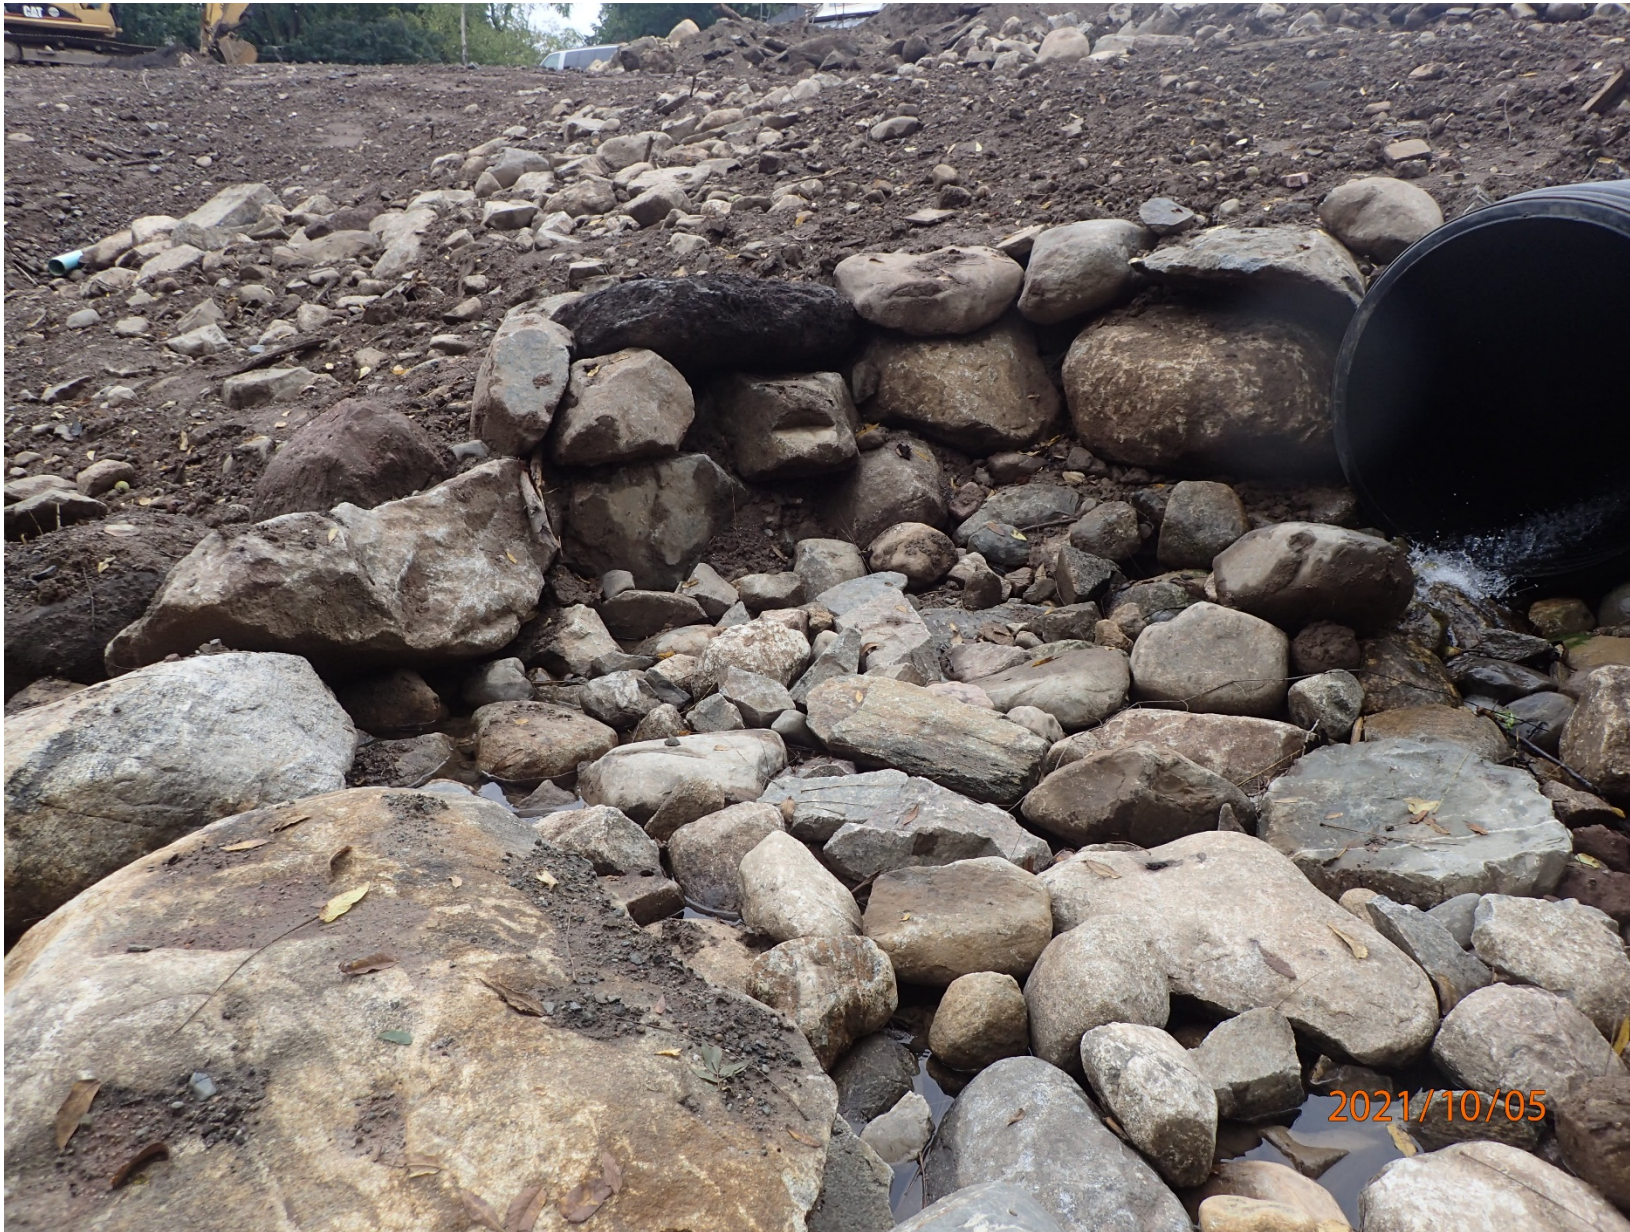
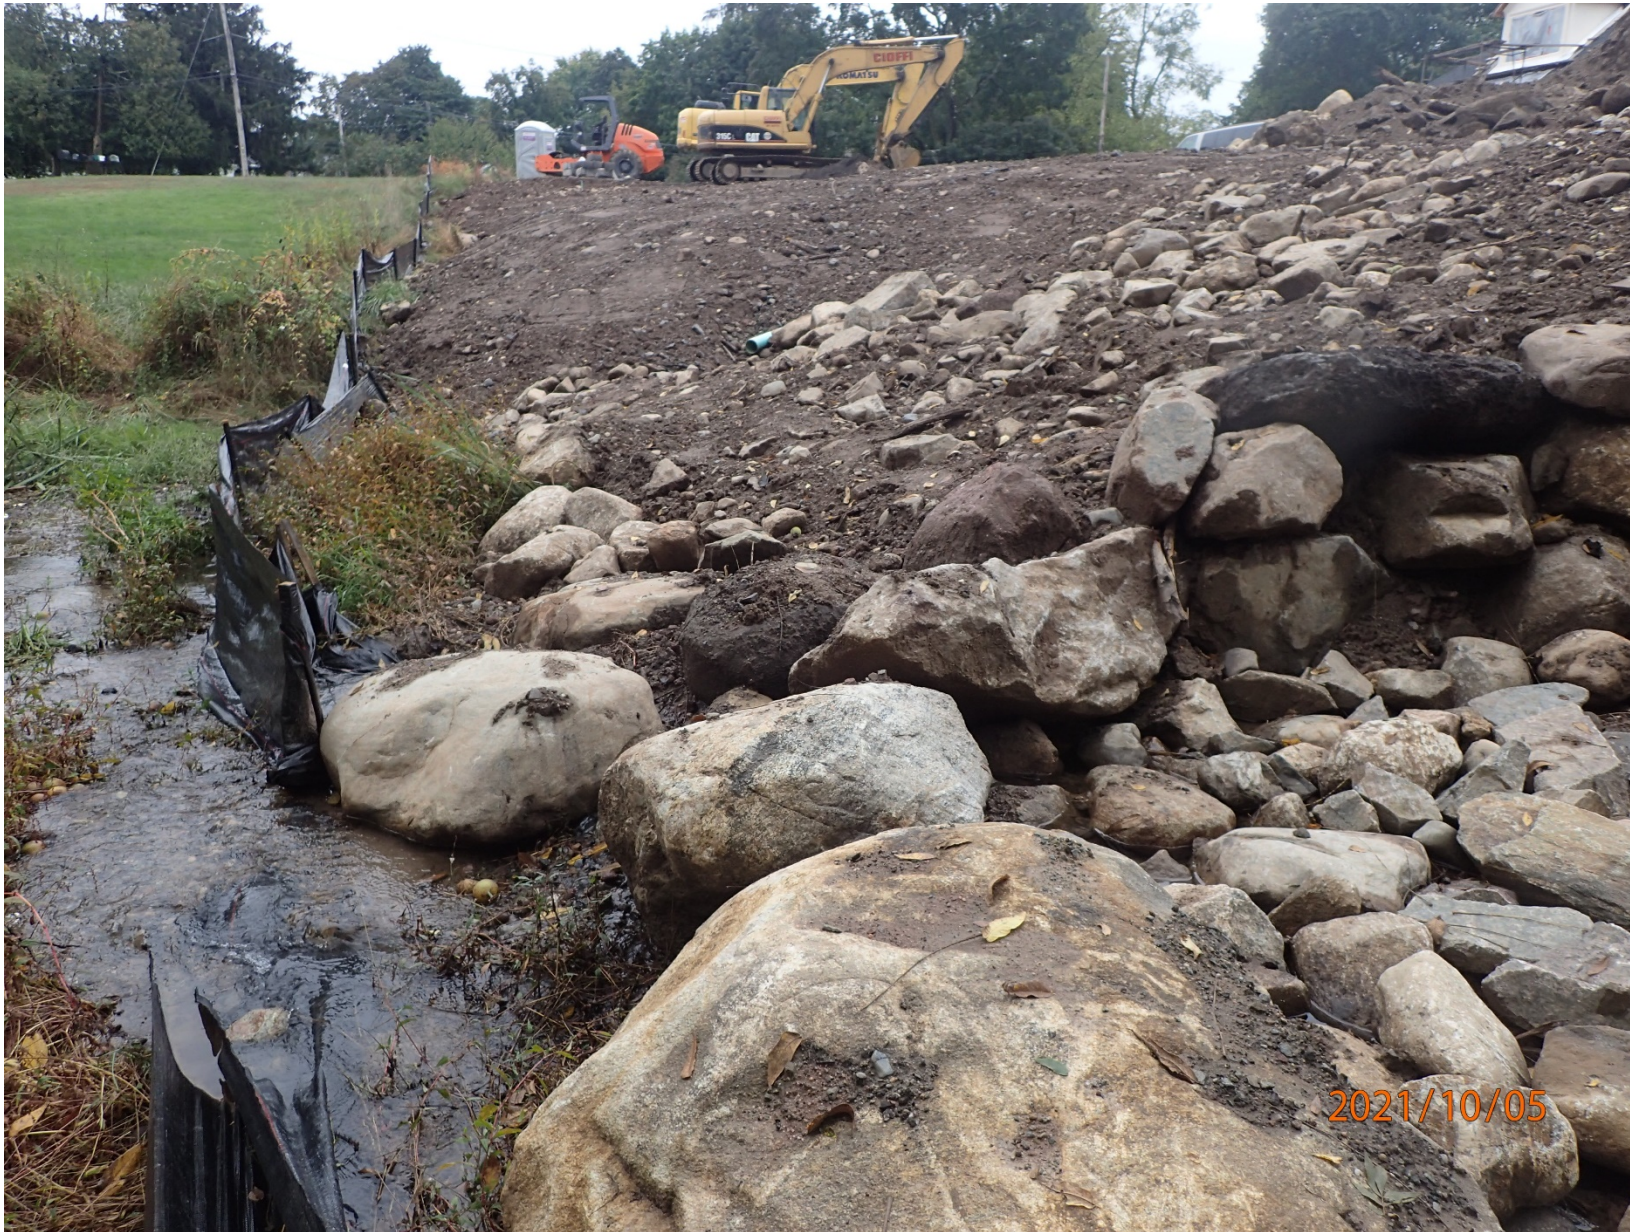
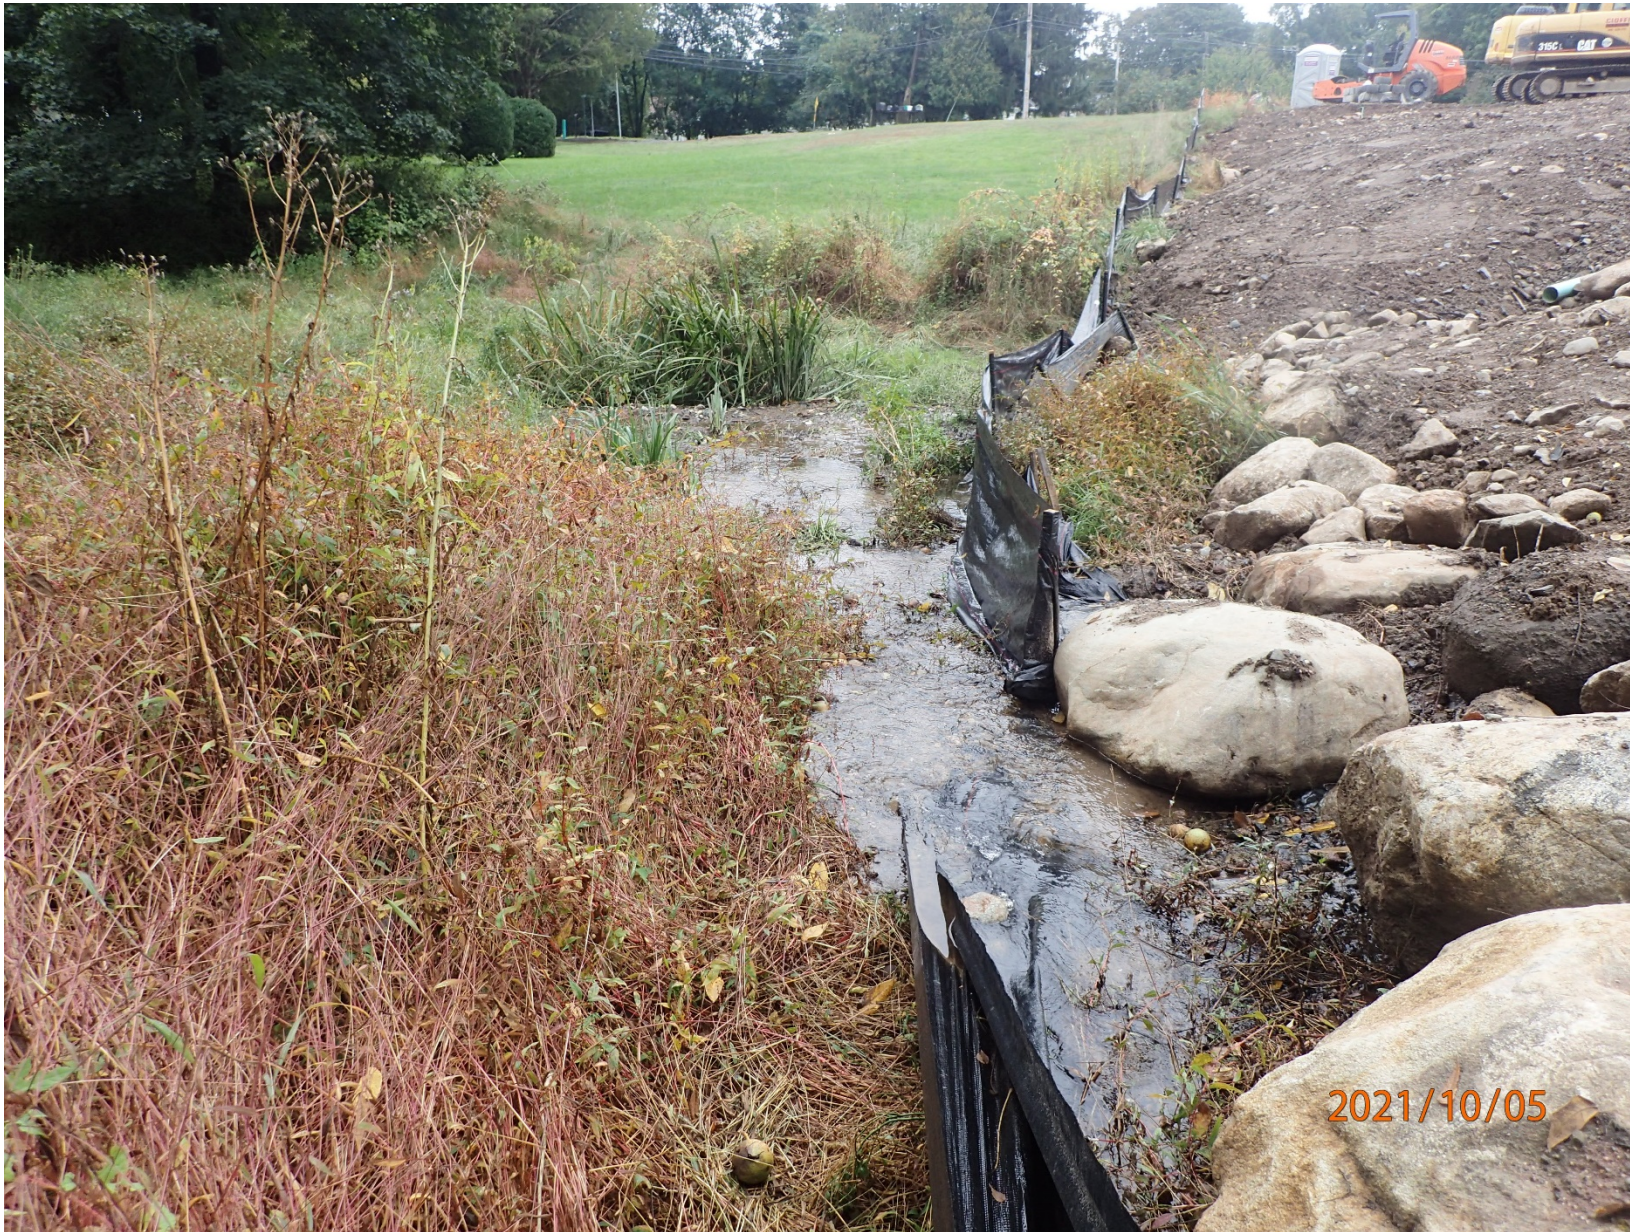
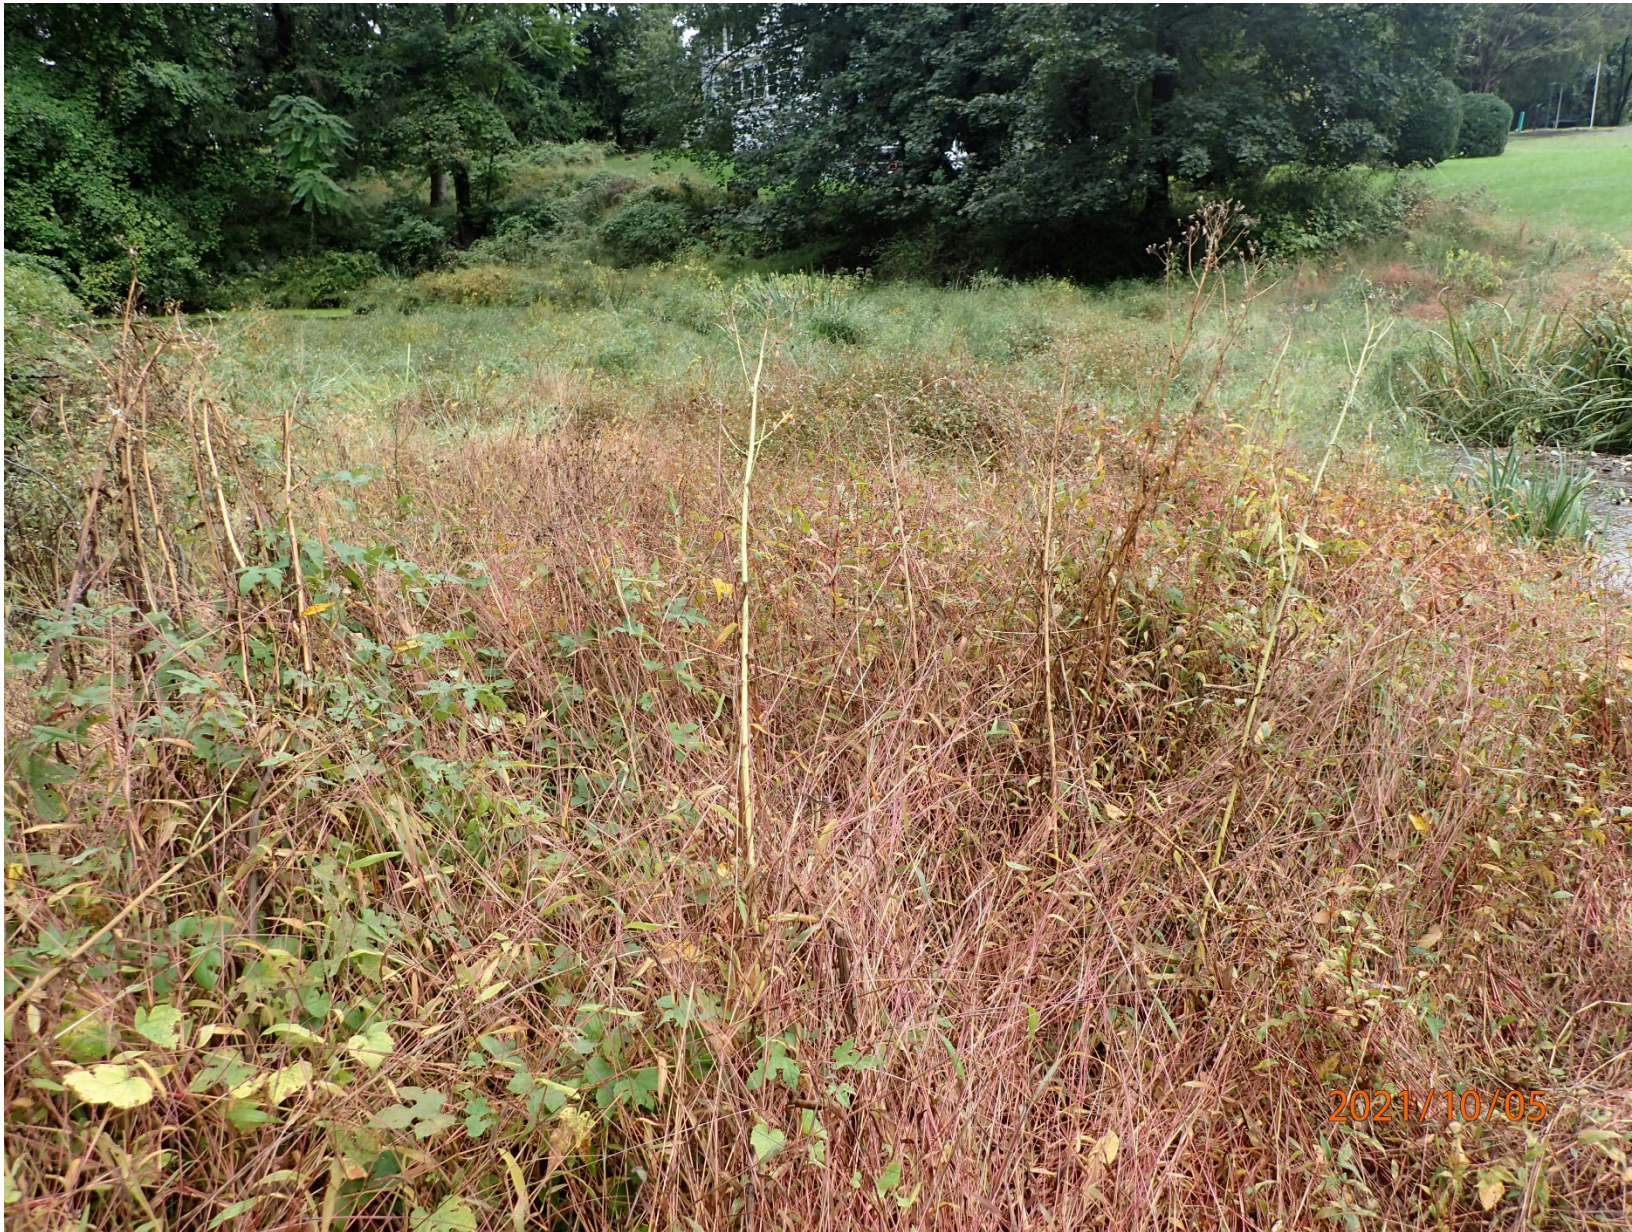
Date: 10/05/2021
Time: 12:12 PM
Photographer: SSA
Photo ID: 5 – PA050136

| EPA walked north along the western perimeter of the property, then east along the northern perimeter, and then south along the eastern perimeter. Fill had been brought onto the parcel to raise its elevation. Along the eastern perimeter, EPA observed the location at which the stream exits the pipe. Water was flowing from the culvert, which had not been properly countersunk, onto an assemblage of small boulders. The water then flowed down to original grade at the edge of the property and into a pond located on the neighboring property. | | | |

(1/5) Panorama of stream beginning at downstream end of culvert that flows towards pond on neighboring property

(2/5) Panorama of stream beginning at downstream end of culvert that flows towards pond on neighboring property

(3/5) Panorama of stream beginning at downstream end of culvert that flows towards pond on neighboring property

(4/5) Panorama of stream beginning at downstream end of culvert that flows towards pond on neighboring property

(5/5) Panorama of stream
beginning at downstream end
of culvert that flows towards
pond on neighboring property

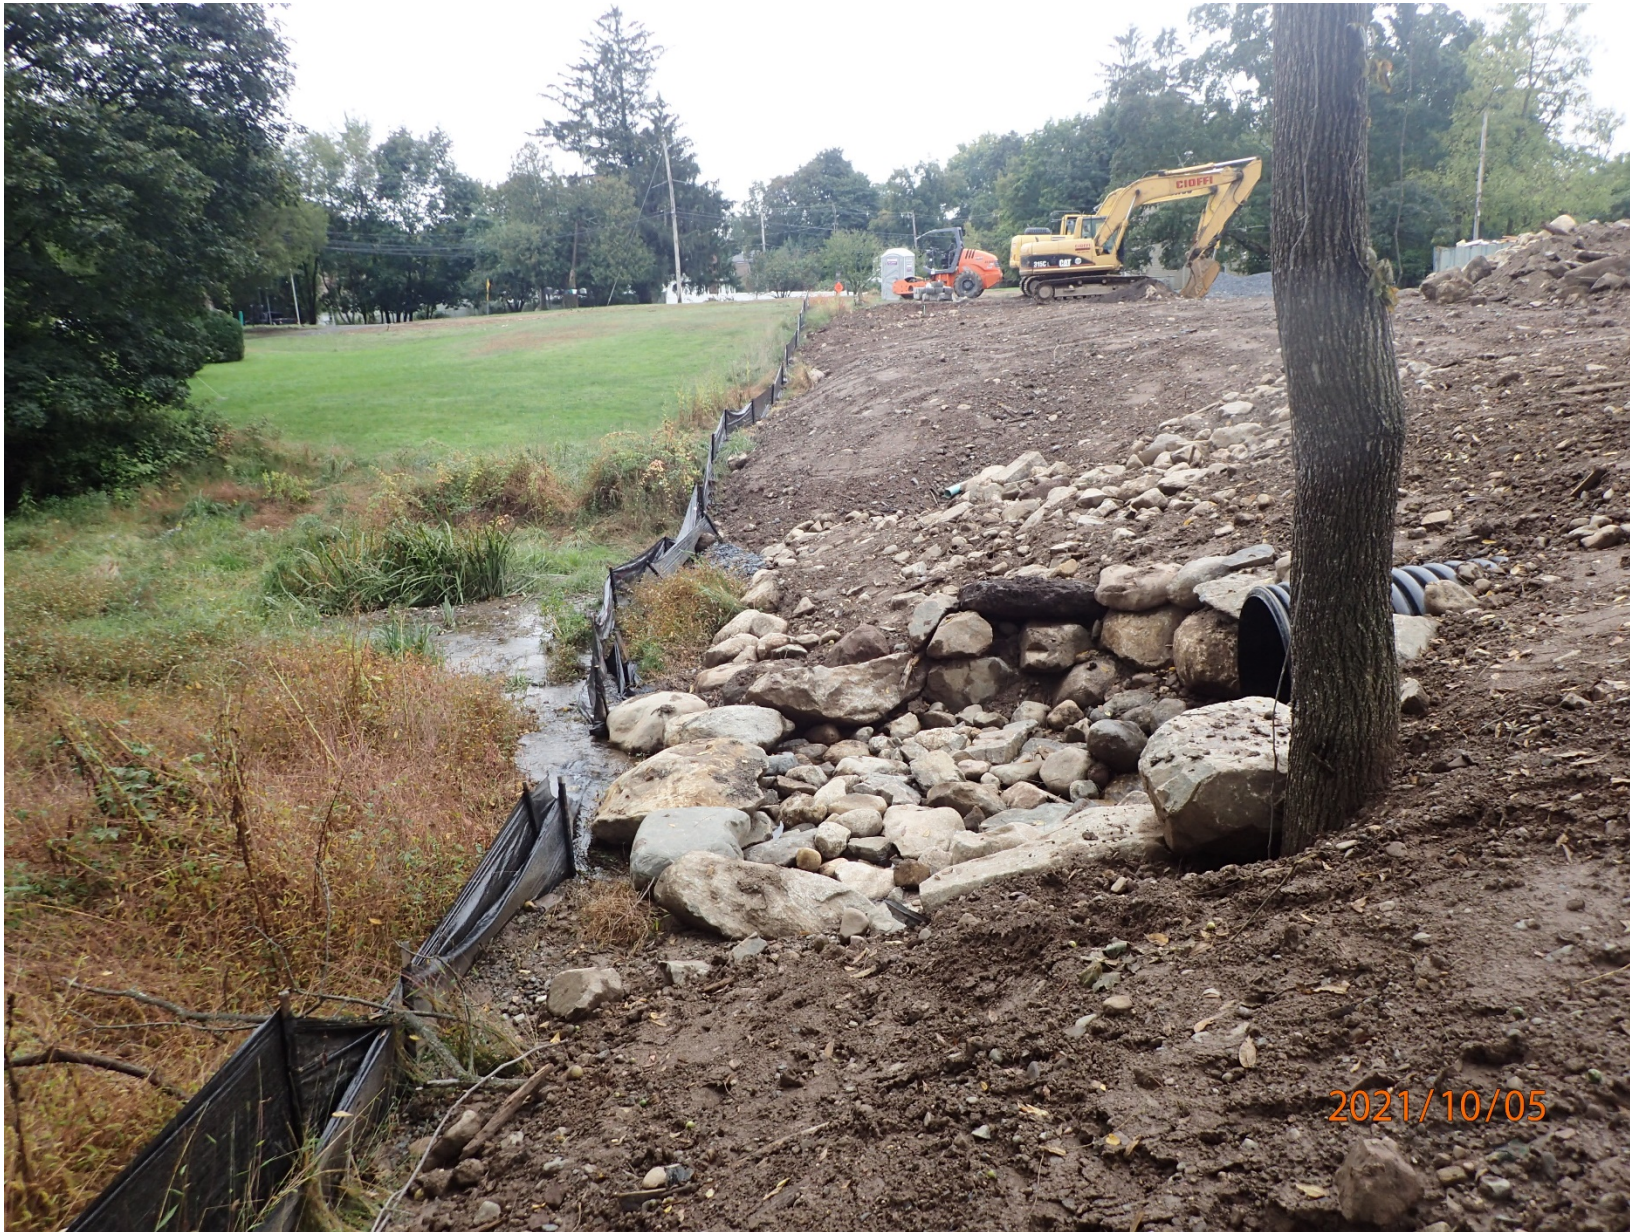
Date: 10/05/2021
Time: 12:17 PM
Photographer: SSA
Photo ID: 10 – PA050141

| Approximately 300 feet of stream has been piped under the property without seeking prior Corps authorization. Additionally, the pipe has not been installed appropriately to comply with Nationwide Permit regional conditions pertaining to the countersinking of pipes and culverts. | | | |

Photo of downstream end of culvert

Photo taken from northeastern corner of property

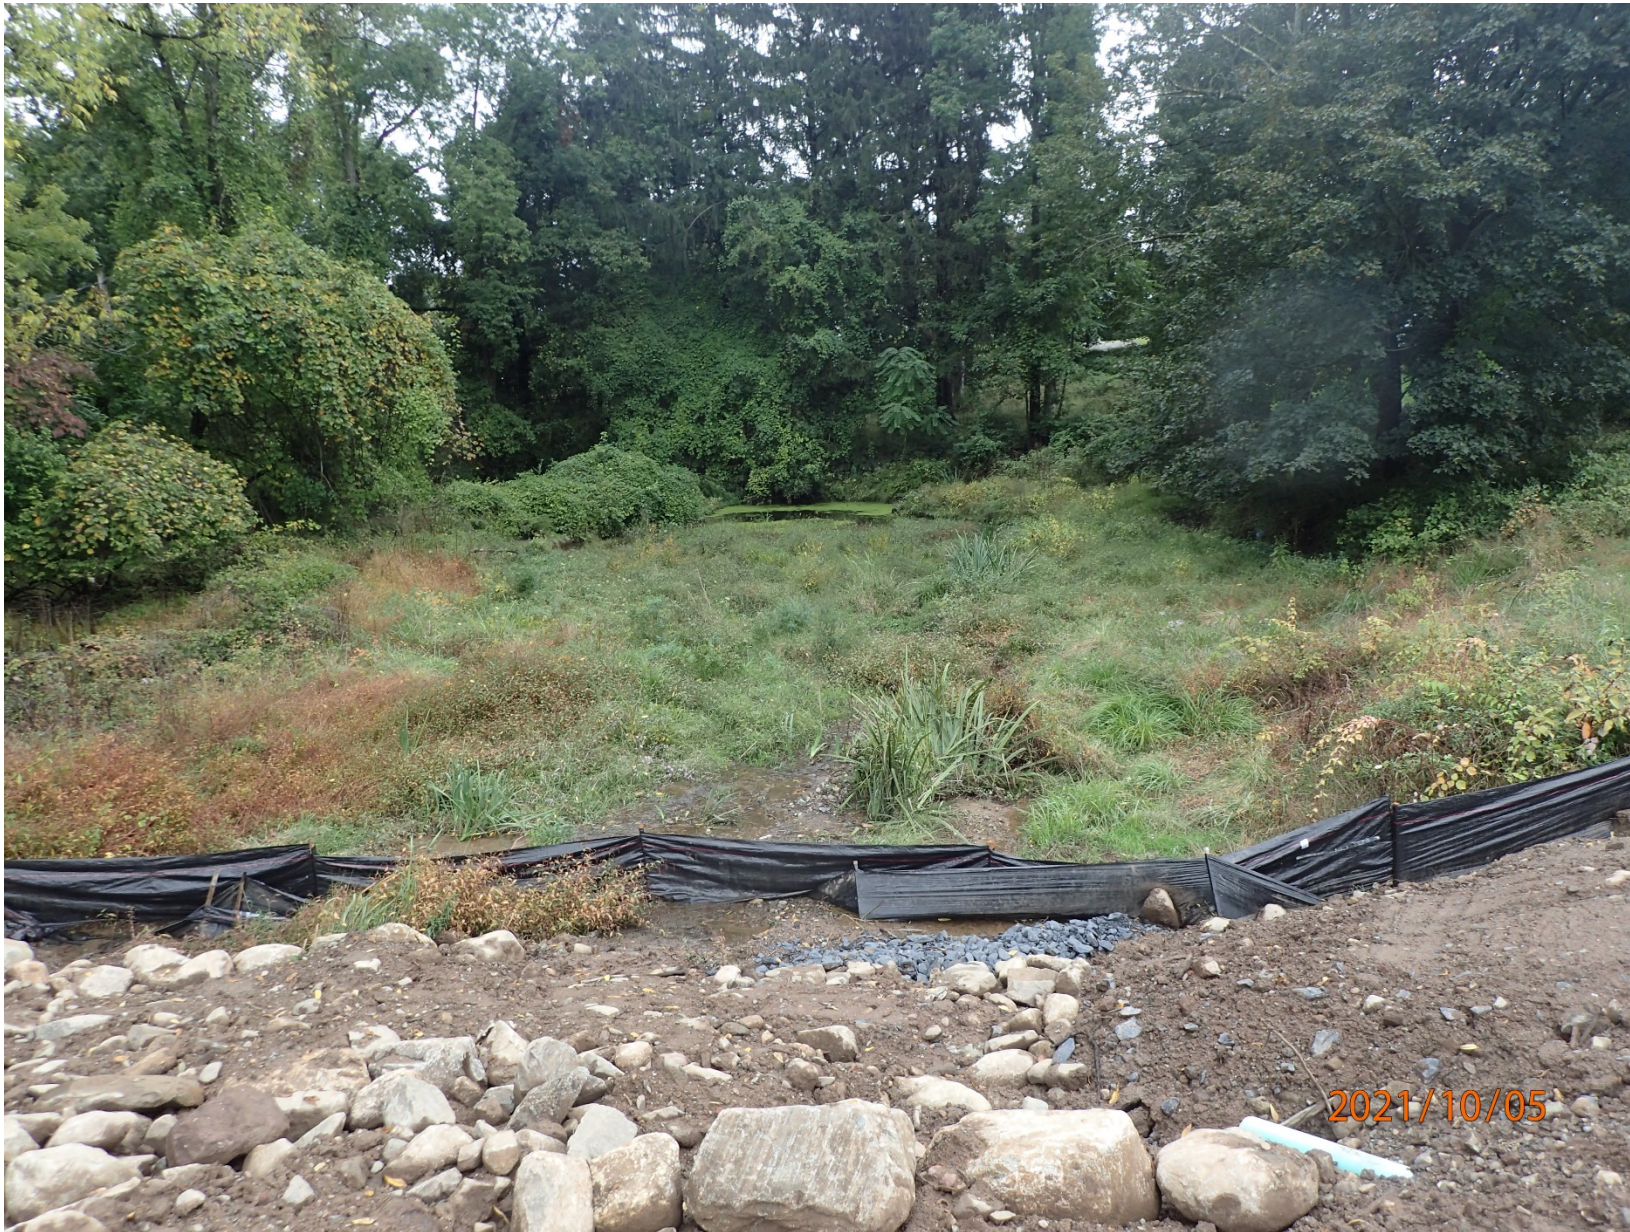
Date: 10/05/2021
Time: 12:19 PM
Photographer: SSA
Photo ID: 11 – PA050142

Pond on downstream
neighboring property
