Clean Water Act Section 404: Site Visit/Case Development

| Site Name | Cioffi Property | Start Date | October 5, 2021 |
| Inspection Purpose | Initial site visit | | |

CWA 404 Inspection
Jerry Cioffi Property / Cioffi Services
5 Mountainside Lane
Stony Point, Rockland County, NY

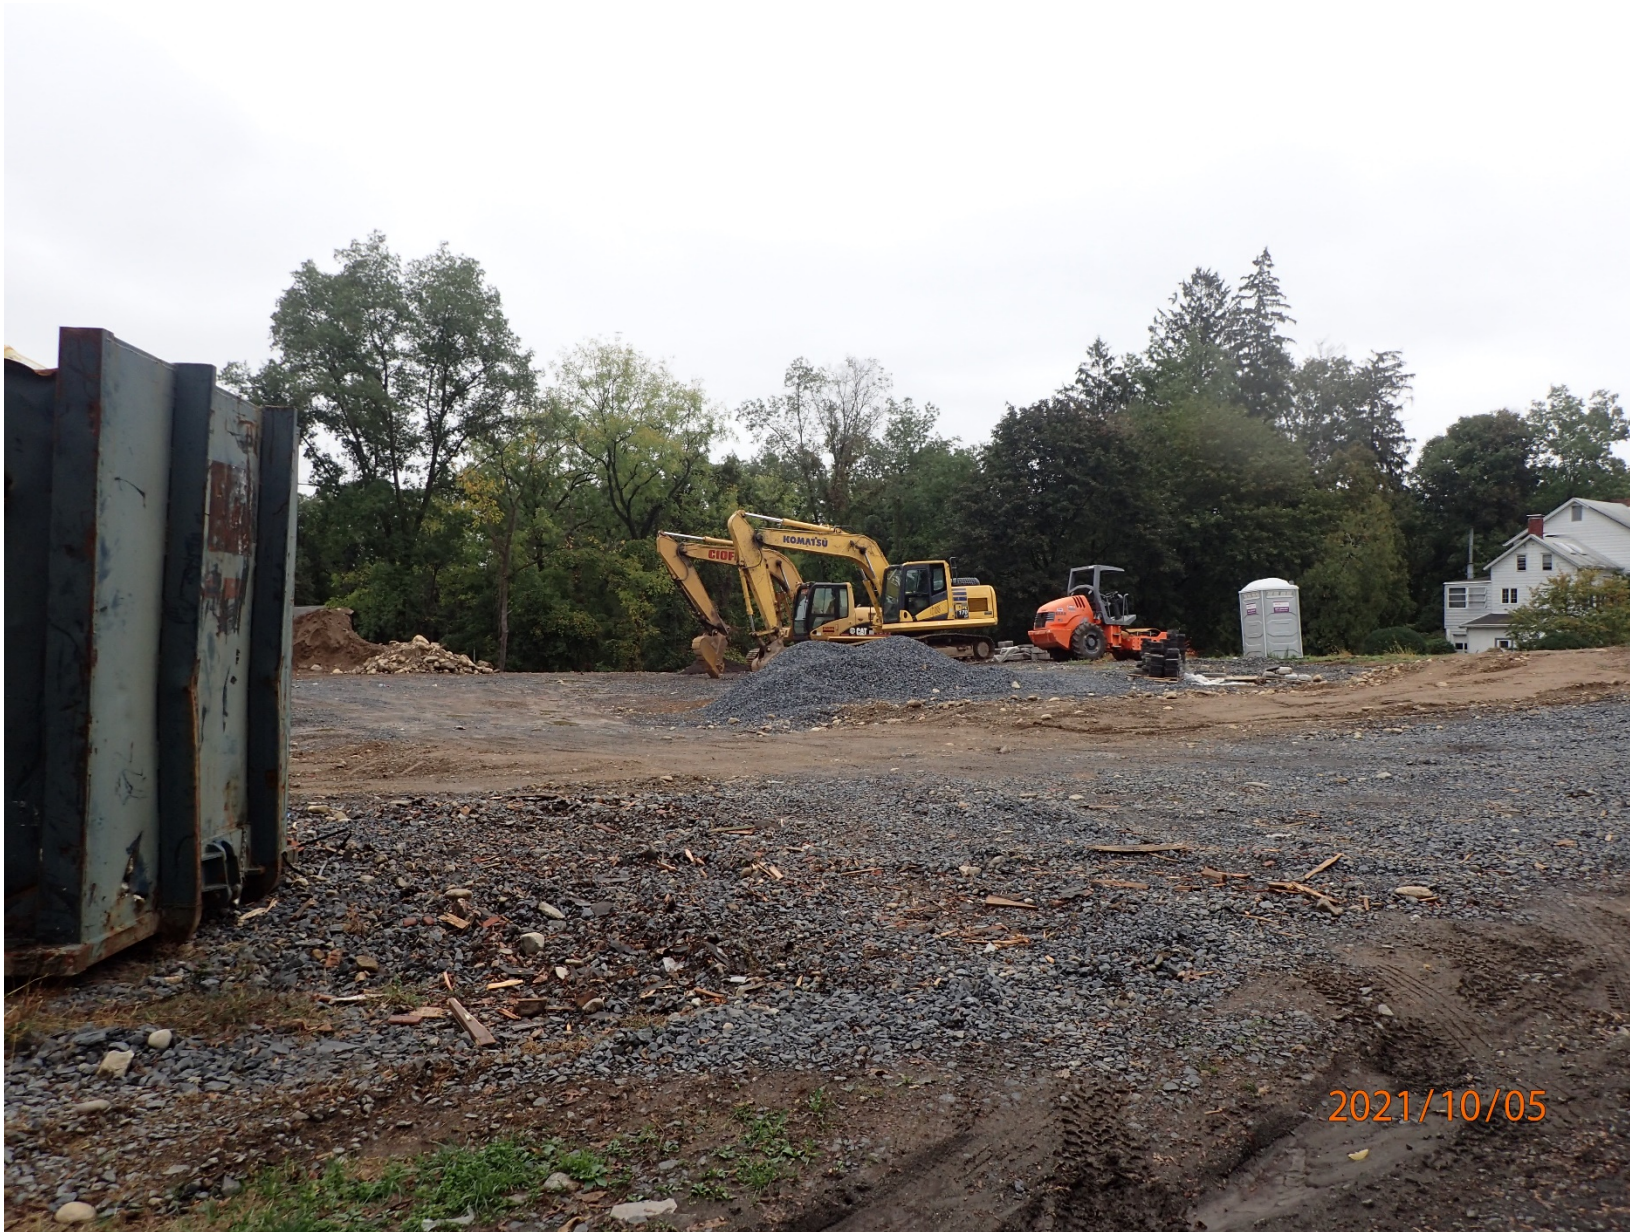
Date: 10/05/2021
Time: 12:33 PM
Photographer: SSA
Photo ID: 12 – PA050143

Heavy equipment (including excavators) on site
