**CWA COMPLIANCE EVALUATION INSPECTION REPORT  
U.S. ENVIRONMENTAL PROTECTION AGENCY, REGION 5**

Quality Dairy, LLC  
N 5232 BK Line Road  
Luxemburg, Wisconsin 54217  
Kewaunee County  
44.513856937943395, -87.764180364316

**NPDES Permit Number:** WI-0059579

**Date of Inspection:** 06/05/2024

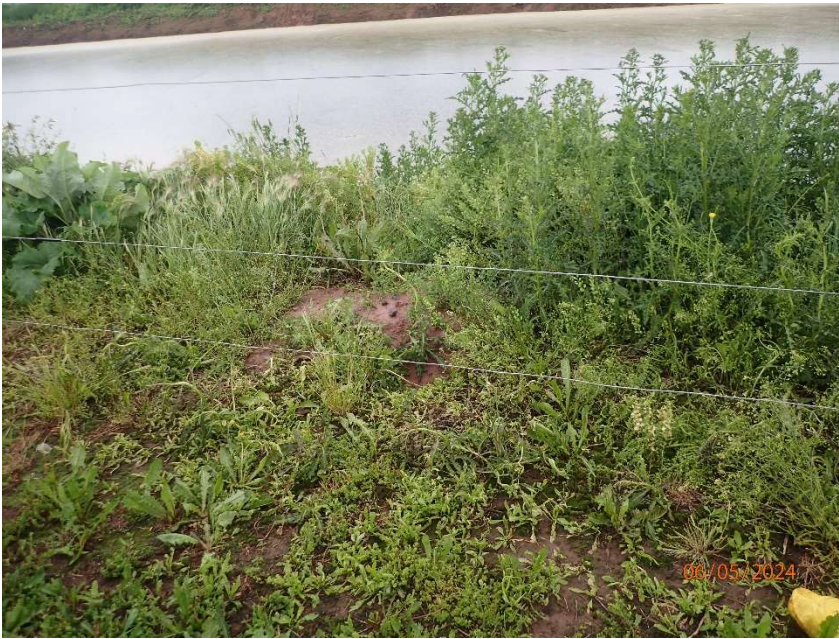
7: P6050664

The Inspectors continued walking east and arrived at Manure Storage 2. The Inspectors observed an animal burrow on the berm of Manure Storage 2 and pointed it out as an area of concern to the Operator. The Inspectors walked south along west side of Manure Storage 2 and observed an additional animal burrow (photo 8). The Inspectors walked south, around the southern end of Manure Storage 2 and then walked north along the east side (photos 9-11). The Inspectors observed indentions left in the pit's berm by the agitator being lowered in (photo 12). WDNR advised that the indentions could lead to erosion and compromising of the clay liner and recommended addressing the indentions. Additionally, WDNR pointed out that the concrete pad in the northwest corner of Manure Storage 2 had been undercut by erosion and should be addressed. The Inspectors walked west along the north side Manure Storage 2 and observed the depth marker for Manure Storage 2 (photo 13).

Description: Animal burrow in the west bank of Manure Storage 2.

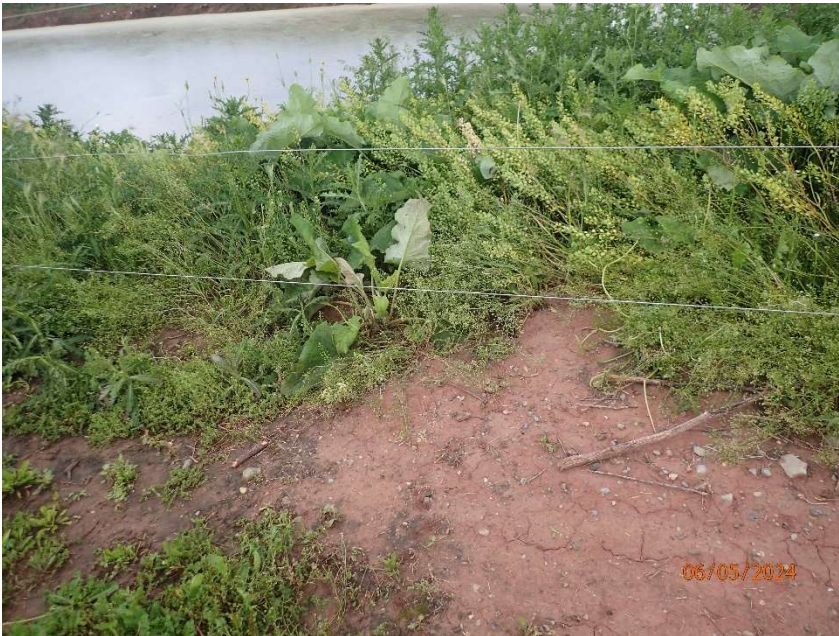
8: P6050665

Description: Additional animal burrow on the side of Manure Storage 2 near the southwest corner.

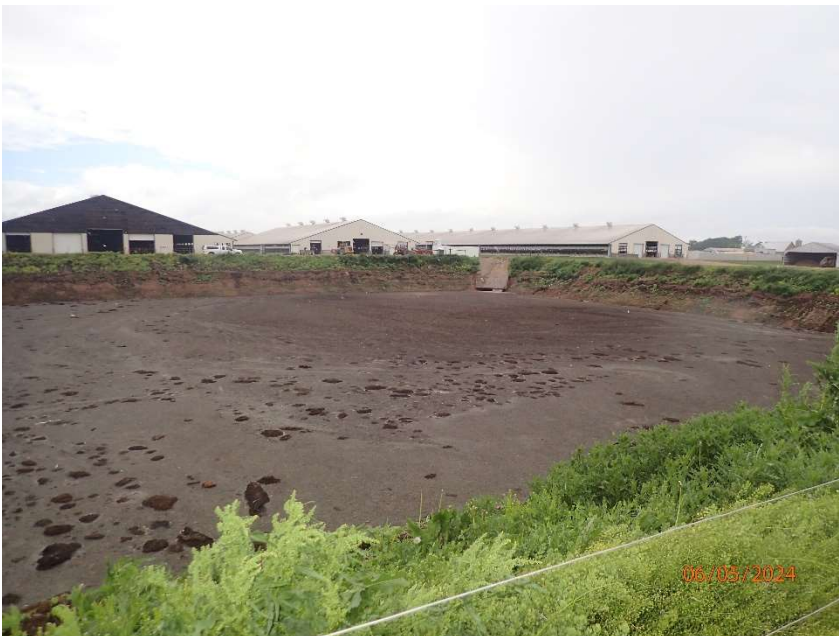
10: P6050667

Description: Looking northwest from the east side of Manure Storage 2. Note that the concrete pad built to protect the storage structures bank has been undercut and there is erosion on the internal walls of the pond.

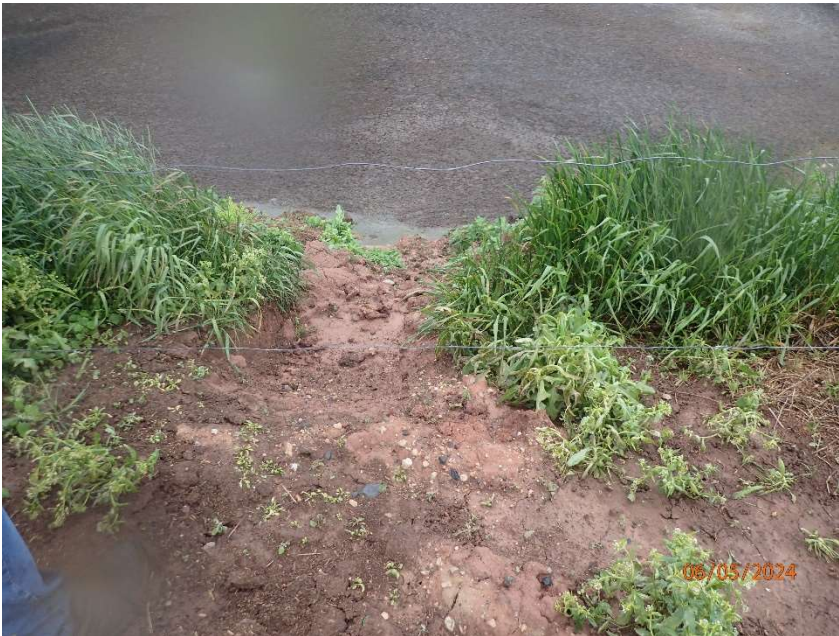
12: P6050669

Description: Erosion in wheel ruts from where equipment was lowered into Manure Storage 2 on the north side.

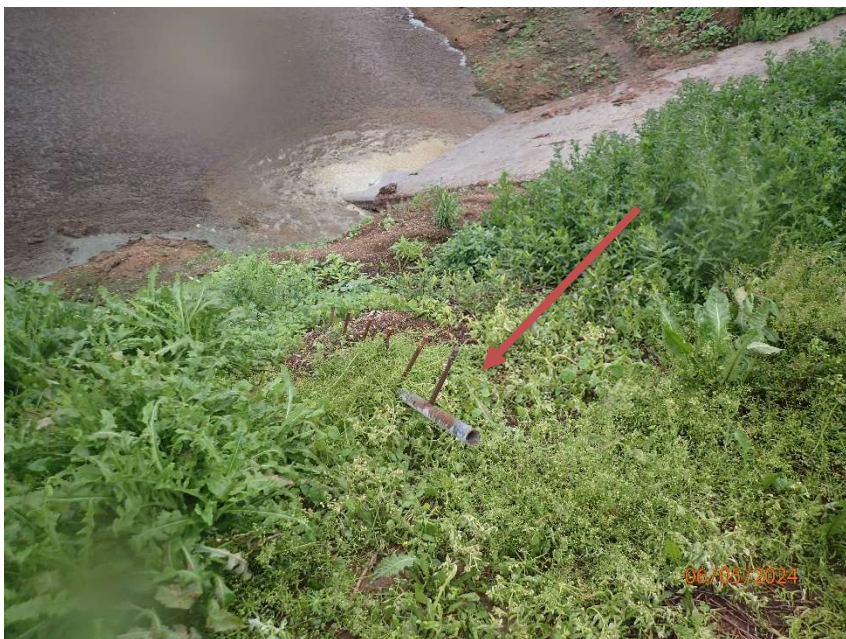
13: P6050670

Description: Depth marker for Manure Storage 2 (red arrow).

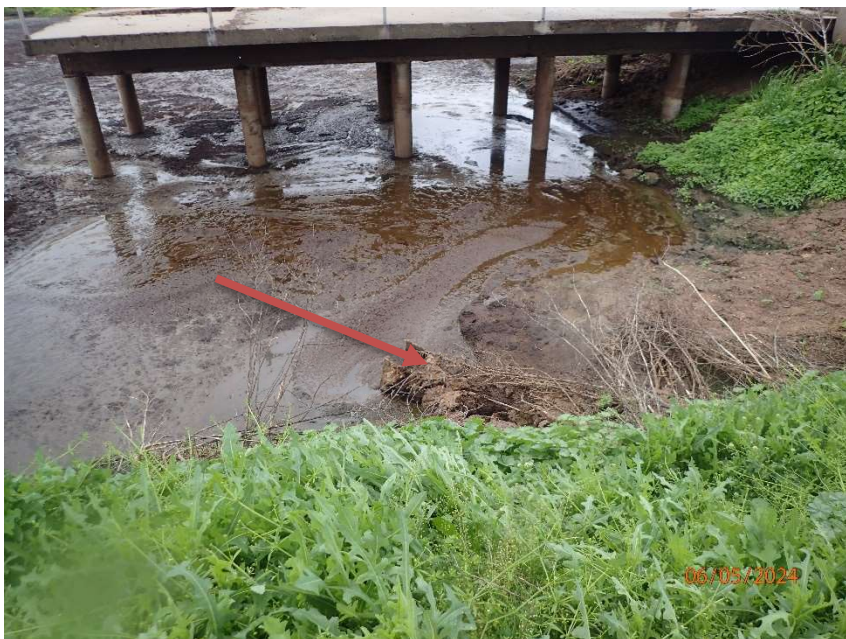
19: P6050676

Description: Looking east from the west side of the southwest corner of Manure Storage 1. Note the outlet of the manure pipe from the Dry Cow Barn (red arrow).

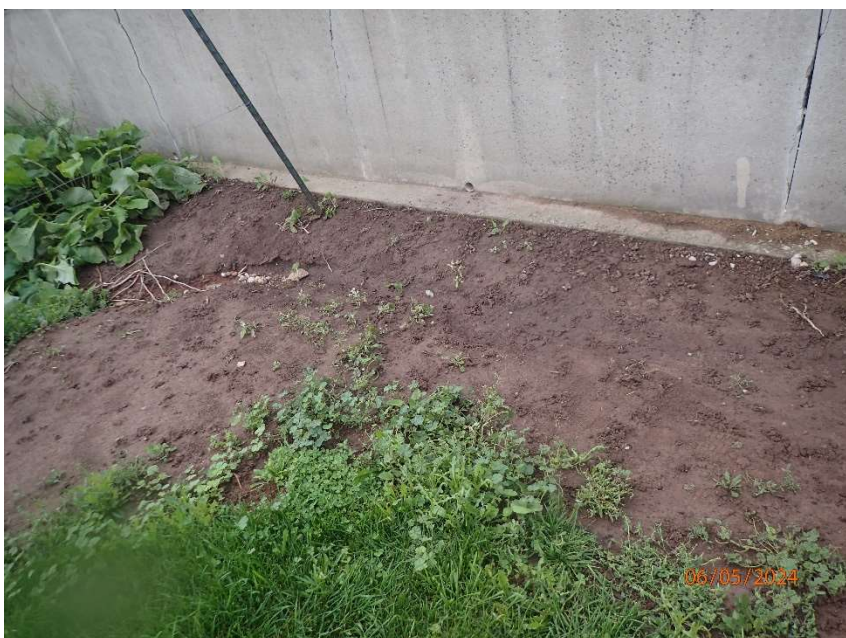
20: P6050677

did observe a pipe coming through the wall of the Dry Cow Barn (photo 20). The Inspectors observed an erosional pathway from the area around the pipe down to Manure Storage 1. The Operator stated that this pipe connected to a hand washing sink located in the maternity area.

Description: Pipe in the wall on the east side of the Dry Cow Barn. Operator stated that his pipe connected to a sink in the maternity pin. The eroded flow to the left led down toward Manure Storage 1.

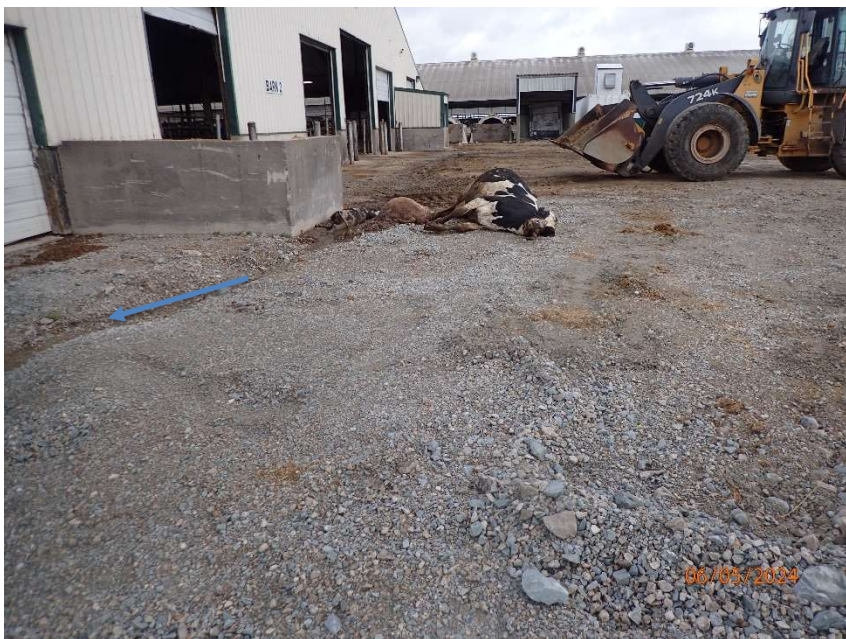
23: P6050680

Description: Mortality holding area located at the east end of Barn 2. Note potential flow path from the mortality holding area to the south toward the grassed area between Barn 2 and Barn 3 (blue arrow).

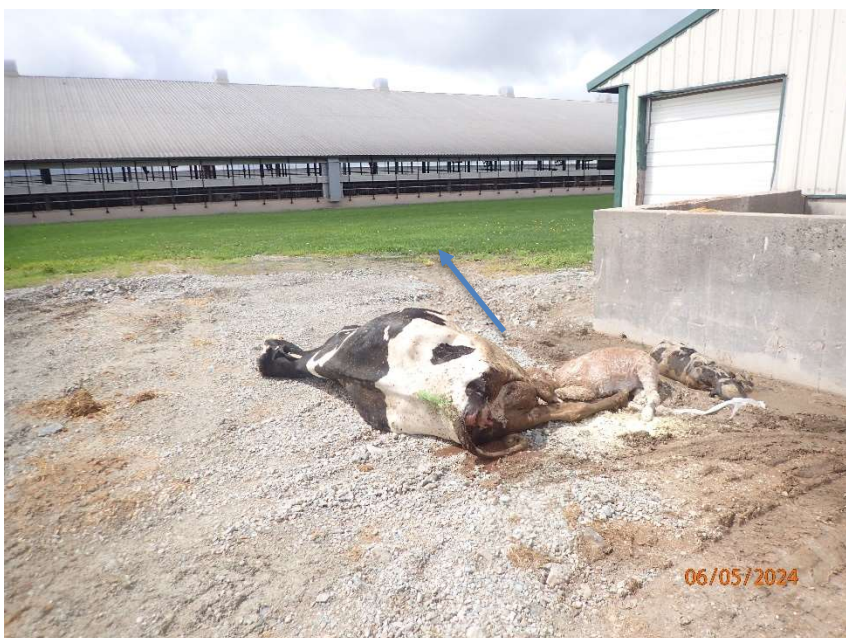
24: P6050681

Description: Mortality holding area located at the east end of Barn 2. Note potential flow path from the mortality holding area to the south toward the grassed area between Barn 2 and Barn 3 (blue arrow).

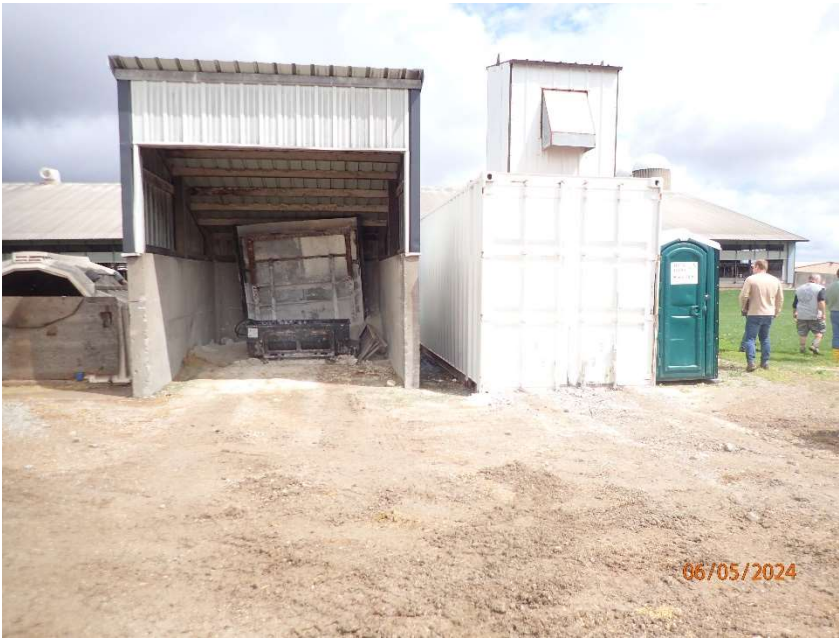
25: P6050682

Description: Covered shed (left) to which the Operator proposed moving the mortality holding area and hydrated lime storage container (right).

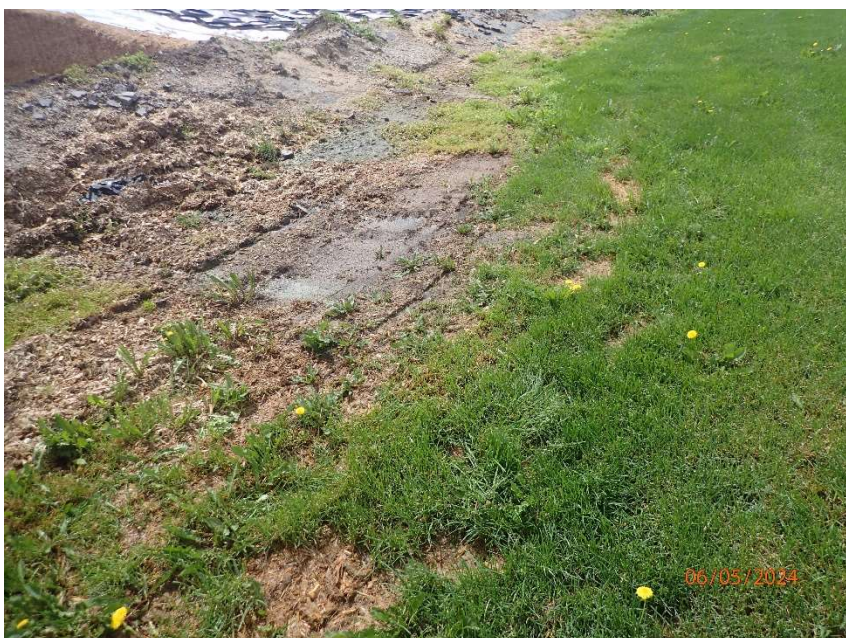
40: P6050697

The Inspectors then walked west across the north end of the feed pad and observed a pipe outletting on the north side of Luxemburg Road north of the northwest corner of the feed pad (photo 38). The Inspectors then walked south along the west side of the feed pad and observed two stormwater drain surface inlets in the grass between the feed pad and BK Line Road (photos 39 and 41). The Inspectors also observed an area where it appeared wind had blown feed over the berm of the feed pad (photo 40).

Description: Feed observed beyond outside of the berm on the west side of the feed pad.

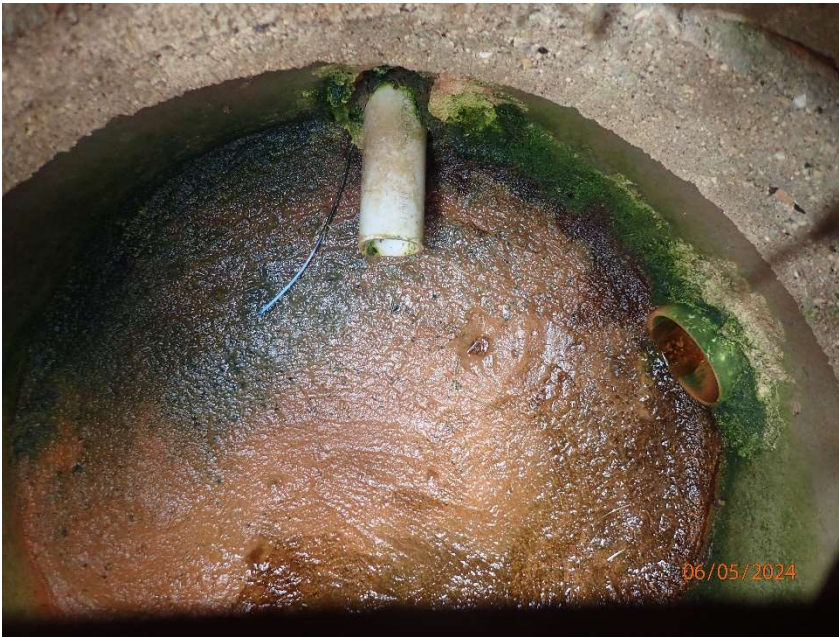
45: P6050702

Description: Looking down into interior of the stormwater drain at the east end of the grassed area between Barn 1 and the milking Parlor. Note white PVC pipe entering stormwater drain from the southwest with locator wire.

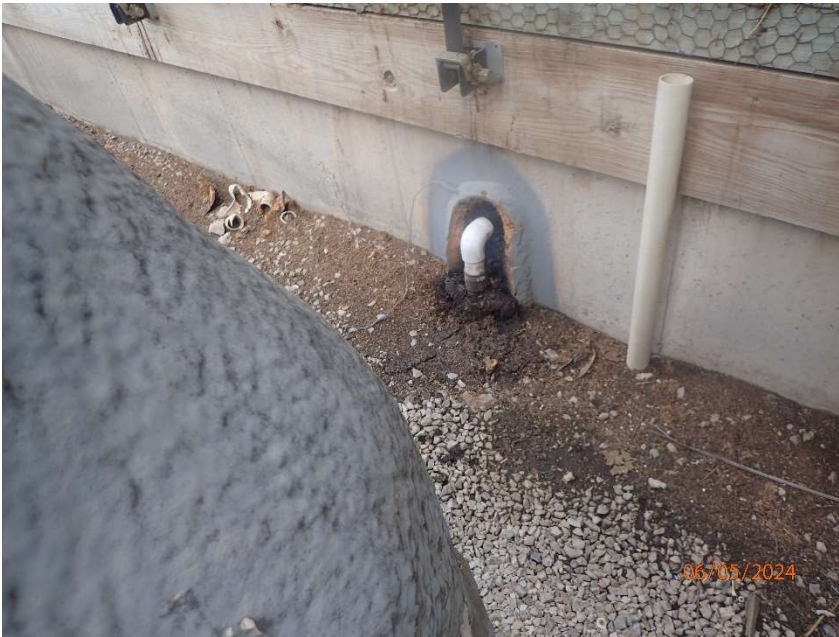
47: P6050704

observed a white pipe coming out of the wall of the animal walkway to the Milking Parlor (photo 47). The Inspectors observed that there was manure around the base of the pipe and on the wall around where the pipe penetrated the wall. The Operator stated that he believed the pipe was coming from a groundwater sump in the basement below the Milking Parlor and that the manure was being pushed around the pipe from the animal walkway but not entering or flowing through the pipe.

Description: White PVC pipe with locator wire protruding the side of the animal walkway. Note manure around PVC pipe and on ground. The operator suspected that the white pipe is from a groundwater sump pump in the basement and that the area around the pipe was not well sealed allowing manure from the animal walkway to escape but he believed that no manure or process wastewater was in the pipe.

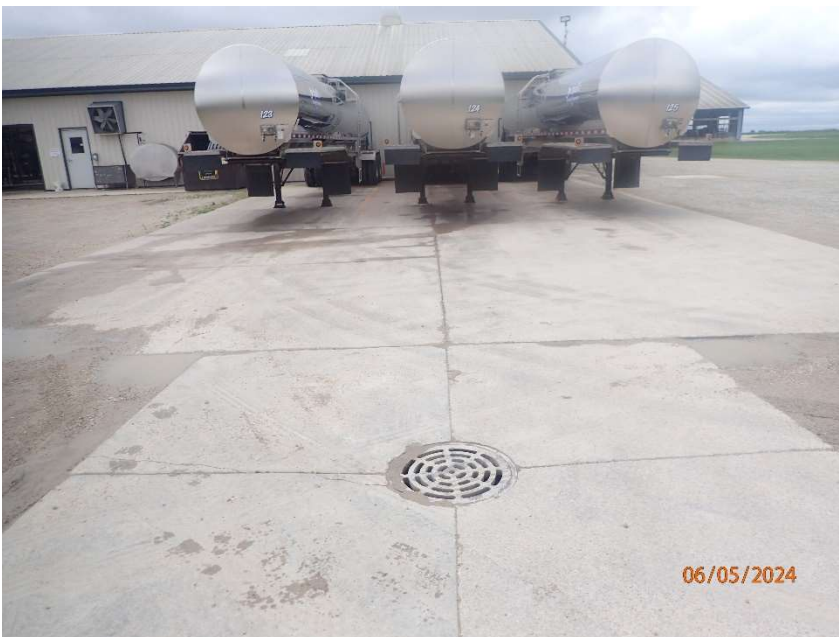
48: P6050705

The Inspectors then walked west and observed a surface drain near the milk tanker parking area (photo 48). The Operator stated that this drain was not connected to the rest of the storm water drains. This drain is collected and sent to storage. He stated that WDNR had required that this drain collect any milk tank wash water. The inspectors then walked south and observed a stormwater drain surface inlet near the northwest corner of the Milking Parlor (photo 49).

Description: Stormwater collection inlet at milk tanker parking. The Operator stated that stormwater collected by this drain was sent to storage.
