## Clean Water Act Section 404: Site Visit/Case Development

| Site Name | DBR Dorado Owner, LLC | | | | |
| Site Address* | Tax parcel 037-000-001-07-000 | | | | |

## Attachment B: Photolog

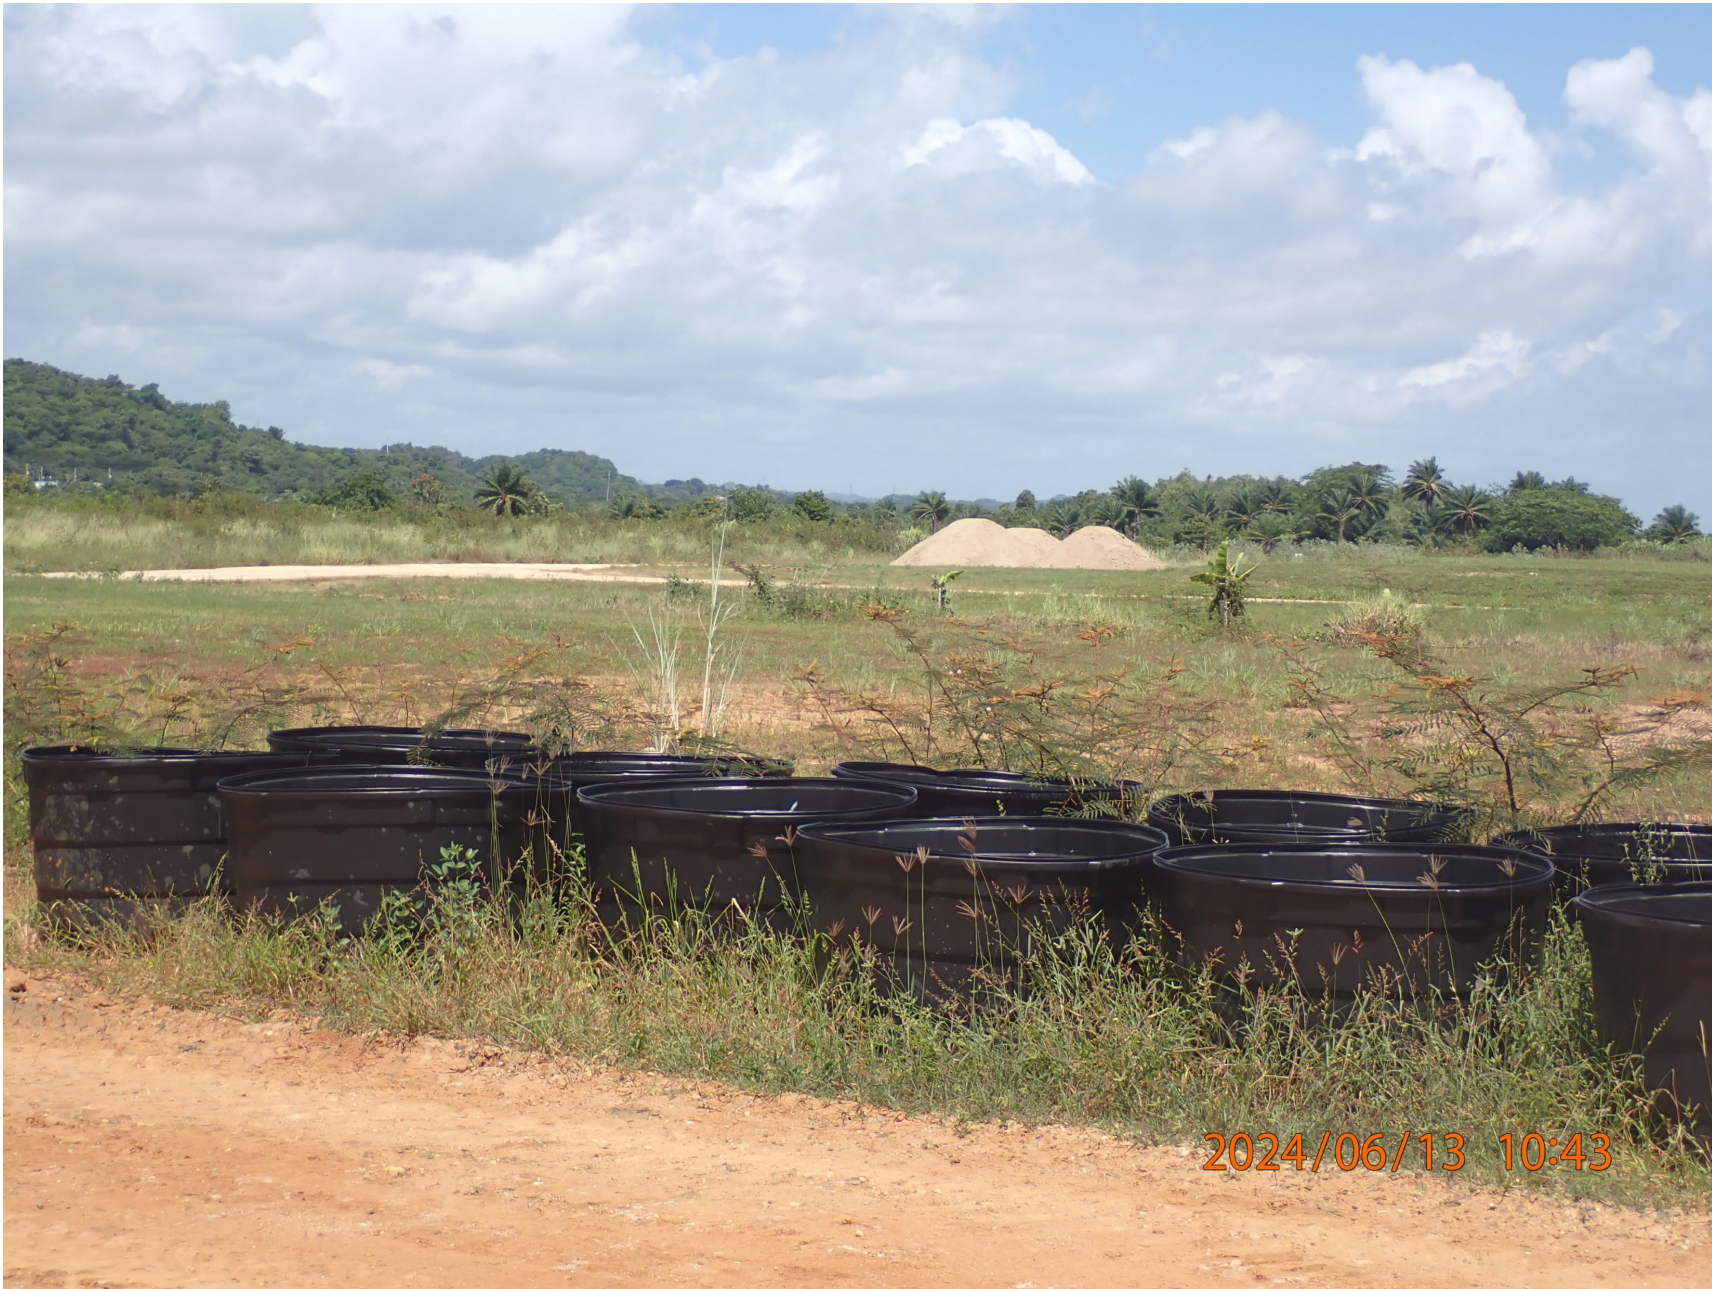
**Date:** June 13, 2024  
**Time:** 10:43 AM  
**Photographer:** Sofía Olivero Lora  
**Photo ID:** P6131052

**Description:** Panorama of the site. Piles of fill material and plastic tree planters can be seen throughout the property.

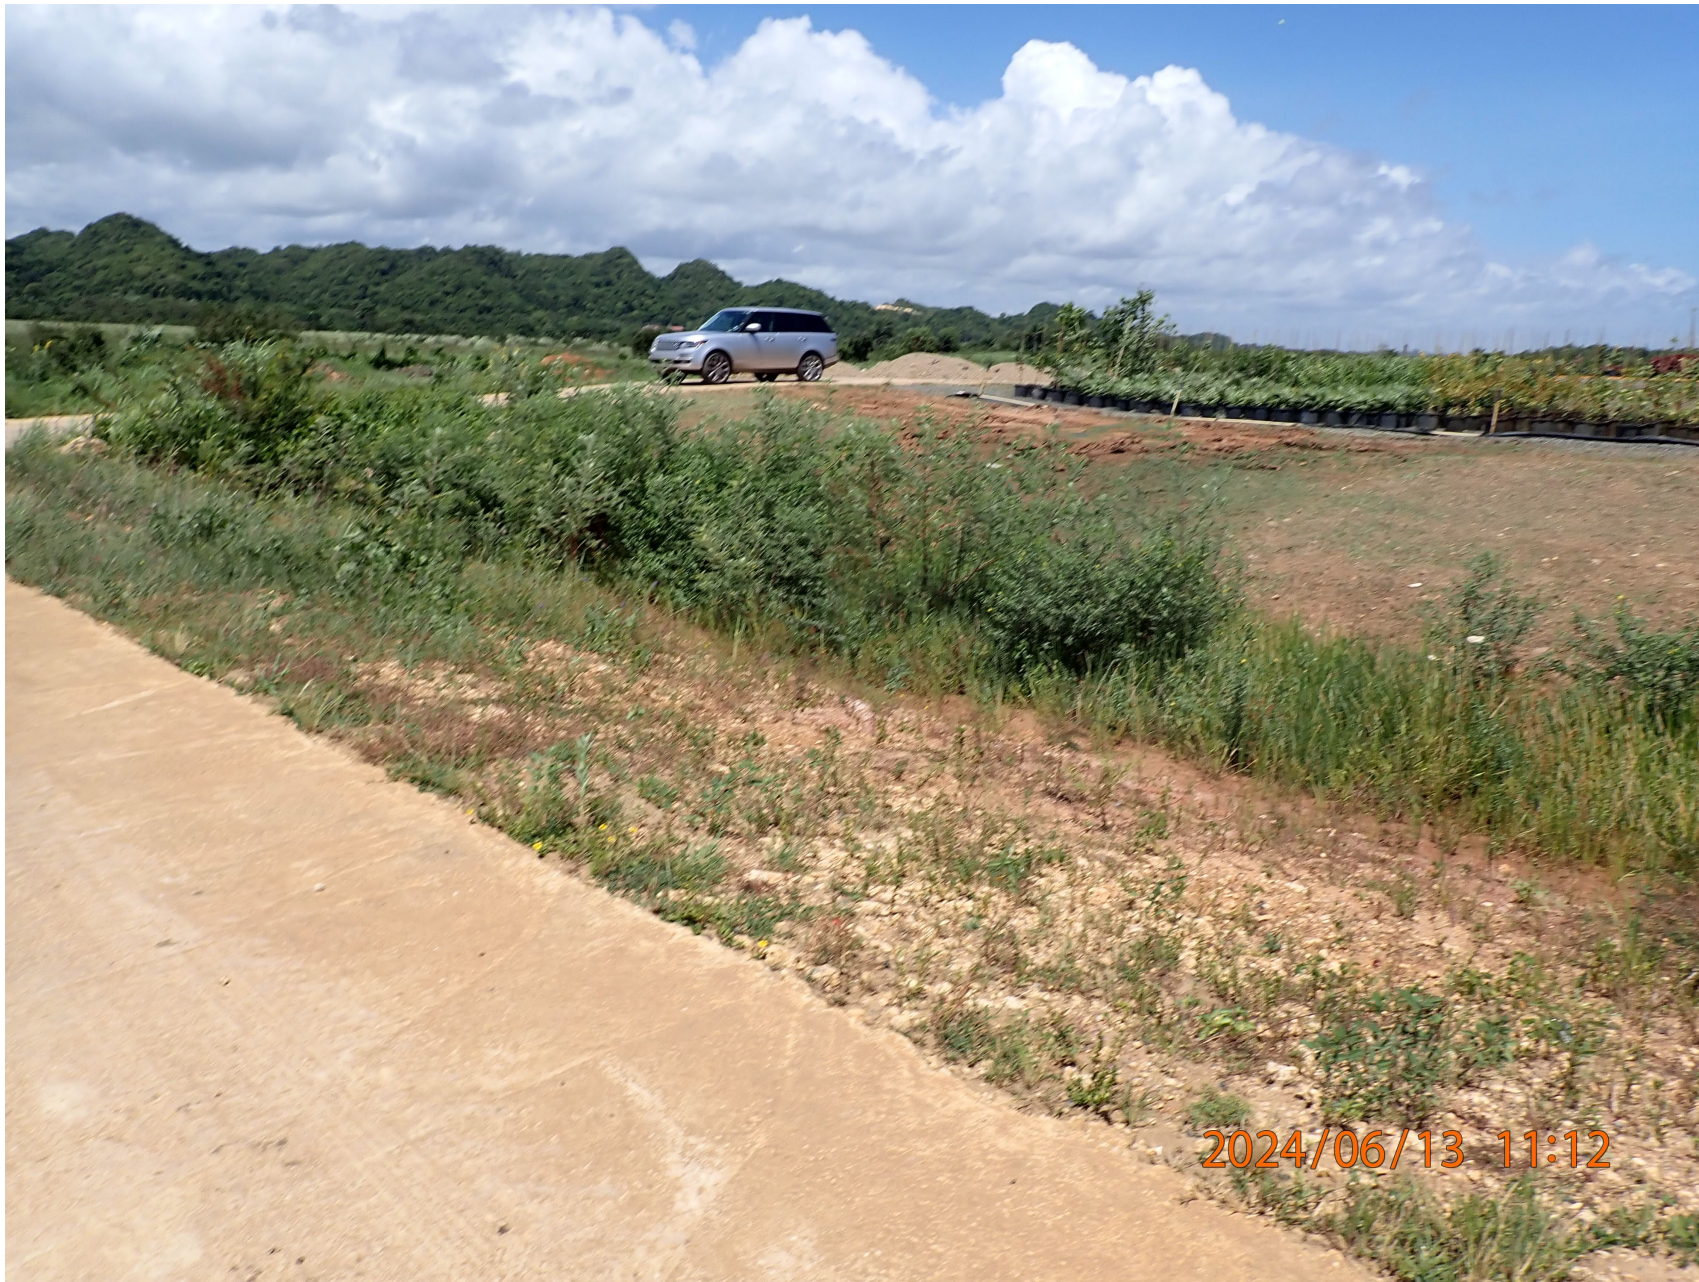
**Photo ID:** P6131069

**Description:** Panorama of the dirt paths on the property. Large planters were observed with avocado trees growing in them.

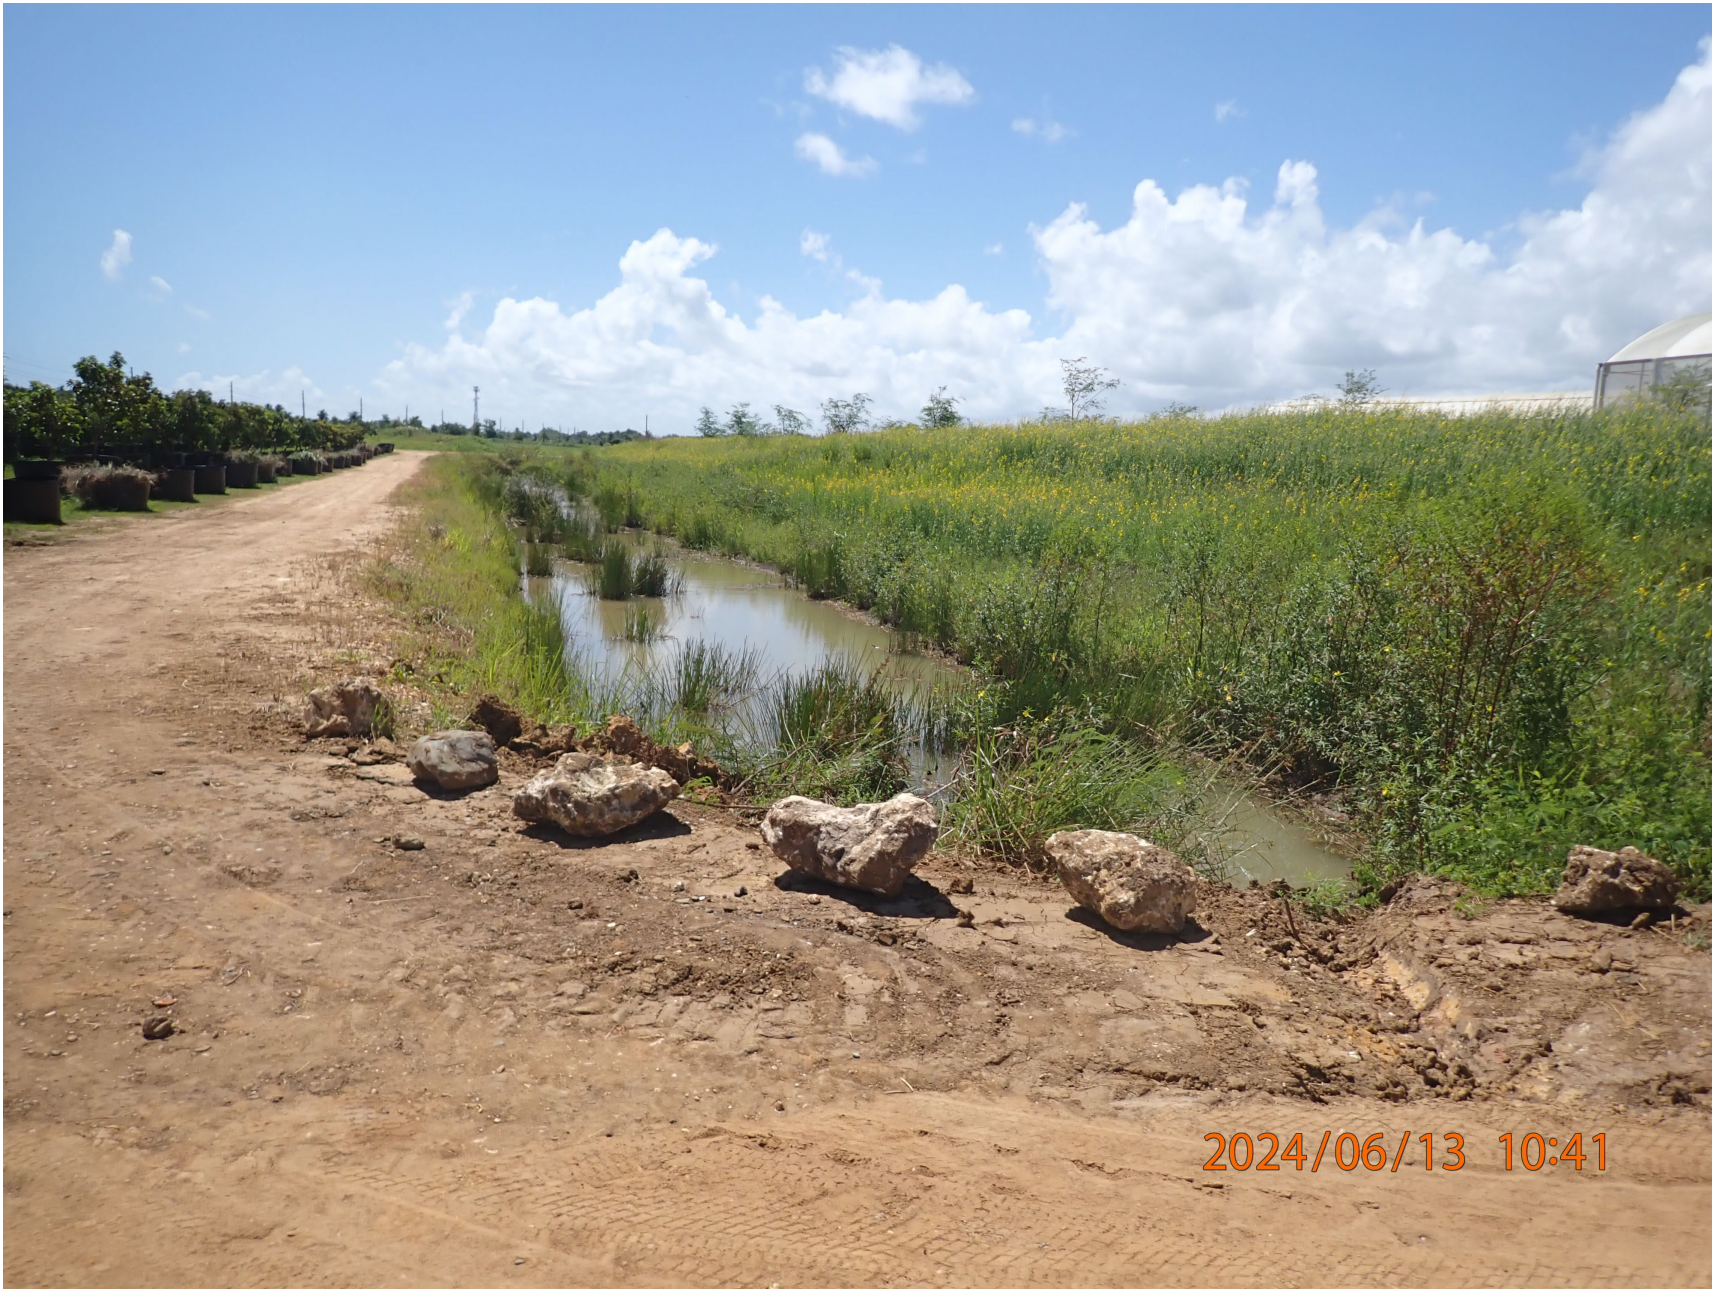
**Photo ID:** P6131049

**Description:** Along the dirt road that EPA walked, channelized ditching was observed.

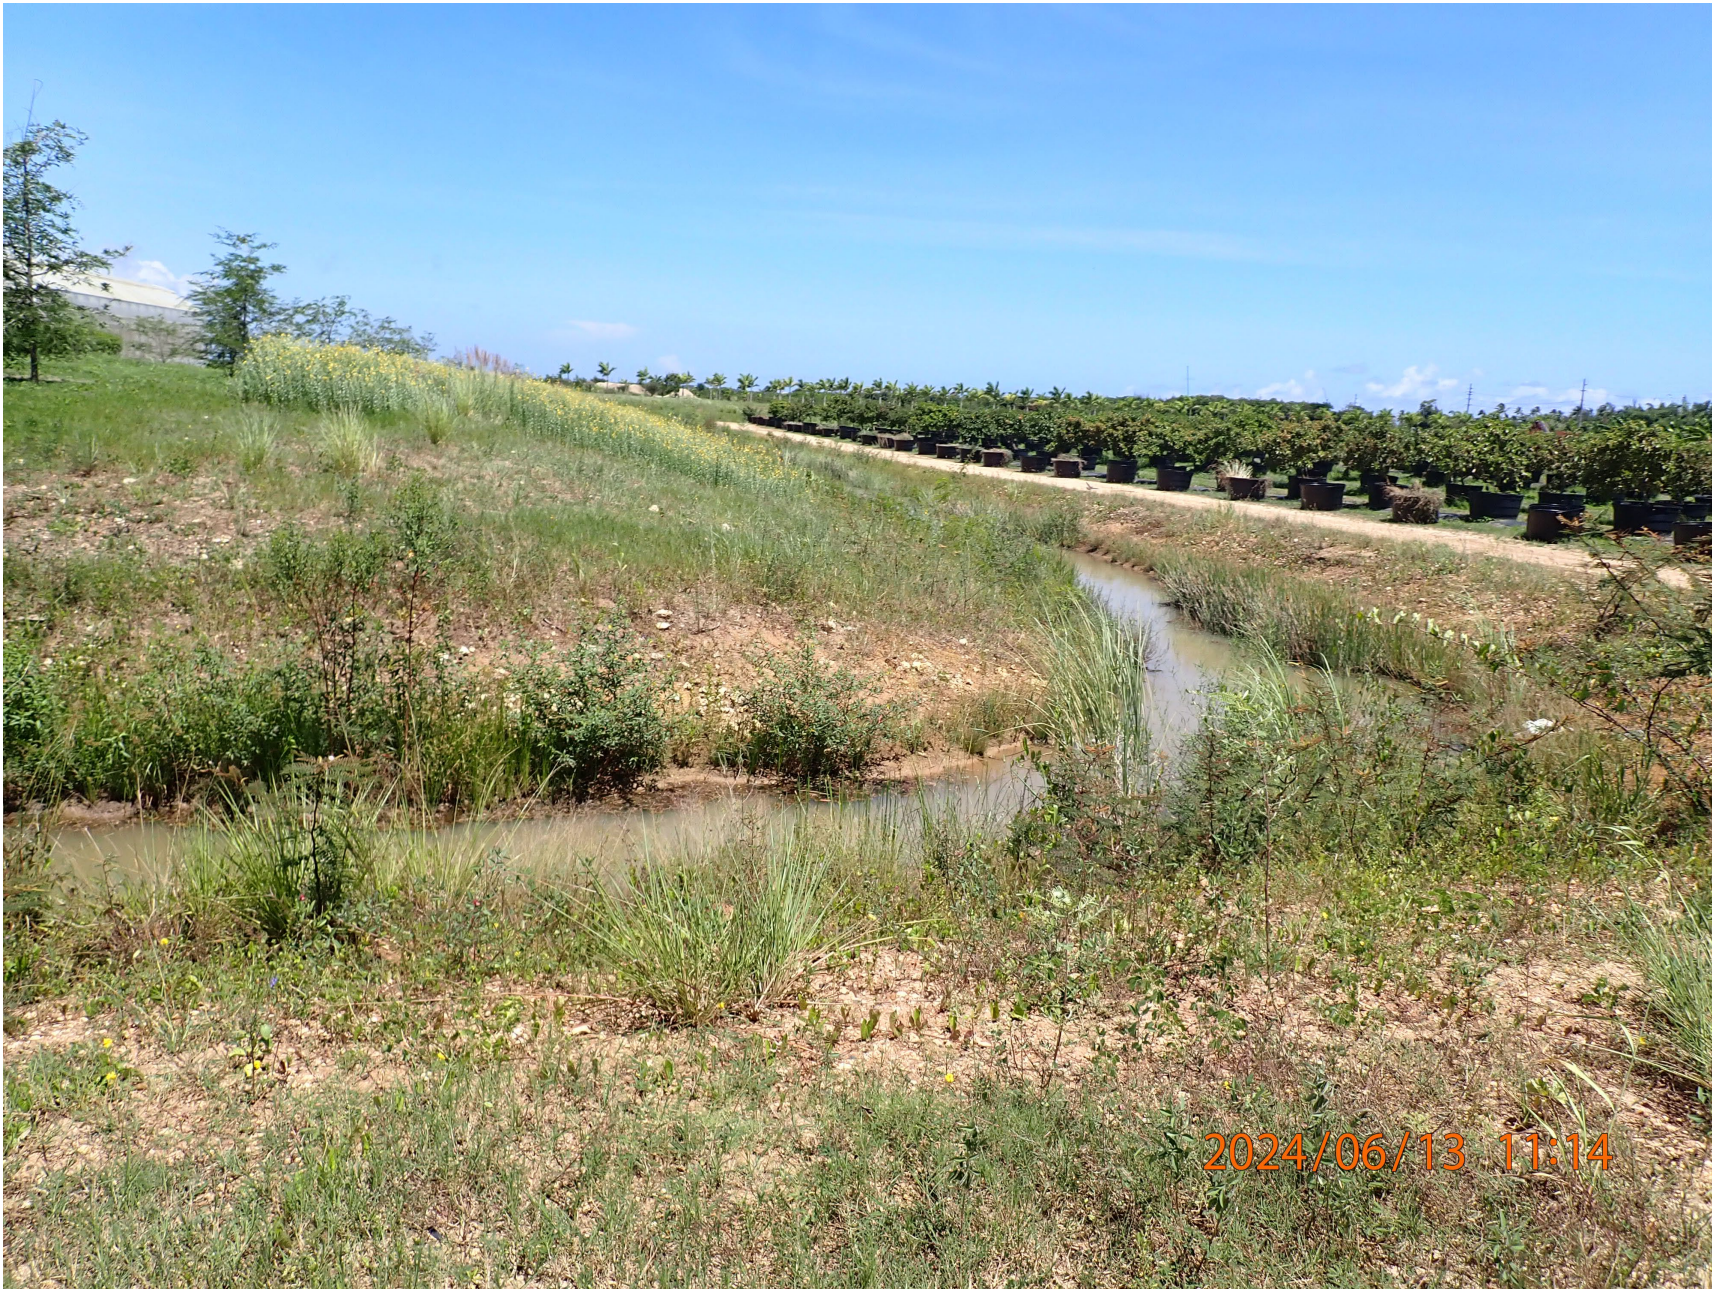
**Photo ID:** P6131072

**Description:** Along the dirt road that EPA walked, channelized ditching was observed. Avocado trees were also observed being grown in large plastic planters.

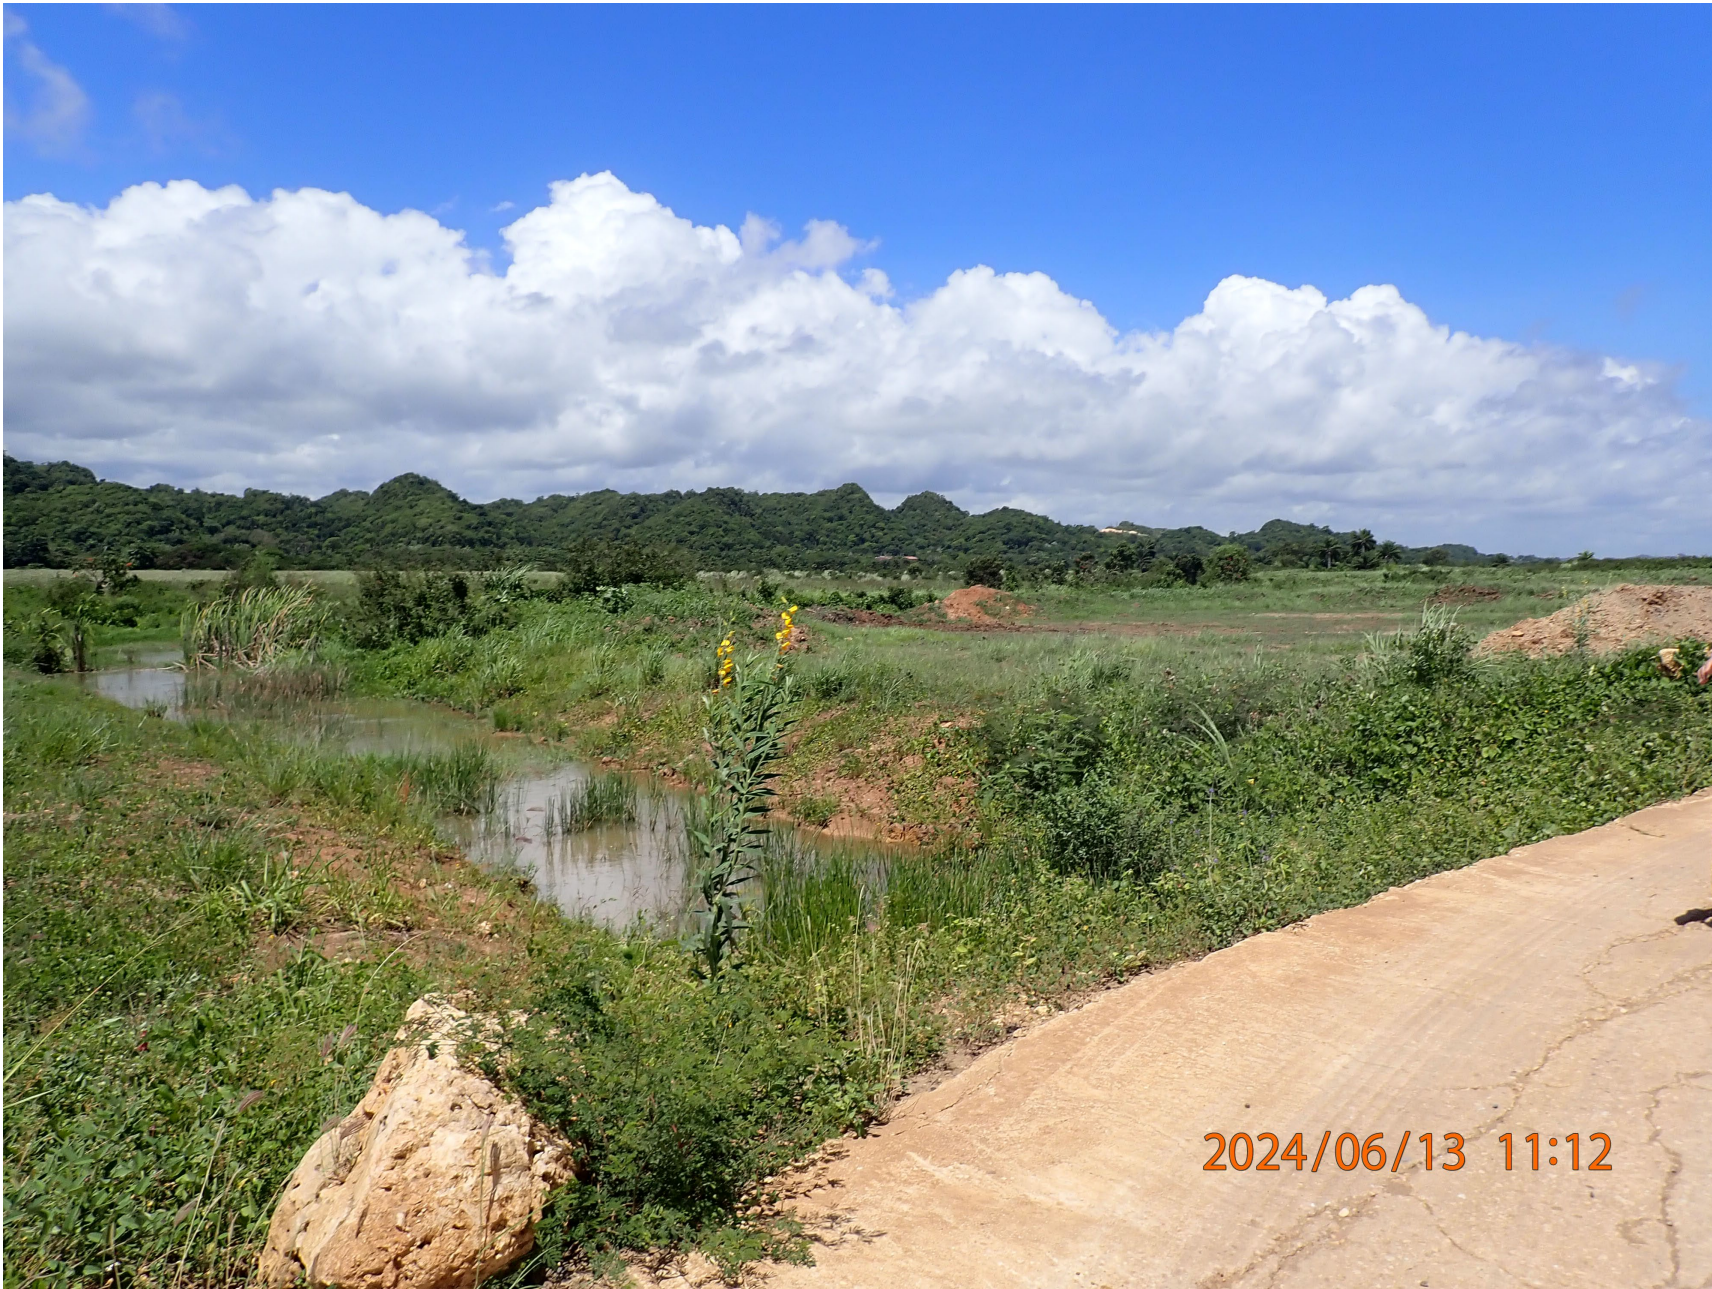
**Photo ID:** P6131070

**Description:** Along the dirt road that EPA walked, channelized ditching was observed.

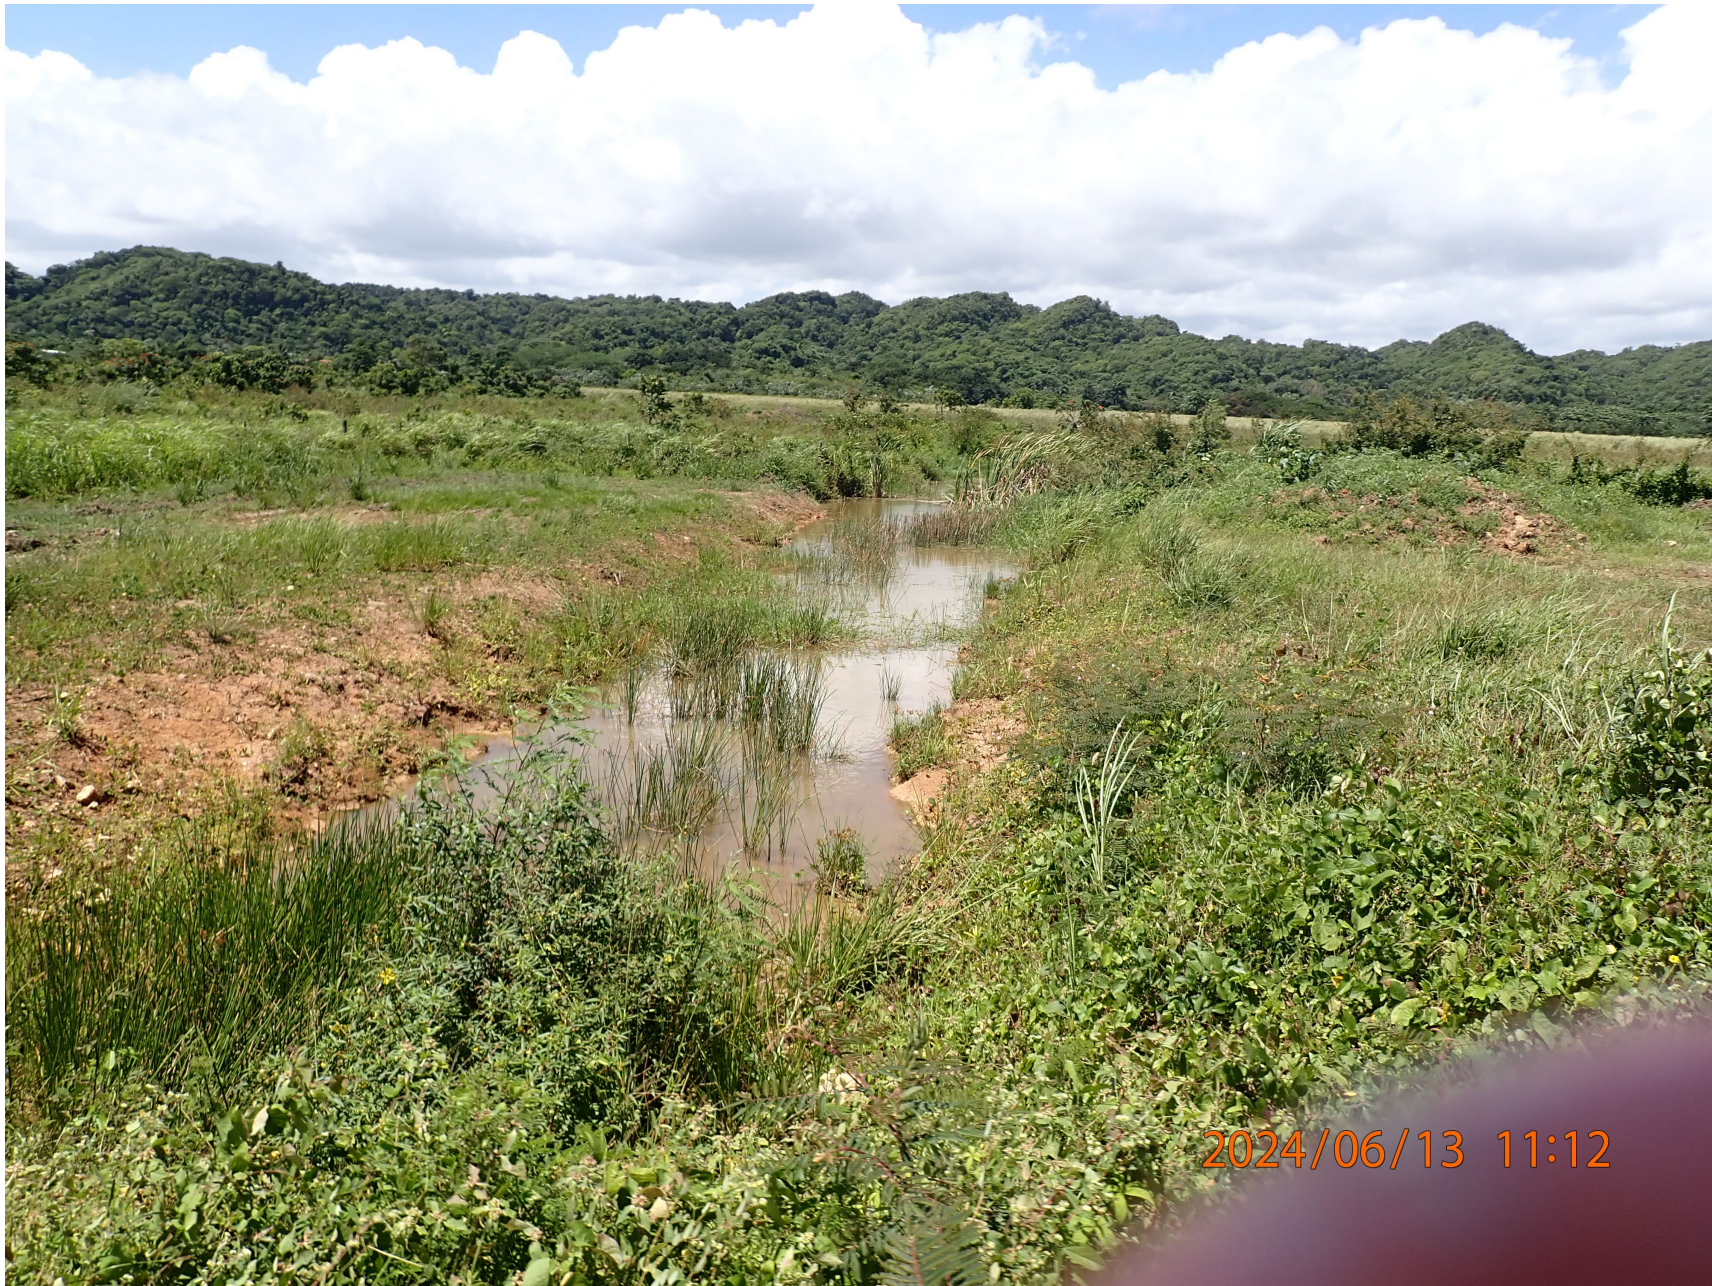
**Date:** June 13, 2024  
**Time:** 11:08 AM  
**Photographer:** Sofía Olivero Lora  
**Photo ID:** P6131068

**Description:** Along the dirt road that EPA walked, channelized ditching was observed.

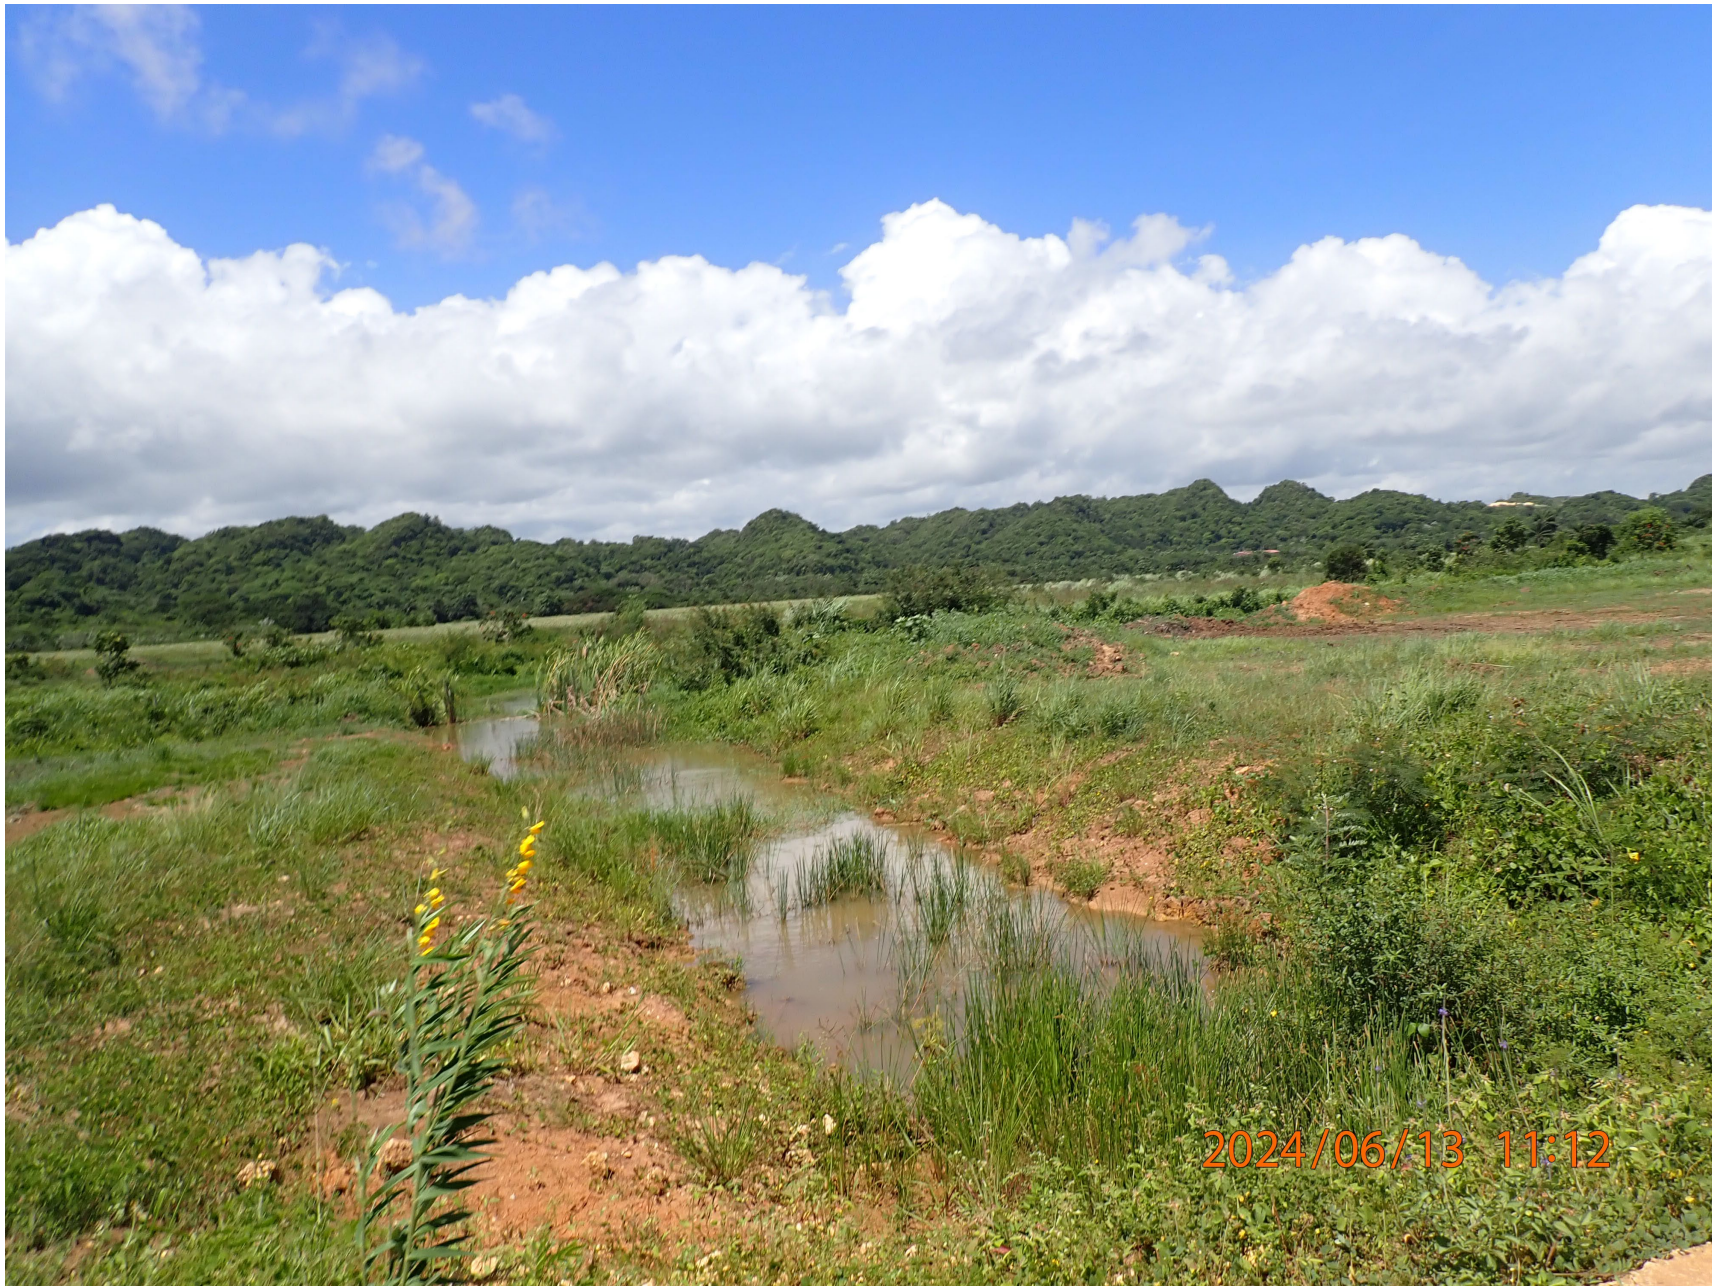
**Date:** June 13, 2024  
**Time:** 11:12 AM  
**Photographer:** Sofía Olivero Lora  
**Photo ID:** P6131069

**Description:** Along the dirt road that EPA walked, channelized ditching was observed.

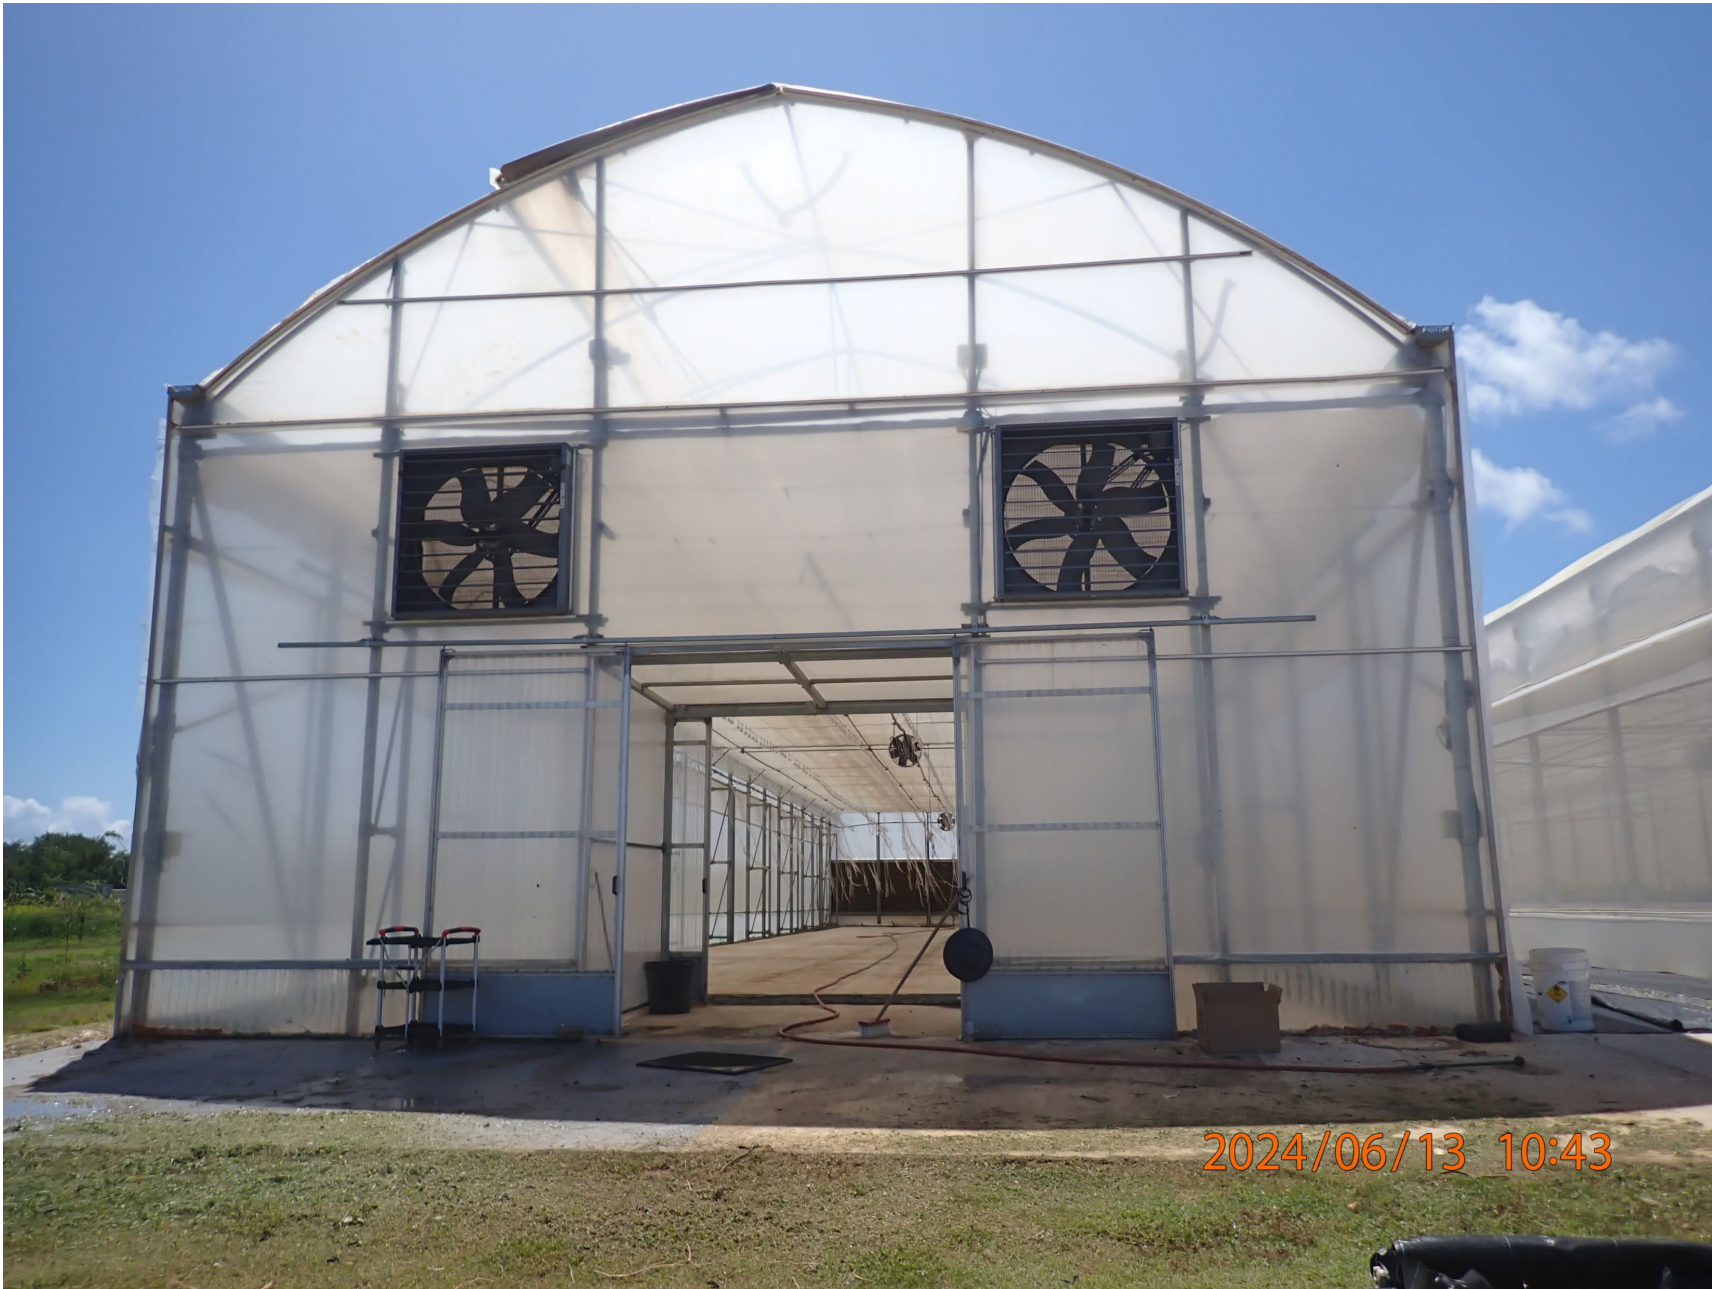
**Photo ID:** P6131051

**Description:** One of the large greenhouses built on the property.

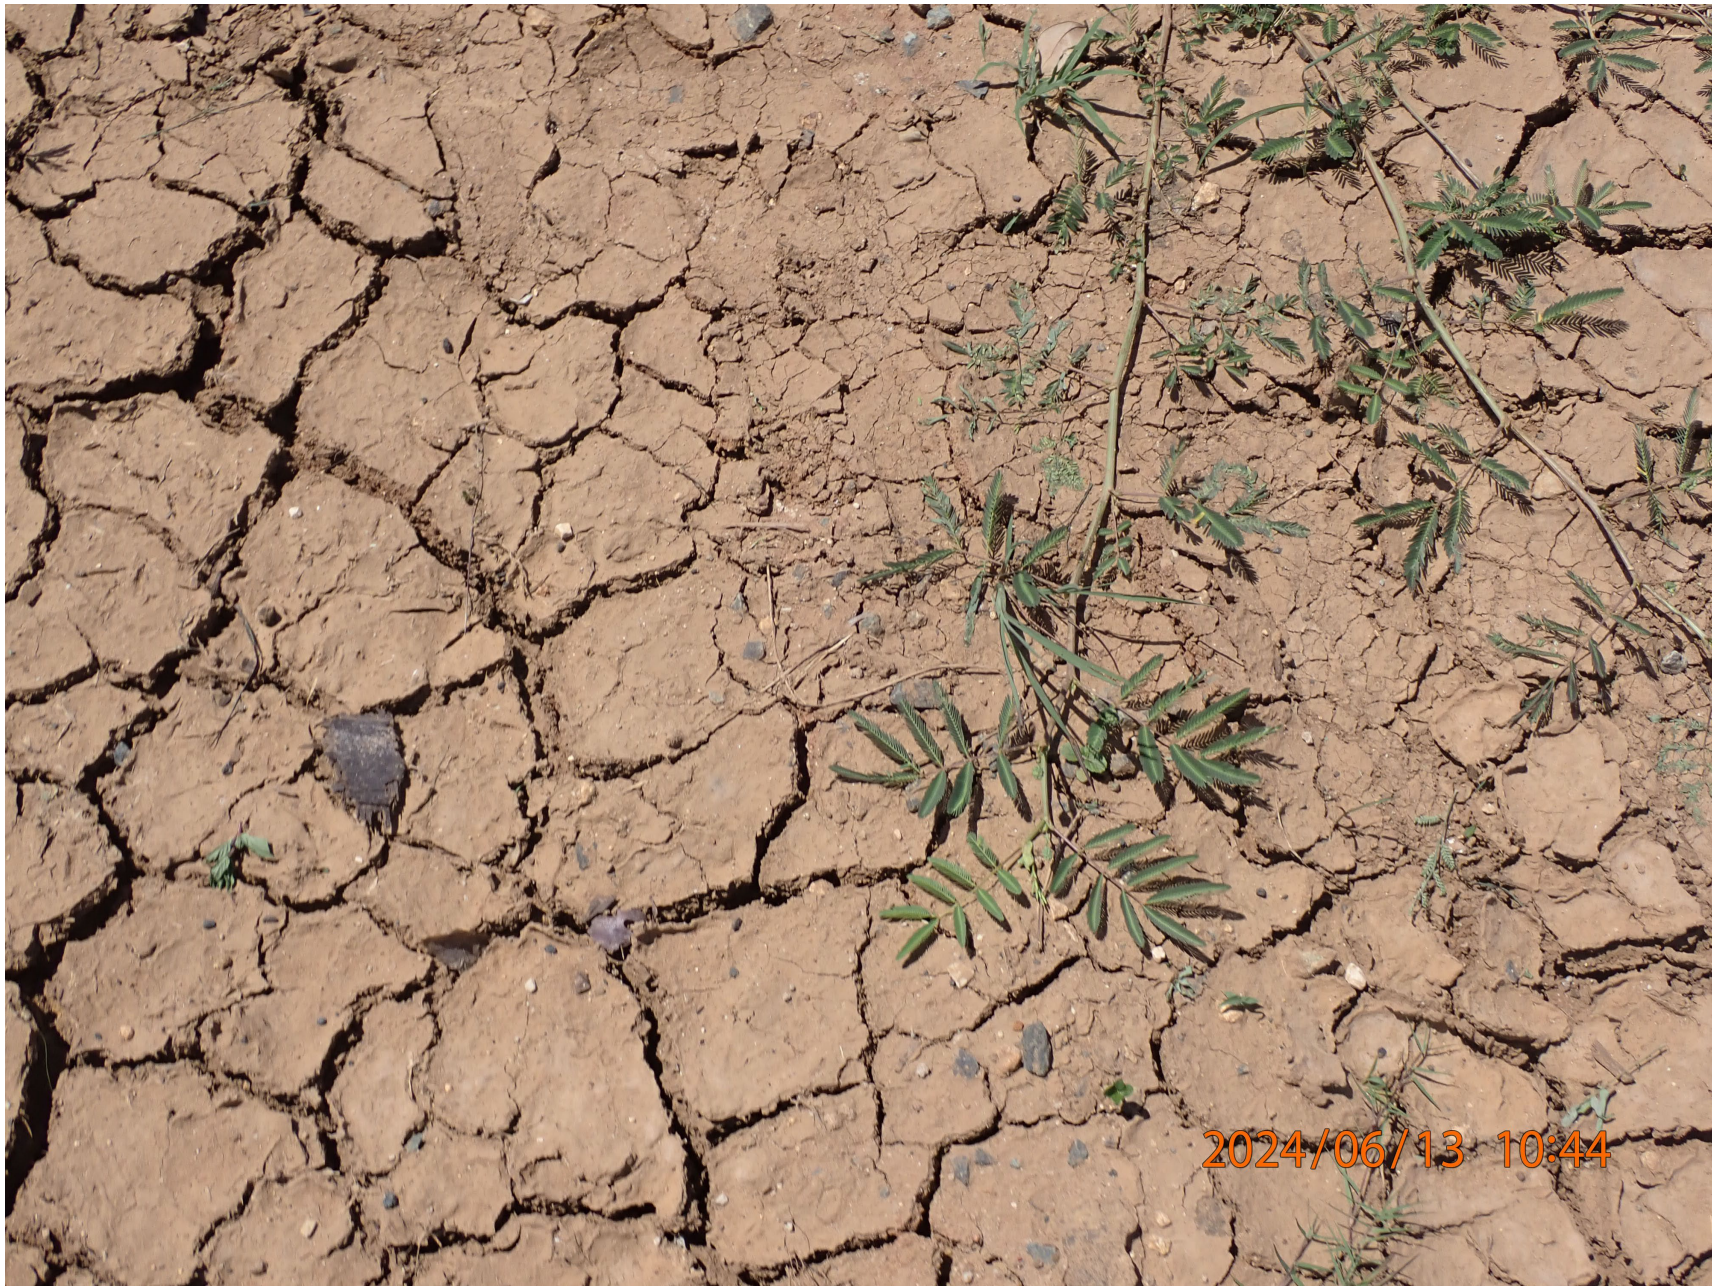
**Photo ID:** P6131054

**Description:** Surface soil cracks can be found throughout the property.

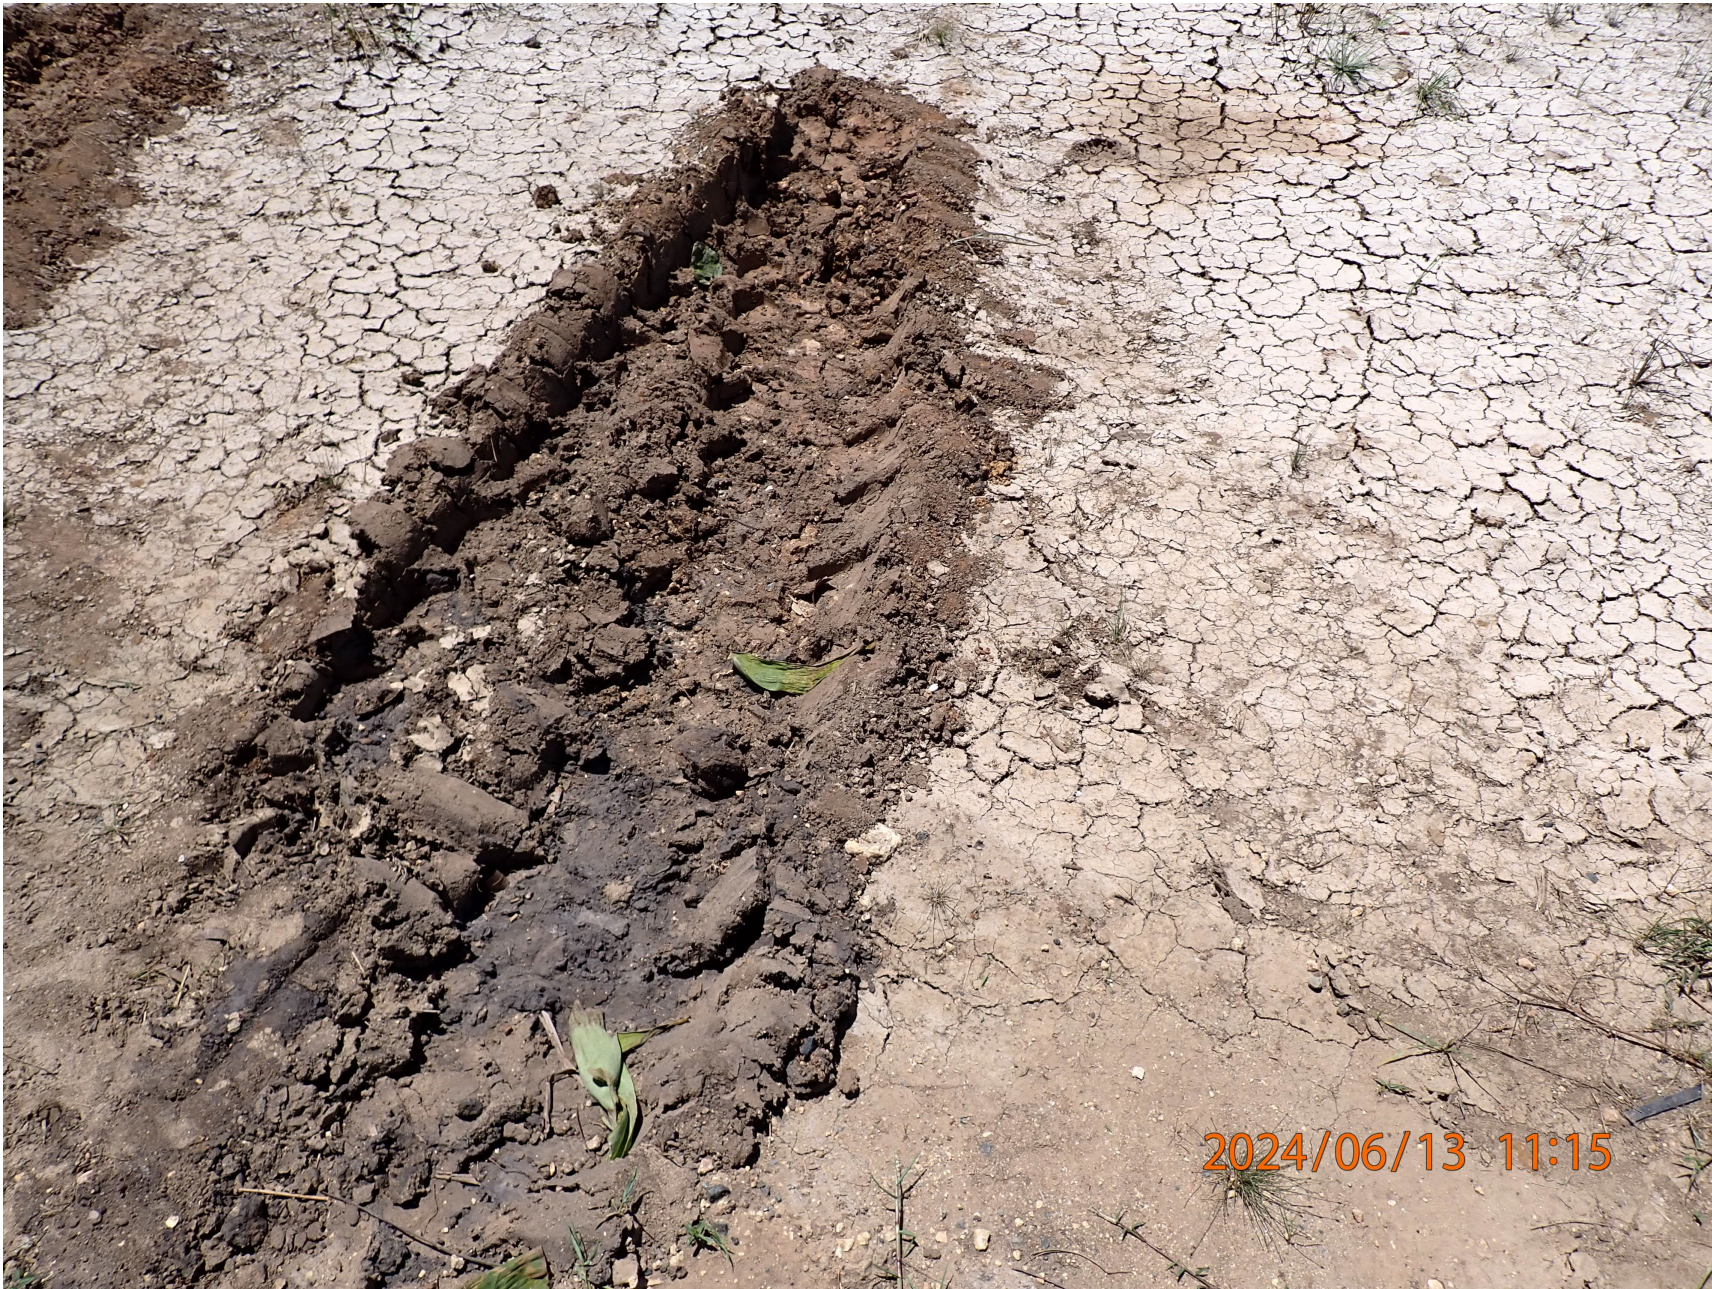
**Photo ID:** P6131073

**Description:** Surface soil cracks can be found throughout the property. Tire tracks were also observed in the mud in areas cleared of vegetation.
