## Clean Water Act Section 404: Site Visit/Case Development

| Site Name | DBR Dorado Owner, LLC | | | | |
| Site Address* | Tax parcel 037-000-001-07-000 | | | | |

## Attachment B: Photolog

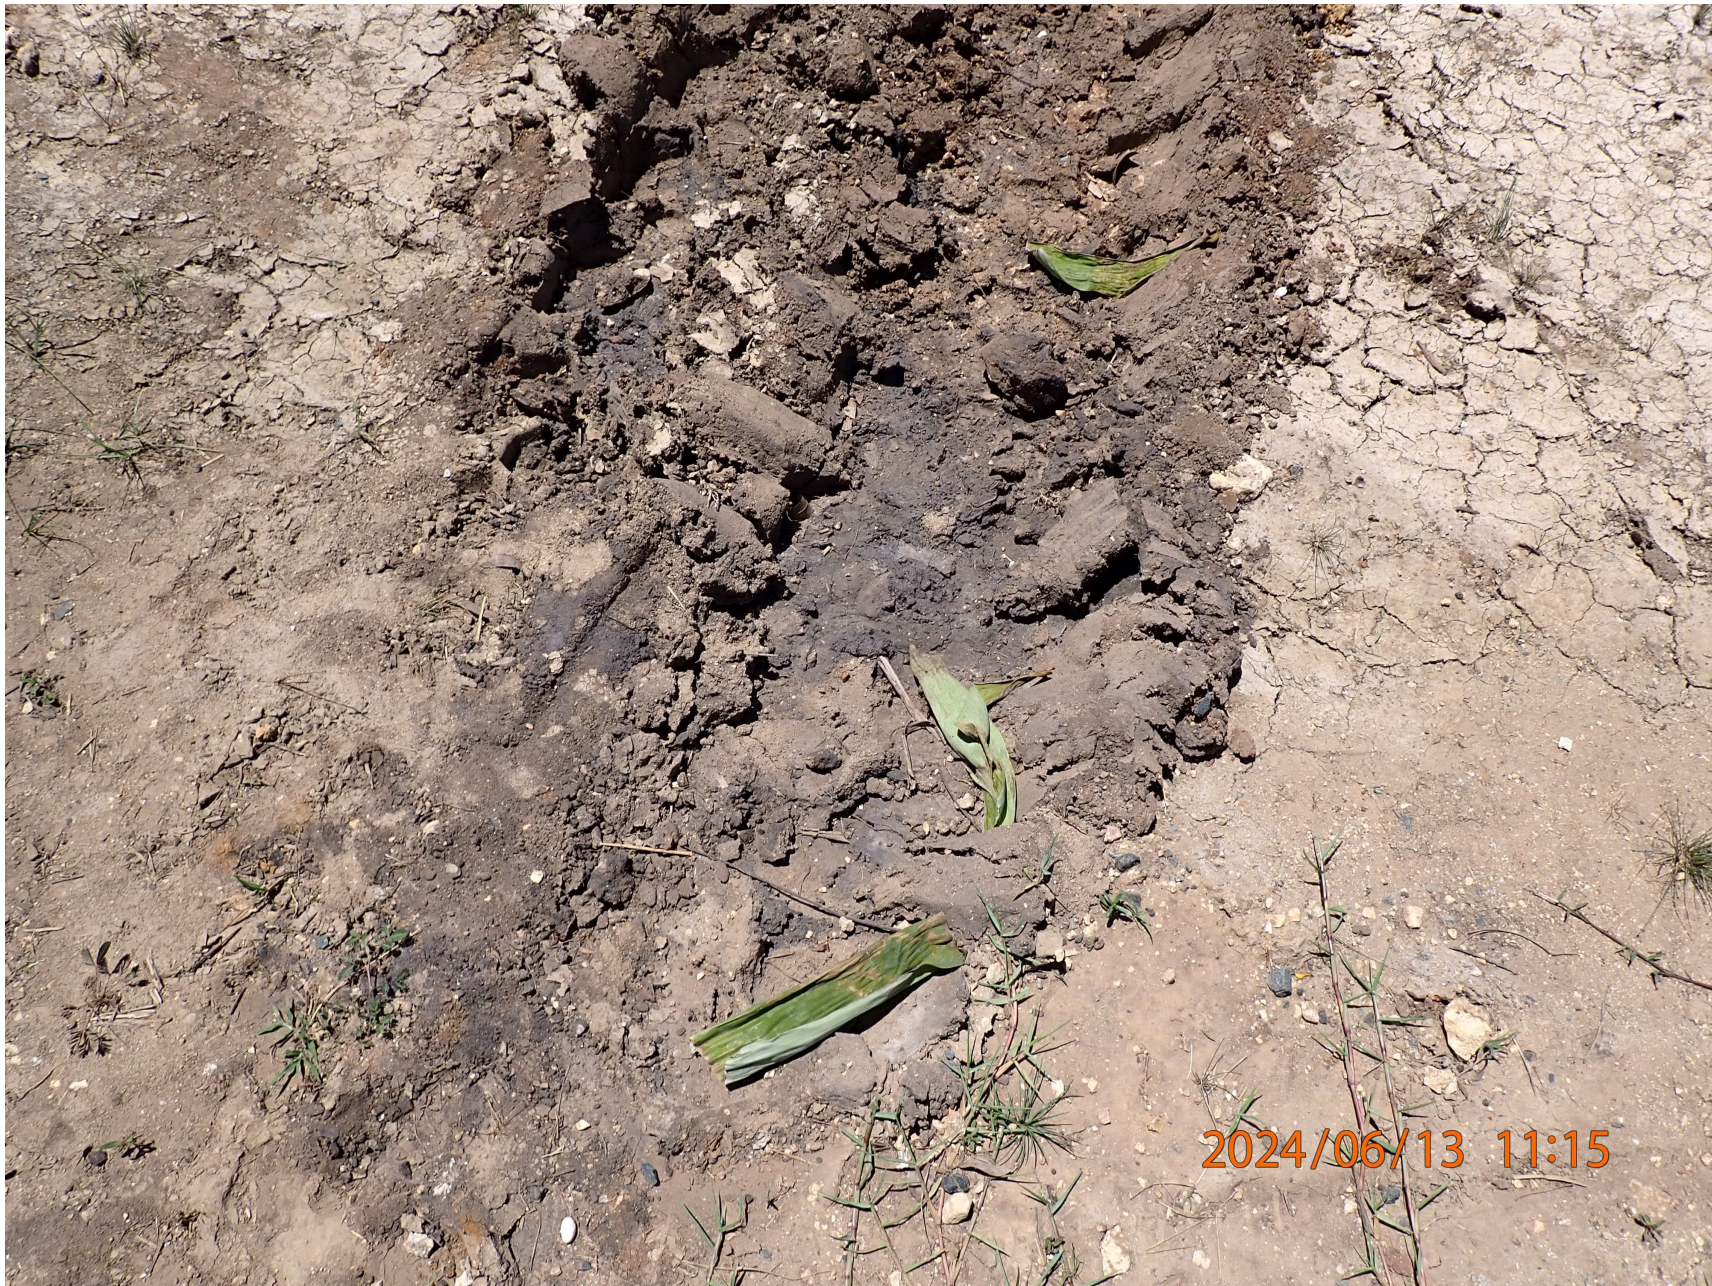
**Date:** June 13, 2024  
**Time:** 11:08 AM  
**Photographer:** Sofía Olivero Lora  
**Photo ID:** P6131074

**Description:** Surface soil cracks can be found throughout the property. Tire tracks were also observed in the mud in areas cleared of vegetation.

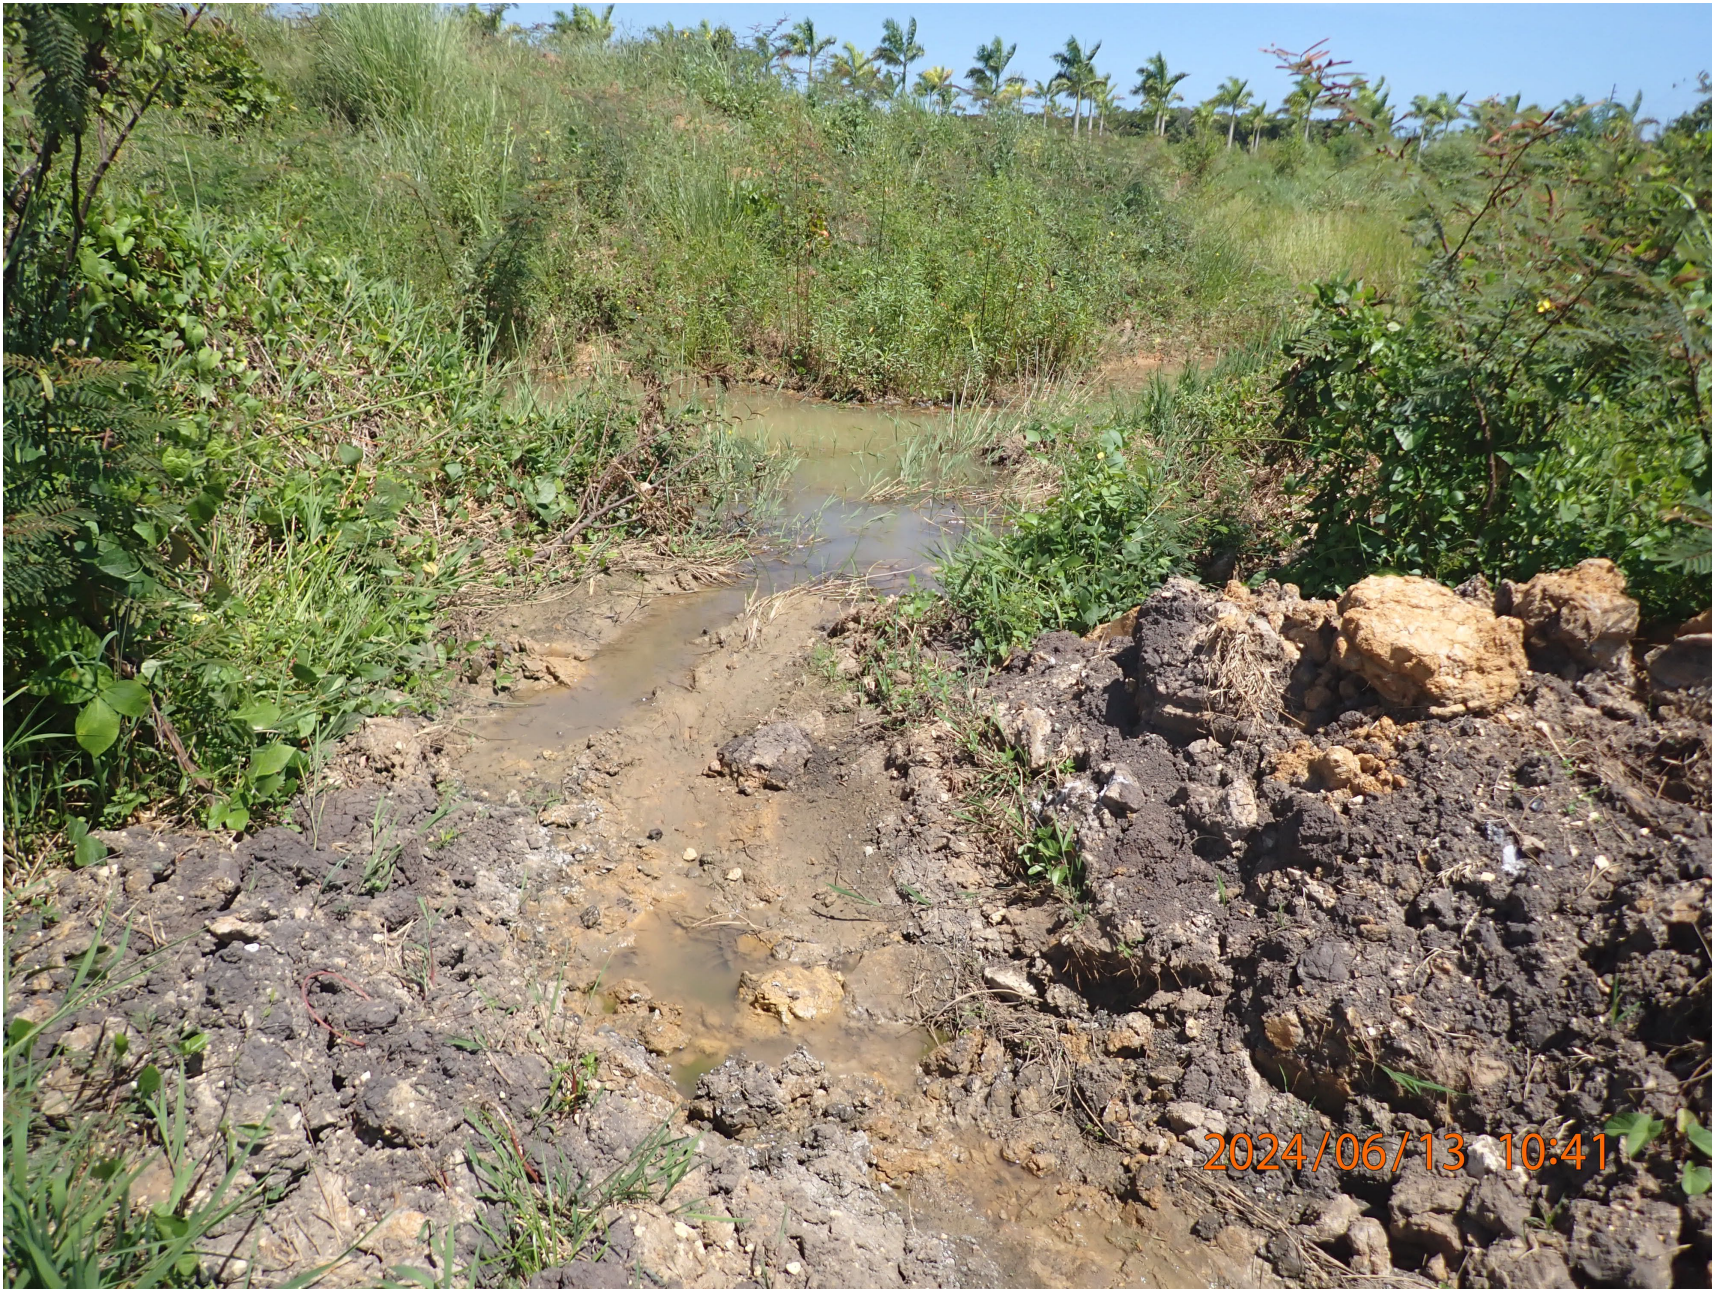
**Photo ID:** P6131046

**Description:** One of the pools of surface water observed on the property. Vegetative clearing and fill material observed along side the dirt path EPA walked during the visit.

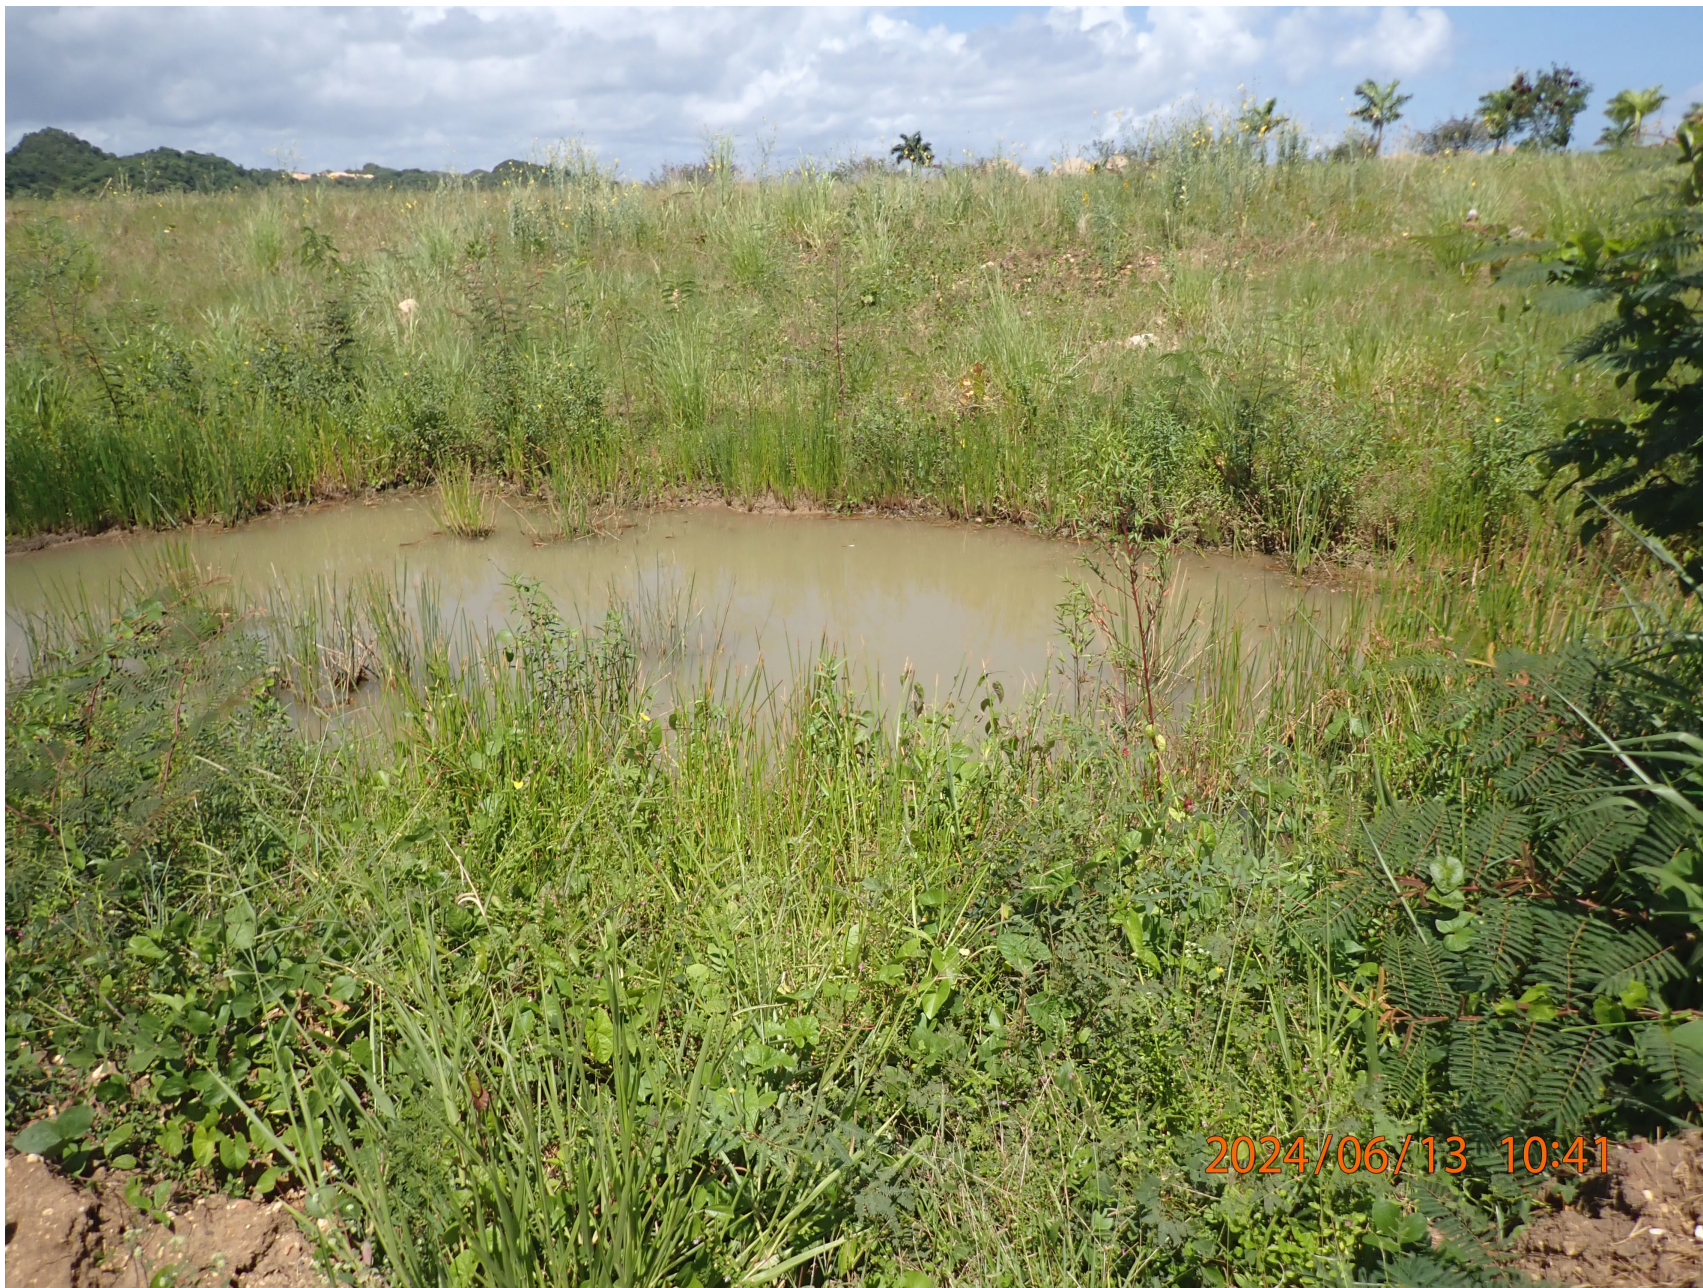
**Photo ID:** P6131048

**Description:** Panorama of the vegetation and hydrology on the property. Pools of surface water were observed on the property.

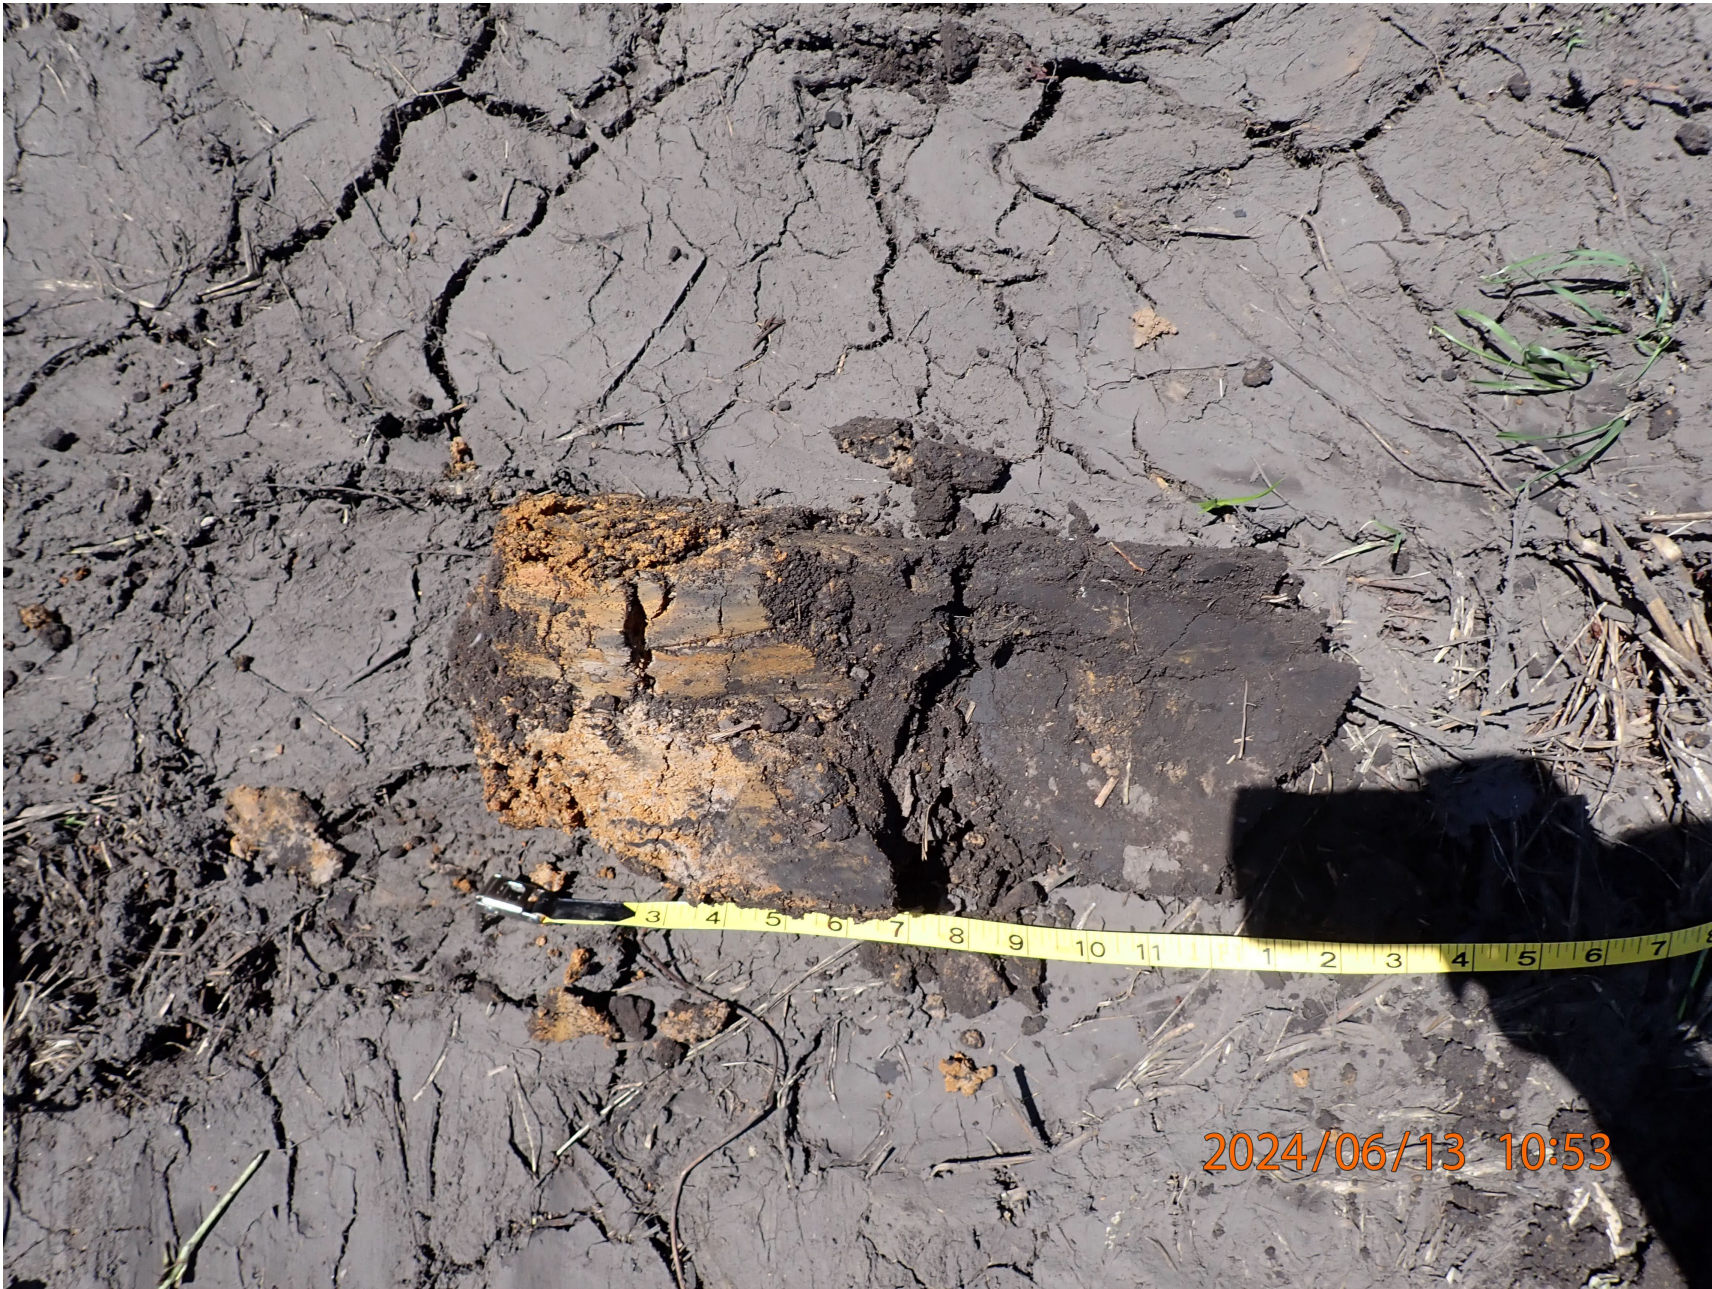
**Photo ID:** P6131060

**Description:** Soil sample that EPA dug up to evaluate for wetland indicators.

Soils in the surrounding area has been impacted from earth moving activities. There is no evidence of fill material over native soils in the location of the soil pit sample.

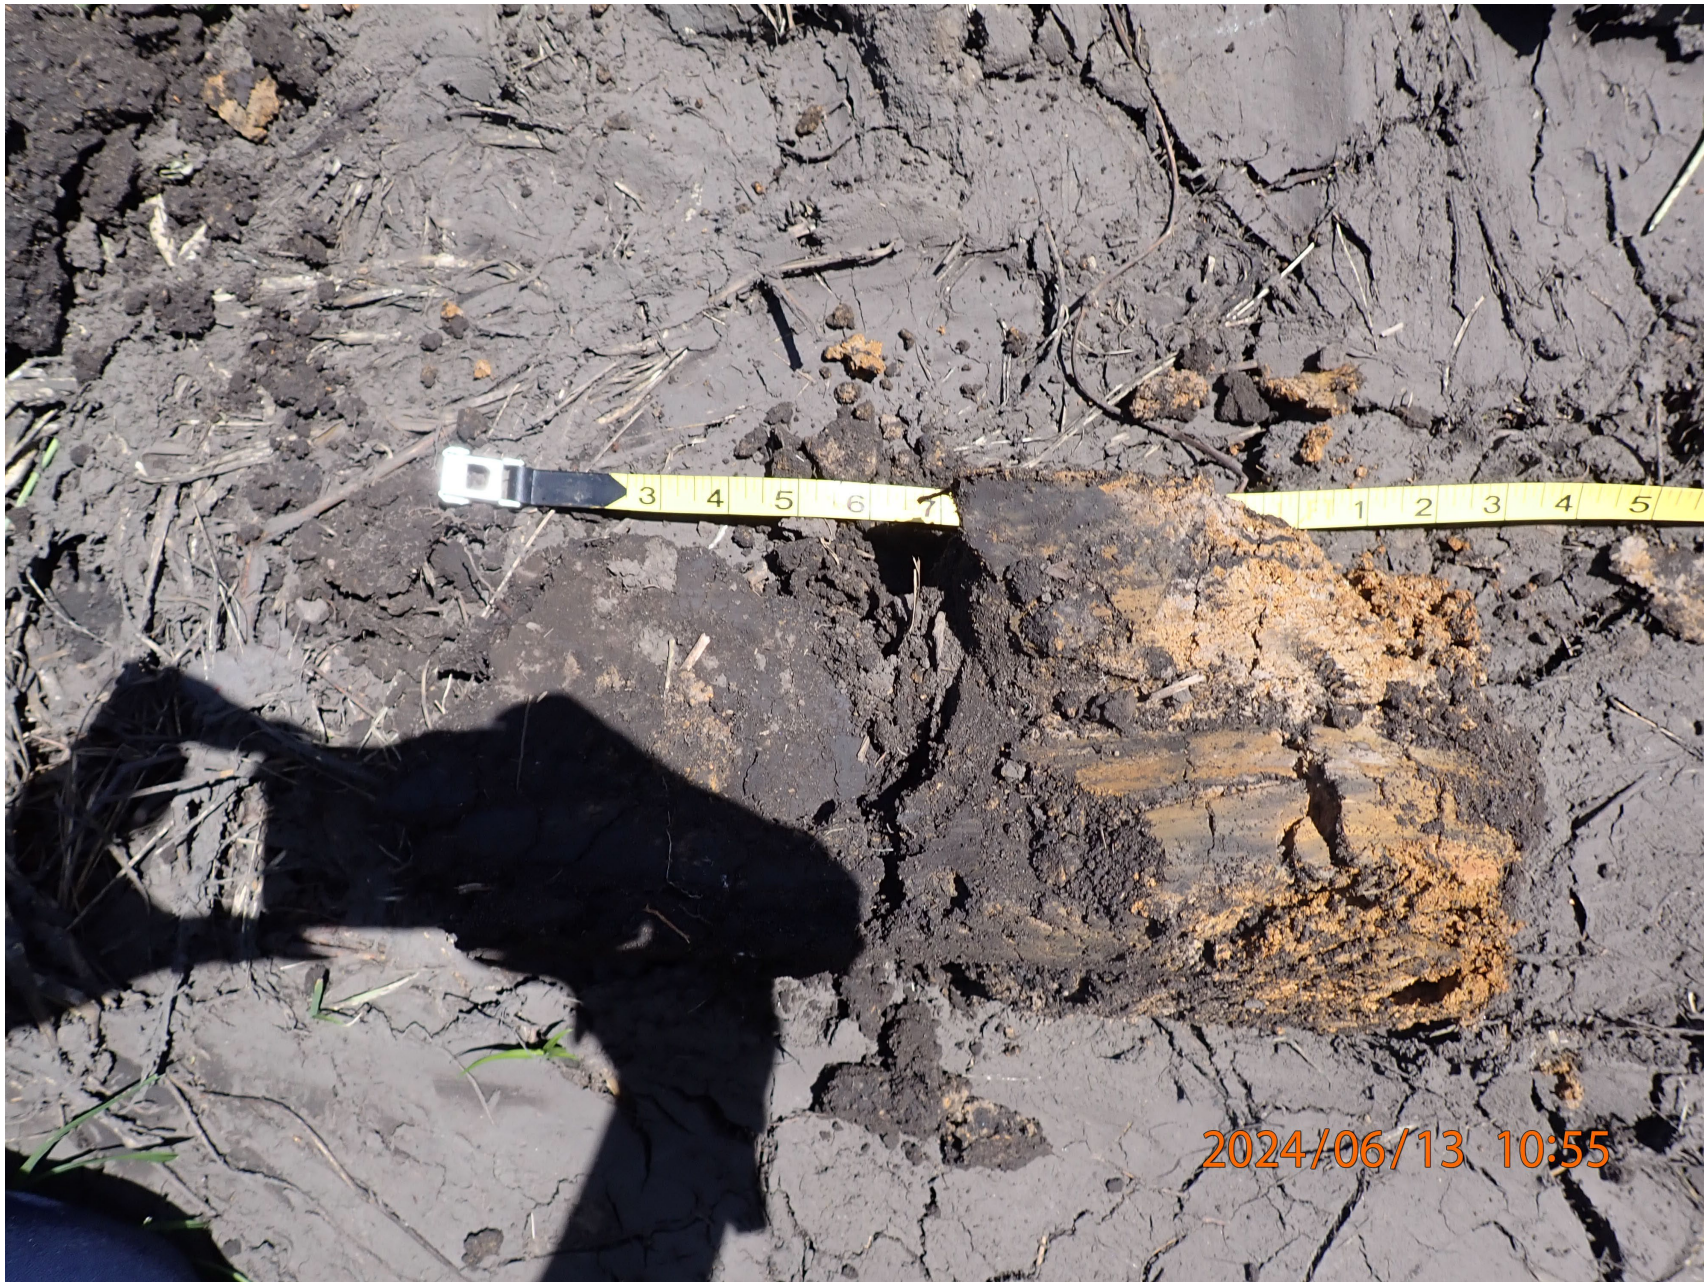
**Photo ID:** P6131061

**Description:** Soil sample that EPA dug up to evaluate for wetland indicators.

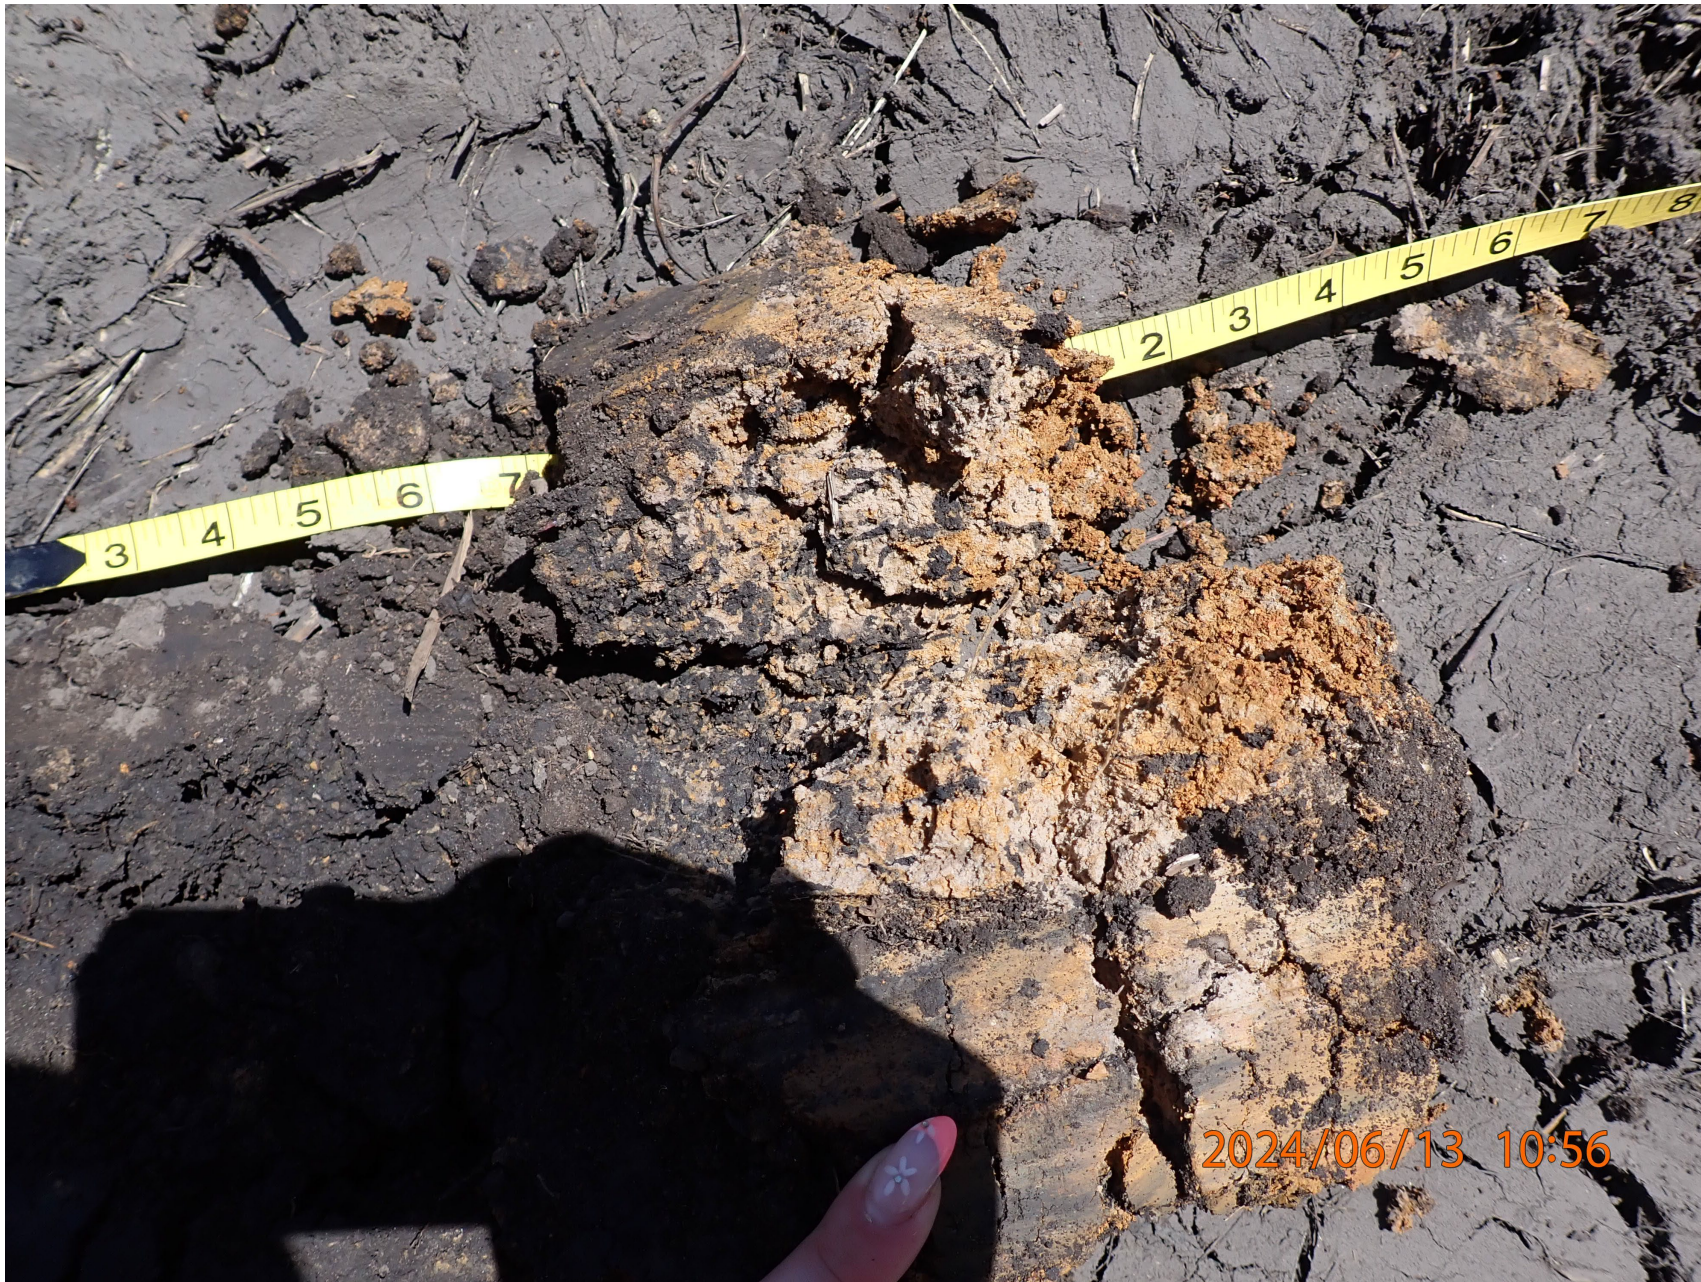
**Photo ID:** P6131062

**Description:** Soil sample that EPA dug up to evaluate for wetland indicators.

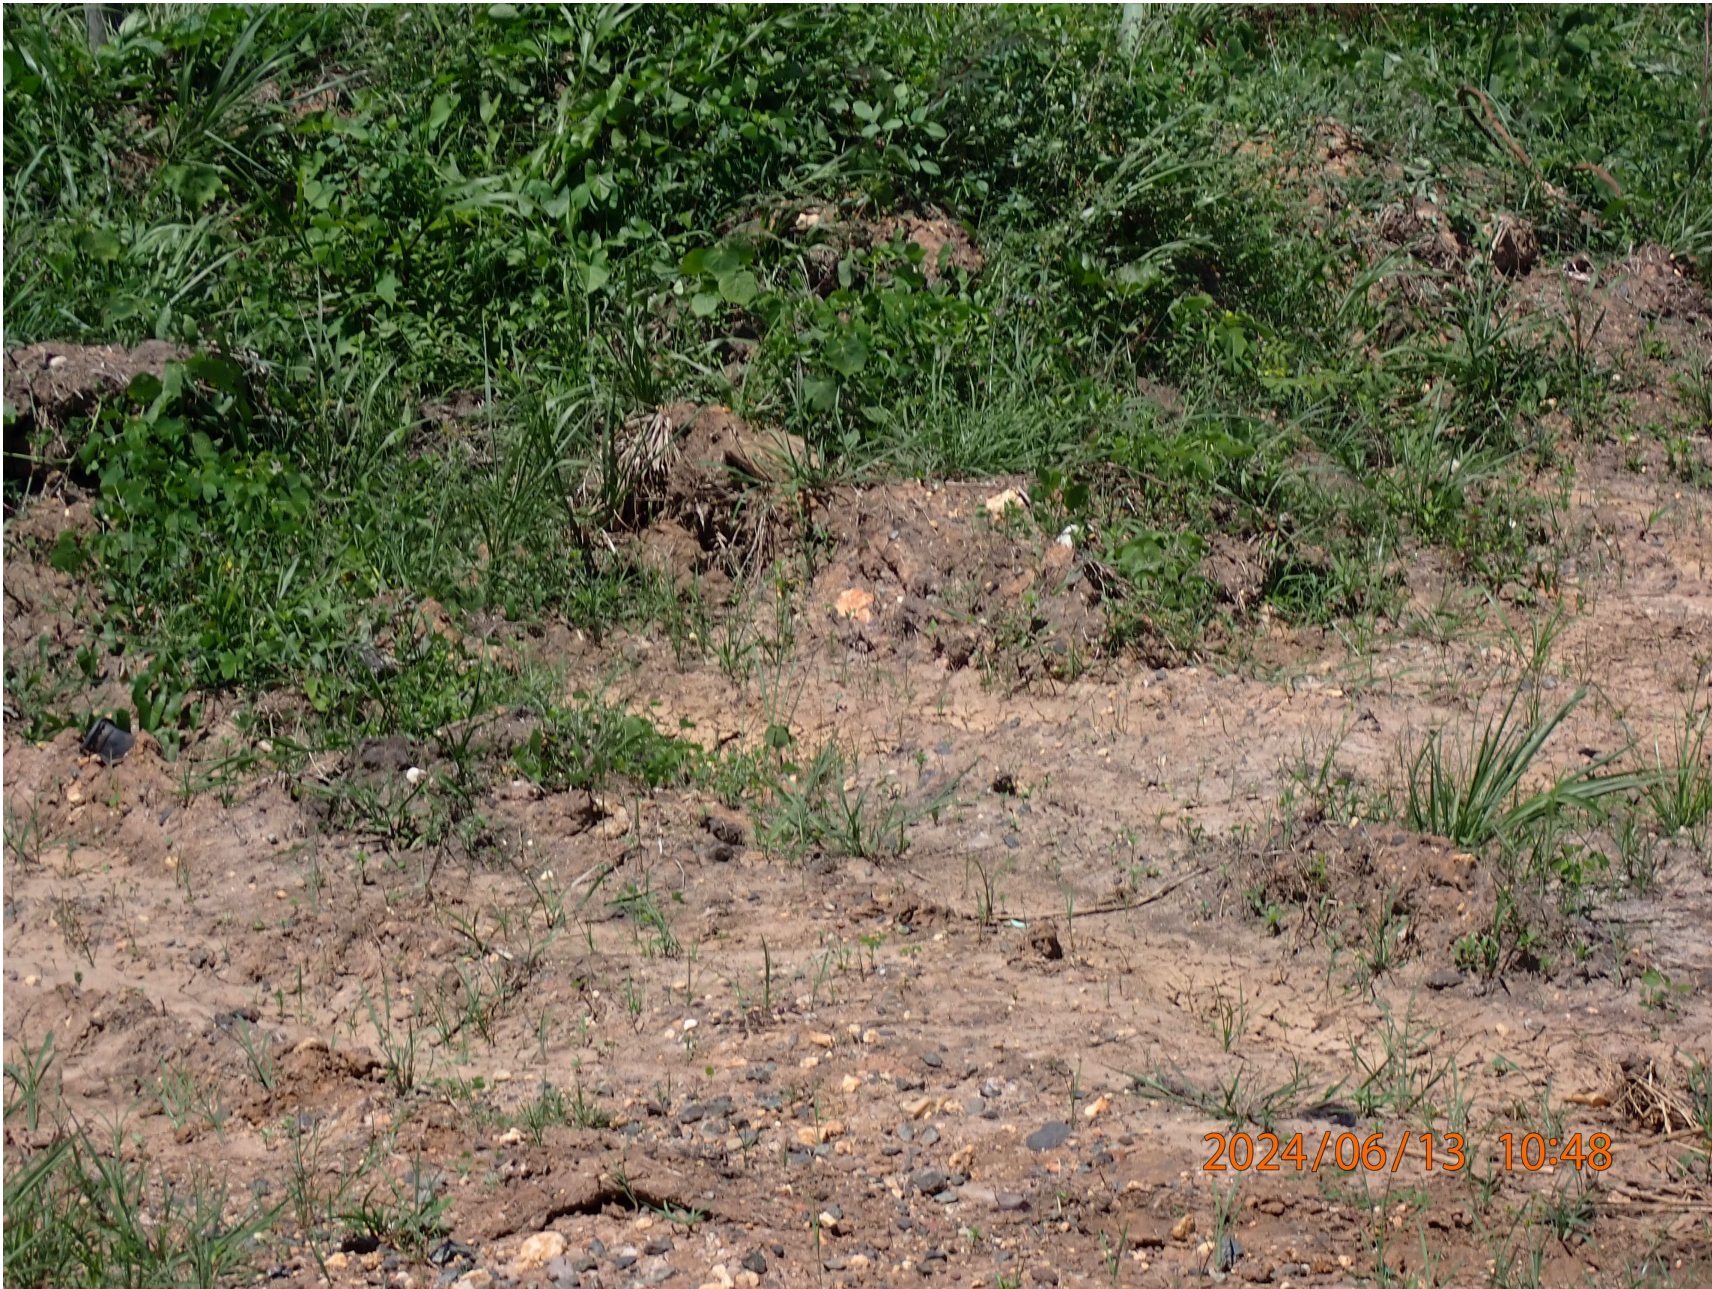
**Photo ID:** P6131057

**Description:** Vegetative clearing and fill material observed surrounding the area where EPA dug a soil pit.

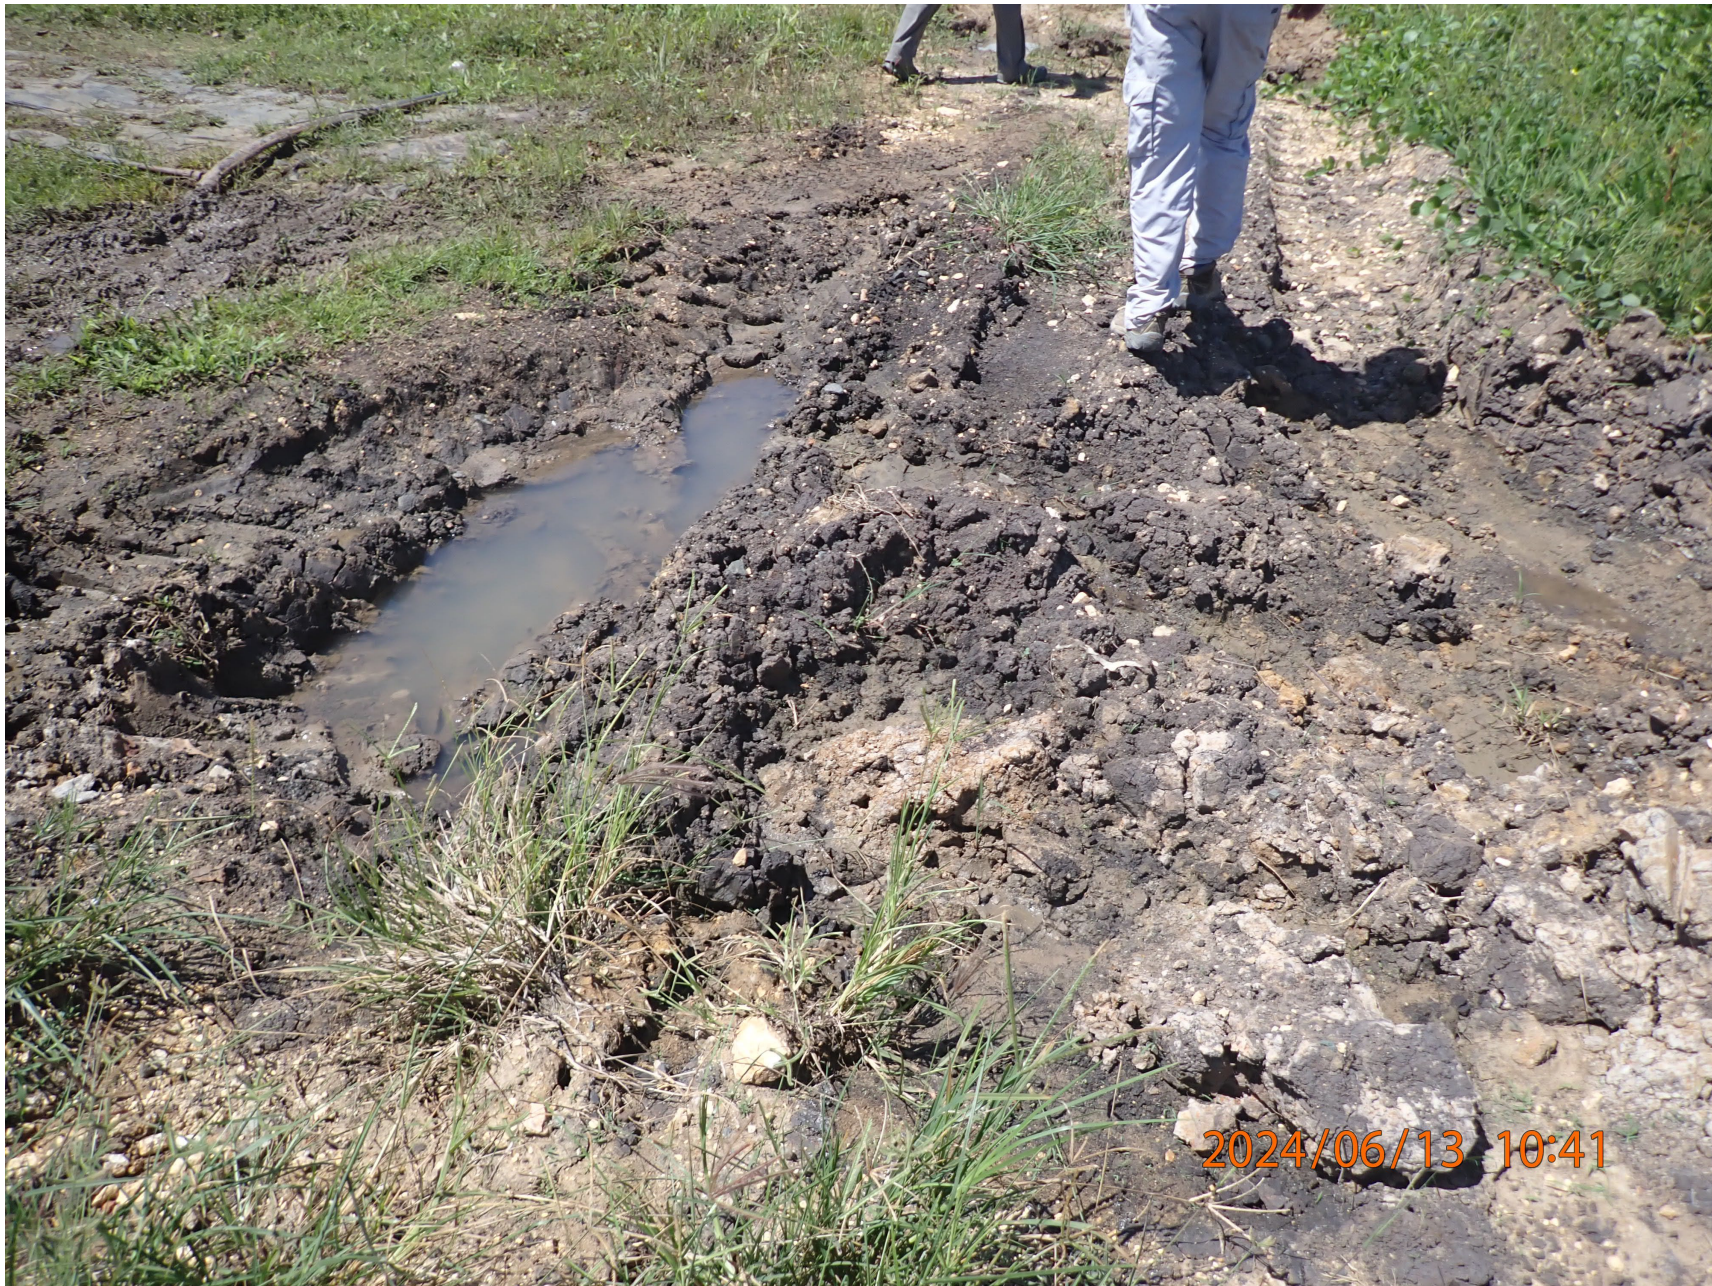
**Date:** June 13, 2024  
**Time:** 10:41 AM  
**Photographer:** Sofía Olivero Lora  
**Photo ID:** P6131045

**Description:** Vegetative clearing and standing surface water observed surrounding the area where EPA dug a soil pit.

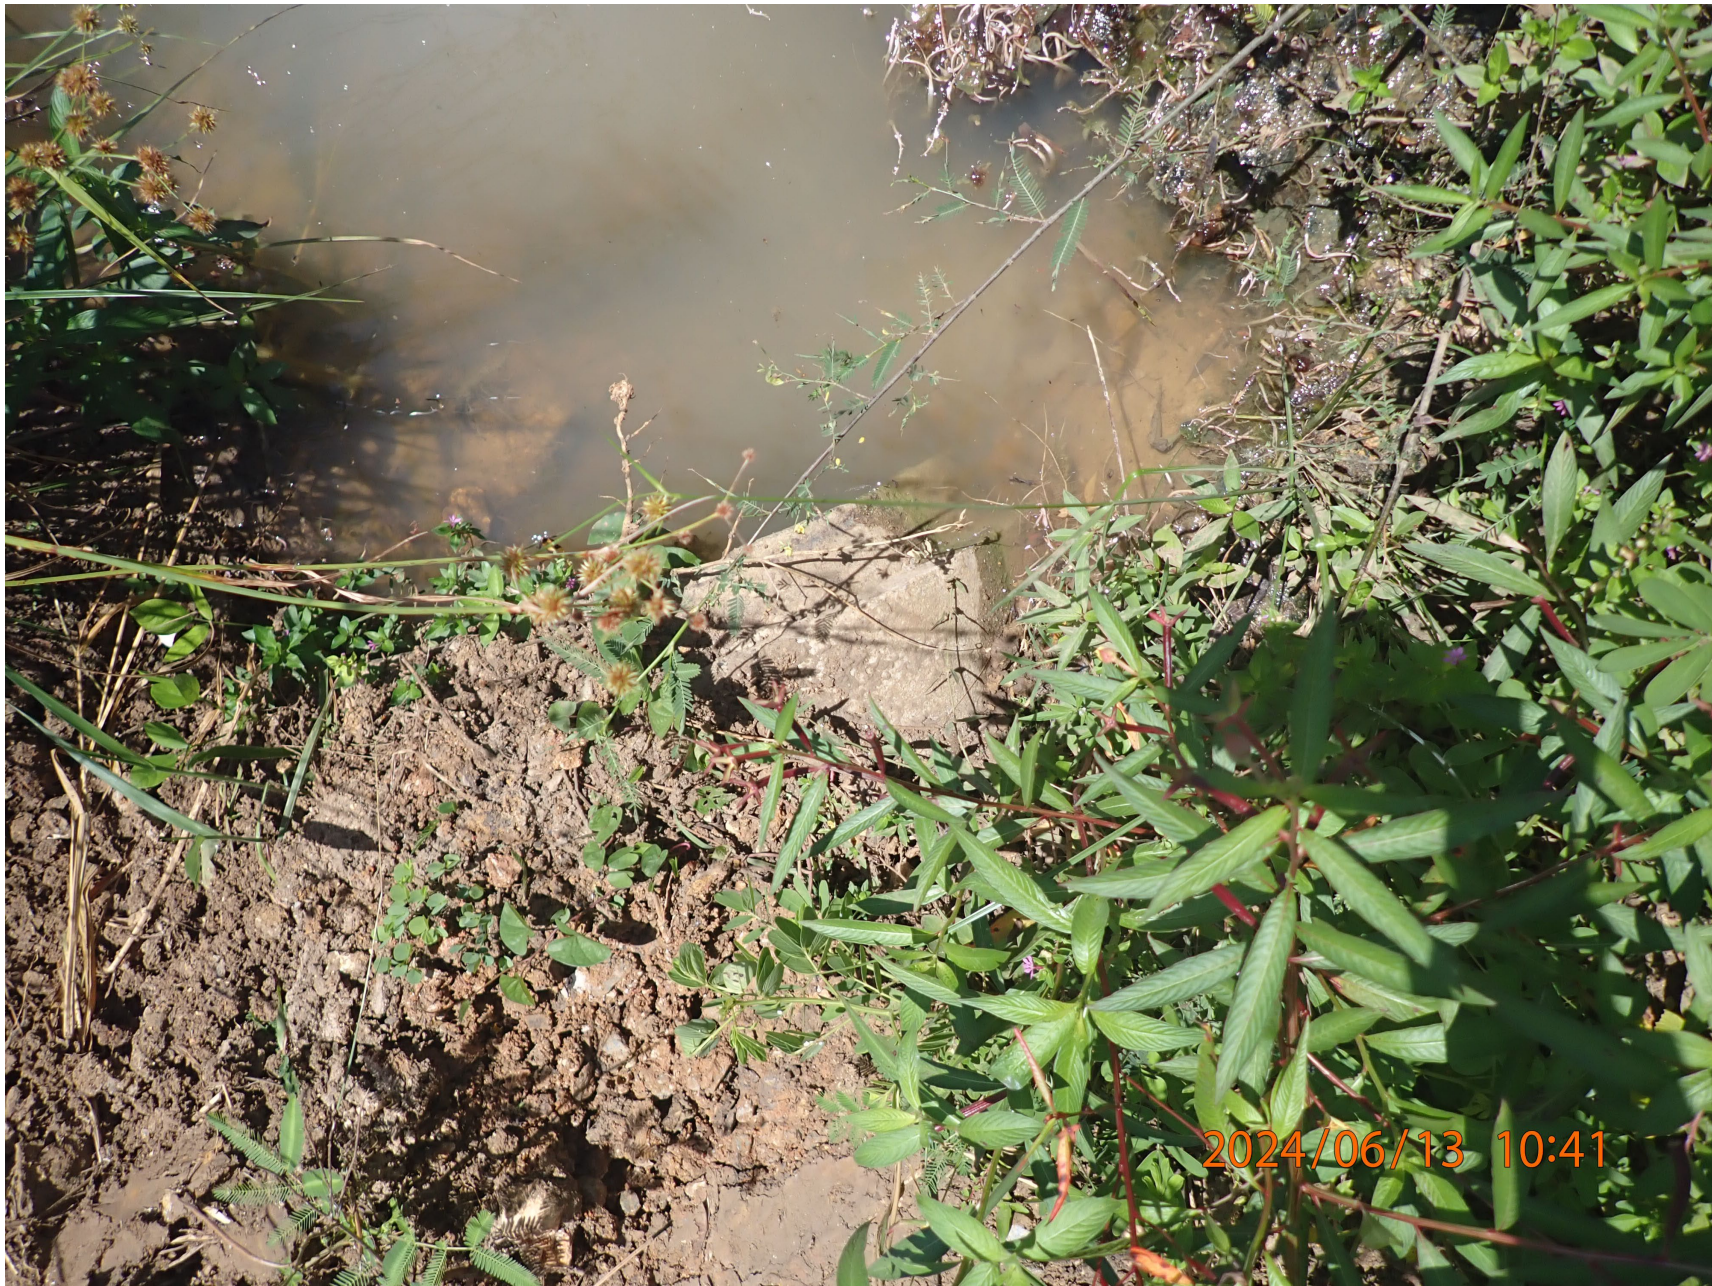
**Photo ID:** P6131050

**Description:** Vegetative clearing and standing surface water observed surrounding the area where EPA dug a soil pit.

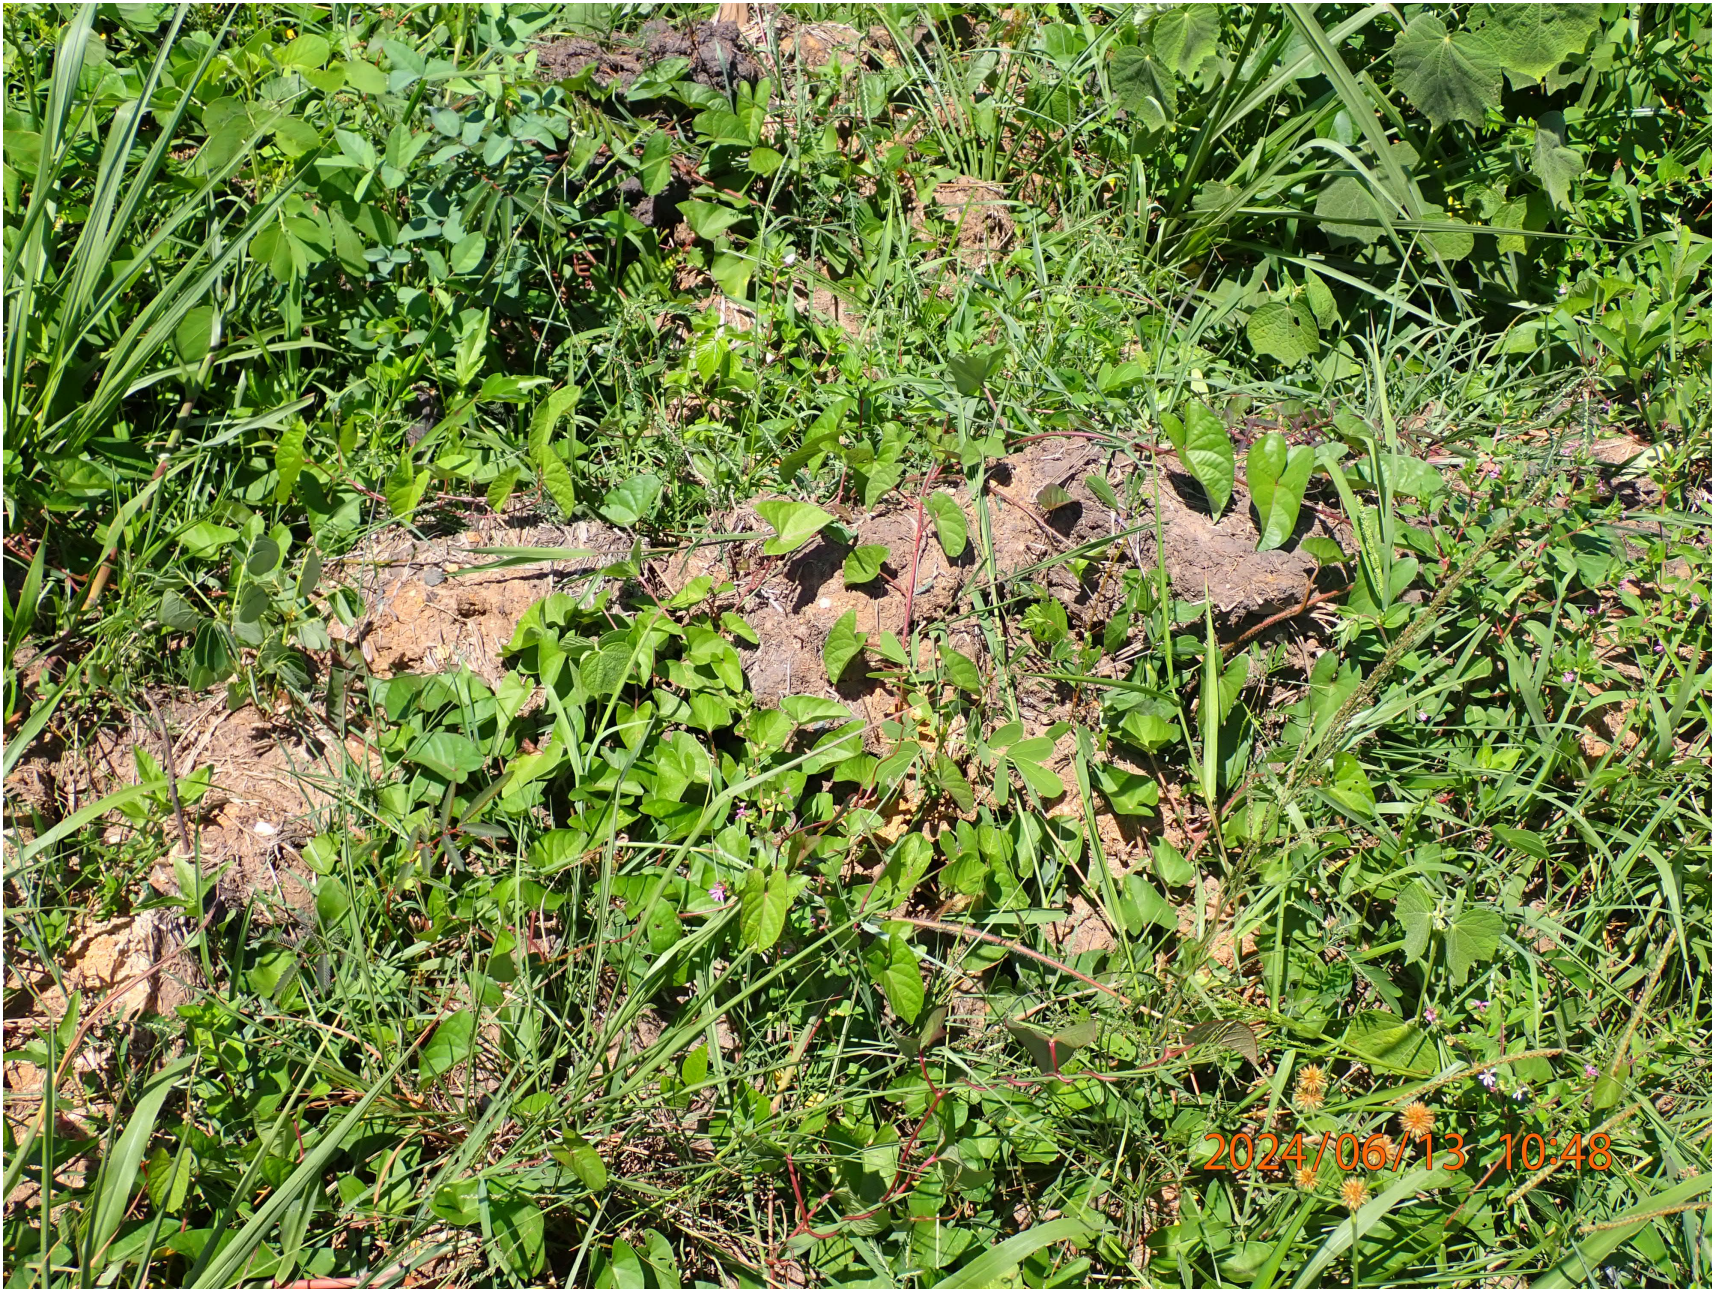
**Photo ID:** P6131058

**Description:** Vegetation and fill material observed surrounding the area where EPA dug a soil pit.
