## Clean Water Act Section 404: Site Visit/Case Development

| Site Name | DBR Dorado Owner, LLC | | | | |
| Site Address* | Tax parcel 037-000-001-07-000 | | | | |

## Attachment B: Photolog

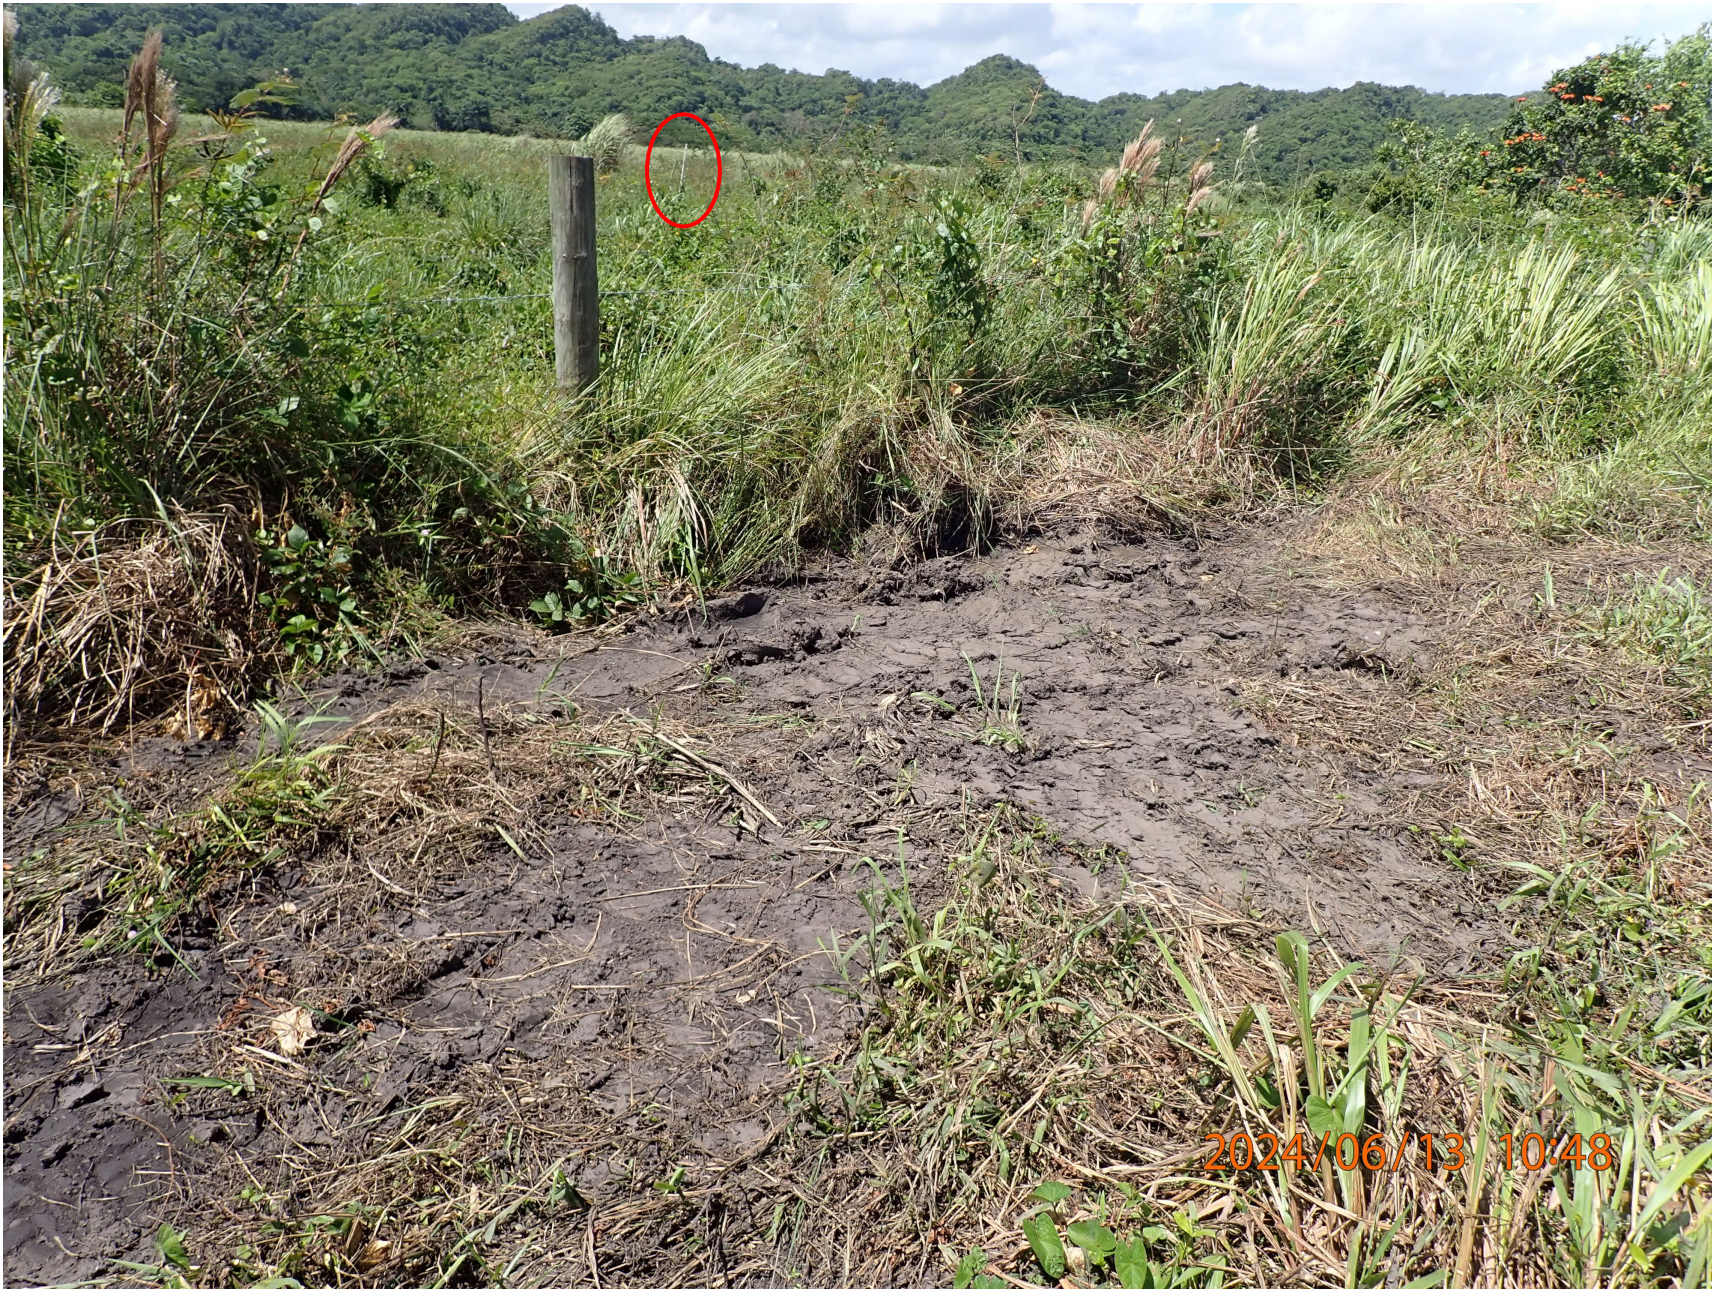
**Photo ID:** P6131059

**Description:** Vegetative clearing and fill material observed surrounding the area where EPA dug a soil pit. Large, white PVC pipes (circled) were observed south of where EPA dug a soil pit.

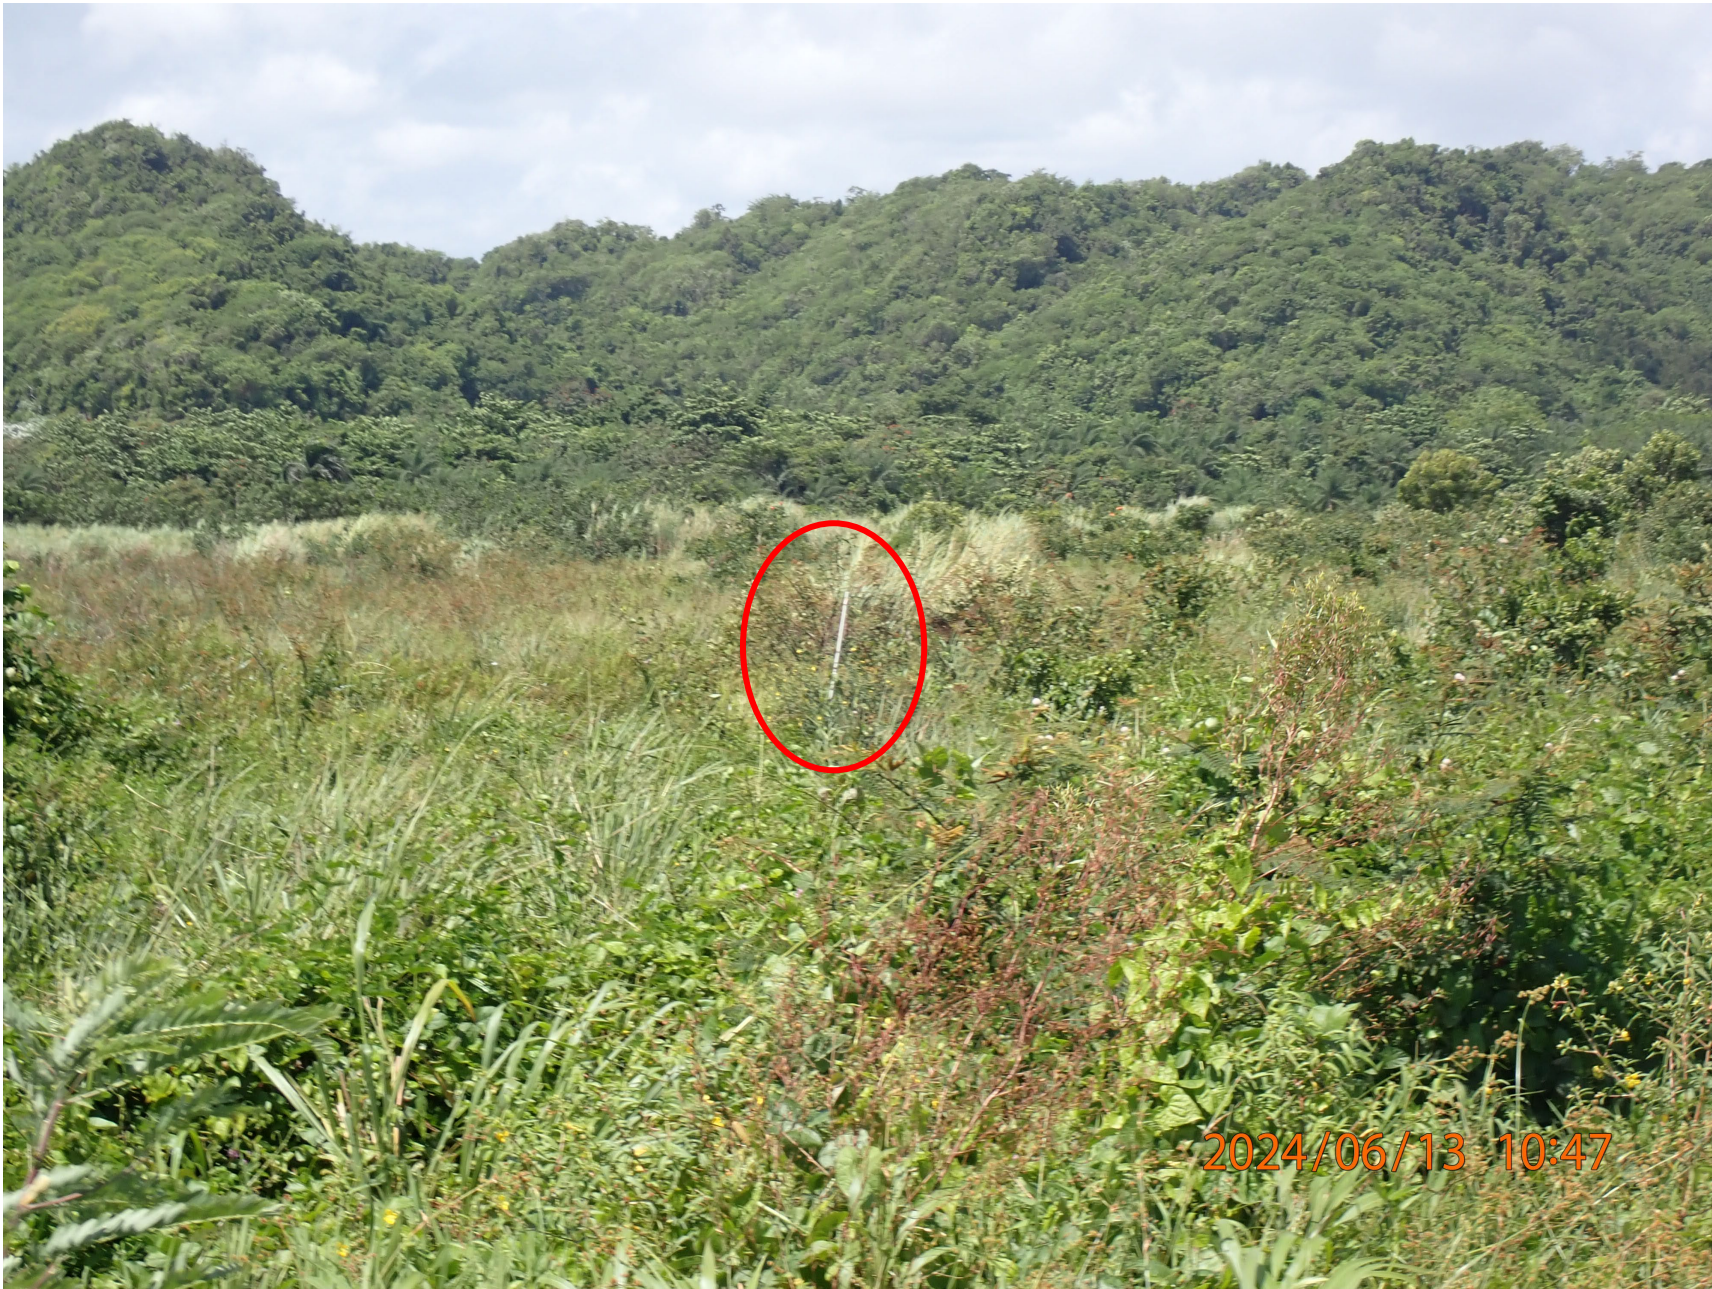
**Date:** June 13, 2024  
**Time:** 10:47 AM  
**Photographer:** Sofía Olivero Lora  
**Photo ID:** P6131056

**Description:** Large, white PVC pipes (circled) were observed south of where EPA dug a soil pit.

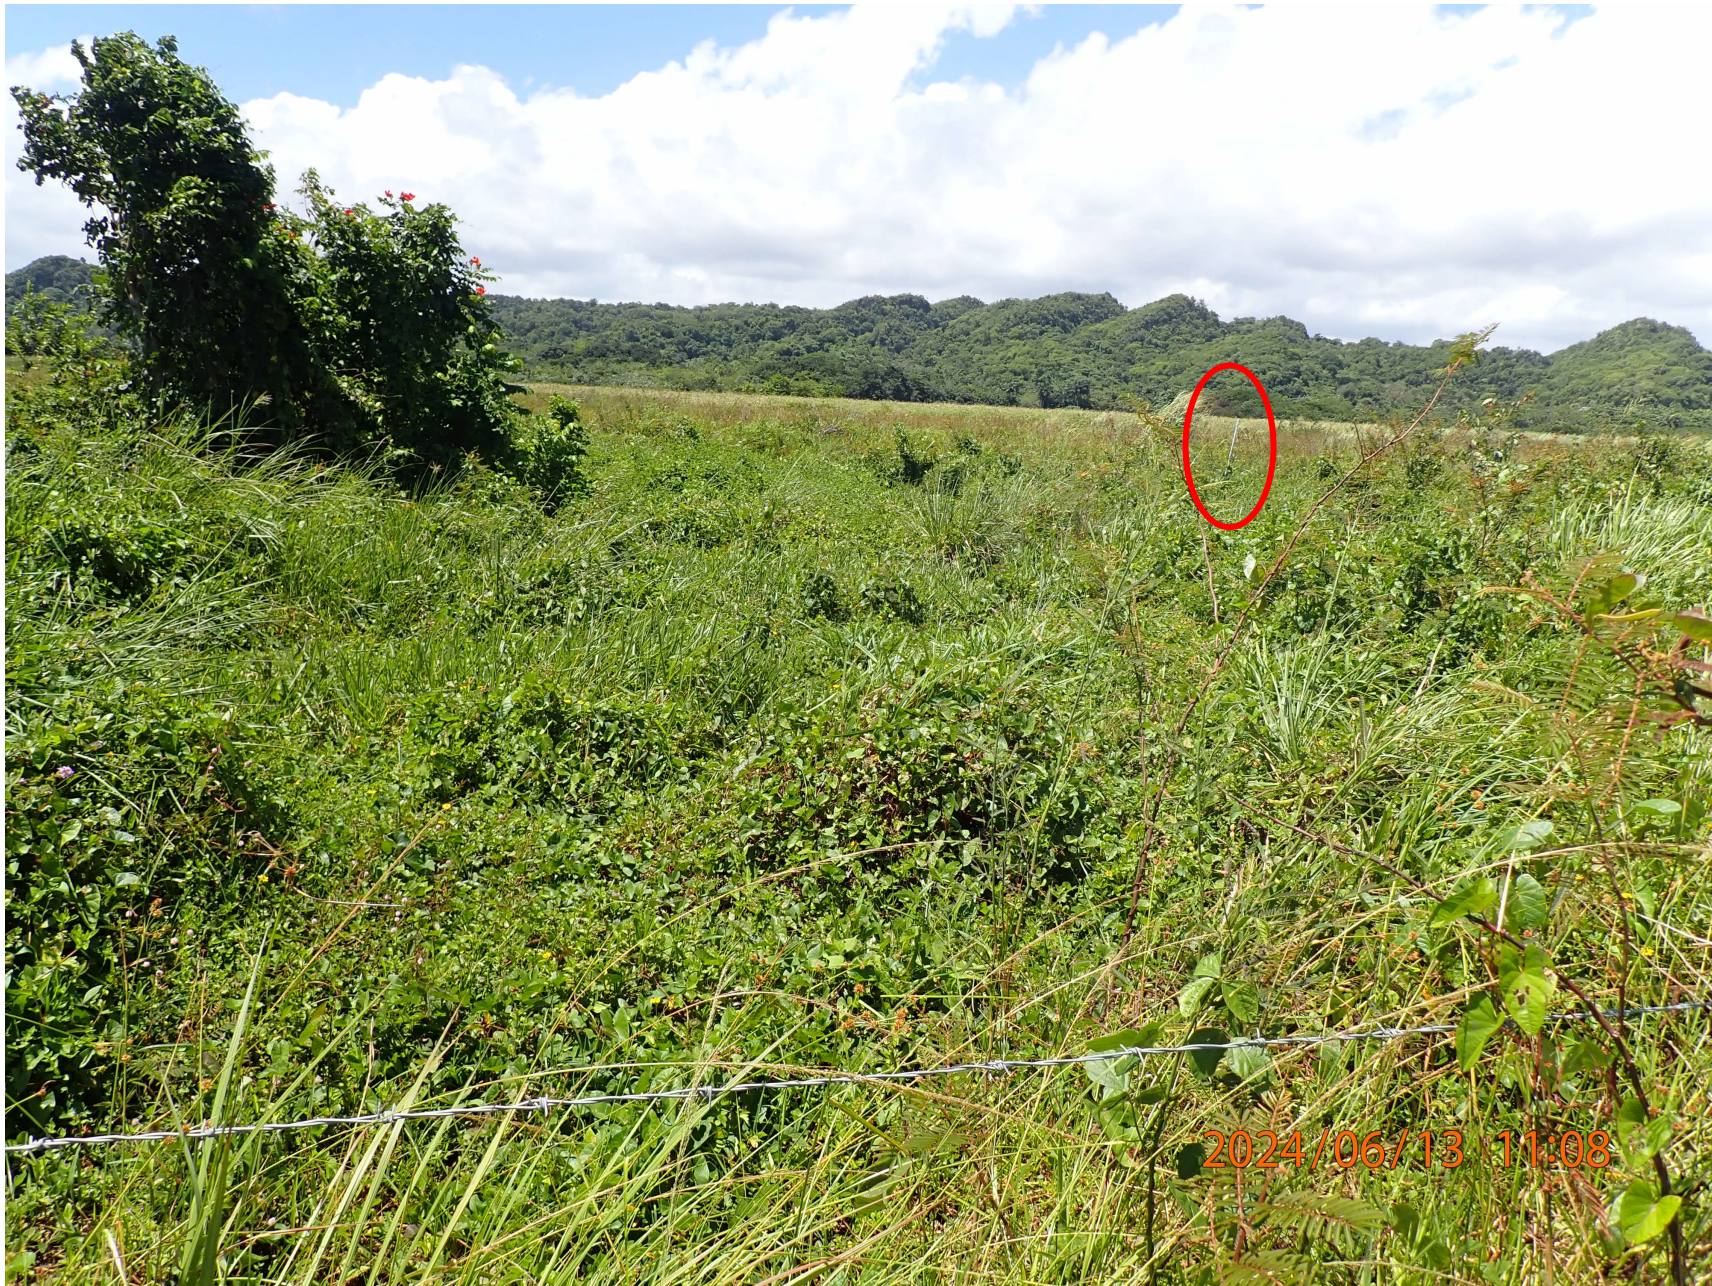
**Photo ID:** P6131064

**Description:** Large, white PVC pipes (circled) were observed south of where EPA dug a soil pit.
