**Region 6 Compliance Assurance and Enforcement Division  
INSPECTION REPORT**

| Inspection Date(s): | 06/19/2015 | | |
| Company Name: | <b>East Texas Salt Water Disposal Company (Respondent)</b> | | |
| Facility Name: | <b>Hopkins Center, RRC # P001154</b> | | |

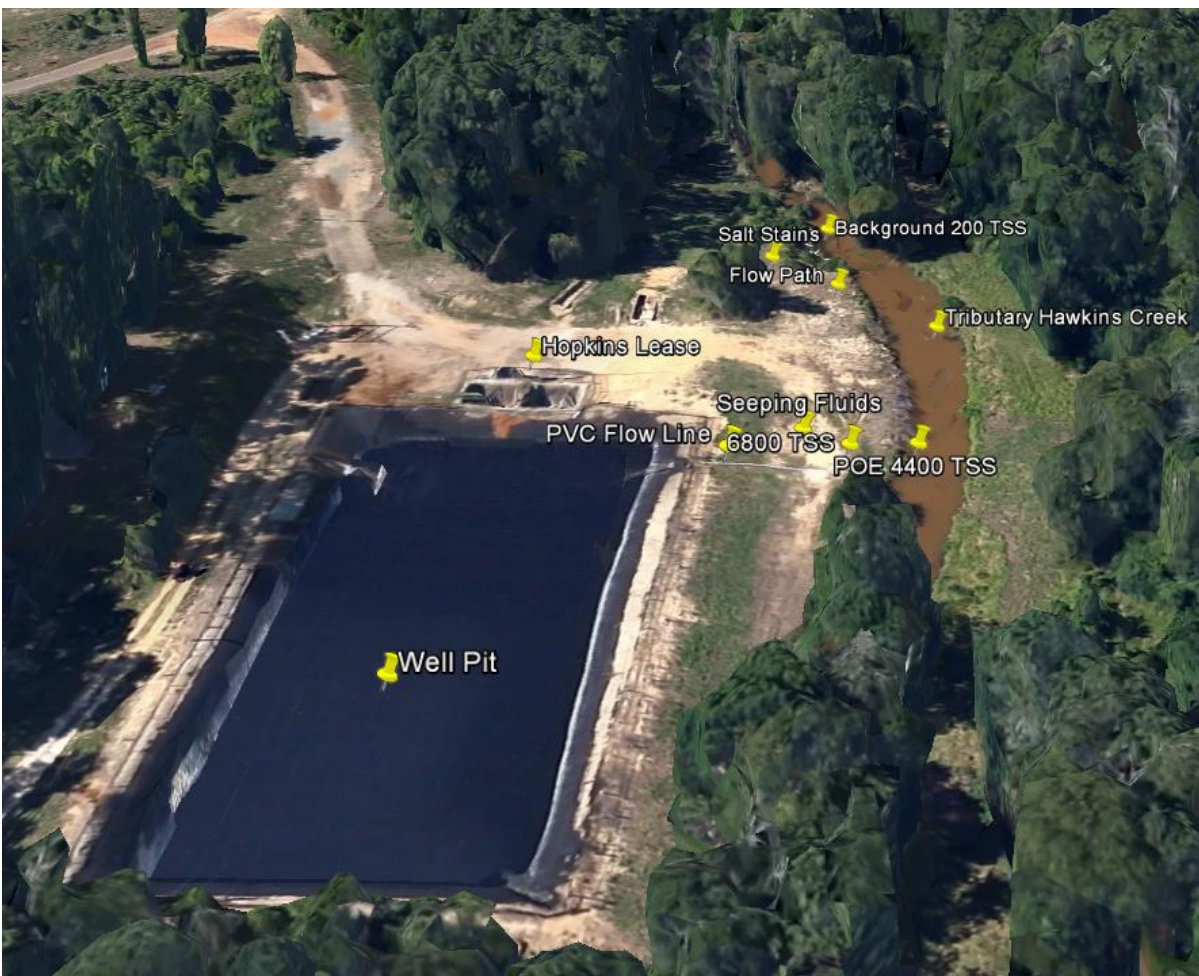
Photo No. 1

Description: Layout of East Texas Salt Water Disposal Company "Hopkins Lease". It is located next to tributary of Hawkins Creek.

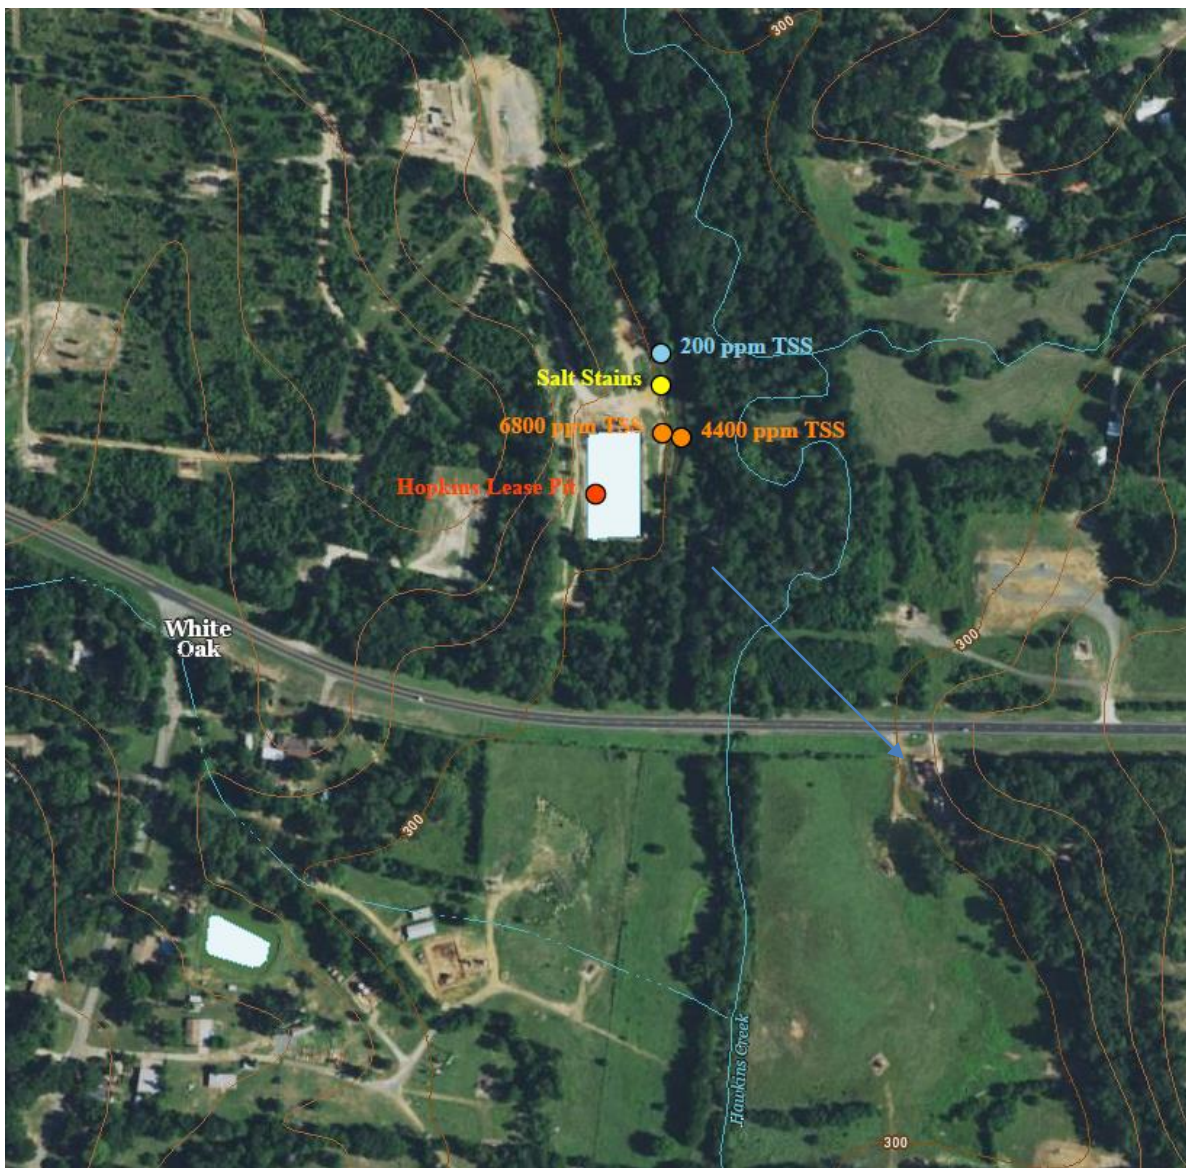
Photo No. 2

Description: Layout of East Texas Salt Water Disposal Company. Blue color indicated background water quality data, red color indicated point source of contamination, orange indicated Total Soluble Salts (TSS), and yellow color indicated salt stains and flow path.

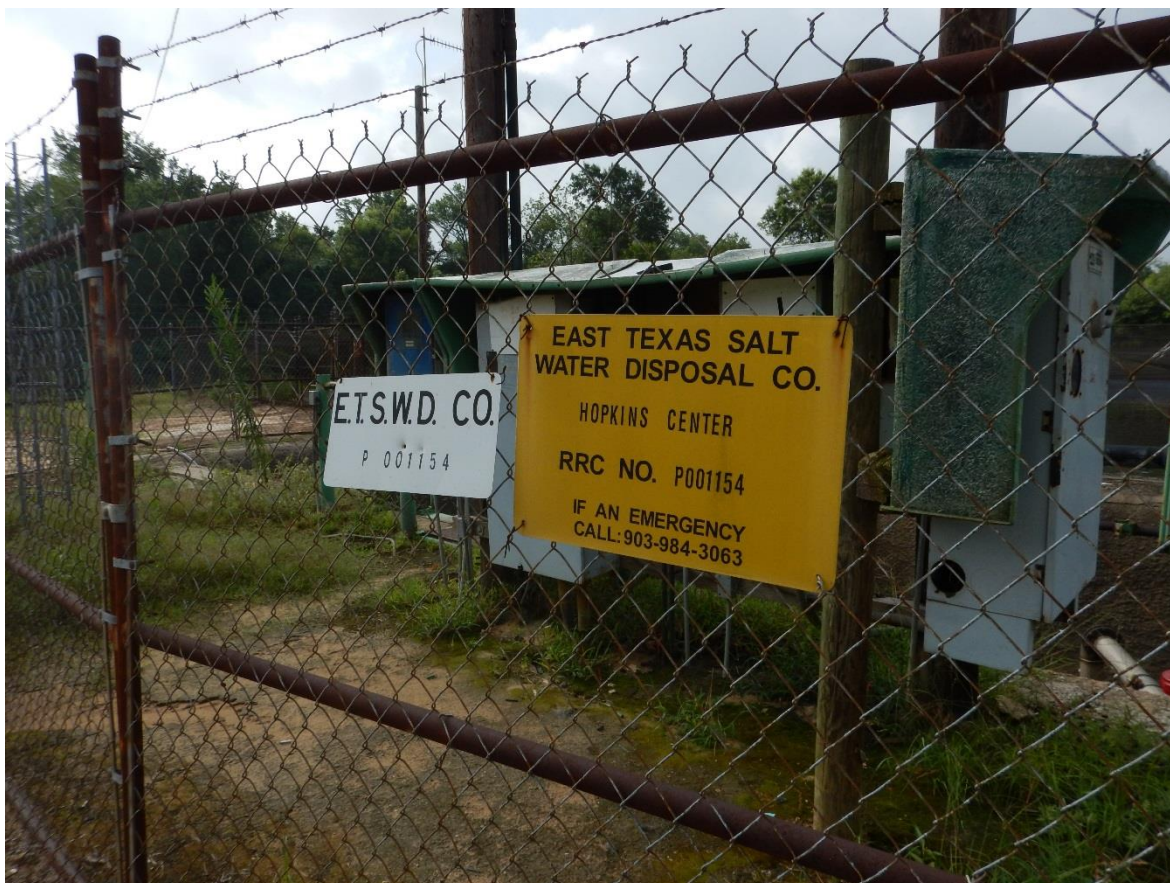
Photo No. 3

Description: East Texas Salt Water Disposal Company showing the information of the lease. It is located 149 feet from tributary of Hawkins Creek.

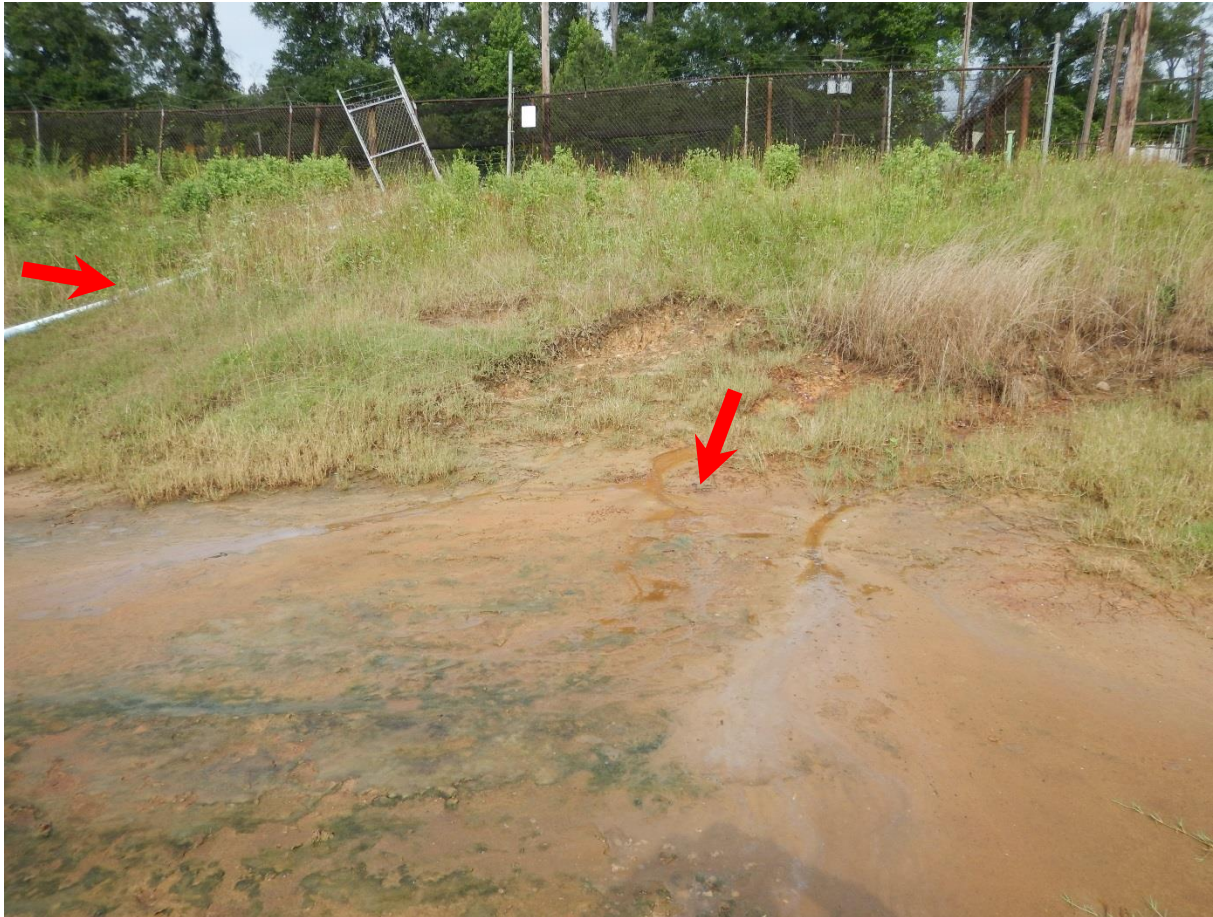
Photo No. 4

When we arrived at this facility on June 19, 2015, we noticed that the Hopkins lease (pit) had discharged produced wastewater (pollutants) to the tributary of Hawkins Creek (photo 4). We walked around the pit and observed well fluids seeping through the walls of the pit (photo 4), a PVC flow line on the ground with an unidentified destination, flow paths of fluids, and a pool of produced water (brine) (photos 4, 5, 6). Calibrated YSI 30 Salinity Conductivity Meter was used to measure the Total Soluble Salt (TSS) in the near tributary. At the pool of fluids, we measured the Total Soluble Salt (TSS) and obtained a reading of 6,800 ppm TSS (photo 7). Also we observed that the flow path of fluids was going into the tributary of Hawkins Creek (photo 8). We followed the flow path downstream into the tributary of Hawkins Creek and obtained a reading of 4,400 ppm TSS (photo 9). Flow path reached the tributary of Hawkins Creek at latitude 32°32'22.42"N, and longitude - 94°50'32.20"W (photo 9). We walked upstream of the Hopkins Lease and at latitude 32°32'23.83"N and longitude - 94°50'33.00"W (photos 10 & 11) we observed disturbed soil, salt stains, soil saturated with well fluids, and flow paths of fluids going into the tributary of Hawkins Creek (photos 10 & 11). **We recorded background water quality data** (water quality in the area) approximately 197 feet upstream of the point of entry and at latitude 32°32'24.22"N and Longitude -94°50'32.77"W. We obtained a reading of 200 ppm TSS (photos 12 & 13).

Description: An overview of fluids seeping through the walls of the pit and going into the tributary of Hawkins Creek. We observed a PVC flow line on the ground with an unidentified destination, containment improperly constructed, flow paths of fluids, and a pool of produced water (brine).

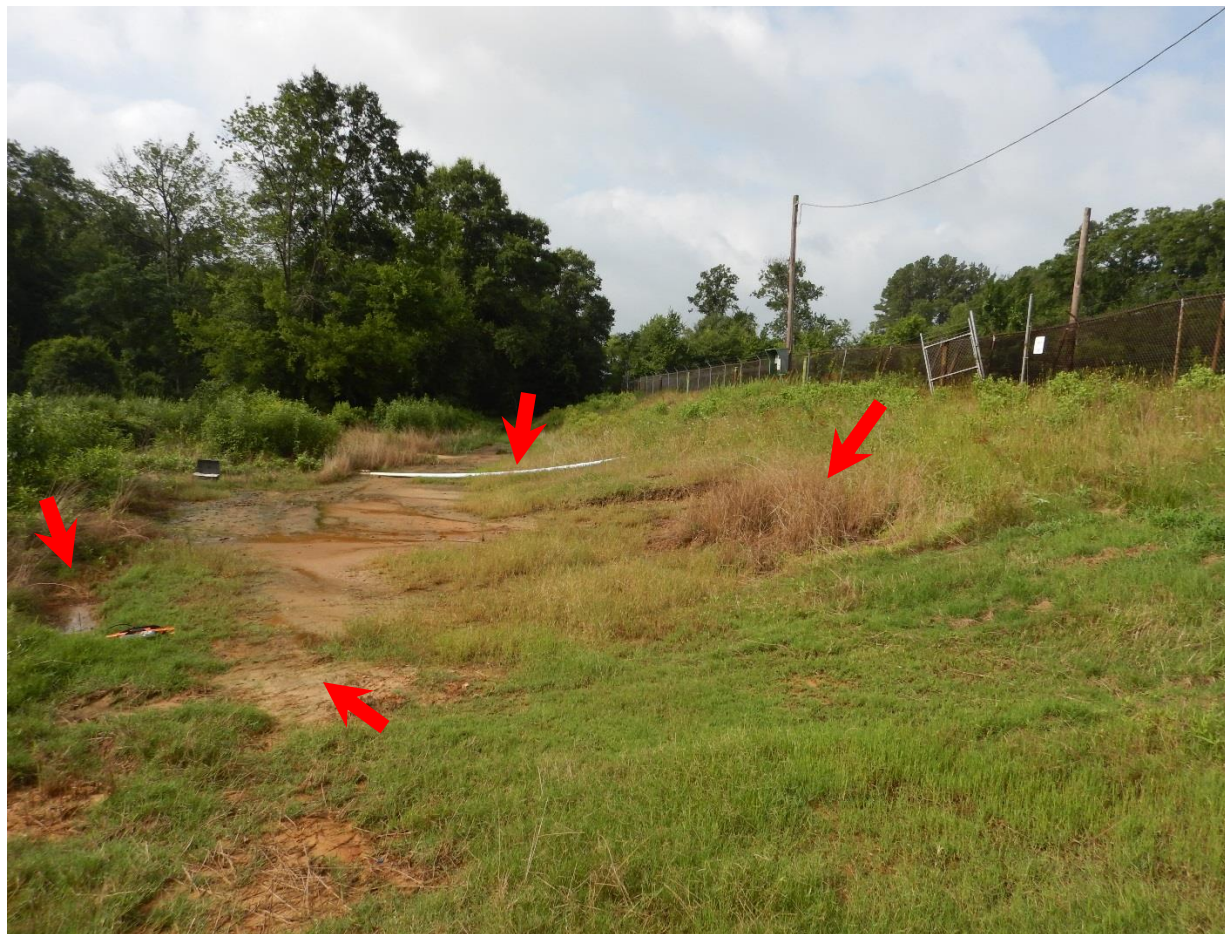
Photo No. 5

Description: An overview of fluids seeping through the walls of the pit (photo), a PVC flow line on the ground with an unidentified destination (photo), flow paths of fluids, and a pool of produced water (brine).

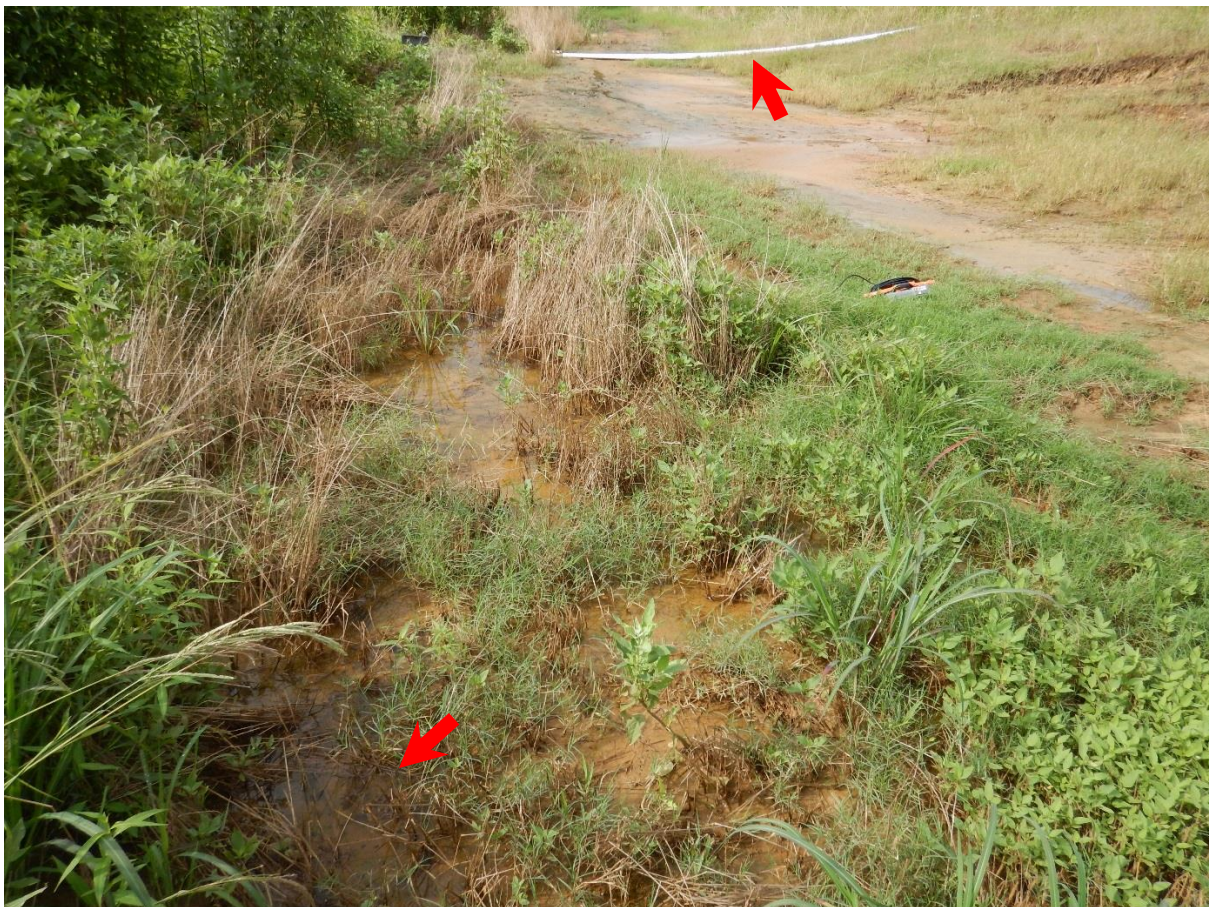
Photo No. 6

Description: An overview of pool and flow path of fluids going into the tributary of Hawkins Creek. We observed a PVC flow line on the ground with an unidentified destination, containment improperly constructed, flow paths of fluids, and a pool of produced water (brine).

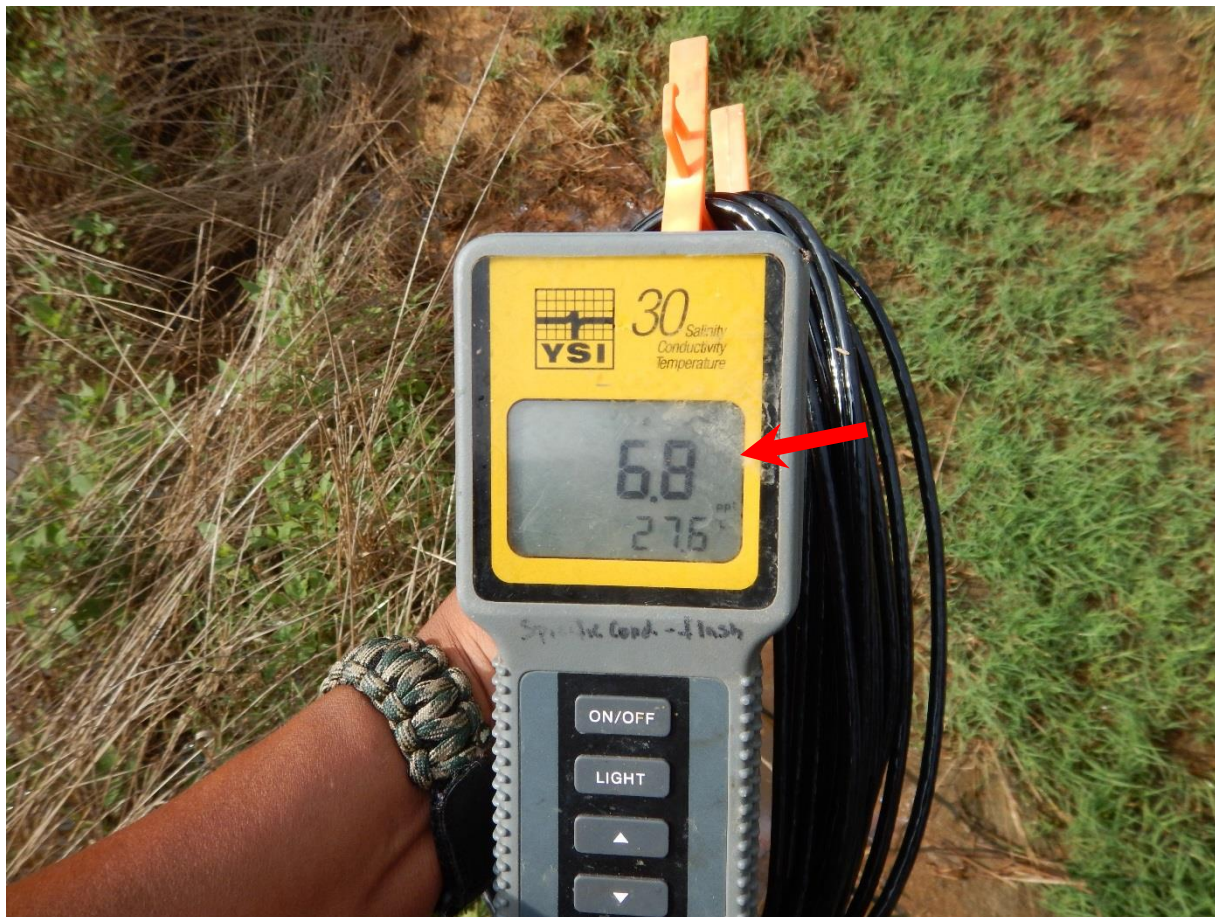
Photo No. 7

Description: Overview of the YSI Salinity Conductivity Meter. We measured the Total Soluble Salts (TSS) and obtained a reading of 6,800 ppm TSS. This point is located 29 feet from the tributary of Hawkins Creek.

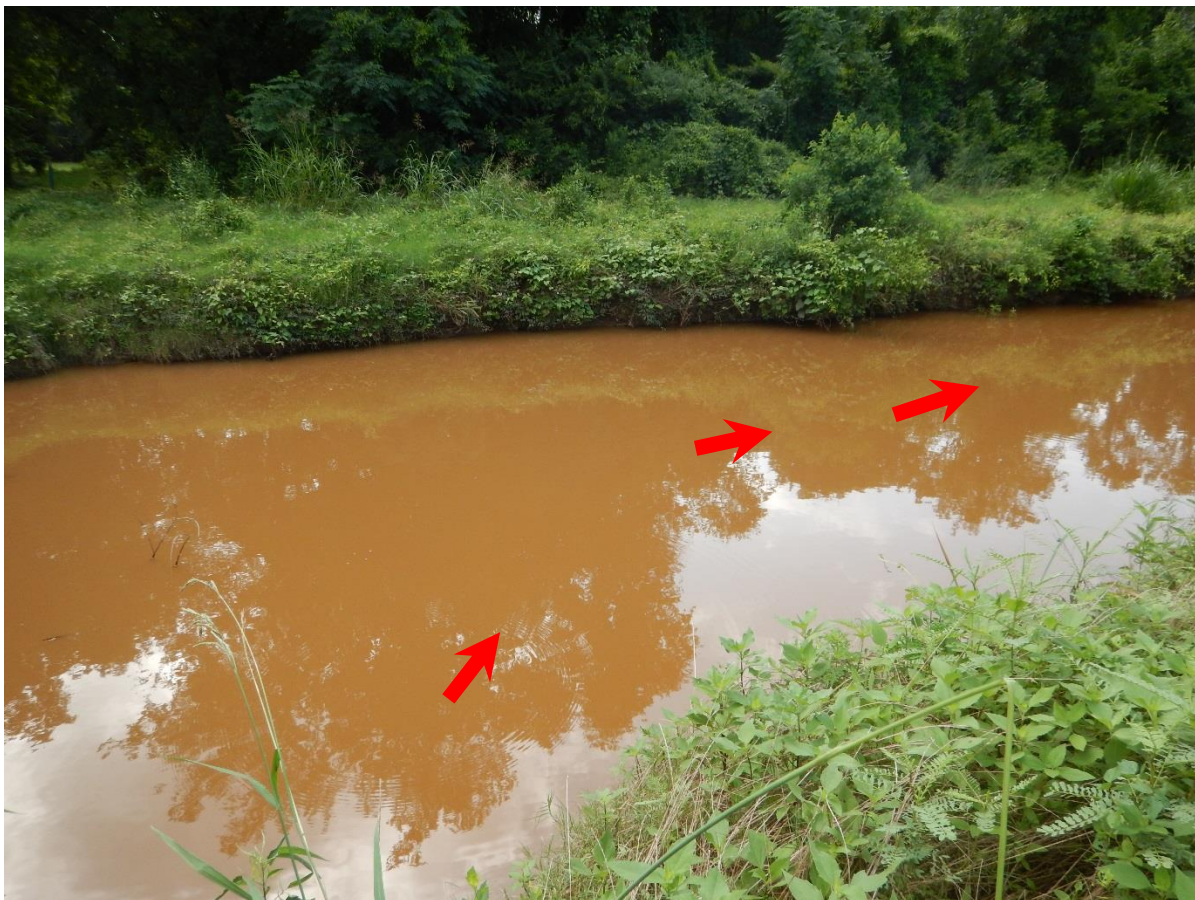
Photo No. 8

Description: Overview of fluids going into the tributary of Hawkins Creek. We measured the Total Soluble Salts (TSS) and obtained a reading of 4,400 ppm TSS.

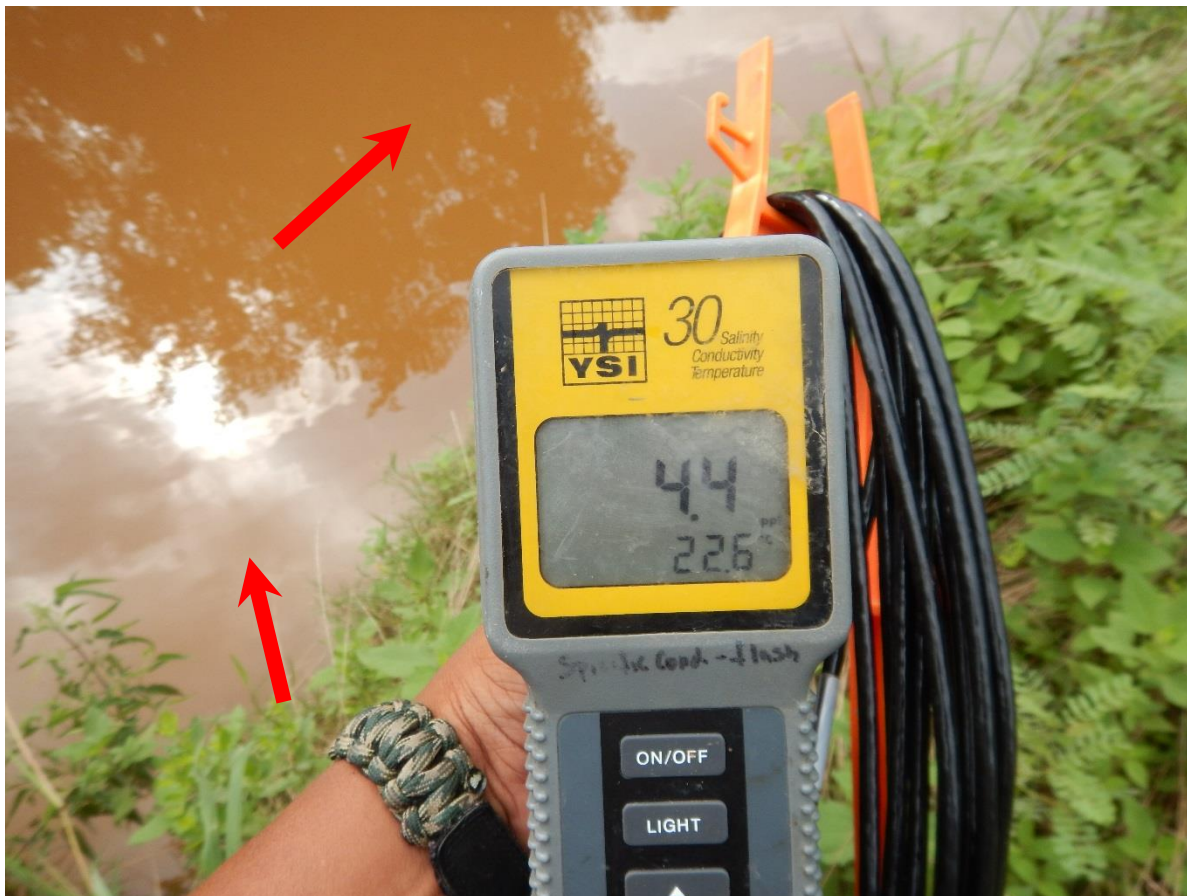
Photo No. 9

Description: Overview of YSI Salinity Conductivity Meter. We observed fluids going into the tributary of Hawkins Creek. We measured the Total Soluble Salts (TSS) and obtained a reading of 4,400 ppm TSS.

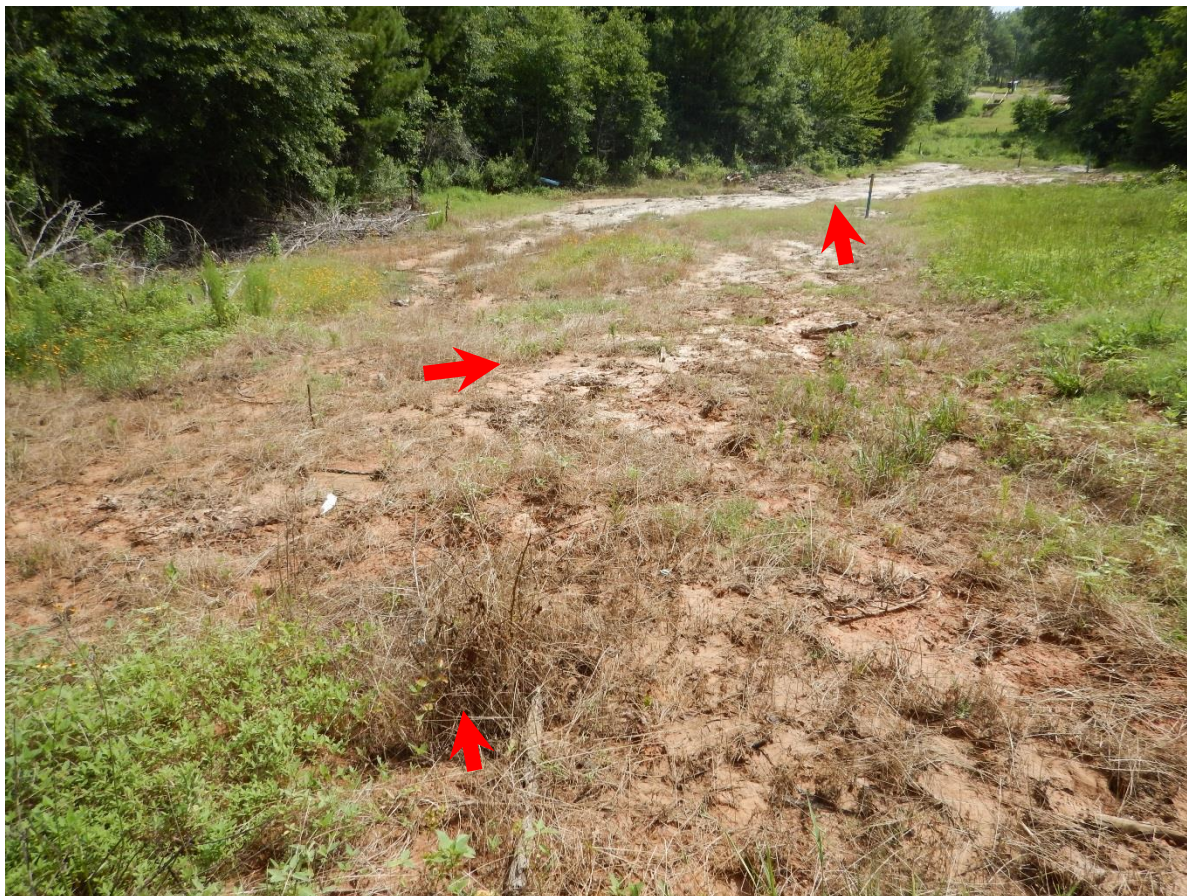
Photo No. 10

Description: Overview of flow path of fluids going into the tributary of Hawkins Creek. We observed a flow path of dead vegetation, disturbed soil, salt stains, and soil saturated with fluids. The flow path is located approximately 24 feet from tributary of Hawkins Creek.

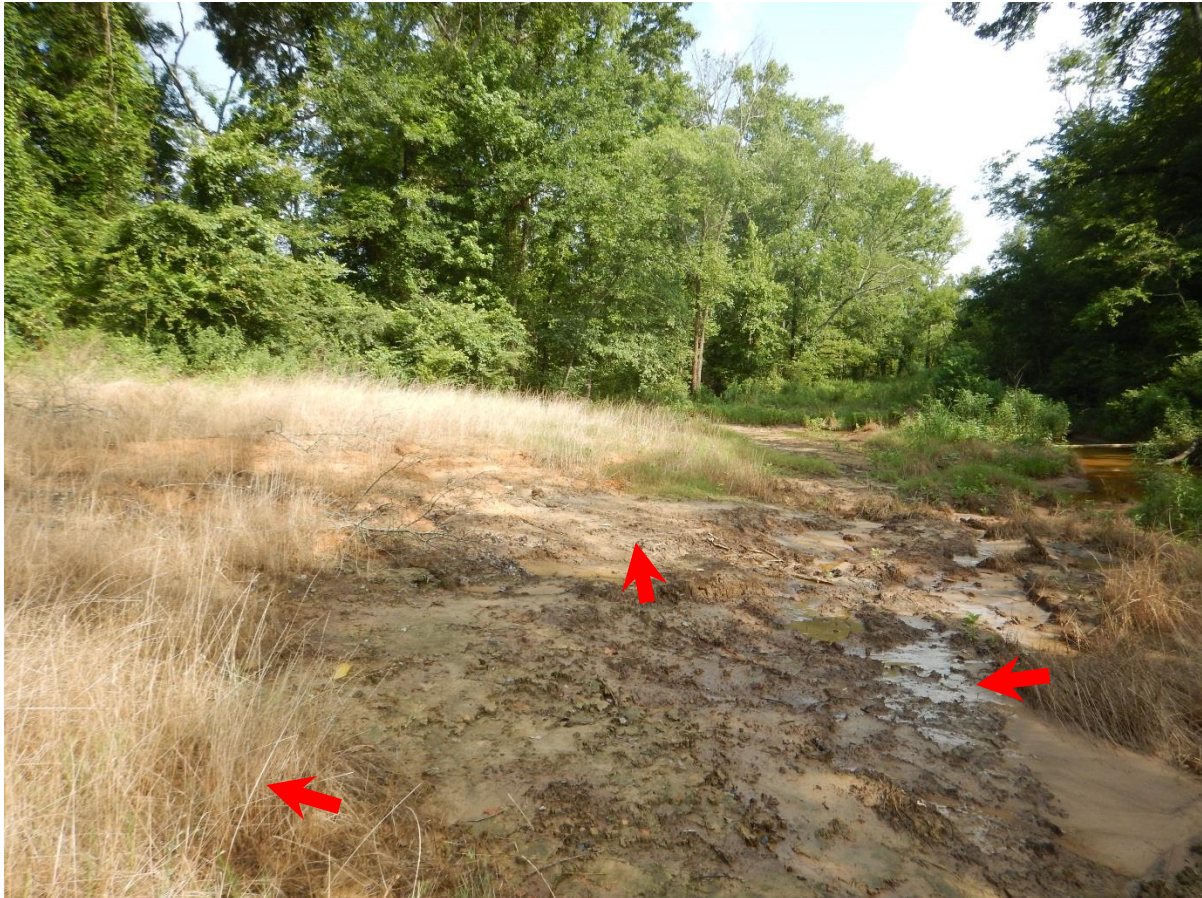
Photo No. 11

Description: Overview of flow path of fluids going into the tributary of Hawkins Creek. We observed dead vegetation, disturbed soil, salt stains, soil saturated with fluids, and produced water (brine). The flow path is located approximately 13 feet from tributary of Hawkins Creek.

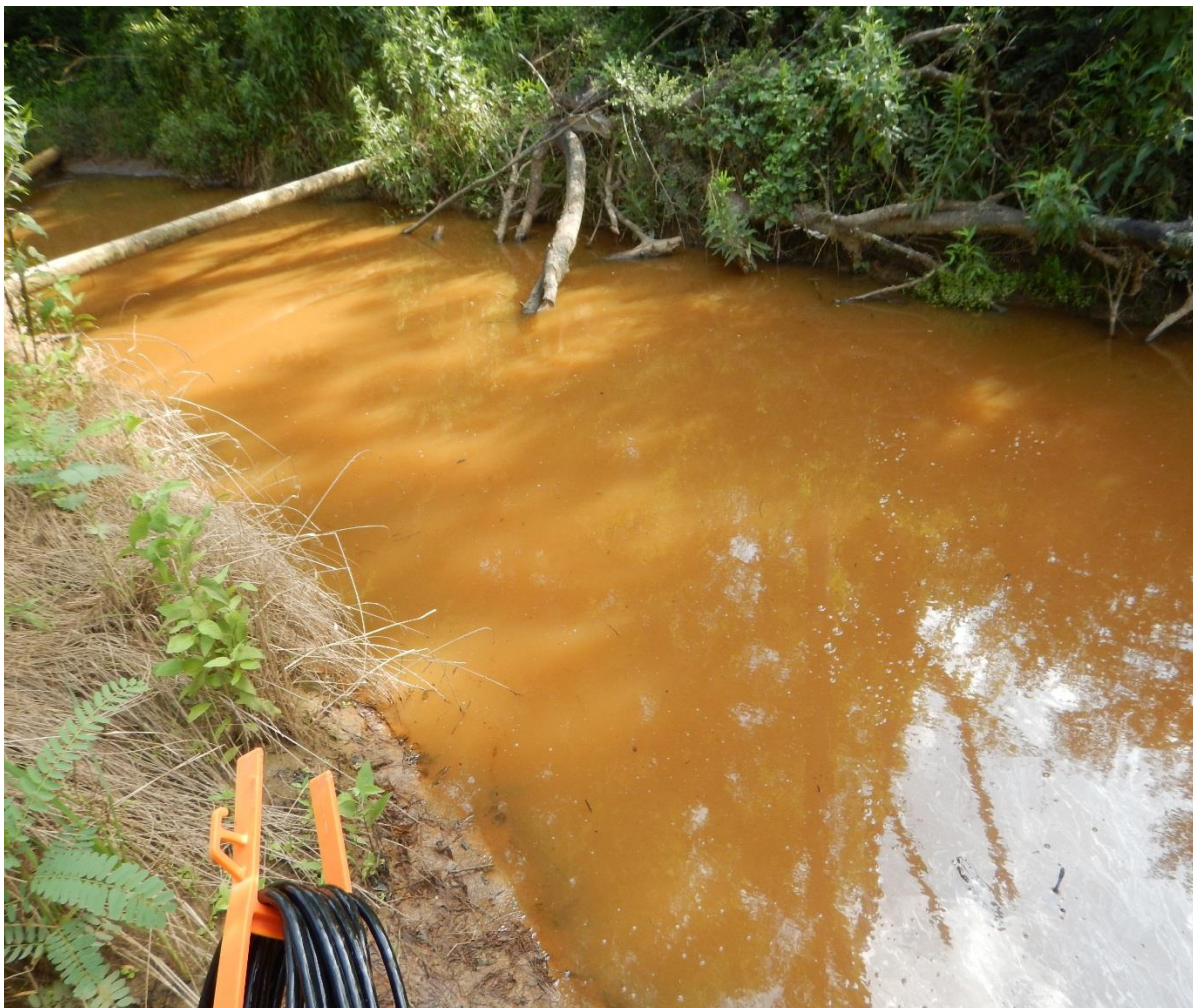
Photo No. 12

Description: Background water quality data (water quality in the area) information. We measured the Total Soluble Salts (TSS) 197 feet upstream of point of entry (POE) in Hawkins Creek and obtained a reading of 200 ppm TSS.

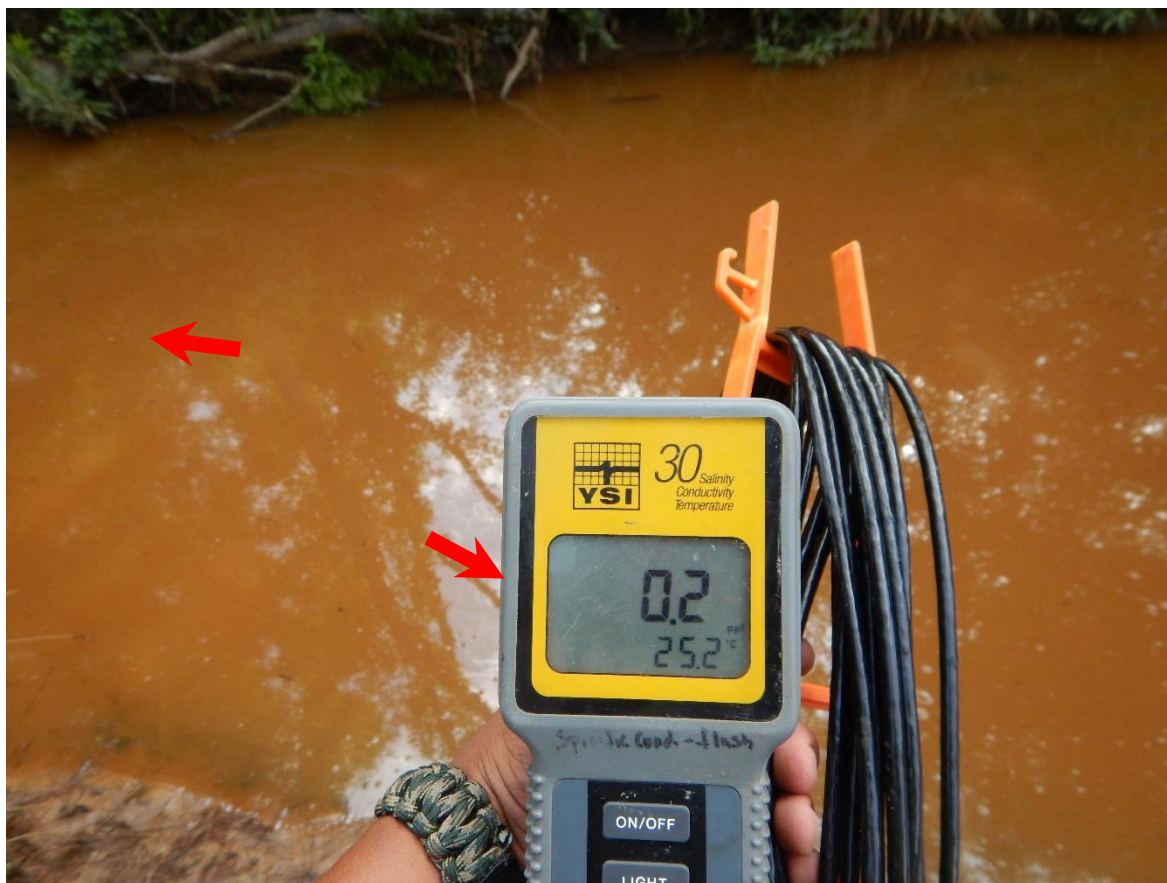
Photo No. 13

Description: Overview of the YSI Salinity Conductivity Meter. We recorded background water quality data (water quality in the area) information. We measured the Total Soluble Salts (TSS) 197 feet upstream of point of entry (POE) in Hawkins Creek and obtained a reading of 200 ppm TSS.
