**Compliance Evaluation Inspection Report**

Artesia Publicly Owned Treatment Works

NPDES Permit No. MS0020770

**Project ID: CV-MS0020770-06072022**

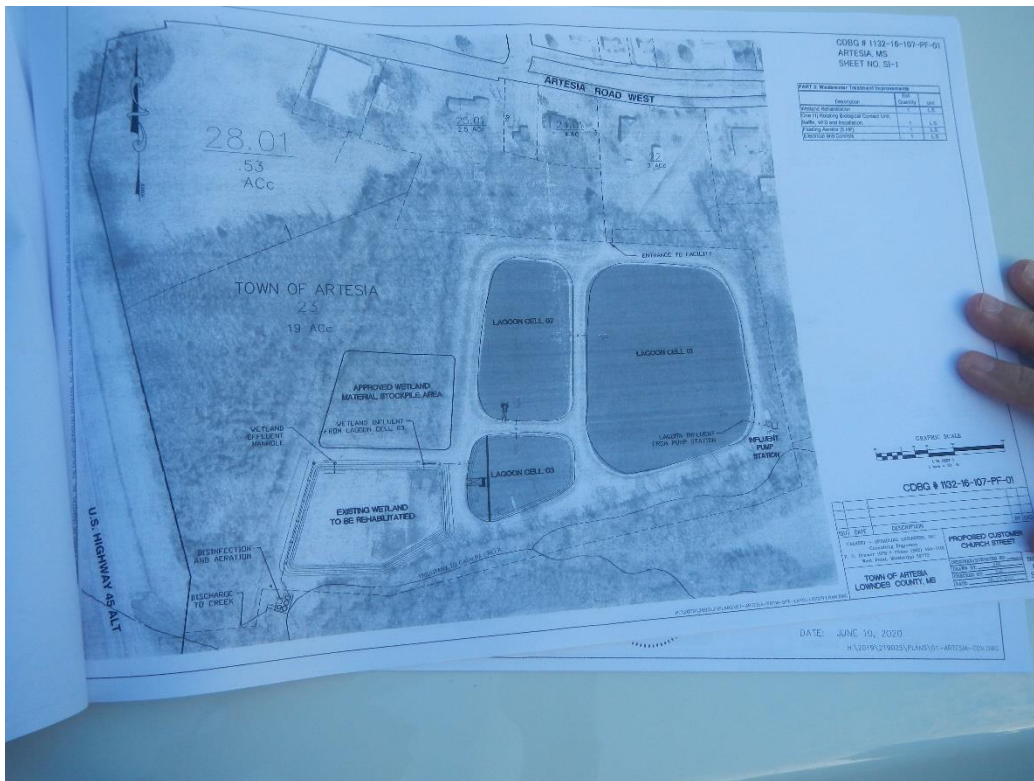
Photo 1. Map of the facility in schematics reviewed. Map shows a second wetland area which was not constructed and thus not part of the facility.

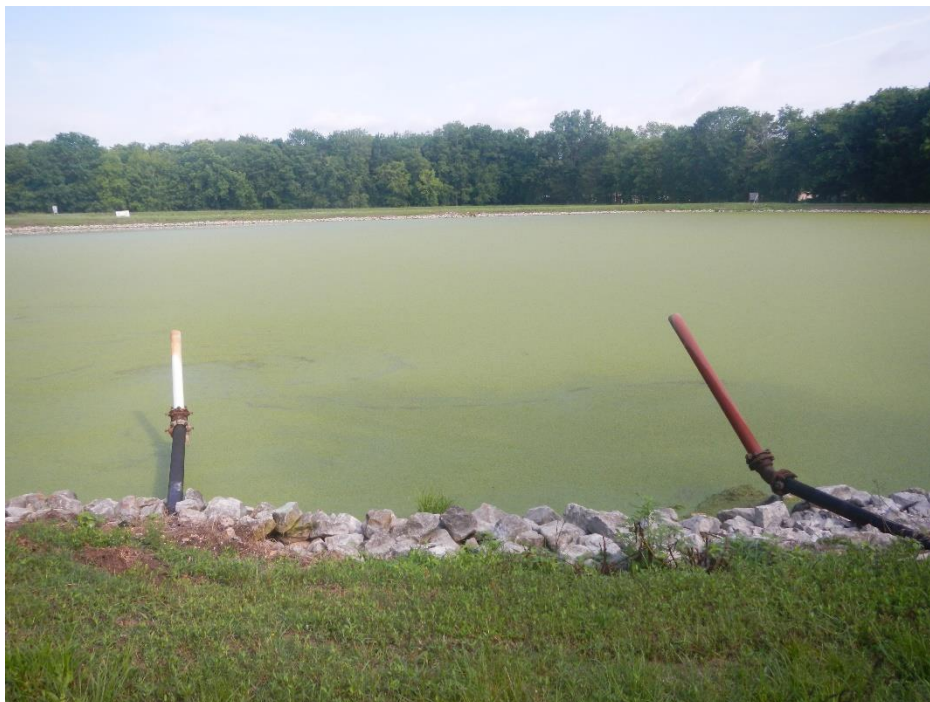
Photo 2. Inlet pipes to Lagoon 01. Lagoon is covered in duckweed.

- a. The aerator in Lagoon 02 should be moved to Lagoon 01 to improve wastewater aeration
- b. A baffle should be installed in Lagoon 02 to lengthen detention time and make use of the full lagoon.
- c. Duckweed should be removed from all three lagoons to improve aeration.
- d. The wetland reed bed should be harvested on a more frequent schedule.

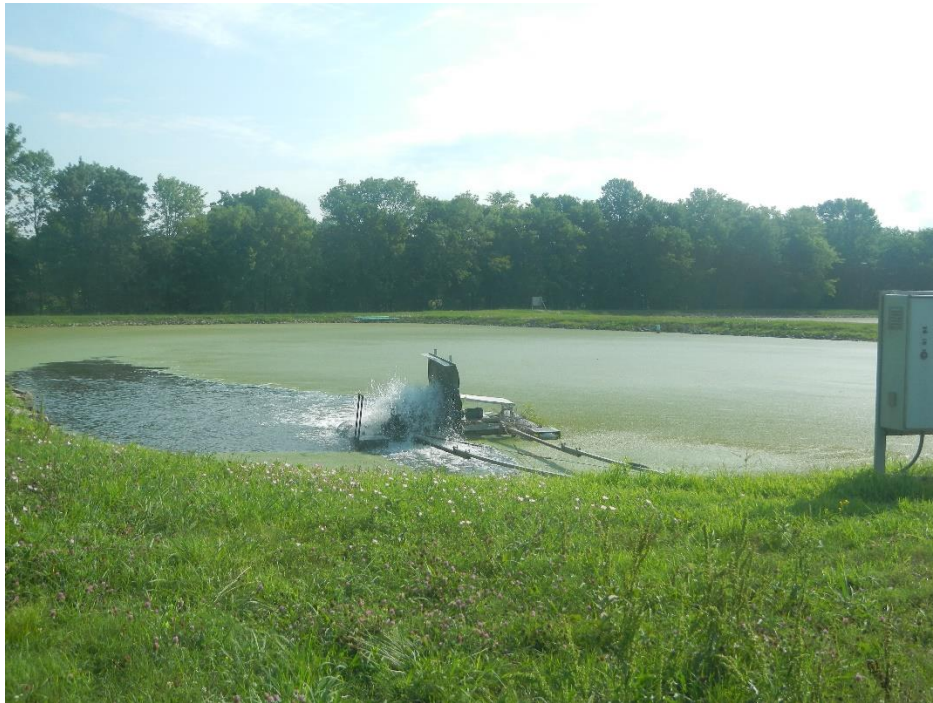
The Artesia POTW is operated by Budreau Marsac. The lagoons had considerable presence of duckweed and algae. Influent to lagoon 2 enters the lagoon in the middle of the eastern longitudinal edge. The influent enters the lagoon very close to the effluent discharge pipe. This configuration greatly increases the potential for short-circuiting in this lagoon. In addition, the placement of the aerator in this lagoon further increases the likelihood of short-circuiting and reduces the effective treatment area in the lagoon significantly.

Photo 3. Lagoon 02. Air release for inlet pip seen on opposite shore. Aerator seen functioning in the foreground. Current layout causing possible short circuiting as evidenced by algae growth seen in back half of the lagoon.

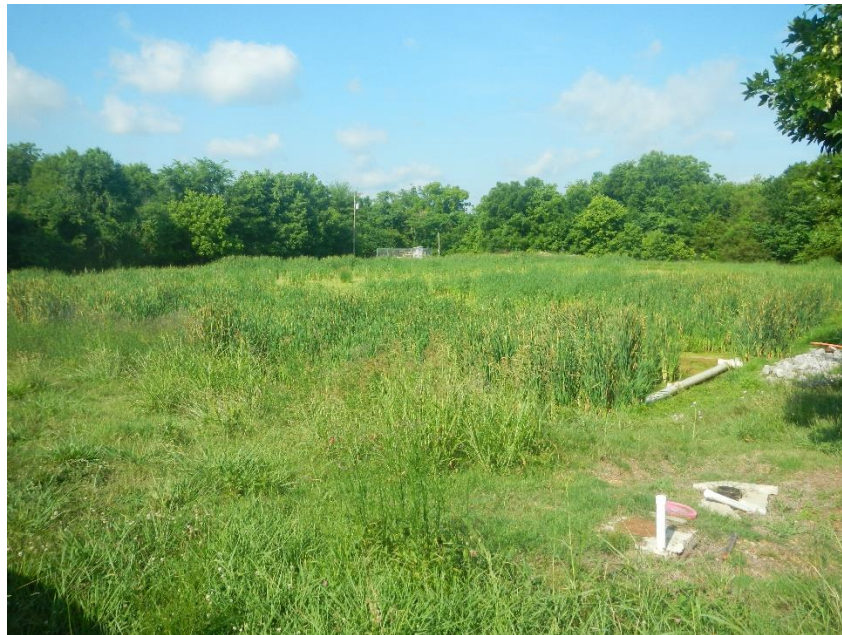
The bull rush in the constructed wetland was overgrown and in need of harvesting. Ponding was observed in several locations in the wetland, indicating flow disruptions likely caused by overgrown bull rush in the wetland.

Photo 4. Constructed subsurface flow wetland growing bull rush. Chlorination structure visible in background.

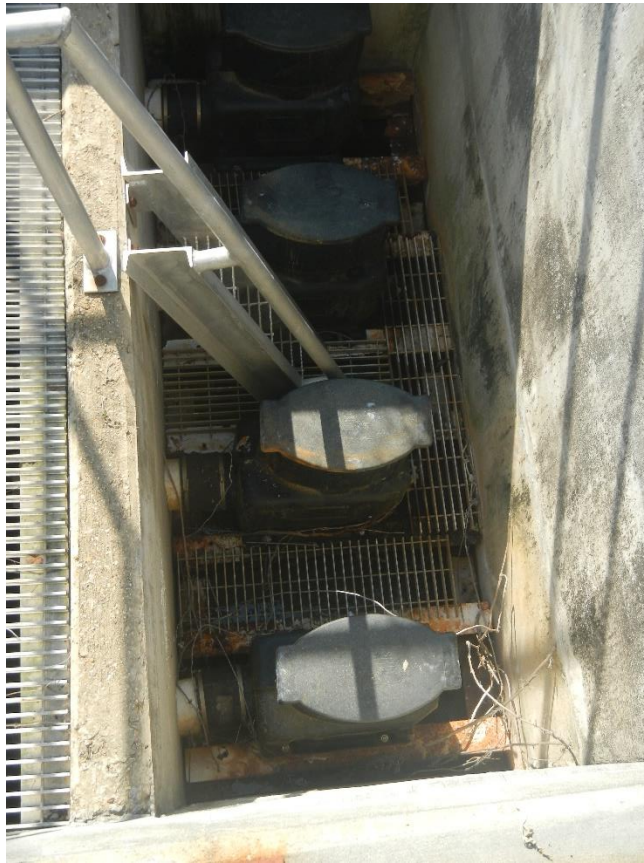
Photo 5. Effluent chlorinators.

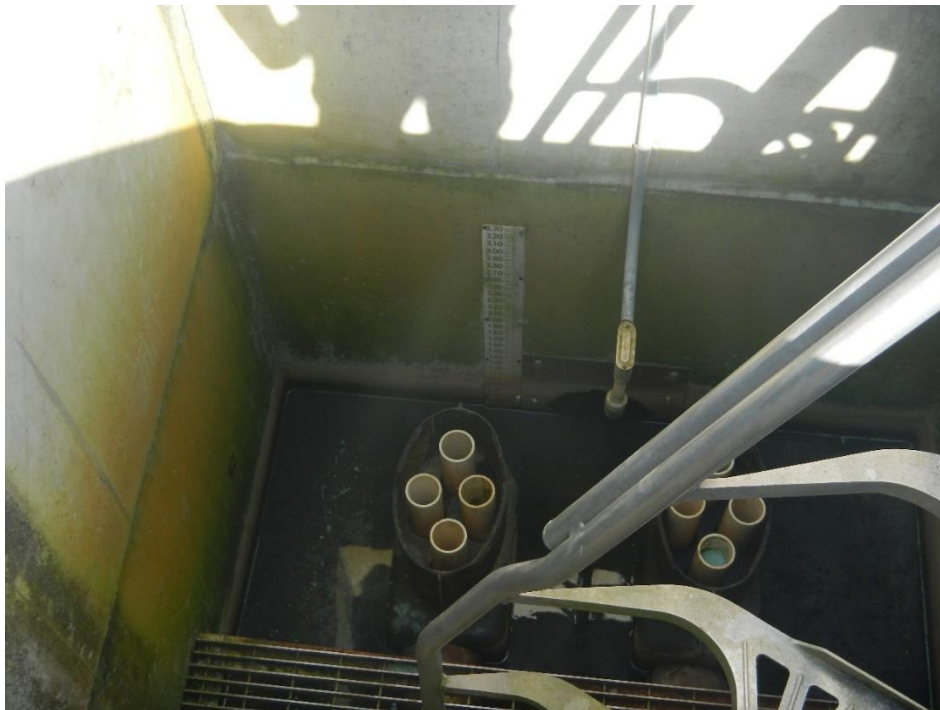
Final effluent flow is measured by an ultrasonic flow meter. The flow meter had an up-to-date calibration sticker. The effluent also had a v-notch weir with a visible staff gauge.

Photo 6. Dechlorinators and flow measurement devices at effluent outlet.
