## Region 6 - Enforcement & Compliance Assurance Division

### INSPECTION REPORT

| Company Name: | <b>Northcote Cleveland LLC</b> | |
| Facility Name: | <b>Osage C Lease</b> | |

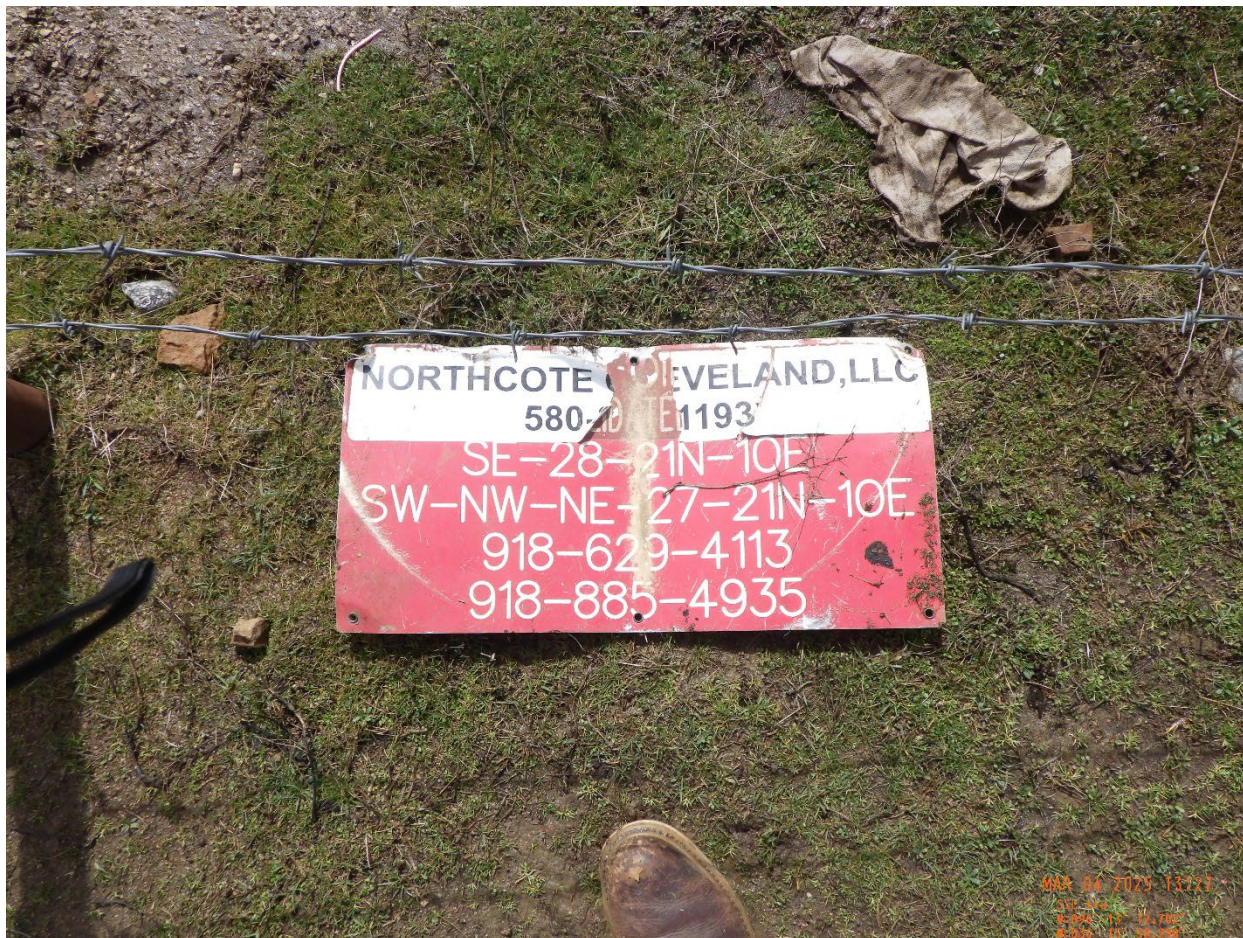
Photo No. 1

I observed the facility signage for the Northcote Cleveland, LLC, Osage B Lease tank battery. See photo No. 1 of Appendix 1 (photo log). For additional GPS location and photo metadata, see Appendix 1.

**Description:** This was the facility signage for the Northcote Cleveland, LLC, Osage C tank battery.

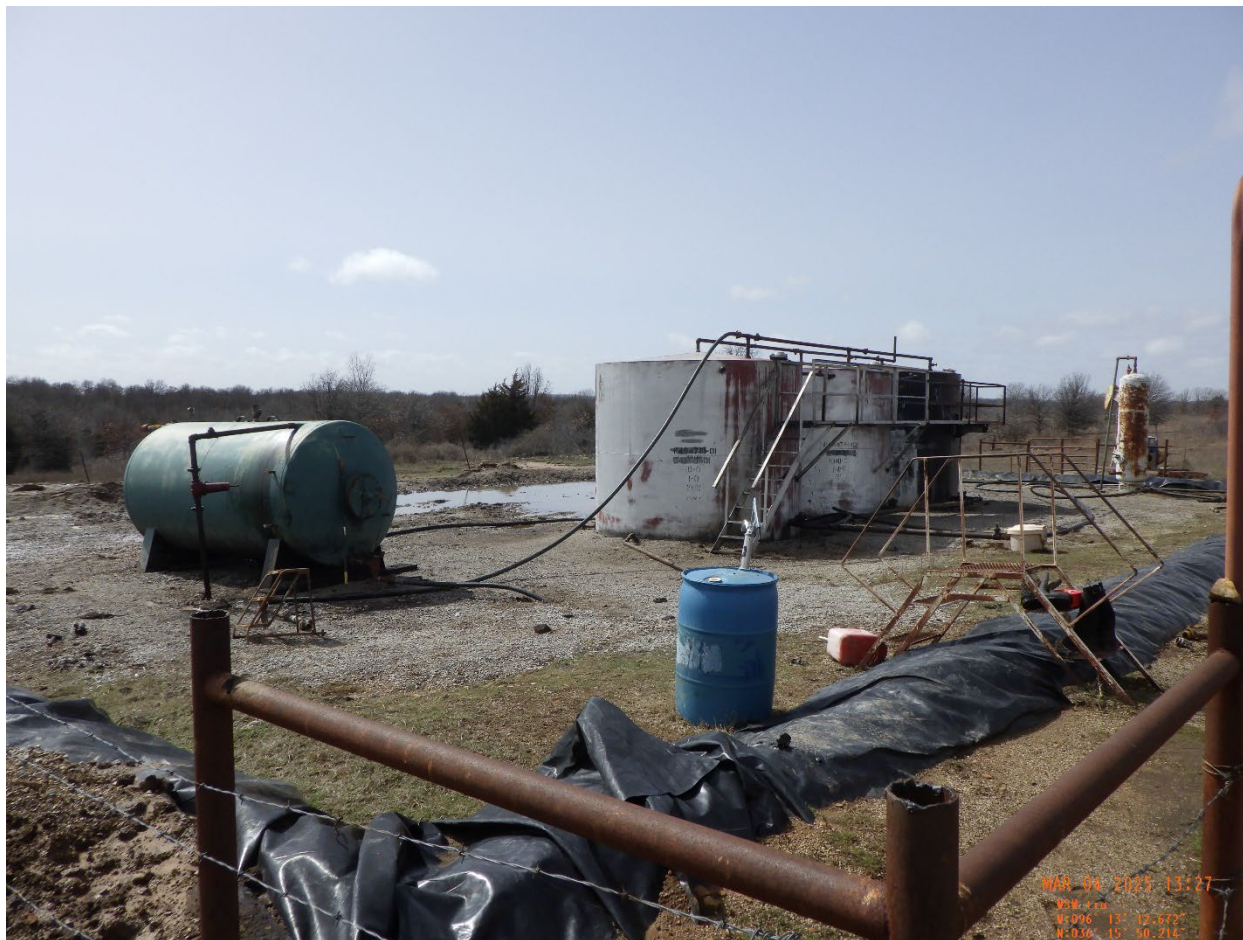
Photo No. 2

I observed the Osage B tank battery from the NE corner of the facility. This overview can be seen in photo No. 2.

**Description:** This was an overview of the Osage C Lease tank batter with a view toward the WSW.

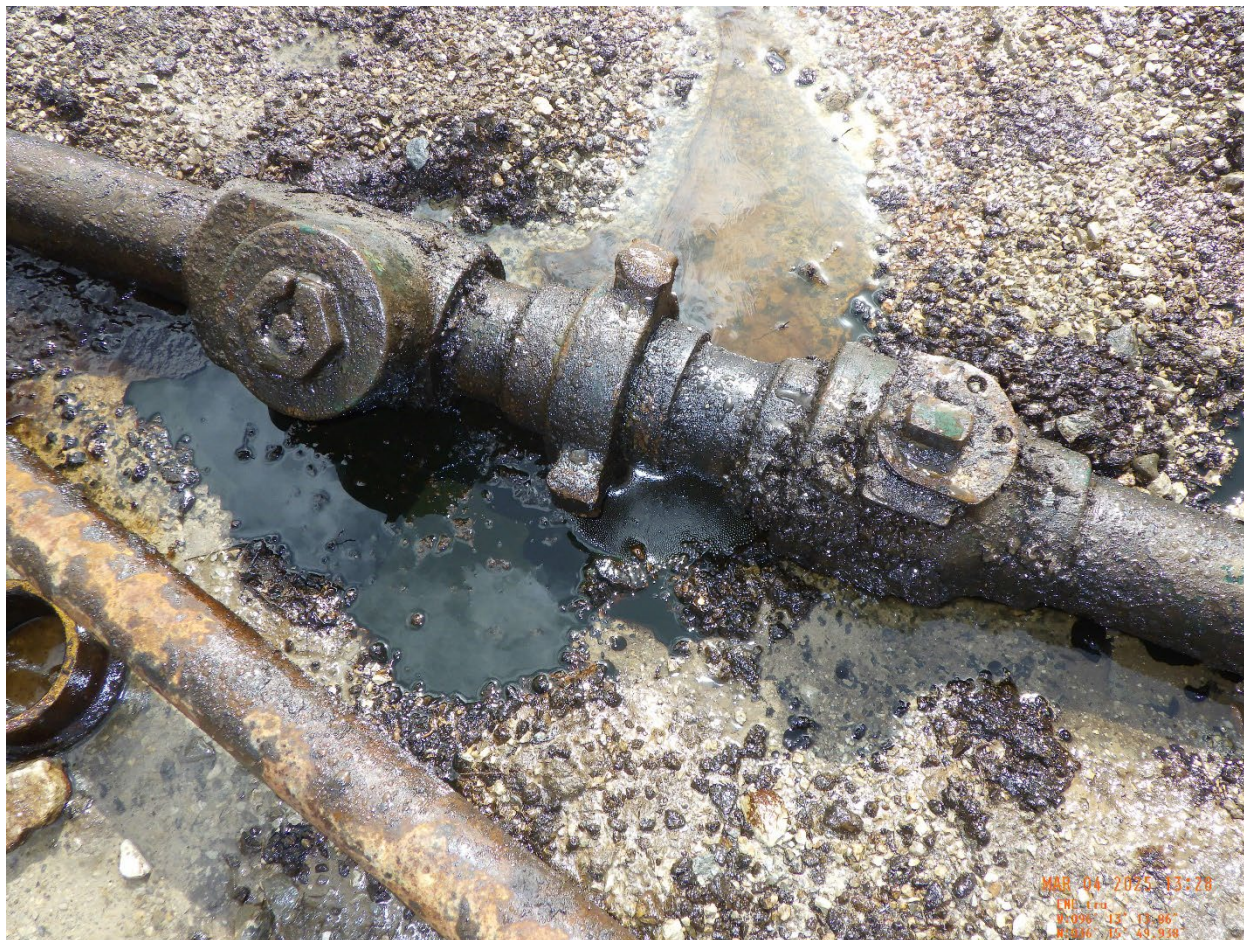
Photo No. 3

Inside the secondary containment of the facility, I observed the release point of the spill, which was a leaking hammer union on a production flowline running across the floor of the facility. At the time of the inspection, produced water and oil was actively leaking from the flowline. This observation can be seen in photo No. 3.

The primary area of concern at the time of the inspection was the fact that the release was ongoing and not secured. The lease owner/operator was also unresponsive to BIA field inspector Mike Perrier, in his attempts to contact the owner/operator.

**Description:** This was the release point of the spill, a leaking hammer union on a flowline, located inside the secondary containment. At the time of the inspection, the leak was ongoing, releasing saltwater and oil to the floor of the facility.

After the inspection concluded, BIA field supervisor, Jeff McGuire was able to contact the facility owner and request the release be secured before further downstream migration of spill impacts.

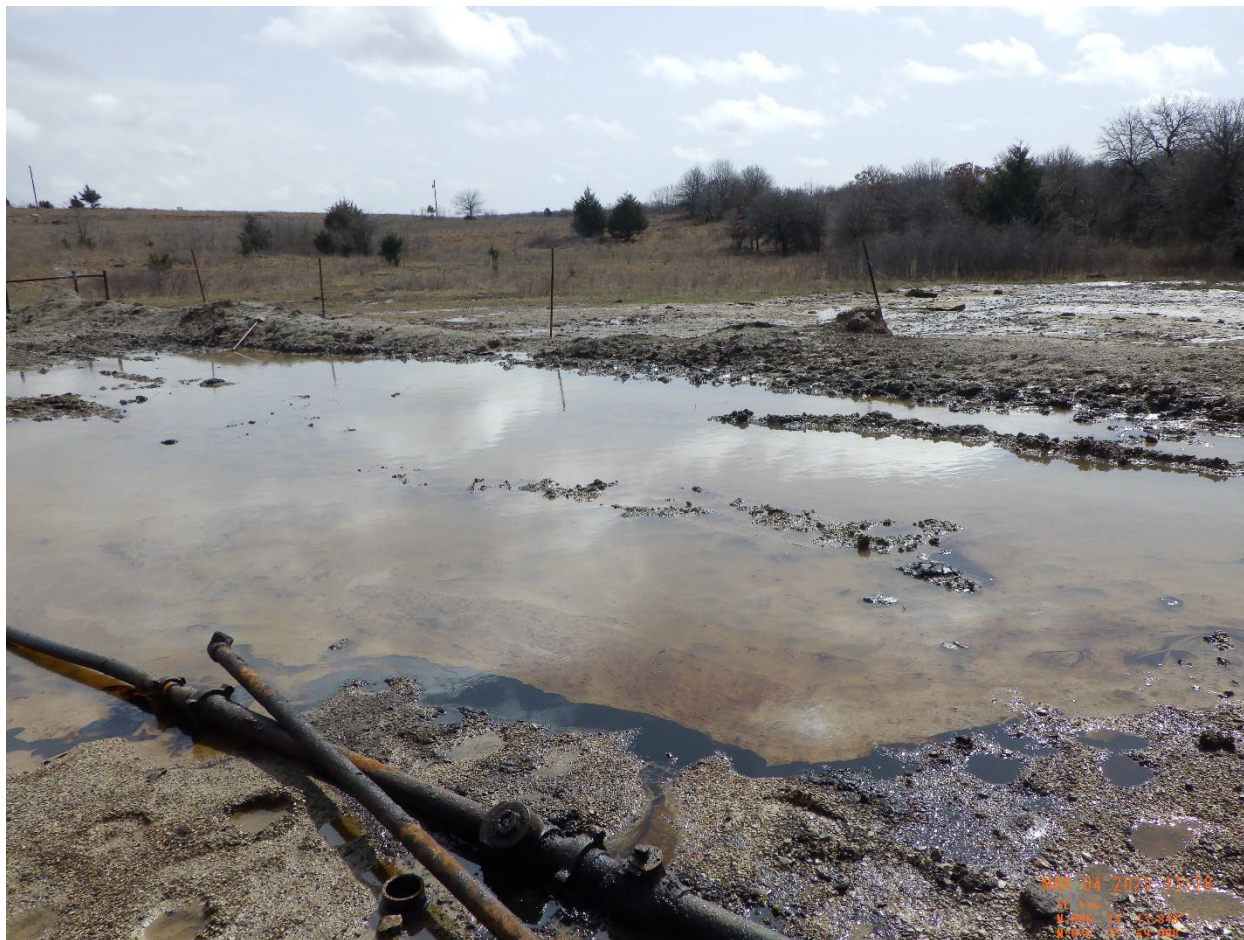
Photo No. 4

I observed the pit area to the south of the facilities' storage and process vessels. The pit area was filled with produced water and had free oil floating atop the water at the time of the inspection. See photo No. 4.

**Description:** This was a view of the pit area inside the secondary containment. There was oil and saltwater covering the area, and the pit was actively discharging through the insufficient berm at the time of the inspection.

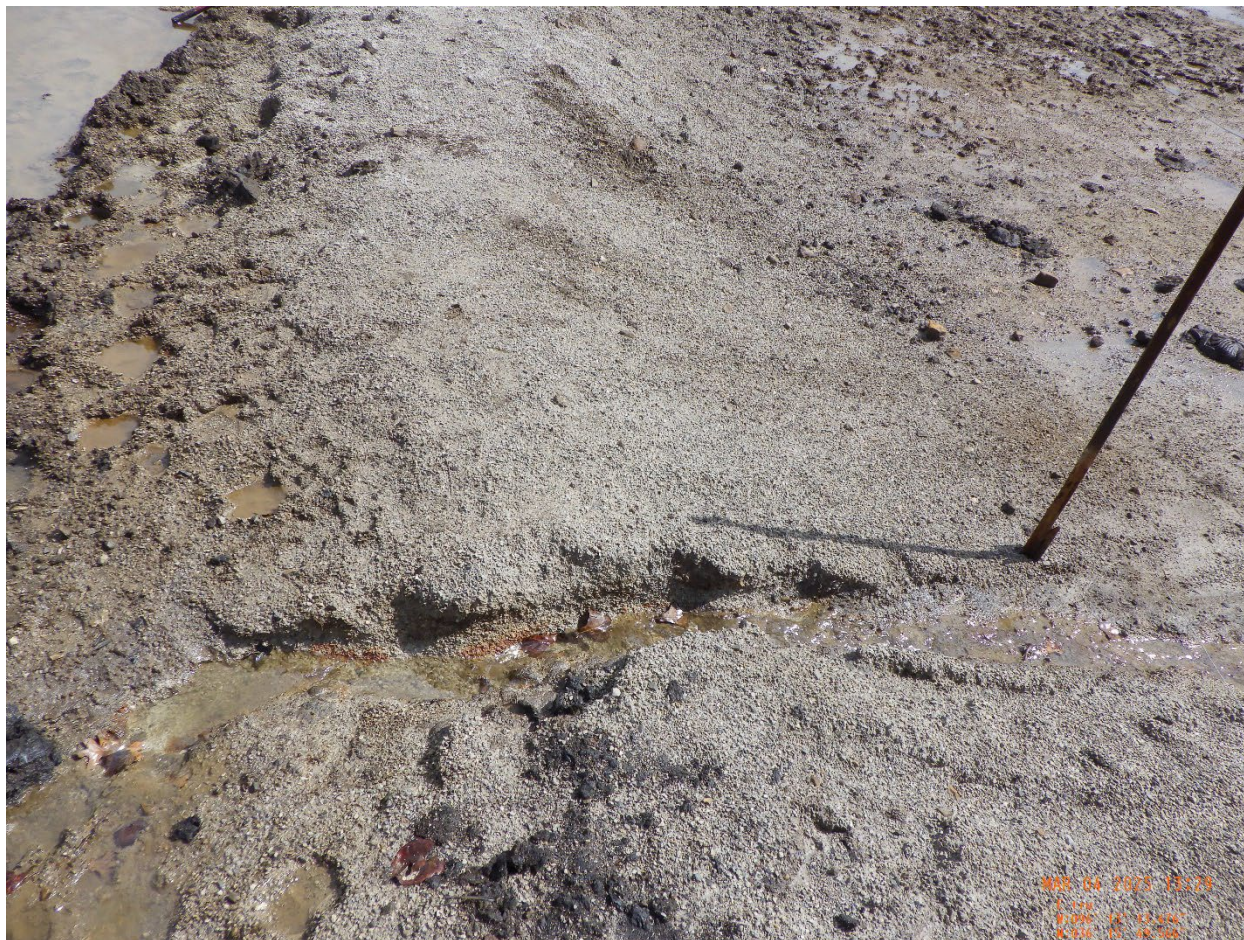
Photo No. 5

I observed an eroded section of the inadequate secondary containment along the south side of the facility. At the time of the inspection, produced water was discharging from the secondary containment as seen in photo No. 5

The improperly constructed and insufficient secondary containment at the facility was also an area of concern.

**Description:** This was the area of eroded secondary containment where the spill was actively discharging out of the facility at the time of the inspection. The TDS of the discharge was observed to be 22,560 mg/L.

EPA inspector has referred the facility to the EPA-SPCC/FRP program for further evaluation.

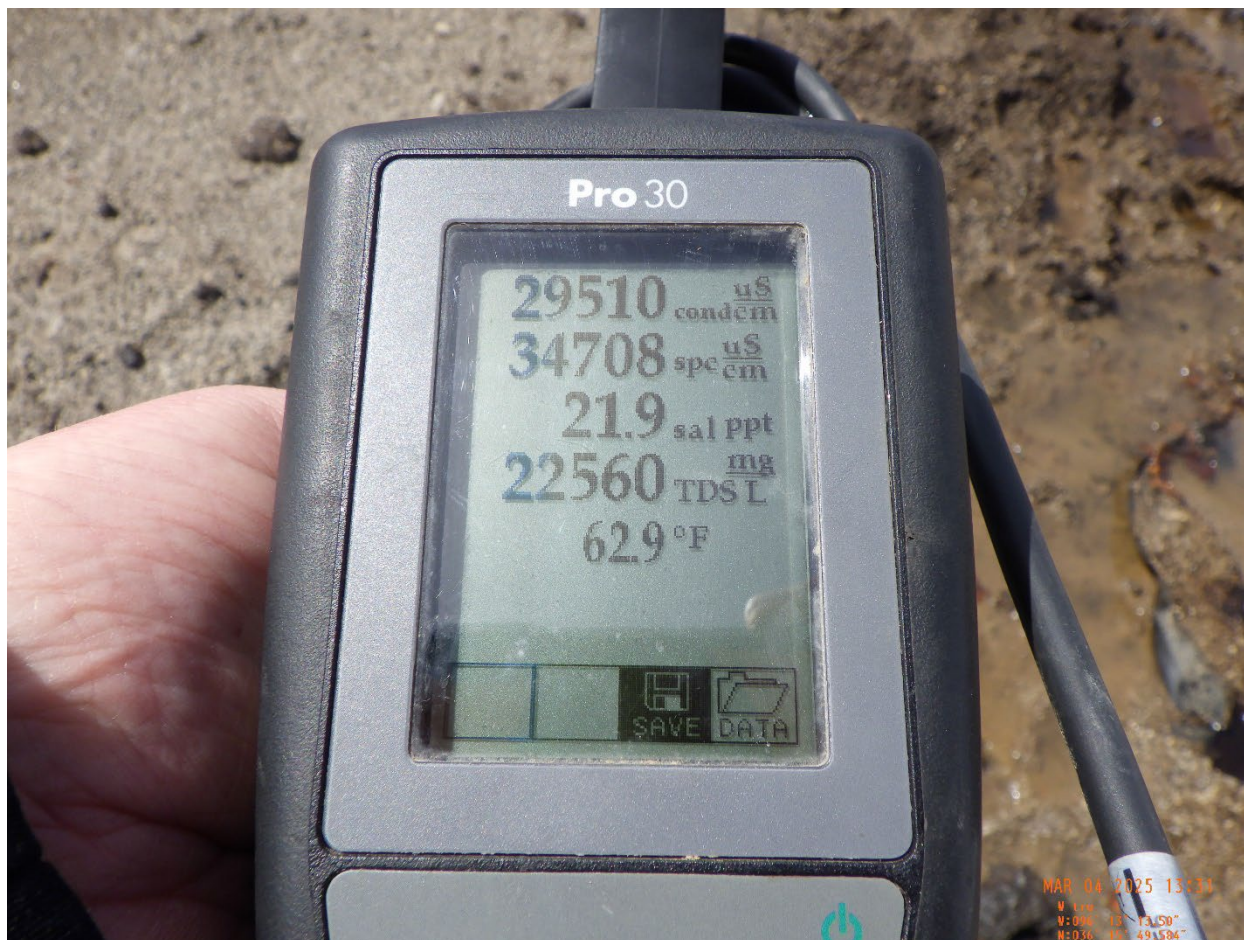
Photo No. 6

I observed a TDS field reading of 22,560 mg/L in the water which was discharging from the secondary containment. This was the highest TDS field reading observed during the inspection. This observation along with all others during the inspection was made with a properly calibrated YSI Pro 30 conductivity meter. The water was discharging to the SE along a natural drainage feature. See photo No. 6.

Additional areas of concern included the elevated TDS waters which were being released with the potential to impact waters of the United States (WOTUS) if the release is not secured. This area of concern was elevated due to the owner/operator being unresponsive/unreachable. Crude oil also had the potential to impact WOTUS.

**Description:** This was a TDS field reading of 22,560 mg/L taken from the water which was discharging from the eroded secondary containment at the facility. The discharge was migrating SW along a drainage feature.

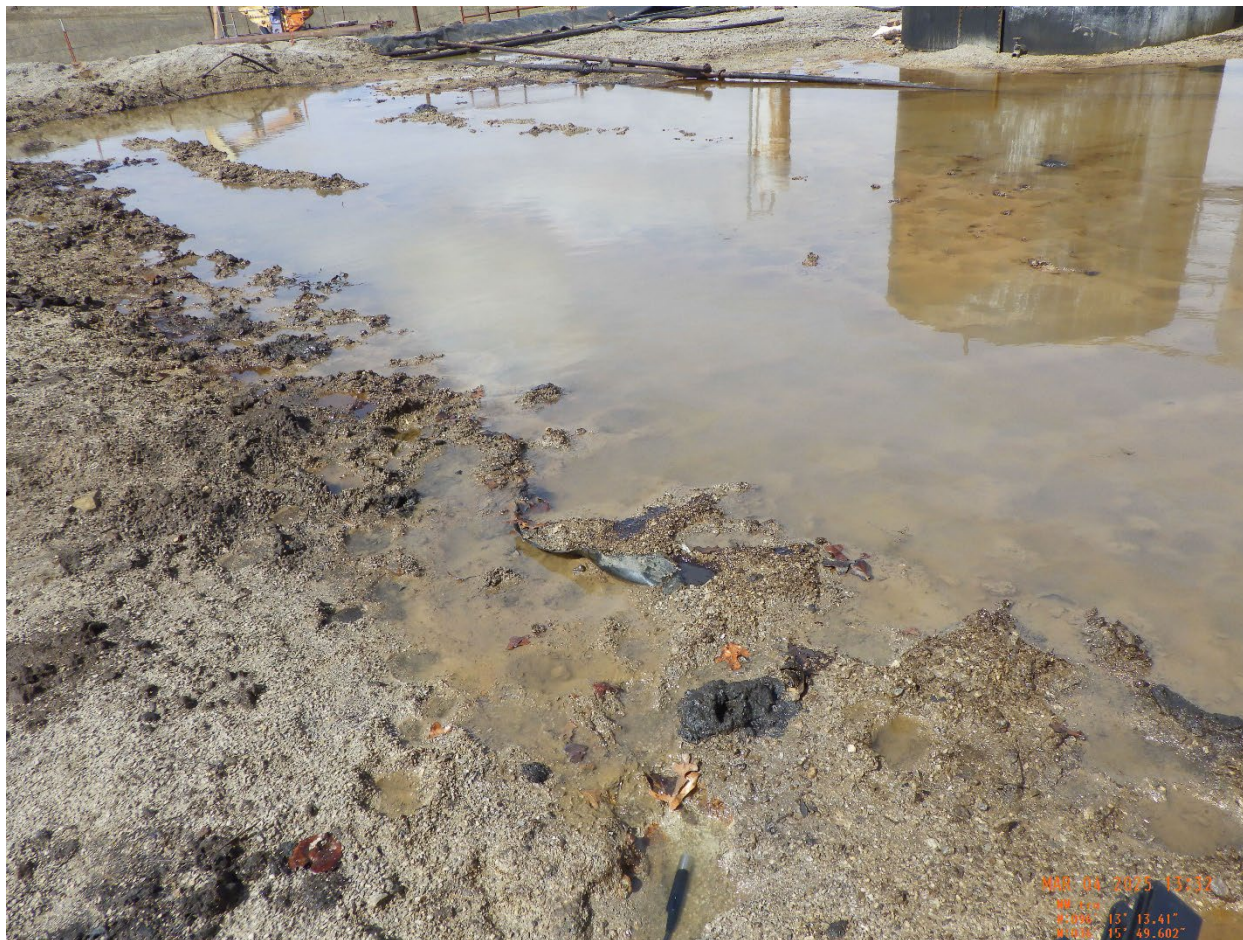
Photo No. 7

Standing at the eroded section of secondary containment I observed the pit area and release point of the spill with a view toward the NW. See photo No. 7.

**Description:** This was a view standing at the eroded secondary containment looking NW across the pit toward the release point of the spill.

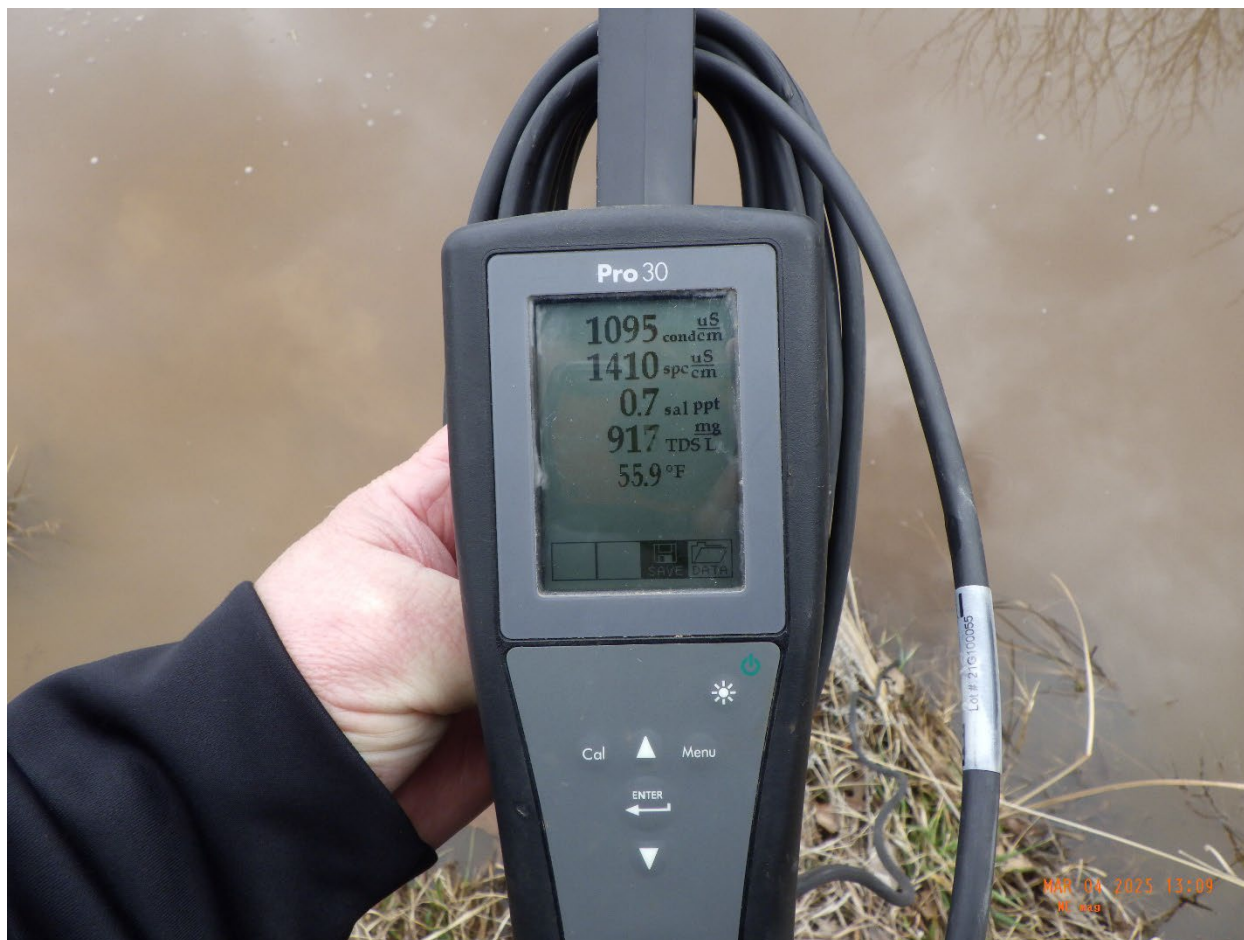
Photo No. 8

Approximately ¼ mile downstream from the Osage B tank battery, I observed a TDS field reading of 917 mg/L at an area where the drainage feature had mixed into an unnamed tributary of Mud Creek. See photo No. 8.

**Description:** This was a TDS field reading of 917 mg/L observed approximately ¼ mile downstream from the release point where the drainage feature had spilled into an unnamed tributary of Mud Creek.
