FROM: INVESTIGATION TEAM  
TO: R. D. SHULTZ - FTM - LUBE MANUFACTURING  
SUBJECT: FIRE ON DE-OILING PRODUCT WAX TO STORAGE LINE

Summary

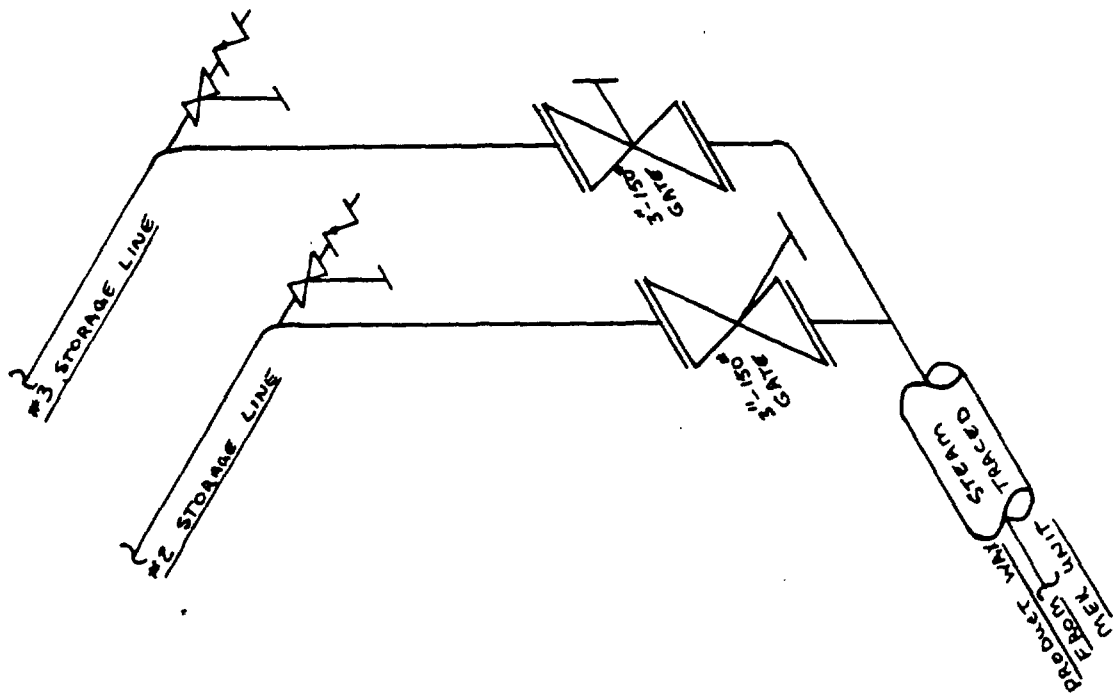
DRAWING NO.  
SKETCH #1

The MEK De-oiling unit routes product wax at approximately 225 degrees F to Lube Logistics down the #1, #2, #3, or #4 storage line. Each of these lines are 3"-150# class lines with 200# steam tracing, asbestos insulation, and metal covered. Isolation valves at the southeast corner of the unit are used to determine the correct routing of product wax to storage. In addition, a 3/4" steamout connection is installed on each product wax to storage line, downstream of the unit isolation valve, to clear the line of wax after use. The piping arrangement at the #2 and #3 lines to storage is shown in attached sketch 1.

The fire occurred in the piperack at the southeast corner of the unit in an area with no obvious ignition sources. However, molten wax from the steam out valve packing was found on the pipe insulation above the fire. The metal covering around the valves on the #2 and #3 lines to storage was not sealed adequately enough to prevent leaking wax from penetrating the insulation.

The temperature of the product wax going to storage (225 degrees F) and the temperature of the 200# steam tracing (390 degrees F) are both below the flash point of the wax that leaked from the valve packing. However, investigation into a similar incidents involving fires in wax soaked insulation revealed that waxes oxidize to form peroxides when exposed to sufficient oxygen. Applying heat to the wax causes formation of more peroxides and a high concentration of peroxides will result in considerably lower auto-ignition temperature.

It is not uncommon to have molten wax on the insulation in this part of the unit. However, in this case all of the conditions existed for the formation of peroxides from the wax. It is concluded that fire was a result of auto-ignition of smoldering wax soaked insulation.

1. Remove all insulation on the steam traced lines in the area of fire and install new cellular glass insulation over a mineral wool wrap. -- S. M. Bear - COMPLETED
2. Tighten or replace all valve packing on the product wax to storage valves and steam out valves. -- S. M. Bear - COMPLETED
3. Investigate other areas of the MEK unit for wax leaks around insulation, correct the leak, and submit a work request for replacing the insulation as necessary. -- J. D. Williamson - COMPLETE BY 8/90
