## Clean Water Act Section 404: Site Visit/Case Development

| Site Name | SVG Holdings, LLC Property - 1821 Albany Post Road | | | | |

CWA 404 Inspection  
SVG Holdings Property  
1821 Albany Post Road  
Wallkill, Ulster County, NY

May 16, 2023

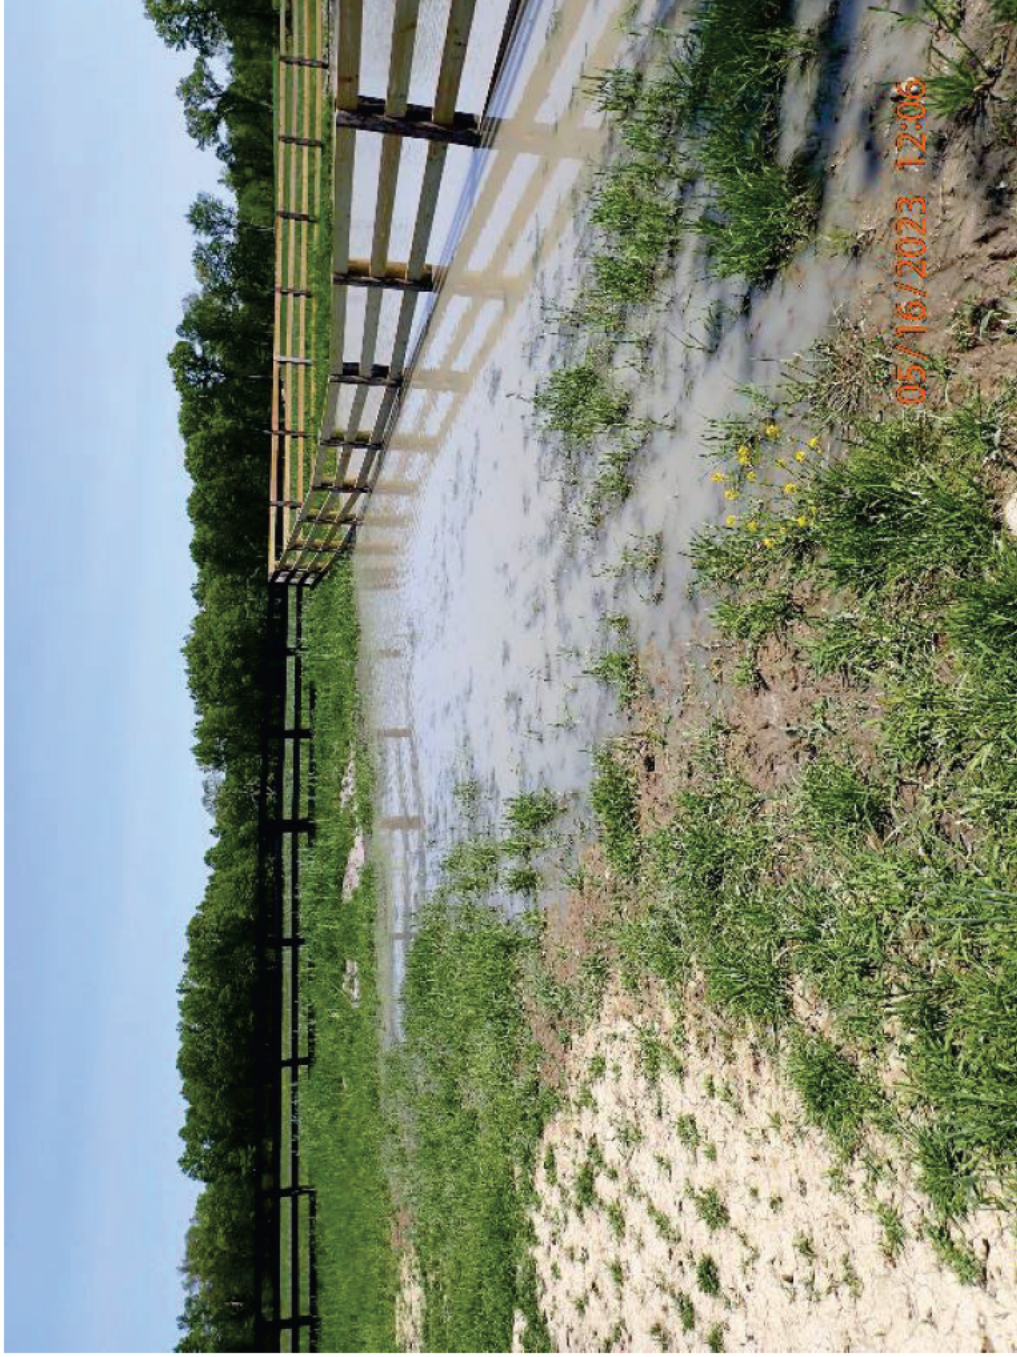
**Date:** 5/16/2023  
**Time:** 12:06 PM  
**Photographer:** SSA  
**Photo ID:** 1 – P5160010

(1/6) Panorama of pond area;  
southeast quadrant of eastern  
portion of site

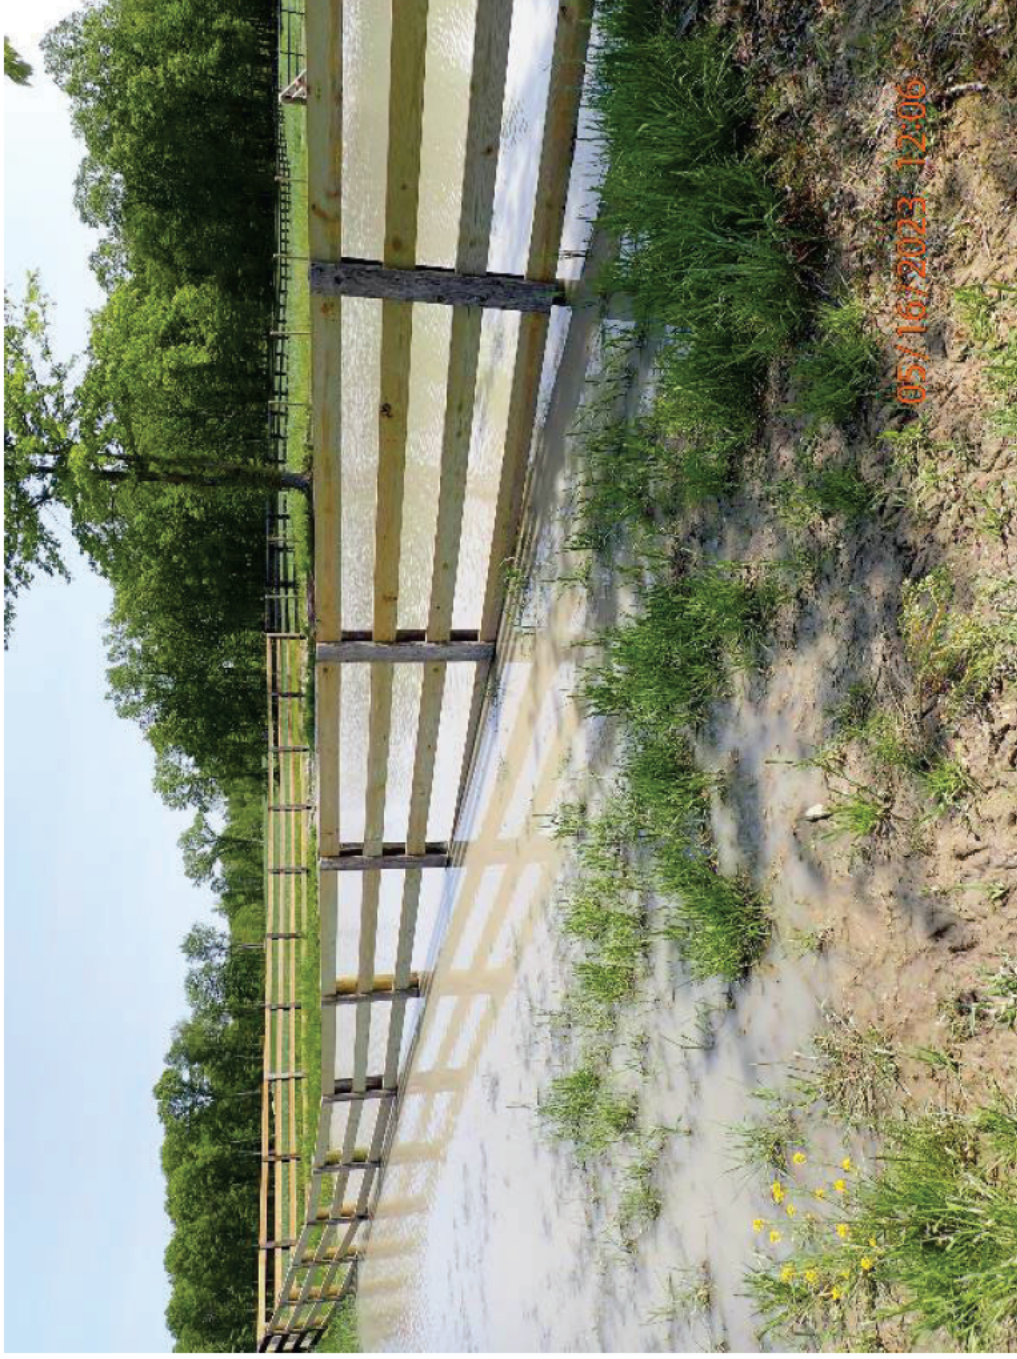
**Date:** 5/16/2023  
**Time:** 12:06 PM  
**Photographer:** SSA  
**Photo ID:** 2 – P5160011

(2/6) Panorama of pond area;  
southeast quadrant of eastern  
portion of site

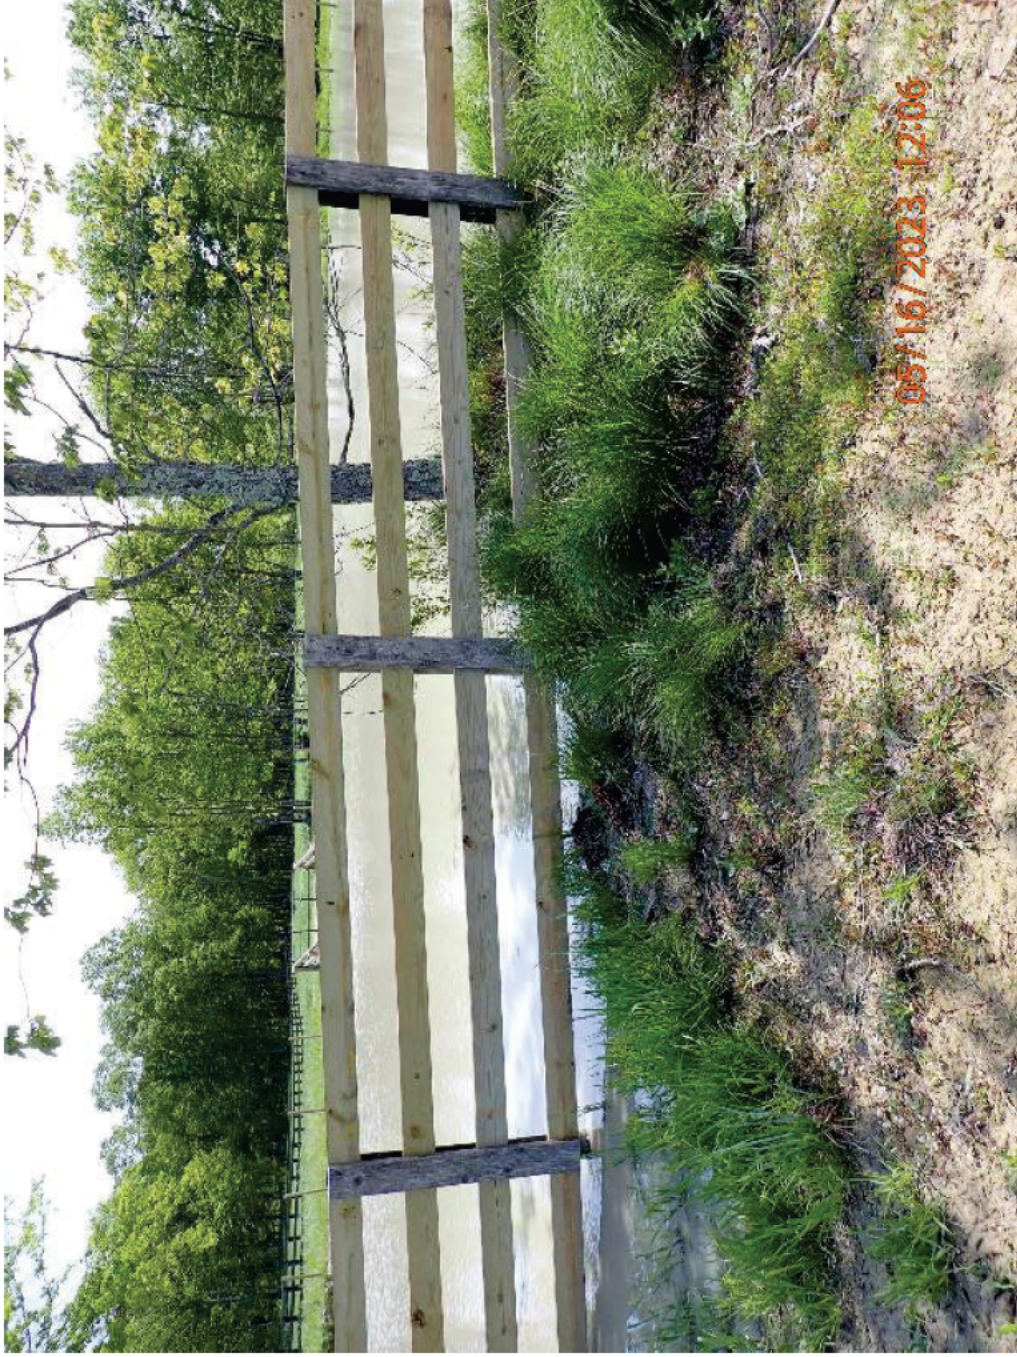
**Date:** 5/16/2023  
**Time:** 12:06 PM  
**Photographer:** SSA  
**Photo ID:** 3 – P5160012

(3/6) Panorama of pond area;  
southeast quadrant of eastern  
portion of site

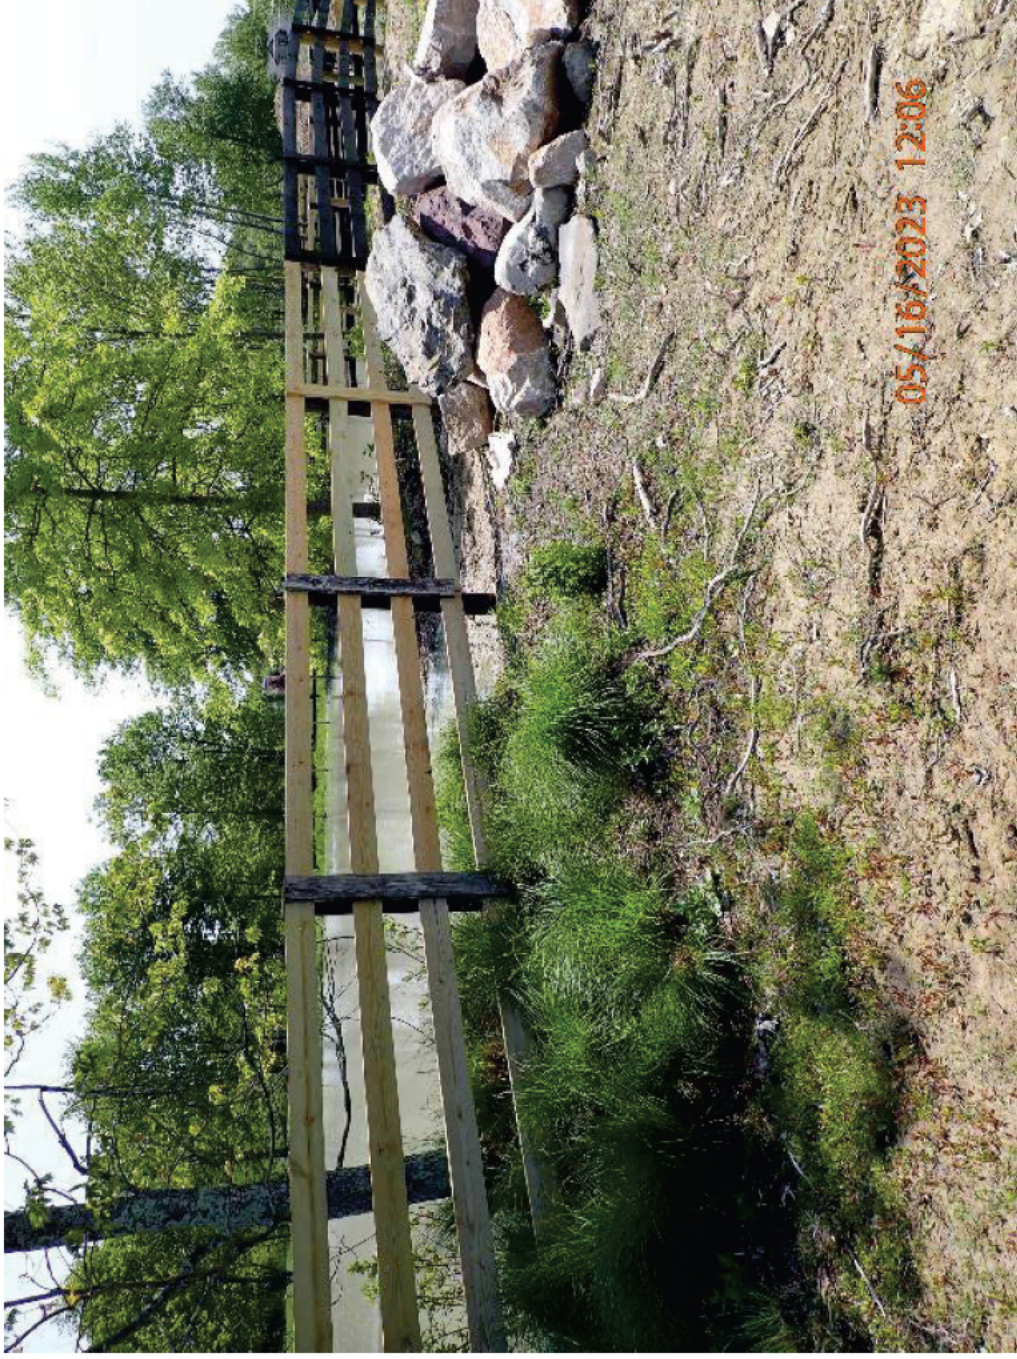
**Date:** 5/16/2023  
**Time:** 12:06 PM  
**Photographer:** SSA  
**Photo ID:** 4 – P5160013

(4/6) Panorama of pond area;  
southeast quadrant of eastern  
portion of site

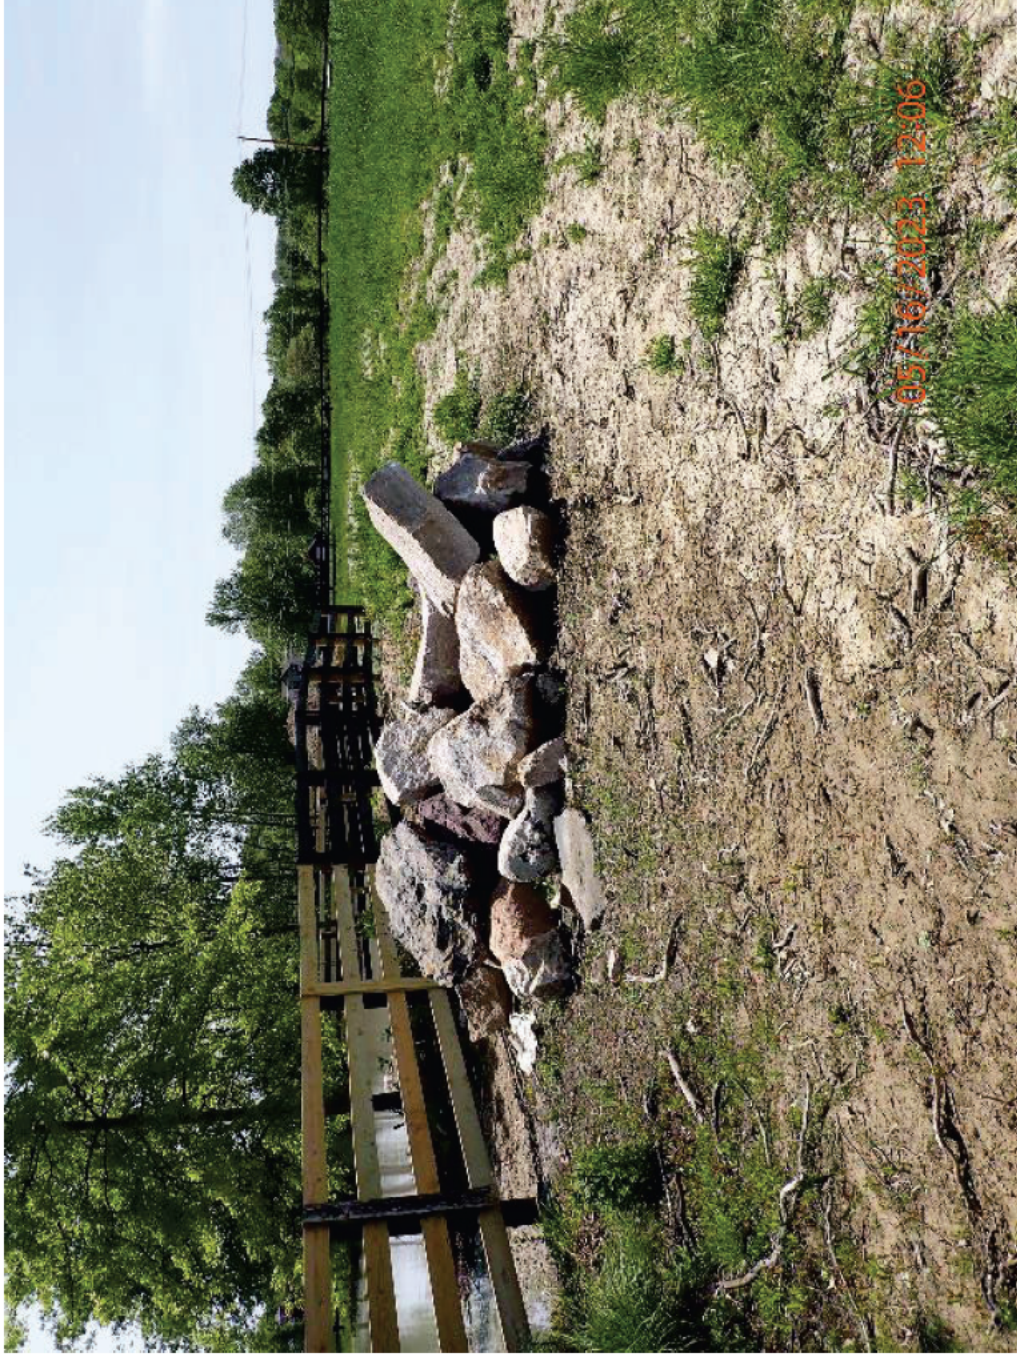
**Date:** 5/16/2023  
**Time:** 12:06 PM  
**Photographer:** SSA  
**Photo ID:** 5 – P5160014

**Description:**  
(5/6) Panorama of pond area;  
southeast quadrant of eastern  
portion of site

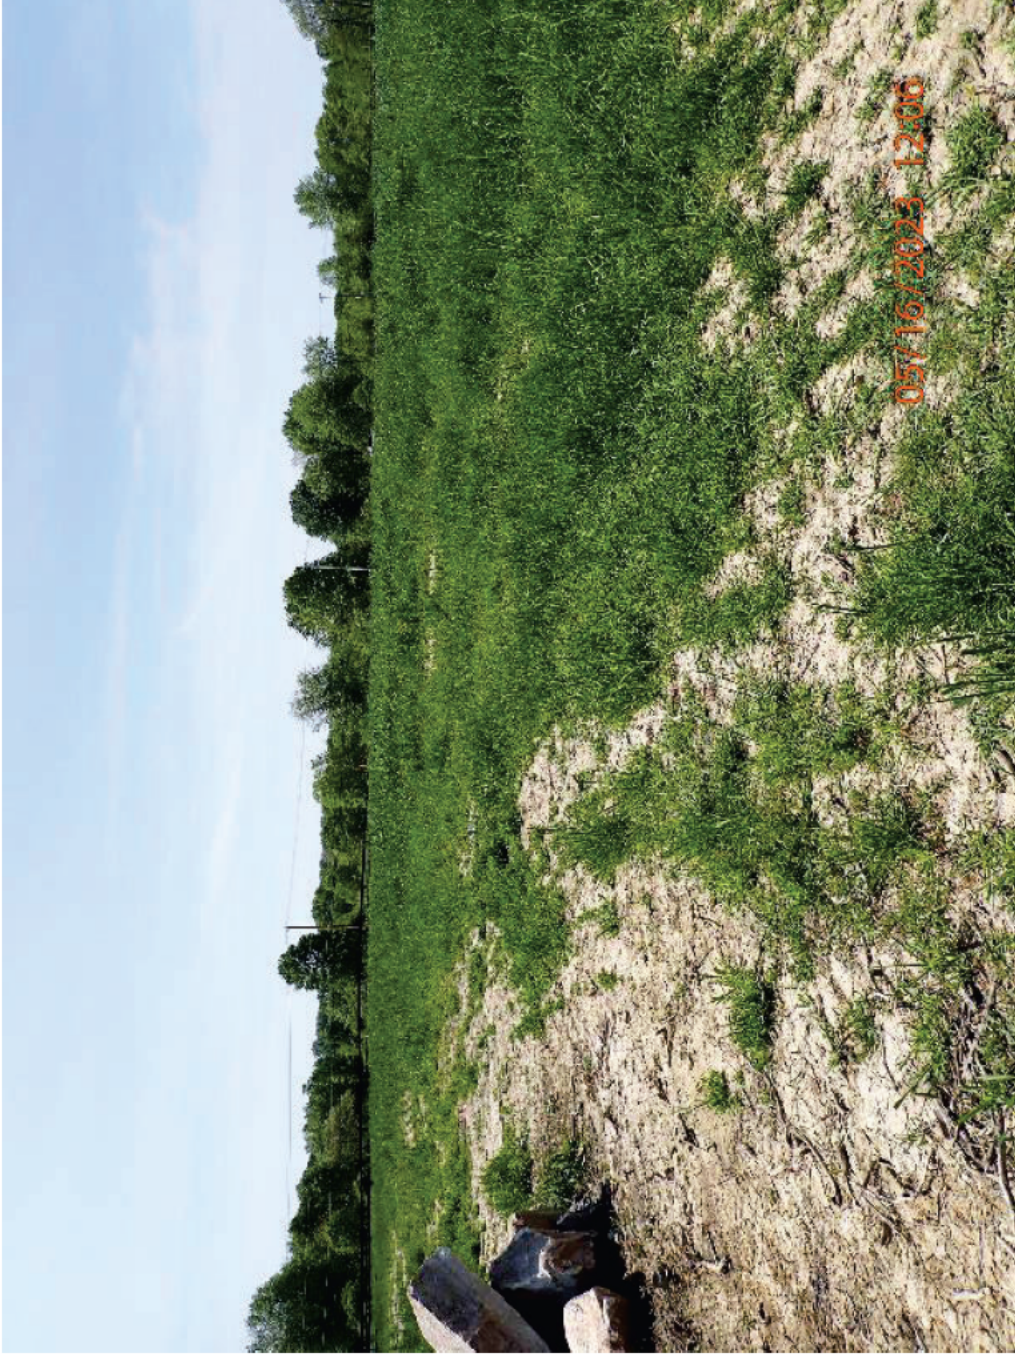
**Date:** 5/16/2023  
**Time:** 12:06 PM  
**Photographer:** SSA  
**Photo ID:** 6 – P5160015

(6/6) Panorama of pond area;  
southeast quadrant of eastern  
portion of site

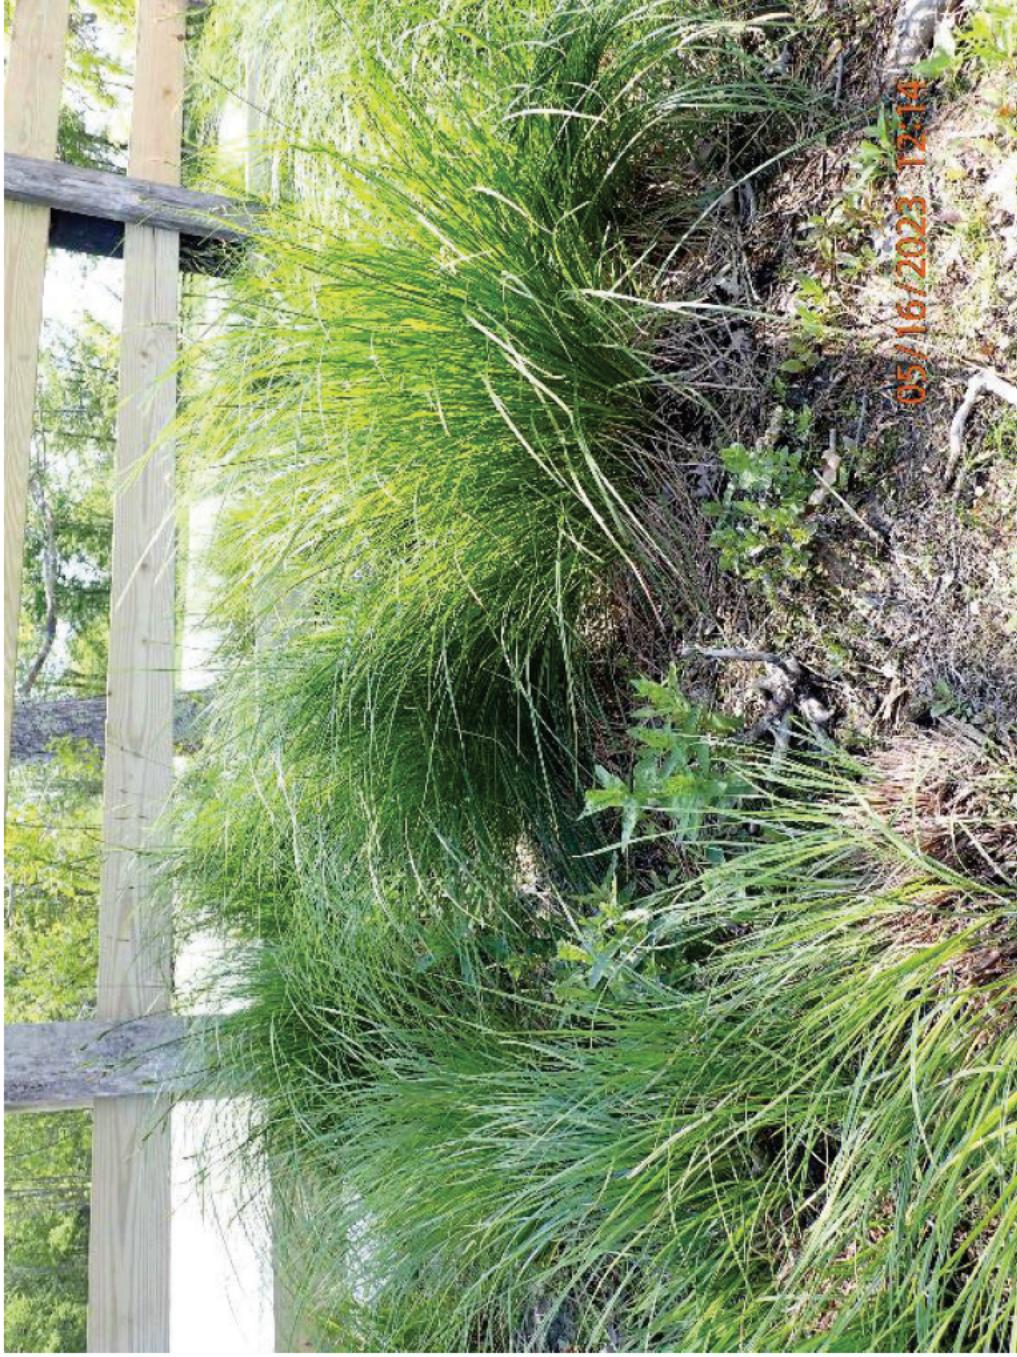
**Date:** 5/16/2023  
**Time:** 12:14 PM  
**Photographer:** SSA  
**Photo ID:** 7 – P5160016

**Description:**  
Tussock sedge (*Carex stricta*)  
and purple loosestrife (*Lythrum  
salicaria*) next to pond  
GPS Point

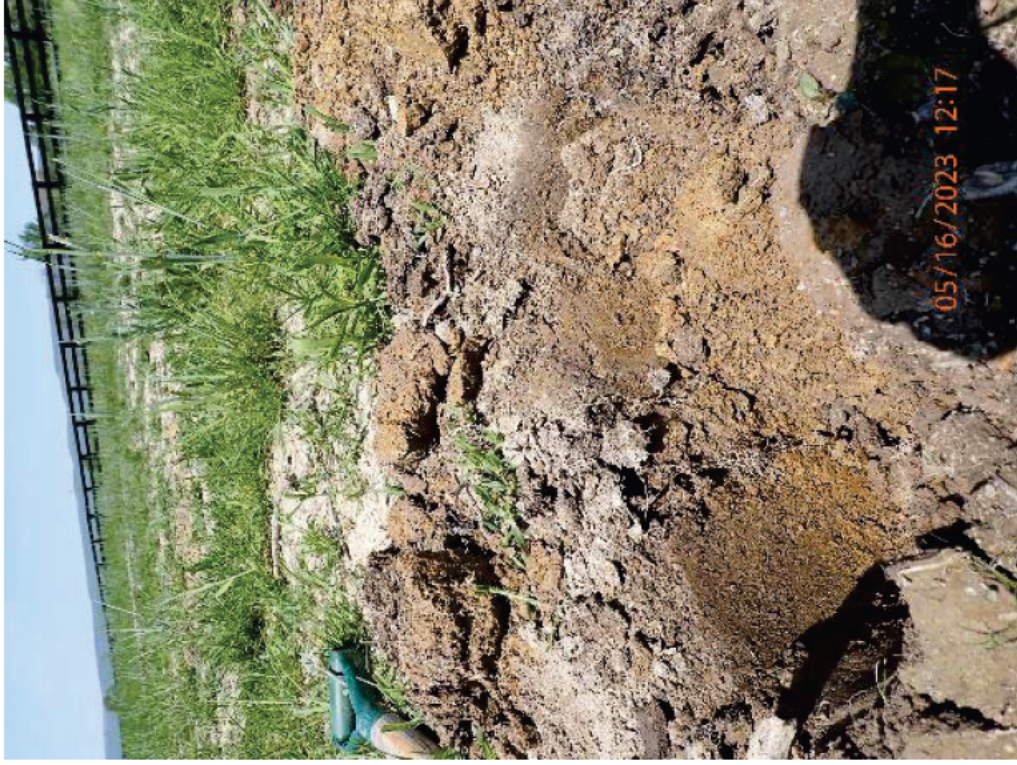
**Date:** 5/16/2023  
**Time:** 12:17 PM  
**Photographer:** SSA  
**Photo ID:** 8 – P5160017  
**Description:**  
Soil sample pit

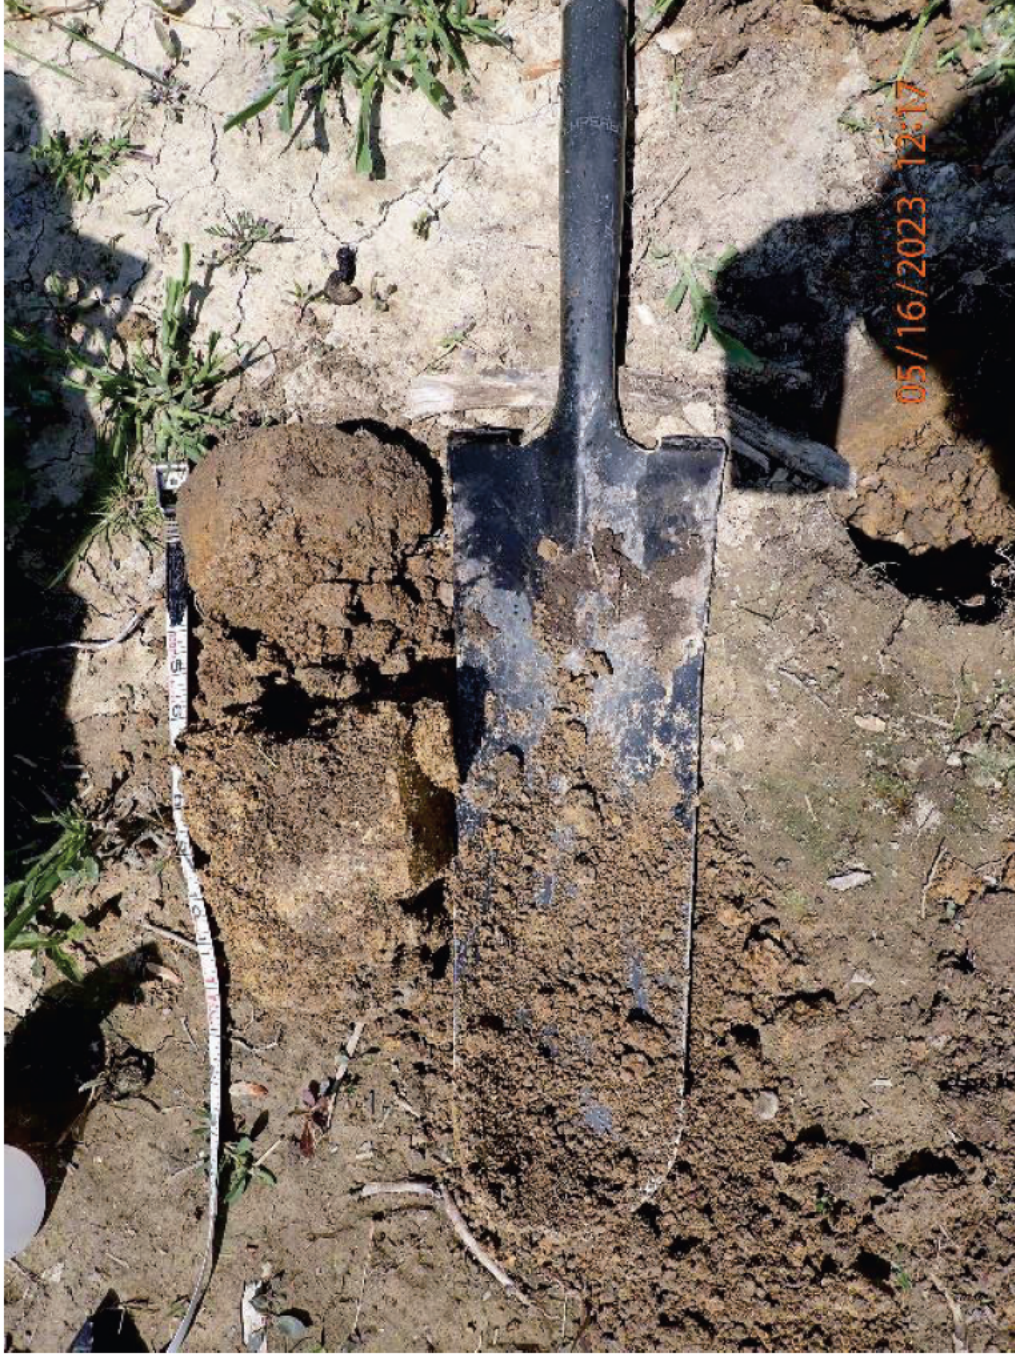
**Date:** 5/16/2023  
**Time:** 12:17 PM  
**Photographer:** SSA  
**Photo ID:** 9 – P5160018

**Description:**  
Soil sample pit

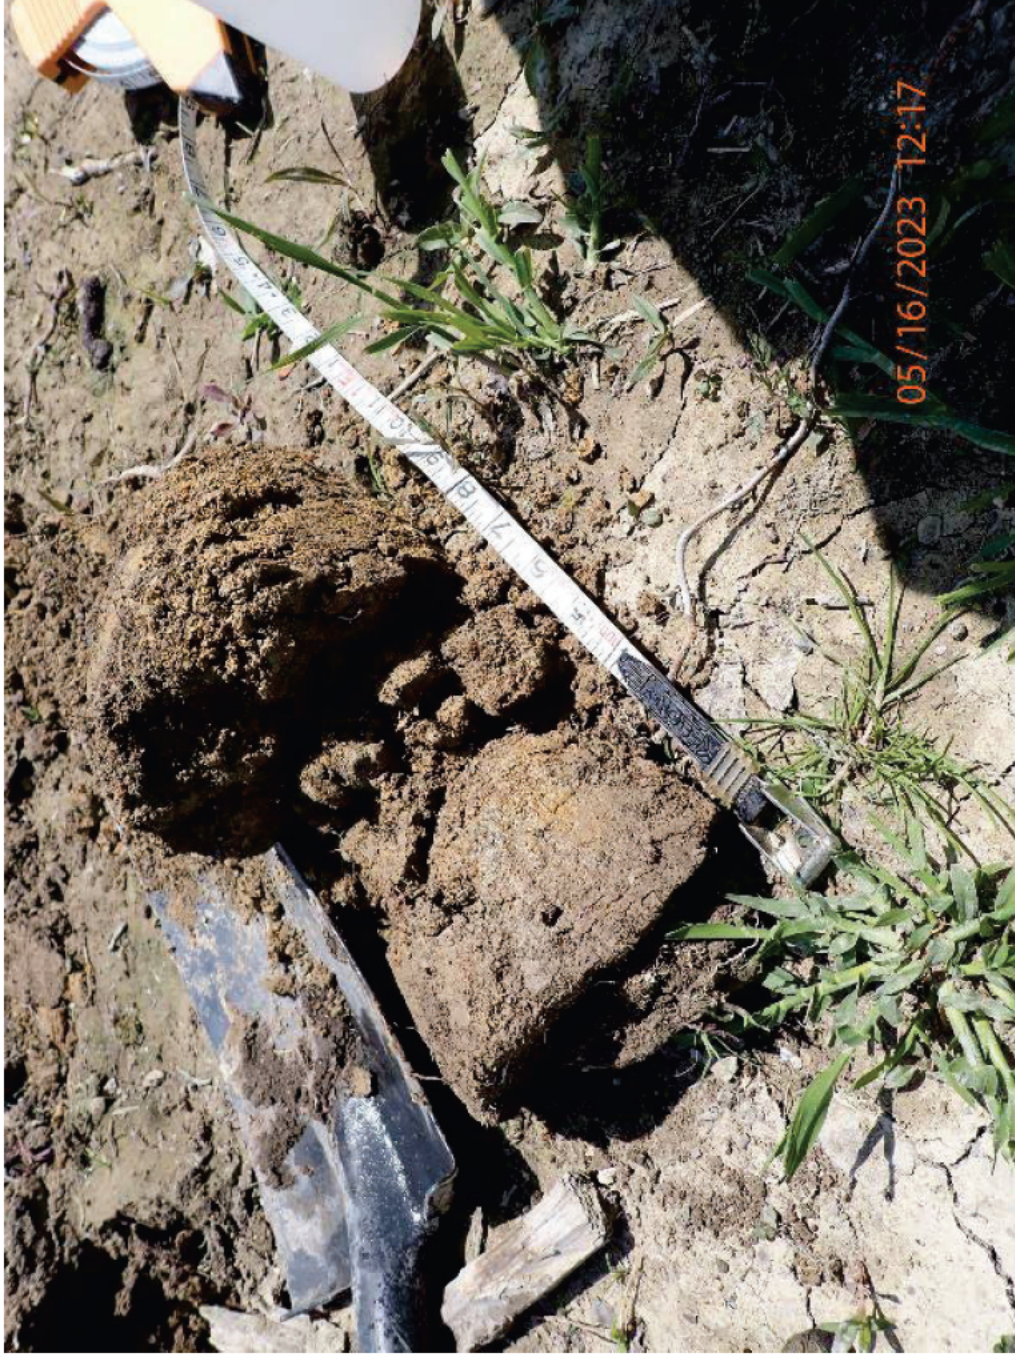
**Date:** 5/16/2023  
**Time:** 12:17 PM  
**Photographer:** SSA  
**Photo ID:** 10 – P5160019

**Description:**  
Soil sample pit

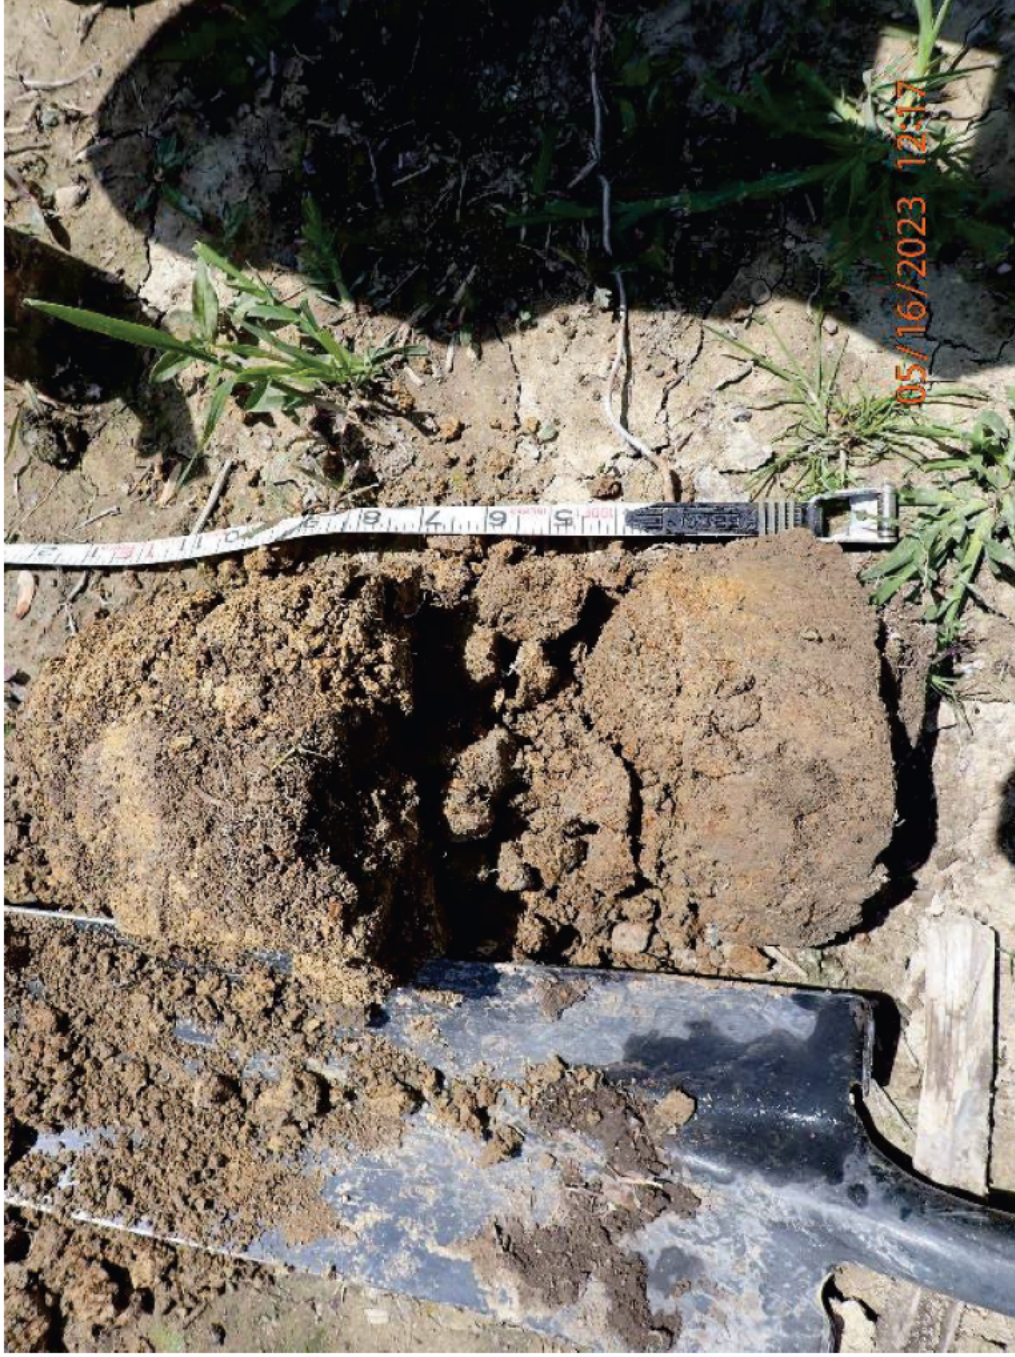
**Date:** 5/16/2023  
**Time:** 12:17 PM  
**Photographer:** SSA  
**Photo ID:** 11 – P5160020

**Description:**  
Soil sample pit

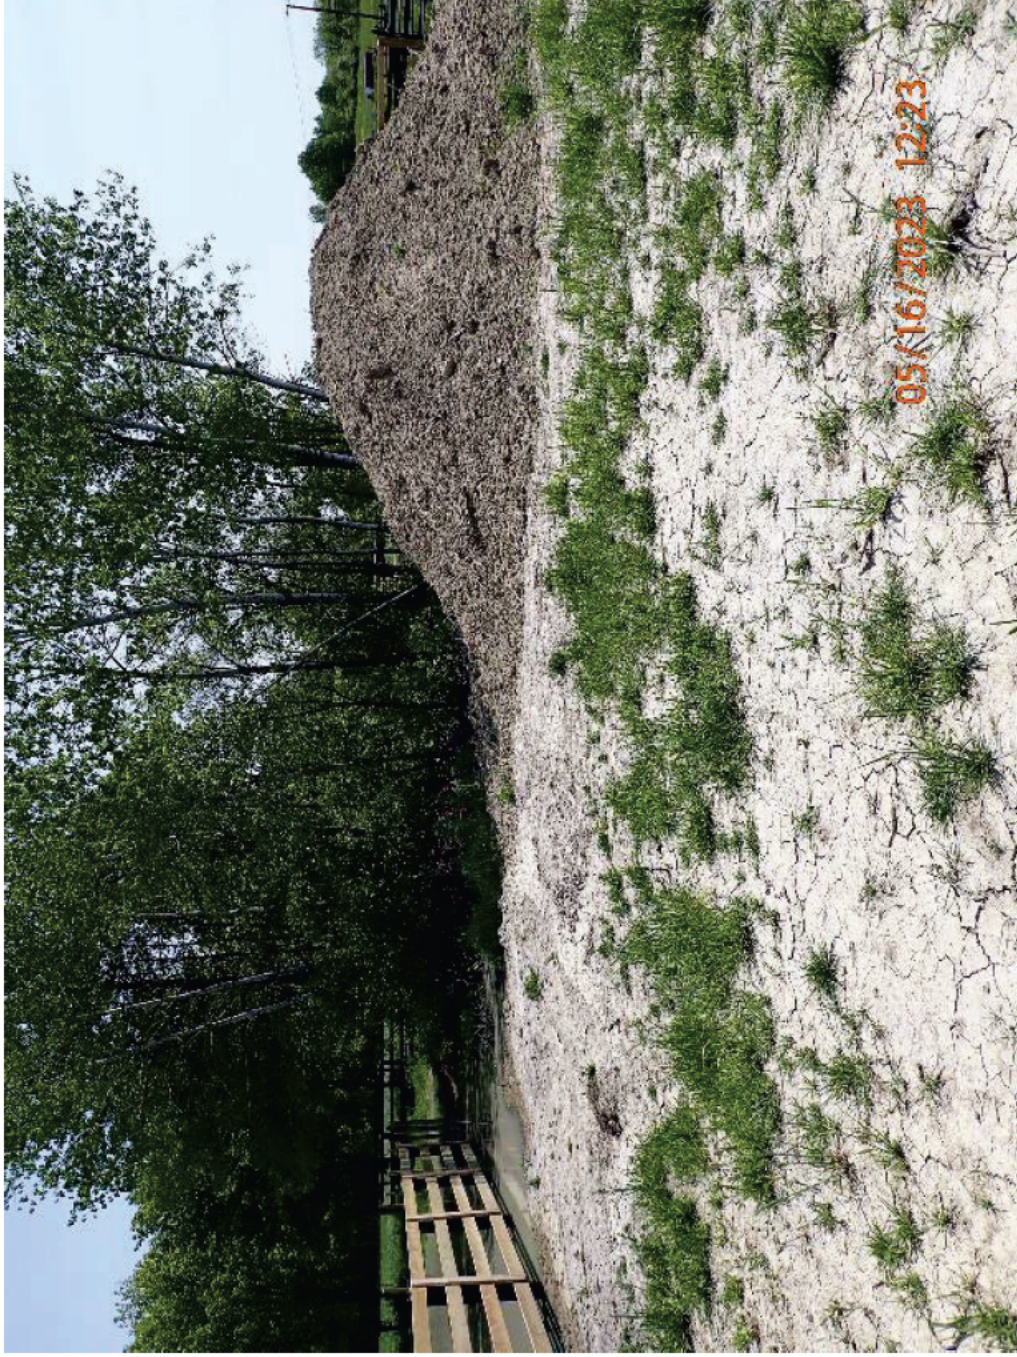
| <p>Mr. Glynn stated that the pond was fed by precipitation/surface water. He also stated that silt from the pond was used to fill in low areas on the property.</p> <p>Prior to this inspection, EPA conducted a second/follow-up inspection at a neighboring property, 260 Bruyn Turnpike, Wallkill, NY, which is also owned by SVG Holdings, LLC.</p> | | | |

**Date:** 5/16/2023  
**Time:** 12:23 PM  
**Photographer:** SSA  
**Photo ID:** 12 – P5160021  
**Description:**  
Fill pile near pond

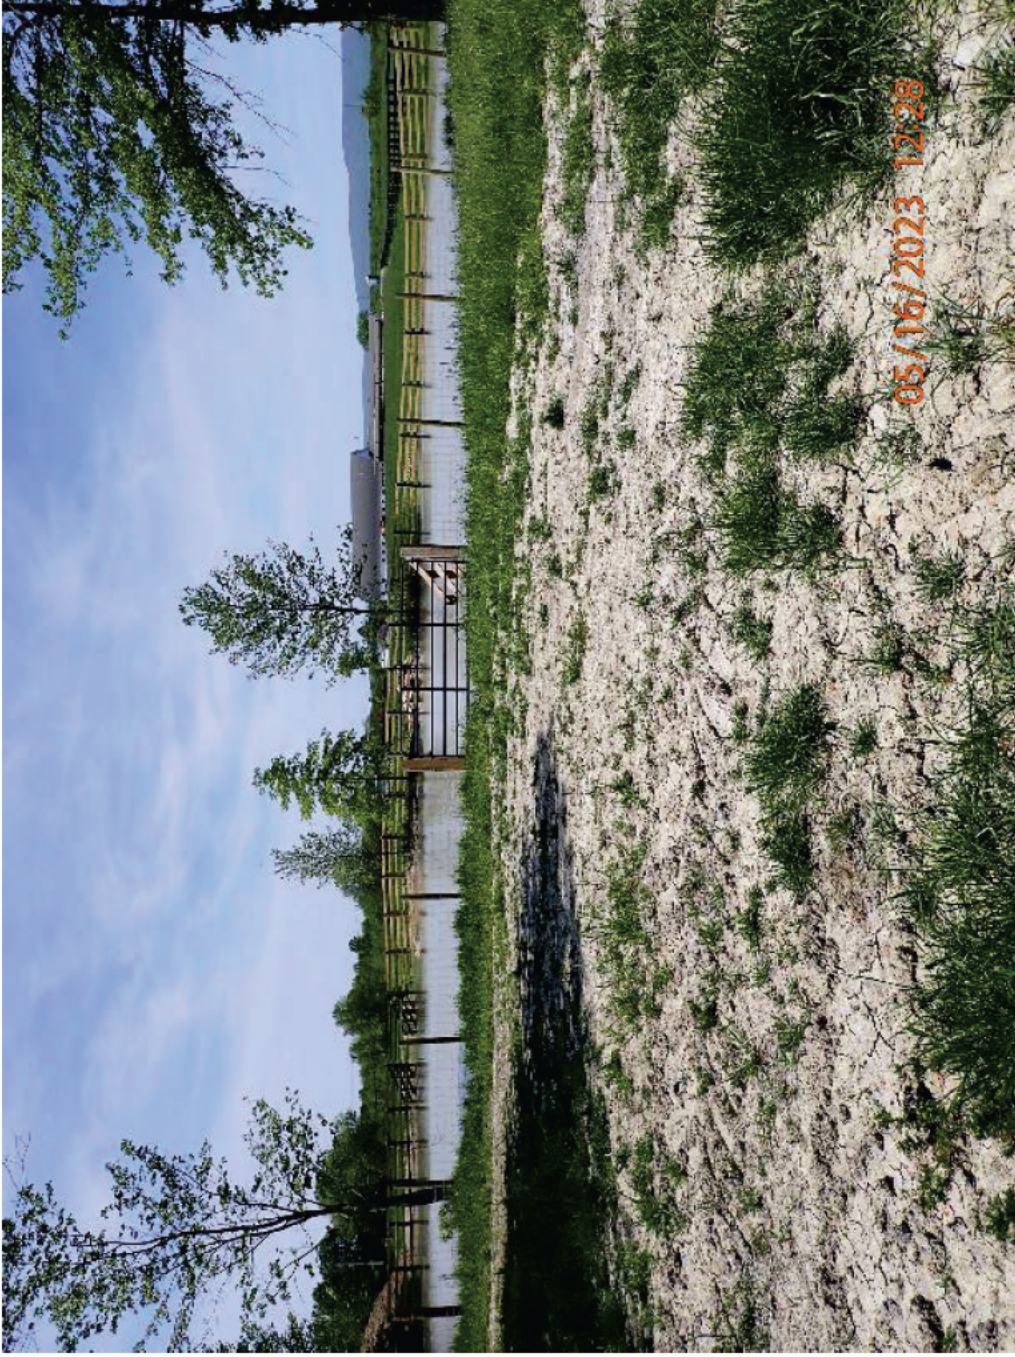
**Date:** 5/16/2023  
**Time:** 12:28 PM  
**Photographer:** SSA  
**Photo ID:** 13 – P5160022

**Description:**  
Fill on east side of pond

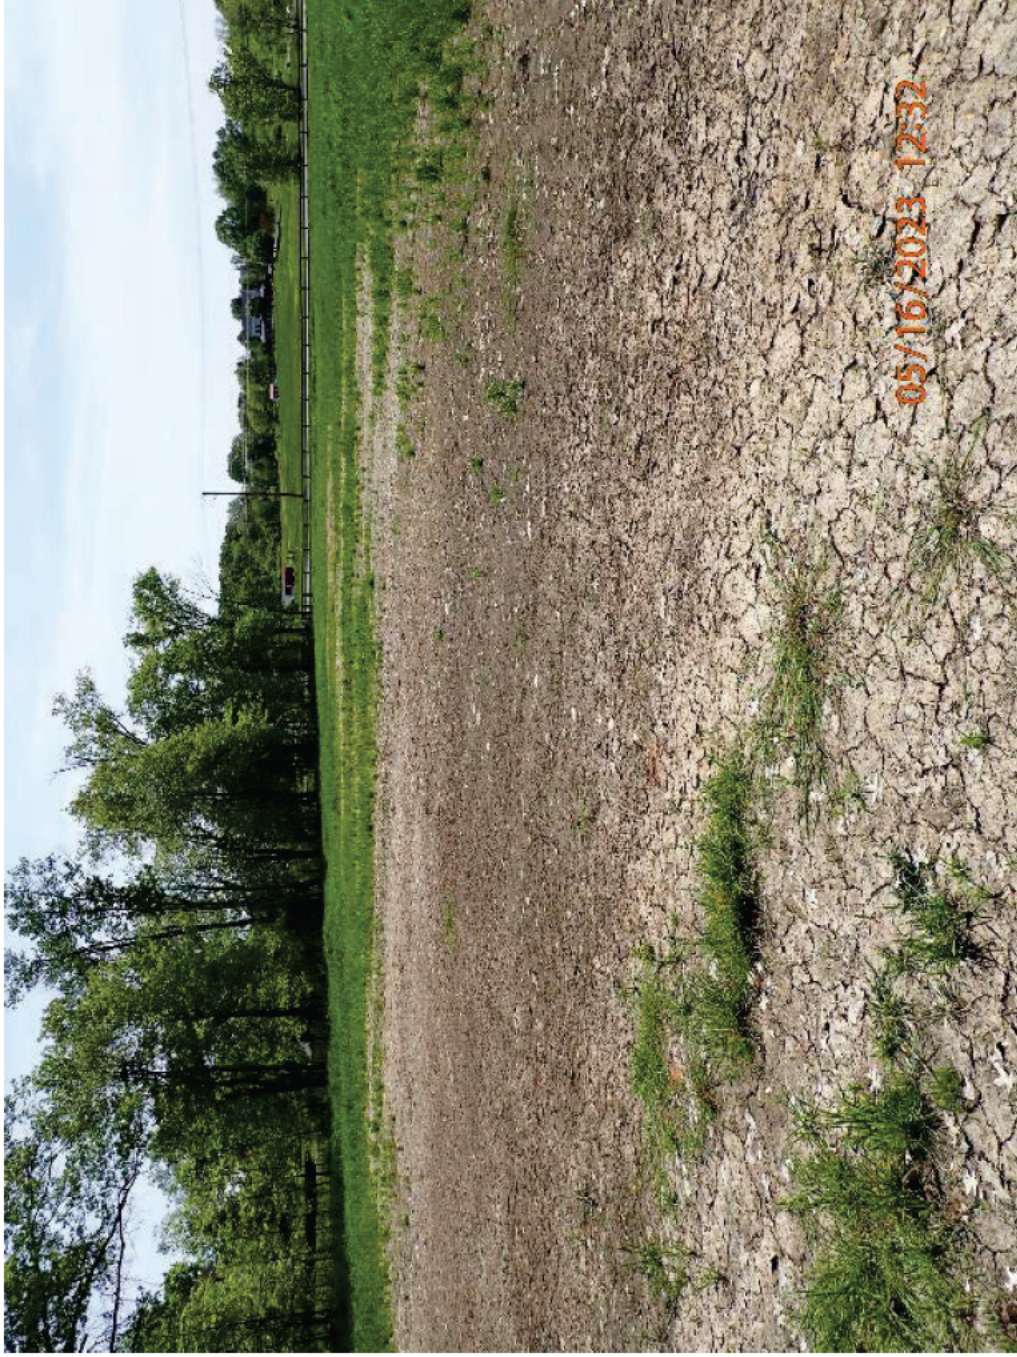
**Date:** 5/16/2023  
**Time:** 12:32 PM  
**Photographer:** SSA  
**Photo ID:** 14 – P5160023

**Description:**  
Unvegetated areas in pasture

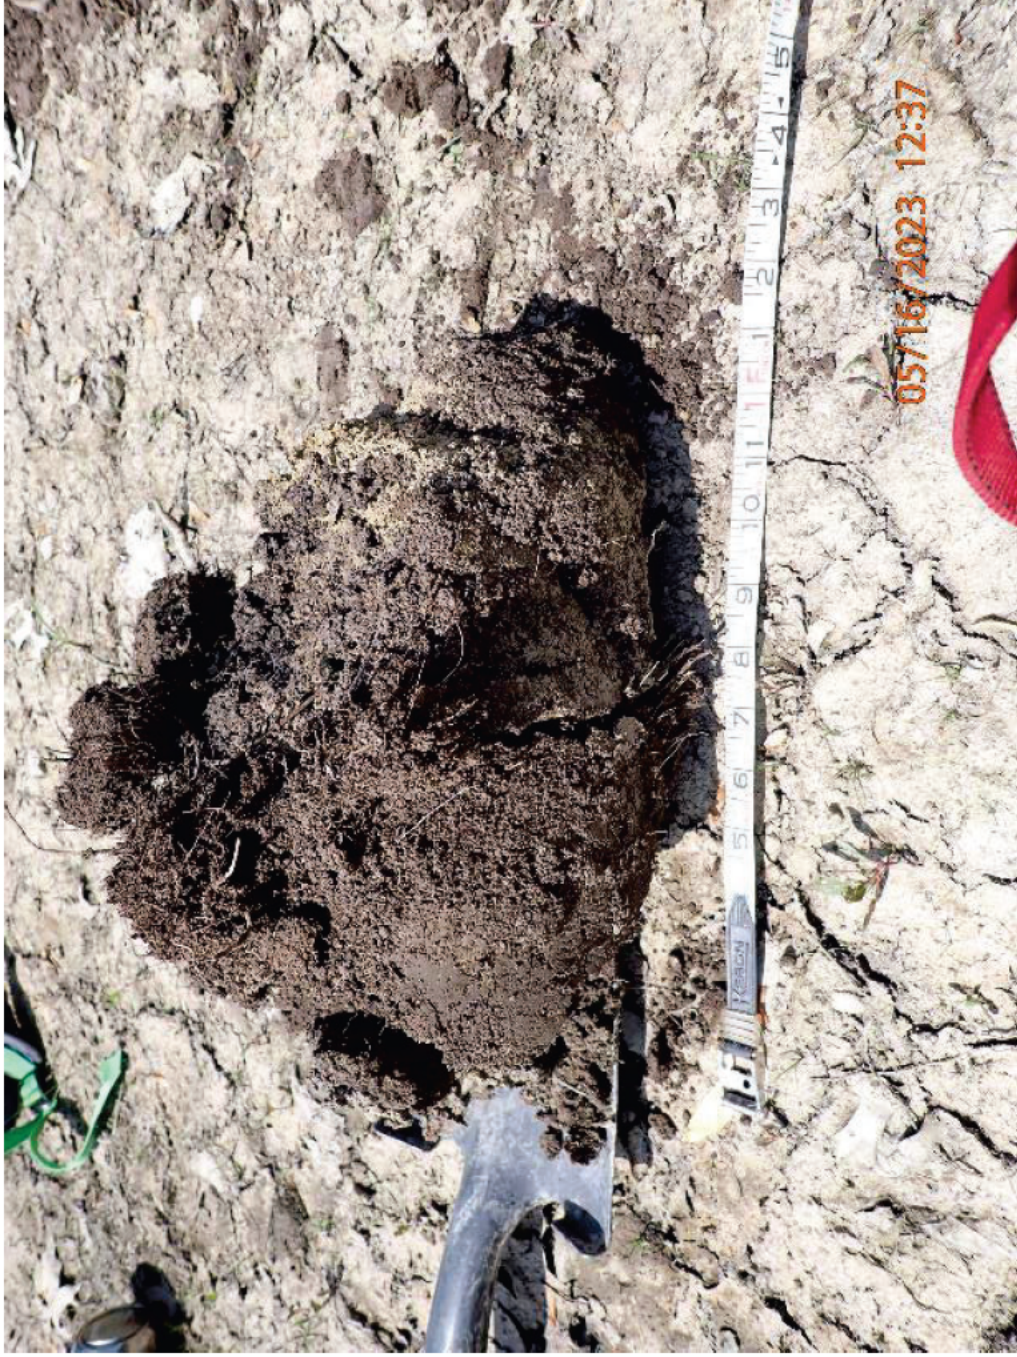
**Date:** 5/16/2023  
**Time:** 12:37 PM  
**Photographer:** SSA  
**Photo ID:** 15 – P5160024

Soil profile from unvegetated area, southeastern quadrant of eastern portion of site

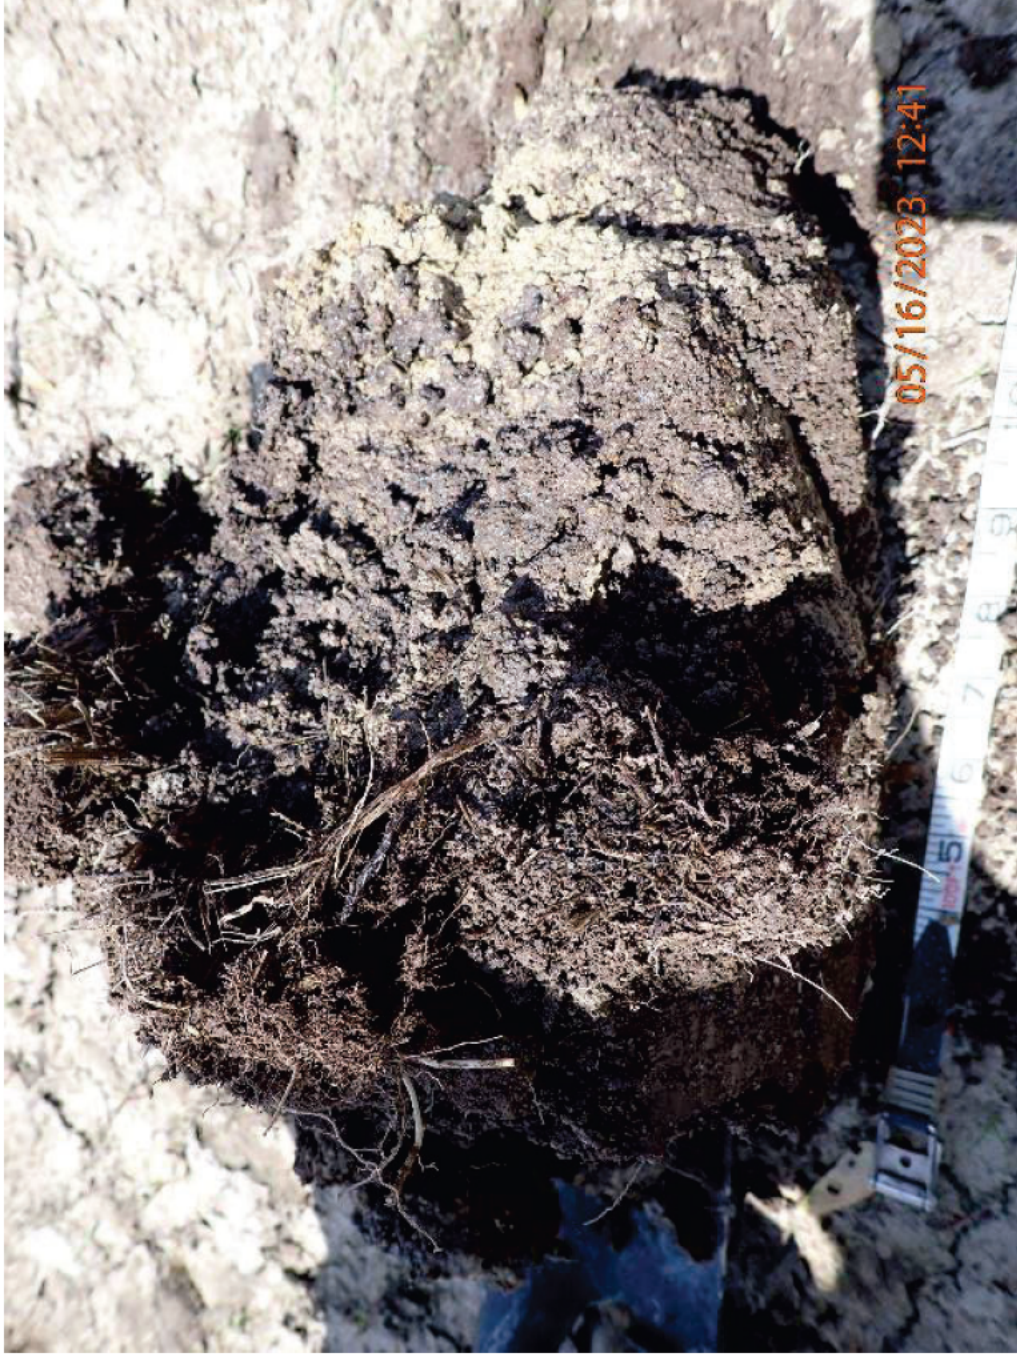
**Date:** 5/16/2023  
**Time:** 12:41 PM  
**Photographer:** SSA  
**Photo ID:** 16 – P5160025

Soil profile from unvegetated area, southeastern quadrant of eastern portion of site  
6 inches of fill material on top of original surface

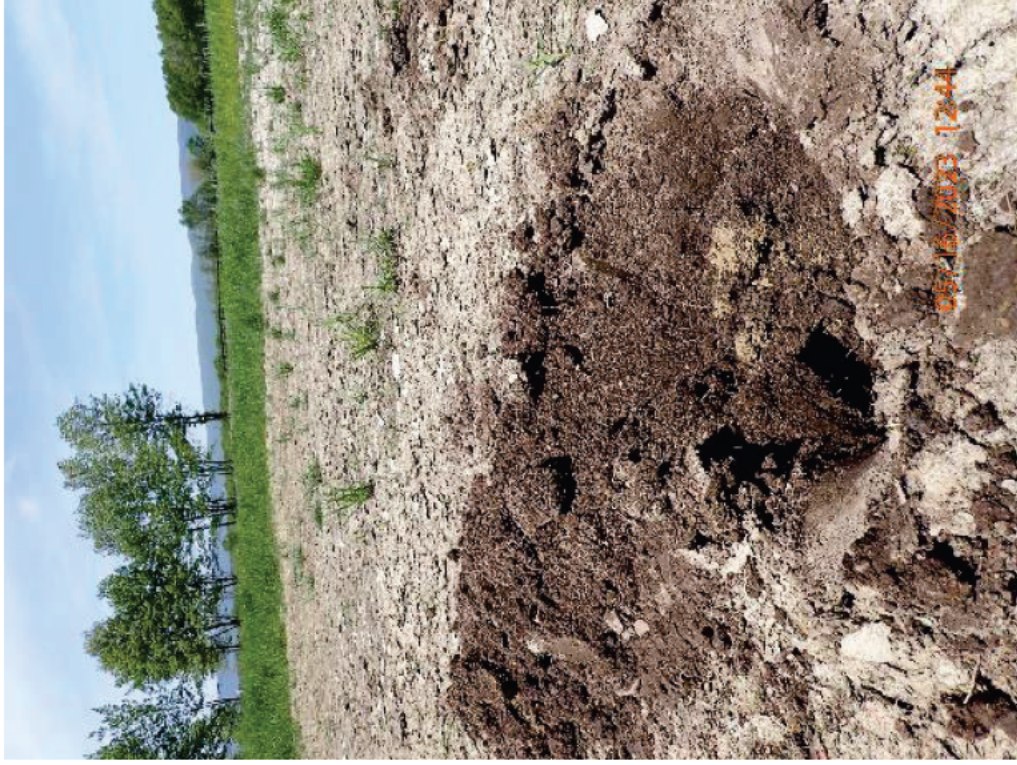
**Date:** 5/16/2023  
**Time:** 12:44 PM  
**Photographer:** SSA  
**Photo ID:** 17 – P5160026

Soil pit location in unvegetated area, southeastern quadrant of eastern portion of site
