## Clean Water Act Section 404: Site Visit/Case Development

| Site Name | SVG Holdings, LLC Property - 1821 Albany Post Road | | | | |

CWA 404 Inspection  
SVG Holdings Property  
1821 Albany Post Road  
Wallkill, Ulster County, NY

May 16, 2023

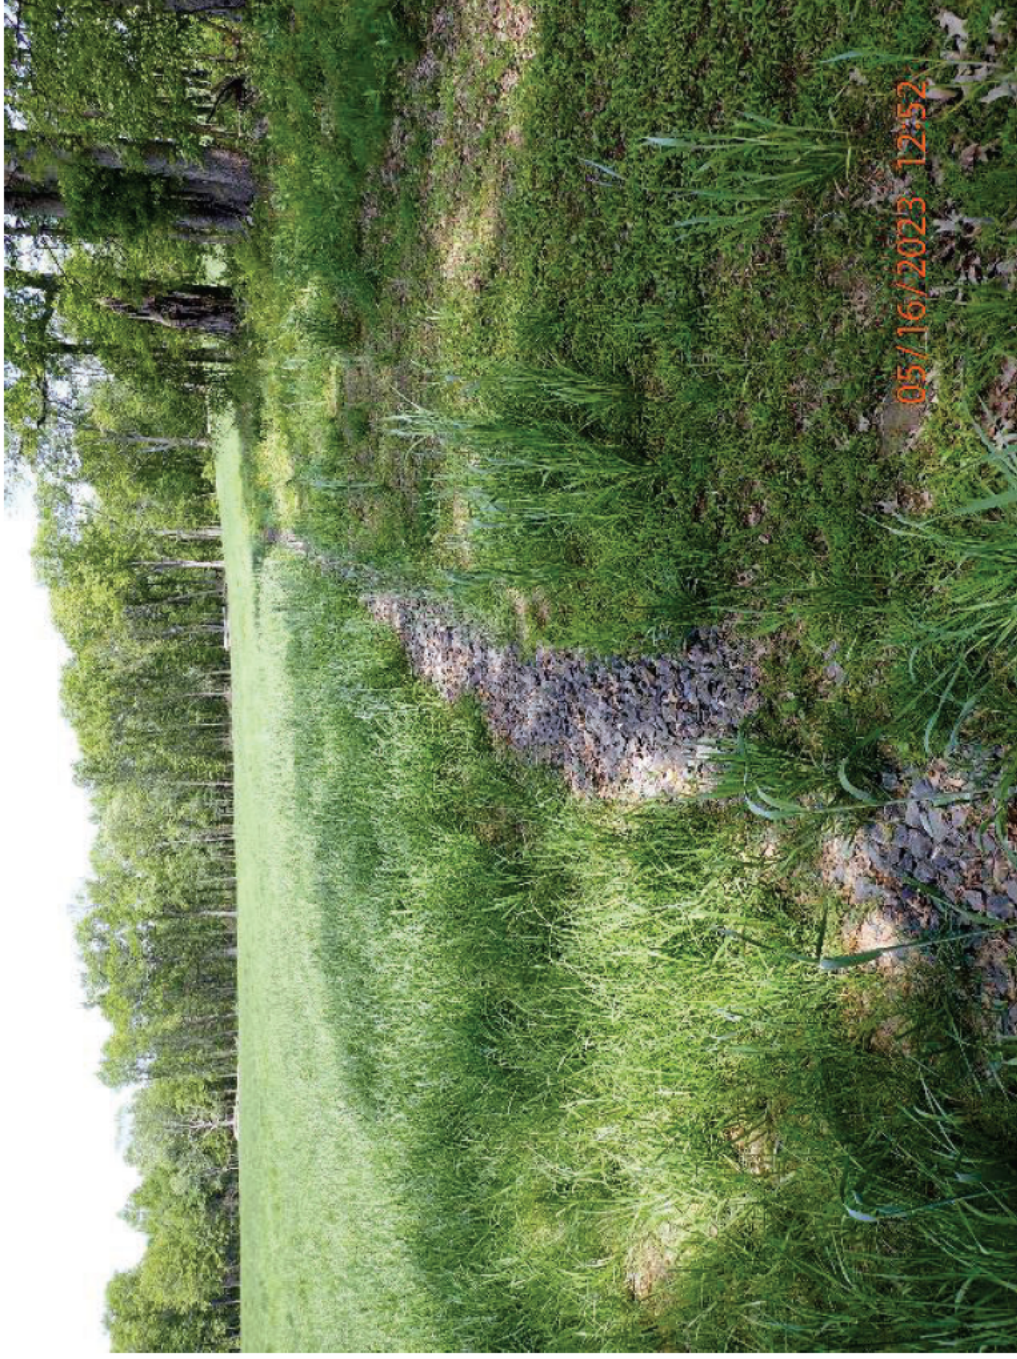
**Date:** 5/16/2023  
**Time:** 12:52 PM  
**Photographer:** SSA  
**Photo ID:** 18 – P5160027

Gravel drainage near eastern  
property boundary

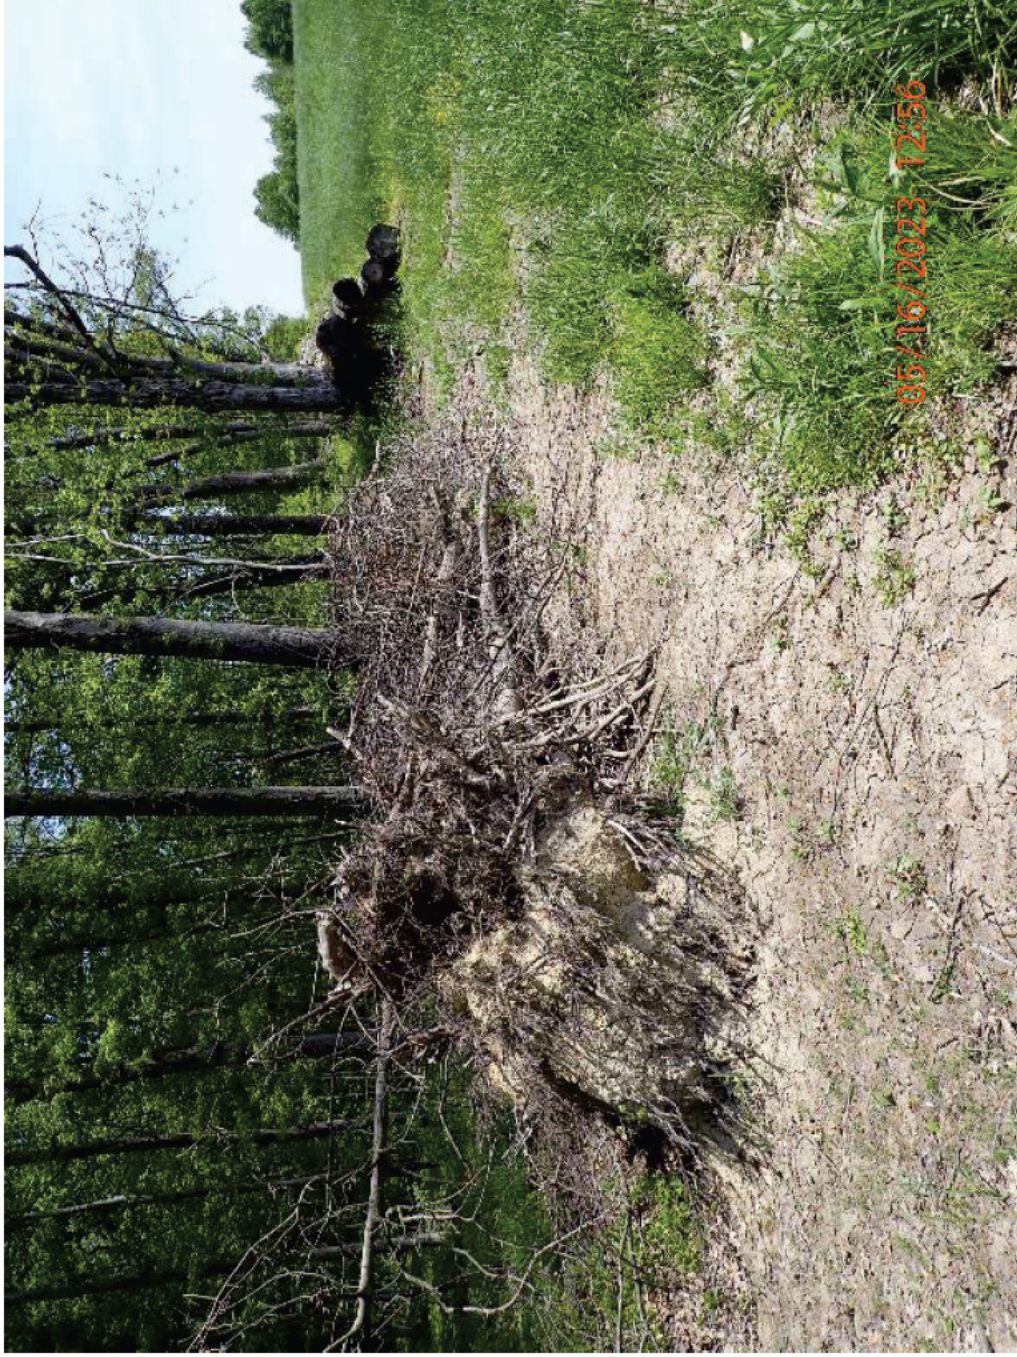
**Date:** 5/16/2023  
**Time:** 12:56 PM  
**Photographer:** SSA  
**Photo ID:** 19 – P5160028

**Description:**  
Northeast corner of property

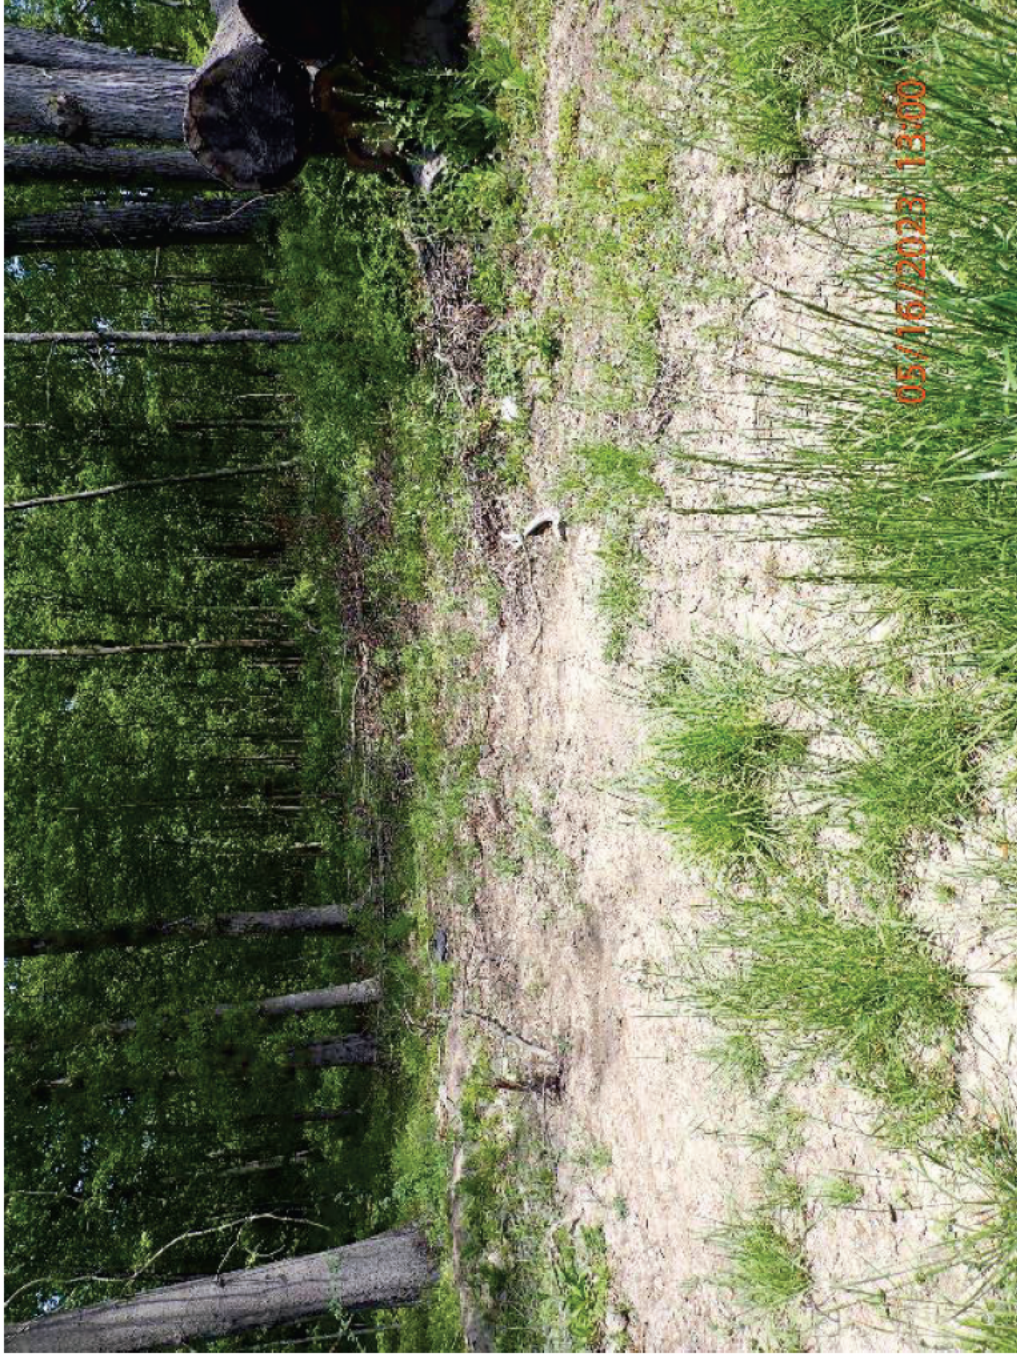
**Date:** 5/16/2023  
**Time:** 1:00 PM  
**Photographer:** SSA  
**Photo ID:** 20 – P5160029

(1/6) Panorama of field and potential drainage outlet north to neighboring property

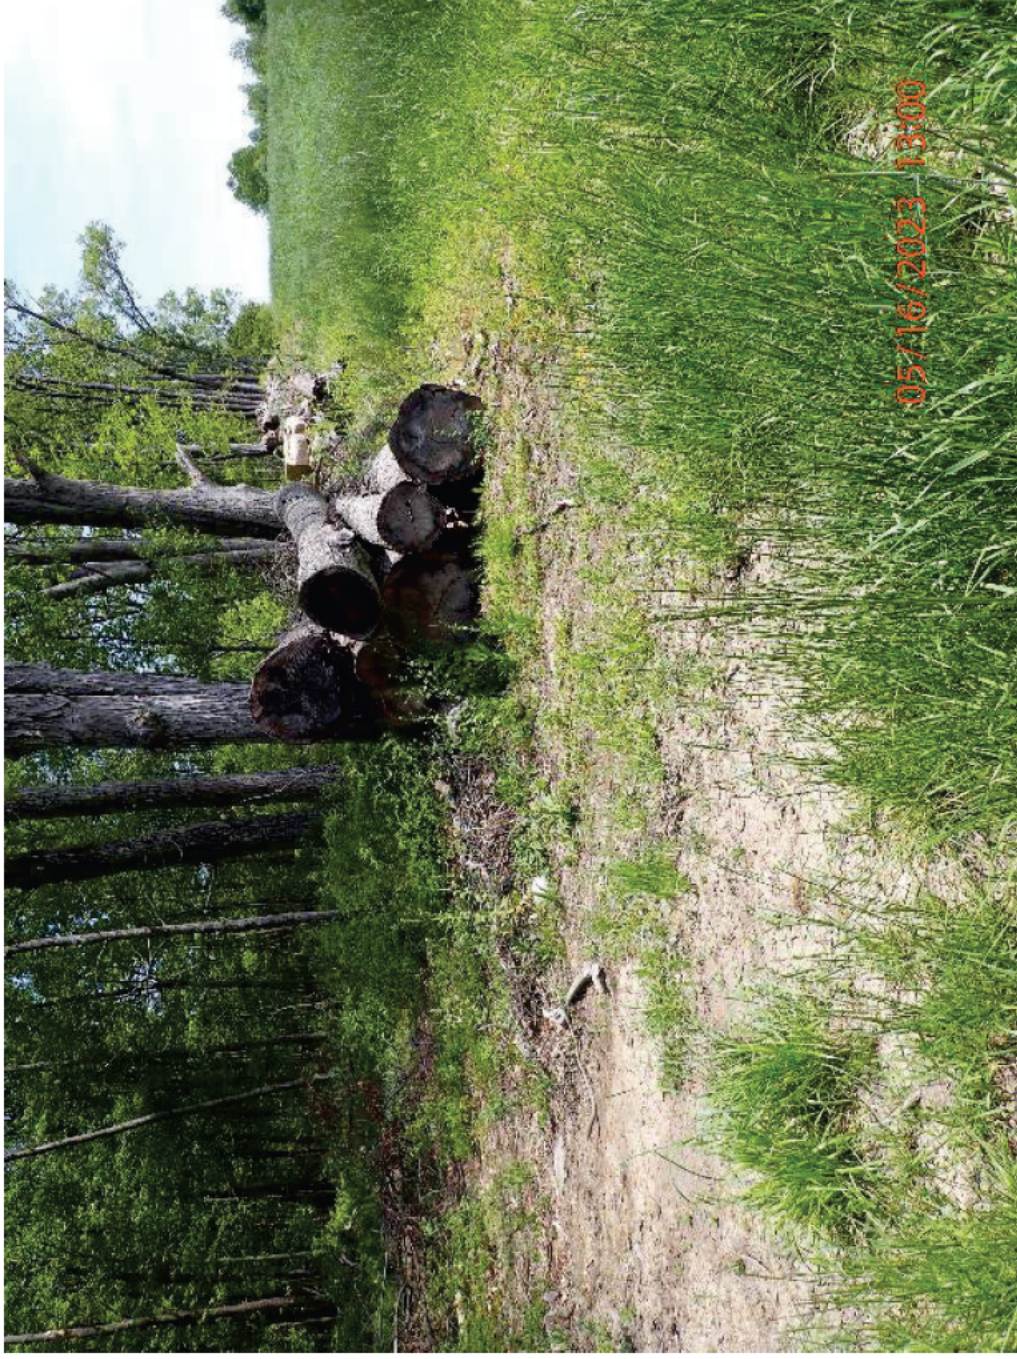
**Date:** 5/16/2023  
**Time:** 1:00 PM  
**Photographer:** SSA  
**Photo ID:** 21 – P5160030

(2/6) Panorama of field and potential drainage outlet north to neighboring property

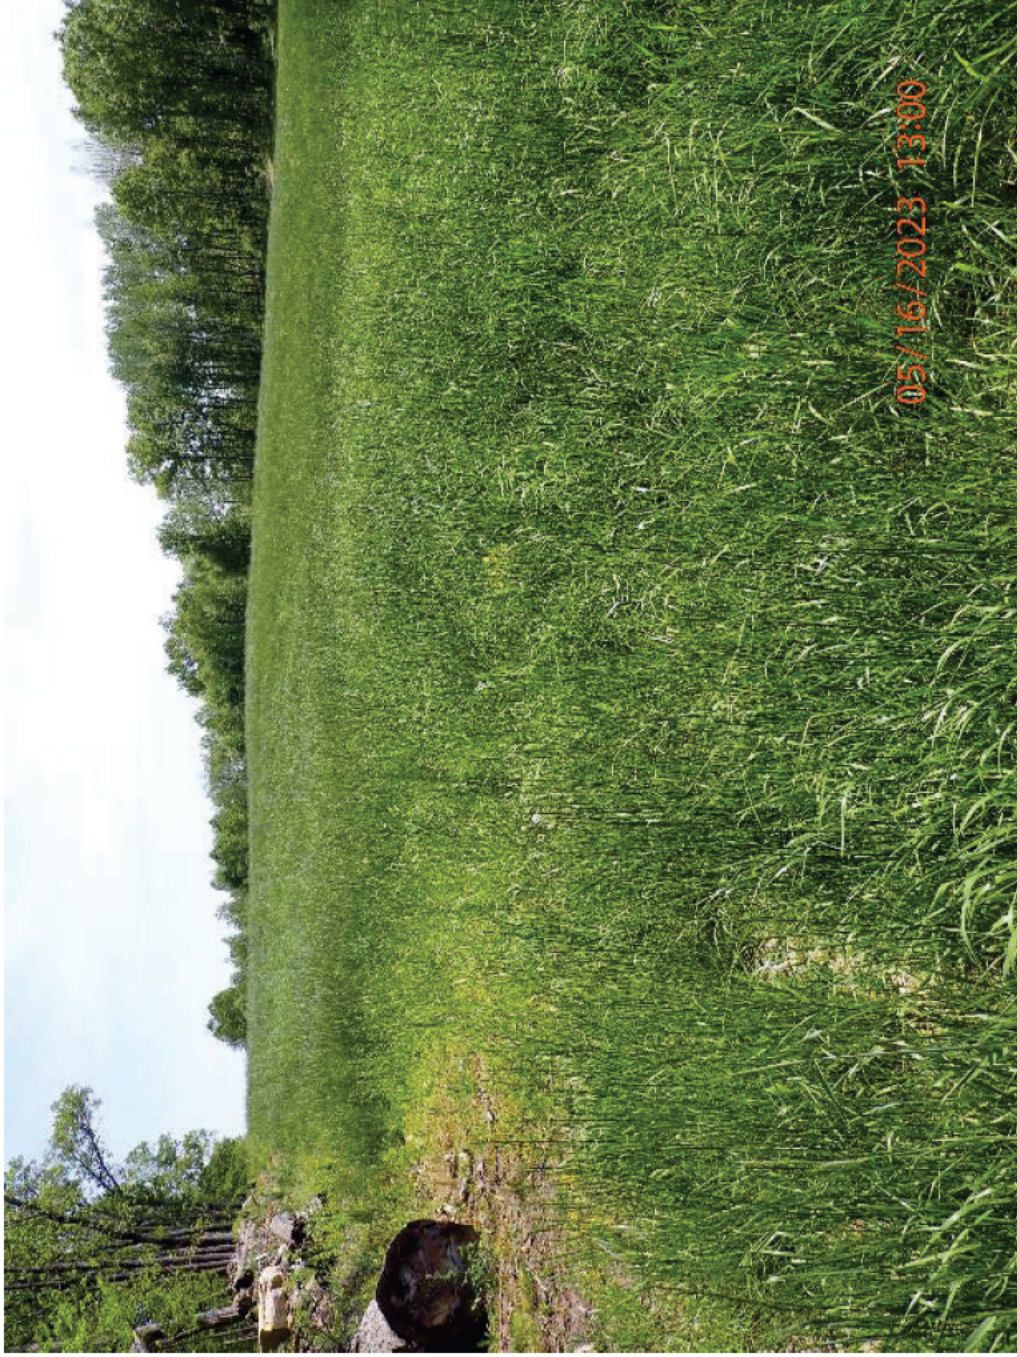
**Date:** 5/16/2023  
**Time:** 1:00 PM  
**Photographer:** SSA  
**Photo ID:** 22 – P5160031

(3/6) Panorama of field and potential drainage outlet north to neighboring property

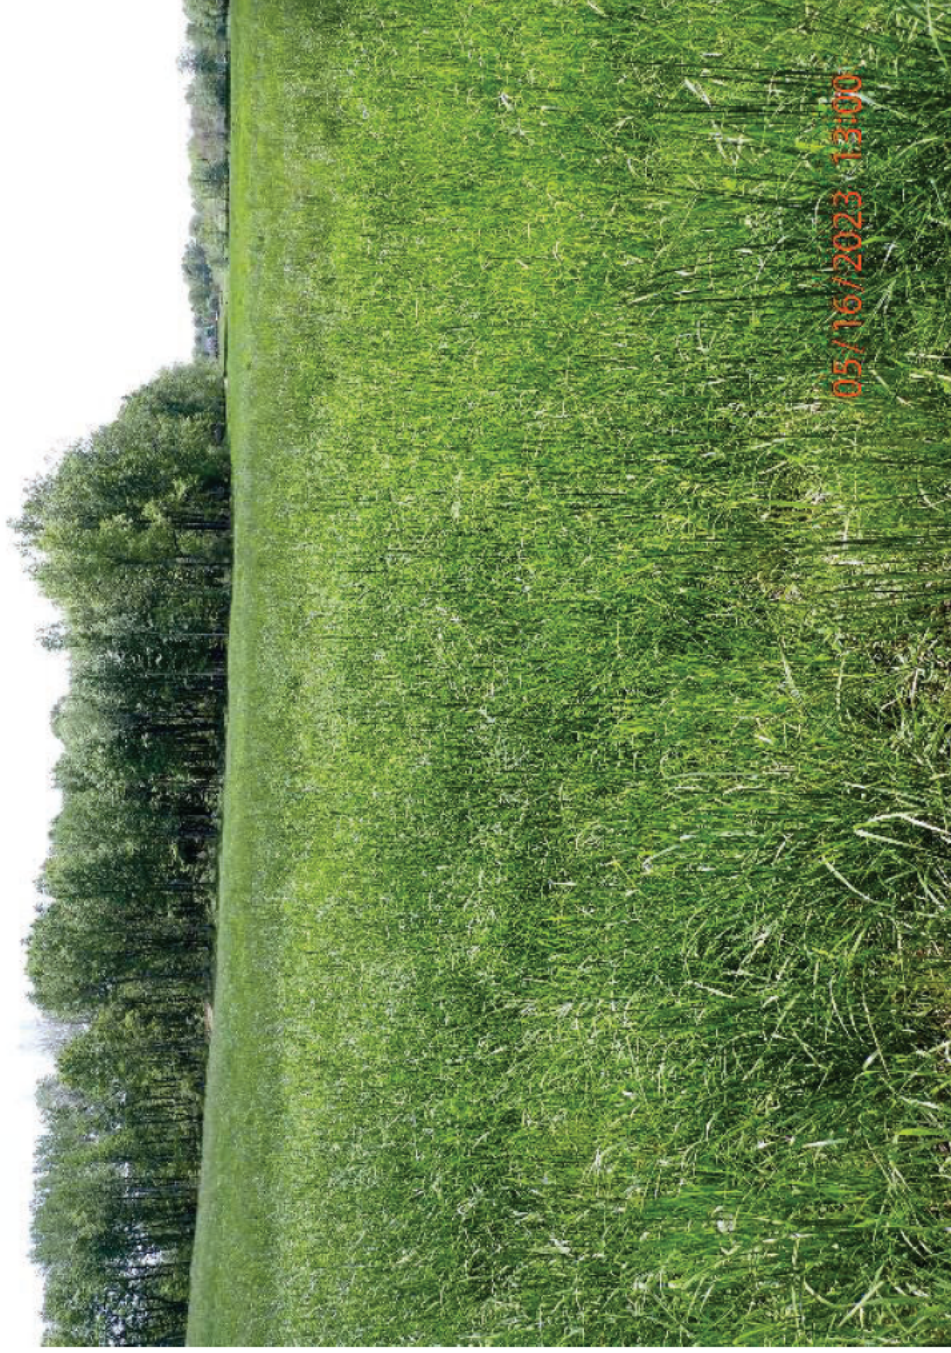
**Date:** 5/16/2023  
**Time:** 1:00 PM  
**Photographer:** SSA  
**Photo ID:** 23 – P5160032

(4/6) Panorama of field and potential drainage outlet north to neighboring property

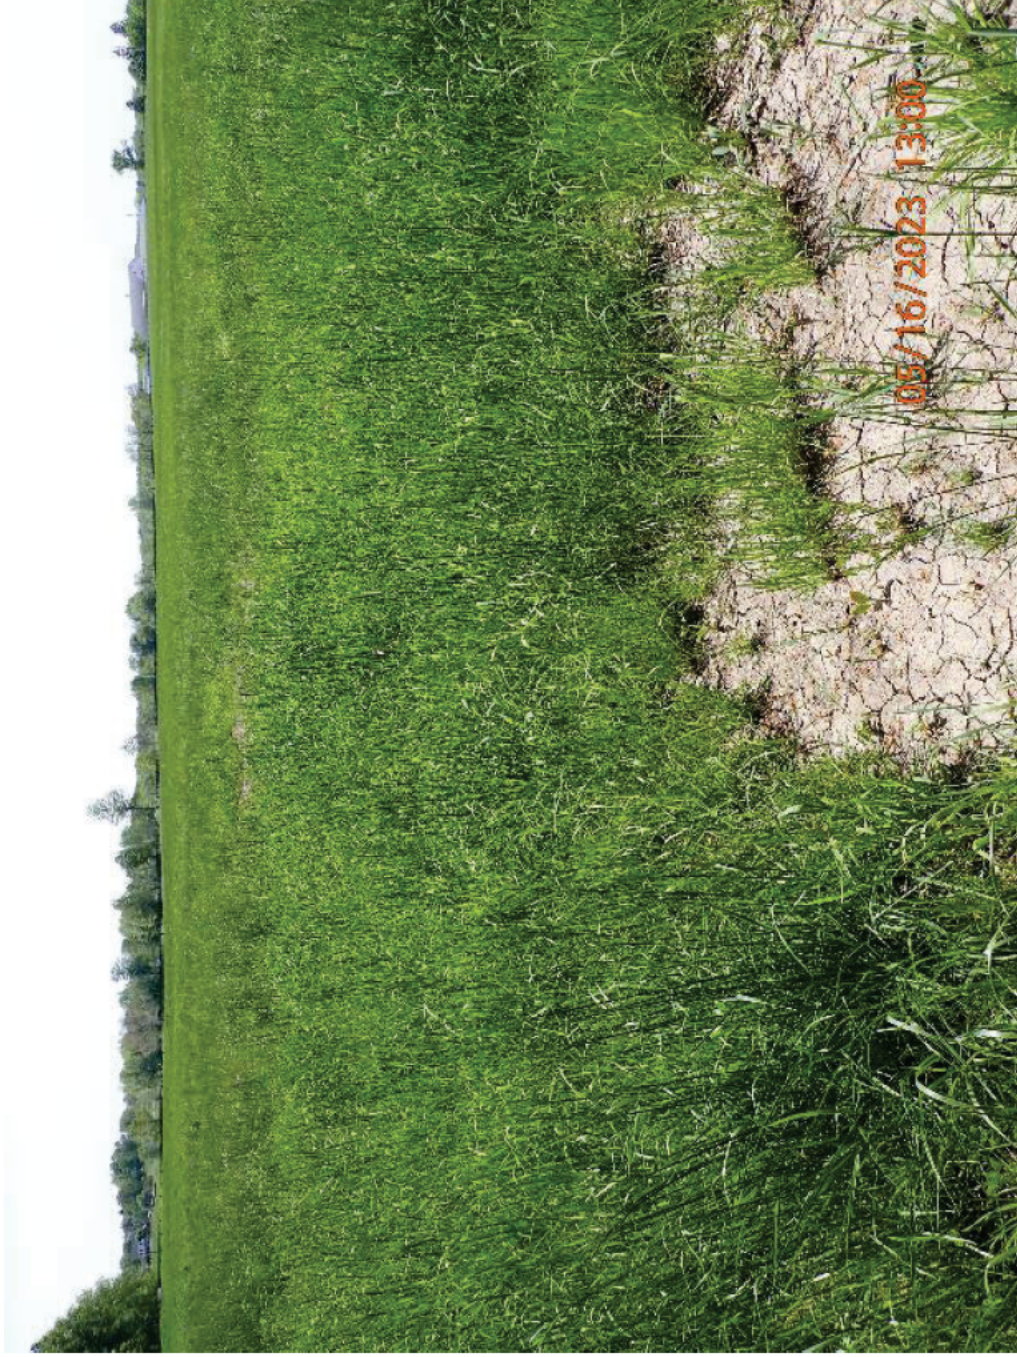
**Date:** 5/16/2023  
**Time:** 1:00 PM  
**Photographer:** SSA  
**Photo ID:** 24 – P5160033

(5/6) Panorama of field and potential drainage outlet north to neighboring property

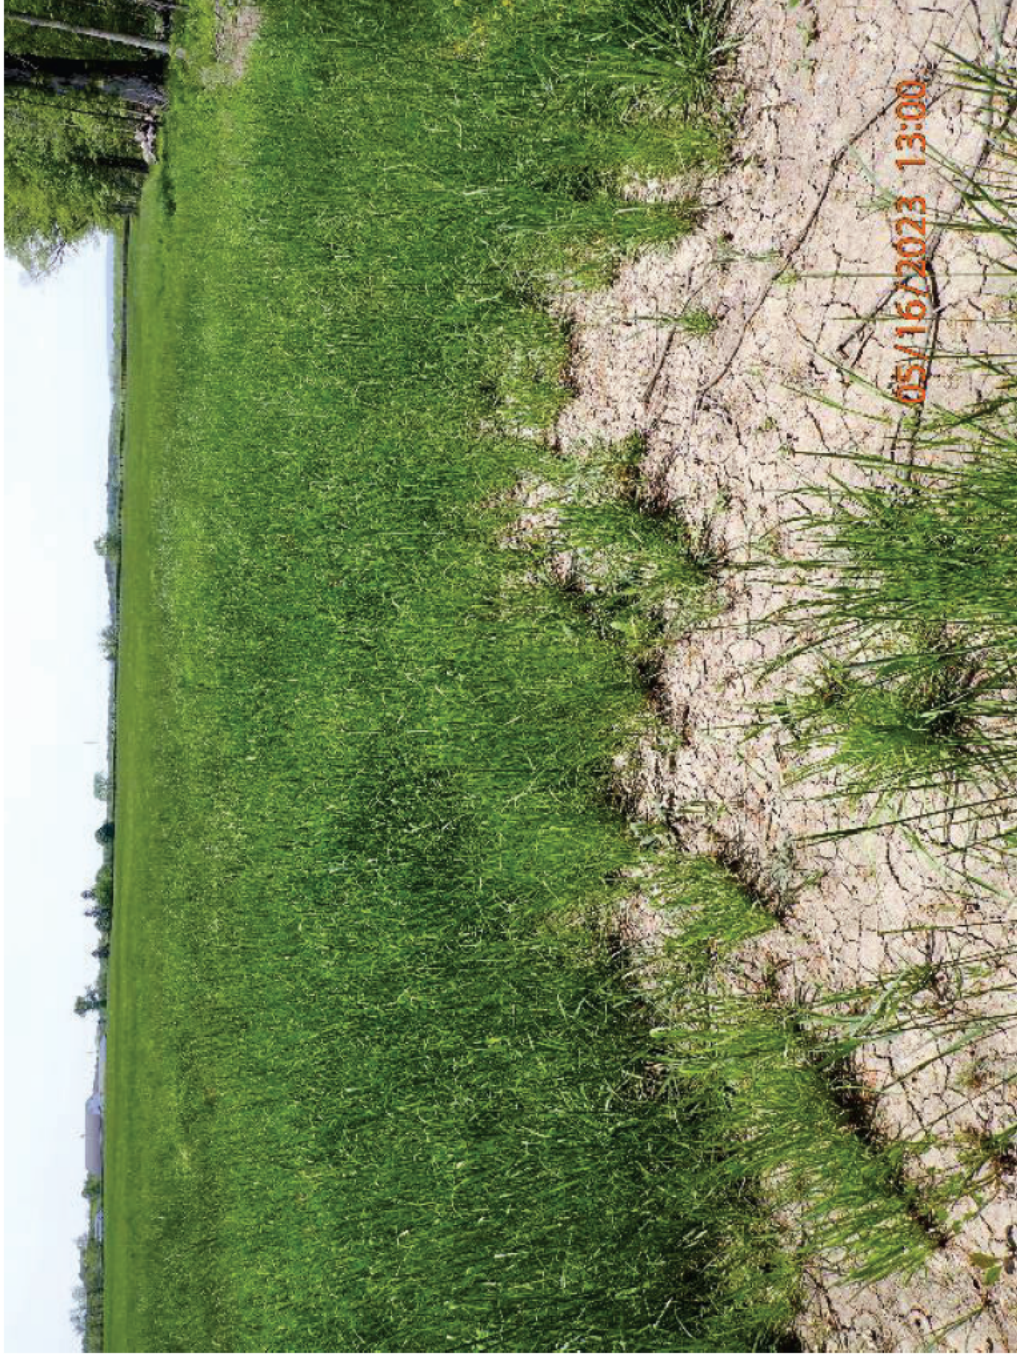
**Date:** 5/16/2023  
**Time:** 1:00 PM  
**Photographer:** SSA  
**Photo ID:** 25 – P5160034

(6/6) Panorama of field and potential drainage outlet north to neighboring property

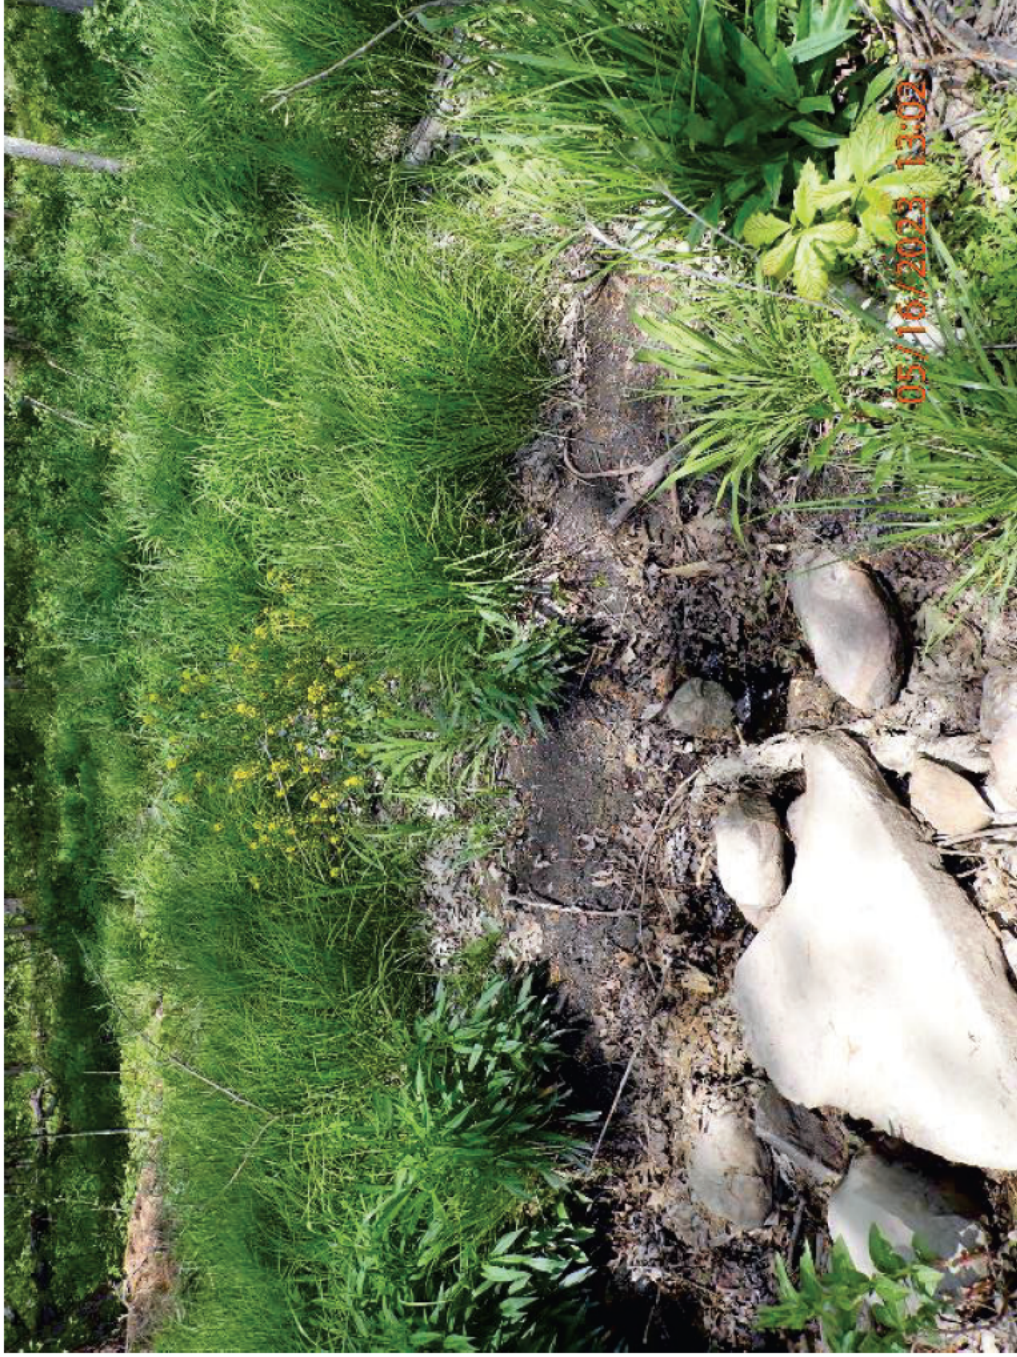
**Date:** 5/16/2023  
**Time:** 1:02 PM  
**Photographer:** SSA  
**Photo ID:** 26 – P5160035

Standing water; potential wetland on property to north  
Potential wetland area dominated by tussock sedge

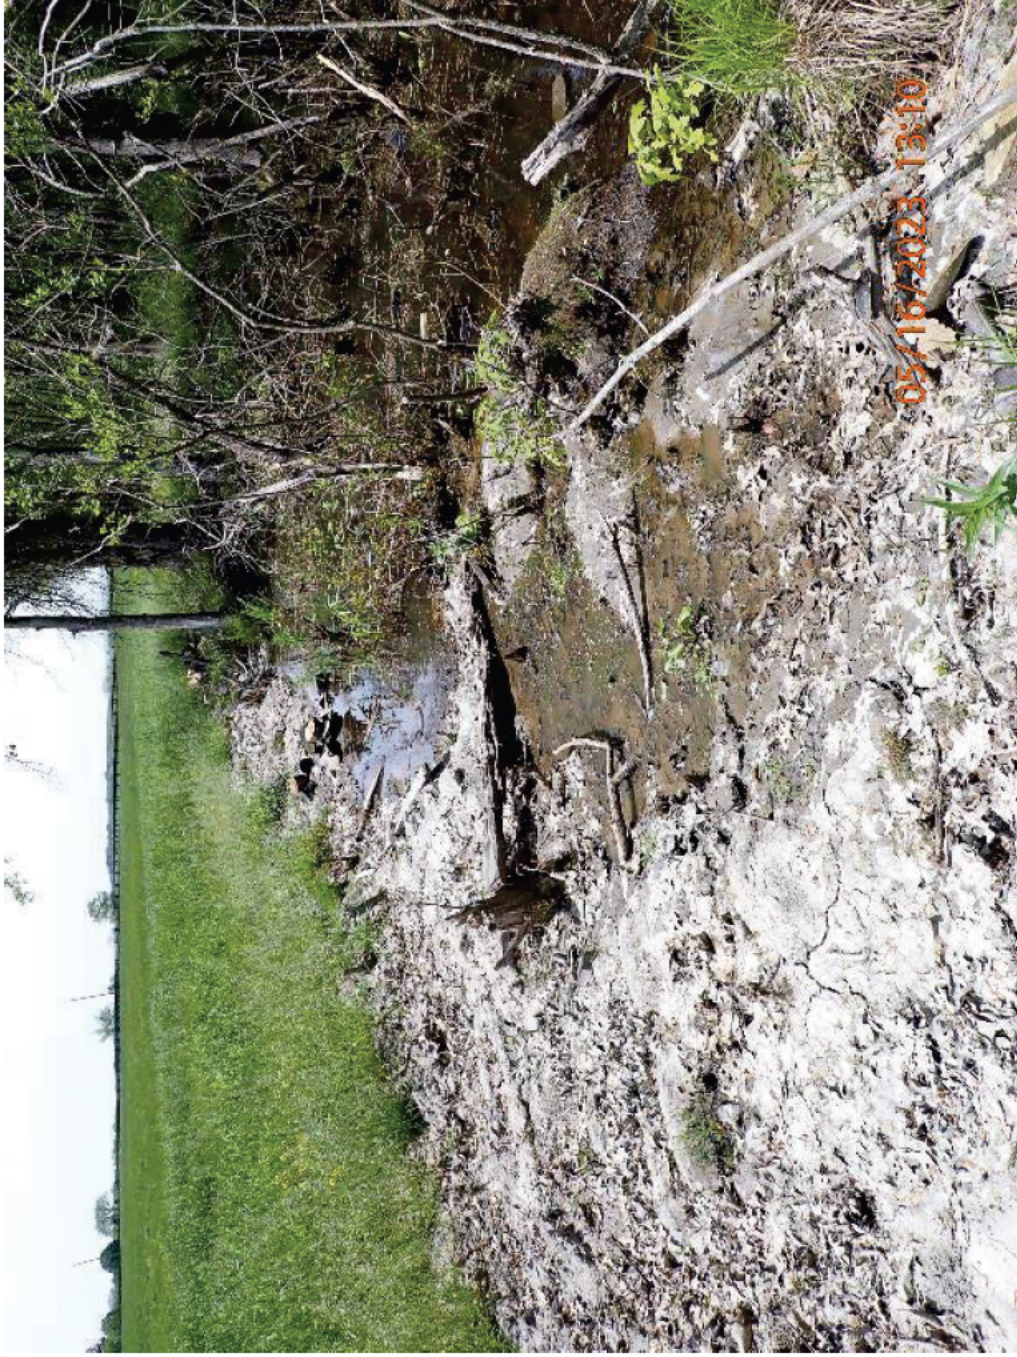
**Date:** 5/16/2023  
**Time:** 1:10 PM  
**Photographer:** SSA  
**Photo ID:** 27 – P5160036

Fill material adjacent to  
potential red maple swamp  
Standing water observed

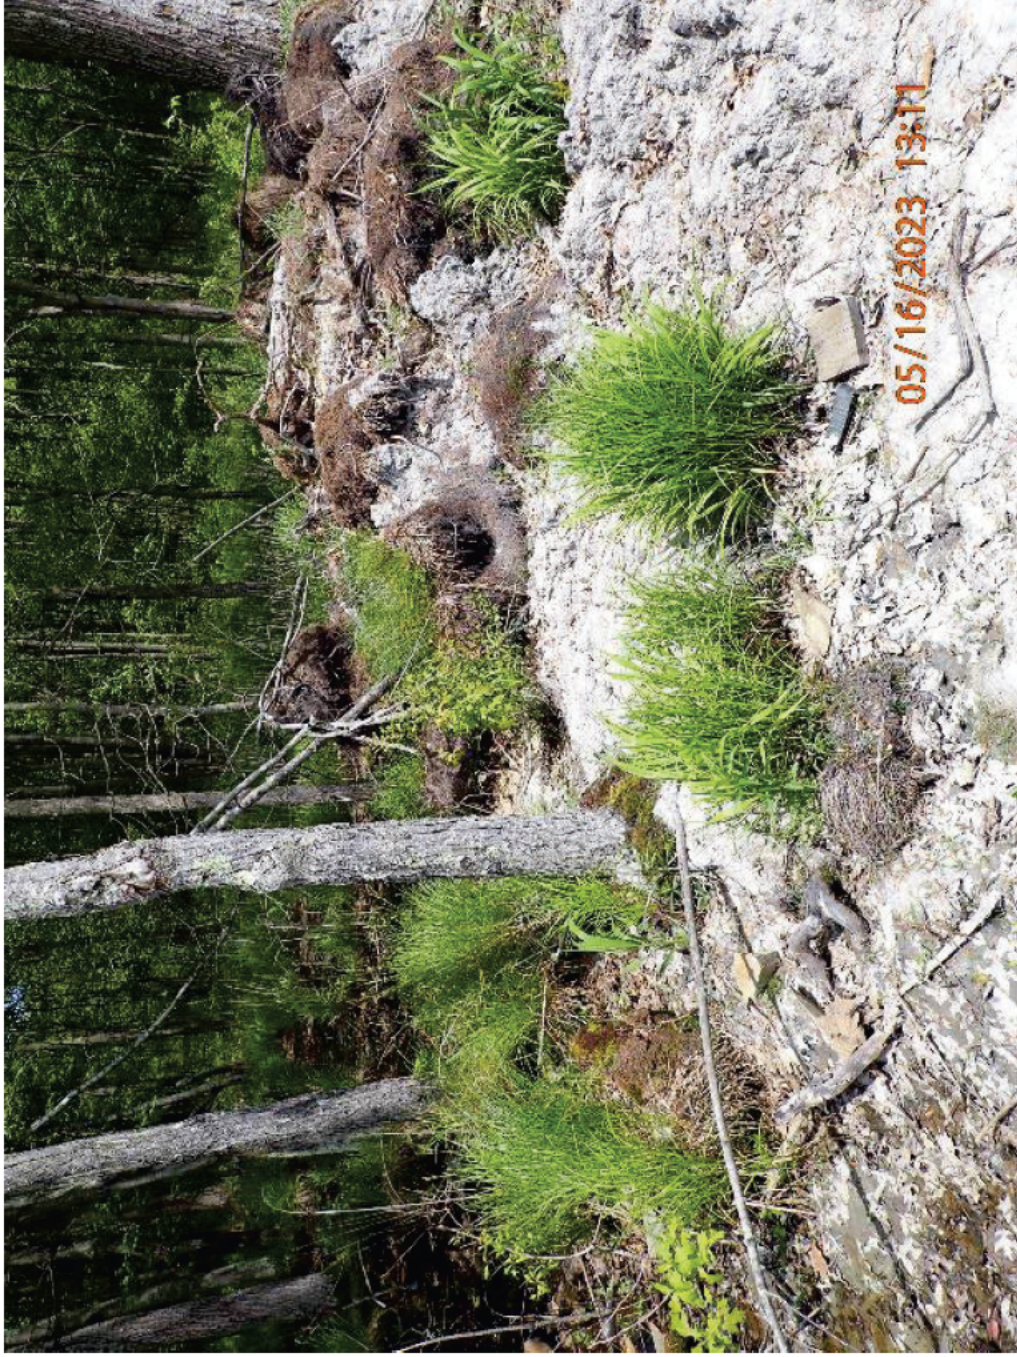
**Date:** 5/16/2023  
**Time:** 1:11 PM  
**Photographer:** SSA  
**Photo ID:** 28 – P5160037

(1/4) Panorama of fill material adjacent to potential red maple swamp

Standing water observed

Wetland vegetation observed growing through fill material

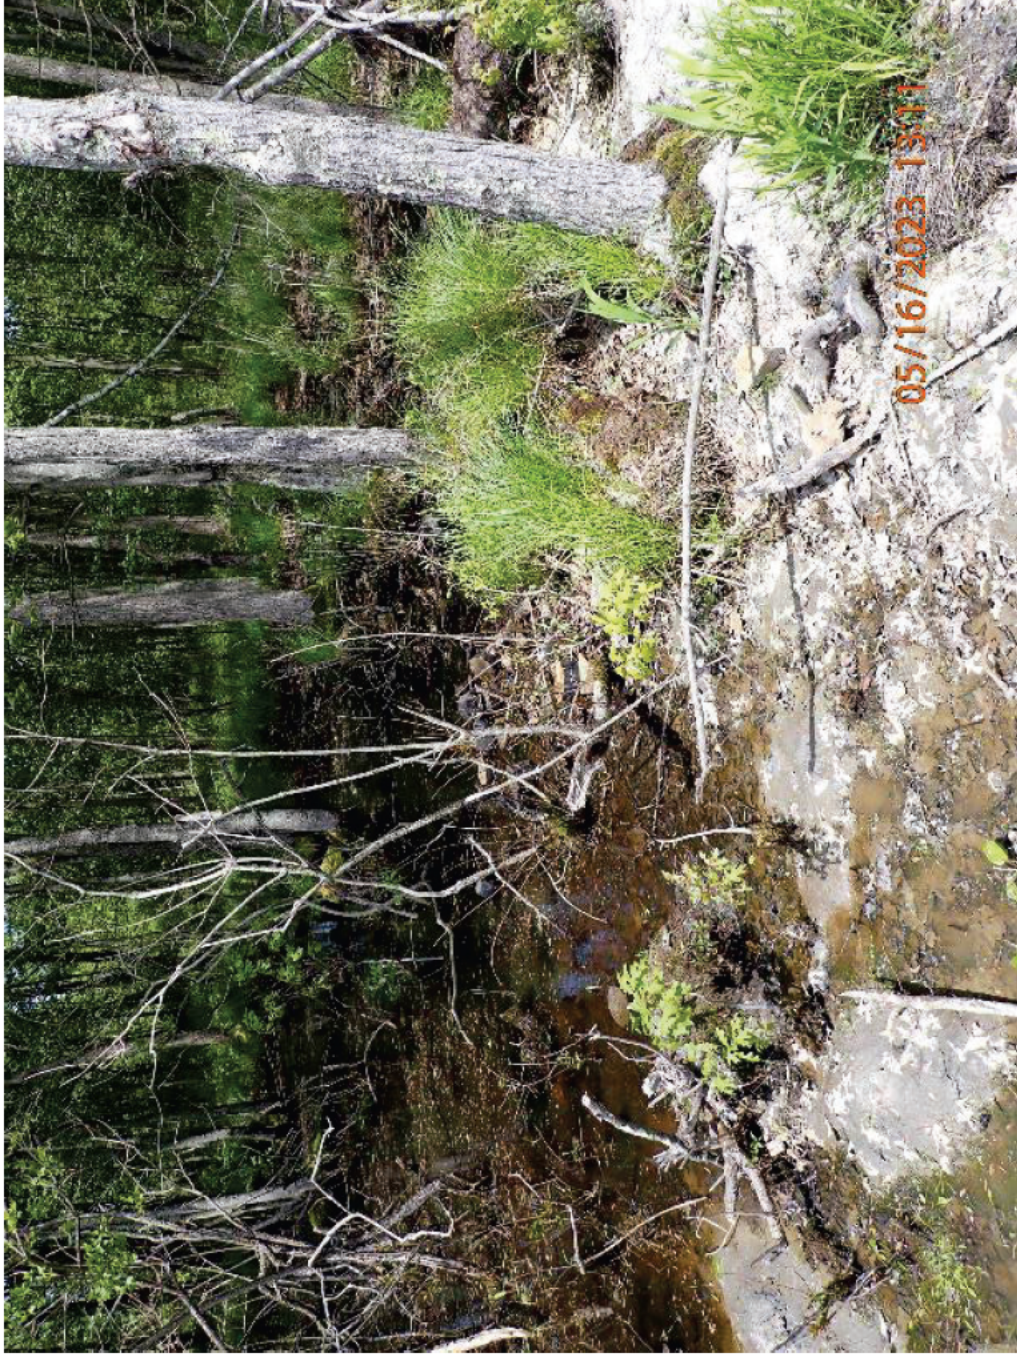
**Date:** 5/16/2023  
**Time:** 1:11 PM  
**Photographer:** SSA  
**Photo ID:** 29 – P5160038

(2/4) Panorama of fill material adjacent to potential red maple swamp  
Standing water observed  
Wetland vegetation observed growing through fill material  
Tree buttressing

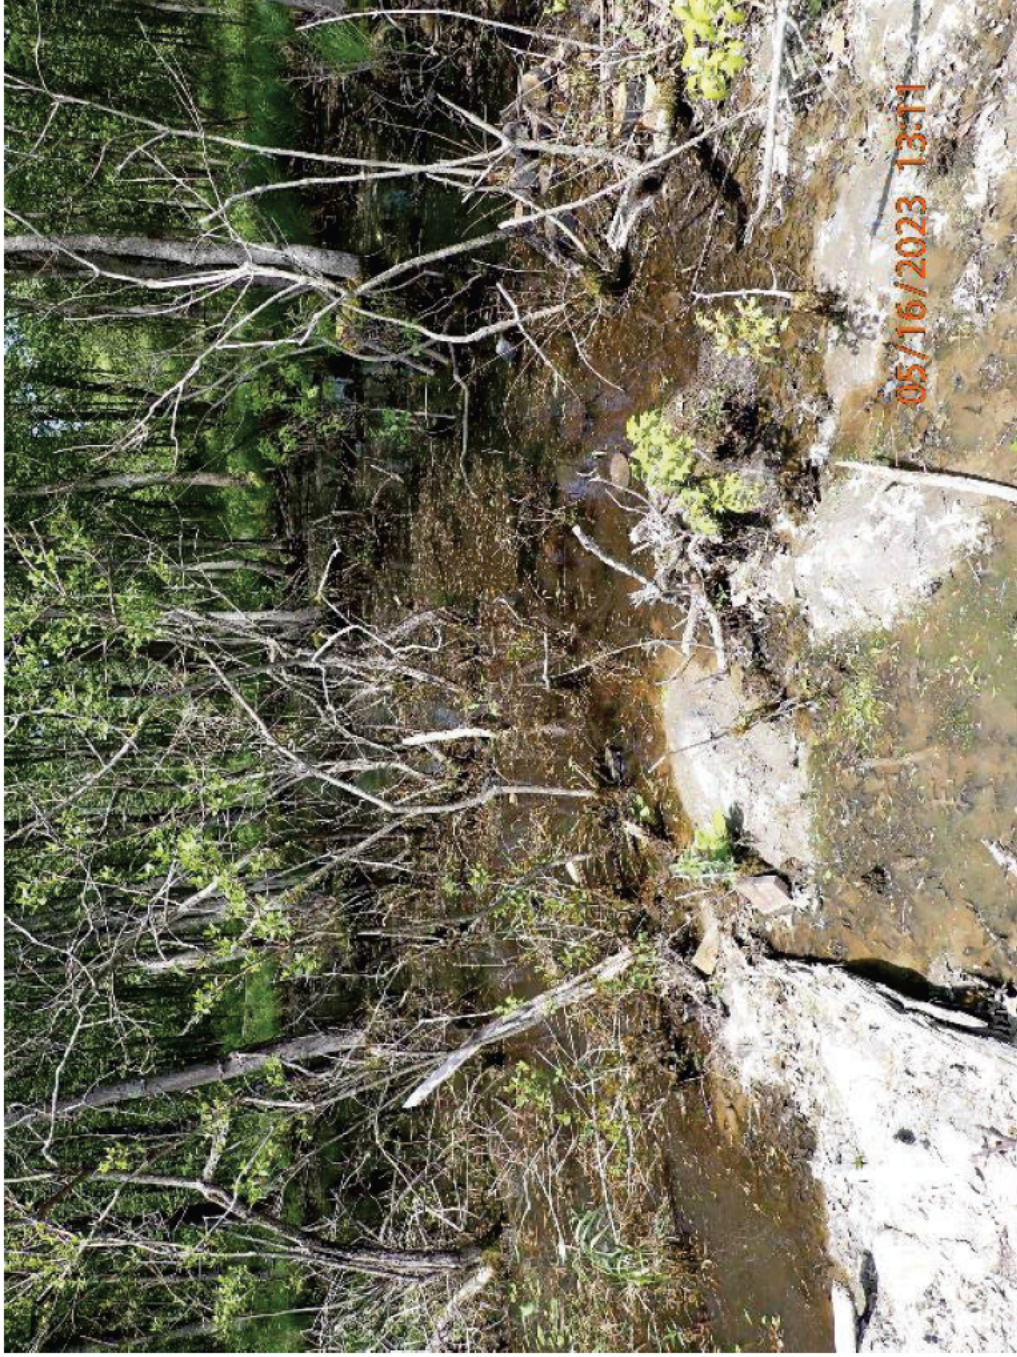
**Date:** 5/16/2023  
**Time:** 1:11 PM  
**Photographer:** SSA  
**Photo ID:** 30 – P5160039

(3/4) Panorama of fill material adjacent to potential red maple swamp

Standing water observed

Tree buttressing

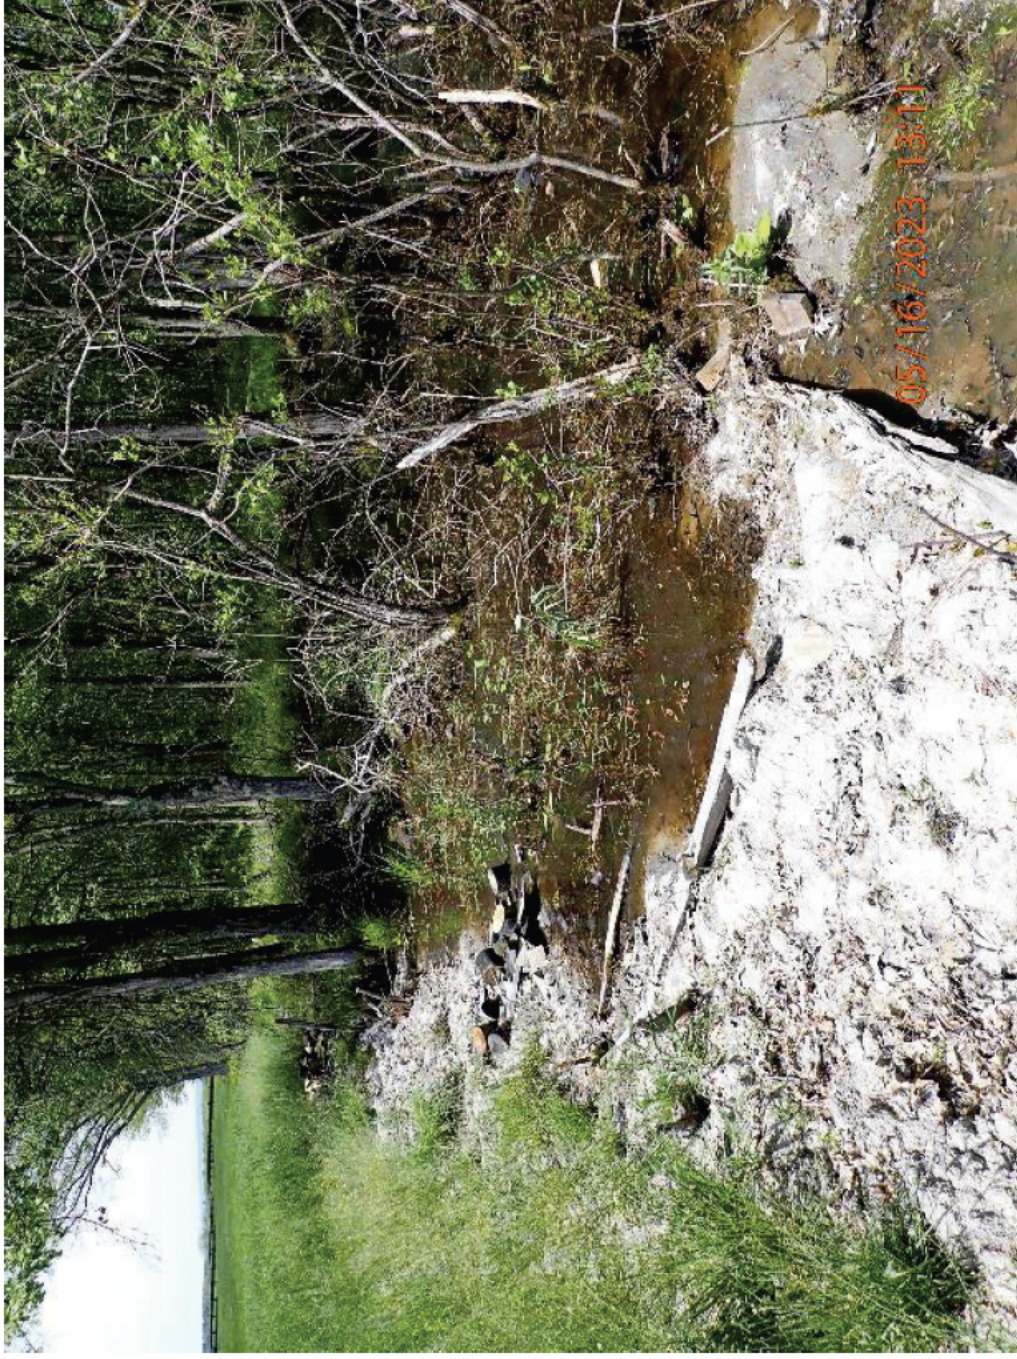
**Date:** 5/16/2023  
**Time:** 1:11 PM  
**Photographer:** SSA  
**Photo ID:** 31 – P5160040

(4/4) Panorama of fill material adjacent to potential red maple swamp

Standing water observed

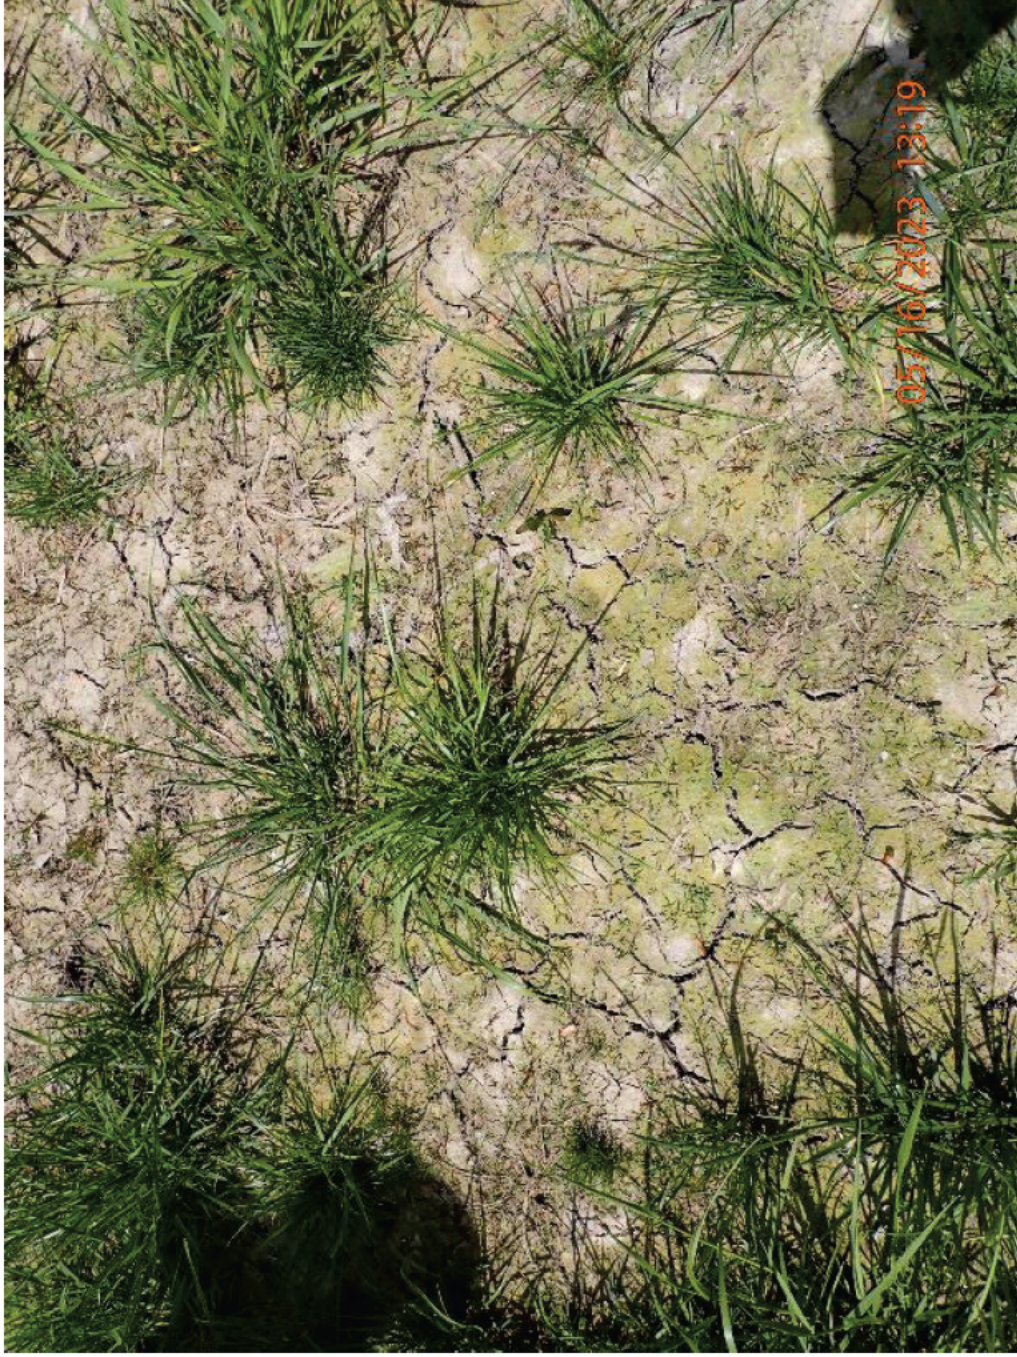
**Date:** 5/16/2023  
**Time:** 1:19 PM  
**Photographer:** SSA  
**Photo ID:** 32 – P5160041

Algae observed on unvegetated areas in pasture

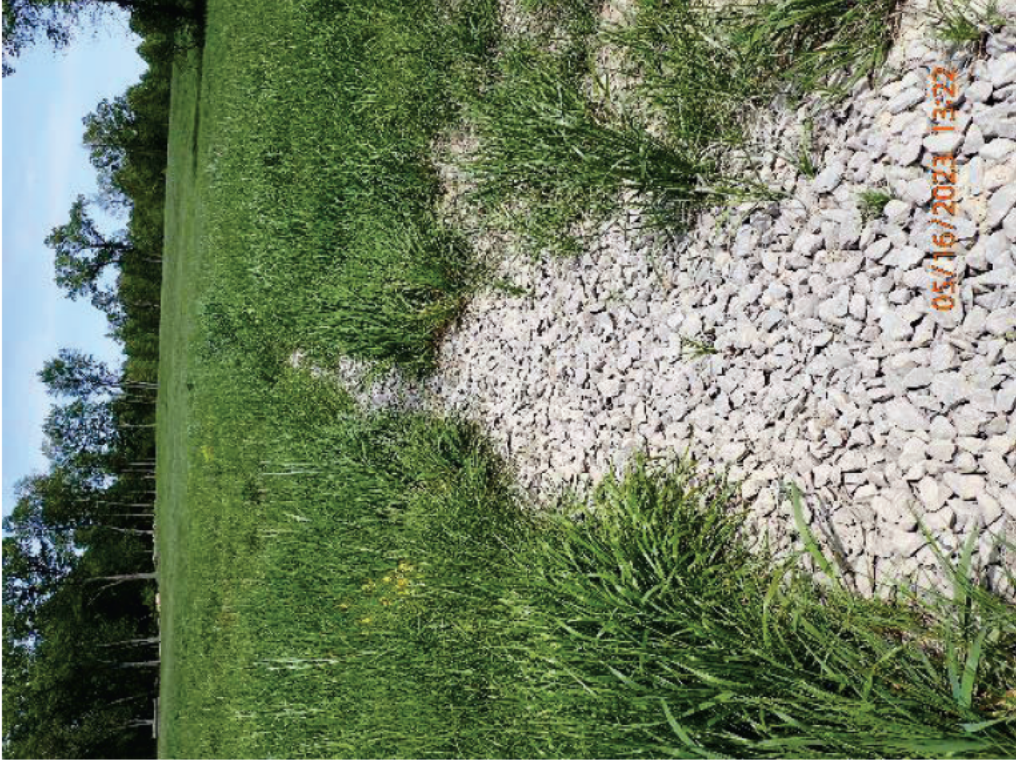
**Description:**  
Gravel drain in pasture  
GPS point
