## Region 6 - Enforcement & Compliance Assurance Division

### INSPECTION REPORT

| Company Name: | <b>El Dorado Operating, LLC</b> | |
| Facility Name: | <b>Gregory Lease Tank Battery</b> | |

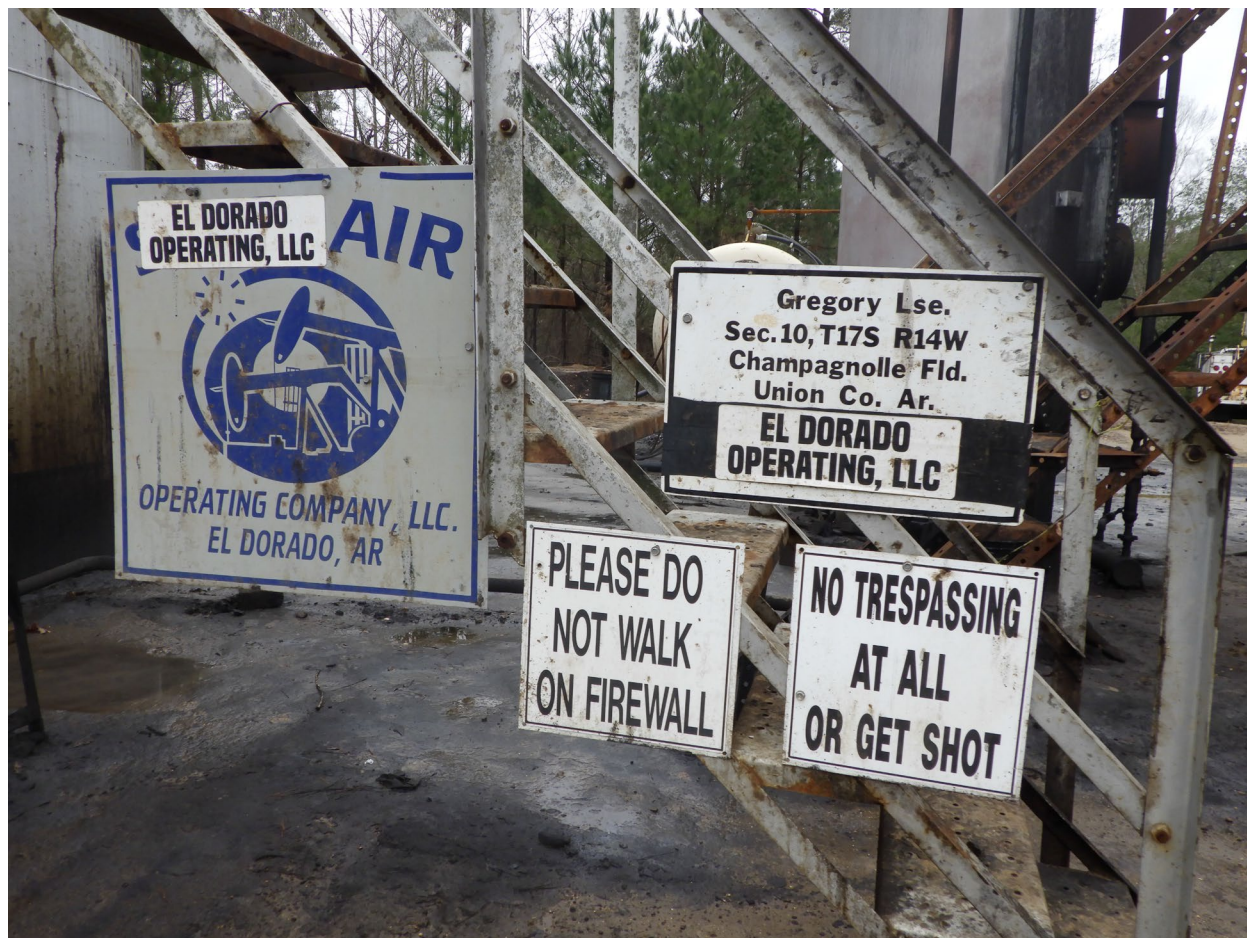
Photo No. 1

**Description:** Looking W, this photo shows the signage at the facility.

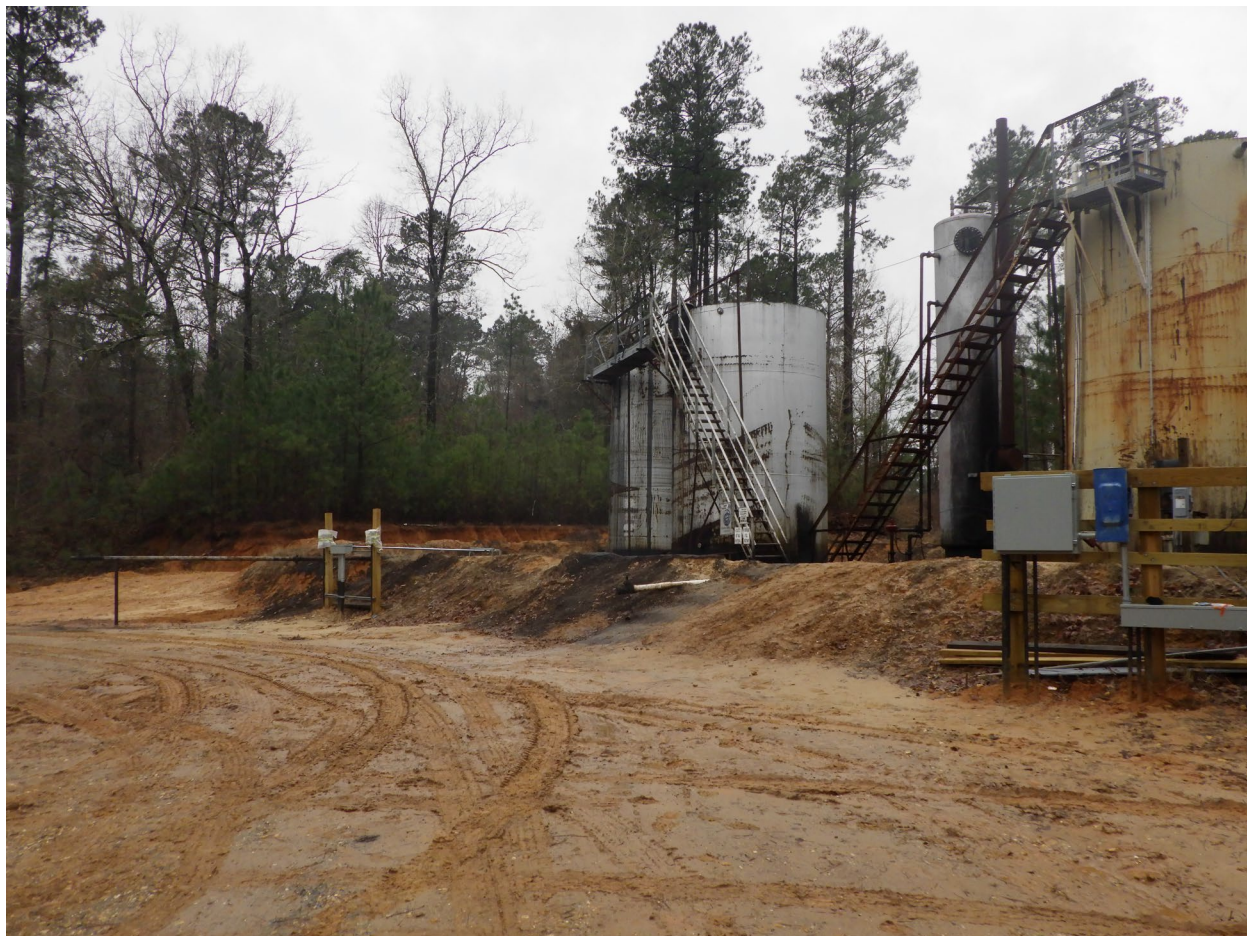
Photo No. 2

**Description:** Looking S, this photo shows an overview of the facility.

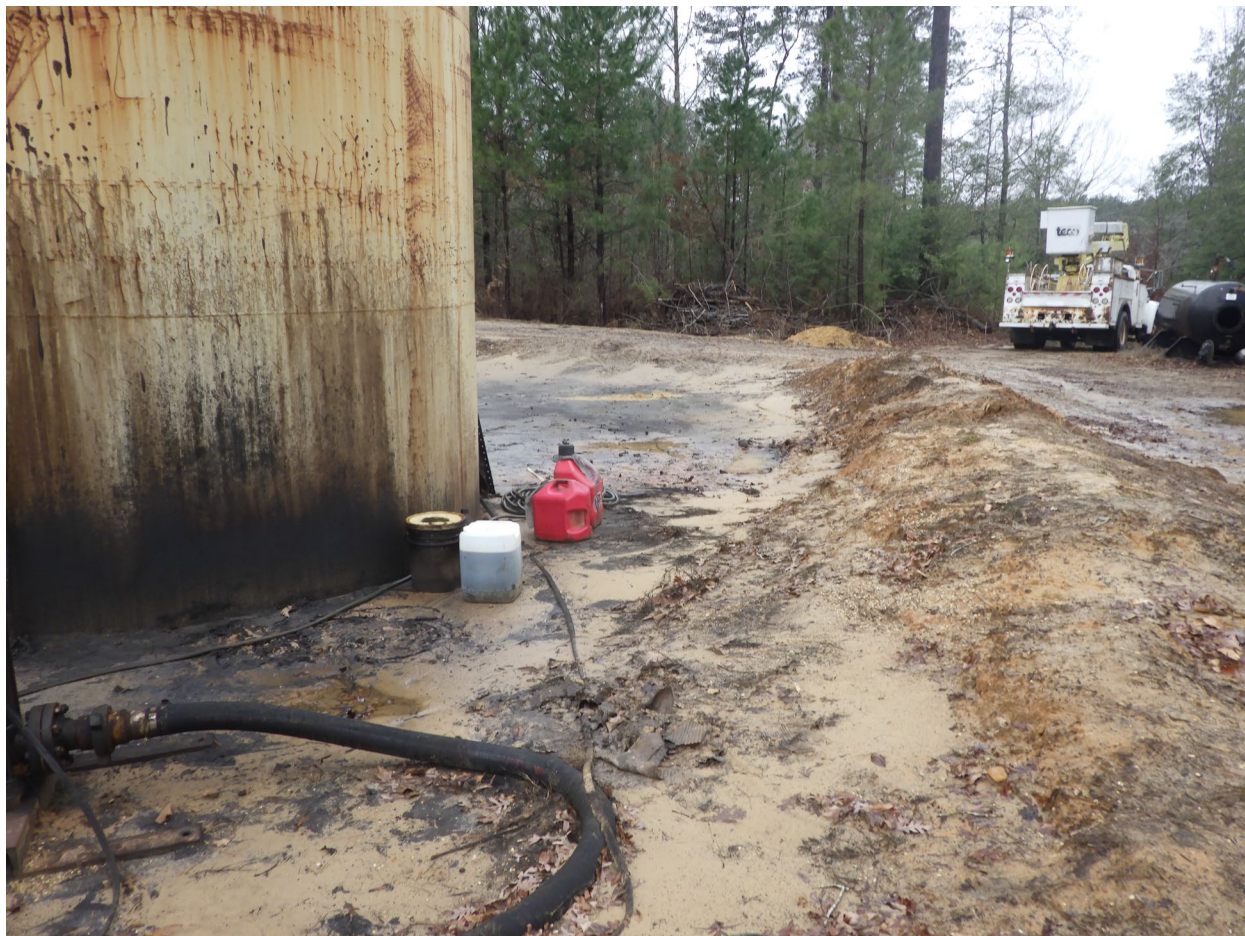
Photo No. 3

I observed the inside of the secondary containment with residual crude oil, salt crystal formation, and dirt work for drainage and berm maintenance, see Photos No. 3 through No. 6.

- Residual crude oil and salt crystal formation inside secondary containment (Photos No. 3 through No. 6 and No. 9),
- Transfer lines without catchment buckets outside secondary containment (Photos No. 7 and No. 8),
- An additional tank battery that appeared to be out of service (Photo No. 11), and
- Two (2) workover pits that contained residual crude oil and saltwater (Photos No. 13, No. 14, and No. 16).

**Description:** Looking W, this photo shows loose oil inside the secondary containment.

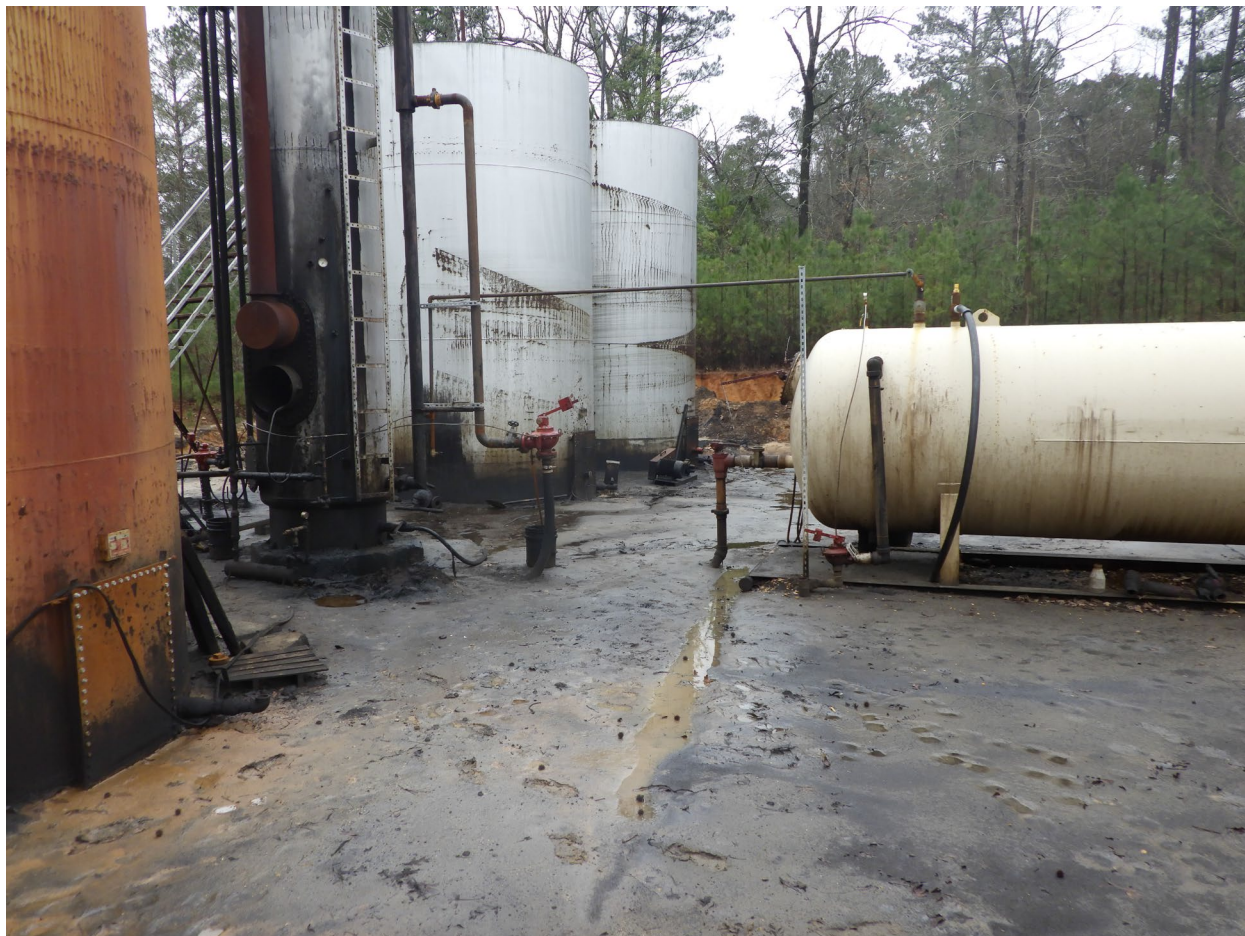
Photo No. 4

**Description:** Looking SE, this photo shows an overview of the storage tanks and treaters/separators inside secondary containment.

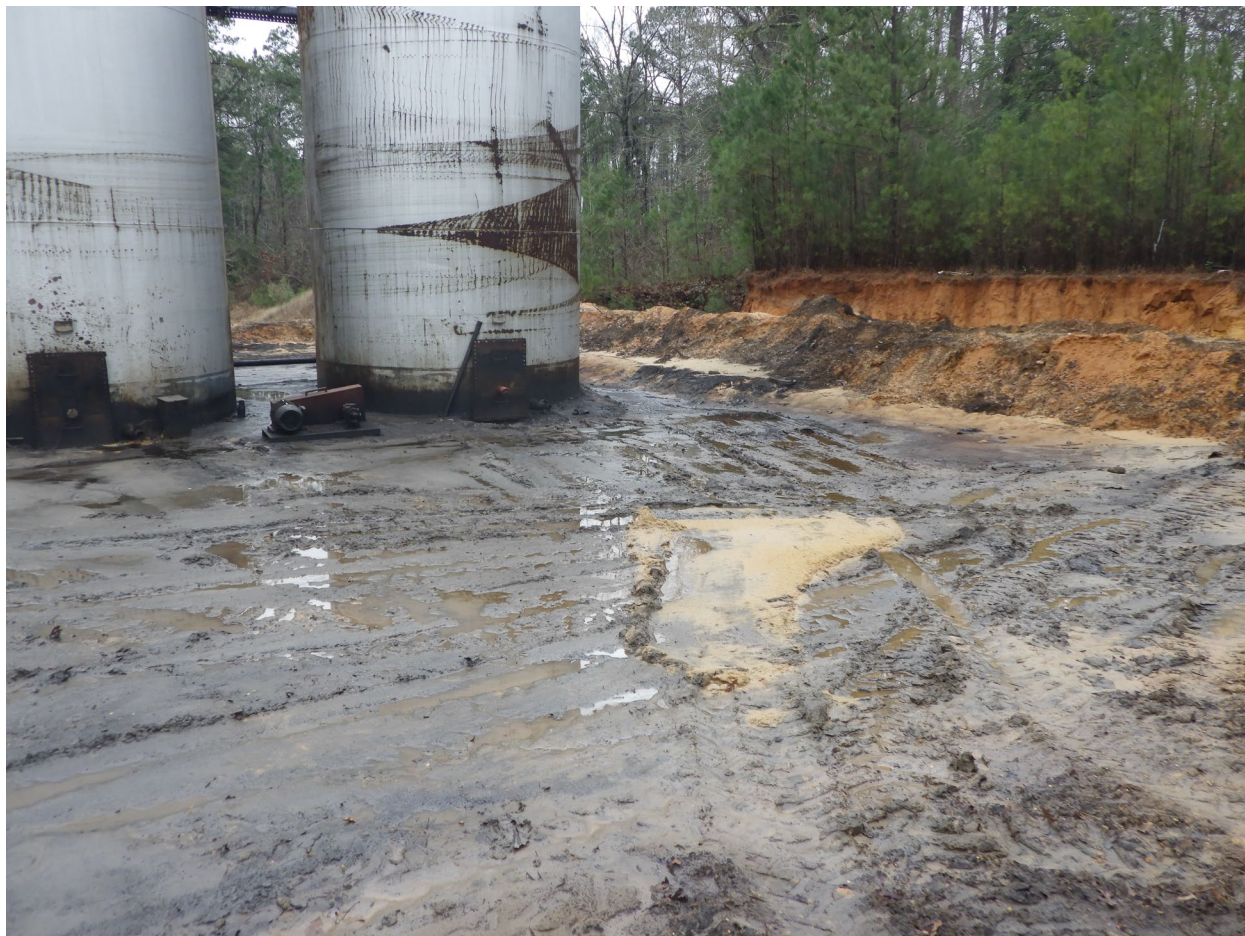
Photo No. 5

**Description:** Looking E, this photo shows some dirt work for drainage and berms inside secondary containment.

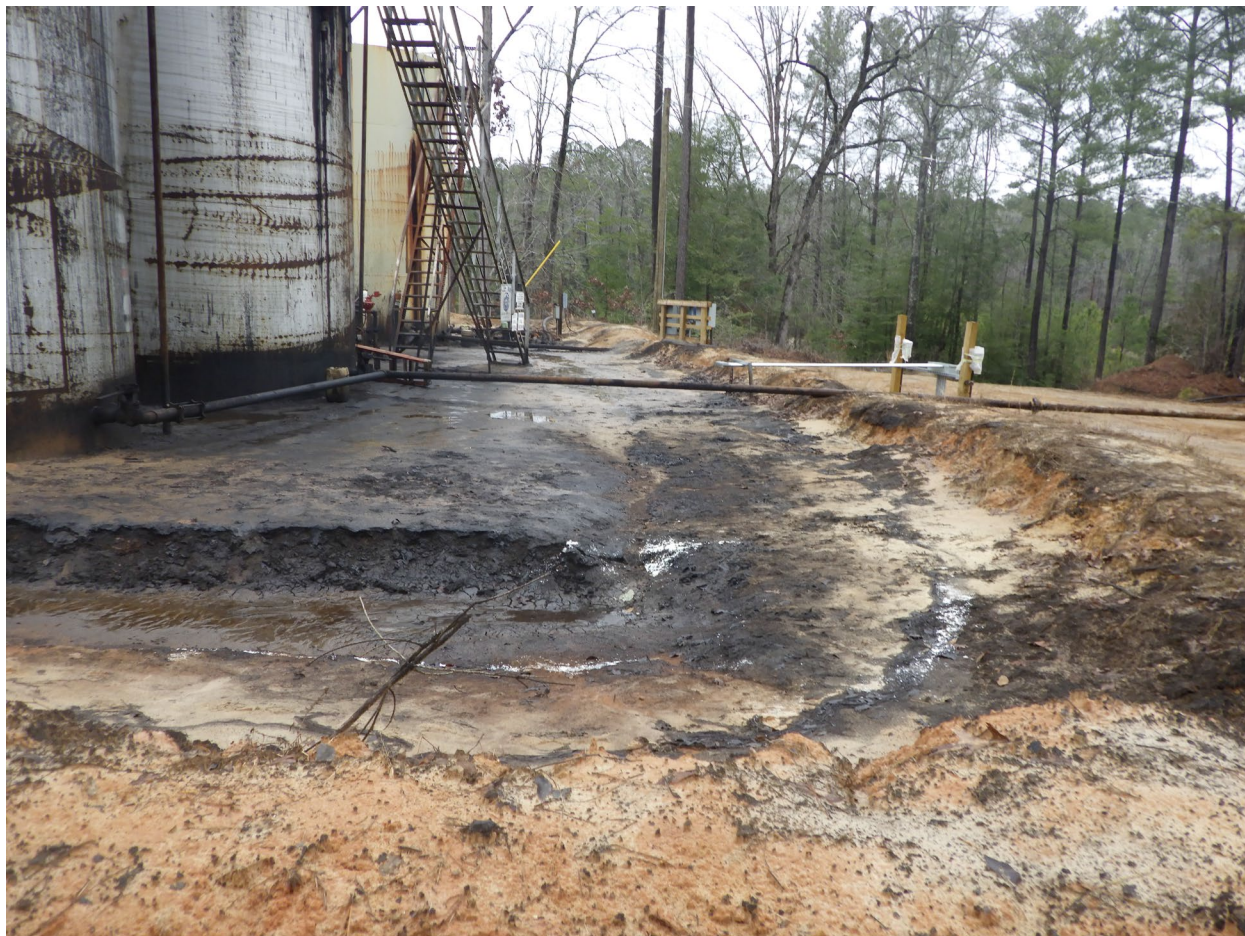
Photo No. 6

**Description:** Looking NNE, this photo shows residual crude oil and salt crystal formation inside secondary containment.

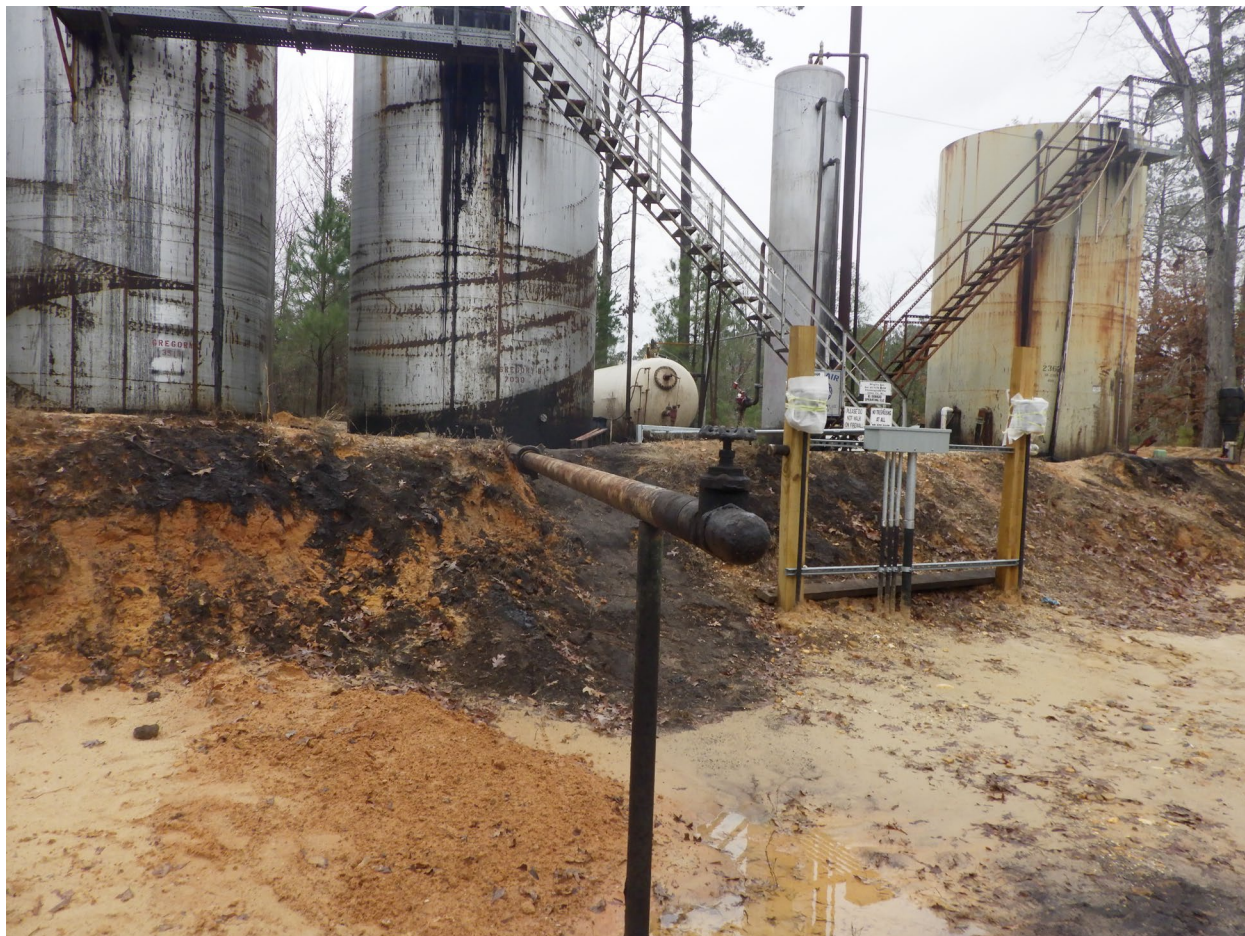
Photo No. 7

I observed two transfer lines without catchment buckets outside secondary containment, see Photos No. 7 and No. 8.

**Description:** Looking NW, this photo shows a transfer line without a catchment bucket.

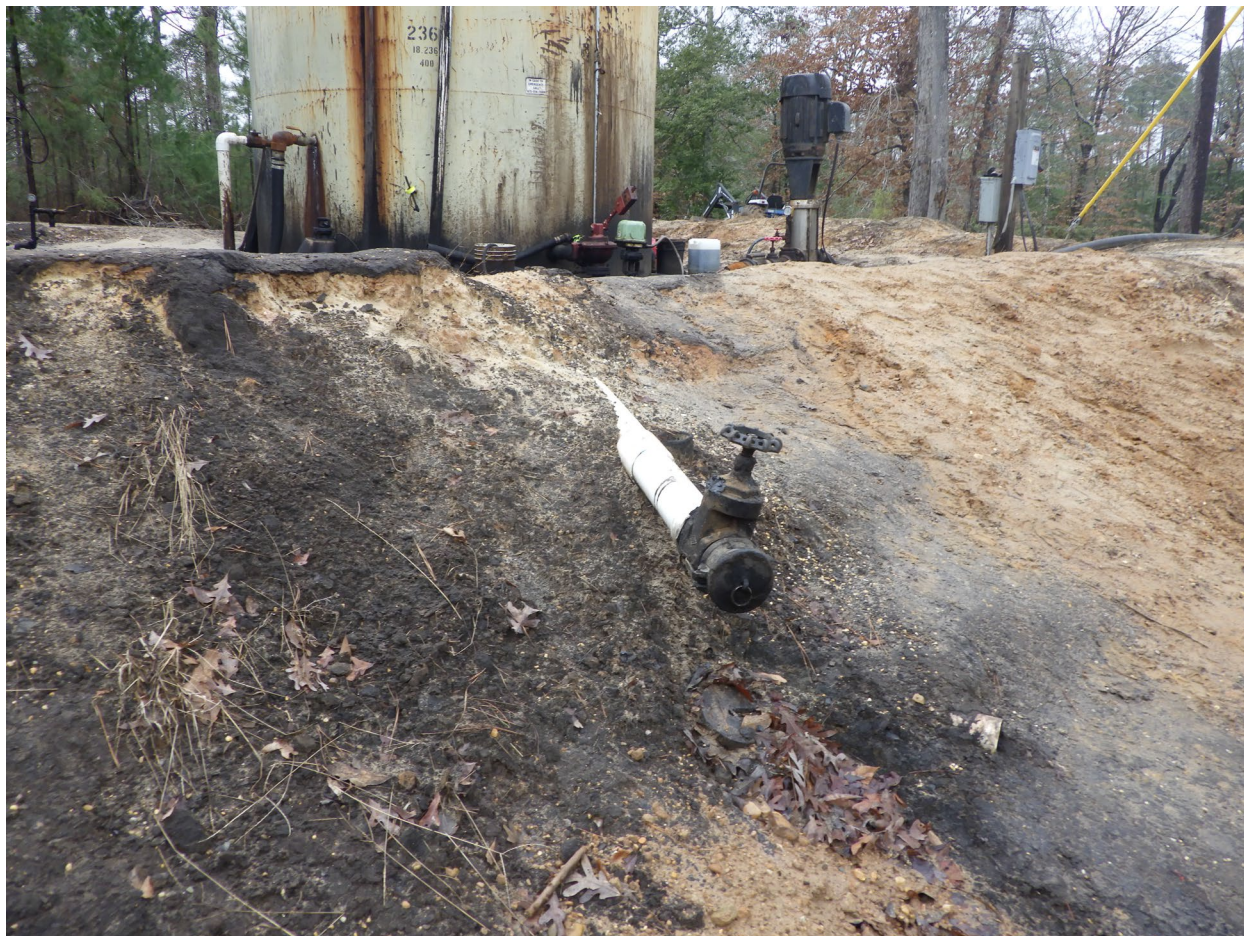
Photo No. 8

**Description:** Looking NNW, this photo shows a transfer line without a catchment bucket.

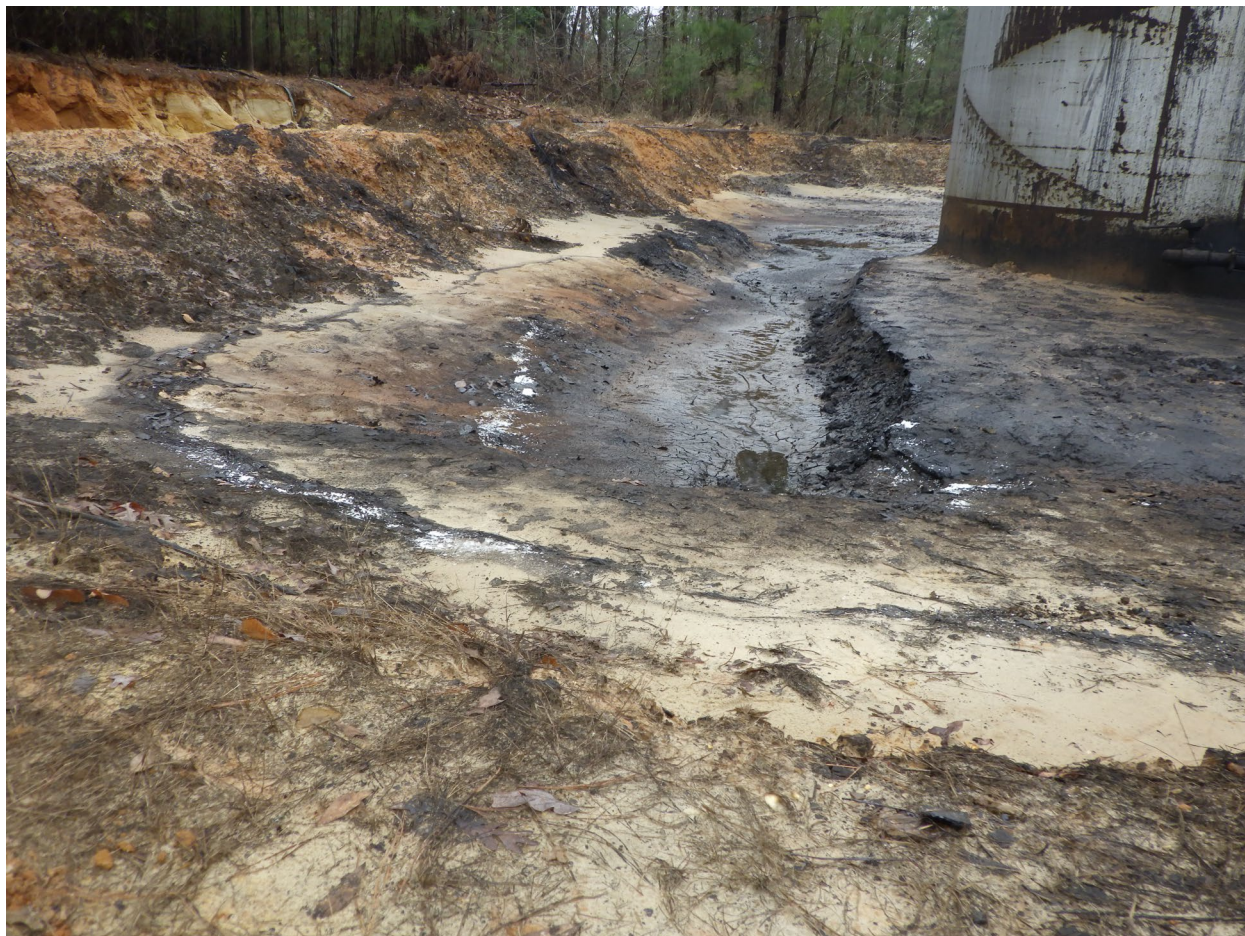
Photo No. 9

**Description:** Looking NW, this photo shows sump area of the secondary containment with loose crude oil and salt crystal formation.

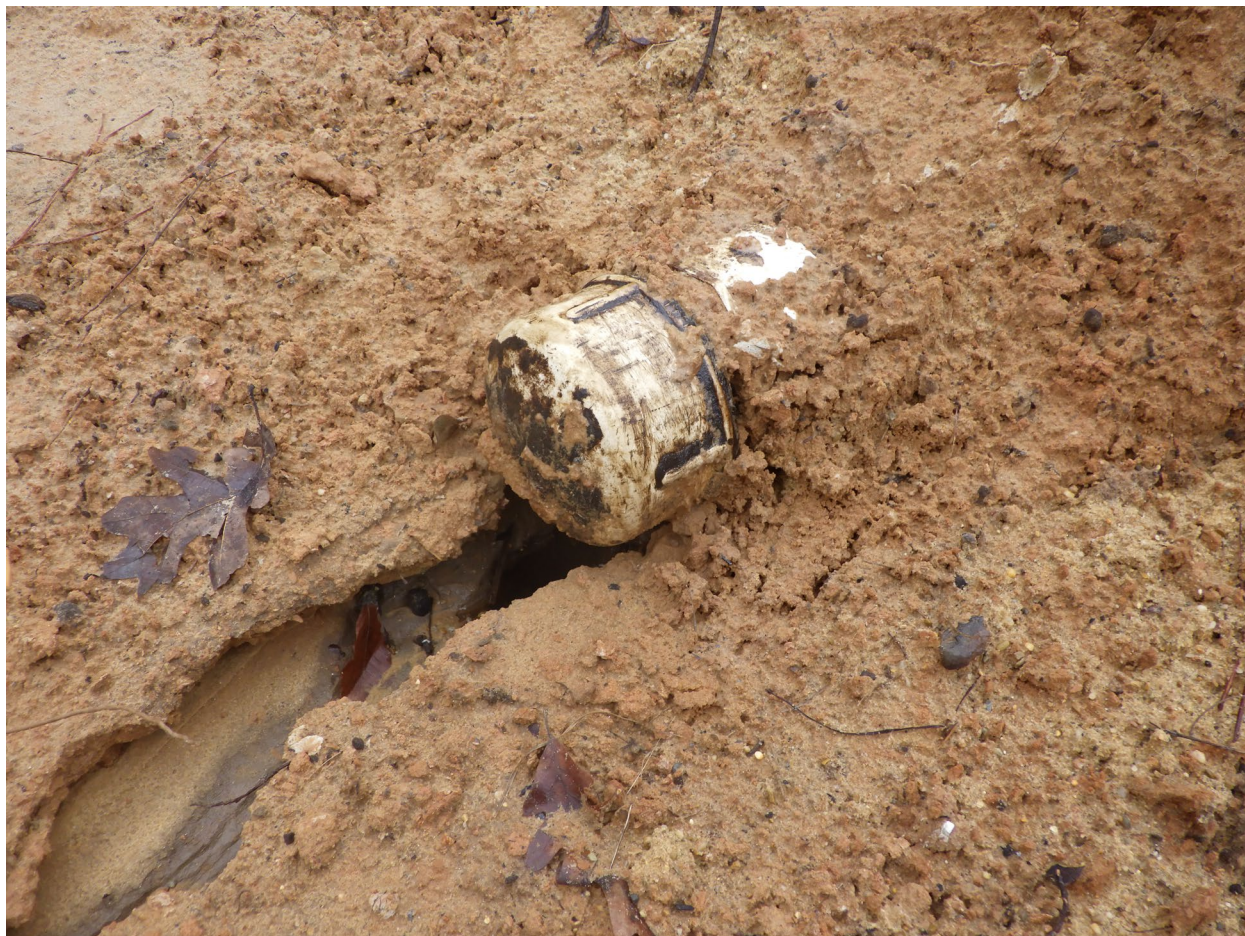
Photo No. 10

**Description:** Looking N, this photo shows the drainpipe for the secondary containment.

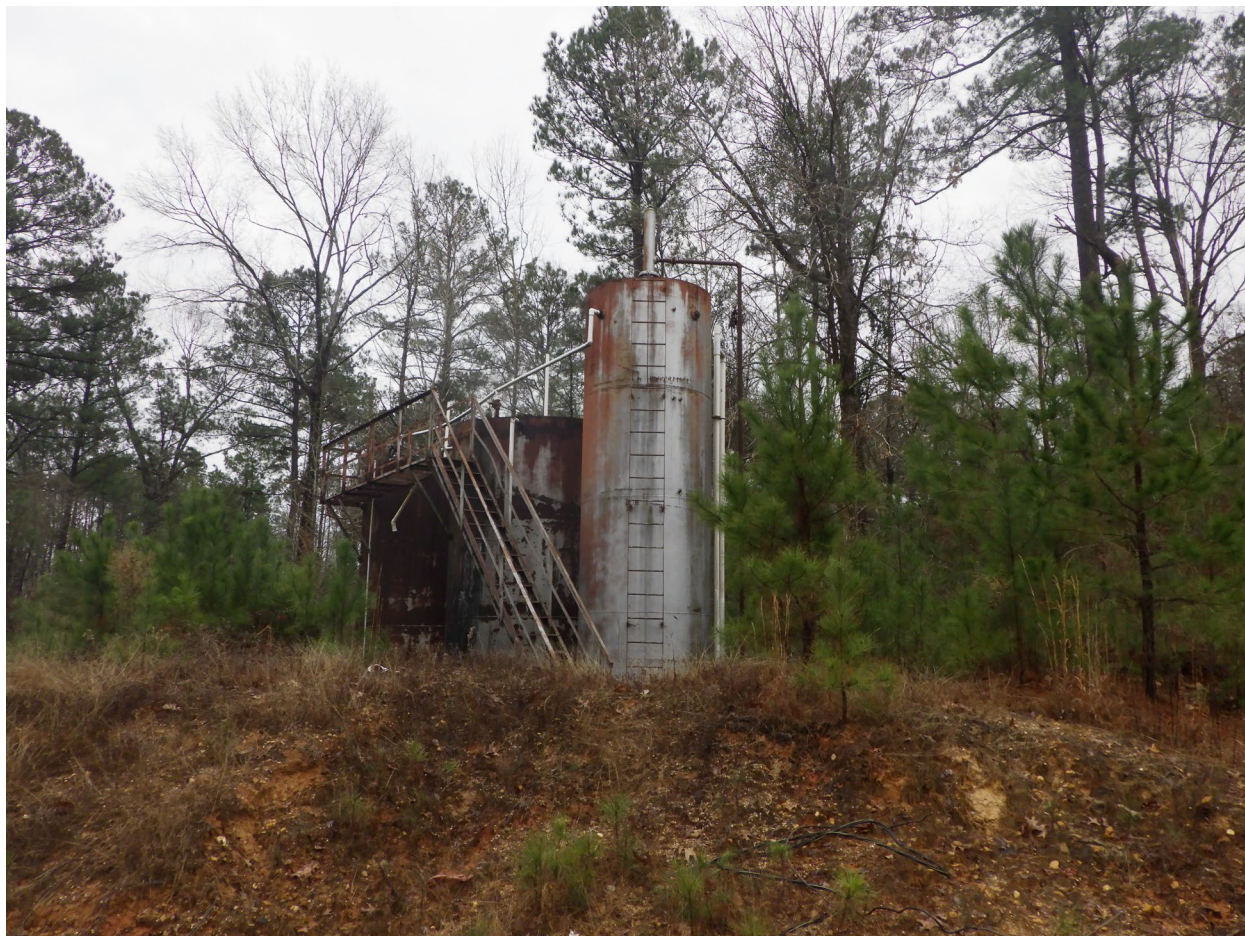
Photo No. 11

I observed an additional tank battery located near the facility that appeared to be out of service, see Photo No. 11.

**Description:** Looking SSE, this photo shows an additional tank battery adjacent to the Gregory Lease Tank Battery that appeared to be out of service.

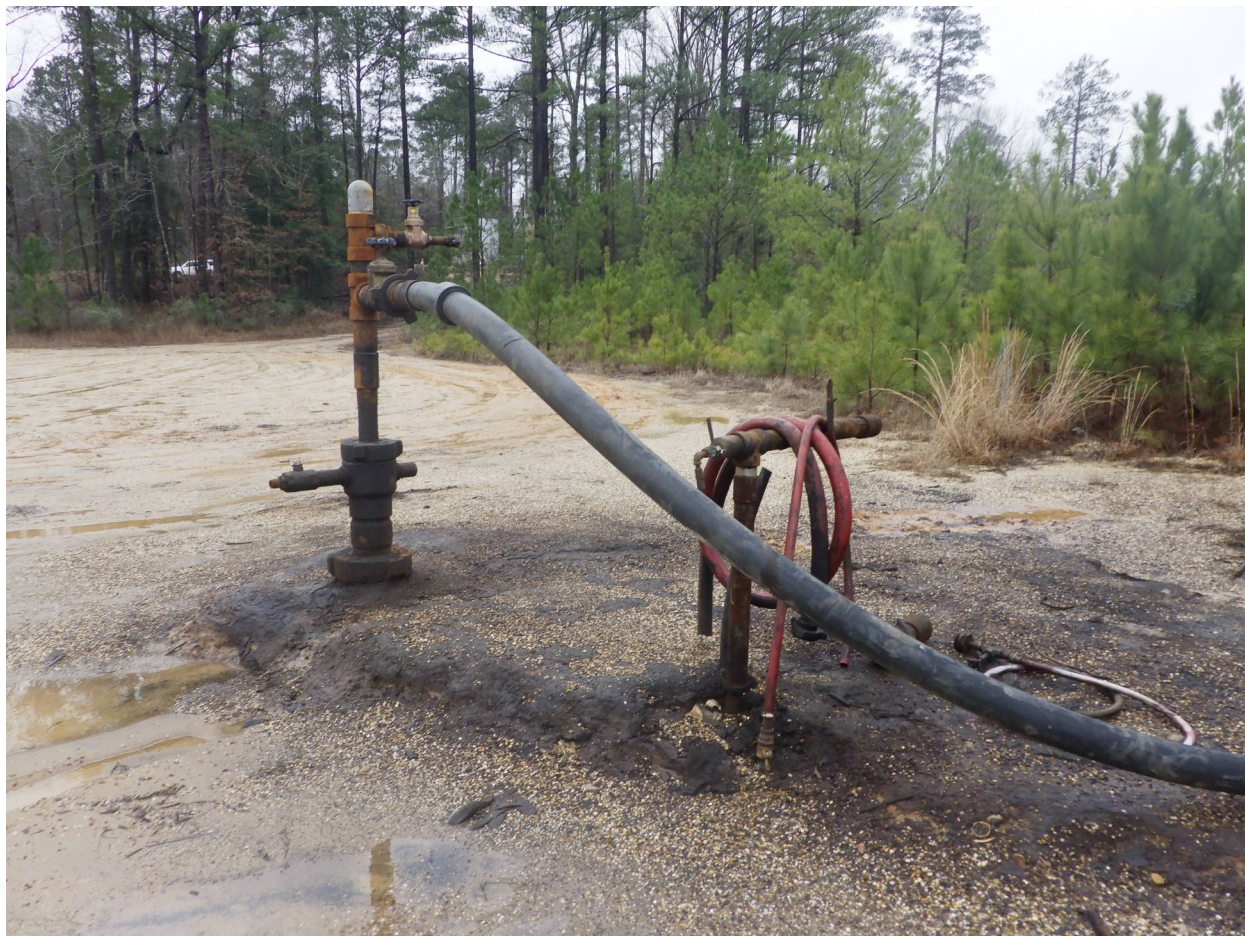
Photo No. 12

**Description:** Looking S, this photo shows a saltwater disposal (SWD) injection well associated with the facility.

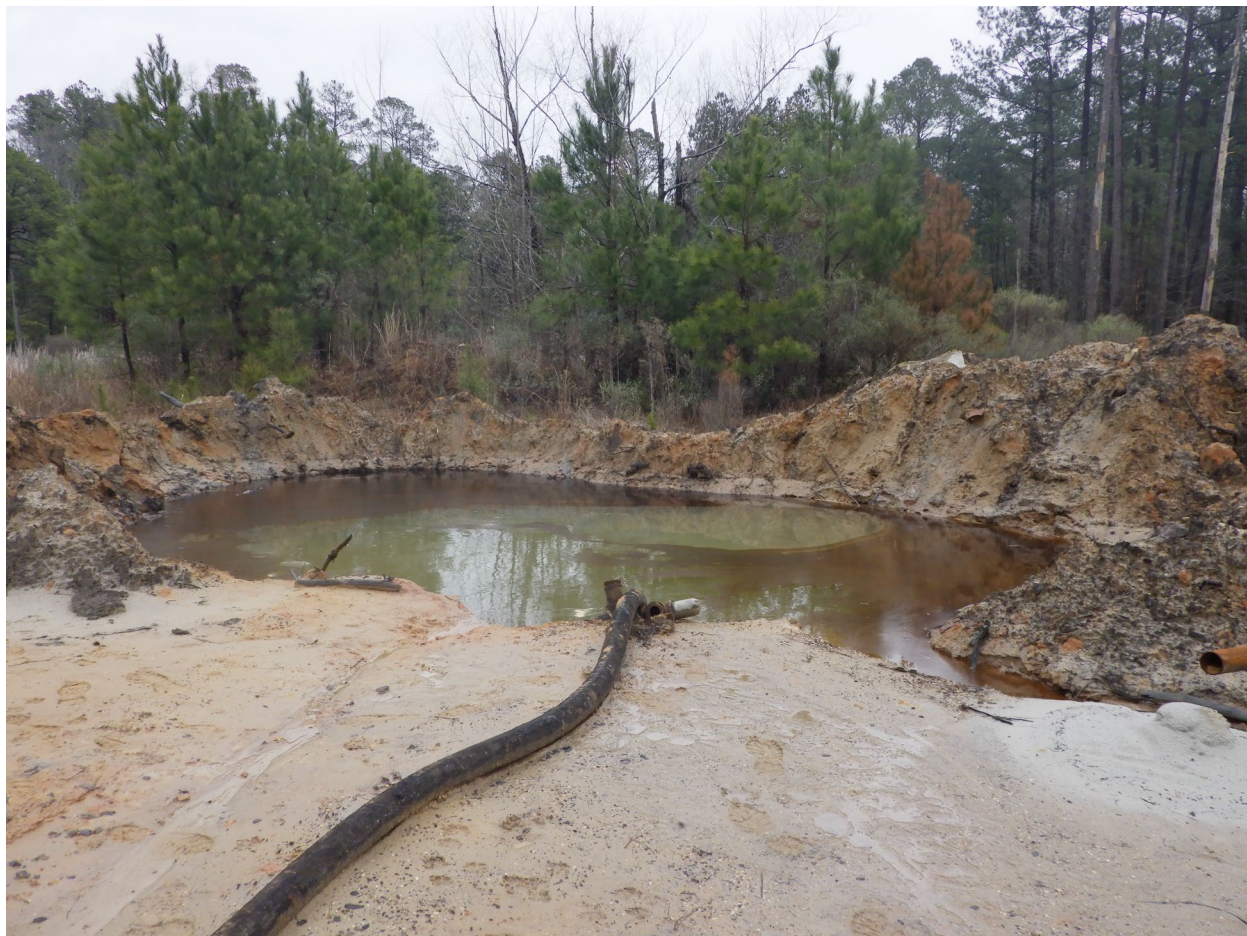
Photo No. 13

I observed two (2) SWD injection wells both with workover pits that contained residual crude oil and saltwater, see Photos No. 12 through No. 16.

**Description:** Looking ENE, this photo shows a workover pit with residual crude oil and saltwater next to the SWD well in Photo No. 12.

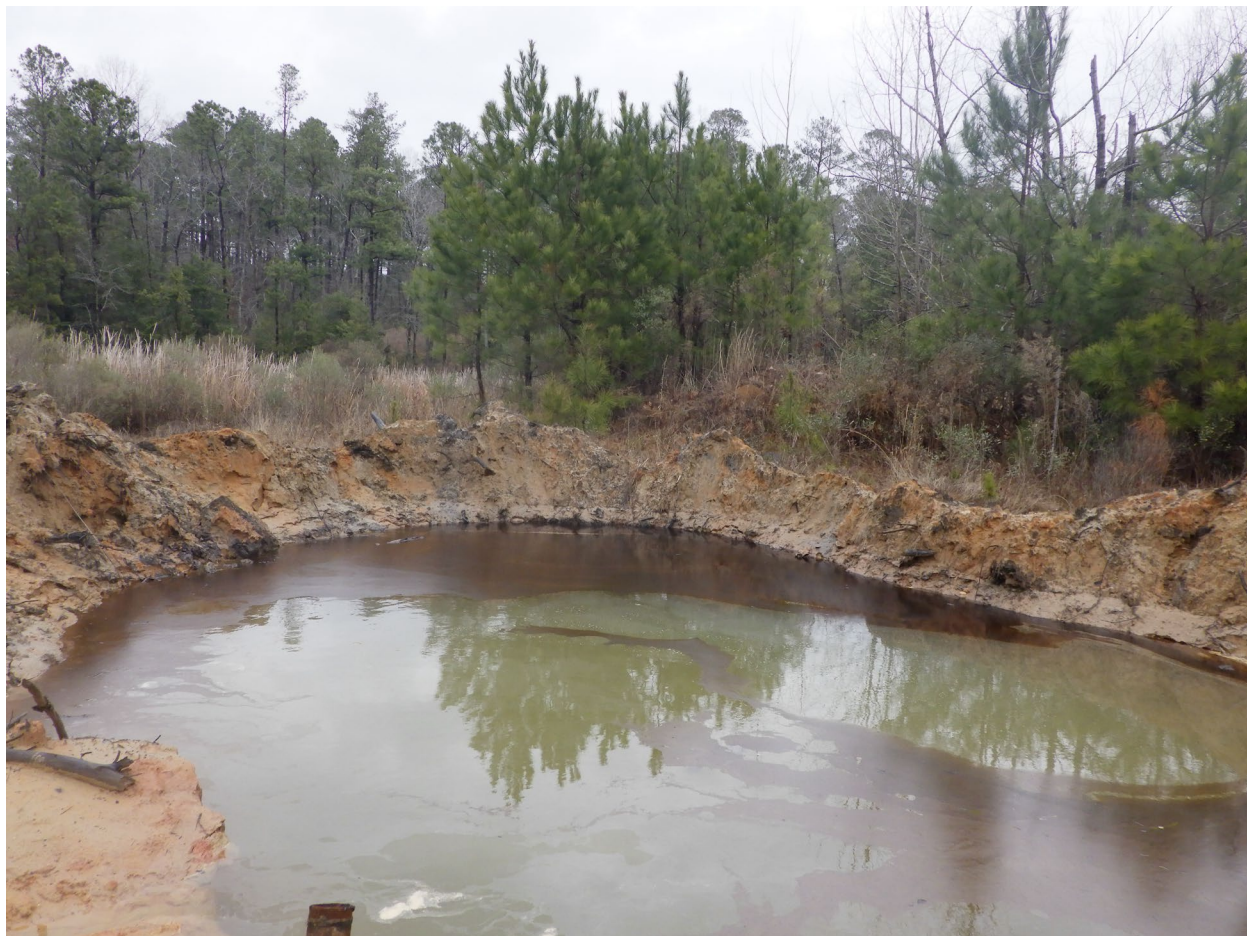
Photo No. 14

**Description:** Looking NE, this photo shows a closeup of the workover pit from Photo No. 13.

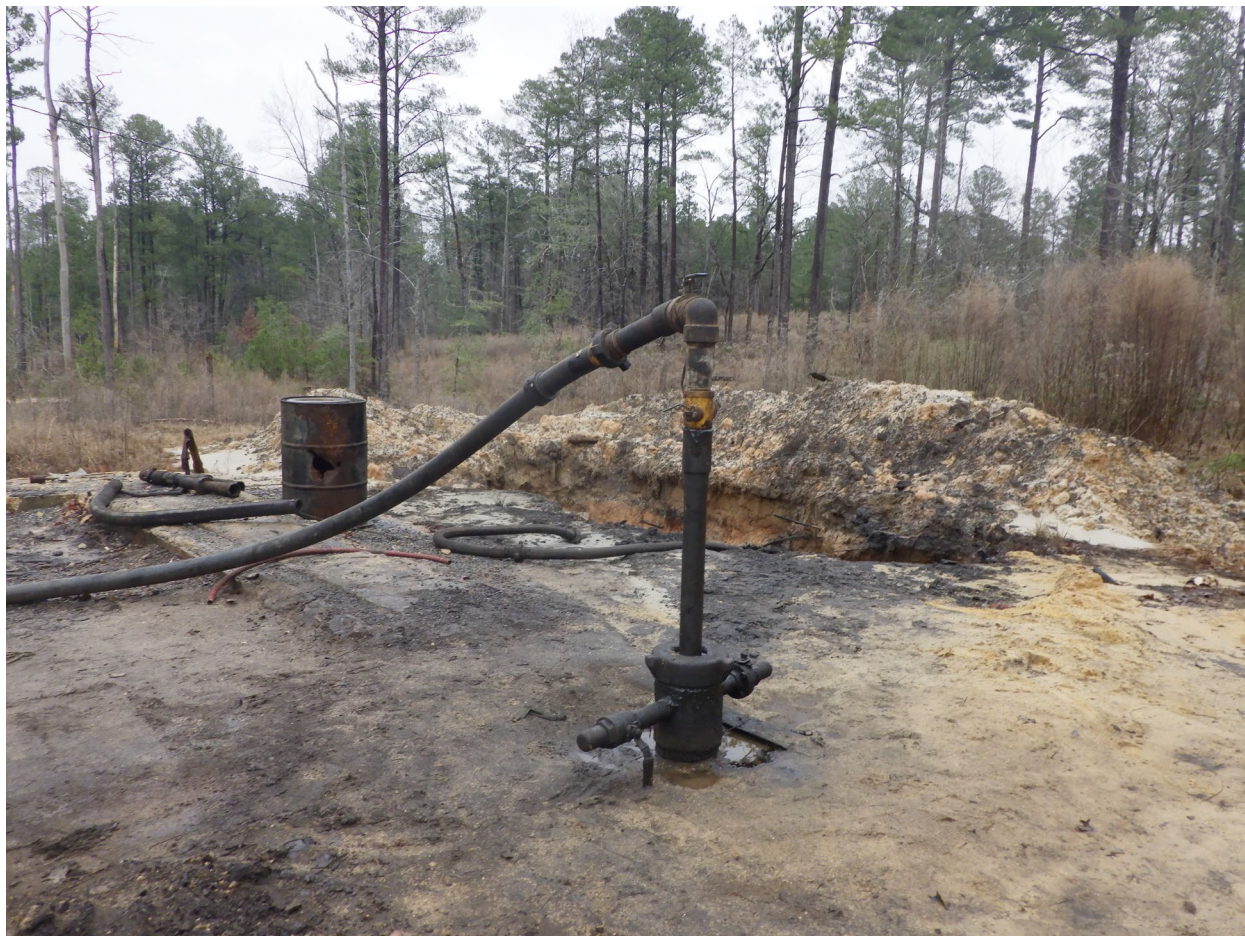
Photo No. 15

**Description:** Looking NE, this photo shows another SWD injection well associated with the facility.

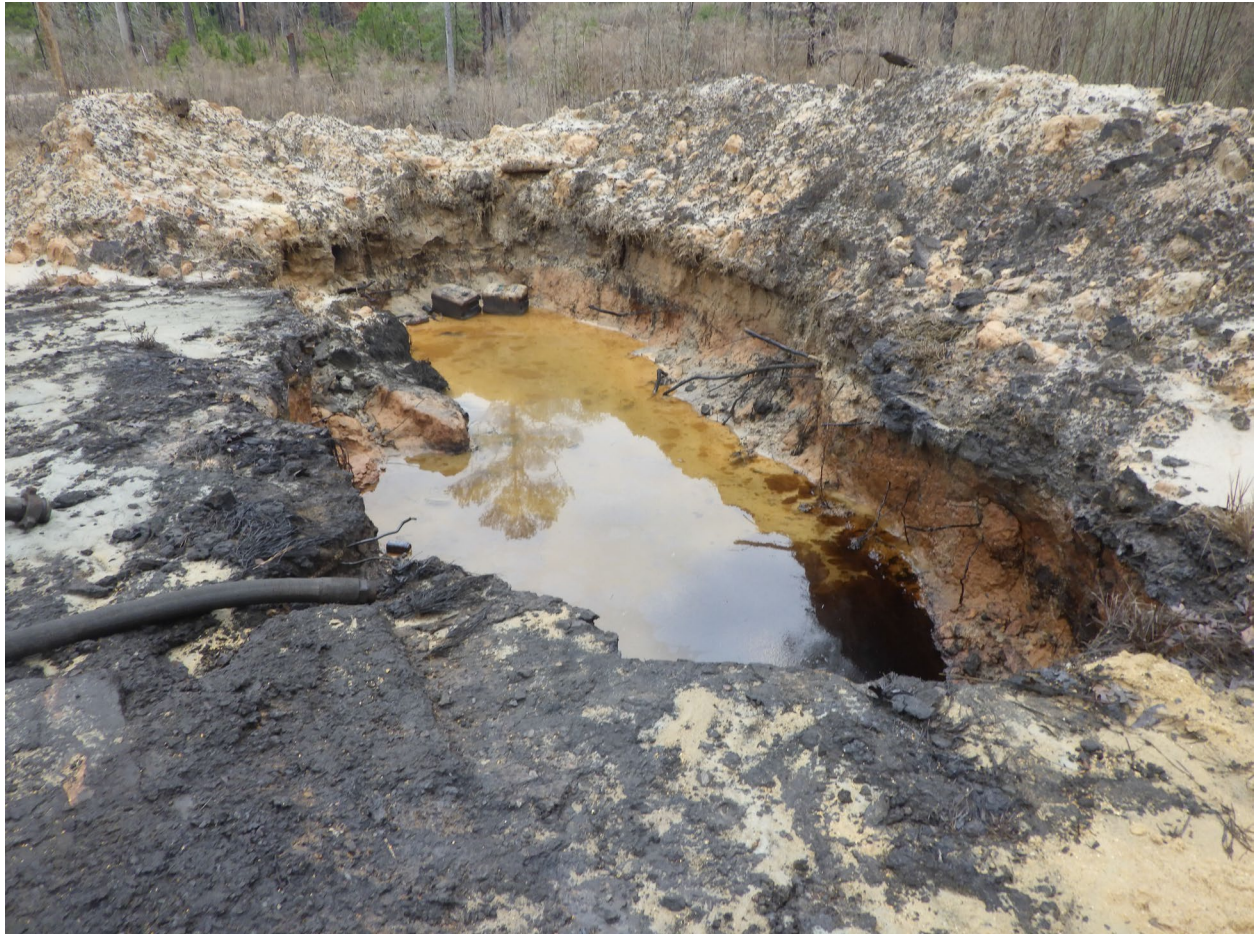
Photo No. 16

**Description:** Looking ENE, this photo shows a workover pit with residual crude oil and saltwater next to the SWD in Photo No. 15.
