**Region 6 - Enforcement & Compliance Assurance Division**  
**INSPECTION REPORT**

| Inspection Date(s): | 1/30/2025 | |
| Company Name: | LBOC, LLC | |
| Facility Name: | Barton-Proetz #1 SWD | |

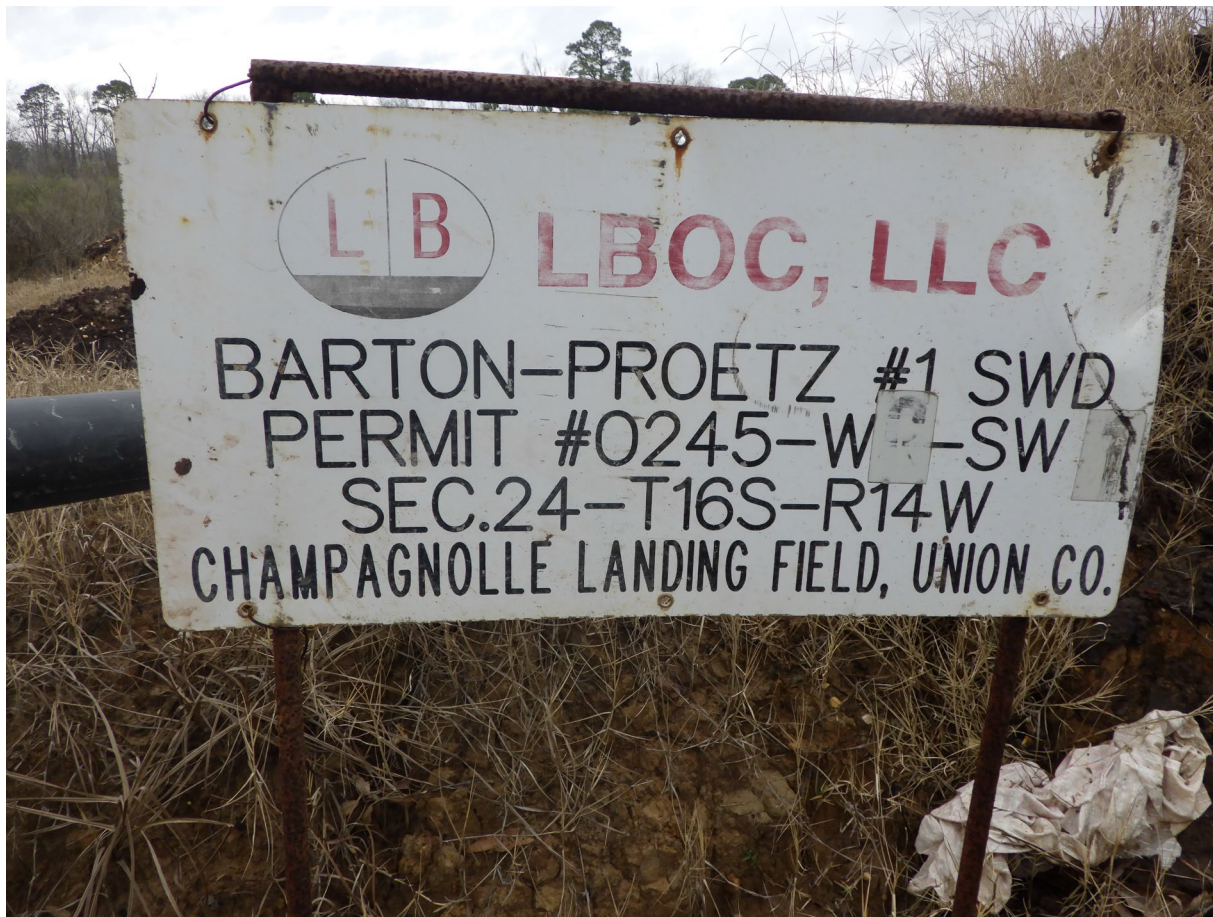
Photo No. 1

I observed the facility sign at the facility, see Appendix 1 (photo log), photo No. 1. For additional GPS location information and photo metadata, see Appendix 1.

**Description:** This photo was taken looking W at the facility showing the facility sign.

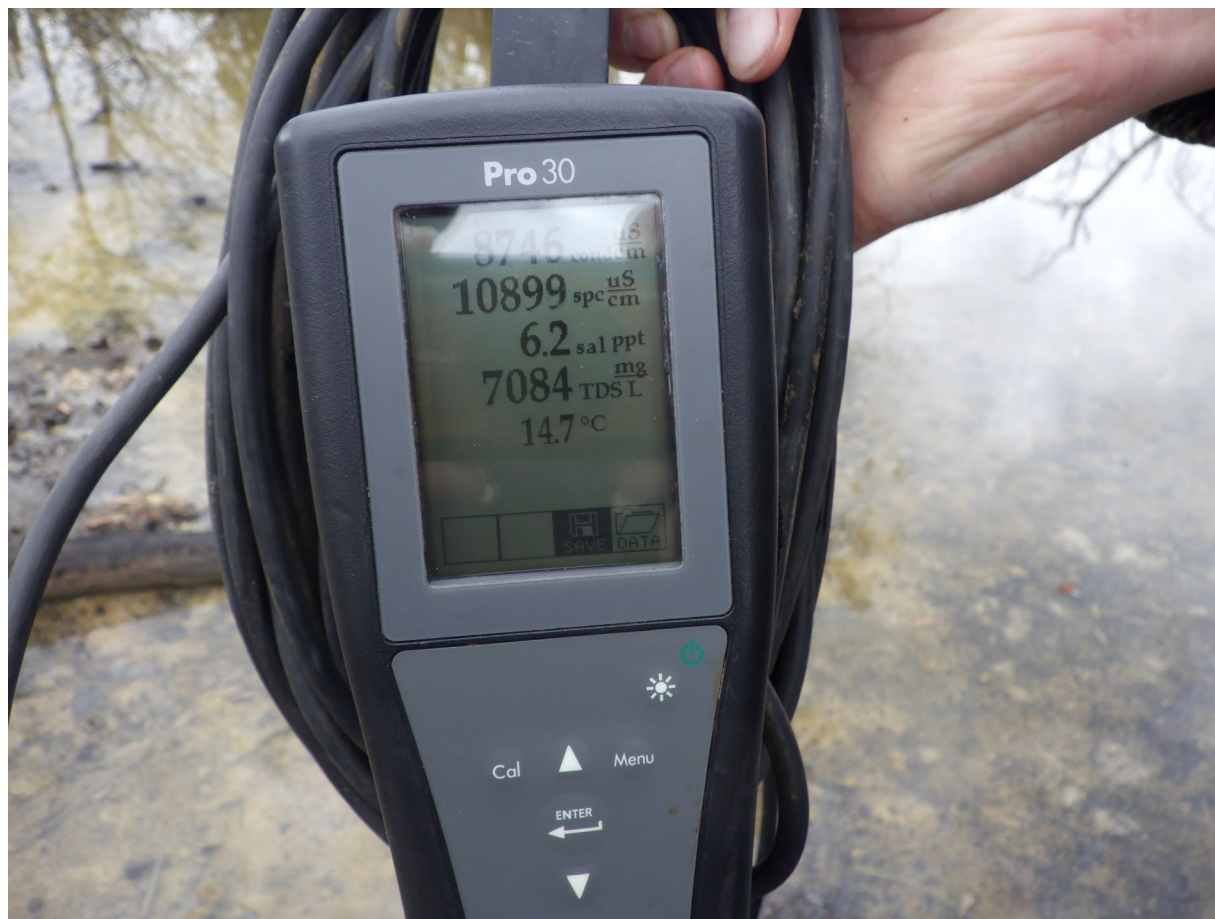
Photo No. 2

I measured a Total Dissolved Solids (TDS) value of 7,084 mg/L along the flow path before the point of entry (POE) into the unnamed tributary and observed the impacted flow path, see photo No. 2 through No. 4.

**Description:** This photo was taken showing a TDS reading of 7,084 mg/L at the standing water along the flow path before the point of entry.

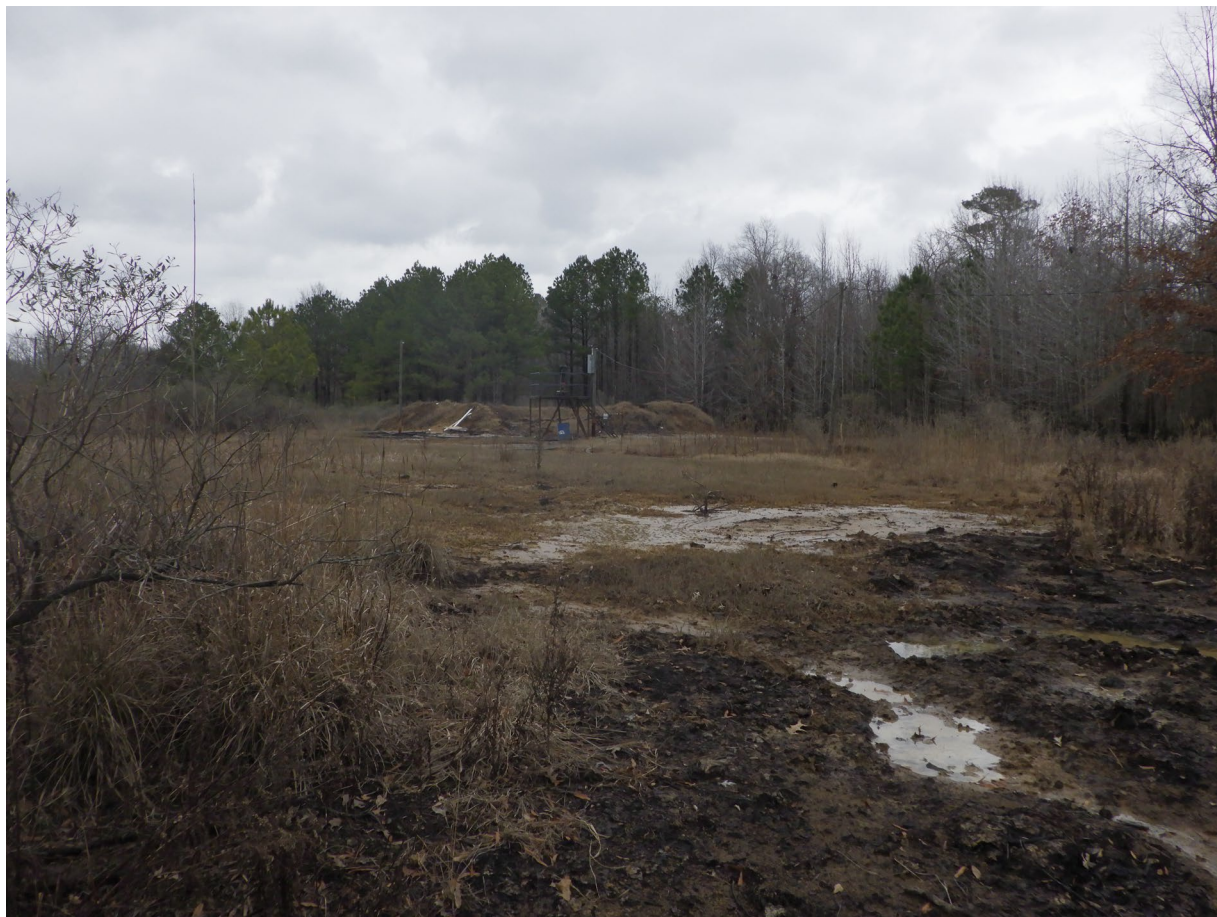
Photo No. 3

**Description:** This photo was taken looking northeast showing the flow path to the unnamed tributary.

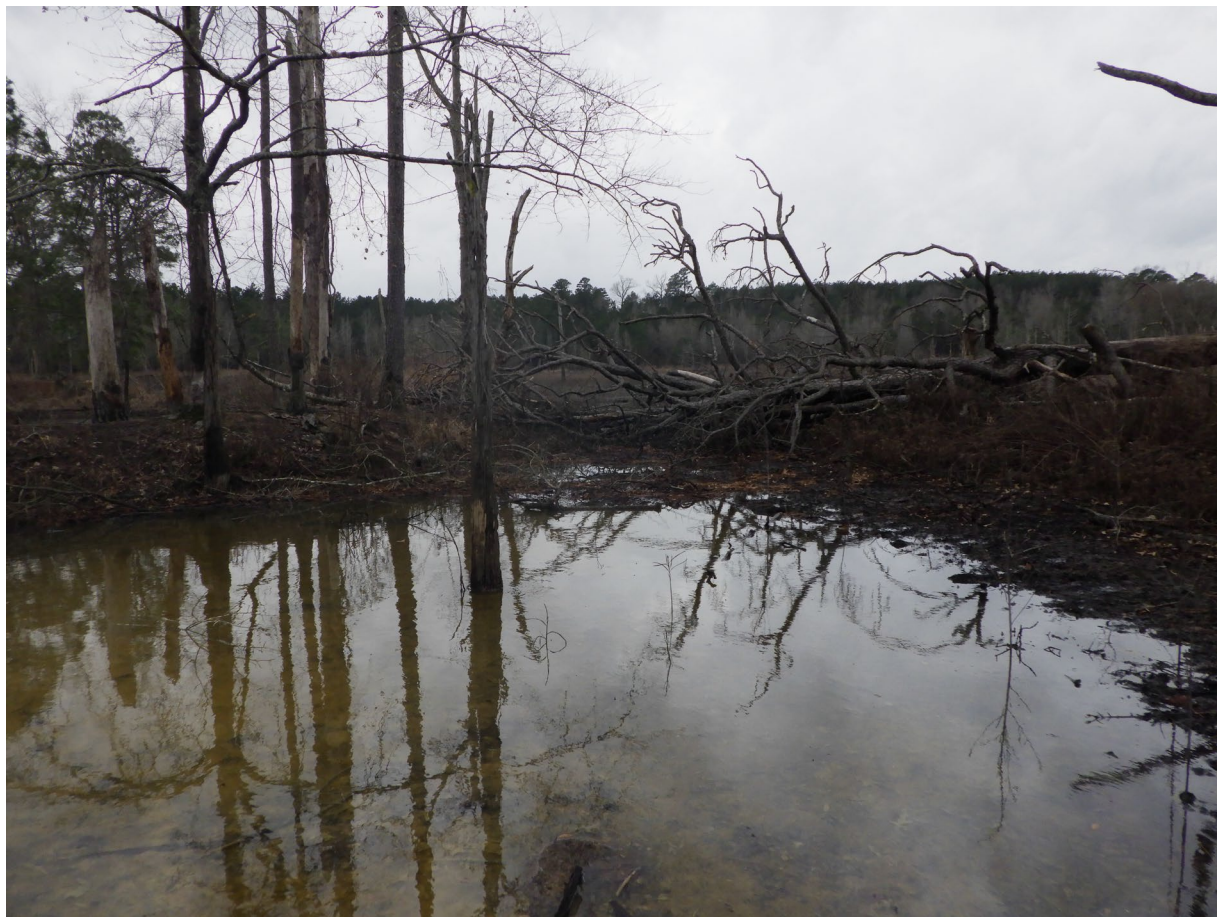
Photo No. 4

**Description:** This photo was taken looking southwest showing the flow path to the unnamed tributary.

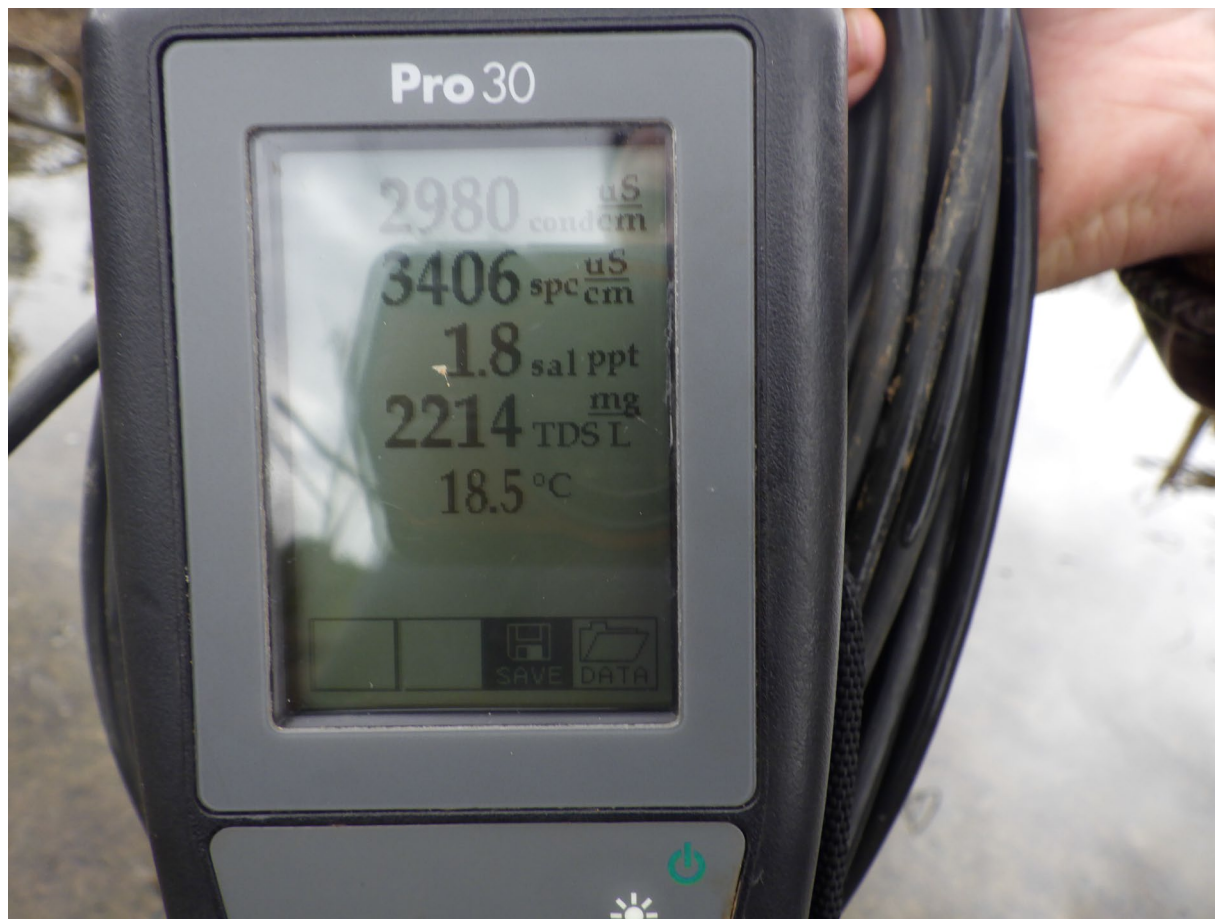
Photo No. 5

I measured a Total Dissolved Solids (TDS) value of 2,214 mg/L at the POE into the unnamed tributary, see photo No. 5 through No. 7.

No closing conference was held due to no LBOC, LLC staff being present during the inspection. Areas of concern at the time of the inspection include oil and brine within remnants of secondary containment, contaminated flow path to the unnamed tributary, and the elevated TDS level of 2,214 mg/L at the POE into the unnamed tributary.

**Description:** This photo was taken showing a TDS reading of 2,214 mg/L at the point of entry into the unnamed tributary.

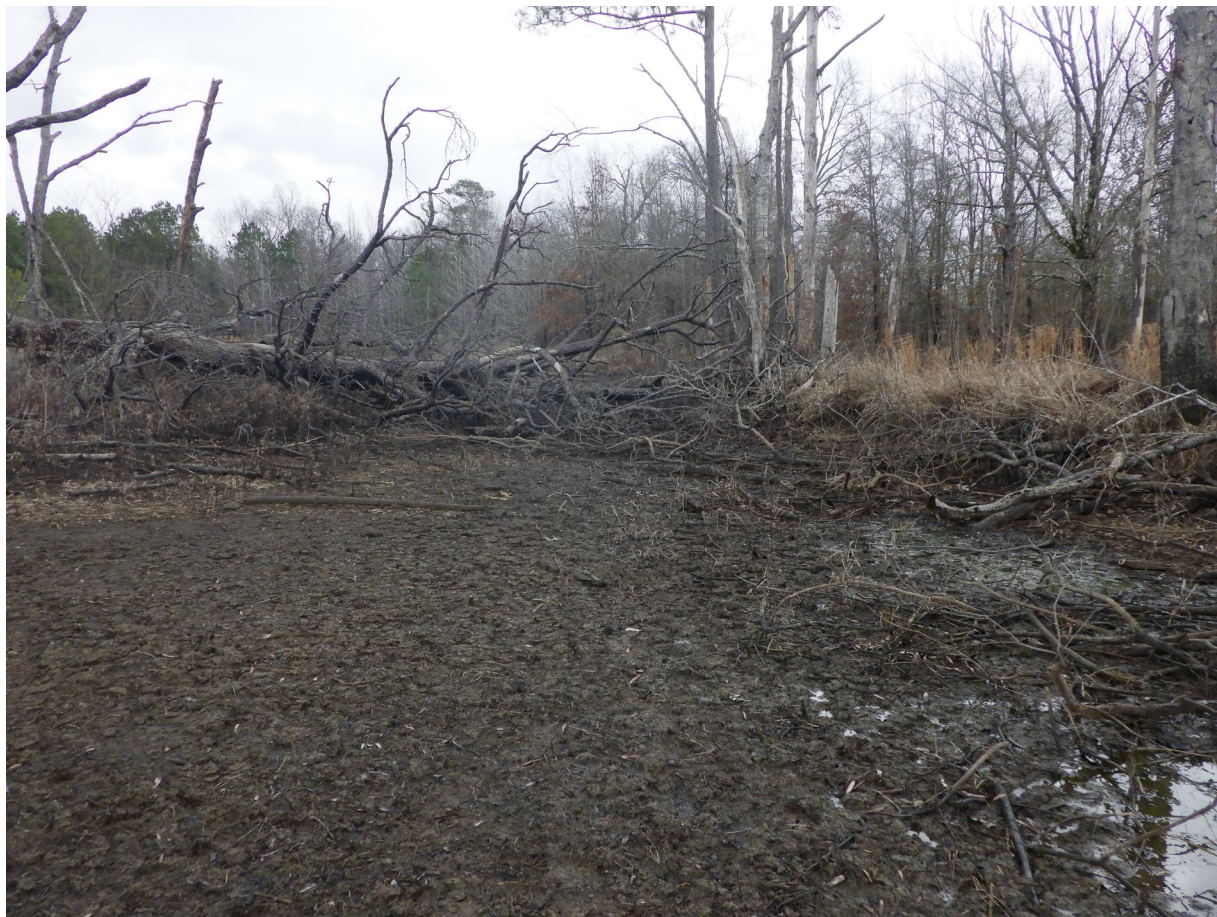
Photo No. 6

**Description:** This photo was taken looking northeast showing the contaminated flow path before it enters the unnamed tributary where the TDS reading was taken.

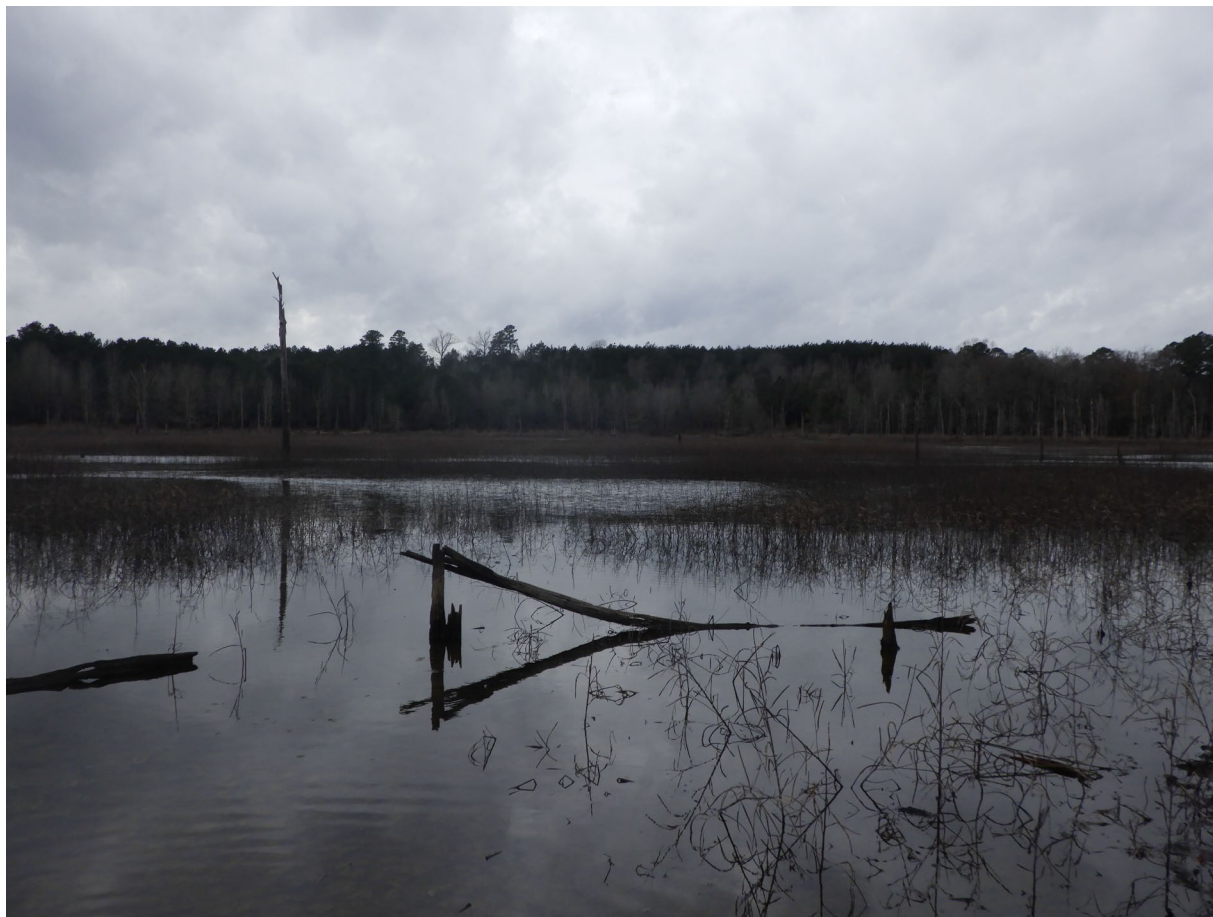
Photo No. 7

**Description:** This photo was taken looking southwest at the unnamed tributary at the point of entry where the TDS reading was taken.
