**Region 6 - Enforcement & Compliance Assurance Division**  
**INSPECTION REPORT**

| Inspection Date(s): | 06/08/2023 | |
| Regulatory Program(s) | AWIA/SDWA | |
| Facility Name: | <b>Cross County Rural Water System</b> | |

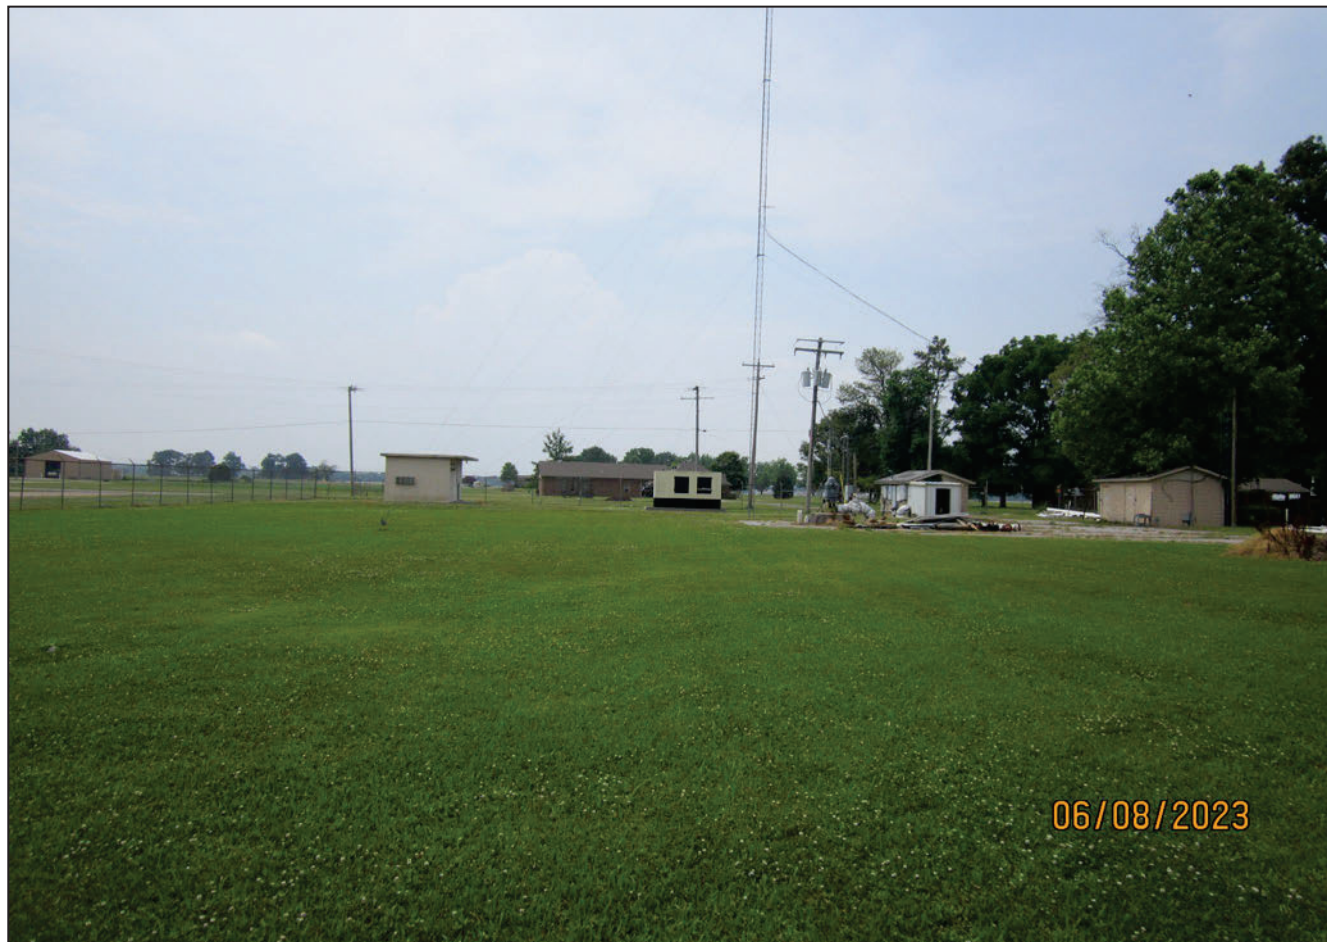
Photo No. 1

**Observation 7.** There was a private residence located on the fence within less than 100 feet of all wells (refer to [Appendix 2, Photograph 1](#)).

**Photograph 1. Fitzgerald Crossing Well Field** View of the Fitzgerald Crossing well field and backup generator. The well field was surrounded by a locked perimeter fence. There was a private residence located on the fence within less than 100 feet of all wells.

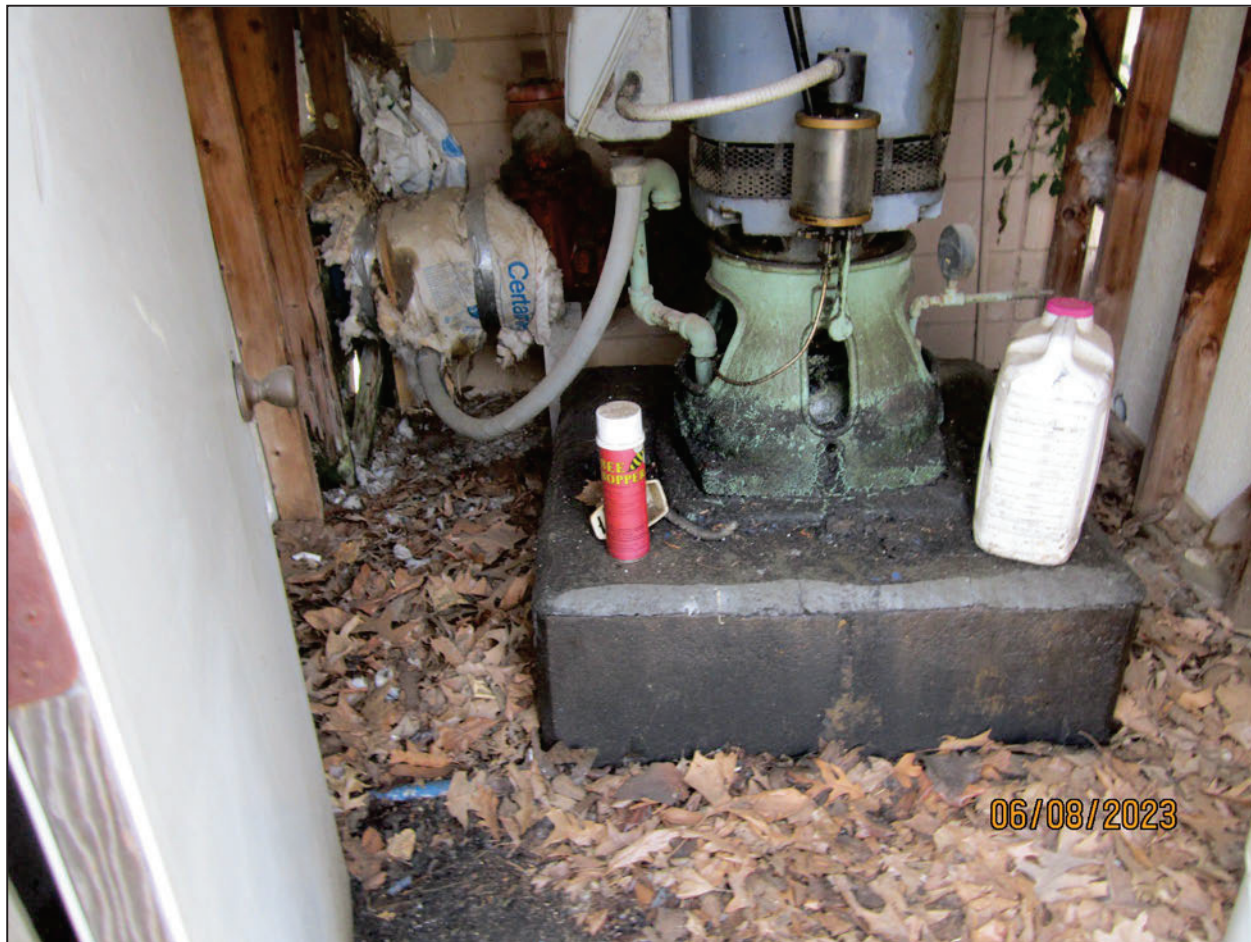
Photo No. 2

**Observation 8.** There was a can of bee spray and an unmarked container resting on the well pedestal. The pedestal and motor stand structure appeared to have a layer of oil. There was an accumulation of leaves and some debris surrounding the well pedestal (refer to [Appendix 2, Photograph 2](#)).

**Photograph 2. Well #1** View of Well #1, that was located within a shed. Components of the raw water lines were wrapped in insulation. There was a can of bee spray and an unmarked container resting on the well pedestal. The pedestal and motor stand structure appeared to have a layer of oil. There was an accumulation of leaves and some debris surrounding the well pedestal.

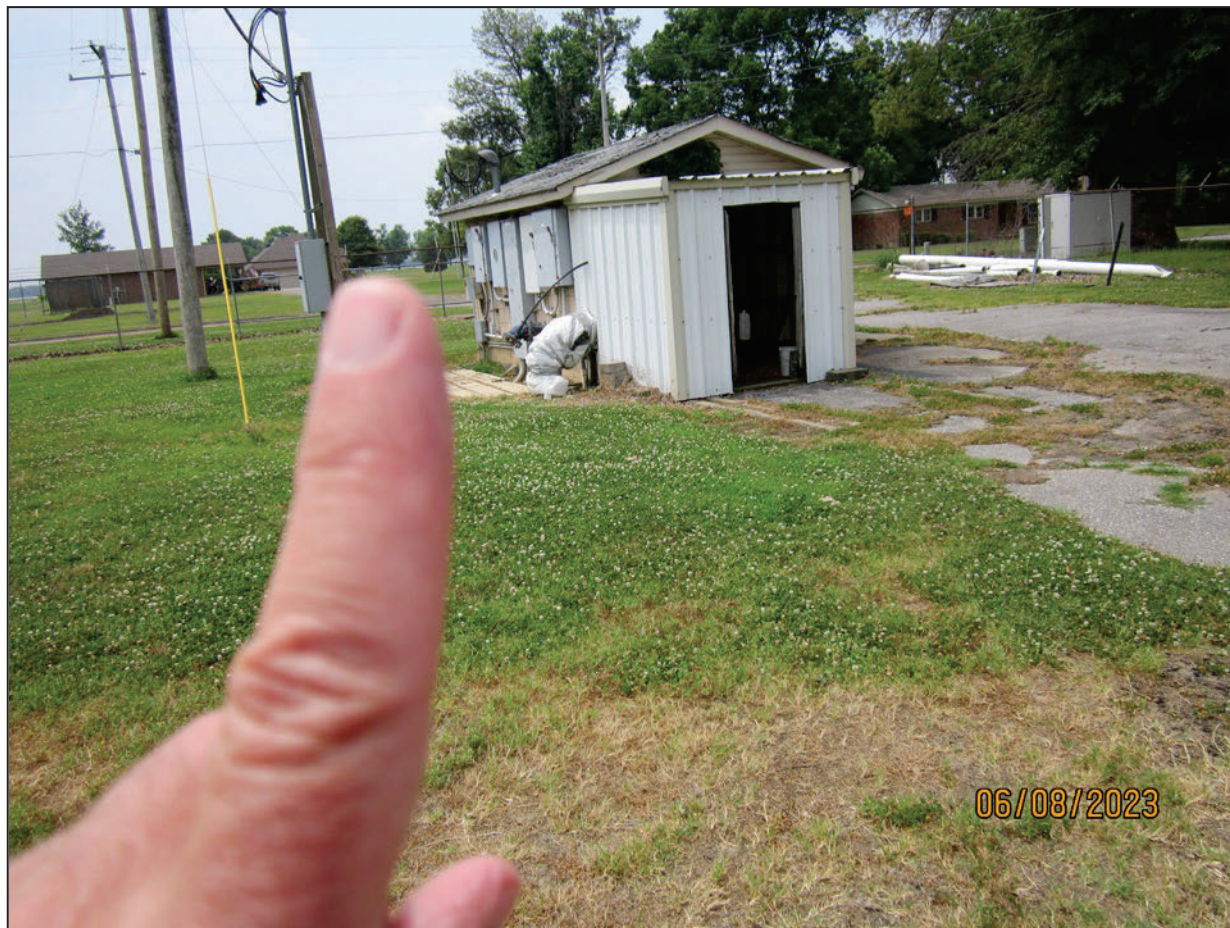
Photo No. 3

**Observation 9.** There was an unmarked shed on the fence line approximately 60 feet from Well #1 (refer to [Appendix 2, Photograph 3](#)).

**Photograph 3. Well #1** View of an unmarked shed that was located on the fence line approximately 60 feet from Well #1.

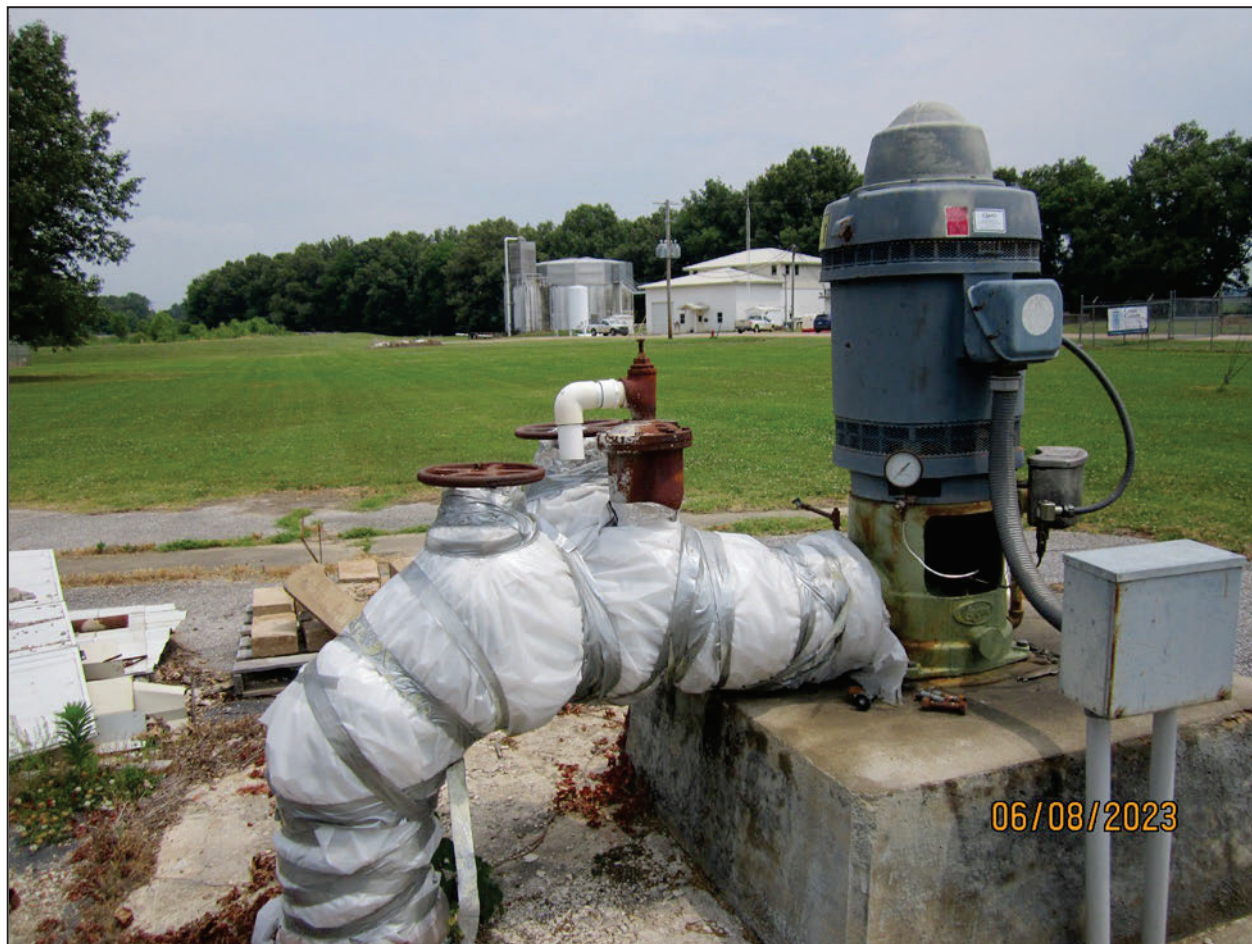
Photo No. 4

**Observation 10.** Well #6, the PVC line from the air relief valve did not have an external screen. It was unclear if there was an internal screen (refer to [Appendix 2, Photograph 4](#)).

**Photograph 4. Well #6** View of Well #6. The well pedestal was located on a concrete pad. Components of the raw water lines were wrapped in insulation. The PVC line from the air relief valve didn't have an external screen. It's unclear if there was an internal screen.

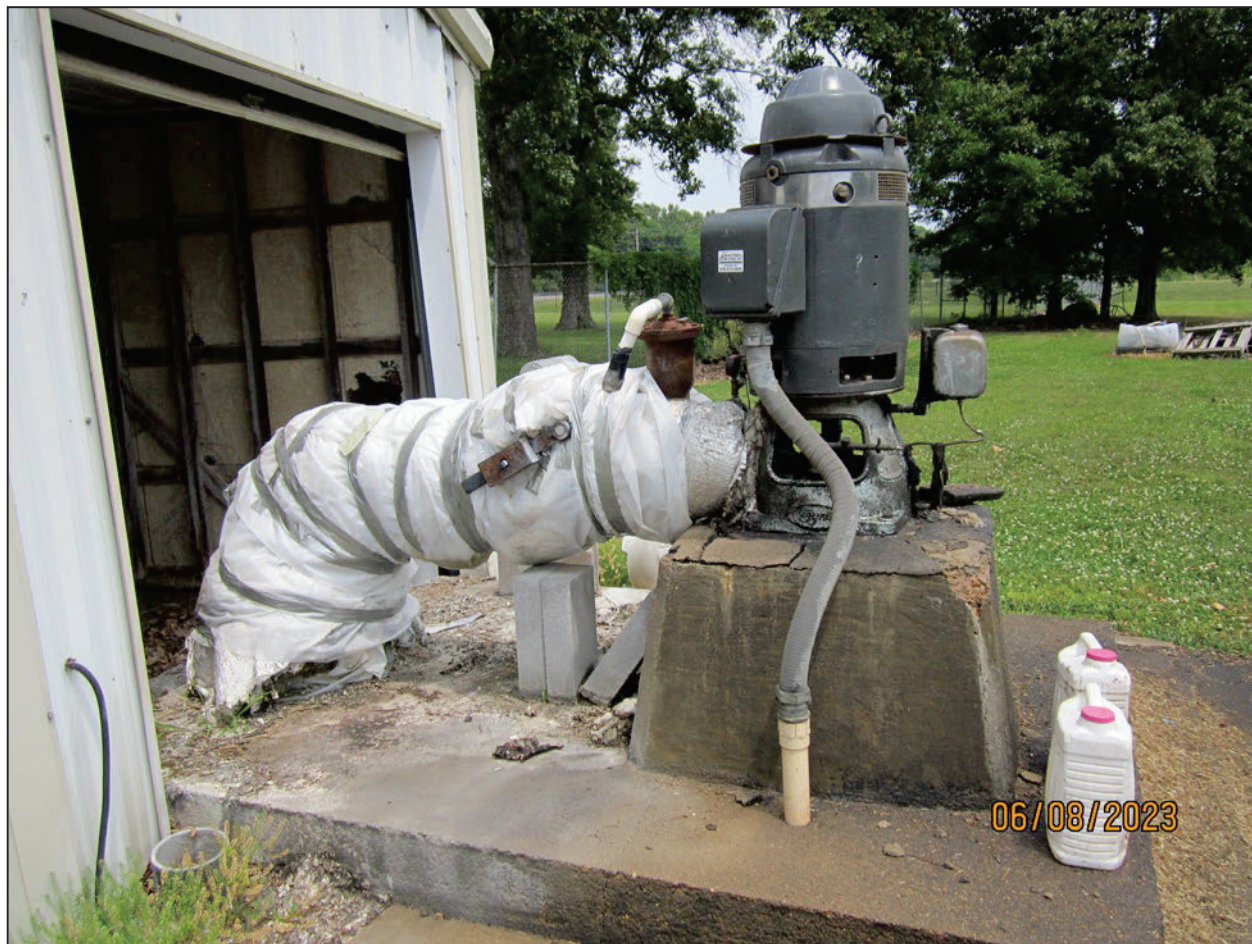
Photo No. 5

**Observation 11.** There were a few concrete blocks under Well #3's check valve. The PVC line off the air relief valve was screened. Two unmarked containers were resting adjacent to the well pedestal. The pedestal and motor structure appeared to have a layer of oil. In addition, the top of the pedestal had cracked concrete surrounding the motor stand structure (refer to [Appendix 2, Photograph 5](#)).

**Photograph 5. Well #3** View of Well #3 and its pedestal that were located outside a shed, on a concrete pad. Components of the raw water lines were wrapped in insulation. There were a few concrete blocks under the well's check valve. The PVC line off the air relief valve was screened. Two unmarked containers were resting adjacent to the well pedestal. The pedestal and motor structure appeared to have a layer of oil. In addition, the top of the pedestal had cracked concrete surrounding the motor stand structure.

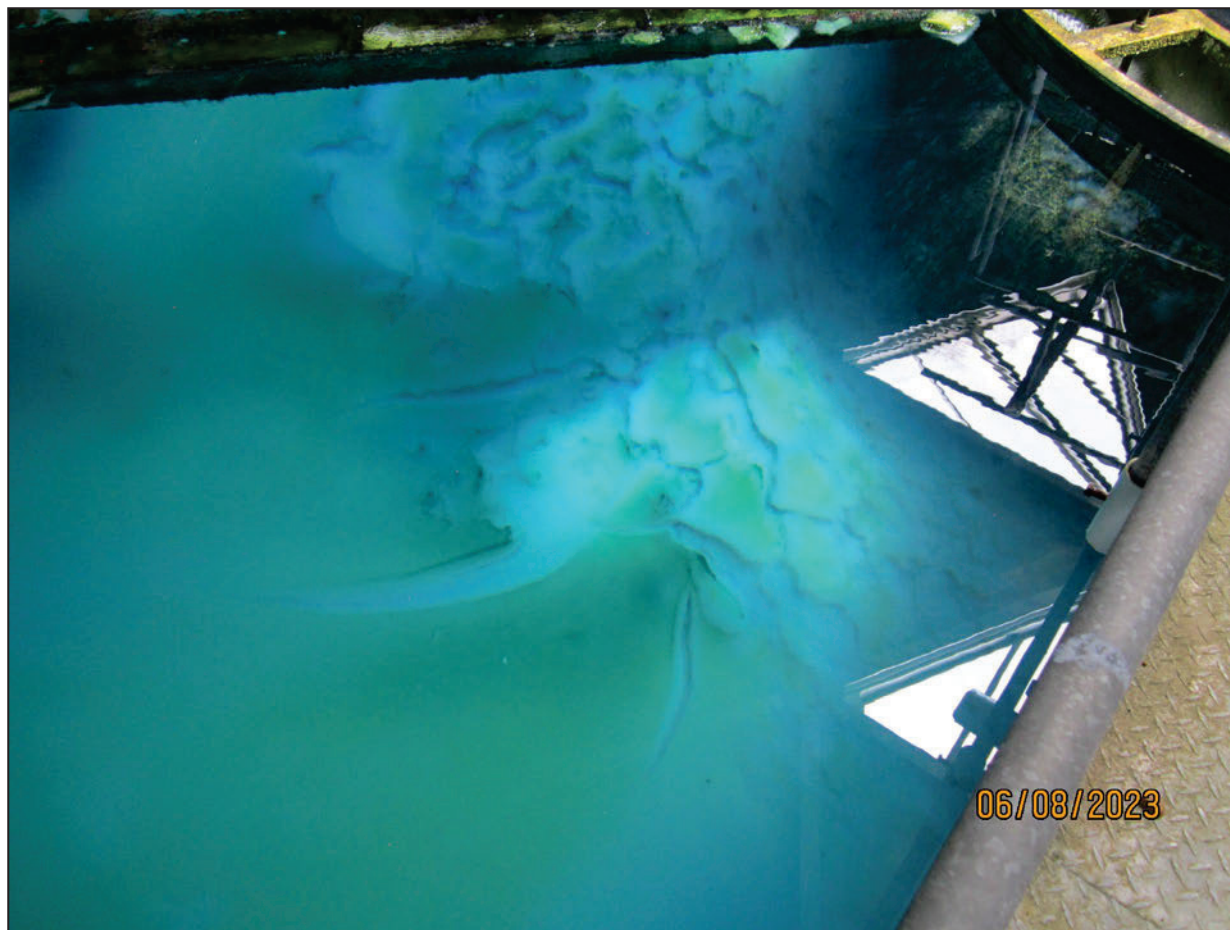
Photo No. 8

**Observation 12.** There were heavy solids built up on the bottom of the clarifier and channeling within the solids. The clarifier's rake arm was not operational and could not be located on the bottom of the clarifier. It was unclear if the rake arm was buried in the solids or if any of the solids were being drained to the sedimentation ponds (refer to [Appendix 2, Photograph 15](#)).

**Photograph 8. Water Treatment Plant, Clarifier** View of the bottom of the clarifier. There were heavy solids built up on the bottom of the unit and channeling within the solids. The clarifier's rake arm was not operational and couldn't be located on the bottom of the clarifier. It was unclear if the rake arm is buried in the solids or if any of the solids were being drained to the sedimentation ponds.

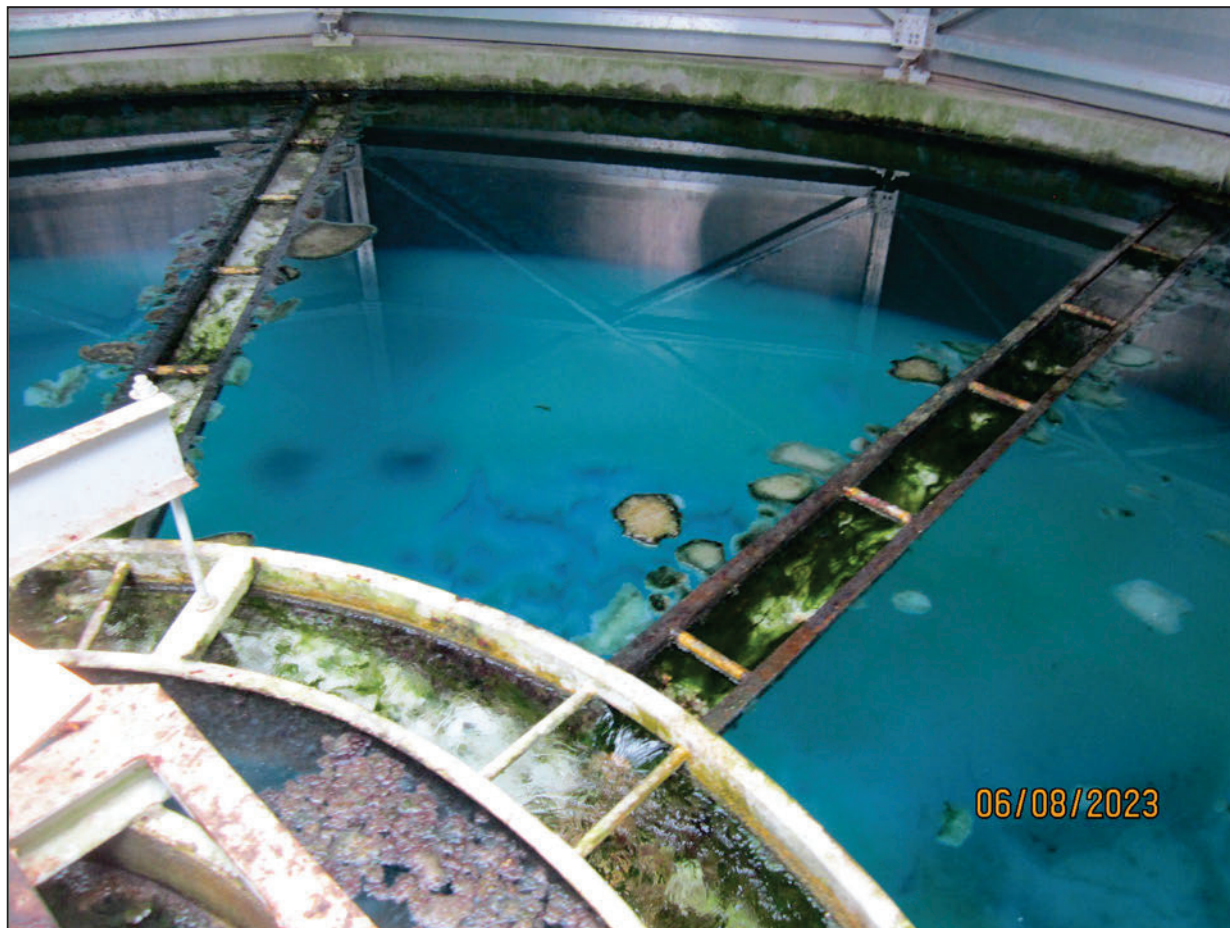
Photo No. 9

**Observation 13.** There were heavy solids, bio-growth, and debris throughout the clarifier, including the troughs delivering produced water to the filters (refer to [Appendix 2, Photographs 9, 10, and 11](#)). Additionally, there were maintenance materials and debris, including a grease gun on the clarifier operations deck (refer to [Appendix 2, Photograph 12](#)).

**Photograph 9. Water Treatment Plant, Clarifier** View of the top of the clarifier. There are heavy solids, bio-growth, and debris throughout the unit, including the troughs delivering produced water to the filters.

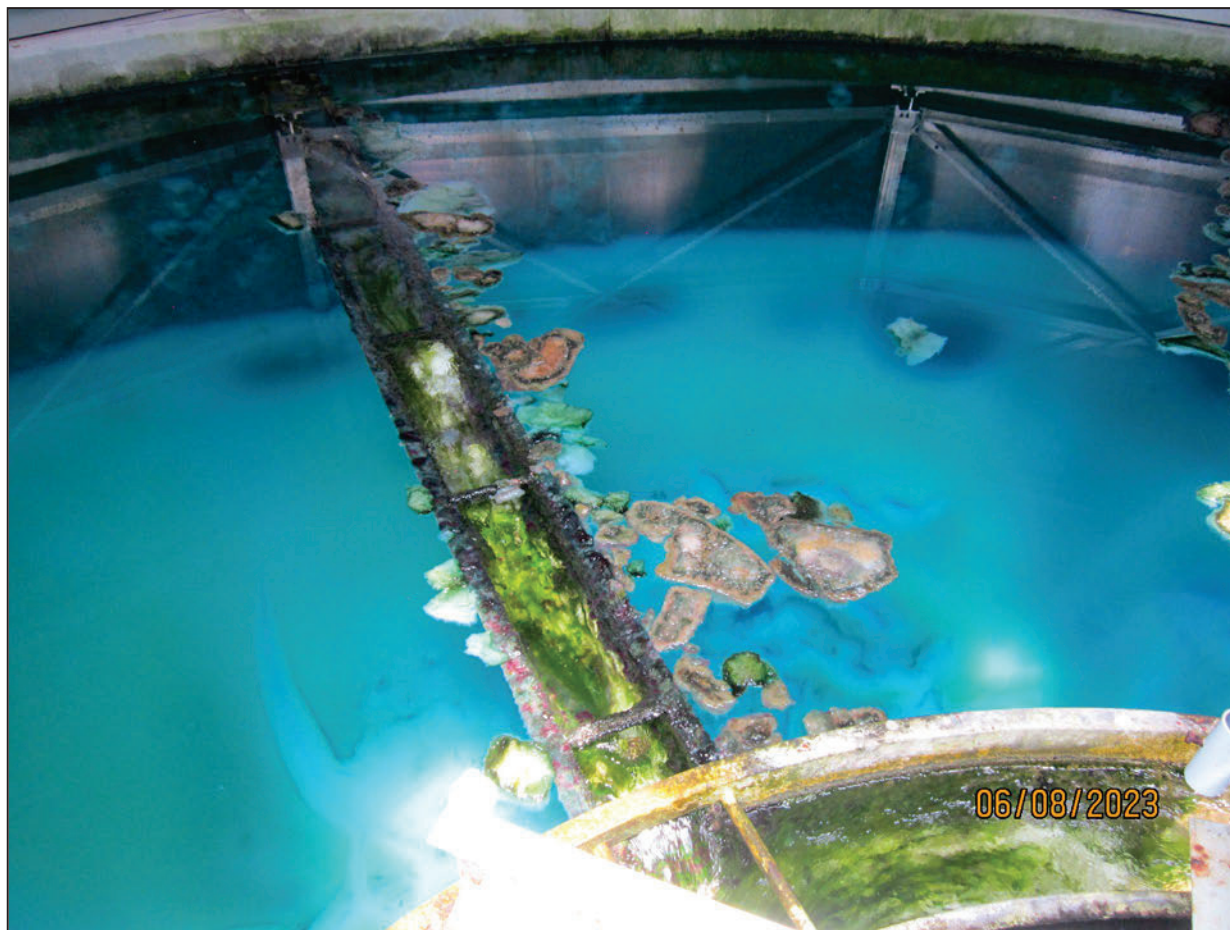
Photo No. 10

**Photograph 10. Water Treatment Plant, Clarifier** Alternate view of the top of the clarifier. There were heavy solids, bio-growth, and debris throughout the unit.

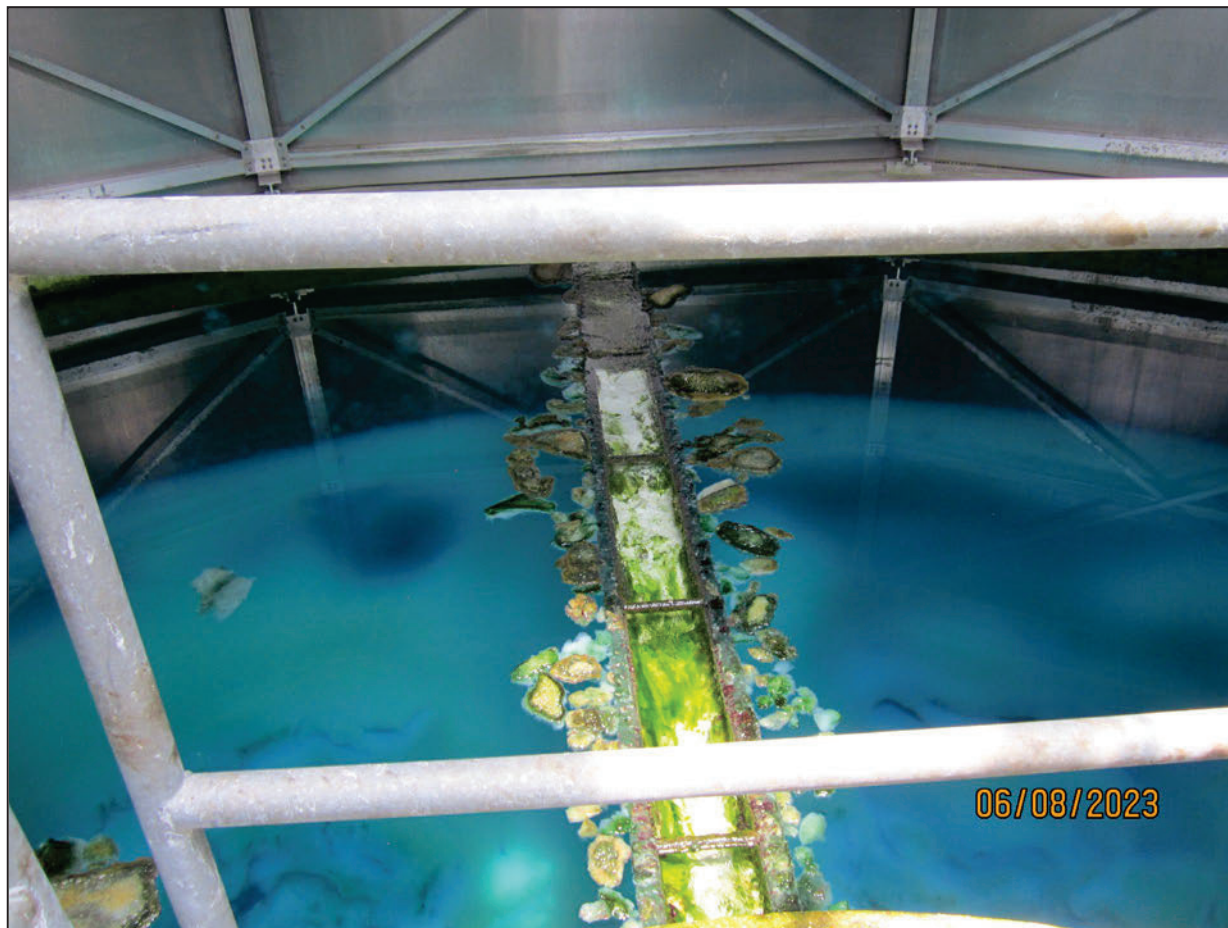
Photo No. 11

**Photograph 11. Water Treatment Plant, Clarifier** Alternate view of the top of the clarifier. There were heavy solids, bio-growth, and debris throughout the unit.

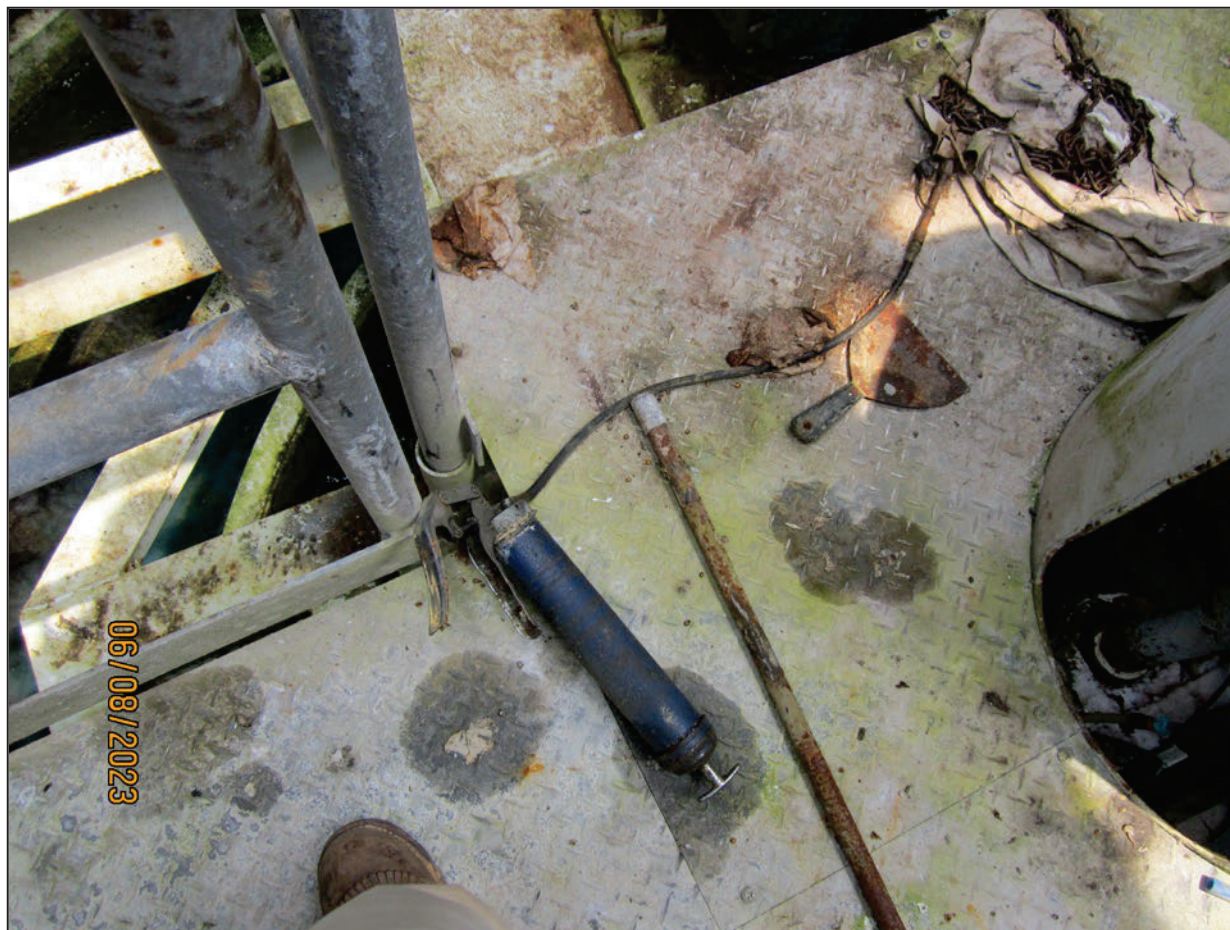
Photo No. 12

**Photograph 12. Water Treatment Plant, Clarifier** View of the center of clarifier operational deck. There were maintenance materials and debris, including a grease gun on the deck.

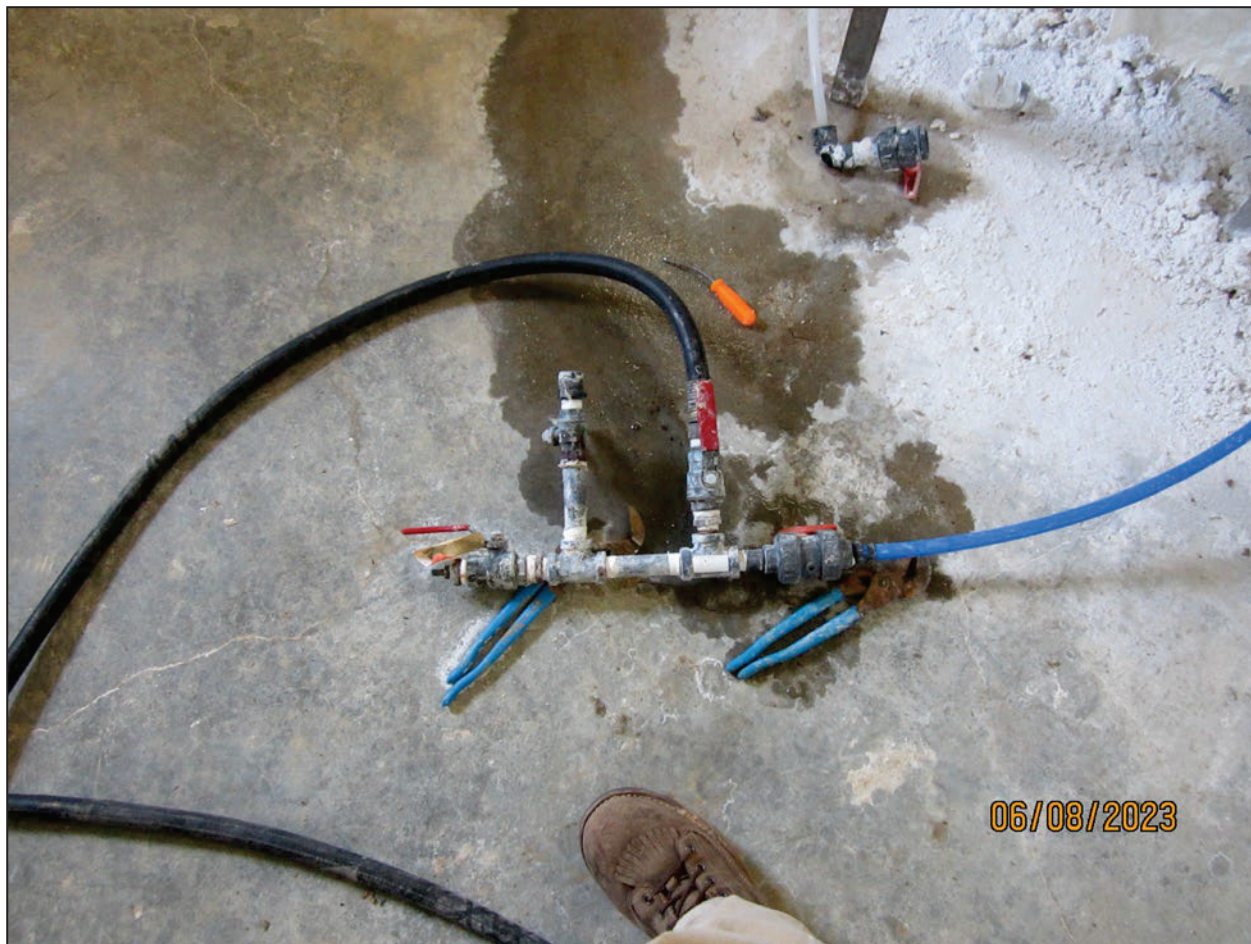
Photo No. 13

**Observation 14.** There was ongoing maintenance being conducted on the tubing supporting the delivery of treatment chemicals to the process areas. It appeared as if the operators were using PEX piping in their current modifications to the chemical delivery system. The delivery system was resting on the floor of the chemical storeroom. There was dried chemical residue in various areas of the room. In addition, a replacement chemical pump was positioned with bungee cords at one of the coagulant pump stations. Various tubing and piping systems in the chemical area were disconnected. Dried chemical debris was observed on the floor, pump pedestals, tubing connections and electrical outlets. (refer to [Appendix 2, Photographs 13, 14, and 15](#)).

**Photograph 13. Water Treatment Plant, Chemical Storage and Pump Area** View of current maintenance being conducted on tubing supporting the delivery of treatment chemicals to the process areas. It appeared that the team was using PEX piping in their current modifications to the chemical delivery system. The delivery system was resting on the floor of the chemical storeroom. There was dried chemical residue in various areas of the room.

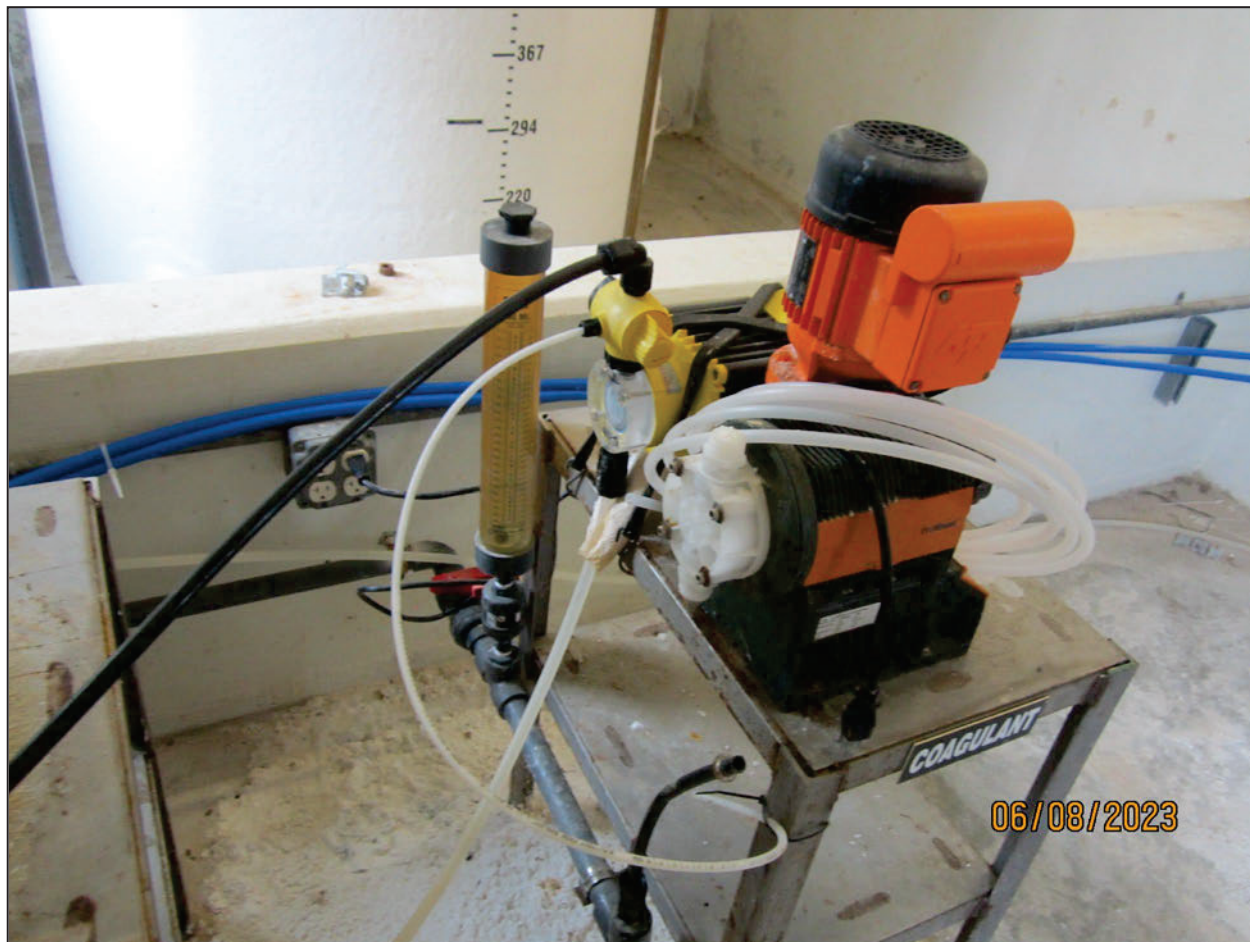
Photo No. 14

**Photograph 14. Water Treatment Plant, Chemical Storage and Pump Area** View of a replacement chemical pump positioned with bungee cords at one of the coagulant pump stations. Various tubing and piping systems in the chemical area were disconnected. What appeared to be a new PEX piping (blue) was cable-tied to the containment wall behind the pumping station.

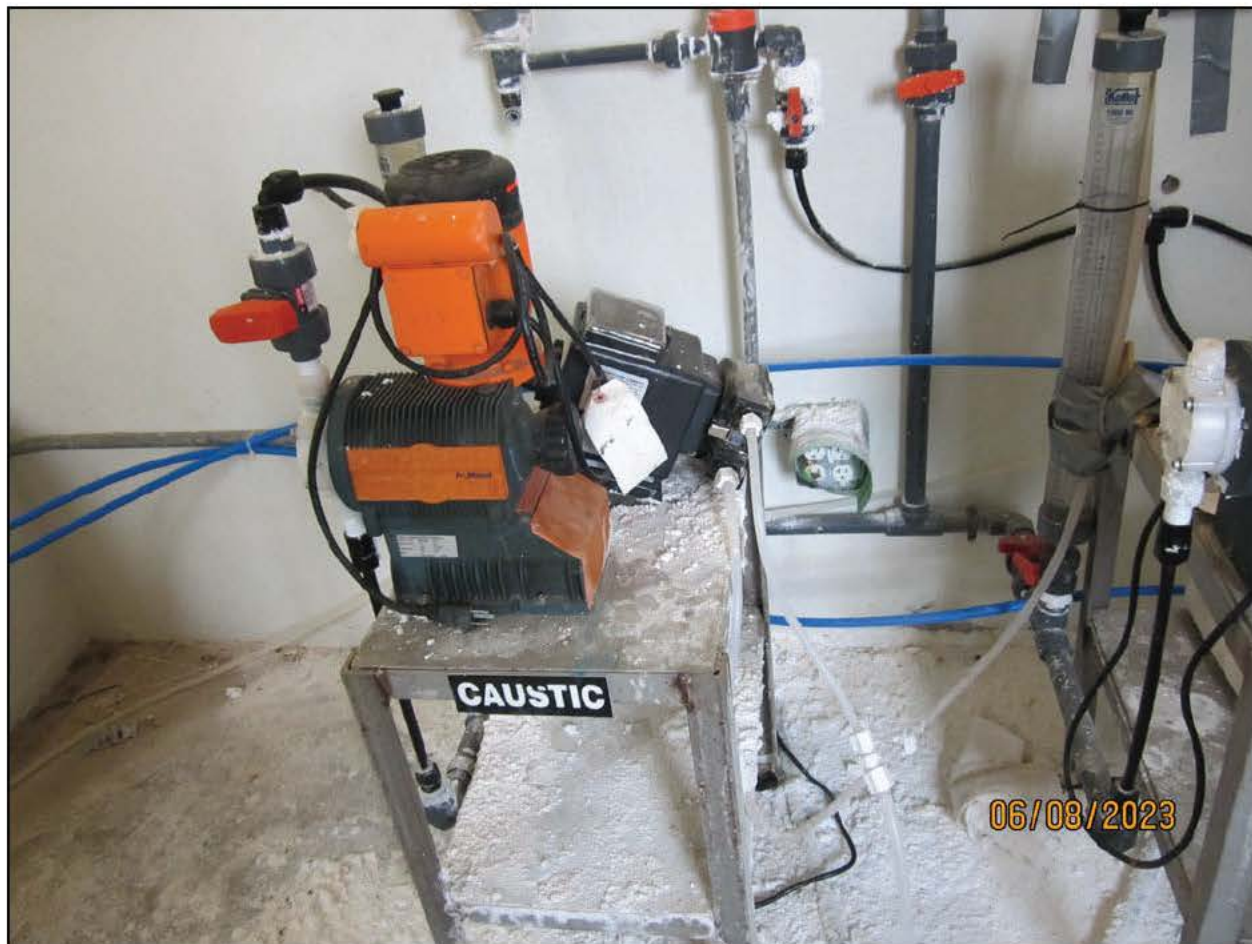
Photo No. 15

**Photograph 15. Water Treatment Plant, Chemical Storage and Pump Area** Alternate view of a replacement caustic chemical pump positioned behind failed pump at one of the stations. Dried chemical debris was observed on the floor, pump pedestals, tubing connections and electrical outlets. The caustic soda was a sodium hydroxide, 50% solution. What appeared to be new PEX piping (blue) was cable-tied to the wall behind the pumping station.

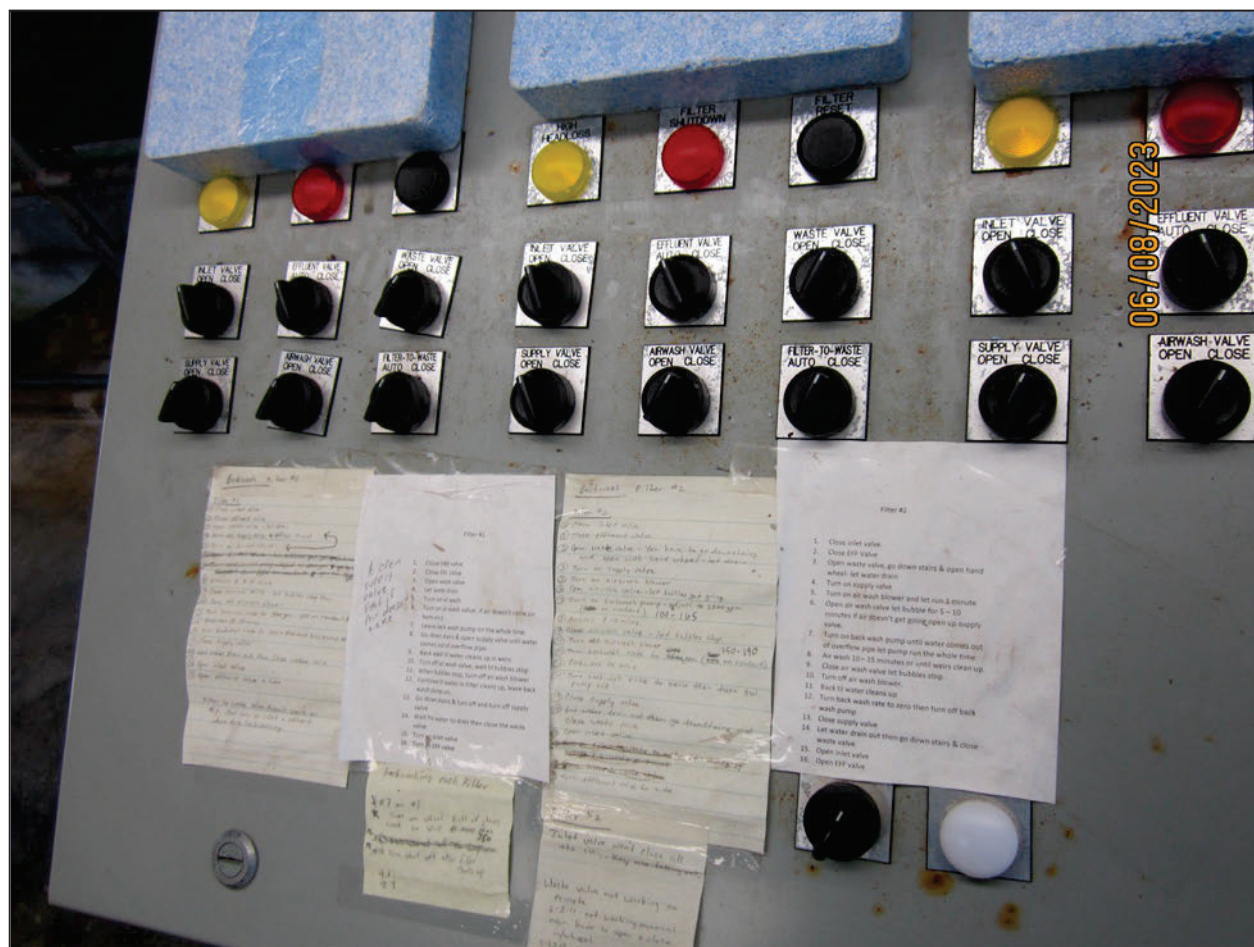
Photo No. 16

**Photograph 16. Water Treatment Plant, Filter Control Center** View of the control center for the filters. Blue Styrofoam boxes were described as protective covers for the control switches and were removed to show control switch settings. Operations steps were described in printed and hand-written notes taped to the control panel.

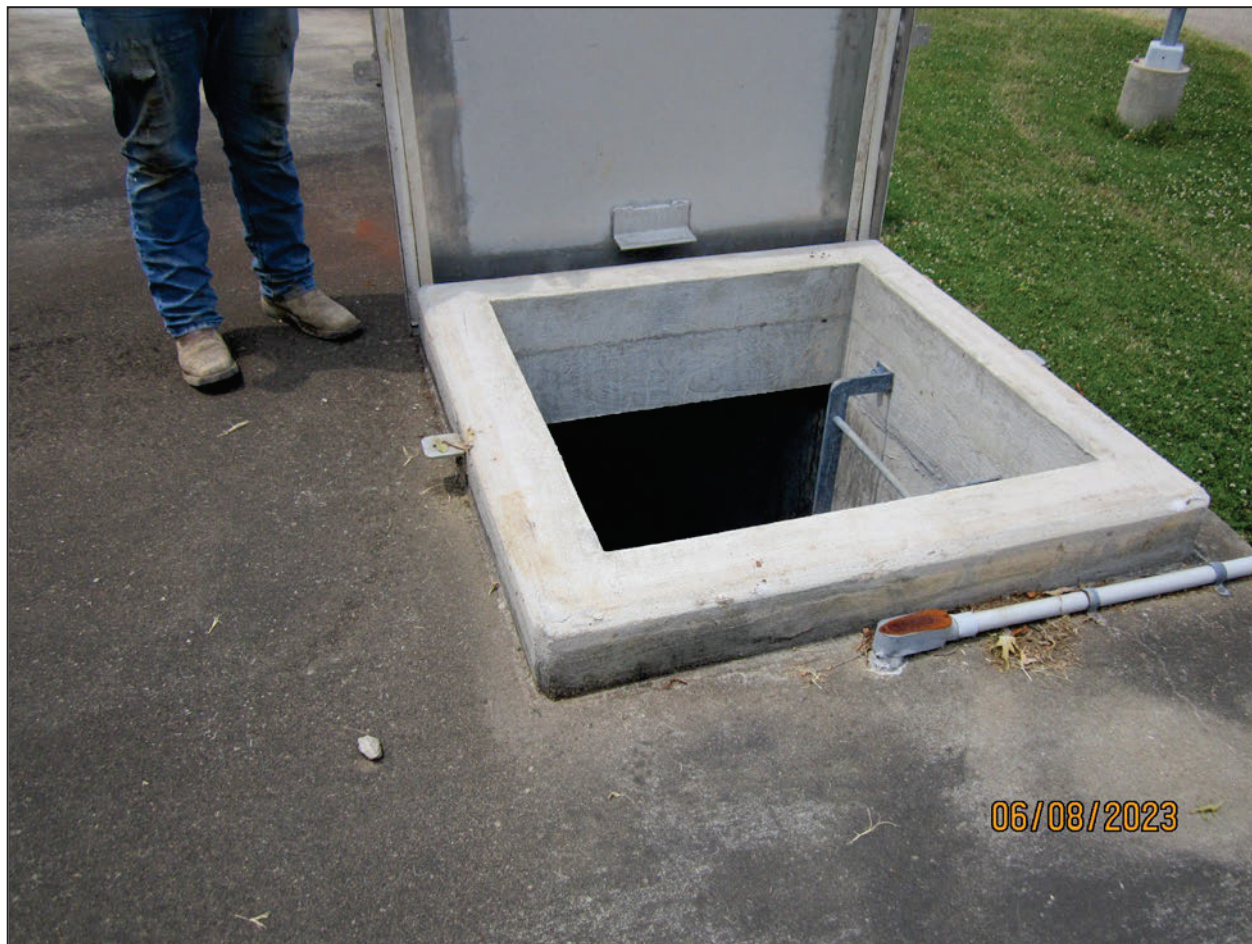
Photo No. 17

**Observation 15.** One of the hatchways to the clear well had some seal tape on the cover; however, it was unclear if the tape maintained a sanitary seal (refer to [Appendix 2, Photograph 17](#)).

**Photograph 17. Water Treatment Plant, Clear Well** View of one of the hatchways to the clearwell. The hatch had a shoebox top cover and some seal tape on the cover. However, it is unclear if the tape maintained a sanitary seal.

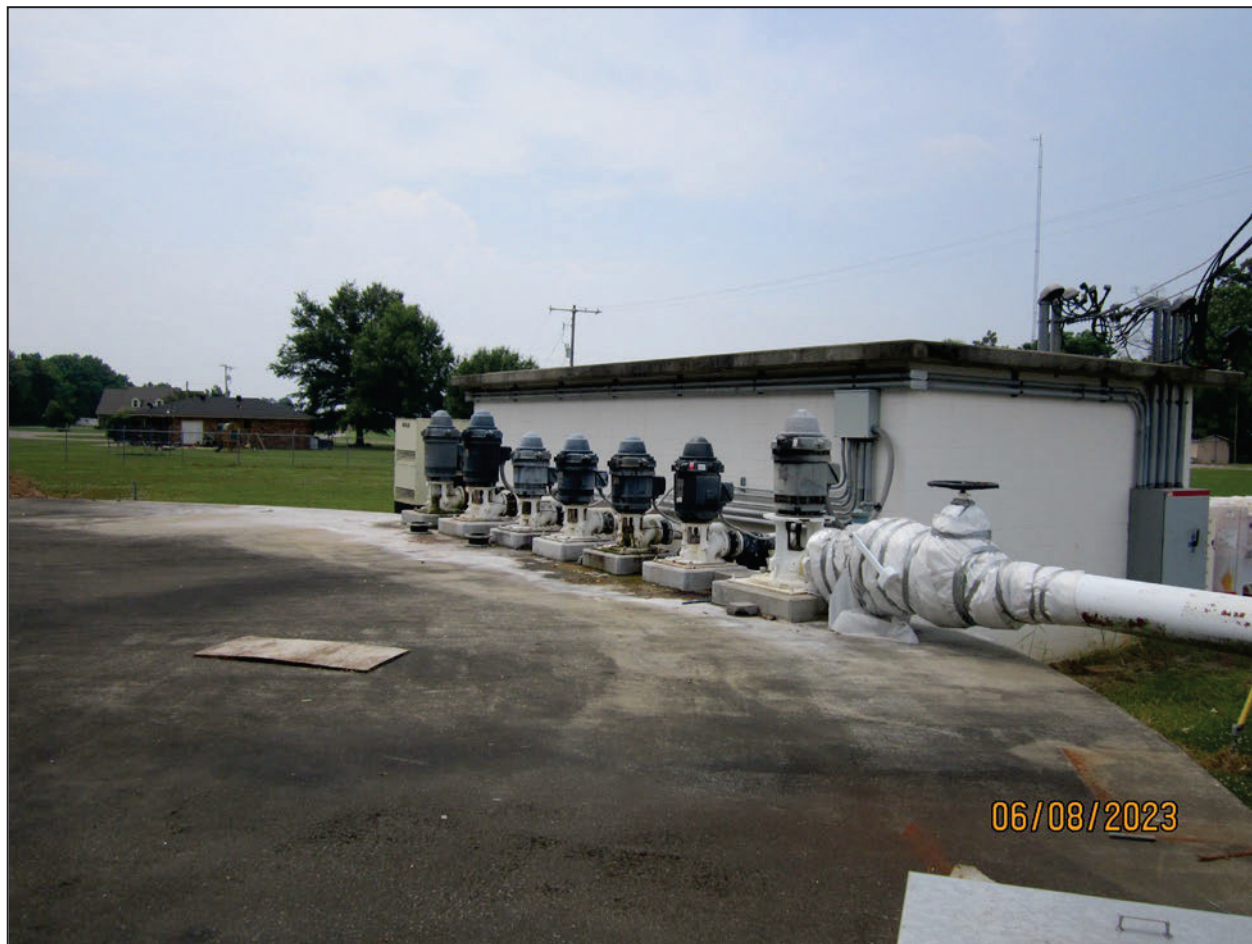
Photo No. 18

**Photograph 18. Water Treatment Plant, Clear Well** View of the top of the clearwell, finished water pumps, the area's backup generator, and the valve house supporting finished water supply to the distribution system. Only one of the pump discharges was still wrapped with insulation.

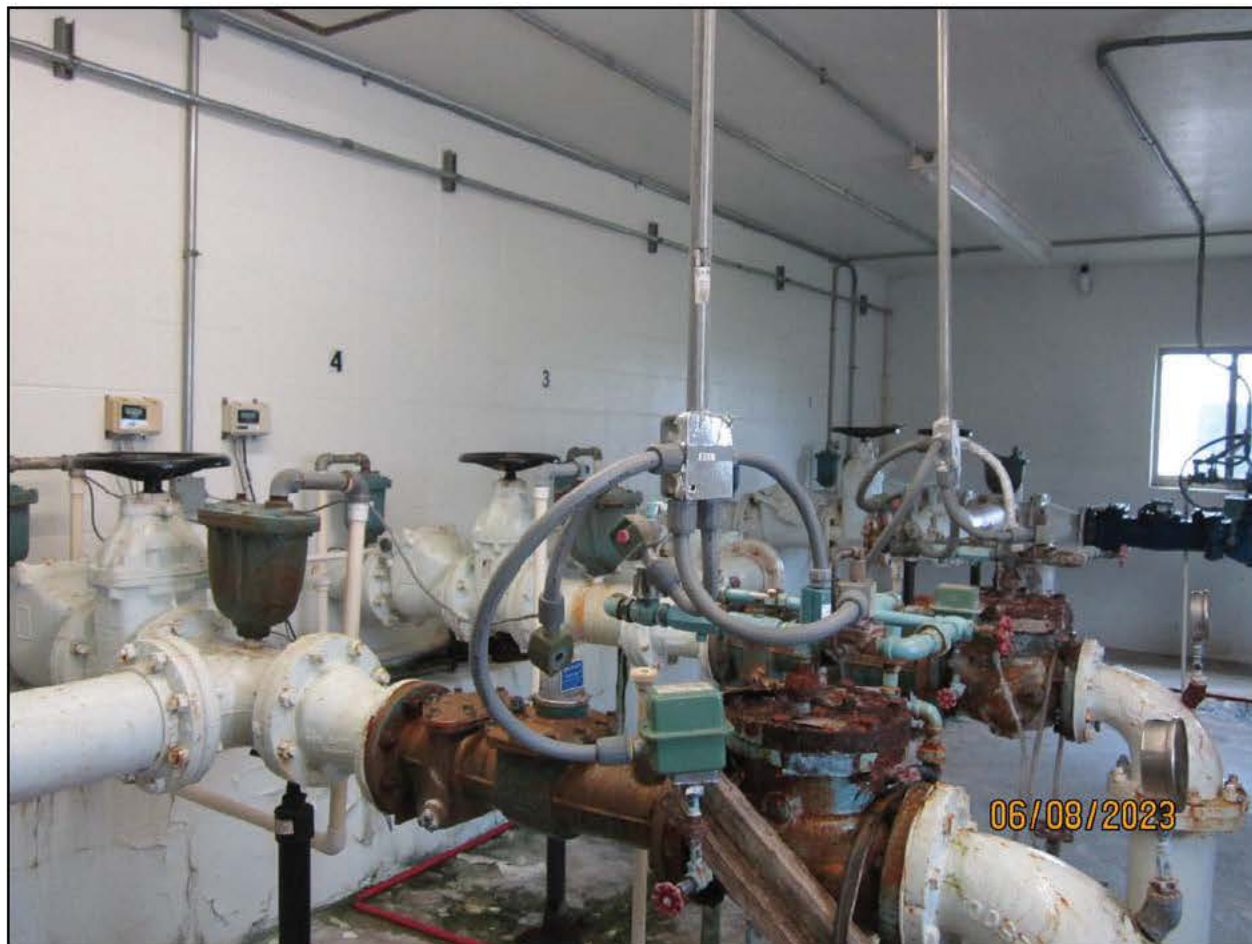
Photo No. 19

**Observation 16.** One of the high service pump lines appeared to be supported by a wooden brace and a few assets had components that had lost their coatings and were rusting (refer to [Appendix 2, Photograph 19](#)).

**Photograph 19. Water Treatment Plant, Clear Well Pump Valve House** View of the piping supporting the pumps delivery of finished water to the distribution system. One of the lines appeared to be supported by a wooden brace and a few assets had components that had lost their coatings and were rusting.
