**Region 6 - Enforcement & Compliance Assurance Division**  
**INSPECTION REPORT**

| Inspection Date(s): | 06/08/2023 | |
| Regulatory Program(s) | AWIA/SDWA | |
| Facility Name: | <b>Cross County Rural Water System</b> | |

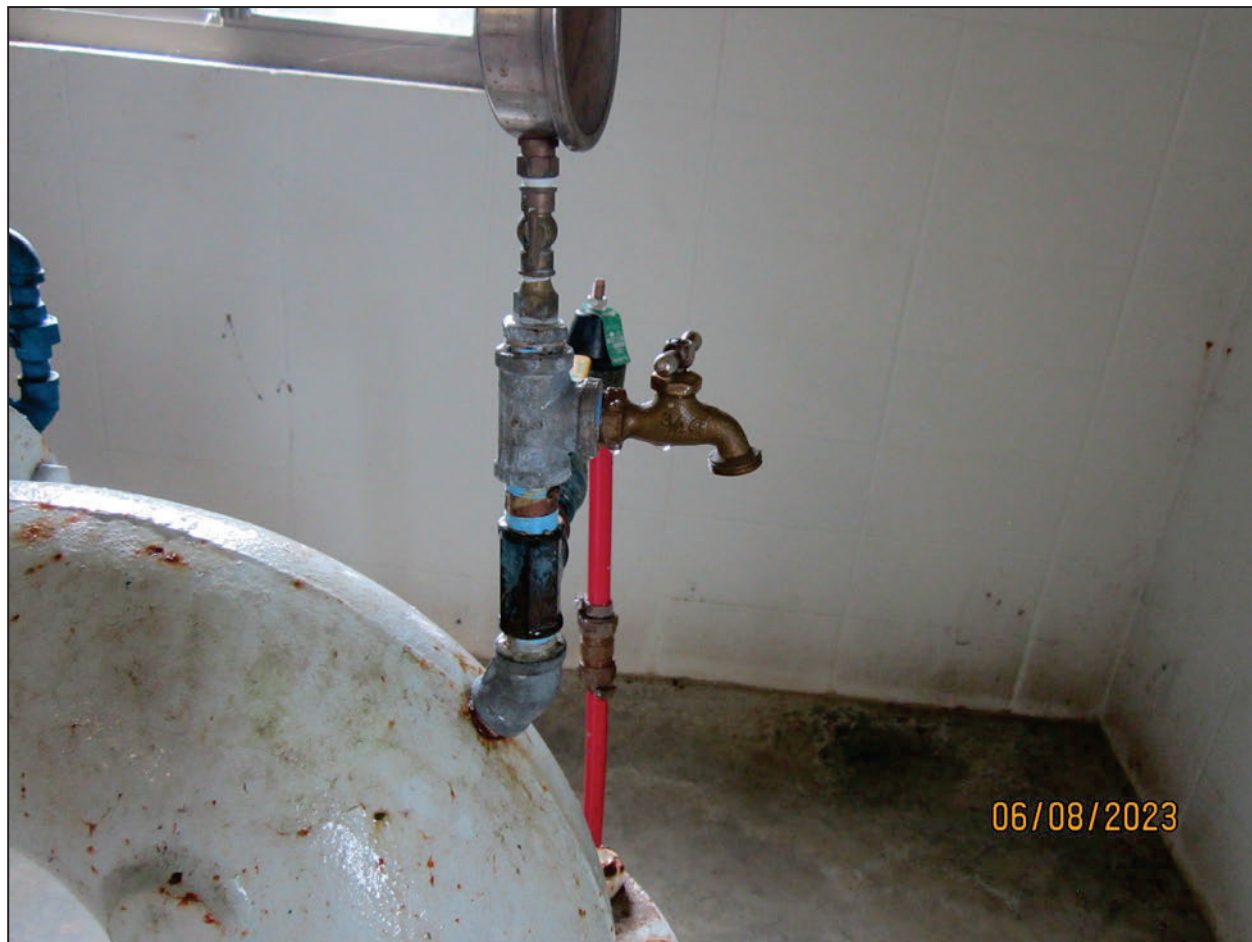
Photo No. 20

**Observation 17.** A finished water line contained a threaded hose tap without backflow protection (refer to [Appendix 2, Photograph 20](#)).

**Photograph 20. Water Treatment Plant, Clear Well Pump Valve House** View of a finished water line with a threaded hose tap without backflow protection.
