**Well Inspection**  
**Osage DNR / Environmental Protection Agency**  
**1201 Elm Street, Suite 500**  
**Dallas, Texas 75270**

| <b>Operator Info</b> | Contango Resources, LLC<br>1717 South Boulder, Suite 900<br>Tulsa, OK 74119<br>Phone: 918-392-3396 | <b>Inventory ID</b> | OS2881000 | | |
| | | <b>Well ID</b> | 20W5 | | |
| <b>Inspection Reason</b> | MIT | <b>Responsible Company at Time of Inspection</b> | Contango Resources, LLC | | |

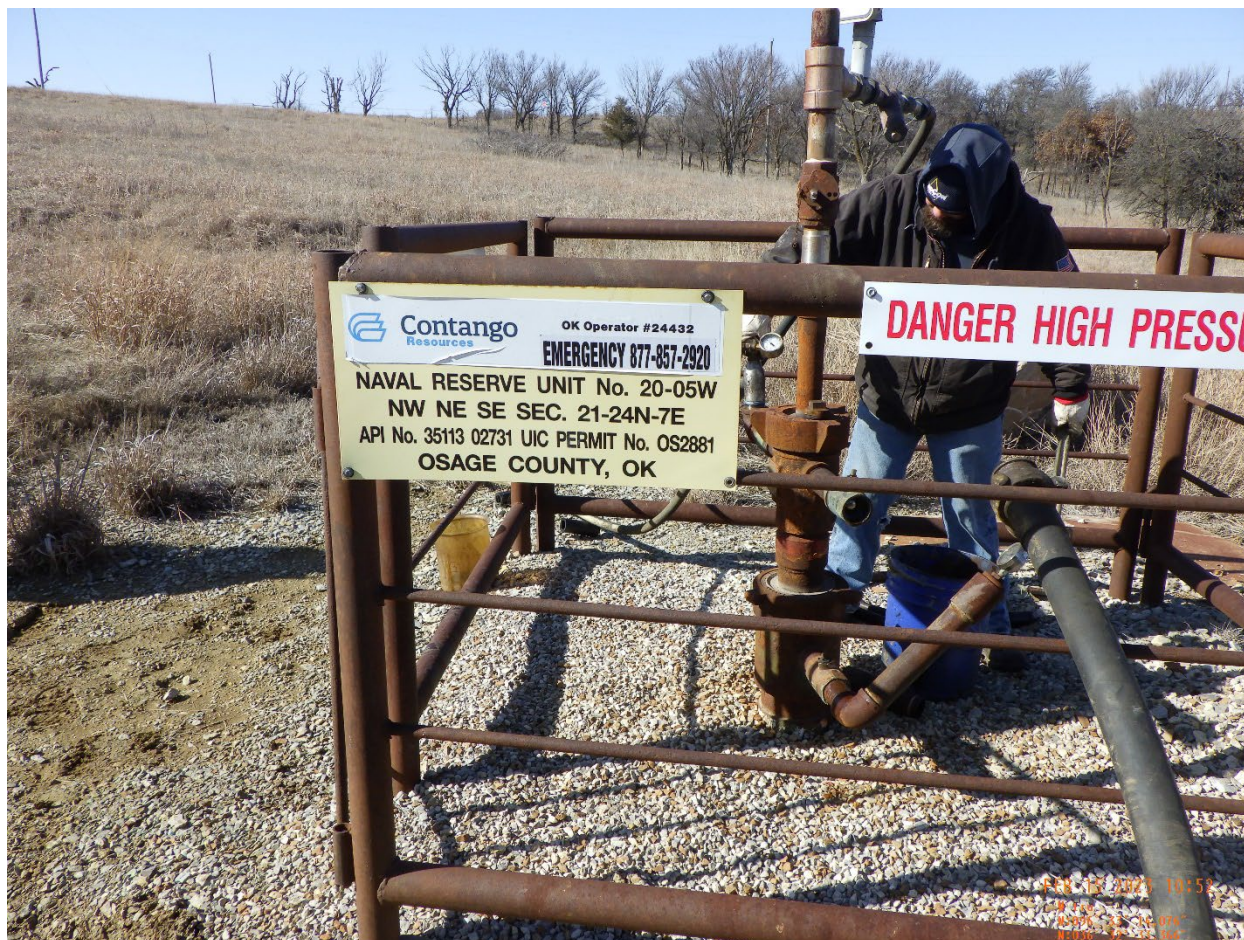
Photo No. 1

**Description:** This was well OS2881000 at the time of the inspection.
