# **NPDES Compliance Inspection Report**

**Paradise WWTP**

**Paradise, WA**

**Inspection Date: August 30, 2022**

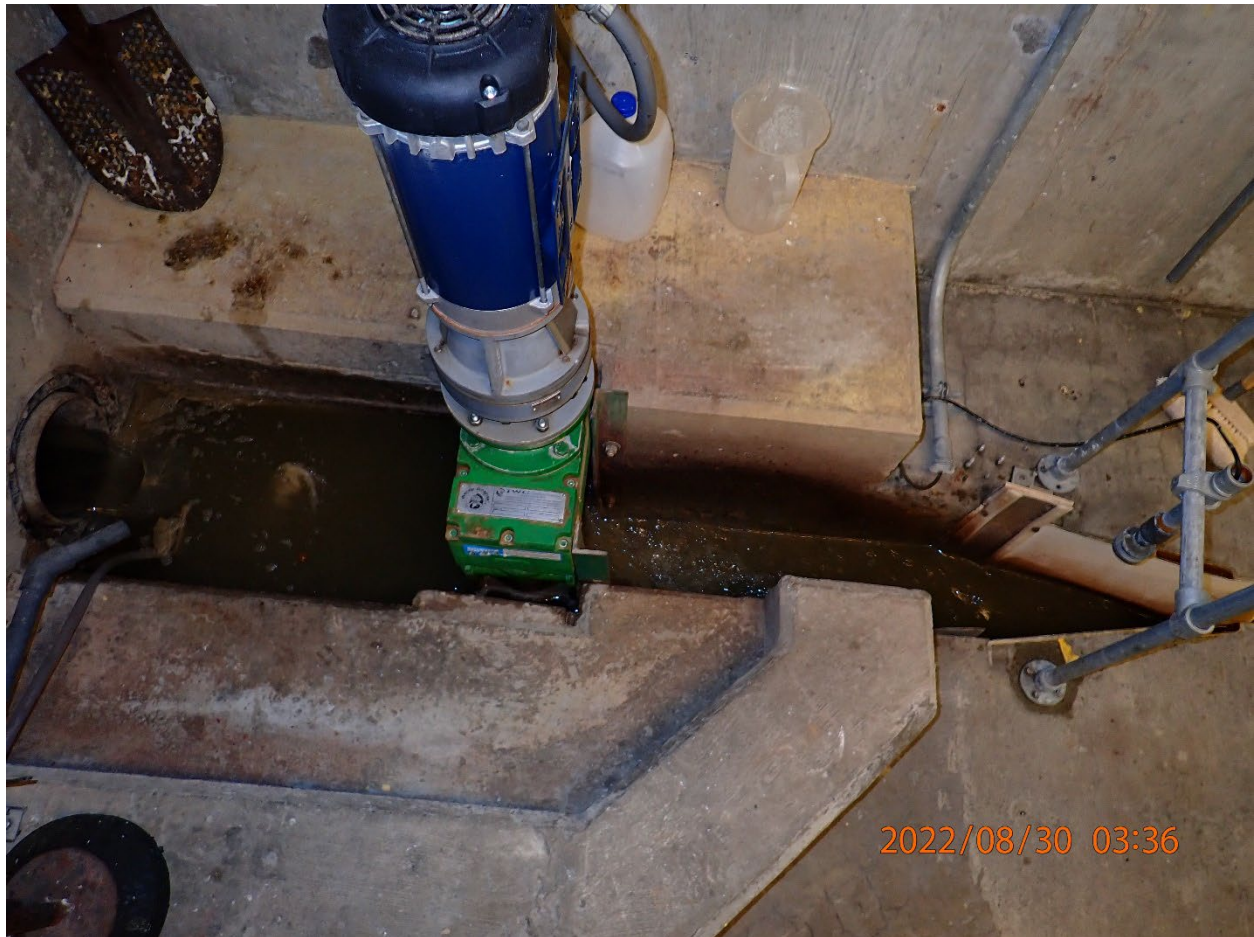
We first started out at the headworks and I inspected the flow meter and flume (**Photo 1**). The facility's influent sampling point is right before the grinder at the headworks. Their effluent and influent samples are collected at approximately the same time. I proceeded to inspect the composite sampler (**Photo 2**), the grinder, and the equalization tank (EQ), and aeration basin. From the aeration basin (**Photo 3**), the effluent flows into the secondary clarifiers and then the surge tank.

*Photo 1 - Flow meter and flume*

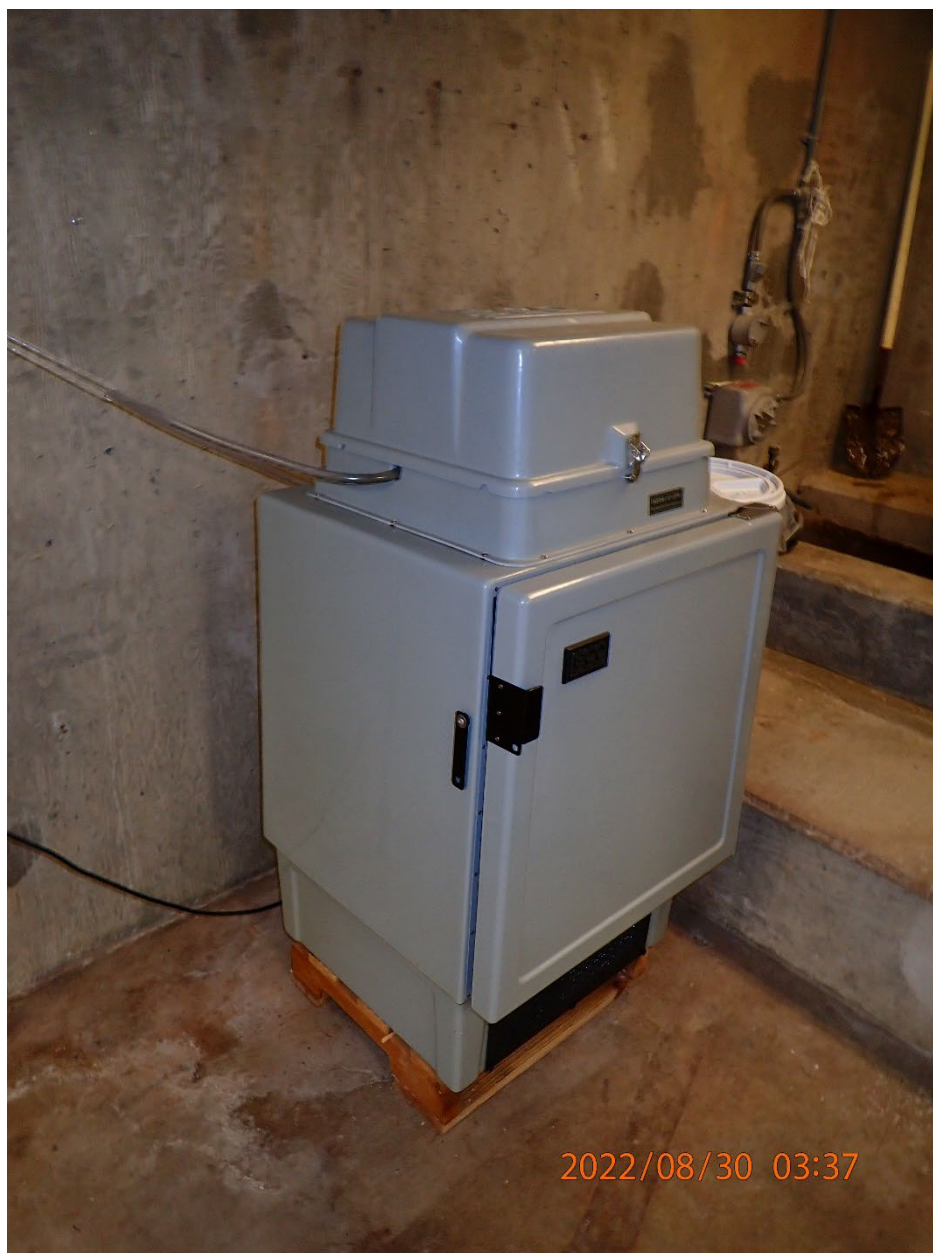
*Photo 2 - Composite sampler*

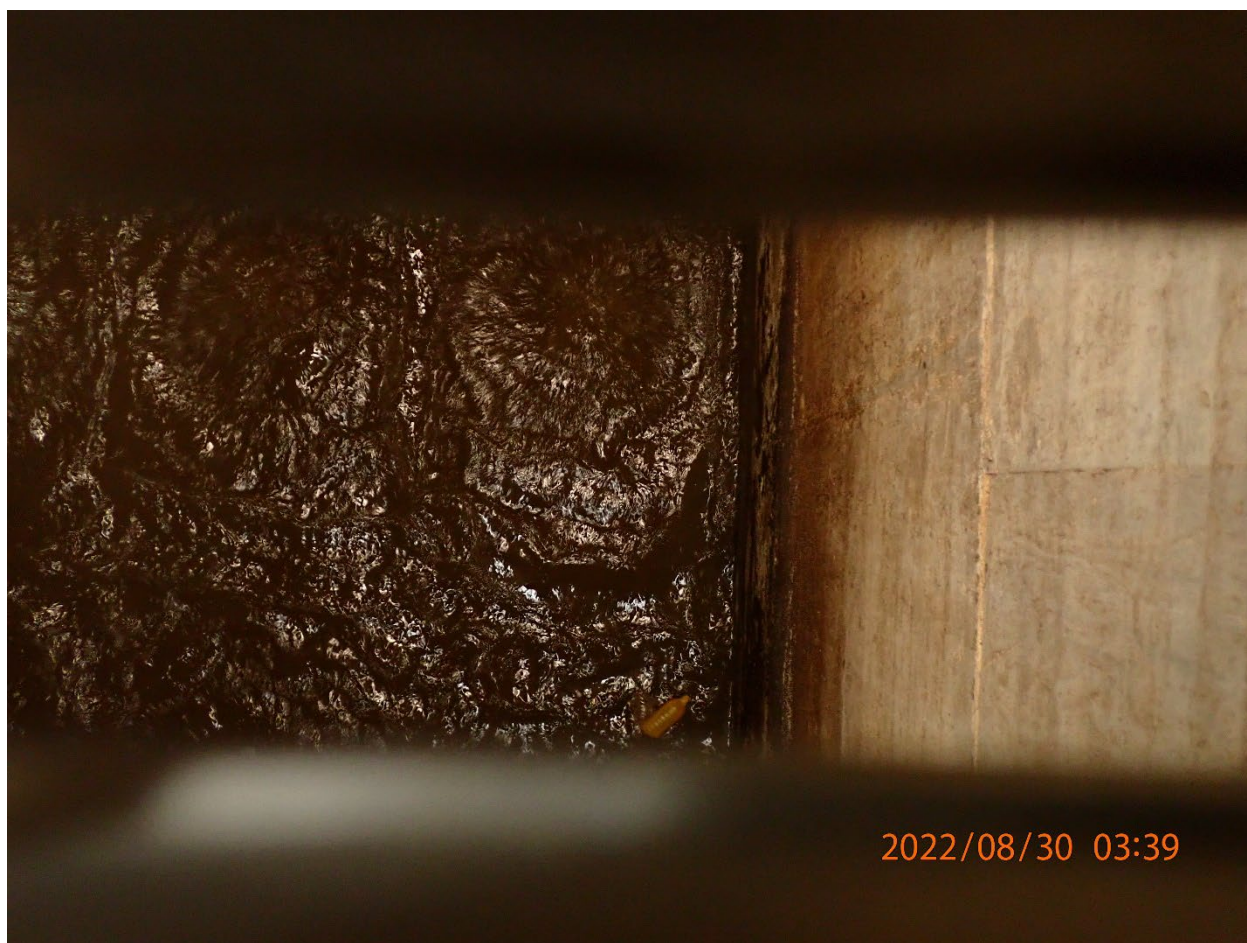
*Photo 3 - Aeration basin*

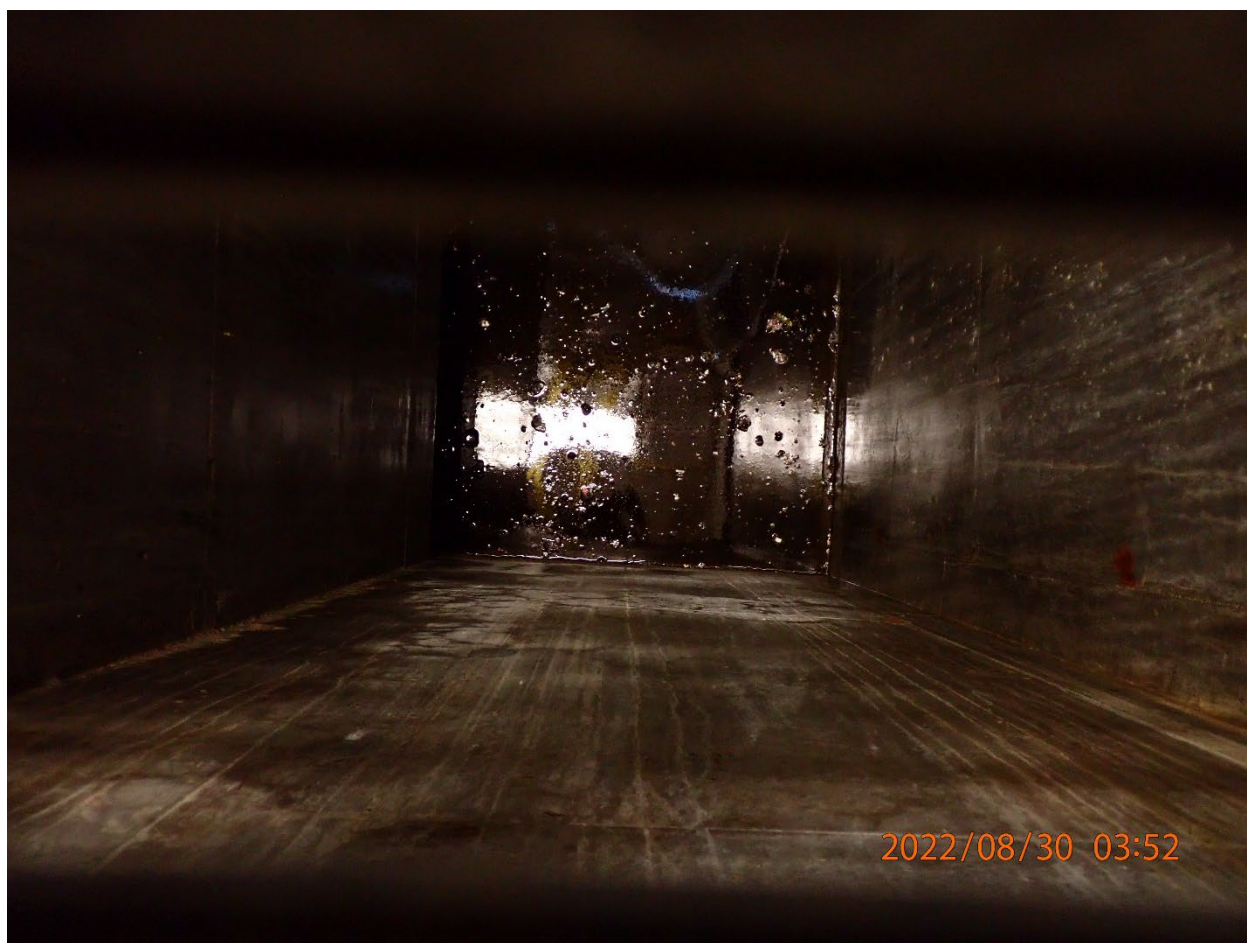
Once the effluent is controlled and buffered, it flows to the flocculation tank, the settling tank, and then the filtration tank. The flow then makes it way to the backwash storage tank, through the chlorine contact pipes (**Photo 4**), the dechlorination tank, and then it leaves the WWTP and the treated wastewater outfalls onto a steep mountain side. The effluent samples are collected after the dechlorination tank before it leaves the building.

*Photo 4 - Chlorine contact chamber*
