Compliance Evaluation Inspection Report
Federal Reserve Bank of New York
100 Orchard Street, East Rutherford, NJ
07/23/2024

COMPLIANCE EVALUATION INSPECTION

Facility Name: Federal Reserve Bank of New York
Facility Address: 100 Orchard Street, East Rutherford, NJ 07073
Latitude & Longitude: 40.82888548908127, -74.09549109746908

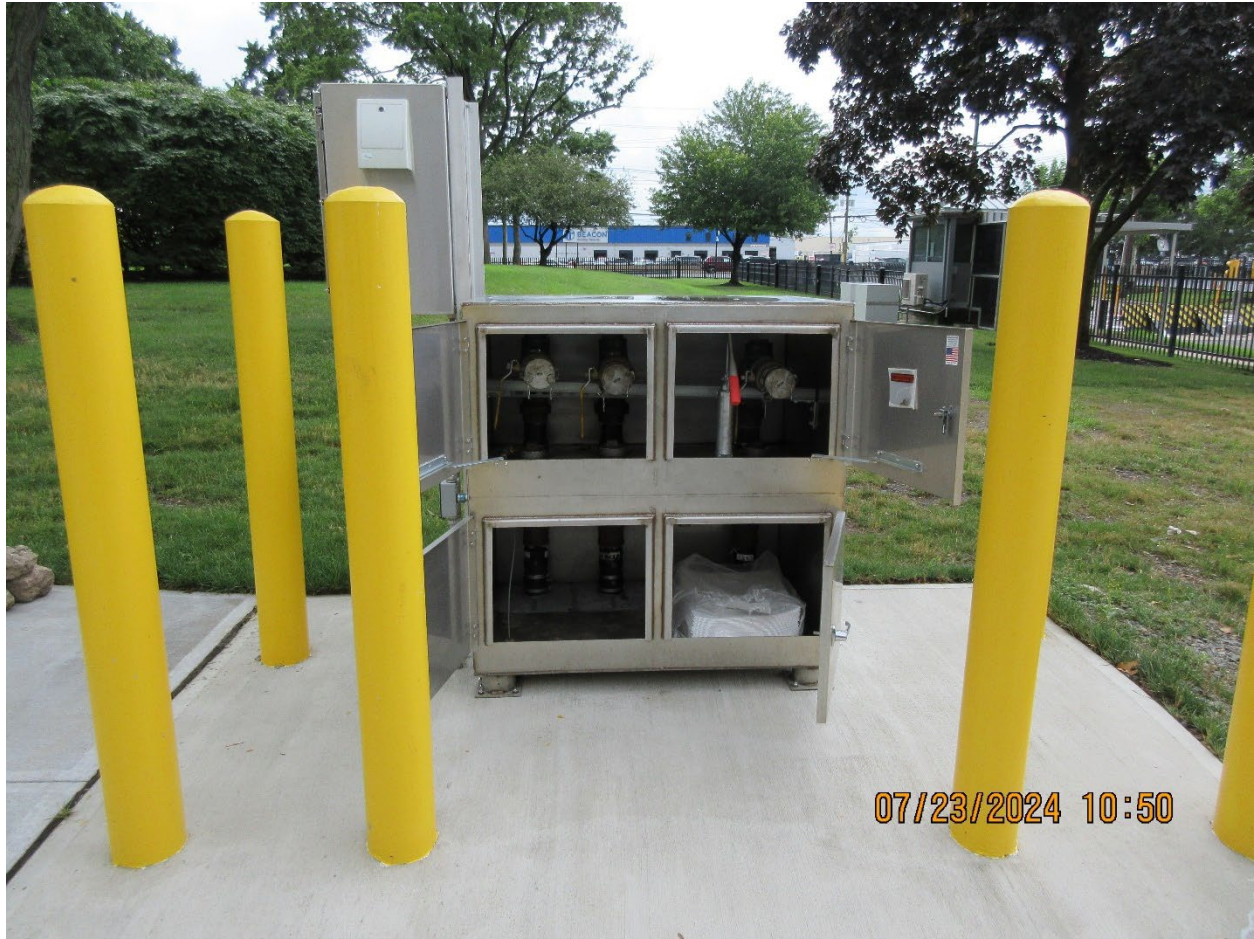
Photo #1

Ron and I were first led to the remote fill ports, which are located outside the facility in the southeast corner of the property facing Orchard Street (Photo #1). Mr. Anton informed us these were installed in the aftermath of Superstorm Sandy due to the flooding in the area inhibiting emergency generator refilling capabilities. The remote fill ports are located within a metal

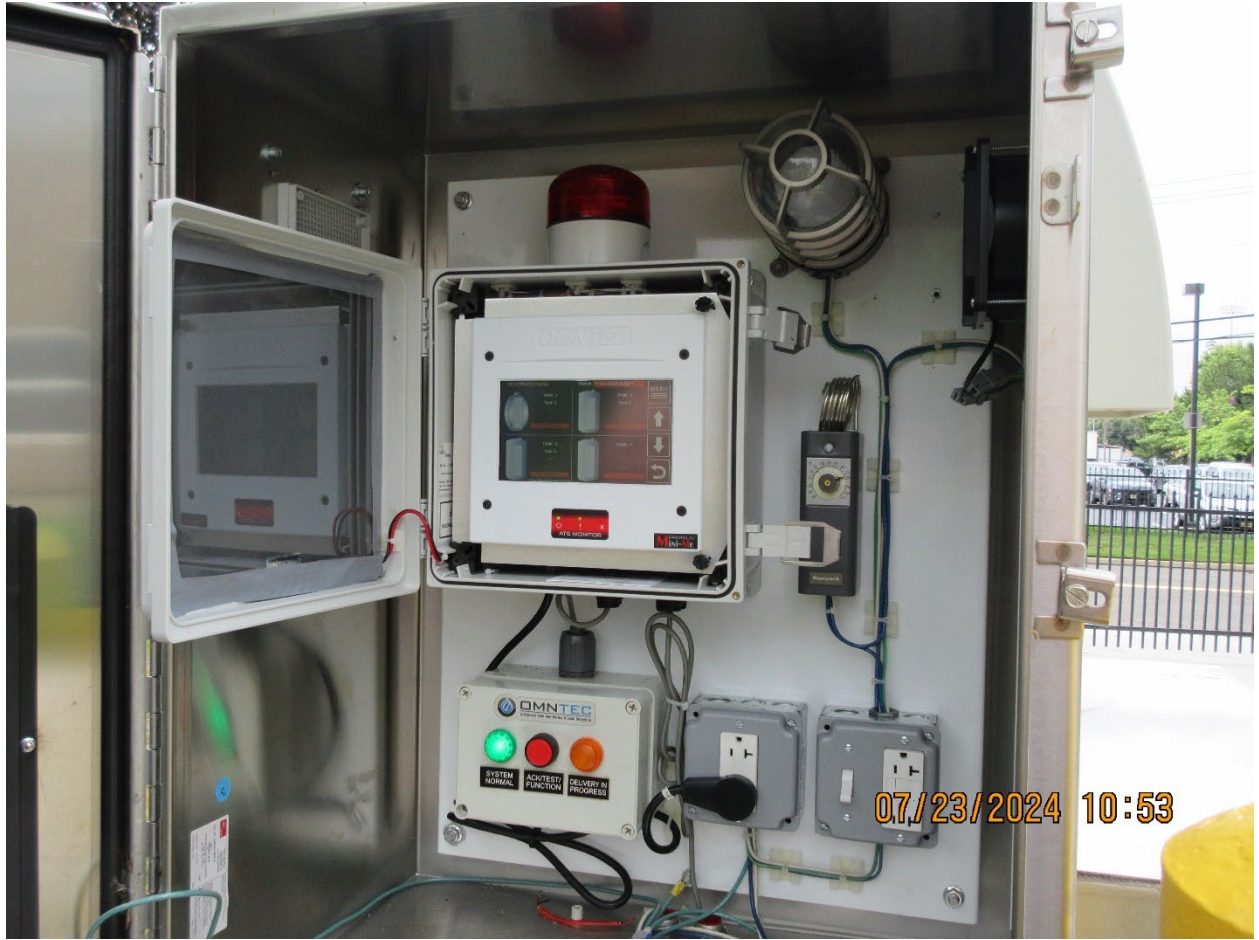
Photo #2

security box for security purposes. To the right of the fill ports is a secure metal box containing a terminal to check the fuel level statuses of the USTs (Photos #2 and 3). Directly across from the remote fuel ports, located on the wall of the facility, was a high-level alarm for the remote fuel ports (Photo #4). The high-level alarm was tested and was clearly audible from the fueling locations.

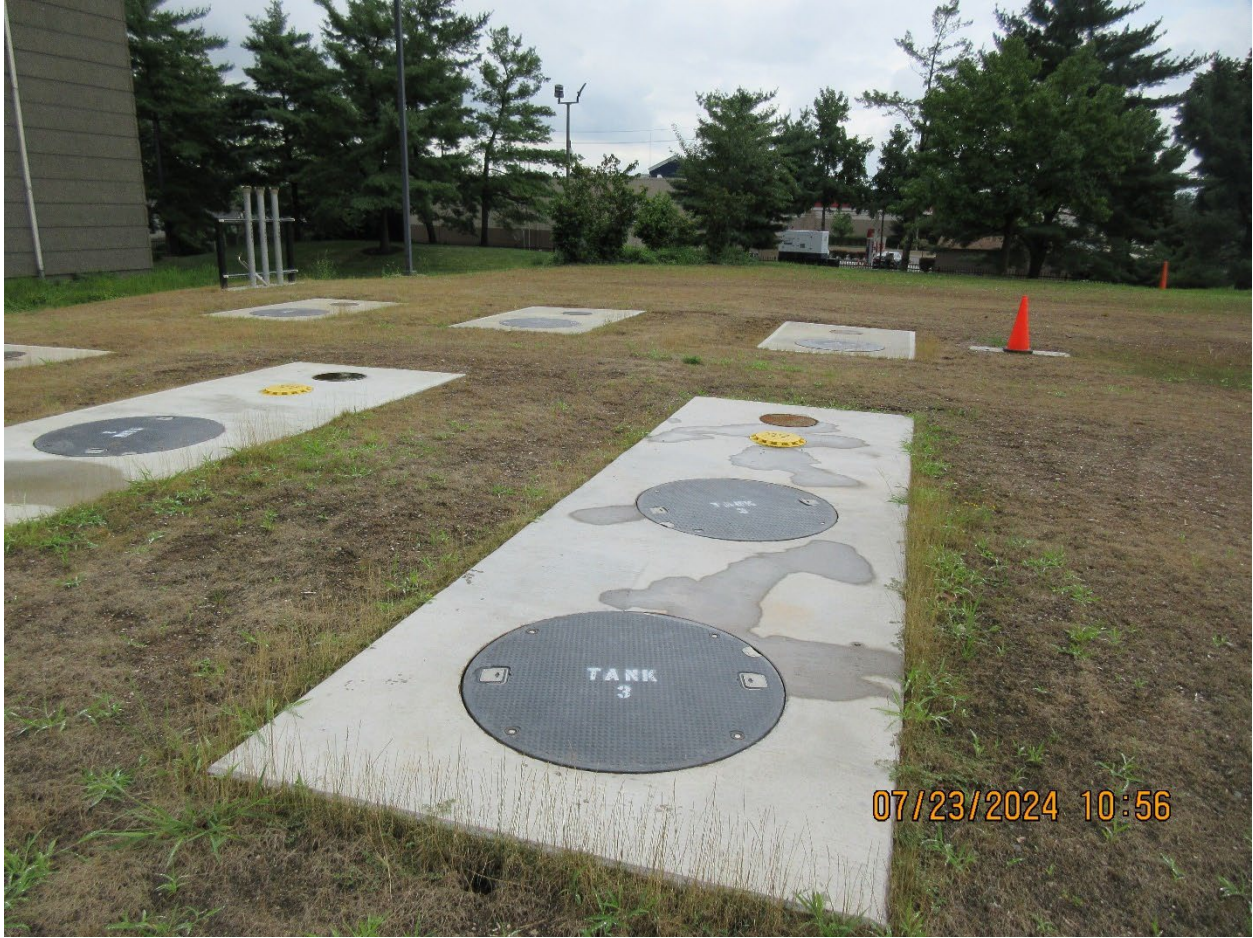
Photo #5

We then looked at the UST sumps for the three tanks, located around 250 feet northeast from the remote fill ports (Photo #5). The tanks, installed in phases starting around October 2022, are all fiberglass reinforced plastic (FRP), double-walled, and have electronic interstitial monitoring. Each tank has a max capacity of 25,000 gallons of medium No.3 diesel fuel. Each tank had a piping sump, a turbine sump, a manway sump, a sensor sump, and a fill port.

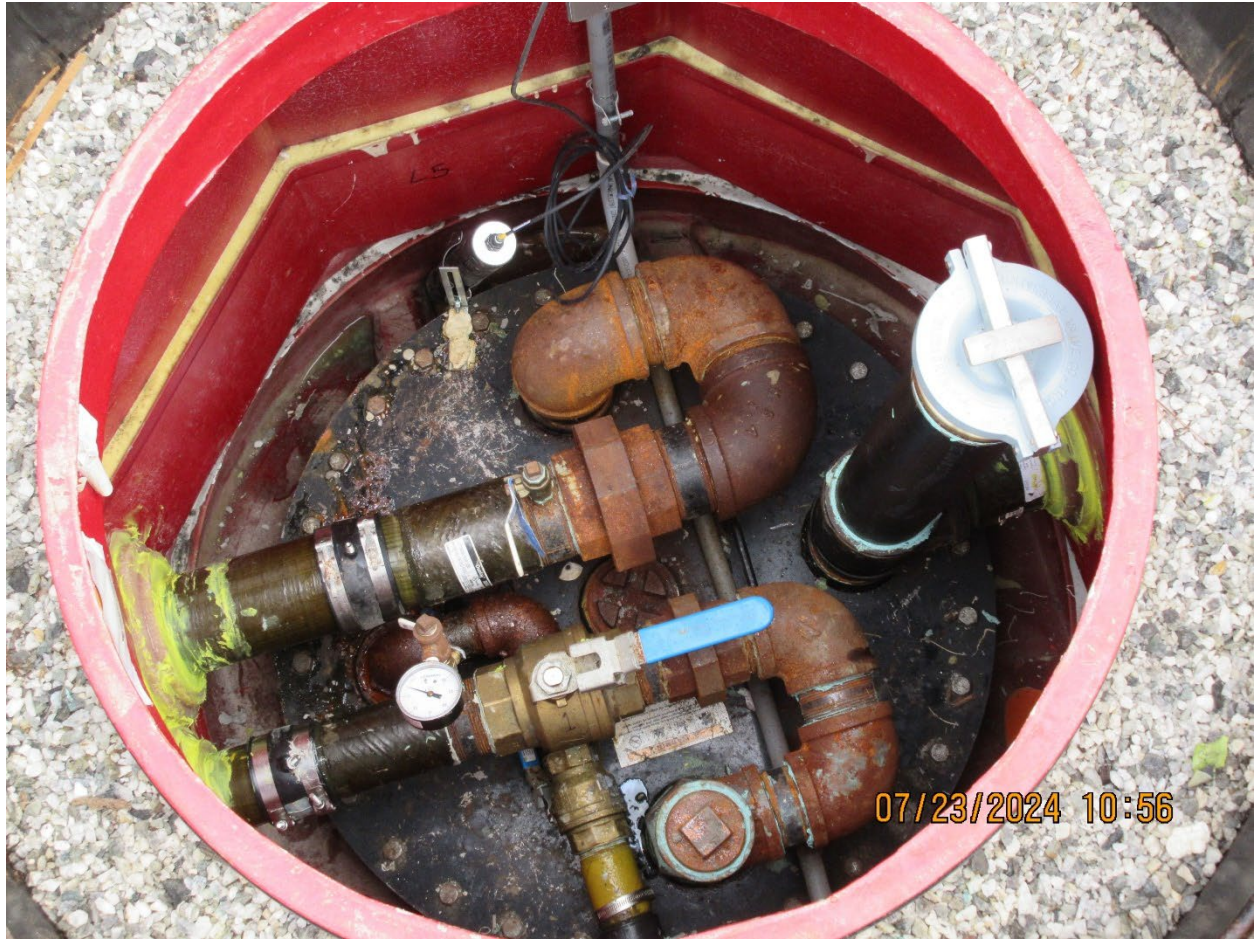
Photo #6

Tank 1, located furthest to the North, had a piping sump clear of any debris or water even after the day's heavy rainfall (Photo #6). The liquid sensor for the sump was located within a reasonable distance from the bottom to be able to detect leaks early (Photo #7). The pipes in these piping sumps are used for the tanks' connections to one another, as they were observed to be manifolded. The "Manway" sump, located directly next to it, was also dry and free from debris with its liquid sensor in an adequate position (Photo #8). The secondary fill port for tank 1 was next, and a flapper valve could be visually seen through the port with no significant debris or liquid present in the spill bucket (Photos #9 and 10). Next to this was a sensor sump with no observed concerns (Photo #11). Upon opening the turbine sump (Photo #12) there was a pungent smell of diesel vapors that was not present in the prior sumps, or the sumps looked at after. Mr. Anton explained these turbine sumps contained a diesel fuel filtration system. Besides the diesel vapor smell, the sump was observed in adequate condition, with no debris or water inside and the water sensor being properly positioned.

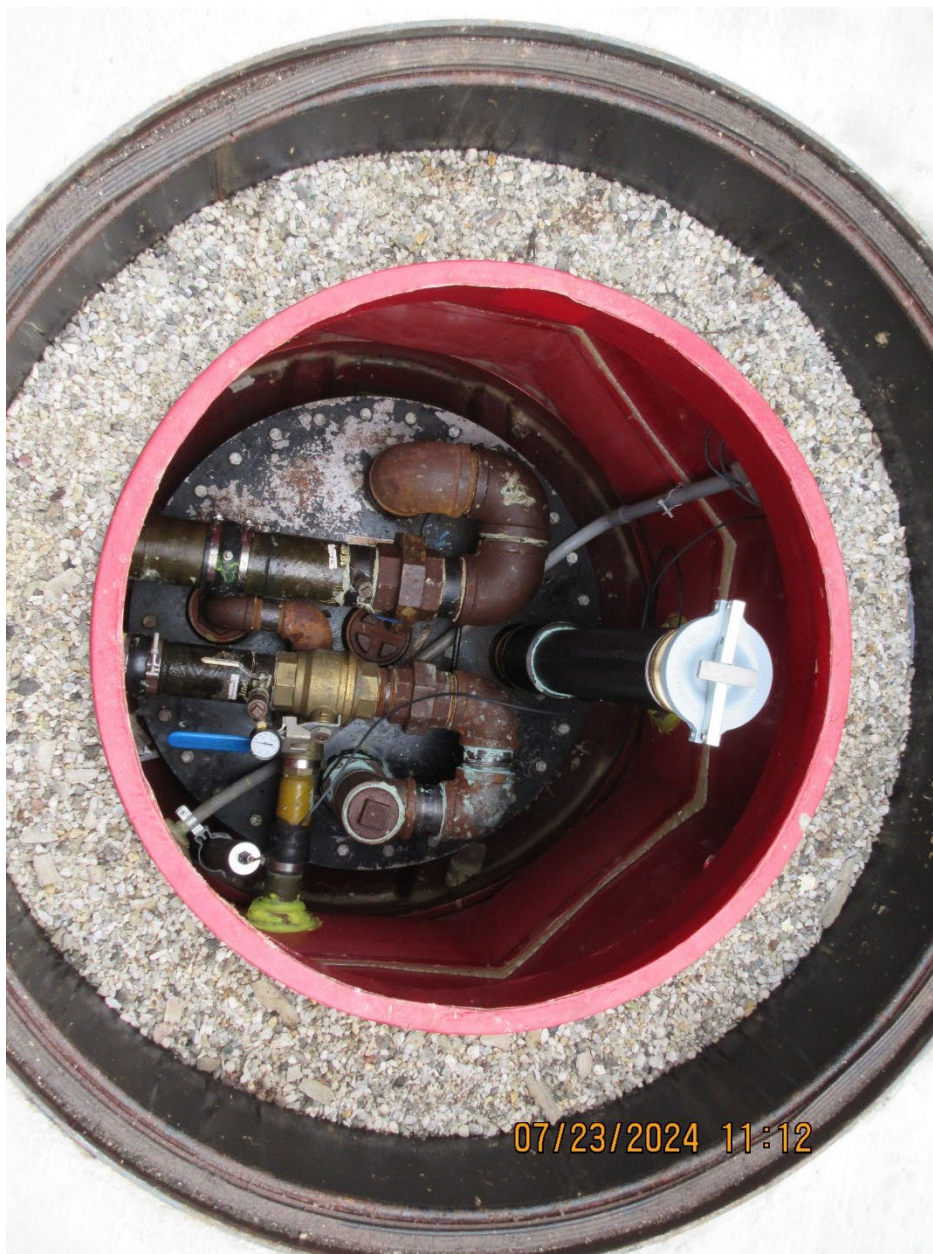
Photo #13

Tank 2, located around four feet to the right of tank 1, was observed to be in adequate order. The tank 2 piping sump was clear of any debris or water, and its liquid sensor was properly positioned (Photo #13 and 14). The "Manway" sump was also dry, free from debris, and had its liquid sensor in its proper position (Photo #15). The secondary fill port had the presence of some liquid in the spill bucket (Photo #16), but there was a rainfall event earlier in the day. The sensor sump next to the fill port had no observed concerns (Photo #17). The turbine sump for tank 2 was observed to be in adequate condition and lacked the strong smell of diesel tank 1's turbine sump had upon opening (Photo #18).

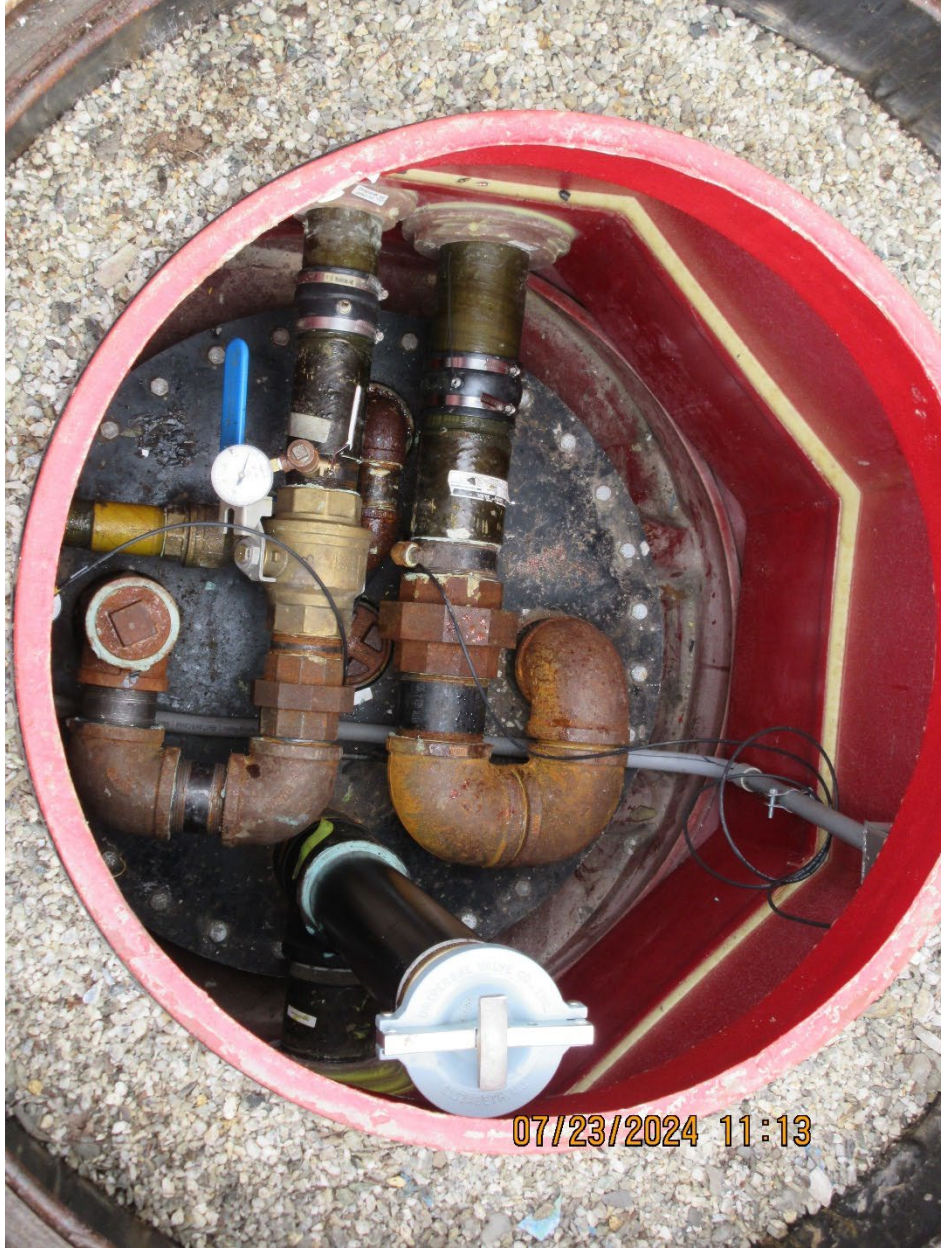
Photo #19

Tank 3 was located another three feet to the right of tank 2 and was not observed to have any concerns. Tank 3's piping sump was water and debris free while its liquid sensor was in the proper orientation and positioning (Photo #19 and 20). The manway sump was dry and free of debris as well, with its liquid sensor in an adequate position (Photo #21). Like tank 2, the secondary fill port for tank 3 had the presence of some liquid in its spill bucket. However, unlike tank 2, this liquid was observed to have a visible oily film on the surface (Photos #22 and 23).

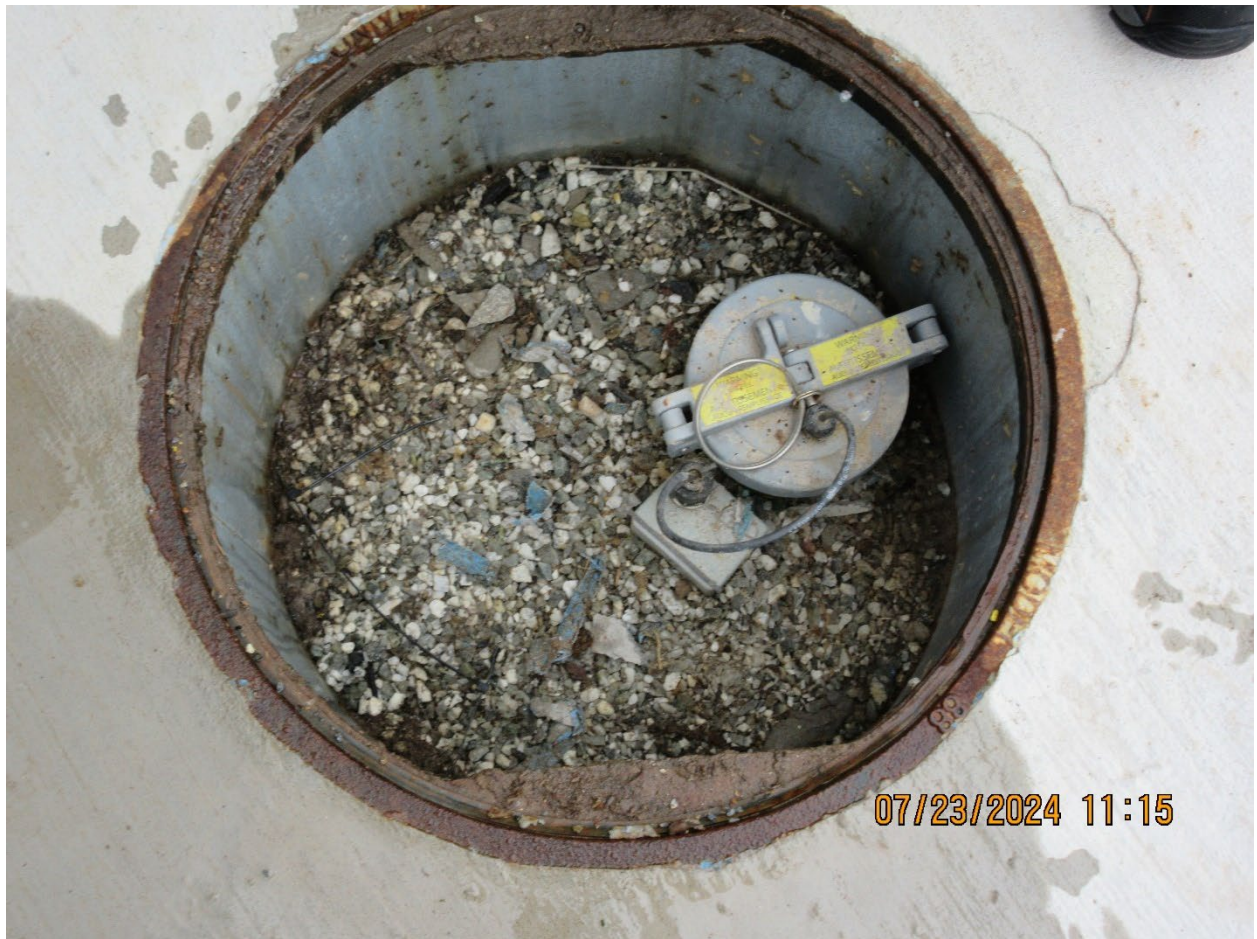
Photo #24

The sensor sump for tank 3 was also observed to be in adequate condition (Photo #24). Tank 3's turbine sump had no water or debris observed and had no smell of diesel present as observed in tank 1's turbine sump (Photo #25).

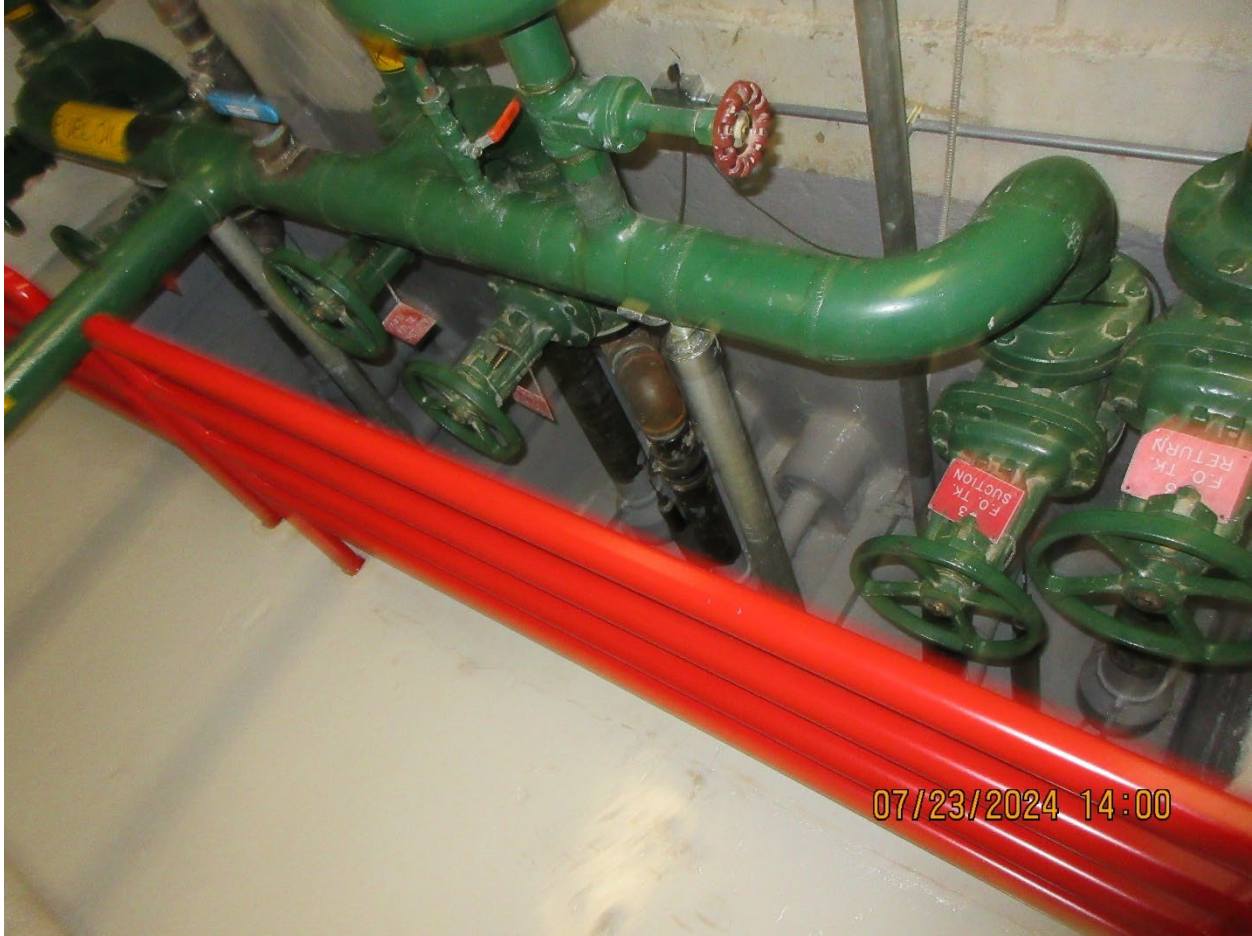
Photo #26

Underground pipes from the three USTs are directed to this room, where they transition into exposed above ground pipes and converge with the pumps and there is a concrete basin to collect any leaks (Photo #26 and 27). Records indicate that electronic leak monitoring is planned for this room, but not installed as of February 2024. The ATG was observed to be a Veeder-Root TLS-450 Plus and was located perpendicular to the pumps on the wall (Photo #28). The ATG showed no error message and indicated that all systems were normal (Photo #29). Unclear whether interstitial monitoring was in use for piping.
