# **Factors Influencing the Effective Life of Chainsaw Protective Legwear**

Mark J.M. Sullman,  
Liro Limited, P.O. Box 2244, Rotorua, New Zealand.  
email [REDACTED]@massey.ac.nz

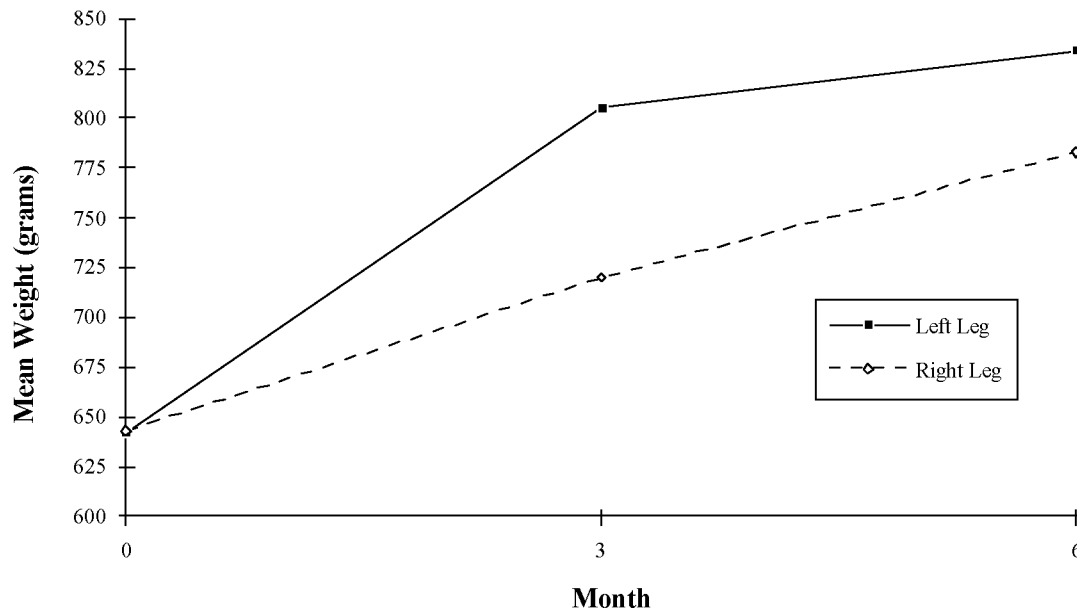
*Figure 2 - Change in mean chap leg weight*

Figure 2 shows that the mean weight of both chap legs increased with increasing use. This was due to the retention of oil, petrol, earth, and water by the legwear. Although statistically insignificant ( $P > 0.05$ ), the left leg increased both at a higher rate, and to a higher level than the right leg.

The presence of nicks/cuts does not appear to have affected the result of the test at three or six months. Even when the protective pads were visibly damaged, the leg still passed. The higher weight of the left leg provides some evidence to support the anecdotal evidence which suggests that the left leg is subjected to a greater amount of petrol/oil contamination, but there was no evidence to suggest that the left leg was subject to more wear.

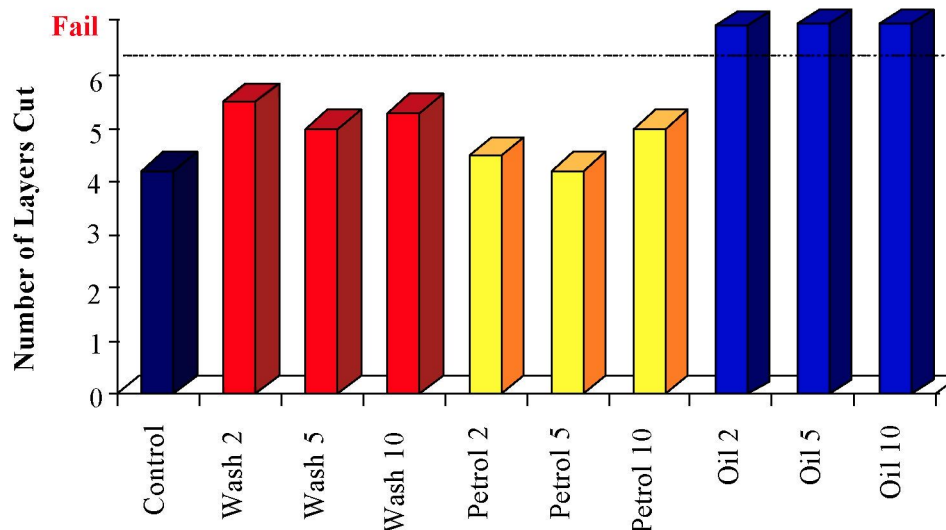
*Figure 3 - Chap performance*

Figure 3 graphically illustrates the performance of the chaps, in terms of the mean number of layers that were cut through for each group of six chap legs, after cut testing to the New Zealand Standard. Each bar consists of the average of the six legs in that group. In the control group, on average, the cut test resulted in 70% of the six layers being cut through. After exposure to petrol, on average 76% (range 70-83%) of the layers were cut through. Surprisingly, the mean number of layers cut through did not increase linearly with an increase in exposure to the petrol. After the chaps had been washed, on average 88% (range 83-92%) of the layers were cut through. Again the mean number of layers cut did not increase linearly with an increase in the number of washes.

Only one of the six legs in each group needs to fail for that group to fail the New Zealand Standards test. However, in all three oil exposed groups, all six chap legs failed. In fact, the chainsaw cut through all six layers of the protective material so easily, it damaged the leg form of the test rig.

All eighteen legs that were exposed to even the smallest amount of oil (0.5L) comprehensively failed. They provided such a small amount of resistance to the chainsaw, that the chainsaw cut through the legwear and into the part of the test rig underneath the legwear. According to the legwear manufacturers, oil exposure caused failure of the legwear by accumulating on the internal fibres of the legwear, thereby increasing the internal friction between the strands. When the strands were touched by the chainsaw, the internal friction caused the strand to be cut through, rather than being pulled out and clogging the chainsaw as they were designed to. Therefore, manufacturers should develop an oil proof outer to prevent the oil being absorbed into the protective material. However, the oil proof outer must not increase the heat retention of the legwear, since thermal comfort has been identified as the most important factor affecting wearer acceptance of protective clothing [2]. Since chaps exposed to even the smallest quantity of oil (0.5L) failed, further research is needed to find out whether exposure to smaller quantities of oil also cause chap failure.

to the control (70%). However, after washing, on average the number of layers cut through (88%) was clearly greater than the control group (70%). According to legwear manufacturers, washing causes the layers of protective materials to tangle slightly, resulting in a small increase in the internal friction between the strands. This slight increase resulted in a greater number of layers being cut through than the control and petrol exposed chaps, but not as much as those exposed to oil.

- Chainsaw operators should replace chaps which have been exposed to 0.5L of oil as they provide almost no protection against a chainsaw.
- Further research is also needed to investigate whether oil exposed chaps can be treated in some way (e.g. hot washed or washed in petrol) to remove the oil and restore the protection offered by the legwear.
- Another factor in need of further investigation is whether different types of washing and washing powder have any impact upon the chaps ability to pass the New Zealand Standards test.
