INSPECTION REPORT

| Type of Inspection | Industrial Stormwater Inspection (ISI) | | |
| Permittee Name | Danone US, LLC | | |
| Facility or Site Name | Danone | | |

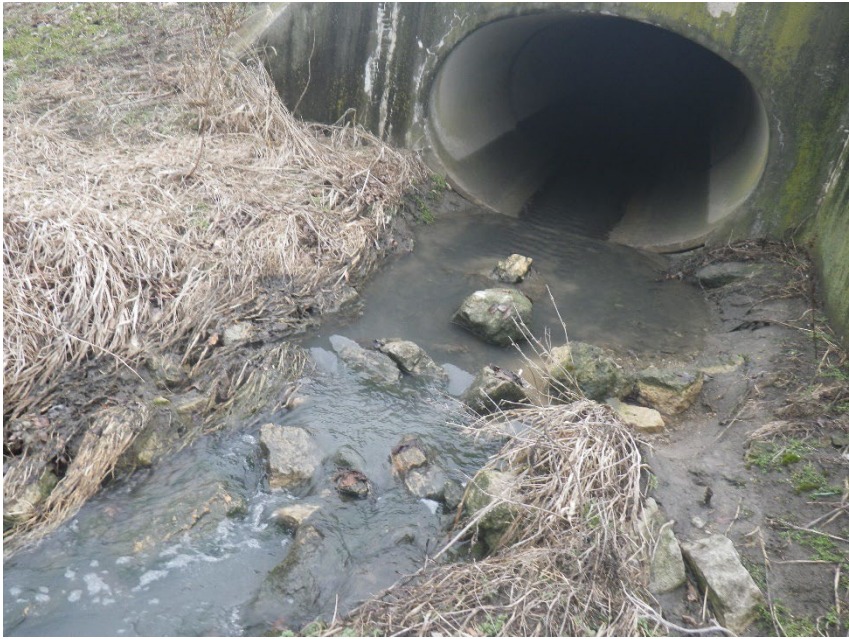
| Location: Storm Sewer Outfall | | |
|---|---|---|
| The storm sewer that Danone reportedly discharges into appeared to be relatively clear where it entered the | | |

| Photograph 1. Storm Sewer Outfall into Miami Erie Canal | | | IMGP0001.JPG |

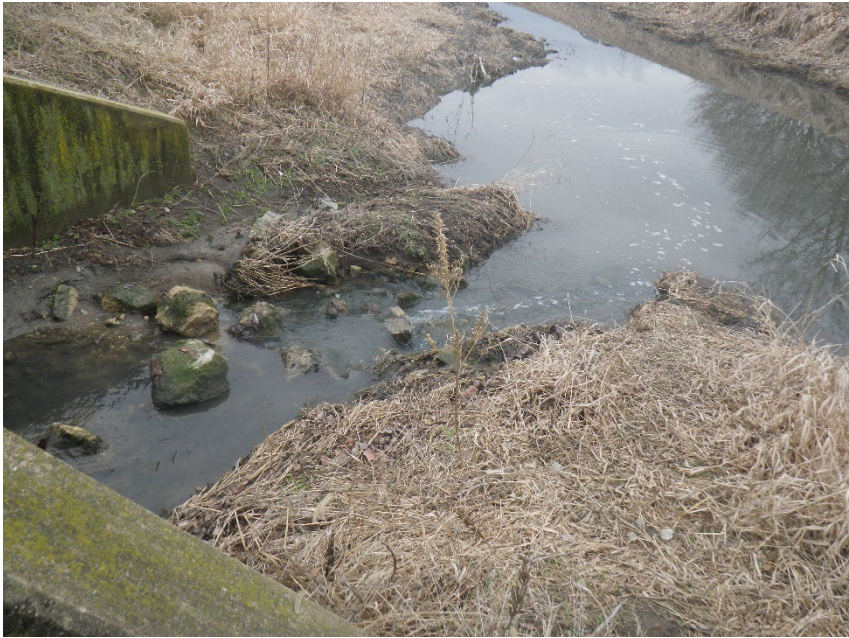
| Photograph 2. Storm Sewer Outfall into Miami Erie Canal. Same outfall as photo 1. | | | IMGP0002.JPG |

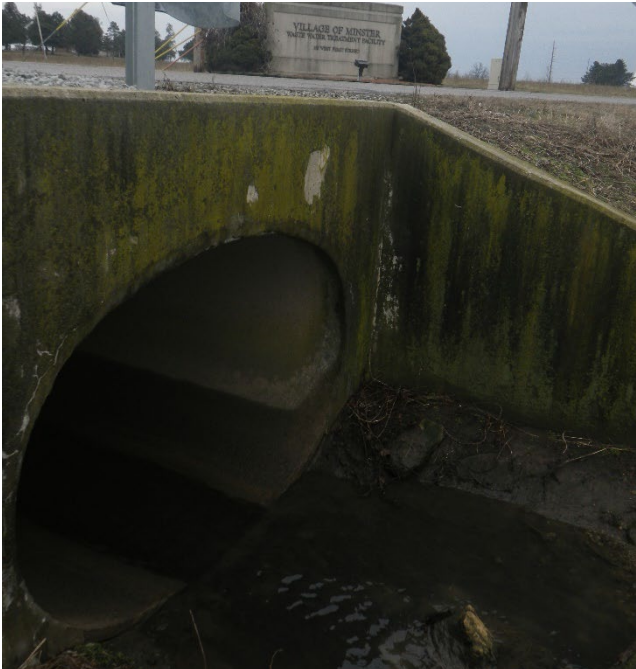
| Photograph 3. Storm Sewer Outfall into Miami Erie Canal. Same outfall as photo 1. | | | IMGP0003.JPG |

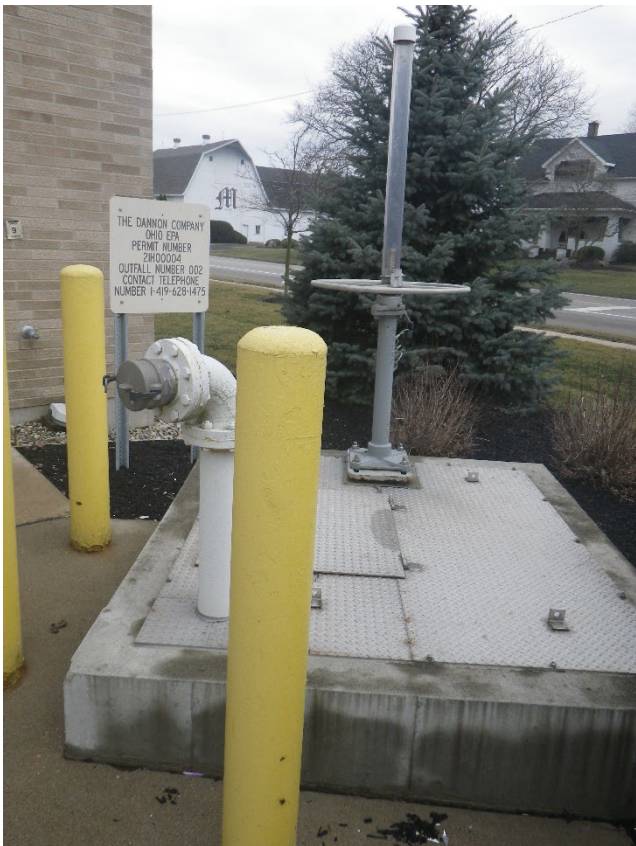
| Photograph 4. Danone outfall 002 and sign | | | IMGP0004.JPG |

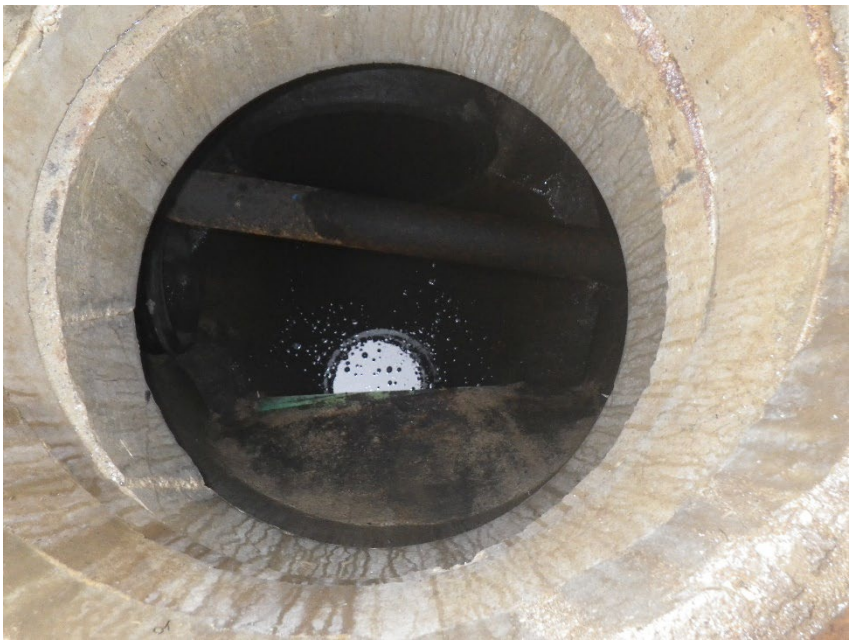
| Photo 5. Manhole near outfall 001. Mr. Scott believes the pipe passing though the chamber is a sanitary line. | | | IMGP0005.JPG |

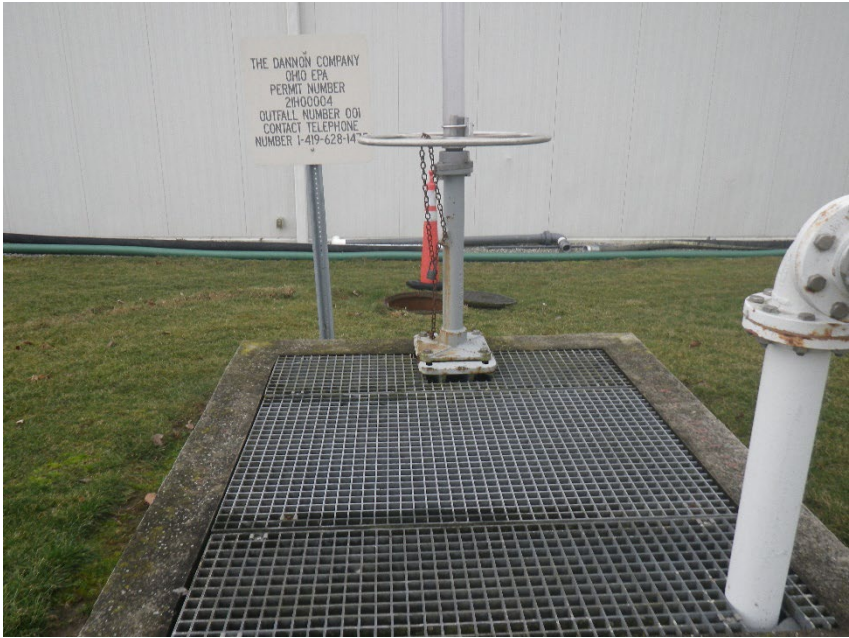
| Photograph 6. Outfall 001 with sign. | | | IMGP0006.JPG |

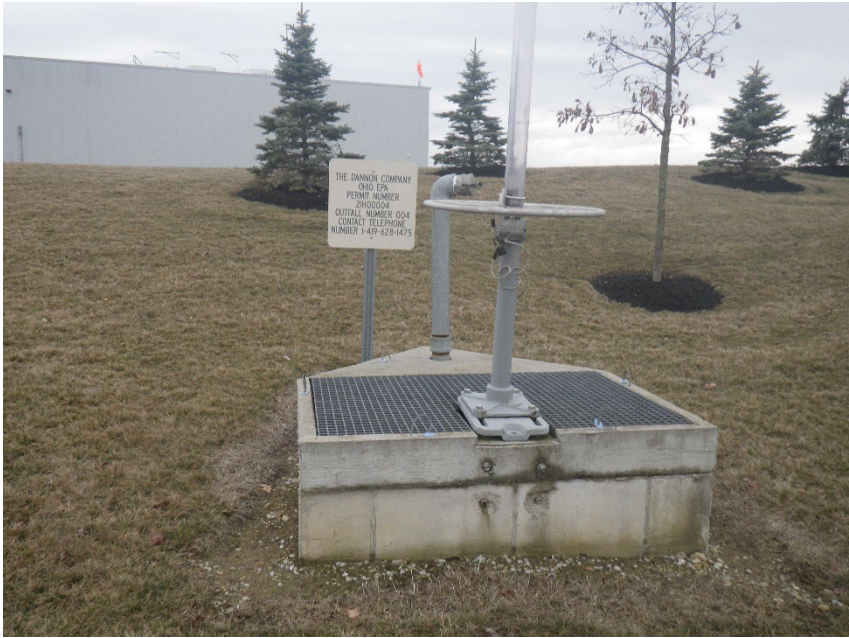
| Photograph 7. Outfall 004 | | | IMGP0007.JPG |

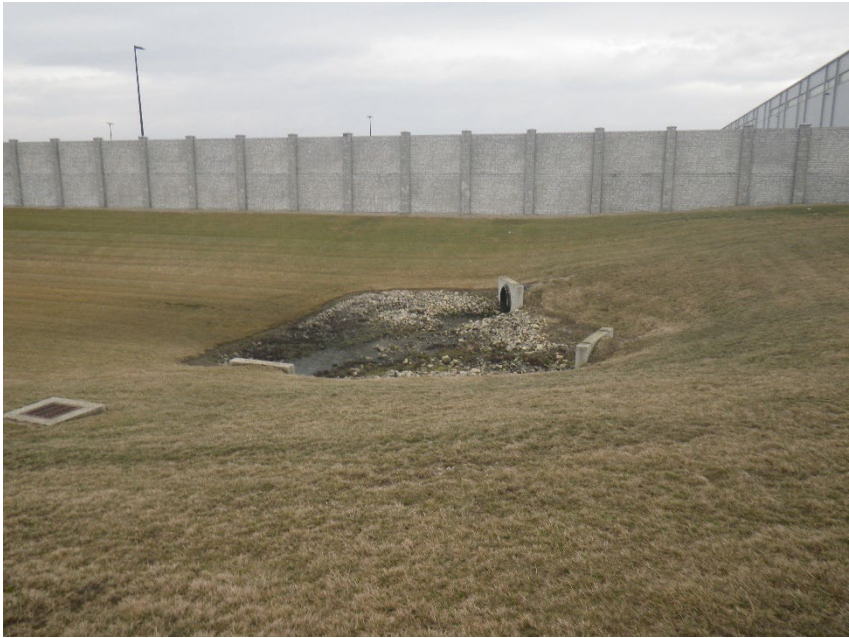
| Photograph 8. Sampling area at retention pond | | | IMGP0008.JPG |

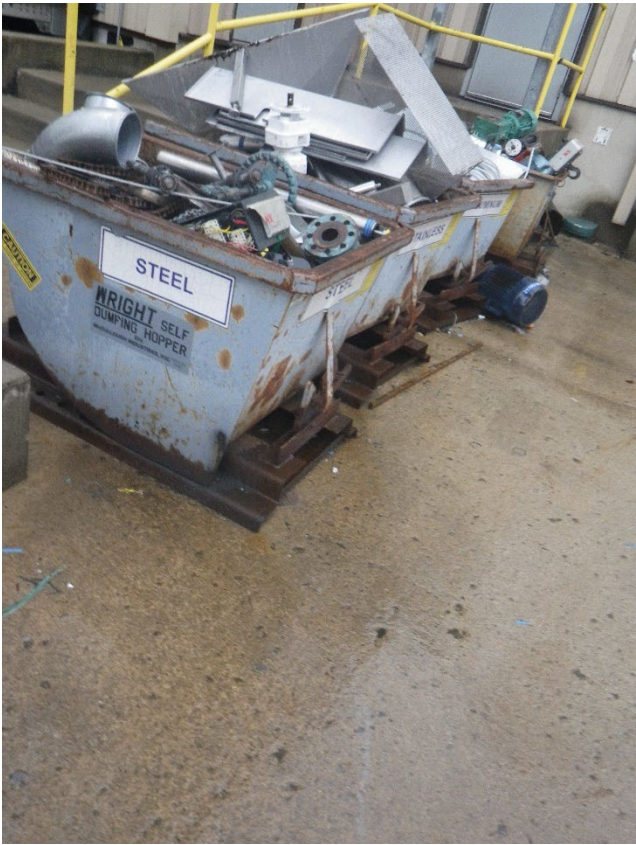
| Photos 9-11 show an area where metal is discarded into hoppers. The metal appeared oily and there was metal outside of the uncovered hoppers, along with an oily sheen on the ground leading towards a storm drain.<br><br>Photo 12 shows an outdoor material area that is mainly under a roof. | | |

| Photograph 9. Uncovered metal recycling hoppers. An oily sheet can be seen on the pavement coming from the hoppers | | | IMGP0009.JPG |

The housekeeping on the site was not good in the areas with the oily metal scrap bins with the oily sheen on the ground. Also, the refueling tank spill was not cleaned up properly with the absorbent material left behind. The plastic pellets we observed near the Graham area needed to be addressed.

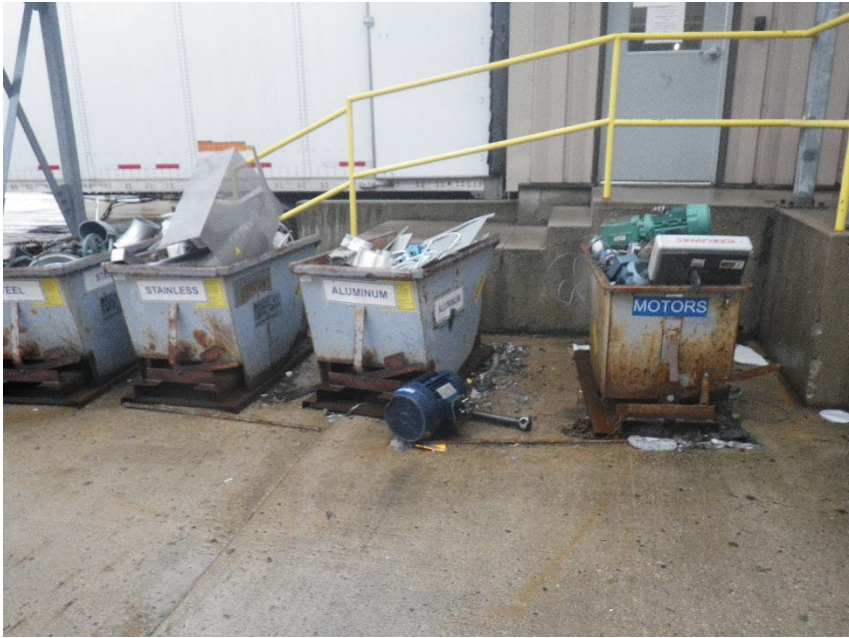
| Photograph 10. Uncovered metal recycling hoppers. Metal is outside of the hoppers. An oily sheen can be seen on the ground. | | | IMGP0010.JPG |

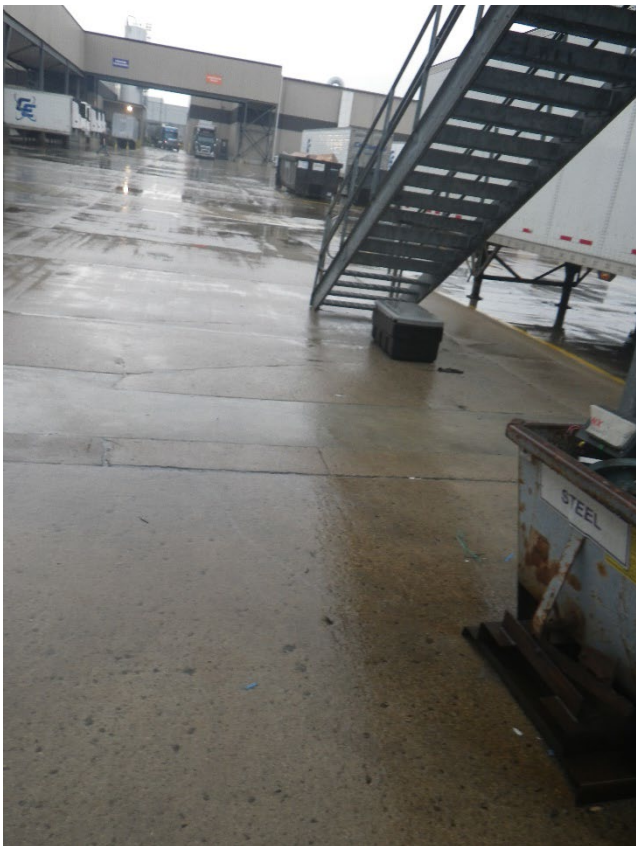
| Photograph 11. Oily metal was observed inside the<br>hoppers. An oily sheen was flowing towards a storm<br>drain inlet in the top of the photograph | | | IMGP0011.JPG |

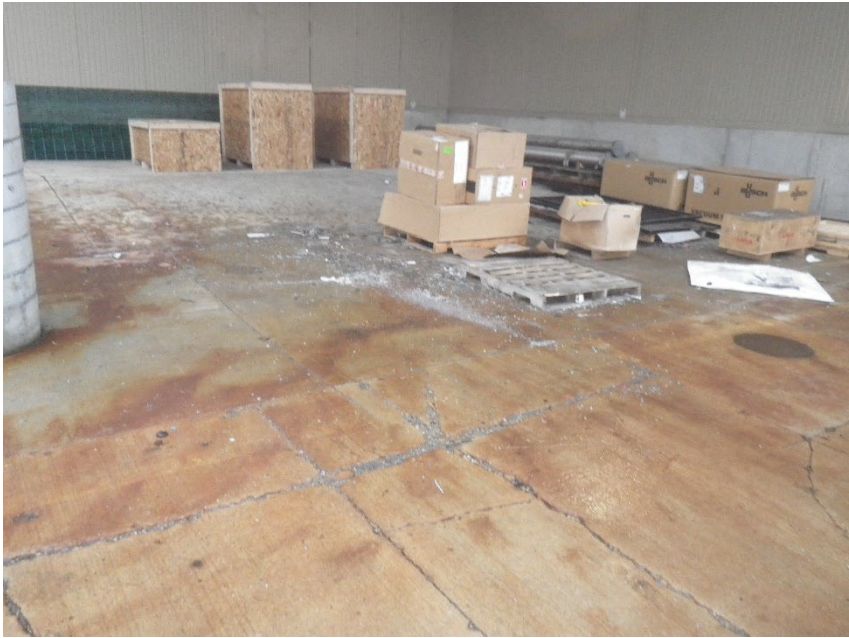
| Photograph 12. Miscellaneous equipment storage | | | IMGP0012.JPG |

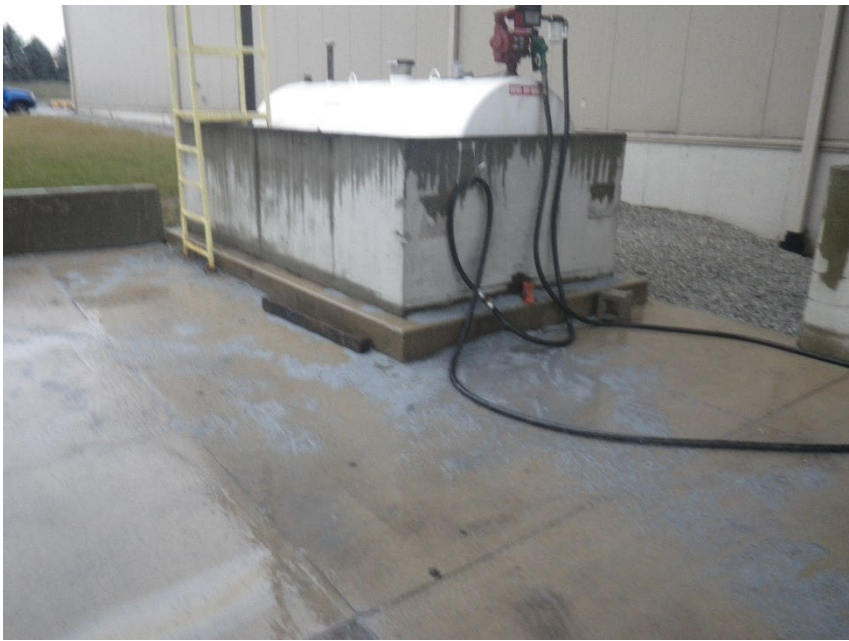
| Photos 13 and 14 shows a refueling area with used absorbent material left on the ground. An oily sheen can be seen in one of the photos. | | |

| Photograph 13. Diesel Fuel tank with spill cleaning materials around the tank. An oily sheen can be seen at the bottom left of the photo. | | | IMGP0013.JPG |

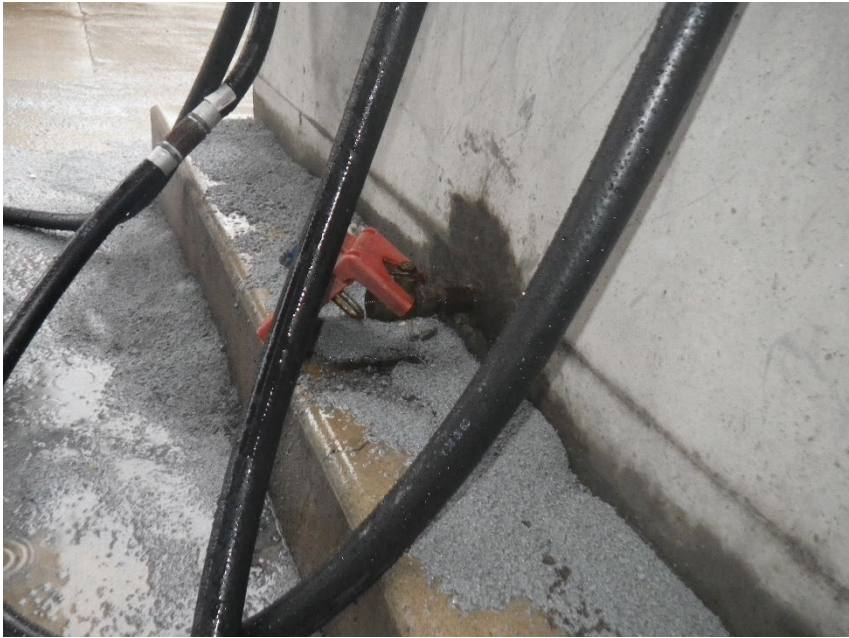
| Photograph 14. Diesel Fuel tank with fuel cleanup materials present around refueling area. It was raining during the inspection. The drain valve appeared to be open and water was draining out of it. | | | IMGP0014.JPG |

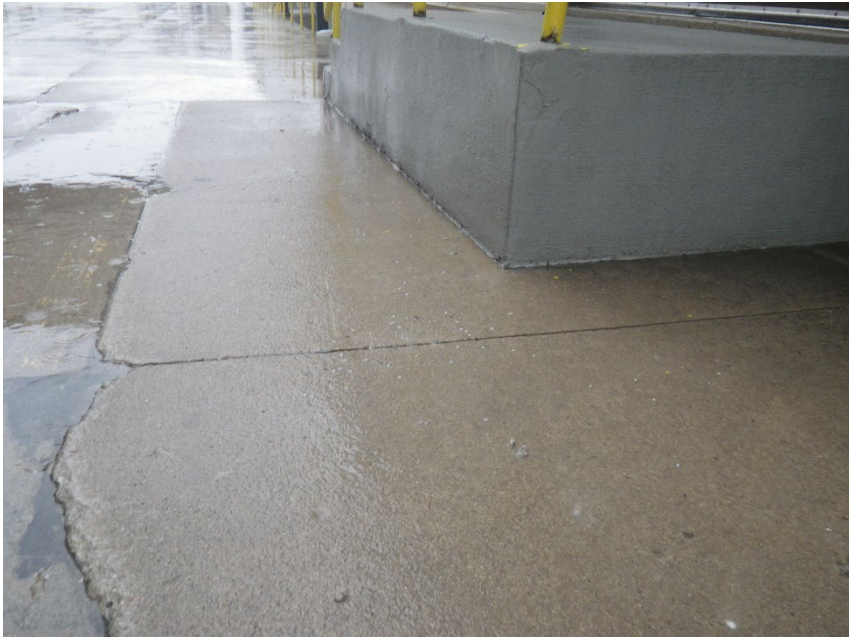
| Plastic pellets (white granules) were observed outdoors on the ground. | | |

| Photograph 15. Graham Packaging Receiving area.<br>Pleastic pellets were observed on the ground. | | | IMGP0015.JPG |

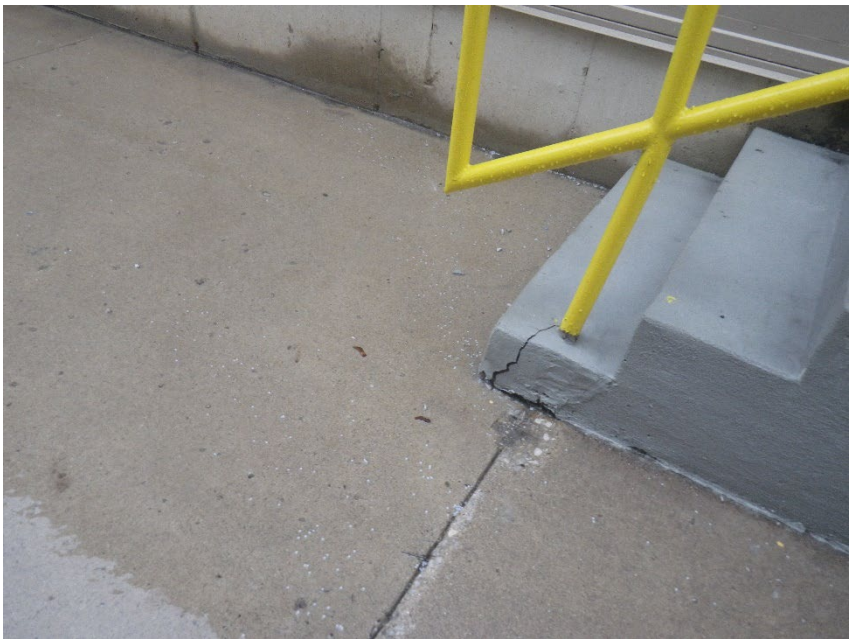
| Photograph 16. Graham Packaging Receiving area.<br>Pleastic pellets were observed on the ground | | | IMGP0016.JPG |

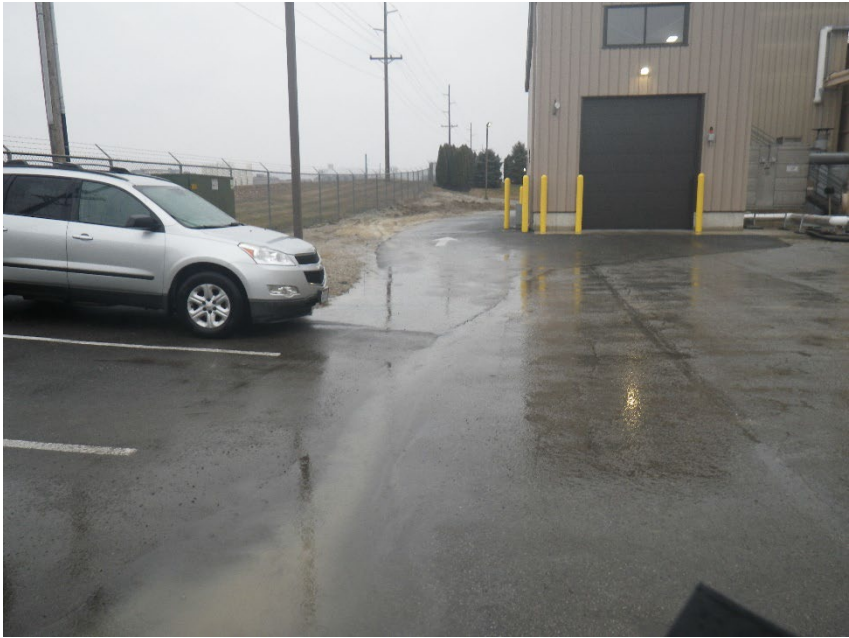
| Recent grading work has left the ground unstabilized and muddy water is making its way into the storm drain inlets, which drain to storm water outfall 3. | | |

| Photograph 17. Silty water can be seen flowing from the unstabilized area near the center of the photograph to the bottom left corner of the photograph. | | | IMGP0017.JPG |

At the Pretreatment area, the sediment laden water running into the outfall from the disturbed area needed to be addressed.

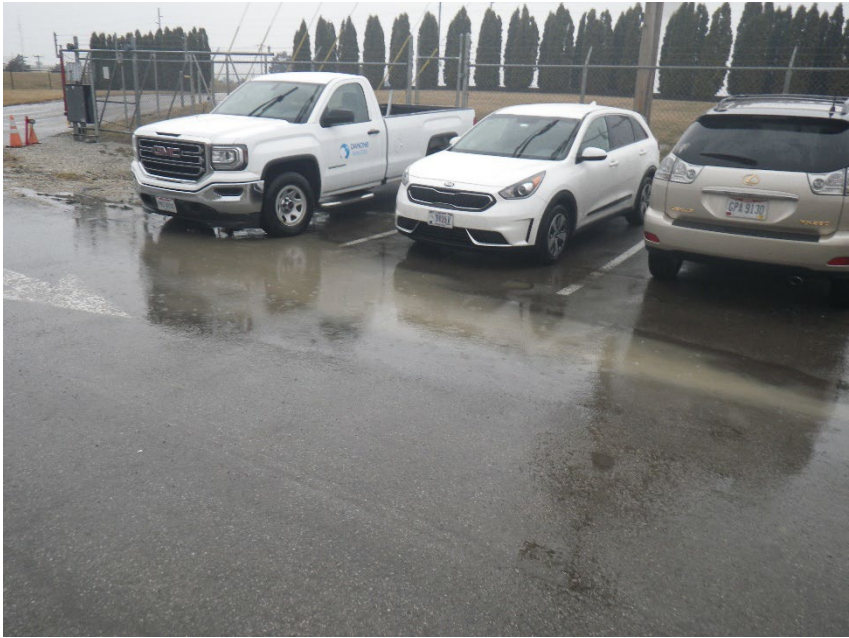
| Photo 18. Silty water can be seen flowing from the right of the photograph to the left. This is the same flow of water that is show in photograph 17. | | | IMGP0018.JPG |

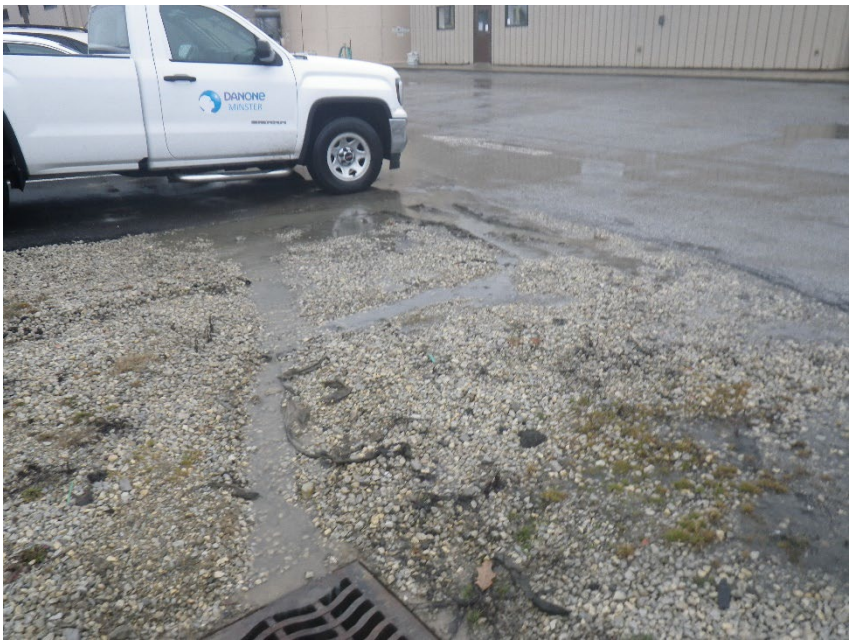
| Photo 19. Silty water can be seen flowing from the top center of the photograph to the storm drain inlet at the bottom of the phtograph. This is the same flow of water that is show in photograph 18. | | | IMGP0019.JPG |

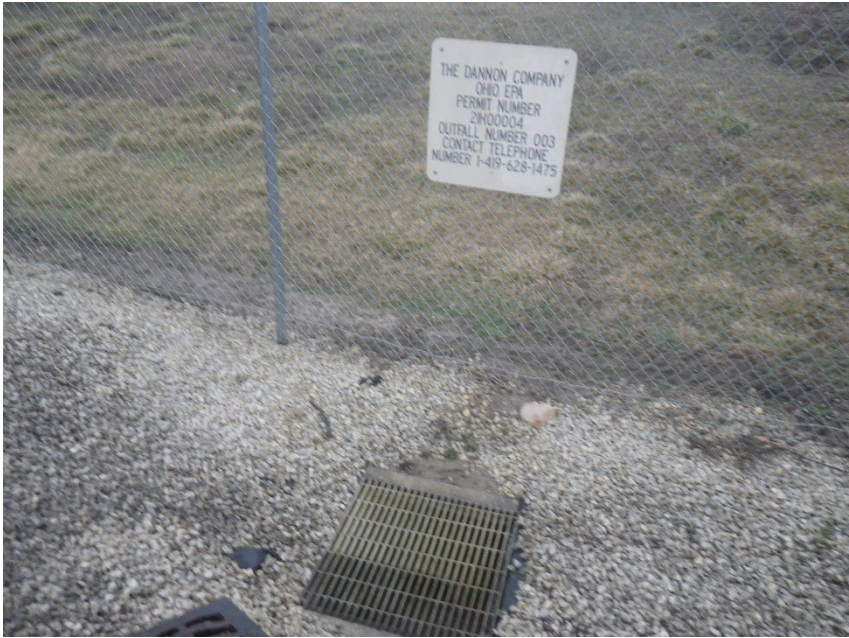
| Photograph 20. Storm Drain inlet/location of outfall 003 | | | IMGP0020.JPG |

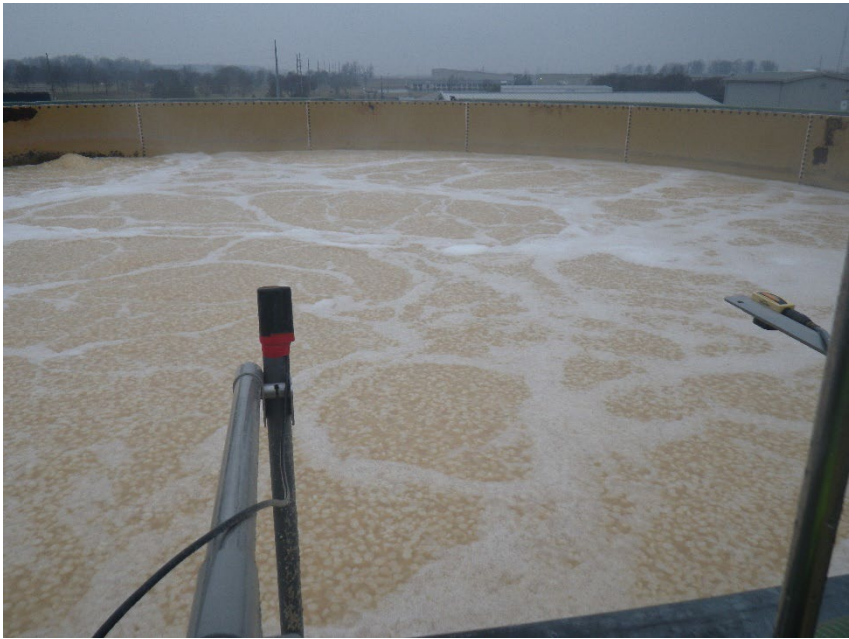
| Photograph 21. Moving Bed Biofilm Reactor process | | | IMGP0021.JPG |
