The time and date stamp for these photos are incorrect, the inspection occurred on November 7, 2023 beginning at 11:29 AM.

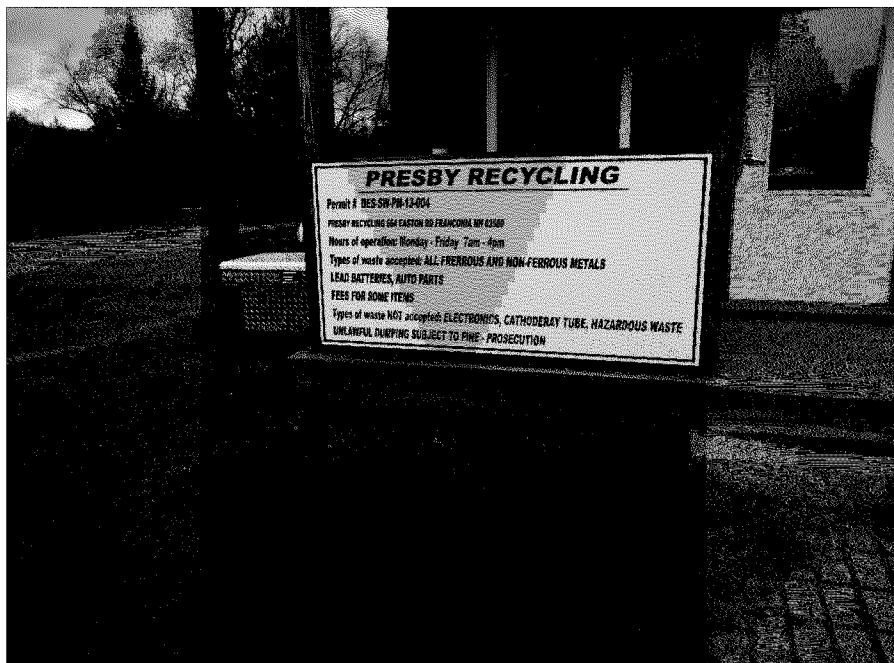
**Photograph 1.** Presby Recycling 11/6/2023 23:30 DSCN0604.JPG  
Description: Facility Sign.

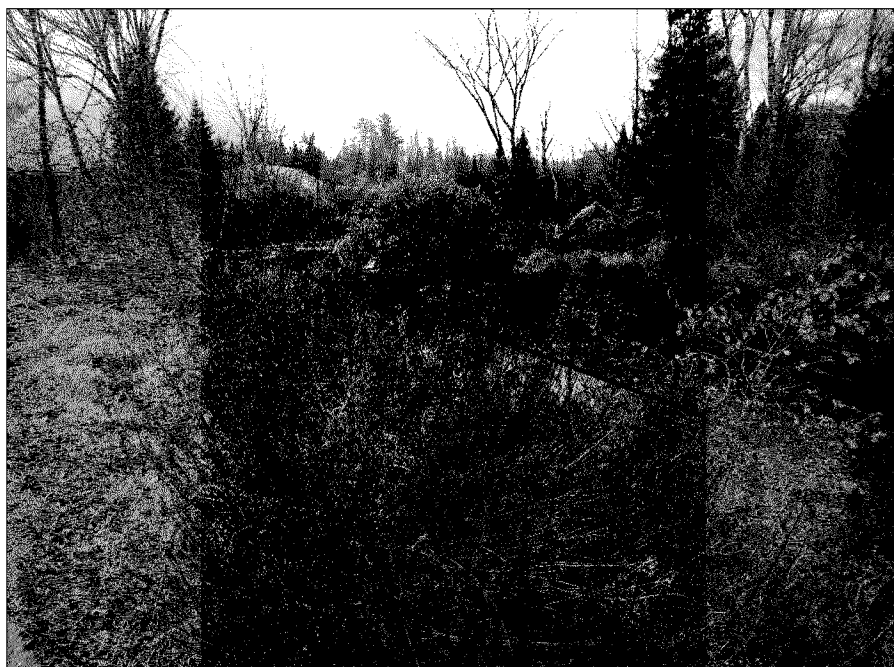
**Photograph 2.** Presby Recycling 11/6/2023 23:40 DSCN0605.JPG  
Description: View of the Ham Branch looking southwest from the Facility's western perimeter. The solid blue line depicts flow direction.

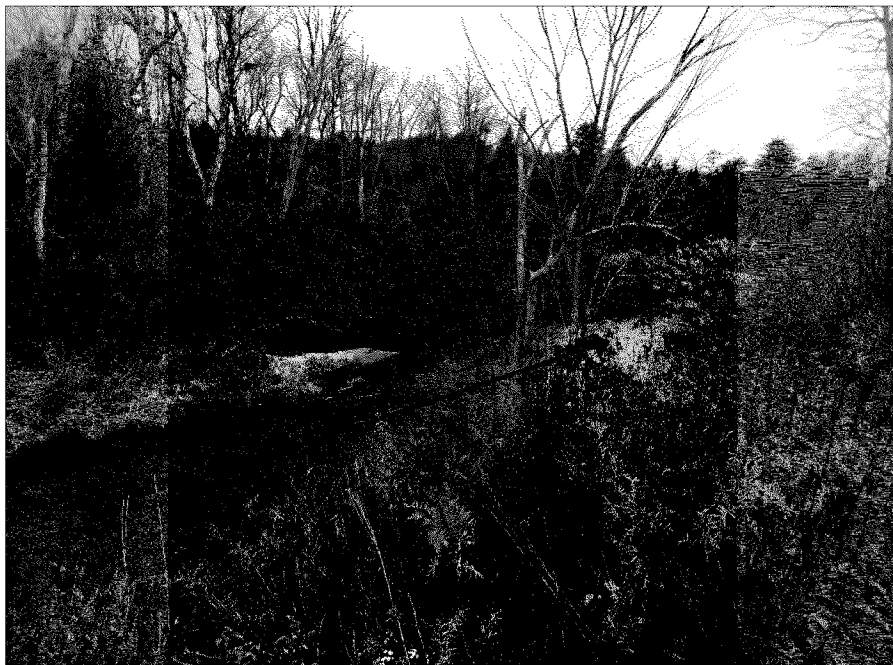
**Photograph 3.** Presby Recycling 11/6/2023 23:40 DSCN0606.JPG  
Description: View of the Ham Branch looking southwest from the Facility's western perimeter.

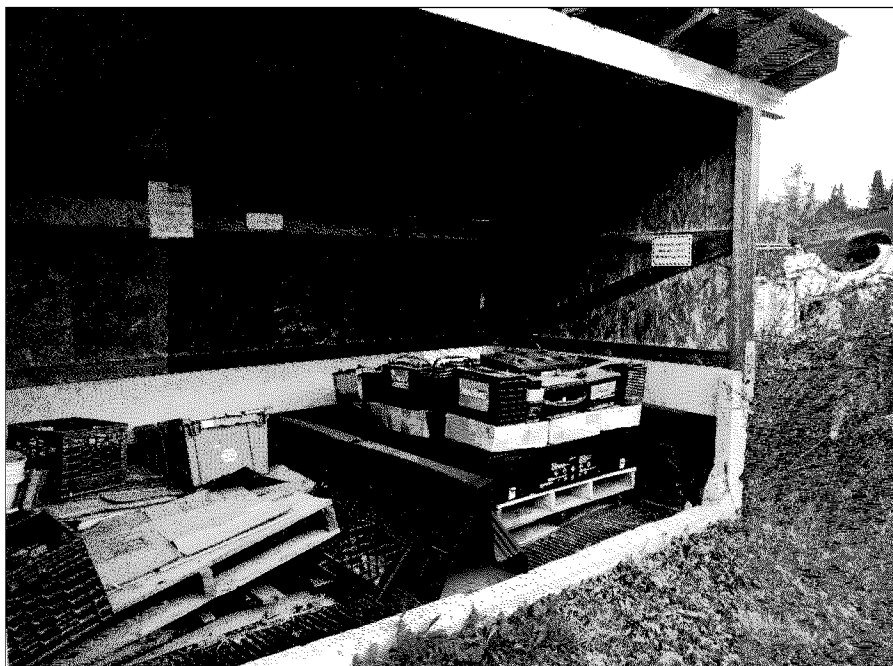
**Photograph 4.** Presby Recycling 11/6/2023 23:42 DSCN0607.JPG  
Description: View of scrap batteries stored undercover, on a pallet, with the two levels separated by cardboard boxes.

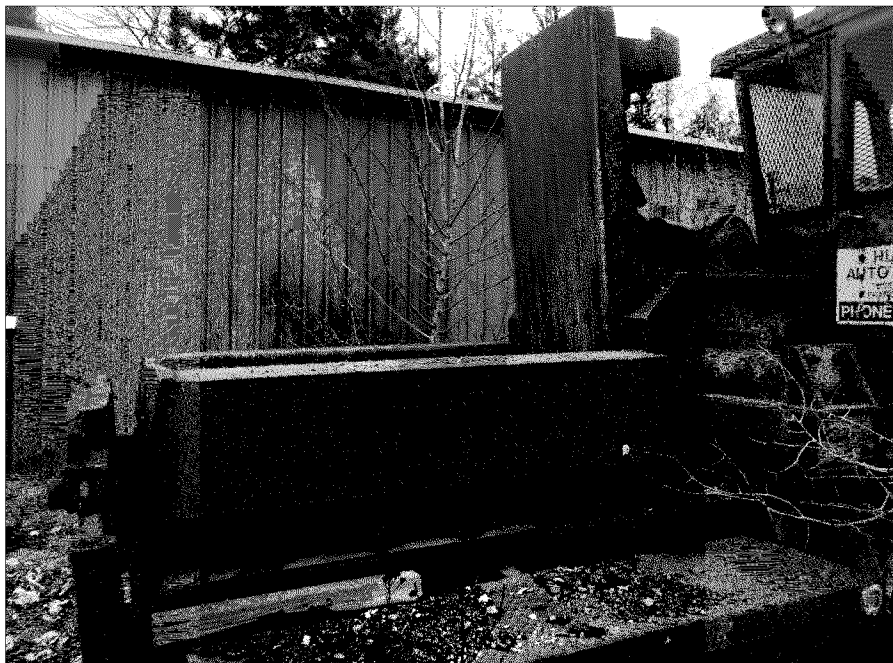
**Photograph 5.** Presby Recycling 11/6/2023 23:44 DSCN0608.JPG  
Description: The Facility's aluminum bailer.

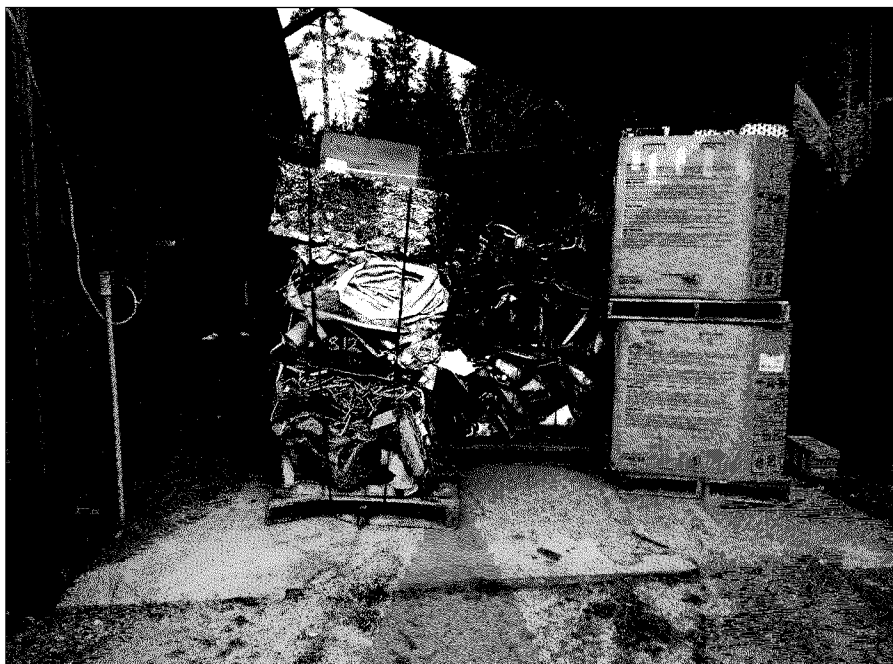
**Photograph 6.** Presby Recycling 11/6/2023 23:45 DSCN0609.JPG  
Description: View of baled aluminum stored under cover.

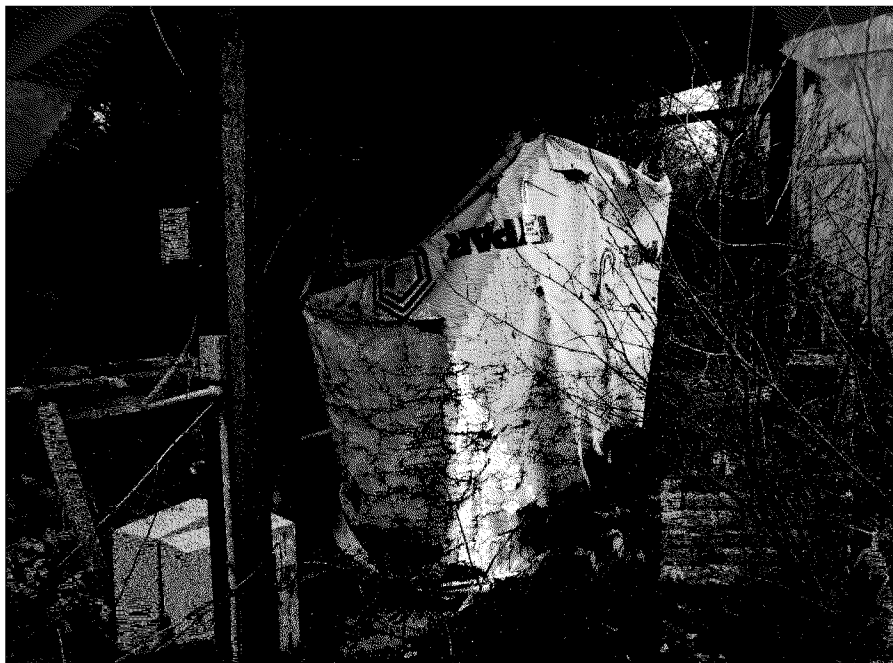
**Photograph 7.** Presby Recycling 11/6/2023 23:46 DSCN0610.JPG

Description: View of the Facility's copper smelter that has not been in use due to air permitting challenges.

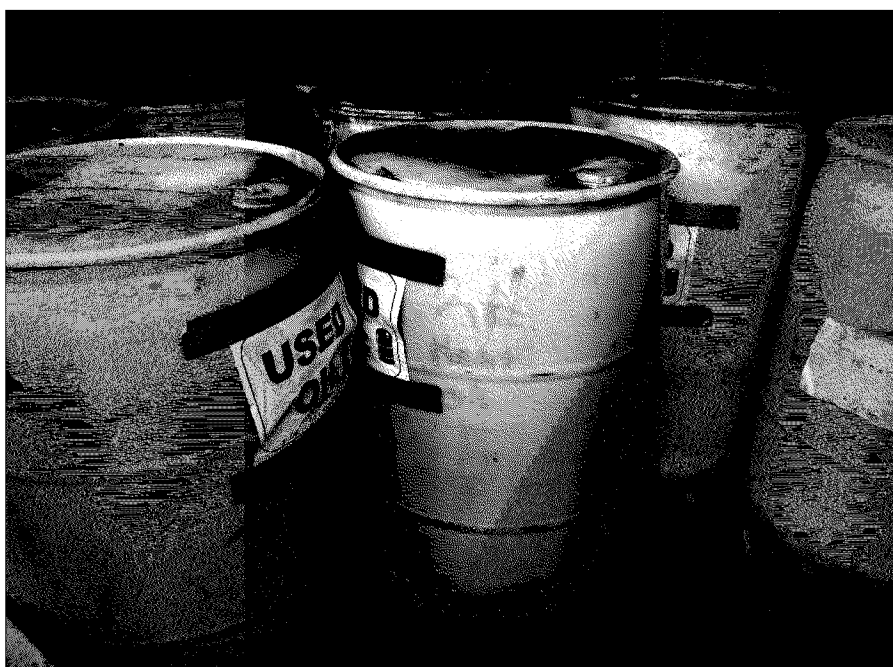
**Photograph 8.** Presby Recycling 11/6/2023 23:47 DSCN0611.JPG

Description: View of 55-gallon plastic waste oil drums stored in a shed, within secondary containment.

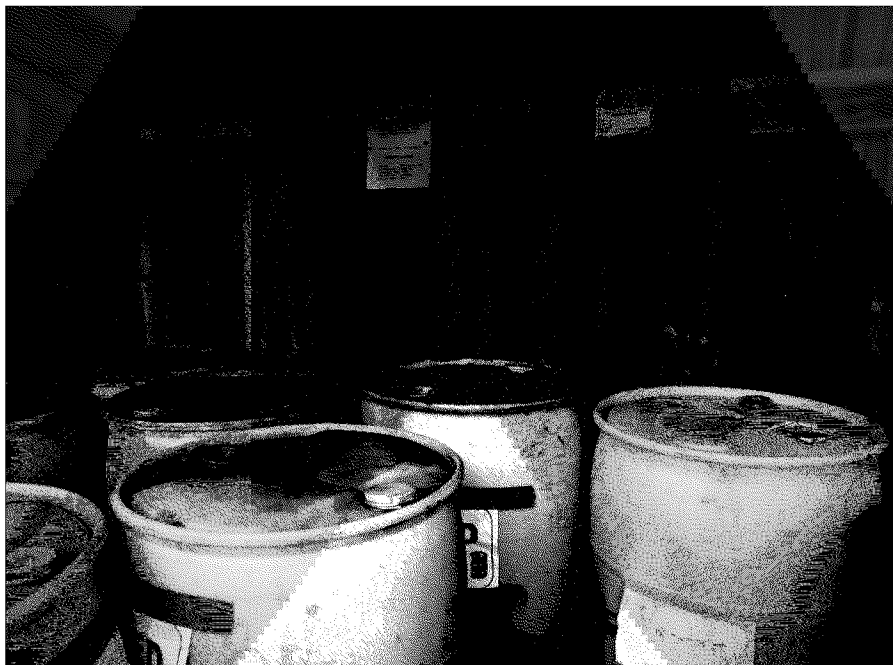
**Photograph 9.** Presby Recycling 11/6/2023 23:47 DSCN0612.JPG

Description: View of 55-gallon used oil drums stored in a shed. The drums were labeled “used oil” and stored in secondary containment.

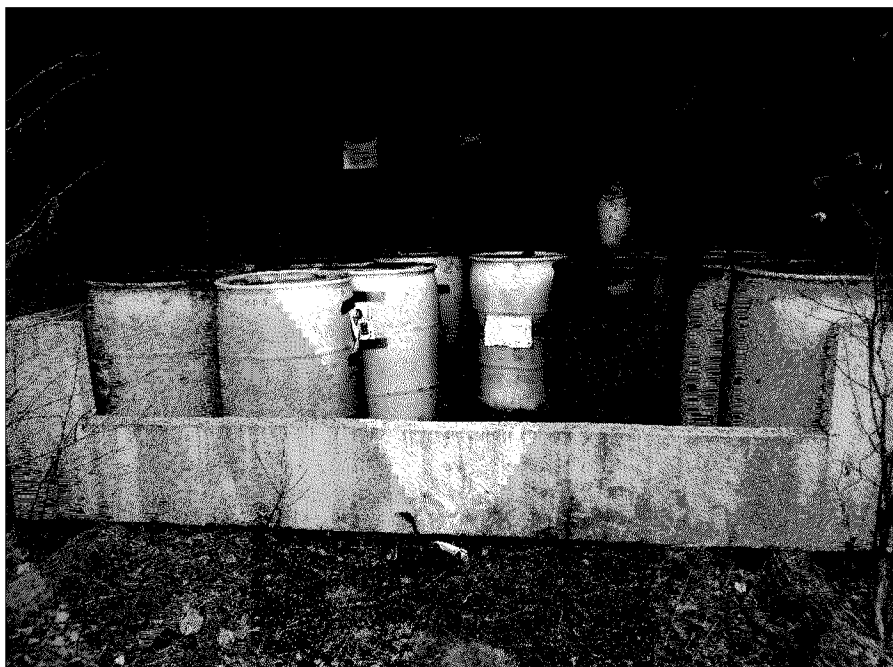
**Photograph 10.** Presby Recycling 11/6/2023 23:47 DSCN0613.JPG

Description: Additional view of 13 55-gallon drums holding waste oil stored undercover, within secondary containment, seen in Photographs 8 and 9.

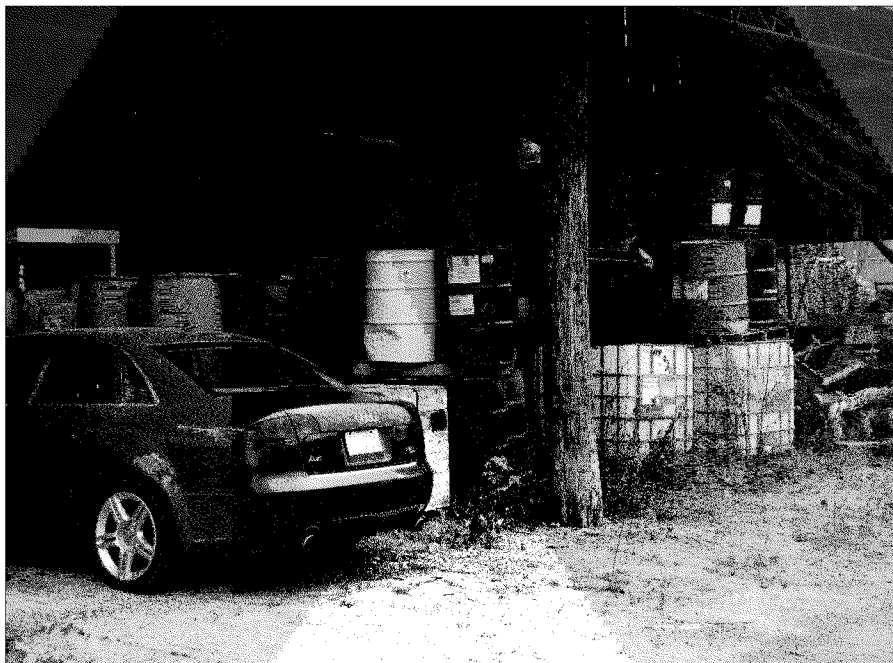
**Photograph 11.** Presby Recycling 11/6/2023 23:48 DSCN0614.JPG  
Description: View of empty 55-gallon drums and totes stored in a shed.

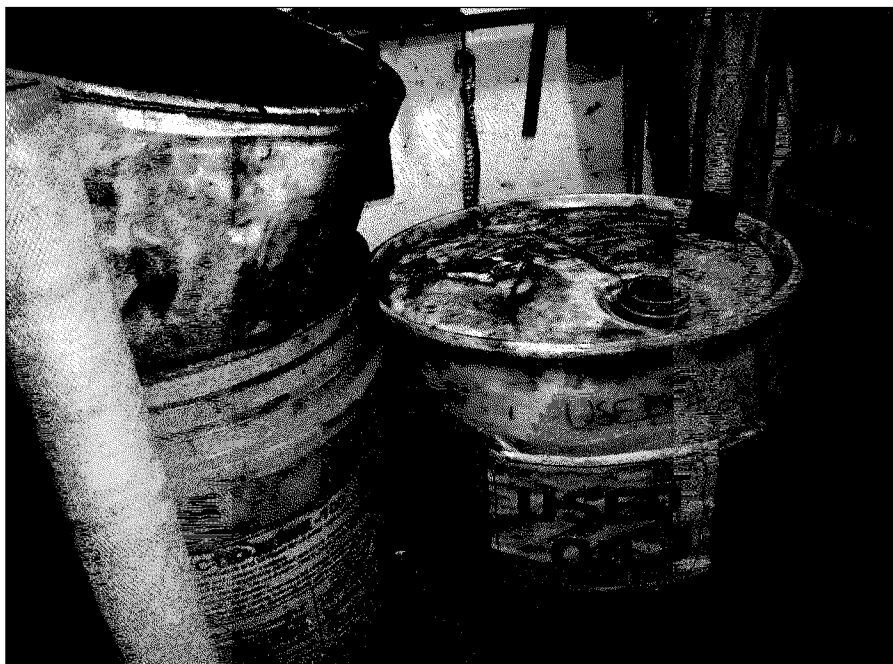
**Photograph 12.** Presby Recycling 11/6/2023 23:51 DSCN0615.JPG  
Description: Metal turnings (yellow bucket) being drained into the blue bucket and a used oil drum. The buckets were under cover and on a containment pallet.

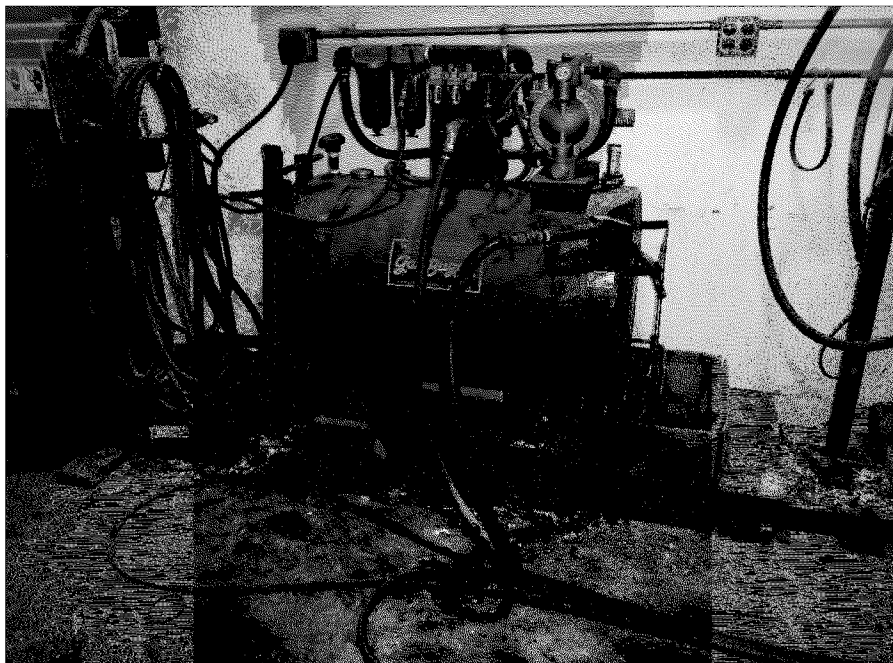
**Photograph 13.** Presby Recycling 11/6/2023 23:51 DSCN0616.JPG

Description: View of the Facility's transfer tank, located inside the garage. The transfer tank is equipped to drain gasoline from equipment or end-of-life vehicles (ELVs) and dispense gasoline.

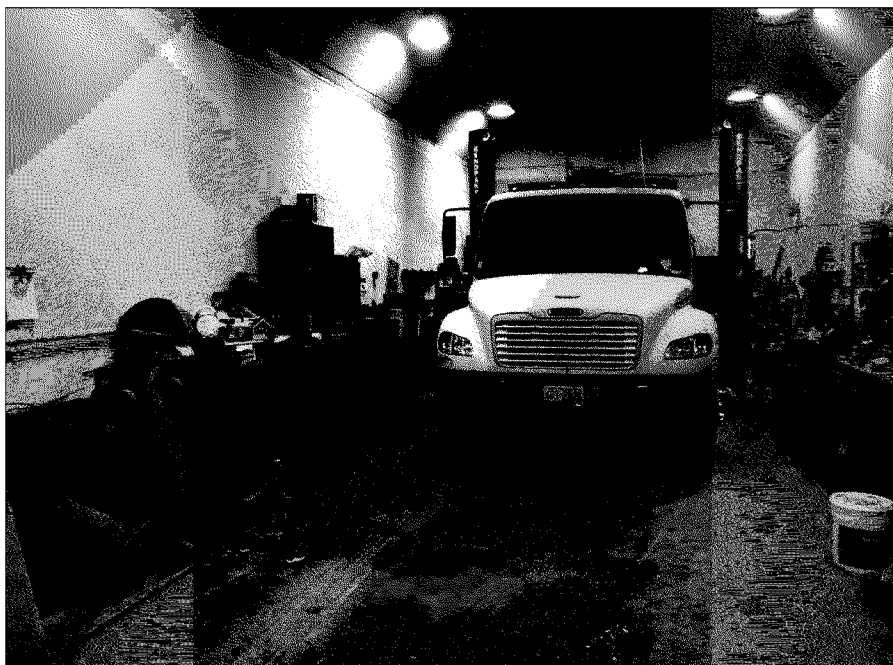
**Photograph 14.** Presby Recycling 11/6/2023 23:54 DSCN0617.JPG

Description: View of the garage used for equipment maintenance.

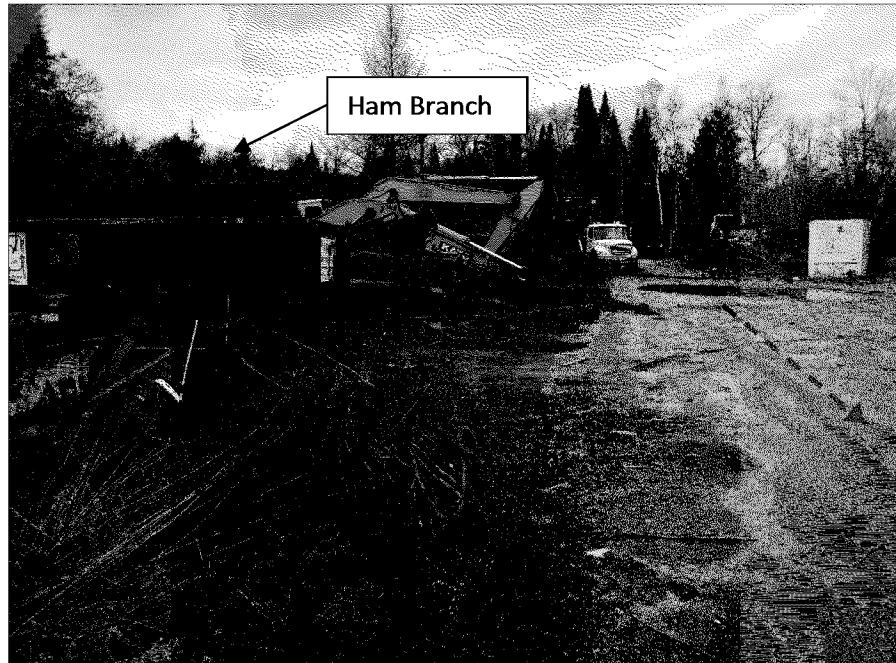
**Photograph 15.** Presby Recycling 11/6/2023 23:56 DSCN0618.JPG

Description: View looking north along the Facility's western perimeter adjacent to Ham Branch. Heavy equipment, empty roll-off dumpsters, and a truck-mounted asphalt hot box were parked on the western perimeter. The dashed blue line depicts the estimated stormwater flow direction.

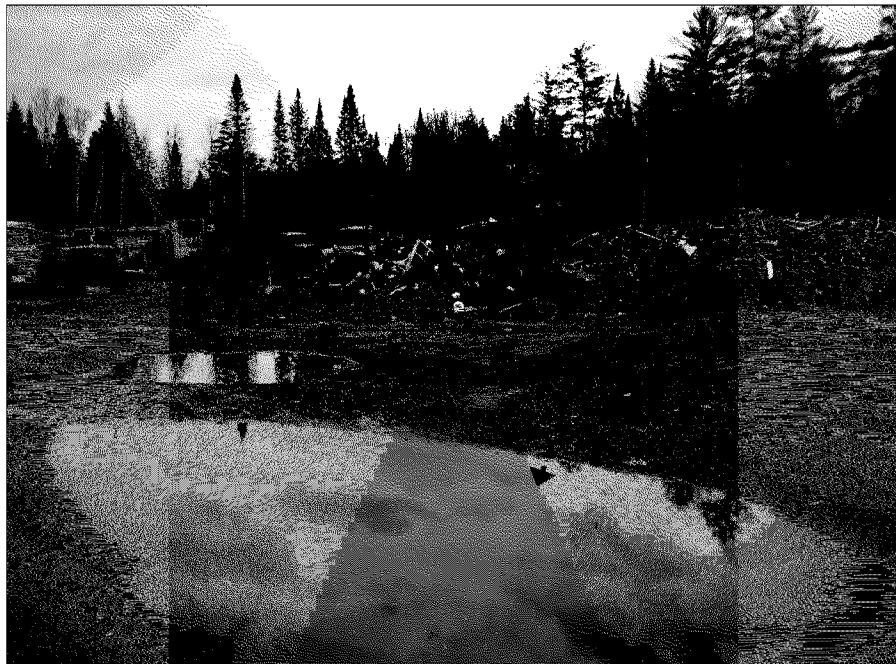
**Photograph 16.** Presby Recycling 11/6/2023 23:56 DSCN0619.JPG

Description: View of ferrous metals stockpiled on the eastern side of the yard and pooled stormwater in the center of the yard.

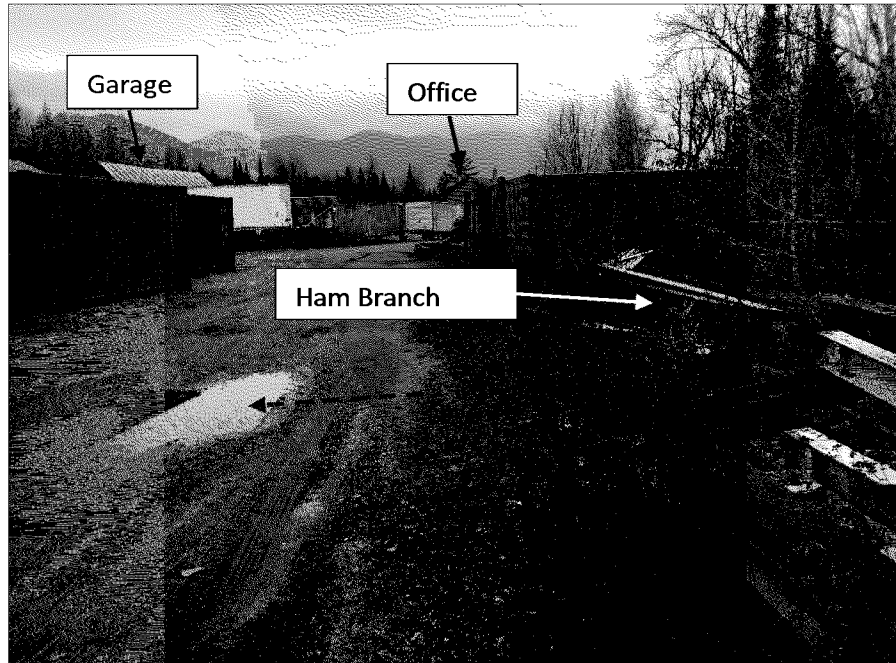
**Photograph 17.** Presby Recycling 11/6/2023 23:56 DSCN0620.JPG  
Description: View looking south toward the office from the same location as Photograph 16.

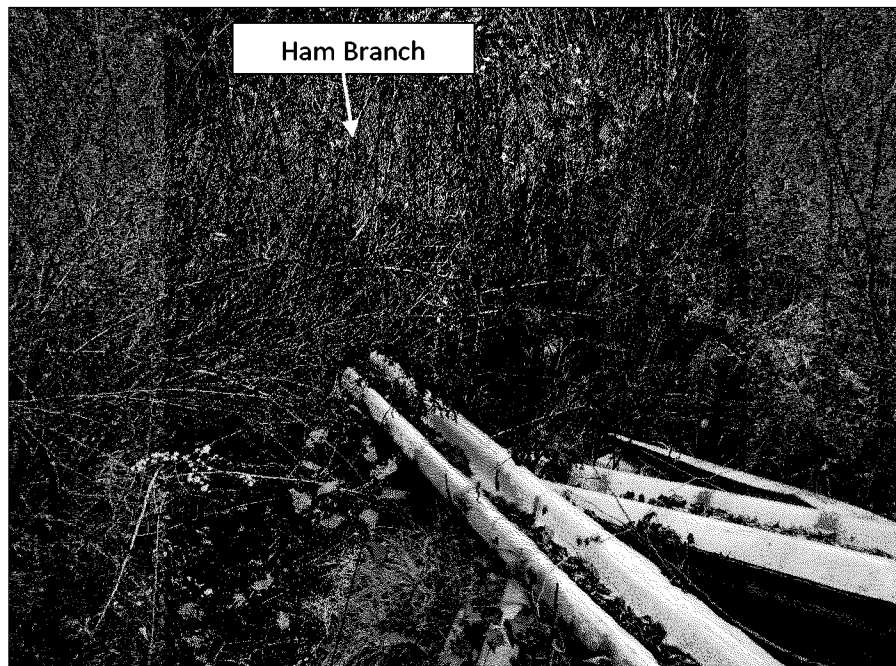
**Photograph 18.** Presby Recycling 11/6/2023 23:57 DSCN0621.JPG  
Description: View looking west at Ham Branch from the Facility's western perimeter. Ham Branch is barely visible through the vegetation. Scrap steel guard rails were on the ground in this location.

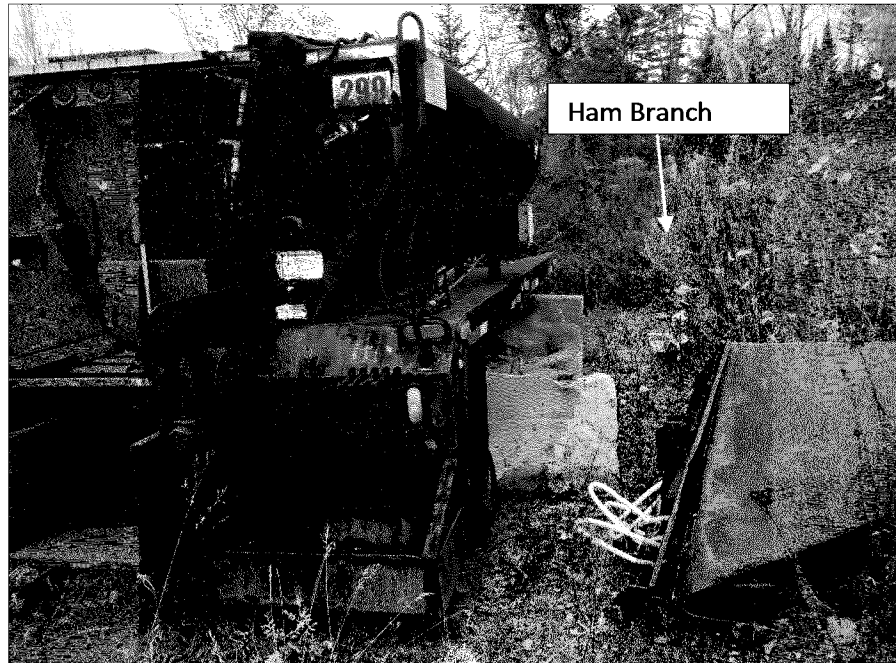
**Photograph 19.** Presby Recycling 11/6/2023 23:58 DSCN0622.JPG

Description: View of a truck-mounted asphalt hot box stored on the western perimeter, adjacent to Ham Branch.

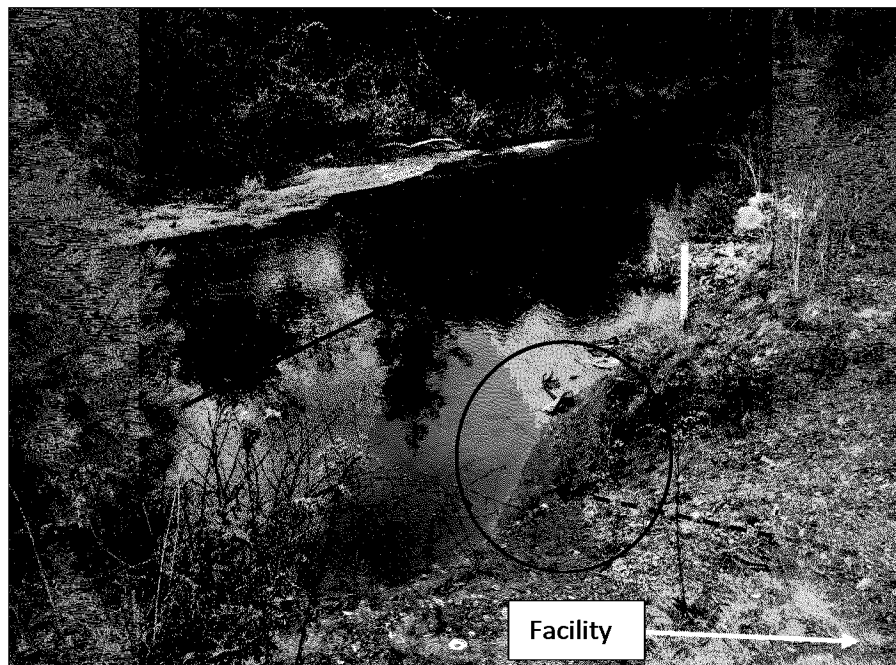
**Photograph 20.** Presby Recycling 11/7/2023 00:00 DSCN0623.JPG

Description: View of Ham Branch looking northwest from the side of the truck-mounted asphalt hot box. A discrete conveyance path is indicated by the blue dashed arrow and sediment deposition on the east bank of Ham Branch is circled in red.

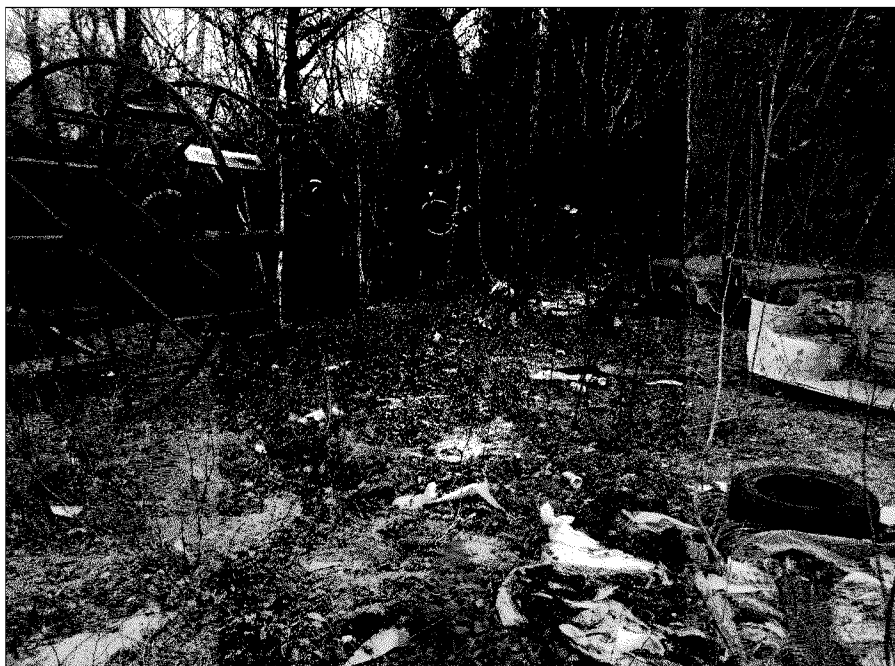
**Photograph 22.** Presby Recycling 11/7/2023 00:02 DSCN0625.JPG  
Description: View of used tires baled together used as a fence on the north side of the property.

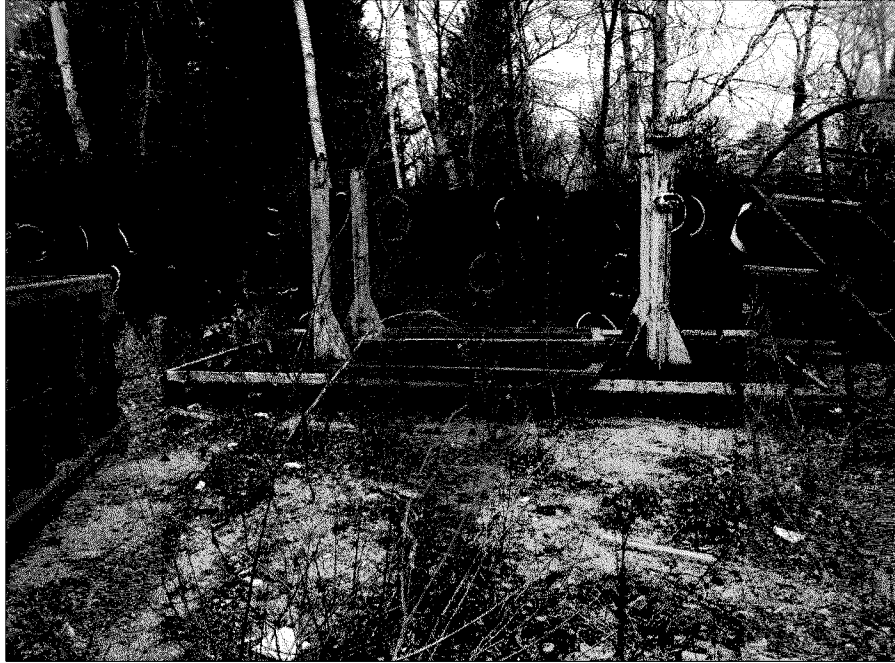
**Photograph 23.** Presby Recycling 11/7/2023 00:02 DSCN0626.JPG

Description: View of the rack on the north side of the property that the Facility previously used to lift and drain ELVs. The rack was replaced with the transfer tank pictured in [Photograph 13](#).

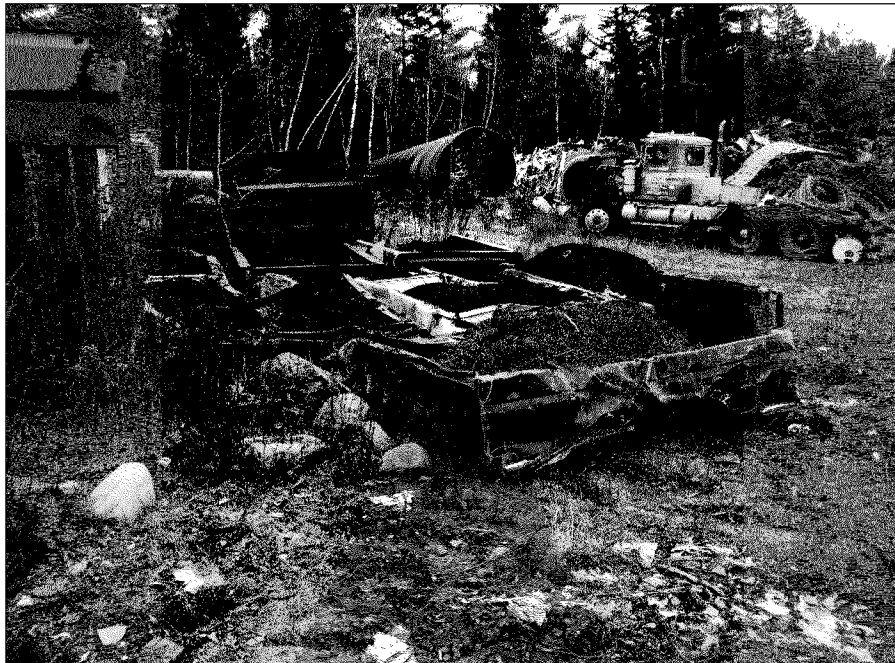
**Photograph 24.** Presby Recycling 11/7/2023 00:04 DSCN0627.JPG

Description: View of piles of metal shavings accumulating in truck beds.
