Happy Import Auto Salvage
Industrial User Inspection Report
May 19, 2021

U.S. Environmental Protection Agency Region 5

Purpose: Industrial Stormwater Inspection

Facility: Happy Import Auto Salvage, INRM00795
305 South Tibbs Avenue
Indianapolis, Indiana 46261 (317) 484-9780

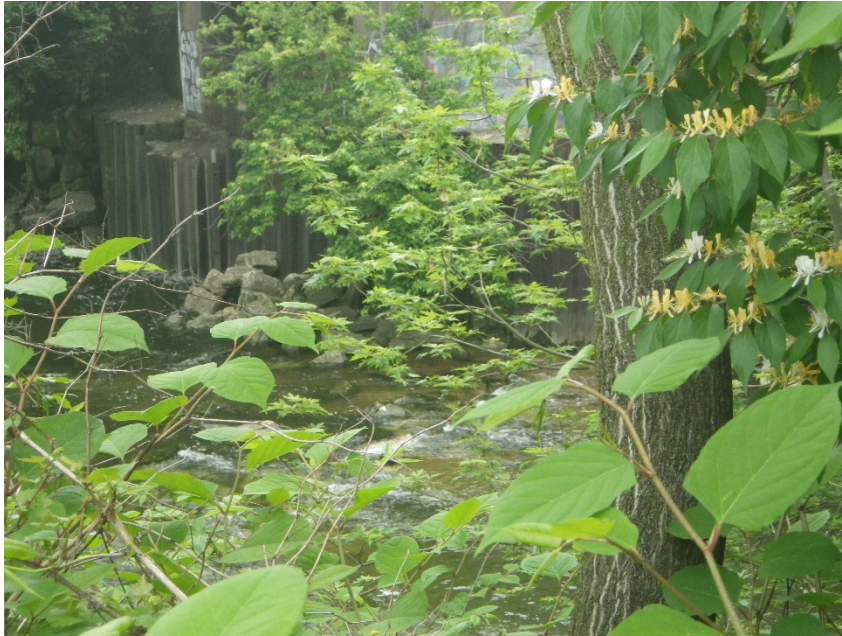
IMGP0013

A primary focus of the inspection team was to locate Outfall 001 as described in the NOI and SWPPP BMP layout. The inspection team investigated the heavily vegetated and very steep embankment for a discrete pipe thought to be Outfall 001. Several low areas on the East embankment of Eagle Creek appeared to contain broken pipes. Upon investigation, some of these locations were comprised of old vehicle wheel cowlings and automotive parts integrated into the embankment soil matrix. Mr. Browder did not think that a unique discharge pipe designated as Outfall 001 existed to Eagle Creek (Photo #13) as there are no storm sewers or storm inlets within the salvage area.

Description: Eagle Creek looking down heavily vegetated steep embankment.

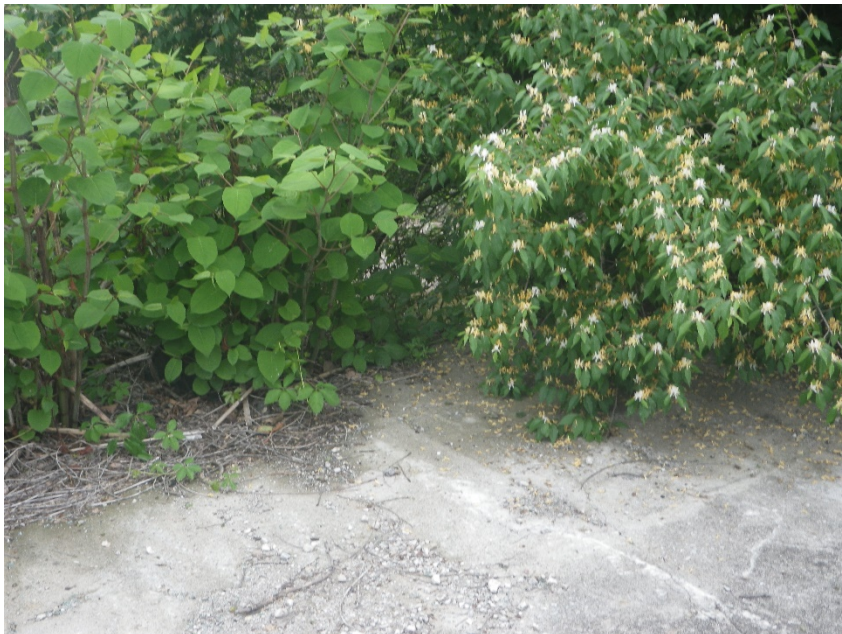
IMGP0014

Working our inspection activities south along the Eagle Creek embankment located east of the salvage yard, the team discovered numerous areas of potential storm water runoff location to Eagle Creek from the salvage yard (Photo #14). These areas contained accumulated vegetation and debris on the low side of the concrete sloped toward Eagle Creek at the embankment.

- At several areas along the embankment, EPA observed concrete sloped toward Eagle Creek indicating that stormwater flow from the facility could flow by gravity to Eagle

Creek. Holes observed in the embankment indicated that the embankment may not be sufficiently stabilized to prevent point source discharges.

Description: The concrete in this area was sloped toward Eagle Creek.

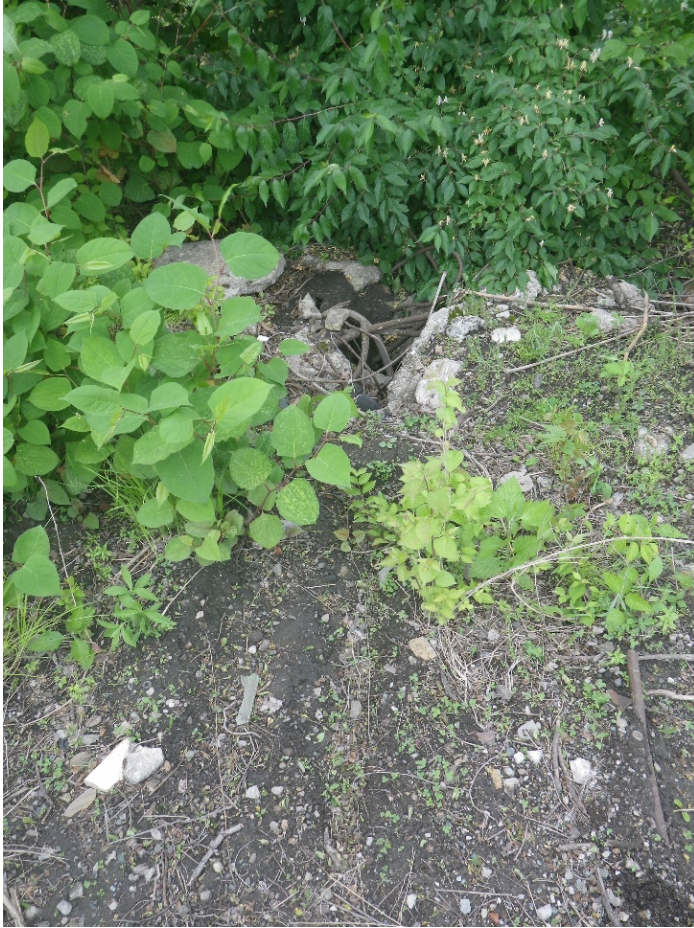
IMGP0016

The inspection team continued along Eagle Creek and located a low area with a hole (Photo #16). Upon close inspection, the hole appeared to be a void in the embankment due to soil erosion through rip rap and car parts.

Description: This area was lower, wet, and had a hole as pictured.

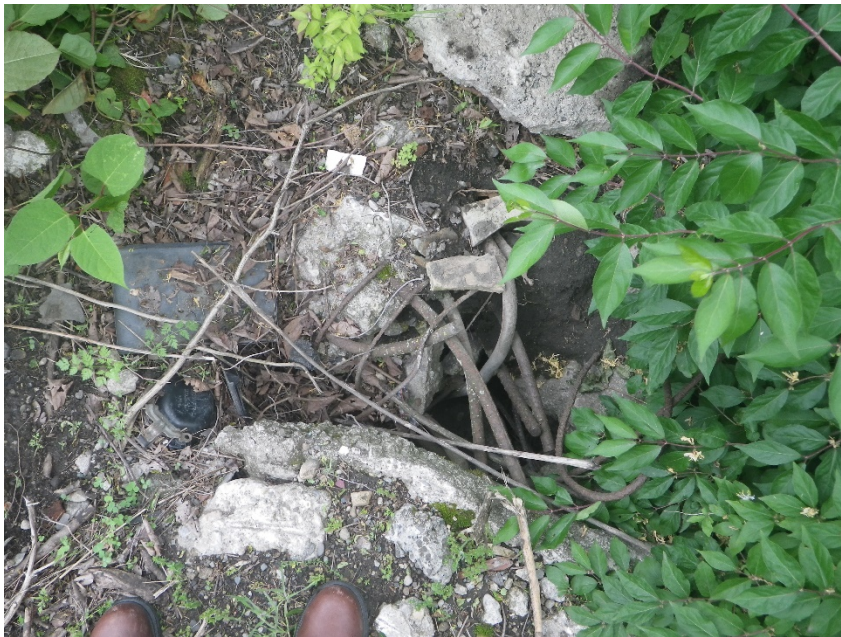
IMGP0018

As the inspection team continued south along the embankment, another potential stormwater runoff path and pipe aperture to Eagle Creek was discovered (Photo #18).

Description: At this location, we observed this hole in the ground.

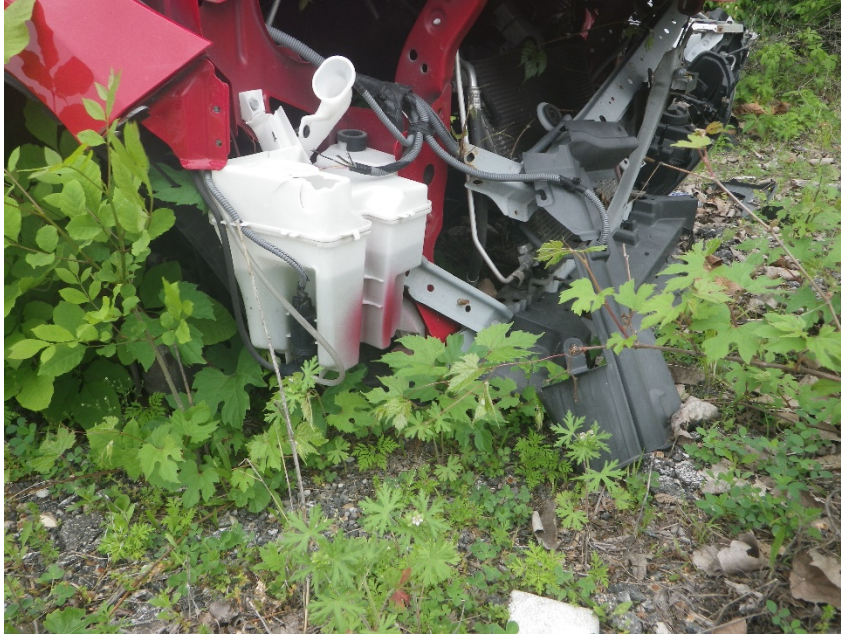
IMGP0019

The inspection team then proceeded south and found a vehicle with fluids in the containers. One container had a pink fluid and appeared to be window wash container; the other had a clear liquid and appeared to be a radiator overflow reservoir (Photo #19).

Description: Vehicle reservoir with pink liquid inside.

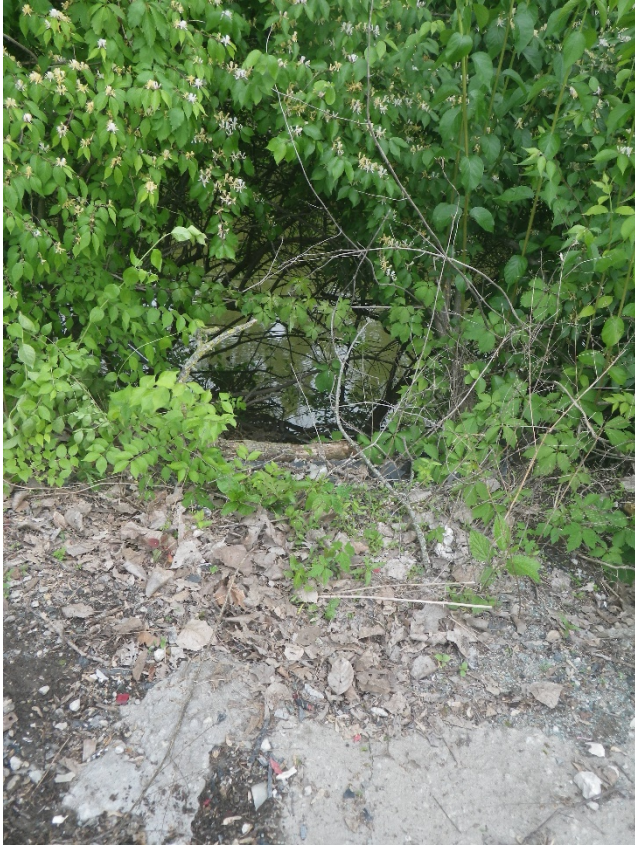
IMGP0020

Creek (Photo #20). It was unable to be determined if this aperture contained a pipe or rip rap debris as the end was obstructed with rip rap materials.

Description: Concrete in this area slopes downhill toward Eagle Creek with leaves and debris.

Top of rounded concrete object observed which was full of debris.

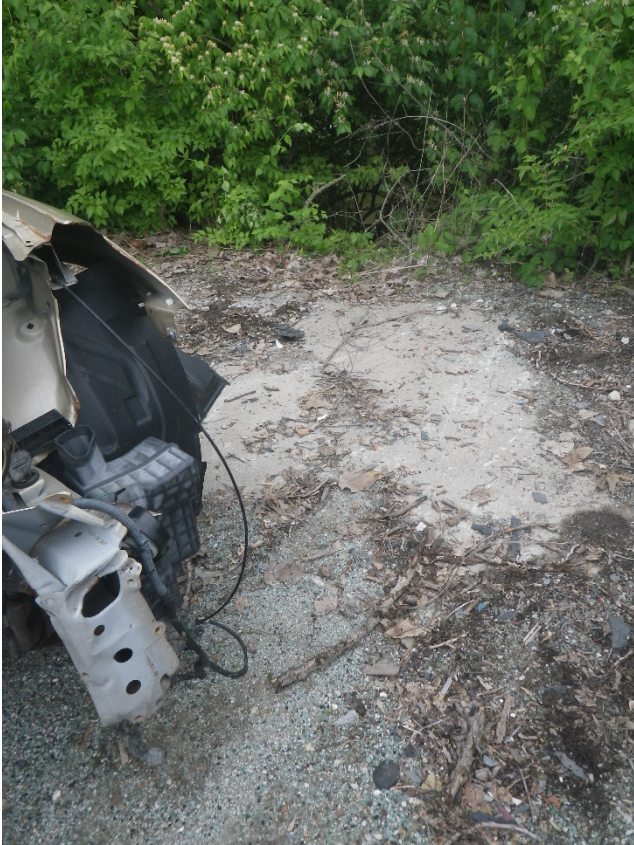
IMGP0021

As we continued south along the embankment, the team located another stormwater runoff path to Eagle Creek (Photo #21).

Description: Concrete in this area slopes downhill toward Eagle Creek.

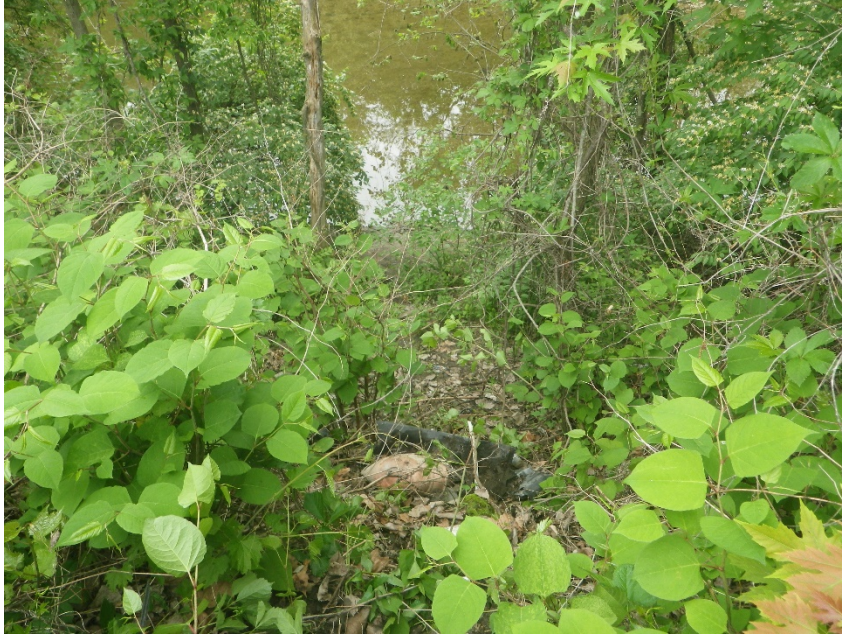
IMGP0022

Toward the extreme south of the property along the embankment to Eagle Creek, the inspection team located an area of washout/erosion where there was a path through the vegetation from a hole in the side of the embankment to Eagle Creek. (Photo #22). The five areas photographed are in the general locations illustrated on Photo #1, where the SWPP BMP site layout map illustrates the flow routes with red arrows. No discrete Outfall 001 as a pipe discharge was confirmed during the site inspection.

Description: Large circular metal object observed protruding from ground.

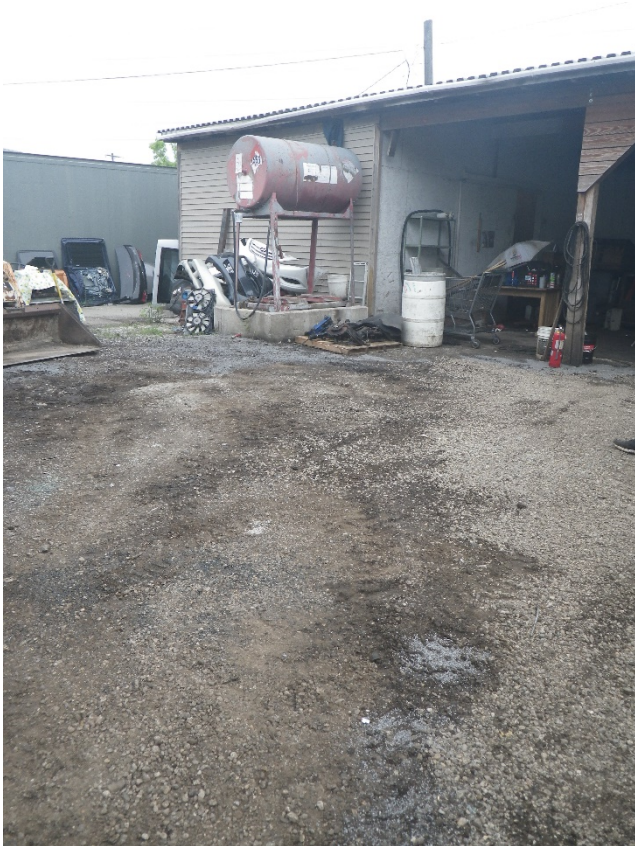
IMGP0024

After inspecting the vehicle storage area and the embankment located west of Eagle Creek, the inspection team observed covered storage of transmission and engines that were drained of fluids (Photo #23). The team then inspected the shop area and found the 300-gallon diesel fuel storage tank which had a concrete secondary containment structure located below. This tank was adjacent to a white 55-gallon drum that served as a secondary containment structure for collected antifreeze. The secondary containment structure appeared to be inadequate for the 300-gallon diesel fuel tank and was found to have a drain plug attachment that was not secured to the concrete structure (Photo #24 & #25).

- The drain plug on the secondary containment structure for the 300-gallon diesel tank was not secure. The secondary containment structure appeared to not provide adequate volume to contain 300-gallons from the diesel fuel tank.
- The 300-gallon used engine oil storage tank showed signs of overflow or leakage to the secondary containment vessel which also exhibited oil overflow or spillage.

Description: Diesel fuel storage tank and antifreeze storage tank in white secondary drum.

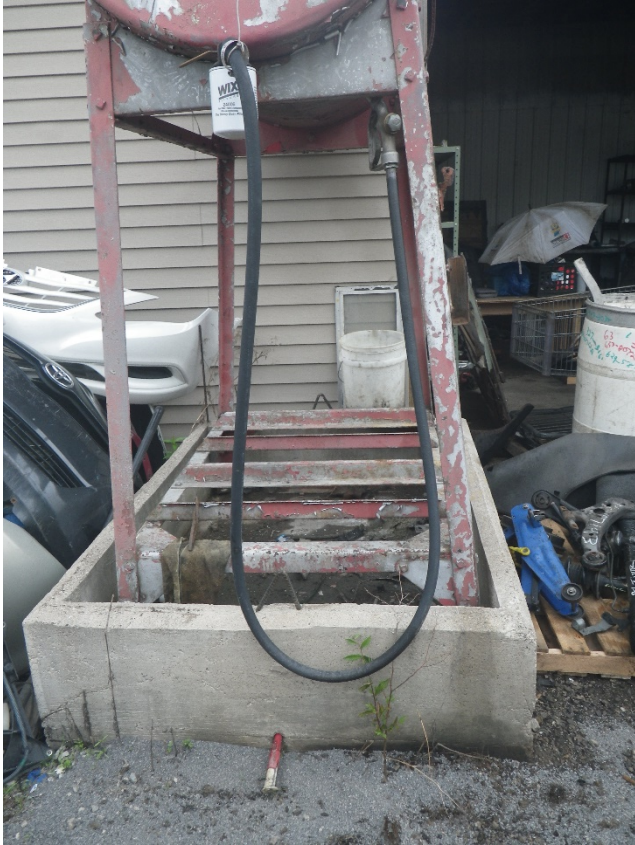
IMG0025

Description: Disjuncted drain plug from secondary containment structure.

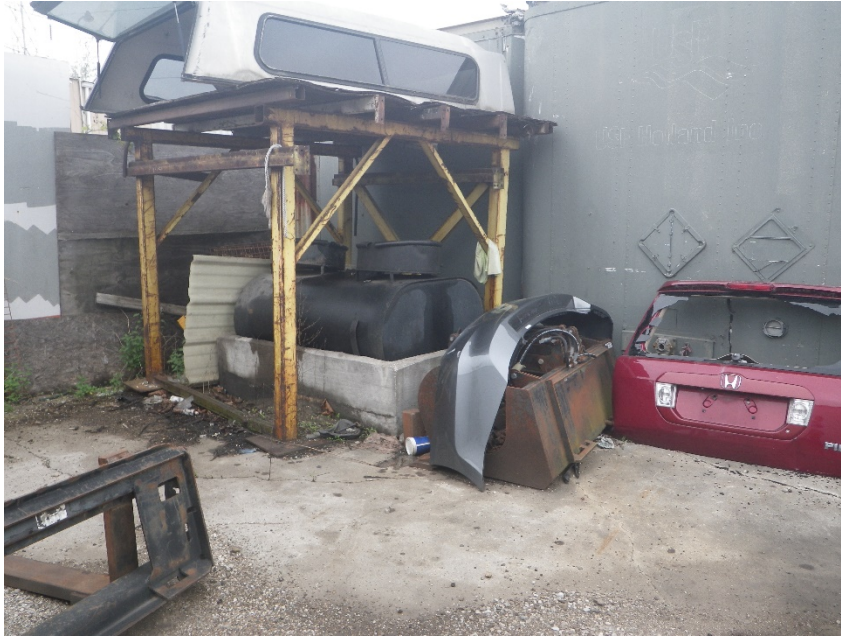
IMGP0026

The team inspected the 300-gallon engine oil storage tank with secondary containment as a concrete structure. The structure exhibits evidence of an overflow or spill train from filling the tank with used oil from the salvage vehicles (Photo #26).

Description: Engine oil storage tank.
