CAA Inspection Report

Inspection Date: 2/12/2024

Facility Name: Safetech Corporation

Appendix A: Digital Image Log for Safetech Corporation, Arecibo, PR

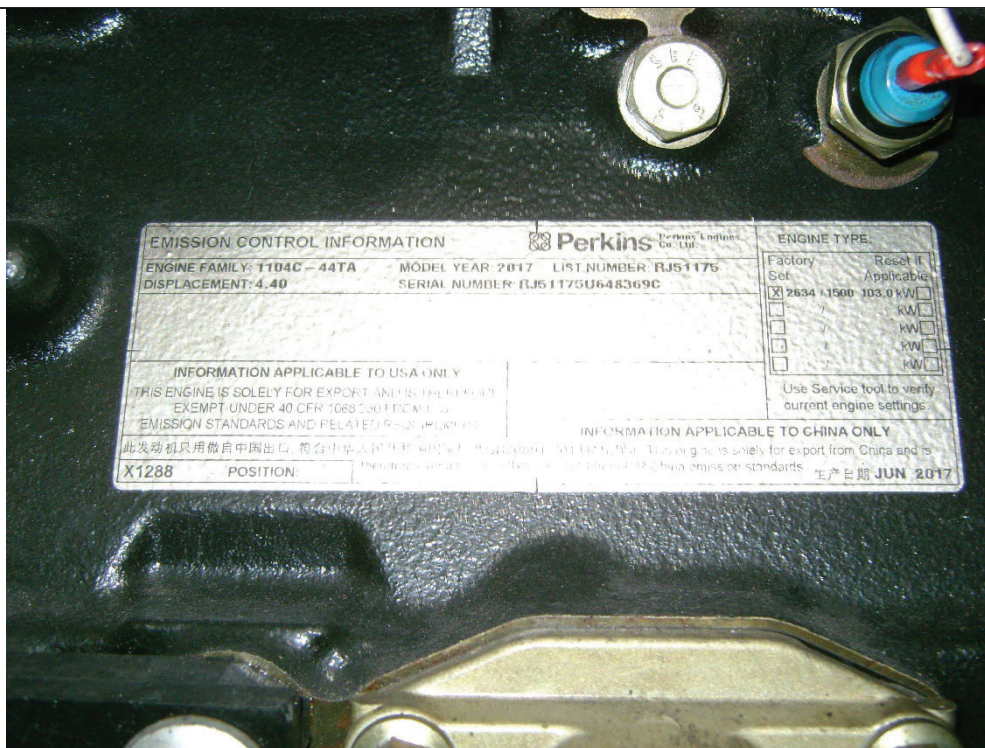
7

Plate on emergency generator engine.

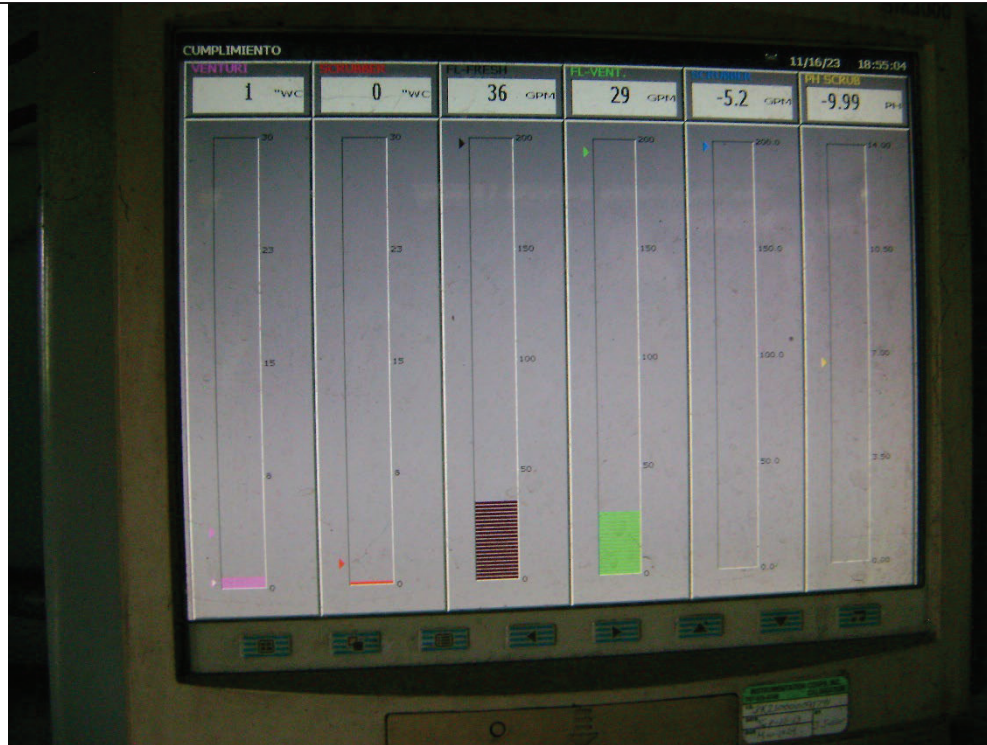
The group then returned to the incinerator area where the inspectors observed the monitoring devices for the incinerator and wet scrubber. The inspectors observed that the digital scrubber monitoring screen and pressure drop meters for both the venturi and the scrubber all indicated pressure drops of 0 inches of water column (see images 11 and 12). When they pointed this out to Mr. Saldaña, he informed the inspectors that the scrubber was not operating because incinerator had not been burning any waste since the inspectors arrived earlier that morning. The incinerator was on standby, meaning it was running only on propane. Ms. Hubbard recorded the following temperatures shown on the incinerator control while the incinerator was on standby:

Monitoring screen indicating pressure drop across the venturi and the scrubber, flow rates through the incinerator and scrubber, and scrubber water pH. Photo taken when incinerator was on standby. Date and time shown on screen are inaccurate.

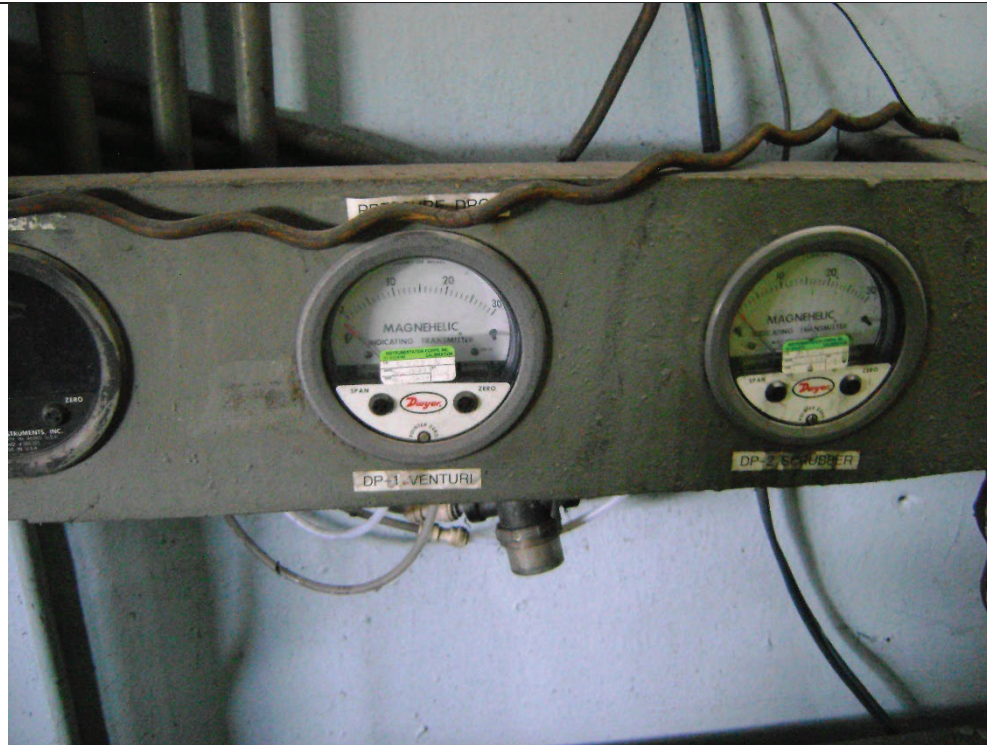
12

Differential pressure gauges for venturi and scrubber. Both gauges read 0 inches of water. Photo taken when incinerator was on standby.

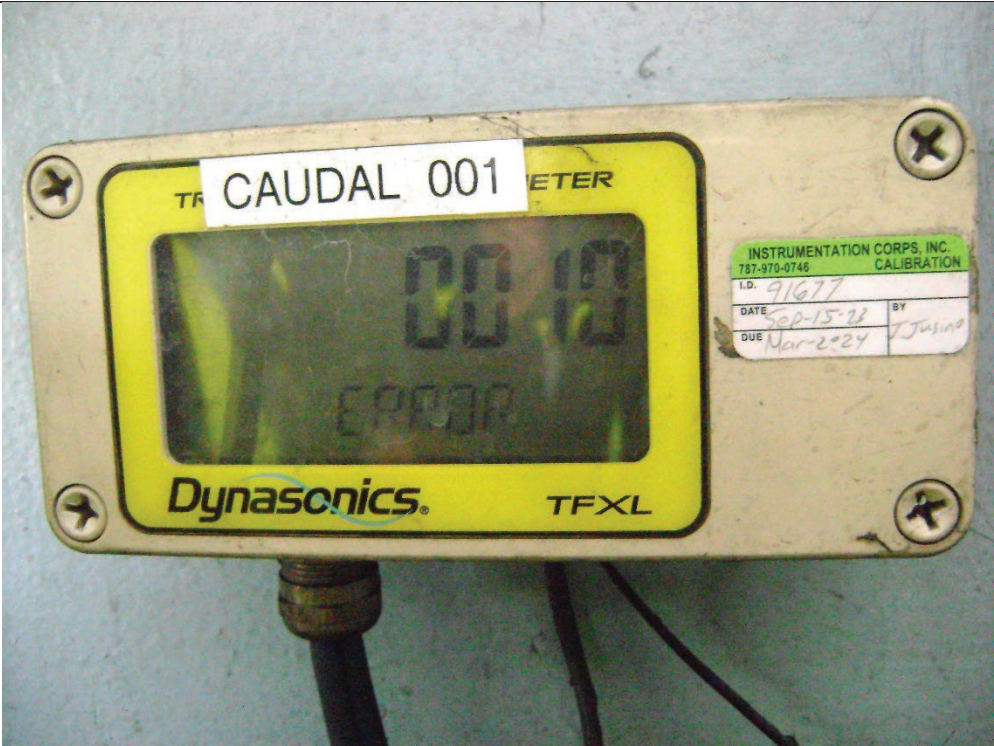
13	DSC01241.JPG

Wet scrubber flow meter.

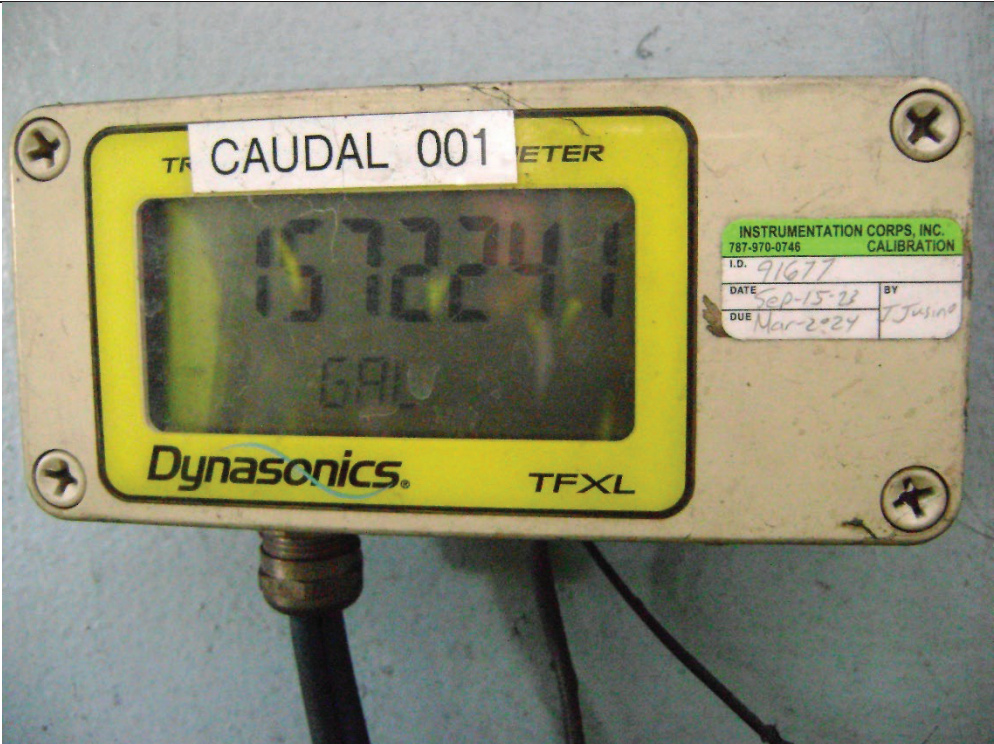
14	DSC01242.JPG

Wet scrubber flow meter.

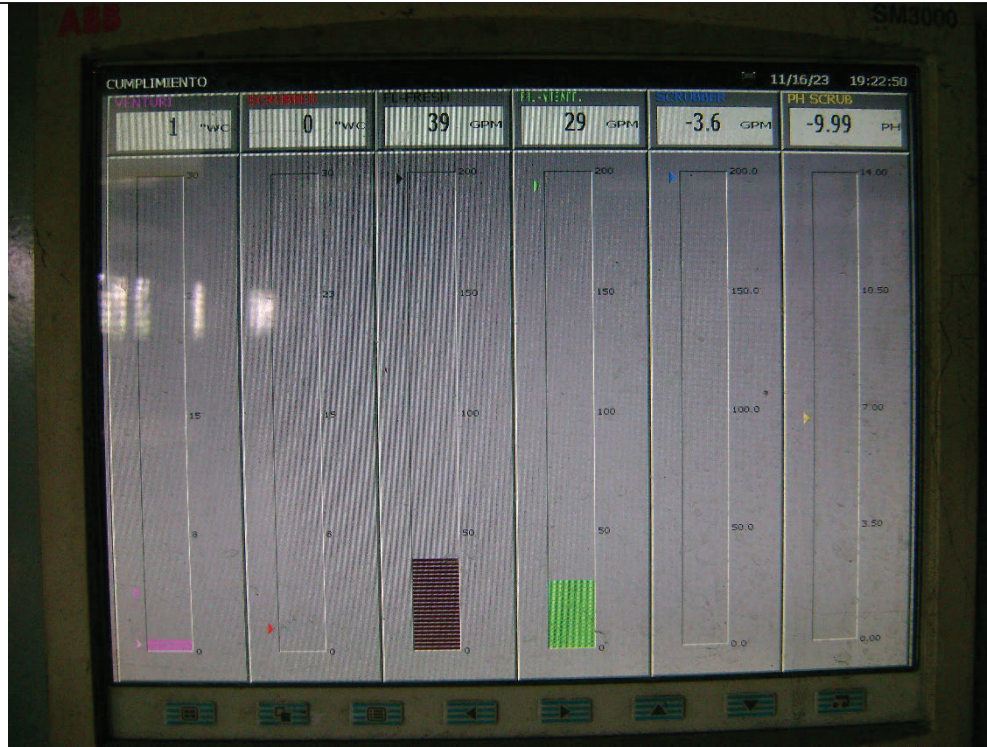
18

Monitoring screen indicating pressure drop across the venturi and the scrubber, flow rates through the incinerator and scrubber, and scrubber water pH. Photo taken after waste was added to the incinerator. Date and time shown on screen are inaccurate.

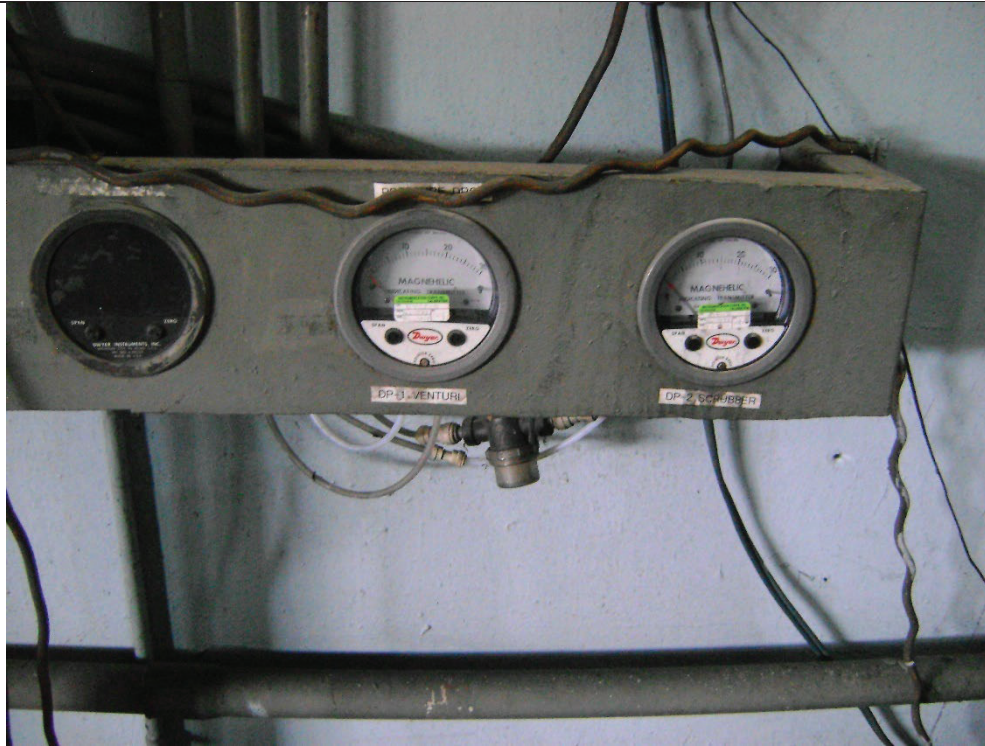
19

Differential pressure gauges for venturi and scrubber. Both gauges read 0 inches of water. Photo taken after waste was added to the incinerator.
