**Well Inspection**  
**Osage DNR / Environmental Protection Agency**  
**1201 Elm Street, Suite 500**  
**Dallas, Texas 75270**

| | Allen, TX 75013 | <b>Well ID</b> 27-W23 | | | |
| <b>Inspection Reason</b> | Plugging Witnessed | <b>Responsible Company at Time of Inspection</b> | | CapturePoint, LLC | |

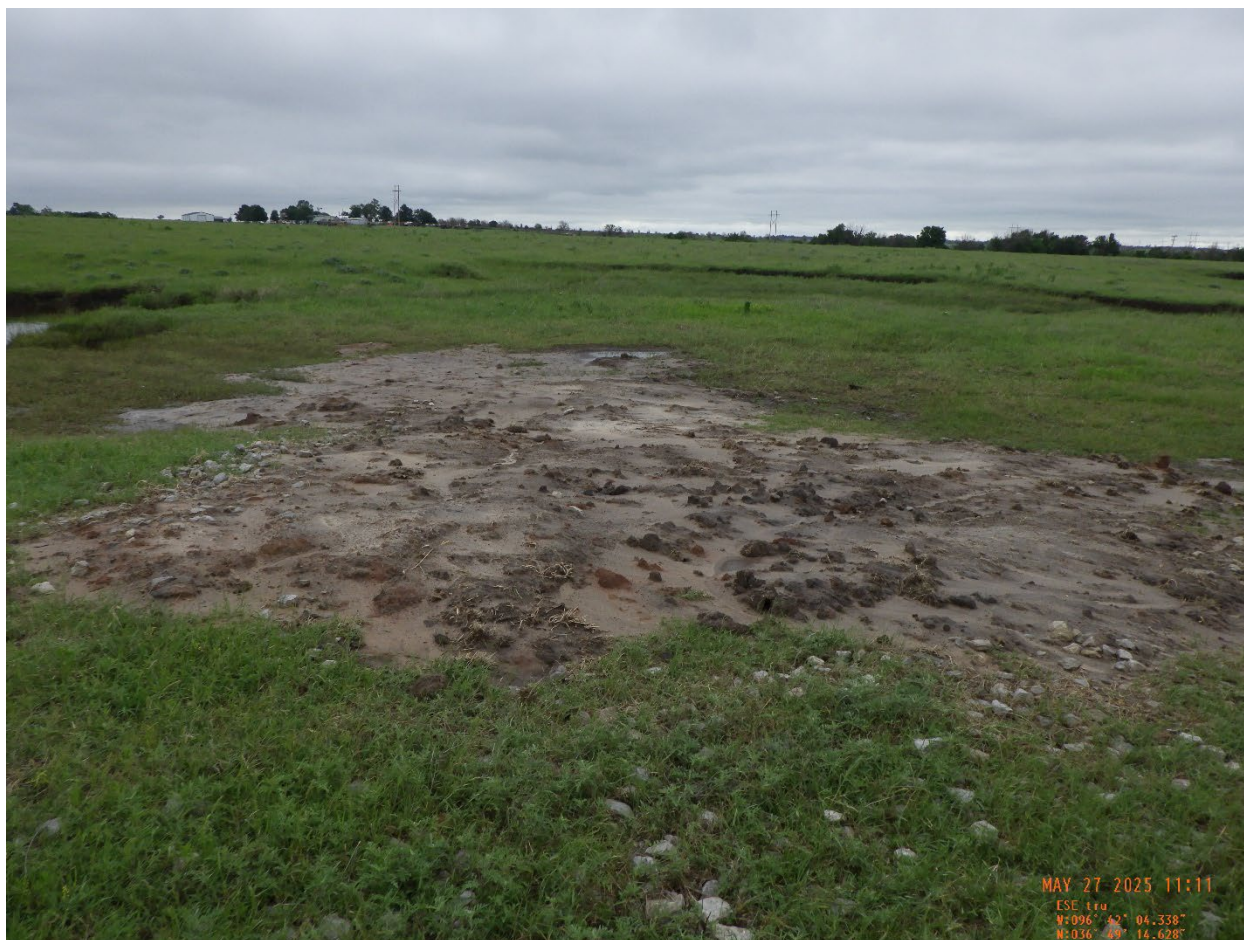
Photo No. 1

| <b>Inspection Comments</b> | | Inspector observed the well location after surface restoration was completed. There were no areas of concern at the time of the inspection. | | | |

**Description:** This was the location of well OS0284000 after surface restoration was completed.
