**U.S. ENVIRONMENTAL PROTECTION AGENCY  
REGION 4  
ENFORCEMENT AND COMPLIANCE ASSURANCE DIVISION  
CLEAN WATER ACT COMPLIANCE INSPECTION REPORT**

**Name of System:** Walls Wastewater Collection System

| <b>Type of Inspection:</b> | Wastewater Collection System CEI |

*Inspection Date: October 24, 2024*

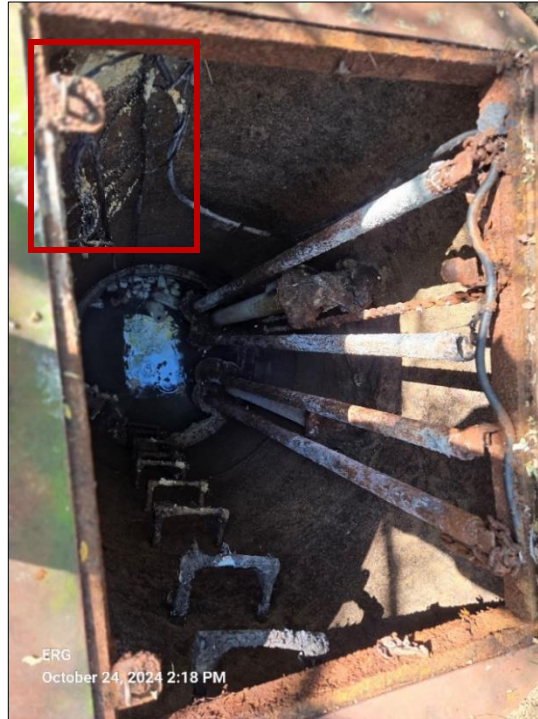
**Photograph 1.** Library lift station wet well. Note the rust and corrosion on the interior of the wet well and the float gauges. Also note evidence of high-water levels in the wet well, outlined in red.

| Name | Library Lift Station | Morningside Lift Station | Trailer Park Lift Station | Railroad Lift Station |
|---|---|---|---|---|
| Observations | Erosion near the wet well; rust and corrosion inside the wet well and on the float gauges; evidence of high-water levels in the wet well | None | None | Grease accumulation in the wet well |

- Observation 1.** The inspectors requested documentation containing more detailed SOPs for the lift stations, along with the system's total number of manholes and the total miles of sewer lines for review after the inspection. The system was unable to provide these records.
- Observation 2.** The inspectors observed grease accumulation in the Railroad Lift Station wet well (refer to Appendix A, Photograph 14).
- Observation 3.** The inspectors observed gaps/cracks in the grout and concrete exterior of the Railroad manhole (refer to Appendix A, Photograph 17).
- Observation 4.** The inspectors observed erosion near the Library Lift Station wet well (refer to Appendix A, Photograph 3). The inspectors also observed rust and corrosion inside the wet well and on the float gauges, in addition to evidence of high-water levels in the wet well (refer to Appendix A, Photograph 1).

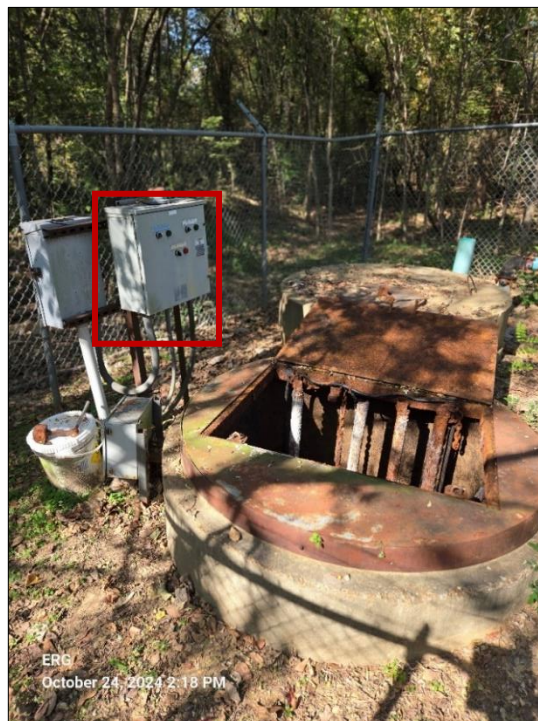
**Photograph 2.** Library lift station. The pump control panel is outlined in red. Note the rust and corrosion on the wet well access.

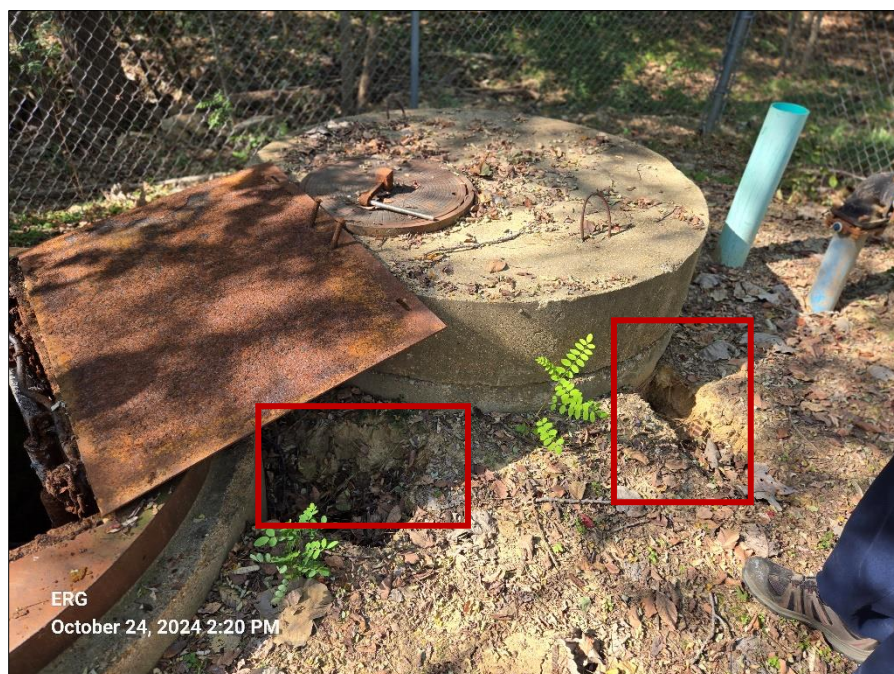
**Photograph 3.** Library lift station with erosion, outlined in red, by the wet well.

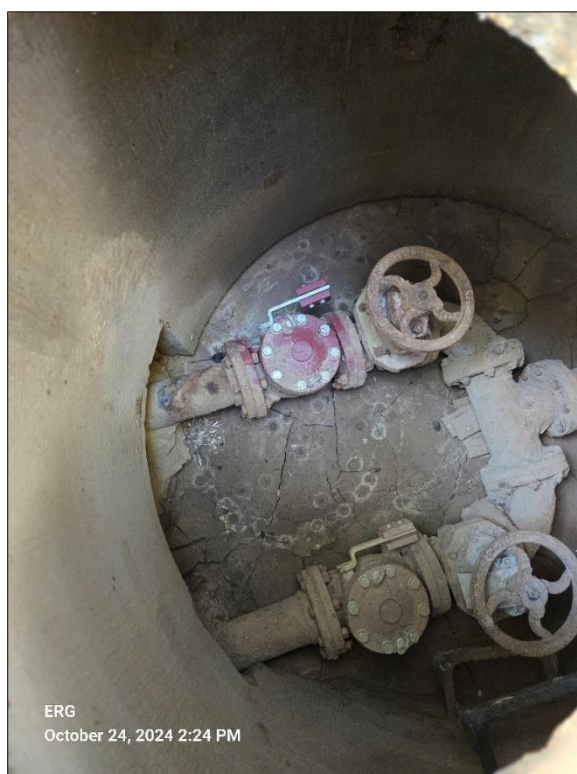
**Photograph 4.** Library lift station valve pit. Note evidence of flooding.

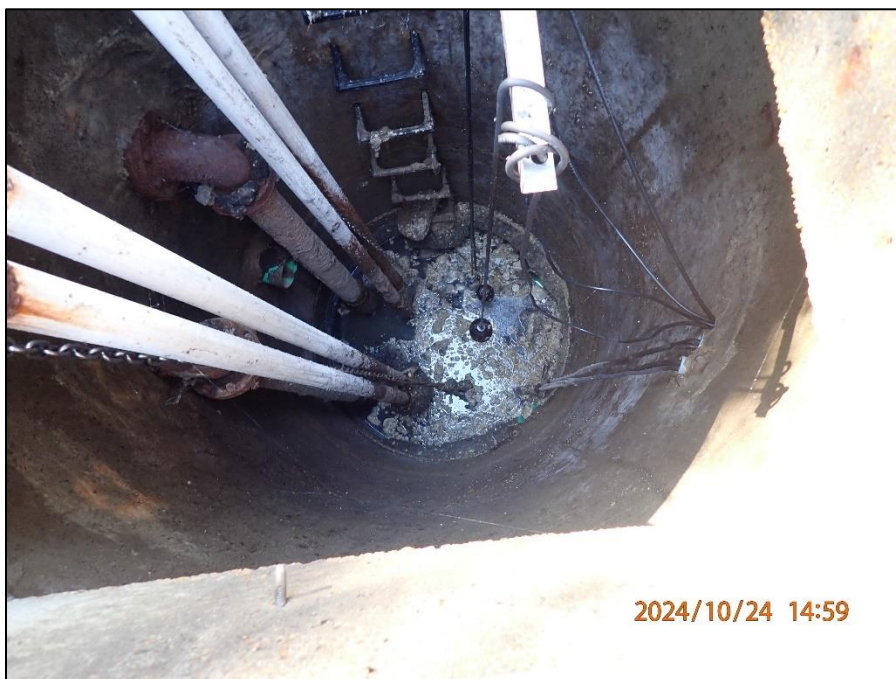
**Photograph 14.** Railroad lift station wet well. Note the grease accumulation in the wet well.

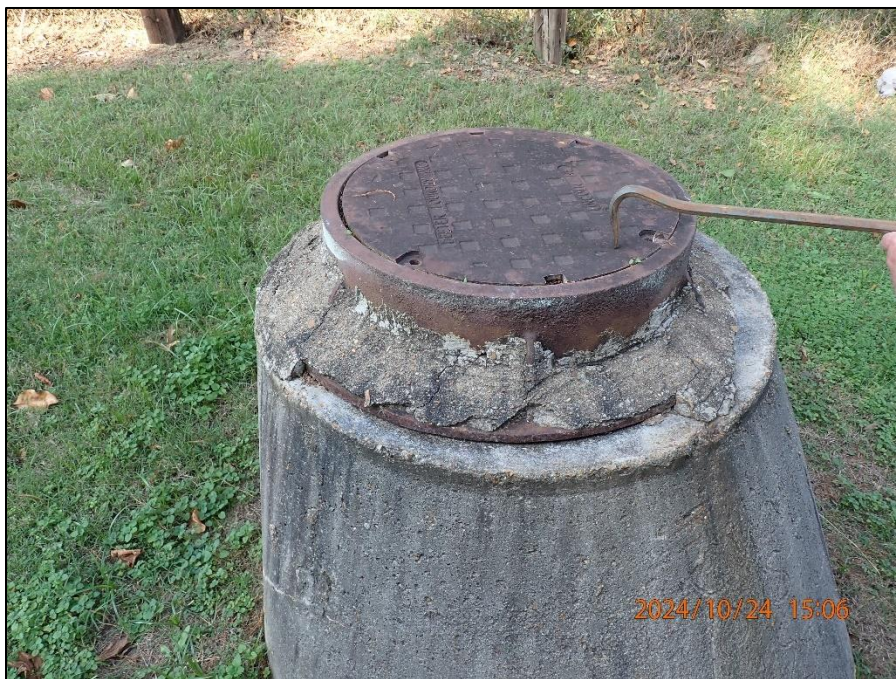
**Photograph 17.** Exterior of the Railroad manhole. Note the gaps/cracks in the grout and concrete exterior of the manhole.

| Name | Morningside | Railroad |
|---|---|---|
| Observations | None | Gaps/cracks in the grout and concrete exterior of the manhole |
