**CAA Inspection Report**

**Inspection Date:** April 30, 2024

**Facility Name:** Municipality of Arecibo Landfill

**Facility Address:** PR-682 Interior, Bo. Factor, Garrochales Sector, Arecibo, Puerto Rico

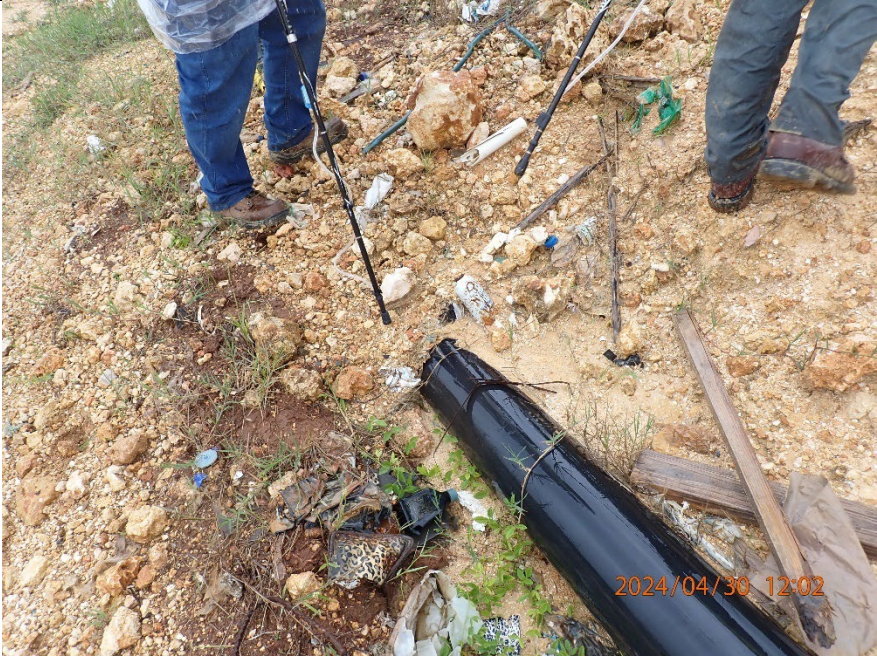
| ID | Description | Time | Reading ppm | Latitude | Longitude |
|---|---|---|---|---|---|
| A1 | Pipe horizontal | 12:00 | 6449 | 18.46638 | -66.62420 |

| 7 | P4300052.JPG | <p>Horizontal pipe penetrating ground</p> | 4/30/2024 | 1202 |

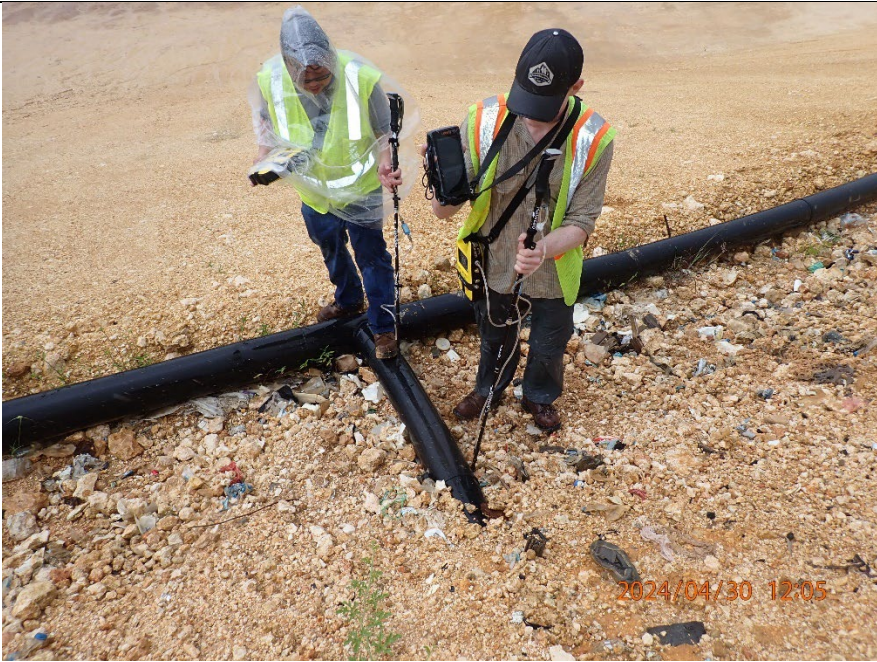
| ID | Description | Time | Reading ppm | Latitude | Longitude |
|---|---|---|---|---|---|
| A2 | Pipe horizontal | 12:04 | 7500 | 18.46629 | -66.62372 |

| 8 | P4300053.JPG | <p>Horizontal pipe penetrating ground</p> | 4/30/2024 | 1205 |

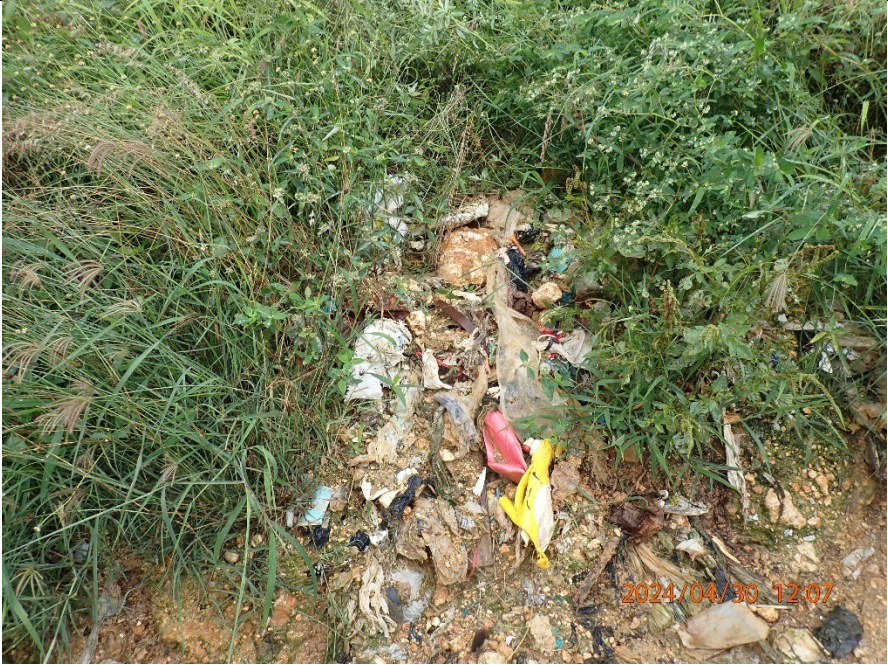
| 9 | P4300054.JPG | <p>Exposed waste</p> | 4/30/2024 | 1207 |

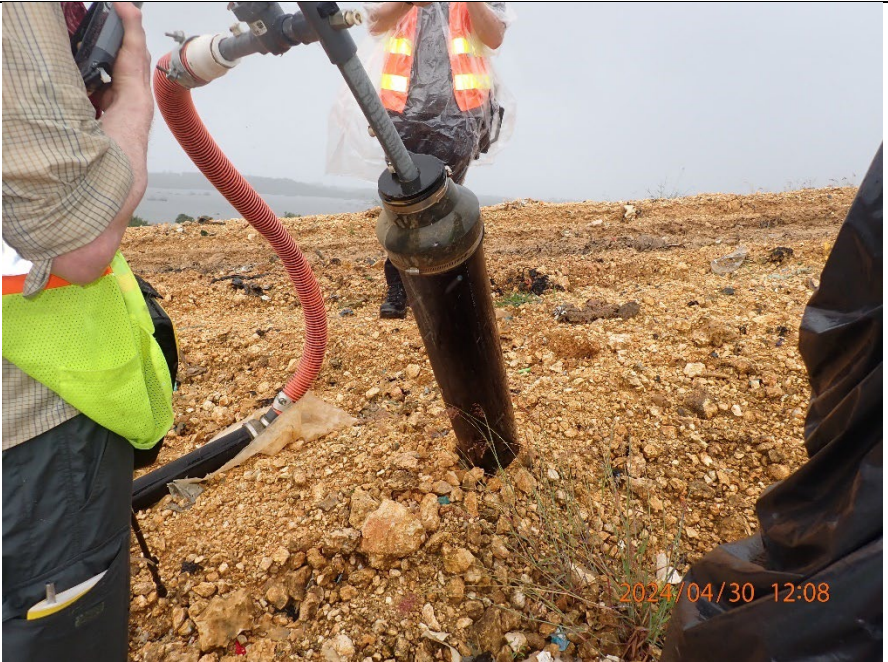
| ID | Description | Time | Reading ppm | Latitude | Longitude |
|---|---|---|---|---|---|
| A3 | Well 33 | 12:09 | 1175 | 18.46647 | -66.62380 |

| 10 | P4300055.JPG | <p>Landfill gas monitoring well #33</p> | 4/30/2024 | 1208 |

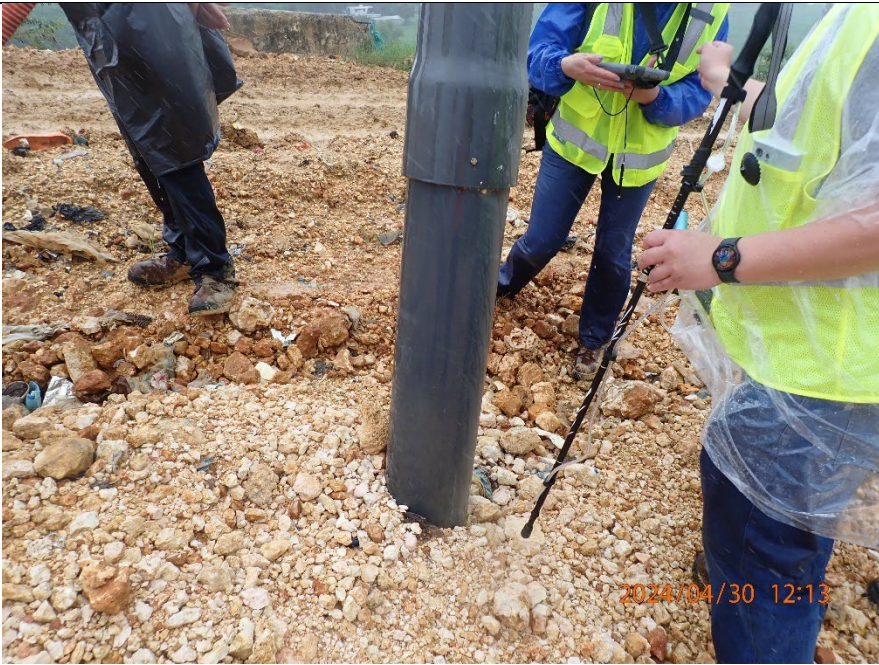
| ID | Description | Time | Reading ppm | Latitude | Longitude |
|---|---|---|---|---|---|
| A4 | Well 34 | 12:12 | 107223 | 18.46654 | -66.62350 |

| 11 | P4300056.JPG | <p>Landfill gas monitoring well #34</p> | 4/30/2024 | 1213 |

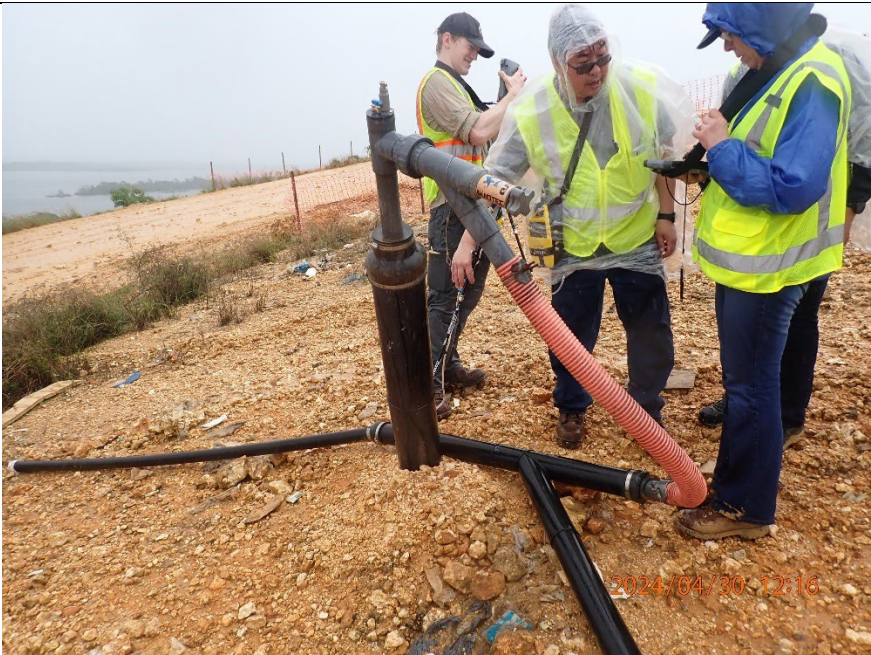
| ID | Description | Time | Reading ppm | Latitude | Longitude |
|---|---|---|---|---|---|
| A5 | Well 35 | 12:15 | 818 | 18.46670 | -66.62308 |

| 13 | P4300058.JPG | <p>2024/04/30 12:16</p> <p>Landfill gas monitoring well #35</p> | 4/30/2024 | 1216 |

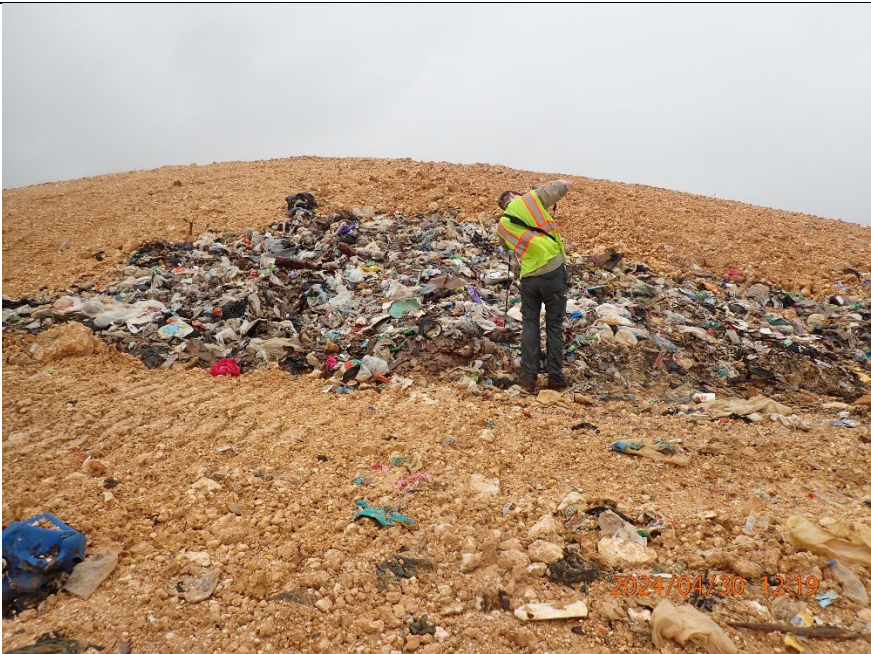
| ID | Description | Time | Reading ppm | Latitude | Longitude |
|---|---|---|---|---|---|
| A6 | Exposed waste | 12:19 | 1033 | 18.46650 | -66.62275 |

| 14 | P4300059.JPG | <p>2024/04/30 12:19</p> <p>Exposed waste</p> | 4/30/2024 | 1219 |

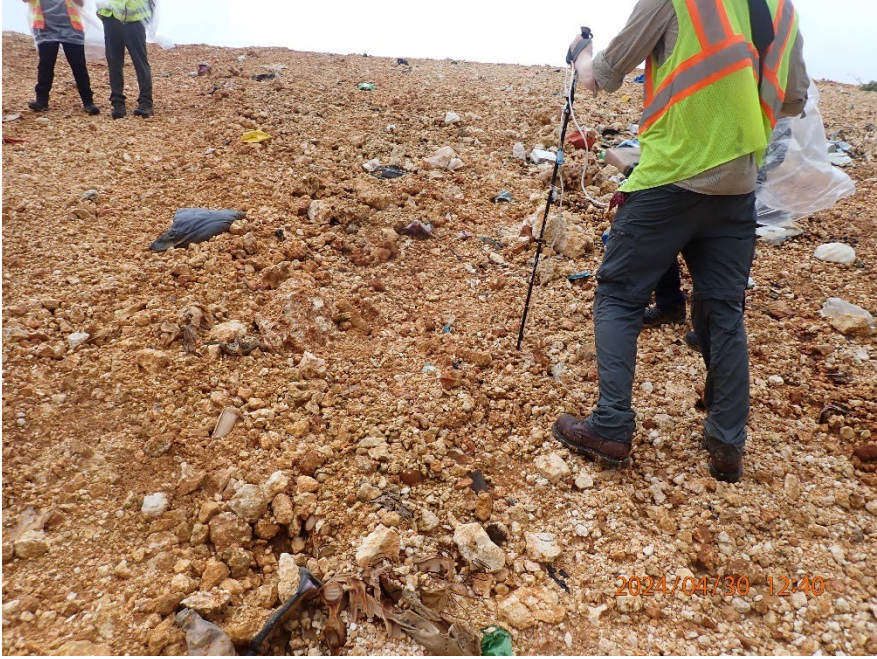
| 20 | P4300065.JPG | <p>Exposed waste</p> | 4/30/2024 | 1240 |

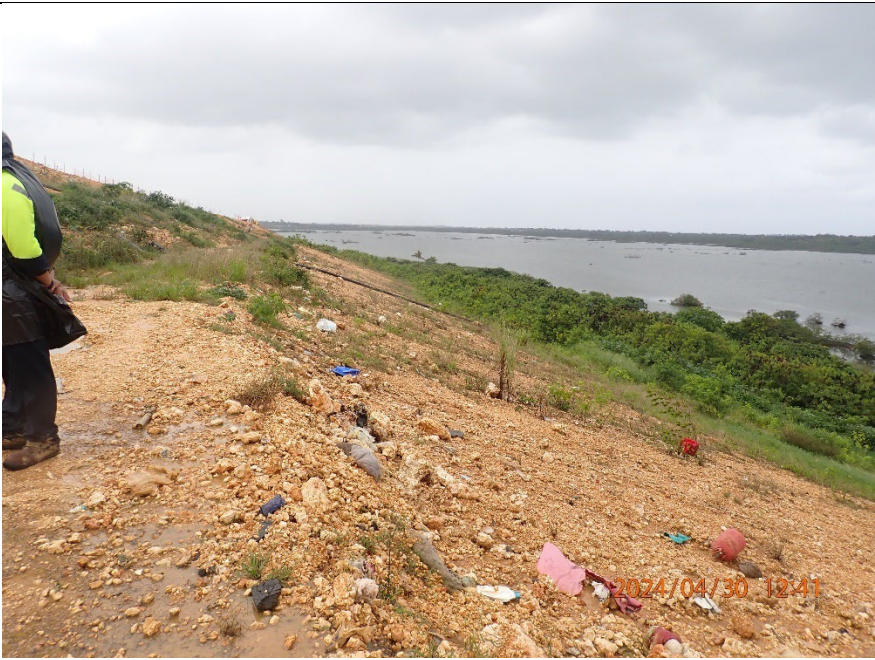
5. Significant vegetation growth at the edges of the landfill presents a challenge to properly conduct SEM.
6. Disparity between the inspectors SEM findings and what it is being reported in the facility SEM quarterly reports. The SEM reports EPA reviewed from 2021 and 2022 prior to inspection reported 0 exceedances in every quarter, and the opening conference confirmed that facility still does not find SEM exceedances.

| 21 | P4300066.JPG | <p>Vegetation at bottom of the slope near adjacent waterbody</p> | 4/30/2024 | 1241 |

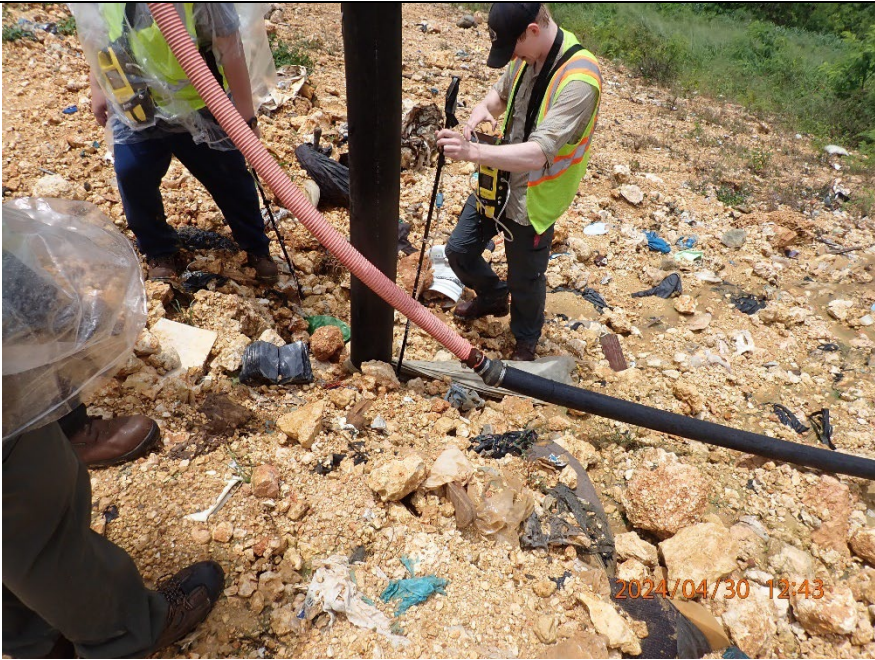
| ID | Description | Time | Reading ppm | Latitude | Longitude |
|---|---|---|---|---|---|
| A9 | Well 38 | 12:34 | 72977 | 18.46641 | -66.62139 |

| 22 | P4300067.JPG | <p>Landfill gas monitoring well #38 (tag # 79179)</p> | 4/30/2024 | 1243 |

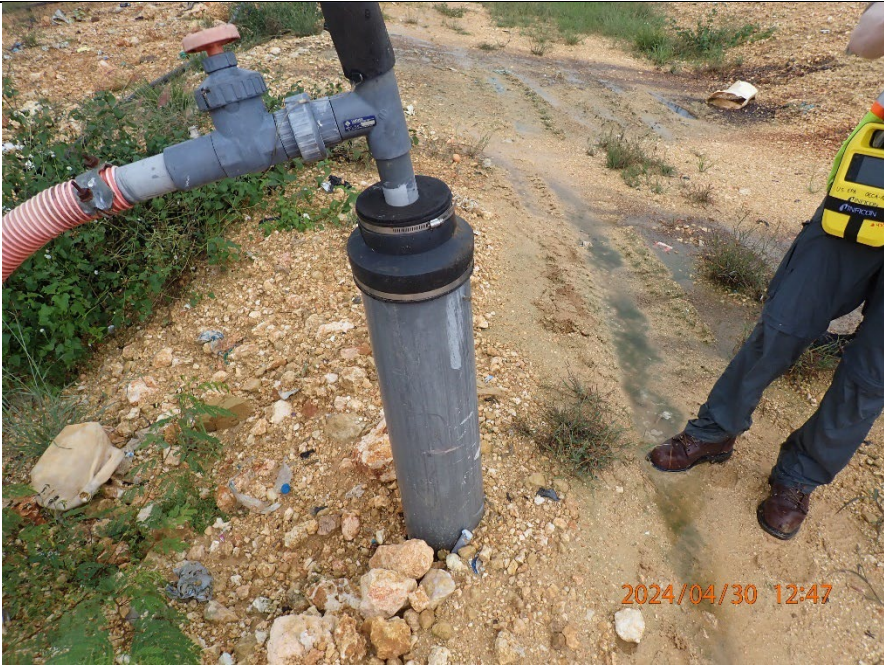
| ID | Description | Time | Reading ppm | Latitude | Longitude |
|---|---|---|---|---|---|
| A13 | Well with #73039 | 12:47 | 1117 | 18.46647 | -66.62035 |

| 24 | P4300069.JPG | <p>Landfill gas monitoring well (tag # 73039)</p> | 4/30/2024 | 1247 |

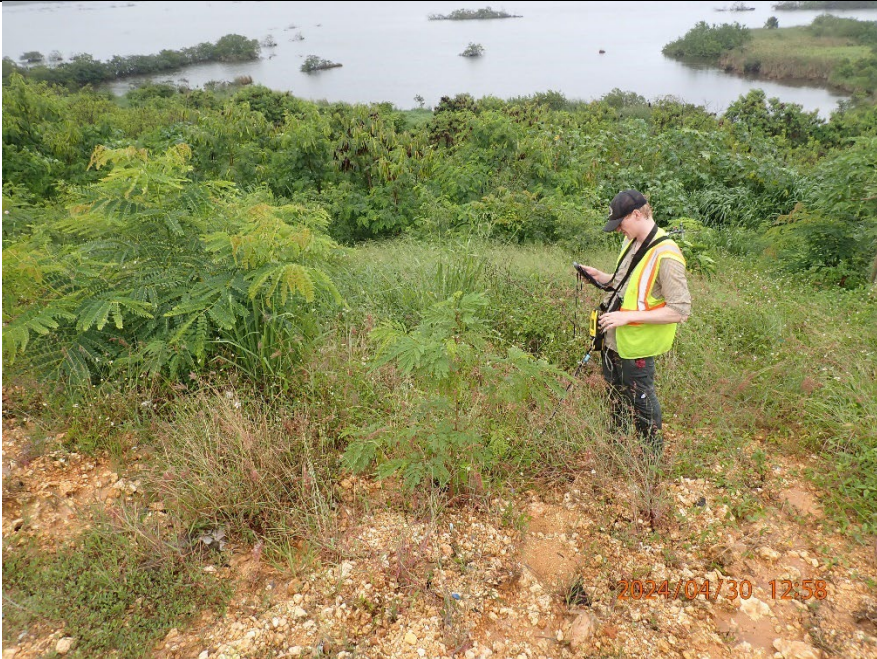
| ID | Description | Time | Reading ppm | Latitude | Longitude |
|---|---|---|---|---|---|
| A14 | Exposed waste/erosion | 12:57 | 1609 | 18.46669 | -66.62017 |

| 26 | P4300071.JPG | <p>2024/04/30 12:58</p> <p>Erosion exposed waste and vegetation</p> | 4/30/2024 | 1258 |

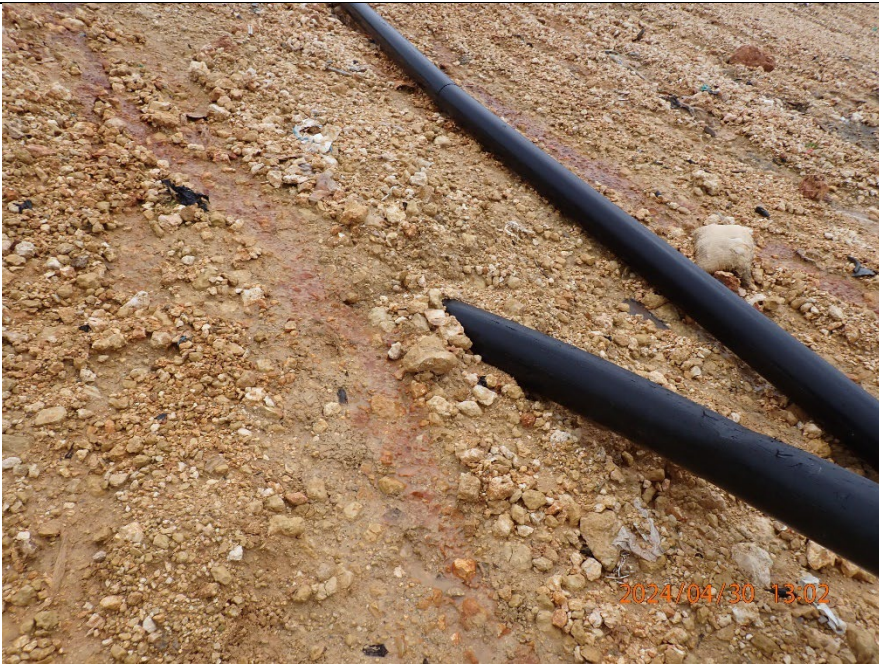
| ID | Description | Time | Reading ppm | Latitude | Longitude |
|---|---|---|---|---|---|
| A15 | Pipe sticking out | 13:01 | 20282 | 18.46642 | -66.62002 |

| 27 | P4300072.JPG | <p>Pipe sticking out of ground</p> | 4/30/2024 | 1302 |

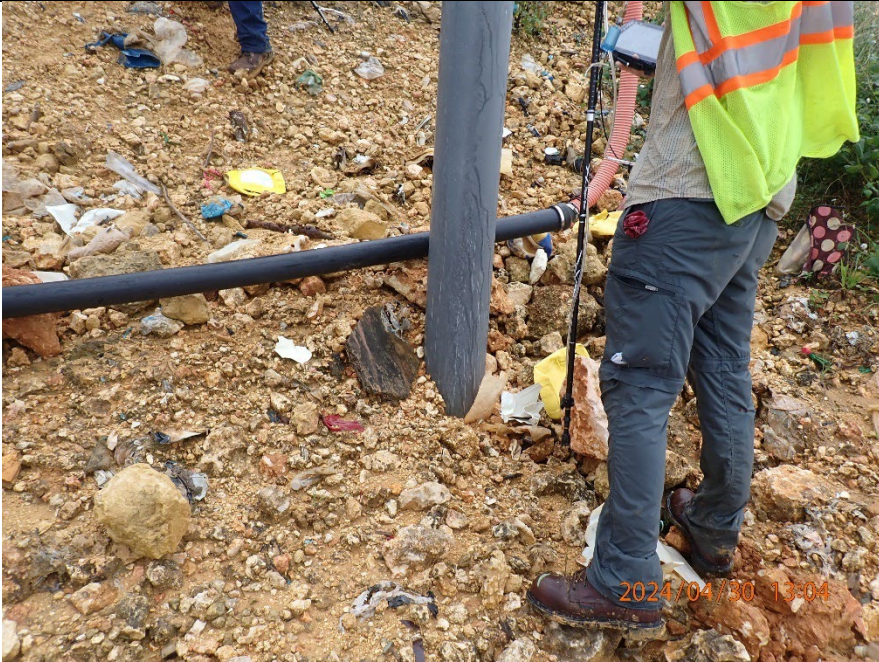
| ID | Description | Time | Reading ppm | Latitude | Longitude |
|---|---|---|---|---|---|
| A16 | Well 41 | 13:03 | 4899 | 18.46654 | -66.61971 |

| 28 | P4300073.JPG | <p>Landfill gas monitoring well #41</p> | 4/30/2024 | 1304 |

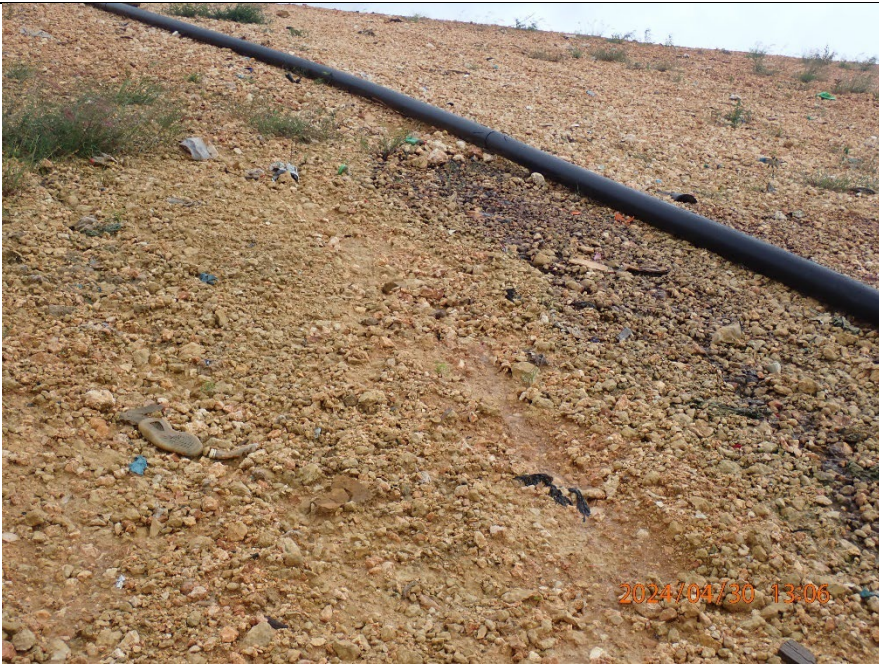
4. Significant leachate breakouts observed throughout the walkthrough. Mr. Camis was informed that although cover integrity issues were the common denominator for most of these breakouts, leachate breakouts could also be observed in areas without erosion issues too. The inspectors noted that the number of leachate breakthroughs could also indicate that numerous wells are watered-in and therefore not able to carry the quantity of gas as designed.

| 29 | P4300074.JPG | <p>Leachate seep on hill of landfill</p> | 4/30/2024 | 1306 |

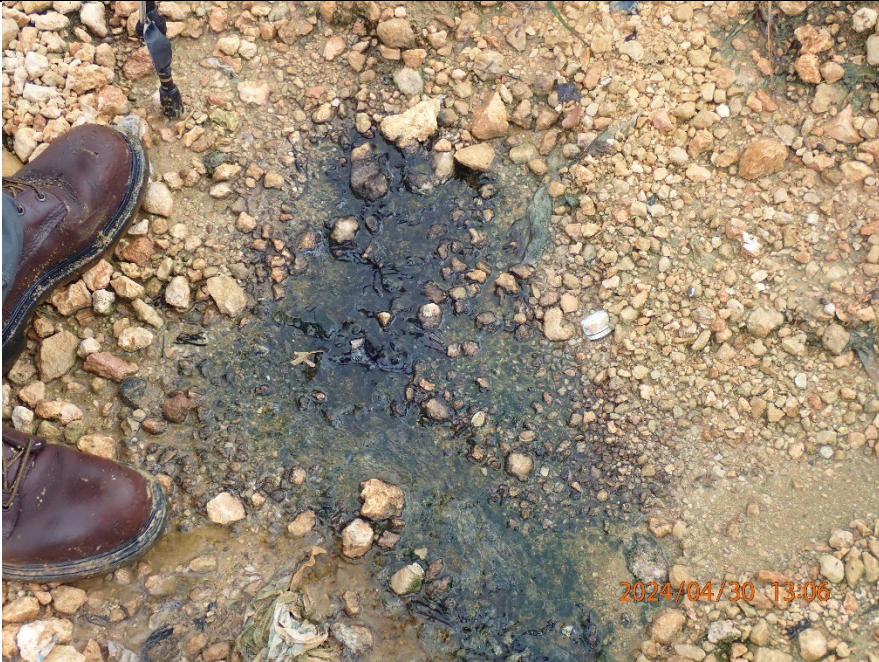
| 30 | P4300075.JPG | <p>Leachate discoloration</p> | 4/30/2024 | 1306 |

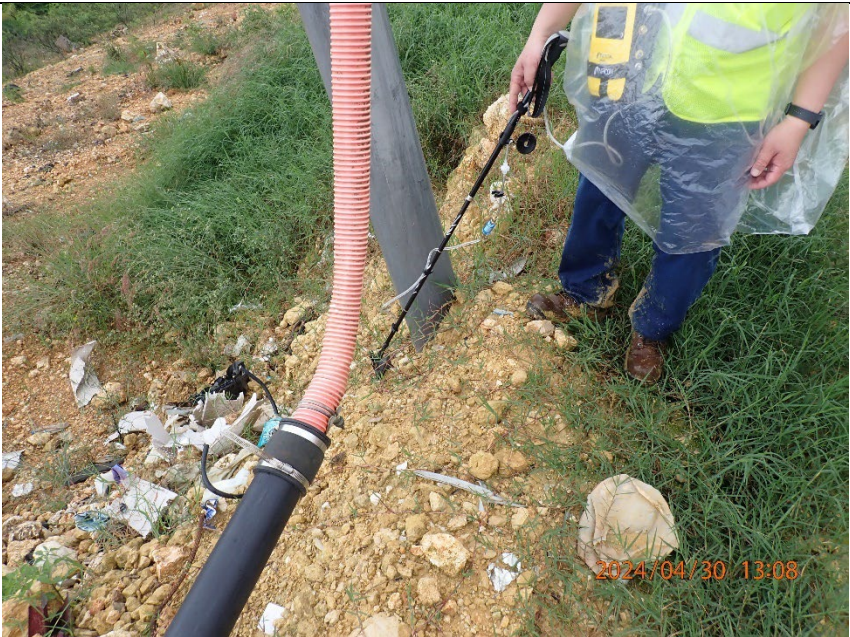
| ID | Description | Time | Reading ppm | Latitude | Longitude |
|---|---|---|---|---|---|
| A17 | Well 42 | 13:07 | 1115 | 18.46649 | -66.61914 |

| 31 | P4300076.JPG | <p>Landfill gas monitoring well #42</p> | 4/30/2024 | 1308 |

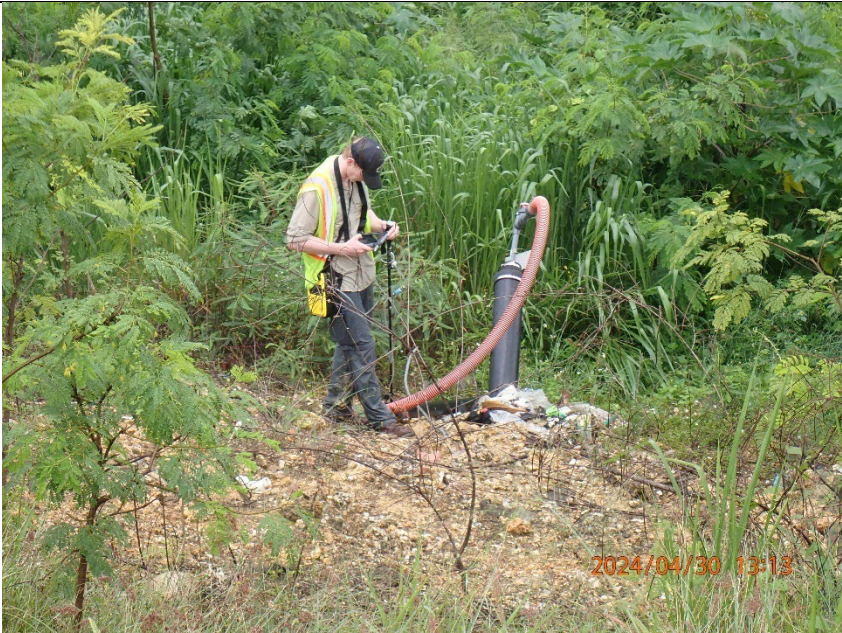
| ID | Description | Time | Reading ppm | Latitude | Longitude |
|---|---|---|---|---|---|
| A19 | Well 30 | 13:12 | 43195 | 18.46676 | -66.61872 |

| 33 | P4300078.JPG | <p>Landfill gas monitoring well #30</p> | 4/30/2024 | 1313 |

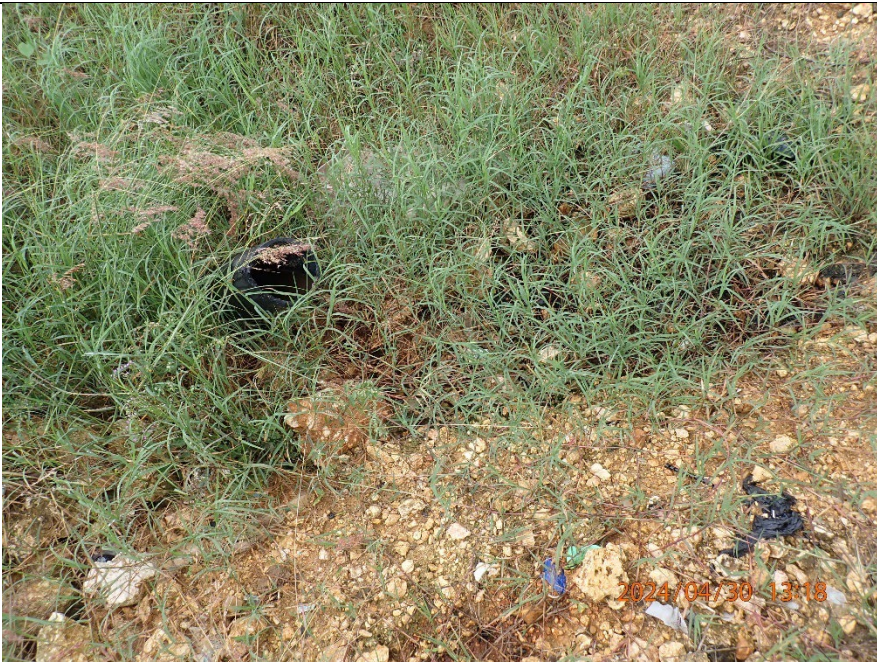
| 35 | P4300080.JPG | <p>Leachate breakout and open pipe</p> | 4/30/2024 | 1318 |

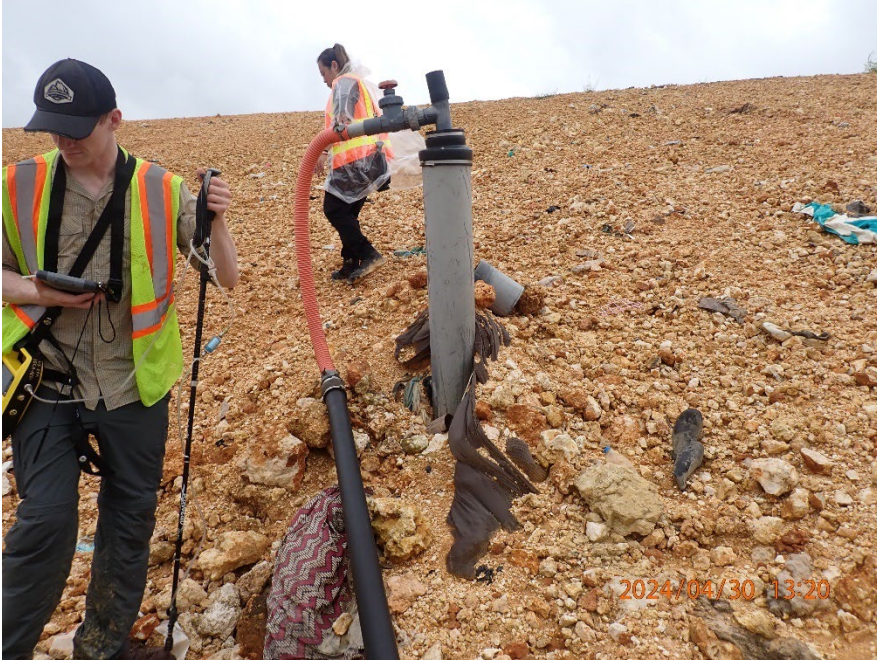
| ID | Description | Time | Reading ppm | Latitude | Longitude |
|---|---|---|---|---|---|
| A21 | Well 44 | 13:18 | 12075 | 18.46639 | -66.61799 |

| 36 | P4300081.JPG | <p>Landfill gas monitoring well #44</p> | 4/30/2024 | 1320 |

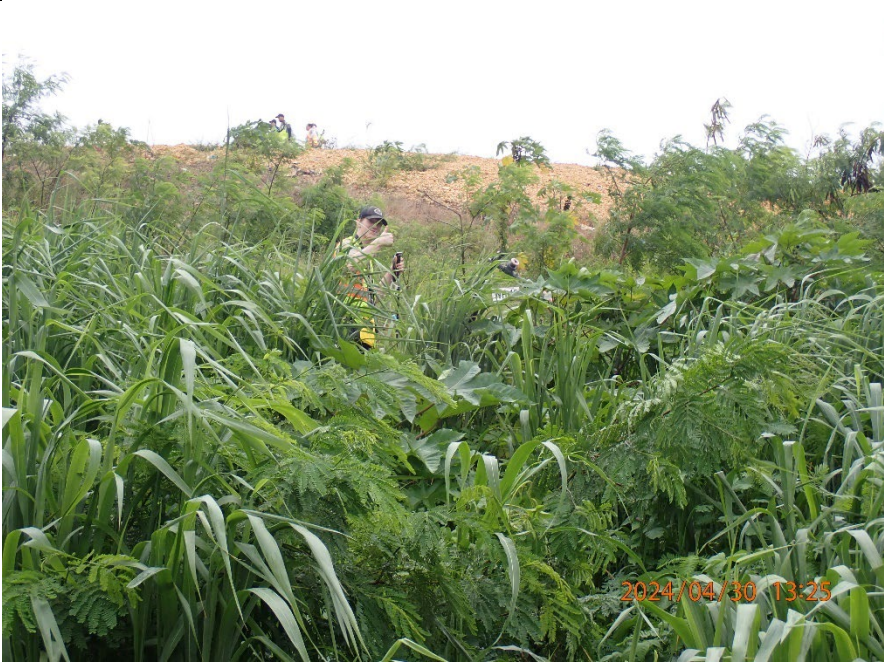
| ID | Description | Time | Reading ppm | Latitude | Longitude |
|---|---|---|---|---|---|
| A22 | Well 13 | 13:24 | 2941 | 18.46666 | -66.61748 |

| 37 | P4300082.JPG | <p>Landfill gas monitoring well #13 surrounded by thick vegetation of &gt;4 feet.</p> | 4/30/2024 | 1325 |

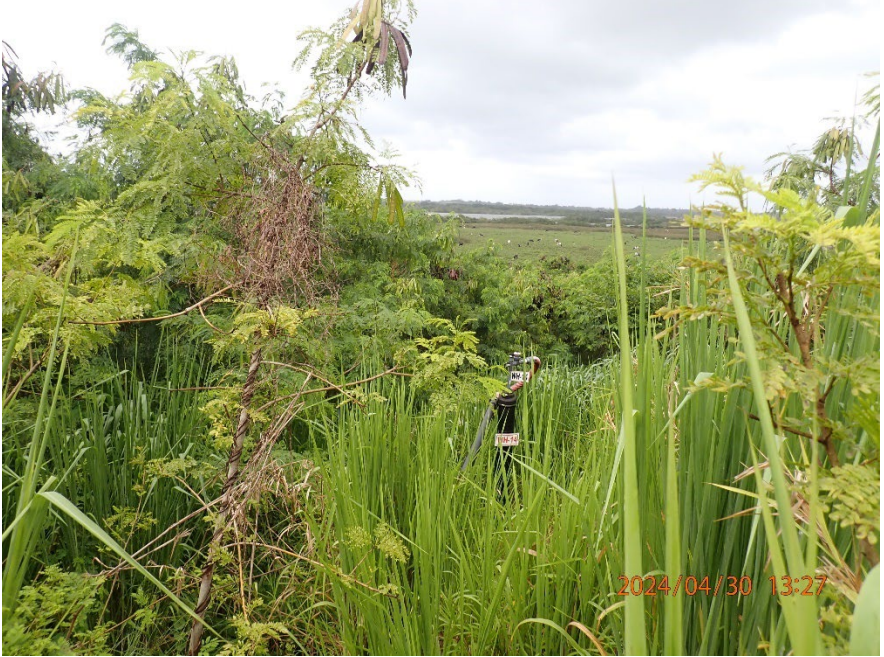
| ID | Description | Time | Reading ppm | Latitude | Longitude |
|---|---|---|---|---|---|
| A23 | Well 14 | 13:26 | 1367 | 18.46673 | -66.61702 |

| 38 | P4300083.JPG | <p>Landfill gas monitoring well #14 surrounded by vegetation</p> | 4/30/2024 | 1327 |

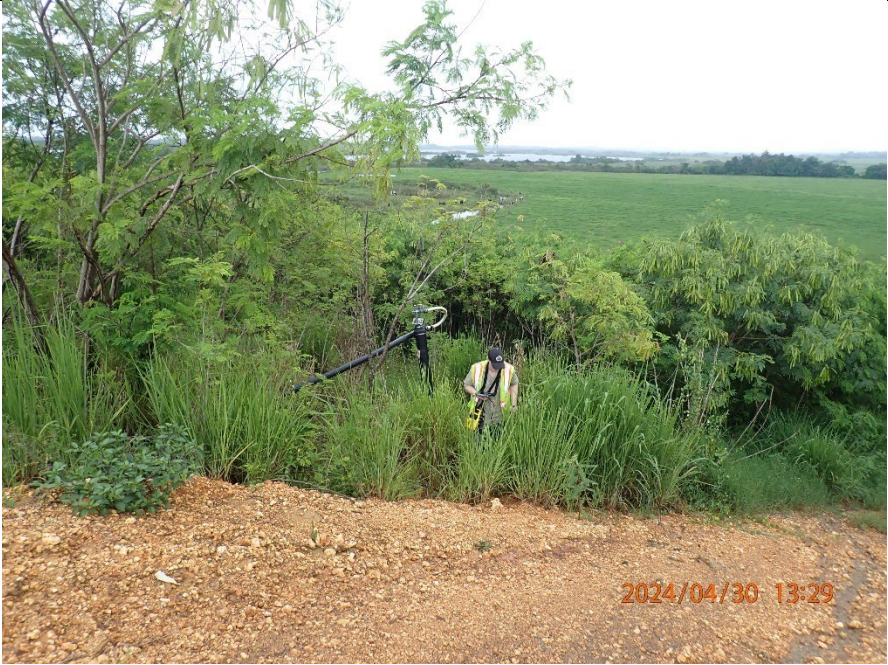
| ID | Description | Time | Reading ppm | Latitude | Longitude |
|---|---|---|---|---|---|
| A24 | Well 15 | 13:28 | 1830 | 18.46648 | -66.61701 |

| 39 | P4300084.JPG | <p>Landfill gas monitoring well #15</p> | 4/30/2024 | 1329 |

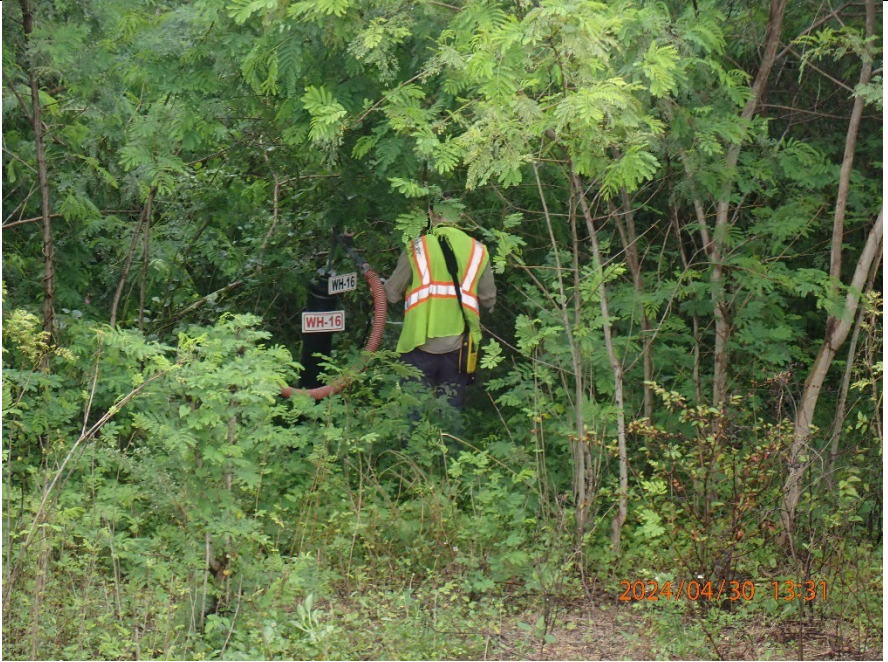
| ID | Description | Time | Reading ppm | Latitude | Longitude |
|---|---|---|---|---|---|
| A25 | Well 16 | 13:31 | 977 | 18.46614 | -66.61709 |

| 40 | P4300085.JPG | <p>Landfill gas monitoring well #16</p> | 4/30/2024 | 1331 |

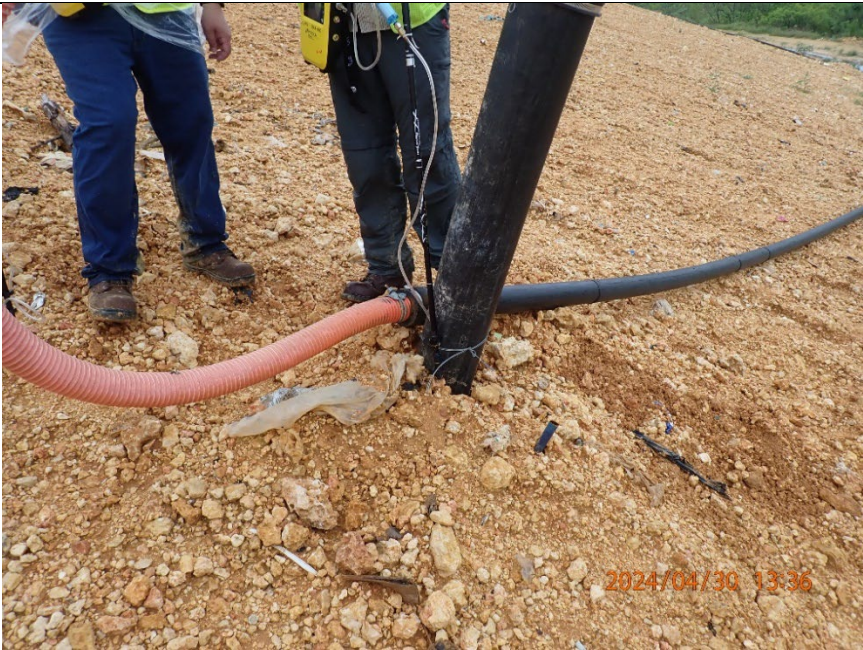
| ID | Description | Time | Reading ppm | Latitude | Longitude |
|---|---|---|---|---|---|
| A26 | Well with #79170 | 13:37 | 8946 | 18.46589 | -66.61770 |

| 41 | P4300086.JPG | <p>Landfill gas monitoring well (tag #79170)</p> | 4/30/2024 | 1336 |

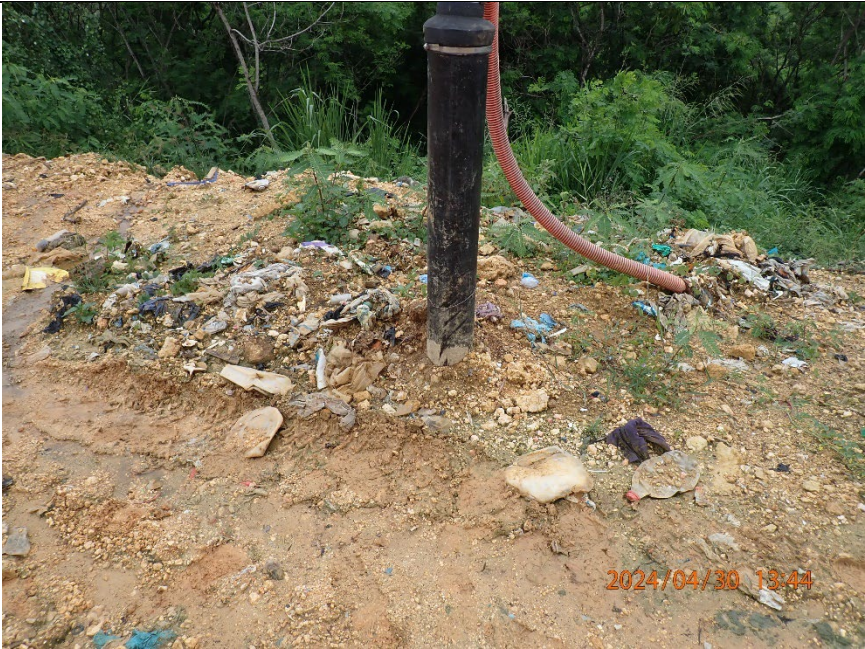
| 43 | P4300088.JPG | <p>Exposed waste</p> | 4/30/2024 | 1344 |

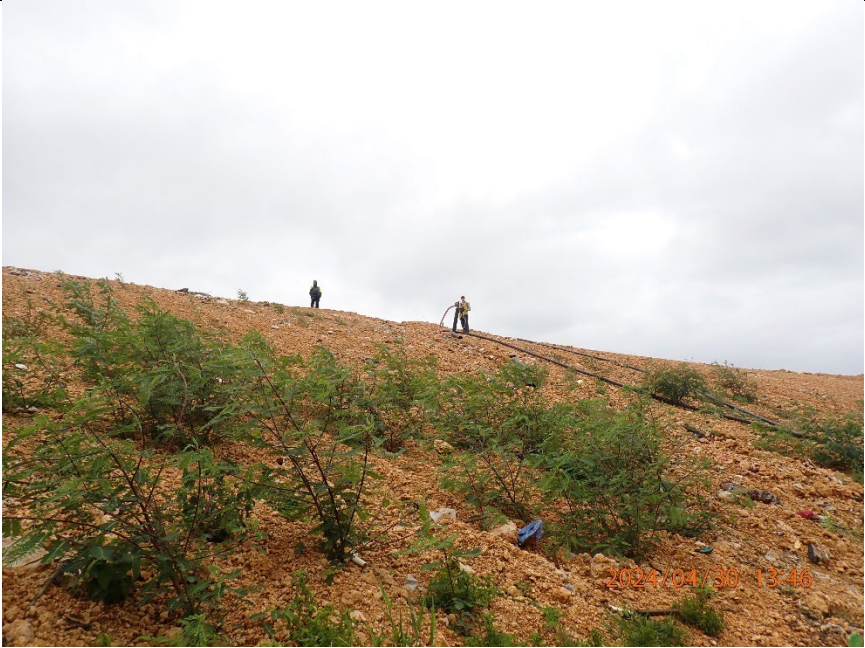
| ID | Description | Time | Reading ppm | Latitude | Longitude |
|---|---|---|---|---|---|
| A28 | Well 64 | 13:45 | 1009 | 18.46546 | -66.61802 |

| 44 | P4300089.JPG | <p>Landfill gas monitoring well #64</p> | 4/30/2024 | 1346 |

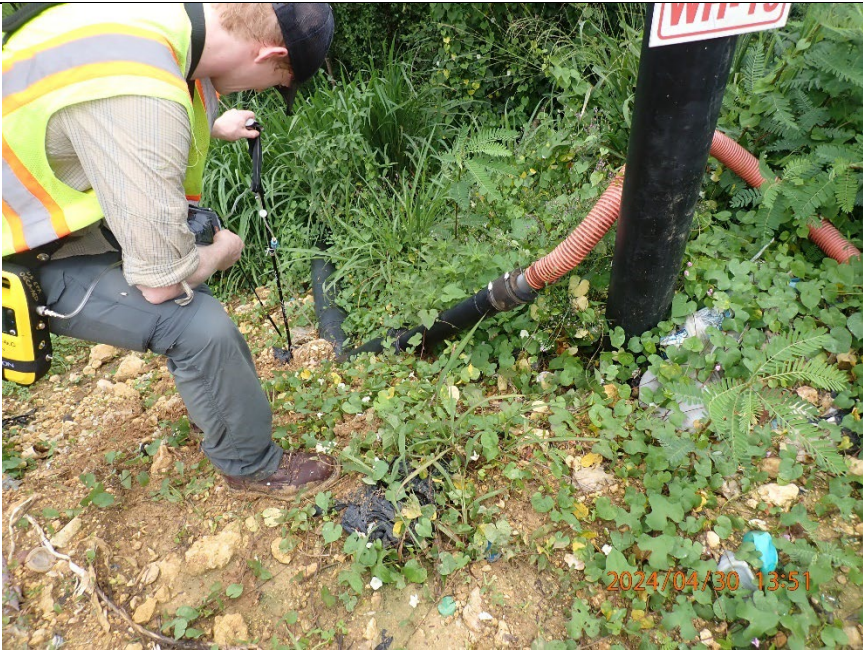
| ID | Description | Time | Reading ppm | Latitude | Longitude |
|---|---|---|---|---|---|
| A29 | Well 19 + waste | 13:51 | 10895 | 18.46485 | -66.61805 |

| 45 | P4300090.JPG | <p>Landfill gas monitoring well #19</p> | 4/30/2024 | 1351 |

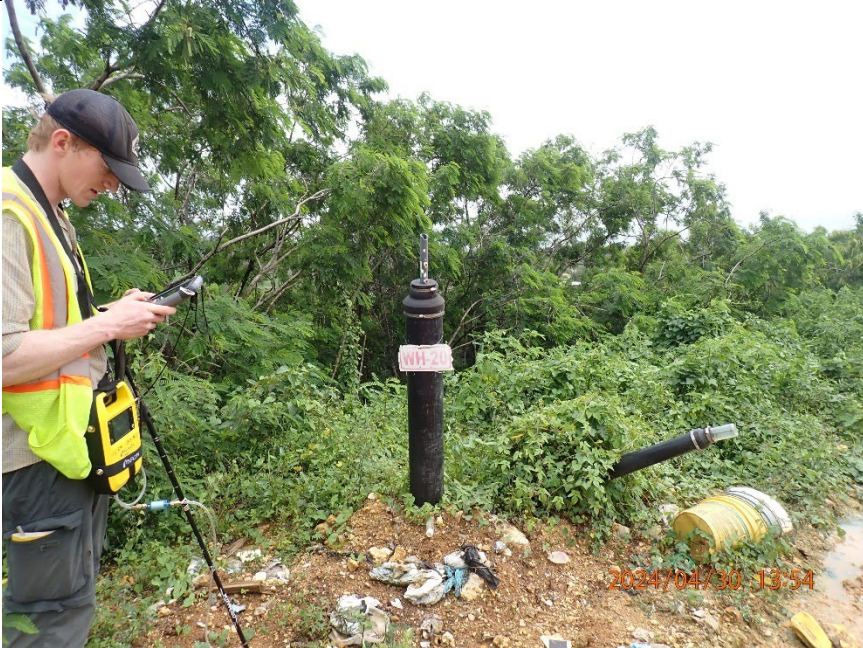
9. Cover integrity issues generating avenues for gases to migrate through the landfill surface into the atmosphere.
10. Wells venting to the atmosphere - The inspectors provided examples such as wellhead #20, that according to Mr. Fernández it was allegedly broken by a cow that got access to the landfill, the wellhead was venting to the atmosphere with methane concentrations at the top of over 300,000 ppm and 30,000 ppm from its base. The inspectors also mentioned several wellheads that were found under positive pressure. Mr. Camis

| ID | Description | Time | Reading ppm | Latitude | Longitude |
|---|---|---|---|---|---|
| A30 | Well 20 (base and venting at top) | 13:53 | 311877 at top;<br>3000 at base | 18.46455 | -66.61824 |

| 46 | P4300091.JPG | <p>Landfill gas monitoring well #20. Methane leak of &gt;300,000 ppm at the top because top was missing. Exposed waste and 3,000 ppm methane concentration at its base.</p> | 4/30/2024 | 1354 |

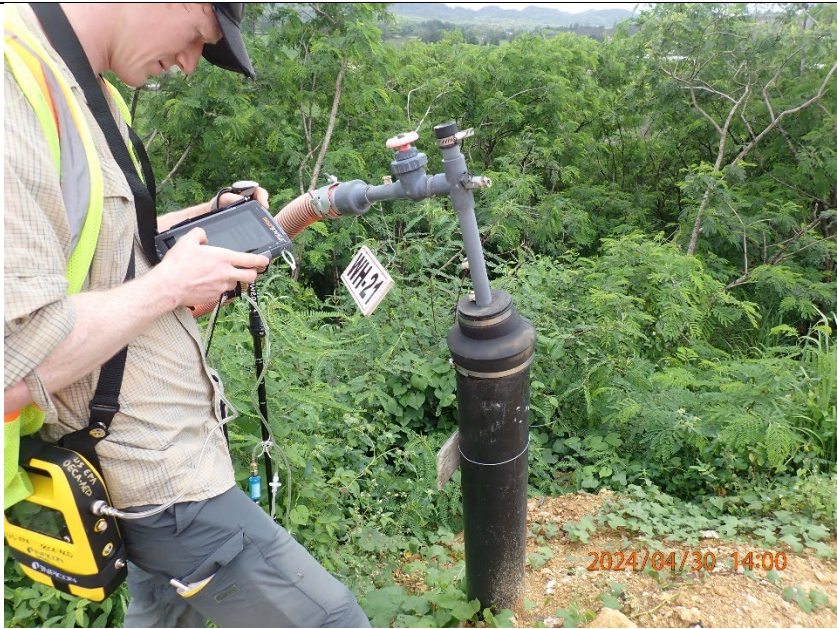
| ID | Description | Time | Reading ppm | Latitude | Longitude |
|---|---|---|---|---|---|
| A31 | Well 21 | 13:59 | 1037 | 18.46421 | -66.61871 |

| 47 | P4300092.JPG | <p>Landfill gas monitoring well #21</p> | 4/30/2024 | 1400 |

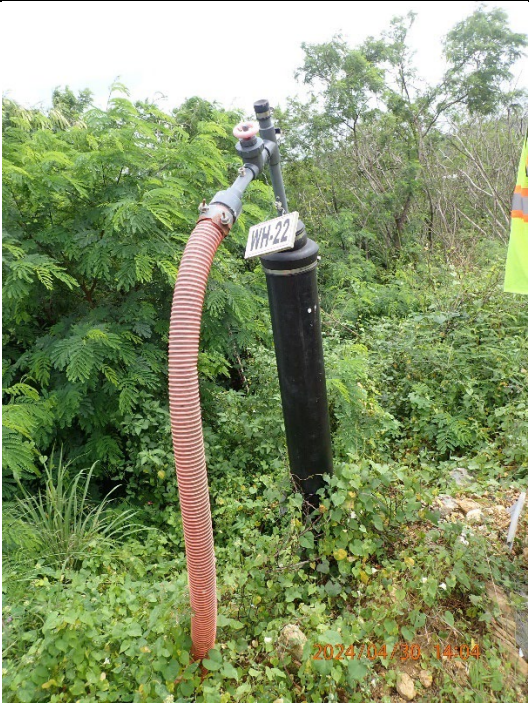
| ID | Description | Time | Reading ppm | Latitude | Longitude |
|---|---|---|---|---|---|
| A32 | Well 22 | 14:03 | 4274 | 18.46385 | -66.61931 |

| 48 | P4300093.JPG | <p>Landfill gas monitoring well #22</p> | 4/30/2024 | 1404 |

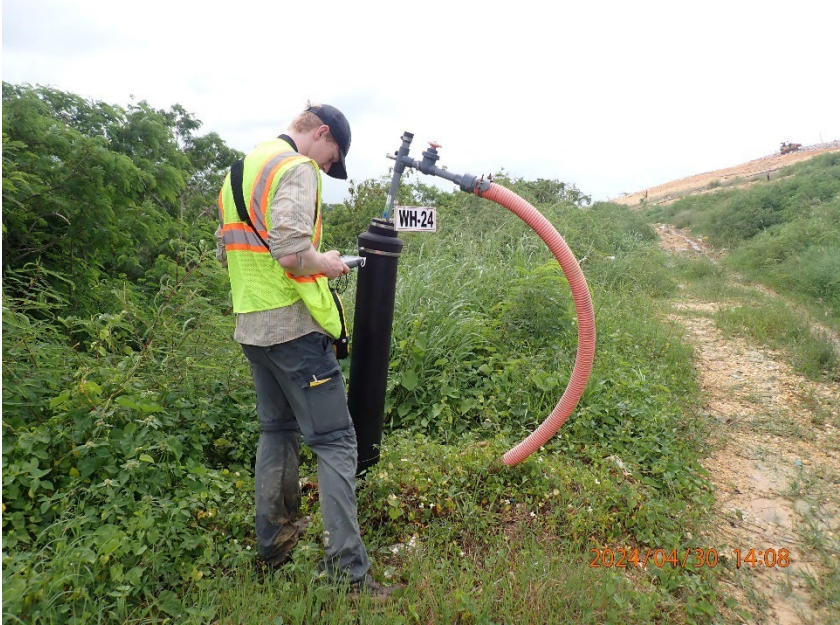
| ID | Description | Time | Reading ppm | Latitude | Longitude |
|---|---|---|---|---|---|
| A34 | Well 24 | 14:07 | 10052 | 18.46378 | -66.62009 |

| 50 | P4300095.JPG | <p>Landfill gas monitoring well #24</p> | 4/30/2024 | 1408 |

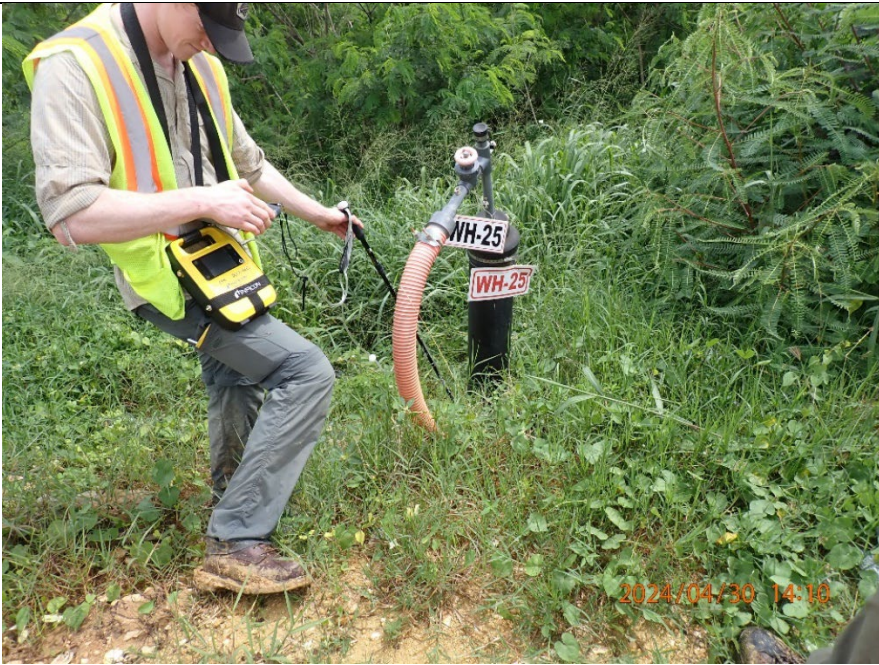
| ID | Description | Time | Reading ppm | Latitude | Longitude |
|---|---|---|---|---|---|
| A35 | Well 25 | 14:09 | 8305 | 18.46395 | -66.62064 |

| 51 | P4300096.JPG | <p>Landfill gas monitoring well #25</p> | 4/30/2024 | 1410 |

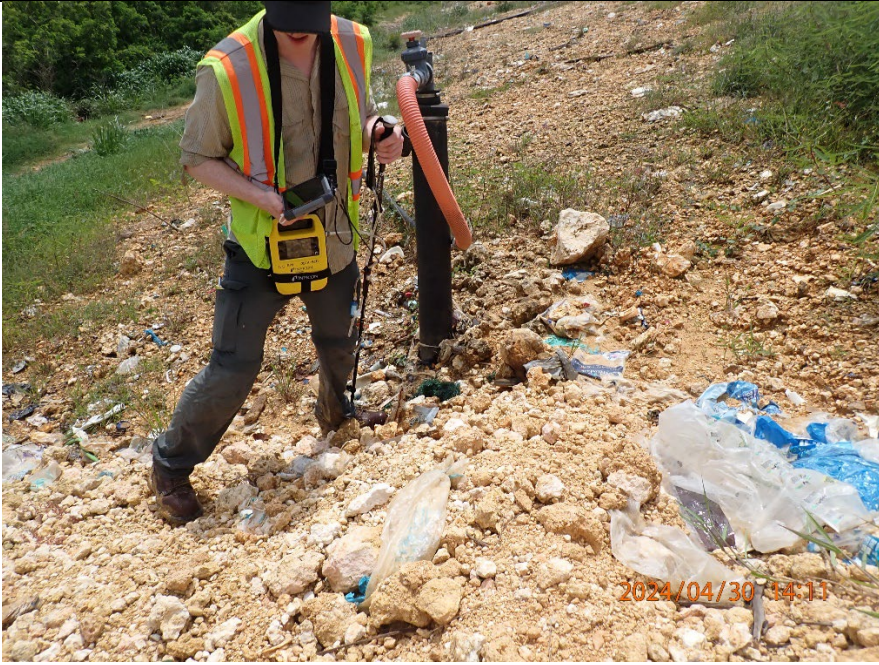
| ID | Description | Time | Reading ppm | Latitude | Longitude |
|---|---|---|---|---|---|
| A36 | Well with #79033, out sampling port and base | 14:11 | 200000 at top;<br>2099 at base | 18.46410 | -66.62069 |

| 52 | P4300097.JPG | <p>Landfill gas monitoring well (tag #79033) venting through sampling port and base</p> | 4/30/2024 | 1411 |

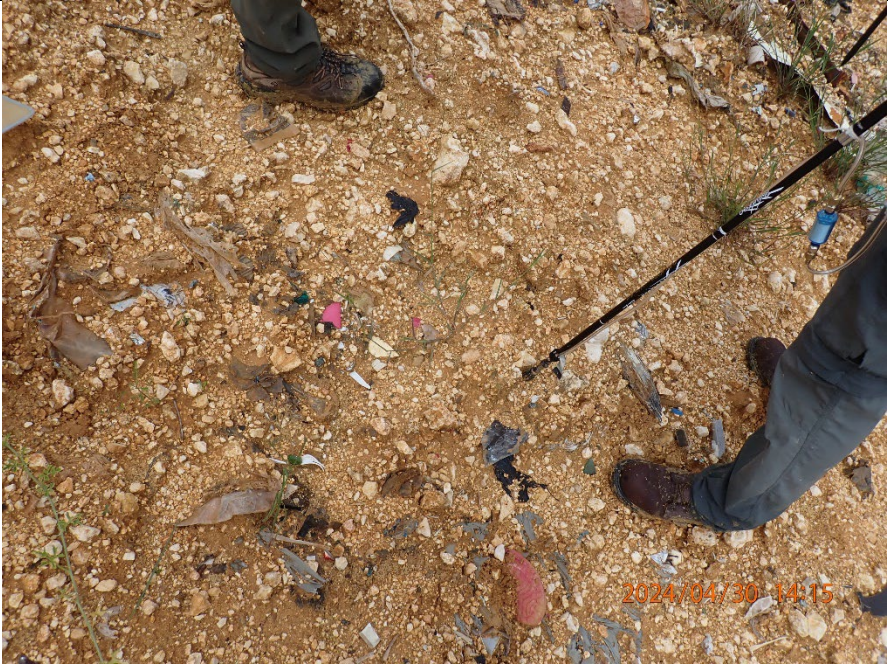
| ID | Description | Time | Reading ppm | Latitude | Longitude |
|---|---|---|---|---|---|
| A37 | Exposed waste and erosion | 14:15 | 810 | 18.46408 | -66.62045 |

| 53 | P4300098.JPG | <p>Exposed waste and erosion</p> | 4/30/2024 | 1415 |

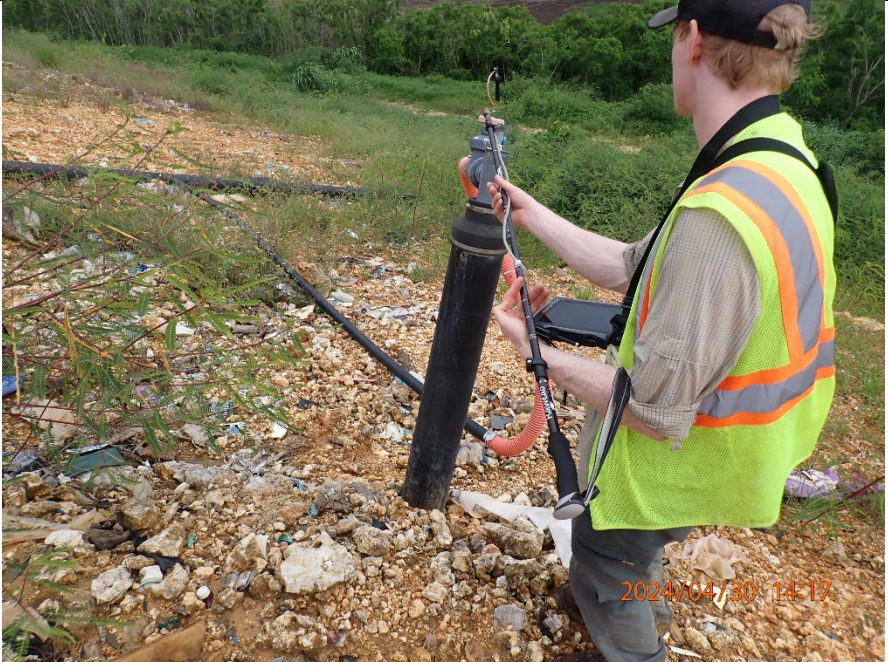
| ID | Description | Time | Reading ppm | Latitude | Longitude |
|---|---|---|---|---|---|
| A38 | Unknown well - coming out top and base | 14:16 | 240000 at top;<br>46515 at base | 18.46400 | -66.62017 |

| 54 | P4300099.JPG | <p>Unidentified landfill gas monitoring well venting through top and base</p> | 4/30/2024 | 1417 |
