**CAA Inspection Report**

**Inspection Date:** April 30, 2024

**Facility Name:** Municipality of Arecibo Landfill

**Facility Address:** PR-682 Interior, Bo. Factor, Garrochales Sector, Arecibo, Puerto Rico

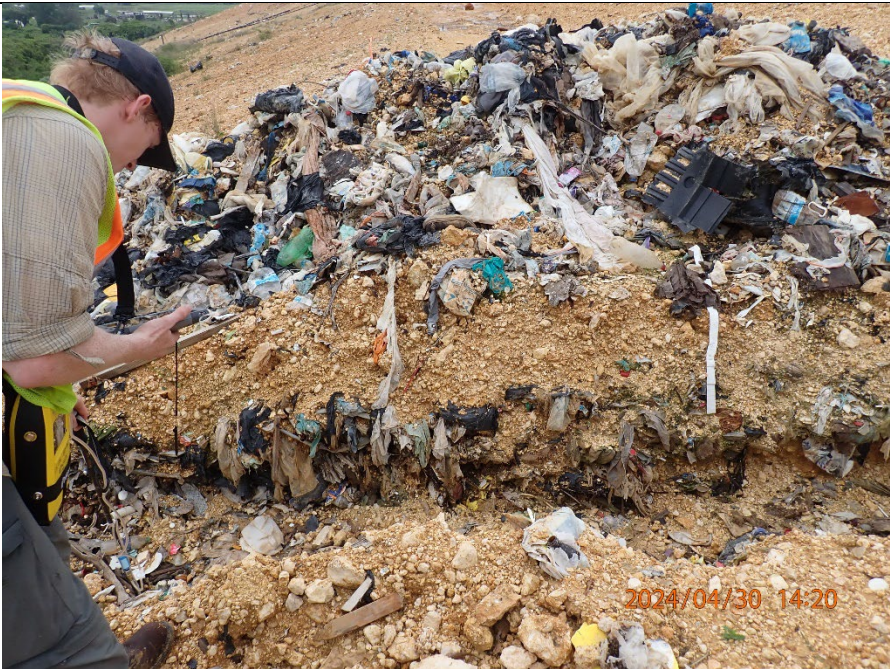
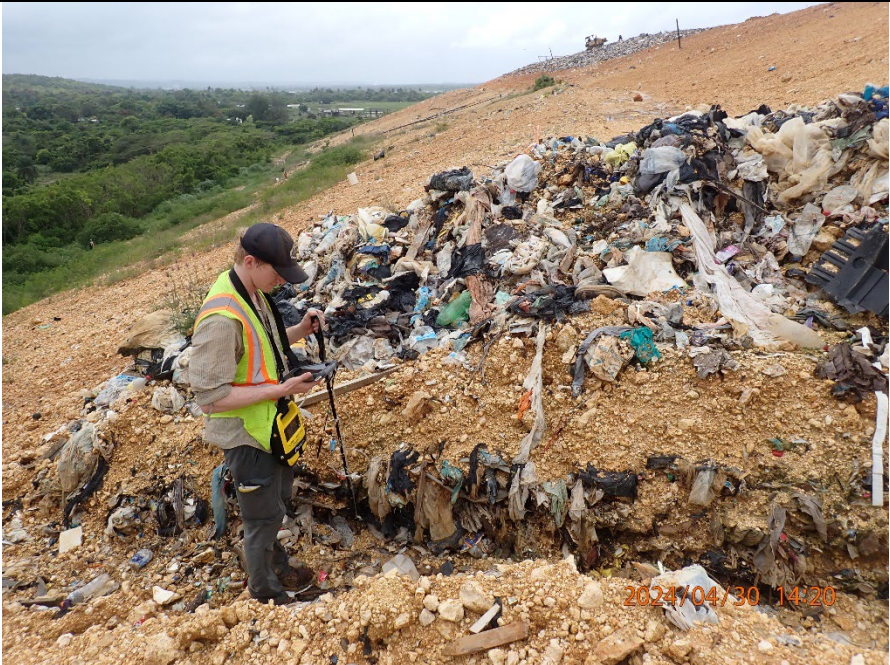
| 55 | P4300100.JPG | <p>Exposed waste and rill</p> | 4/30/2024 | 1420 |
| 56 | P4300101.JPG | <p>Exposed waste and rill</p> | 4/30/2024 | 1420 |

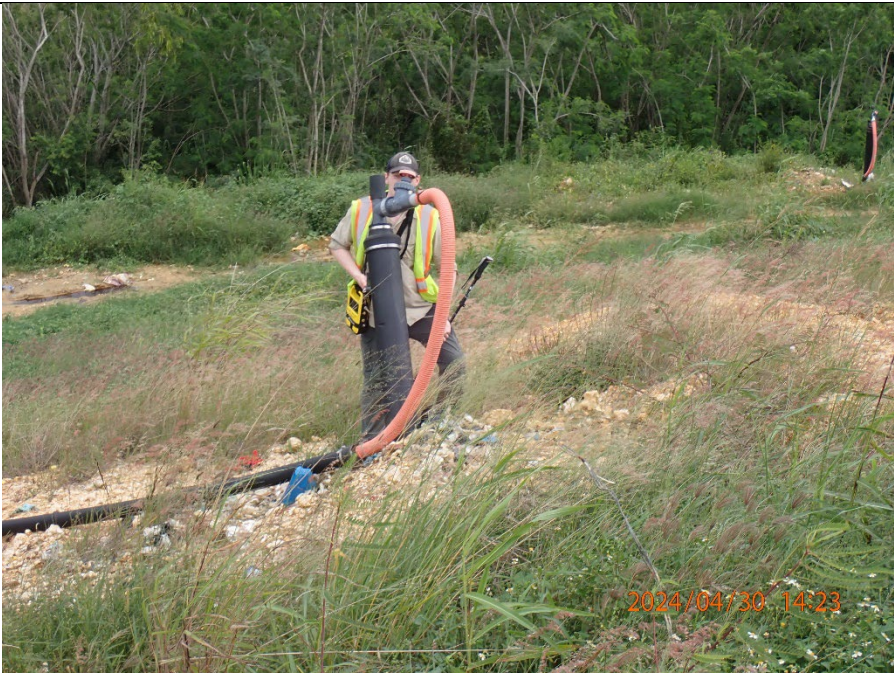
| A39 | Well and exposed waste | 14:22 | 11825 | 18.46399 | -66.61958 |

| 57 | P4300102.JPG | <p>Unidentified landfill gas monitoring well and exposed well</p> | 4/30/2024 | 1423 |

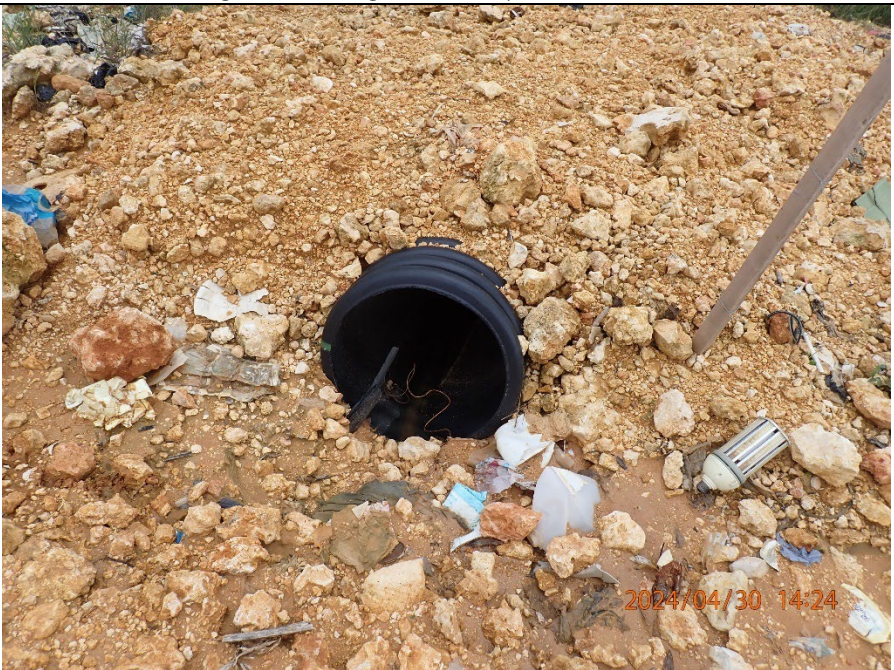
| A40 | Leaks on sides drain | 14:23 | 3477 | 18.46409 | -66.61959 |

| 58 | P4300103.JPG | <p>Leaks found on side of drainage pipe</p> | 4/30/2024 | 1424 |

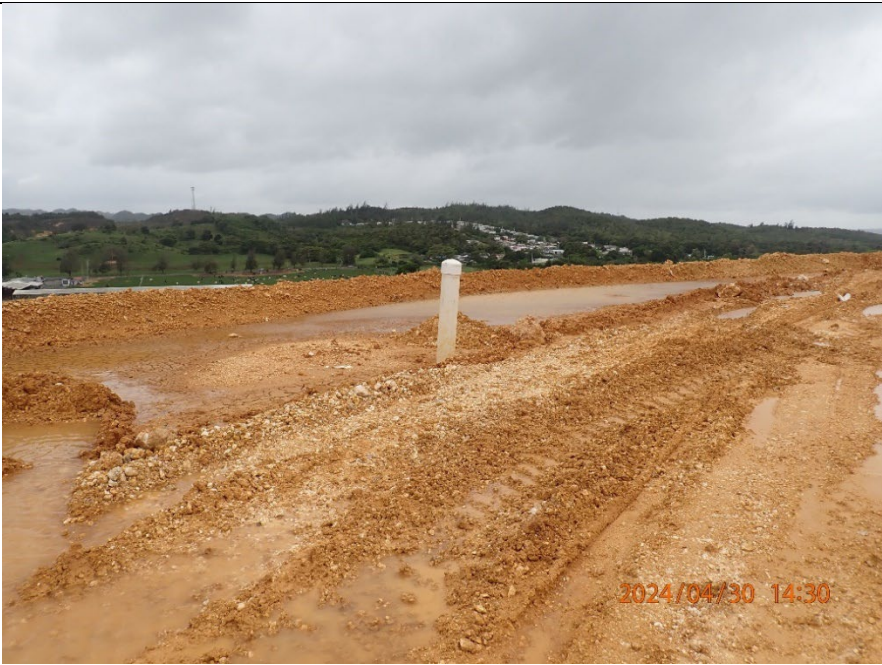
| A41 | Capped PVC pipe (offline well 77) | 14:29 | 3300 | 18.46441 | -66.61959 |

| 59 | P4300104.JPG | <p>Capped PVC pipe, offline landfill gas monitoring well #77</p> | 4/30/2024 | 1430 |

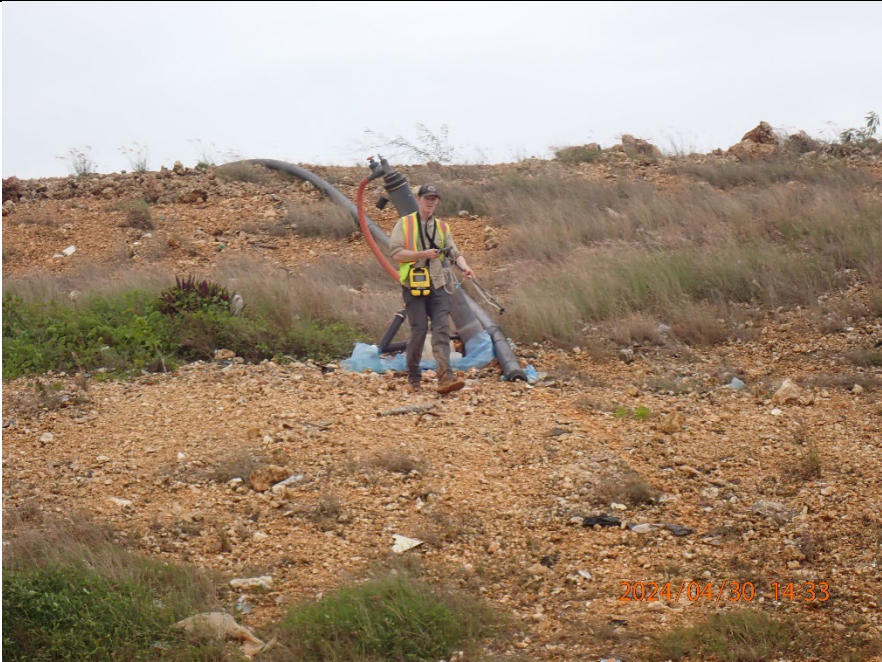
| A42 | Well 70 | 14:32 | 2035 | 18.46494 | -66.61934 |

| 60 | P4300105.JPG | <p>Landfill gas monitoring well #70</p> | 4/30/2024 | 1433 |

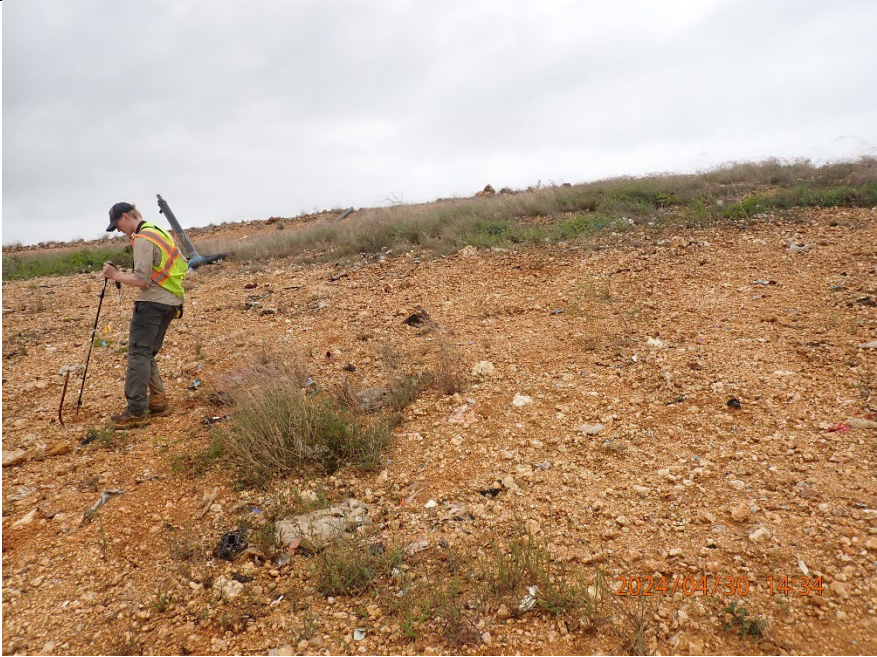
| A43 | Tire (exposed waste) | 14:33 | 780 | 18.46495 | -66.61924 |

| 61 | P4300106.JPG | <p>Exposed waste</p> | 4/30/2024 | 1434 |

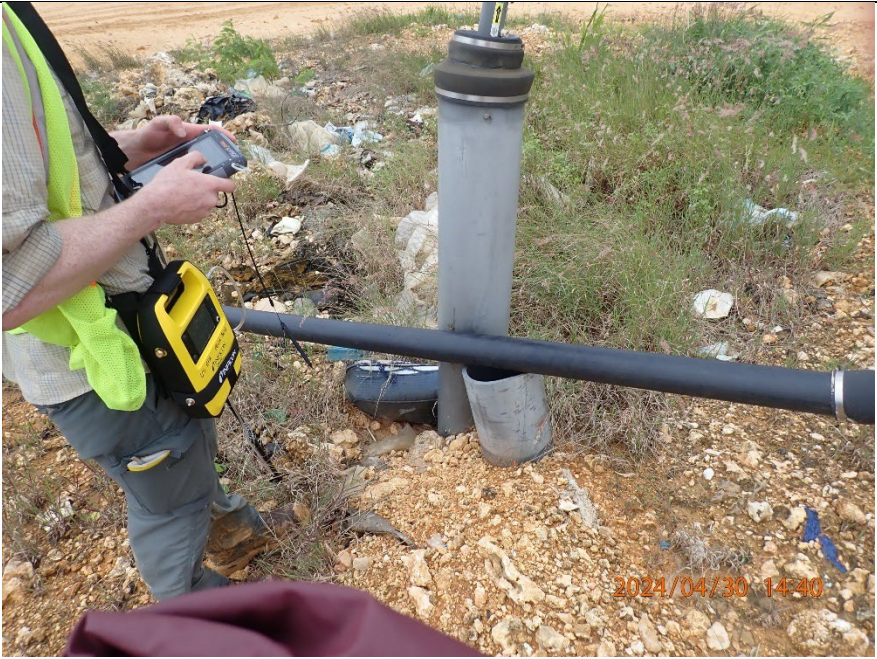
| A44 | Unknown well | 14:39 | 4878 | 18.46549 | -66.61905 |

| 62 | P4300107.JPG | <p>Unidentified landfill gas monitoring well</p> | 4/30/2024 | 1440 |

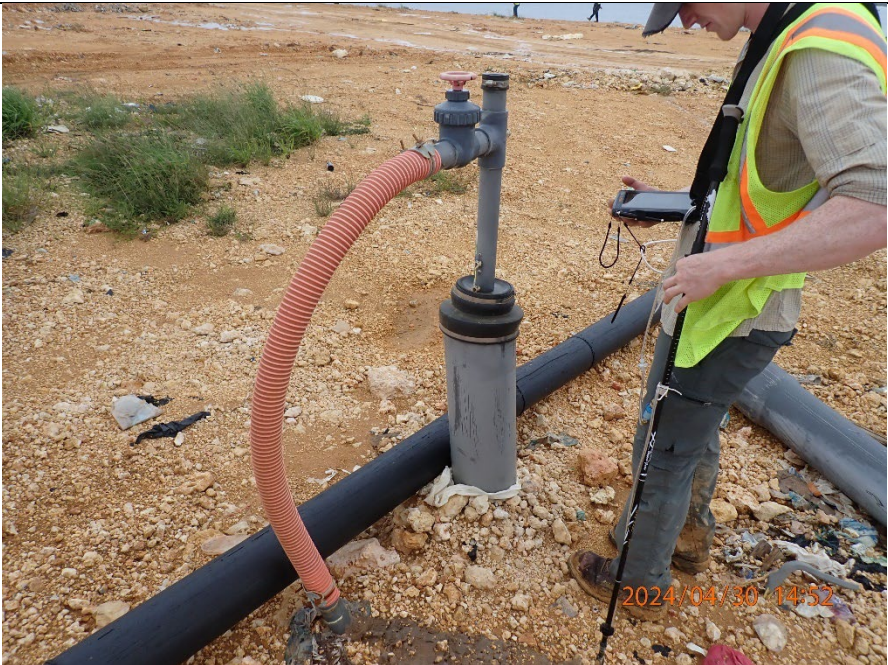
| A47 | Well 61 | 14:51 | 8616 | 18.46552 | -66.62022 |

| 65 | P4300110.JPG | <p>Landfill gas monitoring well #61</p> | 4/30/2024 | 1452 |

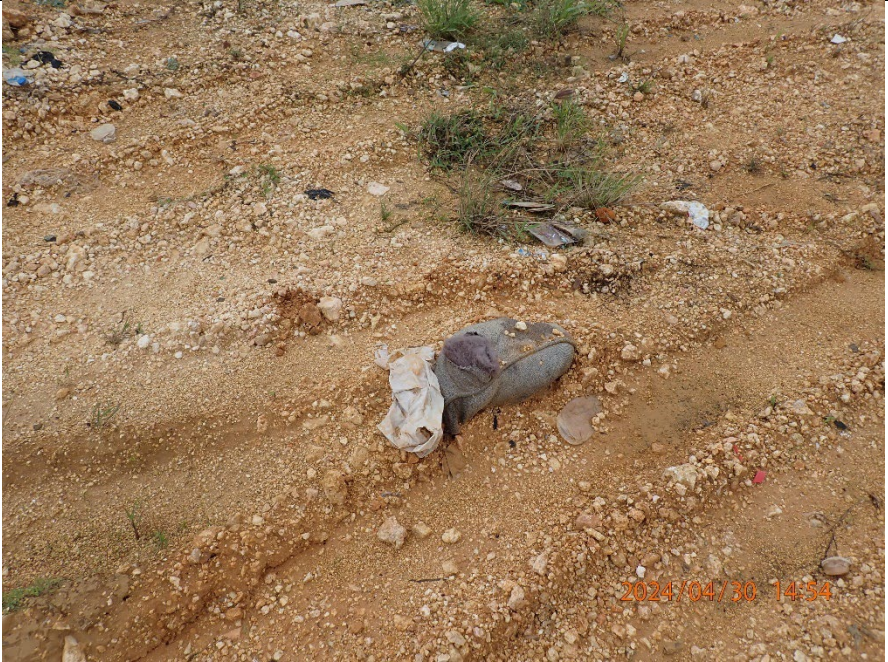
| A48 | Exposed waste (cushion) | 14:52 | 735 | 18.46557 | -66.62048 |

| 66 | P4300111.JPG | <p>Exposed waste</p> | 4/30/2024 | 1454 |

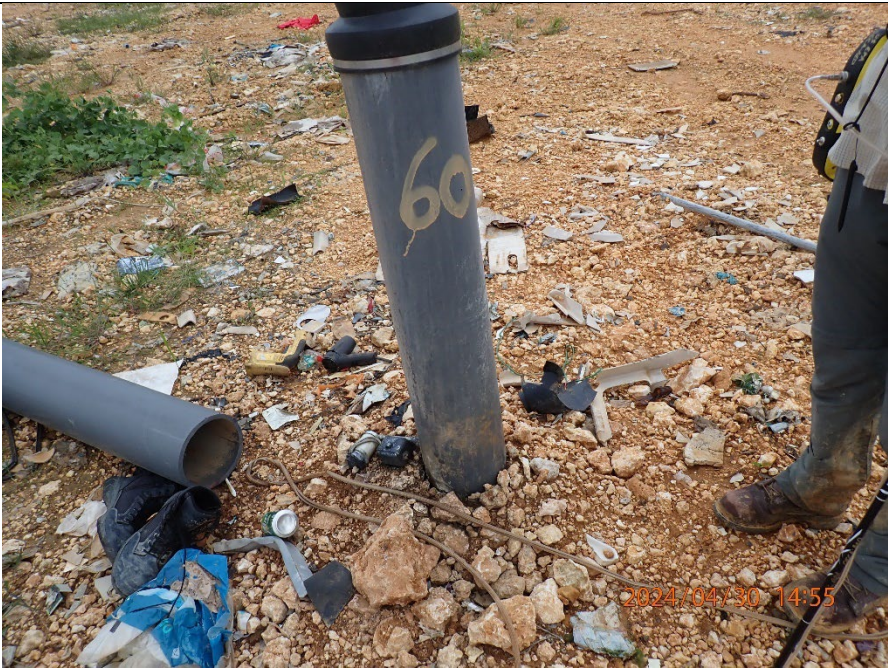
| A49 | Well 60 | 14:55 | 12434 | 18.46561 | -66.62077 |

| 67 | P4300112.JPG | <p>Landfill gas monitoring well #60</p> | 4/30/2024 | 1455 |

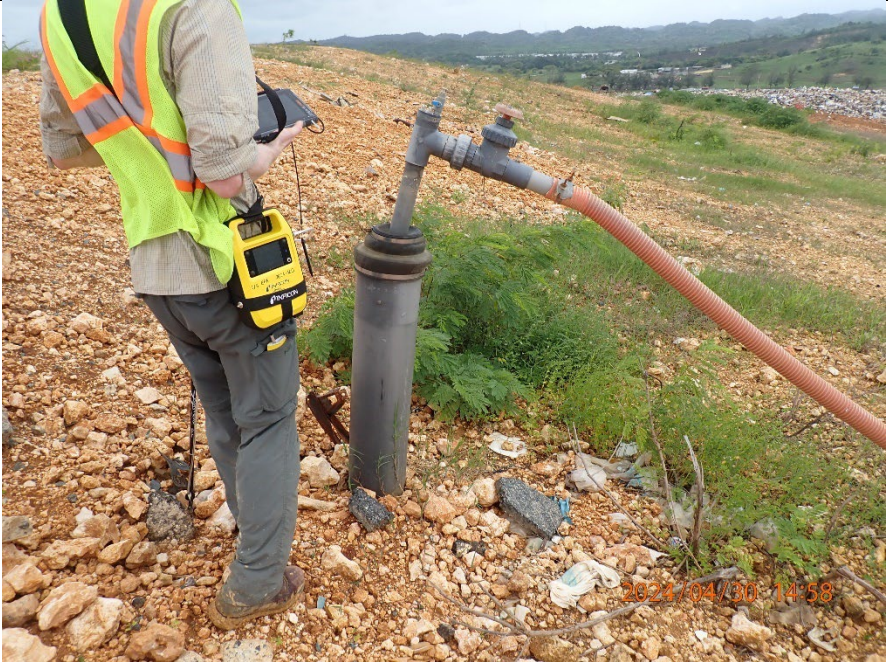
| A50 | Well with #78187 | 14:57 | 62465 | 18.46563 | -66.62131 |

| 68 | P4300113.JPG | <p>Landfill gas monitoring well (tag # 78187)</p> | 4/30/2024 | 1458 |

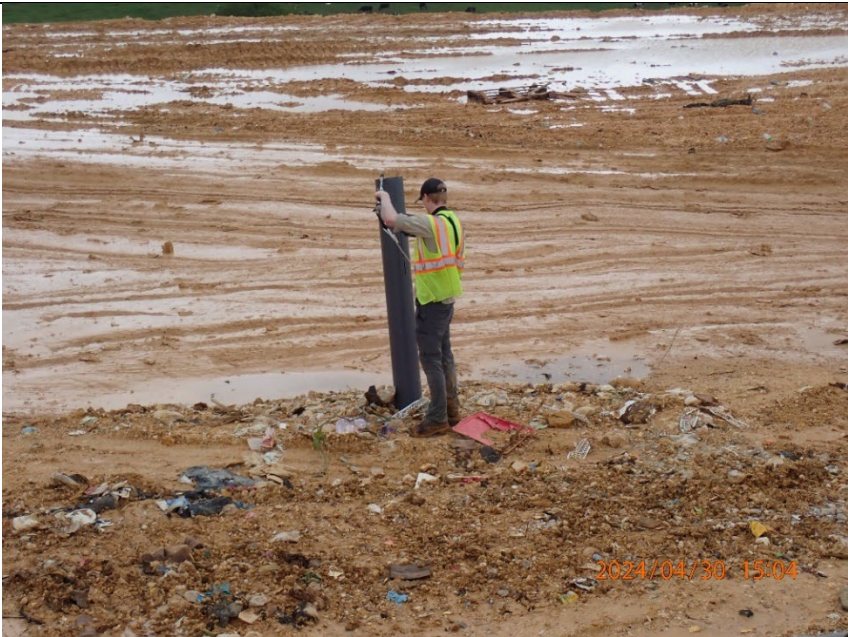
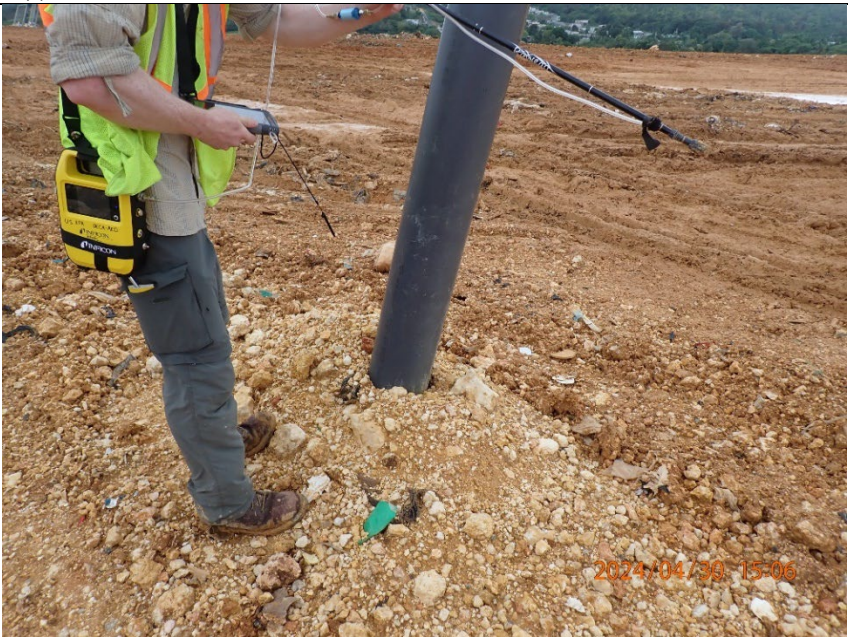
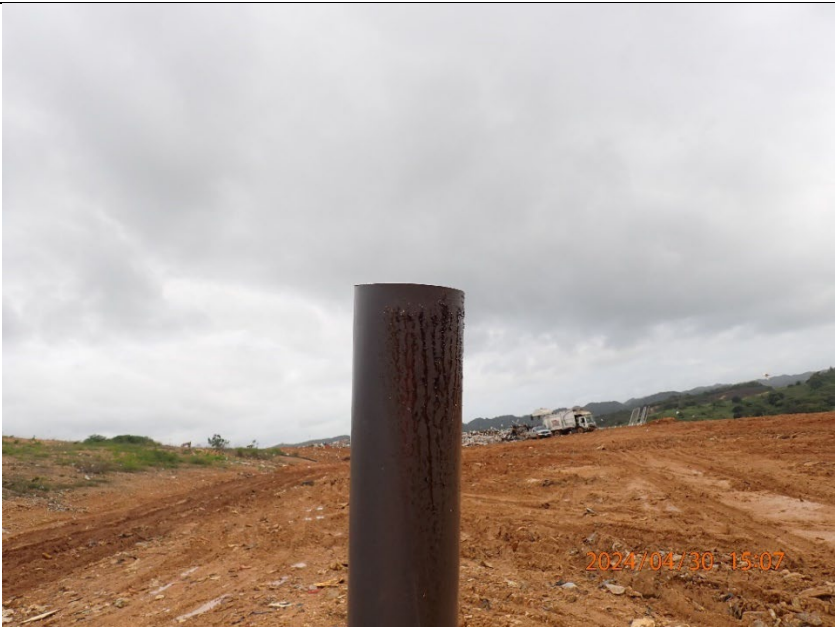
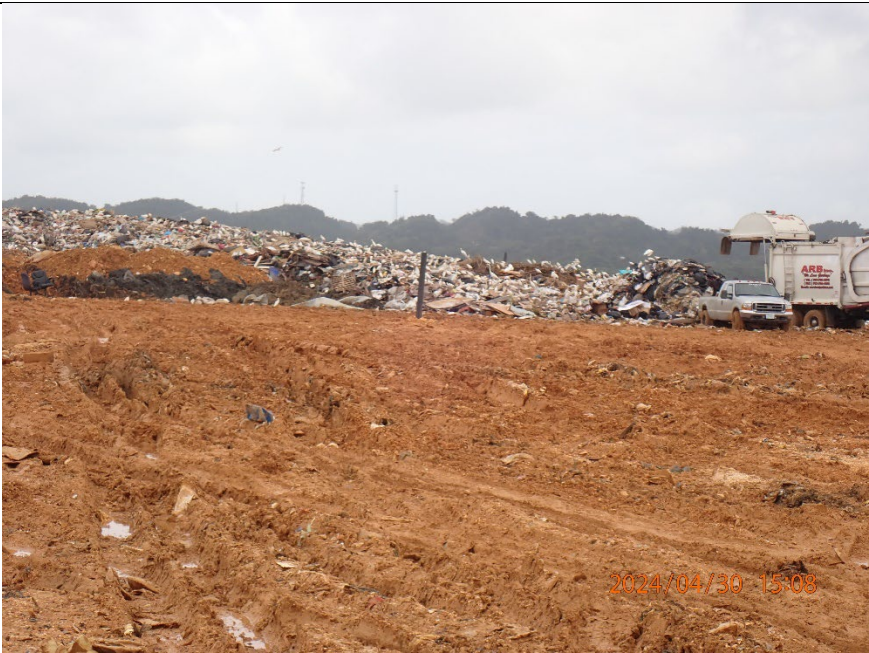
1. Significant number of uncapped GCCS wellheads found. The inspectors noted that it appeared to be a consistent practice for fully offline wells to be directly venting to atmosphere.

| A51 | Venting uncapped disconnected well (exceedance at base and top) | 15:03 | 205000 at top;<br>86705 at base | 18.46613 | -66.62217 |
| A52 | Venting uncapped disconnected well (exceedance at base and top) | 15:05 | 150000 at top;<br>7479 at base | 18.46567 | -66.62188 |

| 69 | P4300114.JPG | <p>Venting uncapped and disconnected landfill gas monitoring well (exceedance at base and top)</p> | 4/30/2024 | 1504 |
| 70 | P4300115.JPG | <p>Venting uncapped and disconnected landfill gas monitoring well (exceedance at base and top)</p> | 4/30/2024 | 1506 |

| 71 | P4300116.JPG | <p>Venting uncapped and disconnected landfill gas monitoring well (exceedance at base and top)</p> | 4/30/2024 | 1507 |

| 73 | P4300118.JPG | <p>Venting uncapped and disconnected landfill gas monitoring well (exceedance at base and top)</p> | 4/30/2024 | 1508 |

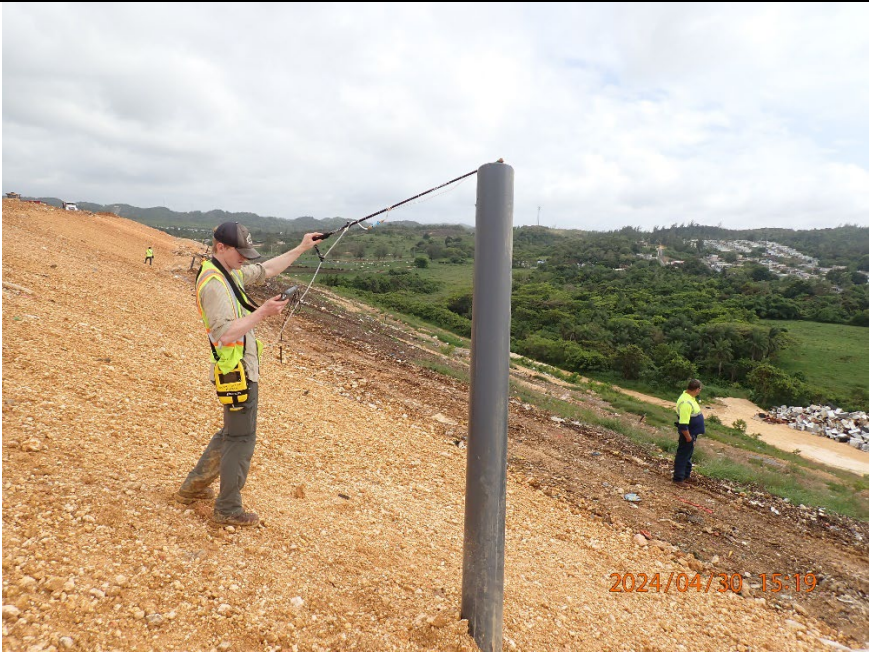
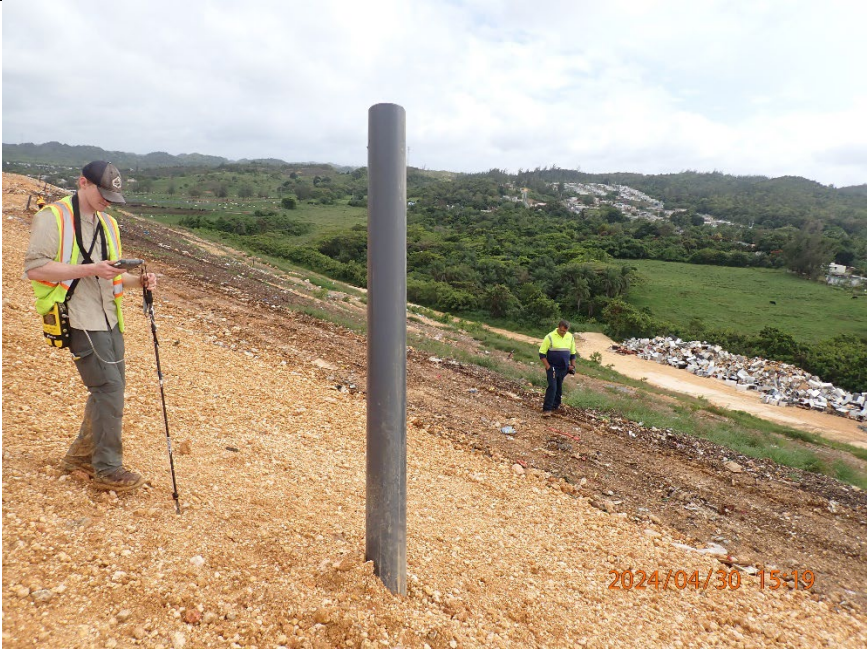
| A53 | Venting uncapped disconnected well | 15:18 | 205864 at top | 18.46622 | -66.62274 |

| 74 | P4300119.JPG | <p>Venting uncapped landfill gas monitoring well</p> | 4/30/2024 | 1519 |

| 75 | P4300120.JPG | <p>Venting uncapped landfill gas monitoring well with white goods pile in background (right side)</p> | 4/30/2024 | 1519 |

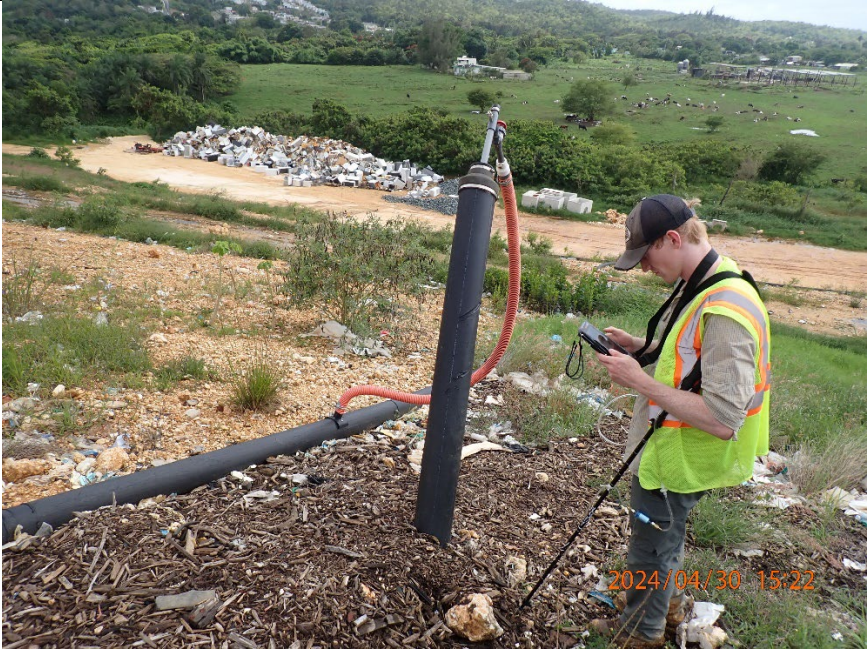
| A54 | Unknown well | 15:21 | 41781 | 18.46613 | -66.62310 |

| 76 | P4300121.JPG | <p>Unidentified landfill gas monitoring well</p> | 4/30/2024 | 1522 |

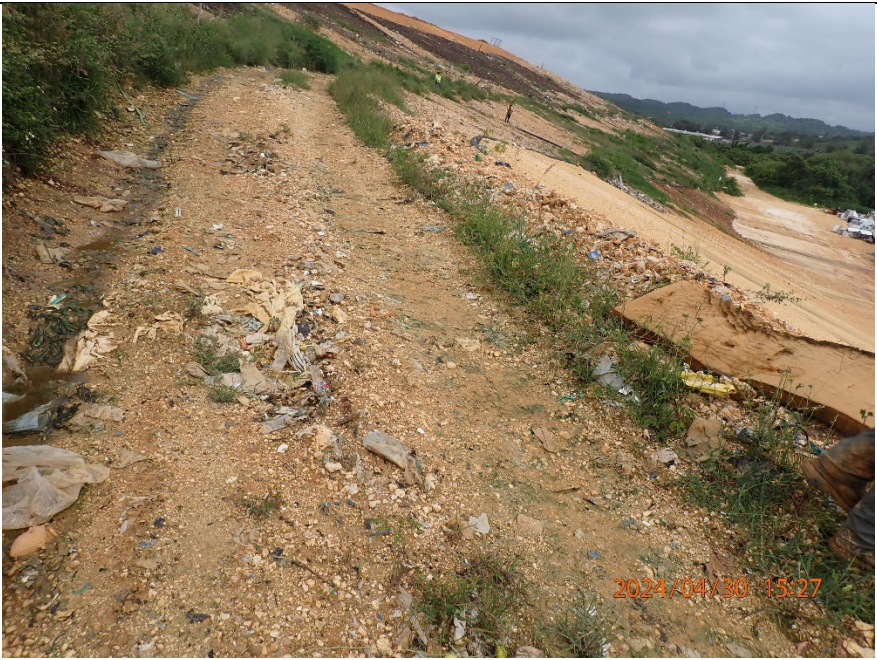
| A55 | Exposed waste | 15:26 | 2067 | 18.46633 | -66.62365 |

| 77 | P4300122.JPG | <p>Exposed waste</p> | 4/30/2024 | 1527 |
