Clean Water Act Section 404: Site Visit/Case Development

Site Name	Vega Baja Landfill (hereinafter as "Landfill")	Start Date	April 7, 2022
		End Date	April 7, 2022
Inspection Purpose	Initial site visit		
Opening Conference			
<input checked="" type="checkbox"/> Presentation of Inspector Credentials			
Name and Title (Use N/A if owner/operator not available to join the inspection)			
Marco Finocchiaro, Inspector presented credentials to Gilberto Martinez Fernandez, Administrator of the landfill on behalf of EcoPark.			
<input type="checkbox"/> Opening Conference			
Name of person authorizing access if applicable			
Gilberto Martinez Fernandez, Administrator of the landfill authorized access to the landfill on behalf of Joseph P. Hernández Cancel, President of EcoPark, who not present at the time of the visit.			
Notes from Opening Conference			
EPA explained the purpose of the inspection, EPA's and the Corps' roles with regulating wetlands under the CWA, and what areas would be inspected.

Vega Baja Landfill

April 7, 2022

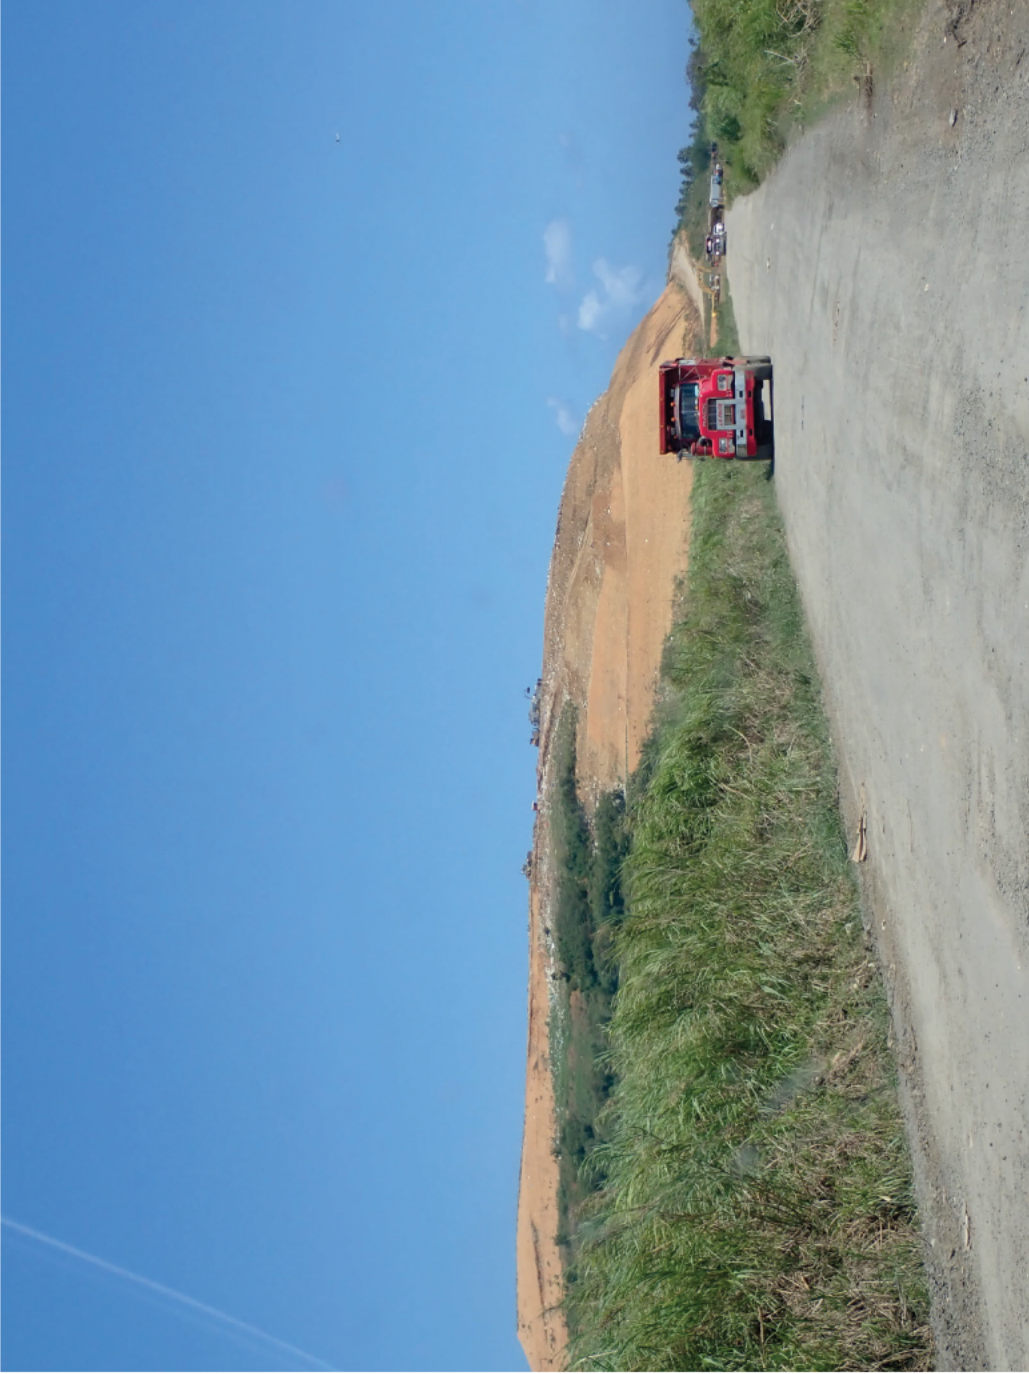
Photo ID: P4070164

Description: Panorama of the landfill while entering the site. There is one road to enter and exit the site.

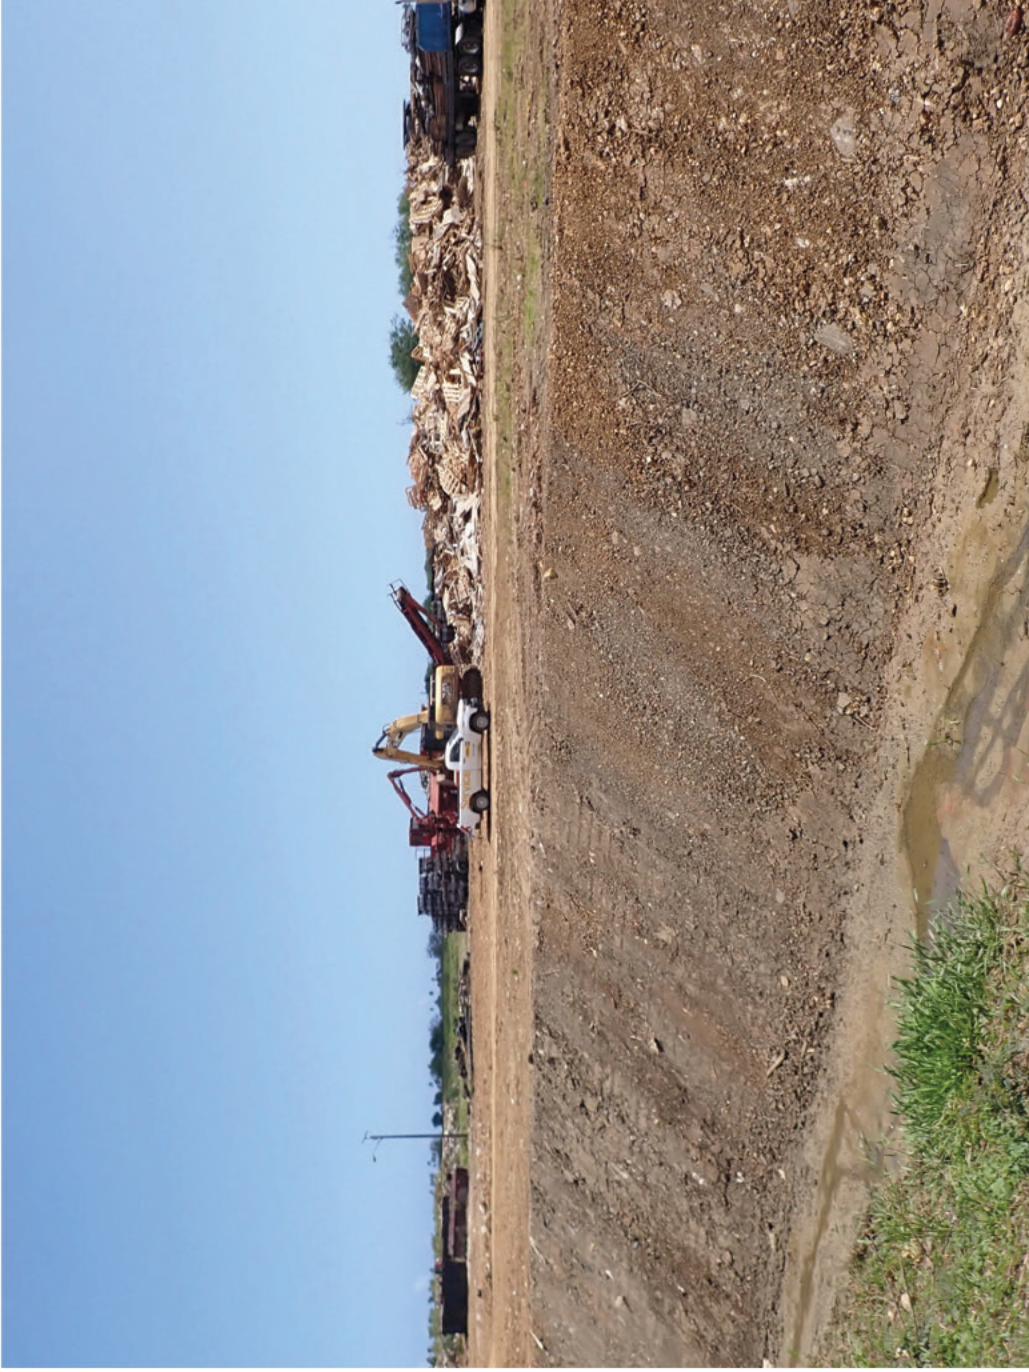
Photo ID: P4070170

Description: Panorama of the landfill while entering the site. Photo was taken pointing northeast at the northern most end of the entrance/exit road.

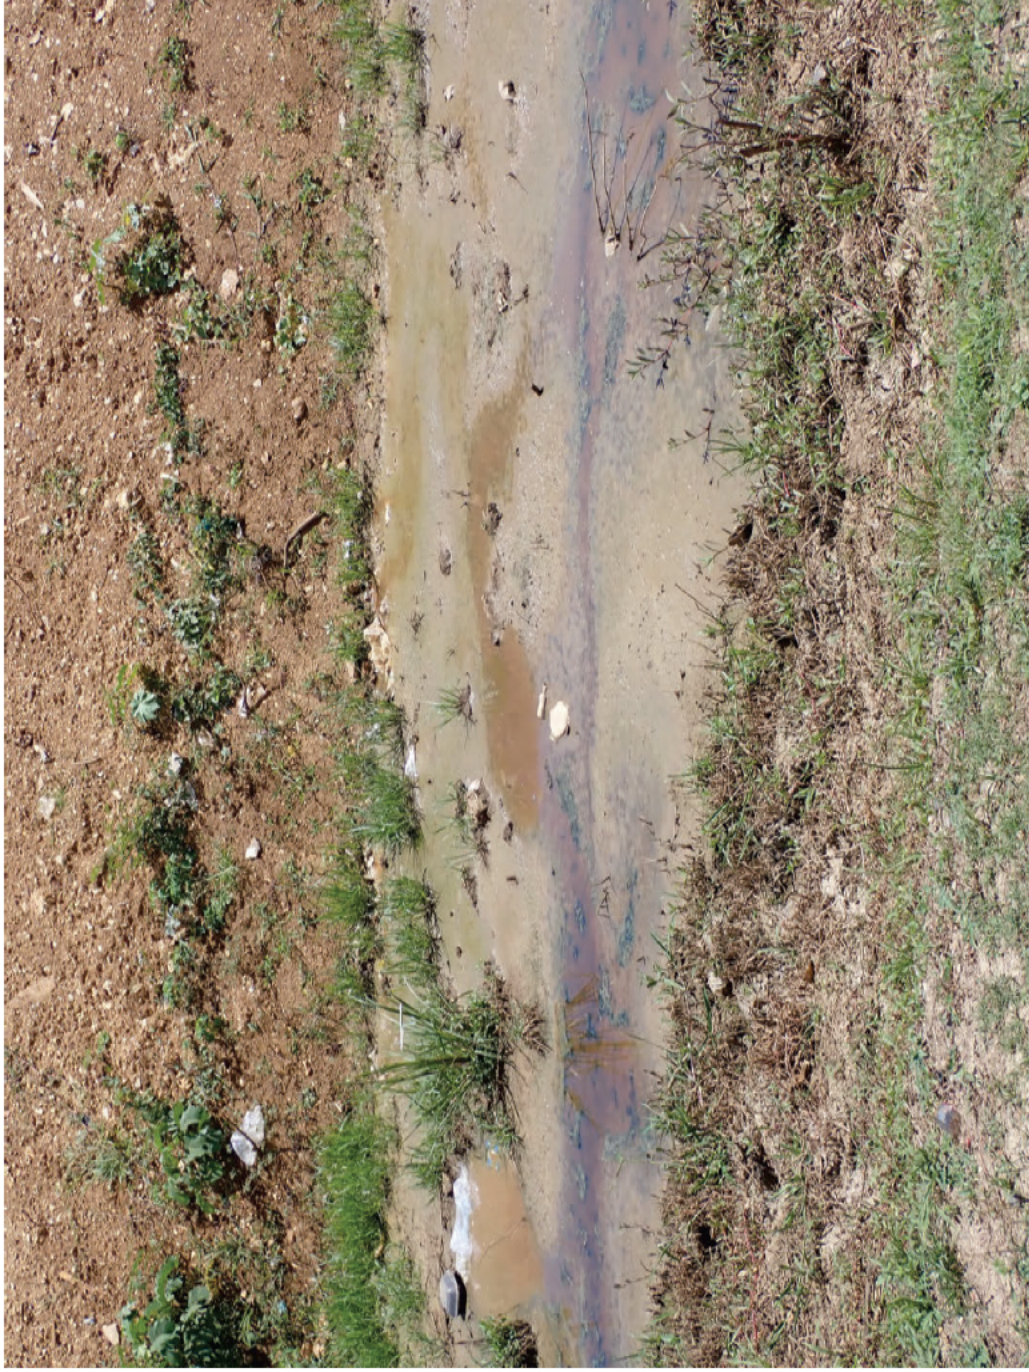
Photo ID: P4070173

Description: Condition of the two manmade channels have been created on both sides of the main road.

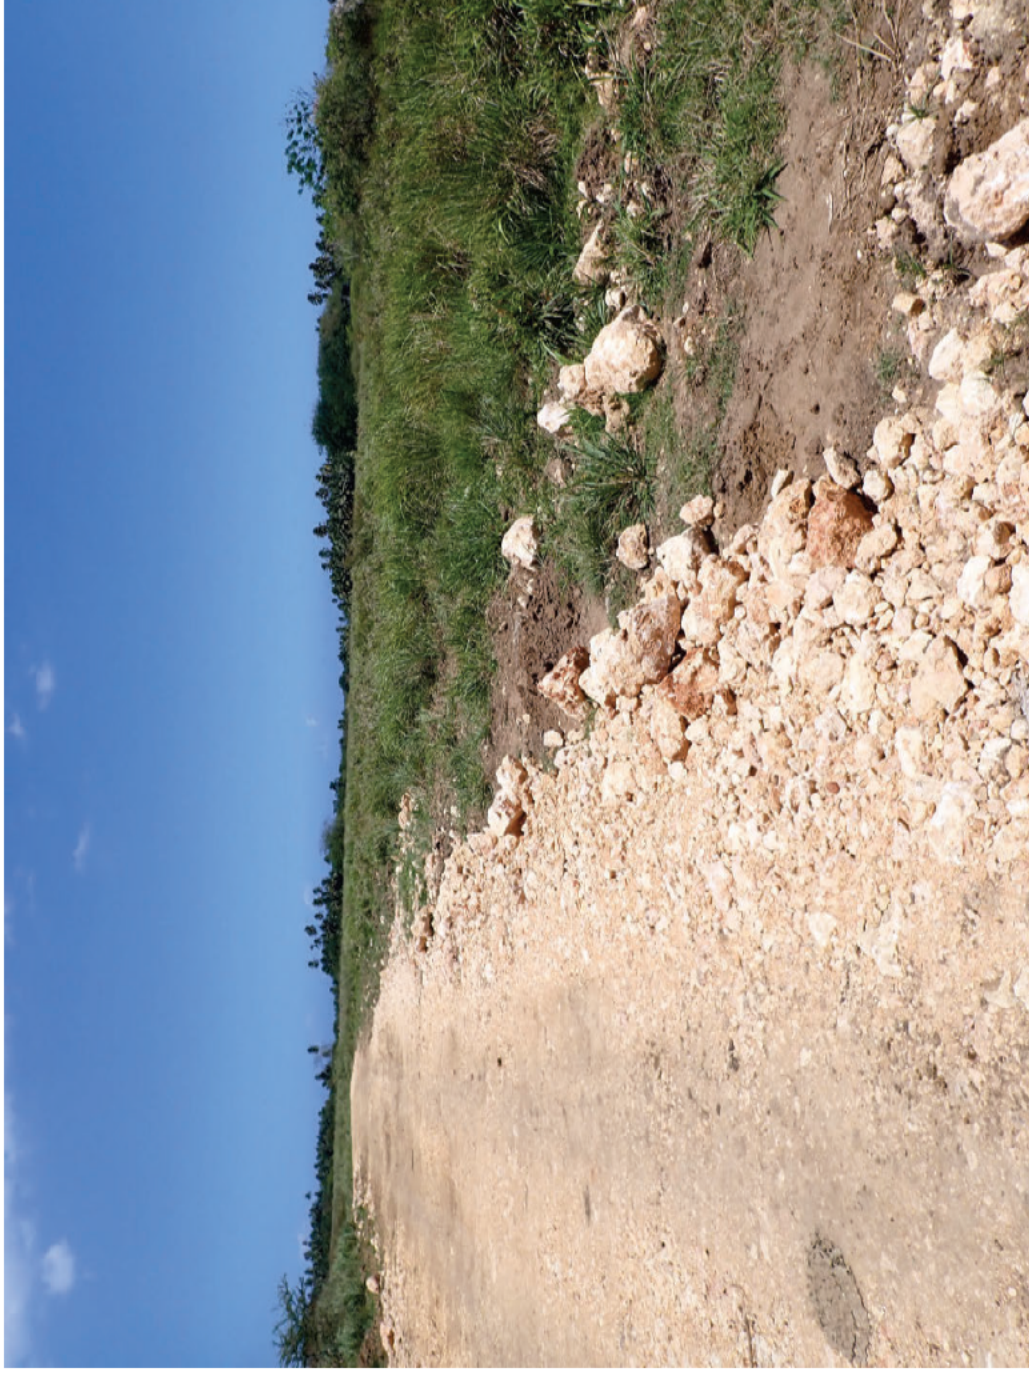
Photo ID: P4070197

Description: Panorama of the eastern most located right of way (camera facing north).

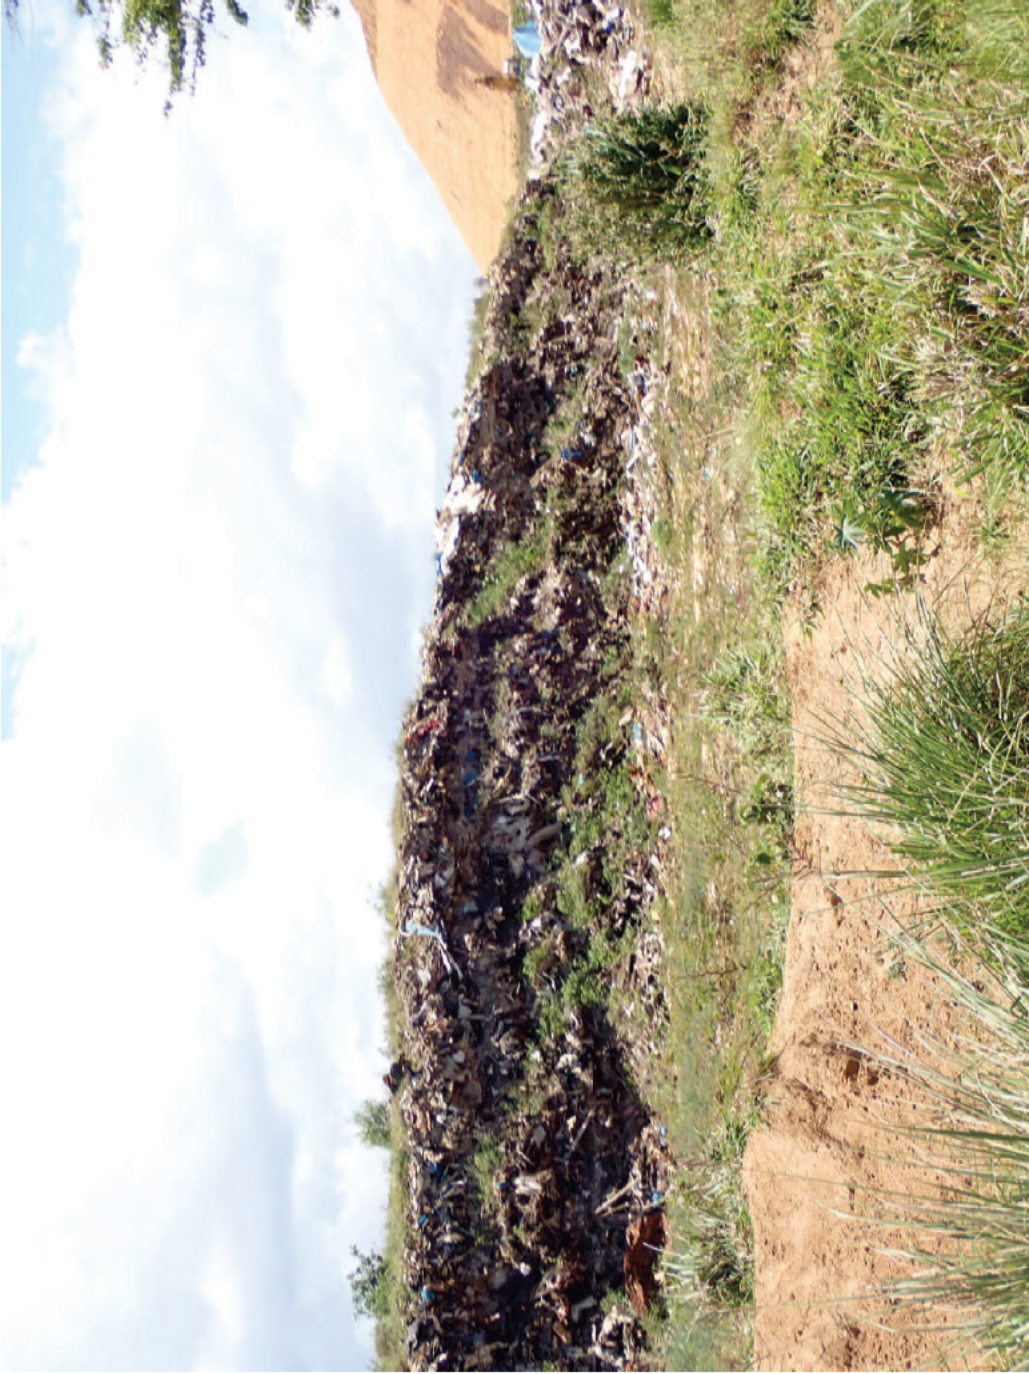
Photo ID: P4070200

Description: Panorama of the landfill from the eastern portion of the property.

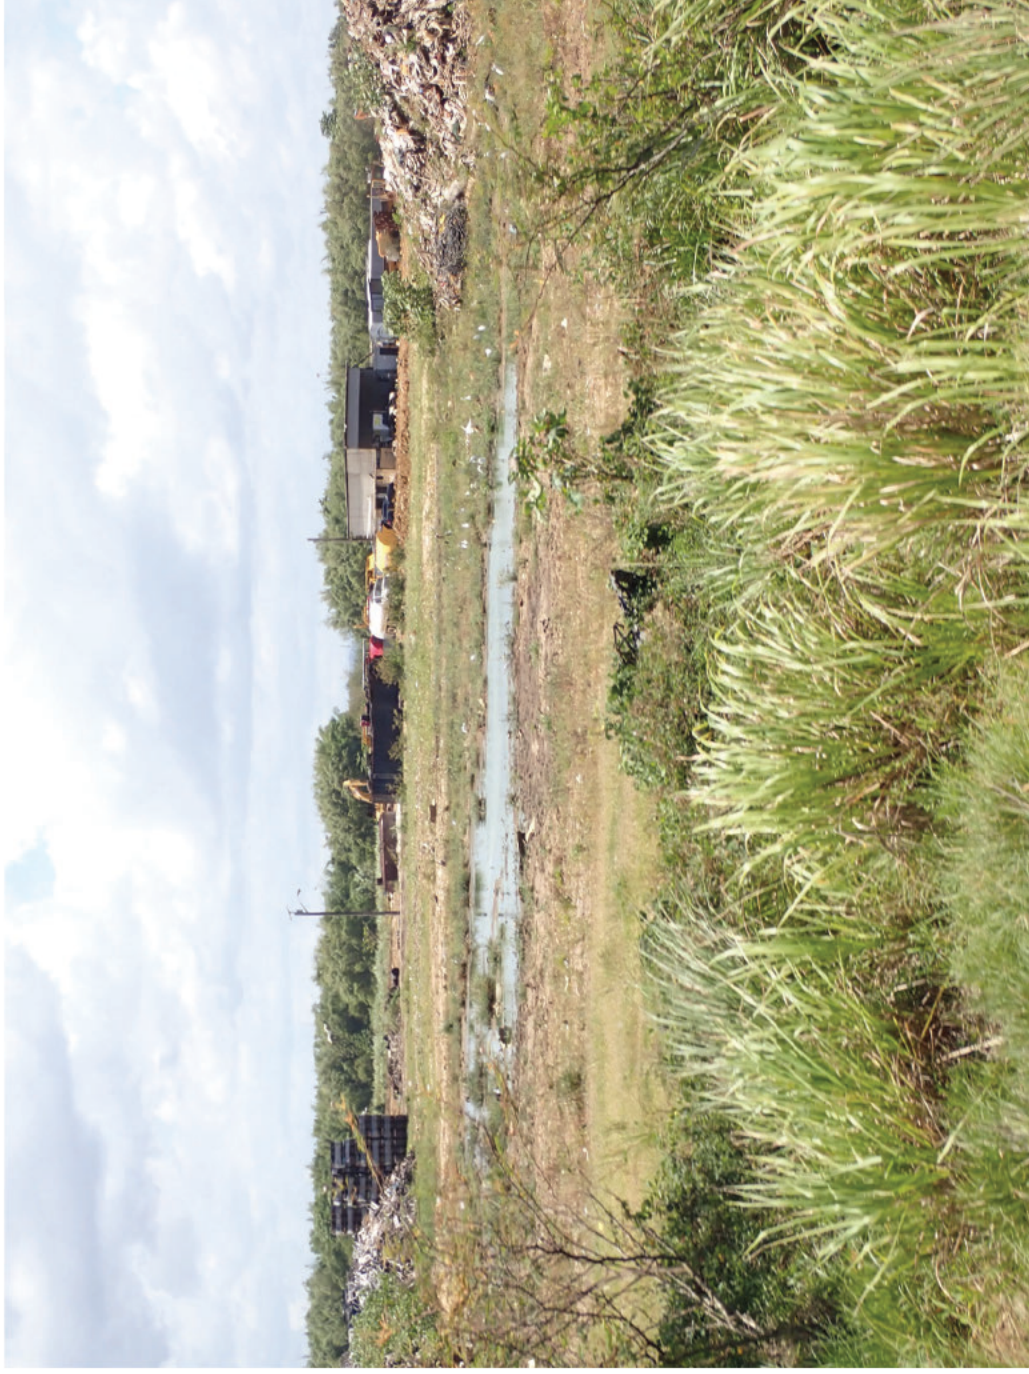
Description: Panorama of the center of the site with standing water.

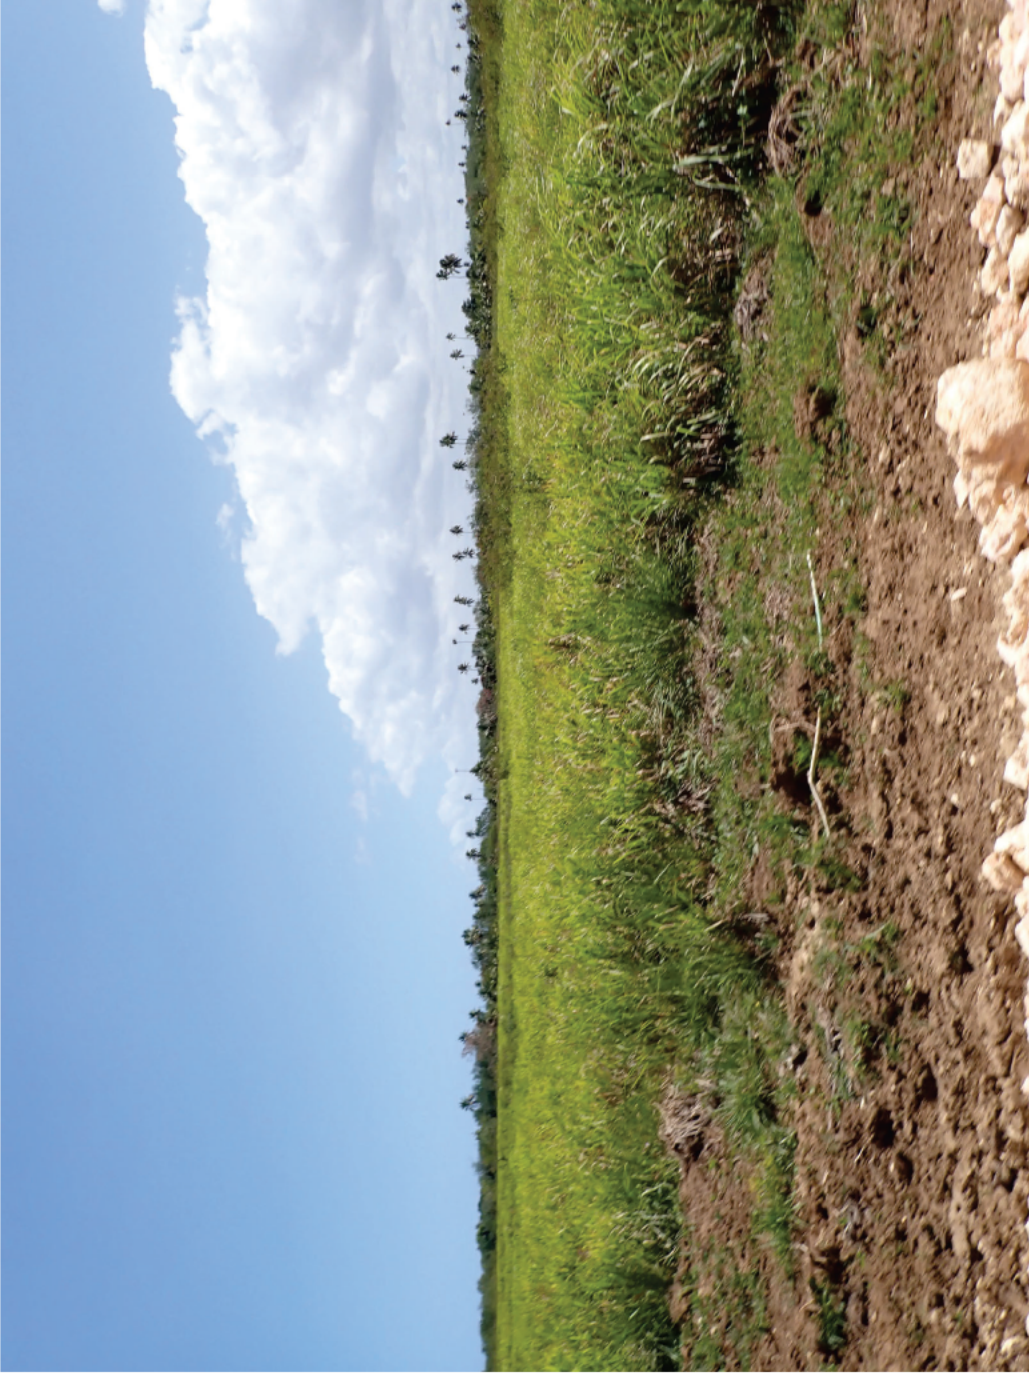
Description: Panorama of the property to the east.

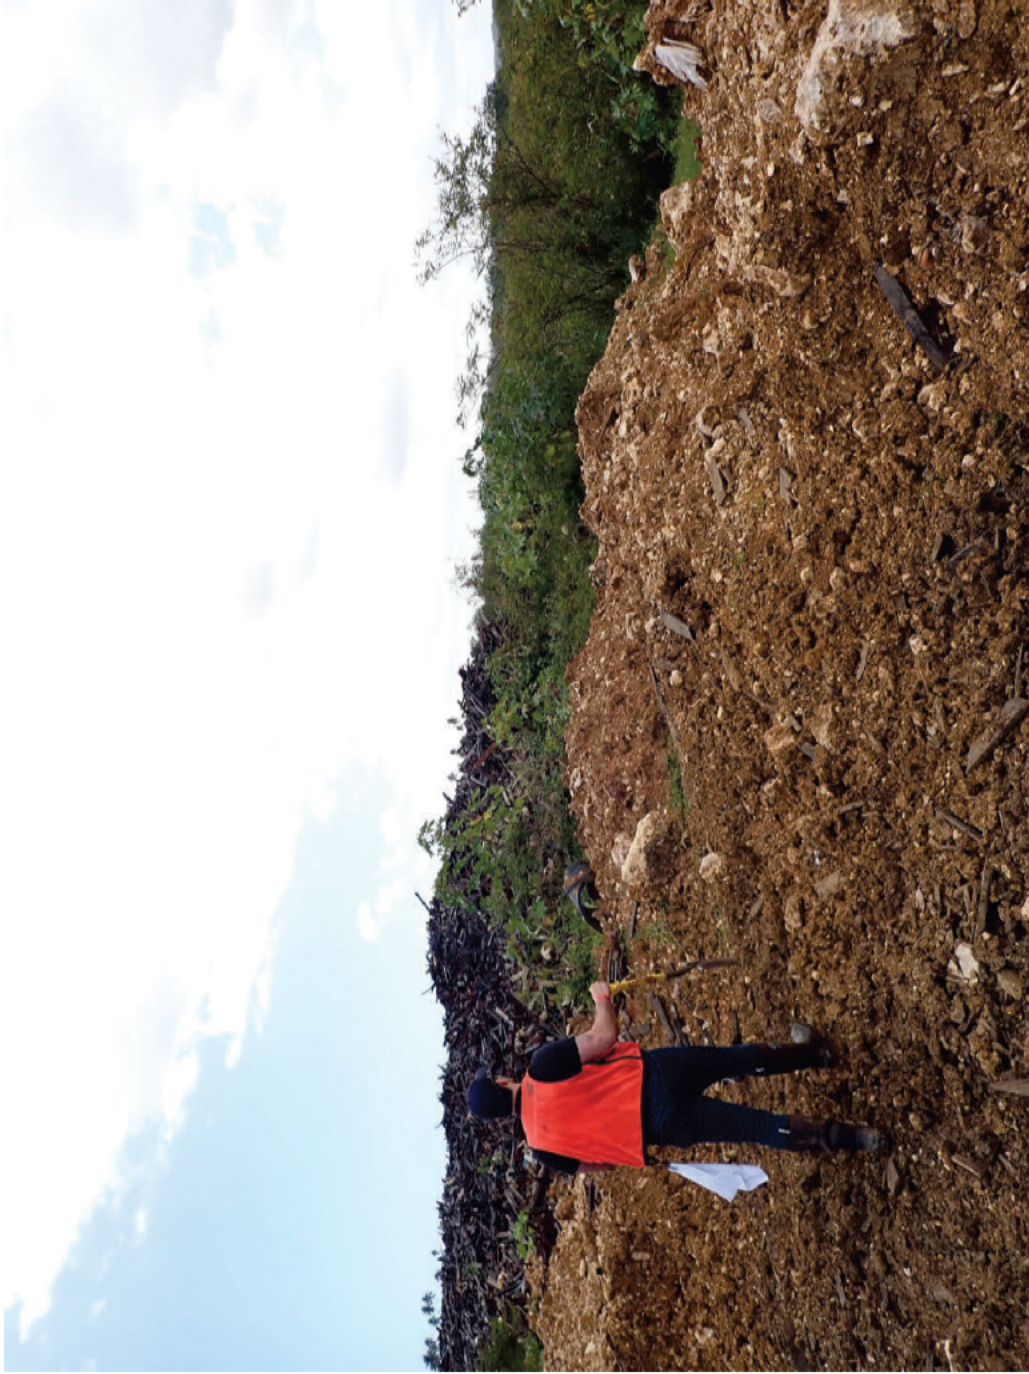
Photo ID: P4070185

Description: Fill pile comprised of debris and earthen material abutting the ditch.

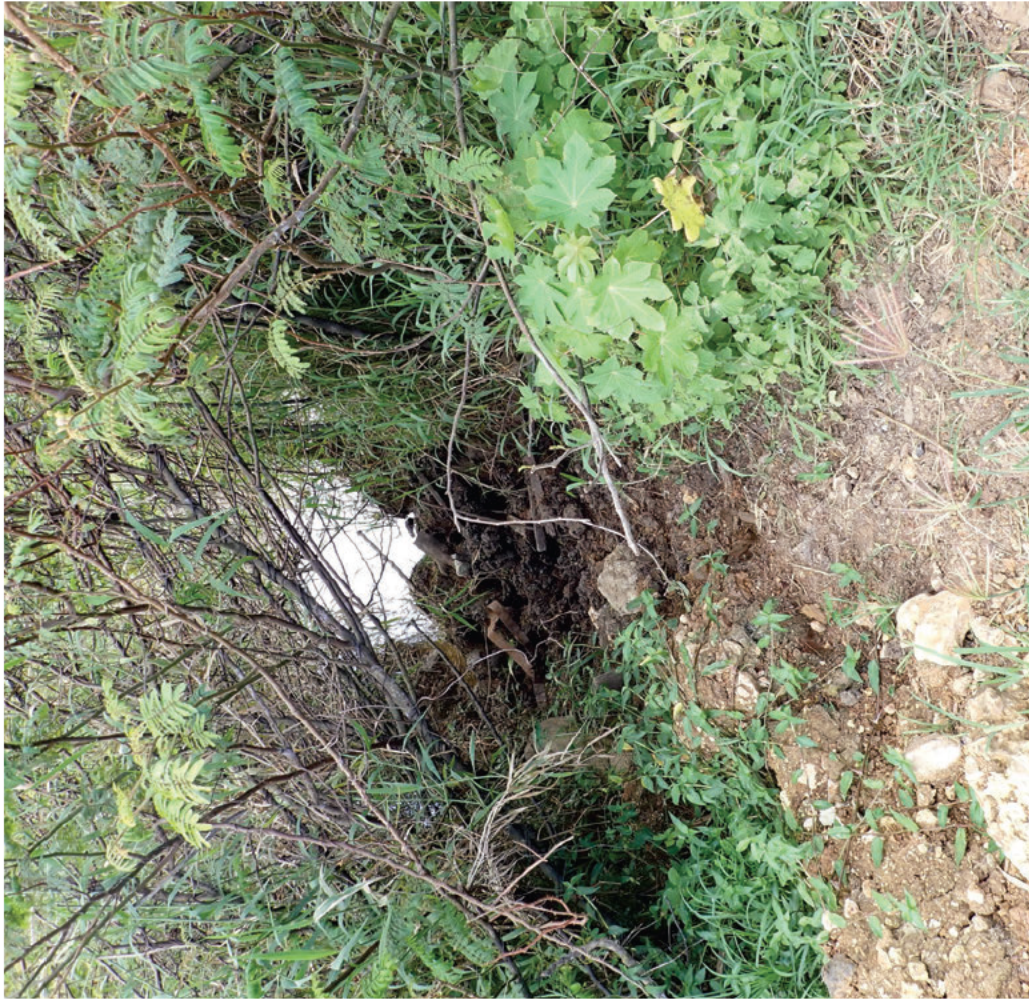
Description: View of the ditch from the top of the fill pile.

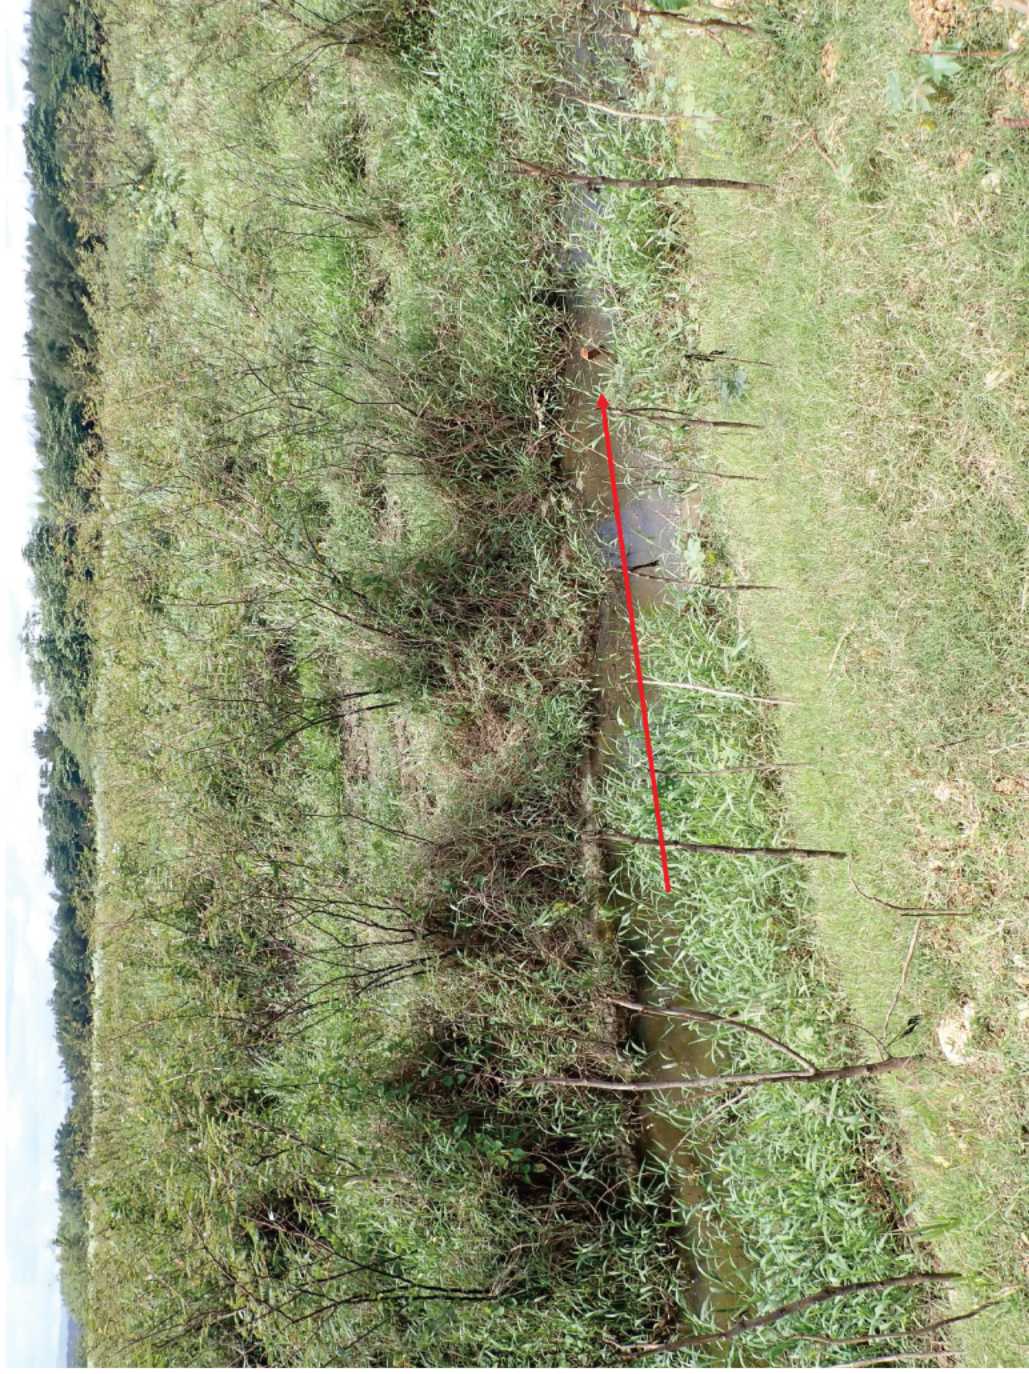
Photo ID: P4070180

Description: Unnamed channelized ditch located south of the eastern portion of the landfill.

Red arrows marks the direction of the flow.

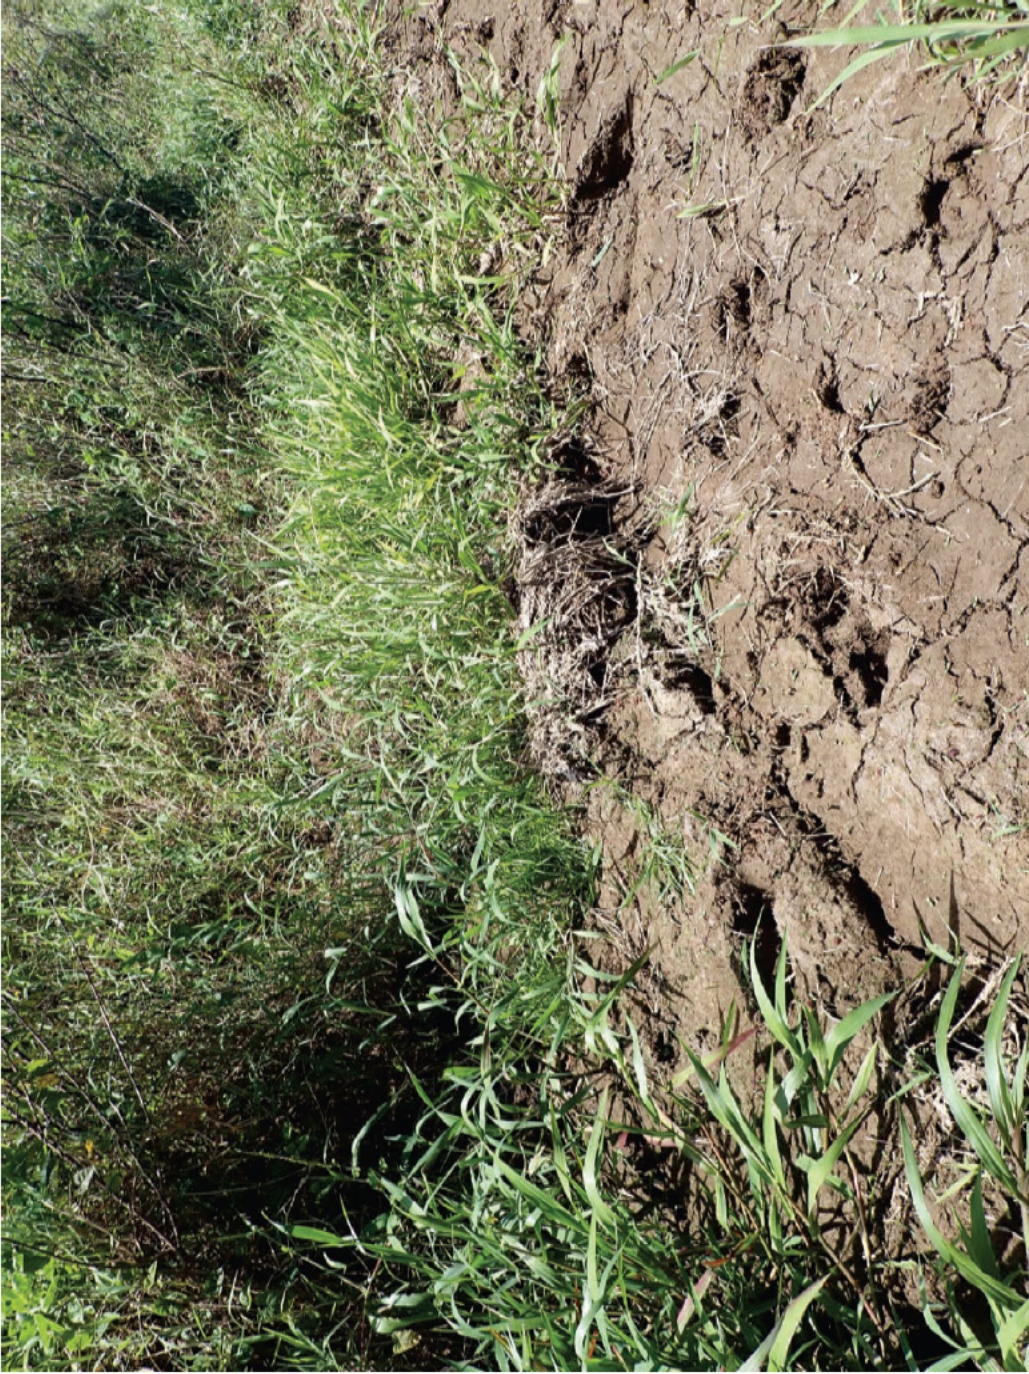
Description: Disturbance from cattle is seen throughout the areas inspected.

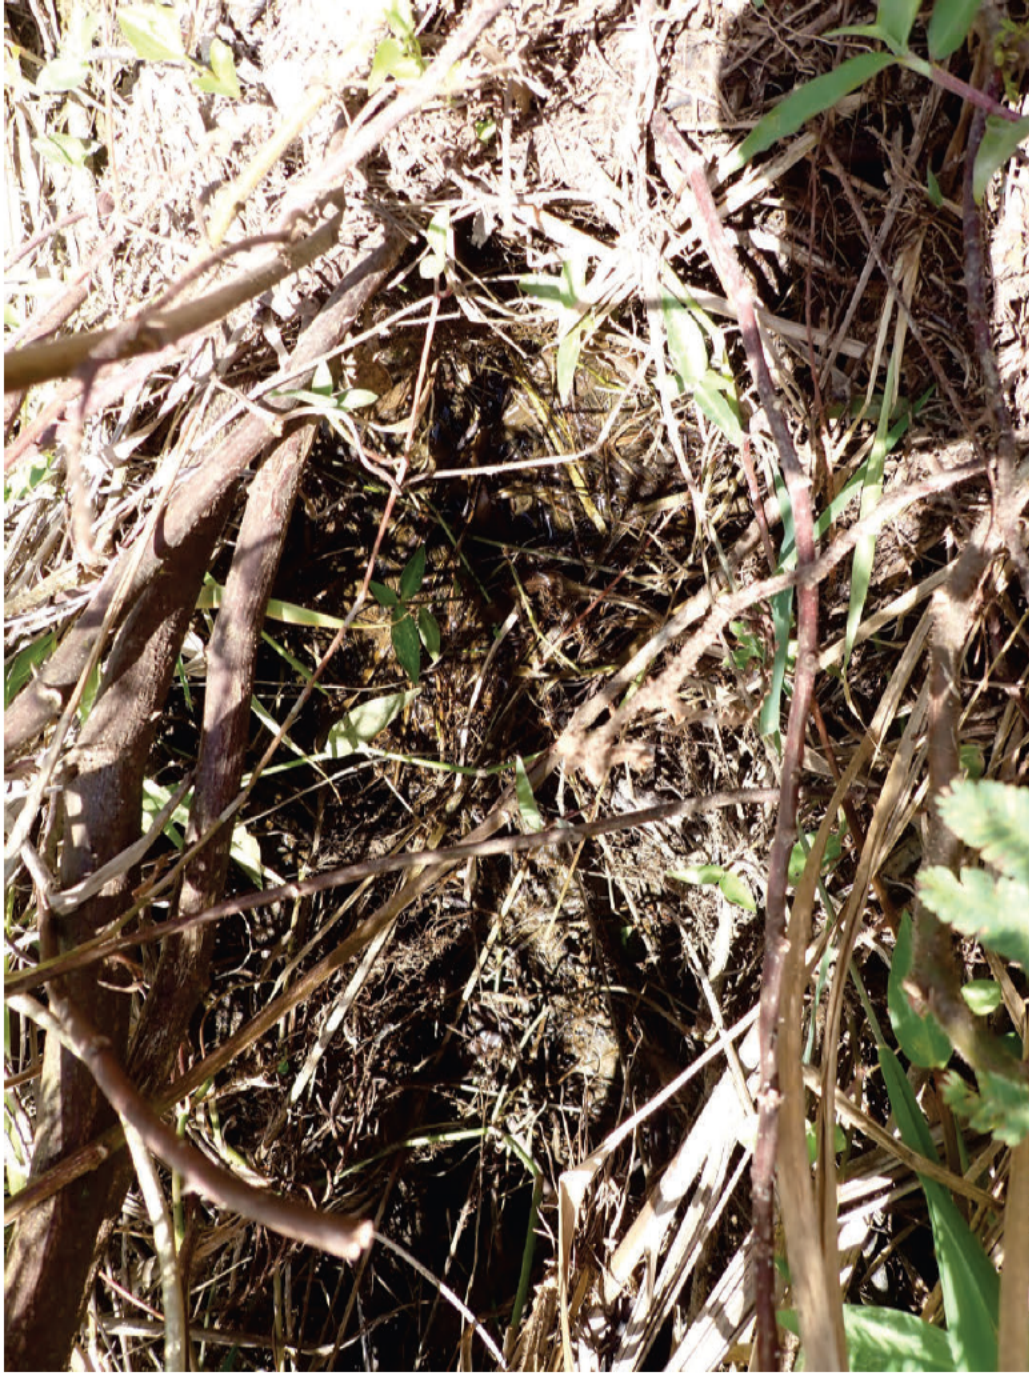
Description: Standing water found adjacent to the soil pit.

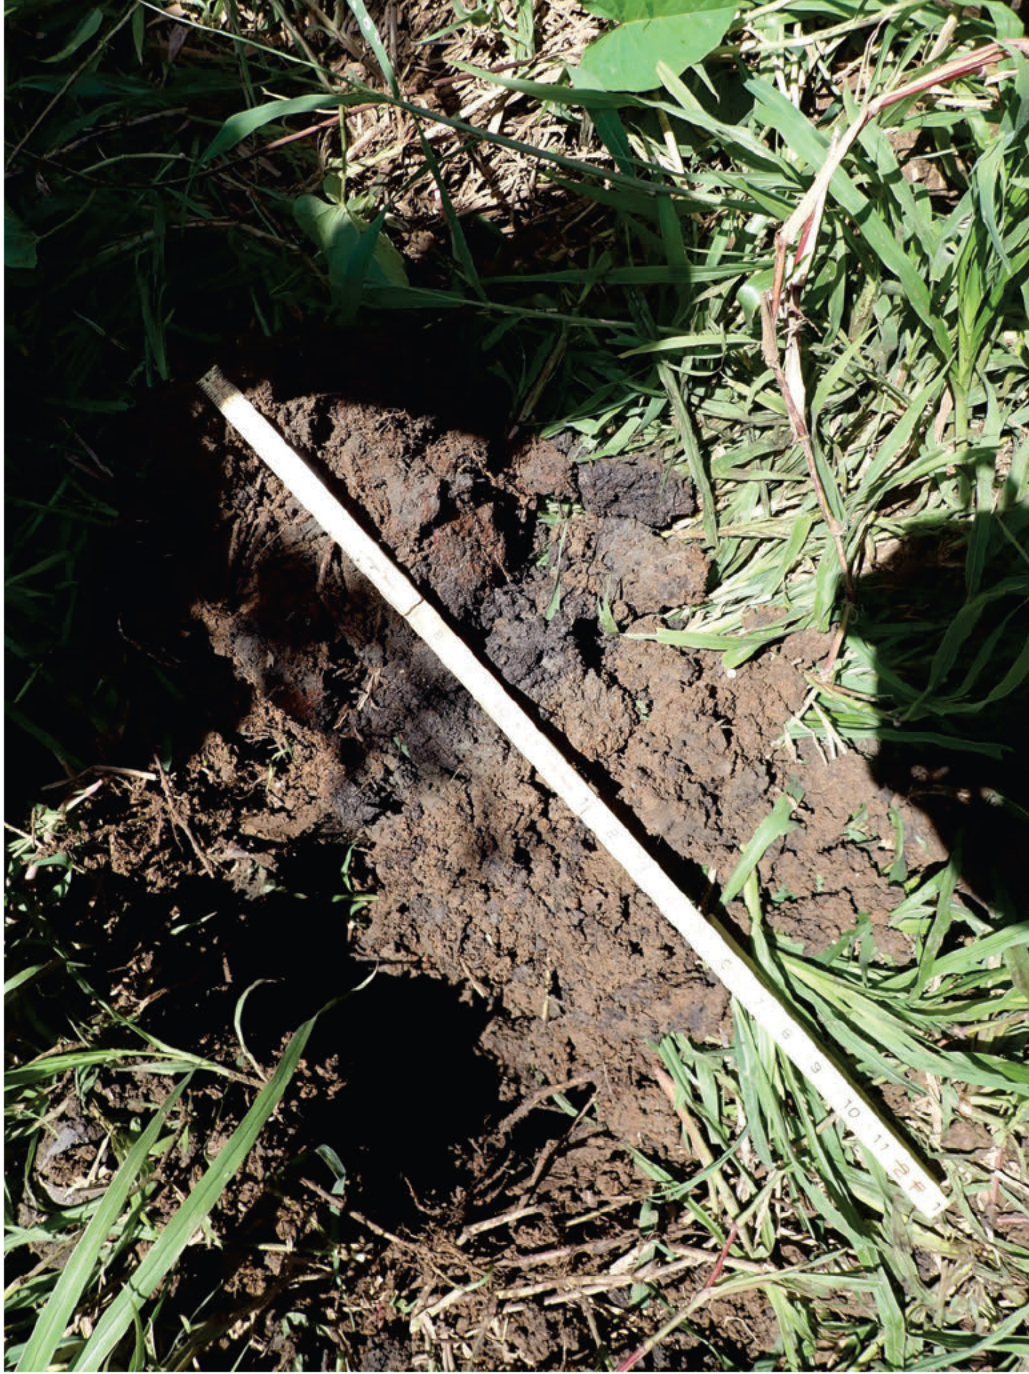
Photo ID: P4070223

Description: Soil Pit dug to test for field indicators of wetland soils.

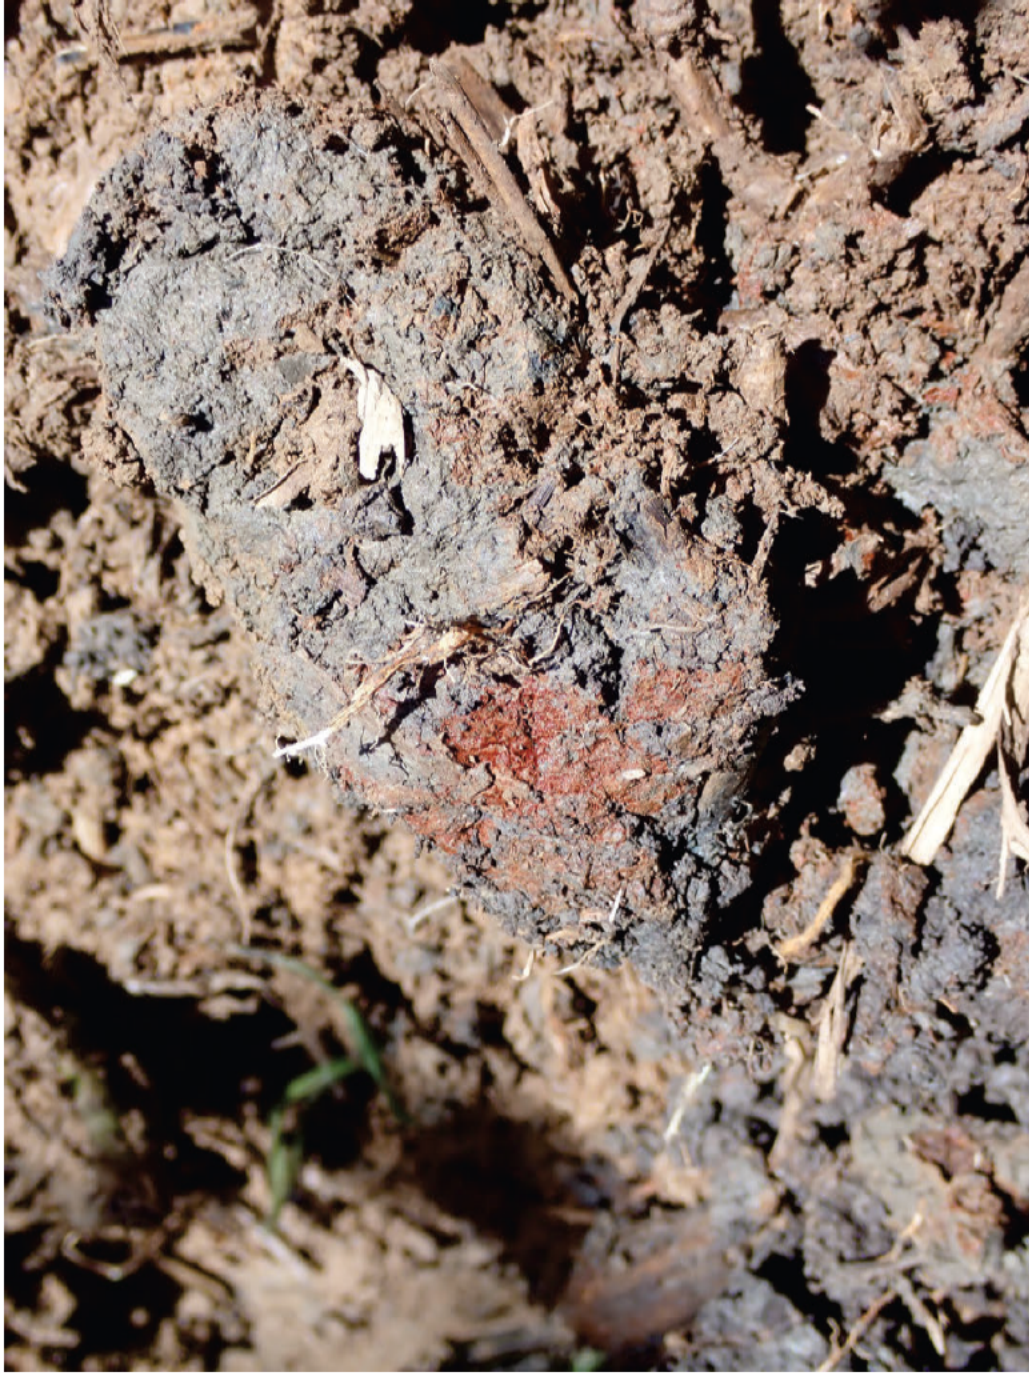
Description: Depletions and redox reaction observed within the soil pit.

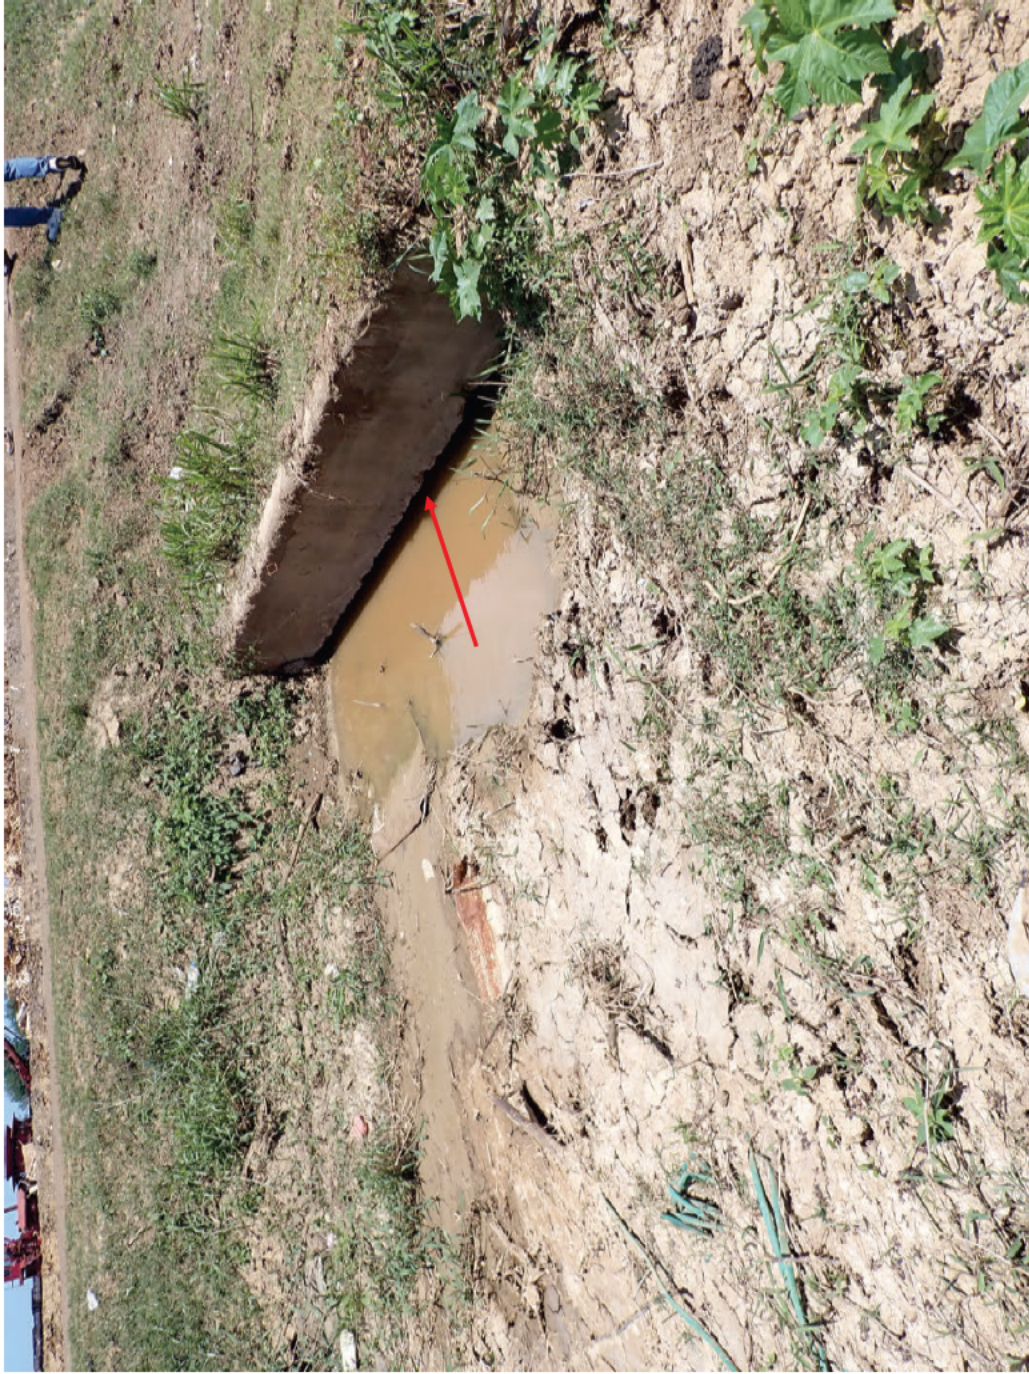
Photo ID: P4070250

Description: Located at the western side of the main road, a low-lying culvert over the manmade roadside channel.

Red arrows marks the direction of the flow.

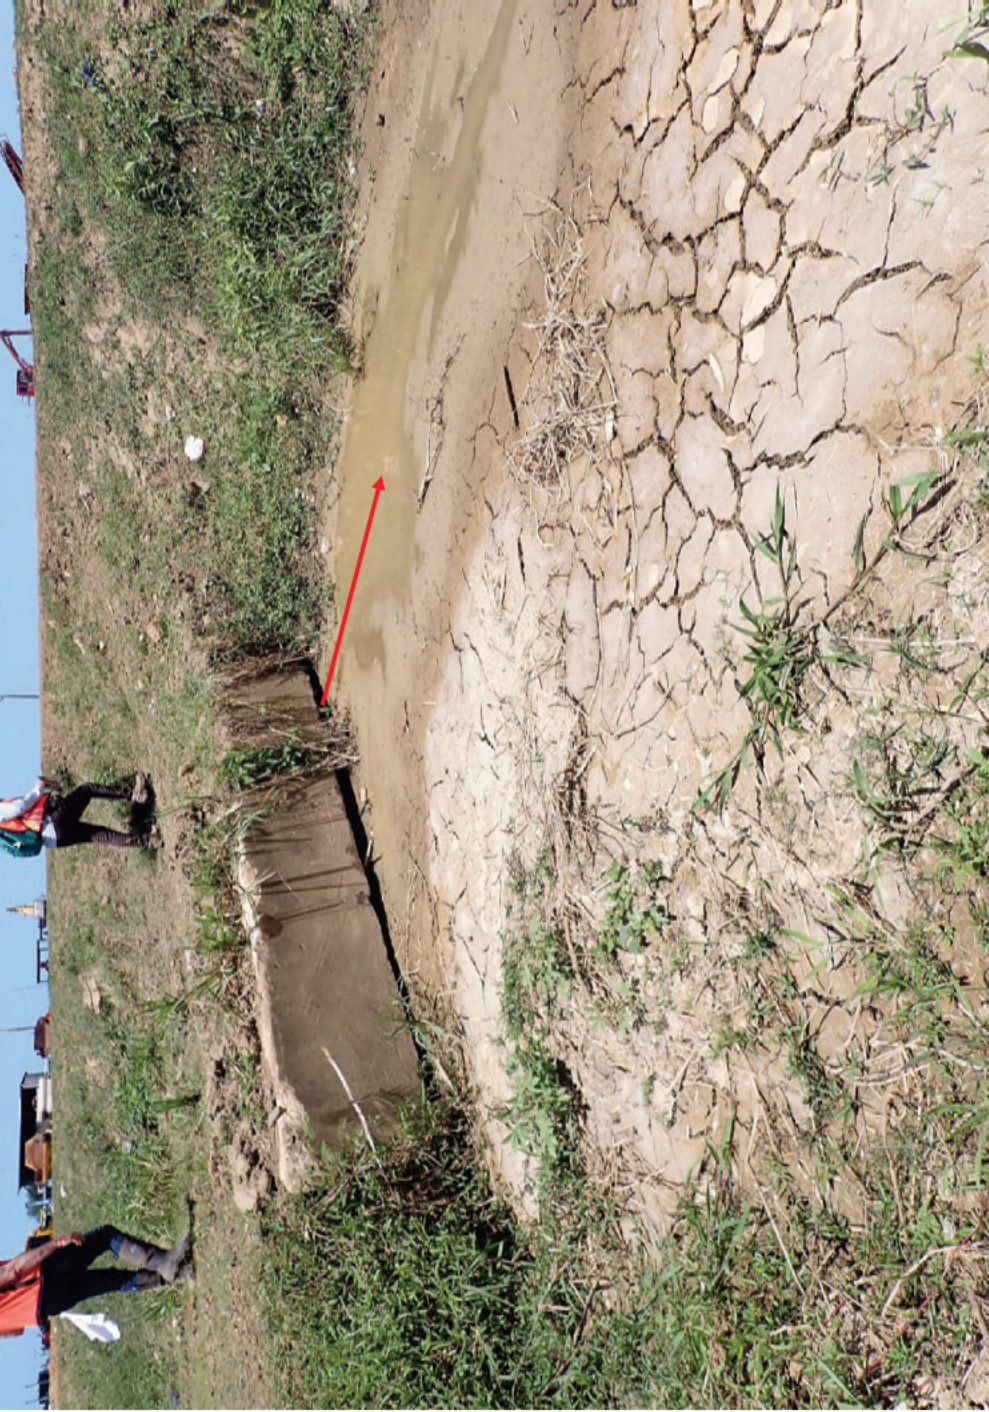
Photo ID: P4070249

Description: Located at the western side of the main road, a low-lying culvert over the manmade roadside channel.

Red arrows marks the direction of the flow.
