Clean Water Act Section 404: Site Visit/Case Development

Site Name	Vega Baja Landfill (hereinafter as "Landfill")	Start Date	April 7, 2022
		End Date	April 7, 2022
Inspection Purpose	Initial site visit		
Opening Conference			
<input checked="" type="checkbox"/> Presentation of Inspector Credentials			
Name and Title (Use N/A if owner/operator not available to join the inspection)			
Marco Finocchiaro, Inspector presented credentials to Gilberto Martinez Fernandez, Administrator of the landfill on behalf of EcoPark.			
<input type="checkbox"/> Opening Conference			
Name of person authorizing access if applicable			
Gilberto Martinez Fernandez, Administrator of the landfill authorized access to the landfill on behalf of Joseph P. Hernández Cancel, President of EcoPark, who not present at the time of the visit.			
Notes from Opening Conference			
EPA explained the purpose of the inspection, EPA's and the Corps' roles with regulating wetlands under the CWA, and what areas would be inspected.

Vega Baja Landfill

April 7, 2022

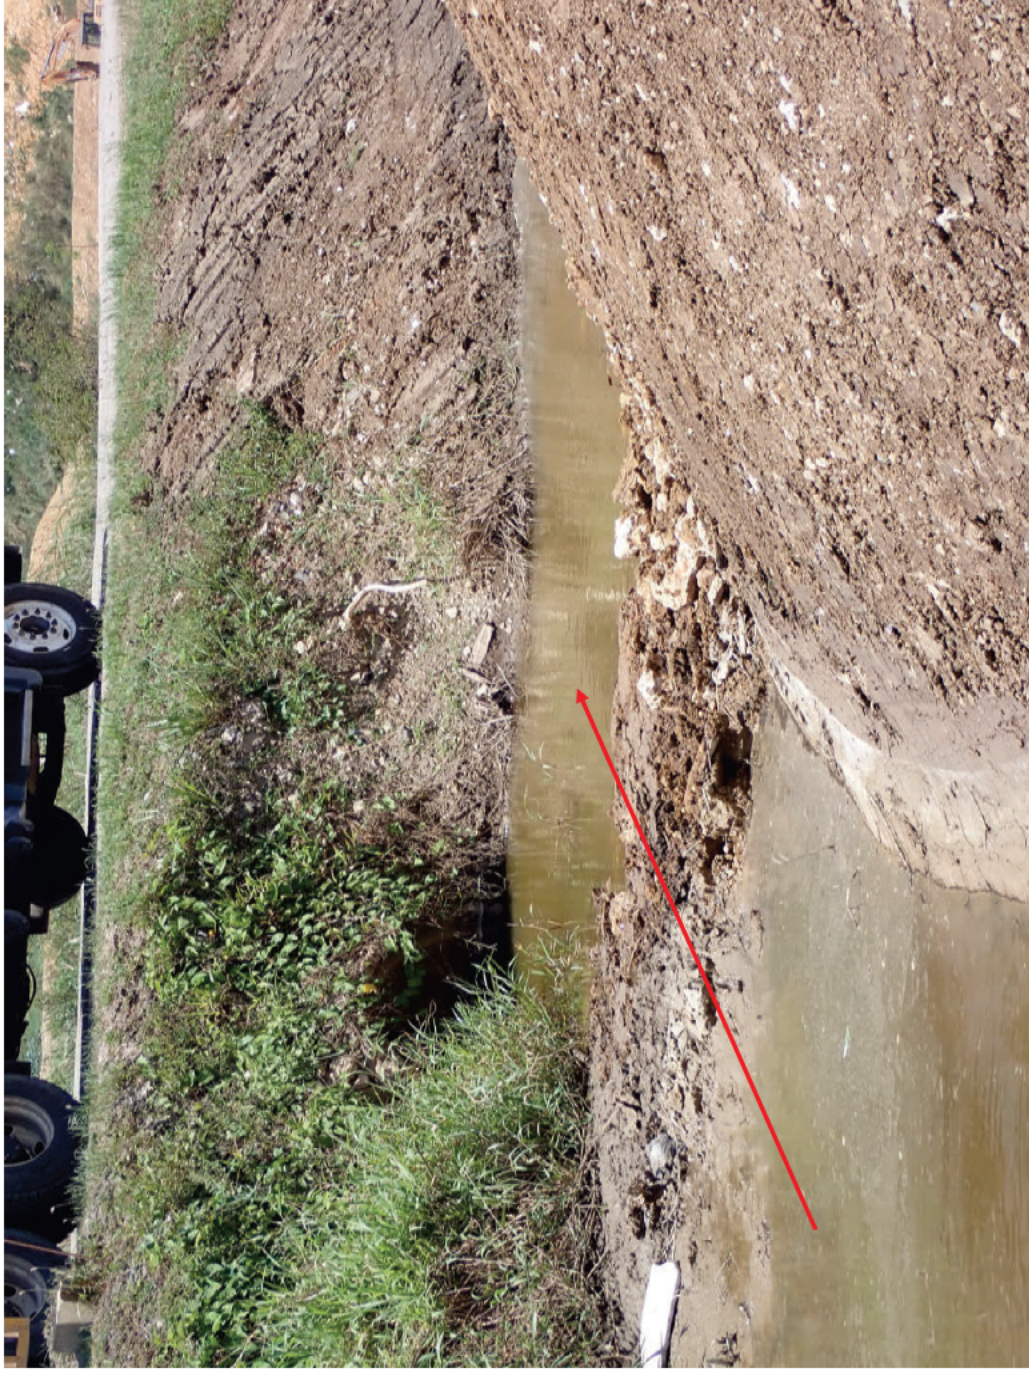
Photo ID: P4070226

Description: Western side of the culverted road.

Red arrows marks the direction of the flow.

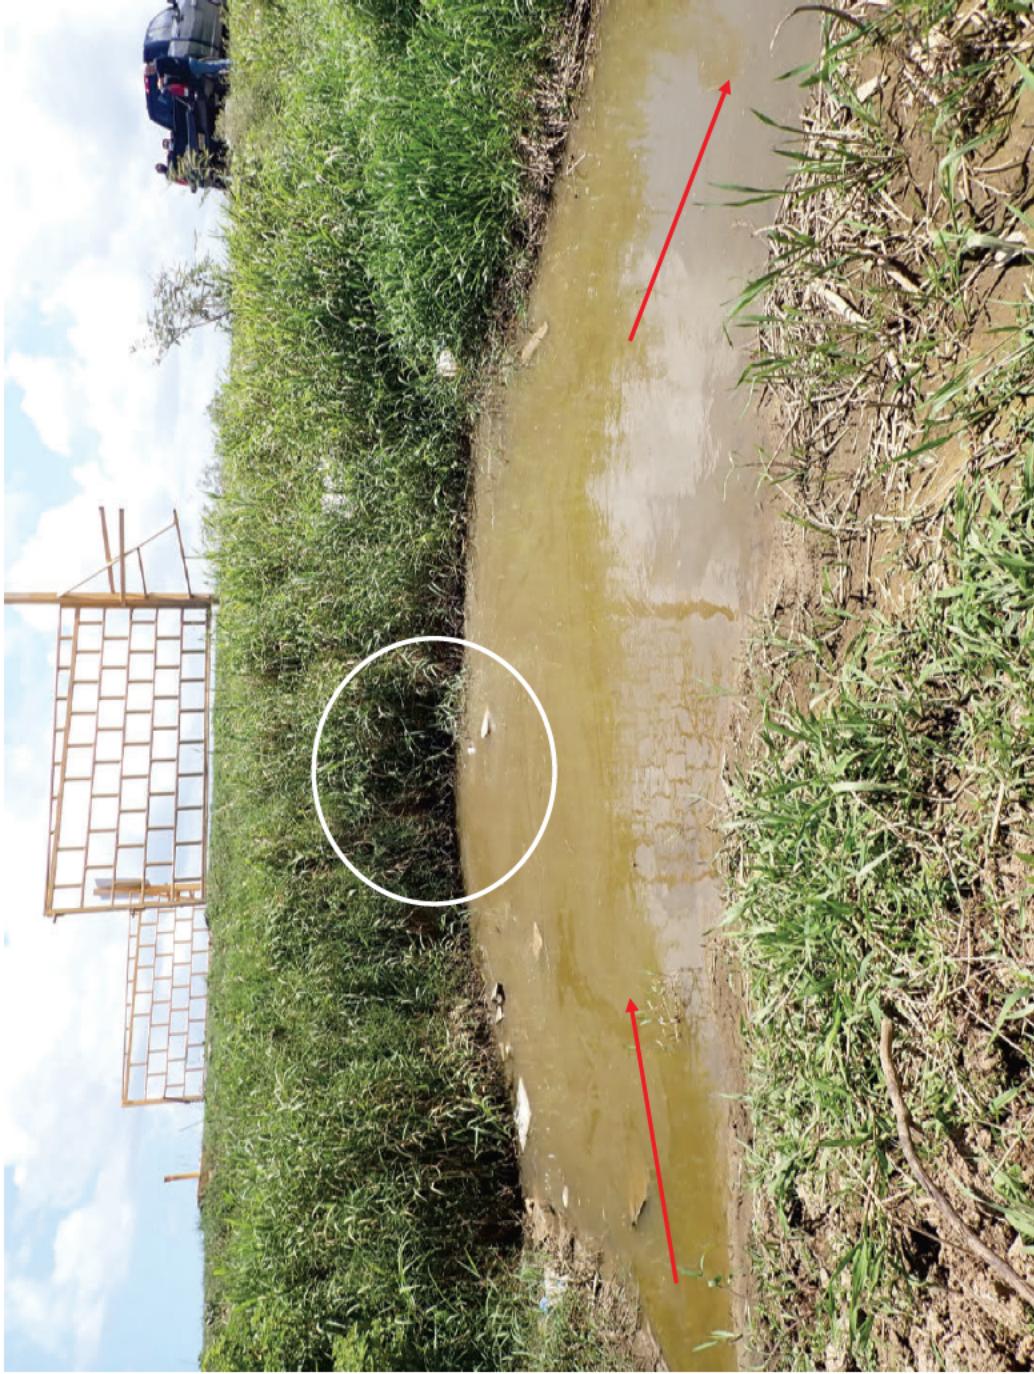
Description: Western side of the culverted main road. Culvert is covered in vegetation. Location of the culvert has been circled.

Red arrows marks the direction of the flow.

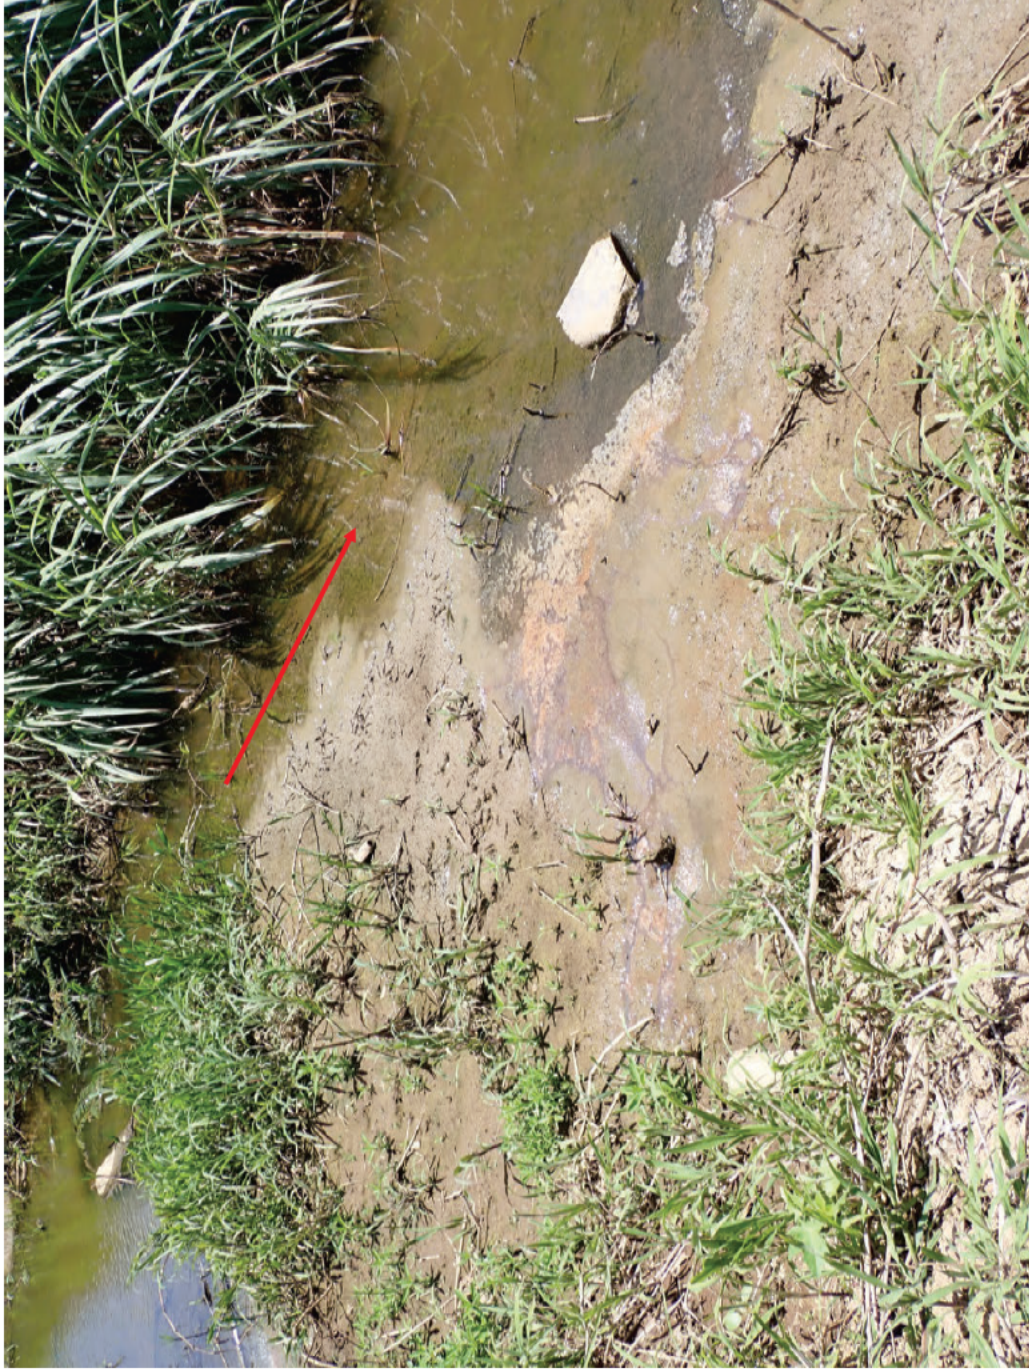
Photo ID: P4070231

Description: Unnamed ditch flowing west of the main road.

Red arrows marks the direction of the flow.

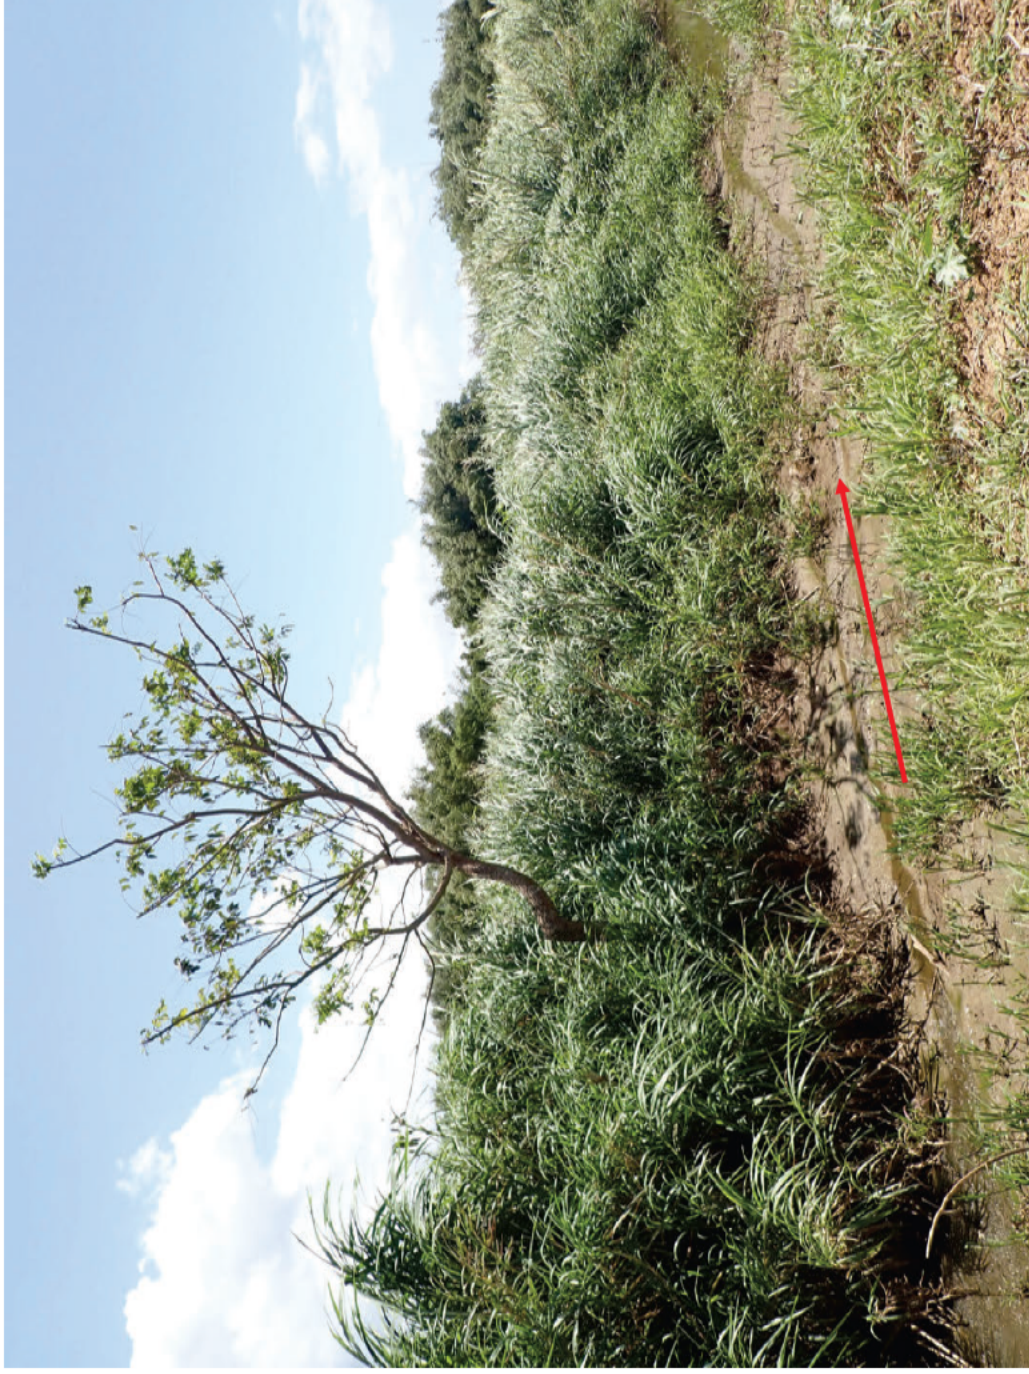
Description: Unnamed ditch flowing west of the main road.

Red arrows marks the direction of the flow.

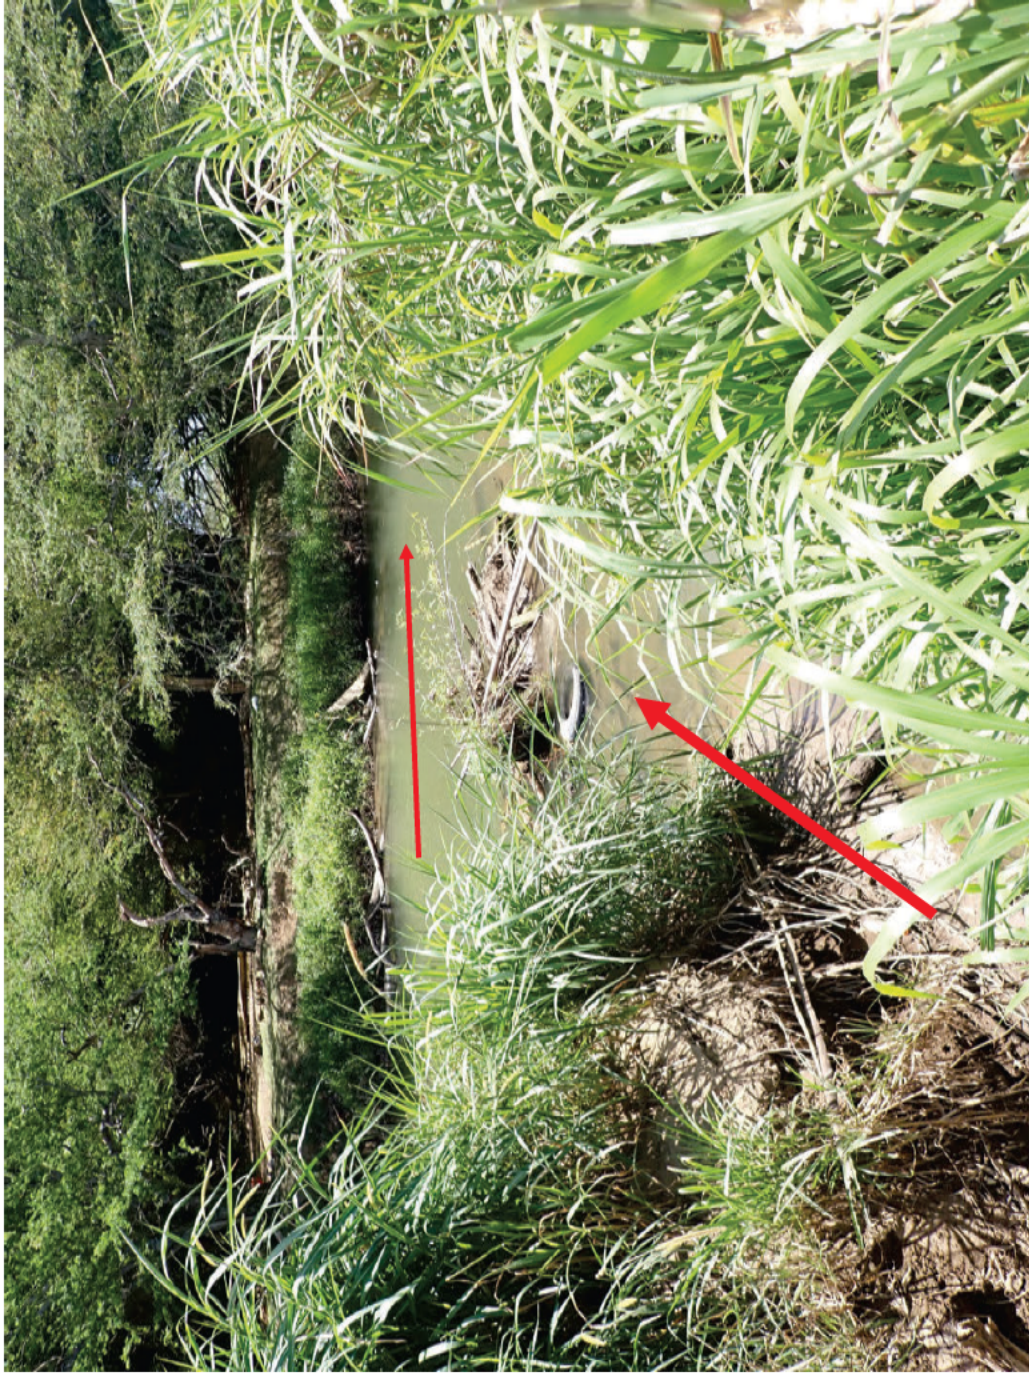
Photo ID: P4070247

Description: The unnamed ditch draining into the Rio Cibuco.

Rio Cibuco in the background and unnamed ditch in the foreground. Red arrows marks the direction of the flow.

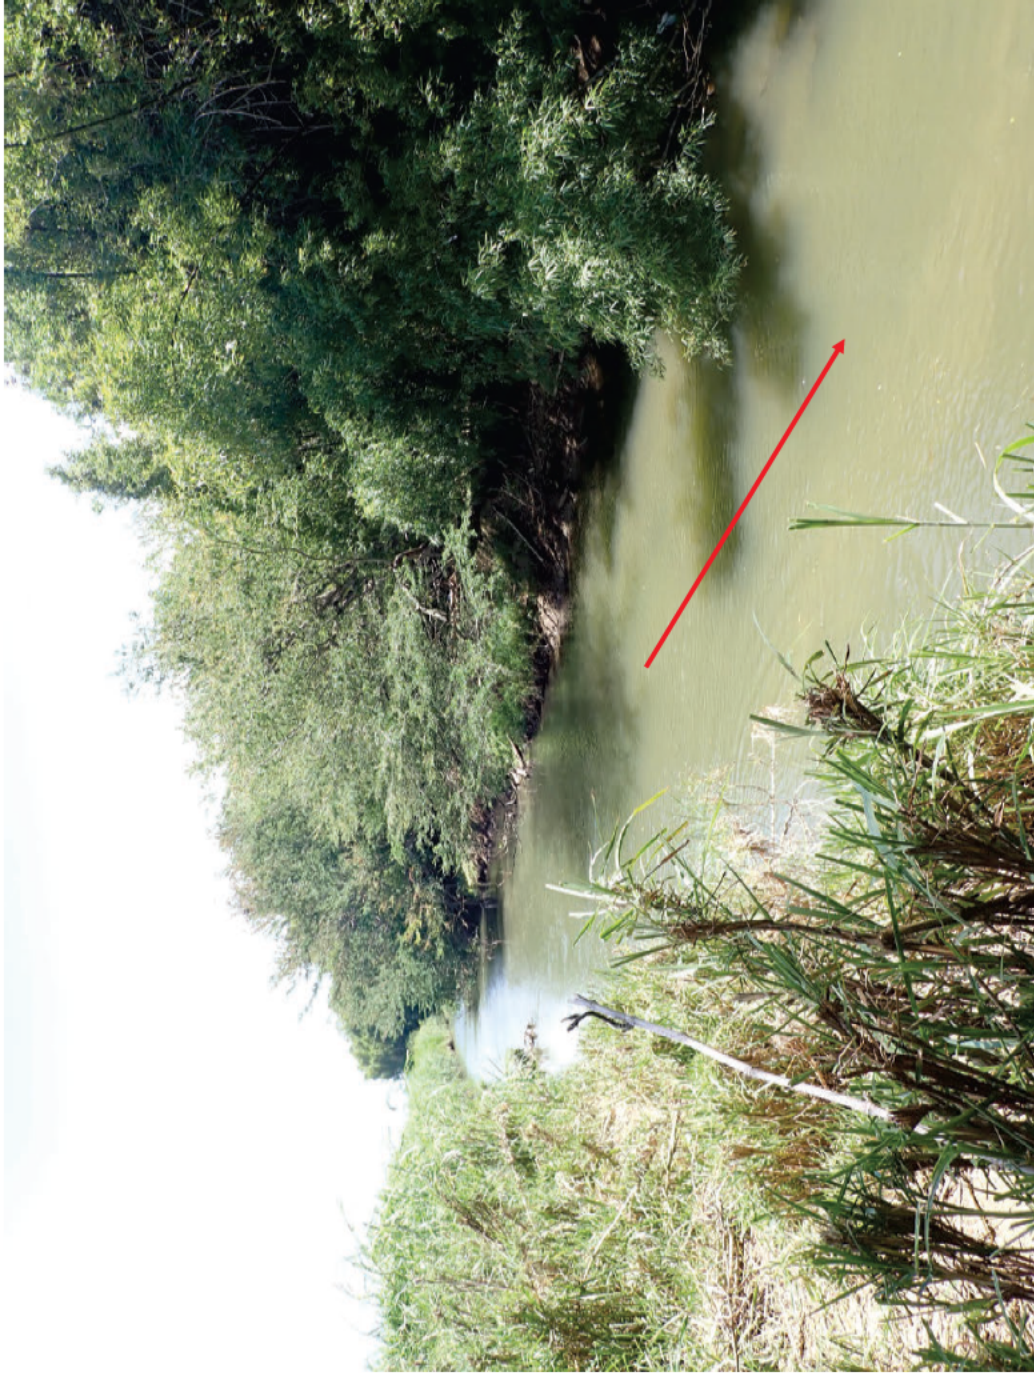
Photo ID: P4070243

Description: Panorama of the Rio Cibucu flowing.

Red arrows marks the direction of the flow.

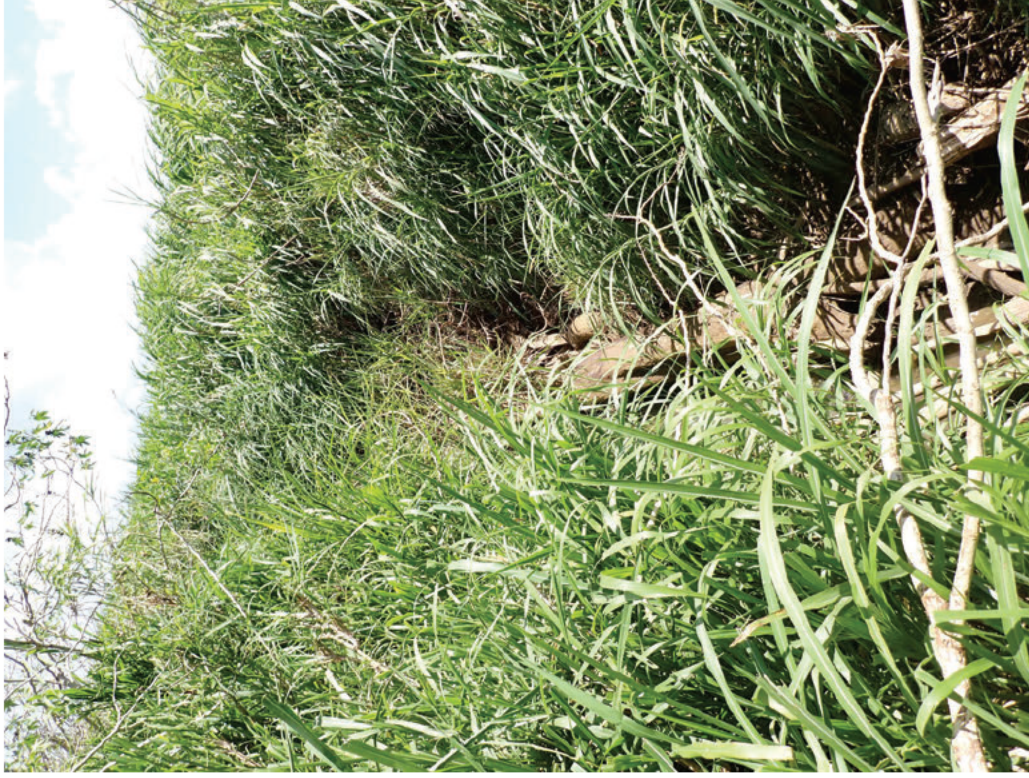
Description: Upland area on the north side of the unnamed ditch.

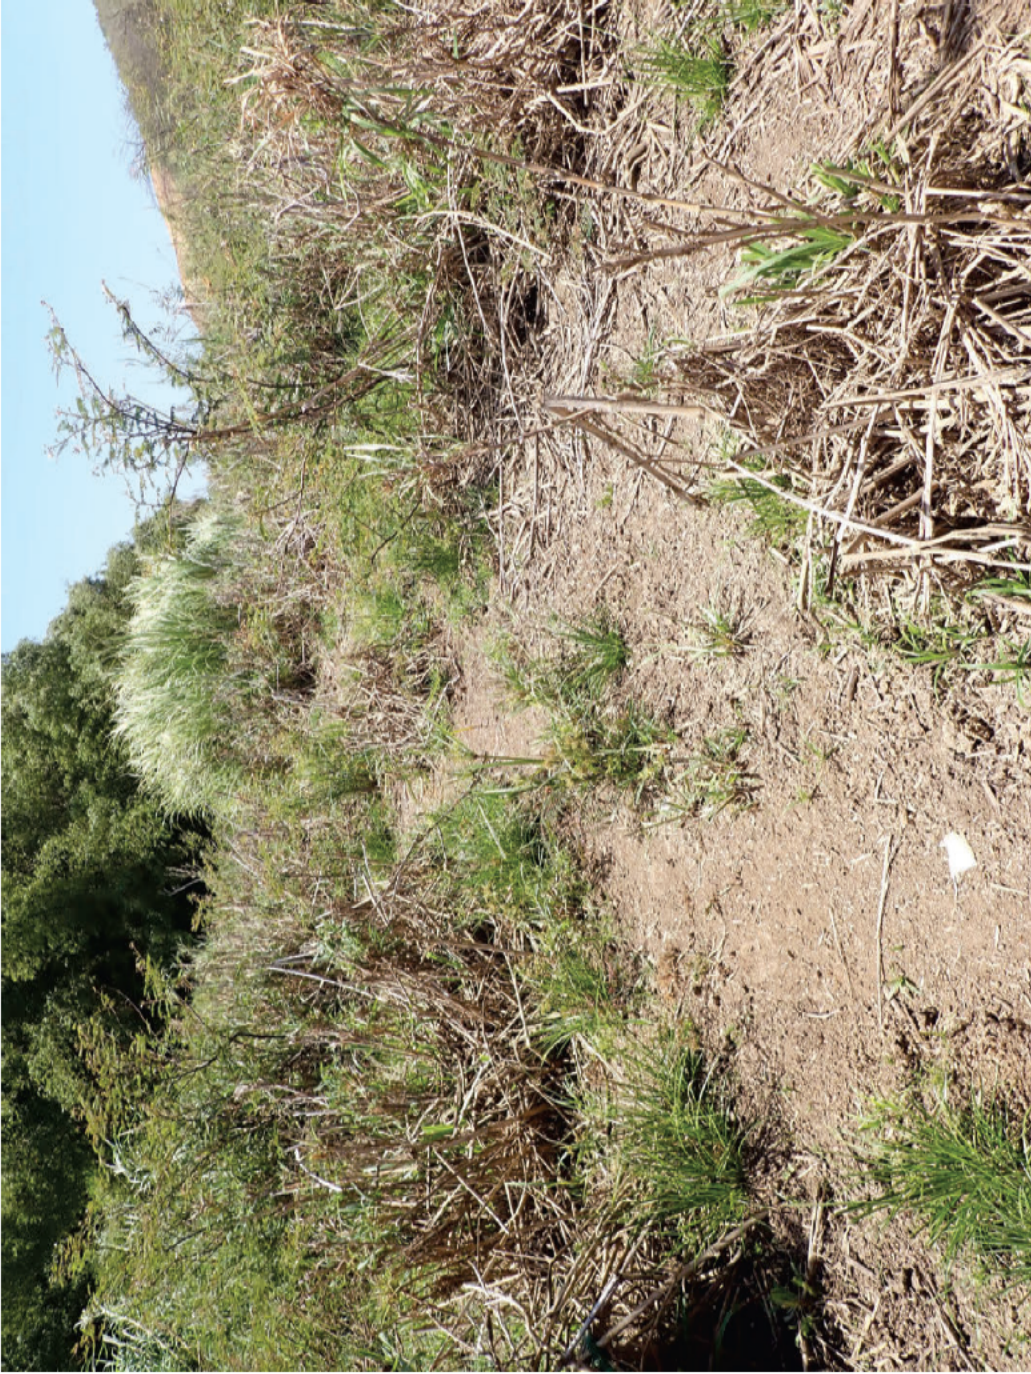
Photo ID: P4070241

Description: Upland area on the north side of the unnamed ditch.
