**Well Inspection**  
**Osage DNR / Environmental Protection Agency**  
**1201 Elm Street, Suite 500**  
**Dallas, Texas 75270**

| | | <b>Well ID</b> | 100-W4 | | |
| <b>Inspection Reason</b> | Plugging Witnessed | <b>Responsible Company at Time of Inspection</b> | CapturePoint, LLC | | |

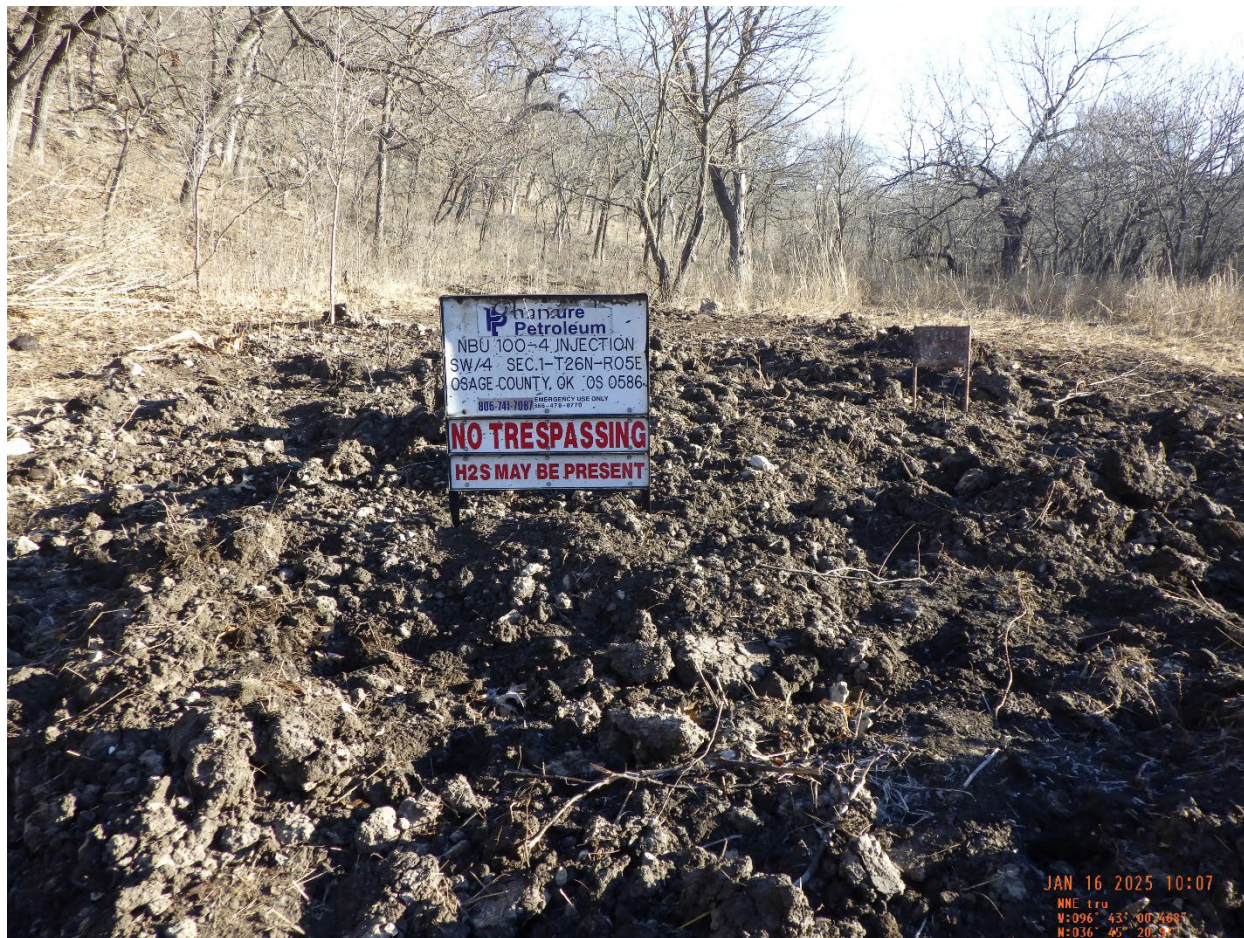
Photo No. 1

**Description:** This was the well location of OS0586000 with the casing cutoff and capped 3 feet below the land surface. Surface restoration completed.
